## 4 GEOTECHNICAL ASPECTS ON THE SOUTH ISLAND OF NEW ZEALAND

This chapter identifies locations of liquefaction manifestations and discusses the effects of liquefaction and related phenomena on the South Island of New Zealand resulting from the 2016,  $M_w$ 7.8 Kaikoura earthquake. Detailed observations are recorded to document the occurrence and non-occurrence of liquefaction in areas shaken at different levels of intensity. Strong motion recordings indicate high peak ground accelerations (PGA) occurred in the Waiiau valley of North Canterbury (marked “Area C” in Figure 4.1). Horizontal accelerations at the Waiiau strong motion station (WTMC) were in excess of 1 g and vertical accelerations in excess of 2.7 g. The ground motions were significantly attenuated in the main urban areas of the South Island; the recorded peak ground accelerations were in the range of 0.14 g to 0.27 g in the areas around Blenheim (Area A) and Kaikoura (Area B). A more detailed summary of the ground motion characteristics across the South Island is provided in Chapter 3 of this report.

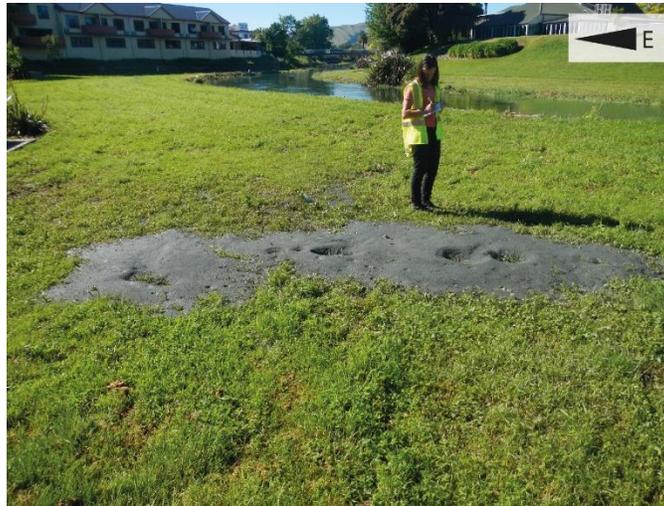
Localized cracking and elliptical liquefaction ejecta features were observed along the northern bank of the Taylor River, in the area behind 3-7 Auckland Street (Location 1 in Figure 4.5). This area was less than a metre above the river level and was relatively flat as shown in Figure 4.6. The ejecta were observed in a depression that was filled with standing water and located approximately 10 m away from river bank. The ejecta feature ranges in length from 5 to 7 m, and 1 to 1.2 m in diameter (Figure 4.6). Cracks approximately 2 to 5 cm wide were observed in a garden, also located within the depression, and were surrounded by localized liquefaction ejecta. The ejecta were uniformly composed of grey fine-medium sand and the particle size distributions of these ejecta are shown in Figure 4.7 (marked in the legend as TR-1 and TR-2). No ejecta or cracking was observed within 10 m of the river bank. The area was formerly within the meandering channel of the Taylor River before modification and straightening of the river took place in 1969, subsequently reducing flow levels (Marlborough District Council 2017). No other evidence of liquefaction manifestation was observed upstream of this point along the Taylor River.

Figure 4.6: Localized elliptical liquefaction ejecta features along the northern bank of the Taylor River (Location 1 in Figure 4.5), approximately 10 to 15 m from the river (S41.5096, E173.9577, facing SE).

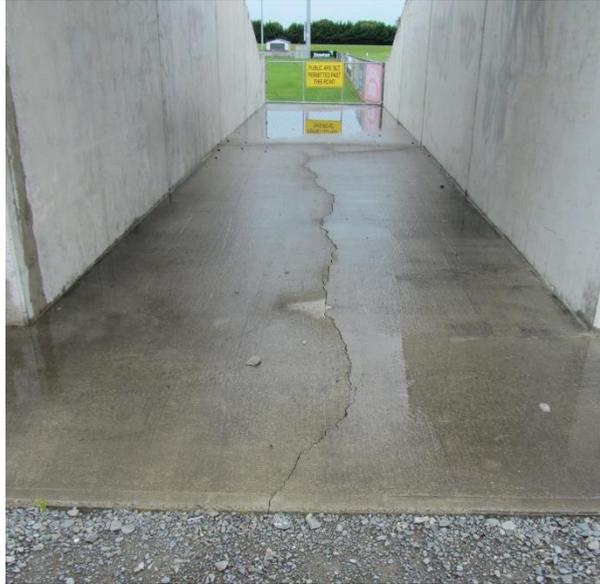
The only readily observable damage to the permanent structures at Lansdowne Park was a crack in the concrete foundation slab running east-west at the location of the stadium entrance, mid-way along the western stand (Figure 4.14).

Figure 4.14: Crack in foundation slab on west stand (17 Nov 2016, S41.4993, E173.9569, facing E).

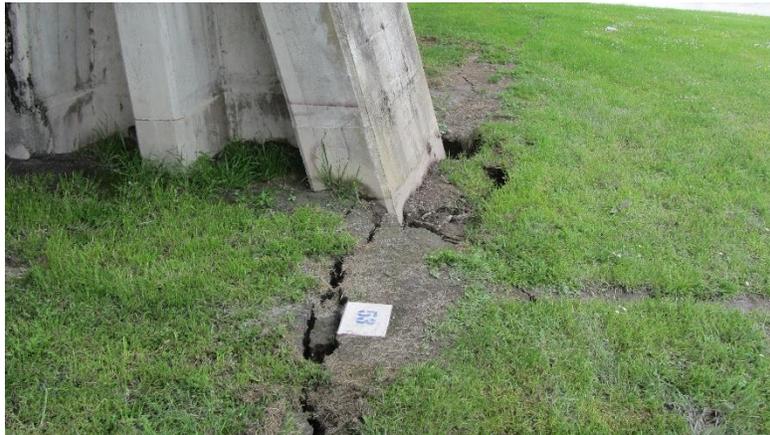
Figure 4.15: Cracking adjacent to the southern pier of the Opawa River Bridge (14 Nov 2016, S41.5006, E173.9616, facing N).

To the east of Lansdowne Park there was evidence of lateral spreading and grey sand ejecta running through the Top 10 Holiday Park and beneath the southern end of the Opaoa River Bridge (Location 2 in Figure 4.5). These features also seem to align with the position of the 1895 river channel described previously. Ground cracking was evident adjacent to the piers of the Opawa River Bridge as shown in Figure 4.15, with a few centimetres of settlement and horizontal displacement recorded.

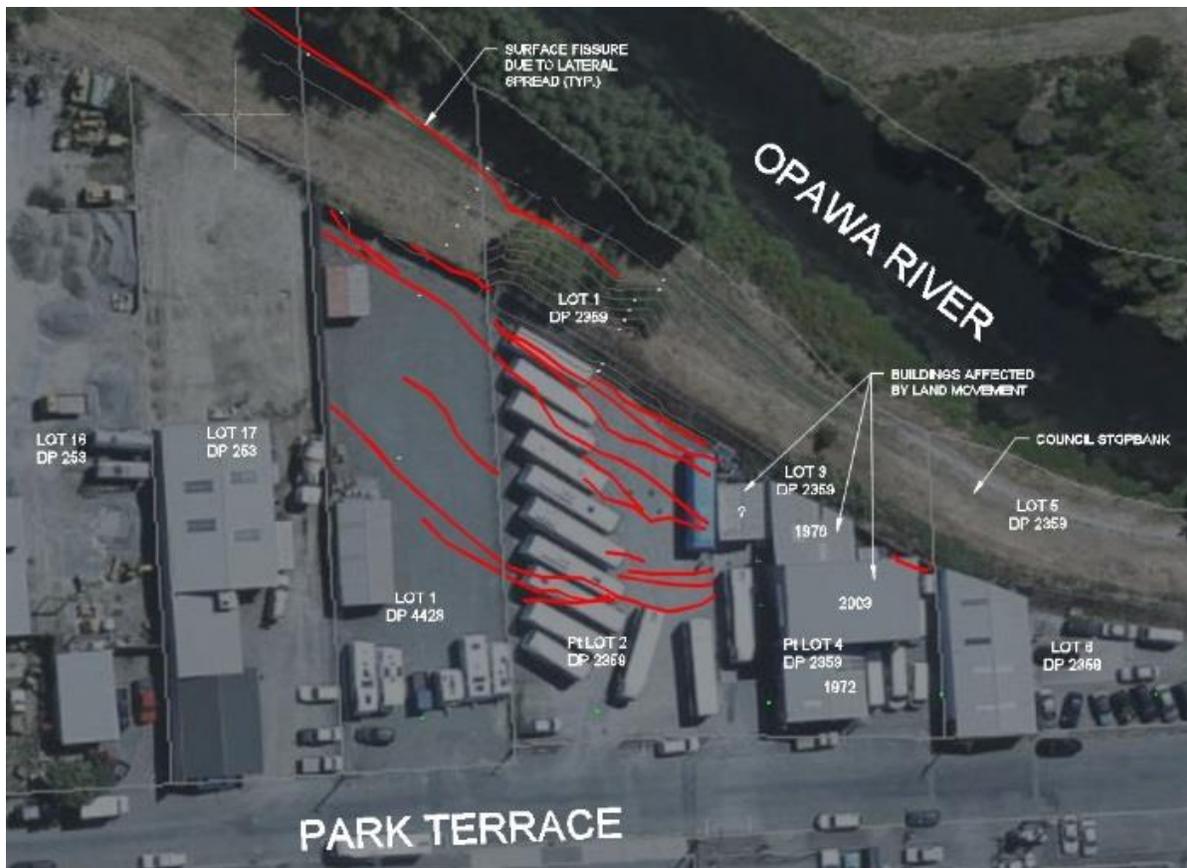
Figure 4.16: Summary of damage at the Park Terrace site. Dashed line indicates location of the historic stopbank (approx. centre of image: S41.5122, E173.9649).

Lateral spreading/deep seated slumping and vertical displacement were observed within the properties on Park Terrace bordering the stopbank, with the location of the cracking summarised in Figure 4.16. Historic photos indicate that the lateral spreading/deep seated slumping in these properties was confined to the areas between the southern river bank and the location of the original stopbanks in this area. The properties affected were constructed on fill that raised the elevation of the zone between the historic stopbanks and the existing stopbanks to the south.

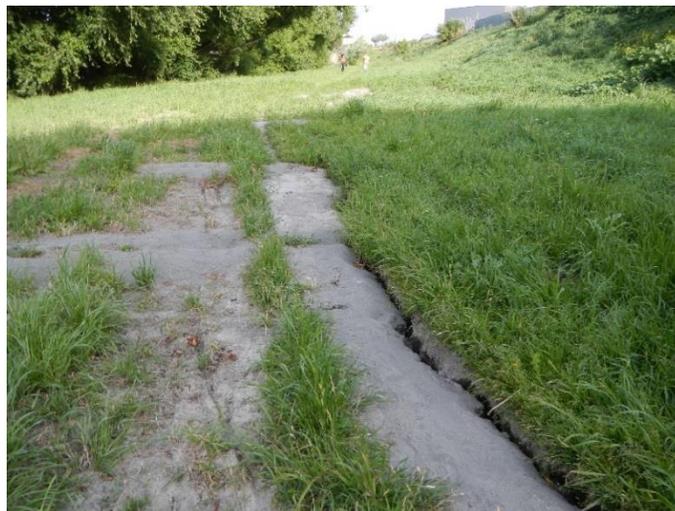
Figure 4.17: Crack parallel to Opaoa River surrounded by grey ejecta to the north of the Park Terrace properties (7 Dec 2016, S41.5121, E173.9651, facing E).

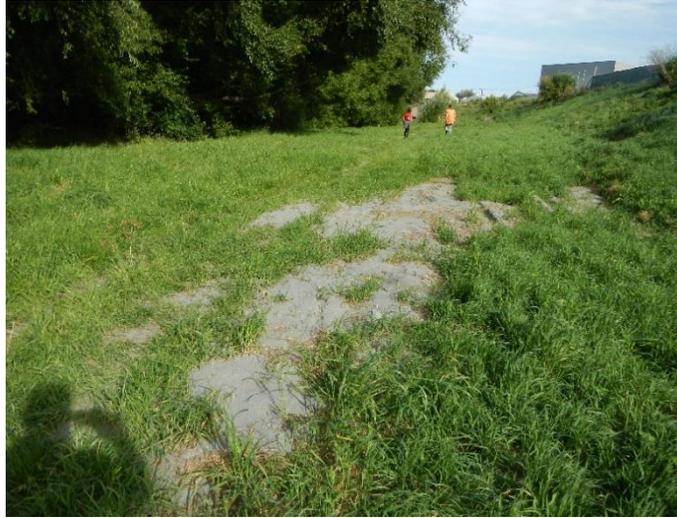
Lateral spread cracks were evident along the river bank, and trees in the area were inclined towards the river suggesting movement towards the open face. The cracks were orientated sub-parallel to the river bank and covered the area extending from the river bank to the base of the stopbank. Cracks ranged in width from a few centimetres to as large as 30 cm (Figure 4.17) and were associated with approximately 1 to 5 cm of vertical settlement. Crack widths decreased with increasing distance from the apex of the inner meander bend and became discontinuous along the river bank further upstream. A block drop of 15-20 cm was also identified in the area. Fine-medium grey sand ejecta up to 10 cm thick was evident in this area and filled many of the lateral spreading cracks (Figure 4.18).

Figure 4.18: Ejecta at the base of the Park Terrace stopbanks (5 Dec 2016, S41.5121, E173.9651, facing E).

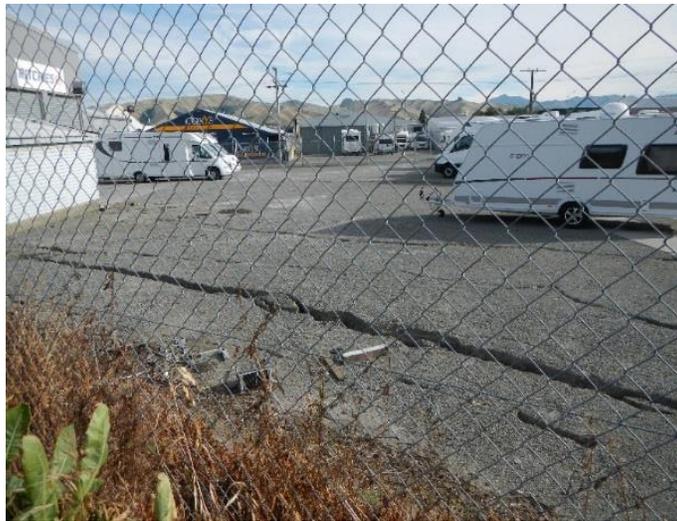
Figure 4.19: Ground damage to industrial properties along Park Terrace (5 Dec 2016, S41.5122, E173.9649, facing SE).

Cracks propagated across a number of properties, resulting in permanent ground deformation, differential settlement of structures, separation between foundation slabs and the surrounding ground, and damage to the stopbanks. Details of the cracking are shown in Figure 4.16, Figure 4.19 to Figure 4.21 and Table 4.1.

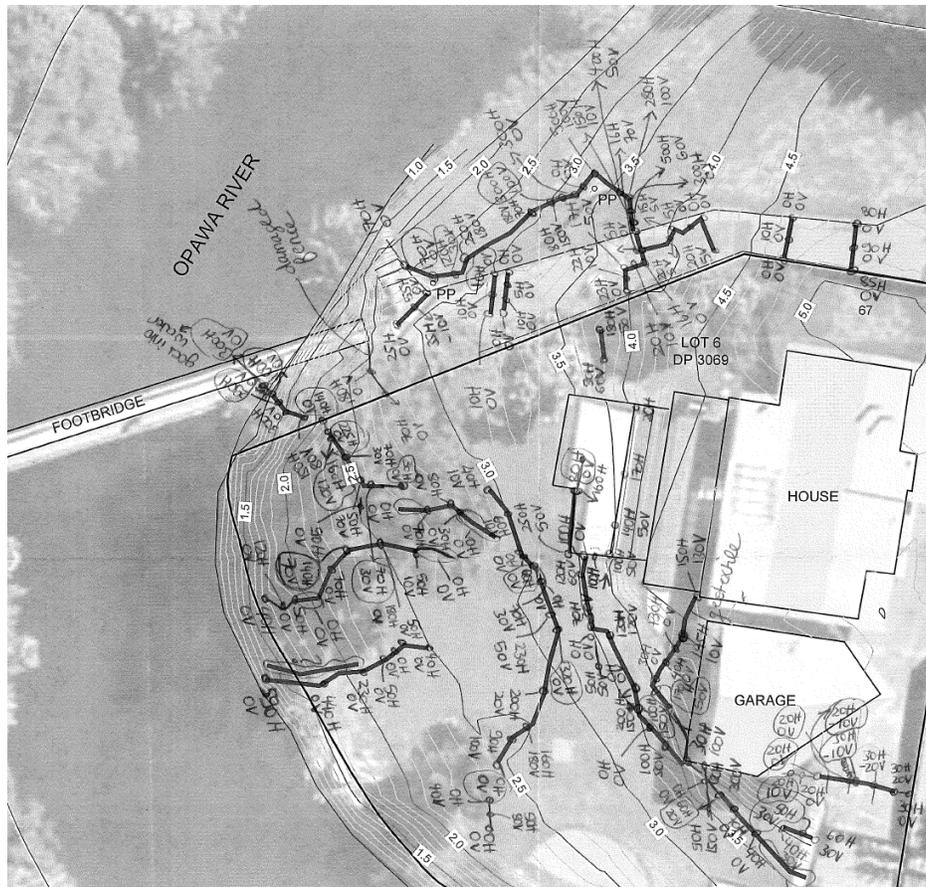
Figure 4.22: Summary of cracking and liquefaction manifestations at the Elizabeth St site (approx. centre of image: S41.5046, E173.9634).

The lateral spreading/slumping cracks in the area was oriented approximately parallel to the riverbanks on either side of the apex of the inner bank of the meander bend. Cracking orientated perpendicular to the river bank occurred at the apex of the meander bend. A summary of the lateral and horizontal displacement across the cracks is presented in Figure 4.22, with up to 50 cm of horizontal displacement and 10 cm of vertical displacement recorded. Cracks were up to 1 m in depth. Near the edge of the river the lateral spreading cracks extended to the water table and were filled with blueish grey fine-medium ejecta. A significant number of roots crossed through the cracks that were oriented perpendicular to the river and may have acted to reduce the severity of the cracking in this area (Figure 4.23).

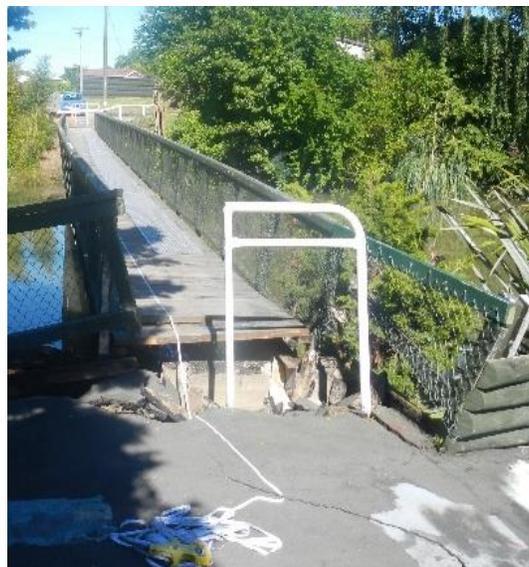
Lateral spreading/deep seated slumping resulted in damage to the eastern end of the footbridge shown in Figure 4.24. The footbridge had two piers and steel I-beam girders with a wooden deck. The bridge deck warped as a result of the abutment having separated from the footpath by approximately 50 cm due to the lateral movement of the banks (Figure 4.24). A steel water main and an asbestos cement (AC) pipe crossed the river. The steel water main experienced movement but was not damaged, while the AC pipe had cracked and separated adjacent to the abutment.

Figure 4.24: Damage to footbridge abutment at the end of Elizabeth Street (17 Nov 2016, S41.5087, E173.9636, facing W).

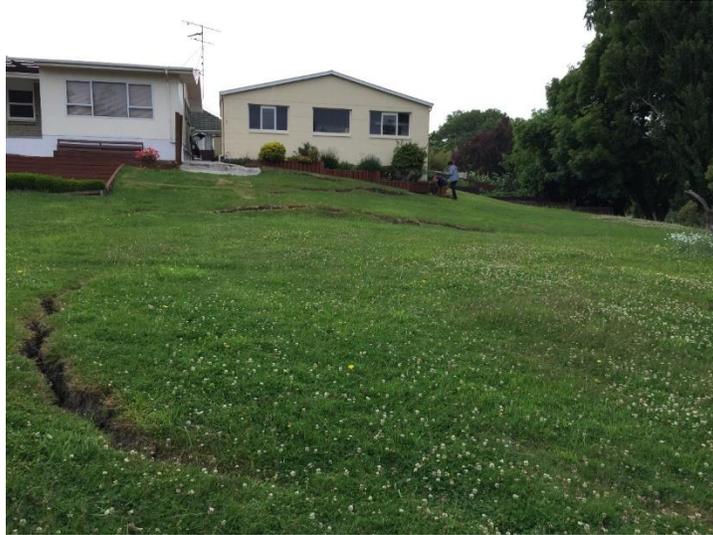
To the south of the footbridge, cracks in the ground extended from the river up to the house on the property resulting differential movement and settlement of the house and cracks in the brick facade. The western side of the house and the garage moved relative to rest of the structure, resulting in warping of the frame and façade damage. This house was subsequently deemed unsafe for permanent occupancy; it was the only house in Blenheim red-tagged due to liquefaction related damage (Figure 4.25).

Figure 4.25: System of lateral spreading/slumping cracks at Elizabeth Street (7 Dec 2016, S41.5089, E173.9636, facing E).

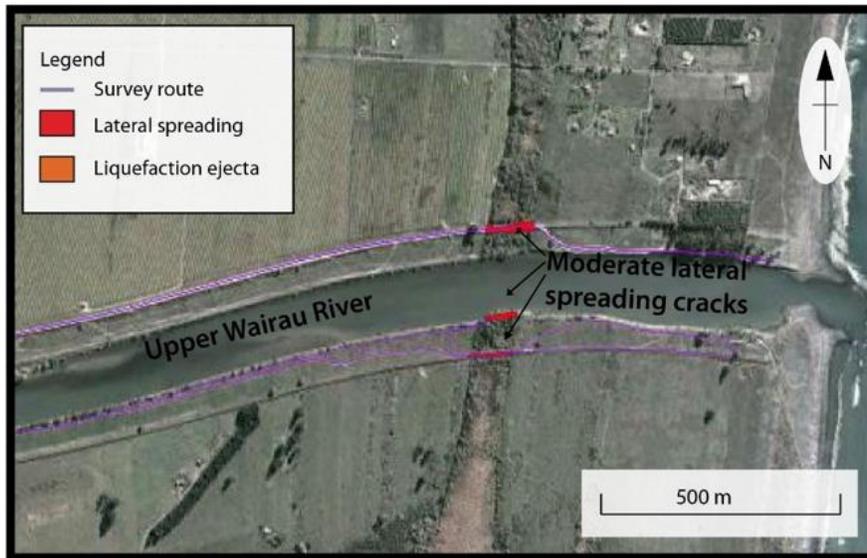
Lateral spreading and slumping of the northern stopbank was characterised by cracking along the top of the stopbank (Figure 4.32). The cracks ranged in width from approximately 30 to 50 cm and were associated with 10 to 50 cm of vertical settlement (Figure 4.33). The cracks all ran sub-parallel to the closest bank of the river. Localized cracking, approximately 2 to 10 cm wide, was observed at the base of stopbank proximal to the river (Figure 4.34a). No liquefaction ejecta were observed at the site, and no liquefaction induced damage was observed proximal to a culvert exiting the stopbank at the easternmost extent of the affected area (Figure 4.34b).

Figure 4.30: Summary of damage observations along the Wairau Diversion (approx. centre of image: S41.4401, E174.0206).

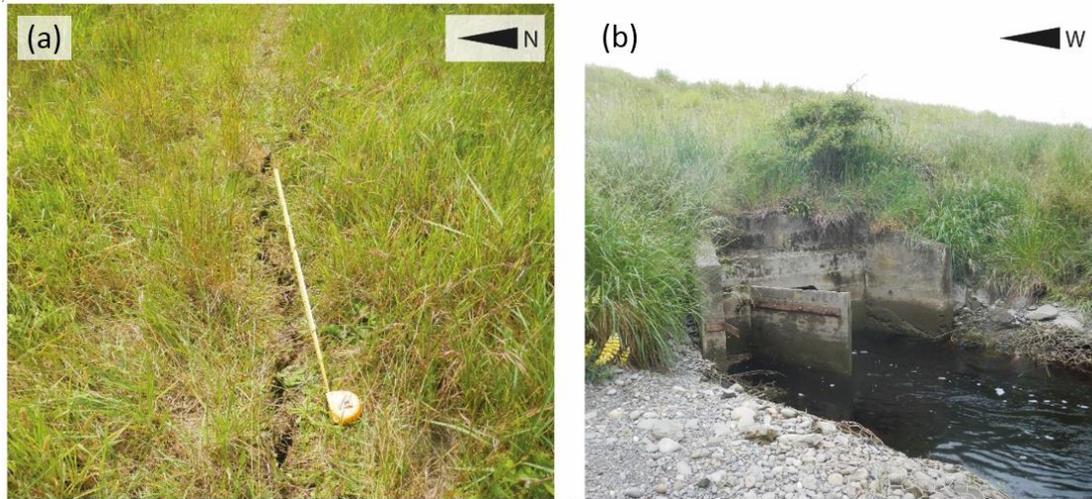
Figure 4.34: a) Cracking observed along the base of the northern stopbank proximal to the river (17 Nov 2016, S41.4390 ,E174.0220, facing E); b) No liquefaction induced damage was observed within the culvert exiting the northern stopbank (17 Nov 2016, S41.4387, E174.0223, facing NE).

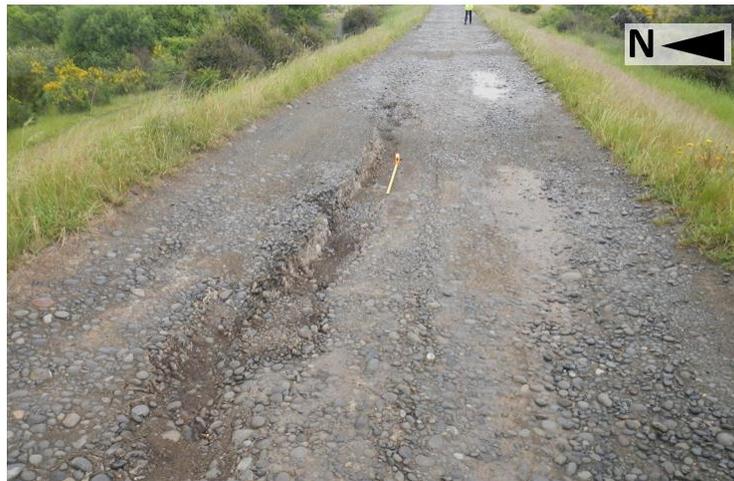
10 to 40 cm of vertical settlement. No cracking was observed along the base of the stopbank, and no liquefaction ejecta were observed at the site.

Figure 4.36: Cracking along the top of the southern stopbank of the Wairau Diversion (Tape set at 1 m) (17 Nov 2016, S41.4414, E174.0219, facing W)

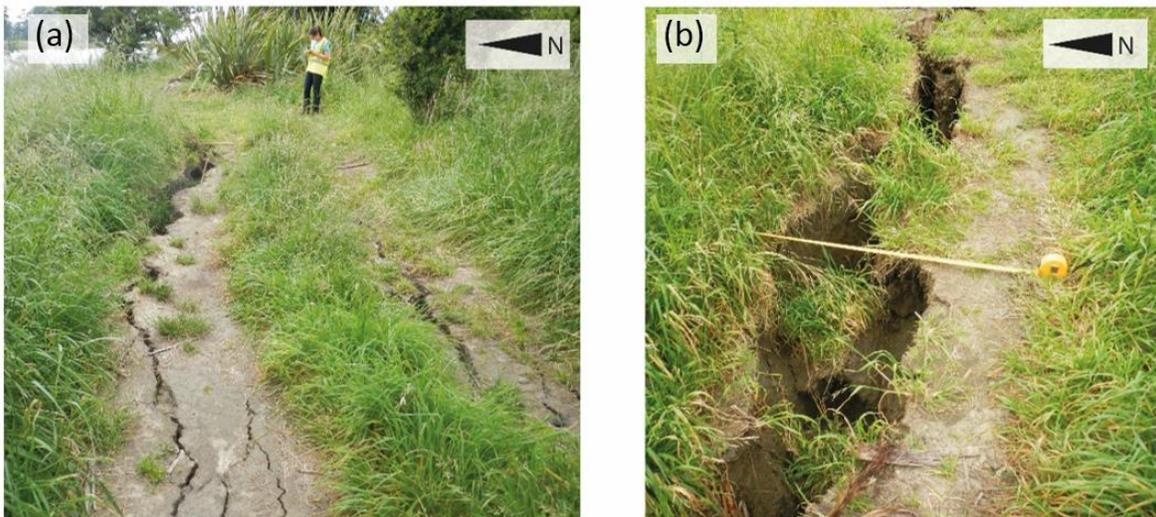
Figure 4.37: Cracking of the southern bank of the Wairau Diversion: (a) 17 Nov 2016, S41.4406, E174.0215; (b) 17 Nov 2016, S41.4406, E174.0215.

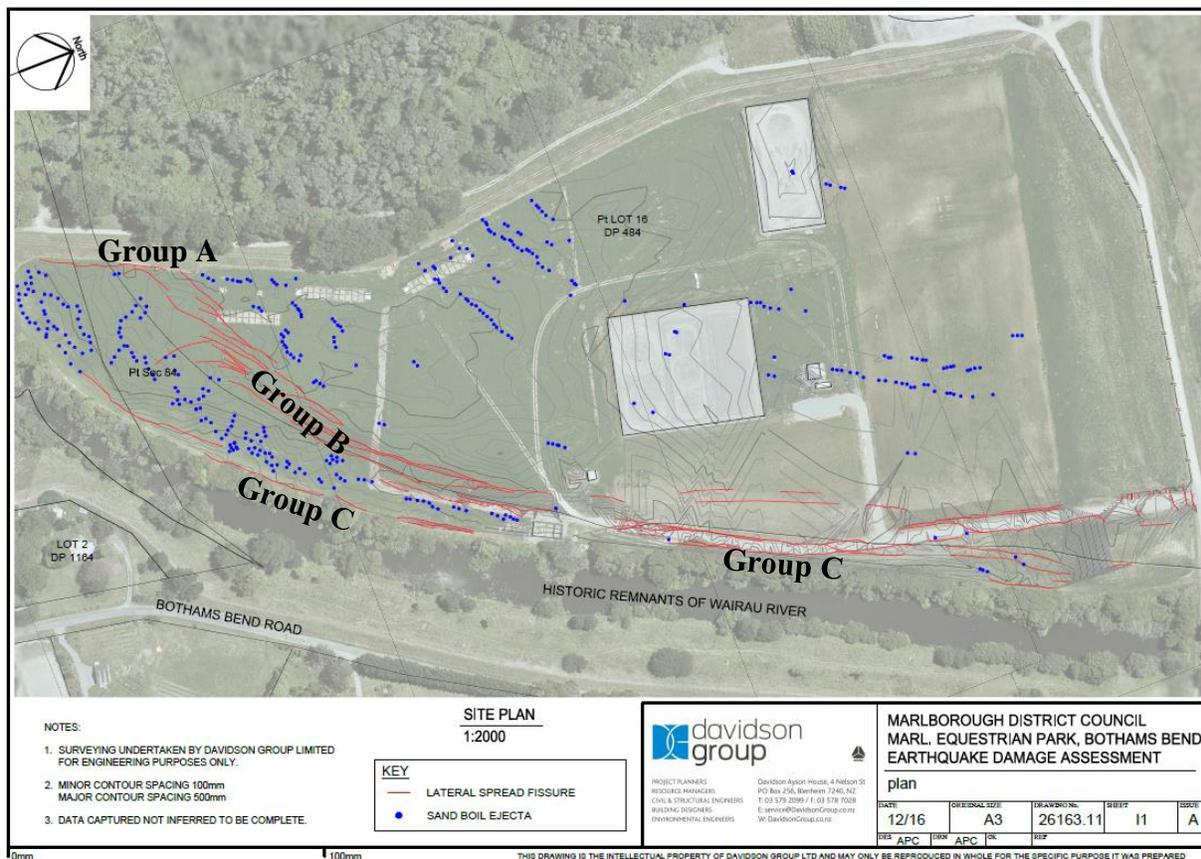
Figure 4.38: Overview of liquefaction induced damage at the Marlborough Equestrian Park (approx. centre of image: S41.4455, E173.9761) (courtesy of Davidson Group)

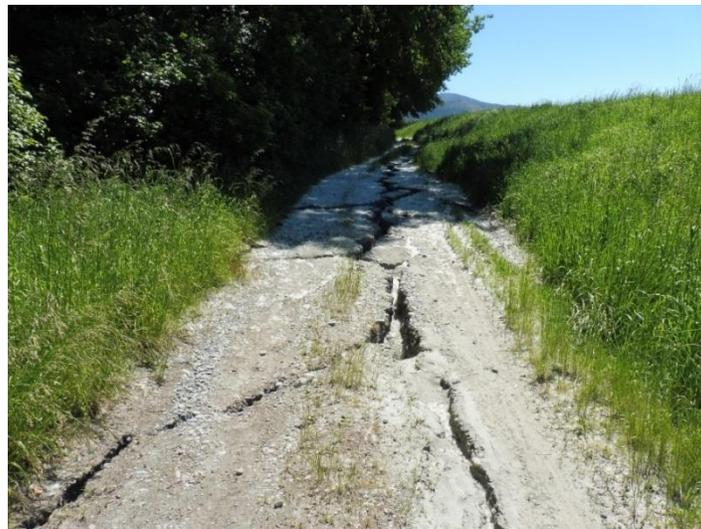
Figure 4.40: Group A cracking along the base of the secondary stopbanks (4 Dec 2016, S41.4487, E173.9738, facing NE).

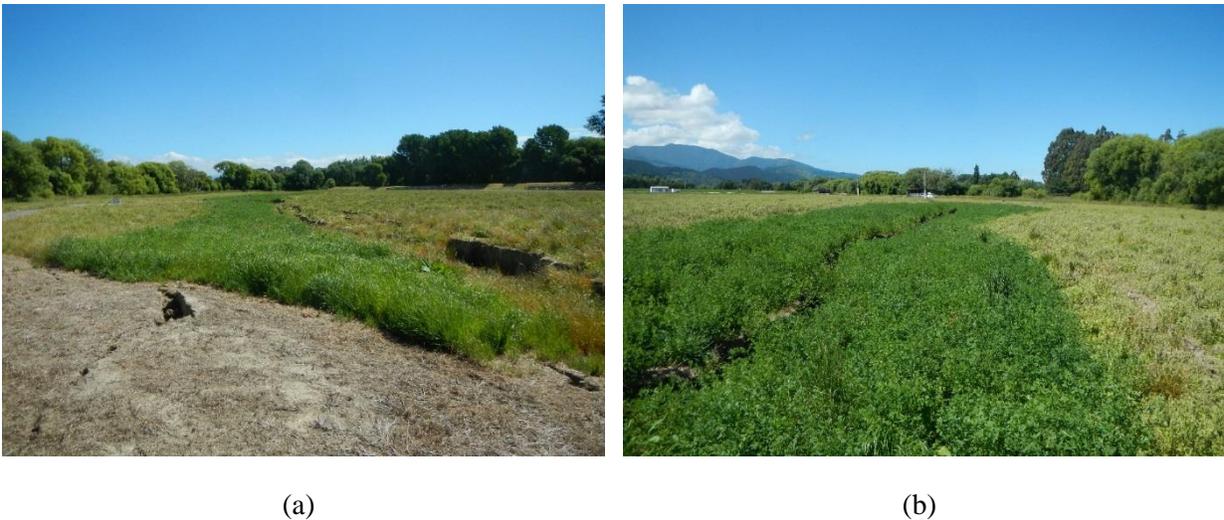
Figure 4.42: Group B cracks following the historic river channel: (a) facing SW, and (b) facing E (4 Dec 2016, S41.4474, E173.9759). Note the lush vegetation strip identifies the location of the historic river channel.

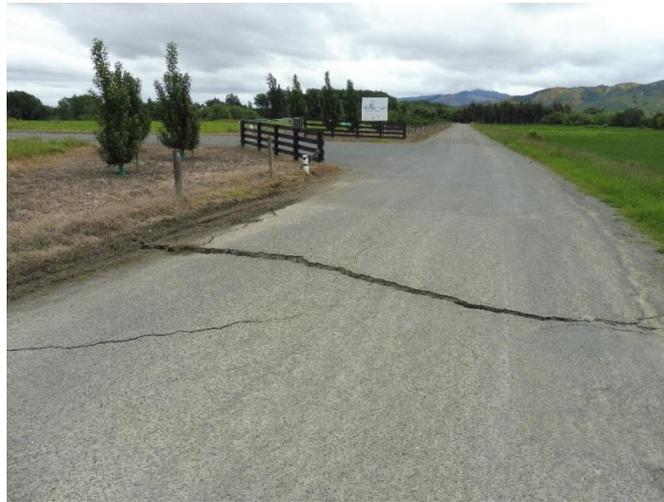
Figure 4.44: Crack at the entrance to the Equestrian park at edge of historic river channel (15 Nov 2016, S41.4436, E173.9790, facing W, Marlborough District Council 2016).

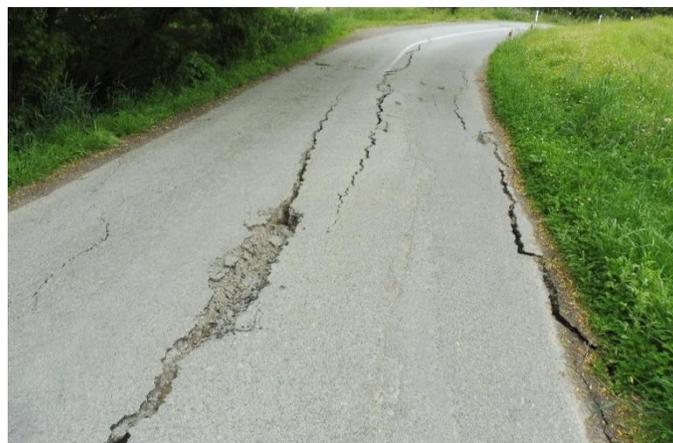
Figure 4.45: Cracks in the access road that crosses a historic river channel at the Equestrian Park (15 Nov 2016, S41.4436, E173.9790, facing E, Marlborough District Council 2016).

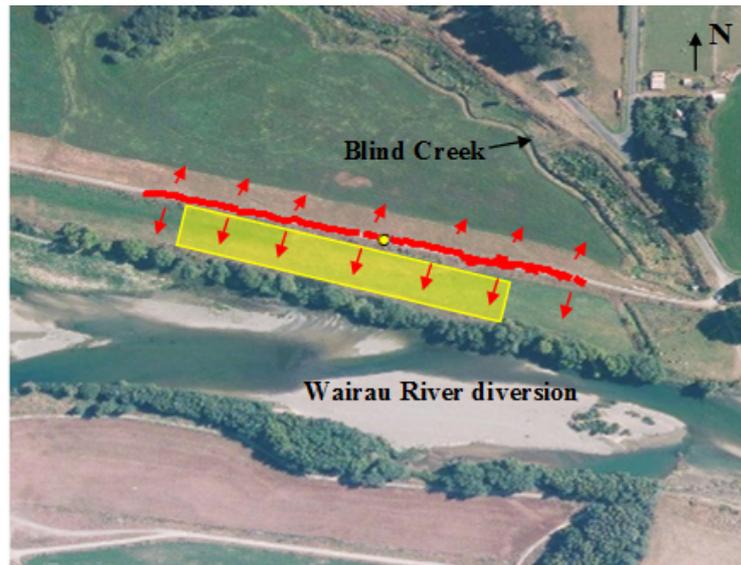
Figure 4.47: Overview of damage at Blind Creek Stopbank (approx. centre of image: S41.4405, E173.9762).

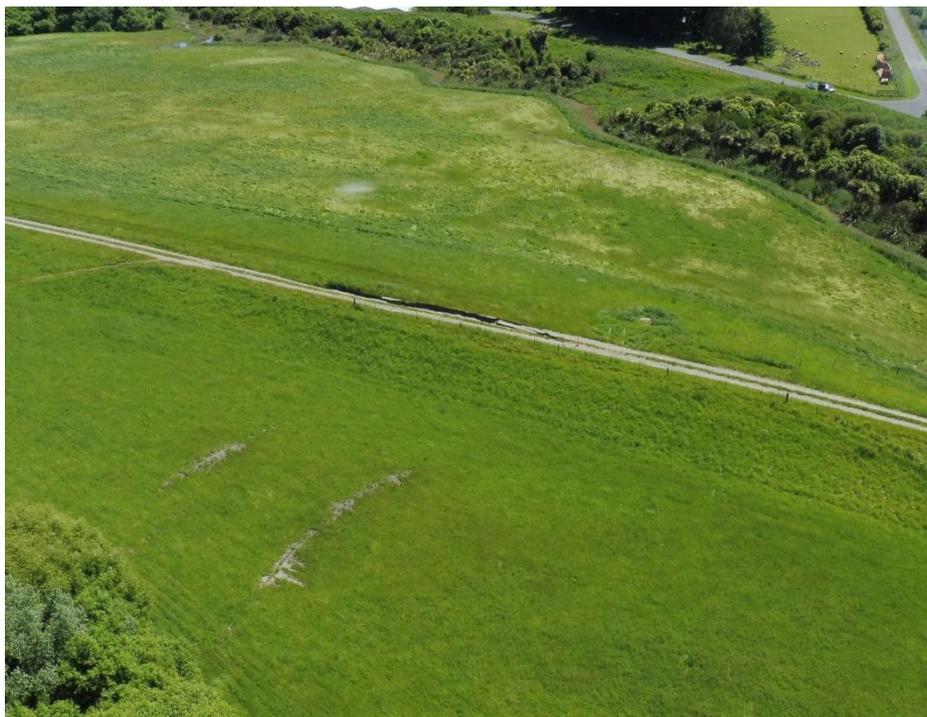
Figure 4.48: Aerial view of the Blind Creek stopbank damage (18 Nov 2016, approx. centre of image: S41.4405, E173.9762, Marlborough District Council 2016).

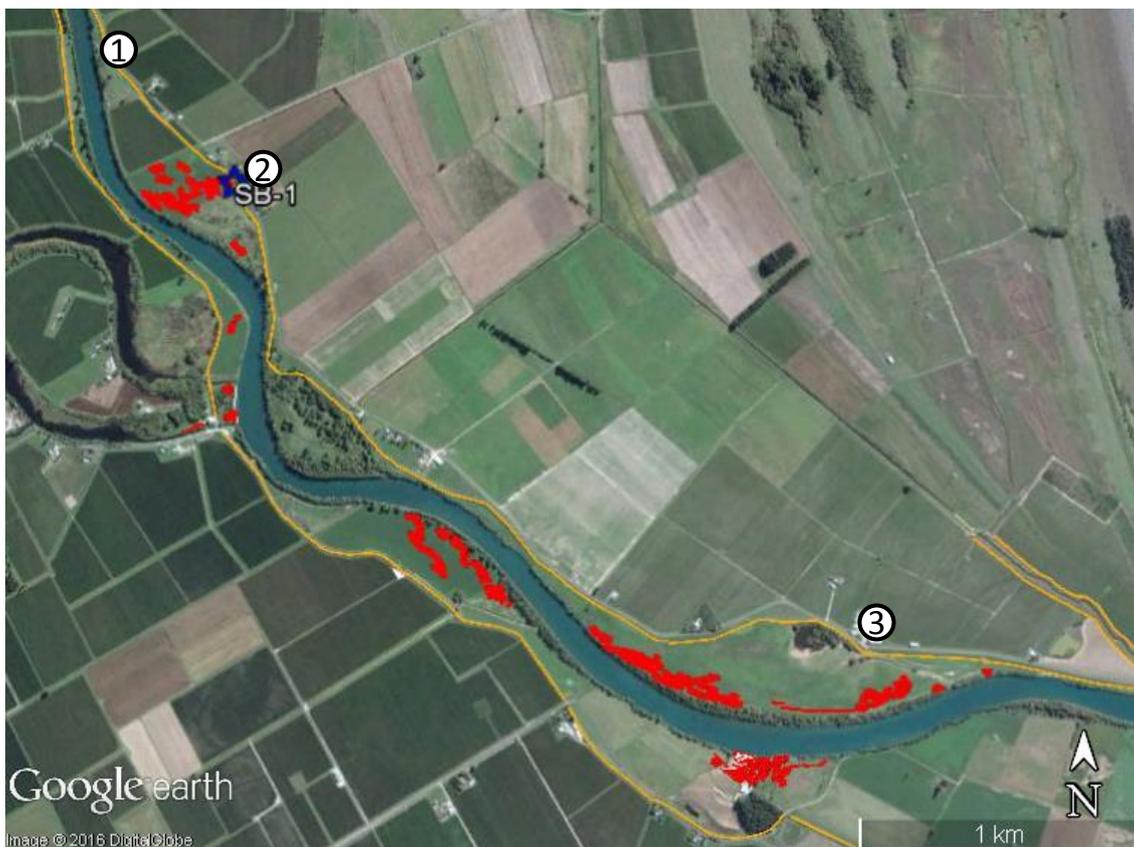
Figure 4.53: Summary of liquefaction induced damage along the banks of the Lower Wairau River, with red areas indicating cracking and ejecta locations. Stopbank damage is shown by the red symbols in this figure. (Approx. centre of image: S41.4799, E174.0006).

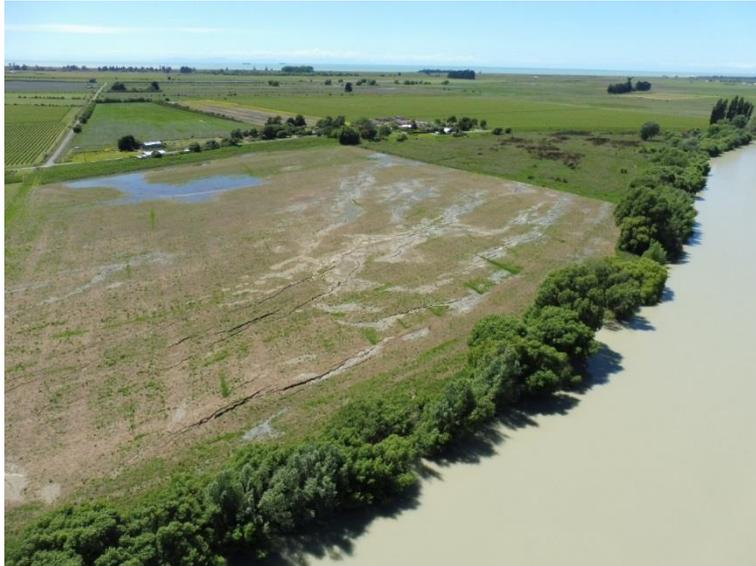
Figure 4.54: Lateral spreading and liquefaction ejecta on the eastern banks of the Lower Wairau River (18 Nov 2016, S41.4687, E173.9807, taken facing SE).

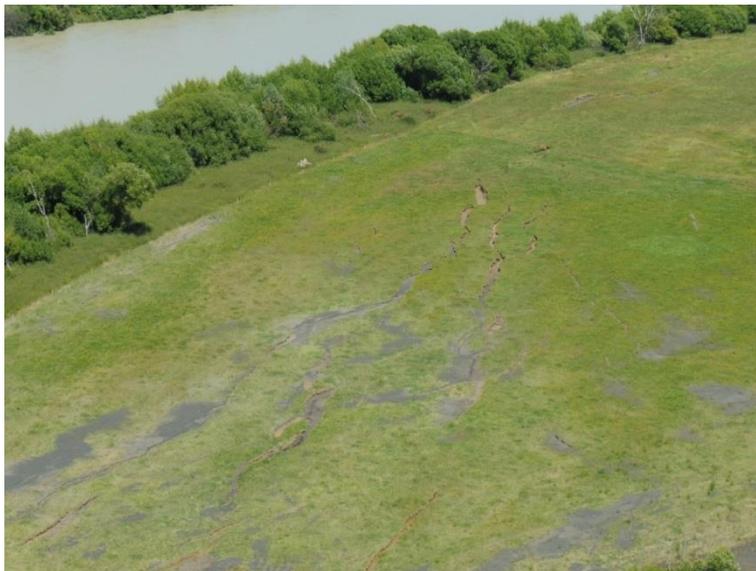
Figure 4.55: Lateral spreading and liquefaction ejecta on the eastern banks of the Lower Wairau River (18 Nov 2016, S41.4854, E174.0160, taken facing W).

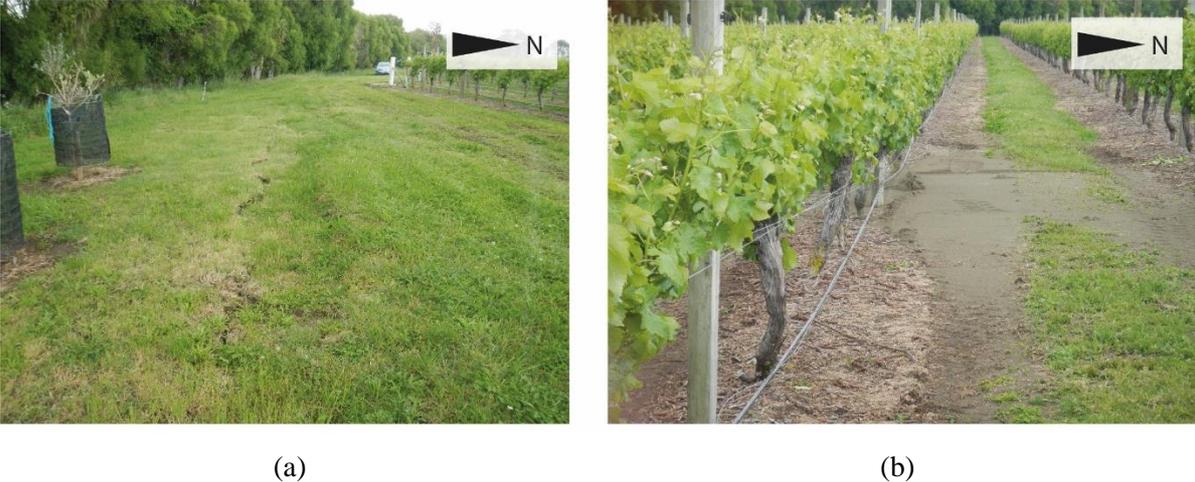
Figure 4.56: a) Lateral spreading induced cracking was observed within 10 m of river bank at 132 Wairau Bar Road. b) Localized liquefaction ejecta associated with cracks were observed at distances >10 m from the stopbank (17 Nov 2016): (a) S41.4671, E173.9802, facing N; (b) S41.4675, E173.9808, facing N.

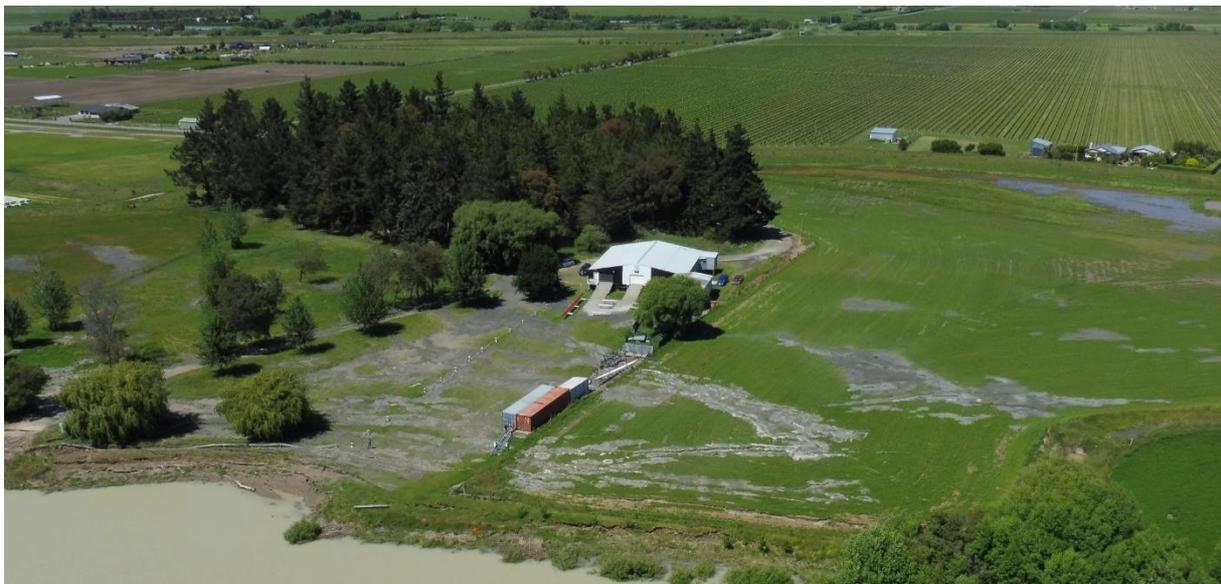
Figure 4.67: Aerial view of liquefaction manifestation at the Blenheim Rowing Club looking south (18 Nov 2016, approx. centre of image: S41.4890, E174.0094, Marlborough Regional Council, 2016).

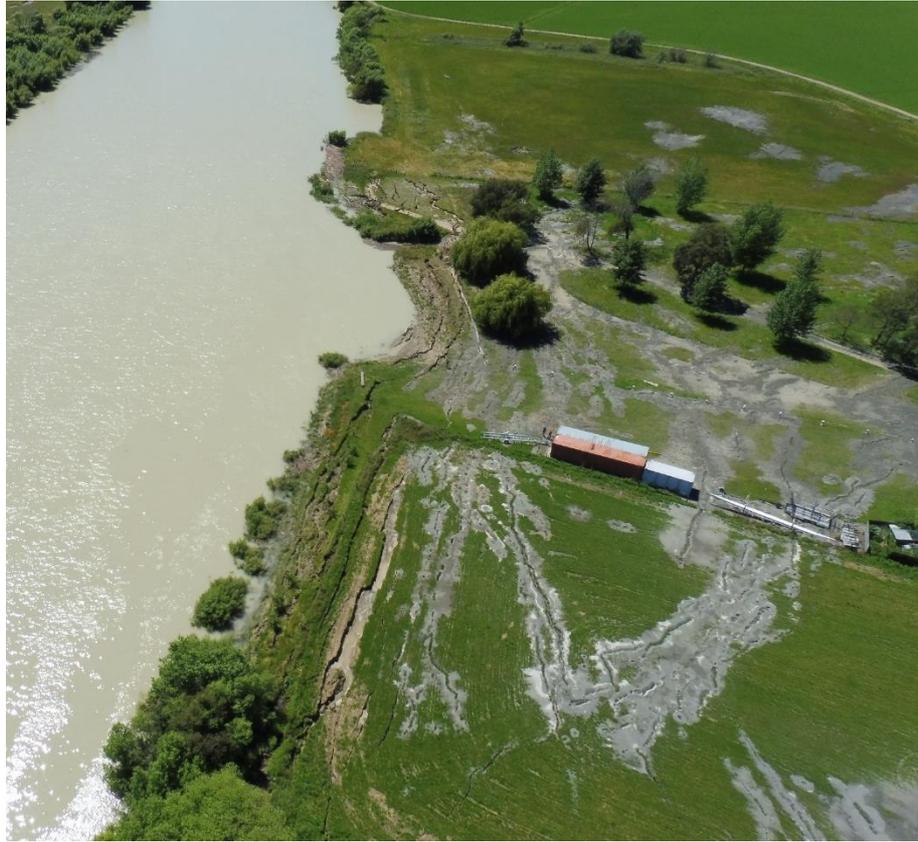
Figure 4.68: Aerial view of liquefaction manifestation at the Blenheim Rowing Club looking east (18 Nov 2016, approx. centre of image: S41.4883, E174.0096, Marlborough Regional Council, 2016).

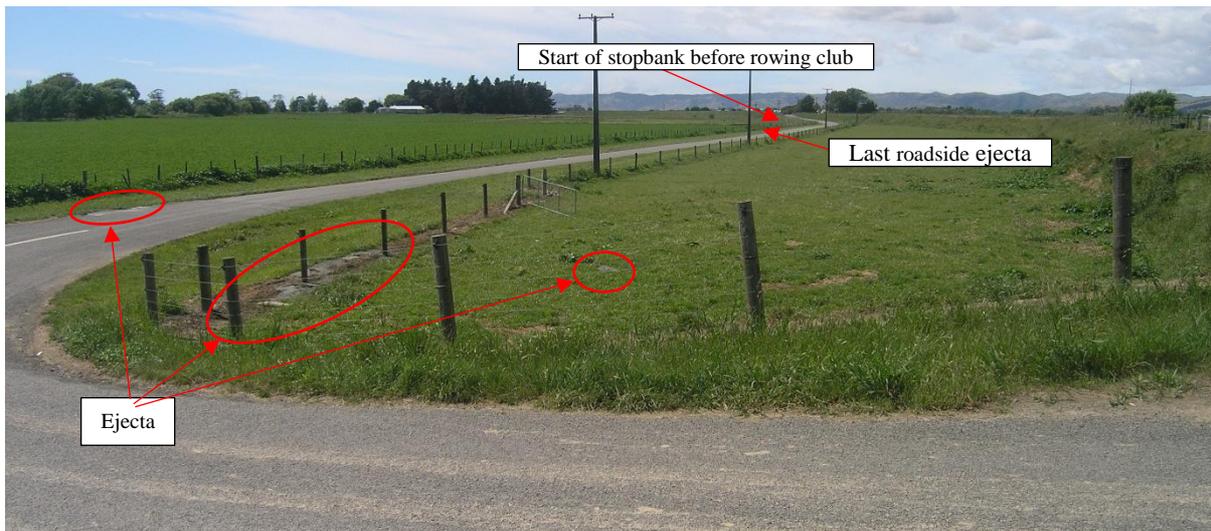
Figure 4.76: Evidence of liquefaction on approach to the Blenheim Rowing Club (17 Nov 2016, S41.4862, E174.0022, facing S).

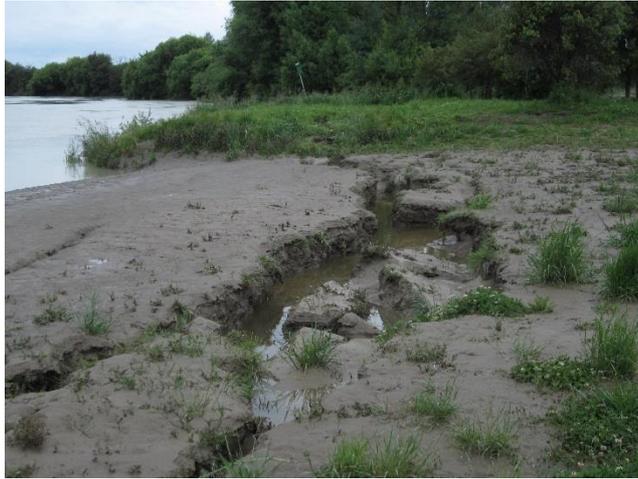
Figure 4.78: Lateral spreading cracks close to the Wairau River in the grassed area to the east of the clubhouse (17 Nov 2016, S41.4765, E173.9862, facing S).

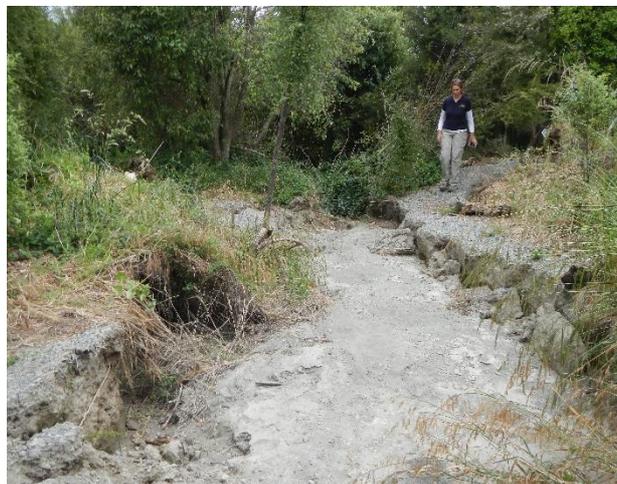
Figure 4.79: Lateral spread crack approximately 2 m wide filled with fine grey ejecta (6 Dec 2016, S41.4761, E173.9860, facing NE).

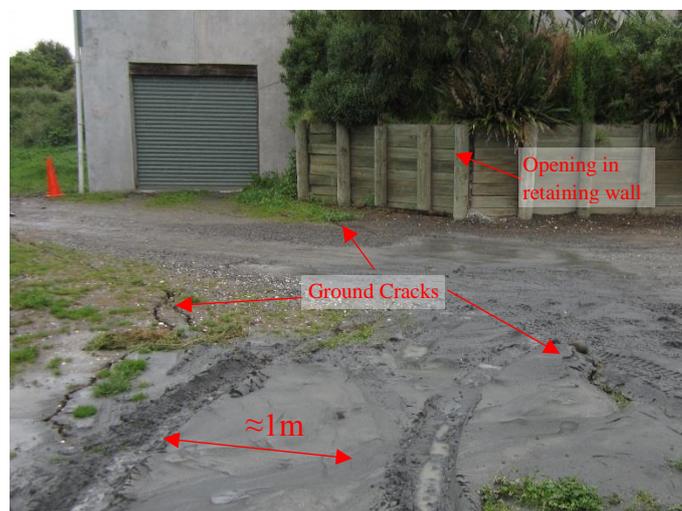
Figure 4.84: Cracks and ejecta to the west of the Wairau Rowing Club (17 Nov 2016, S41.4768, E173.9849, facing E).

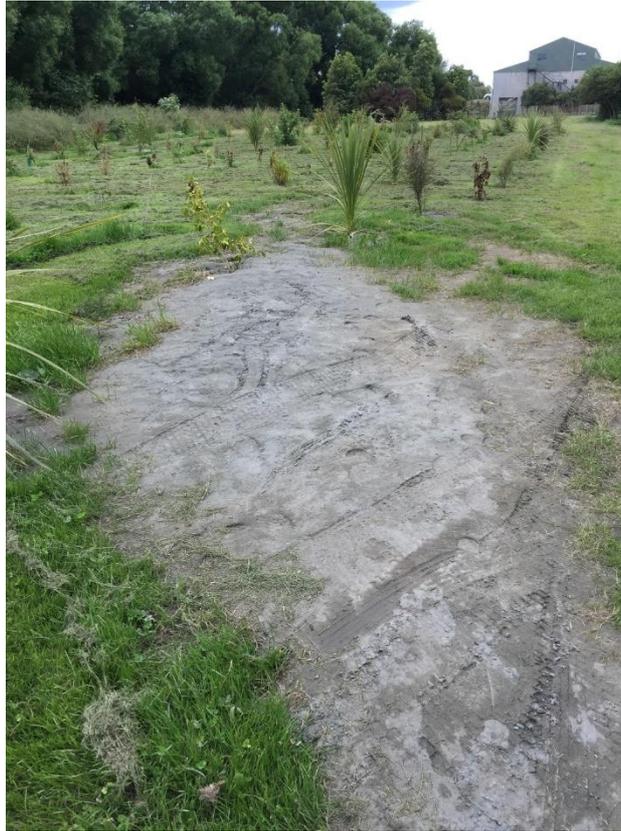
Figure 4.85: Fine grey sand ejecta west of the Wairau Rowing Club (7 Dec 2016, S41.4771, E173.9836, facing E).

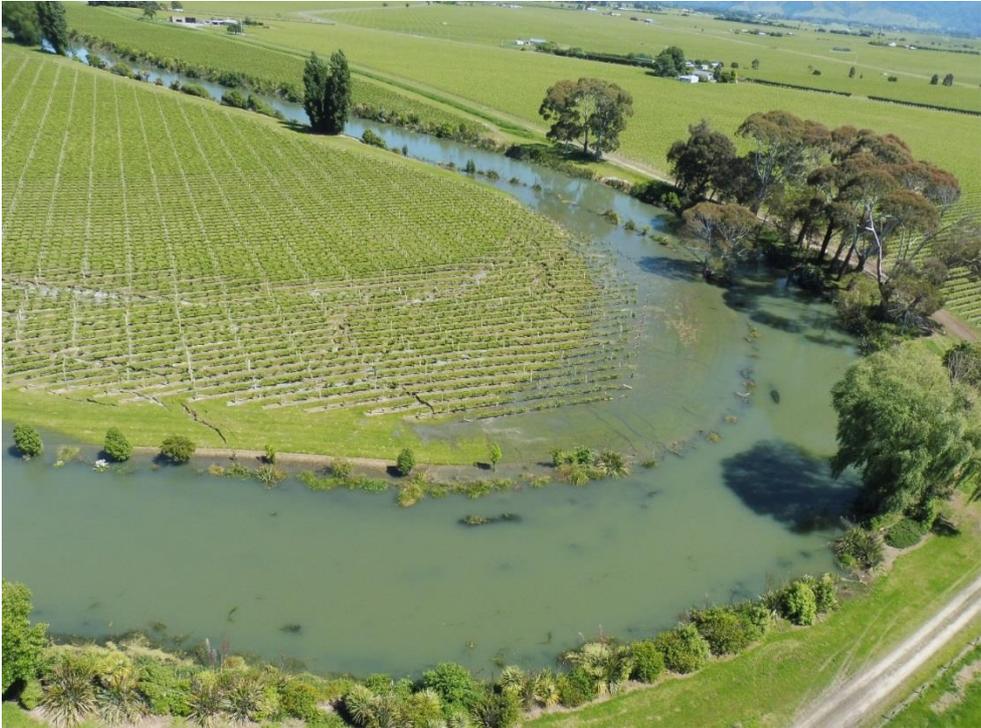
Figure 4.87: Lateral spreading and sand ejecta damage to vineyards along the Lower Opaoa River. Photo taken 4 days after the earthquake showing vine repair yet to commence (18 Nov 2016, S41.5217, E174.0160, facing W, Marlborough District Council 2016).

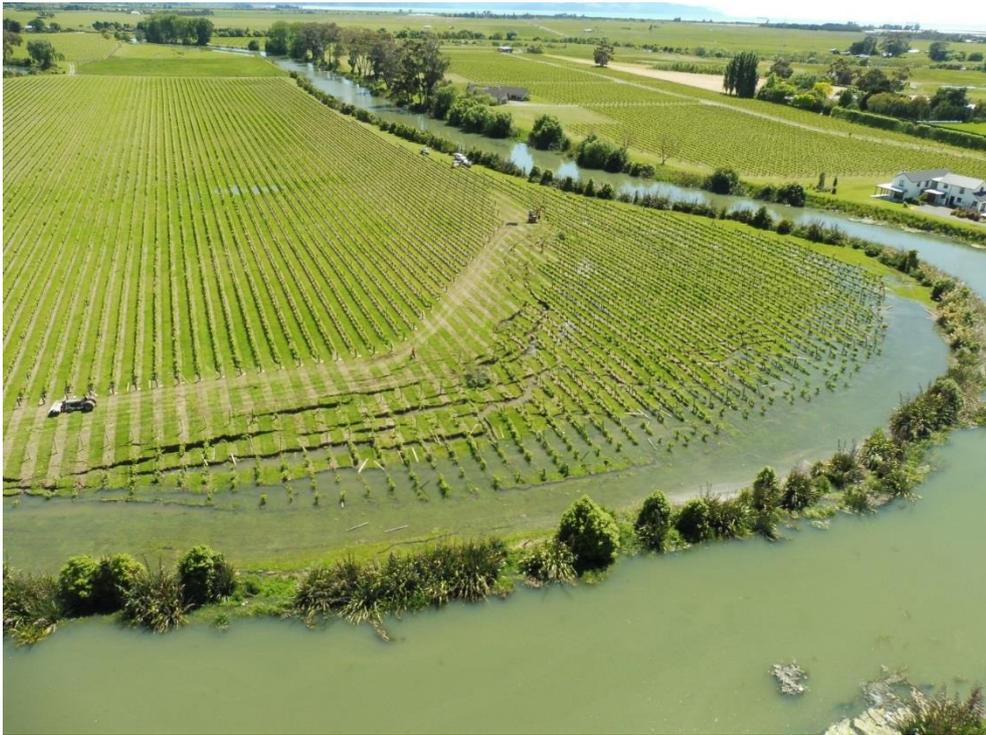
Figure 4.88: Lateral spreading and sand ejecta damage to vineyards along the Lower Opaoa River. Photo taken 4 days after the earthquake showing completed vine repair and remnants of damaged vines. (18 Nov 2016, S41.5270, E174.0179, facing N, Marlborough District Council 2016).

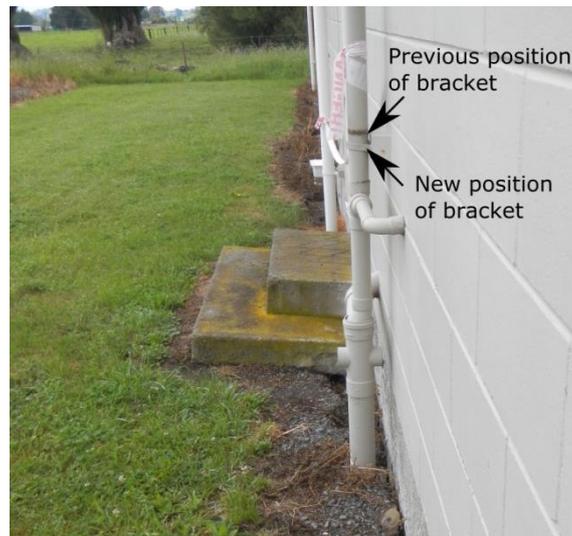
Figure 4.100: View of east wall of house on Schoolhouse Road (-9 Dec 2016, S42.3682, E173.6501, facing S).

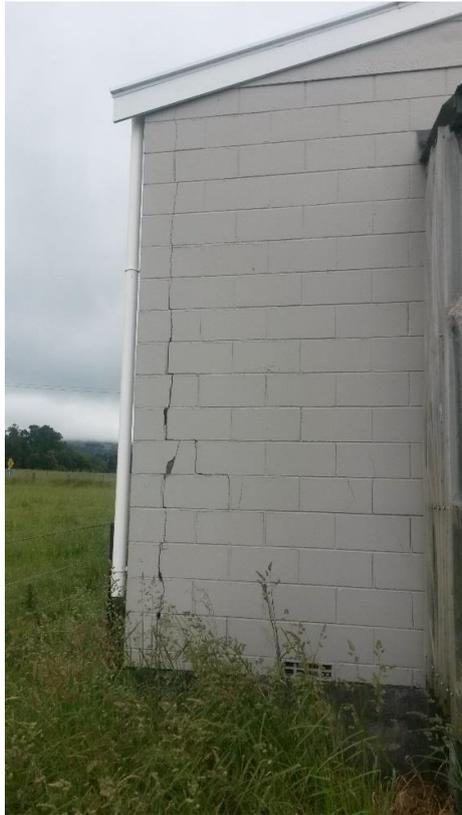
Figure 4.102: Cracking through brick work on SW corner of house on Schoolhouse Road (-9 Dec 2016, S42.3684, E173.6501, facing W).

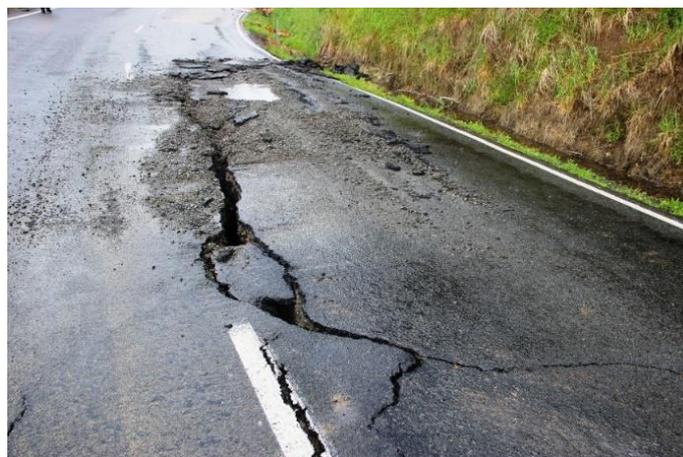
Figure 4.142: Large crack in middle of roadway on Rotherham Road. Crack width 20-30 cm. Vertical offset is approximately 4 cm (S42.6900, E173.9462, 17 Nov 2016).

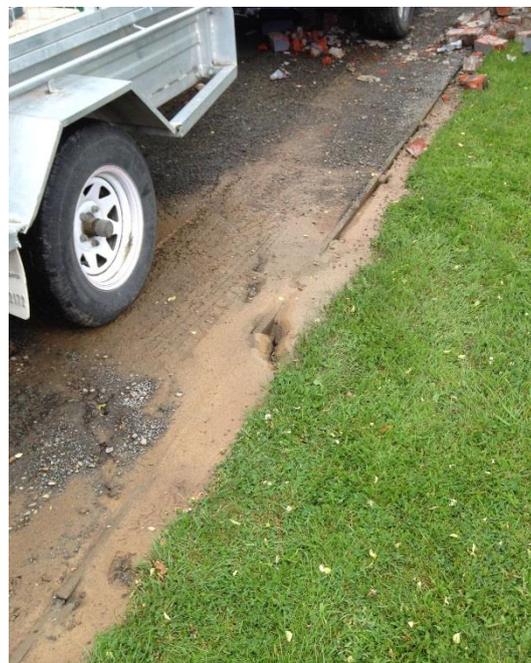
Figure 4.144: Liquefaction at the south of Waiau town (date to be added in V2.0 of report, S42.6592, E173.0440, 17 Nov 2016).
