6 GEOTECHNICAL EFFECTS ON SOUTH ISLAND BRIDGES AND INFRASTRUCTURE

6.1 Hurunui District

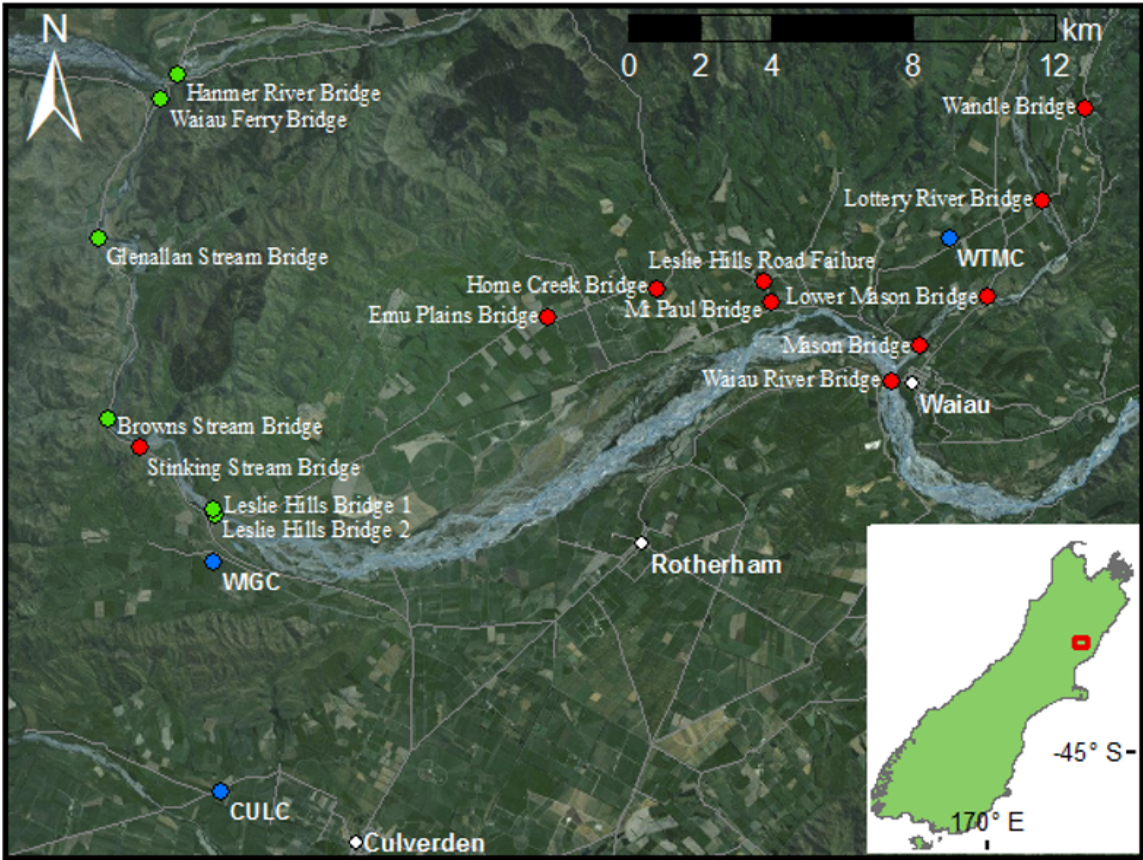
Figure 6.1: Bridge sites surveyed in the Hurunui District. Green markers indicate bridges with minor or no damage observations. Red markers indicate sites with moderate to severe damage observations. Blue markers indicate strong motion stations.

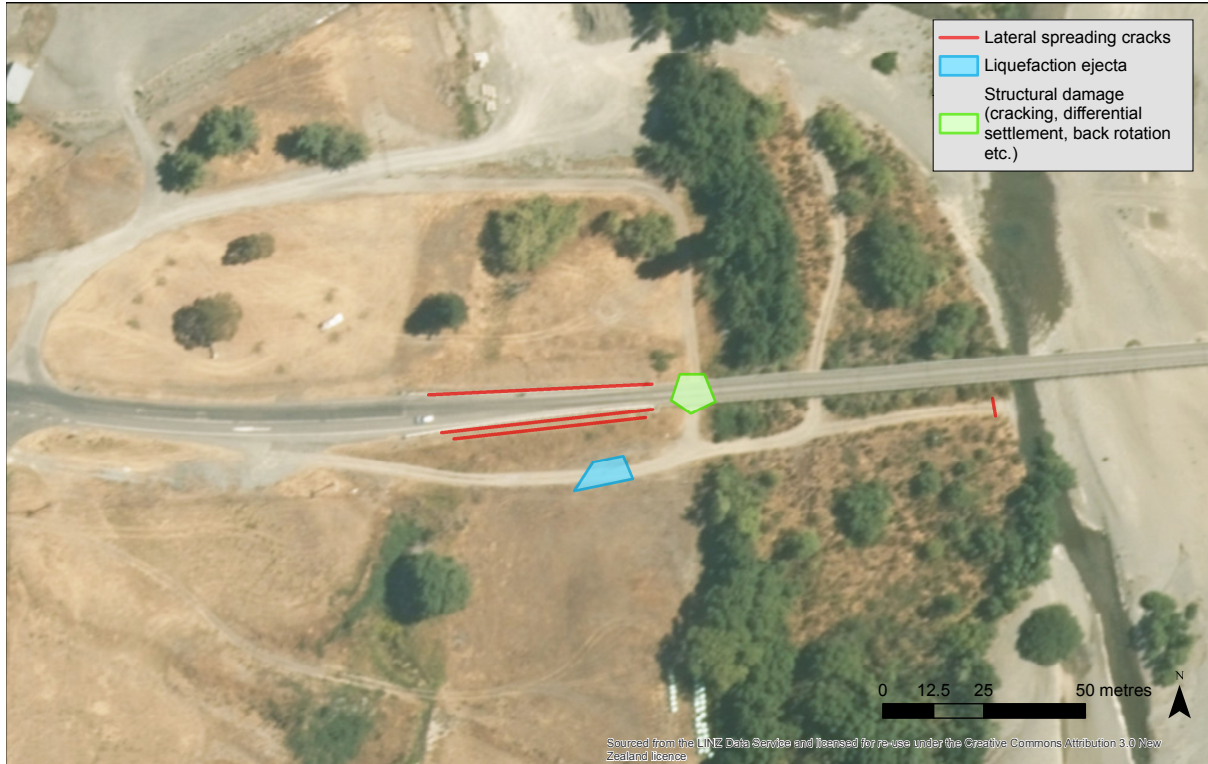
Figure 6.2: Site layout for western approach to Waiau River Bridge [-42.65555, 173.0302].

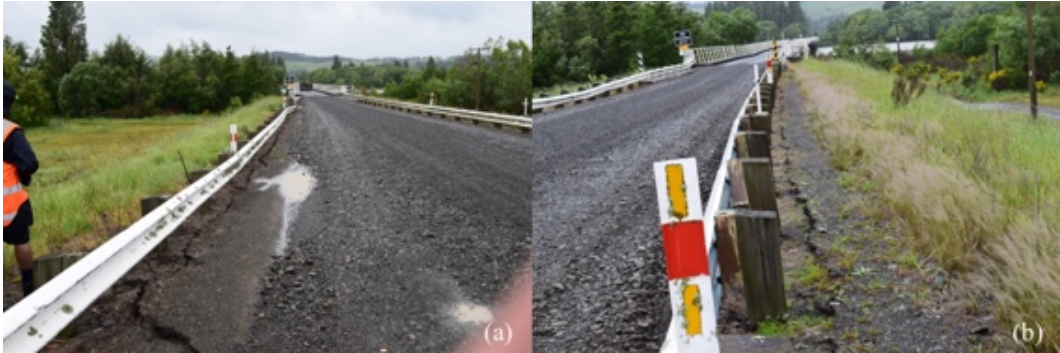
Figure 6.3: Lateral cracking on road side in western approach embankment of Waiiau River Bridge. Photos taken looking east towards bridge [-42.6556, 173.0294]: (a) North side; (b) South side.

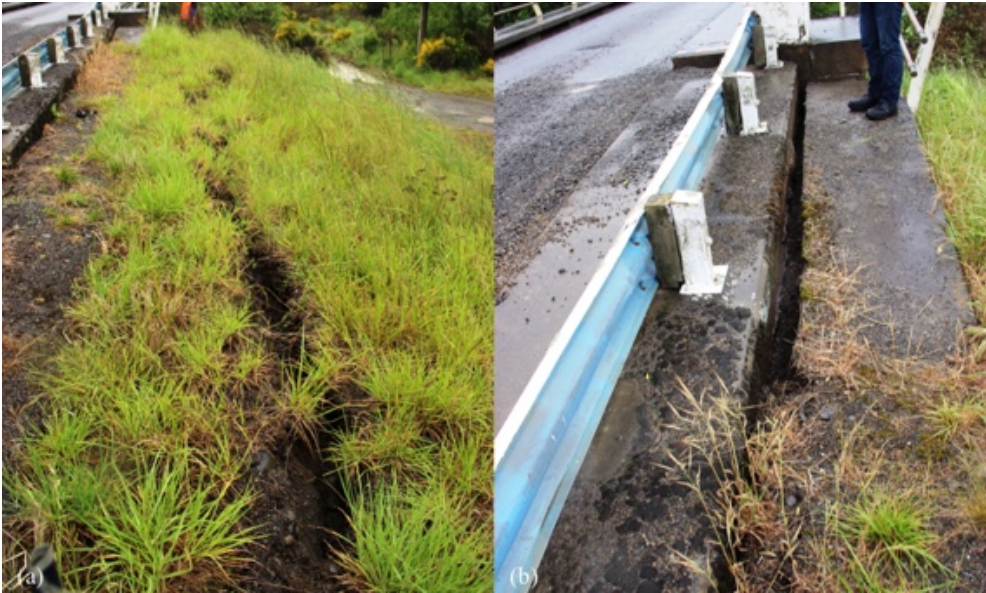
Figure 6.4: South side of western approach embankment to Waiiau River Bridge [-42.6556, 173.03]: (a) Lateral cracks in embankment side; (b) Settlement and outward movement at abutment wall.

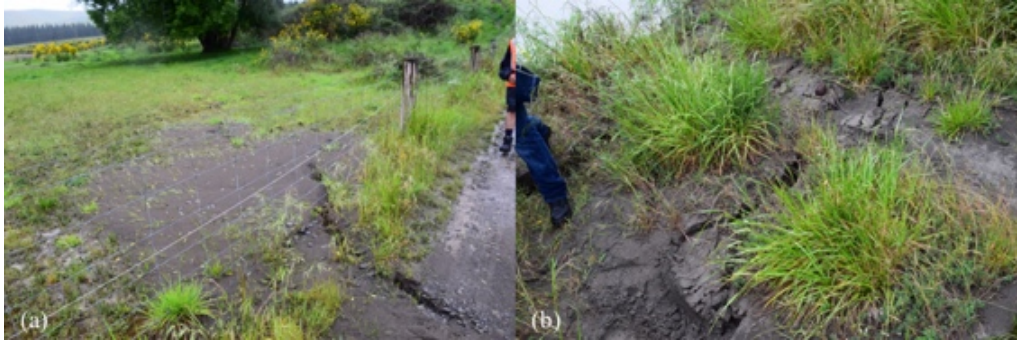
Figure 6.5: Surficial evidence of liquefaction at western approach to Waiau River Bridge: (a) Ejecta and cracking adjacent to southern toe of approach embankment [-42.6558, 173.0297]; (b) Lateral spreading cracks near river bank [-42.6556, 173.0312].

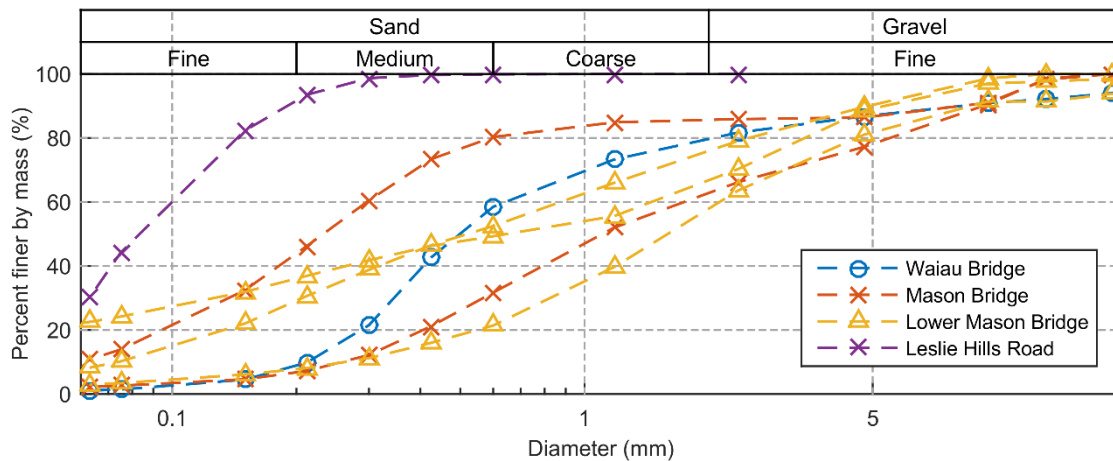
Figure 6.6: Particle size distributions of ejecta samples recovered at bridge sties in the Hurunui district

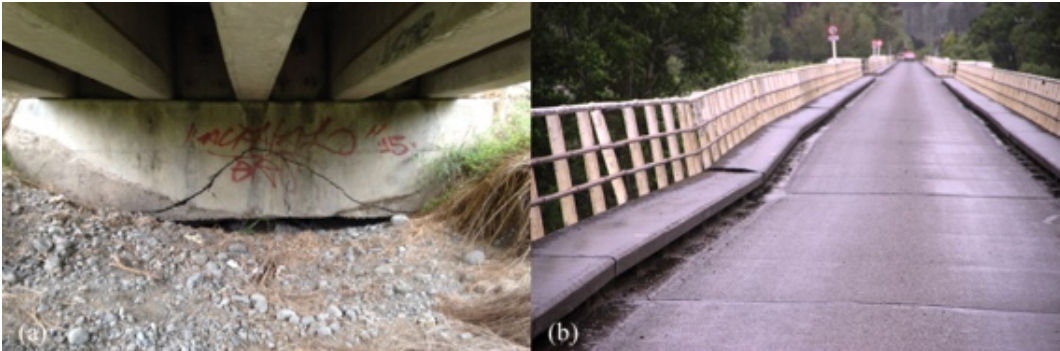
Figure 6.7: Structural damage at western approach area to Waiau River Bridge [-42.6556, 173.0302]: (a) Severe cracking in the abutment wall (looking west from under the bridge deck); (b) Differential settlement at second pier (looking east).

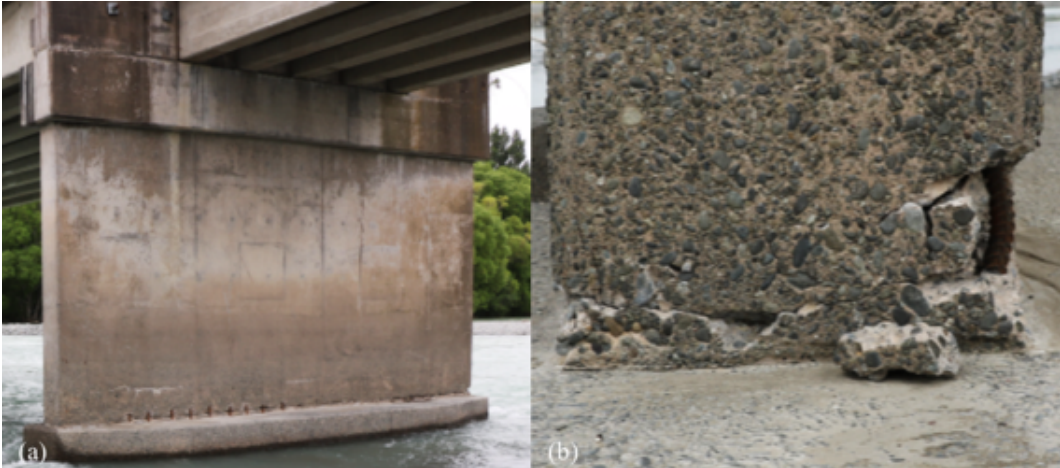
Figure 6.8: Structural damage to base of piers for Waiau River Bridge [-42.6553, 173.0351]: (a) Cracking at pile cap interface; (b) Exposure and buckling of longitudinal bars.

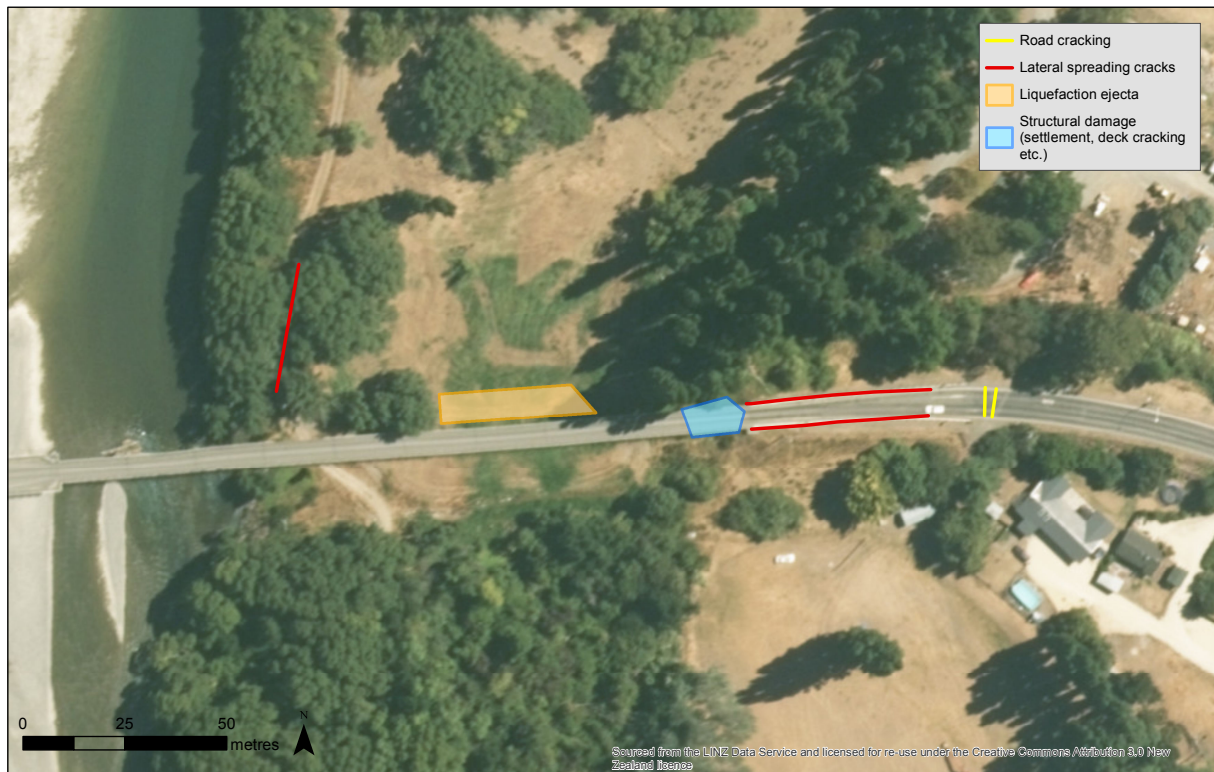
Figure 6.9: Site layout eastern approach to Waiau River Bridge [-42.6552, 173.037].

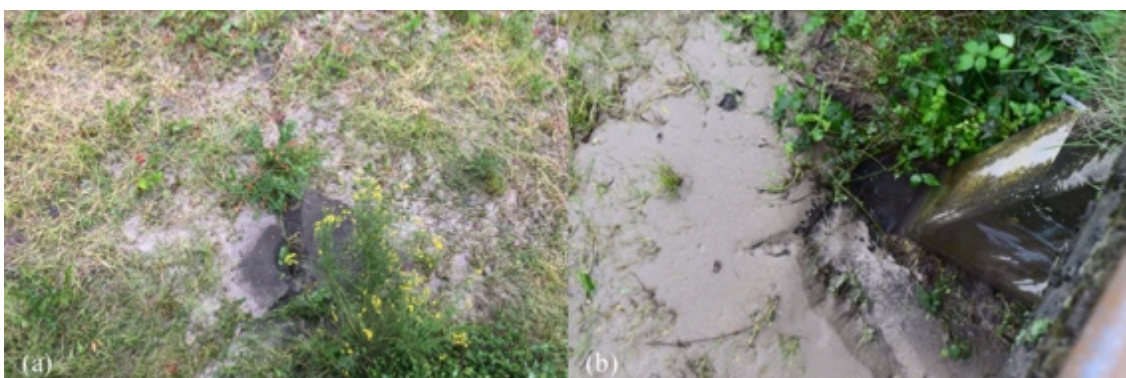
Figure 6.10: Liquefaction ejecta near the eastern approach to Waiau River Bridge [-42.6552, 173.037]: (a) Ejecta in paddock on north side of bridge; (b) Ejecta directly adjacent to bridge pier on south side.

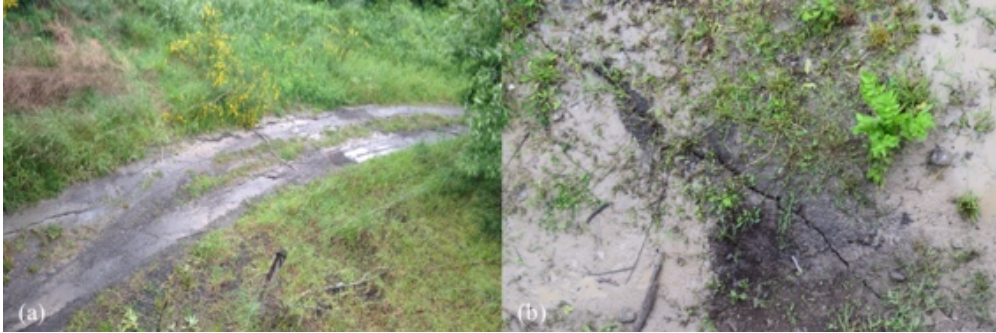
Figure 6.11: Lateral spreading cracks with ejecta near the eastern approach to Waiiau River Bridge [-42.65525, 173.036].

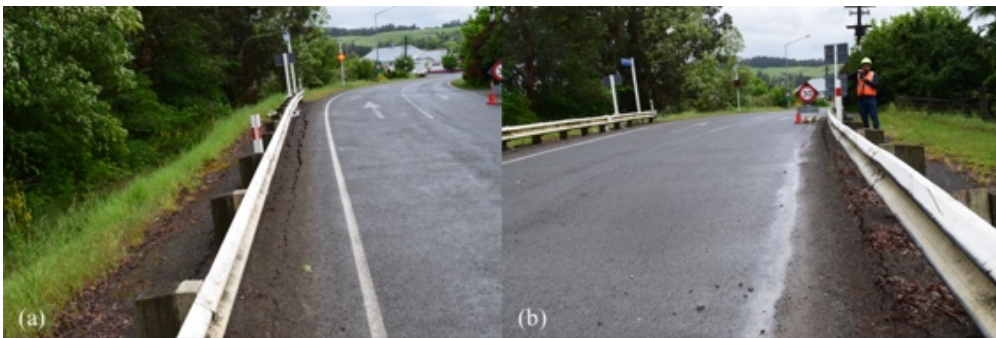
Figure 6.12: Lateral cracking on both sides of roadway in eastern approach embankment to Waiiau River Bridge [-42.6551, 173.0380]: (a) Northern side (looking east away from bridge); (b) Southern side (looking east).

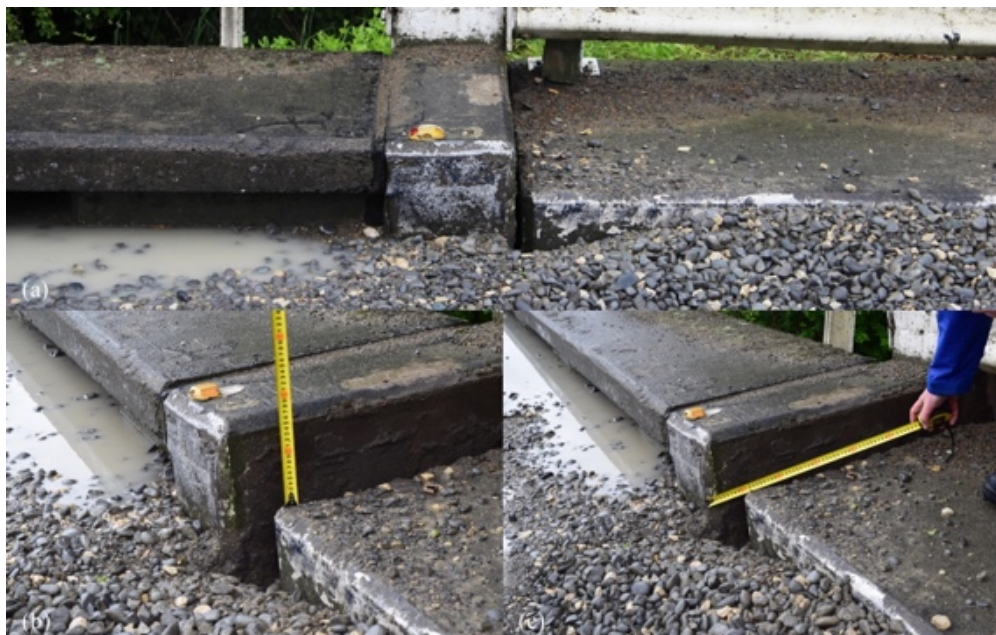
Figure 6.13: Settlement and outward movement at north side of eastern abutment to Waiiau River Bridge as indicated by offset of concrete members [-42.6552, 173.037].

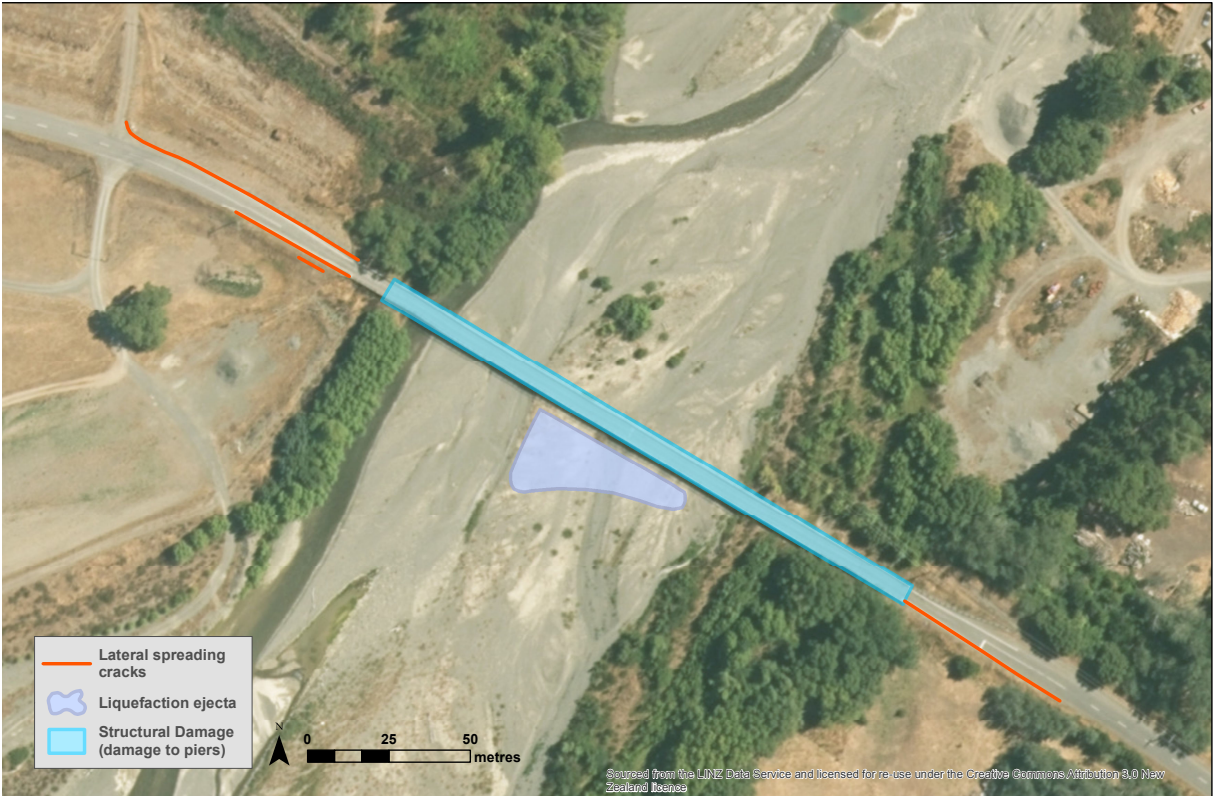
Figure 6.14: Surveyed area and features of interest for Mason Bridge [-42.6469, 173.0431].

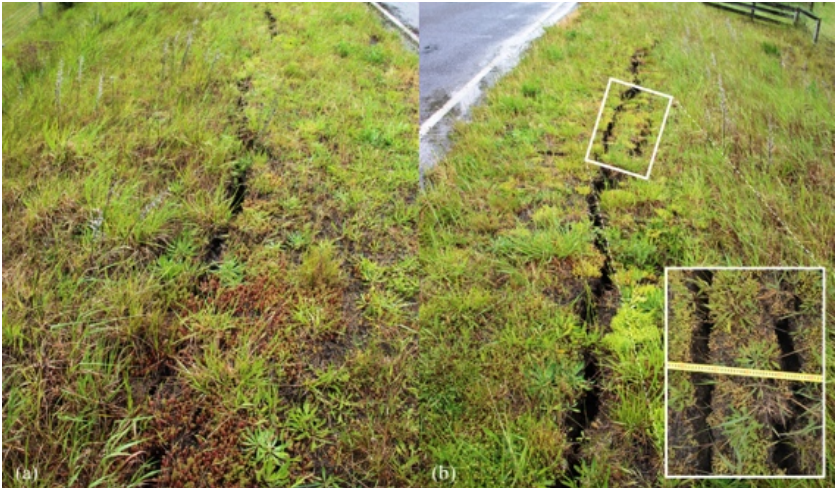
Figure 6.15: Cracks along edges of the western approach embankment for Mason Bridge (looking east towards bridge) [-42.6464, 173.04196]: (a) North side; (b) South side – inset shows close-up of cracks as indicated.

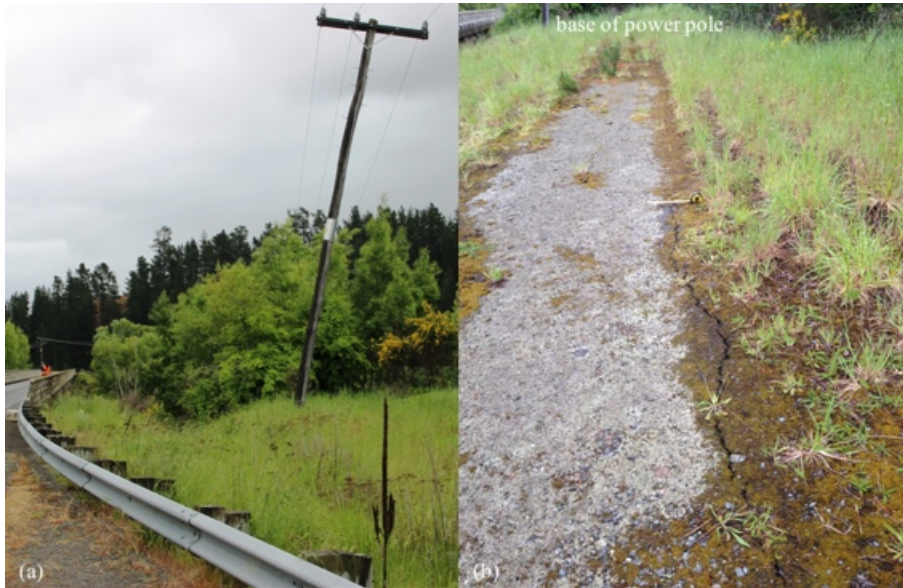
Figure 6.16: Northern side of eastern approach to Mason Bridge (looking west) [-42.6475, 173.04465]: (a) Power pole has moved down the slope of an embankment directly adjacent to bridge approach embankment; (b) Cracks parallel to roadway in embankment fill.

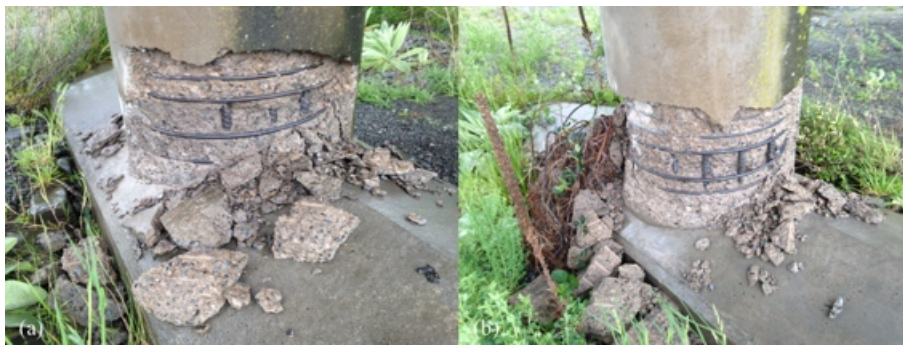
Figure 6.17: Severe examples of plastic hinging at base of Mason Bridge piers (looking north) [-42.6469, 173.0432].

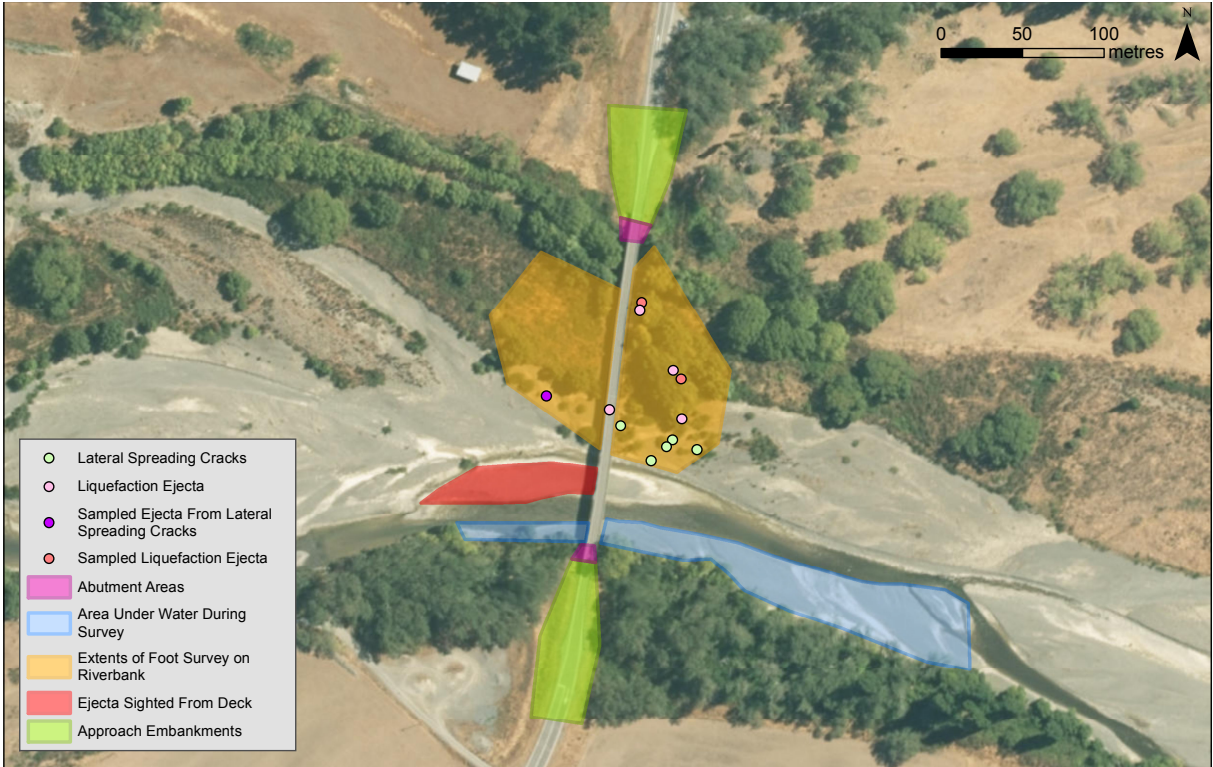
Figure 6.19: Overview of Lower Mason Bridge site indicating areas surveyed and some key features of interest [-42.6343, 173.0664].

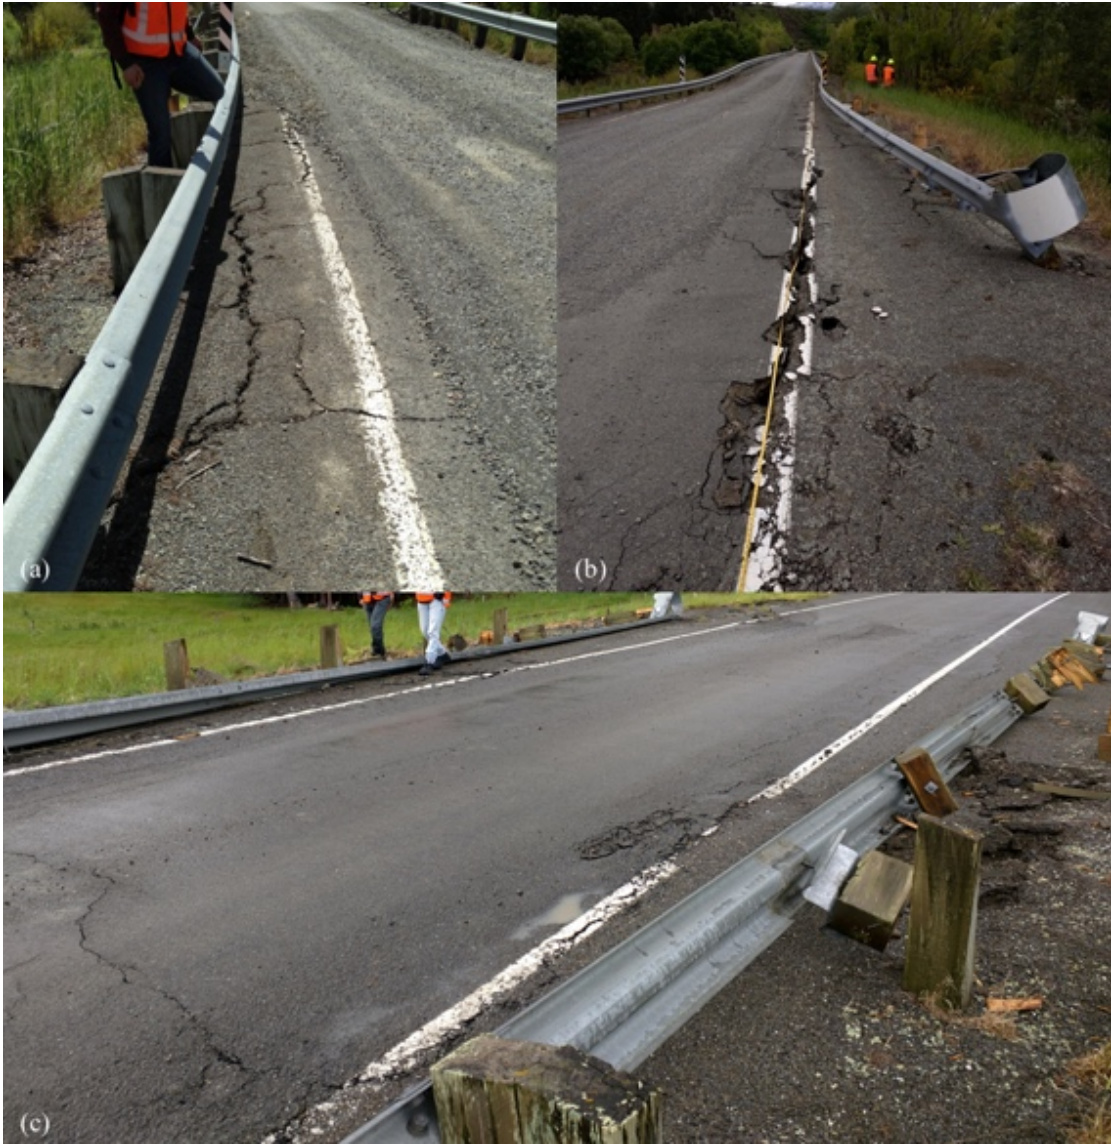
Figure 6.20: Cracking in approach roadways at Lower Mason Bridge: (a) Western side of south approach looking north [-42.6353, 173.0662]; (b) Eastern side of south approach looking north [-42.6353, 173.0662]; (c) North approach looking northwest across road [-42.6330, 173.0666].

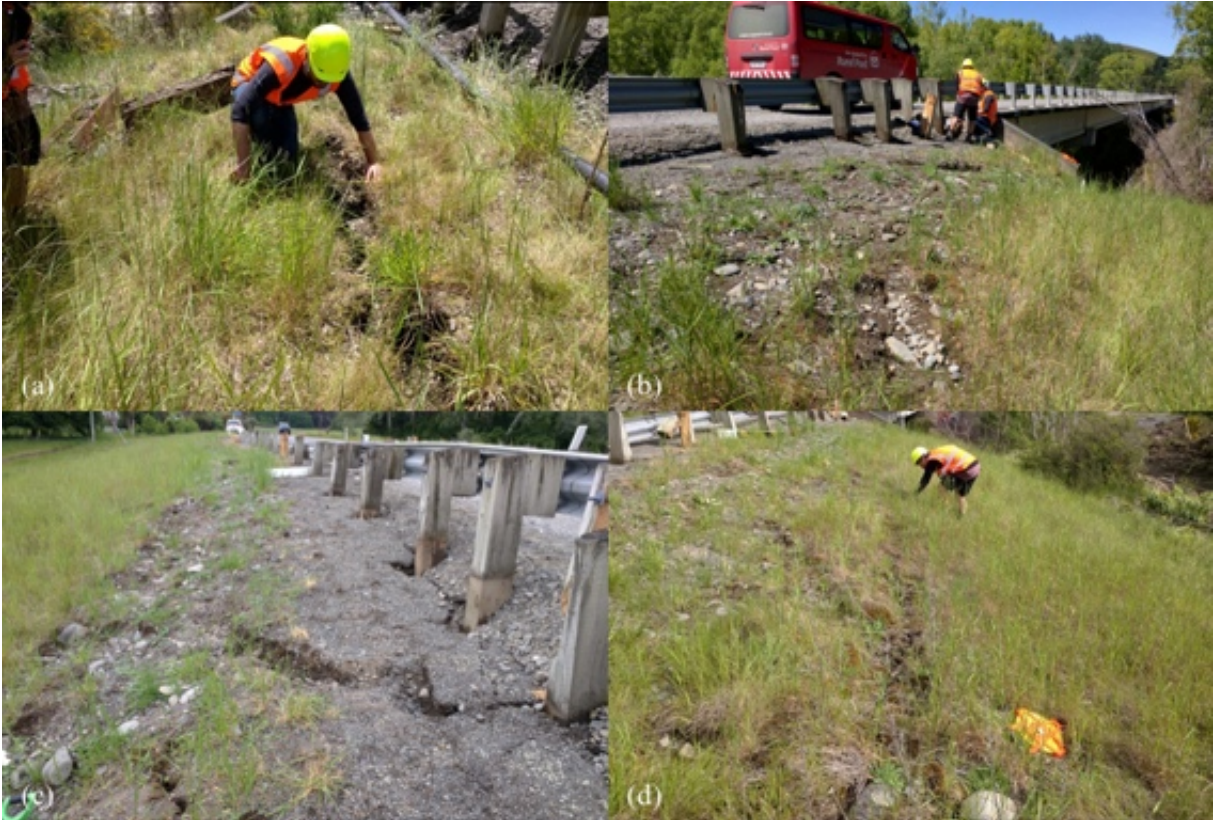
Figure 6.21: Cracking in sides of approach embankments at Lower Mason Bridge. (a) West side of south approach looking north [-42.6353, 173.0662]; (b) East side of south approach looking north [-42.6353, 173.0662]; (c) and (d) West side of north approach looking north and south, respectively [-42.6330, 173.0666].

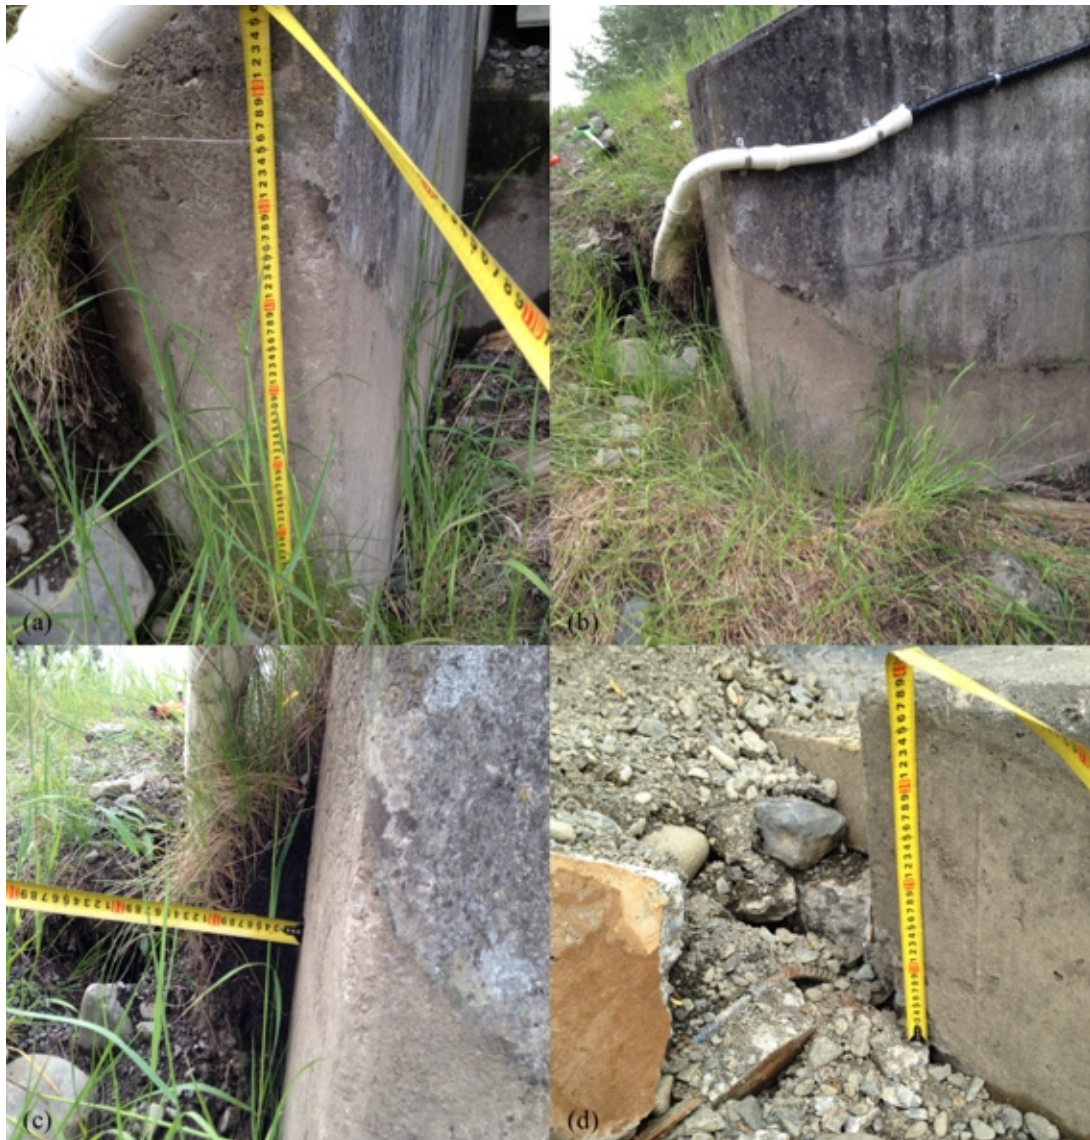
Figure 6.22: Settlement and outward movement at west side of north abutment to Lower Mason Bridge [-42.6334, 173.0666]: (a) Edge of abutment wall looking east; (b) Abutment wall looking north; (c) Edge of abutment wall looking north; (d) Embankment side of abutment wall near deck connection looking south.

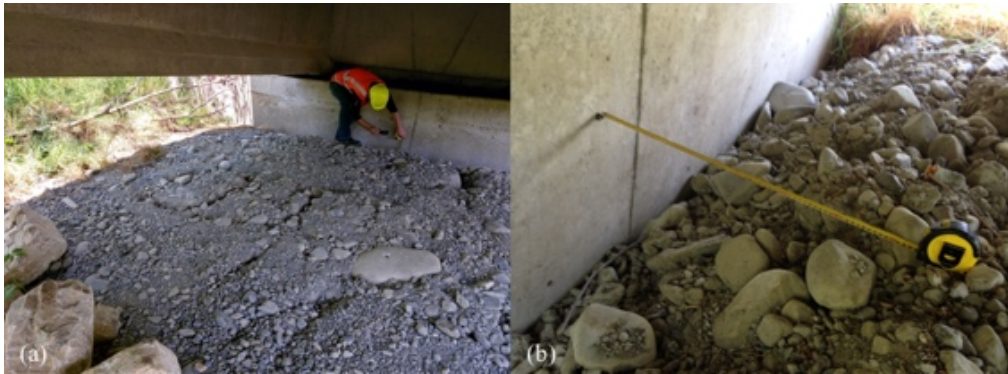
Figure 6.23: Cracking and gapping in fill below bridge deck at northern abutment to Lower Mason Bridge indicating riverward movement of the fill [-42.6334, 173.0666]: (a) Looking north; (b) 60 cm gap between wall and fill.

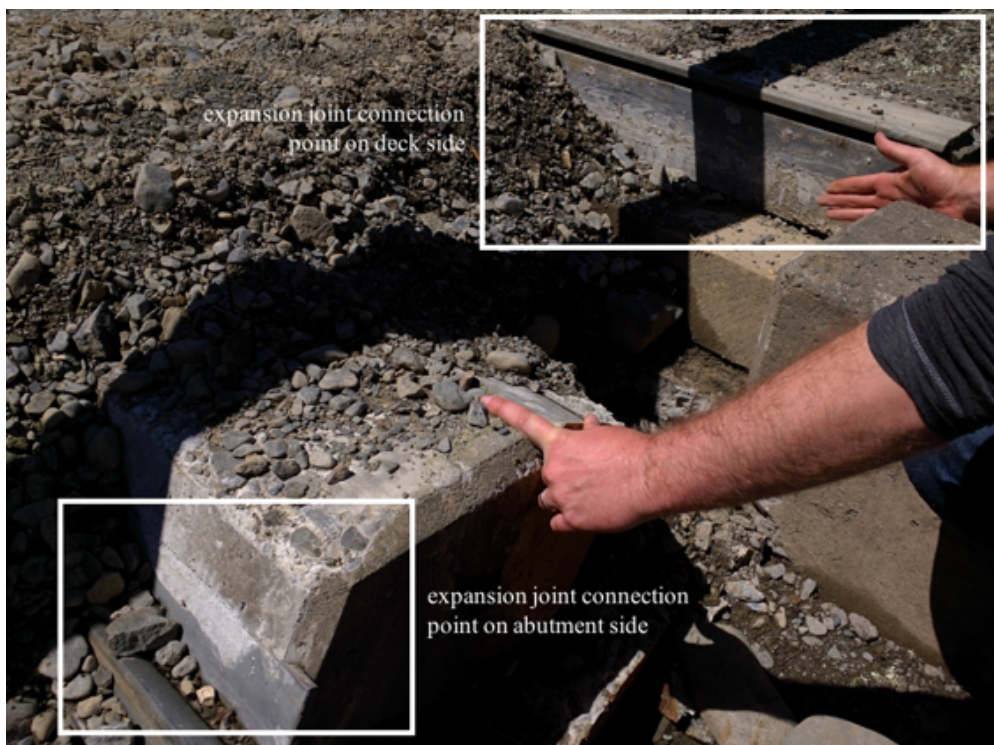
Figure 6.24: Damage to abutment-deck connection at Lower Mason Bridge due to relative movement of abutment wall and deck. The breakaway member to the left was pushed back away from the deck and rotated 180° such that the connection point for the expansion joint faces away from the deck [-42.6334, 173.0666].

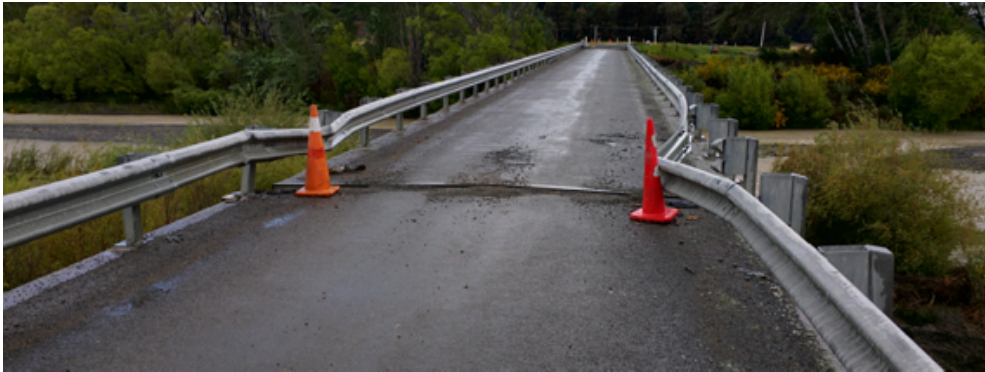
Figure 6.25: Buckling of guard rails at centre expansion joint of Lower Mason Bridge indicating that the two main deck sections have undergone permanent inward deformation. Photo facing south [-42.6343, 173.0664].

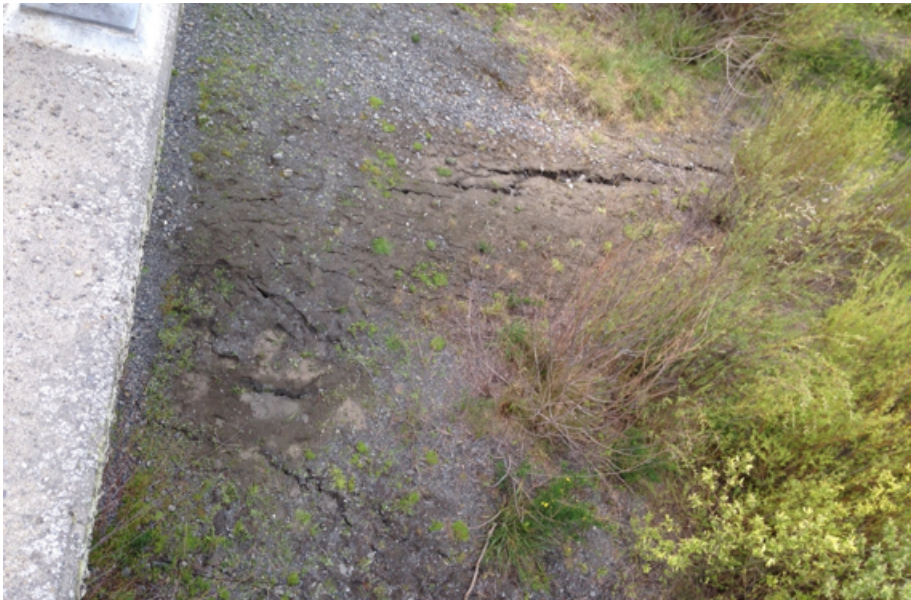
Figure 6.26: Cracks in northern river bank on eastern side of bridge. Photo taken from bridge deck. Riverward direction is down for this orientation [-42.6342, 173.0665].

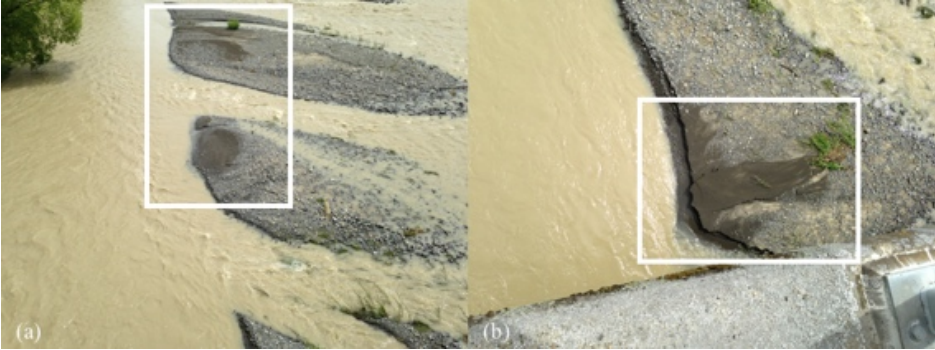
Figure 6.27: Liquefaction ejecta on west side of bridge (looking west). [-42.6345, 173.0657].

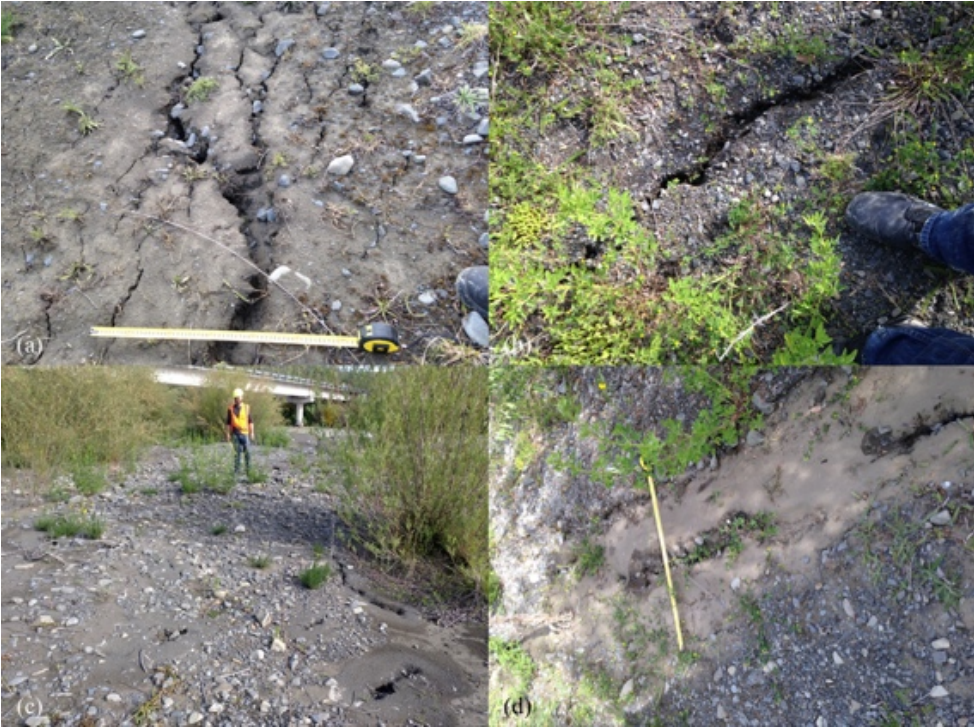
Figure 6.28: Representative photos of the lateral spreading cracking and liquefaction ejecta observed on the Northern river bank near the bridge in the areas indicated by Figure 6.19.

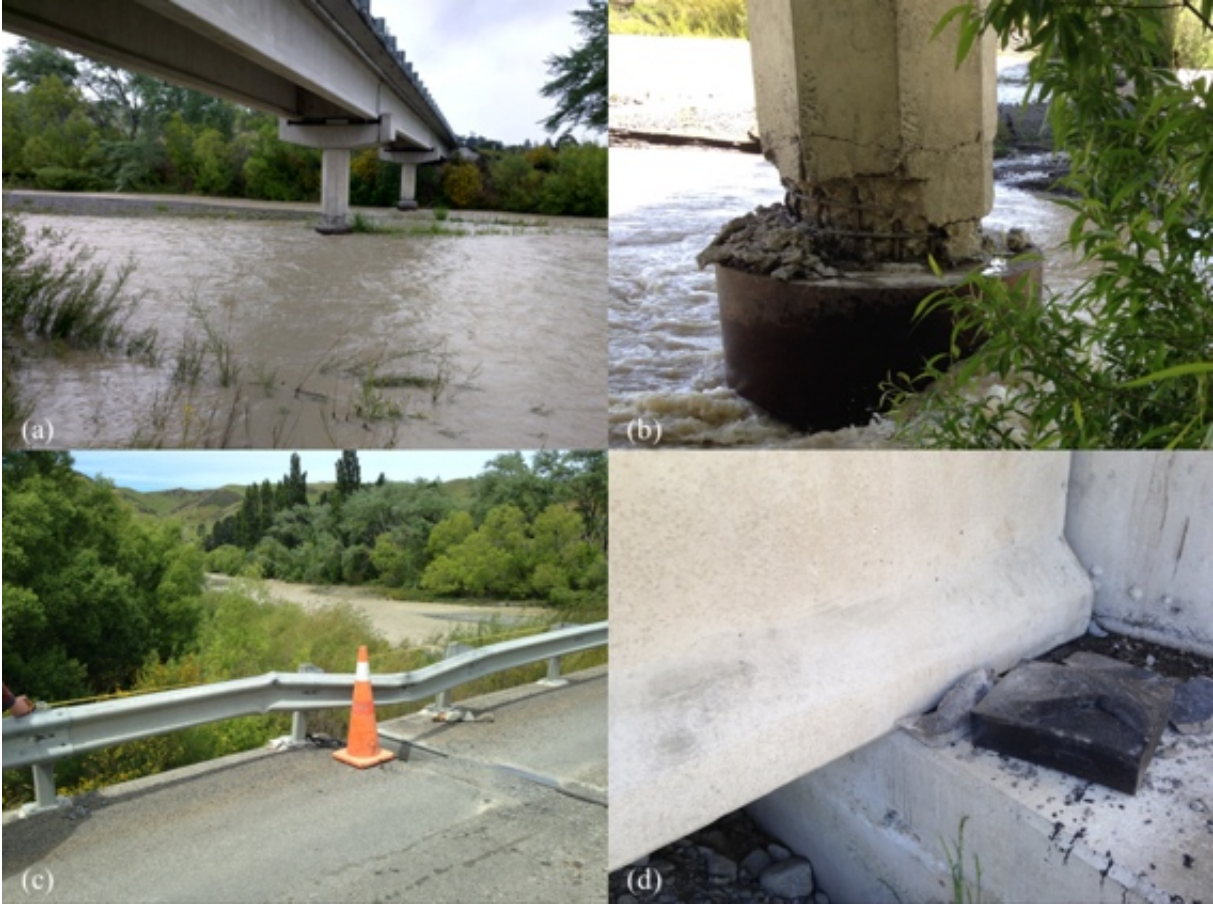
Figure 6.29: Structural damage at Lower Mason Bridge [-42.6343, 173.0664]. (a) Damage at base of piers looking south; (b) Base of southern-most pier looking north; (c) Deformation at central expansion joint looking southeast; (d) Girder unseated from bearing pad.

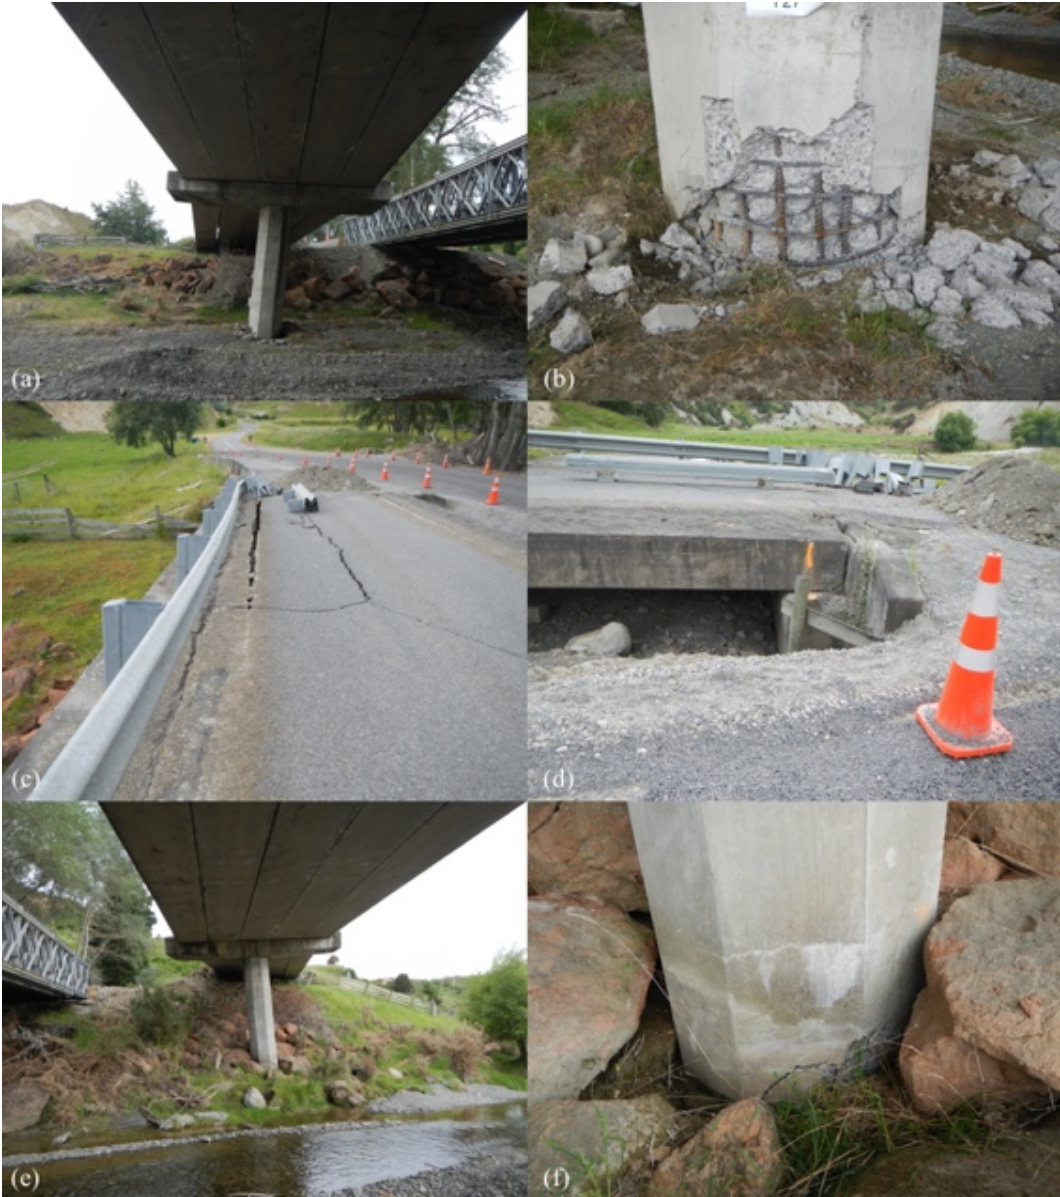
Figure 6.30: Structural damage to Wandle Bridge [-42.5864, 173.1003]: (a) South approach from under bridge; (b) Plastic hinging on pier near south approach; (c) Deck at southern end; (d) South abutment; (e) North approach from under bridge; (f) Minor hinging on pier near north abutment.

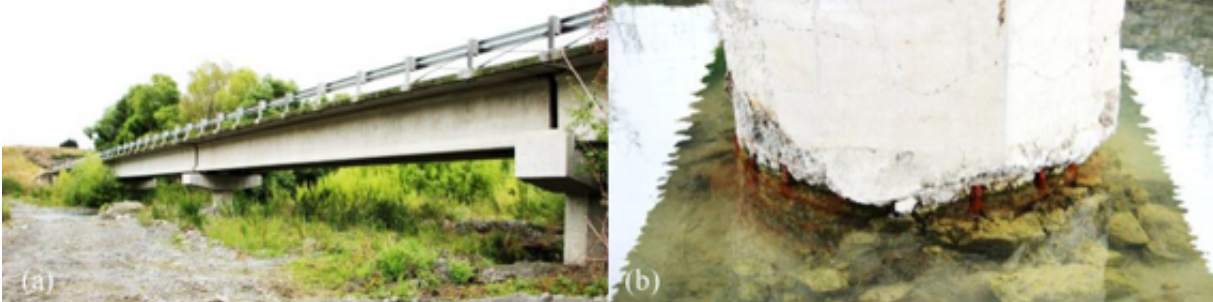
Figure 6.31: Lottery River Bridge [-42.6097, 173.0854]: (a) General layout; (b) Plastic hinge damage at base of pier.

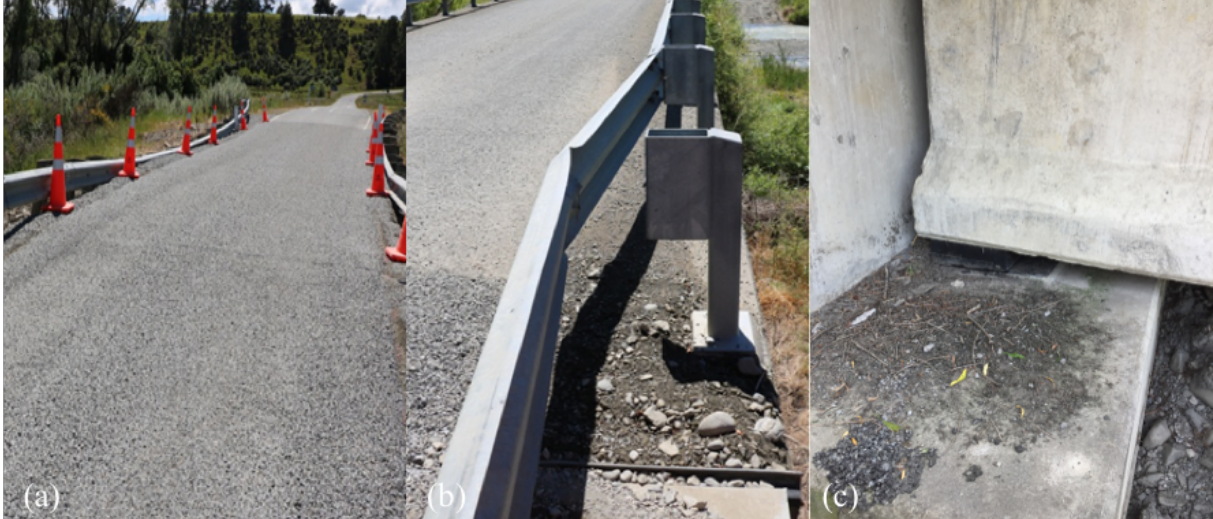
Figure 6.32: Damage at Lottery River Bridge [-42.6097, 173.0854]: (a) Gravel in-fill due to settlement and guardrail damage at northeast approach looking northeast; (b) Residual transverse offset of deck and abutment at northeast abutment looking southwest; (c) Residual displacement of bearing pad at southwest abutment looking west.

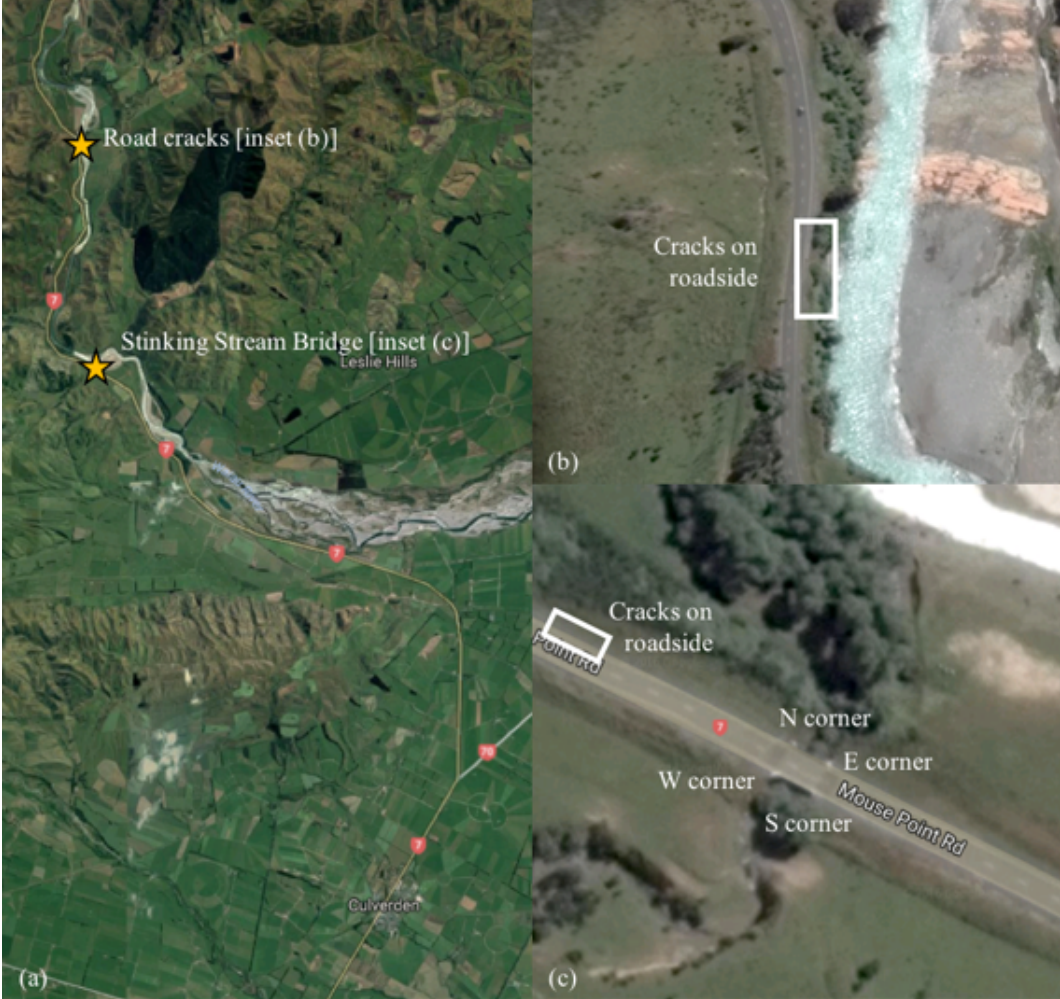
Figure 6.33: Highway 7 area: (a) Site locations for areas of interest; (b) Road crack site layout [-42.6310, 172.7718]; (c) Stinking Stream Bridge site layout [-42.6724, 172.7748].
