6 GEOTECHNICAL EFFECTS ON SOUTH ISLAND BRIDGES AND INFRASTRUCTURE

6.1 Hurunui District

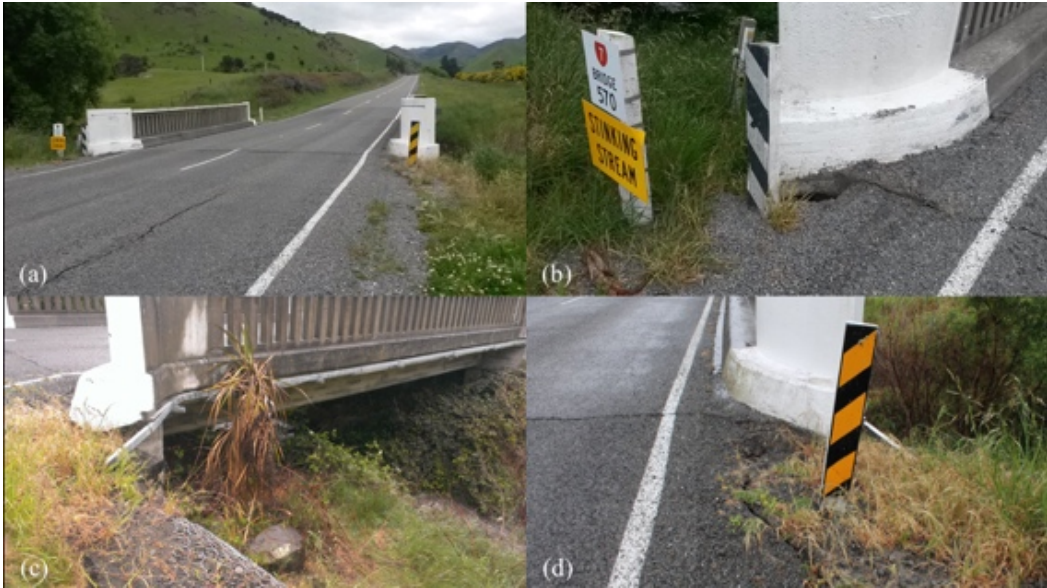
Figure 6.34: Stinking Stream Bridge [-42.6724, 172.7748]: (a) Looking north on 14 November; (b) Southern corner on 14 November; (c) and (d) Eastern corner on 17 November.

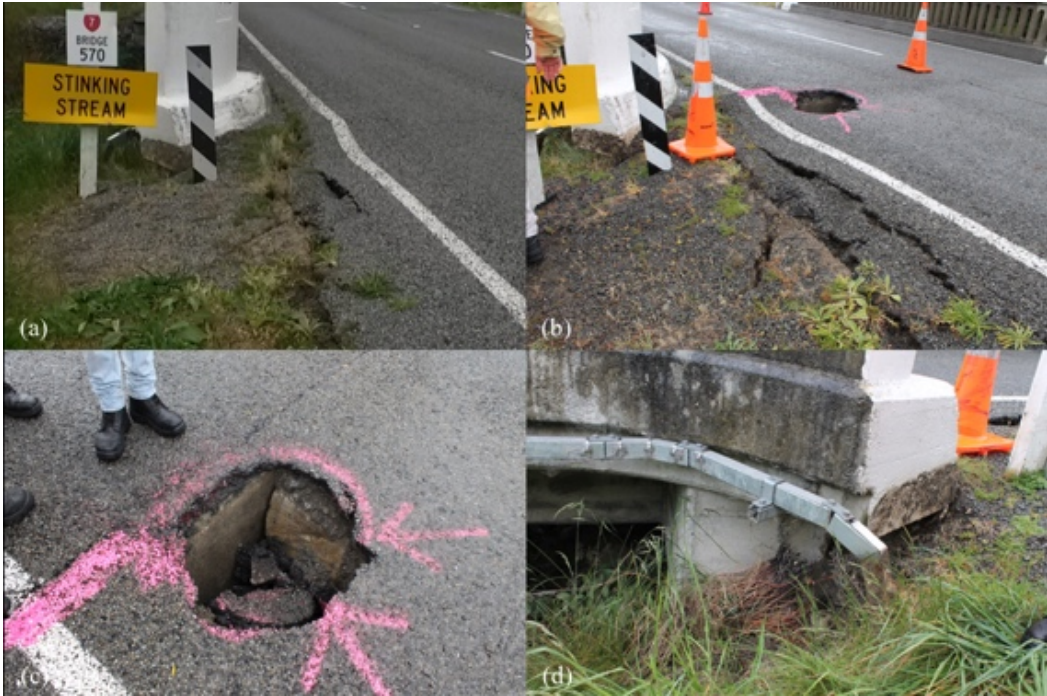
Figure 6.35: Northern corner of Stinking Stream Bridge [-42.6724, 172.7748]. (a) Looking south on 14 November; (b) Looking south on 17 November; (c) Hole in roadway; (d) Settlement on 17 November.

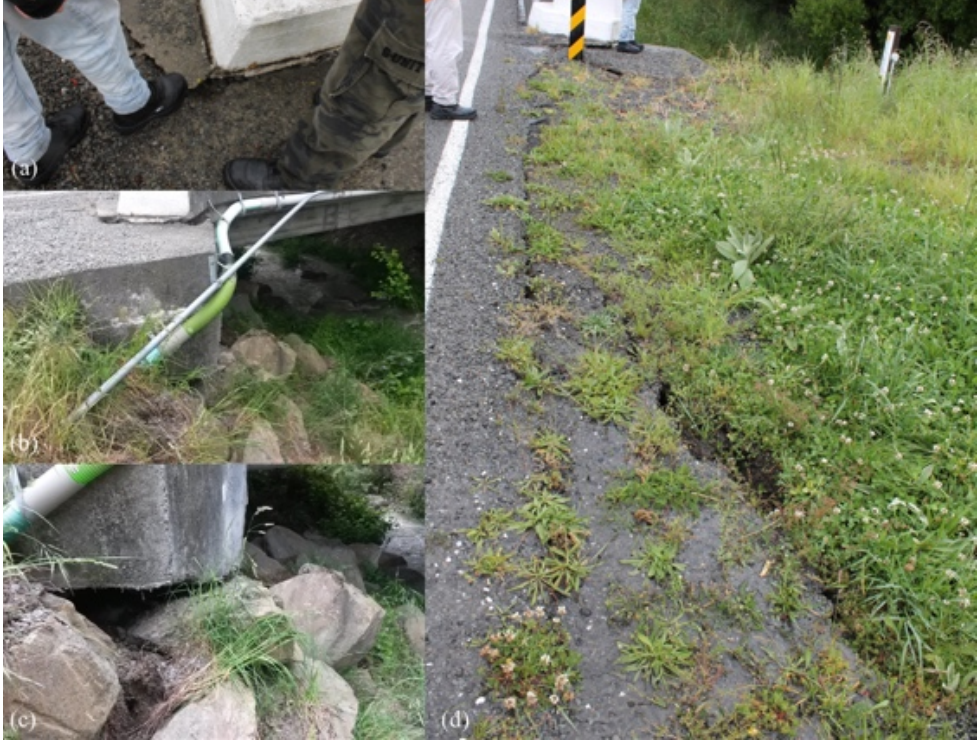
Figure 6.36: West corner of Stinking Stream Bridge [-42.672427, 172.774764]: (a) Settlement and cracking at abutment; (b) Settlement looking east; (c) Rip-rap movement away from the abutment base; (d) Cracking in approach.

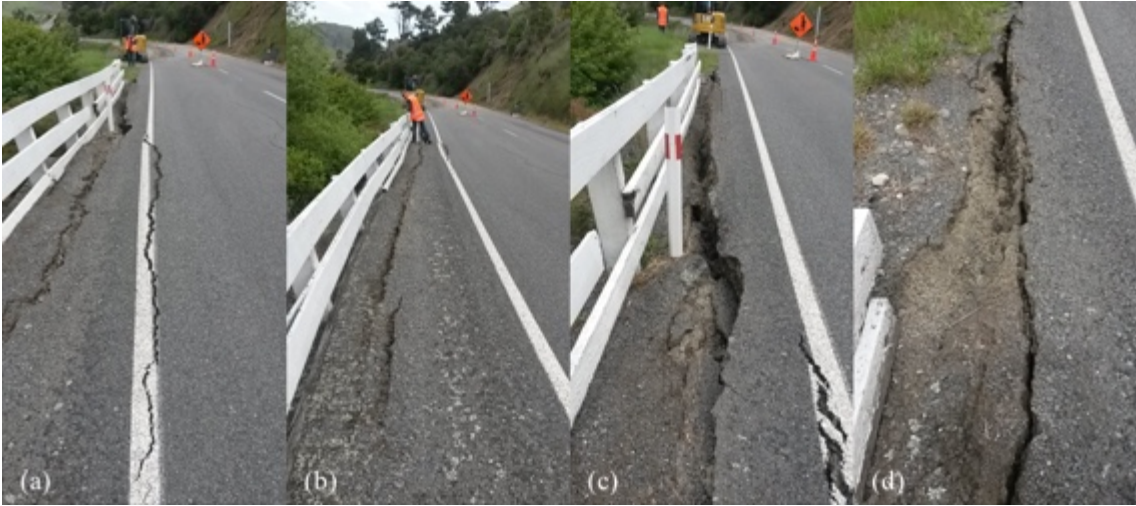
Figure 6.37: Cracks on free-face side of roadway on Highway 7 looking south [-42.6310, 172.7718]. Location and site layout shown in Figure 6.33.

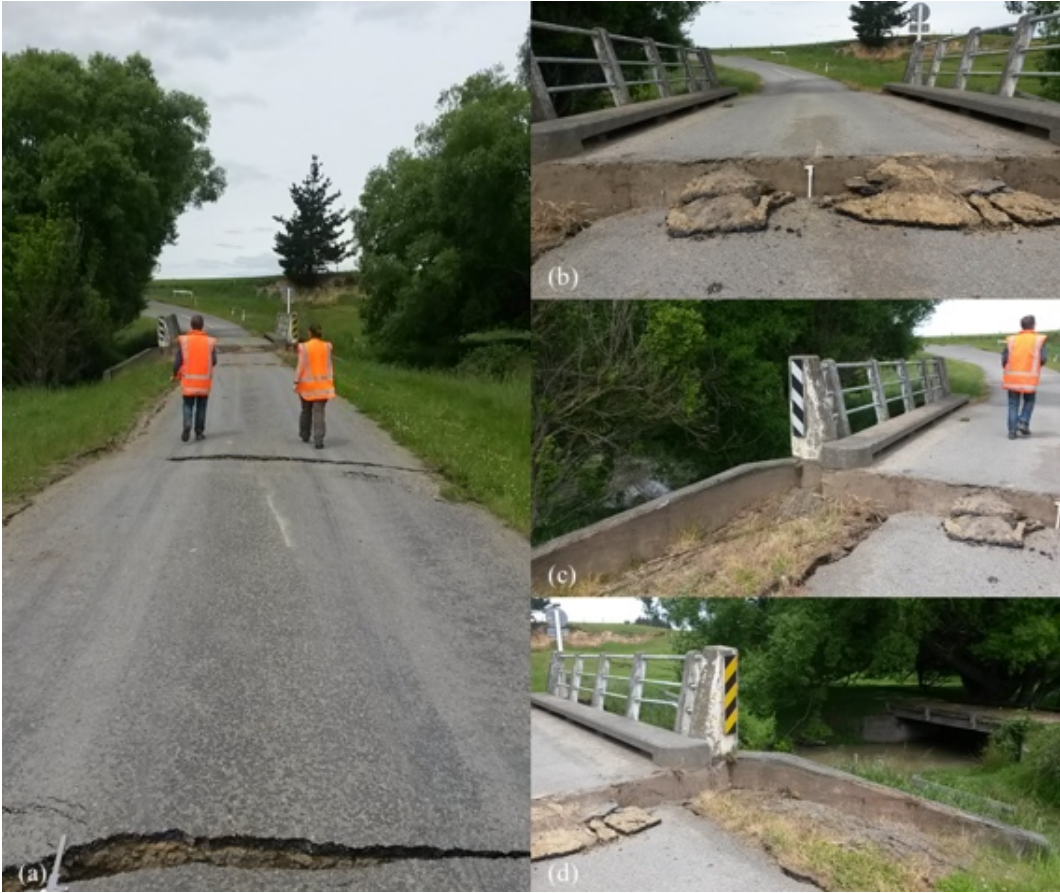
Figure 6.38: Home Creek Bridge [-42.6323, 172.9528]: (a) Roadway cracks in western approach; (b), (c), and (d) Settlement at western abutment.

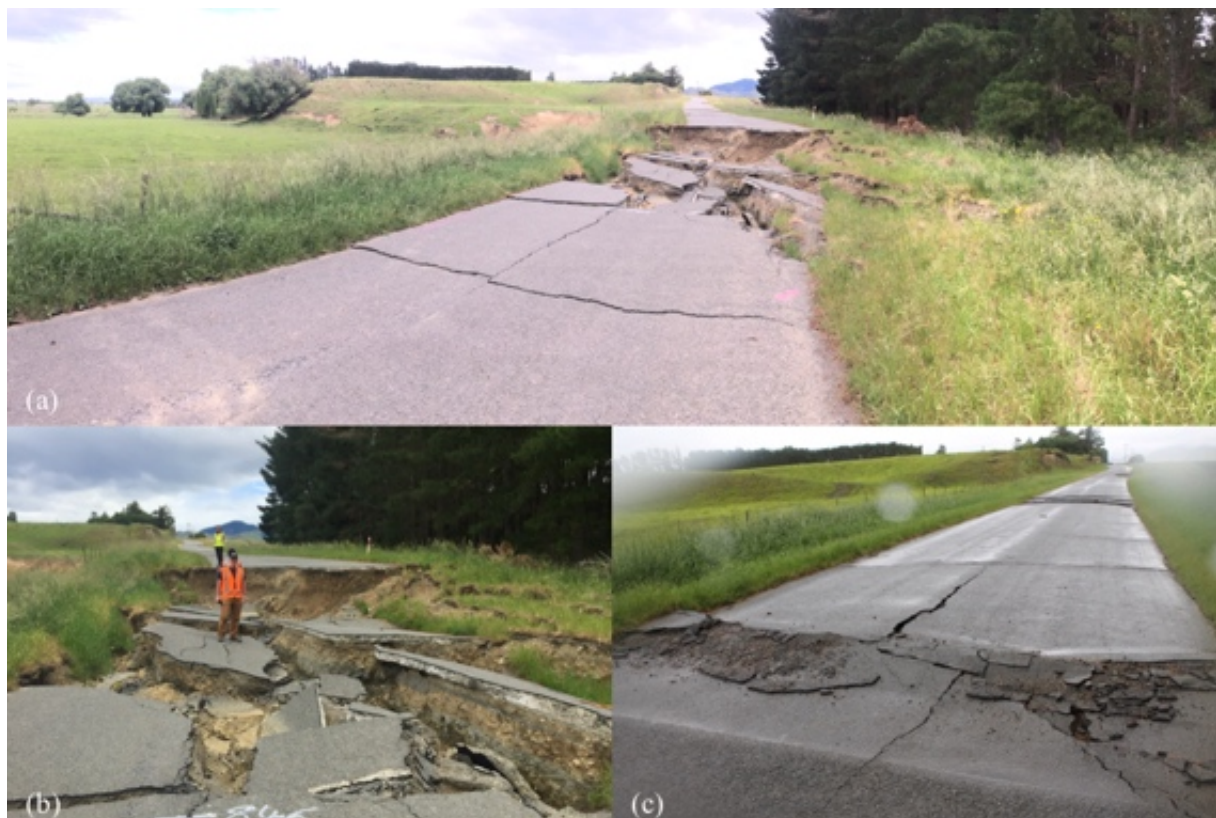
Figure 6.39: Failure and severe cracking on Leslie Hills Road (photos all taken looking west) [-42.6306,172.9895]: (a) Overview of major failure area; (b) Closer view of failure area; (c) Cracking to west of failure area.

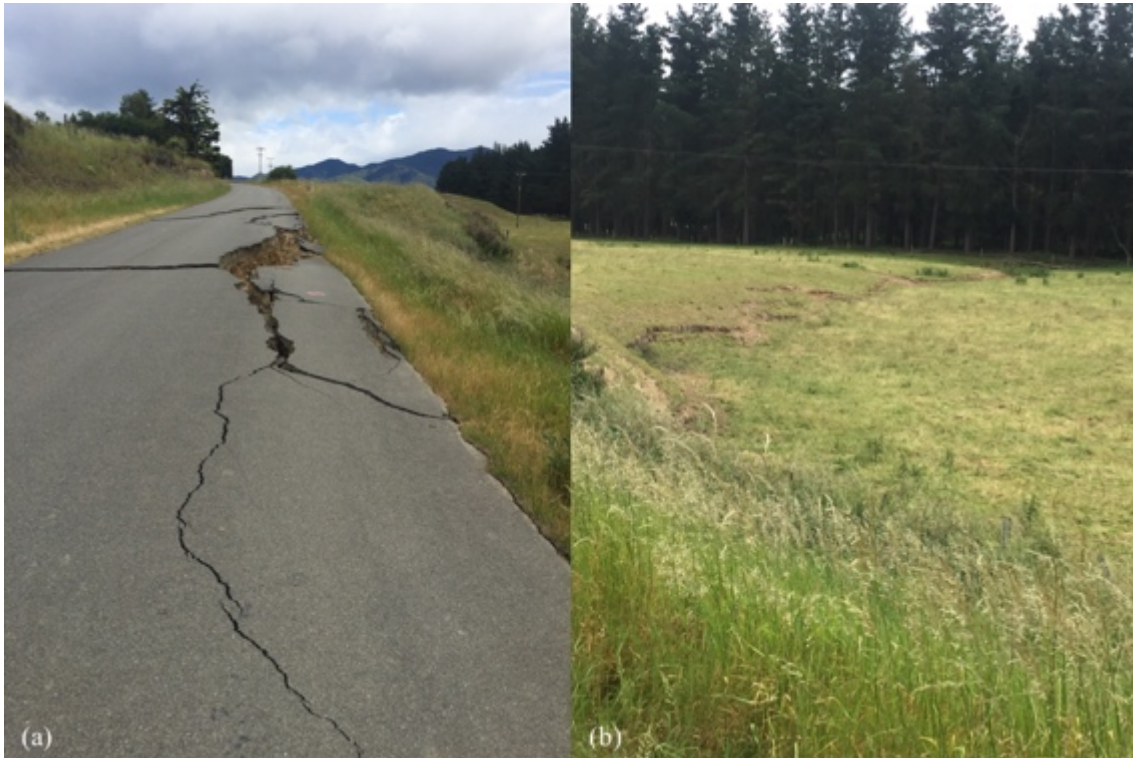
Figure 6.40: Damage west of failure area on Leslie Hills Road (both photos taken looking west) [-42.6306,172.9895]: (a) Cracking and failure of the road on free face of embankment; (b) Adjacent cracking through paddock.

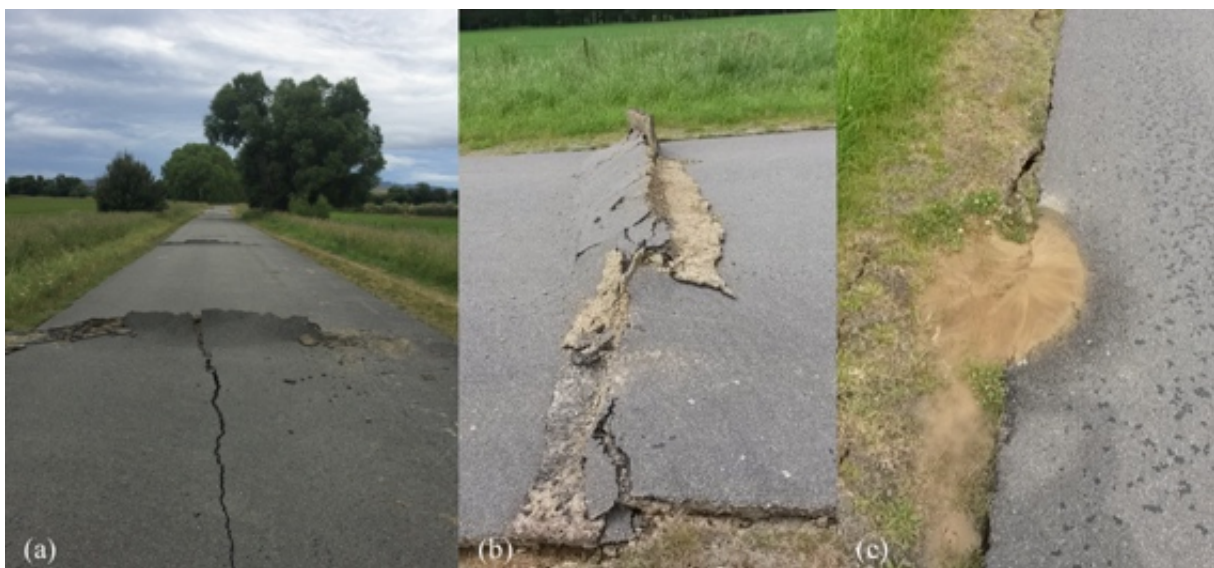
Figure 6.41: Damage observations east of Leslie Hills Road failure area [-42.6306,172.9895]: (a) Compression ridging in pavement material; (b) Side view of compression ridge; (c) Minor liquefaction ejecta.

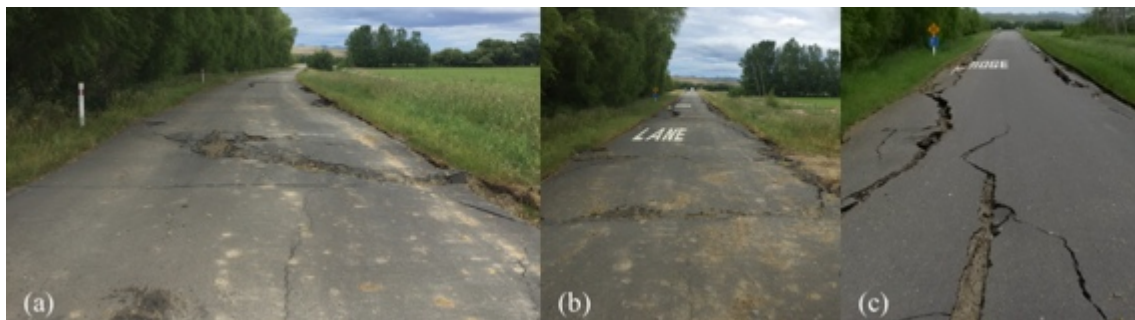
Figure 6.42: Cracking in roadway approaching Mt Paul Bridge from the north along Leslie Hills Road [-42.6355, 172.9924].

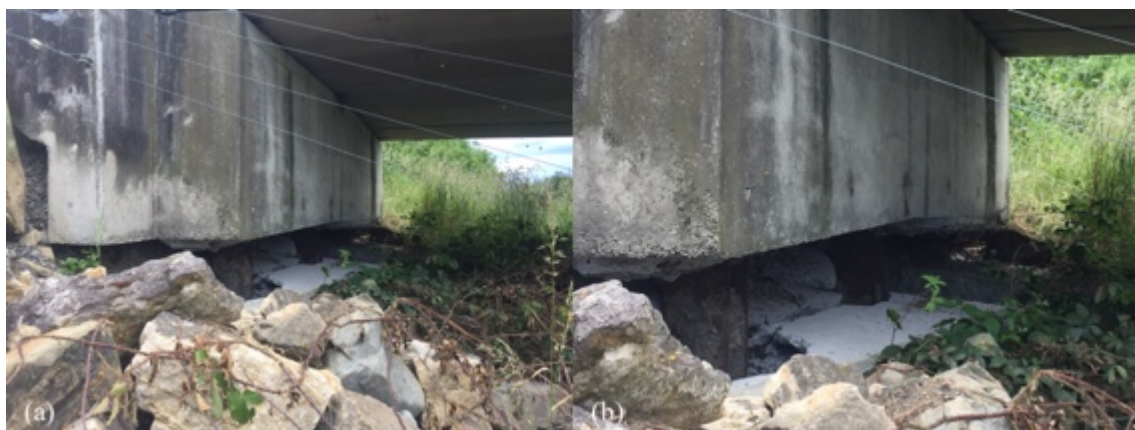
Figure 6.43: Settlement below abutment at Mt Paul Bridge [-42.6355, 172.9923].

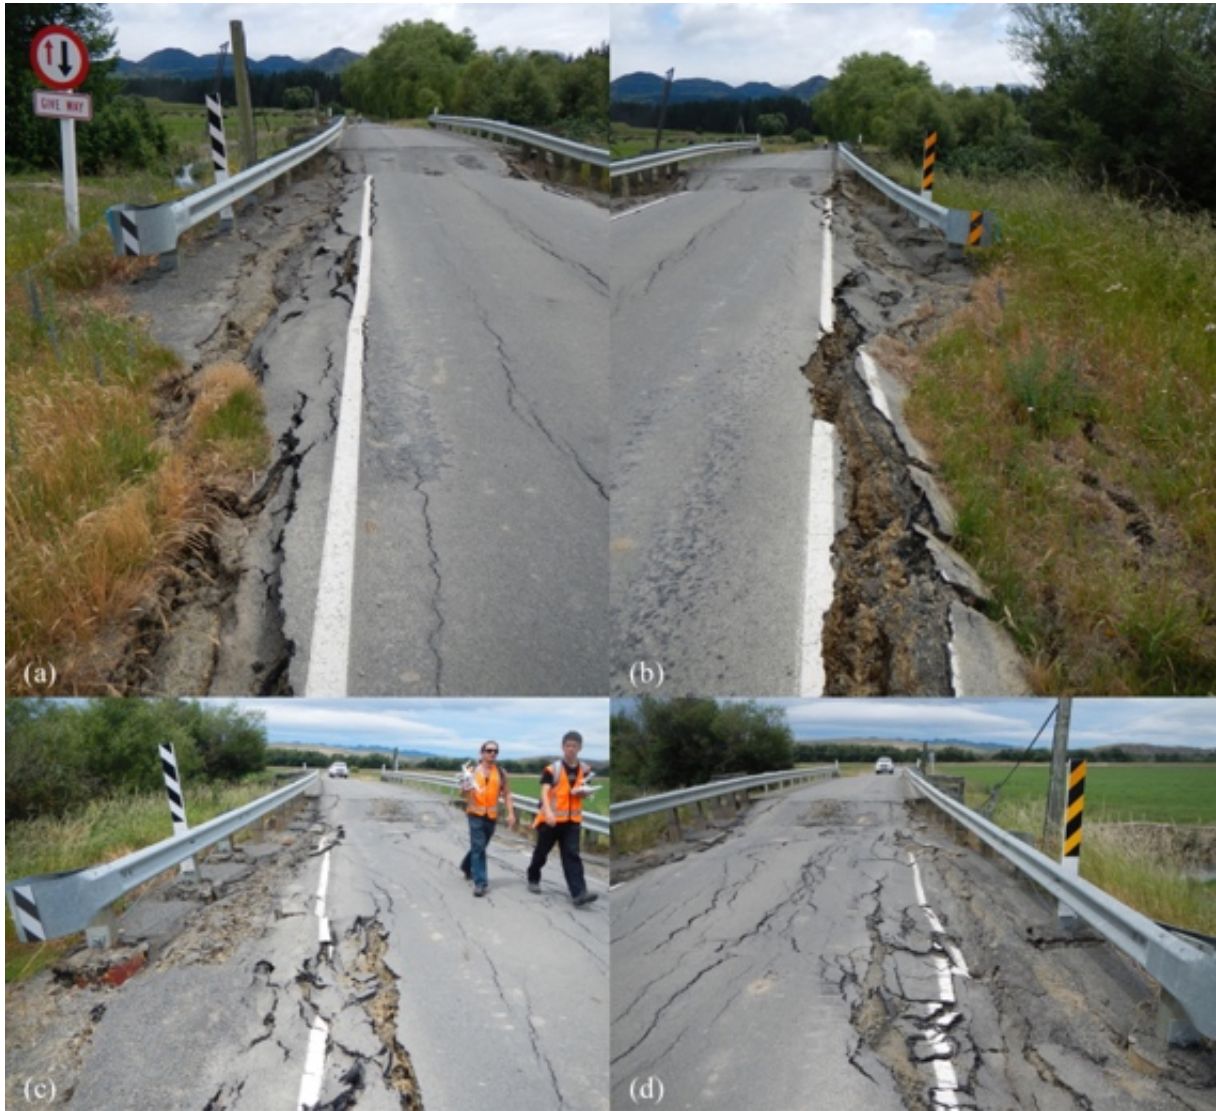
Figure 6.44: Settlement and cracking in approaches to Mt Paul Bridge [-42.6355, 172.9924]: (a) Southwest corner; (b) Southeast corner; (c) Northeast corner; (d) Northwest corner.

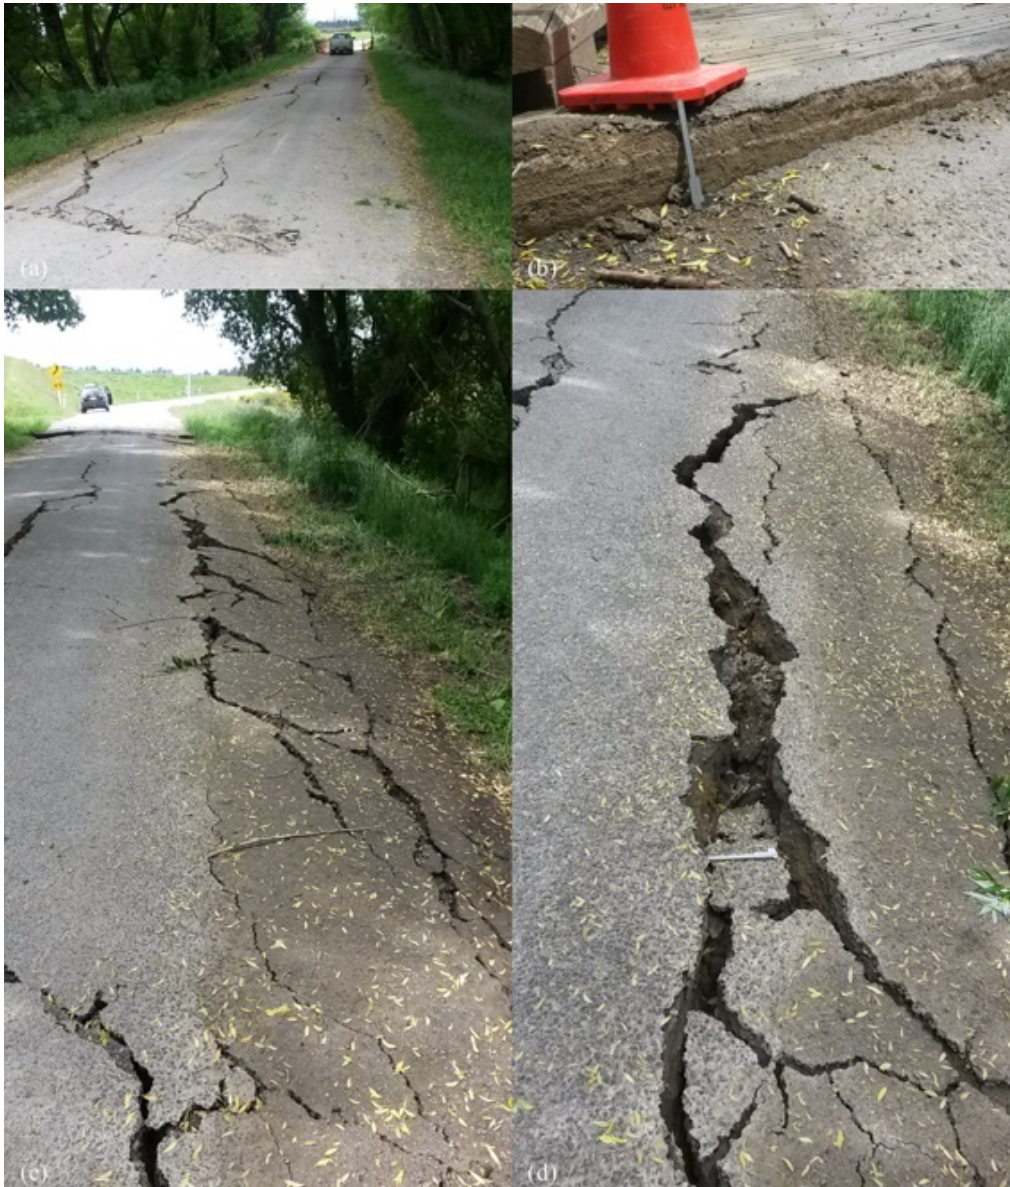
Figure 6.45: Damage at Emu Plains Bridge [-42.6394, 172.9149]: (a) Roadway damage looking west towards bridge; (b) Settlement at eastern abutment; (c) and (d) Significant cracking in roadway on eastern side of bridge (photos taken facing east away from bridge).

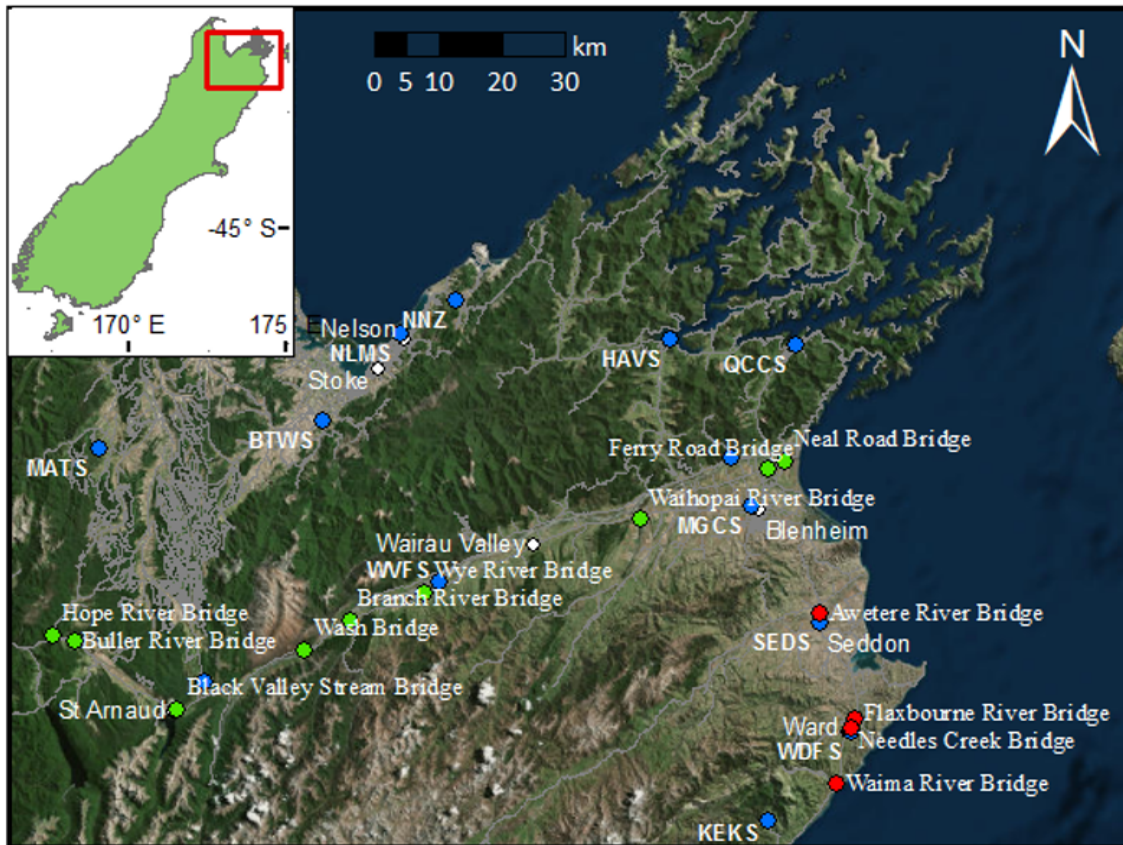
Figure 6.46: Bridge sites surveyed in the Marlborough District. Green markers indicate bridges with minor or no damage observations. Red markers indicate sites with moderate to severe damage observations. Blue markers indicate strong motion stations.

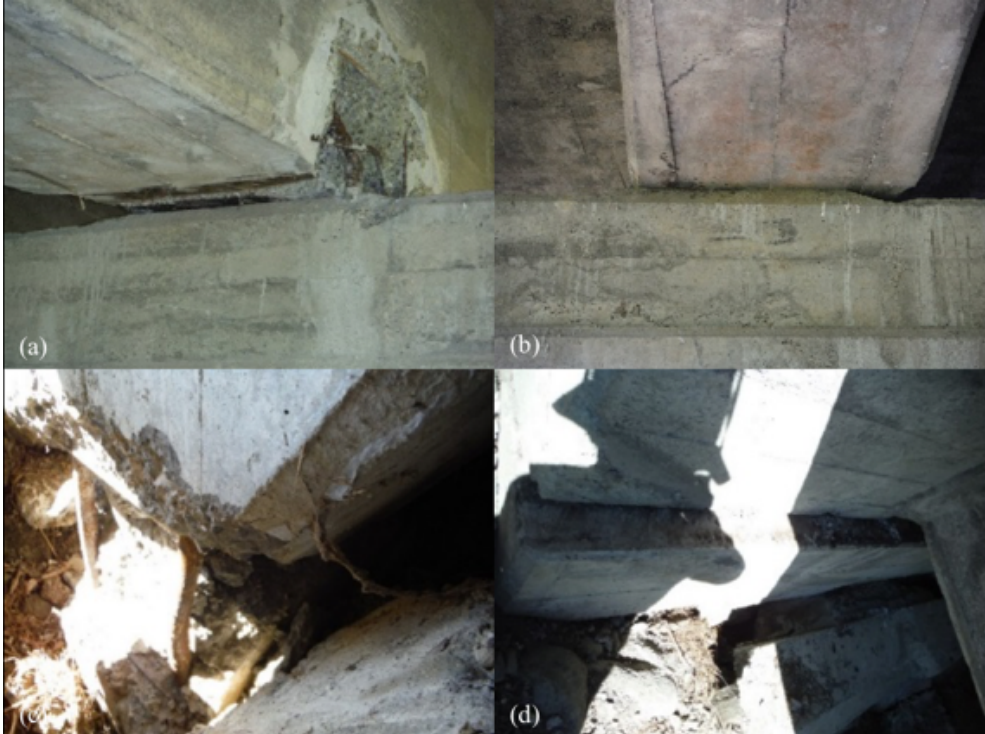
Figure 6.47: Damage at Flaxbourne River Bridge [-41.8085, 174.1458]: (a) Damage at deck-pier connection; (b) Residual transverse deck displacement; (c) Exposed and buckled reinforcement in abutment columns; (d) Residual longitudinal deck displacement.

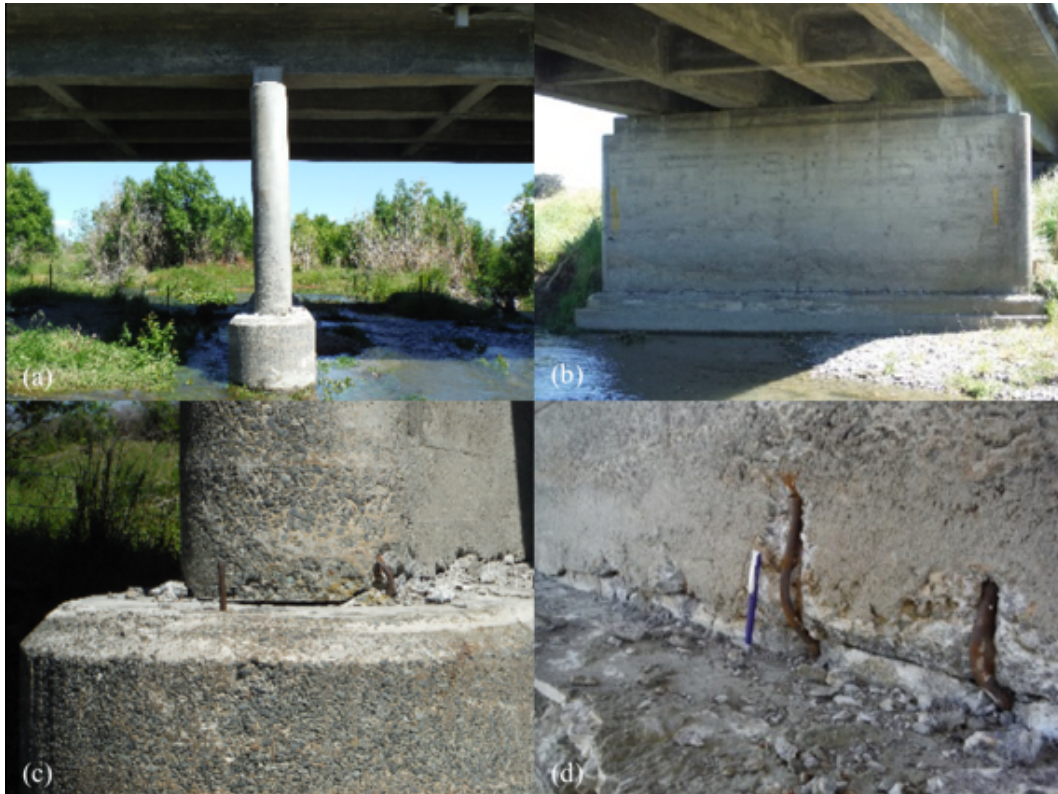
Figure 6.48: Substructure damage at Flaxbourne River Bridge [-41.8085, 174.1458]: (a) Tilted pier; (b) Cracking at pier base; (c) and (d) Cracking and exposed reinforcement at base of piers.

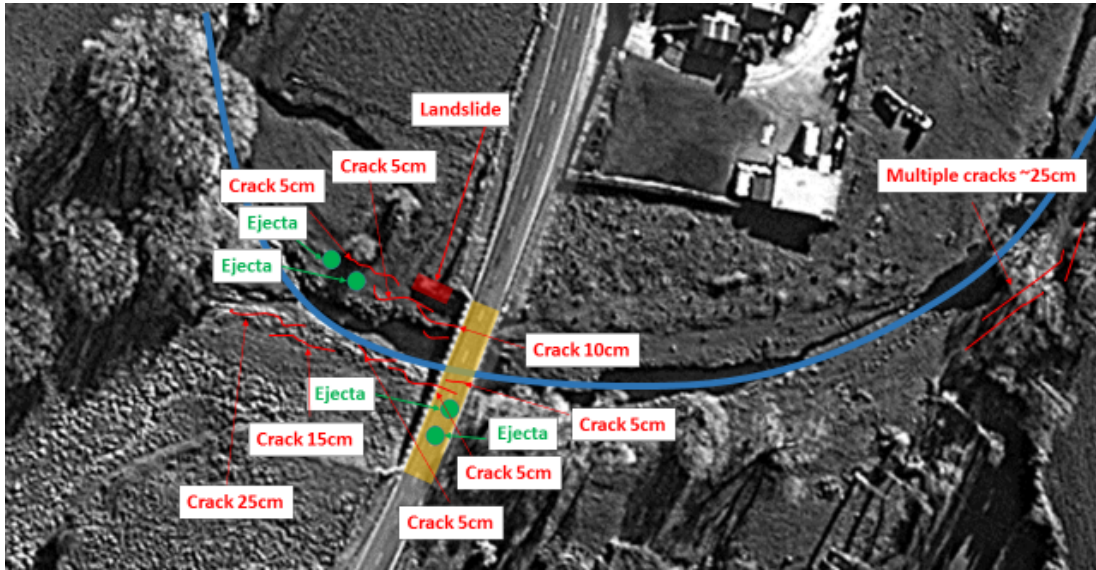
Figure 6.50: Overview of Needles Creek Bridge site with indications of ground damage. Orange area is the bridge deck, red lines indicate cracks, and the green markers indicate sand boils. The blue line indicates the creek bed.

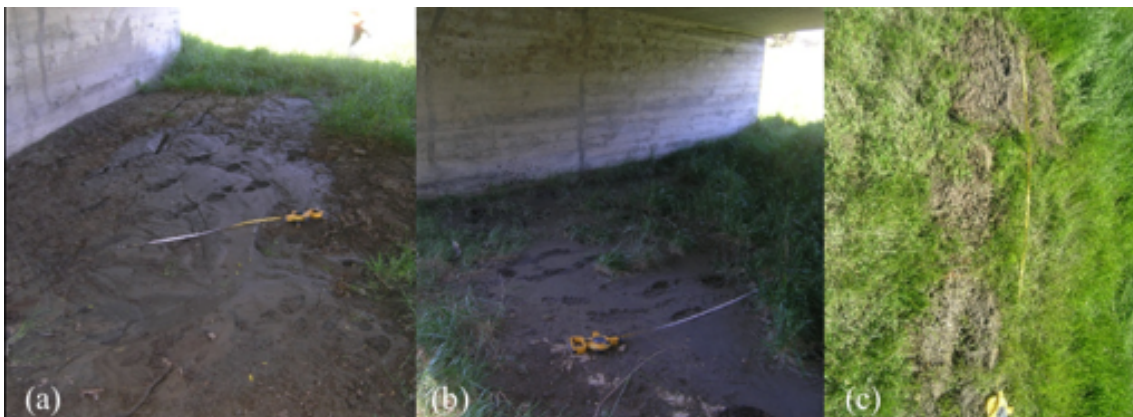
Figure 6.51: Liquefaction ejecta at Needles Creek Bridge site [-41.8217, 174.1370]: (a) Ejecta between piers 1 and 2; (b) Ejecta between piers 3 and 4; (c) Ejecta in free field west of bridge.

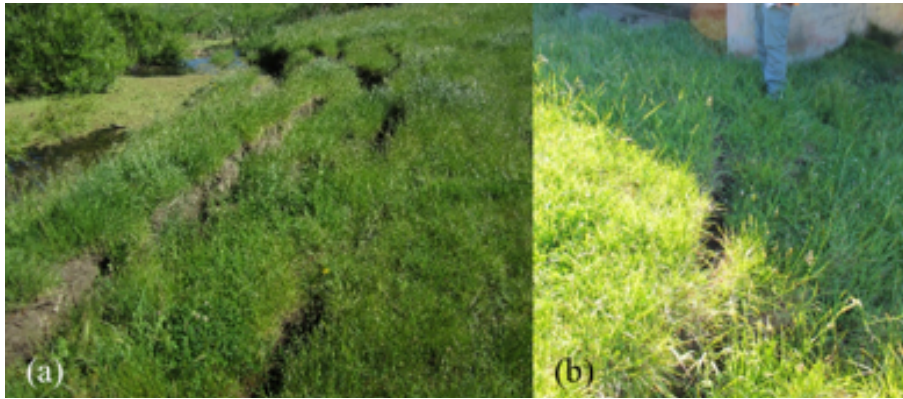
Figure 6.52: Free field lateral spreading cracks at Needles Creek Bridge site [-41.8217, 174.1370]: (a) Cracks along free face of the river; (b) Cracking near bridge pier.

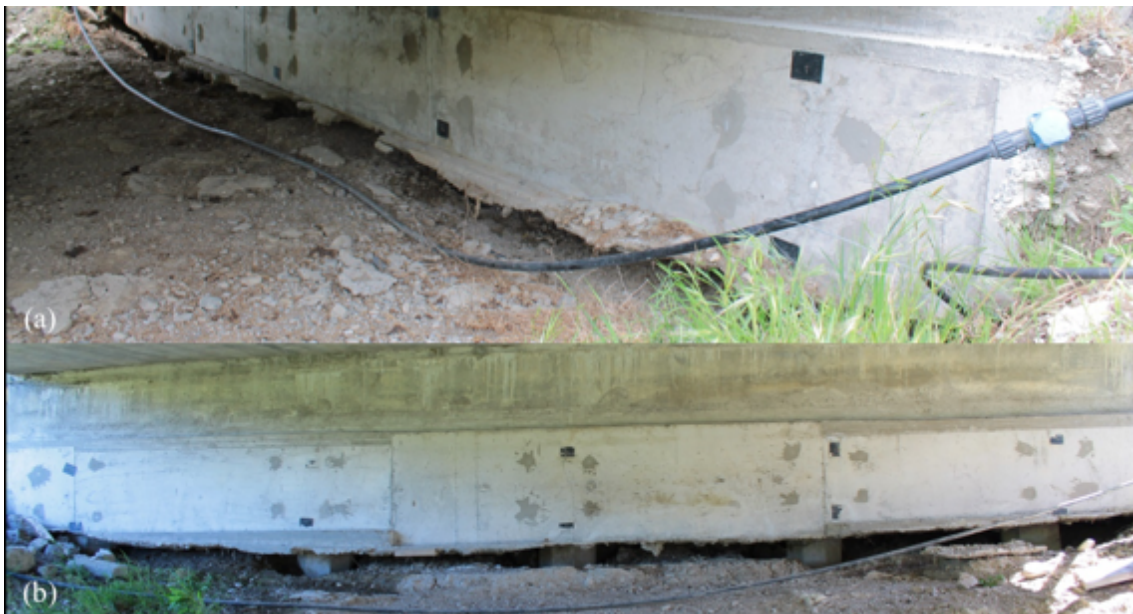
Figure 6.53: Soil subsidence below abutments at Needles Creek Bridge [-41.8217, 174.1370]: (a) North abutment wall looking northwest; (b) South abutment wall looking south.

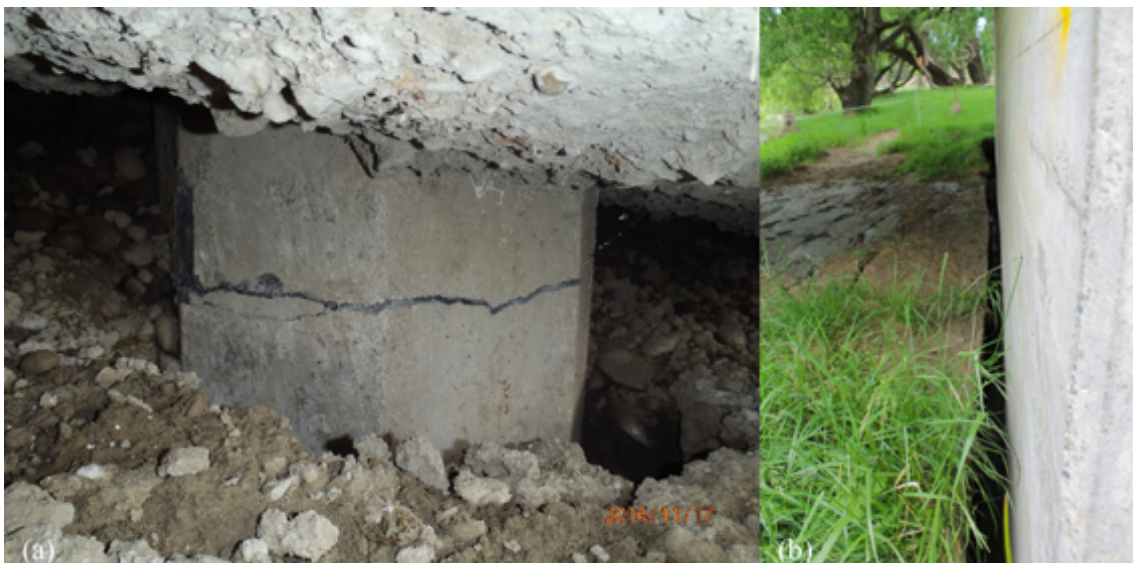
Figure 6.54: Pile and footing damage at Needles Creek Bridge [-41.8217, 174.1370]: (a) Crack in pile for south abutment; (b) Soil-footing gapping at pier 3.

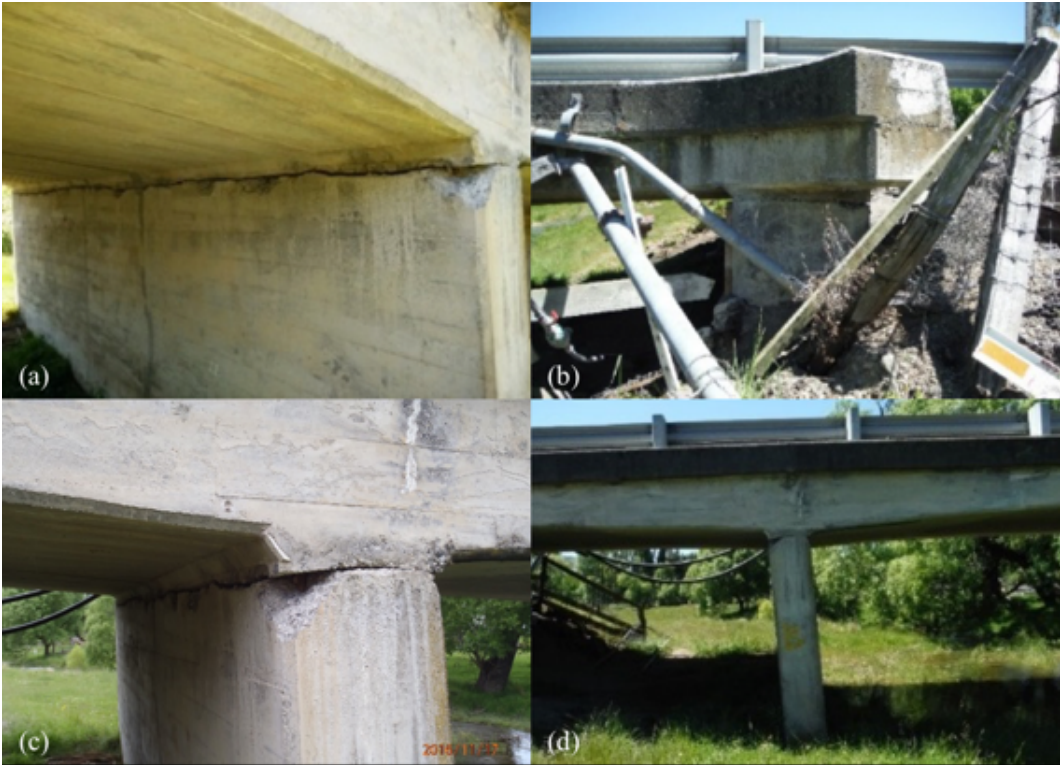
Figure 6.55: Structural damage at Needles Creek Bridge [-41.8217, 174.1370]: (a) Cracking across length of pier 1 looking south; (b) Deck sheared off of abutment 1 facing west; (c) Cracking at pier 1 facing east; (d) Tilting of pier 1 facing east.

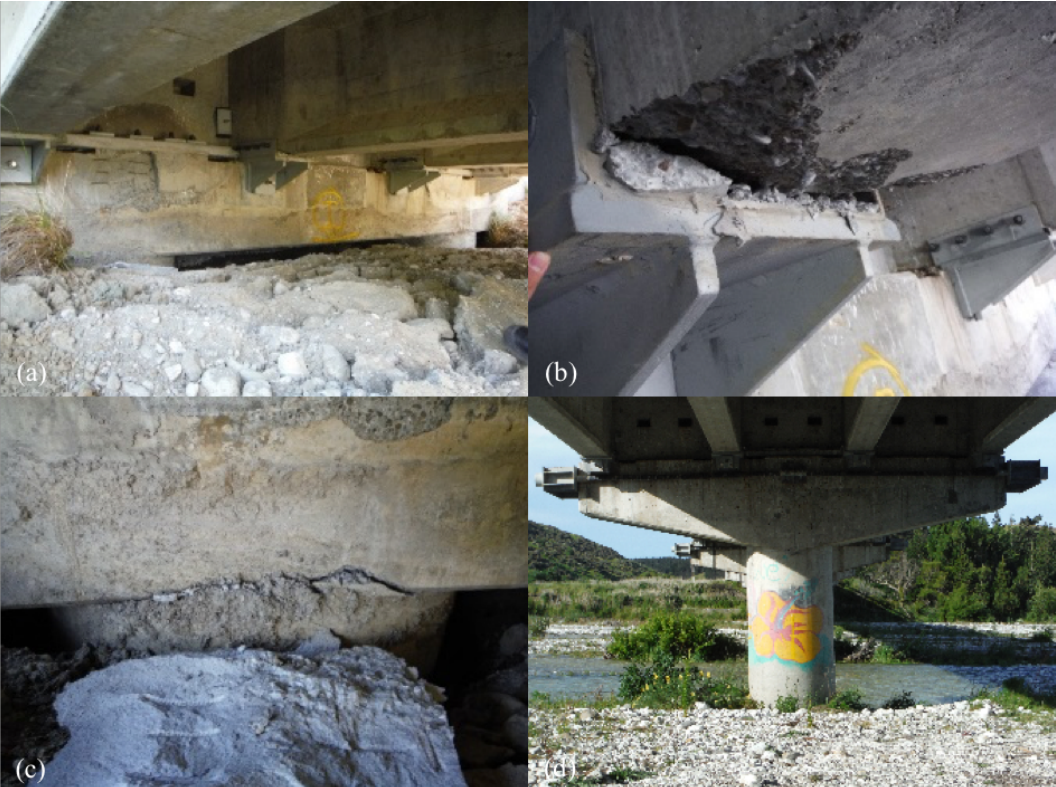
Figure 6.56: Damage at Waima River Bridge [-41.9021, 174.1122]: (a) South abutment facing south; (b) Damage to concrete beams around retrofit brackets; (c) Cracking at top of abutment pile; (d) Tilt of southernmost pier facing north.

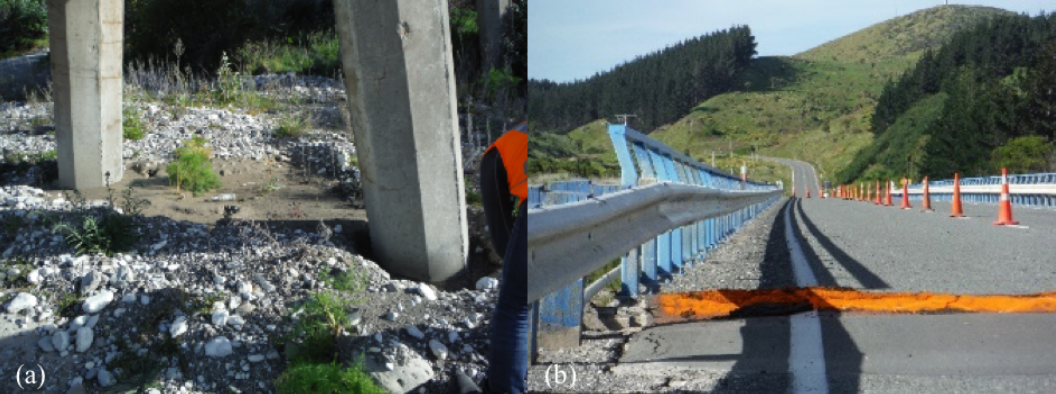
Figure 6.57: Geotechnical damage at Waima River Bridge site [-41.9021, 174.1122]; (a) Ejecta at piers of railroad bridge 50 m upstream; (b) Settlement at south approach looking north.

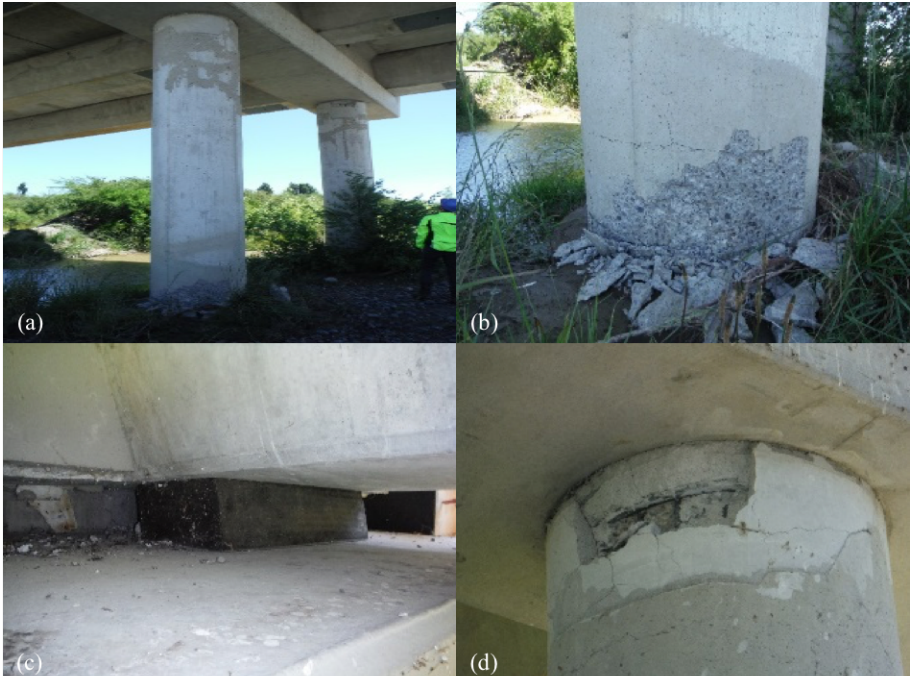
Figure 6.58: Damage at Awatere River Bridge [-41.6585, 174.077]: (a) Flexural damage at top and bottom of pier column near middle of bridge facing west; (b) Spalling of concrete at base of pier column; (c) Residual displacement in bearing pad at southern abutment; (d) Damage to previously grouted area.

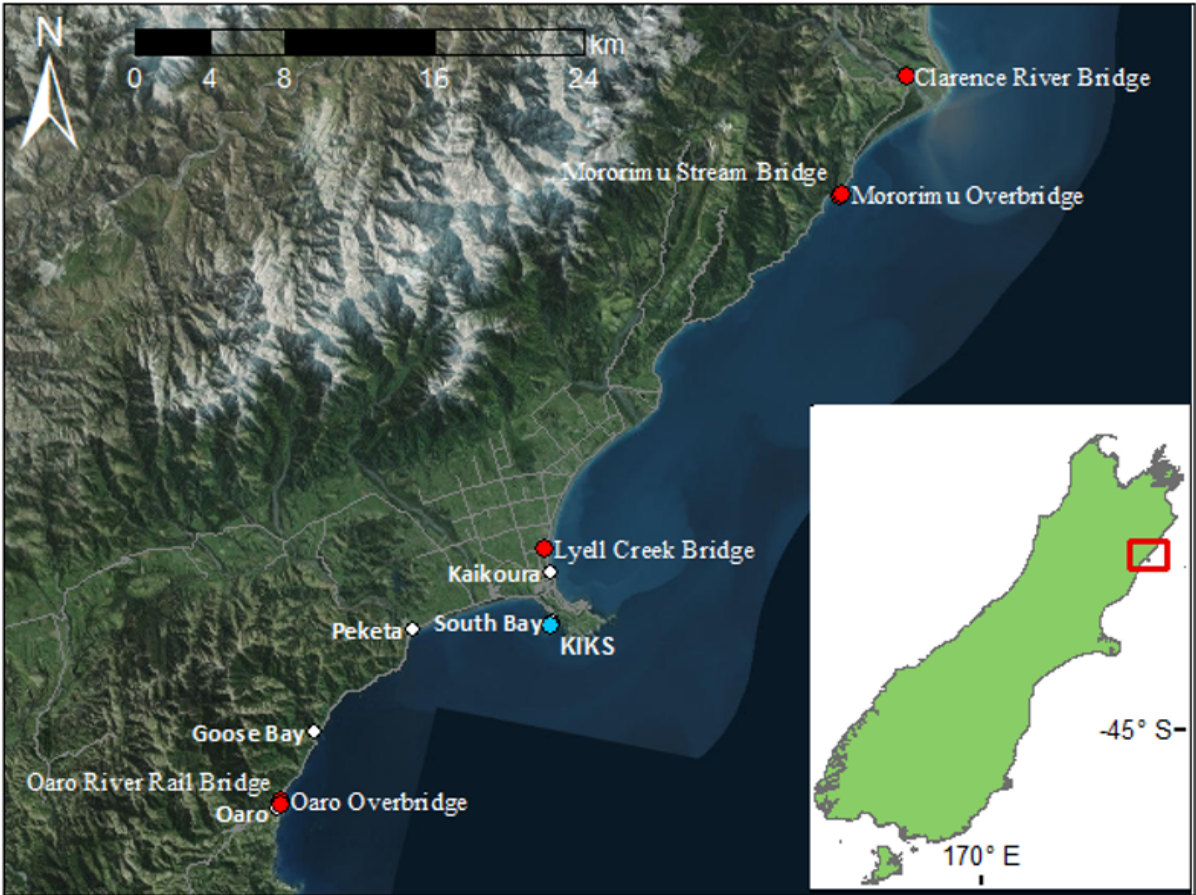
Figure 6.59: Bridge sites in the Kaikoura District with observations of moderate to severe damage. Red markers indicate bridge sites. Blue markers indicate strong motion stations.

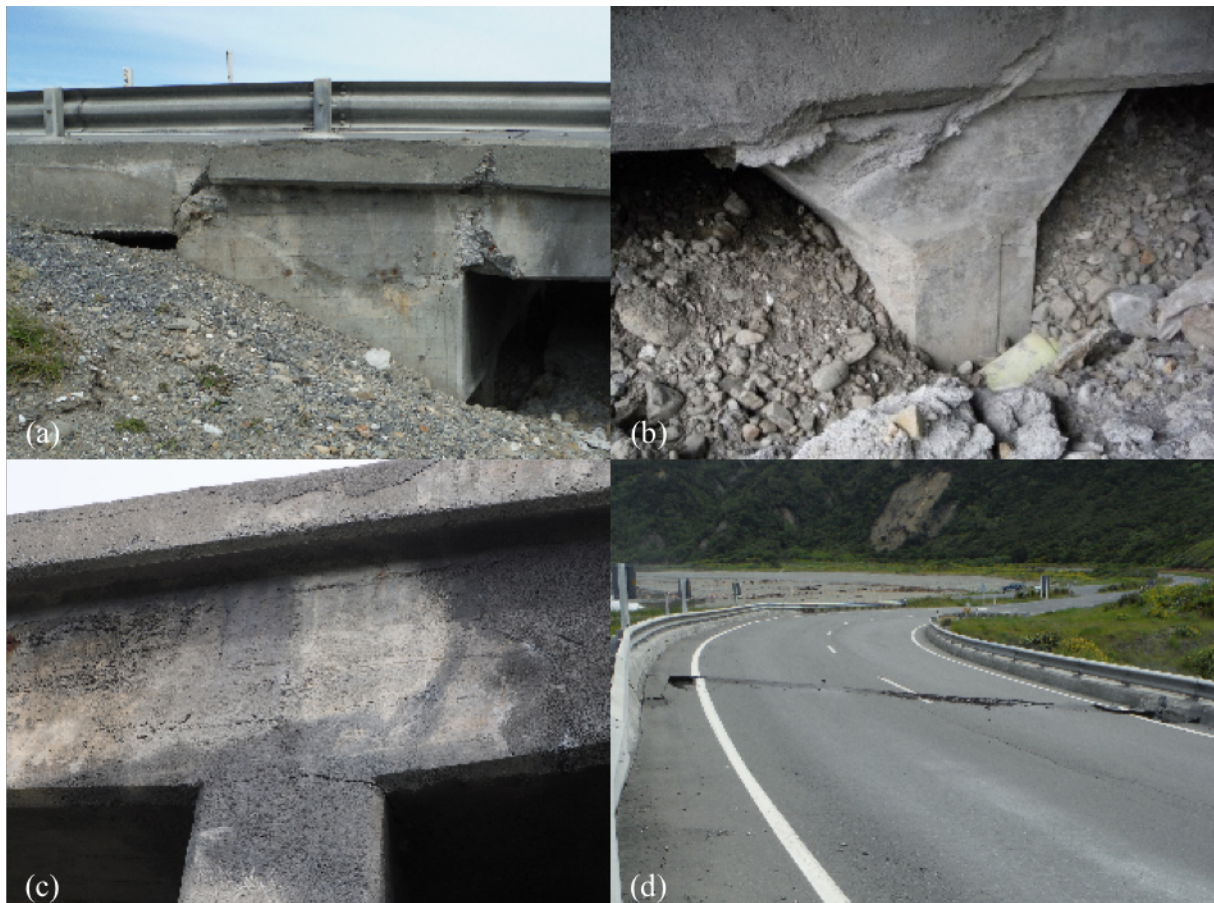
Figure 6.60: Damage observed at Mororimu Stream Bridge [-42.2173, 173.8673]: (a) Cracking in eastern abutment looking south; (b) Abutment column cracking; (c) Cracking at top of pier; (d) Settlement of eastern approach looking west.

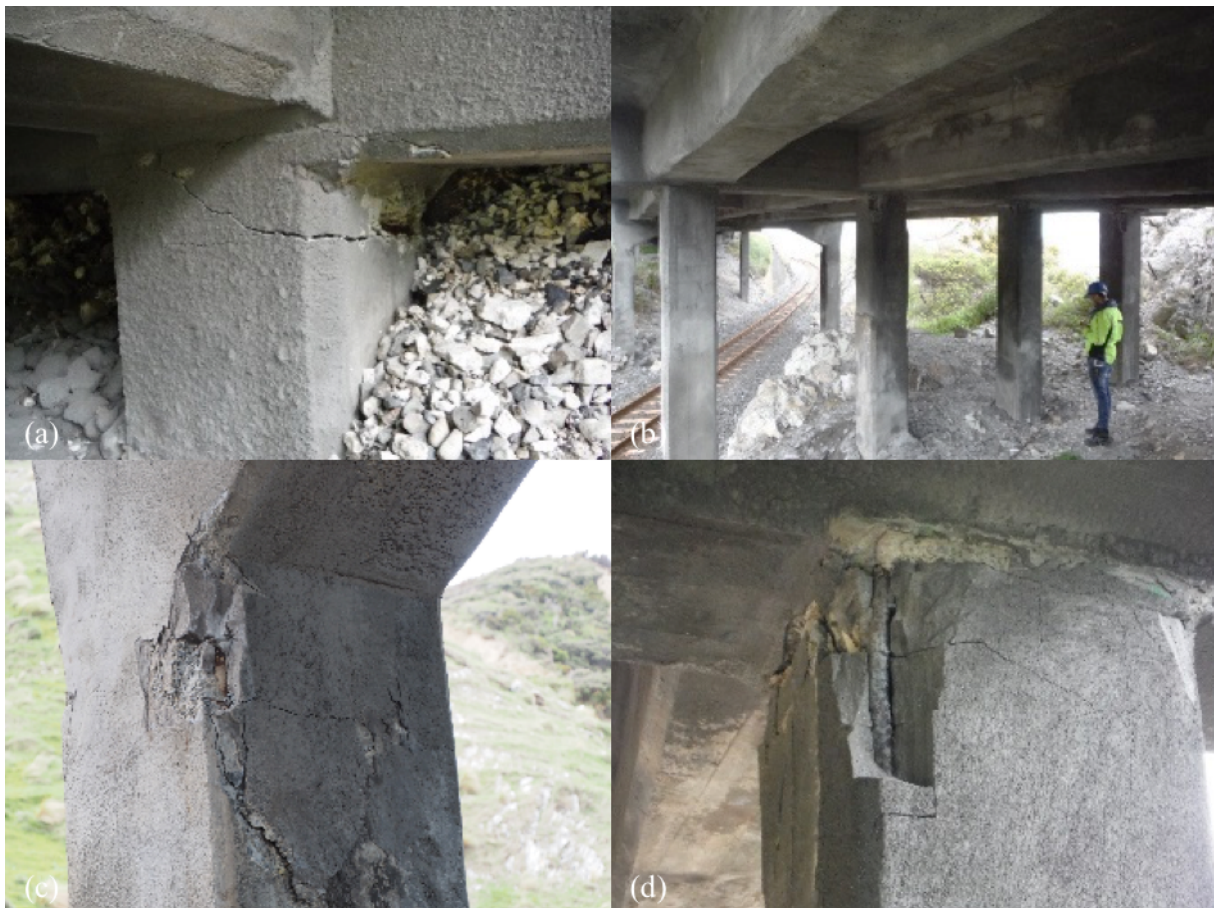
Figure 6.61: Structural damage observations at the Mororimu Overbridge [-42.2166, 173.8686]: (a) Abutment column cracking; (b) Damage to pier columns; (c) Cracking below knee joint of central pier column; (d) Exposed reinforcement at top of pier column.

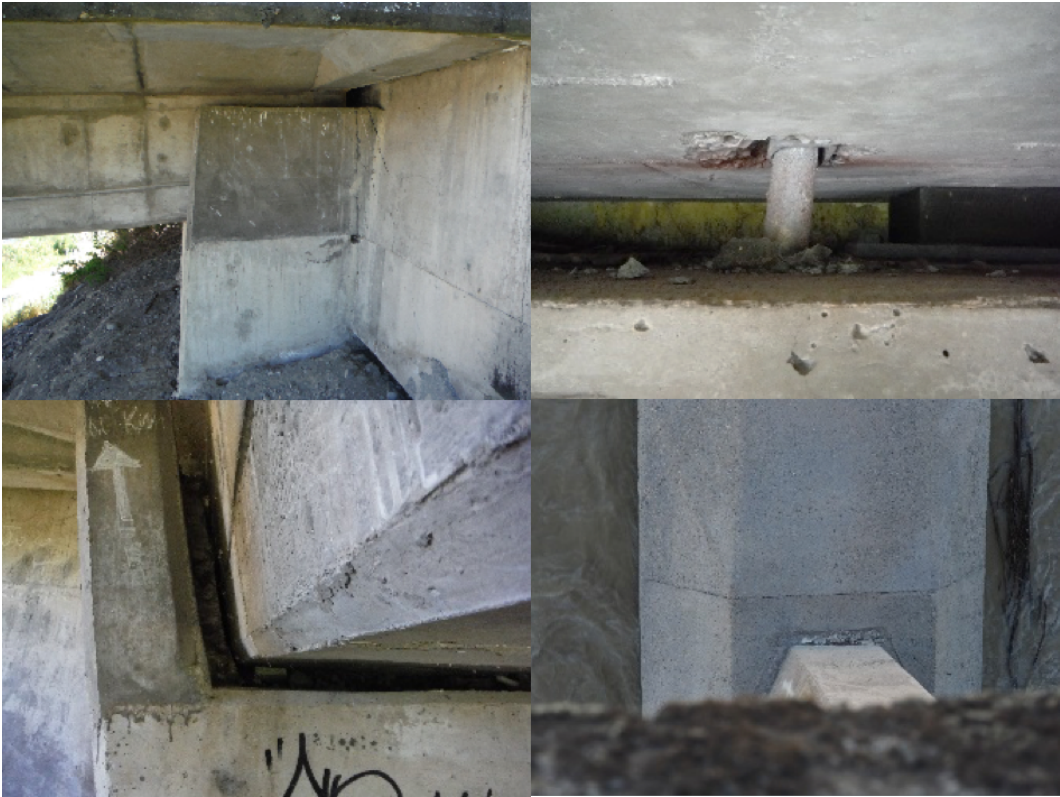
Figure 6.62: Structural damage at Clarence River Bridge [-42.1592, 173.9103]: (a) Cracking in transverse abutment wall; (b) Residual deformation in hold down rod securing deck to abutment; (c) Deck settlement at abutment; (d) Concrete spalling at base of pier.
