6 GEOTECHNICAL EFFECTS ON SOUTH ISLAND BRIDGES AND INFRASTRUCTURE

6.1 Hurunui District

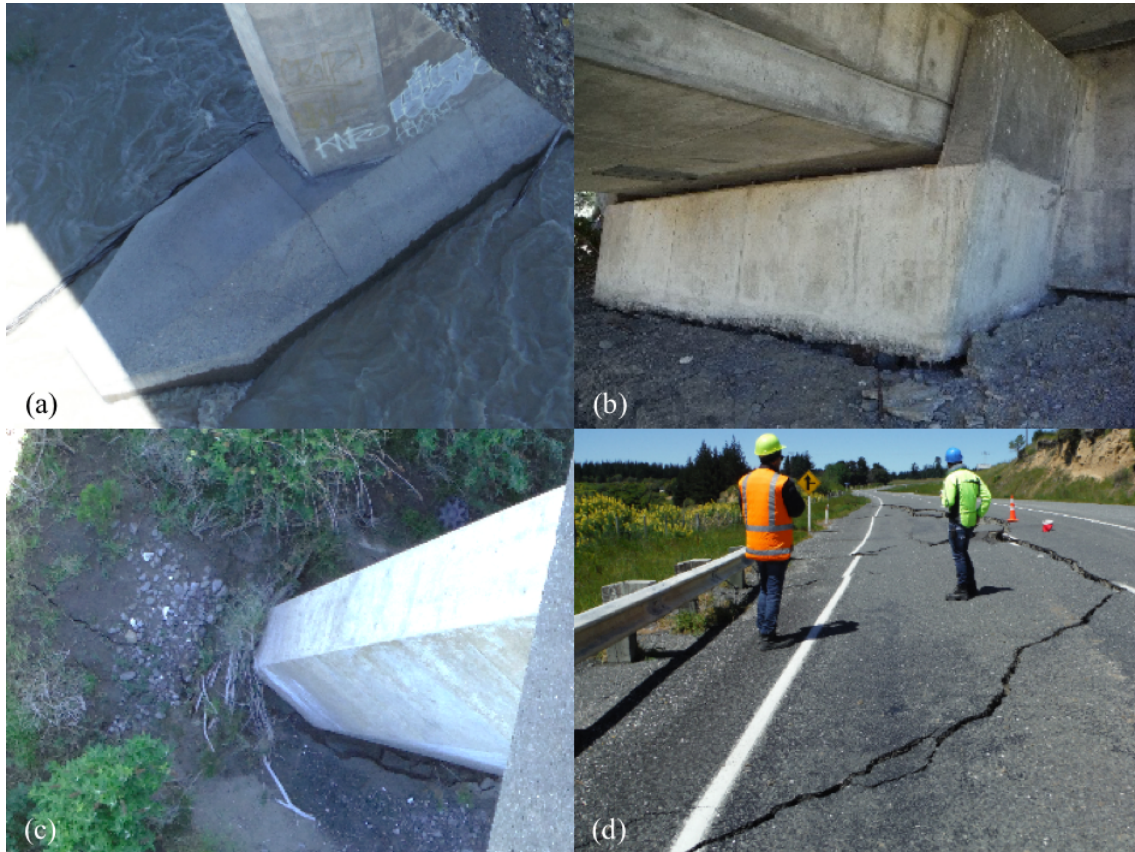
Figure 6.63: Damage at Clarence River Bridge [-42.1592, 173.9103]: (a) Cracking in top of footing; (b) Settlement of fill ahead of abutment; (c) Soil gapping at base of pier; (d) Spreading cracks in roadway at southern approach looking south.

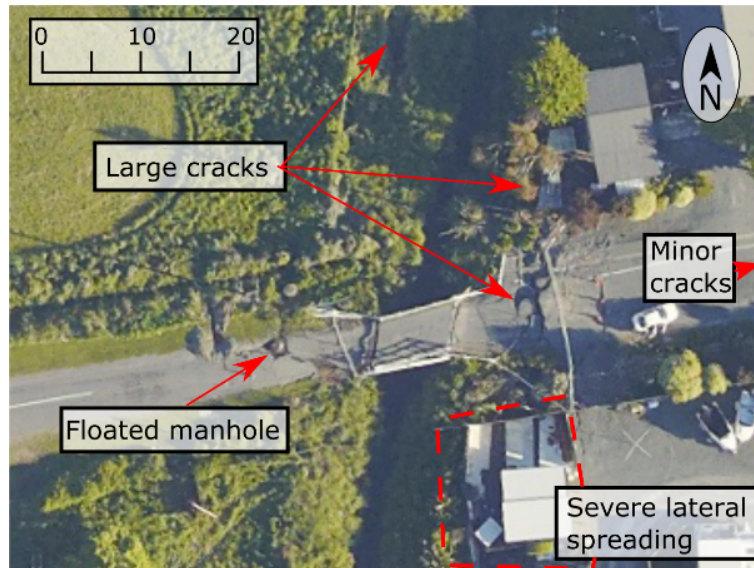
Figure 6.64: Site layout and features of interest at Lyell Creek Bridge [-42.3892, 173.6773].

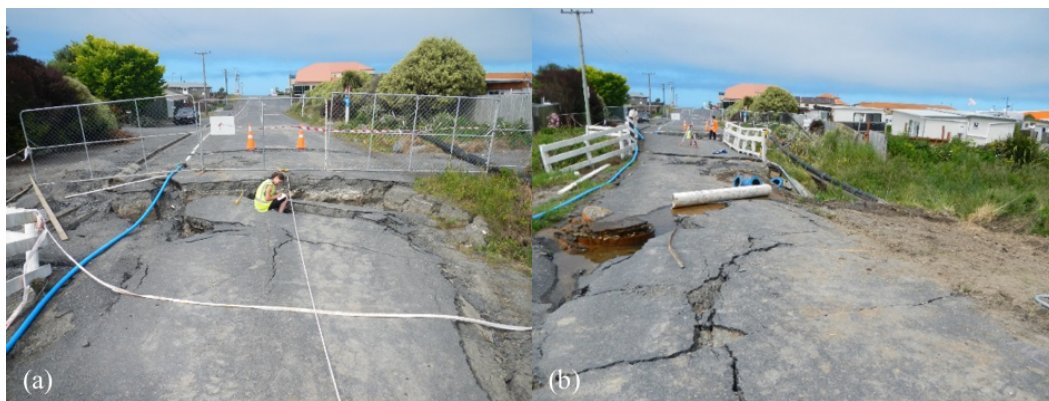
Figure 6.65: Approach cracking at Lyell Creek Bridge [-42.3892, 173.6773]: (a) Eastern approach looking east; Note: crack at 9, from the bridge abutment (location of field member) was 50 cm wide, and had a vertical offset of 30 cm. (b) Western approach looking east.

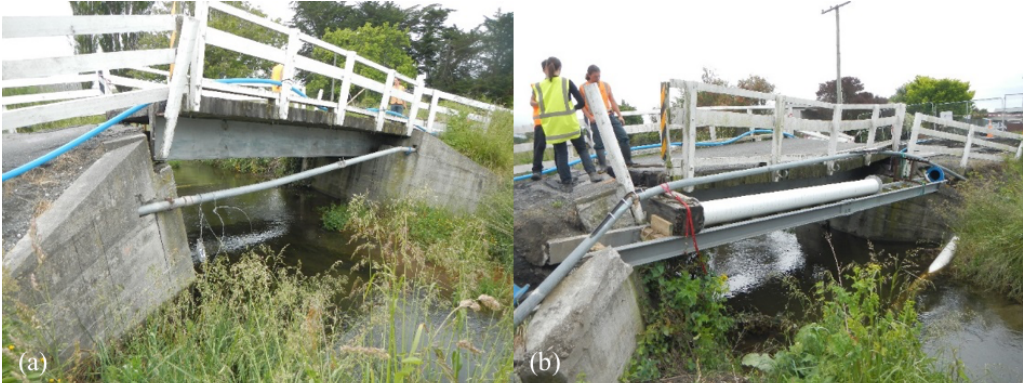
Figure 6.66: Back rotation of east and west abutments at Lyell Creek Bridge [-42.3892, 173.6773]: (a) Looking south at bridge; (b) Looking north at bridge.

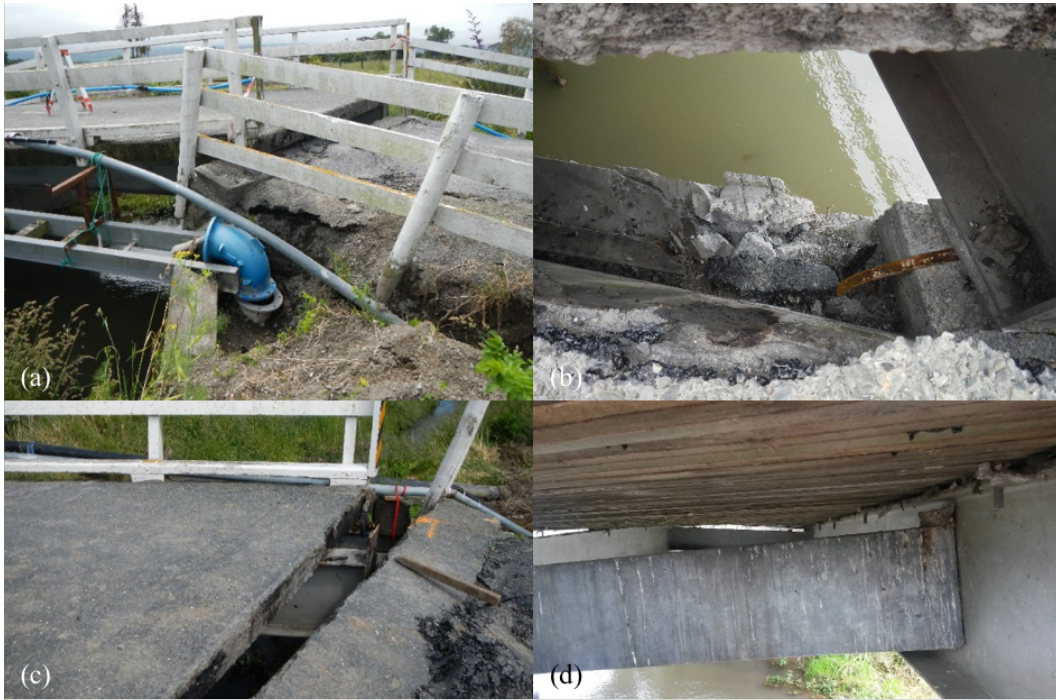
Figure 6.68: Damage at Lyell Creek Bridge [-42.3892, 173.6773]: (a) Eastern end of bridge looking north; (b) Bent anchor bars at east abutment-deck connection; (c) Gap between deck and west abutment looking south; (d) Twisting of deck beams.

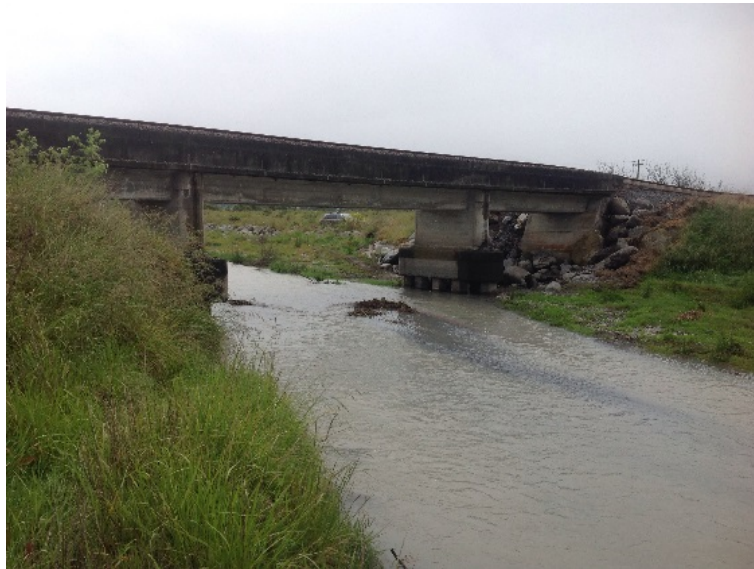
Figure 6.69: Middle Creek Railway Bridge (facing northwest) [-42.3672, 173.6862].

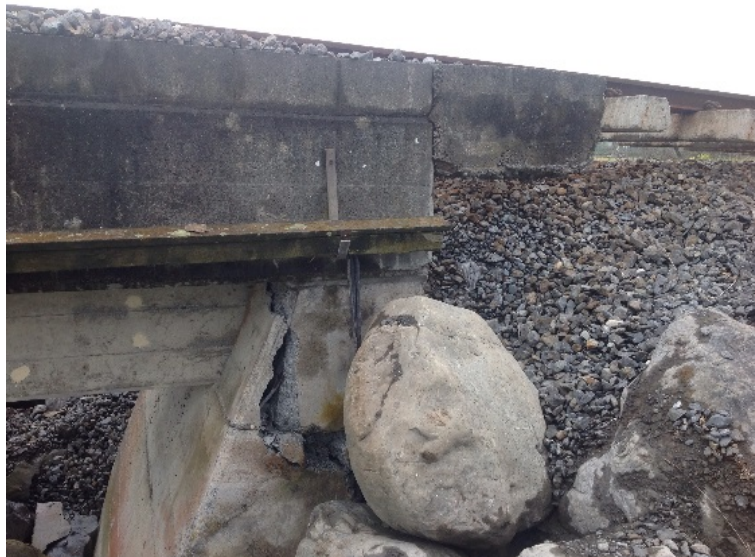
Figure 6.72: Damage to the north abutment of the Middle Creek Railway Bridge facing northwest [-42.3670, 173.6861].

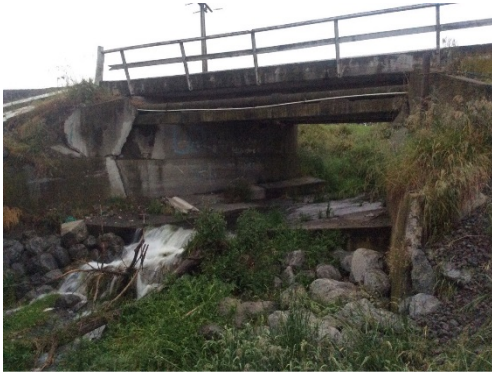
An ~9.5-m long, single lane bridge that crosses Middle Creek on Mt Fyffe Road also experienced damage, as shown in Figure 6.73 through Figure 6.76. As shown in Figure 6.73(b), fill was placed to compensate for subsidence of the both the north and south approaches and the barriers on the northern approach rotated outward. Also, both the reinforced concrete north and south abutments to the bridge experienced cracking (Figure 6.74-Figure 6.76).

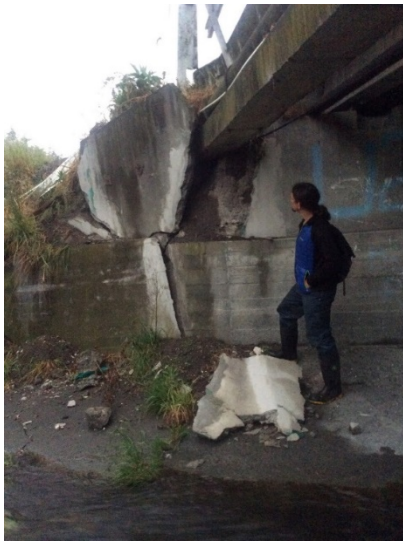
Figure 6.74: Damage to the south abutment on the east side of the bridge (8 Dec 2016, facing south) [-42.3692, 173.6547].

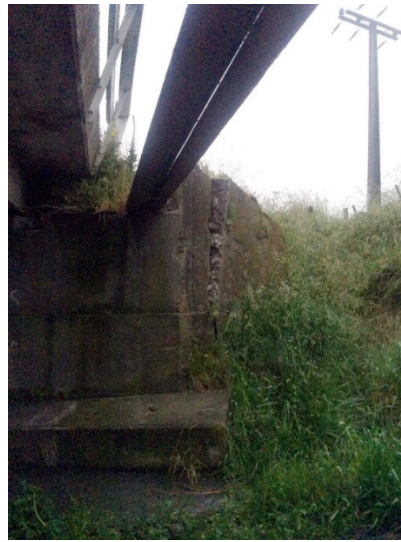
Figure 6.75: Damage to the north abutment on the east side of the bridge (8 Dec 2016, facing north) [-42.3692, 173.6549].

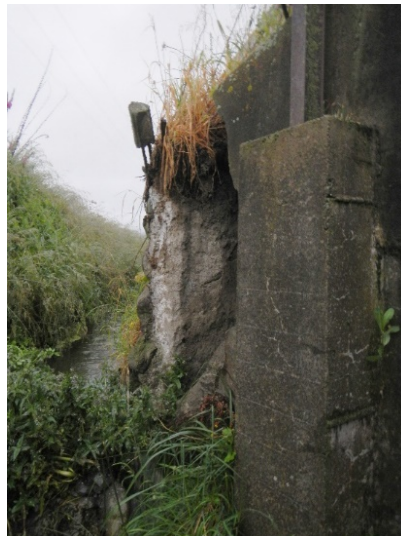
Figure 6.76: Damage to the north abutment on the west side of the bridge (8 Dec 2016, facing north) [-42.3692, 173.6547].

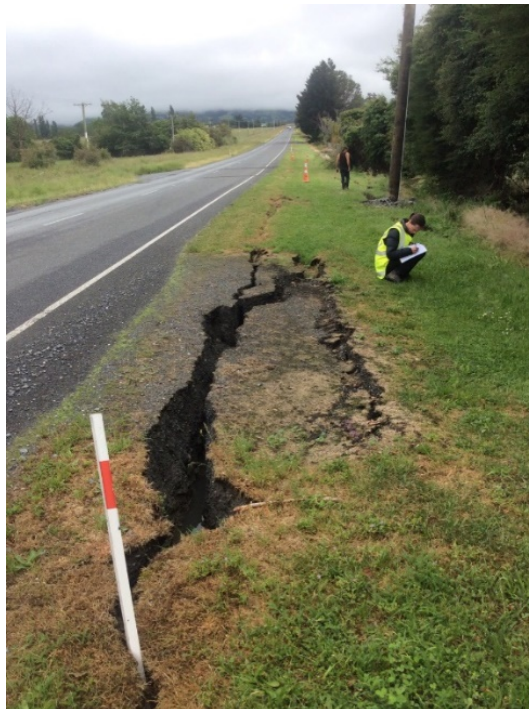
Figure 6.77: Lateral spreading cracks at the side of Athelney Road (9 Dec 2016, facing north) [-42.3598, 173.6765]. Note the drainage ditch to the right of the photo.

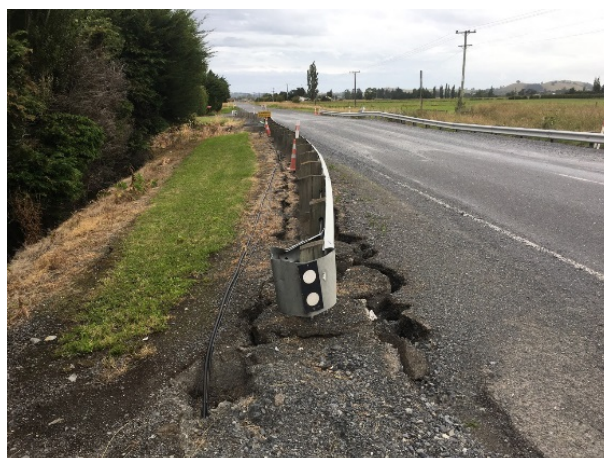
Figure 6.78: Cracking on the north-side of the Waimagarara culvert on Athelney Road (9 Dec 2016, facing south) [-42.3599, 173.6765].

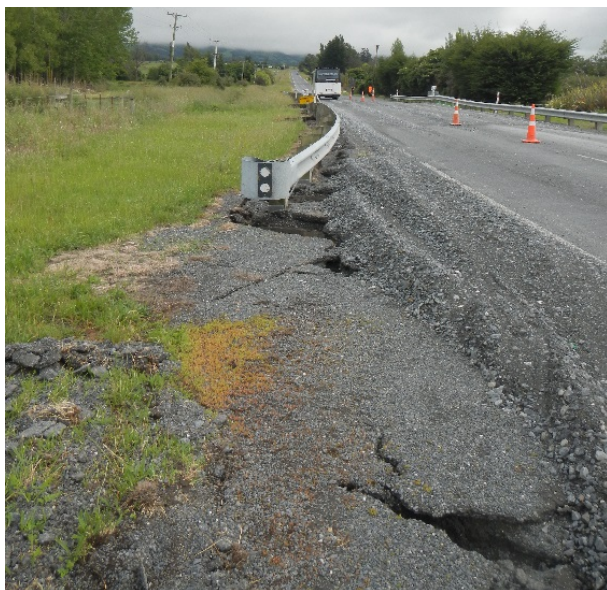
Figure 6.79: Cracking on the south side of the Waimagarara culvert on Athelney Road (9 Dec 2016, facing north) [-42.3606, 173.6765].

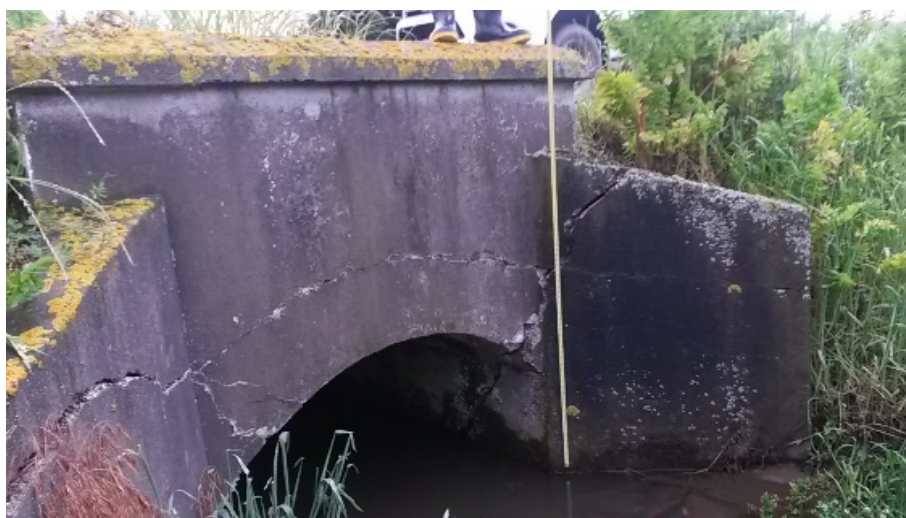
Figure 6.81: Cracking in the concrete at Hawthorne Road culvert (8 Dec 2016, facing northwest) [-42.3900, 173.6675].

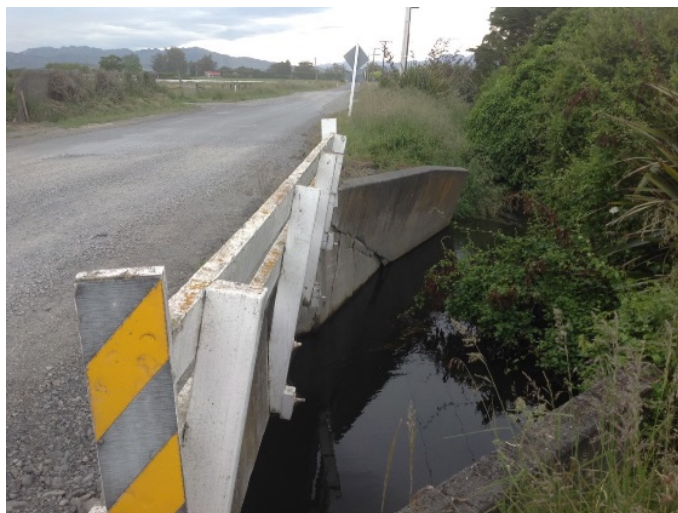
Figure 6.82: Failure of the northwest wingwall of the Lyell Creek culvert on Mill Road (8 Dec 2016, facing west) [-42.3765, 173.6788].

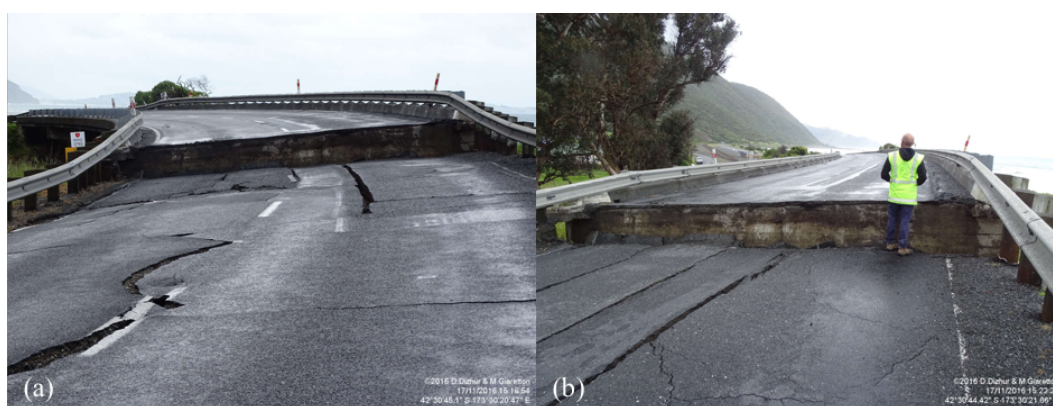
Figure 6.83: Settlement and severe approach roadway cracking at southern abutment to Oaro Overbridge [-42.5121, 173.5063] looking north. Photos by D. Dizhur and M. Giaretton.

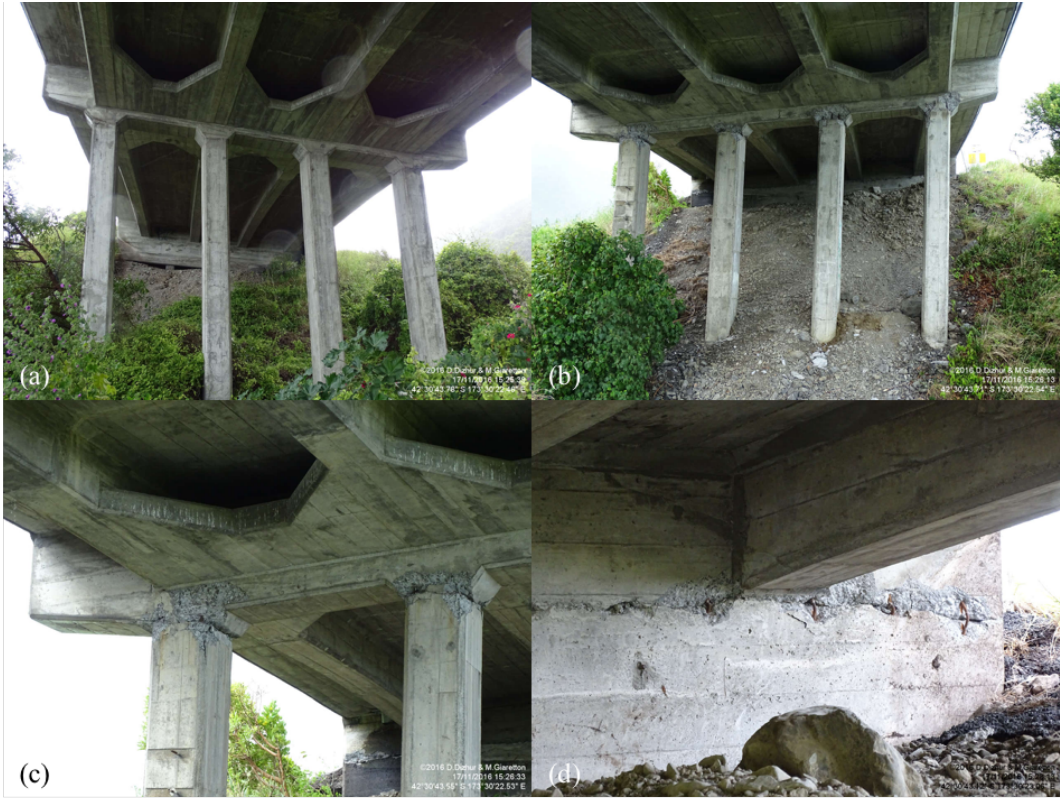
Figure 6.84: Damage at Oaro Overbridge [-42.5121, 173.5063]: (a) Settlement of fill ahead of southern abutment and cracking at top of pier columns looking south; (b) Cracking in fill ahead of northern abutment and plastic hinging at top of pier columns looking north; (c) Closer view of damage at top of pier columns in northernmost pier looking north; (d) Cracking across face of northern abutment wall, just below deck beams looking north. Photos courtesy of D. Dizhur and M. Giaretton.

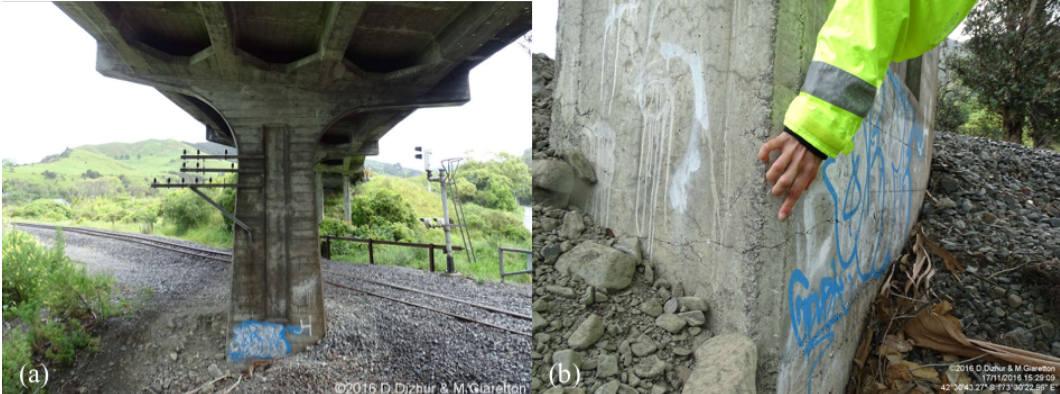
Figure 6.85: Damage at Oaro Overbridge [-42.512089, 173.506345]: (a) Northernmost central hammerhead pier looking south; (b) Flexural cracking at base of northernmost hammerhead pier. Photos courtesy of D. Dizhur and M. Giaretton.

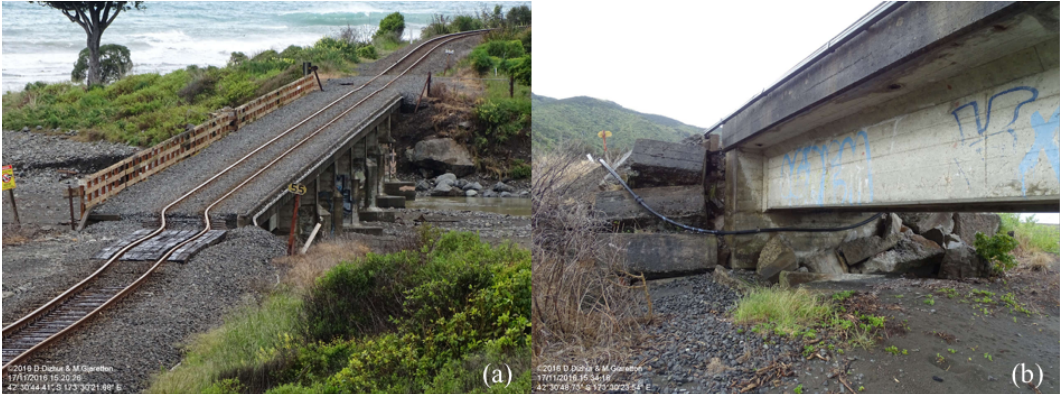
Figure 6.86: Damage at Oaro River Rail Bridge [-42.514025, 173.50682]: (a) Residual lateral deformation towards the east at the northern abutment has bent the tracks (photo looking south); (b) Northern abutment looking north. Photos courtesy of D. Dizhur and M. Giaretton.
