6. GEOTECHNICAL EFFECTS ON CRITICAL STRUCTURES DURING THE MARCH 5TH FLOOD EVENT

Bridge scour

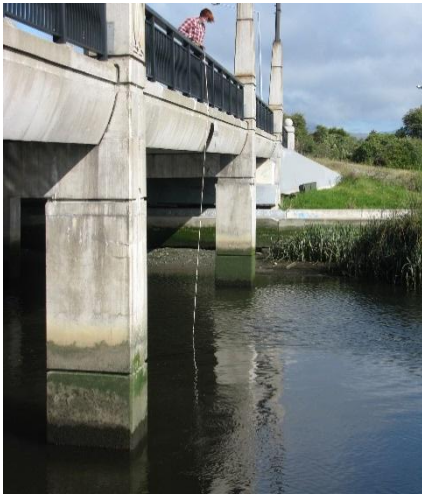
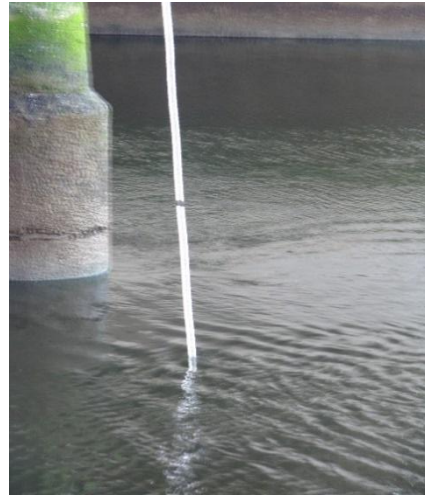
Figure 6-3 (a) Depth soundings at Anzac Drive Bridge and (b) depth reading using a marked rope.

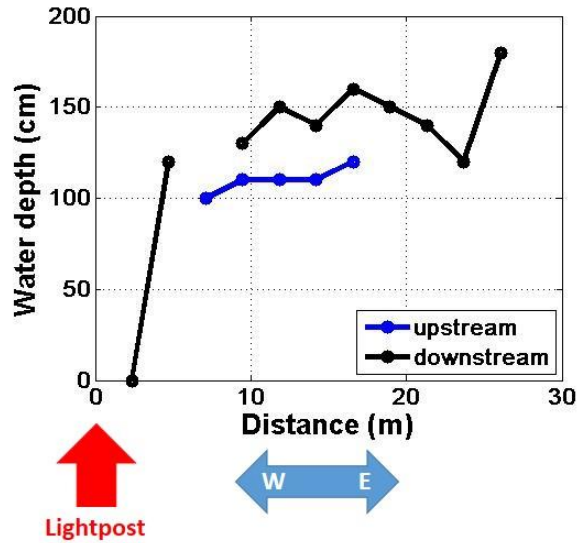
With the original river bed level (Figure 6-5), scour would correspond to the octagonal columns, probably reaching the pile caps and making them a scour protection. With full exposure of the pile caps, scour would be expected to develop in a different shape, in response to the sharp pile cap edges. However, destabilization of the bridge due to scour is very unlikely, because of the support provided by the concrete piles. Surveying was limited due to construction work (Figure 6-6, Figure 6-7, and Figure 6-8). Figure 6-8 shows the soundings generally indicating a deepening towards the east in the channel, and the downstream side was generally deeper by ~30-40 cm. An irregularity was found at a distance of 24-26 m from the western lightpost which served as datum. Due to the limited soundings, it cannot be determined if the shoaling or the deepening represents the irregularity, or if this might be related to scour processes and/or an increase of erosion during the flood. A shoaling could be related to a gravel bank deployed around the piers for a remediation of the pier pile caps. A more detailed investigation after the conclusion of the construction work would answer this question.

Figure 6-8 Soundings at the Avon's Bridge Street Bridge. Zero represents the western lightpost of the bridge. Construction work restricted the sounding particularly on the upstream side, and in close vicinity of the piers.

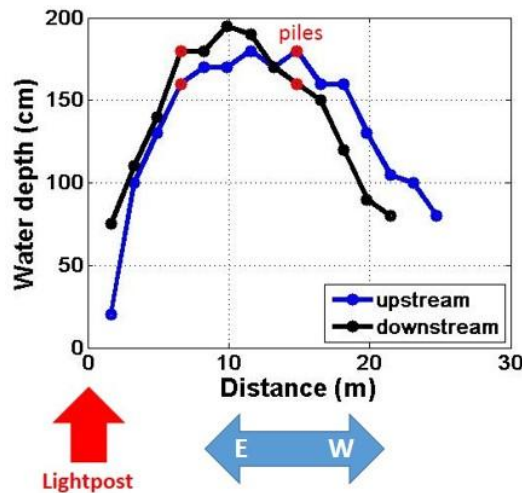
Figure 6-12 shows the sounding results at Pages Road Bridge indicating a deepening by ~ 0.4 m and narrowing of the Avon River downstream. The cross-bridge profiles do not indicate scour. However, at the western pier measurements at a distance of ~1 m (cross-profile) and at ~0.1 m were conducted. Downstream of the pier, the water depth equalled ~1.8 m, which was in accord with the general channel profile (Figure 6-12). Close to the pier foundation the water depth was

only ~1.5 m, possibly corresponding to sediment accumulation in the lee of the structure as is typically seen when scour occurs. On the upstream side, a water depth of ~1.6 m was measured at a distance of ~1 m from the piers, while at the pier foundation a water depth of 1.8-1.9 m was measured over four soundings, likely representing a scour hole as typically seen at the upstream side of a structure. Thus, the results hint at scour at the pier foundations of Pages Road Bridge with erosion reaching scour depths and sediment accumulations in the range of ~ 0.3 m. Such scour depths will unlikely represent a hazard, however, monitoring of scour development should be considered in cases of an increasing occurrence of flood events, and results might be considered for the retrofit of the bridge.

Figure 6-12 Soundings at Pages Road Bridge. Measurements level with the piles are indicated as red circles. Zero corresponds to the eastern lightpost.

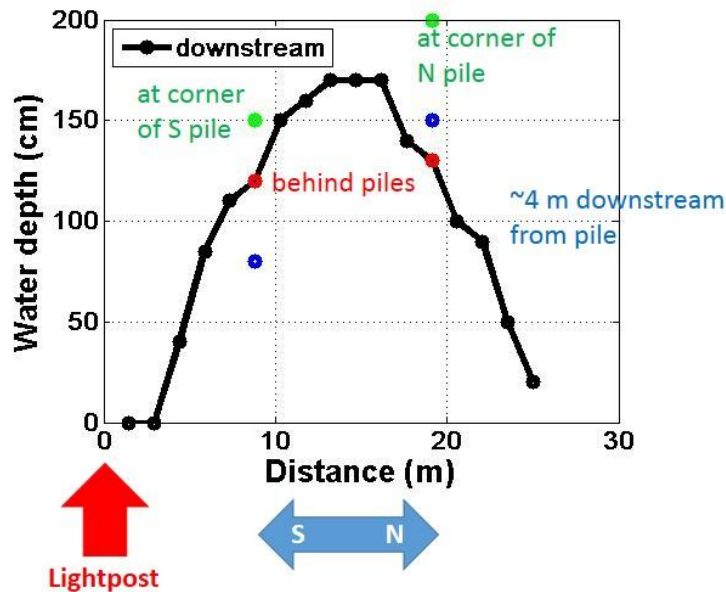
The soundings shown in Figure 6-13 were conducted only on the downstream side of the bridge only due to traffic. The channel profile appears generally approximately symmetric. Different measurements have been conducted in the vicinity of the pier foundations. Behind the piers, the water depths corresponded well to the general profile, possibly showing some slight sediment accumulation at the southern pier foundations. However, both corners were characterized by significant deepening by 0.3-0.7 m. Approximately 4 m downstream of the southern pier, sediment accumulation of ~ 0.4 m was identified. This was not confirmed at the northern pier. Nevertheless, these results suggest the development of some scour at Bower Bridge. A more sophisticated survey strategy is recommended to investigate the scour and possible related hazards in more detail. The coarse and very simple method presented here is certainly not sufficient to draw any definitive conclusions.

Figure 6-13 Soundings at Bowers Bridge. No measurements were conducted on the upstream side of the bridge due to traffic. Regarding measurements at the pier pile foundations, red circles indicate sounding behind the square piles, green circles at the corner and blue circles ~ 4 m downstream.

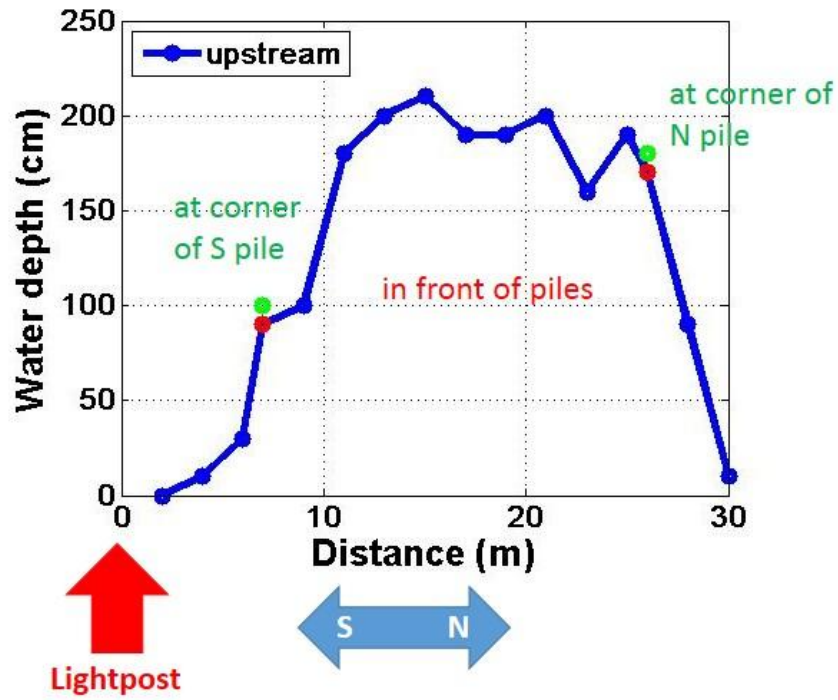
Figure 6-17 shows the riverbed profile determined from soundings. The riverbed at Anzac Drive Bridge is defined by directing the major part of the flow through the piers. No significant variation in morphology can be observed at the piers. Immediate deepening in front and slightly more at the pier foundations corners can possibly be related to scour, but (i) has no significant impact on channel morphology, and (ii) from this limited data set, cannot be determined if related to scour.

Figure 6-17 Soundings at Anzac Drive Bridge. Only upstream measurements were possible due to traffic.

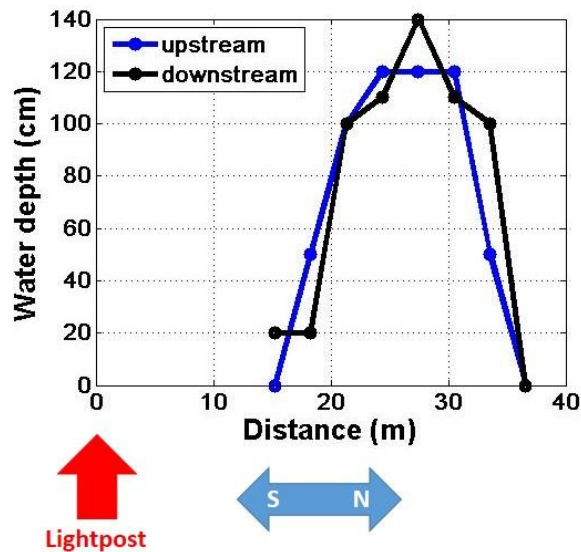
The soundings at Heathcote River Bridge are shown in Figure 6-19 and indicated that most of the flow is going between the two pile groups. No significant water depth variations were noted at the foundations, while downstream a slight deepening in the center of the channel by ~ 0.2 m was observed, likely eroded due to compression of streamlines between the piers.

Figure 6-19 Soundings at the Heathcote River Bridge.

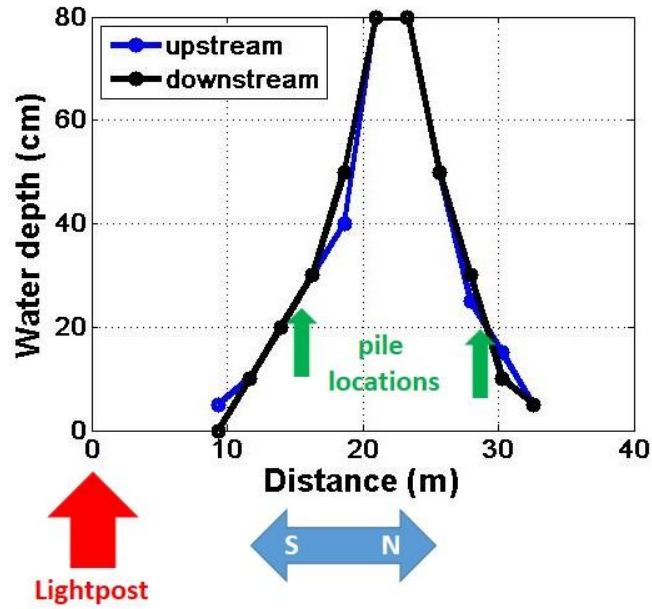
The soundings shown in Figure 6-21 highlighted that flow is funneled through the two pier structures, but no indicators for scour were observed.

Figure 6-21 Soundings at Rutherford Street Bridge. Pier pile locations are indicated in green.

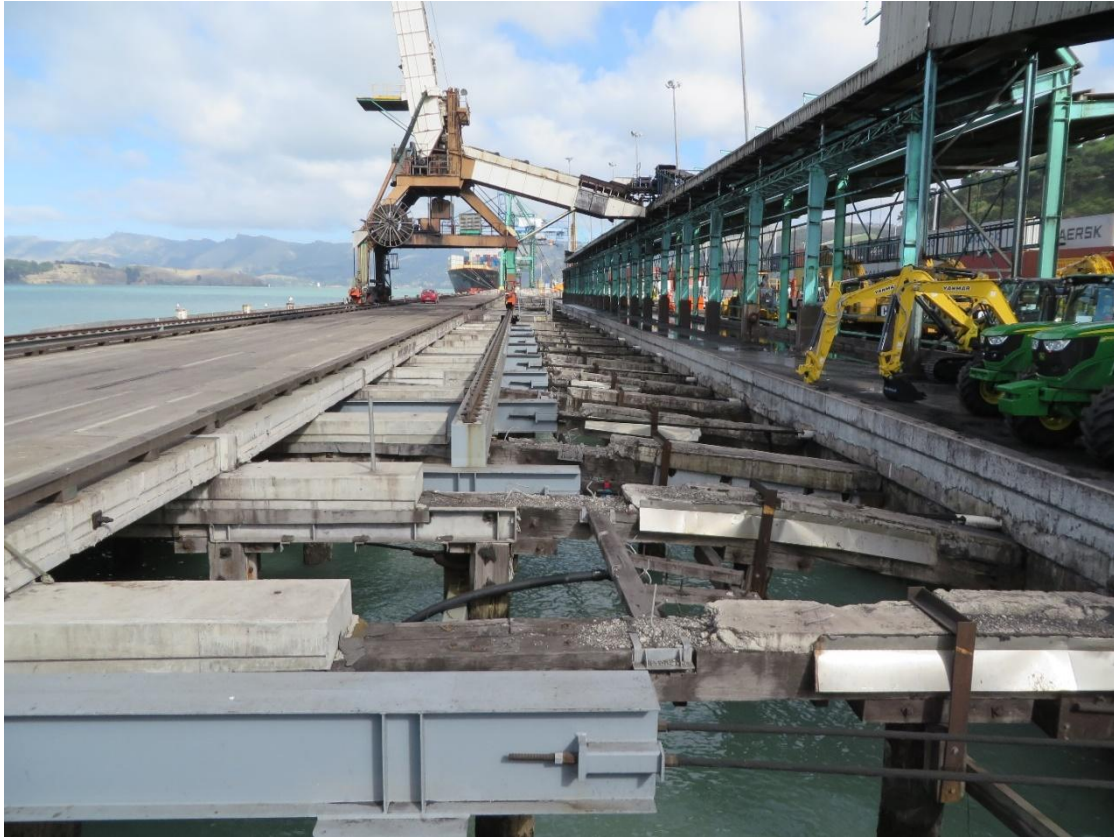
Figure 6-24 Example of visible earthquake induced damage to Cashin Quay in March 2014.

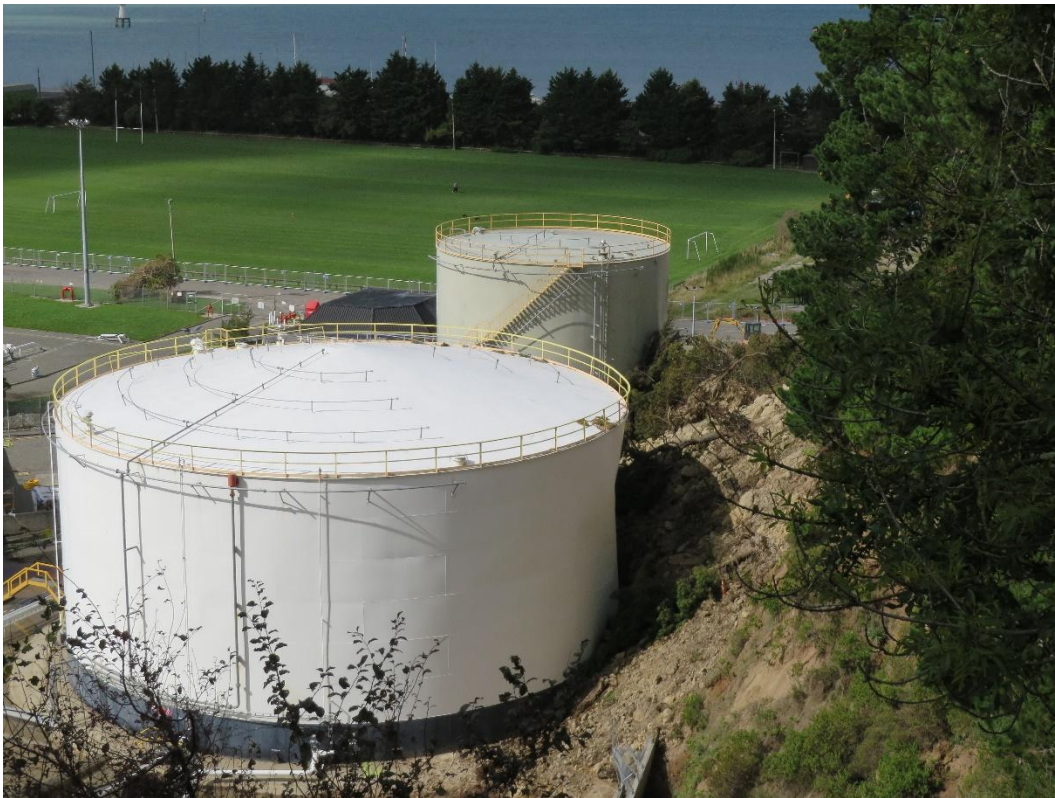
Most of the port structures were not affected by the flood. However, Figure 6-27 shows two tanks damaged by debris from a slope failure below Brittan Tce on the afternoon of March 5th. This landslide initiated during the heavy rainfall event.

The debris from the landslide damaged one tank storing 1.2 million liters of jet fuel, leading to a leak that forced the evacuation of 19 households in the immediate area and closure of nearby roads. This evacuation was in place for two days while fumes dissipated and some of the fuel was pumped into other undamaged tanks. The majority of leaked fuel was captured in the concrete walled containment area around the tank. Some of the leaked fuel entered the stormwater system and was released into the harbor before the spill could be contained.

Another tank also storing fuel was dented by the slope failure debris, but its contents were not affected.

Figure 6-27 Tank impacted by landslide that initiated during periods of heavy rainfall.

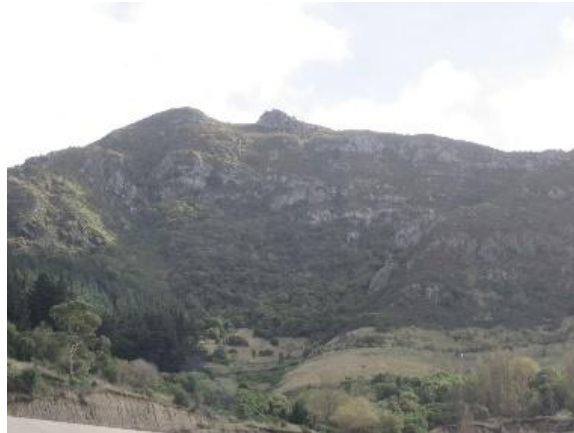
Concerns were expressed regarding the safety issue and current closure of (Old) Sumner Rd. These roads represented an alternative access route to Lyttelton and the port in the case of tunnel closure. Significant destabilization of the steep slopes along these roads as shown in Figure 6-28 made them a major safety issue and led to closure. An alternative trucking route to the port is highly desired as a backup to the tunnel. The tunnel entrances are subject to risk of closure due to landslides, which risk may even increase during heavy rain events. If it came to a flood in the tunnel at the same time, the port could theoretically become inaccessible. No such observations were made during the flood and heavy rainfalls in March 2014, but it was mentioned as a possible concern related to flood and heavy rainfall events.

Figure 6-28 Steep slopes and destabilized debris still represent a risk for Sumner Rd.

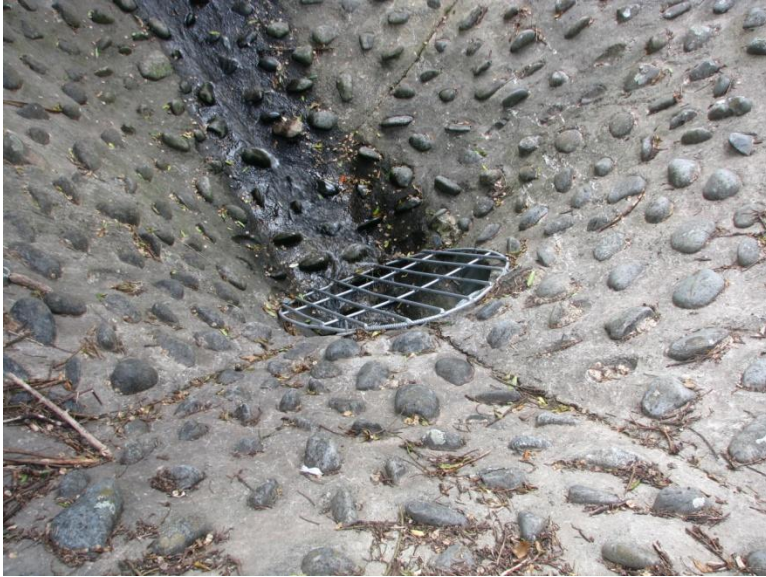
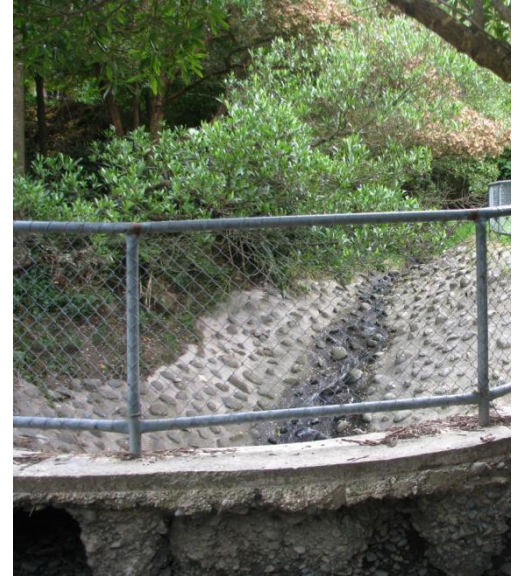
The over topping of the storm water inlet shown in Figure 6-29 at the top of Canterbury Street in Lyttelton led to progressive failures downstream during the March 5th flood event. This storm water inlet is at the top of the drainage system and collects water that flows off the top of the Port Hills in an undeveloped section above Lyttelton. The GEER team found the culvert unplugged and free flowing at the time of its field reconnaissance. Evidence was found that the inlet became plugged at some point during the storms leading to overtopping of the collection basin and undermining/erosion downstream of the inlet structure as shown in Figure 6-29b.

Figure 6-29 Storm water inlet at the top of Canterbury Street that was overtopped during the March 5th event (Canterbury Street: -43.596225° , 172.723001°).

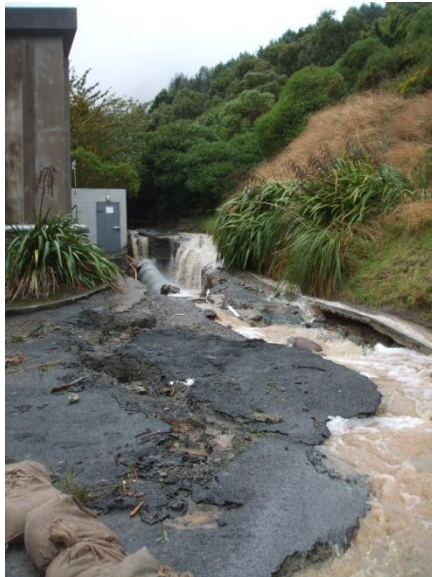
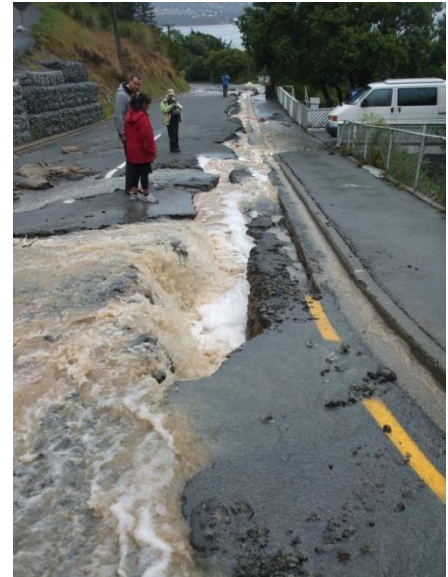
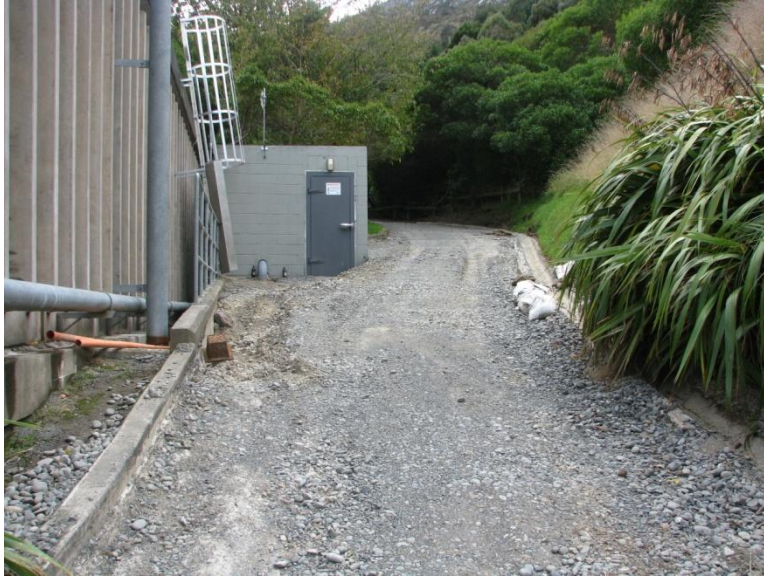
Water then eroded the pavement and base course exposing the storm water pipe as shown in Figure 6-30a. As shown in Figure 6-30b, the erosion of pavement and the base course continued down Canterbury Street. Repairs to the streets shown in Figure 6-30c had been made at the time of the GEER team's reconnaissance.

Figure 6-30 Erosion as a result of the storm water inlet in Figure 6-29 overtopping. (Photos (a) and (b) courtesy of Michael Hayes) (c) Canterbury Street restored to grade (93 Canterbury Street: -43.596590° , 172.722847°).

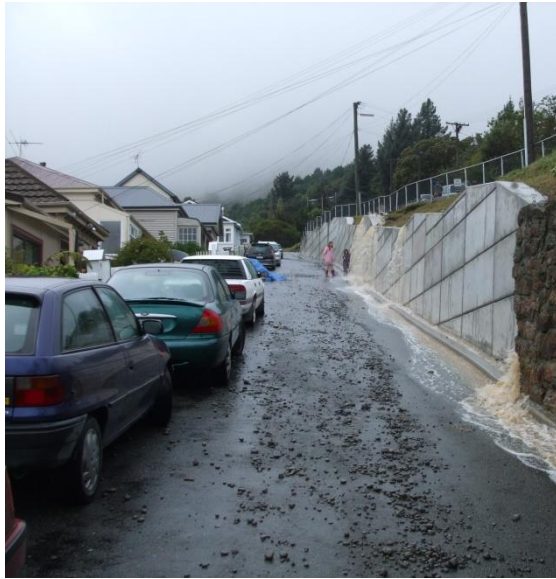
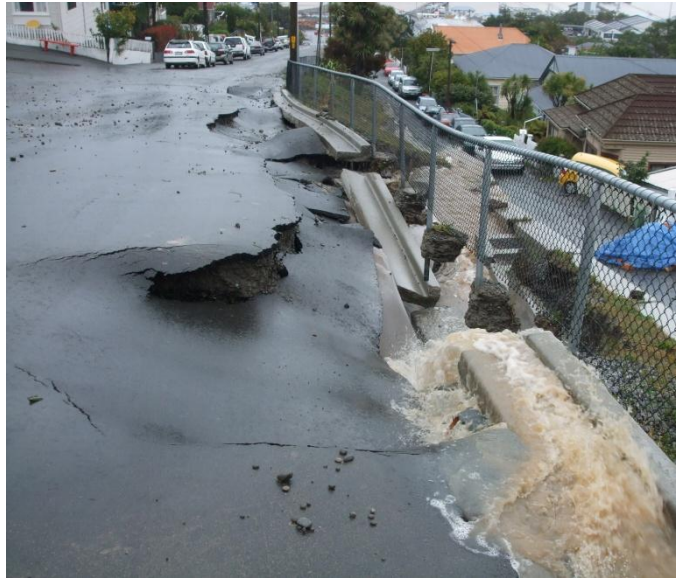
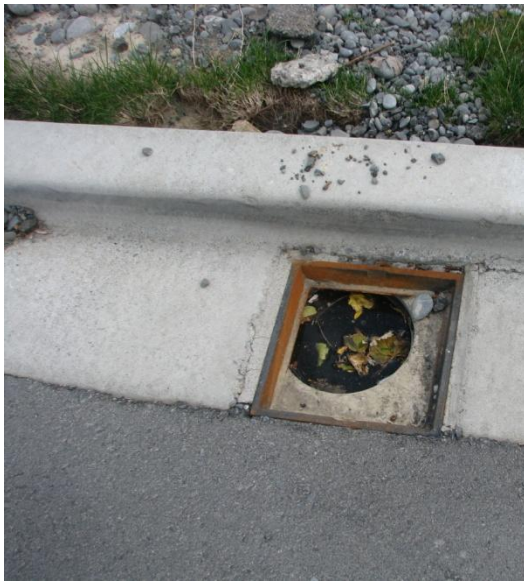
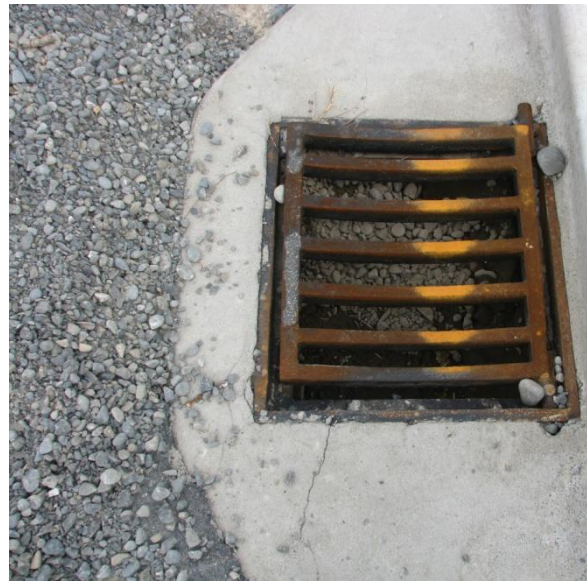
Further down Canterbury Street, water eroded the retained earth and street above a retaining wall shown in Figure 6-31, which had previously failed and been replaced in 2013 by SCIRT. The new retaining wall consists of a wet cast block. As shown in Figures 6-31c and 6-31d, the drainage system behind the wall was found to be plugged at the time of the GEER teams visit on March 22, 2014. SCIRT reported that the wall was found to be safe. GEER found no noticeable horizontal wall movement. SCIRT also reported damage to a new retaining wall being constructed on Sumner Road as a result of the flood event.

Figure 6-31 (a) Storm water flowing over the Canterbury Street retaining wall. (b) Erosion of Canterbury Street and retained earth above the wall. (c) and (d) plugged drains directly behind the wall as a result of upstream erosion seen in Figure 6-30 (a and b). Photos (a) and (b) courtesy of Michael Hayes (73 Canterbury Street: -43.599005° , 172.722243°).

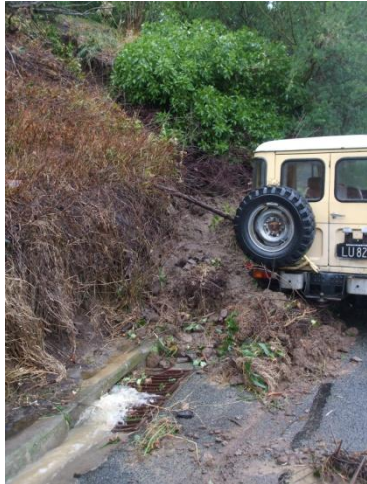
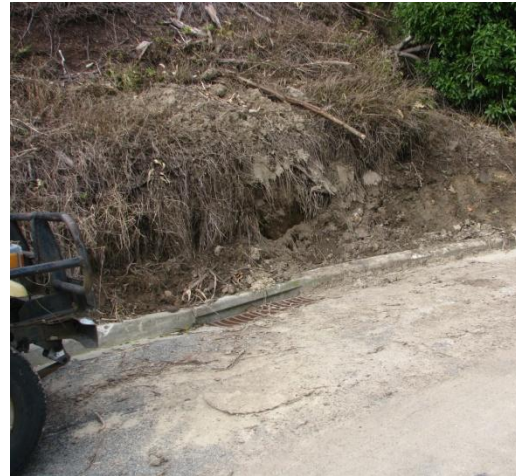
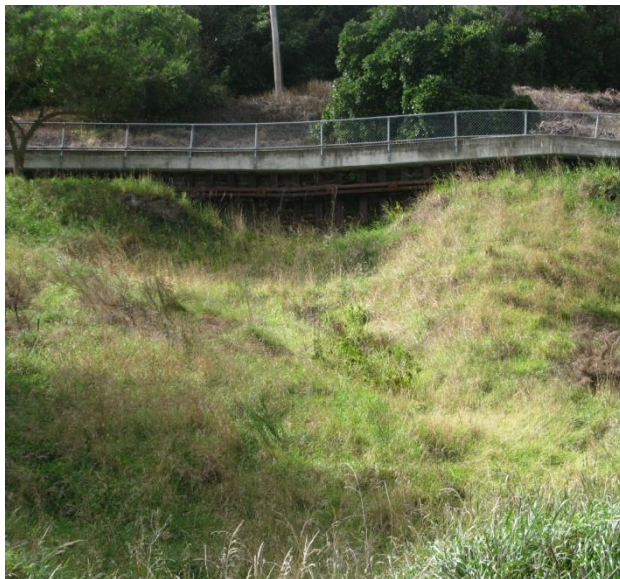
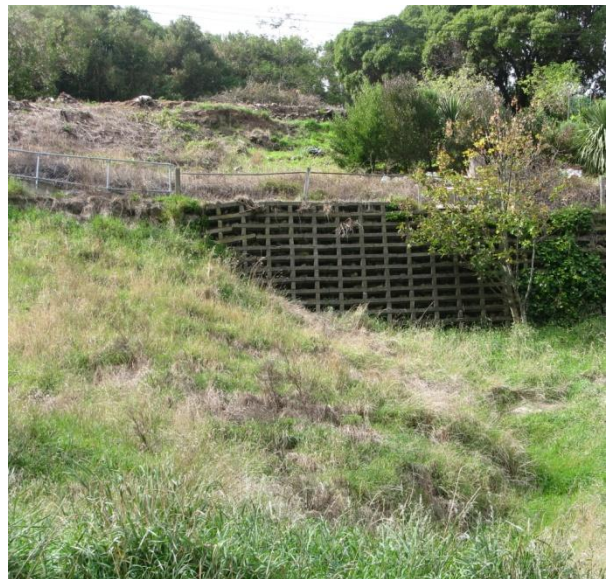
GEER found evidence of numerous plugged inlets to the storm water system such as that on Selwyn Street in Lyttelton, shown in Figure 6-32. In interviewing the local community GEER found that locals unearthed the plugged inlets to enable the runoff to enter the storm water system. The Selwyn Street example in Figure 6-32a and b shows a small slump that fell from

above the drainage inlet and plugged it resulting in the flow being routed down Selwyn Street instead of into the storm water system.

It's plausible that had the culvert not been unplugged during the storm event that water pressure behind the walls in Figures Figure 6-32c and Figure 6-32d could have resulted in failure, or failure of another type further downstream. A previous landslide below the sheet pile wall in Figure 6-32c had occurred prior to the 2010-2011 Canterbury earthquake sequence resulting in damage to the home below which is no longer present.

Figure 6-32 Unplugged culvert on Selwyn Street above crib retaining wall, Photo courtesy of Michael Hayes (a). Post cleanup by CCC at the drain inlet (b). Previous slope failure and

installed sheet pile retaining wall (c) adjacent to crib wall with culvert out let picture left (d) (17 Selwyn Road: -43.598748°, 172.716026°).
