## **7. PERFORMANCE OF LIFELINE SYSTEMS DURING 5<sup>TH</sup> MARCH 2014 FLOODING**

The GEER team followed up on the performance of the lifelines following March 5<sup>th</sup> flood event.

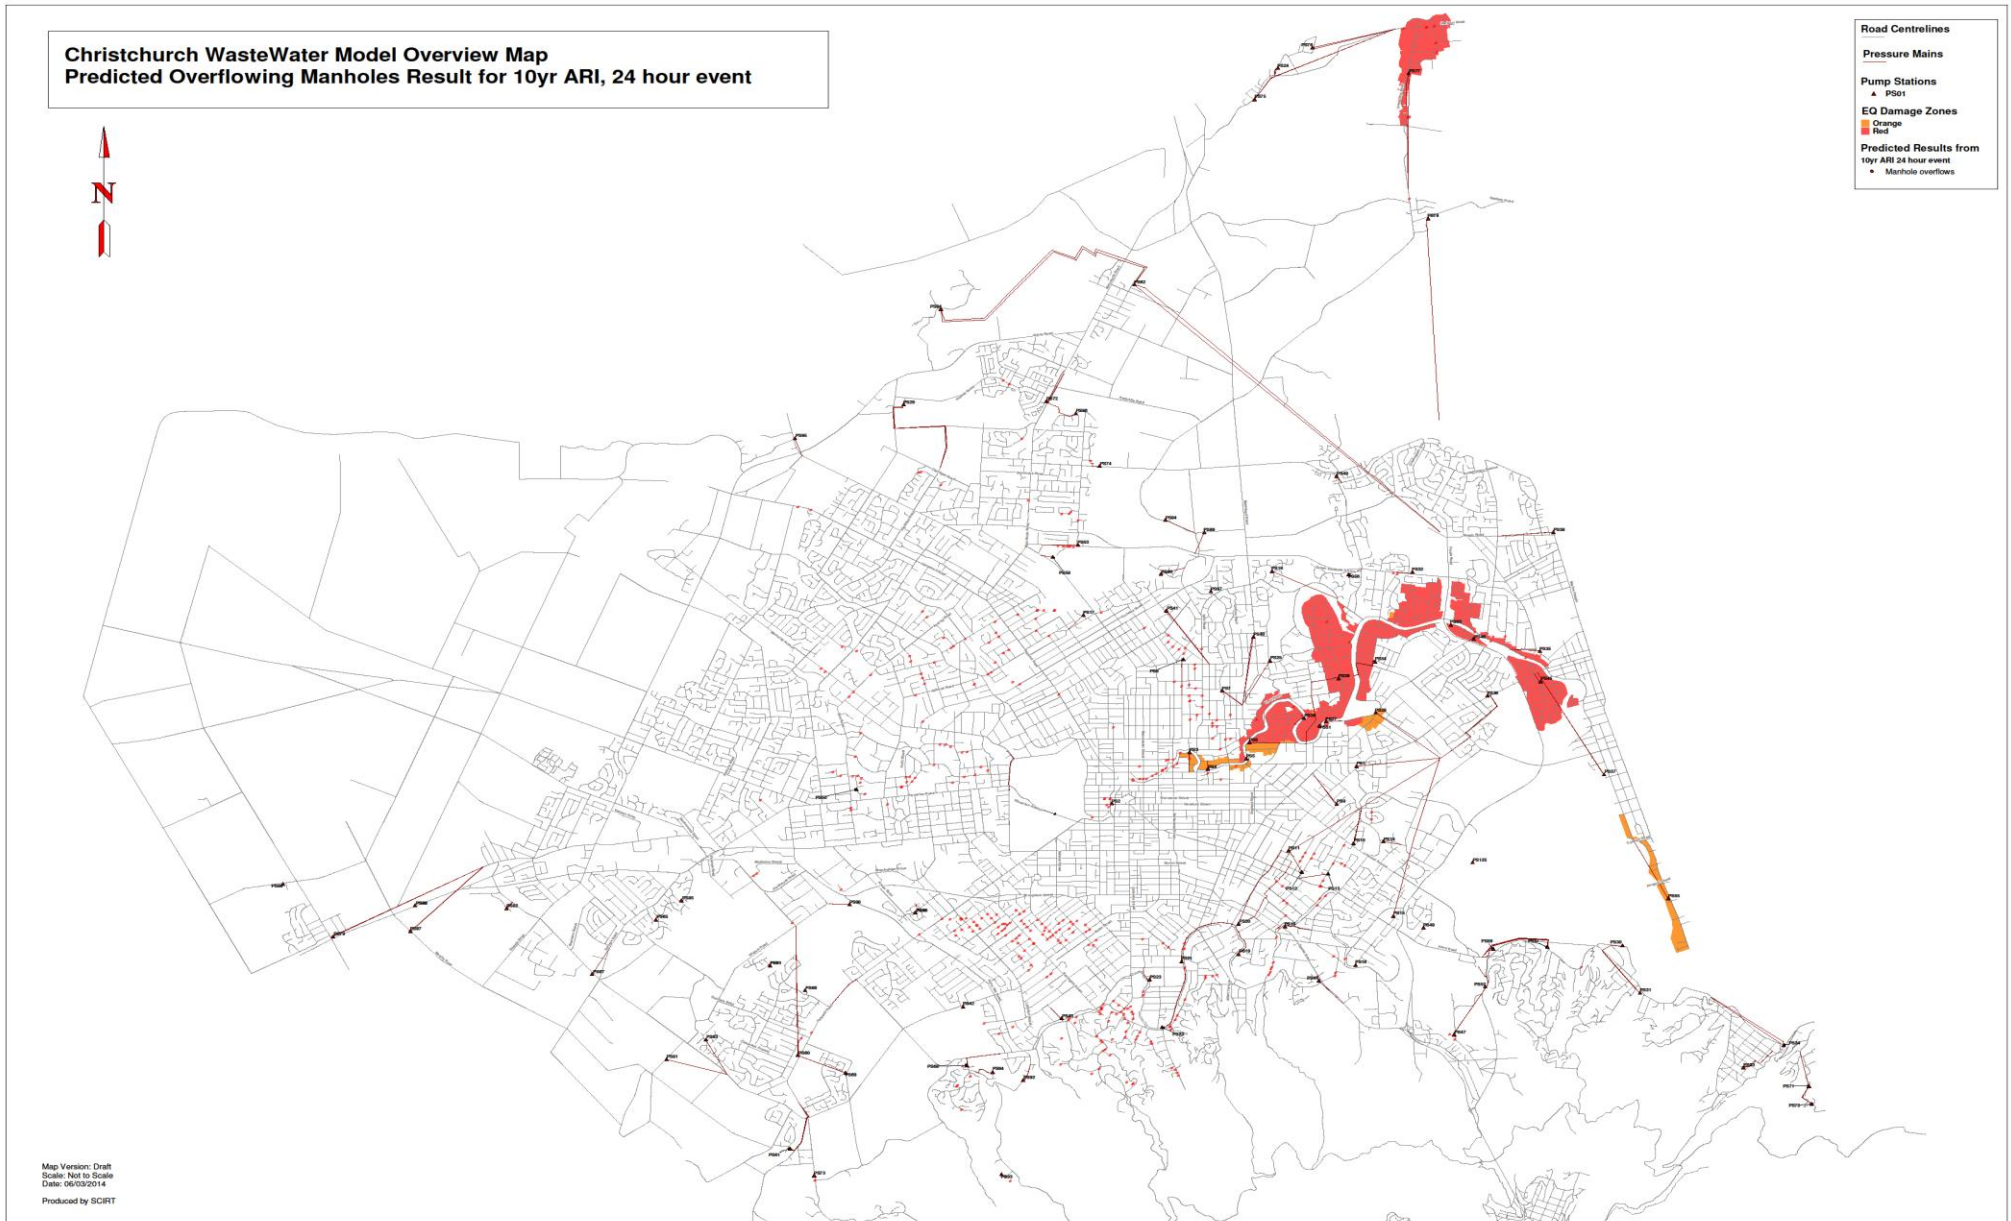
The CCC Asset Network & Planning team modelled the predicted surcharging from manholes, under urgency on 6<sup>th</sup> March, as seen in Figure 7-1. This model prediction was then used in the response as an indicator for where the WW maintenance crews should go to clean up the effects of surcharging WW and inspect/replace manhole covers. This prediction was used in conjunction with WW related geospatially located phone calls placed to CCC in the March 5th event as seen in Figure 7-2, noting that phone call data from a prior flood event in June 2013 was used as a comparison. Specific mention should be made of the Southwest area of Christchurch in Figure 7-1 which the model predicted to have surcharging but which experienced substantially less, most likely due to recent WW project completions.

Figure 7-1 Prediction modelling of a 1 in 10 year rain event effects on the wastewater system in Christchurch, used as a guide only for the 5<sup>th</sup> March event, source R. Meek (personal communication, 7th April 2014).

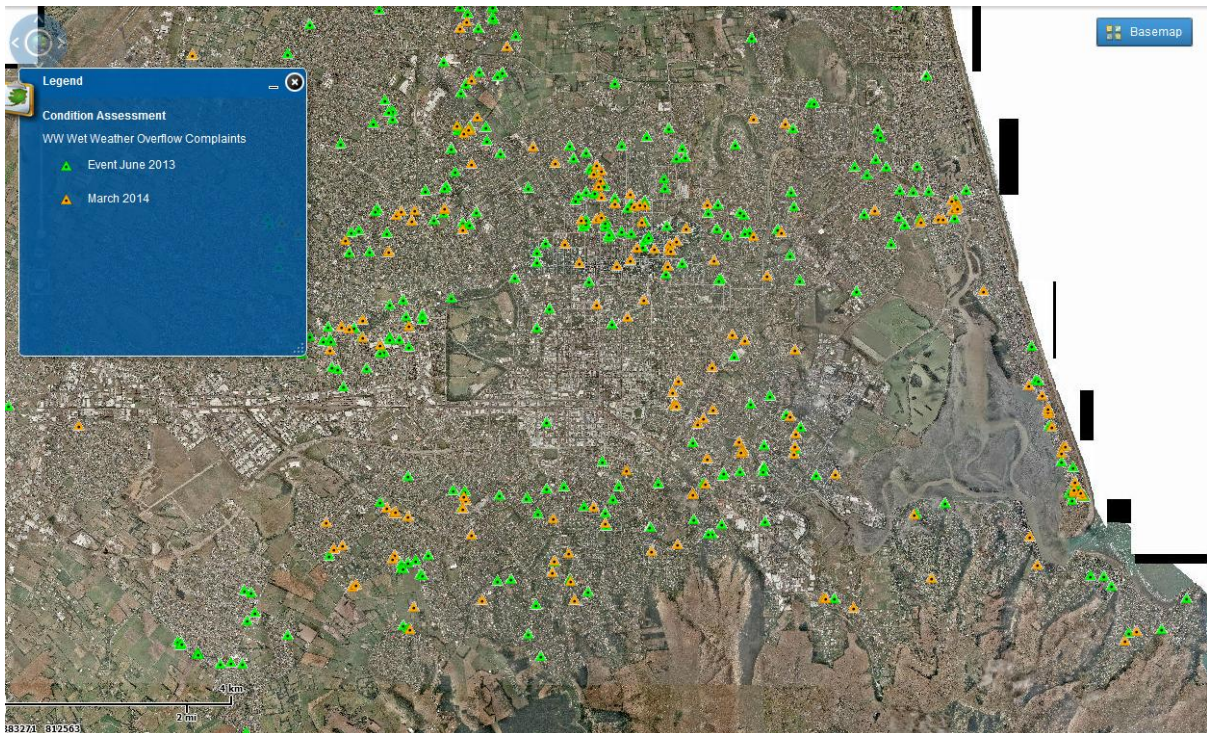
Figure 7-2 Location of WW related received calls taken by the CCC call centre during the event with calls from a previous large rainfall event in June 2013, R. Meek (personal communication, 7th April 2014).

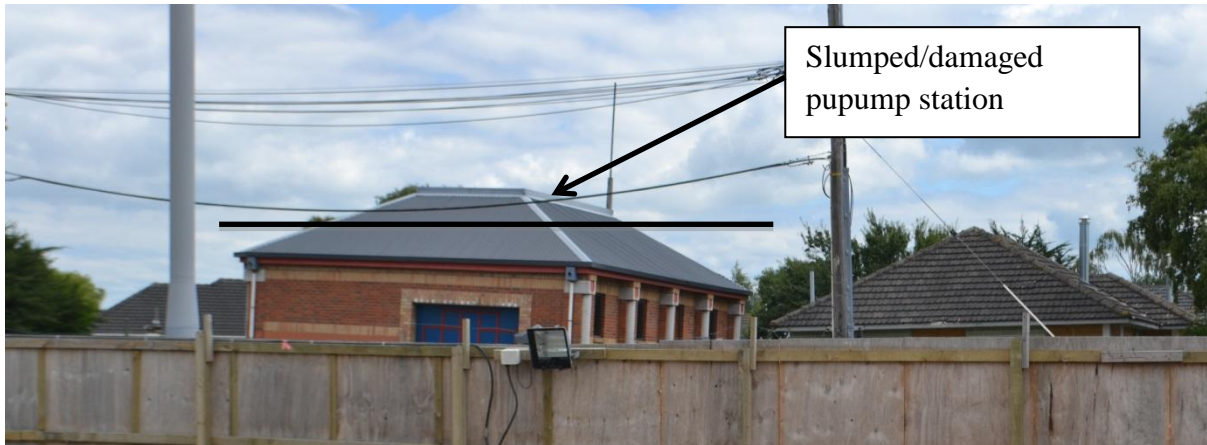
A large terminal pump station located in Pages Rd that is responsible for directing 35% of the city's WW to the WWTP suffered extensive damage in the earthquake sequence as seen in Figure 7-3. The pumping station moves wastewater via two 1.2 m diameter pipes to the WWTP, but currently is only pumping through one new Glass Reinforced Plastic (GRP) 1.2 m diameter pipe. The conveyance capacity in this part of the network has been reduced by 50%. The WWTP had available capacity that was unable to be utilised during the flooding which caused overflows to be activated into the Avon and Heathcote river systems and the estuary in line with normal business process.

Figure 7-3 Currently damaged Pages Road gravity pump station (-43.513658°, 172.709793°). View from new gravity pump station construction site opposite. Photo courtesy of Dave Holland.

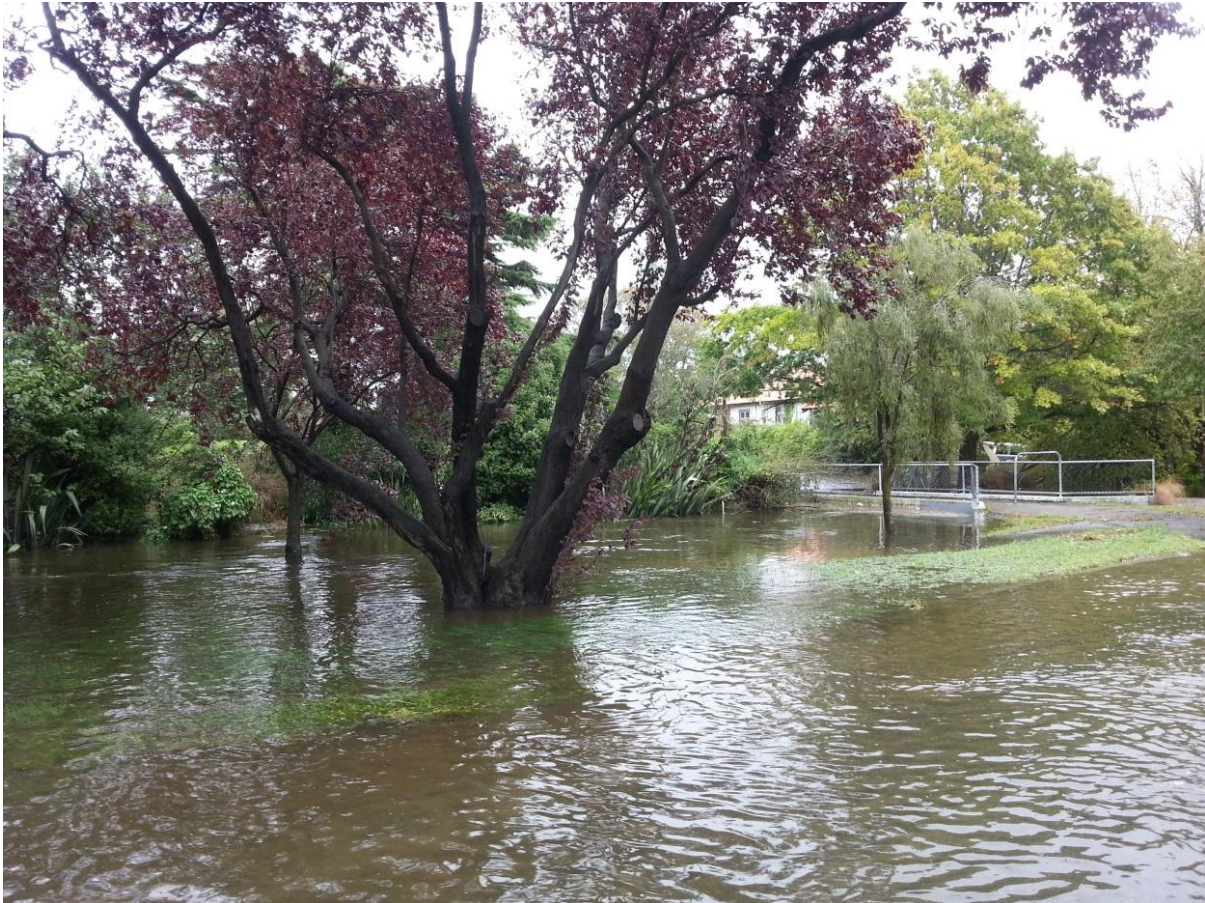
The magnitude of the 5 March event was significantly greater than what the stormwater pipes and the open flow networks were designed for. Therefore, city-wide flooding was experienced, especially in the low-lying areas and floodplains. In particular, as shown in Figure 7-4 the very low-lying flood-prone Dudley Creek catchment suffered the greatest. The water level survey data obtained on 5 March has been used to determine the number of houses that may have flooded.

Figure 7-4 Dudley Creek overflowing on to Stapletons Road (-43.509433°, 172.655949°) and footbridge in Richmond, Christchurch. Photo courtesy of Su Young Ko.

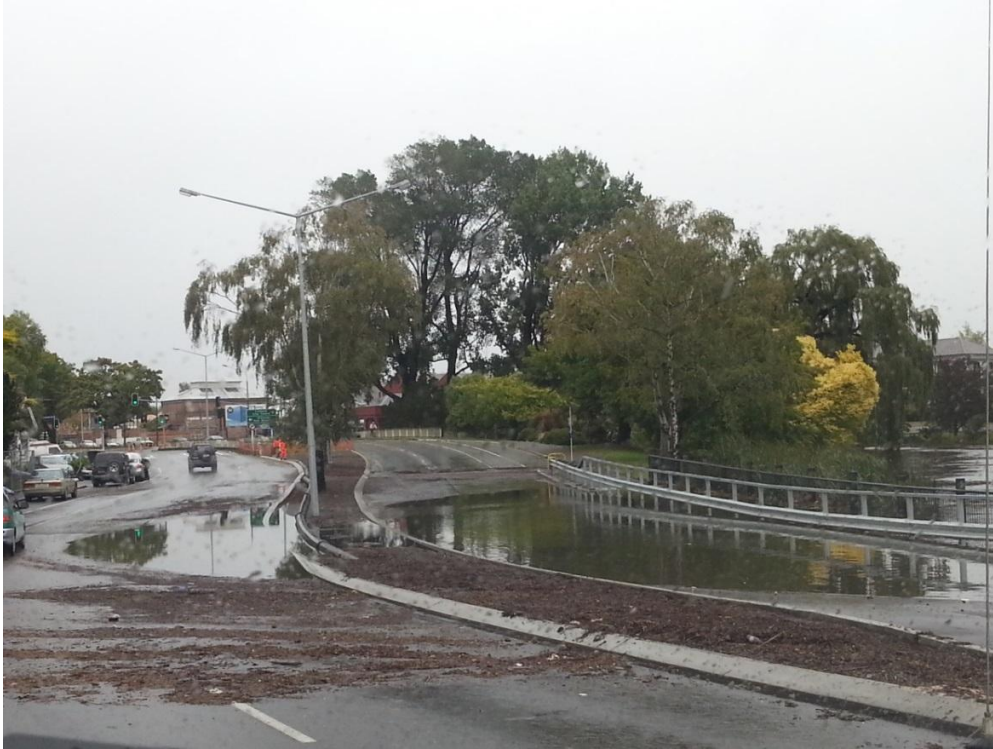
Figure 7-5 Avon River overflow causing surface flooding on Fitzgerald Avenue (-43.524078°, 172.650935°), Central City, Christchurch. This road demonstrates a post-earthquake reconstruction design error. The road should have been built at a higher elevation to avoid flooding. Photo courtesy of Su Young Ko.

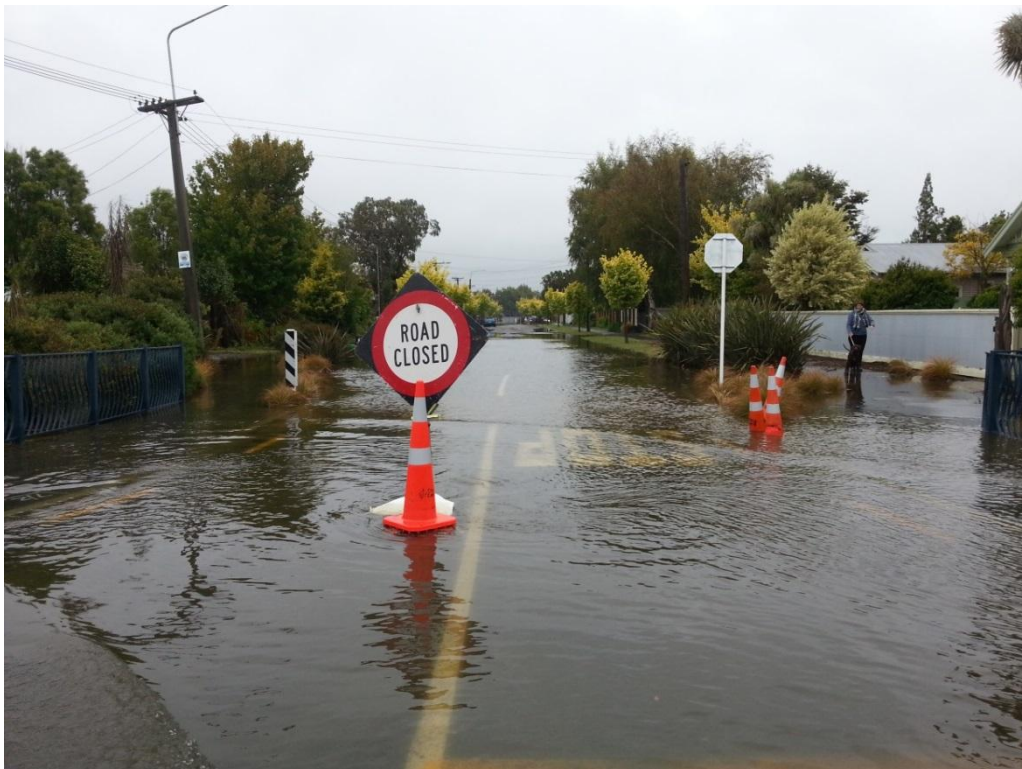
Figure 7-6 Road closure due to temporary traffic management – Geraldine Street (-43.515579°, 172.647506°), Edgware, Christchurch. Photo courtesy of Su Young Ko.

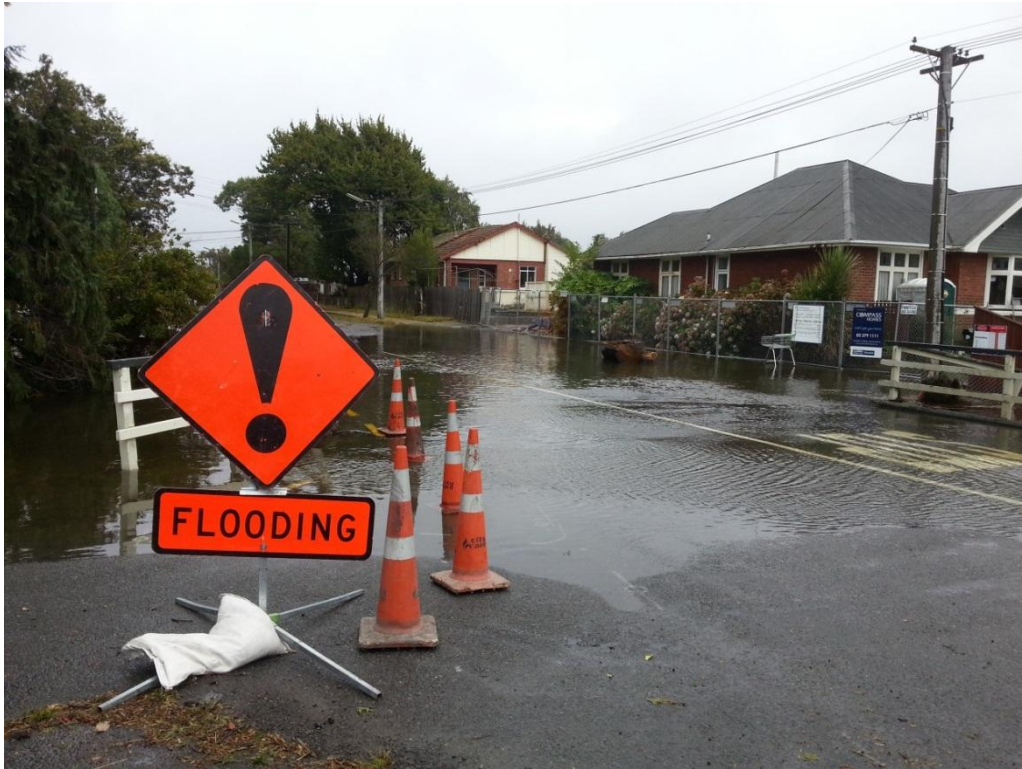
Figure 7-7 Warning sign for flooded streets – Warden Street (-43.510297°, 172.655095°), Richmond, Christchurch. Photo courtesy of Su Young Ko.

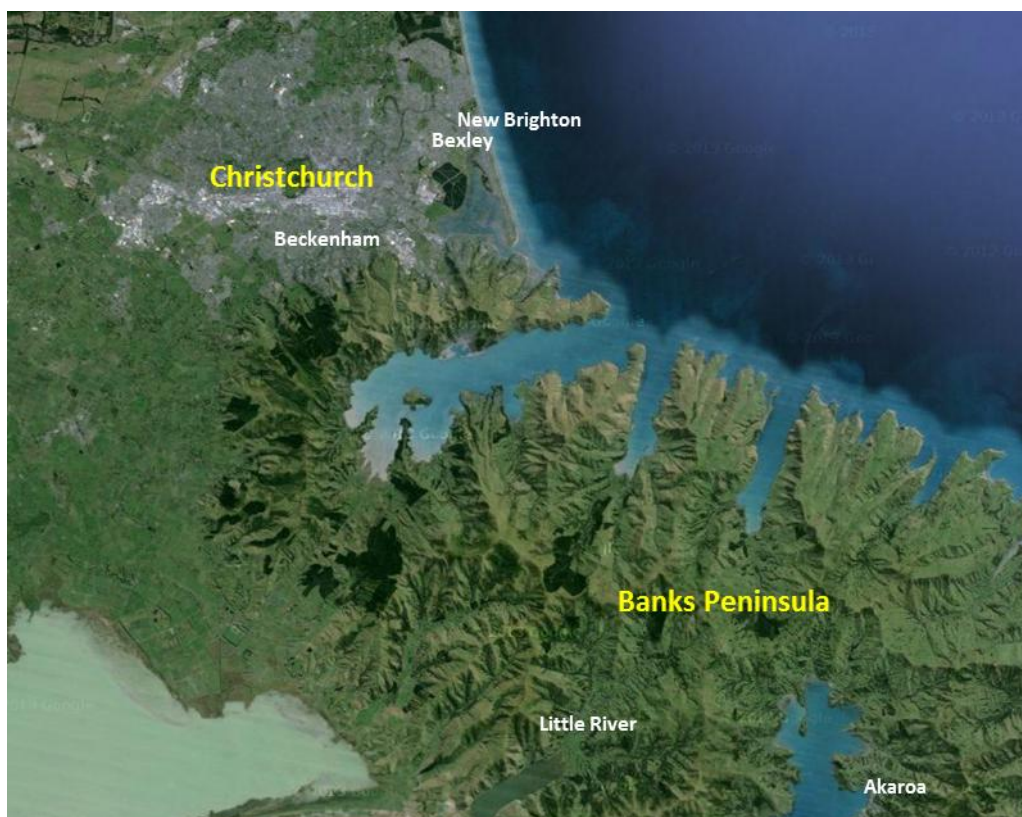
Figure 7-8 shows where the major cable fault locations occurred in Bexley, New Brighton and Beckenham as a result of the flooding. Access to some of the sites was not possible because large portions of these suburbs were inundated to depths of 1.5 m.

Figure 7-8 Map showing the locations of major telecommunication cable faults in Christchurch and Banks Peninsula (Google, 2014).
