8. POST-EARTHQUAKE SEQUENCE FLOODING IMPACTS ON THE BUILT-ENVIRONMENT

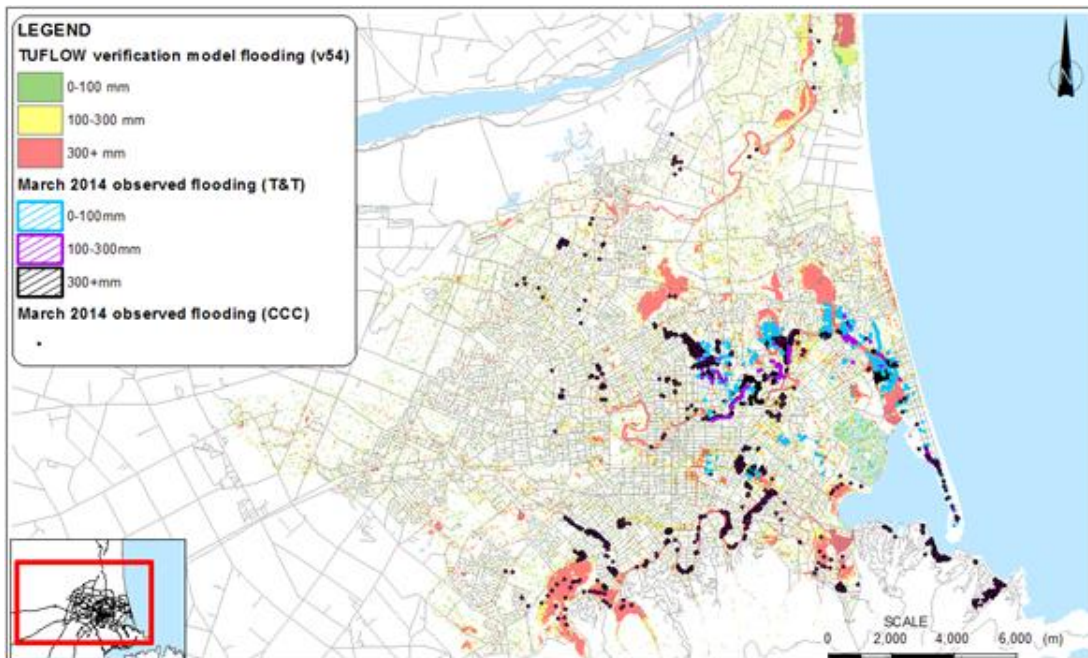
be found at CCC Task Force 2014b). The focus is on areas where earthquake-induced geotechnical and tectonic impacts on flooding were discussed by the GEER team in Chapter 5, namely in the areas of: 1) Lower Avon River (Figure 8-1b and dark green boundary in Figure 8-1a); 2) Dudley Creek, Flockton area (Figure 8-1b and purple boundary in Figure 8-1a); 3) Lower Heathcote (Figure 8-1c and dark yellow boundary in Figure 8-1a). These areas suffered the most severe flooding after the 5th March event as shown in Figure 8-2.

Figure 8-2 Observed Flooding in Christchurch March 2014 with hind cast model predictions (courtesy of Tonkin & Taylor, 2014).

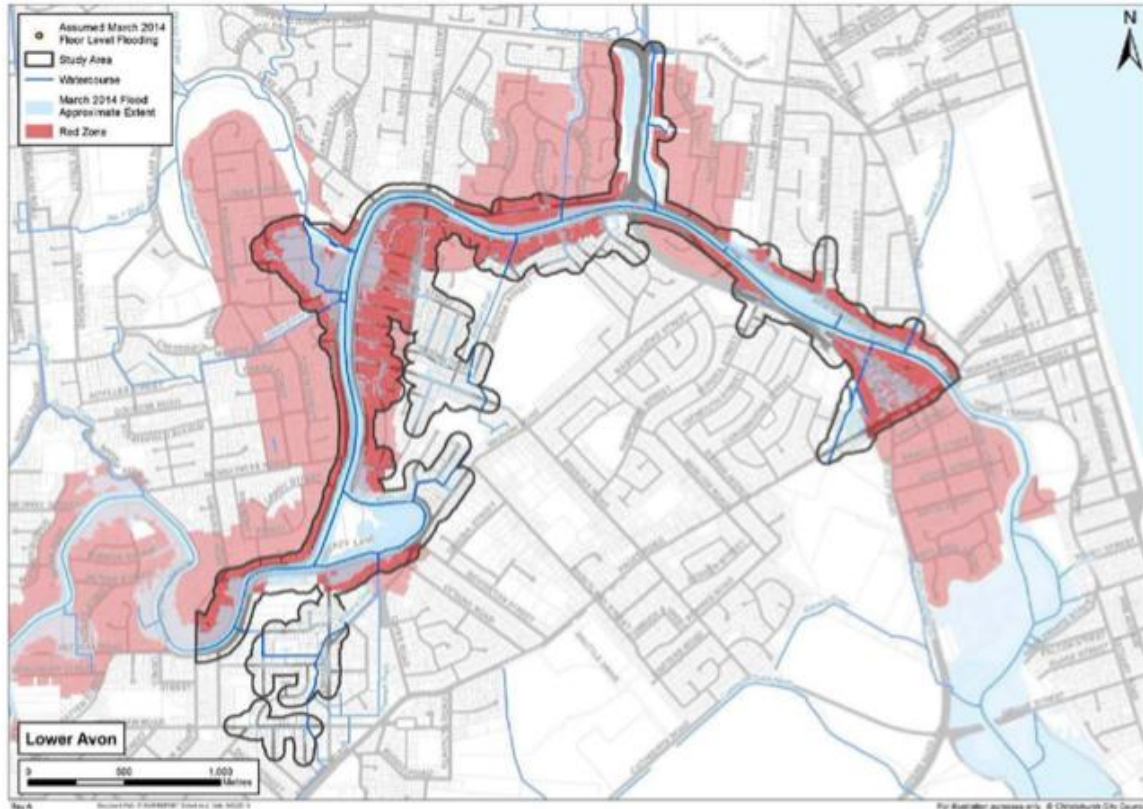
Figure 8-3 shows the Lower Avon River area that was declared Residential Red Zone (RRZ)² area after the 2010-2011 earthquake sequence. This area suffered significant ground settlement as a result of the earthquakes and is now typically at river level (RL)10.0 – RL11m. Vertical and horizontal ground movements in the range of -0.1 m to -0.5 m have been observed along the Avon, with some localised movement of -0.5 m to -1.0 m. As described in Chapter 3, moderate to significant liquefaction accompanied by moderate to severe lateral spread occurred along the length of the Lower Avon River and within the RRZ. The riverbed experienced heaving. Some parts of the RRZ area are now below annual high tide level and the river flood level for moderate to major storm events (CCC Task Force, 2014b).

The Avon River banks suffered significant slumping as part of liquefaction and lateral spreading. Temporary stopbanks were reconstructed along the river's edge. Each major earthquake event caused further damage and settlement to the stopbanks. These stopbanks continue to suffer from bank slumping and fill consolidation. This results in portions of the stopbanks being lower than the river flood level.

Figure 8-3 Lower Avon River: boundary of the area analysed by the CCC Taskforce and extent of March 2014 flood (map from CCC Task Force 2014b).

Flooding along the urban side of the stopbanks was caused by both: (1) the river floodwaters back flowing through the flap valves and (2) rainfall within the catchment (i.e., behind the stopbanks) not being able to drain into the river.

The river also over-topped the stopbanks in some locations. Bank overtopping occurred as a result of stopbank slumping and settlement and the flooding in these areas was exacerbated by post-earthquake maintenance practices of blocking off some piped stormwater outfalls. The blocking of outfall been undertaken primarily because: (a) post-earthquake stopbank restorations required some manholes to be covered and as a result prevents access to flap gates for maintenance; or (b) to prevent backflow from the river, but this resulted in surface ponding.

flood extent along the Avon River indicates about 396 properties experienced some flooding. Most of these properties would have been abandoned and likely demolished because they are in the RRZ, however not all homes have been abandoned. 120 houses in the RRZ were reported as flooded by the owners/residents, and 8 garages were confirmed as flooded outside the RRZ area. A number of properties also reported flooding up to the house foundations.

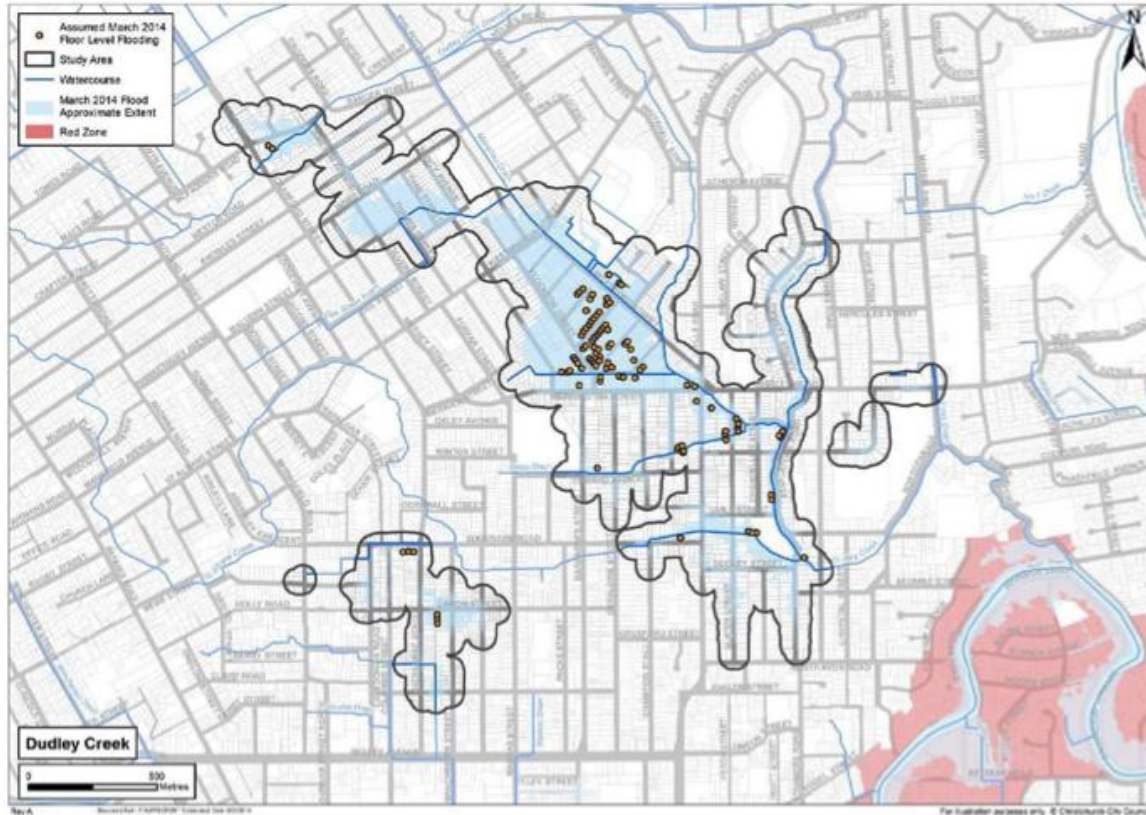
A large proportion of the catchment has subsided between 200 and 500 mm (Chapter 3 and Chapter 5). Bed heave has occurred extensively along Dudley Creek and its tributaries and a subsequent loss in hydraulic capacity has occurred (Chapter 3). Damage to culverts and failure of timber retaining structures has occurred across the lower catchment. Culvert repairs and replacements are proposed by SCIRT, and CCC has been undertaking remedial works, such as silt clearance, since the earthquakes. Further damage to the drainage infrastructures is being addressed through the SCIRT programme as described in Chapter 7.

Figure 8-4 Dudley Creek location plan: boundary of the area analysed by the Taskforce; extent of March 2014 flood and location of flooded houses (map from Task Force, 2014b).

Figure 8-4 shows the extent of recorded pluvial floodwaters recorded from the March event, which exceeded 600mm in depth in some areas. Flooding in the Dudley Creek catchment resulted from the previously described under capacity waterways, which restrict flows causing water to back up in heavy rainfall. Additionally, flooding is enhanced from the significant seismic-induced ground settlement coupled with the waterways suffering from lateral spreading and bed heave. The inability of the waterways to convey flow has a direct impact on the ability of drainage infrastructure to function. Fluvial water backflows the associated piping and spills into the Flockton area exacerbating pluvial flooding issues.

The Flockton area flooding caused an estimated 97 properties to experience water intrusion above floor level at locations shown in Figure 8-4. This number of flooded properties was based on GIS data and the surveyed flood extent. For the wider area, the majority of properties experienced flooding across the section or under foundations.

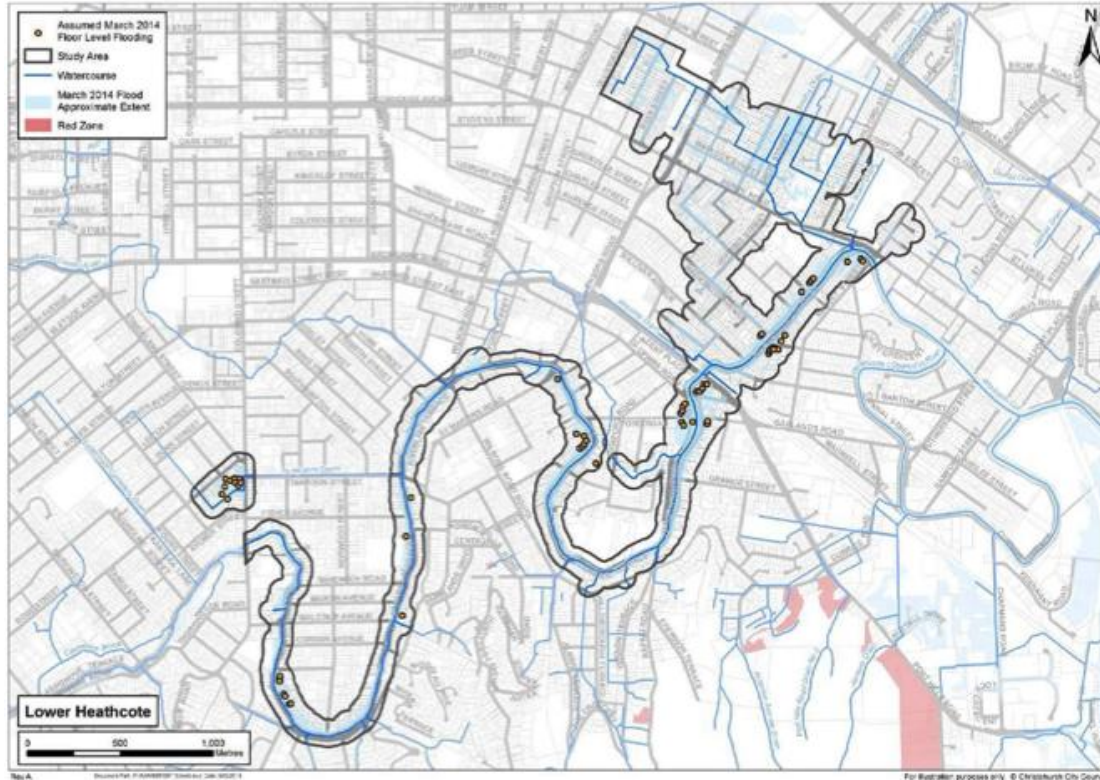
Although flooding had previously been experienced in the catchment, a number of residents in the area indicated that there had been no previous flooding on their properties prior to the earthquakes (CCC Task Force, 2014b). After the earthquake sequence, it is fairly common for riverside properties in this catchment to experience shallow flooding or have restricted access during large rainstorms. Three severe rain events from March 2014 to April 2014, have resulted in the recent floor level flooding in the area, along with widespread road, property, and ancillary buildings flooding. Figure 8-5 shows flooded areas from the March 2014 event.

Figure 8-5 Lower Heathcote: boundary of the area analysed by the CCC Taskforce; extent of March 2014 flood and location of flooded houses (map from CCC Task Force 2014b).

The Heathcote River has sustained earthquake damage with lateral spreading, siltation and bed heave reducing the capacity of the river system. Surveys undertaken between Garlands Road and Radley Street in May 2014 indicates that there has been some localized reduction in tide bank heights; the design level for this bank (1986) was set at 10.9 mRL, however the survey indicates that approximately 20% of the banks have lower levels than designed, with some areas now having a level as low as 10.4 m RL.

Flooding depths varied along the length of the Heathcote River; depths were anecdotally recorded from 300 -1000mm on properties. 19 properties were identified as flooded 'Above Floor Level' in the Lower Heathcote area. However, LiDAR contour maps predict that unrecorded flooding exists in the same area.
