# GEOTECHNICAL RECONNAISSANCE OF THE 2016 $M_w$ 7.8 KAIKOURA, NEW ZEALAND EARTHQUAKE

Version 1.0: 10 JUNE 2017

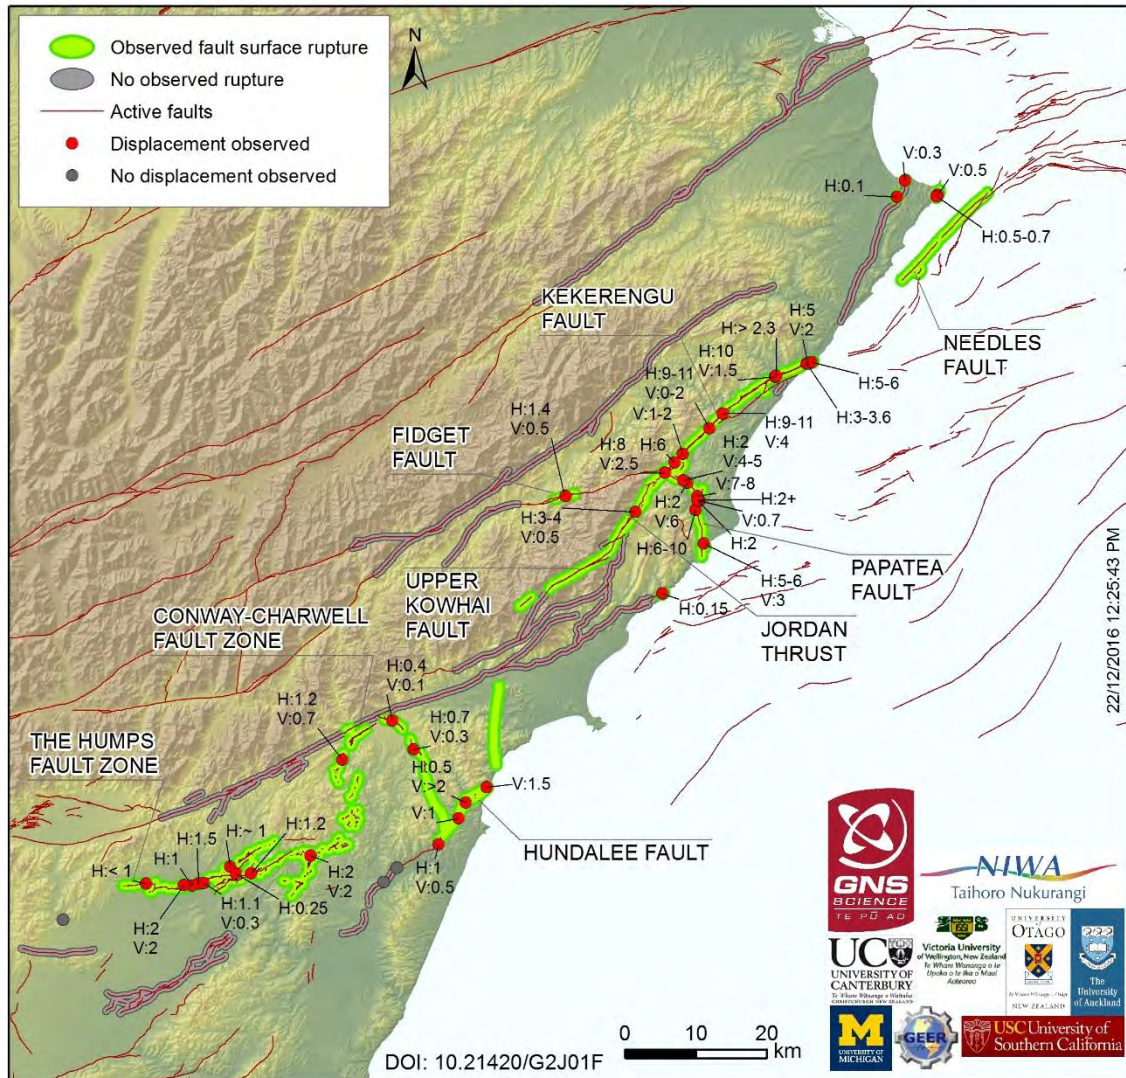
Figure 2.3: Observed and documented fault ruptures as at 22 December 2016 from the 2016  $M_w7.8$  Kaikoura Earthquake and associated displacements, as measured in the field by scientists from GNS Science, Victoria University of Wellington, University of Canterbury, University of Otago, NIWA, and GEER, among others.

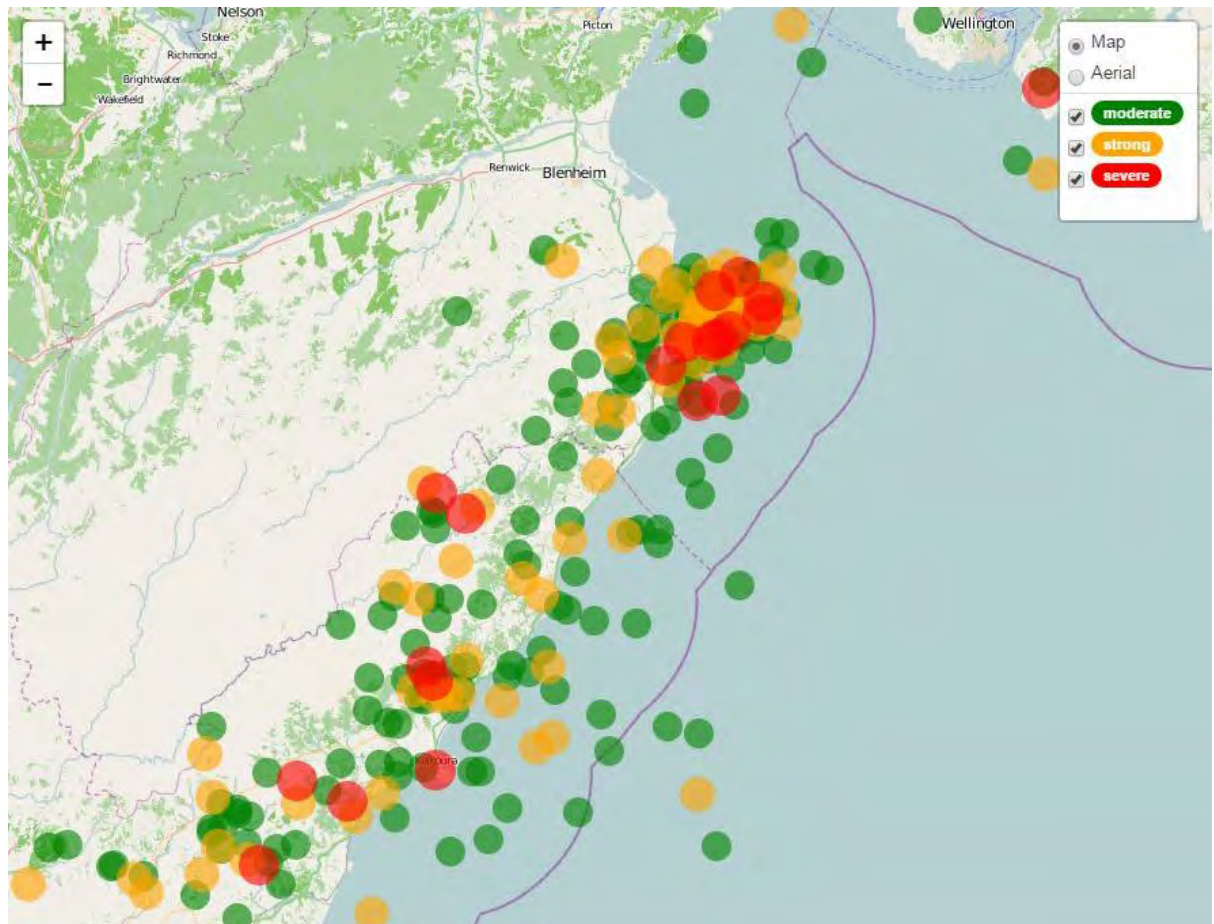
Figure 2.4: Map of aftershock locations in the 24 hours following the  $M_w$ 7.8 Kaikoura Earthquake as compiled by GeoNET.

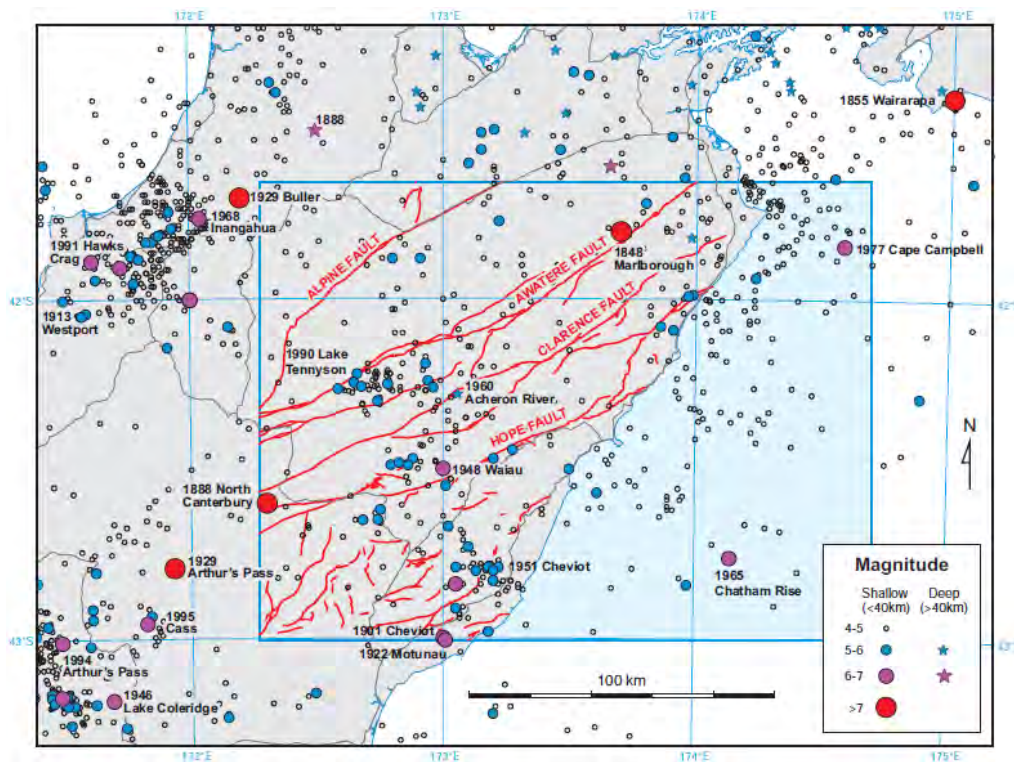
Figure 2.5: Historic earthquakes within the northern South Island of New Zealand (Rattenbury et al., 2006).

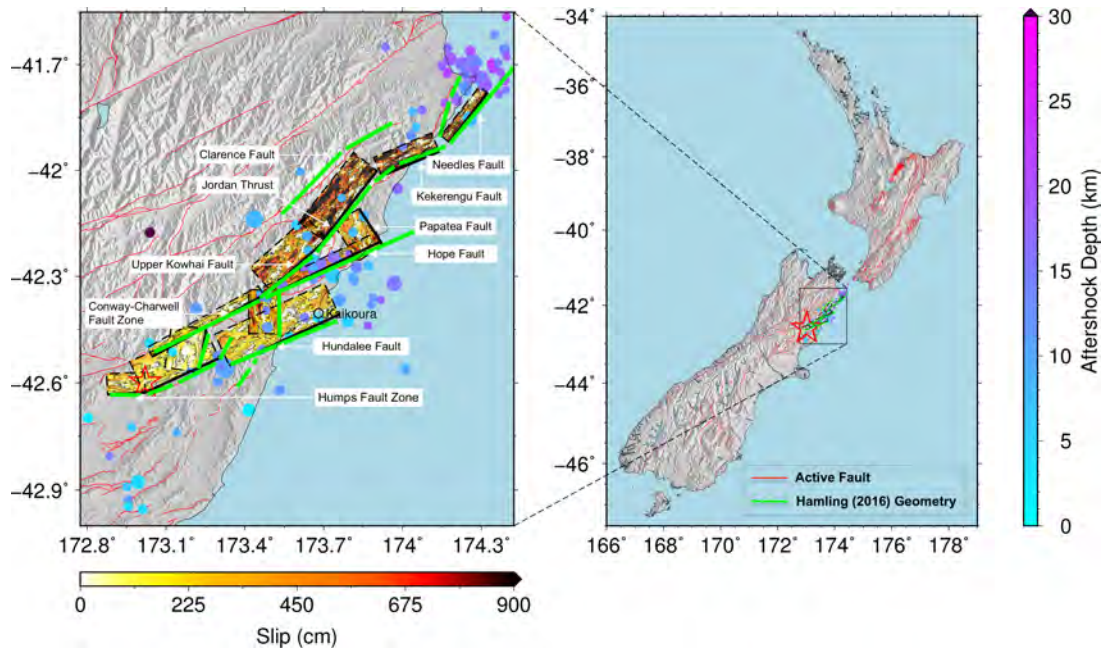
Figure 3.1: Location of the  $M_w$ 7.8 Kaikoura earthquake and causative faults on the east coast of the South Island, New Zealand. Hypocentre is marked with a red star. Surface trace of the source inversion of Hamling (2016) shown in green, and adopted kinematic rupture model faults shown as planes coloured by slip amplitude and contoured by rupture time.  $M_w > 4.5$  GeoNet CMT aftershocks till 15 Dec 2016 also illustrated as a function of centroid depth (after Bradley et al. (2017b)).

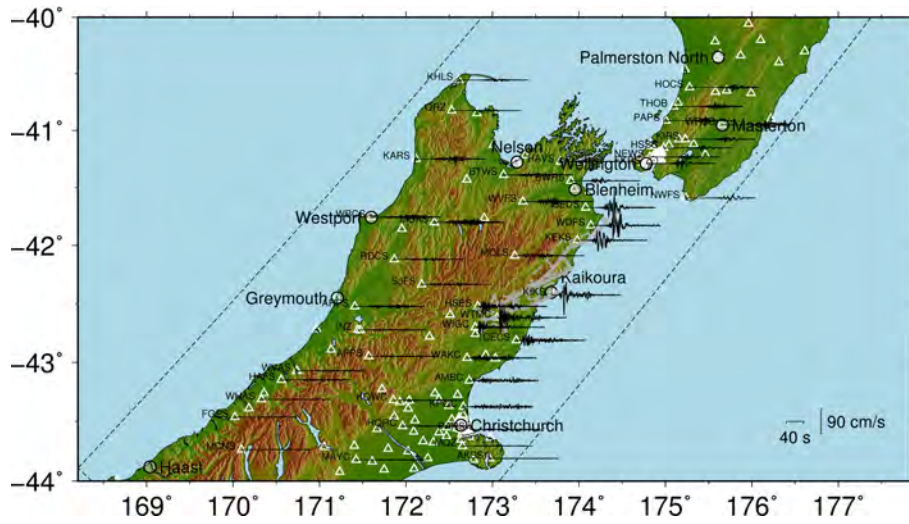
<sup>1</sup> Geometric mean metrics are used throughout unless noted.

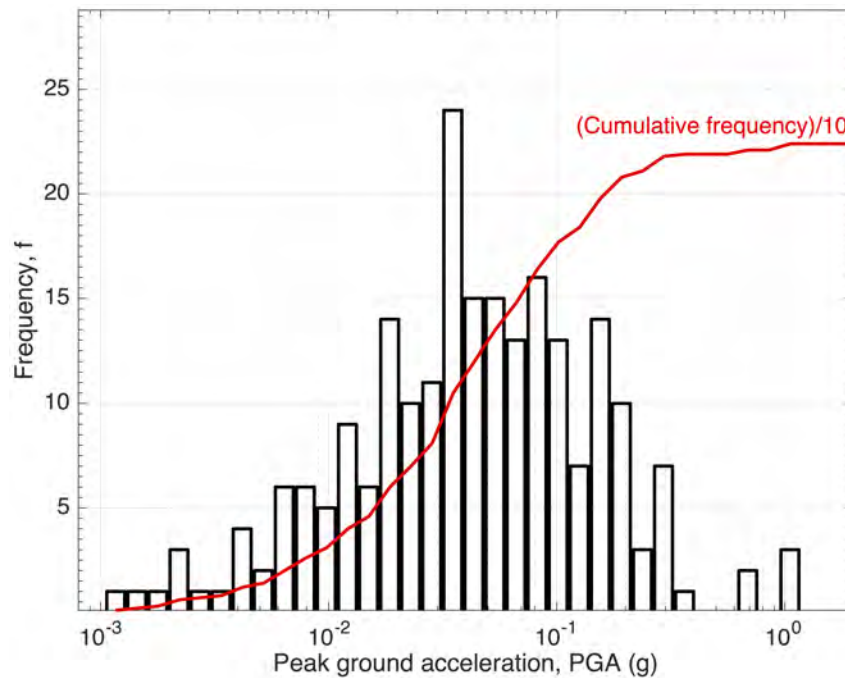
Figure 3.3: Distribution of geometric mean horizontal peak ground acceleration, PGA, recorded by strong motion stations (after Bradley et al. (2017b)).

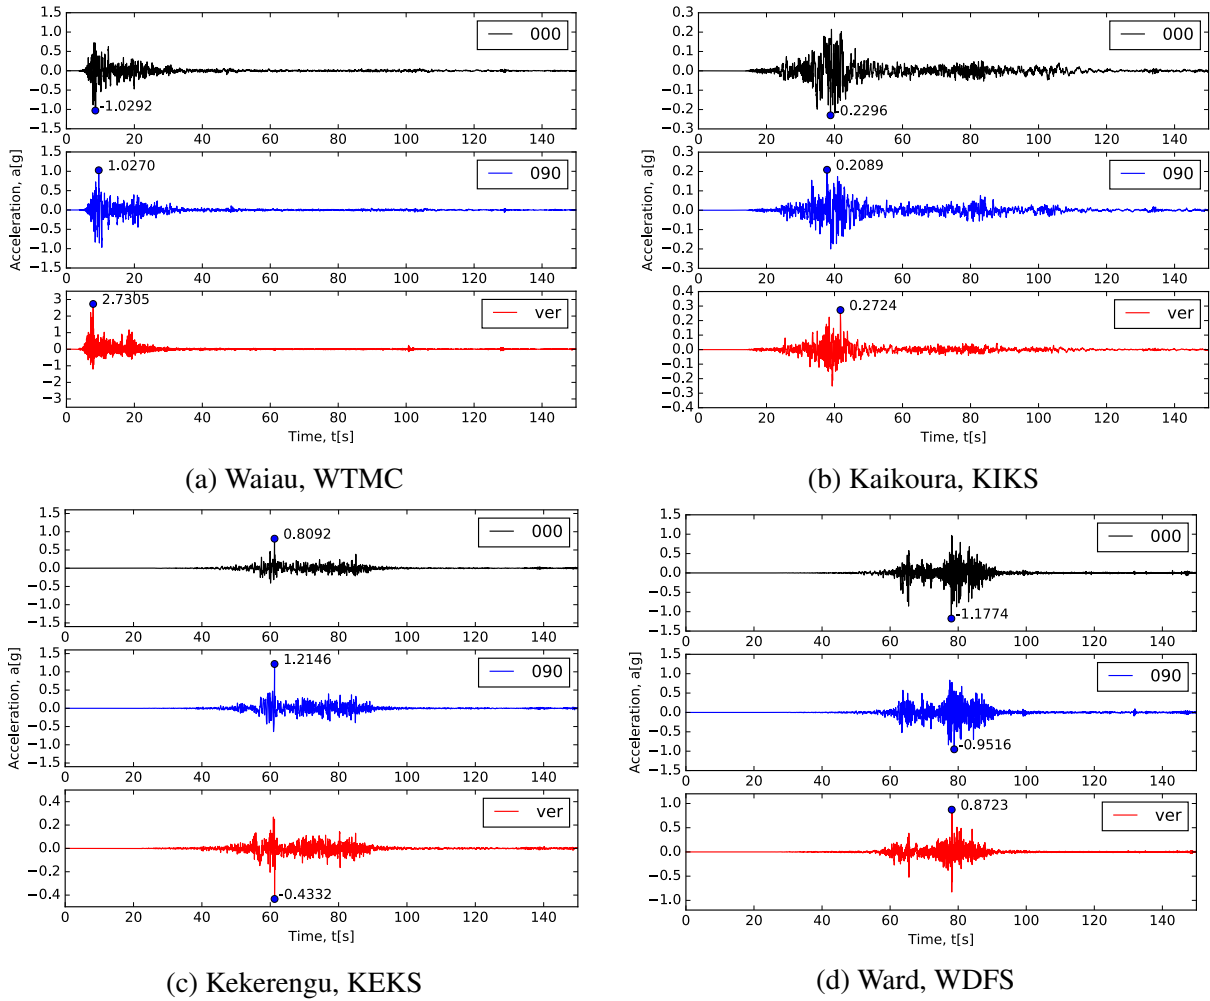
Figure 3.4: Recorded ground motion accelerations in the immediate vicinity of the rupturing faults (locations noted in Figure 3.2). 000, 090, and ver represent north-south, east-west and vertical components, respectively. Maximum accelerations in each component are explicitly noted. Different vertical axis scales are used for each station, and between horizontal and vertical components for clarity (after Bradley et al. (2017b)).

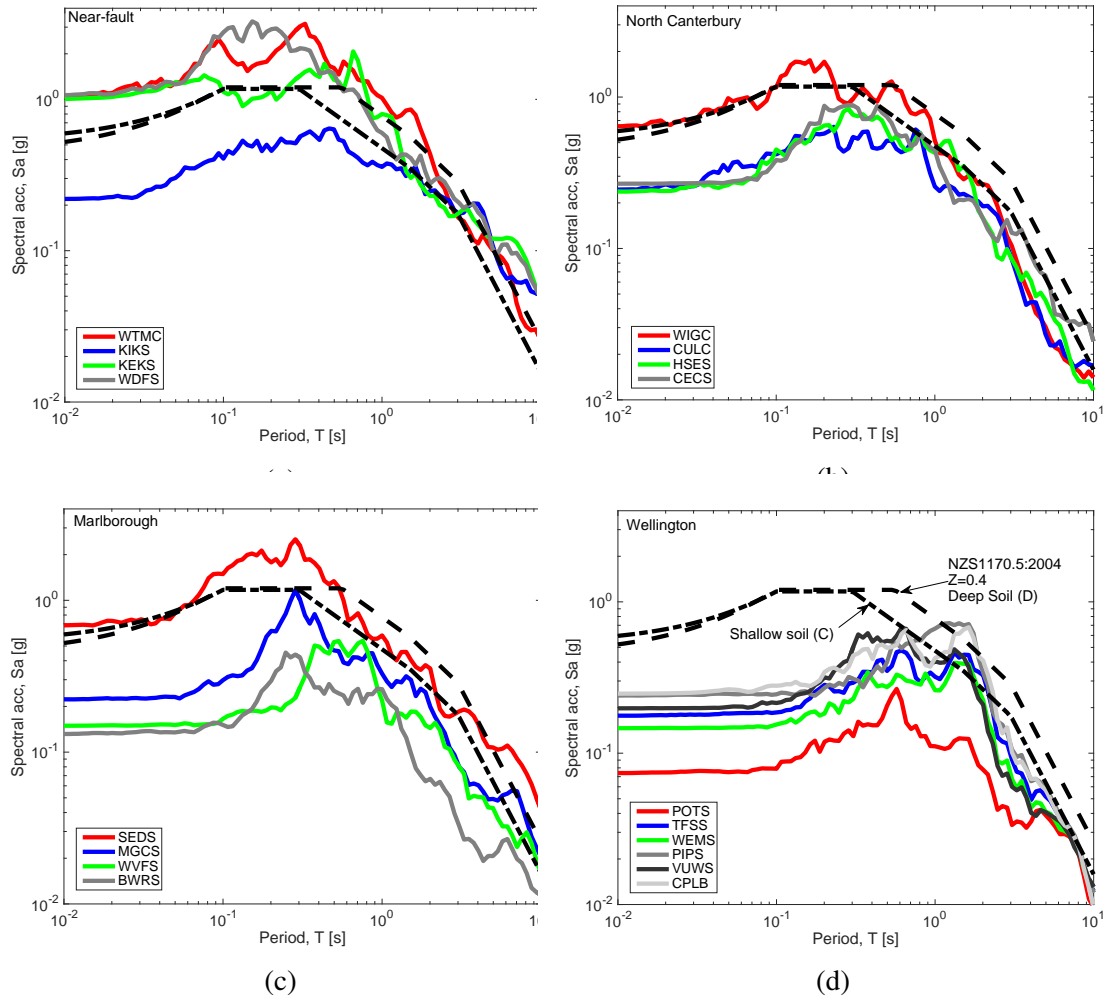
Figure 3.5: A regional depiction of the geometric mean horizontal 5% damped pseudo-acceleration response spectra observed in: (a) the near-fault; (b) North Canterbury; (c) Marlborough; and (d) Wellington. Four letter station codes in the figure legends can be located spatially in Figure 3.2

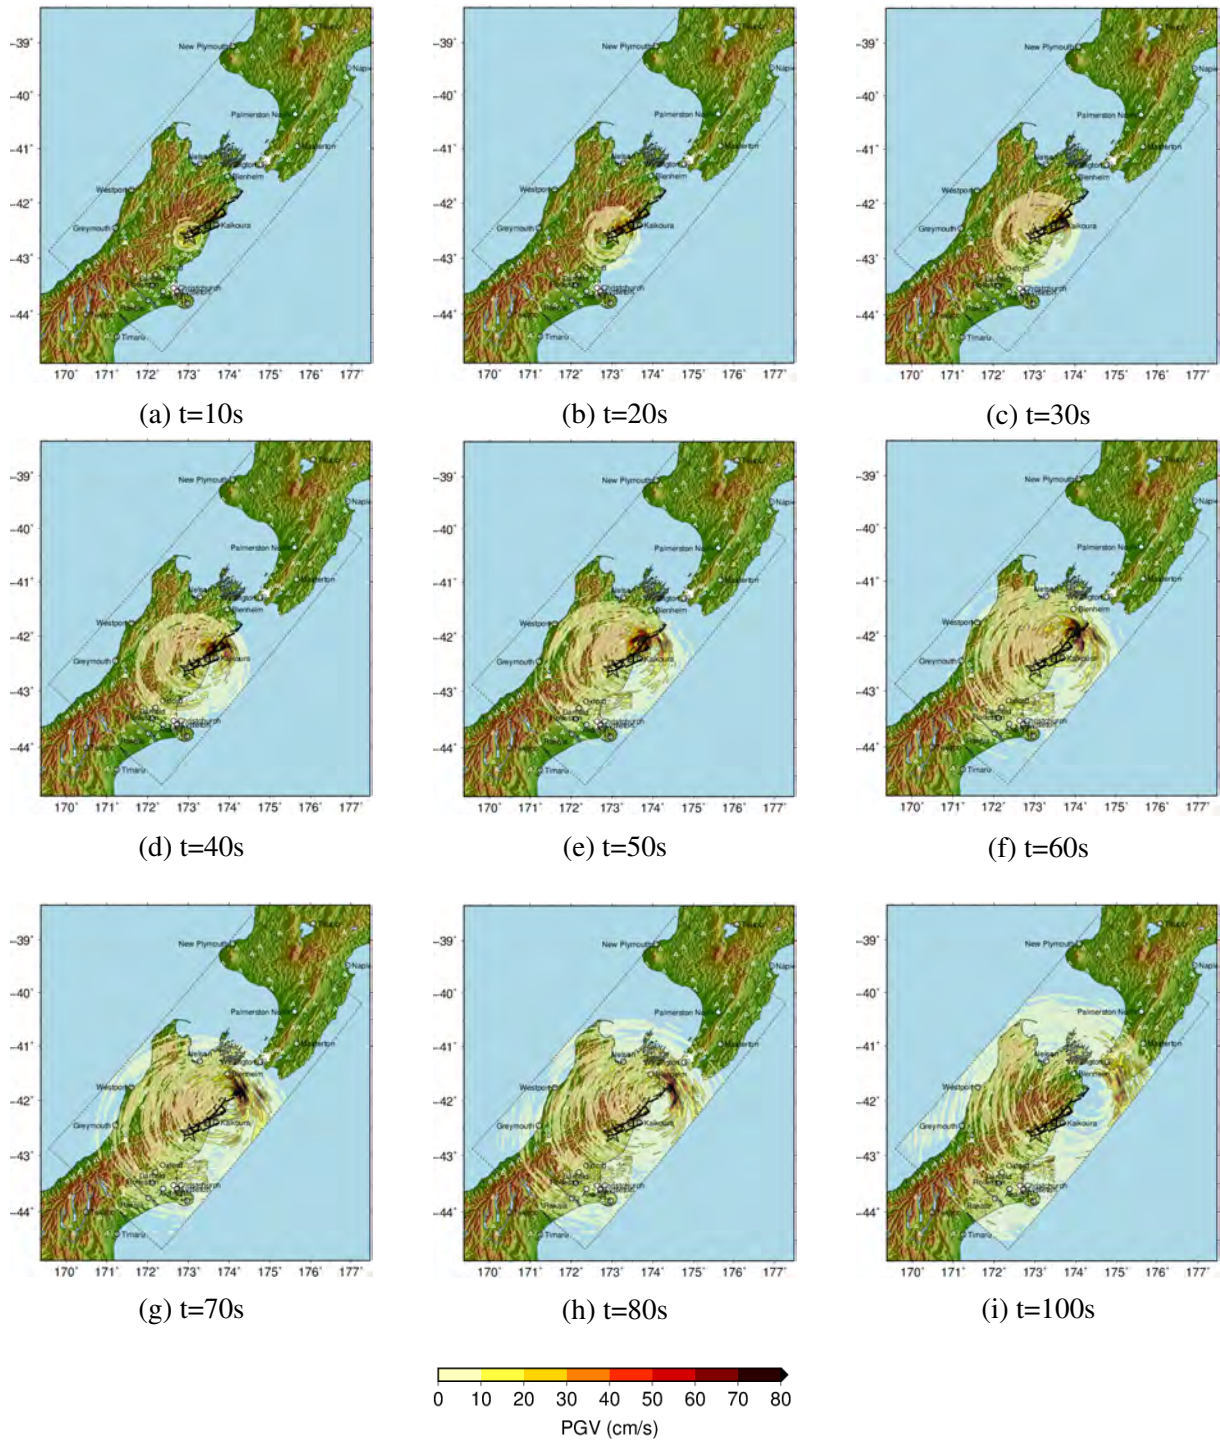
Figure 3.6: Time snapshots of simulated peak ground velocity (three component maximum). The causative fault segments and simulation domain are also indicated. A video of the simulation is available in the electronic supplement to this article and at: <https://youtu.be/ZbI7rgnZ2U8> (after Bradley et al. (2017b)).

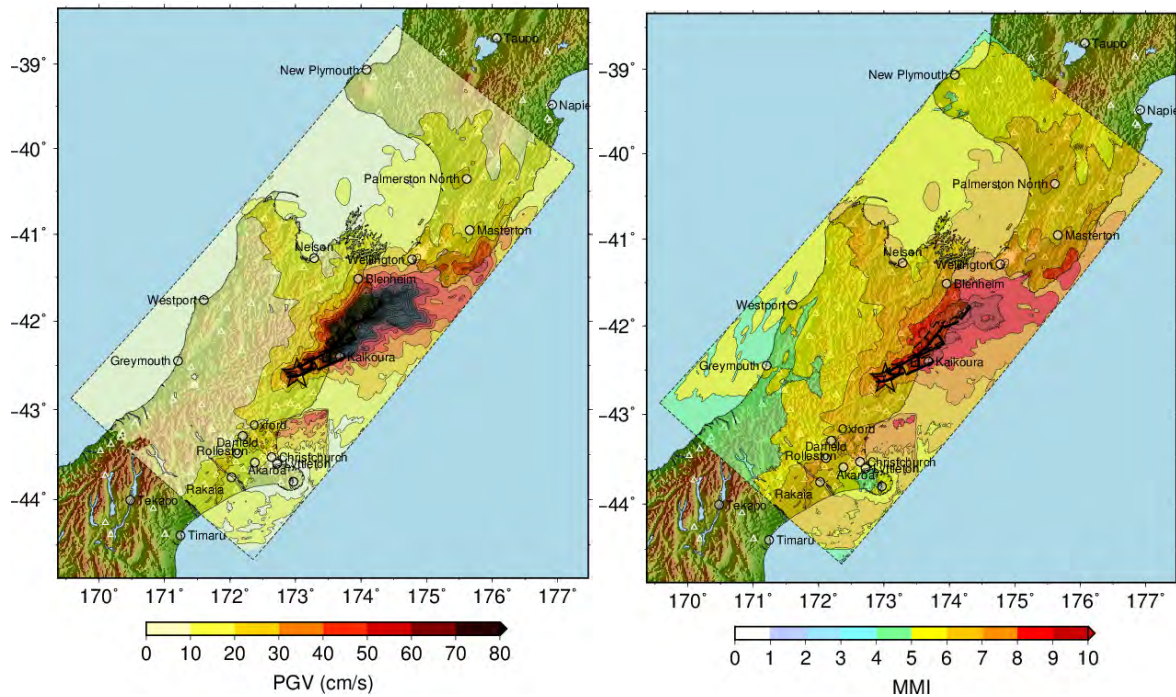
Figure 3.7: Spatial variation of: (a) peak ground velocity (PGV); and (b) Modified Mercalli Intensity (MMI) from the ground motion simulation (vector maximum of the two horizontal components).

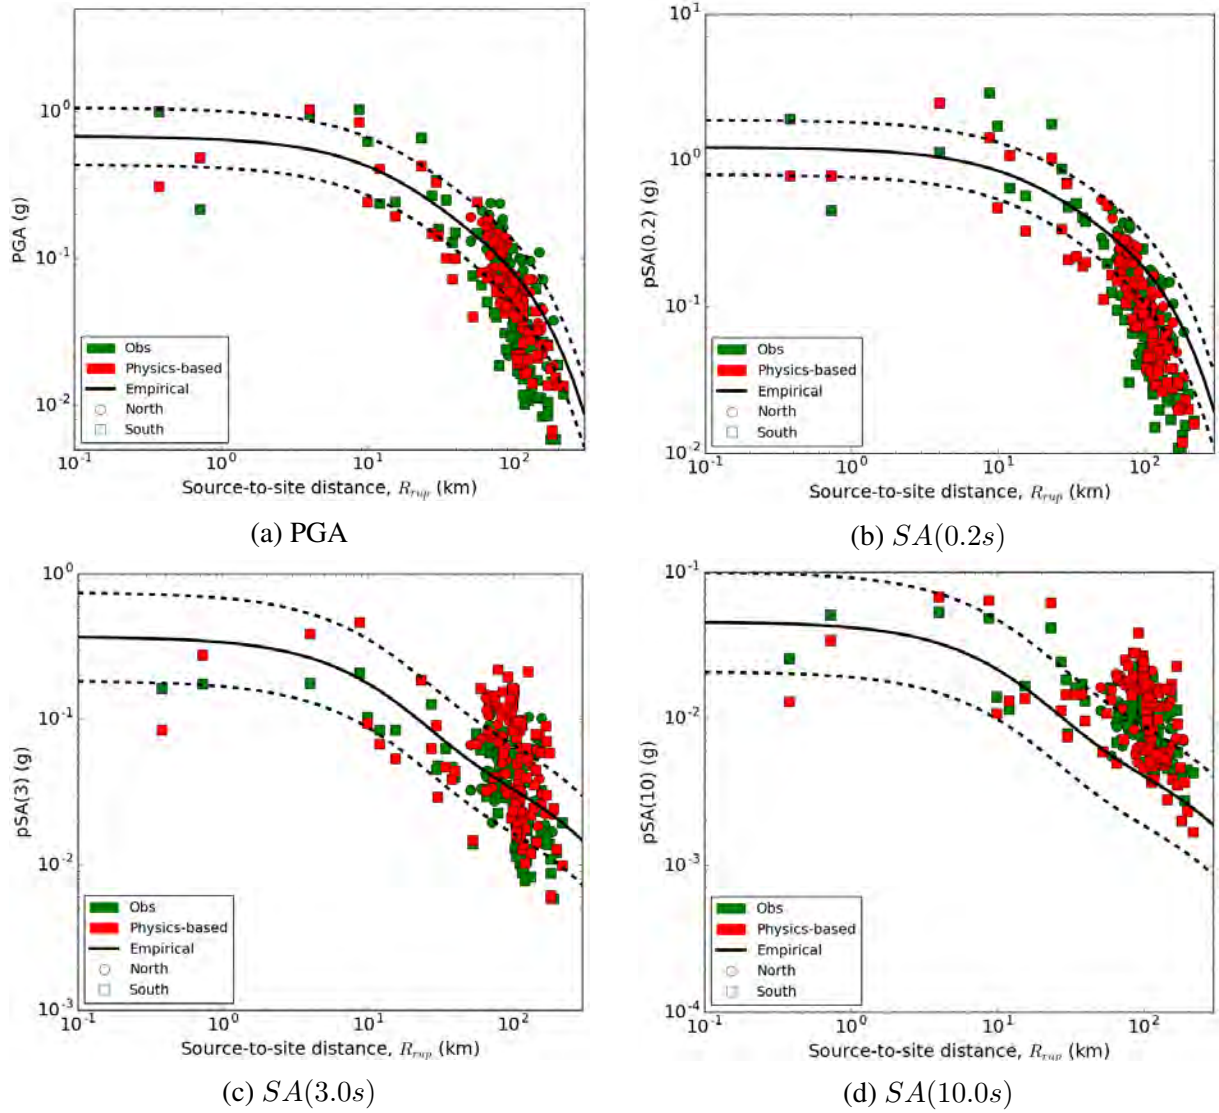
Figure 3.8: Observed, simulated, and empirically-predicted geometric mean 5% damped response spectra as a function of source-to-site distance,  $R_{rup}$ . Symbol shape indicates location of the station in the North or South Island. The median, and 16<sup>th</sup>/84<sup>th</sup> percentiles of the empirical prediction Bradley (2013) are represented by solid and dashed lines, respectively (after Bradley et al. (2017b)).

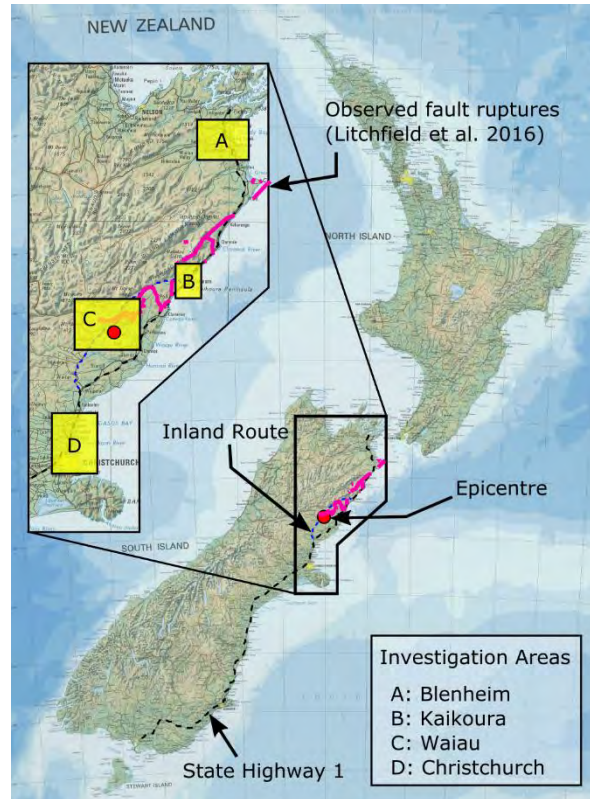
Figure 4.1: Location of main reconnaissance areas. Dashed lines indicate road routes outside of these main areas that were also surveyed by reconnaissance teams.

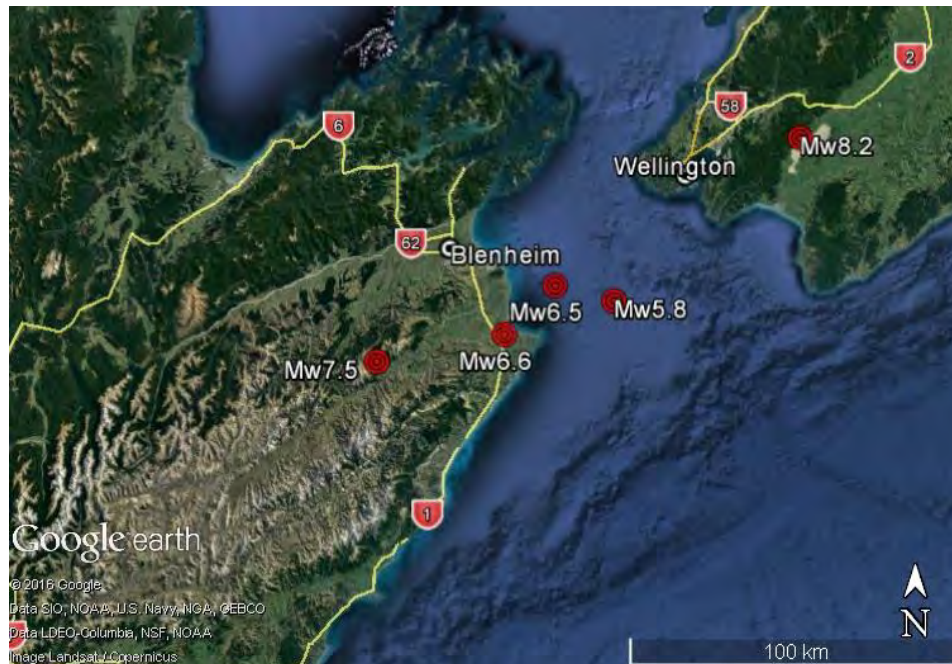
Figure 4.2: Overview of the Marlborough region and location of significant historic earthquakes.

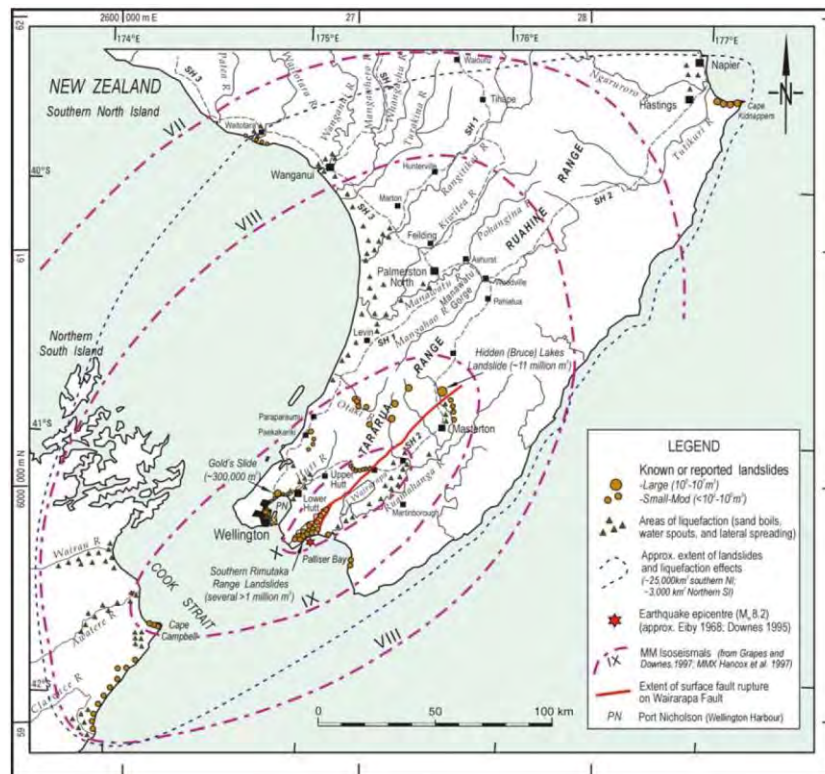
Figure 4.3: Map showing location of known landsliding and manifestation of liquefaction due to the 1855 Wairarapa earthquake (after Hancox 1997). The Marlborough region is in the lower left corner of this figure.

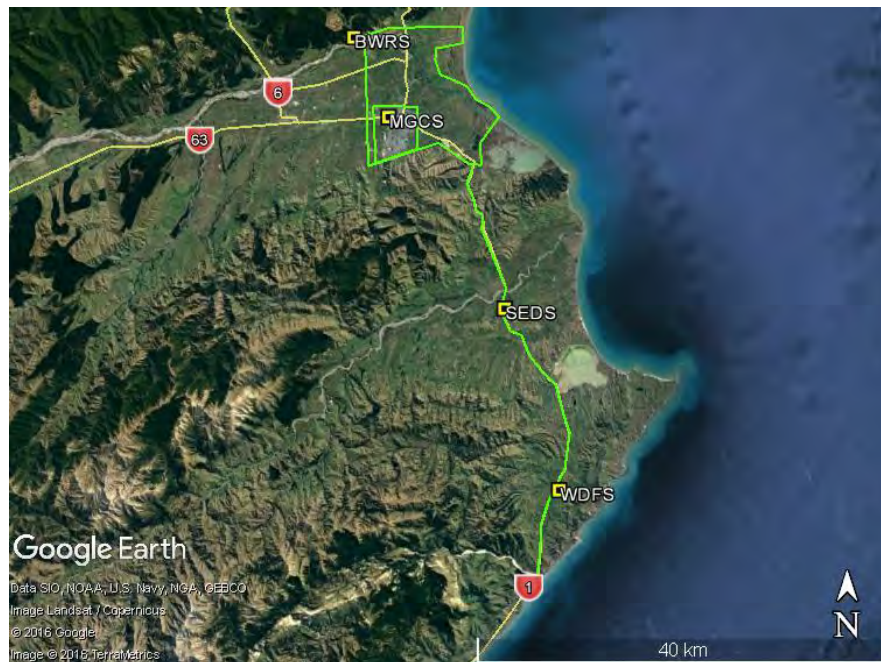
Figure 4.4: Overview map of reconnaissance areas in Marlborough outlined in green and path along State Highway 1. Location of strong motion stations highlighted in this figure, with MGCS in the Blenheim Urban Area.

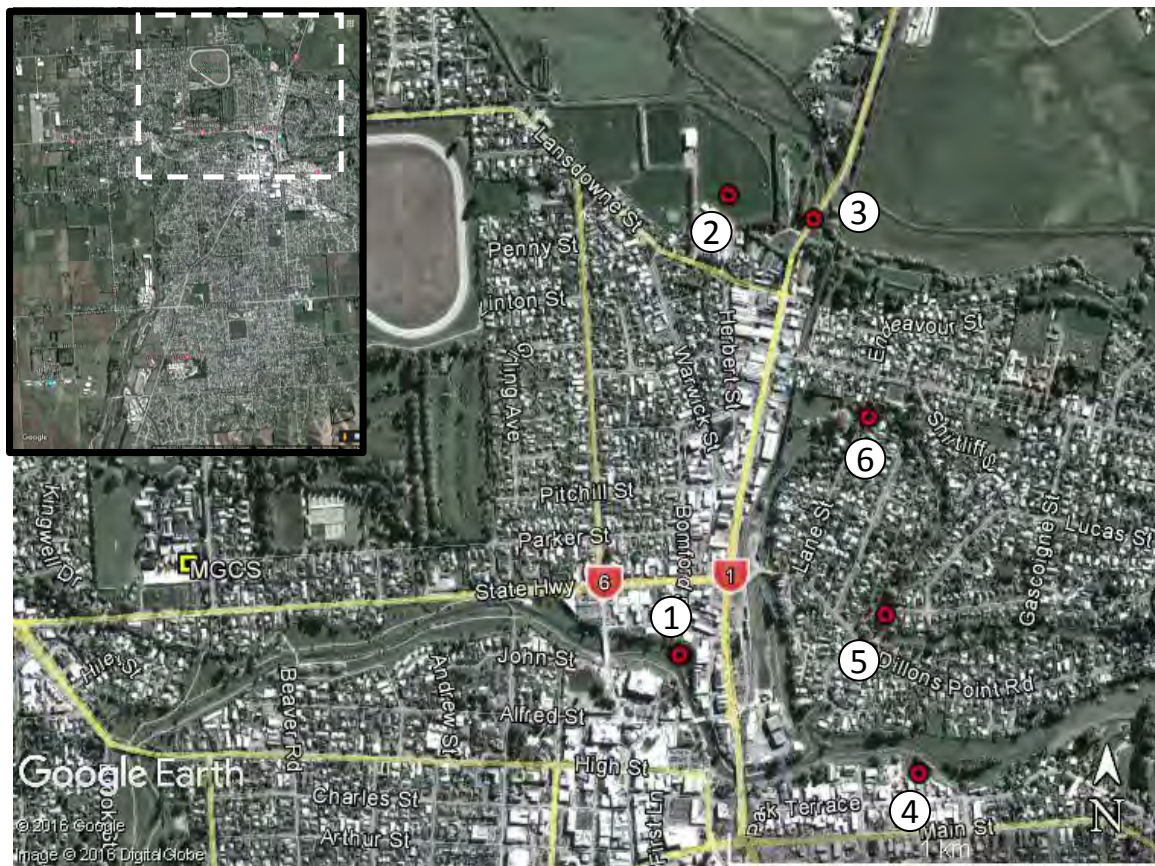
Figure 4.5: Map summarising impacts in urban Blenheim, and location of the MGCS SMS. Inset indicates area where all liquefaction impacts have been summarised and the zoomed in area highlighted in the wider figure (approx. centre of image: S41.5046, E173.9545).

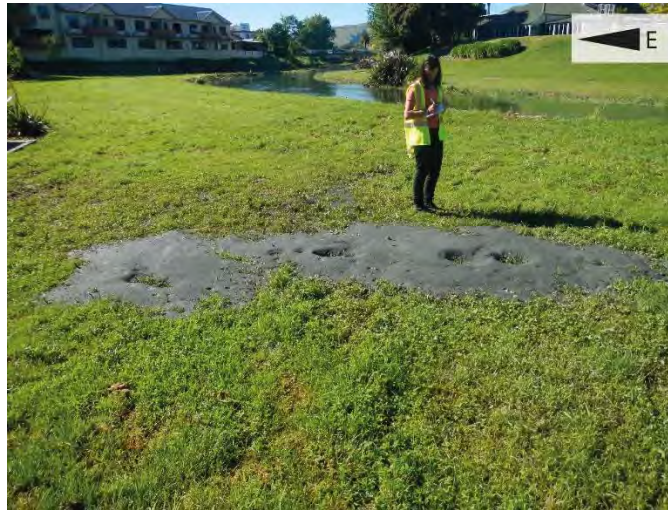
Figure 4.6: Localized elliptical liquefaction ejecta features along the northern bank of the Taylor River (Location 1 in Figure 4.5), approximately 10 to 15 m from the river (S41.5096, E173.9577, facing SE).

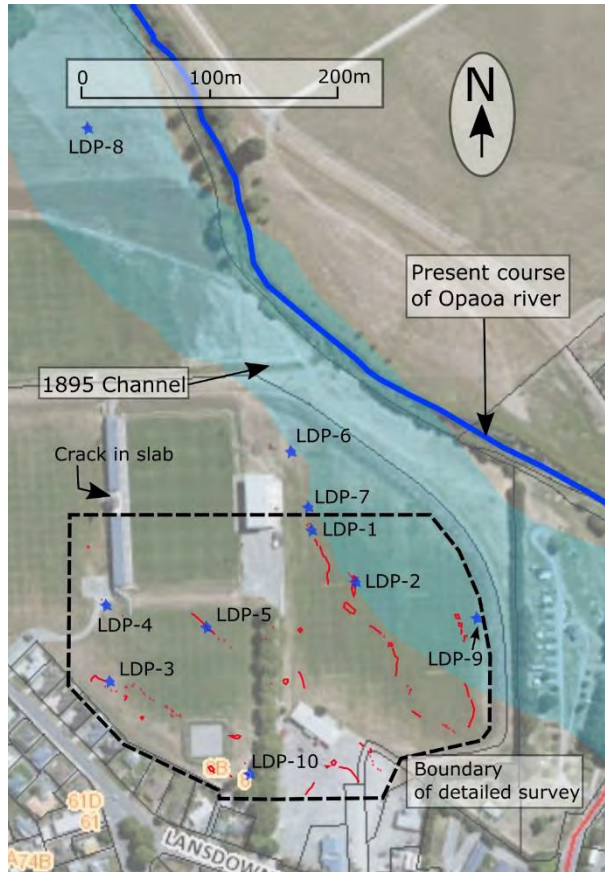
Figure 4.8: Location of ejecta at Lansdowne Park designated by red regions, with sample locations designated by blue stars. The present course and the abandon channel of the Opaoa River are designated by a blue line and blue shading, respectively (approx. centre of image: S41.4980, E173.9587).

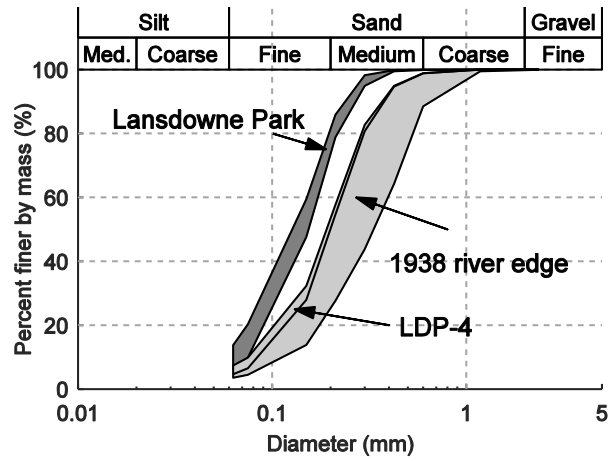
Figure 4.9: Particle size distributions of ejecta samples at Lansdowne Park.

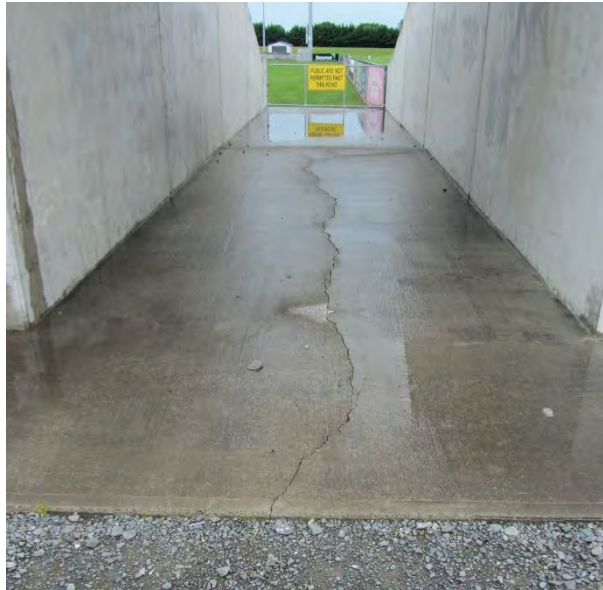
Figure 4.14: Crack in foundation slab on west stand (17 Nov 2016, S41.4993, E173.9569, facing E).

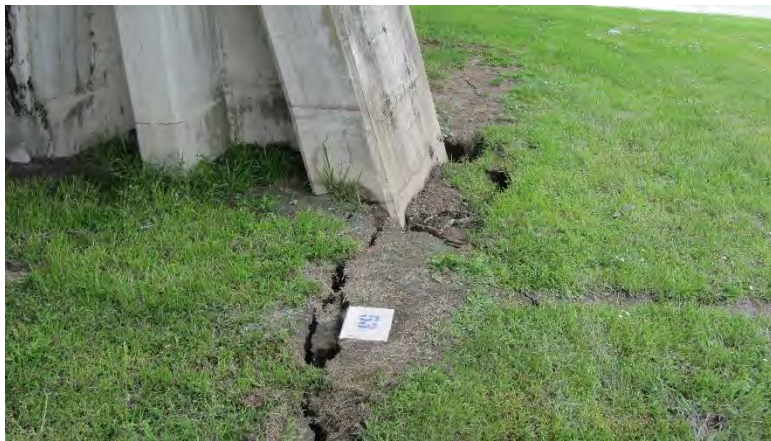
Figure 4.15: Cracking adjacent to the southern pier of the Opawa River Bridge (14 Nov 2016, S41.5006, E173.9616, facing N).

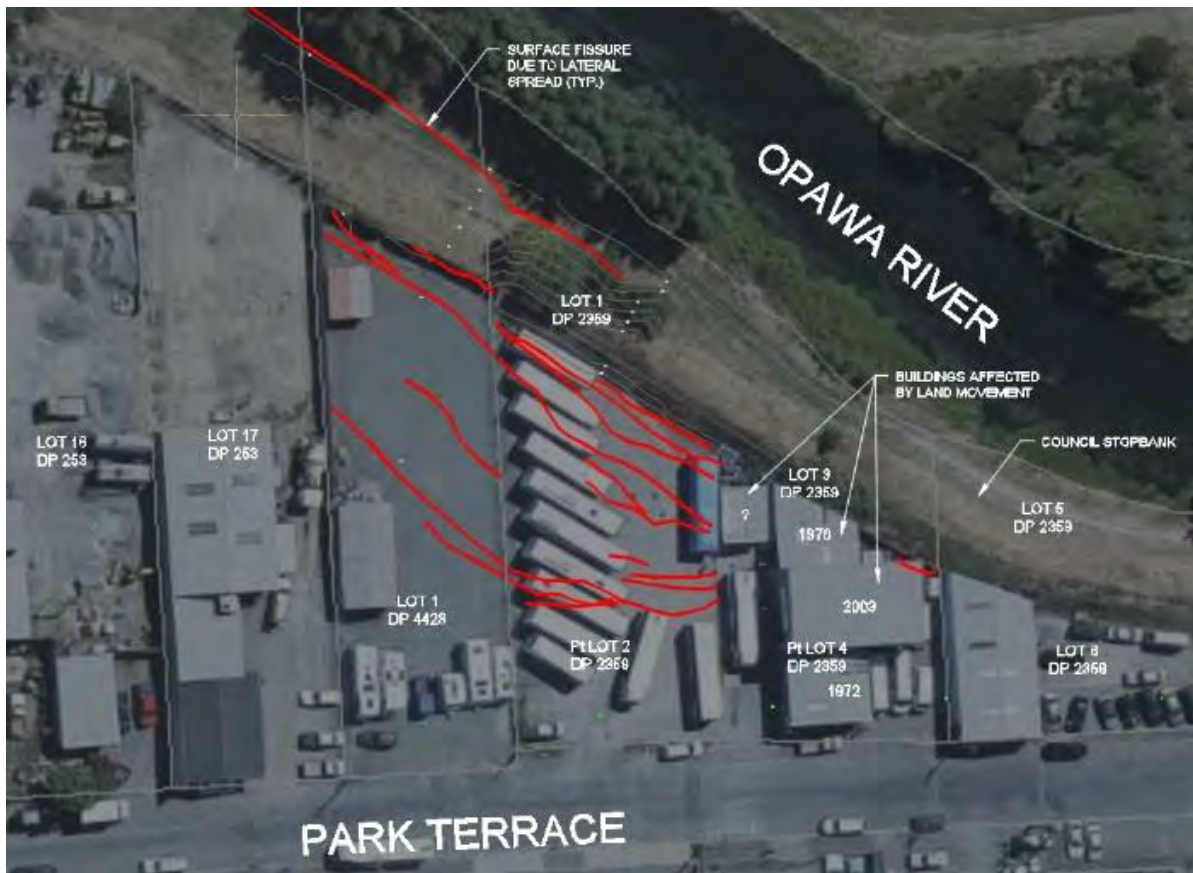
Figure 4.16: Summary of damage at the Park Terrace site. Dashed line indicates location of the historic stopbank (approx. centre of image: S41.5122, E173.9649).

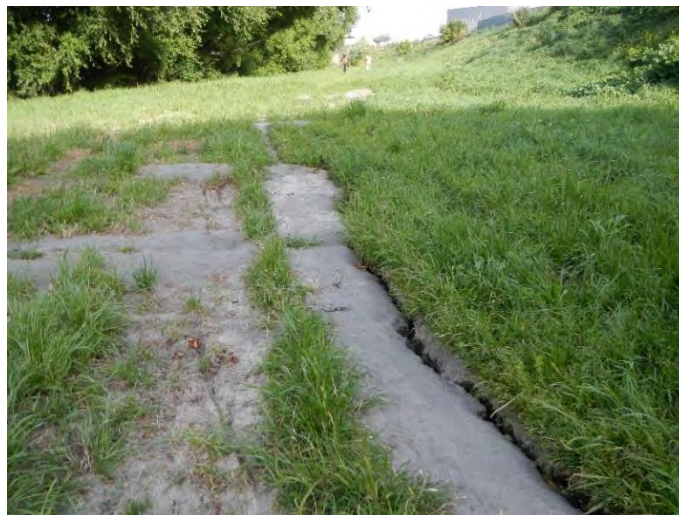
Figure 4.17: Crack parallel to Opaoa River surrounded by grey ejecta to the north of the Park Terrace properties (7 Dec 2016, S41.5121, E173.9651, facing E).

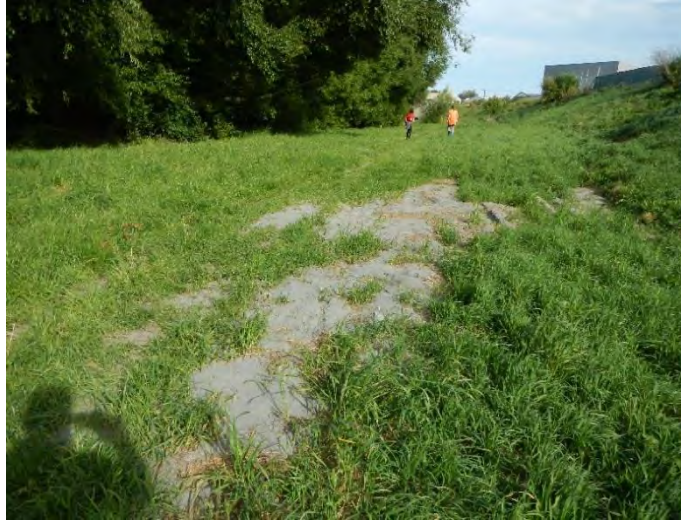
Figure 4.18: Ejecta at the base of the Park Terrace stopbanks (5 Dec 2016, S41.5121, E173.9651, facing E).

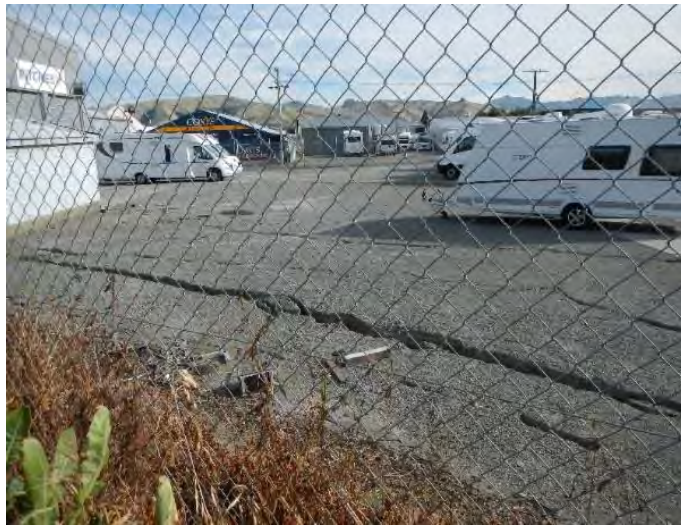
Figure 4.19: Ground damage to industrial properties along Park Terrace (5 Dec 2016, S41.5122, E173.9649, facing SE).

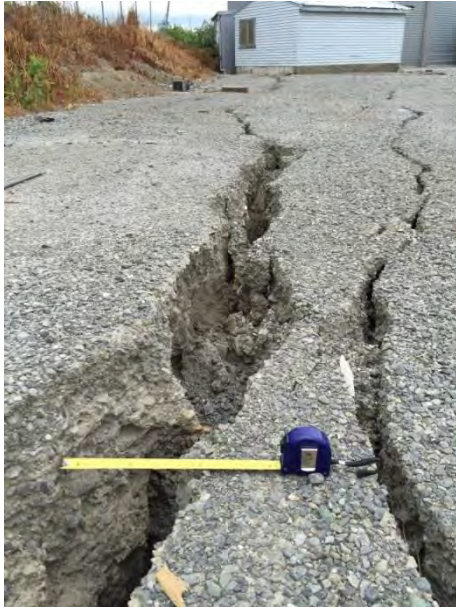
Cracks propagated across a number of properties, resulting in permanent ground deformation, differential settlement of structures, separation between foundation slabs and the surrounding ground, and damage to the stopbanks. Details of the cracking are shown in Figure 4.16, Figure 4.19 to Figure 4.21 and Table 4.1.

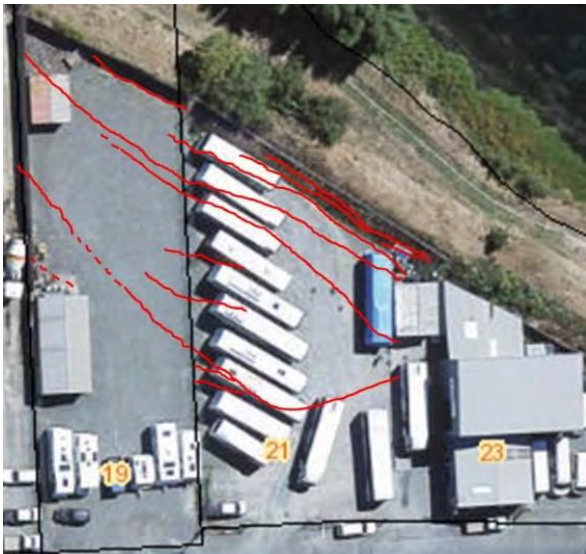
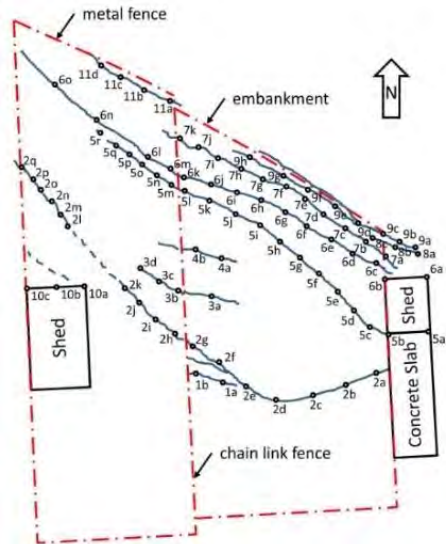
Figure 4.21: Mapping of surficial cracking at two properties on Park Tce. (approx. centre of image: S41.512306, E173.964887): (a) Aerial photograph with locations of observed cracks superimposed; (b) schematic of property boundaries, observed cracks, and approximate locations where horizontal and vertical displacements on cracks were measured (see Table 1).

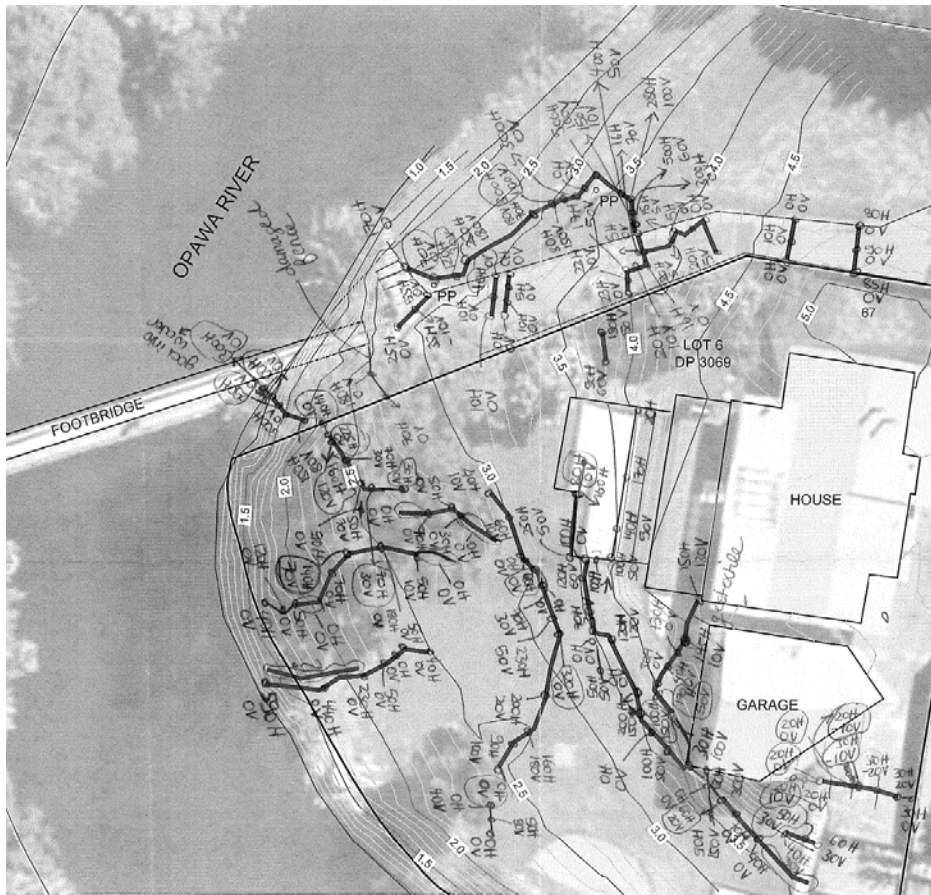
Figure 4.22: Summary of cracking and liquefaction manifestations at the Elizabeth St site (approx. centre of image: S41.5046, E173.9634).

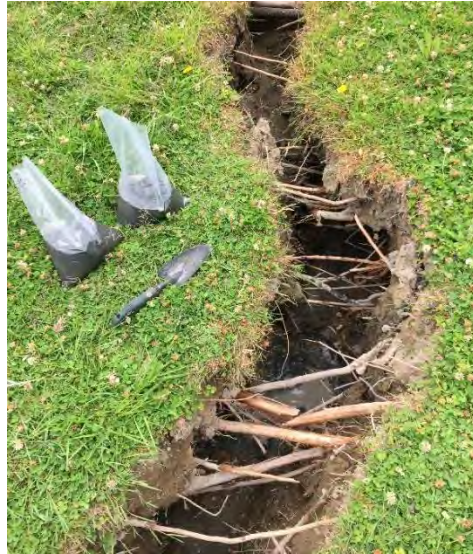
Figure 4.23: Crack at Elizabeth Street perpendicular to river filled with bluish-grey ejecta and intersected with roots (7 Dec 2016, S41.5088, E173.9635, facing E).

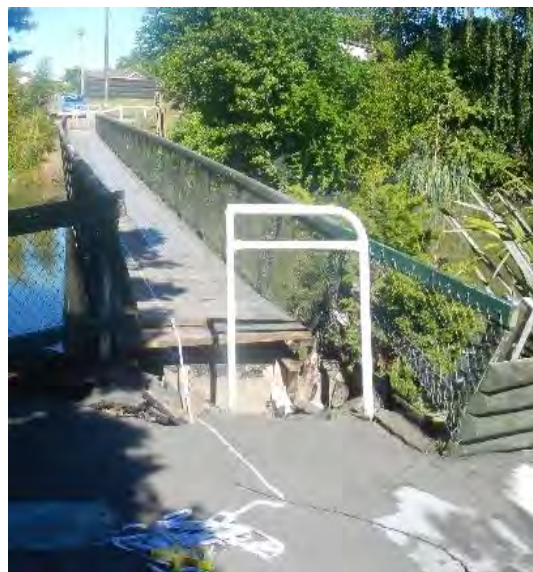
Figure 4.24: Damage to footbridge abutment at the end of Elizabeth Street (17 Nov 2016, S41.5087, E173.9636, facing W).

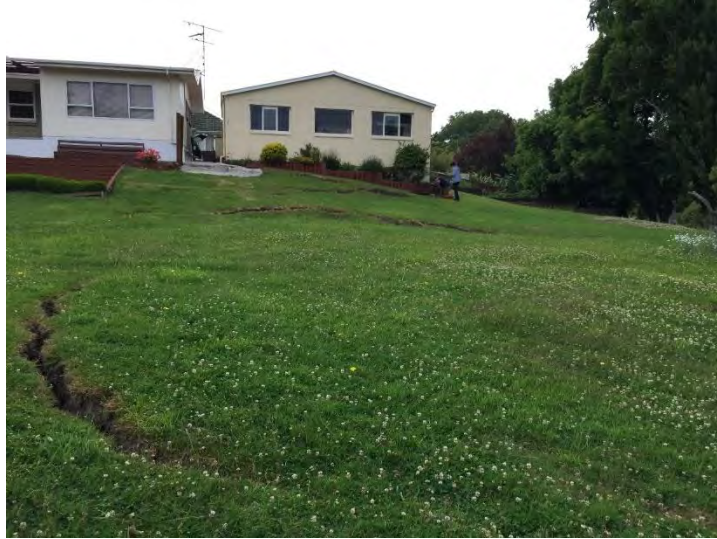
Figure 4.25: System of lateral spreading/slumping cracks at Elizabeth Street (7 Dec 2016, S41.5089, E173.9636, facing E).

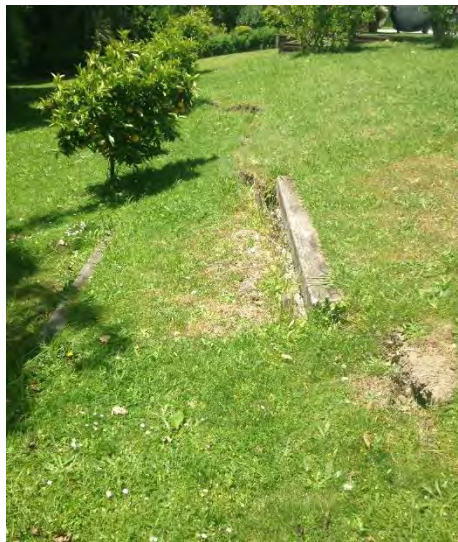
Figure 4.26: Minor lateral spreading adjacent to the Opaoa River (6 Dec 2016, S41.5046, E173.9633, facing E).
