# GEOTECHNICAL RECONNAISSANCE OF THE 2016 $M_w$ 7.8 KAIKOURA, NEW ZEALAND EARTHQUAKE

Version 1.0: 10 JUNE 2017

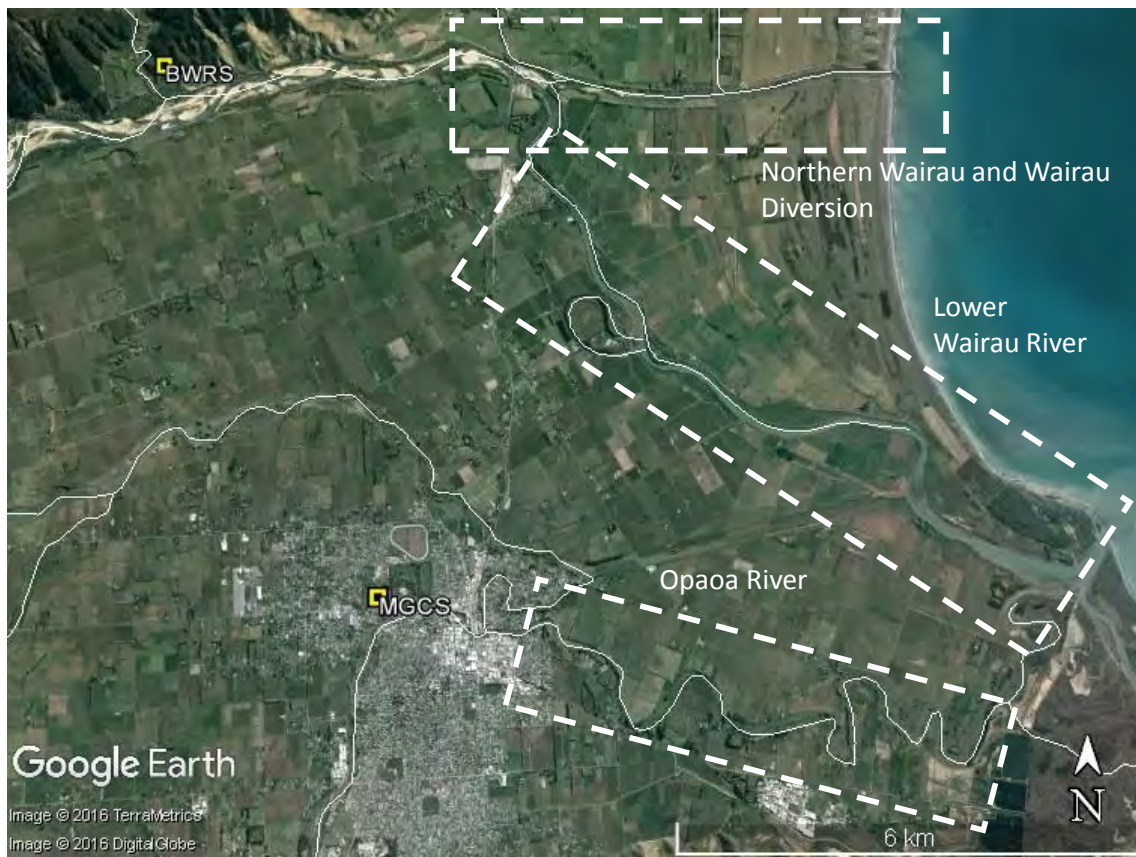
Figure 4.27: Overview of the Wairau Plain region and areas of focus outlined in subsequent sections (approx. centre of image: S41.4913, E173.9670).

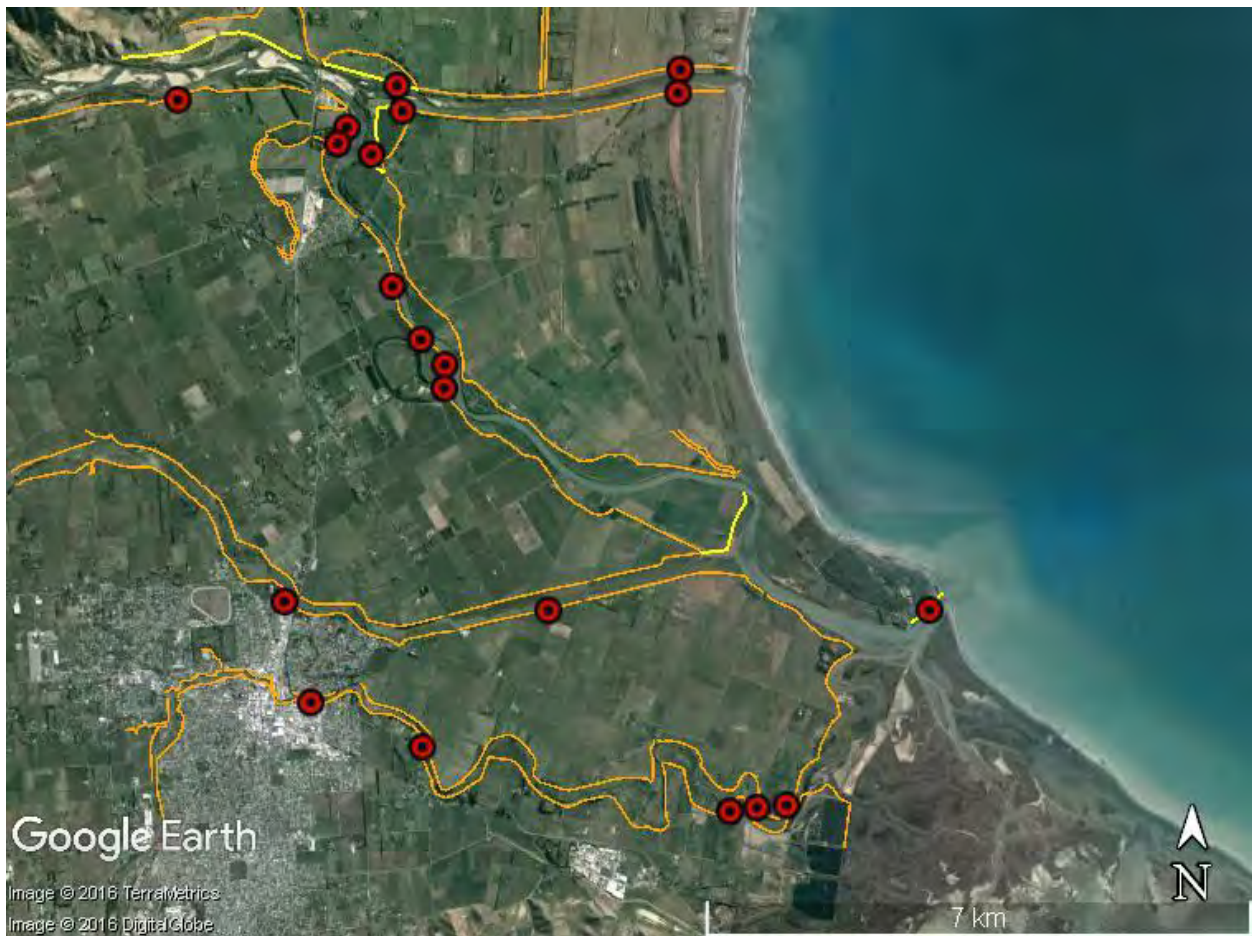
Figure 4.28: Overview of the stopbank network on the Wairau Plains and locations of damage identified by red markers. Orange are the main stopbanks and yellow are the secondary stopbanks (approx. centre of image: S41.4913, E173.9670).

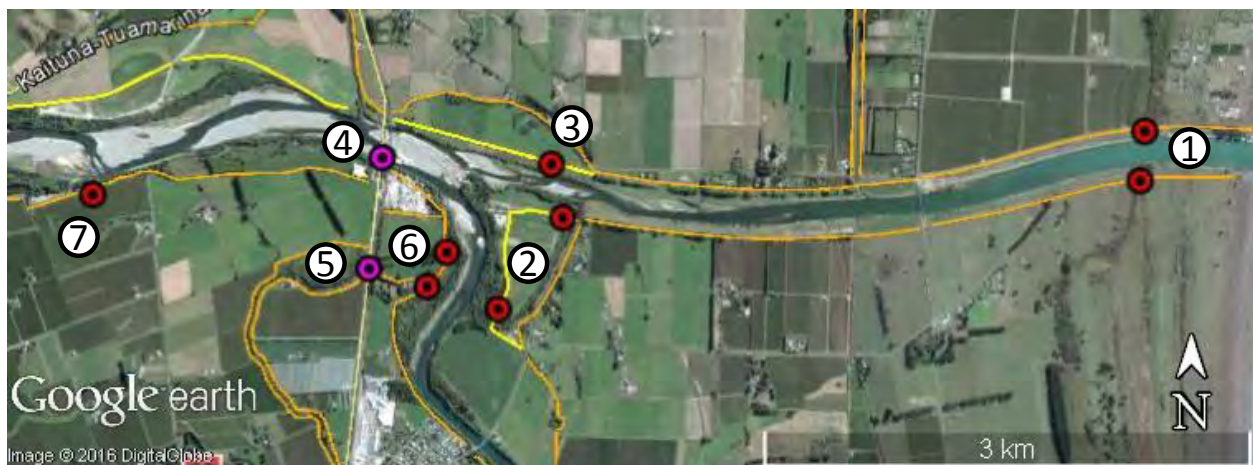
Figure 4.29: Map of liquefaction related damage in the northern Wairau River and Wairau Diversion area. Orange are the main stopbanks, and yellow are the secondary stopbanks. (approx. centre of image: S41.4484, E173.9831)

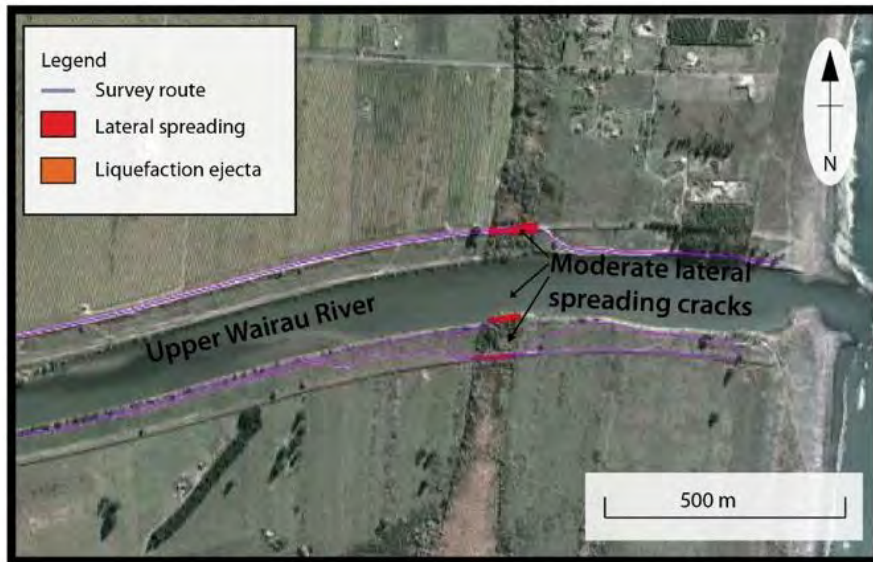
Figure 4.30: Summary of damage observations along the Wairau Diversion (approx. centre of image: S41.4401, E174.0206).

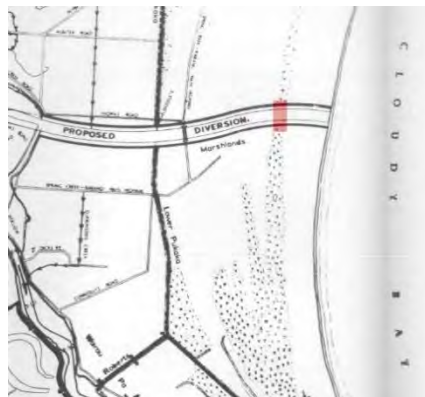
Figure 4.31: Historical drawing of Wairau Diversion. The dotted regions indicate locations of swamps, with the location of failed stopbank highlighted in red (approx. centre of image: S41.4401, E174.0206, Marlborough Catchment Board, 1959)

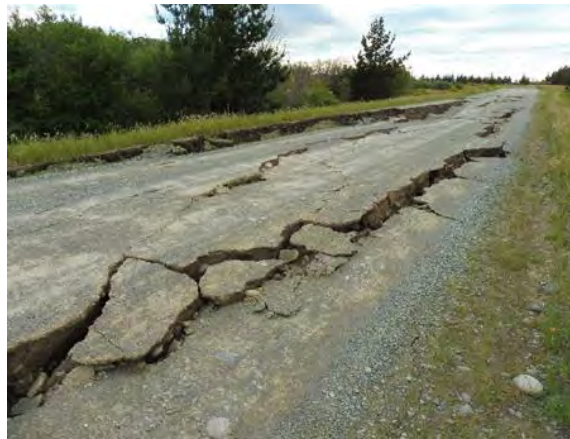
Figure 4.32: Lateral spreading induced cracking along top of northern stopbank (17 Nov 2016, S41.4387, E174.0214, facing E).

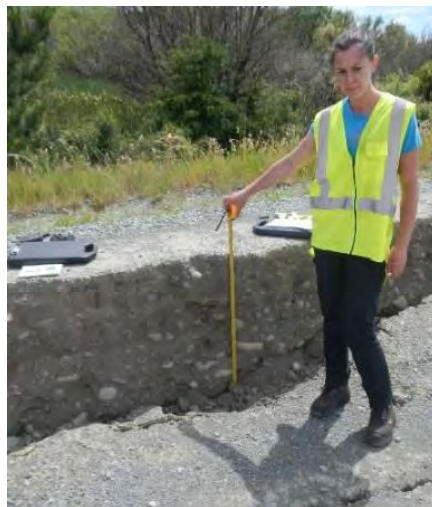
Figure 4.33: Maximum vertical settlements of 50 cm were observed along the cracks in the northern stopbank (17 Nov 2016, S41.4386, E174.0216, facing N)

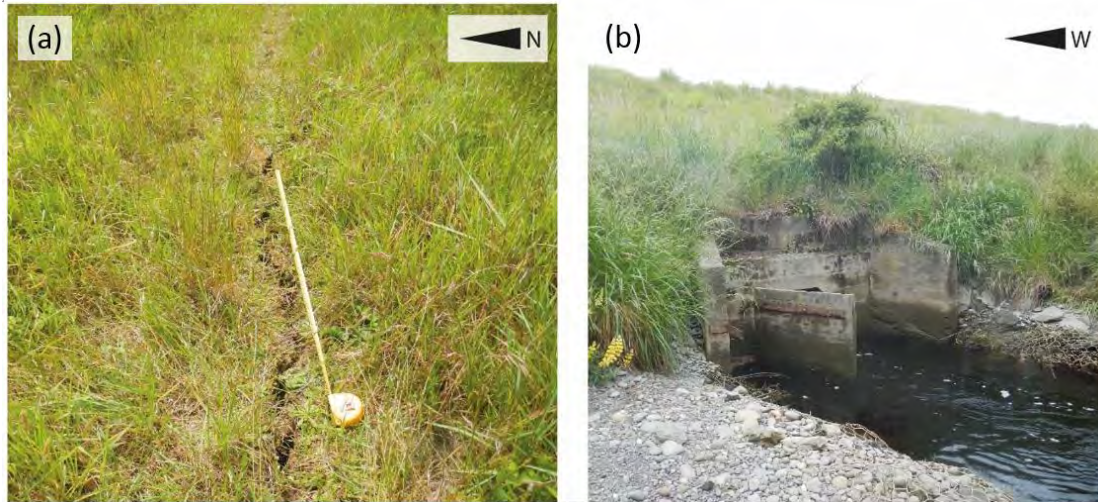
Figure 4.34: a) Cracking observed along the base of the northern stopbank proximal to the river (17 Nov 2016, S41.4390 ,E174.0220, facing E); b) No liquefaction induced damage was observed within the culvert exiting the northern stopbank (17 Nov 2016, S41.4387, E174.0223, facing NE).

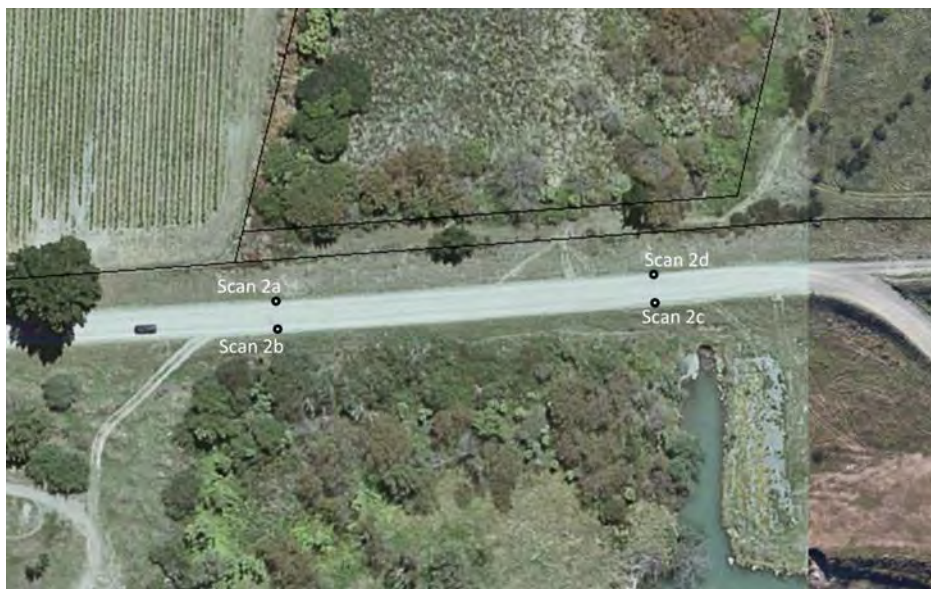
Figure 4.35: Approximate locations of four LiDAR scans performed on 6 Dec 2016 (approx. centre of image: S41.4387, E174.0218).

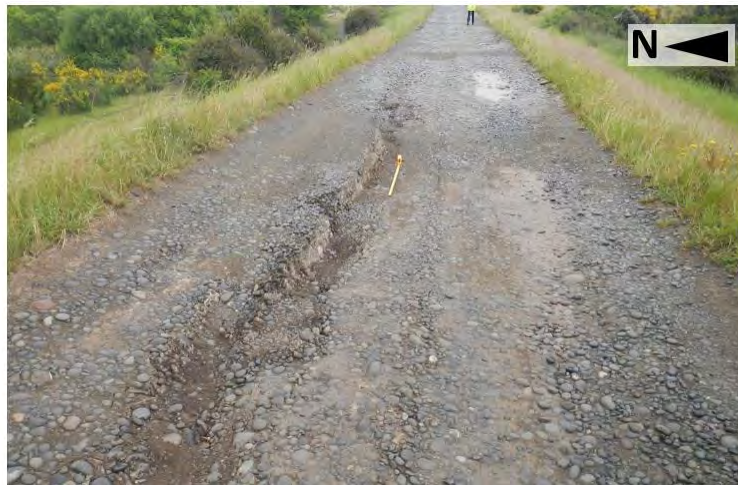
Figure 4.36: Cracking along the top of the southern stopbank of the Wairau Diversion (Tape set at 1 m) (17 Nov 2016, S41.4414, E174.0219, facing W)

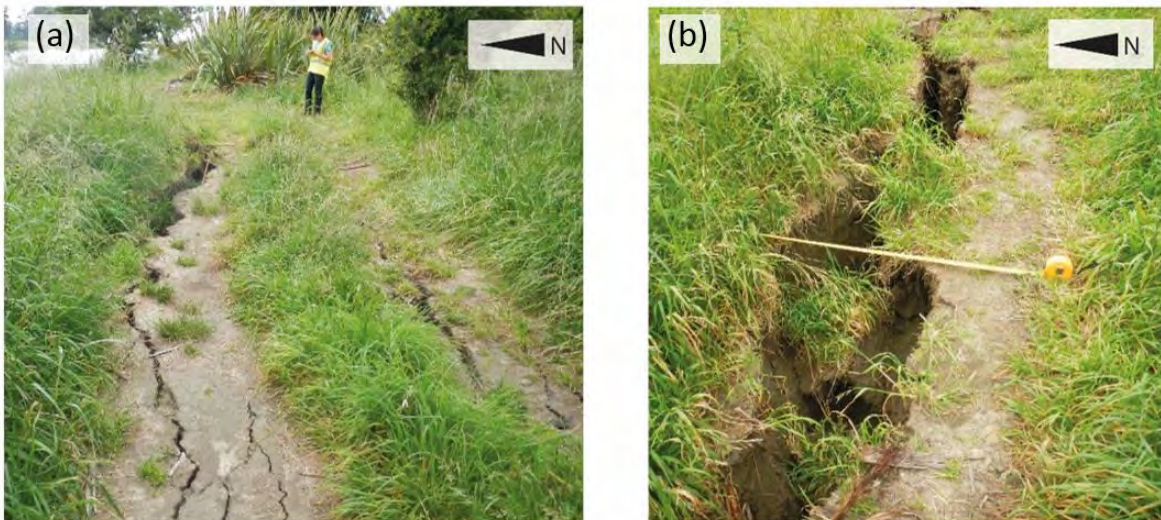
Figure 4.37: Cracking of the southern bank of the Wairau Diversion: (a) 17 Nov 2016, S41.4406, E174.0215; (b) 17 Nov 2016, S41.4406, E174.0215.

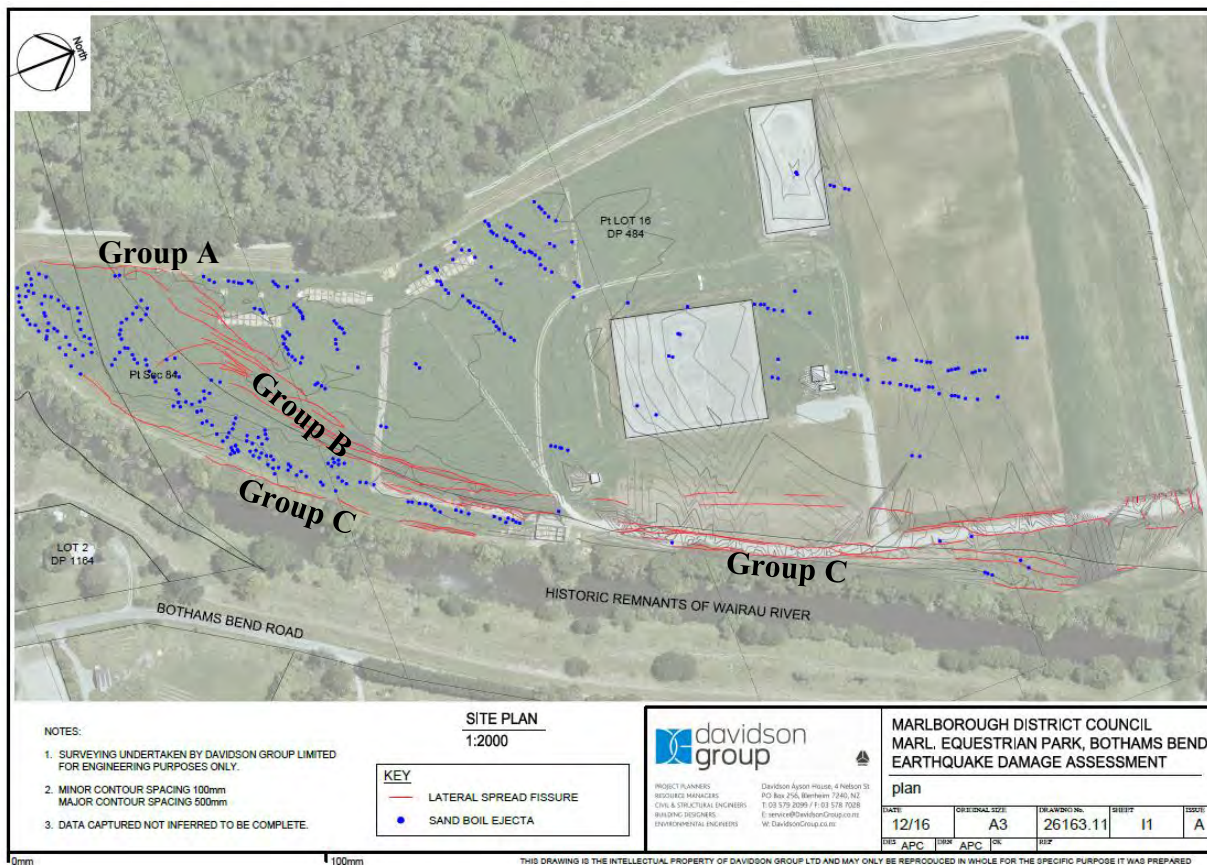
Figure 4.38: Overview of liquefaction induced damage at the Marlborough Equestrian Park (approx. centre of image: S41.4455, E173.9761) (courtesy of Davidson Group)

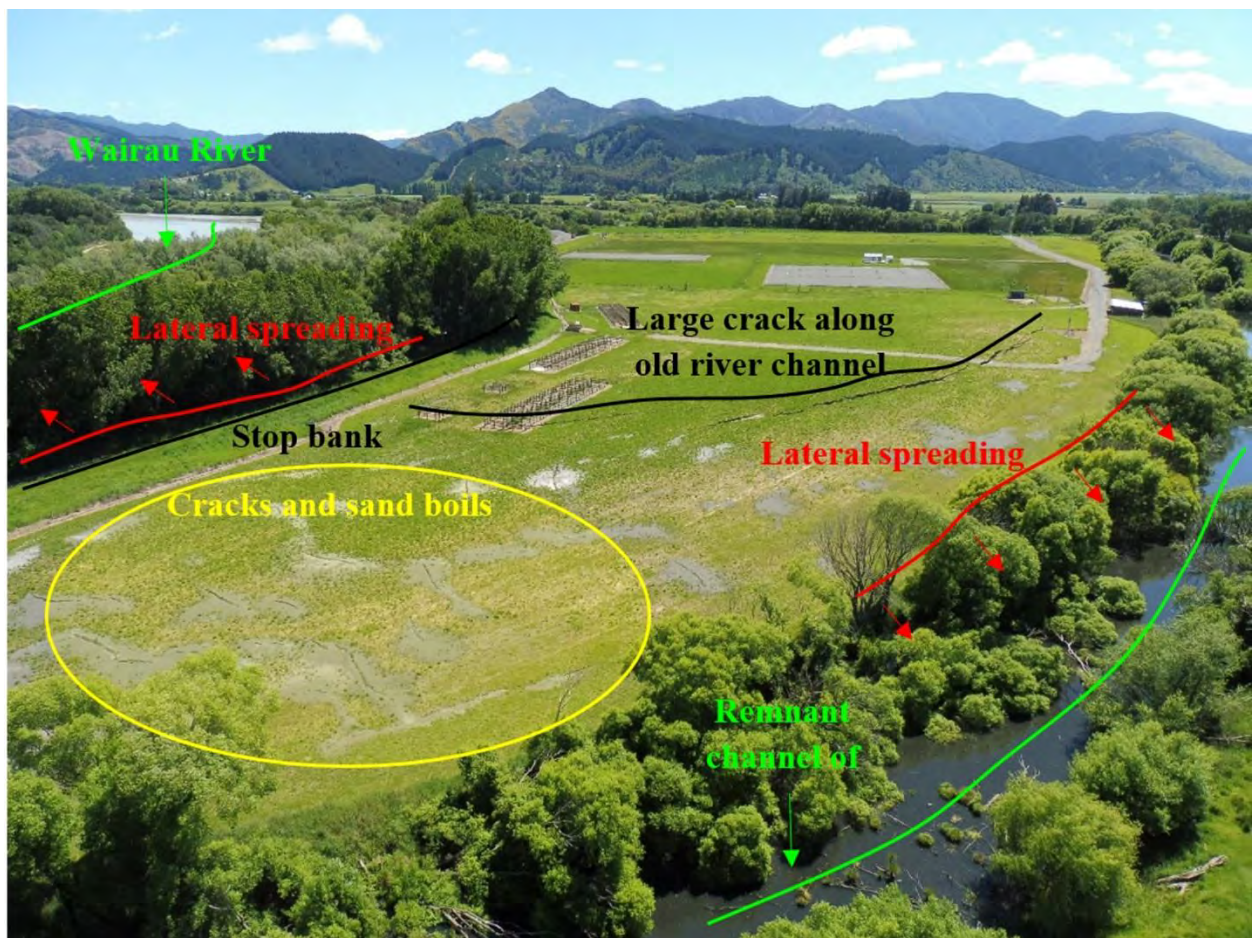
Figure 4.39: Aerial view of Marlborough Equestrian Park (14 Nov 2016, S41.4474, E173.9768, facing NE, Marlborough District Council 2016).

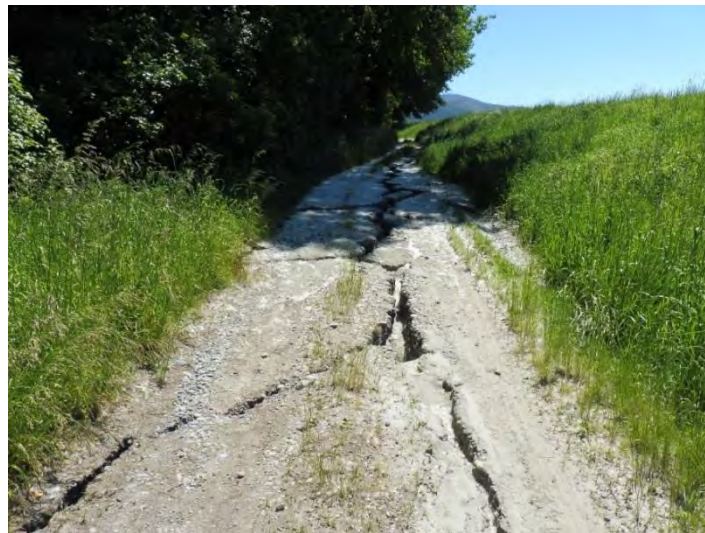
Figure 4.40: Group A cracking along the base of the secondary stopbanks (4 Dec 2016, S41.4487, E173.9738, facing NE).

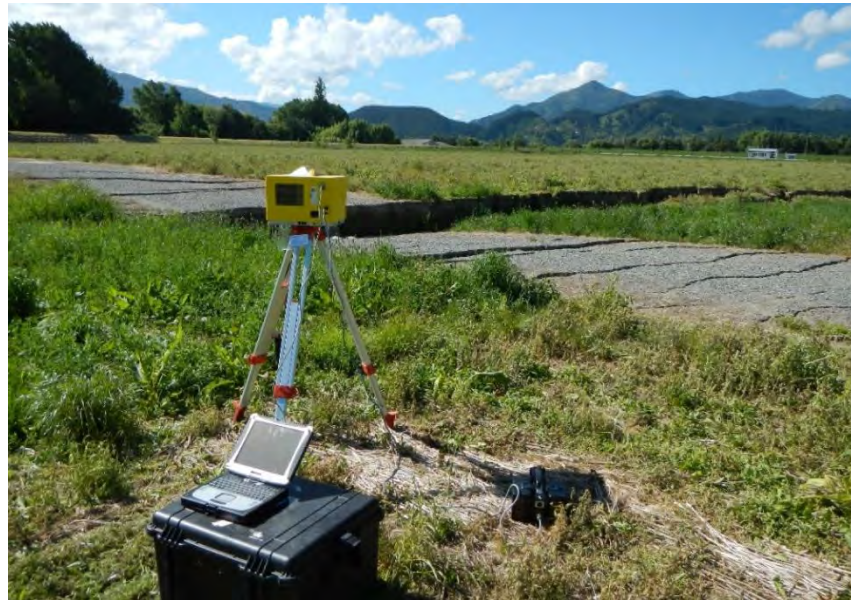
The portion of the Group B lateral spread cracks that crossed the dirt access road to the Equestrian Park was scanned using a terrestrial LiDAR scanner (Optech, Inc. ILRIS-3D laser scanner) on 5 Dec 2016. Six scans were performed from the approximate locations shown in Figure 4.43. The data from the scans are still being processed. They will produce a three-dimensional point cloud that will allow cm-scale determination of horizontal and vertical displacements of the lateral spreading features.

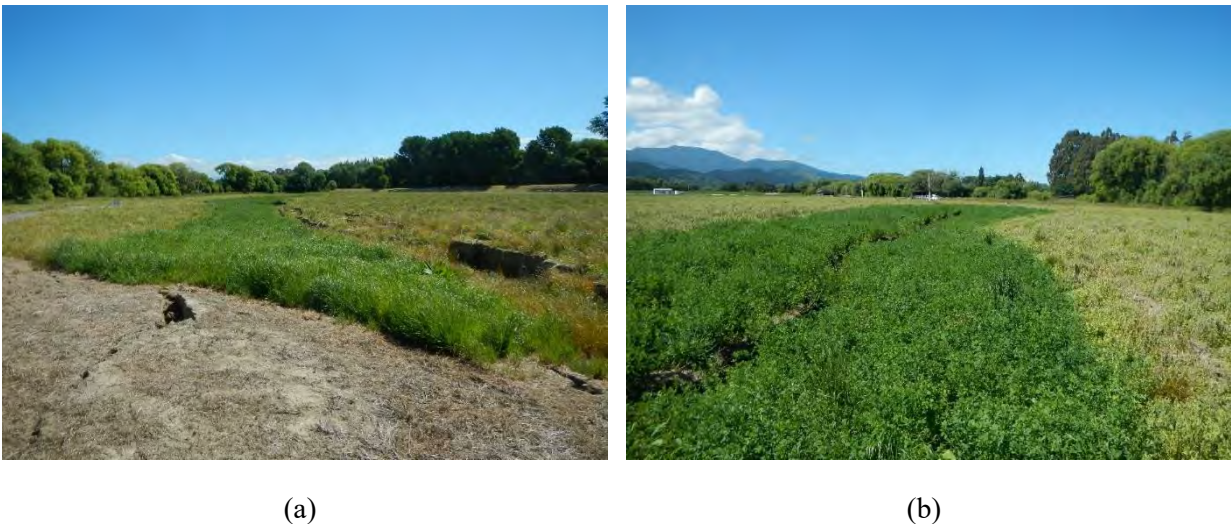
Figure 4.42: Group B cracks following the historic river channel: (a) facing SW, and (b) facing E (4 Dec 2016, S41.4474, E173.9759). Note the lush vegetation strip identifies the location of the historic river channel.

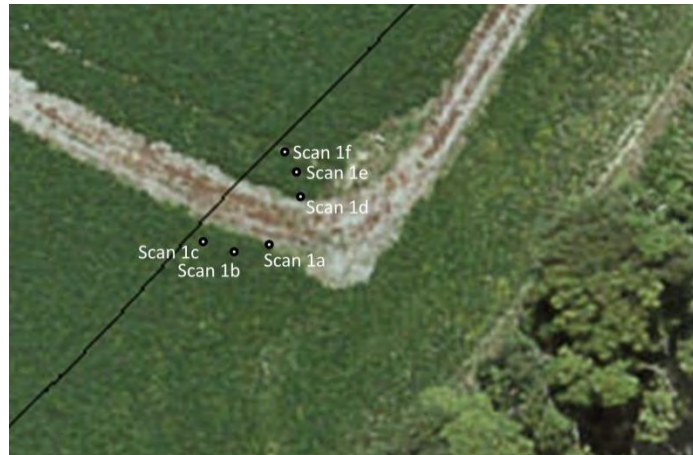
Figure 4.43: Approximate locations of six LiDAR scans performed on 5 Dec 2016 (The black line is the approximate location of the largest lateral spread crack; approx. centre of image: S41.4477, E173.9760).

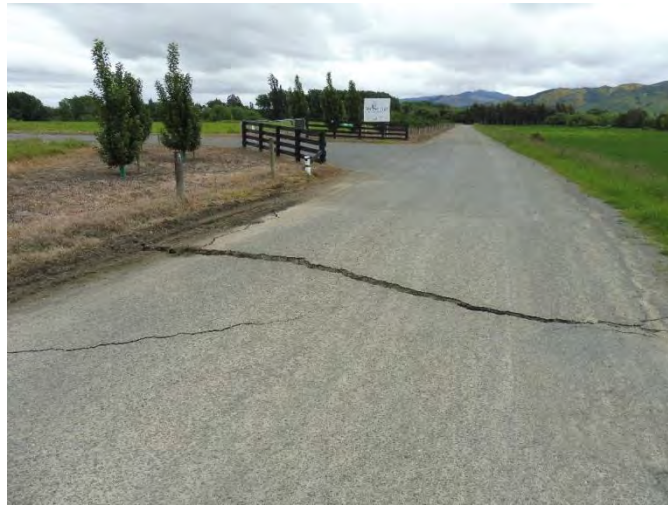
Figure 4.44: Crack at the entrance to the Equestrian park at edge of historic river channel (15 Nov 2016, S41.4436, E173.9790, facing W, Marlborough District Council 2016).

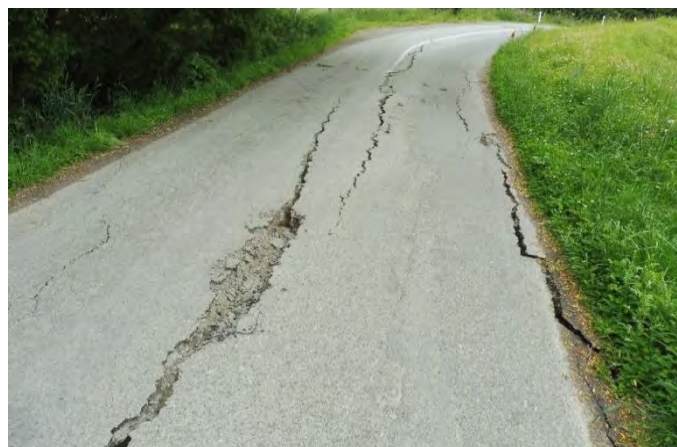
Figure 4.45: Cracks in the access road that crosses a historic river channel at the Equestrian Park (15 Nov 2016, S41.4436, E173.9790, facing E, Marlborough District Council 2016).

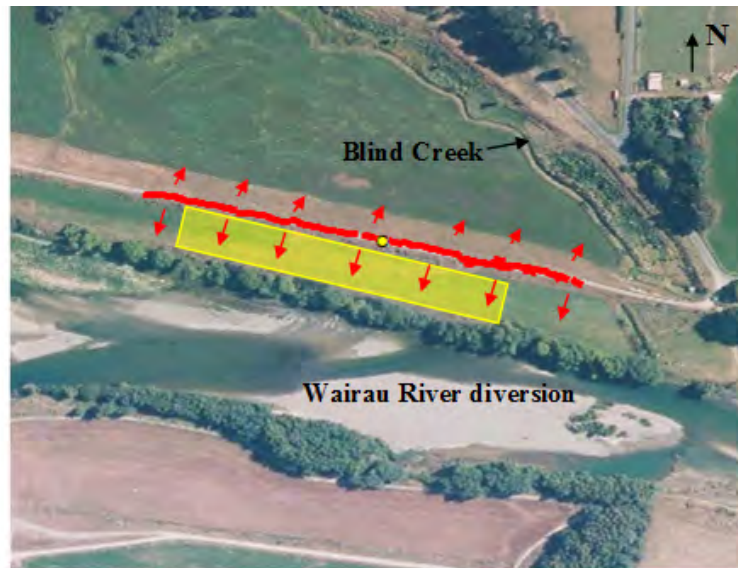
Figure 4.47: Overview of damage at Blind Creek Stopbank (approx. centre of image: S41.4405, E173.9762).

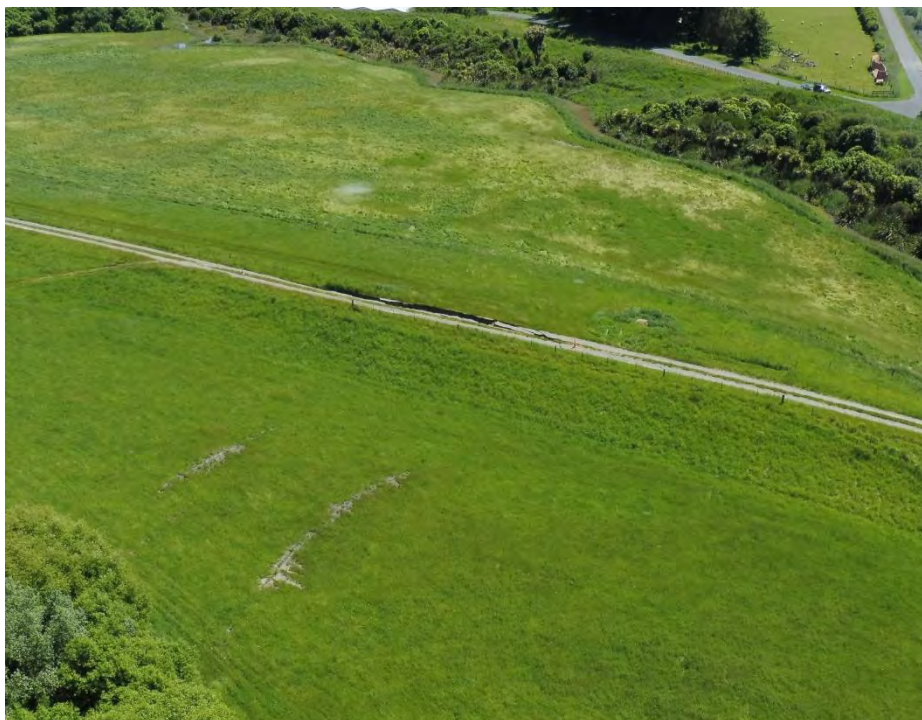
Figure 4.48: Aerial view of the Blind Creek stopbank damage (18 Nov 2016, approx. centre of image: S41.4405, E173.9762, Marlborough District Council 2016).

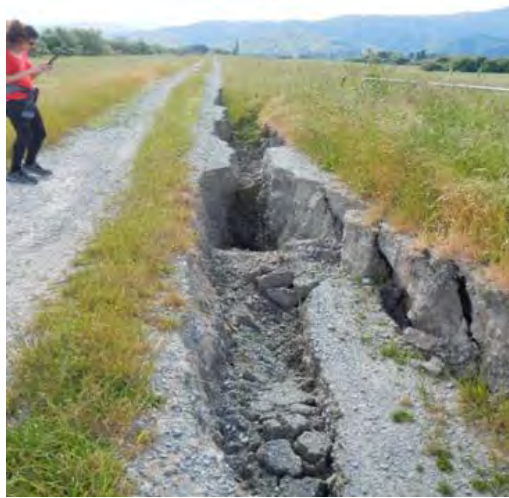
Figure 4.49: Damage to the secondary stopbank at Blind Creek (5 Dec 2016, S41.4407, E173.9791, facing W).

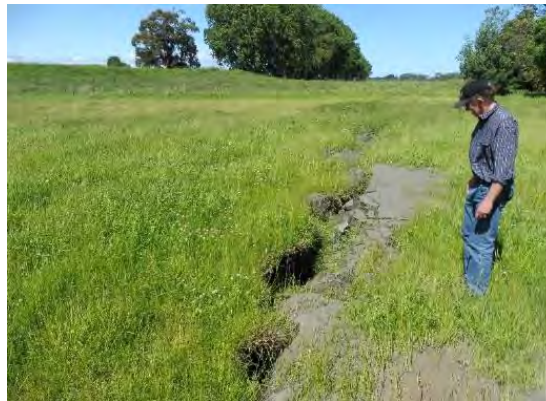
Figure 4.50: Cracks and ejecta on the foundation soil between the secondary stopbank and the river (5 Dec 2016, S41.440967, E173.980122, facing NE).

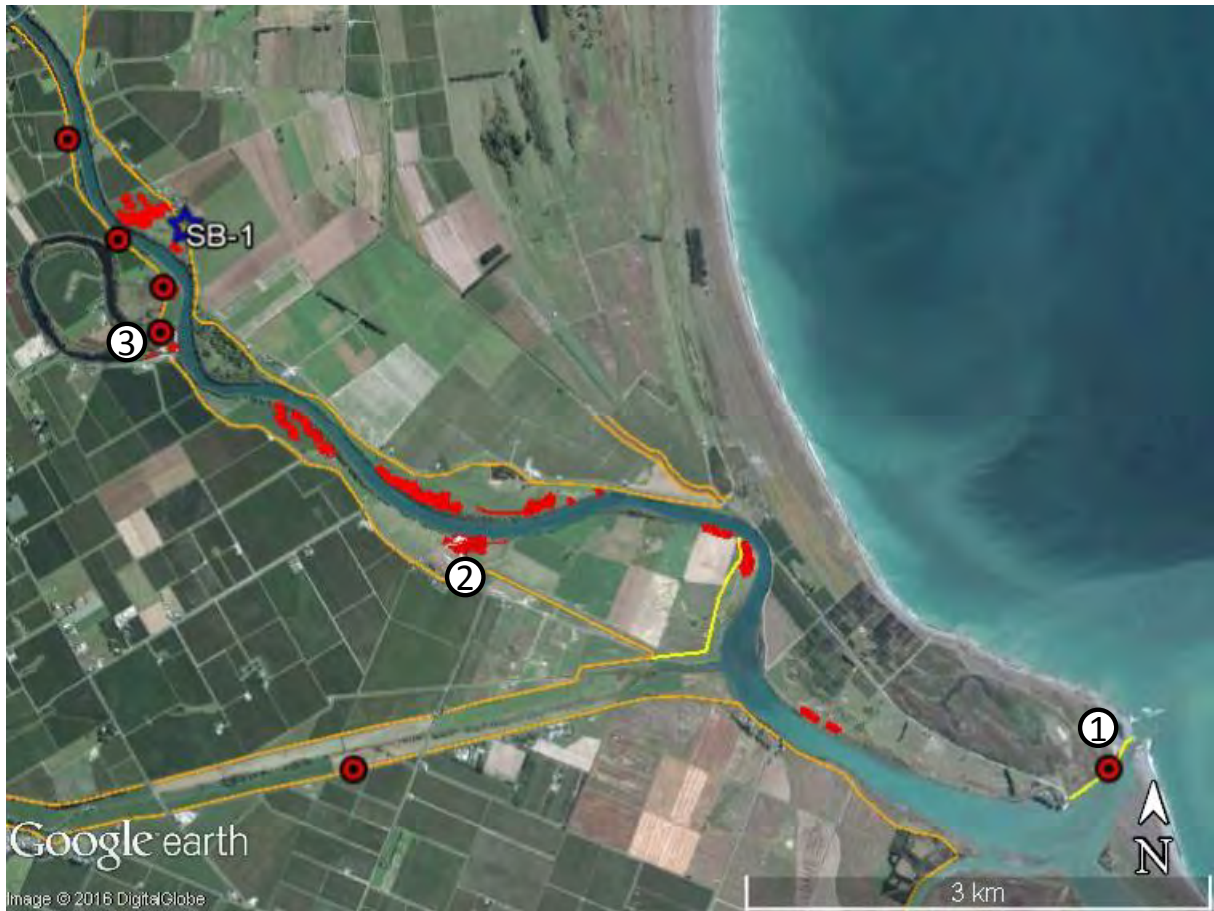
Figure 4.51: Aerial overview of the reconnaissance along the Lower Wairau River. Locations with detailed investigations are identified numerically, and locations where samples have been collected from are shown by blue stars. (Approx. centre of image: S41.4871, E174.0127).

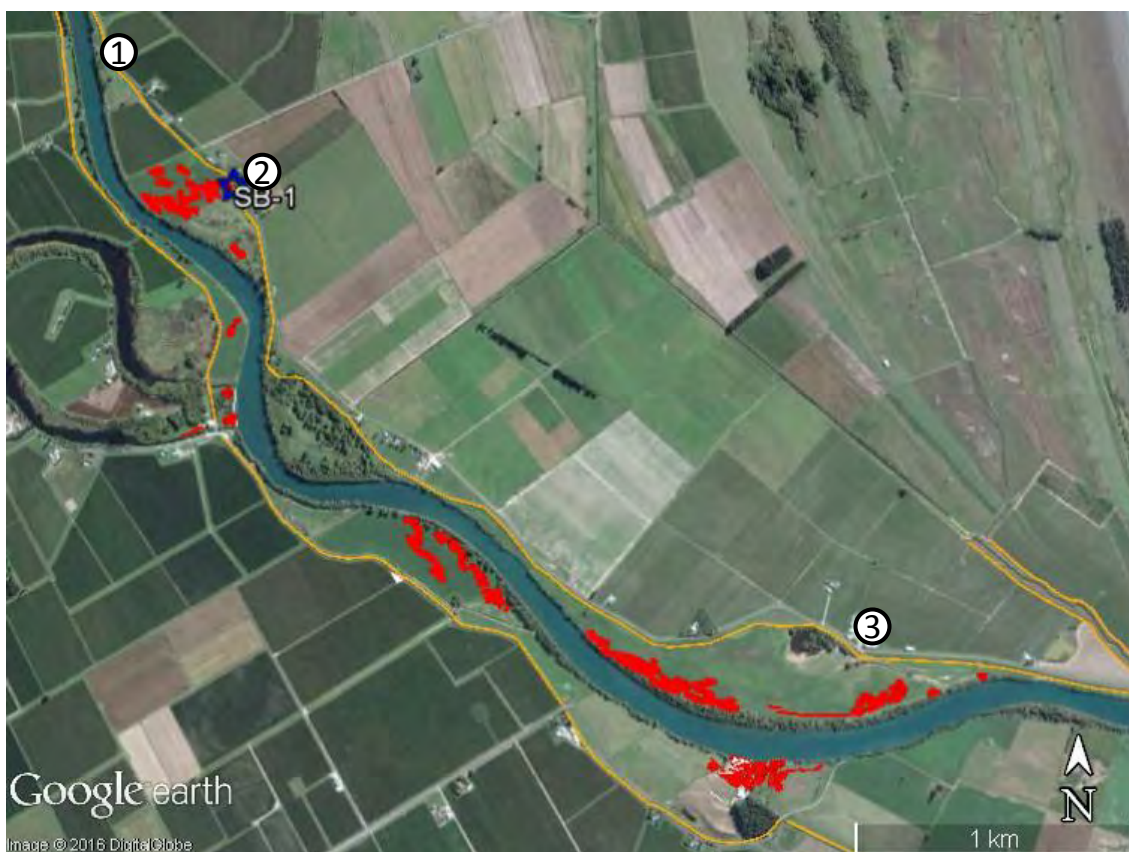
Figure 4.53: Summary of liquefaction induced damage along the banks of the Lower Wairau River, with red areas indicating cracking and ejecta locations. Stopbank damage is shown by the red symbols in this figure. (Approx. centre of image: S41.4799, E174.0006).

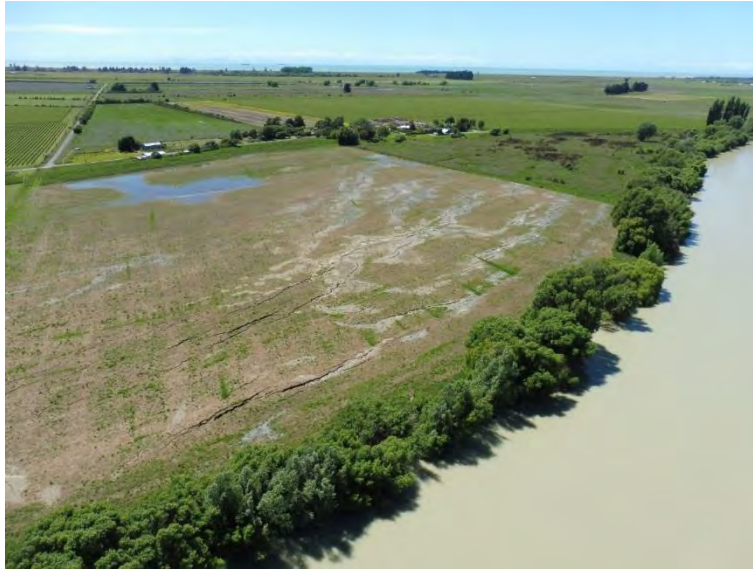
Figure 4.54: Lateral spreading and liquefaction ejecta on the eastern banks of the Lower Wairau River (18 Nov 2016, S41.4687, E173.9807, taken facing SE).

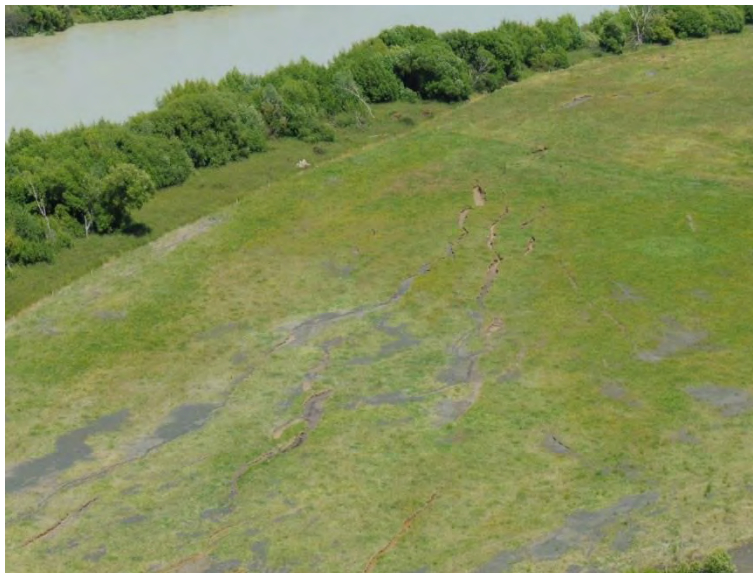
Figure 4.55: Lateral spreading and liquefaction ejecta on the eastern banks of the Lower Wairau River (18 Nov 2016, S41.4854, E174.0160, taken facing W).

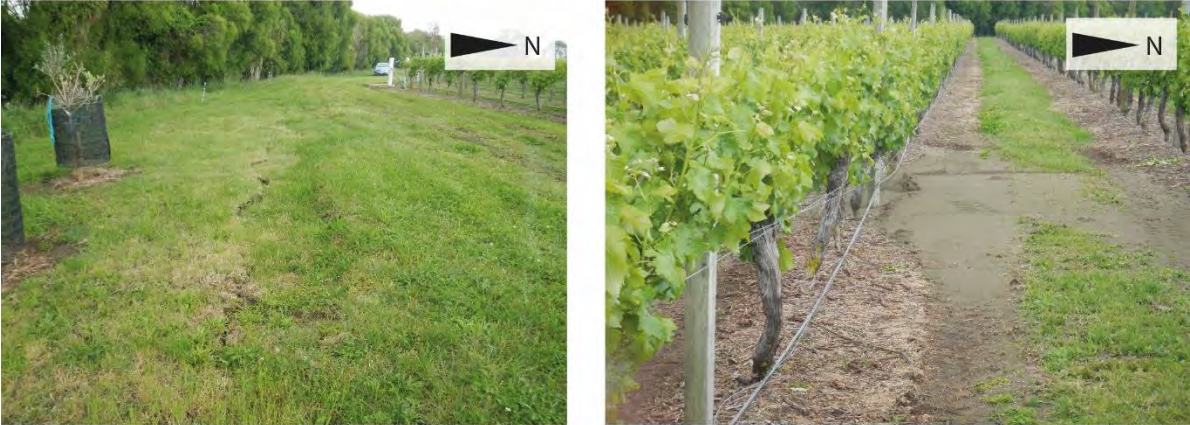
A series of localized elliptical liquefaction ejecta features were observed within the farmland extending from the base of the stopbank to the river bank (Figure 4.58b). The features range in length from 5 to 7 m and 1 to 2 m in diameter, and are uniformly composed of grey, fine sand. The river bank was not surveyed at this location; however, it is assumed that localized lateral spreading occurred within 10 m of the river bank.

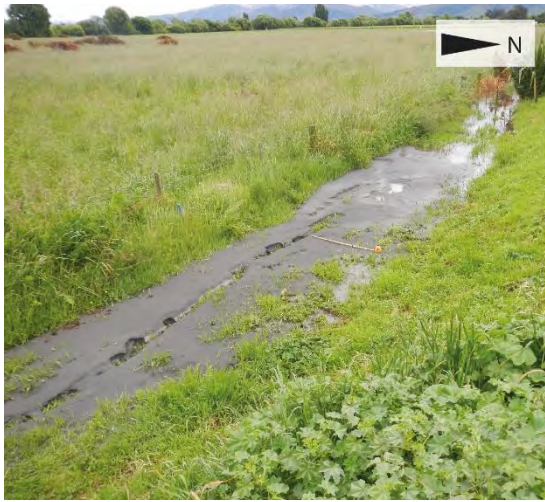
Figure 4.56: a) Lateral spreading induced cracking was observed within 10 m of river bank at 132 Wairau Bar Road. b) Localized liquefaction ejecta associated with cracks were observed at distances >10 m from the stopbank (17 Nov 2016): (a) S41.4671, E173.9802, facing N; (b) S41.4675, E173.9808, facing N.

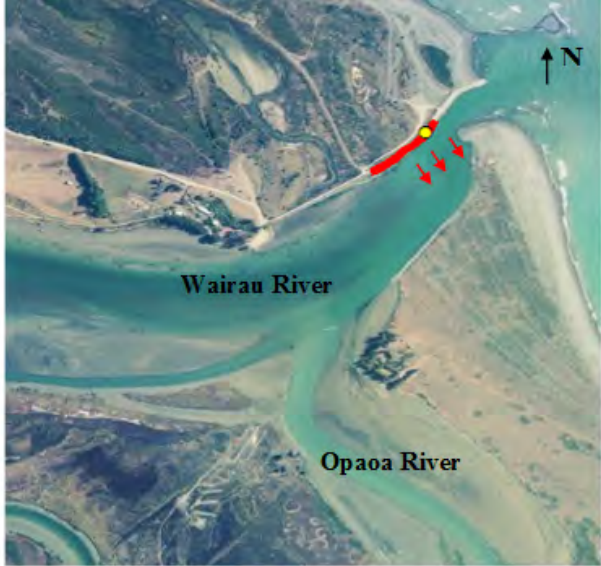
Figure 4.59: Top view of stopbank along Wairau River (centre of image S41.502404, E174.058915).

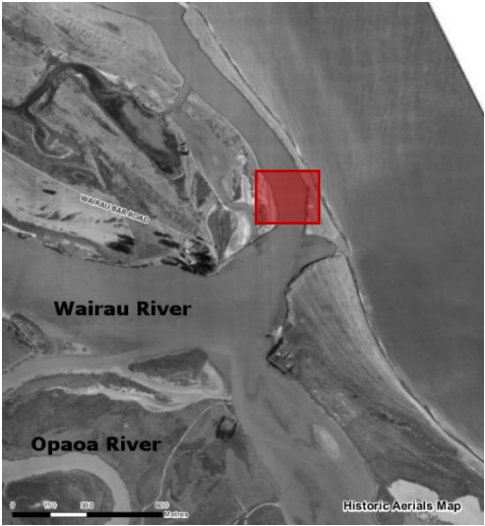
Figure 4.60: Aerial photo of the Wairau river mouth in 1948. In red: location of failed stopbank (centre of image S41.5027, 174.05777, Marlborough District Council 2017).

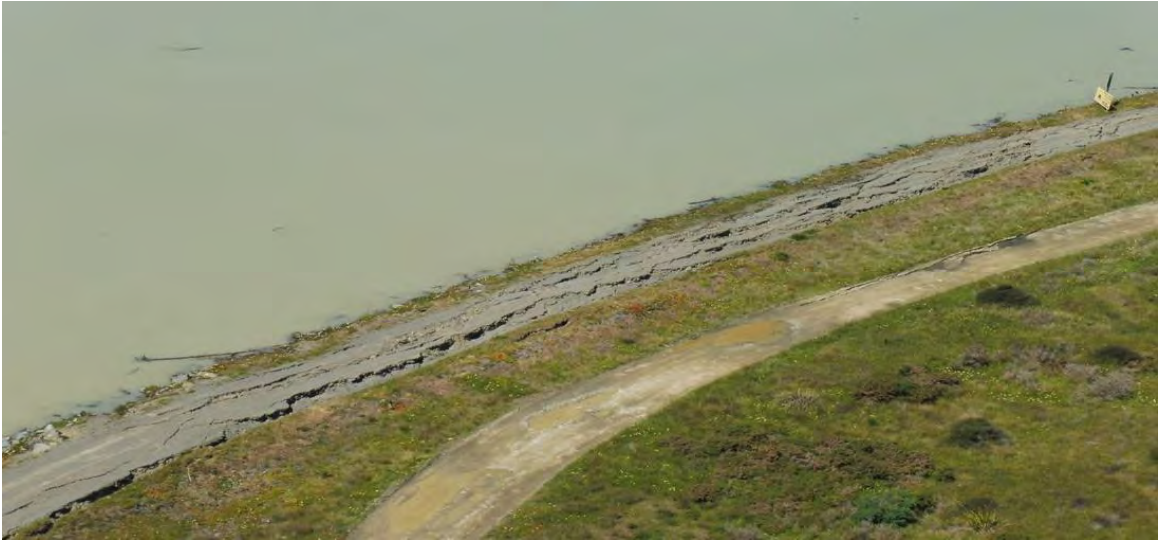
Figure 4.61: Aerial view of left stopbank at Wairau River mouth (18 Nov 2016, S41.5003, E174.0600, facing S, Marlborough District Council 2016).

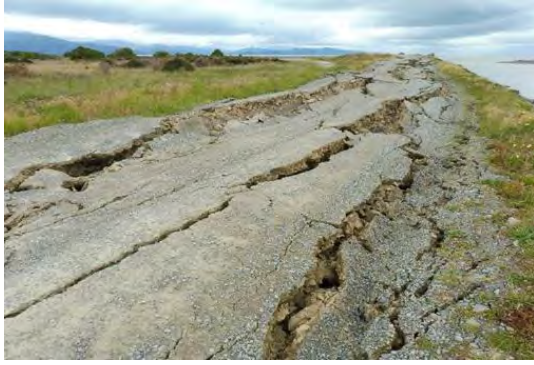
Figure 4.62: Severe cracking of levee (17 Nov 2016, S41.50122, E174.060071, facing E).

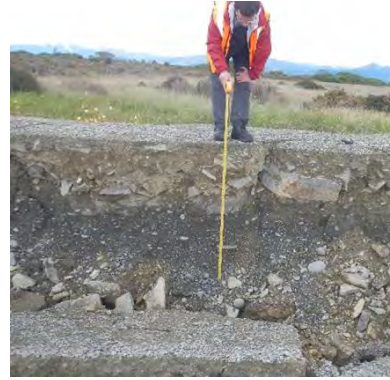
Figure 4.63: Measurement of vertical relative displacement along crack, tape set at 150 cm (17 Nov 2016, S41.5012, E174.0603, facing N).

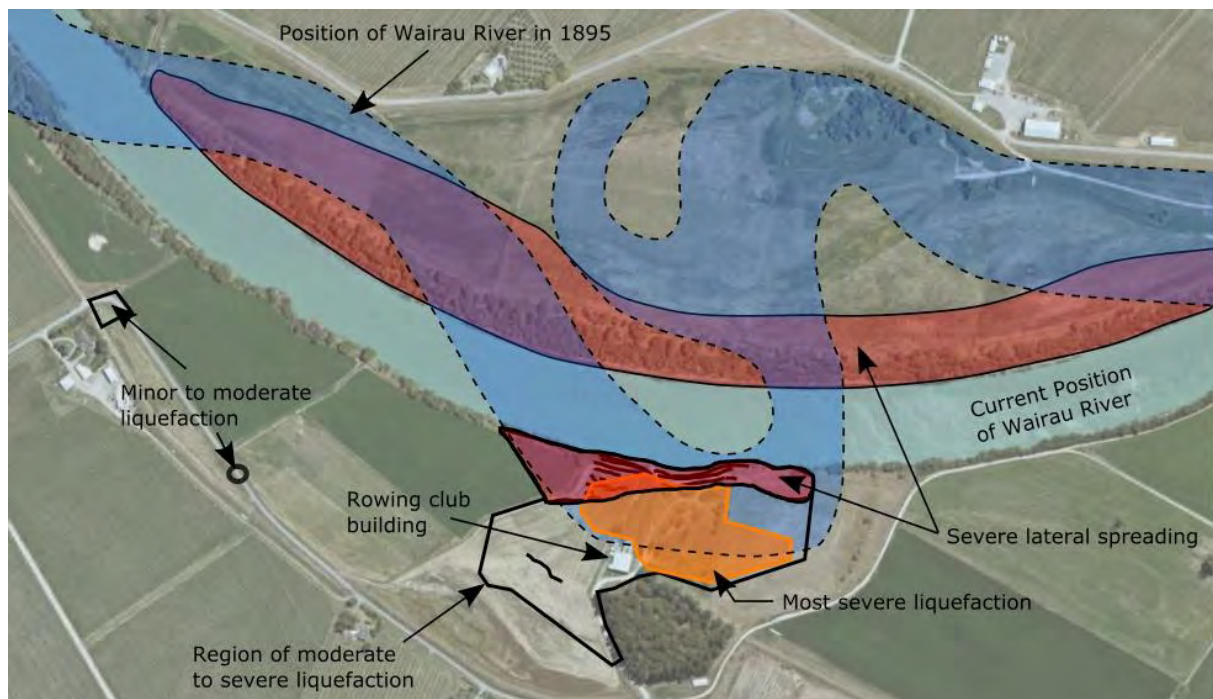
Figure 4.65: Summary of observations at Blenheim Rowing Club (approx. centre of image: S41.4860, E174.0105, Basemap: Marlborough District Council, 2017)

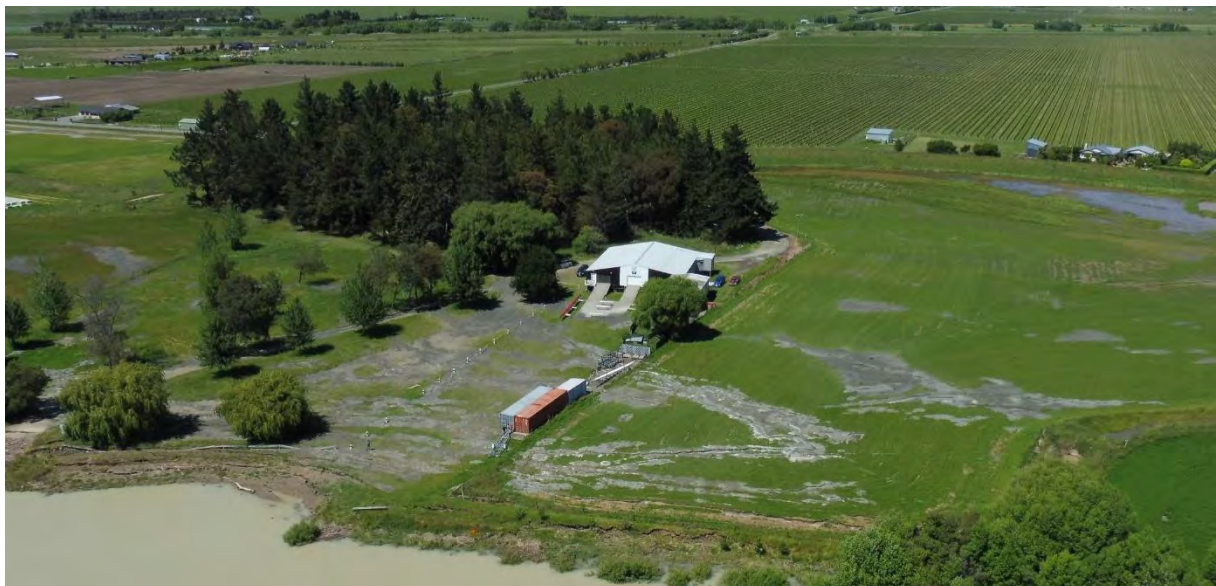
Figure 4.67: Aerial view of liquefaction manifestation at the Blenheim Rowing Club looking south (18 Nov 2016, approx. centre of image: S41.4890, E174.0094, Marlborough Regional Council, 2016).

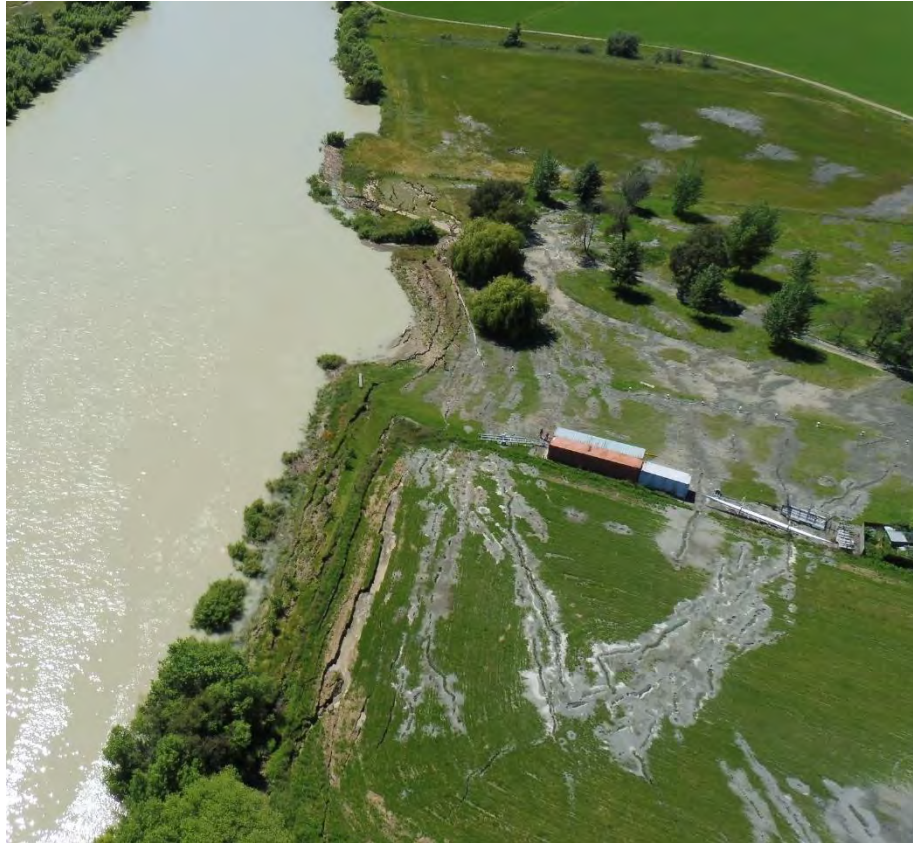
Figure 4.68: Aerial view of liquefaction manifestation at the Blenheim Rowing Club looking east (18 Nov 2016, approx. centre of image: S41.4883, E174.0096, Marlborough Regional Council, 2016).

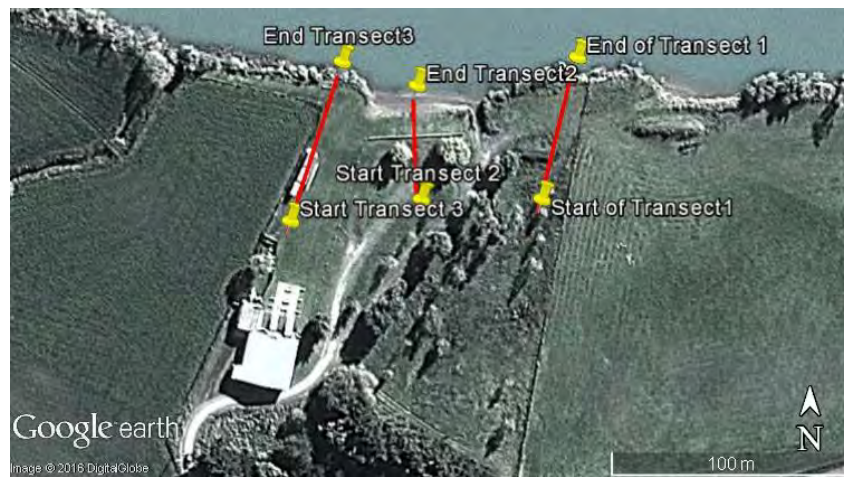
Figure 4.71: Transects where cumulative crack widths were measured to estimate lateral spreading displacements. (Approx. centre of image: S41.4886, E174.0102, Imagery from GoogleEarth).

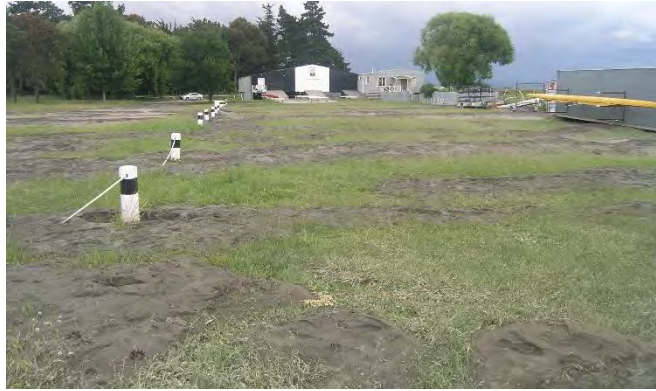
Figure 4.72: View close to river looking back towards clubhouse. Lines of ejecta are associated with lateral spreading cracks. (17 Nov 2016, S41.4881, E174.0099, facing W).

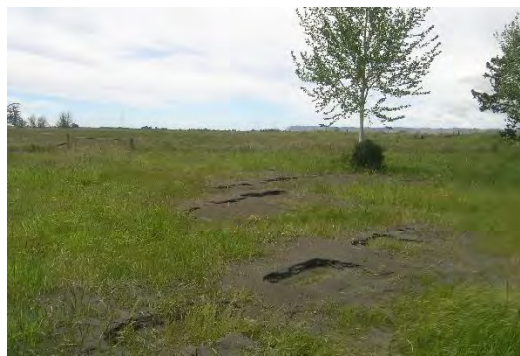
Figure 4.73: Liquefaction ejecta located 90 m east of clubhouse. (17 Nov 2016, S41.4890, E174.0105, facing E).

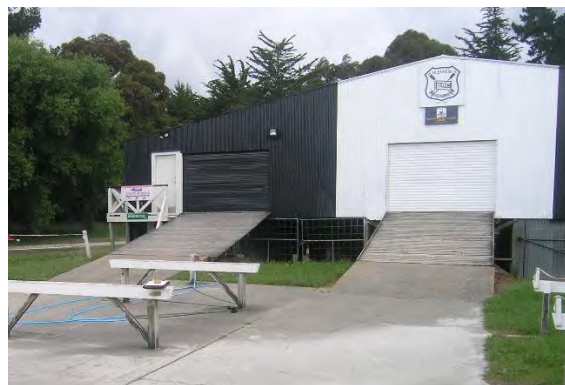
Figure 4.74: View of Blenheim rowing clubhouse from the north (17 Nov 2016, S41.4886, E174.0096, facing S).

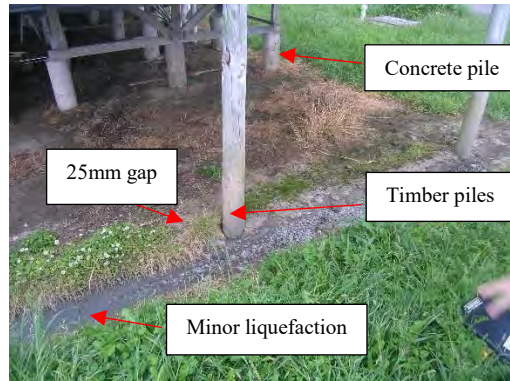
Figure 4.75: Gapping on North side of timber pile (17 Nov 2016, S41.4890, E174.0092).
