# GEOTECHNICAL RECONNAISSANCE OF THE 2016 $M_w$ 7.8 KAIKOURA, NEW ZEALAND EARTHQUAKE

Version 1.0: 10 JUNE 2017

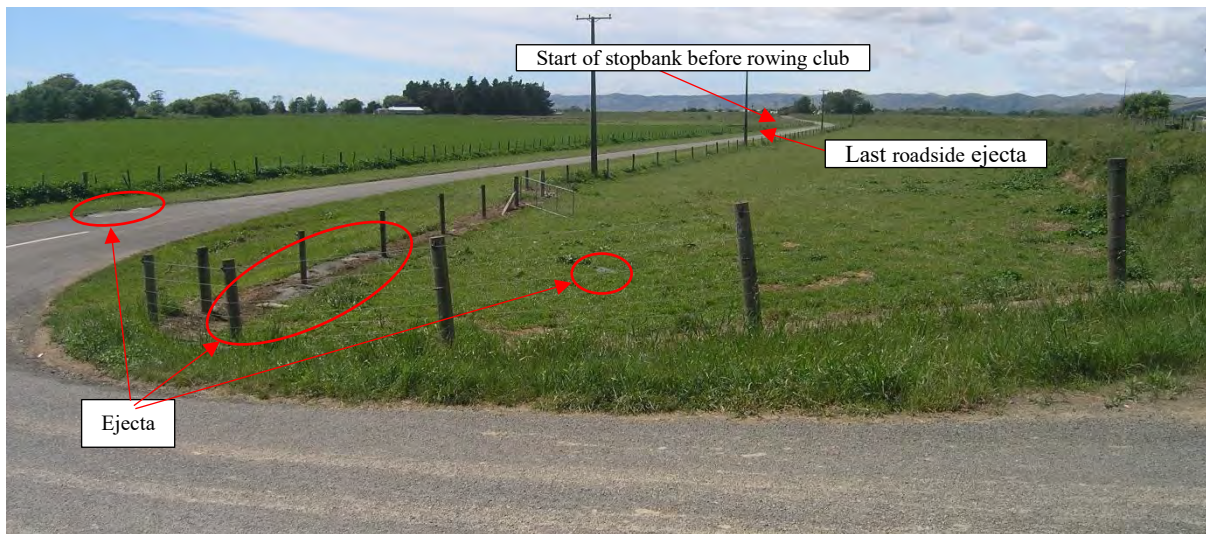
Figure 4.76: Evidence of liquefaction on approach to the Blenheim Rowing Club (17 Nov 2016, S41.4862, E174.0022, facing S).

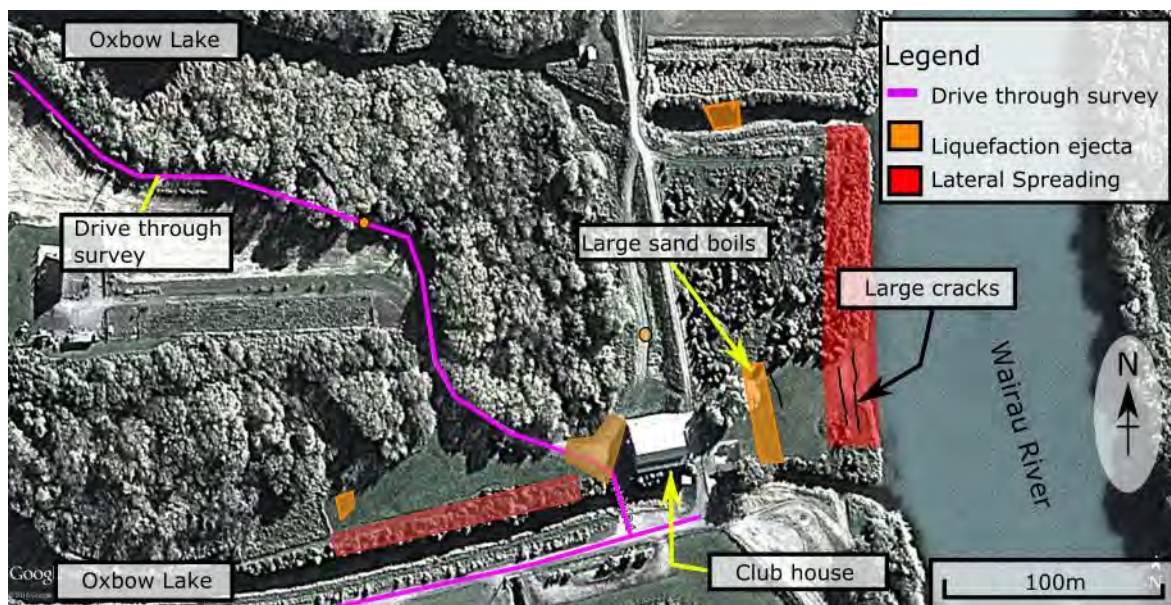
Figure 4.77: Summary of observations at Wairau Rowing Club (approx. centre of image: S41.4762, E173.9843, Imagery from GoogleEarth).

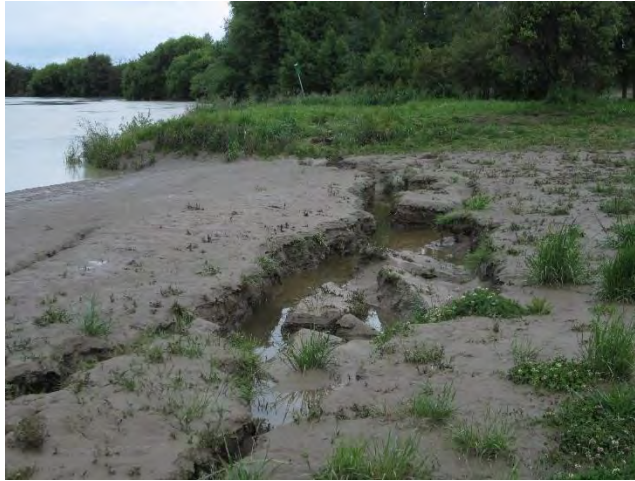
Figure 4.78: Lateral spreading cracks close to the Wairau River in the grassed area to the east of the clubhouse (17 Nov 2016, S41.4765, E173.9862, facing S).

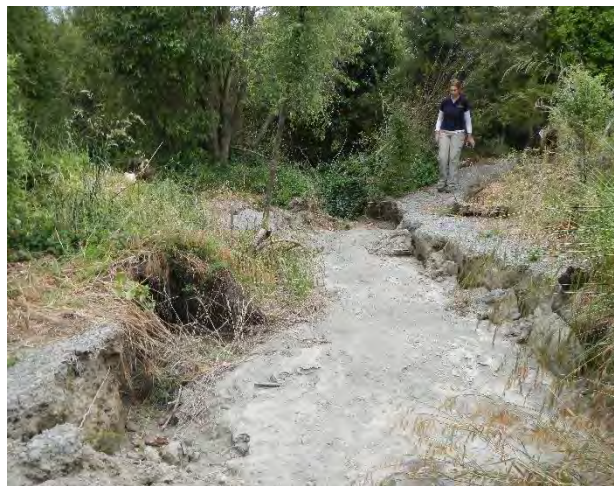
Figure 4.79: Lateral spread crack approximately 2 m wide filled with fine grey ejecta (6 Dec 2016, S41.4761, E173.9860, facing NE).

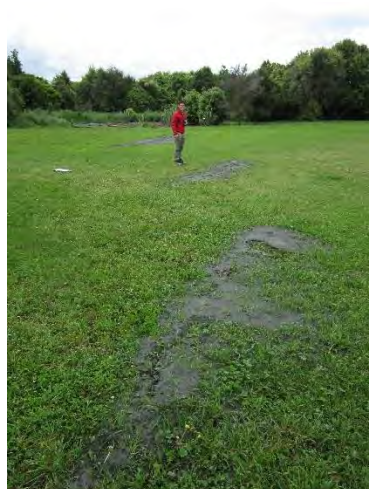
Figure 4.80: Sand boils on lawn in front of club house shown as large sand boils in Figure 4.77 (17 Nov 2016, S41.4766, E173.9858, facing N).

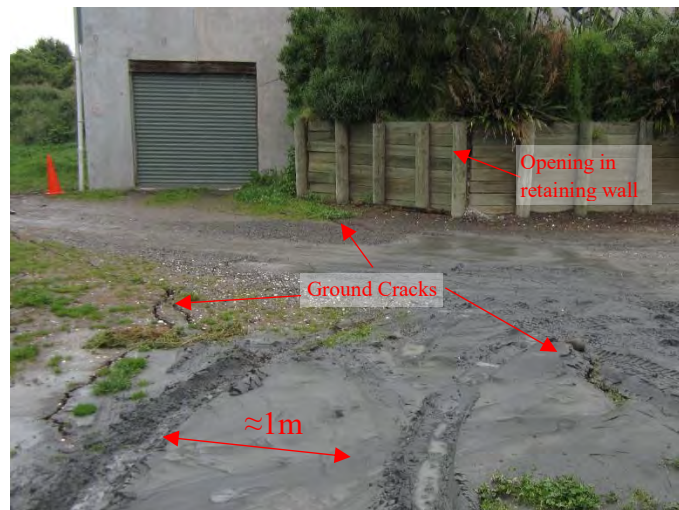
Figure 4.84: Cracks and ejecta to the west of the Wairau Rowing Club (17 Nov 2016, S41.4768, E173.9849, facing E).

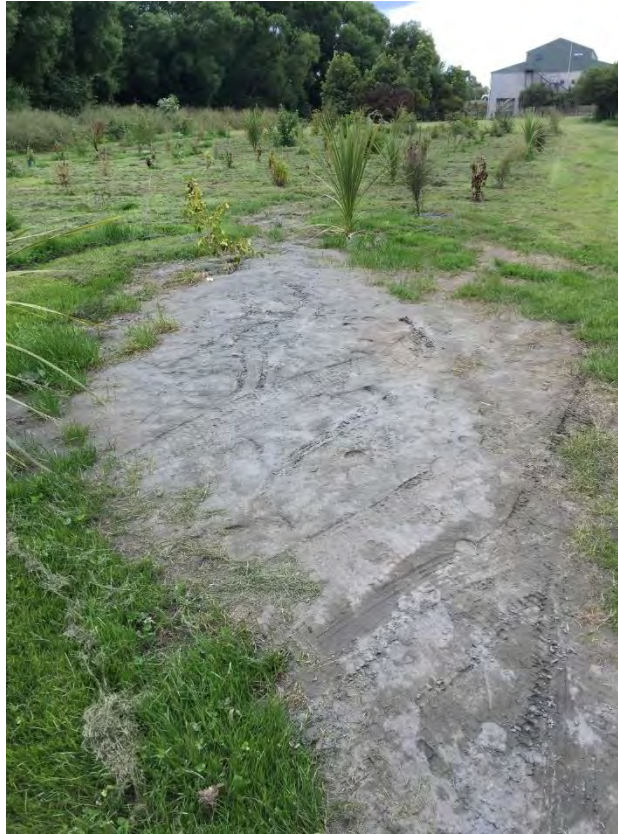
Figure 4.85: Fine grey sand ejecta west of the Wairau Rowing Club (7 Dec 2016, S41.4771, E173.9836, facing E).

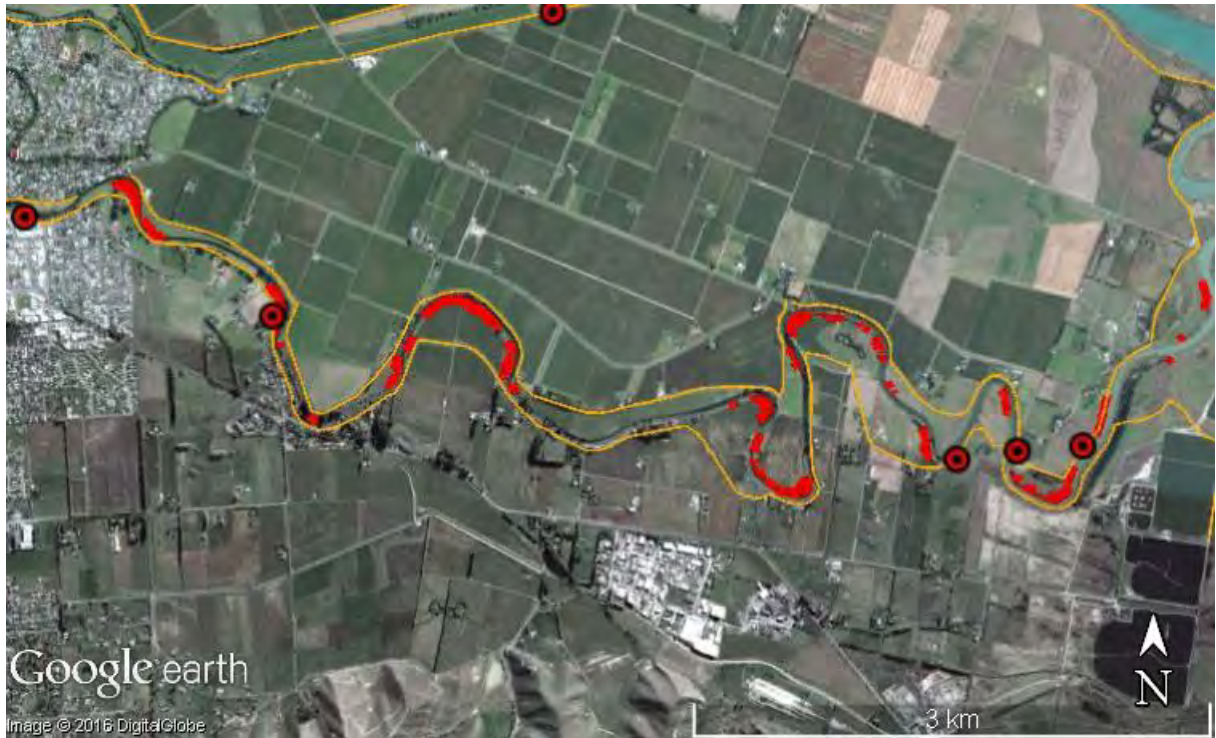
Figure 4.86: Summary of damage along the Lower Opaoa River. Red areas indicate locations of cracking and ejecta, with stopbank damage shown by the red symbols in this figure. Orange lines indicate locations of stopbanks. (Approx. centre of image: S41.5219, E174.0076, Imagery from GoogleEarth).

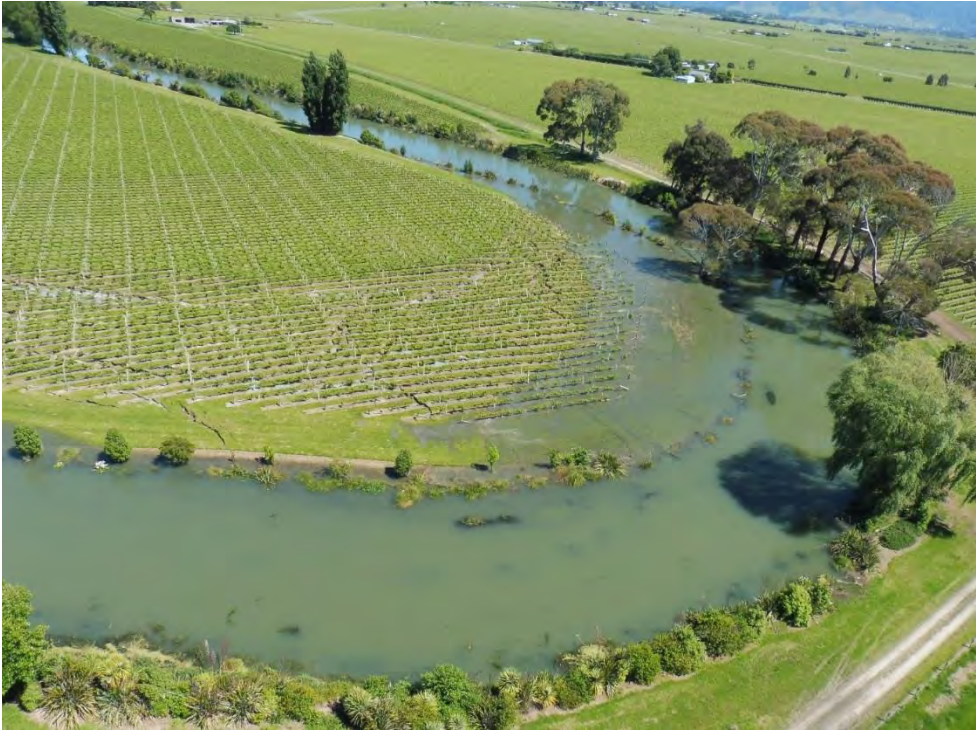
Figure 4.87: Lateral spreading and sand ejecta damage to vineyards along the Lower Opaoa River. Photo taken 4 days after the earthquake showing vine repair yet to commence (18 Nov 2016, S41.5217, E174.0160, facing W, Marlborough District Council 2016).

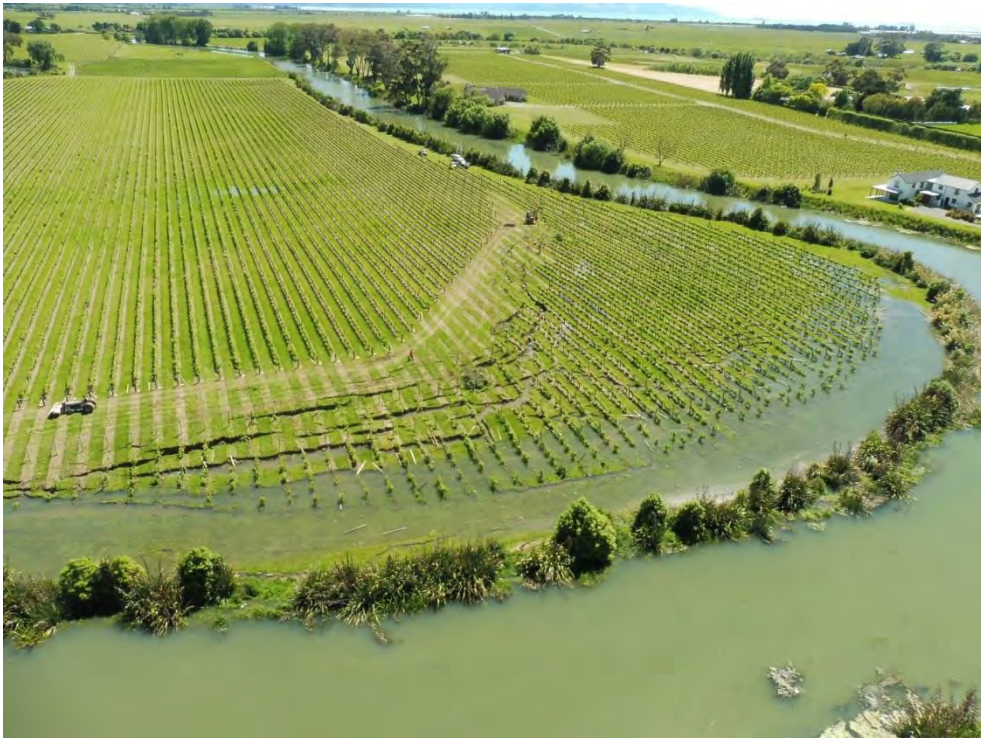
Figure 4.88: Lateral spreading and sand ejecta damage to vineyards along the Lower Opaoa River. Photo taken 4 days after the earthquake showing completed vine repair and remnants of damaged vines. (18 Nov 2016, S41.5270, E174.0179, facing N, Marlborough District Council 2016).

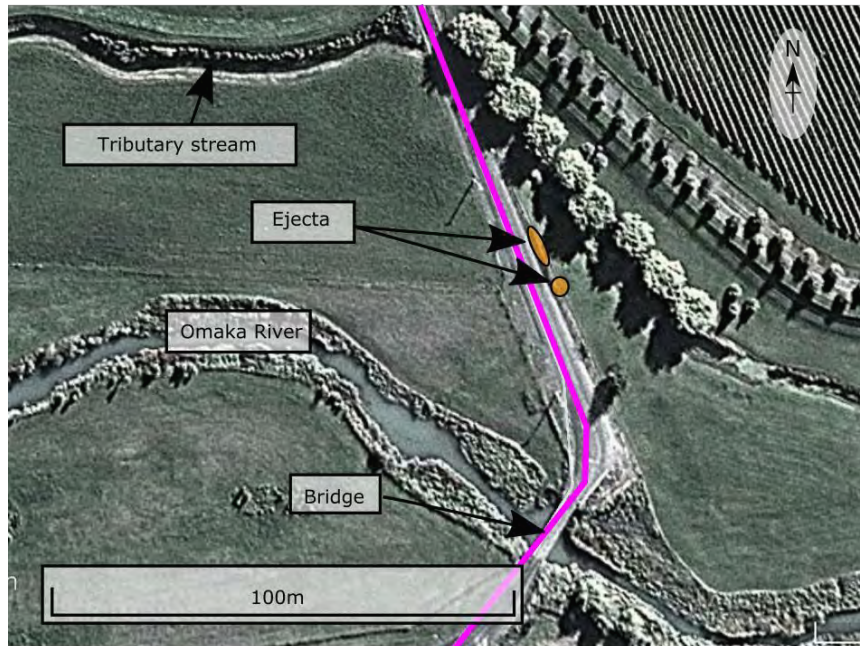
Figure 4.89: Summary of observations at O’Dwyers Road/Thomsons Ford Road bridge (approx. centre of image: S41.4825, E173.9336, Imagery from GoogleEarth).

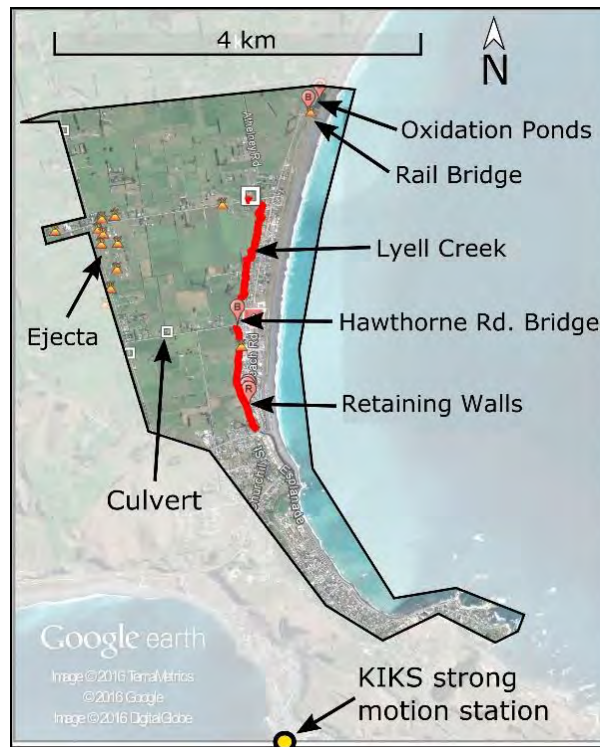
Figure 4.91: Reconnaissance in Kaikoura (approx. centre of image: S42.389, E173.682).

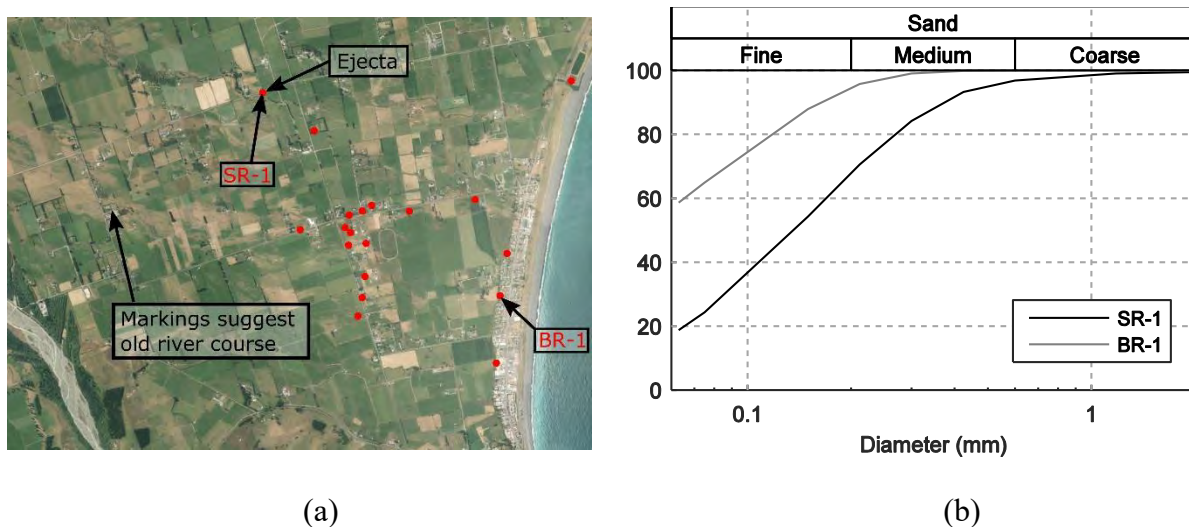
Figure 4.92: (a) Locations of observed liquefaction ejecta; SR-1 and BR-1 refer to locations where ejecta samples were obtained (approx. centre of image: S42.375, E173.647). (b) Particle size distribution of the samples SR-1 and BR-1.

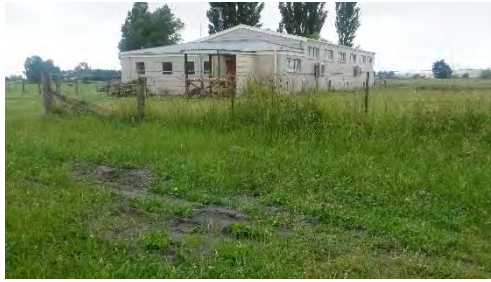
Figure 4.93: Liquefaction ejecta on Schoolhouse Road where sample SR-1 was taken (-9 Dec 2016, S42.3681, E173.6496, facing SE).

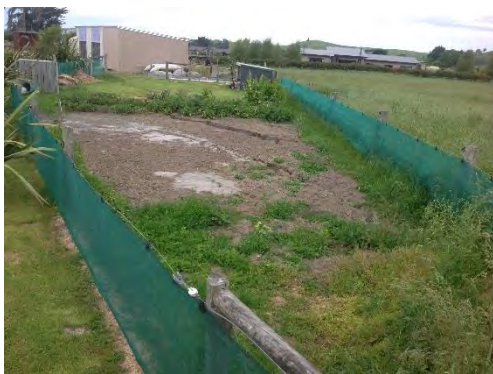
Figure 4.95: Liquefaction in a vegetable patch on Mt Fyffe Road. Note the ejecta issued from ground cracks (-date to be added in V2.0 of report, S42.3813, E173.6622, facing S).

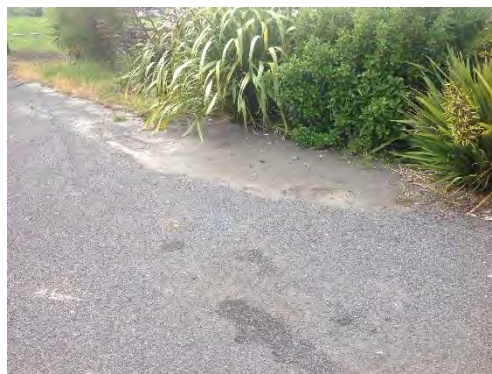
Figure 4.96: Liquefaction in driveway on Mt Fyffe Road (- date to be added in V2.0 of report, S42.3800, E173.6600).

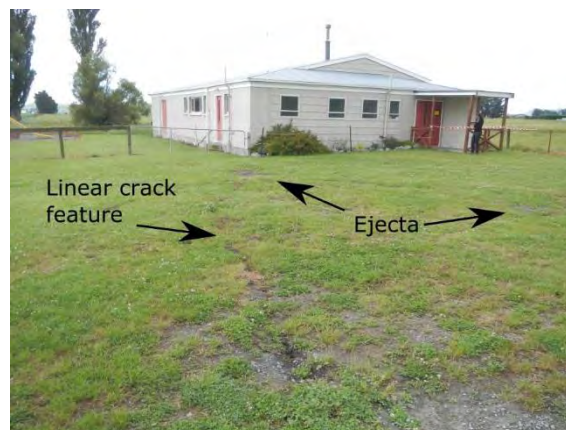
Figure 4.99: Front area of house on Schoolhouse Road (–9 Dec 2016, S42.3680, E173.6500, facing SW).

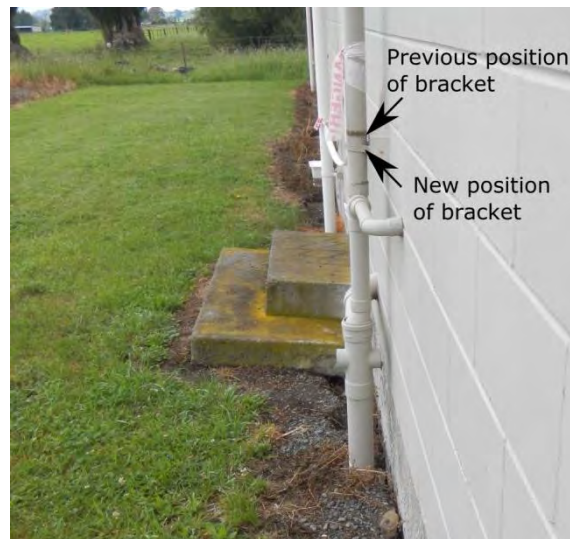
Figure 4.100: View of east wall of house on Schoolhouse Road (-9 Dec 2016, S42.3682, E173.6501, facing S).

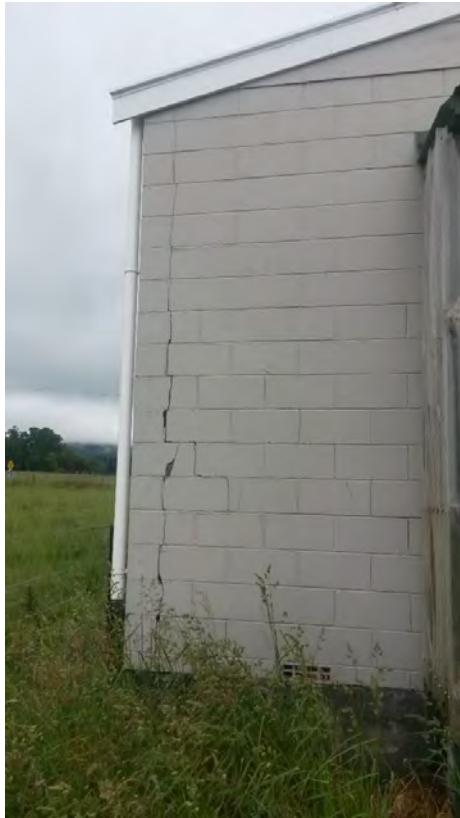
Figure 4.102: Cracking through brick work on SW corner of house on Schoolhouse Road (–9 Dec 2016, S42.3684, E173.6501, facing W).

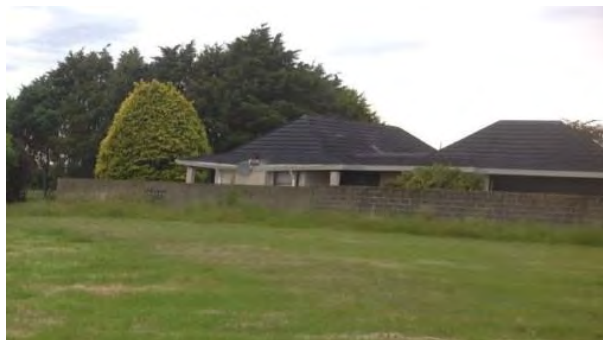
Figure 4.103: Damage caused to house on Mill Road by lateral ground movements (– date to be added in V2.0 of report, S42.3784, E173.6675, facing NE)

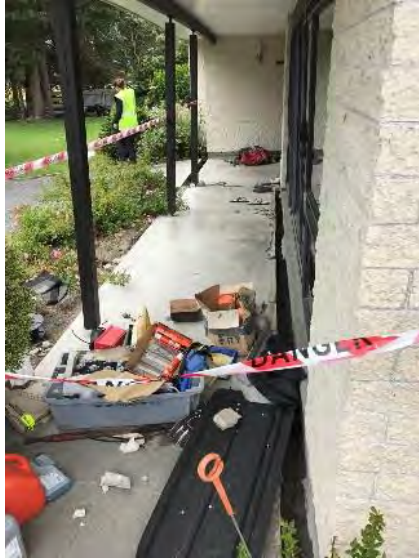
Figure 4.104: Separation of outdoor slab from main foundation slab (date to be added in V2.0 of report, S42.3784, E173.6675, facing E)

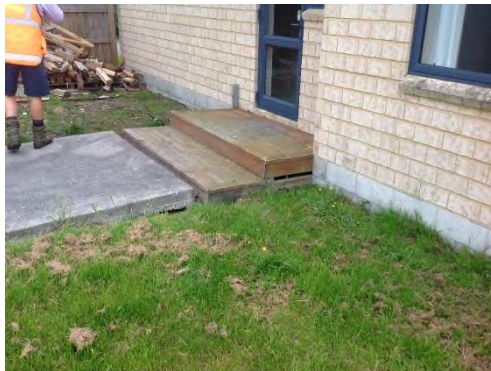
Figure 4.105: Southern side of new house on Mt Fyffe Road (8 Dec 2016, S42.3877, E173.6620, facing W).

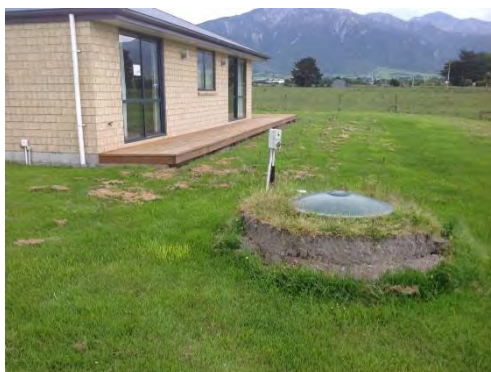
Figure 4.106: Floation of septic tank at SE corner of house on Mt Fyffe Road (8 Dec 2016, S42.3876, E173.6621, facing N).

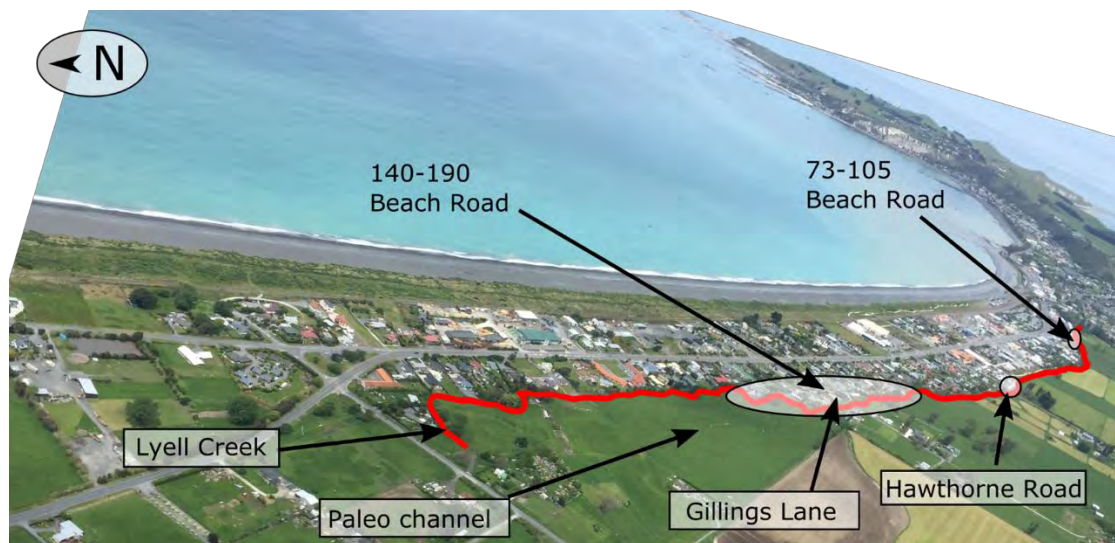
Figure 4.107: Lyell Creek and locations of photographs of interest (for reference the coordinates of 4 Gillings Ln are S42.3841, E173.6786).

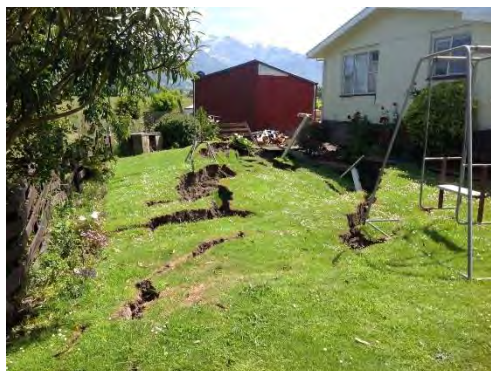
Figure 4.110: Lateral displacements (approx. 1.5 m in total) caused a loss of support at the NW corner of a house on Beach Road, causing cracking in the brick wall (date to be added in V2.0 of report, S42.3823, E173.6800).

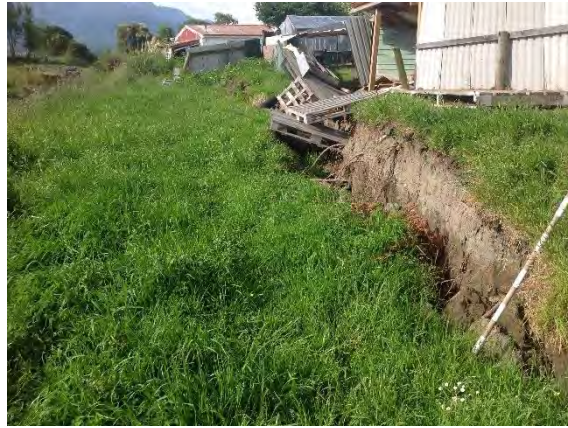
Figure 4.111: Large vertical offset (50 cm) associated with the ground movement north of Gillings Lane (– date to be added in V2.0 of report, S42.3841, E173.6784).

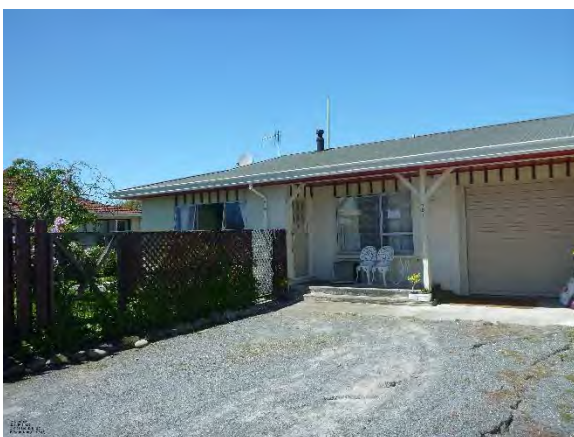
Figure 4.114: Complete loss of support to foundations at west end of house on Beach Road (– date to be added in V2.0 of report, S42.3851, E173.6783).

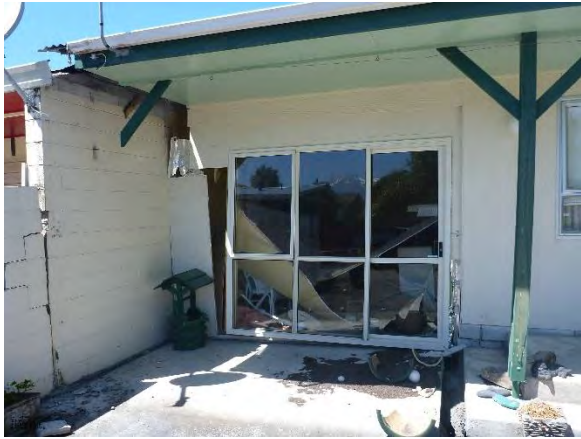
Figure 4.116: Cracks running through the house closer to Lyell Creek (– date to be added in V2.0 of report, S42.3857, E173.6783).

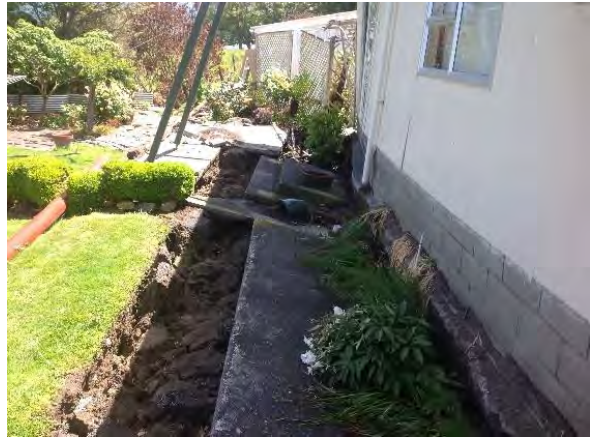
Figure 4.117: Gapping at the west side of the house closer to Lyell Creek (date to be added in V2.0 of report, S42.3857, E173.6783).

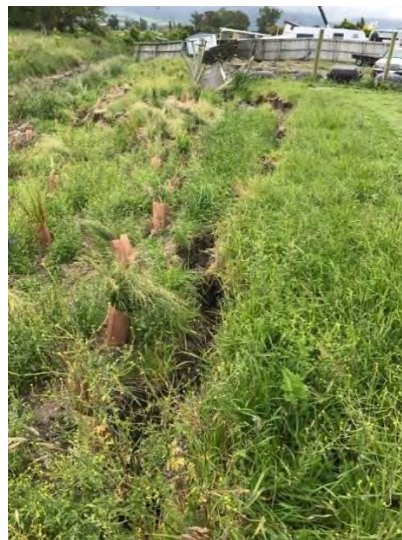
Figure 4.120: Lateral displacements at 105 Beach Road. Note: Cracks are associated with vertical offsets and blocks have rotated away from the river (i.e., slumped) (9 Dec 2016, S42.3902, E173.6777).

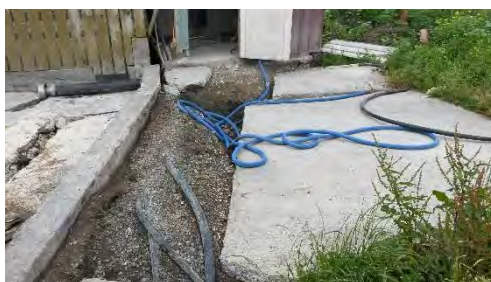
Figure 4.122: Lateral displacement at 87 Beach Road 13 m east of Lyell Creek (date to be added in V2.0 of report, S42.3917, E173.6778).

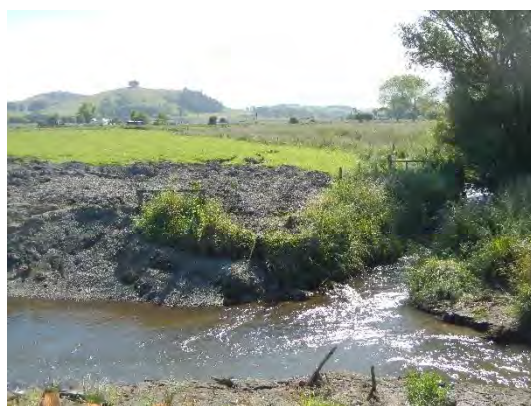
Figure 4.123: Recent earthworks on west side of Lyell Creek, opposite 87 Beach Road. (9 December 2016, S42.3922, E173.6777).

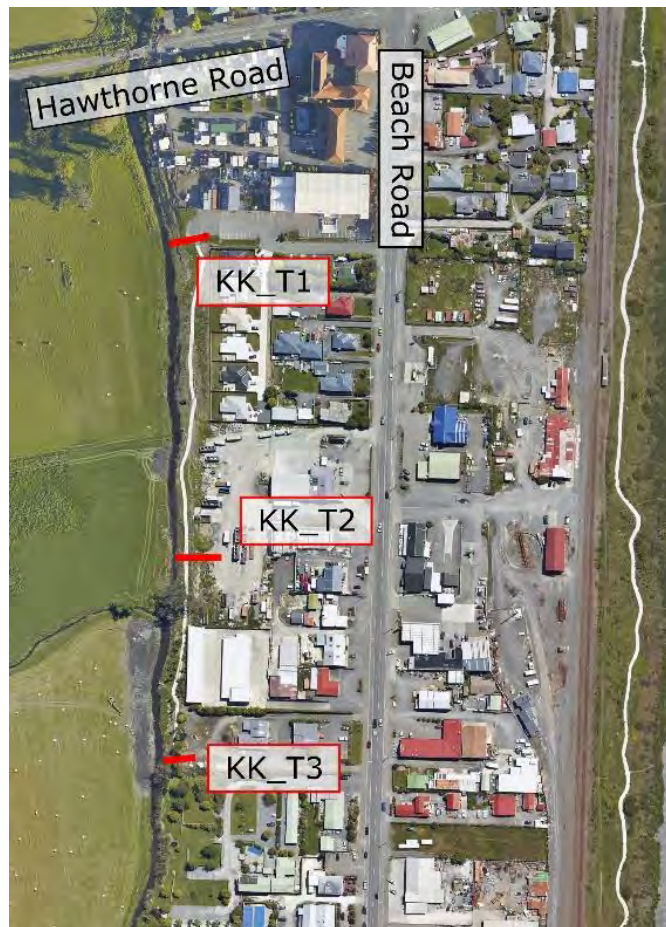
Figure 4.124: Location of transects (approx. centre of image: . S42.3922, E173.6791).

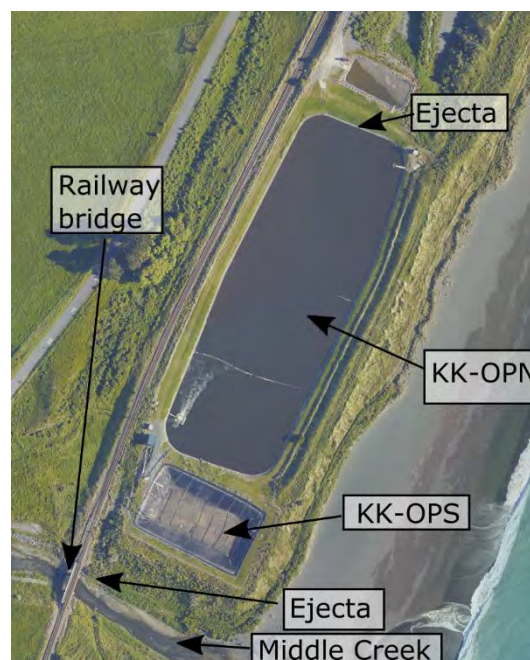
Figure 4.125: Overview of Oxidation Ponds north of Kaikoura (approx. centre of image: S42.366, E173.687). (modified from LINZ, 2016)

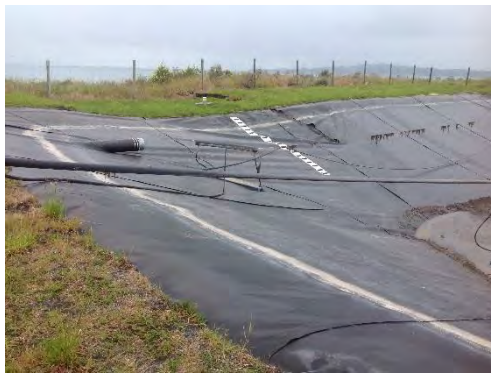
Figure 4.130: East side of KK-OPS. Note ripped geo-liner in line with crack by third post from left (– date to be added in V2.0 of report, S42.3667, E173.6875, facing SE).

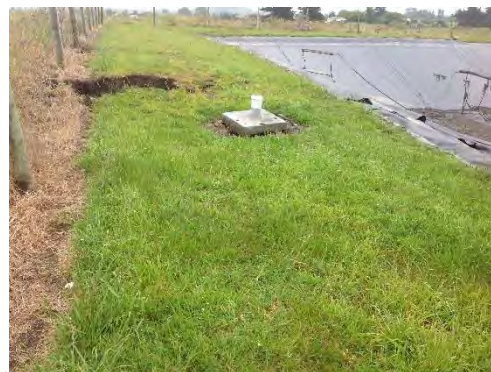
Figure 4.131: Protruding vent pipe on east edge of KK-OPS due to ground settlement (– date to be added in V2.0 of report, S42.3668, E173.6875, facing S).

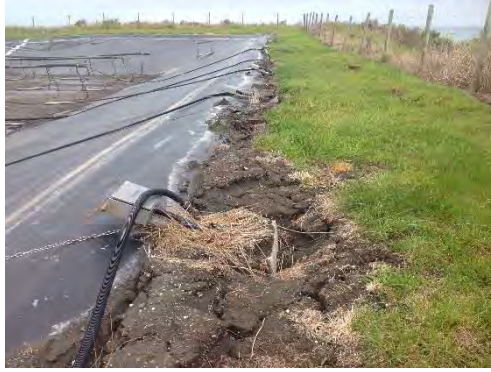
Figure 4.132: Rotation of the aeration-line control posts on the south side of KK-OPS (– date to be added in V2.0 of report, S42.3669, E173.6867, facing E).

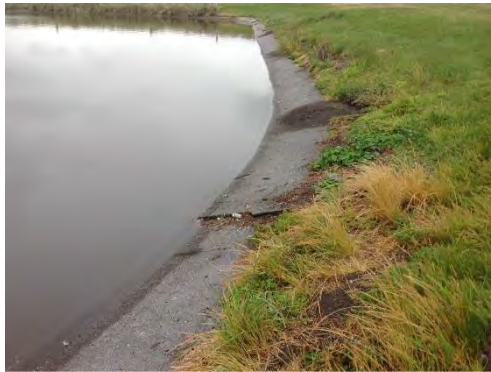
Figure 4.133: North edge of KK-OPN. Note cracking and overlayering of concrete. Ejecta visible on concrete. (– date to be added in V2.0 of report, S42.3647, E173.6884, facing W).

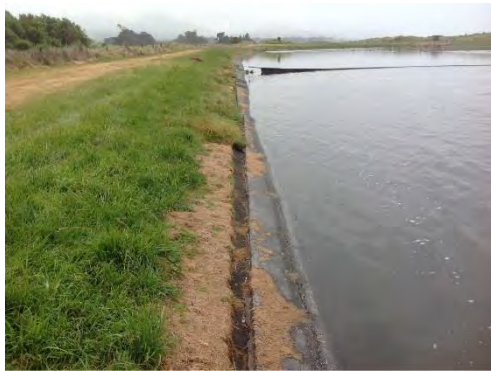
Figure 4.134: West edge of KK-OPN. Note concrete panel has displaced into pond (– date to be added in V2.0 of report, S42.3660, E173.6868, facing N).

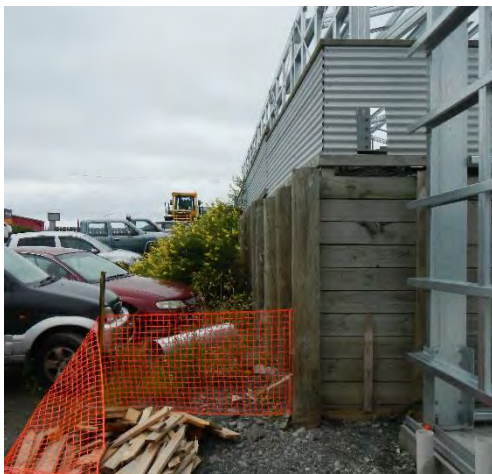
A second retaining wall on Beach Road is located roughly 30 m east of Lyell Creek. Figure 4.138 shows this retaining wall, where the top of the retaining wall had bulged 20-30 cm towards the creek. Cracks of up to 5 cm wide were present in the concrete slab approximately 5 m back from the top of the wall and are visible in Figure 4.139.

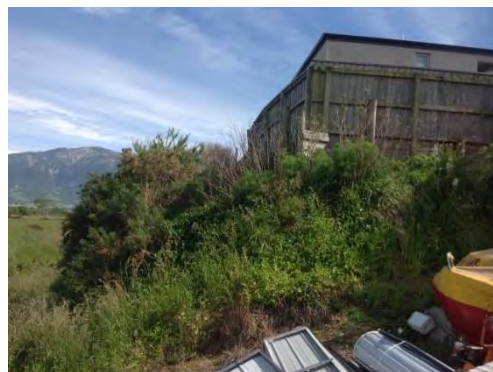
Figure 4.136: Failure of retaining wall (– date to be added in V2.0 of report, S42.3973, E173.6798, facing N).

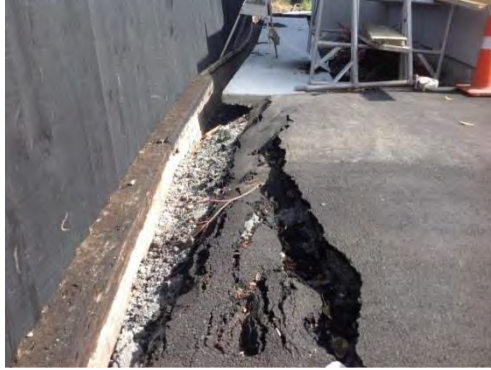
Figure 4.137: Cracks behind retaining wall (– date to be added in V2.0 of report, S42.3971, E173.6798, facing N).

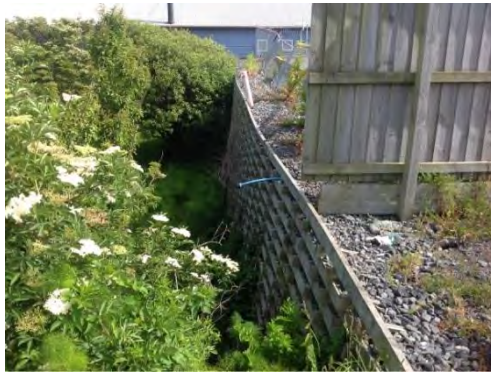
Figure 4.138: Failure of retaining wall (– date to be added in V2.0 of report, S42.3964, E173.6793, facing N). Note: Cracks visible in the car park on the retained side of the wall.

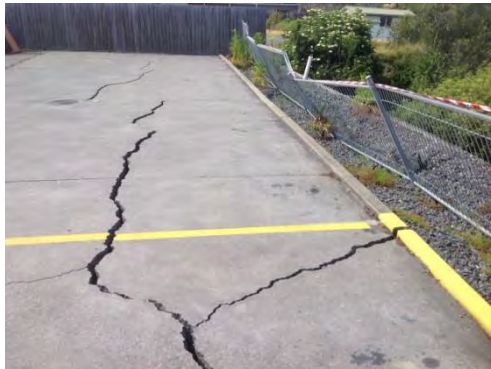
Figure 4.139: Cracks visible behind retaining wall (– date to be added in V2.0 of report, S42.3968, E173.6796, facing S).

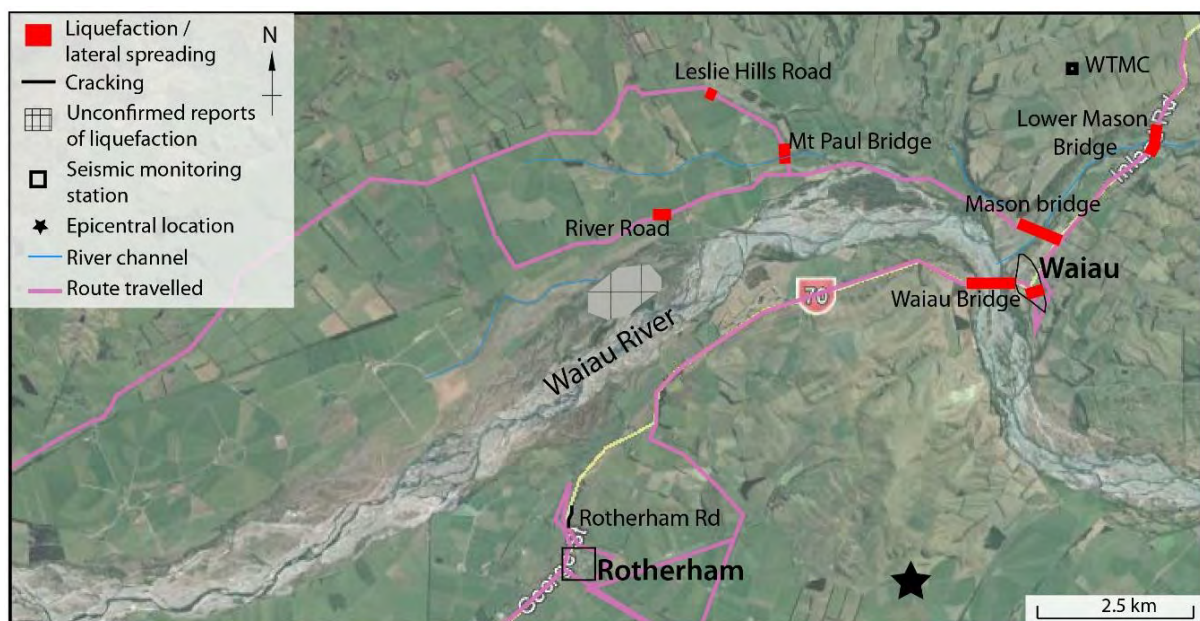
Figure 4.140: Map of the Waiau area indicating areas with liquefaction manifestation. (approx. centre of image: S42.658, E173.005).

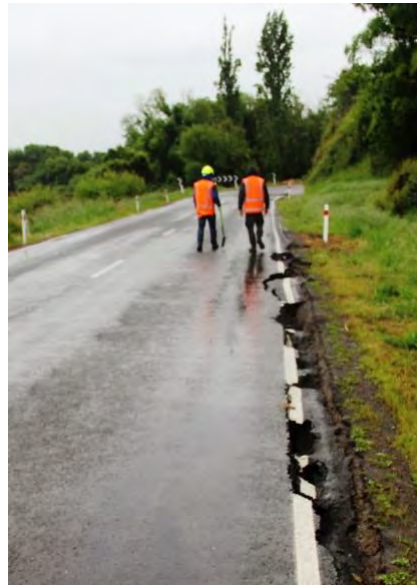
Figure 4.141: Cracks alongside Rotherham road (S42.6908, E172.9470, 17 Nov 2016).

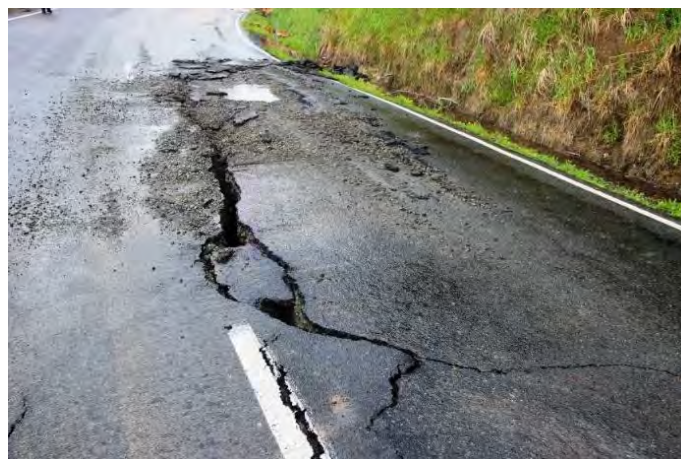
Figure 4.142: Large crack in middle of roadway on Rotherham Road. Crack width 20-30 cm. Vertical offset is approximately 4 cm (S42.6900, E173.9462, 17 Nov 2016).

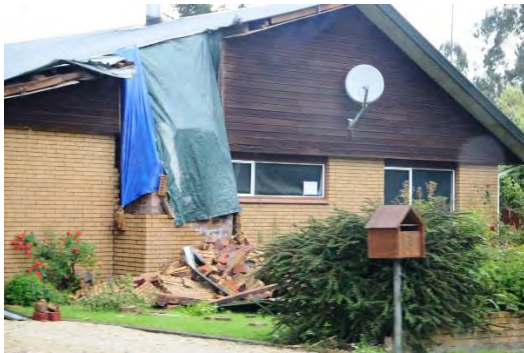
In the town of Waiau, the strong shaking caused damage to a large number of building facades and chimneys (examples are shown in Figure 4.143), however there was only evidence of liquefaction at two locations at the south end of the town. In this part of town, there were a number of cracks in the road, and the two locations of ejecta were either associated with the cracks (Figure 4.144), or with fence posts which surrounded a paddock SW of the end of Parnassus Street. The particle size distribution of a sample of this ejecta is shown in Figure 4.145. It was reported by utility workmen that there was a significant amount of ejecta inside the paddock, but the owner could not be located to obtain access to this area.

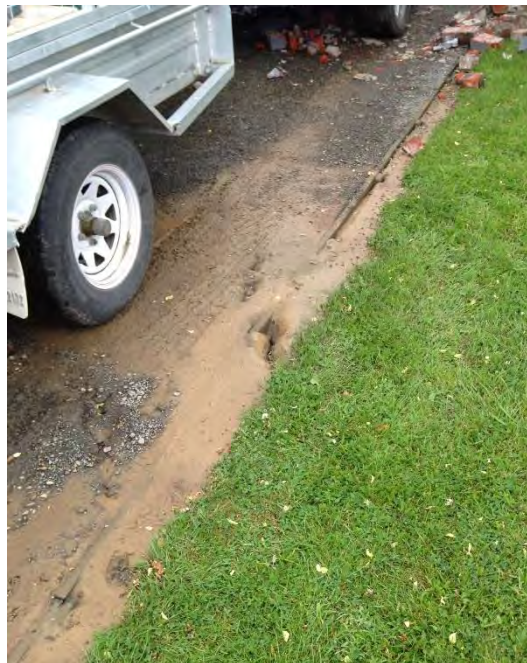
Figure 4.144: Liquefaction at the south of Waiau town (date to be added in V2.0 of report, S42.6592, E173.0440, 17 Nov 2016).

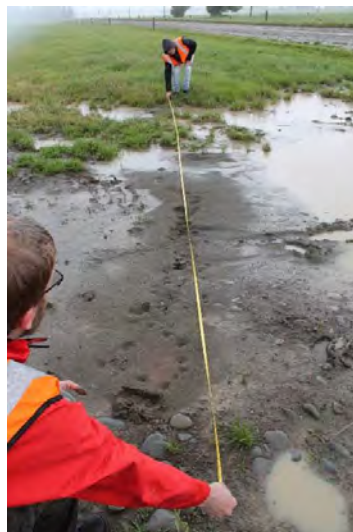
Figure 4.147: Liquefaction ejecta on River Road (S42.6427, E172.9743, 17 Nov 2016).

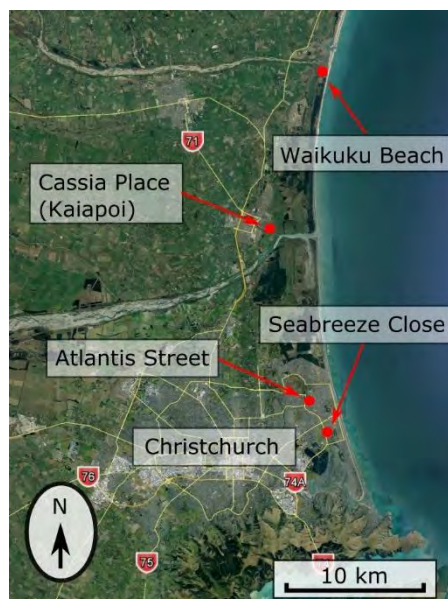
Figure 4.148: Locations of potential liquefaction sites in and around Christchurch (approx. centre of image: S43.417, E172.647).

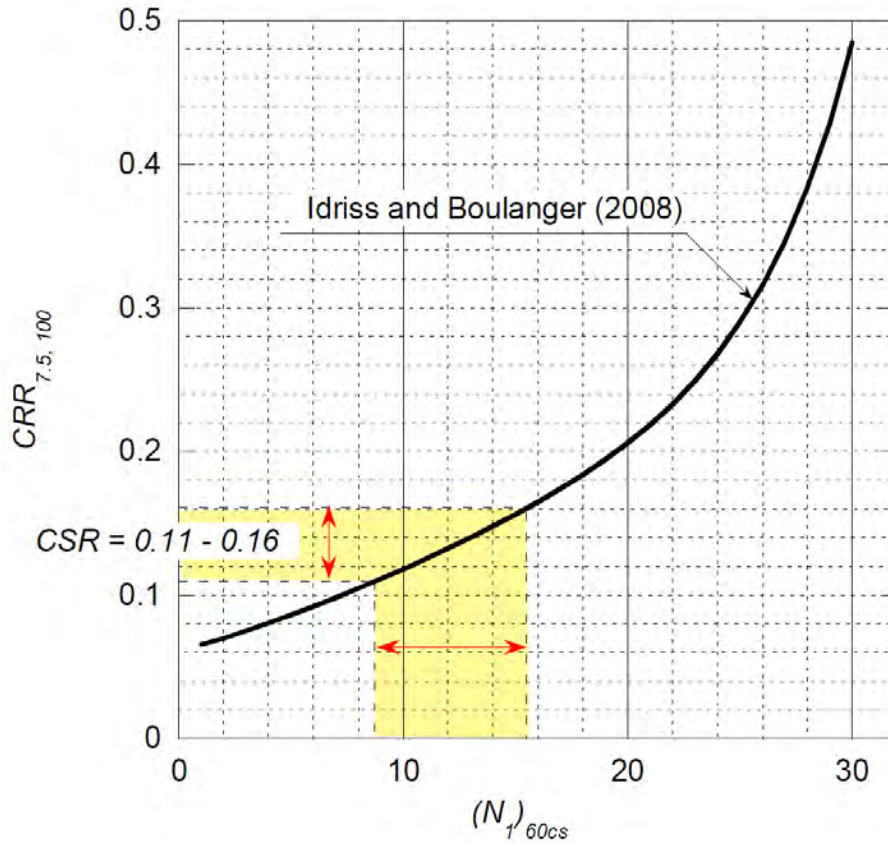
Figure 5.16: Illustration of seismic demand for assessing liquefaction triggering by the 2016 Kaikoura earthquake at depth of the water table for the three sites on reclaimed soils in the vicinity of the port (PIPS, TFSS and CPLB).

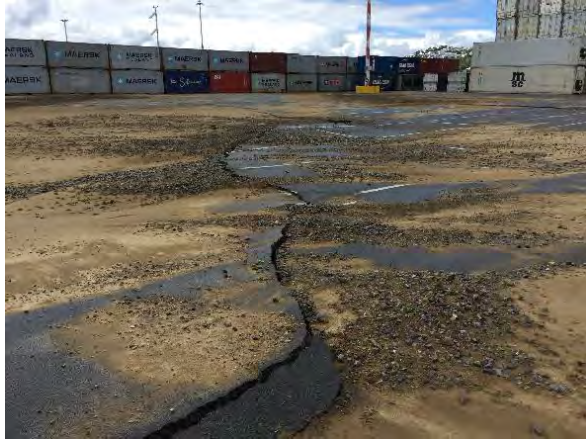
The photos shown in Figures 5.17 to 5.21 illustrate some of the key liquefaction manifestation features observed in several areas of CentrePort.

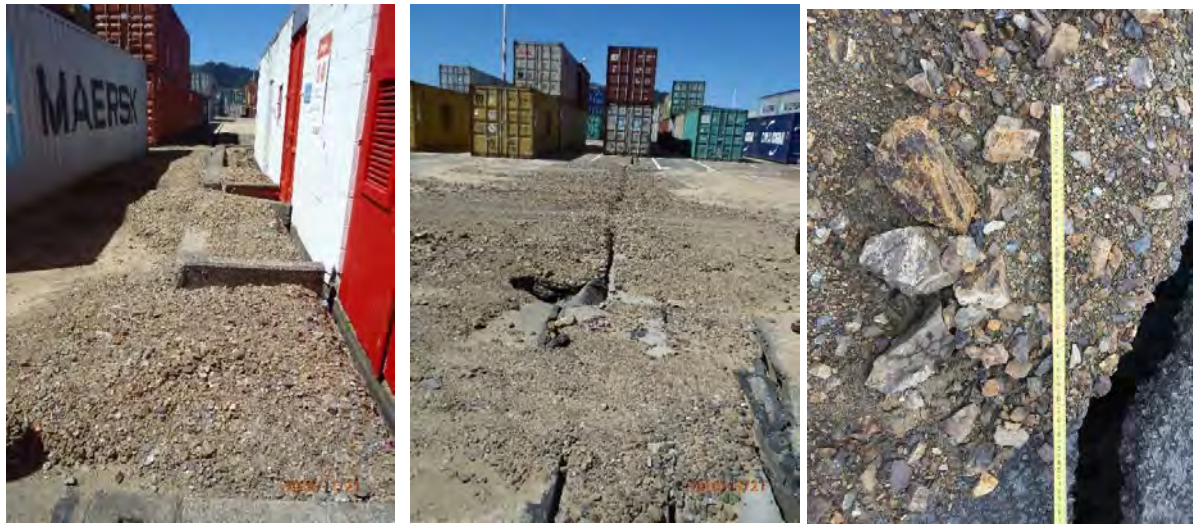
Figure 5.17: Gravelly ejecta at the Thorndon Container Terminal: (a) pavement cracking and ejected gravelly material (S41.280175°, E174.787308°); (b) characteristic gravel-size fractions of the ejecta with some cobbles observed in this area (S41.280206°, E174.787431°); (c) larger amount of gravelly ejecta around a cavity and collapsed pavement surface (S41.280361°, E174.789336°); (d) large volumes of ejecta observed along drainage lines (S41.278347°, E174.788069°, taken on 17NOV16).

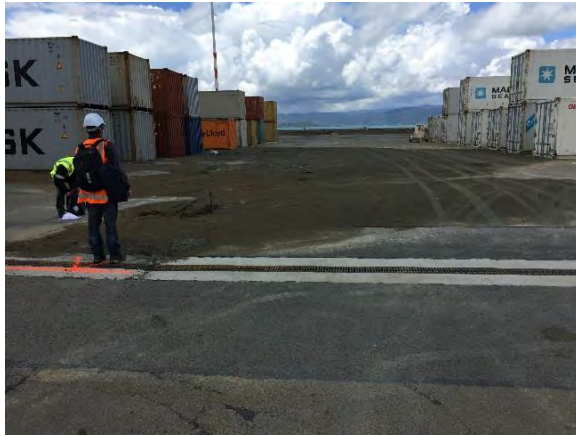
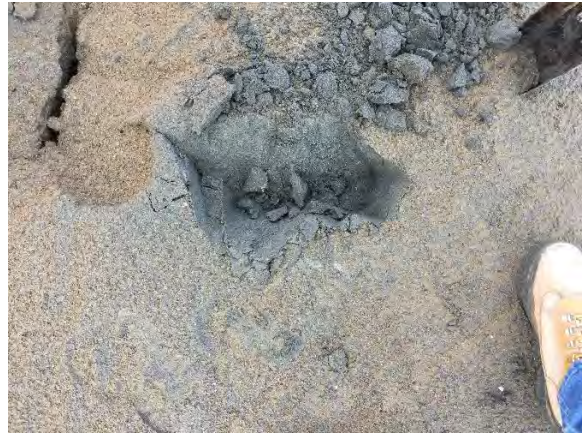
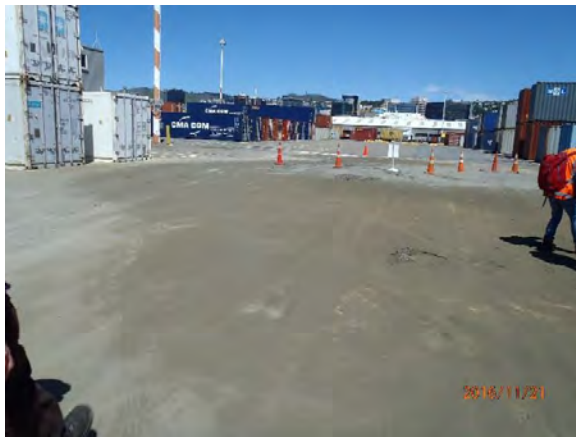
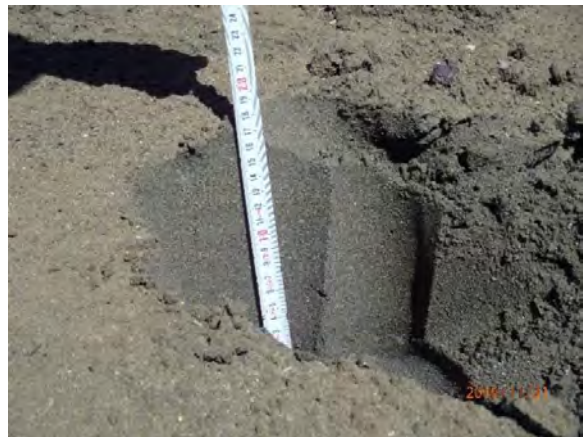
Figure 5.19: Sandy liquefaction ejecta with trace gravel among area of 1970's end-dumped quarry rock reclamation (i.e., Thorndon Reclamation) at STA 145 and approximately 60 m upland of the bulkhead. The ejecta deposit was approximately 170 mm thick at this location. Samples S11 and S12 were collected here (S41.279067°, E174.788792°, taken on 17NOV2016 and 21NOV16).

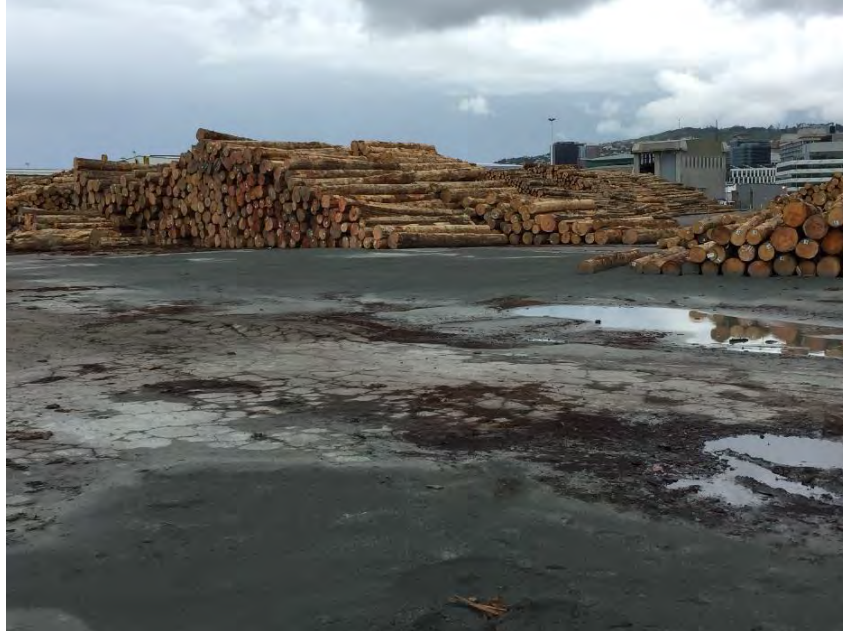
Figure 5.21: Sandy liquefaction ejecta in the log stacking area in the northeast corner of CentrePort (Sample S13). Area of hydraulic fill reclamation. (S41.274972°, E174.788347°, taken on 17 NOV16)
