# GEOTECHNICAL RECONNAISSANCE OF THE 2016 $M_w$ 7.8 KAIKOURA, NEW ZEALAND EARTHQUAKE

Version 1.0: 10 JUNE 2017

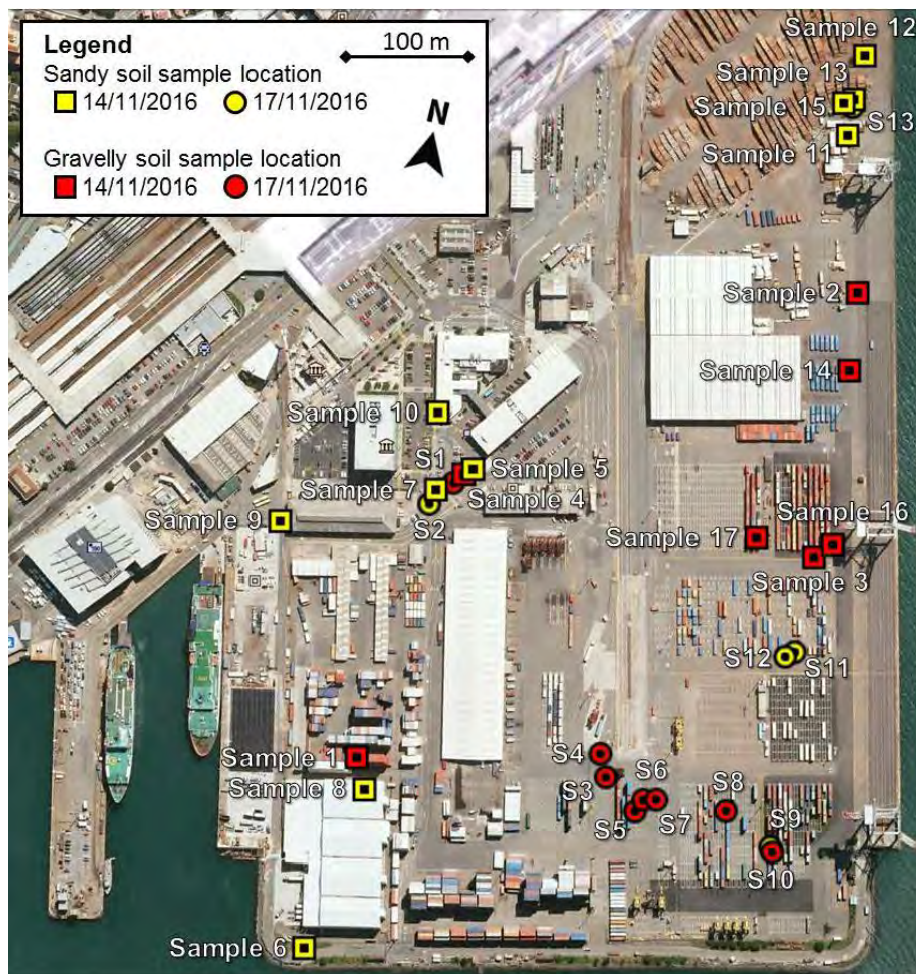
Figure 5.22: Location of liquefaction ejecta samples collected on 14 November (Sample 1 to Sample 17), and 17 November (S1 to S13). (Base image from Google Earth™)

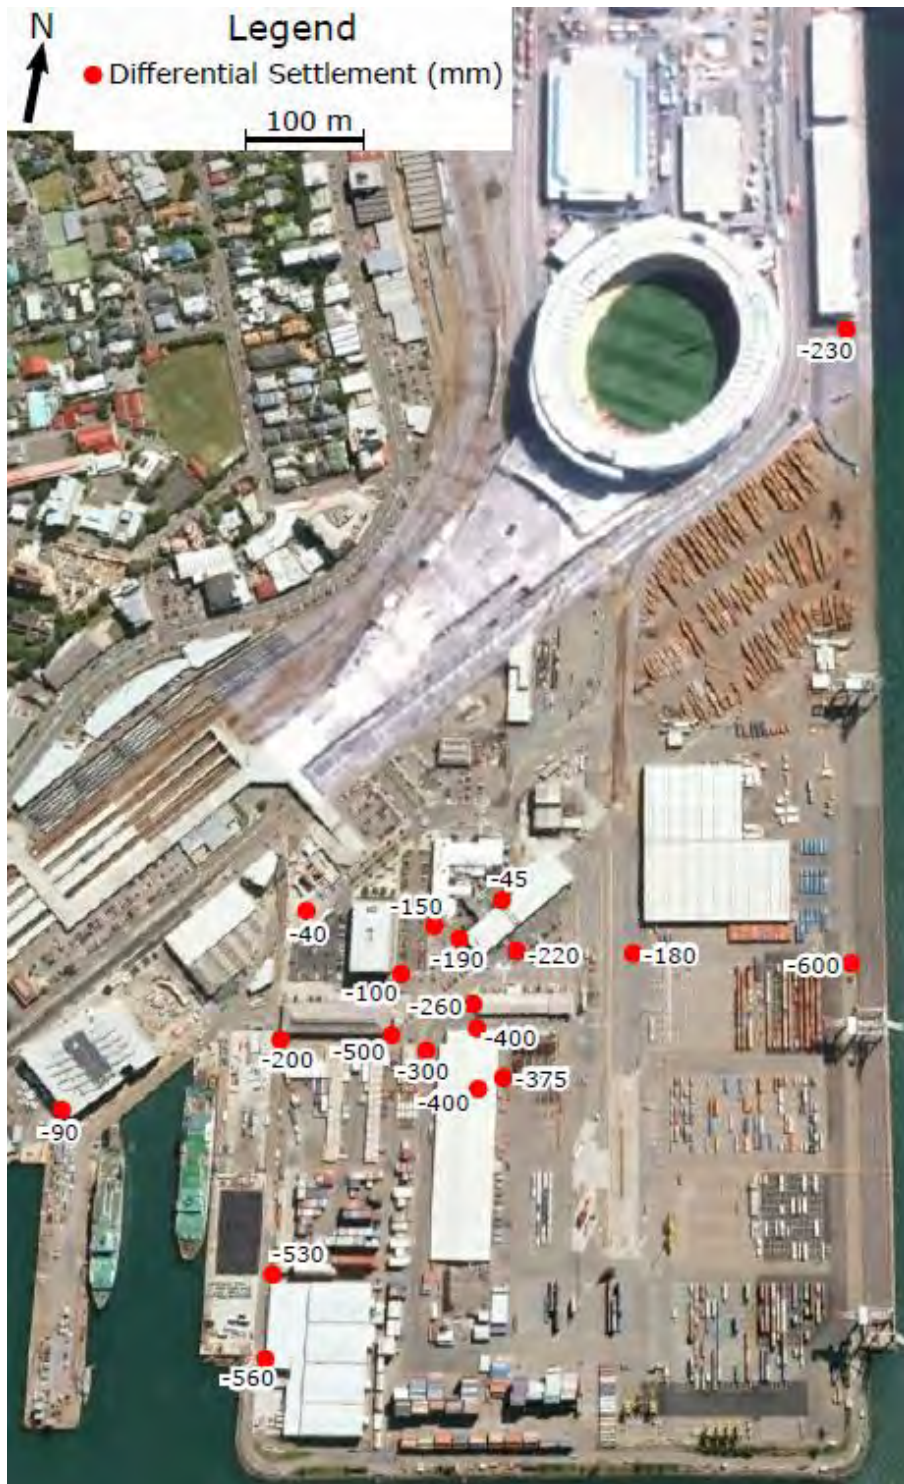
Figure 5.24: Location and magnitude of differential settlement measurements obtained during inspections. All values are in mm, and represent settlement of the ground surface relative to a pile supported structure. (Base image from Google Earth™)

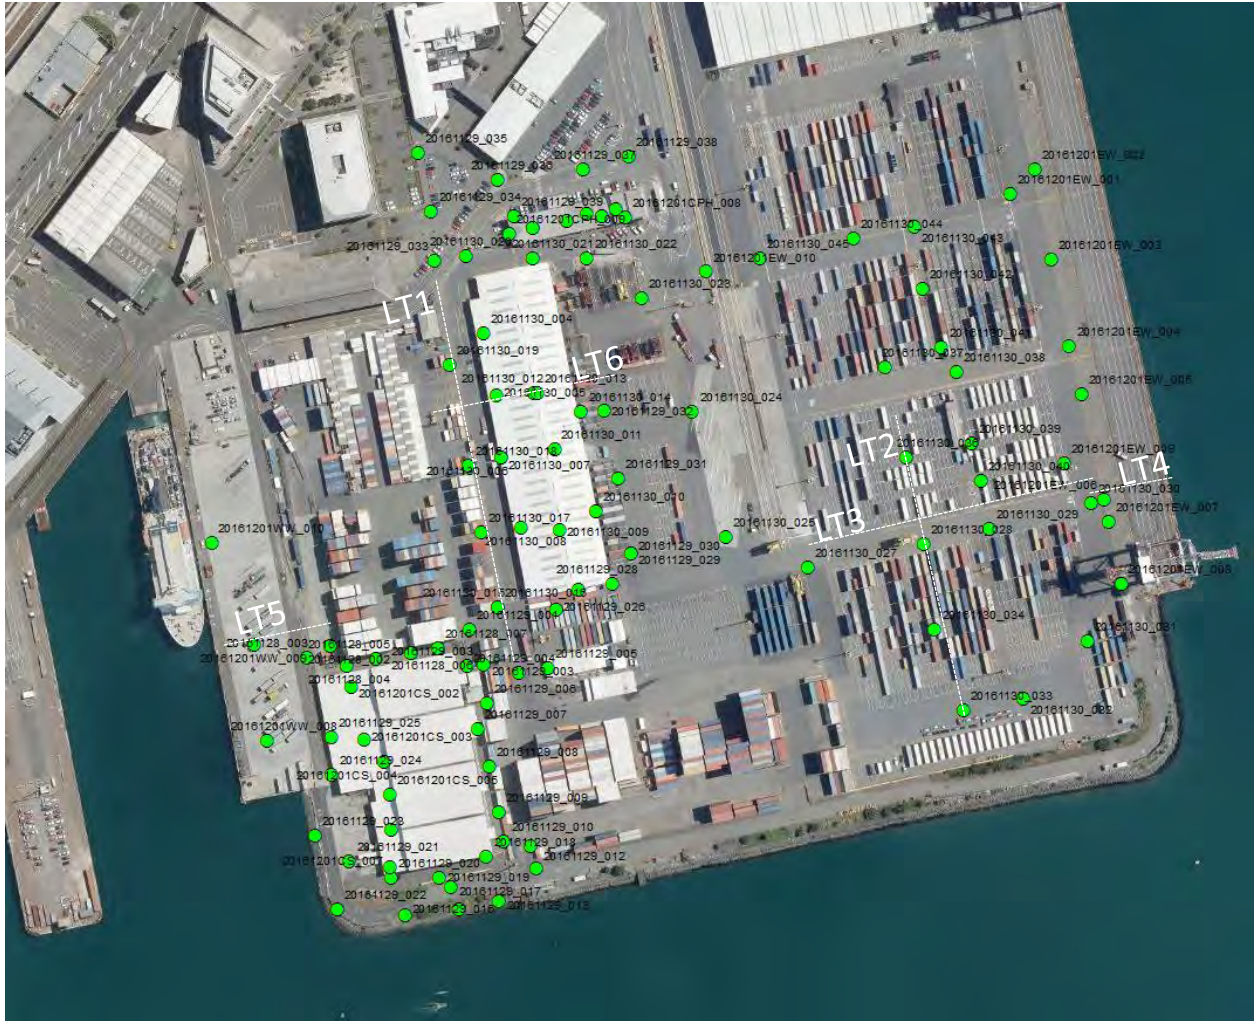
Figure 5.27: Locations (green circles) where terrestrial laser scans were obtained at the CentrePort. Additional scans were captured inside the Cruise Ship Terminal to the North that are not shown on the map because they are being processed. Transects from the LiDAR data shown later in the report are identified. Note that the basemap is from ESRI prior to the earthquake.

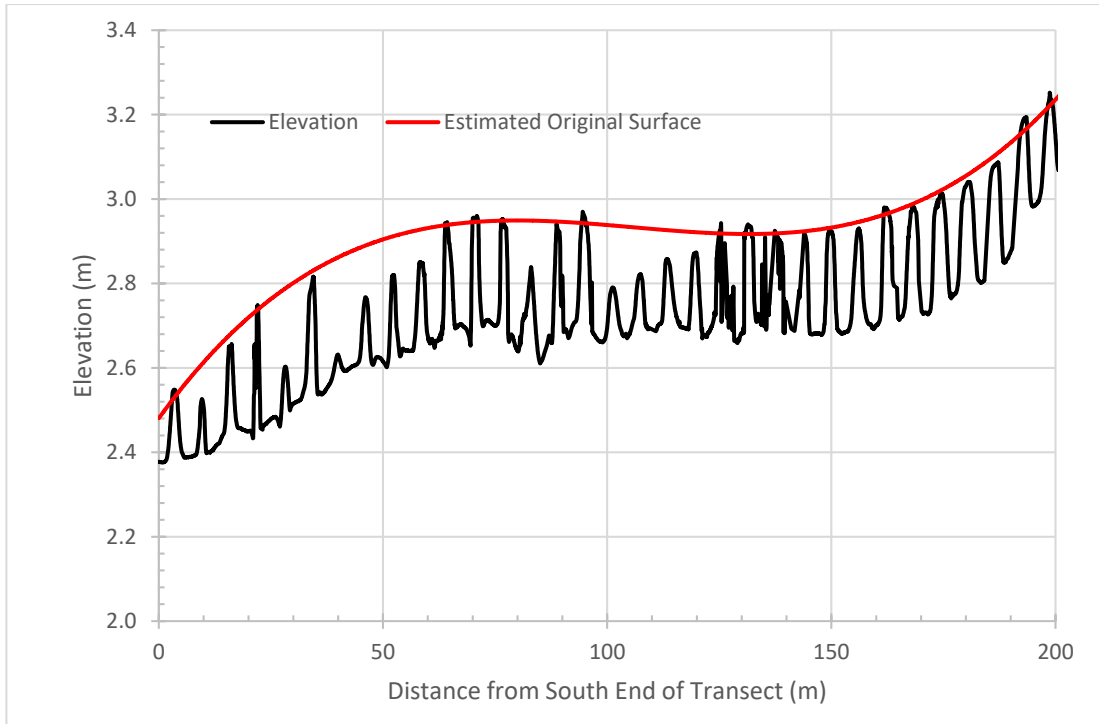
Figure 5.31 presents example DEMs with perspective views. From the lidar scans, significant differences in elevation from liquefaction are apparent. Figure 5.32 presents two cross-sections through this locale, one running north to south (Figure 5.32(a)) and one running west to east (Figure 5.32(b)). Although the pre-event surface was not available for comparison, it is likely that settlement increases significantly towards the south as a result of the increased liquefaction-induced ground spreading towards the south and west.

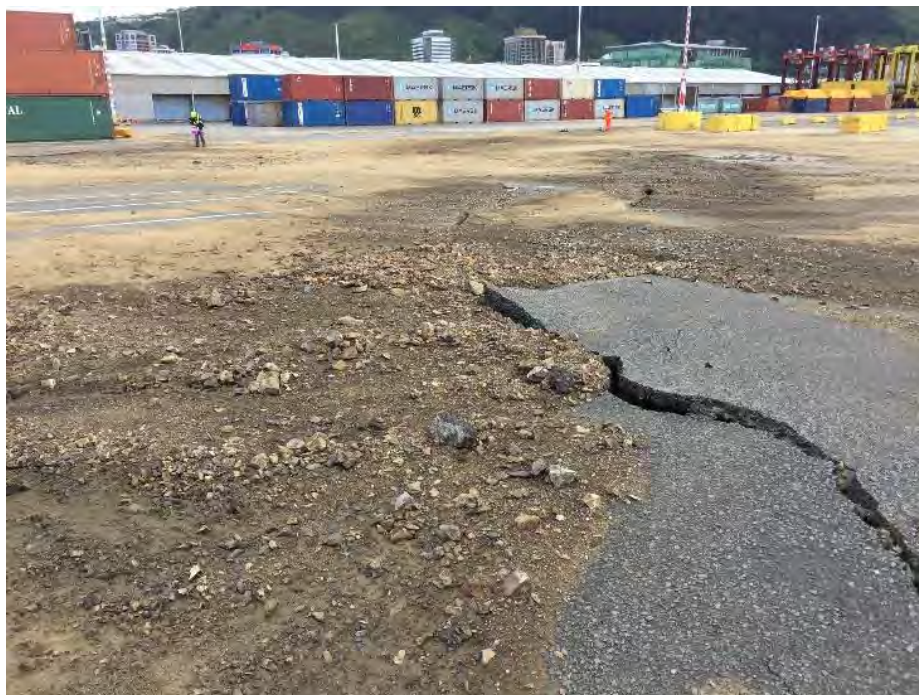
Figure 5.34: Widespread liquefaction of gravelly end-dumped quarry rock reclamation in container stacking area inland of Thorndon Wharf (S41.276608° E174.786309°, taken on 21NOV16)

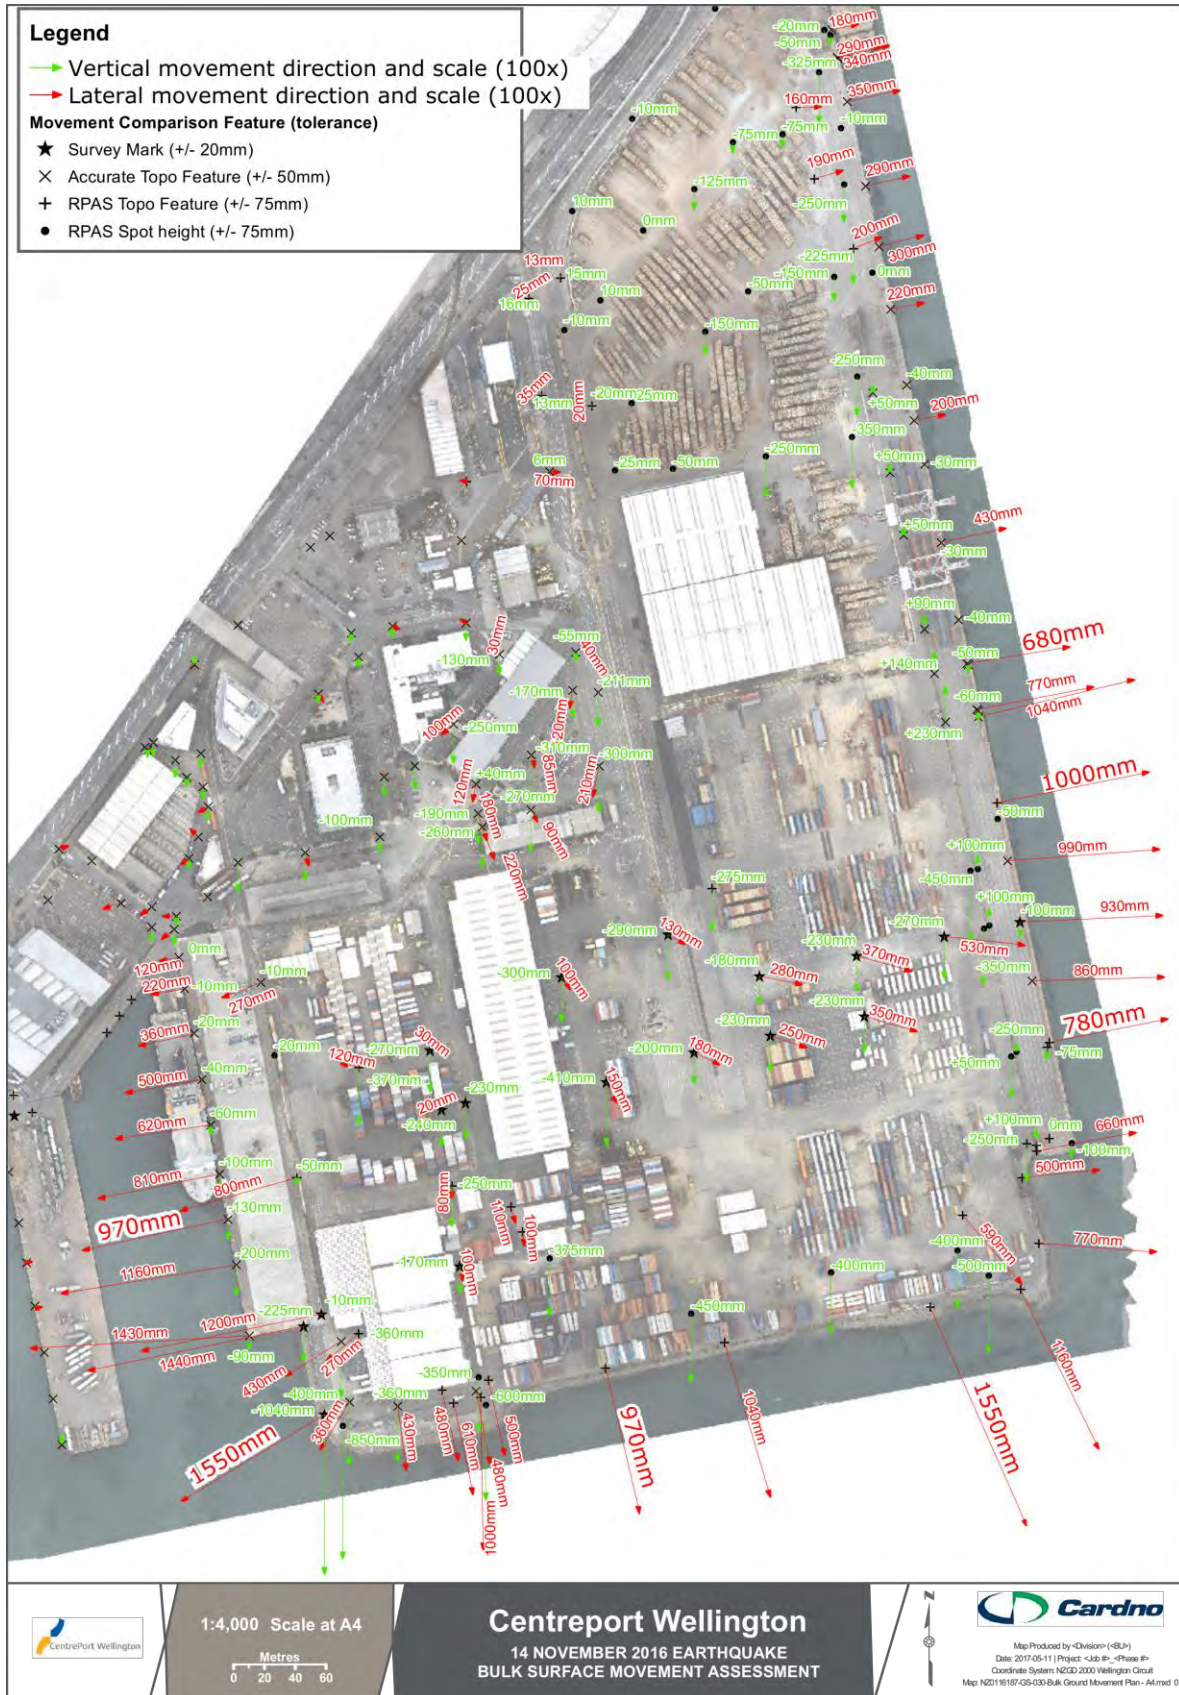
Figure 5.38: Aerial survey of Thorndon Reclamation and Wharf (performed by Cardno).

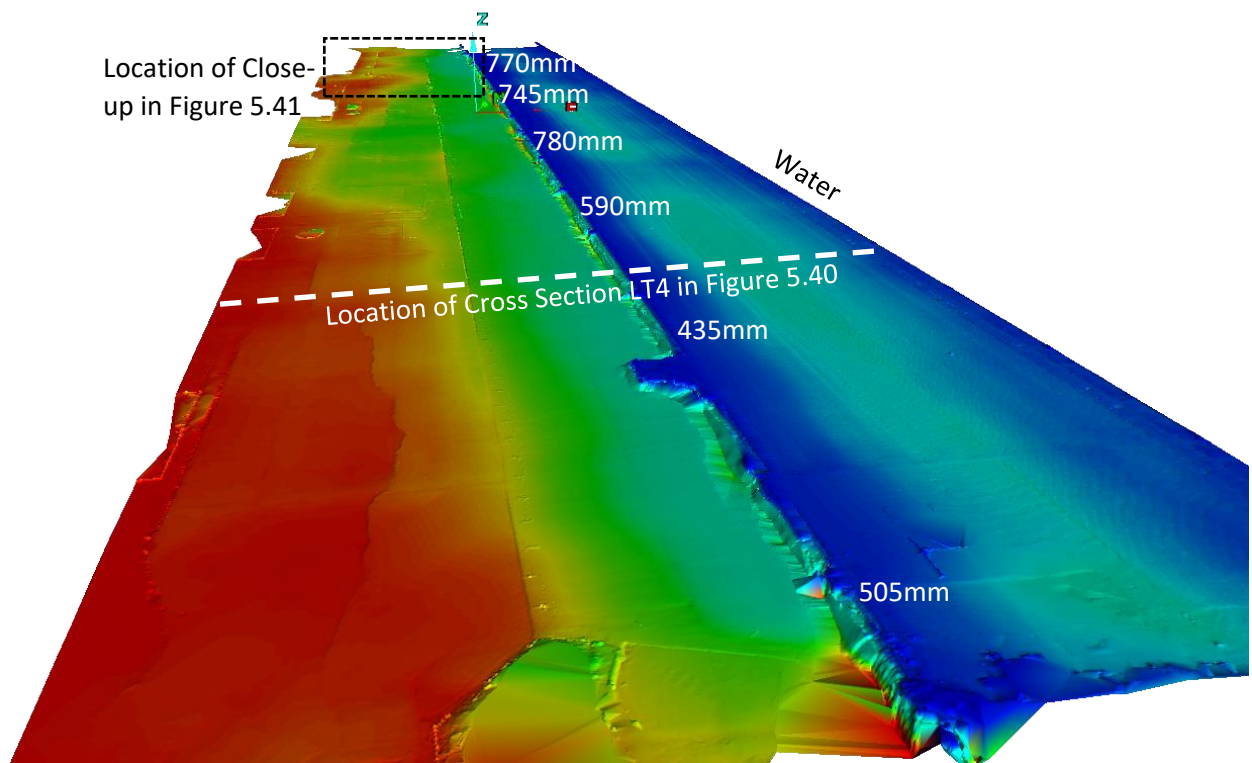
Figure 5.39: Perspective view of the LiDAR DEM of the eastern section of the port looking northward including the Thorndon Wharf and surrounding area colored by elevation to highlight discontinuities from cracks. Elevation ranges from approximately 2.60 m (red) to 3.60 m (dark blue). Differential settlements between the Wharf and Port are identified.

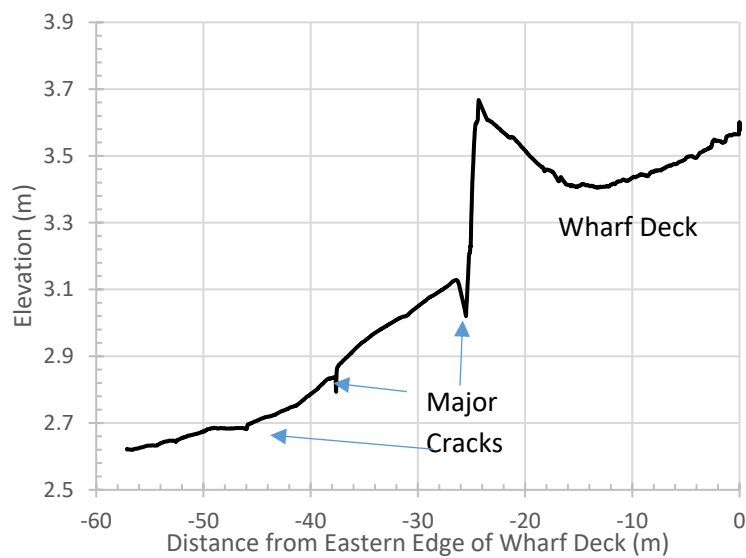
Figure 5.40: Elevation profile for cross section LT4 across Thorndon Wharf and inland fill. The location of the cross section is shown in Figure 5.39.

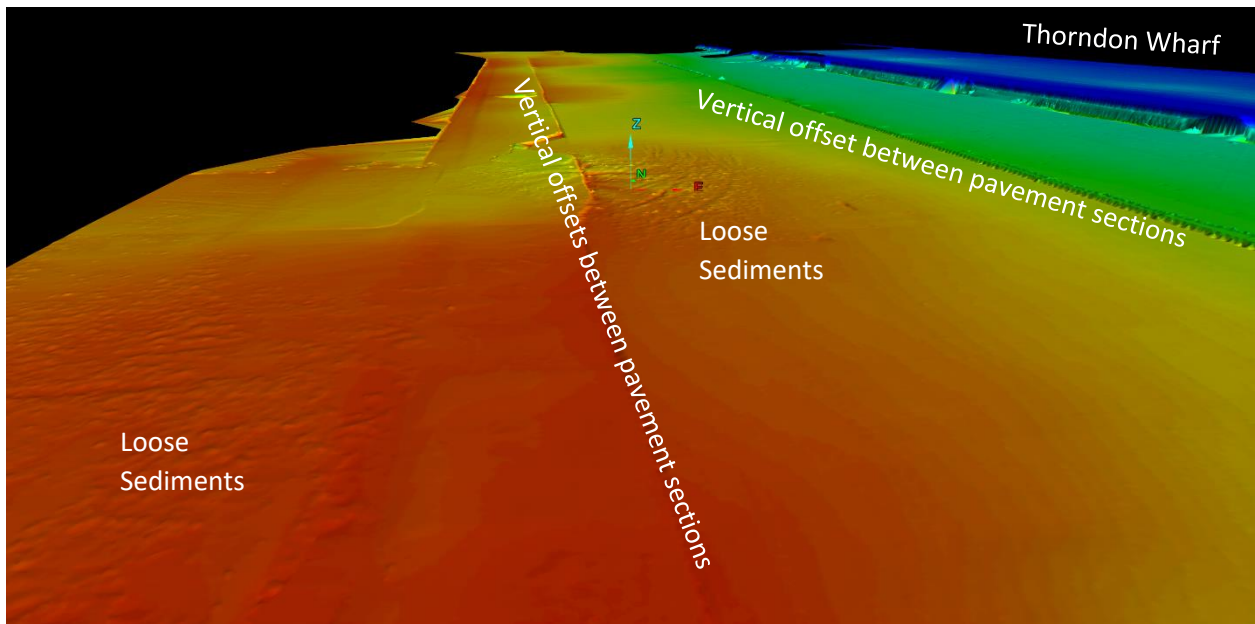
Figure 5.41: Close-up of the port surface highlighting cracking and separation between asphalt sections as well as loose sediments from ejecta (rougher sections of DEM) in the vicinity of Thorndon Wharf (see Figure 5.39).

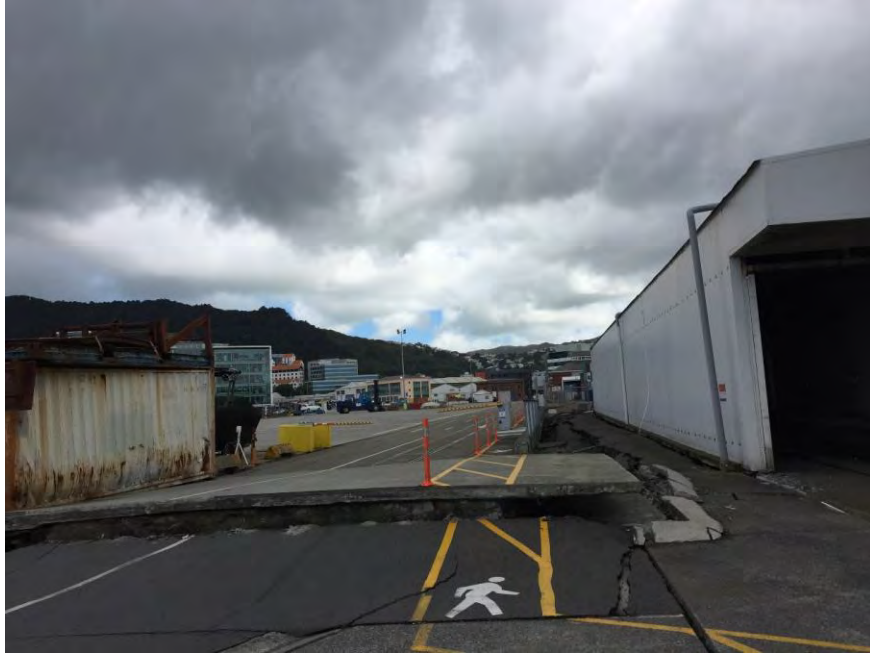
Figure 5.42: Looking North along bulkhead of King's Wharf. Approximately 560 mm of ground settlement relative to deck at southeast corner of King's Wharf. The west wall of the Cold Store shed is visible to the right of the photograph. (S41.281142° W174.784444°, taken at 1416 hrs on 21NOV16)

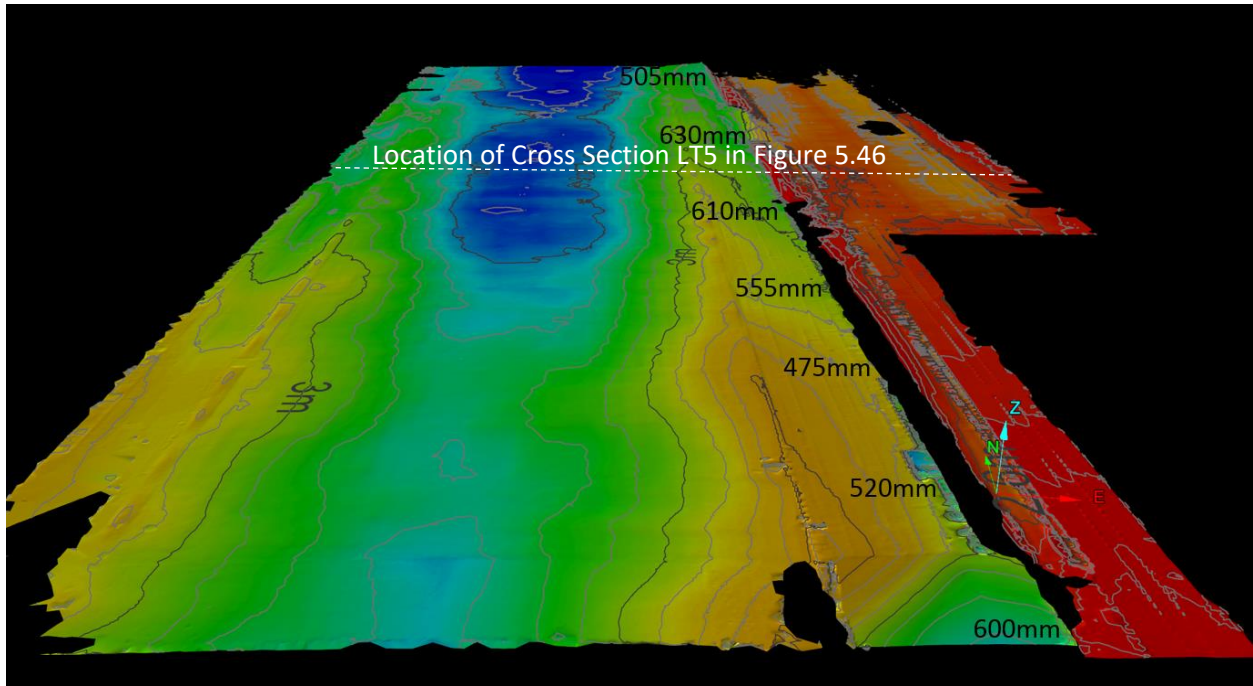
Figure 5.45: Perspective view of the LiDAR derived DEM (looking northward) of the pile supported King's Wharf showing measurements of differential settlement the adjacent ground. Elevation ranges from approximately 2.50 m (red) to 3.30 m (dark blue)

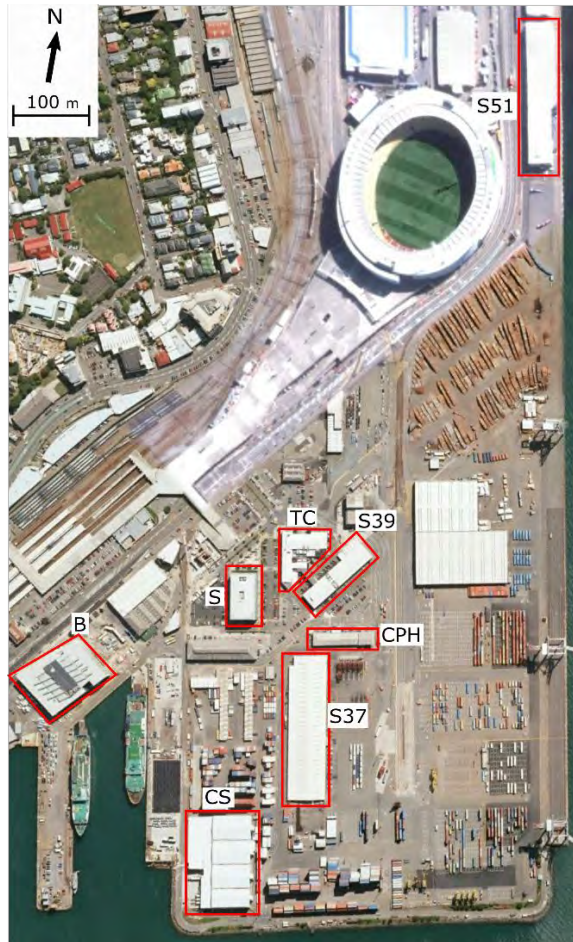
Figure 5.47: CentrePort Wellington map identifying buildings studied in this reconnaissance. (Base image from Google Earth™)

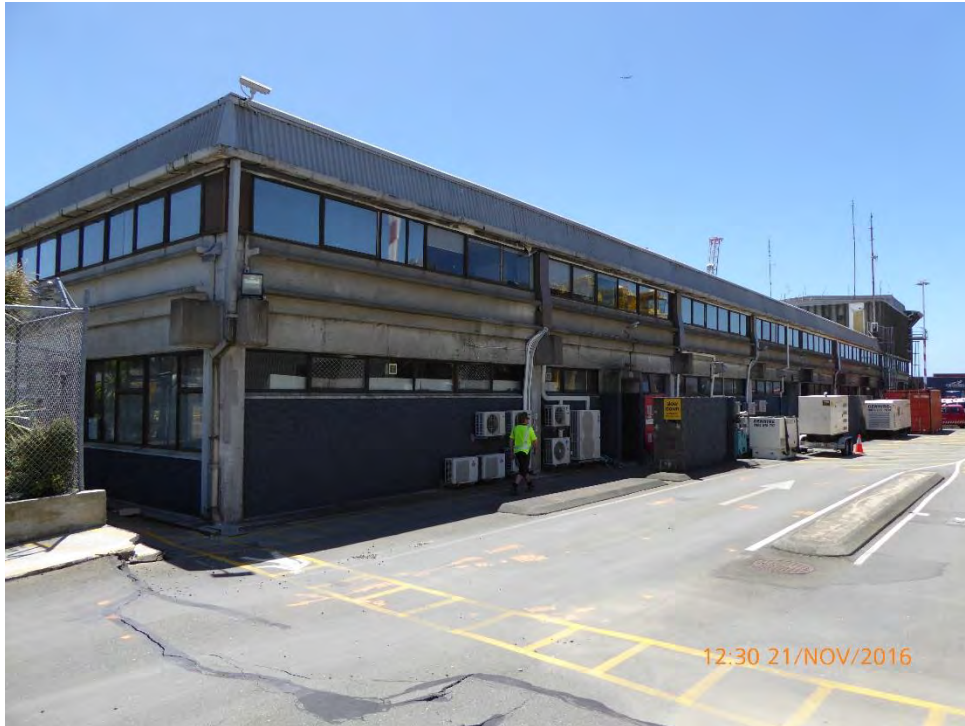
Figure 5.48: Uniform settlement of CPH building which is founded on shallow foundations that apparently displaced downward the same amount as the surrounding fill. This photo is looking northeast at the southwest corner of the building. (S41.278395° E174.785639°, taken at 1230 hrs on 21NOV16)

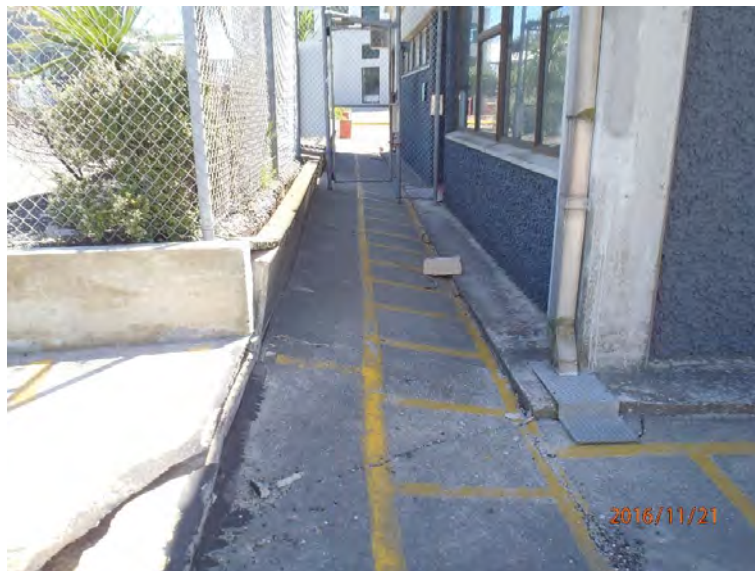
Figure 5.49: Uniform settlement (230-260 mm) of the building relative to ground supported on old bulkhead piles of Pipitea Wharf. Looking north along western wall of CPH building. The perimeter walkway slopes down towards the building at 11 degrees over 1.35 meters. (S41.278395° E174.785639°, taken at 1225 hrs on 22NOV16)

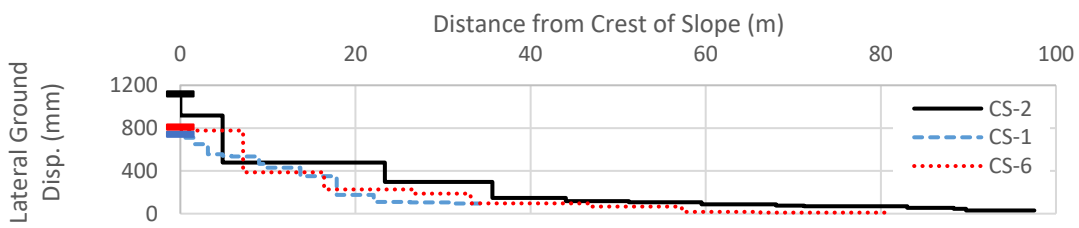
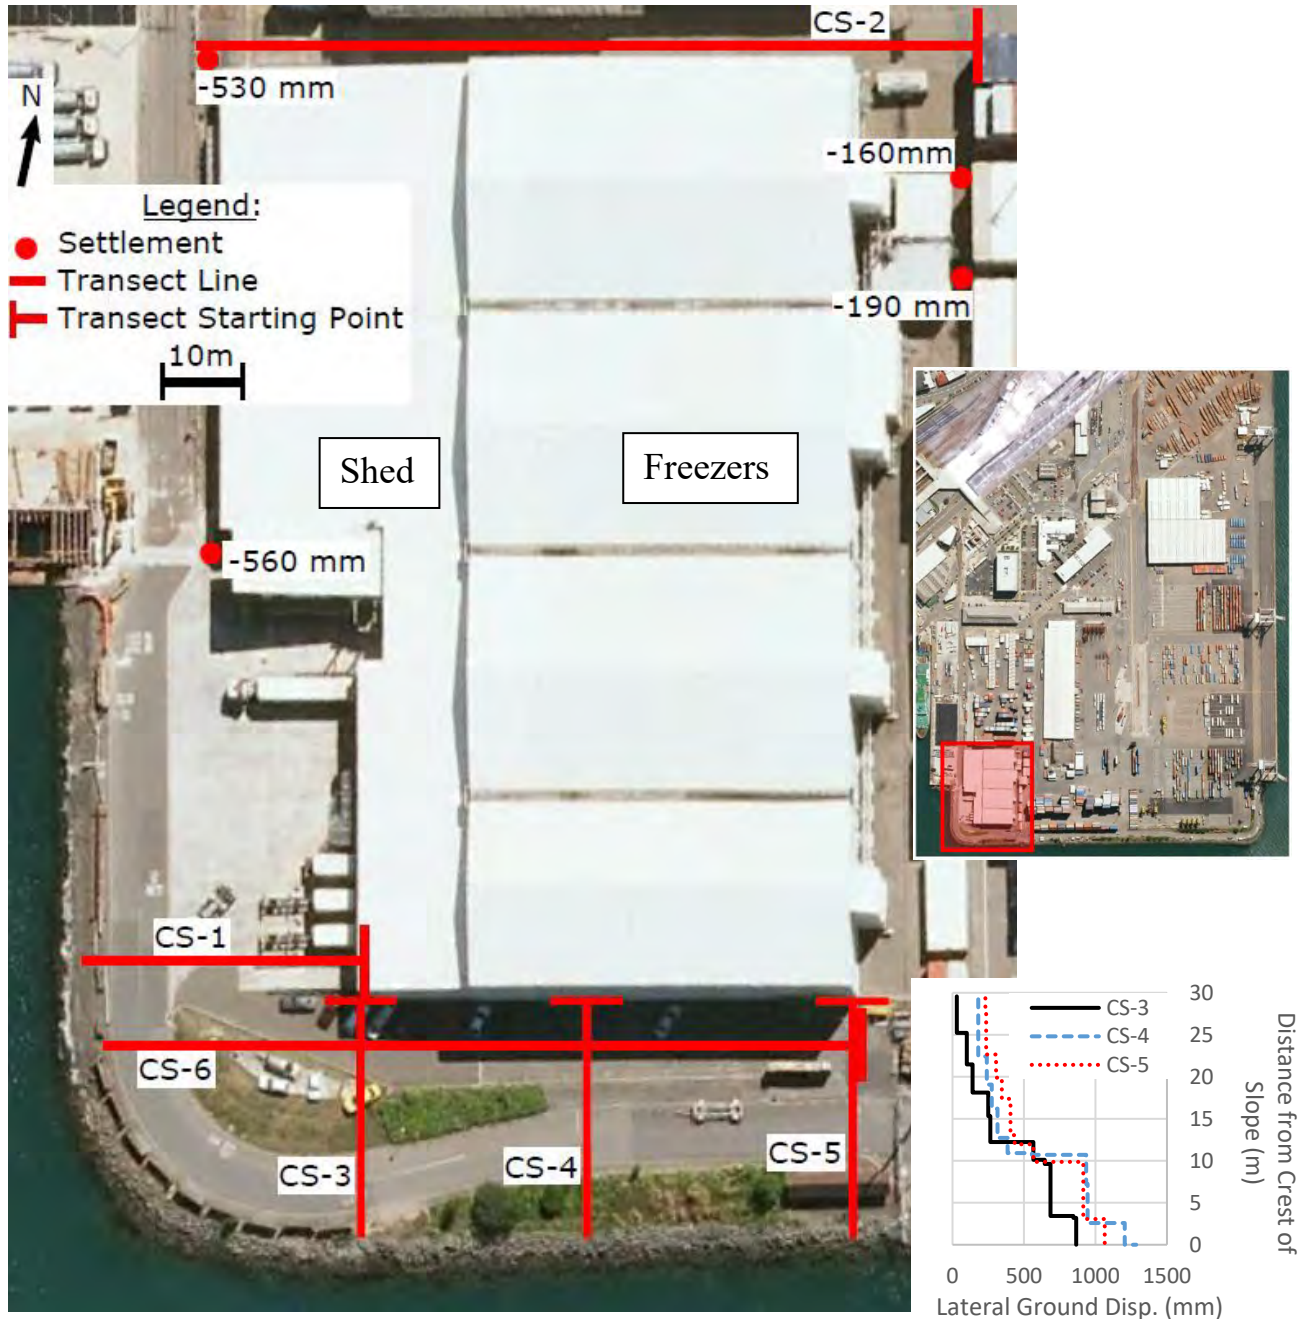
Figure 5.50: CS building lateral ground movement transects and vertical settlement measurement locations. Cumulative ground displacement versus distance from crest of slope are provided. Note that the crest of slope is further east at CS-2 than at CS-1 and CS-6, therefore, displacement plots do not perfectly align with satellite image for CS-2. Settlement measurements to the northeast are relative to the building which also settled.

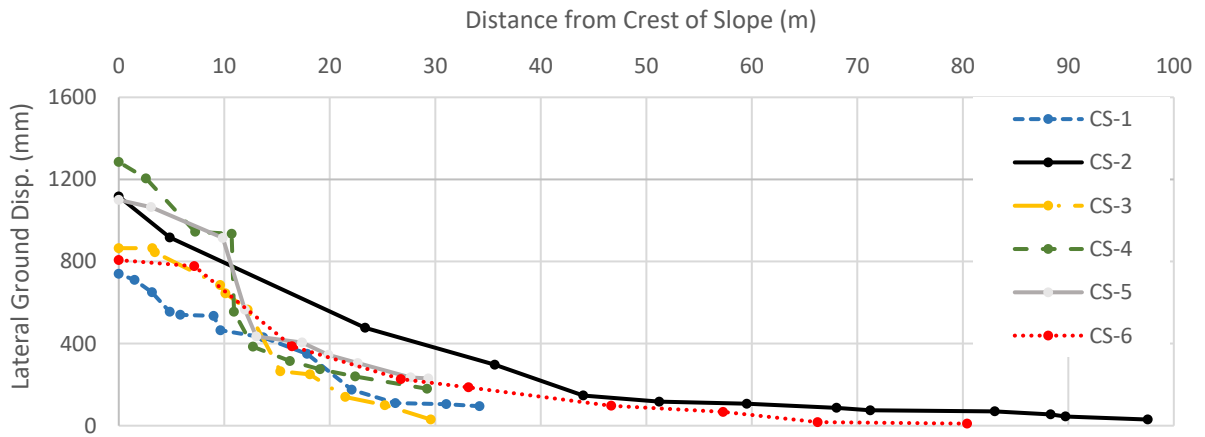
Figure 5.51: Cumulative lateral ground displacement versus distance from the crest of the waterfront slope for Cold Store lateral spread transects.

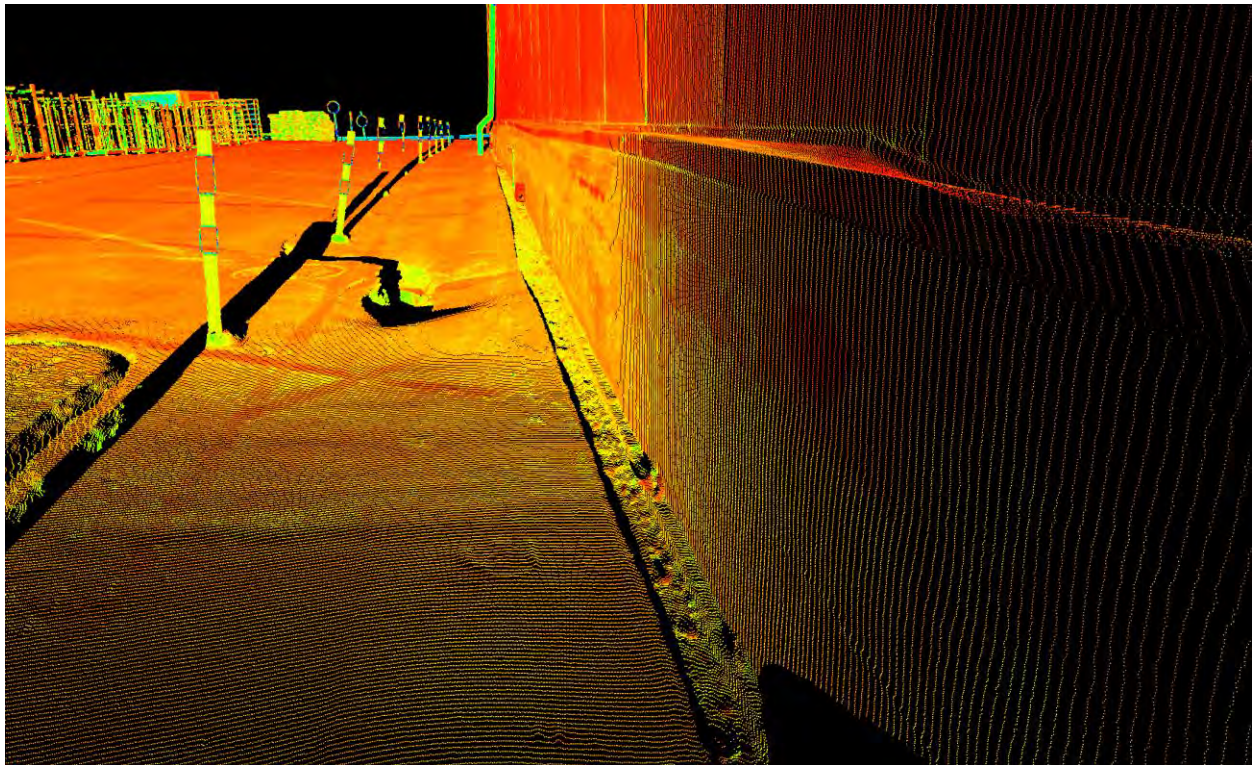
Figure 5.52: Perspective view of LiDAR scan looking westward showing the horizontal separation from building foundation and settlement of pavement observed on the south side of the CS building looking west (colored indicates intensity). The separation varies from 0.23 m wide to 0.03 m wide horizontally from the building's eastern side to its western side.

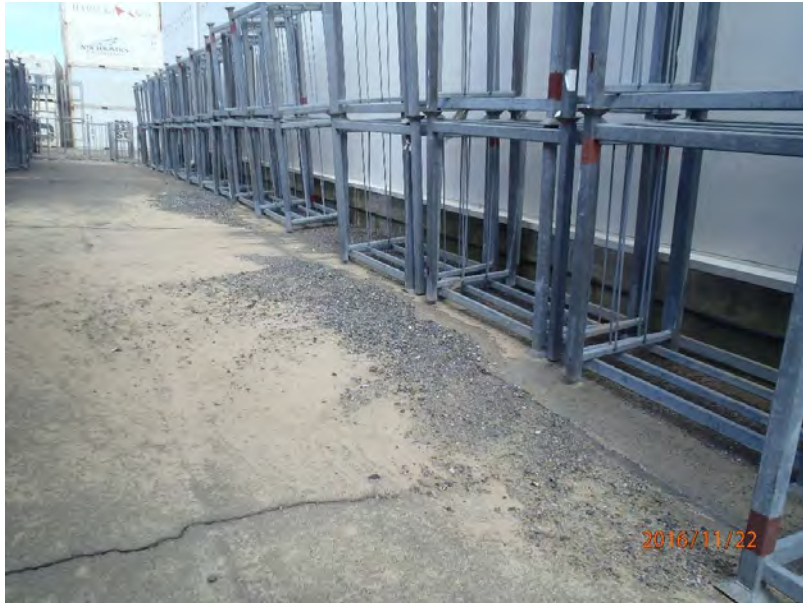
Figure 5.53: Gravelly liquefaction ejecta looking east along the northern wall of the CS building. (S41.280528° E174.784984°, taken at 1651 hrs on 22NOV16)

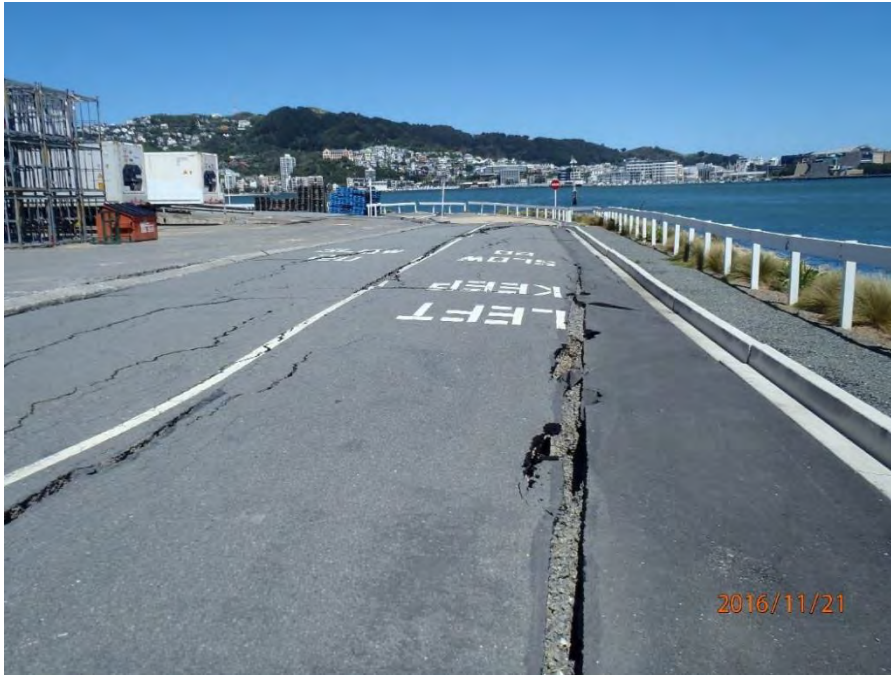
Figure 5.55: Ground cracks in area west of the CS building and along the southwestern slopes of CentrePort (looking south). The CS building can be partially seen on the upper left corner of the photograph. (S41.281478° E174.784430°, taken at 1418 hrs on 21NOV16)

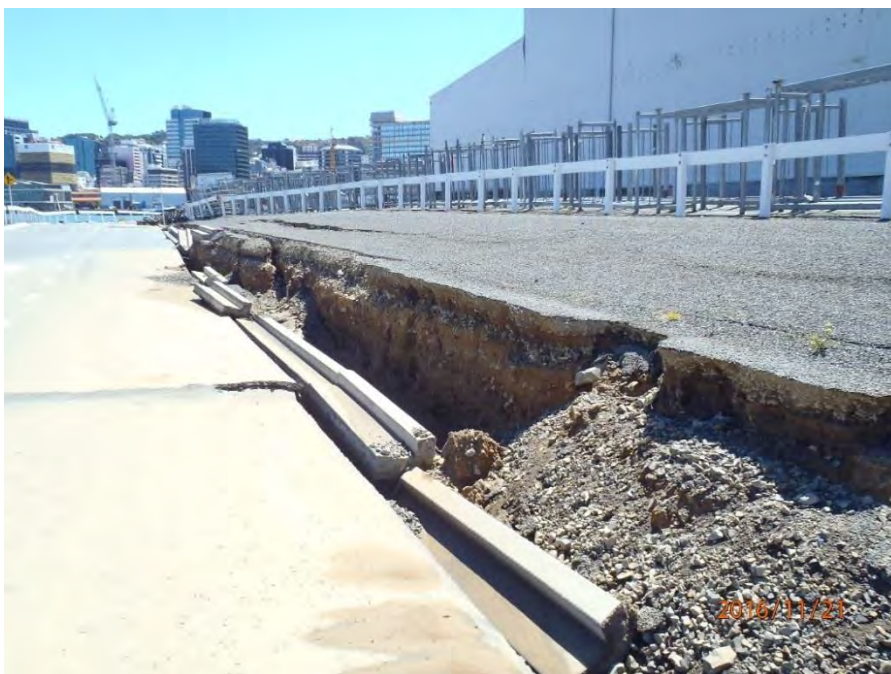
Figure 5.56: Approximately 1.1 m of vertical offset resulting from the southward lateral movement of the southern edge of CentrePort reclaimed land near its western side. Looking west near the southern wall of the CS building. (S41.281701° E174.785268°, taken at 1427 hrs on 21NOV16)

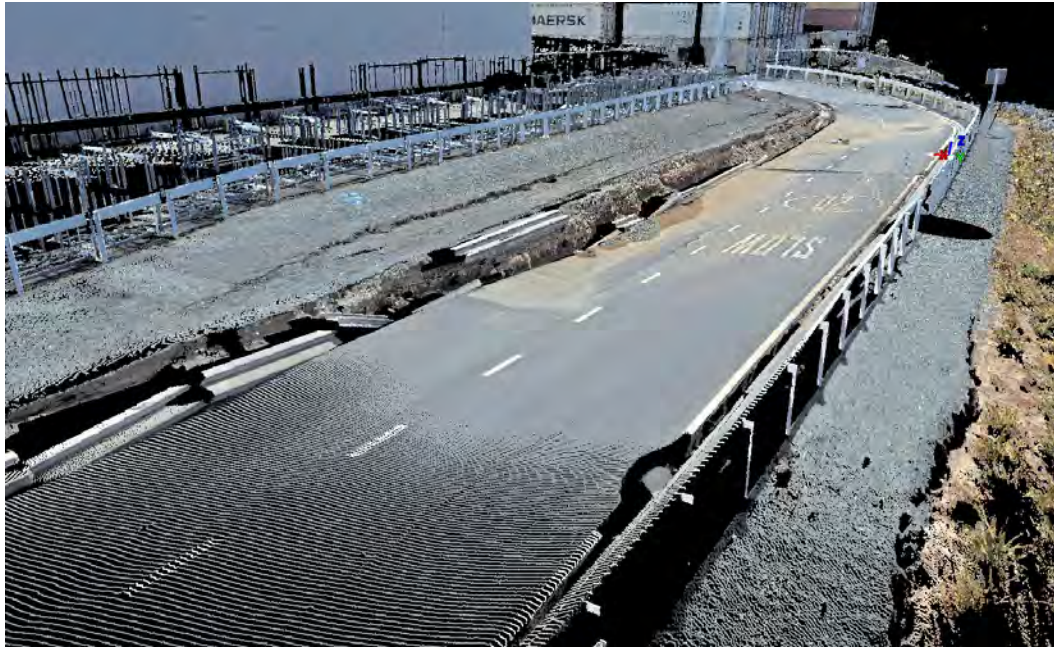
Figure 5.57: LiDAR scan of damage to the asphalt pavement and concrete curbs on the access road located south of the CS building. The vertical offset is approximately 1.1 m. This view is looking to the northeast.

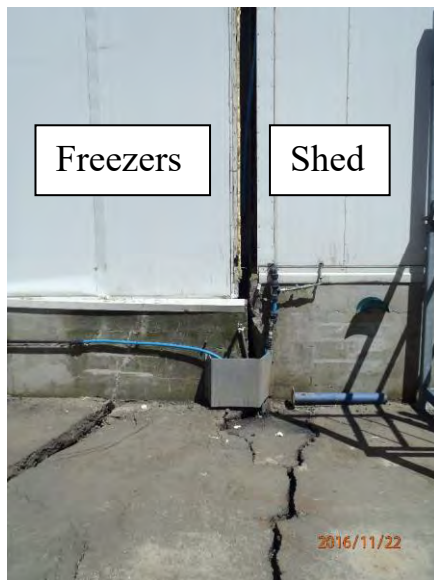
Figure 5.59: (a) Significant damage and cracking observed in the LiDAR scan data at the north end of the CS building. (b) The same crack extending northward across the port.

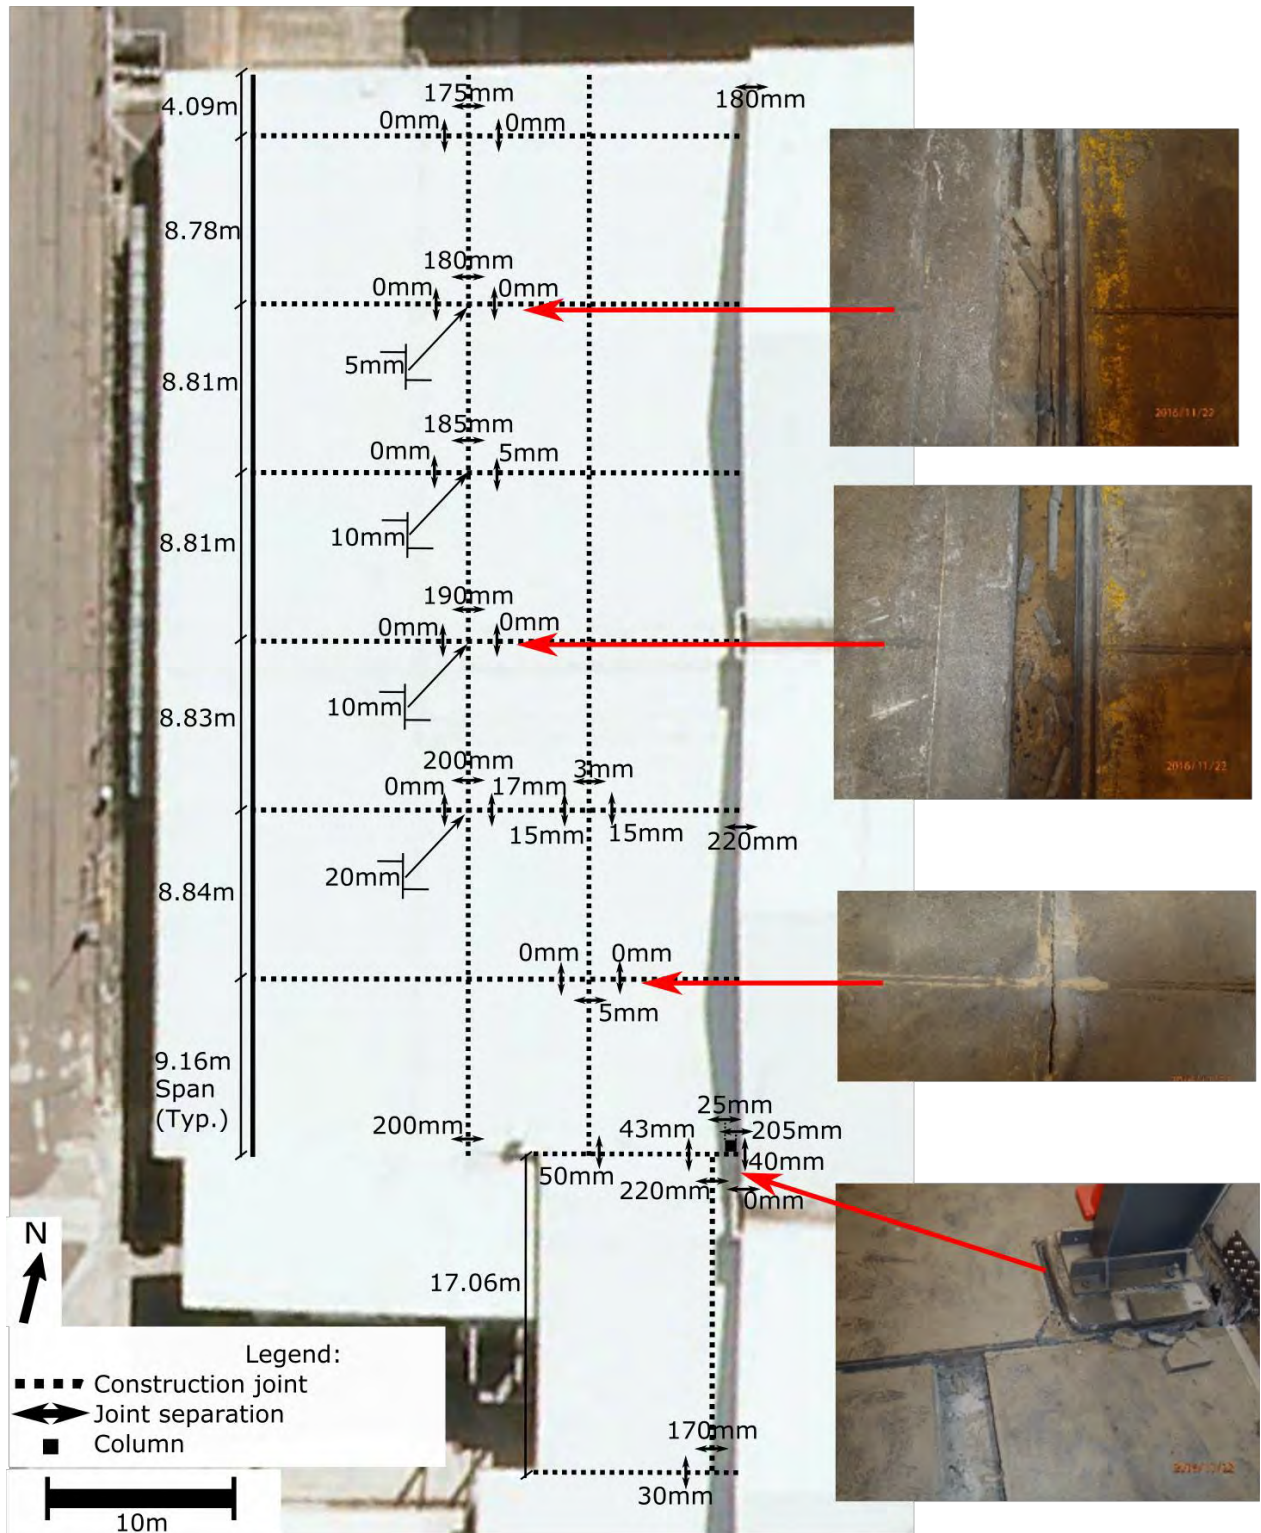
Figure 5.61: Northern part of Shed floor slab contraction joint separation measurements. Photographs along right side of figure are of contraction joints at which measurements were taken and are aligned vertically with each depicted joint. (Taken 22NOV16)

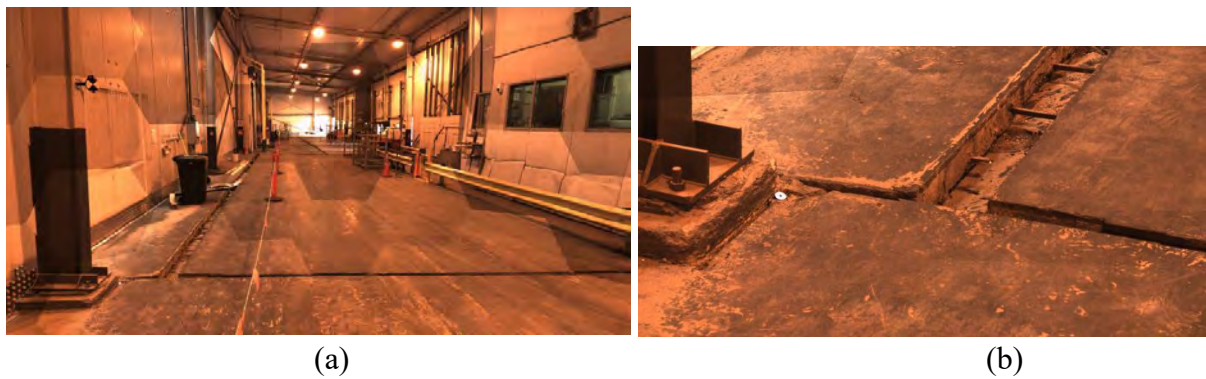
Figure 5.64: Example panoramic imagery co-acquired with the laser scans: (a) overview, and (b) close-up of floor separation in the CS building. The larger crack measures 230 mm in width and the smaller crack measures 75 mm in width.

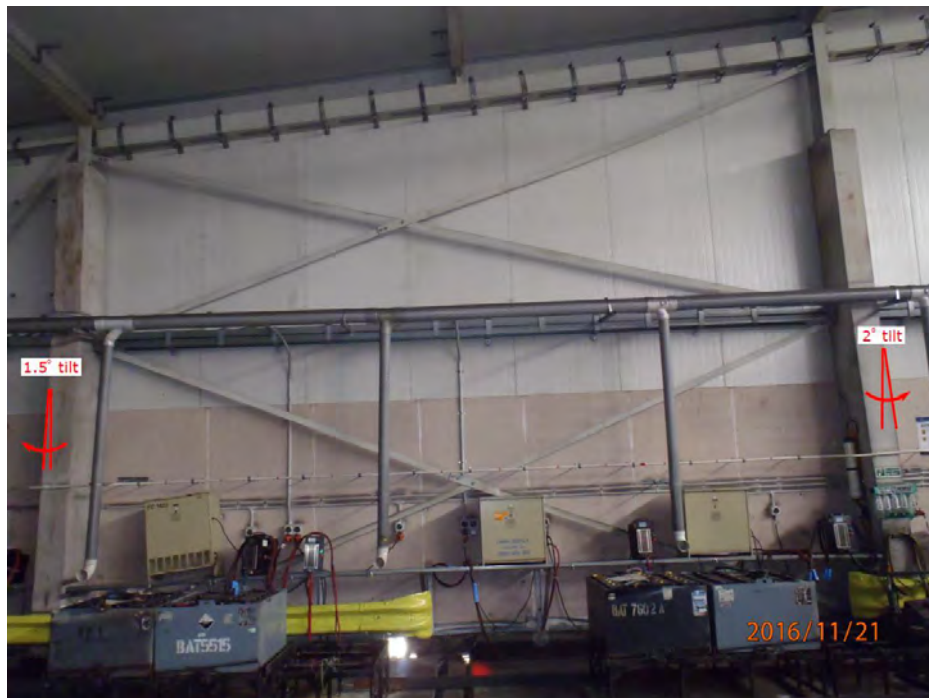
Figure 5.65: Internal north wall of Shed of CS building showing 1.5° clockwise tilt of the left column (2<sup>nd</sup> column from the west along north wall), and 2° counterclockwise tilt of the right column (3<sup>rd</sup> column from the west along north wall). This deformation was caused by a 180 mm opening in the RC base wall, which is visible in the bottom middle of the photograph where light is entering building. This column span is 8.789 m from centerline of column to centerline at a height of 1.5 m above the floor slab. (S41.280626° W174.784450°, taken at 1452 hrs on 21NOV16)
