# GEOTECHNICAL RECONNAISSANCE OF THE 2016 $M_w$ 7.8 KAIKOURA, NEW ZEALAND EARTHQUAKE

Version 1.0: 10 JUNE 2017

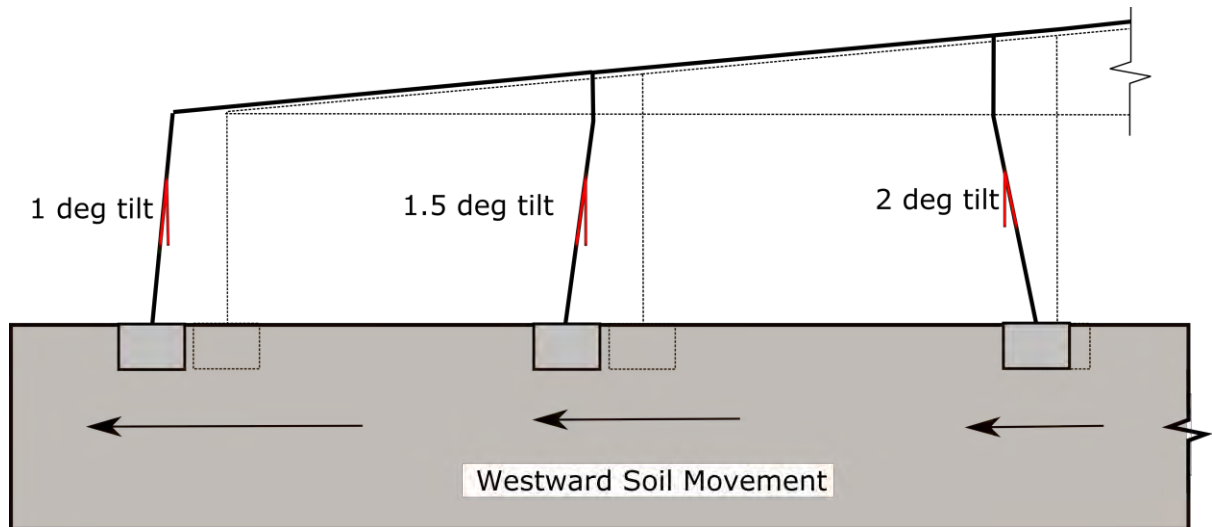
Figure 5.66: Schematic of deformation pattern of steel frame along the north wall of CS building (3 west-most columns of the Shed; looking north from interior).

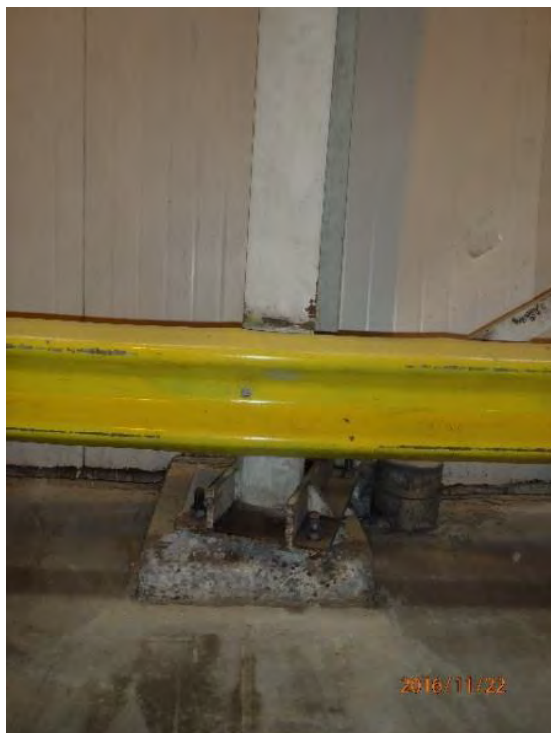
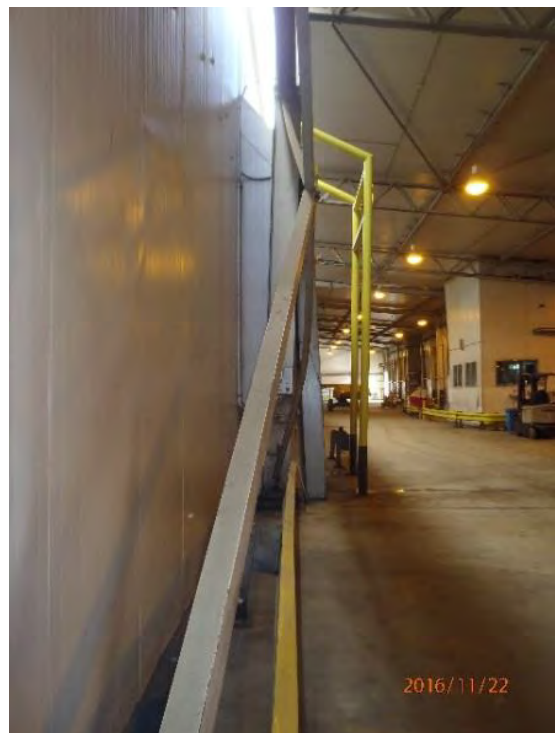
Figure 5.67: Internal east wall in northern part of the Shed, which shows column-pedestal connection failure due to rotation of the base of the column and buckling of concentric bracing. (Approx. at S41.280939° E174.784778°, taken at 1615 hrs on 22NOV16)

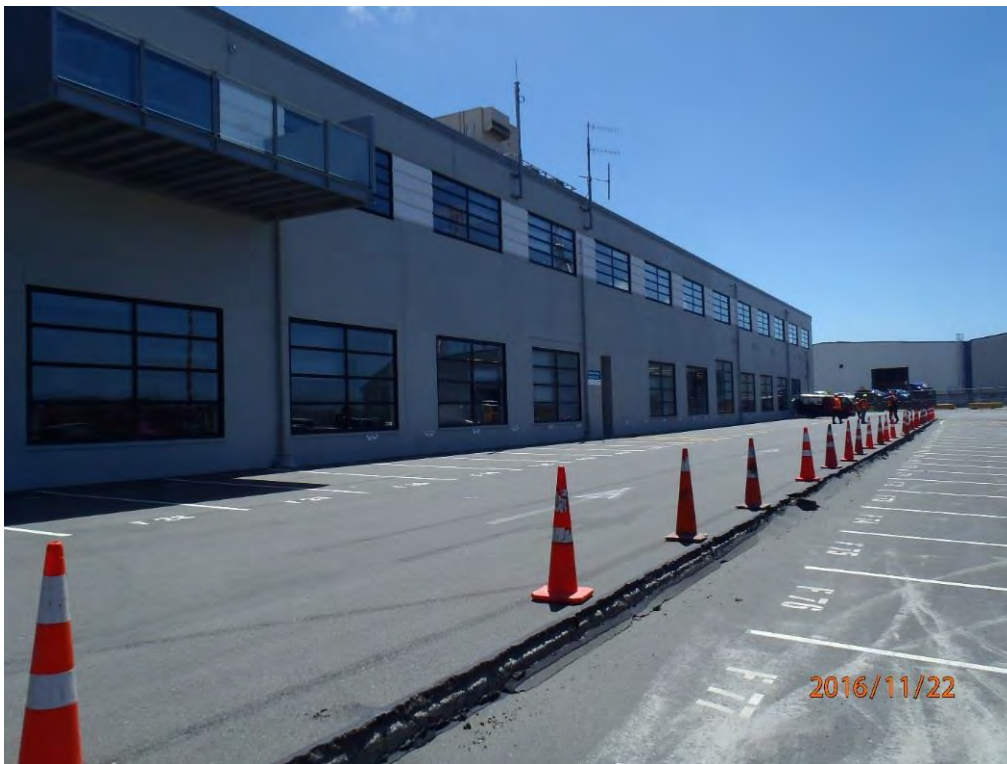
Figure 5.68: Southeast side of Building S39 and a buried segment of the Fryatt Quay Wharf deck parallel to the building. Fill to the south of the buried mass concrete seawall/wharf settled 220 mm relative to the pile-supported building and wharf deck. (S41.277984°, E174.785776°, taken at 1230 hrs on 22NOV16)

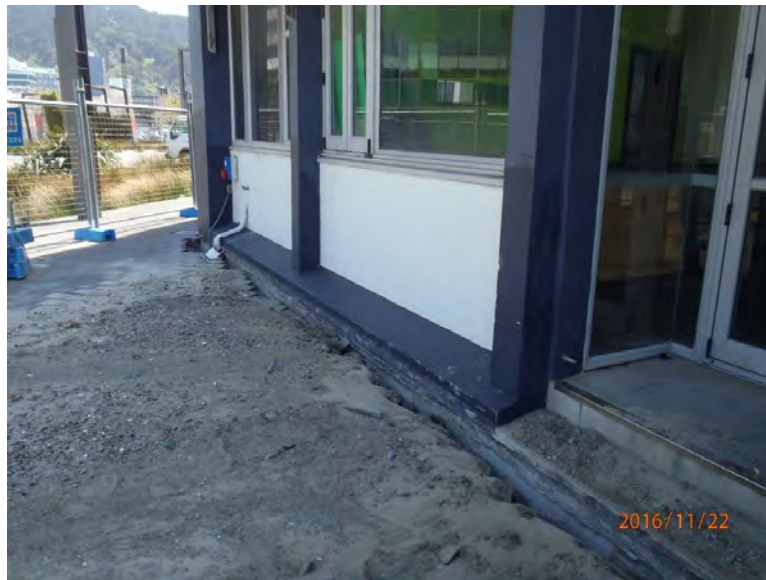
Figure 5.71: Southwest wall of TC building with liquefaction ejecta and 150 mm of ground settlement relative to building. (S41.277858°, E174.785081°, taken at 1246 hrs on 22NOV16)

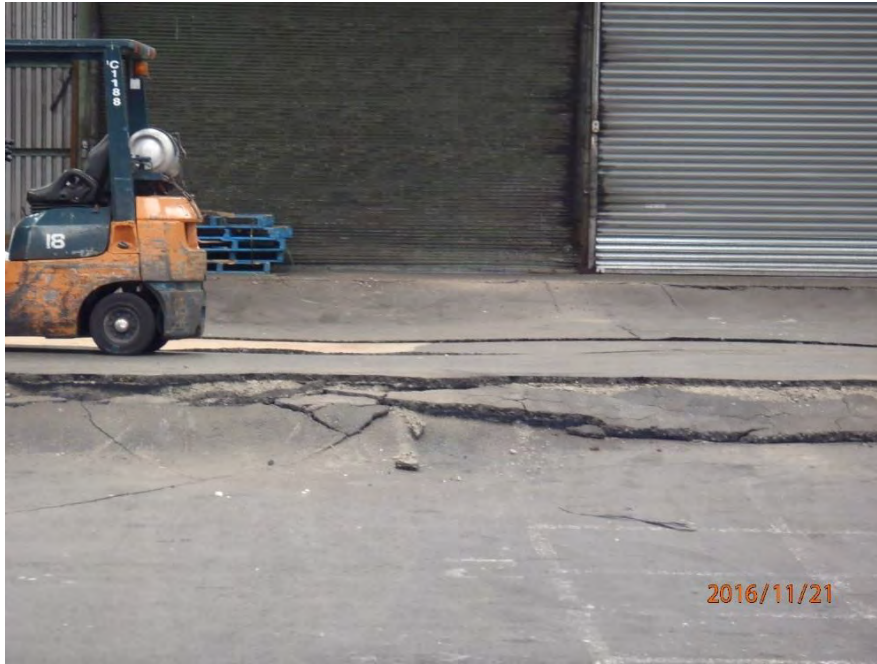
Figure 5.72: Looking west across inside of the S37 building. Approximately 400-550 mm of differential settlement between the ground and the buried precast concrete seawall that runs south-to-north through the center of the building. (S41.279065°, E174.785787°, taken at 1220 hrs on 21NOV16)

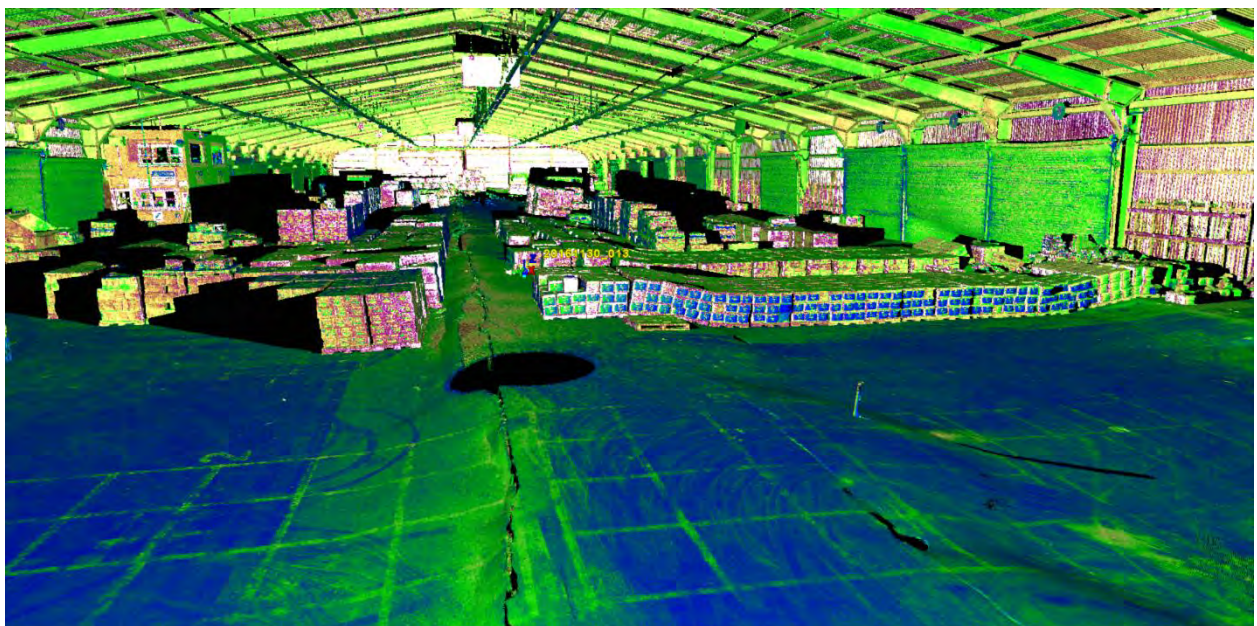
Figure 5.75: LiDAR scan obtained inside Building S37 showing cracking and settlement of the pavement around the buried precast concrete seawall (up to 550 mm of differential settlement occurred).

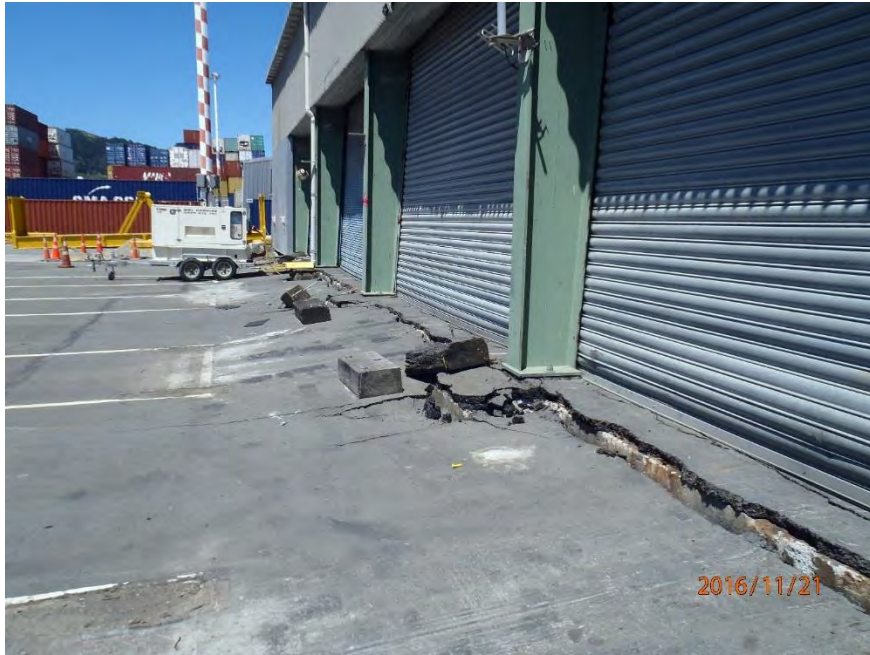
Figure 5.76: Looking south along east wall of Building S37, which shows approximately 375 mm of differential settlement between fill and pile-supported east wall of the building. (S41.279065°, E174.785787°, taken at 1220 hrs on 21NOV16)

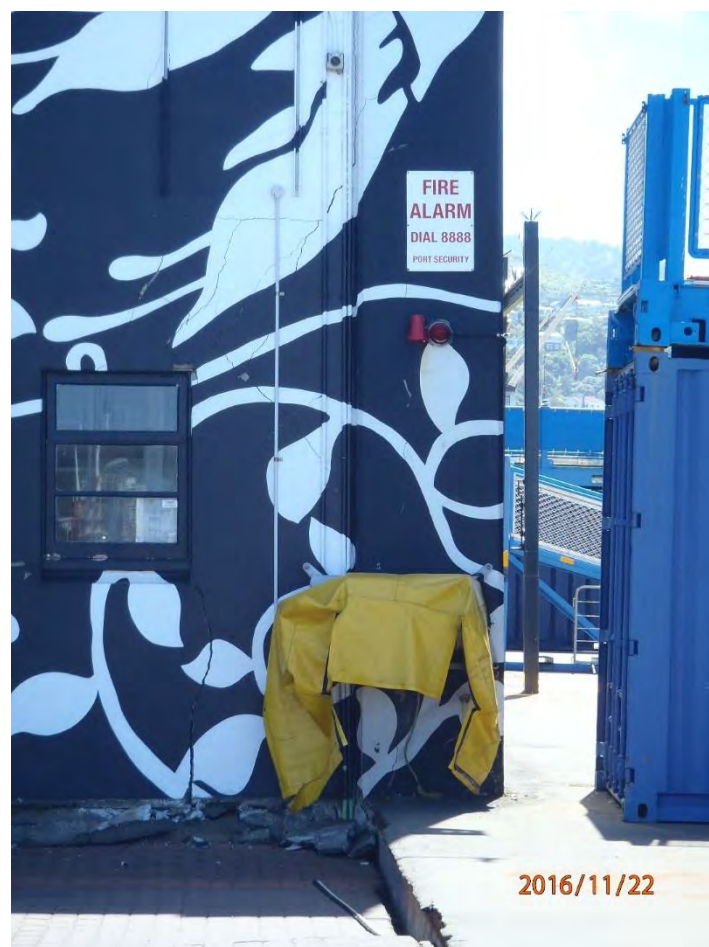
Figure 5.78: Southeast corner of Building S51 looking north, which shows 230 mm of differential settlement between wharf that supports its east wall and the inland fill. Also visible is 35 mm crack from seaward movement of wharf relative to adjacent ground. (S41.272404°, E174.787815°, taken at 1303 hrs on 22NOV16)

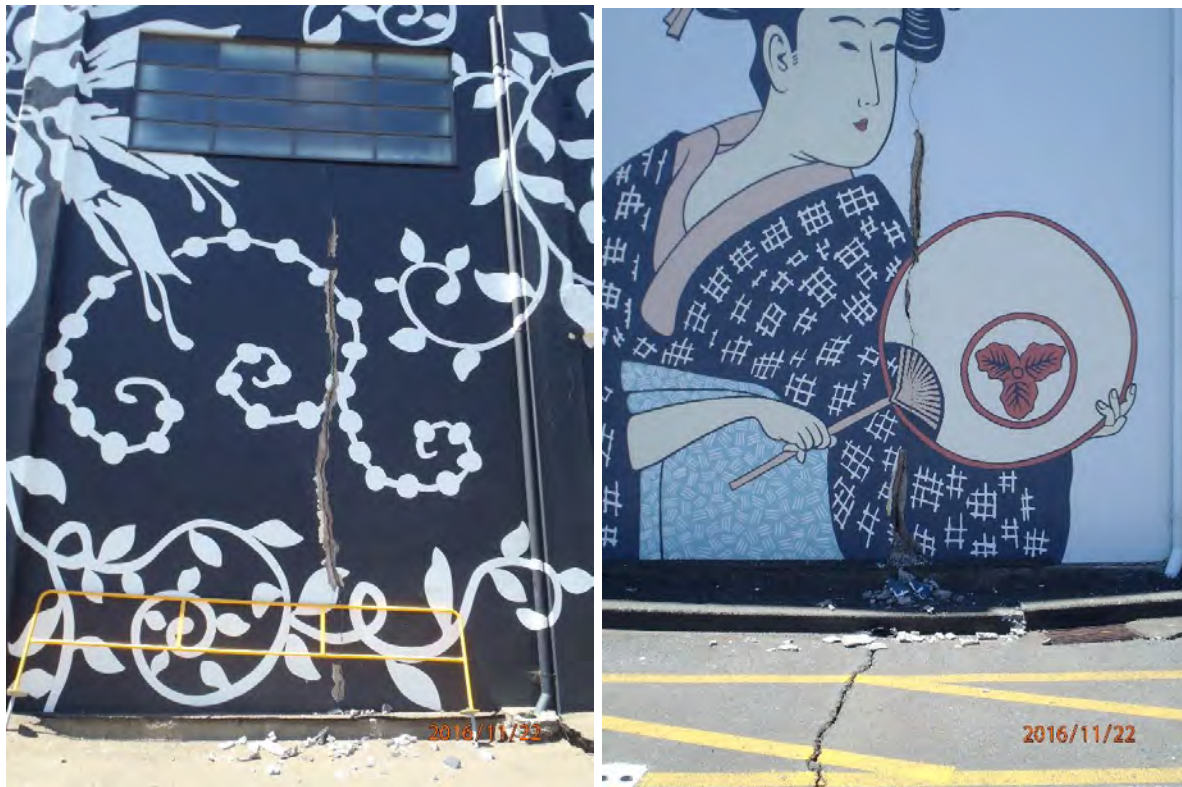
Figure 5.79: Vertical cracks along exterior west wall of S51 located at approximately 25 meters (left photo), and 60 meters (right photo) north of the southwest building corner. (Left: S41.272224°, E174.787391°, taken at 1316 hrs on 22NOV16. Right: S41.271906°, E174.787307°, taken at 1312 hrs on 22NOV16)

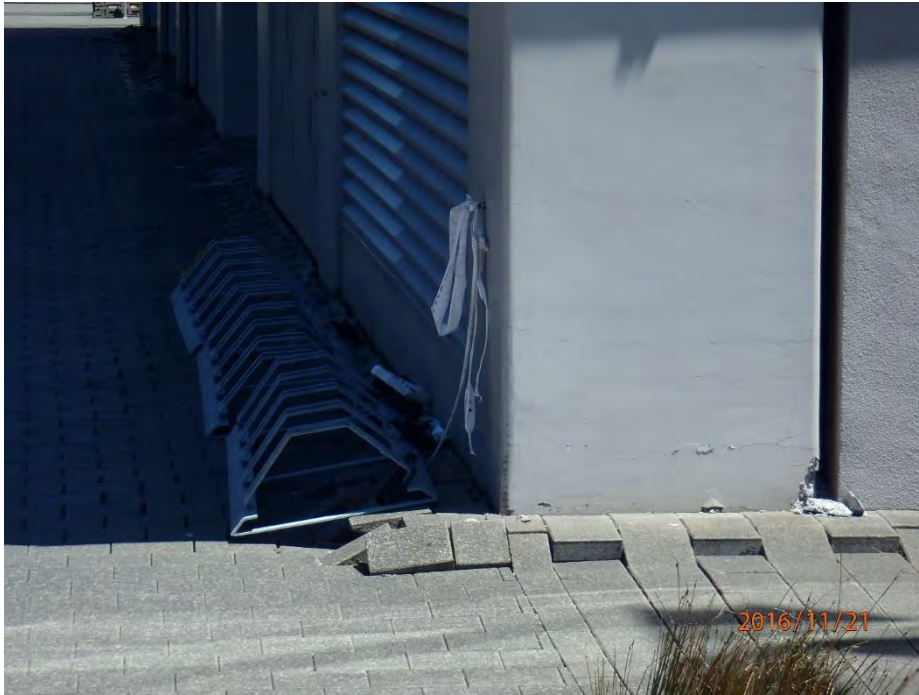
Figure 5.80: Looking west at southeast corner of the S building at which fill settled approximately 100 to 200 mm relative to pile-supported building. (S41.278285°, E174.784757°, taken at 1243 hrs on 21NOV16)

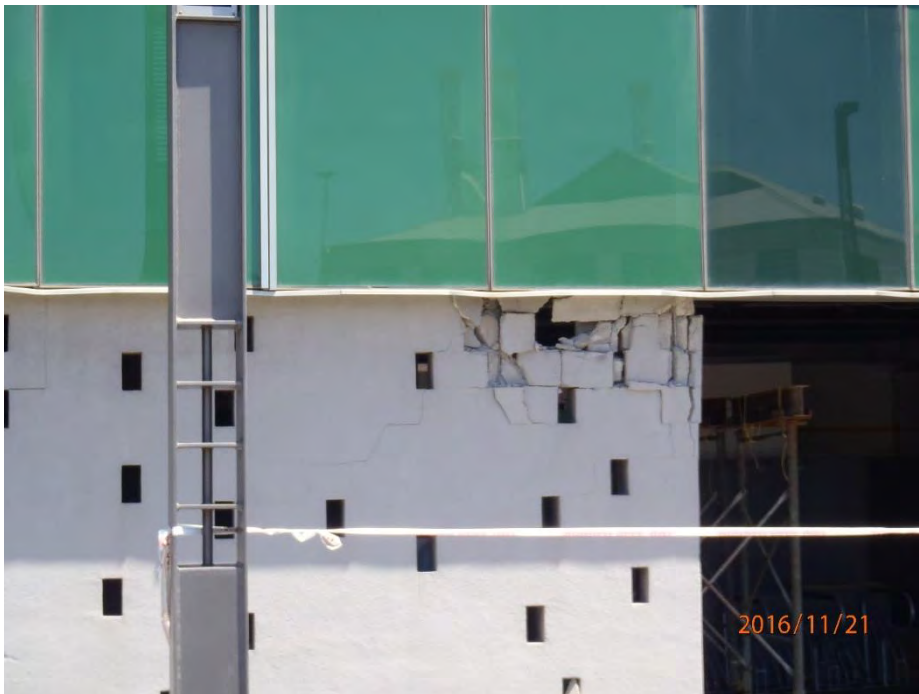
Figure 5.81: Damage to ground floor infill wall on the east side of the S building (S41.278114°, E174.784715°, 1241 hrs on 21NOV16)

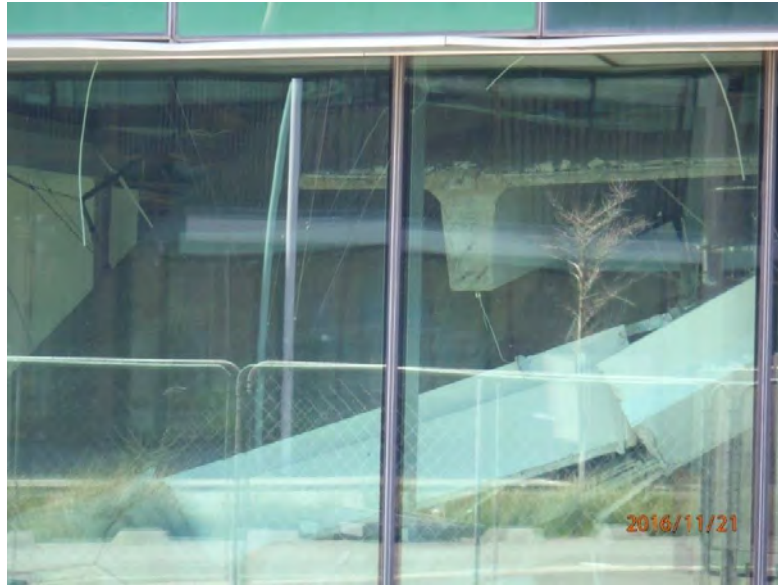
Figure 5.82: Pull-out and partial collapse of Level 1 floor slab in the S building taken along the west wall of the building. (S41.277982°, E174.784255°, taken at 1246 hrs on 21NOV16)

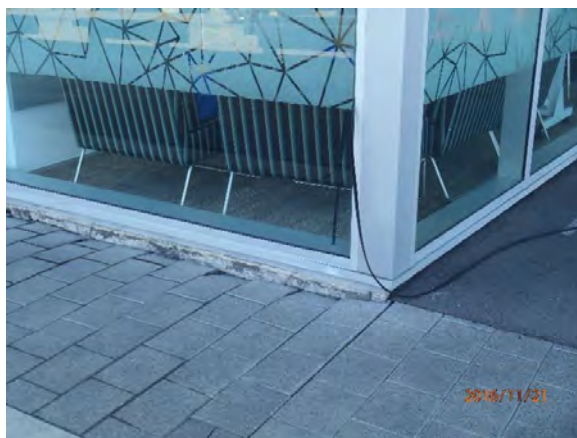
The B building is supported on piles with stone column ground improvement performed over the southeastern (seaward) half of the building footprint. The surrounding ground settled approximately 50 to 90 mm uniformly relative to the building (Figure 5.83). No other significant movements were observed.

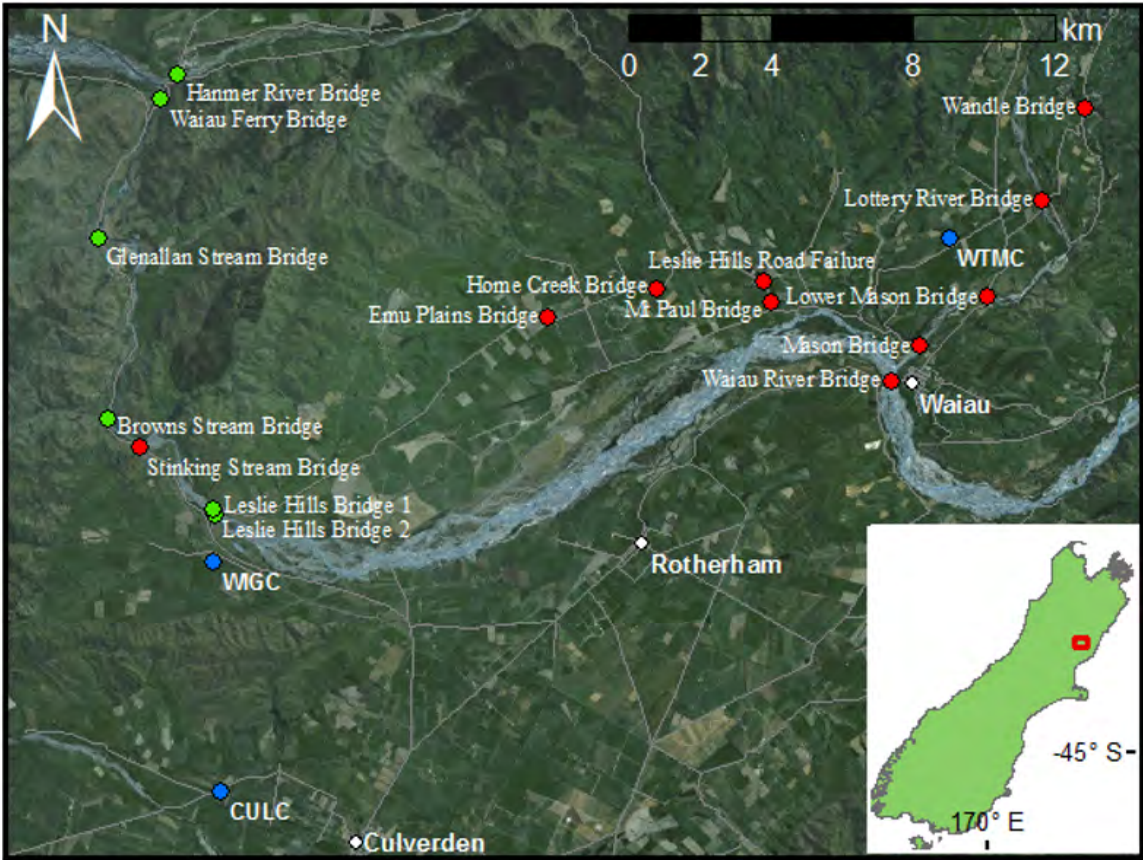
Figure 6.1: Bridge sites surveyed in the Hurunui District. Green markers indicate bridges with minor or no damage observations. Red markers indicate sites with moderate to severe damage observations. Blue markers indicate strong motion stations.

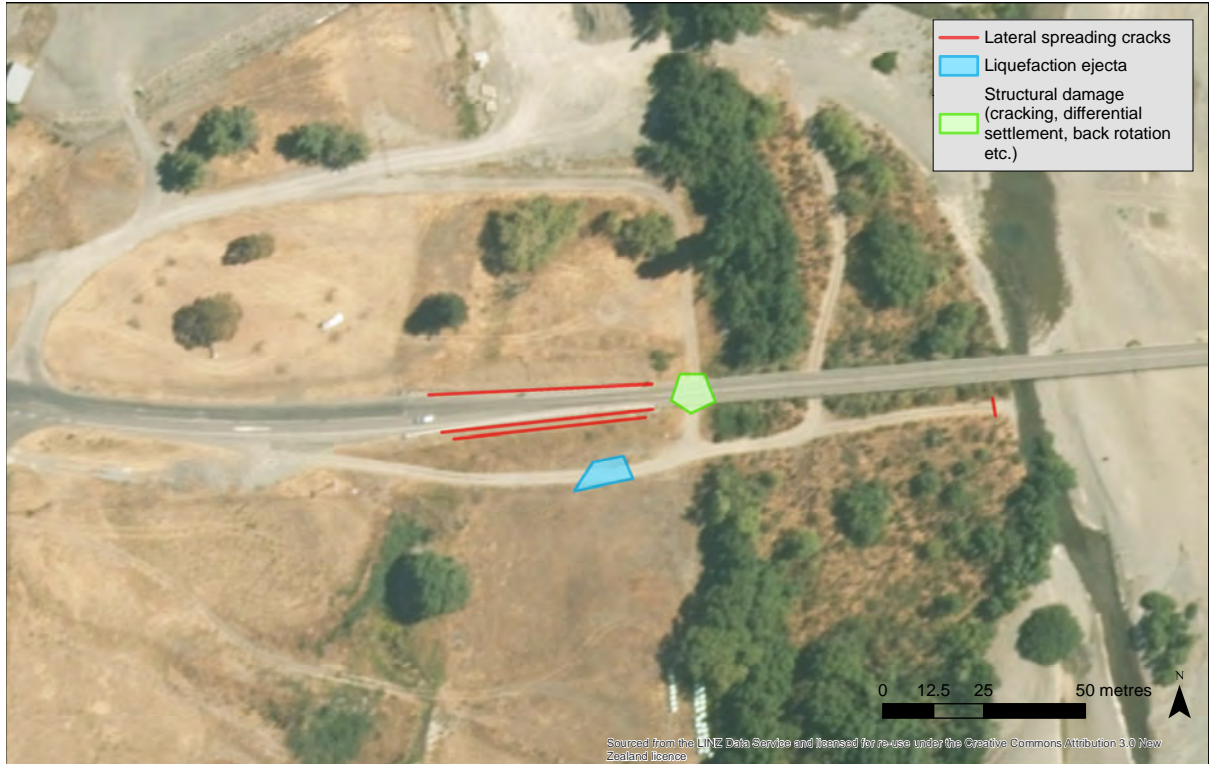
Figure 6.2: Site layout for western approach to Waiau River Bridge [-42.65555, 173.0302].

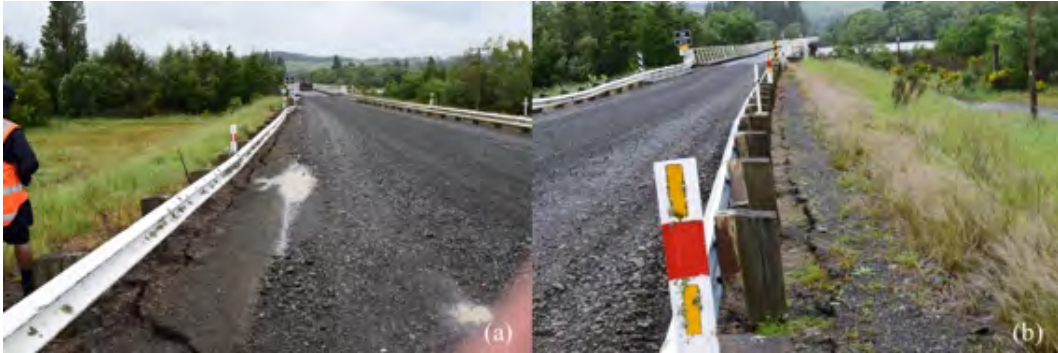
Figure 6.3: Lateral cracking on road side in western approach embankment of Waiiau River Bridge. Photos taken looking east towards bridge [-42.6556, 173.0294]: (a) North side; (b) South side.

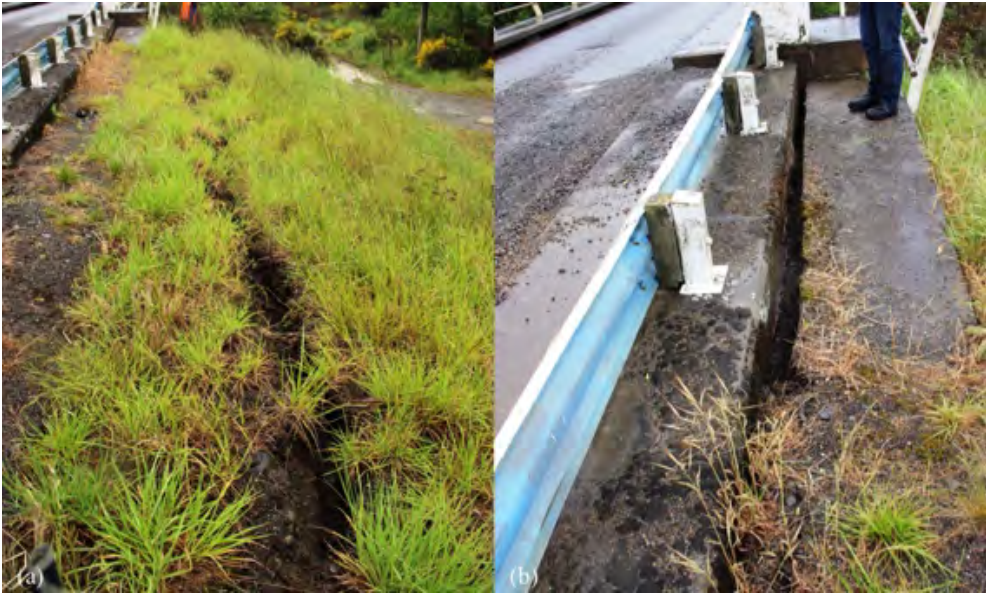
Figure 6.4: South side of western approach embankment to Waiiau River Bridge [-42.6556, 173.03]: (a) Lateral cracks in embankment side; (b) Settlement and outward movement at abutment wall.

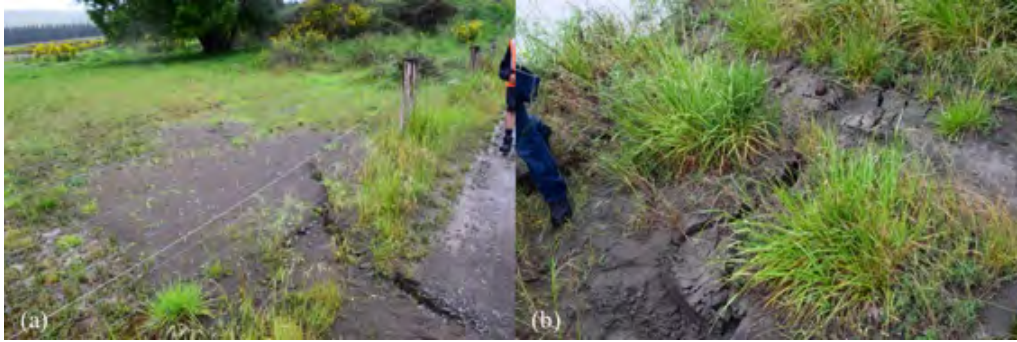
Figure 6.5: Surficial evidence of liquefaction at western approach to Waiiau River Bridge: (a) Ejecta and cracking adjacent to southern toe of approach embankment [-42.6558, 173.0297]; (b) Lateral spreading cracks near river bank [-42.6556, 173.0312].

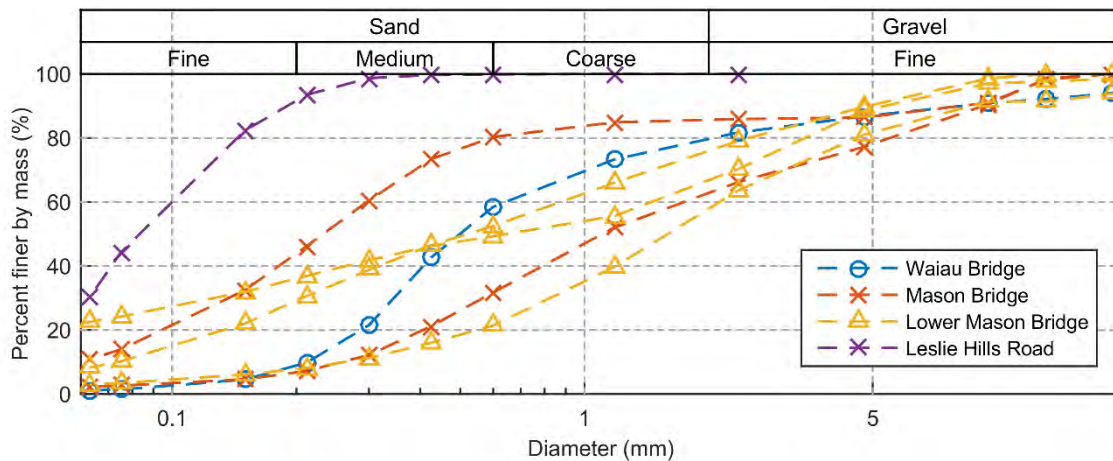
Figure 6.6: Particle size distributions of ejecta samples recovered at bridge sties in the Hurunui district

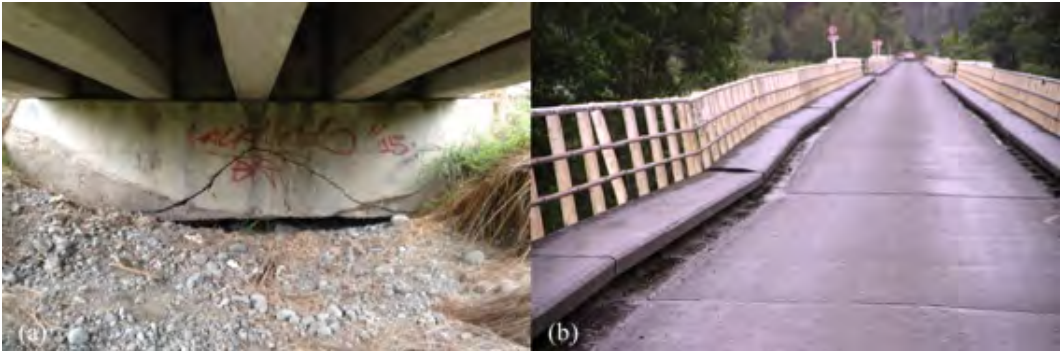
Figure 6.7: Structural damage at western approach area to Waiau River Bridge [-42.6556, 173.0302]: (a) Severe cracking in the abutment wall (looking west from under the bridge deck); (b) Differential settlement at second pier (looking east).

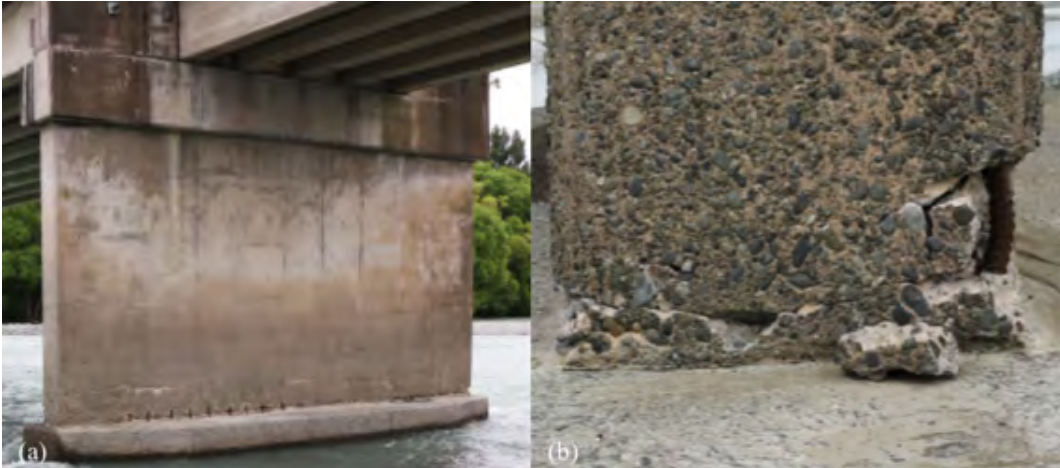
Figure 6.8: Structural damage to base of piers for Waiau River Bridge [-42.6553, 173.0351]: (a) Cracking at pile cap interface; (b) Exposure and buckling of longitudinal bars.

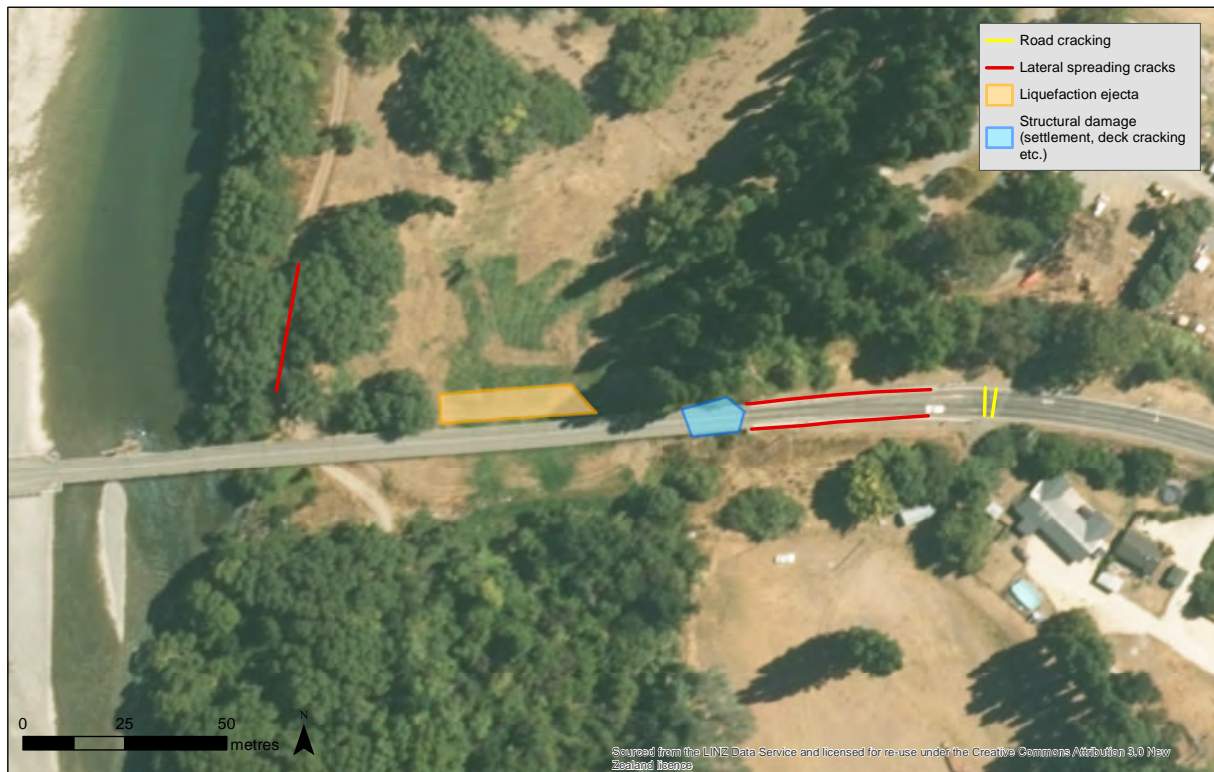
Figure 6.9: Site layout eastern approach to Waiau River Bridge [-42.6552, 173.037].

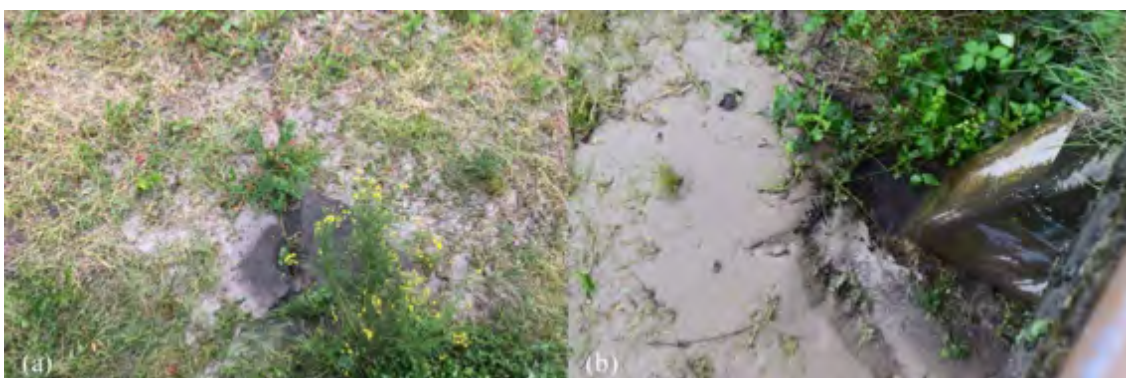
Figure 6.10: Liquefaction ejecta near the eastern approach to Waiau River Bridge [-42.6552, 173.037]: (a) Ejecta in paddock on north side of bridge; (b) Ejecta directly adjacent to bridge pier on south side.

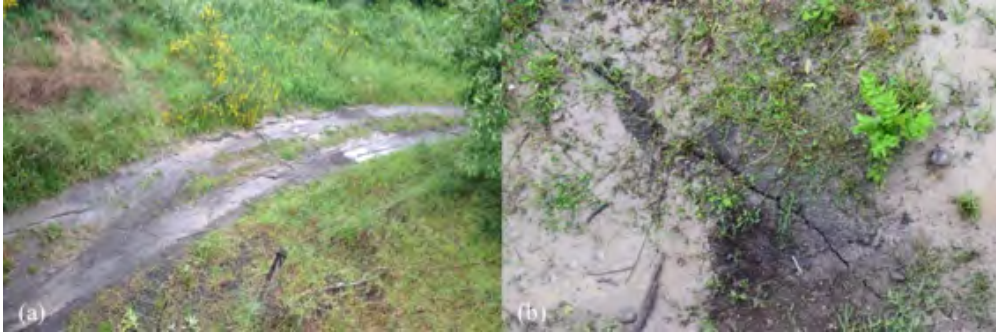
Figure 6.11: Lateral spreading cracks with ejecta near the eastern approach to Waiiau River Bridge [-42.65525, 173.036].

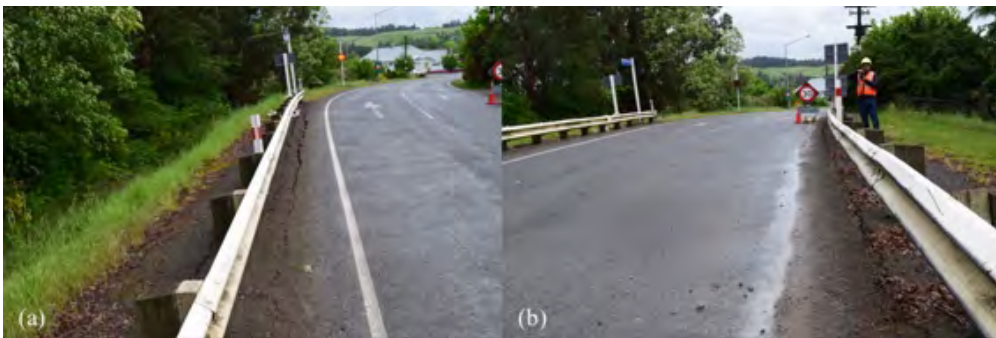
Figure 6.12: Lateral cracking on both sides of roadway in eastern approach embankment to Waiiau River Bridge [-42.6551, 173.0380]: (a) Northern side (looking east away from bridge); (b) Southern side (looking east).

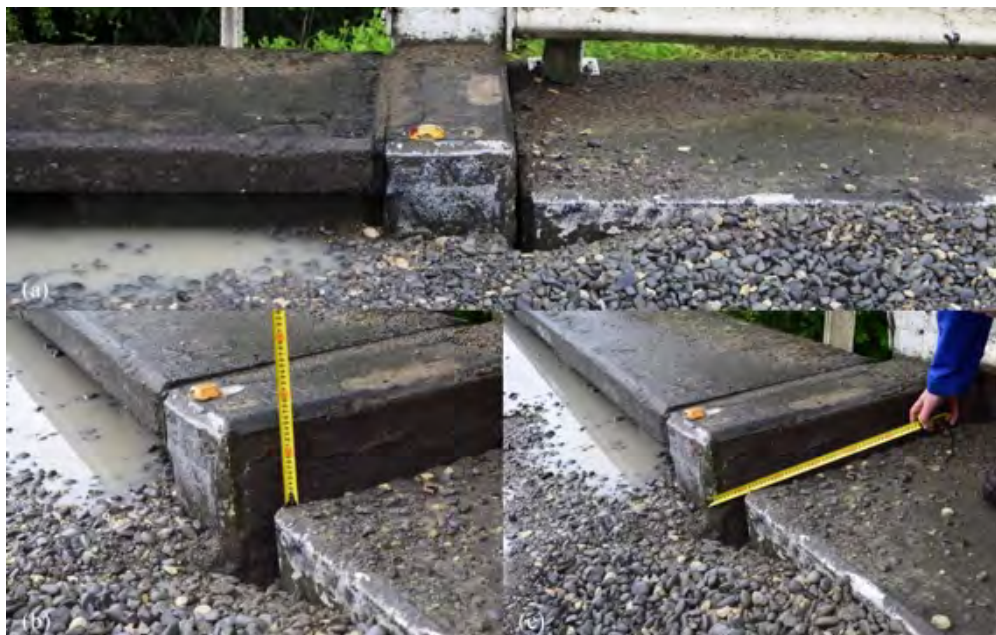
Figure 6.13: Settlement and outward movement at north side of eastern abutment to Waiiau River Bridge as indicated by offset of concrete members [-42.6552, 173.037].

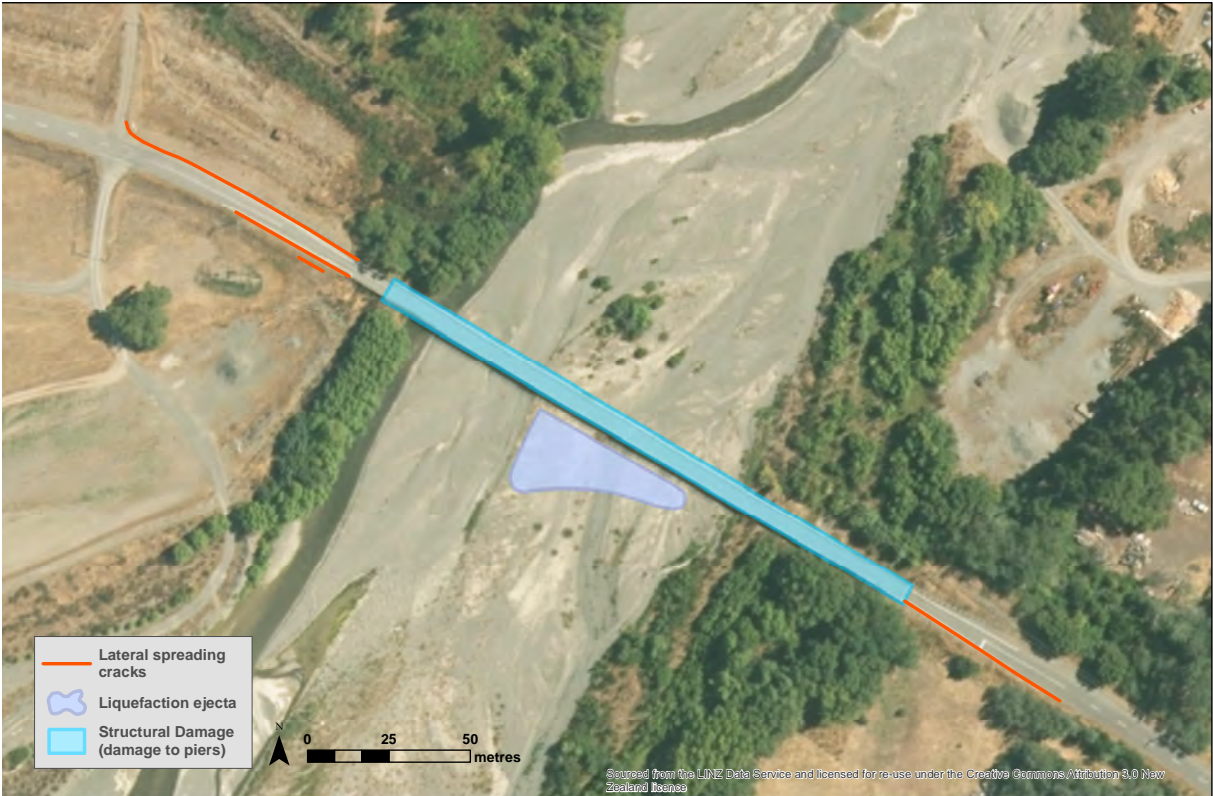
Figure 6.14: Surveyed area and features of interest for Mason Bridge [-42.6469, 173.0431].

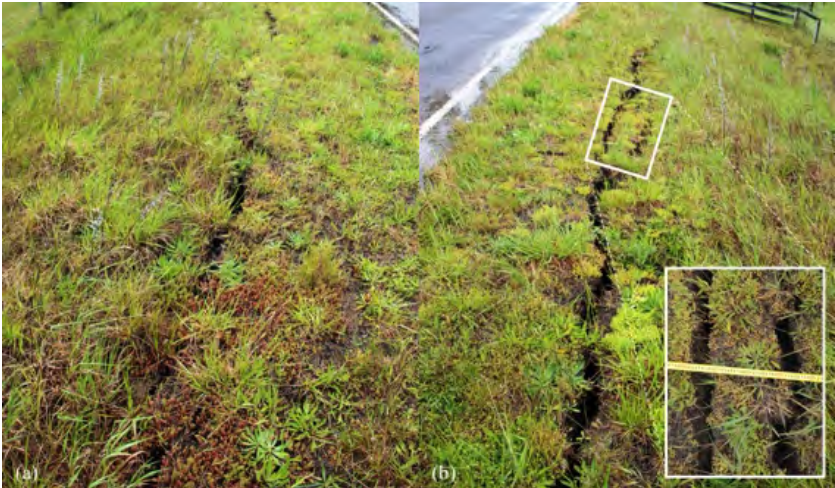
Figure 6.15: Cracks along edges of the western approach embankment for Mason Bridge (looking east towards bridge) [-42.6464, 173.04196]: (a) North side; (b) South side – inset shows close-up of cracks as indicated.

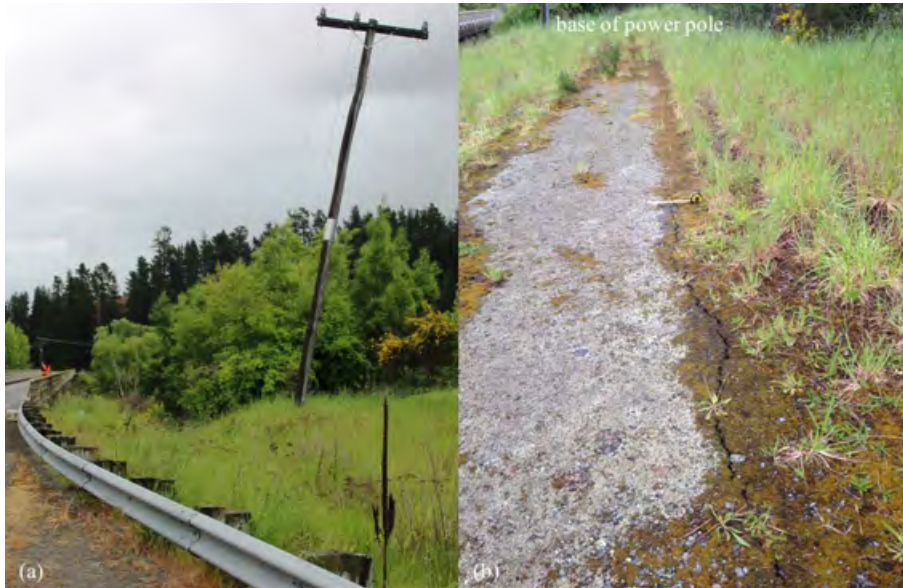
Figure 6.16: Northern side of eastern approach to Mason Bridge (looking west) [-42.6475, 173.04465]: (a) Power pole has moved down the slope of an embankment directly adjacent to bridge approach embankment; (b) Cracks parallel to roadway in embankment fill.

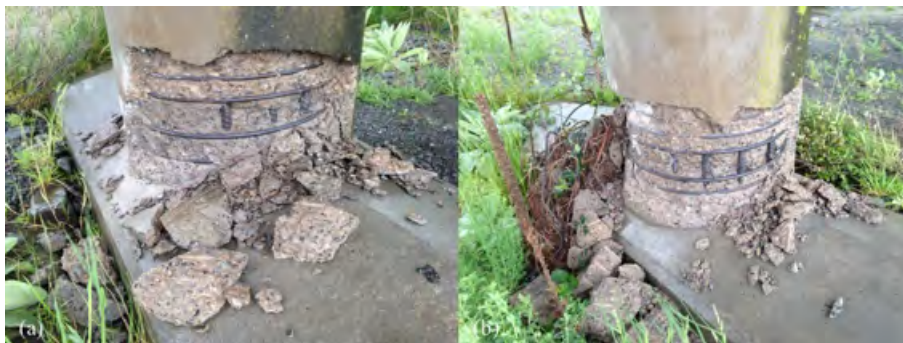
Figure 6.17: Severe examples of plastic hinging at base of Mason Bridge piers (looking north) [-42.6469, 173.0432].

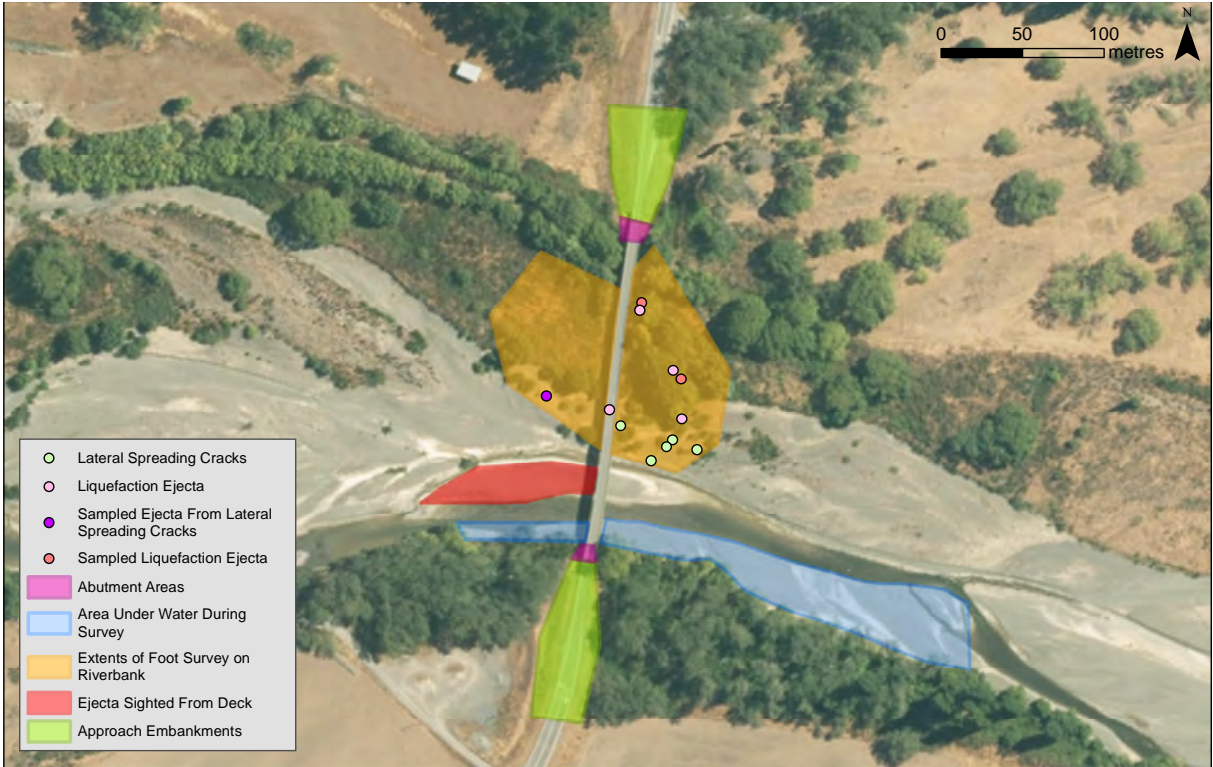
Figure 6.19: Overview of Lower Mason Bridge site indicating areas surveyed and some key features of interest [-42.6343, 173.0664].

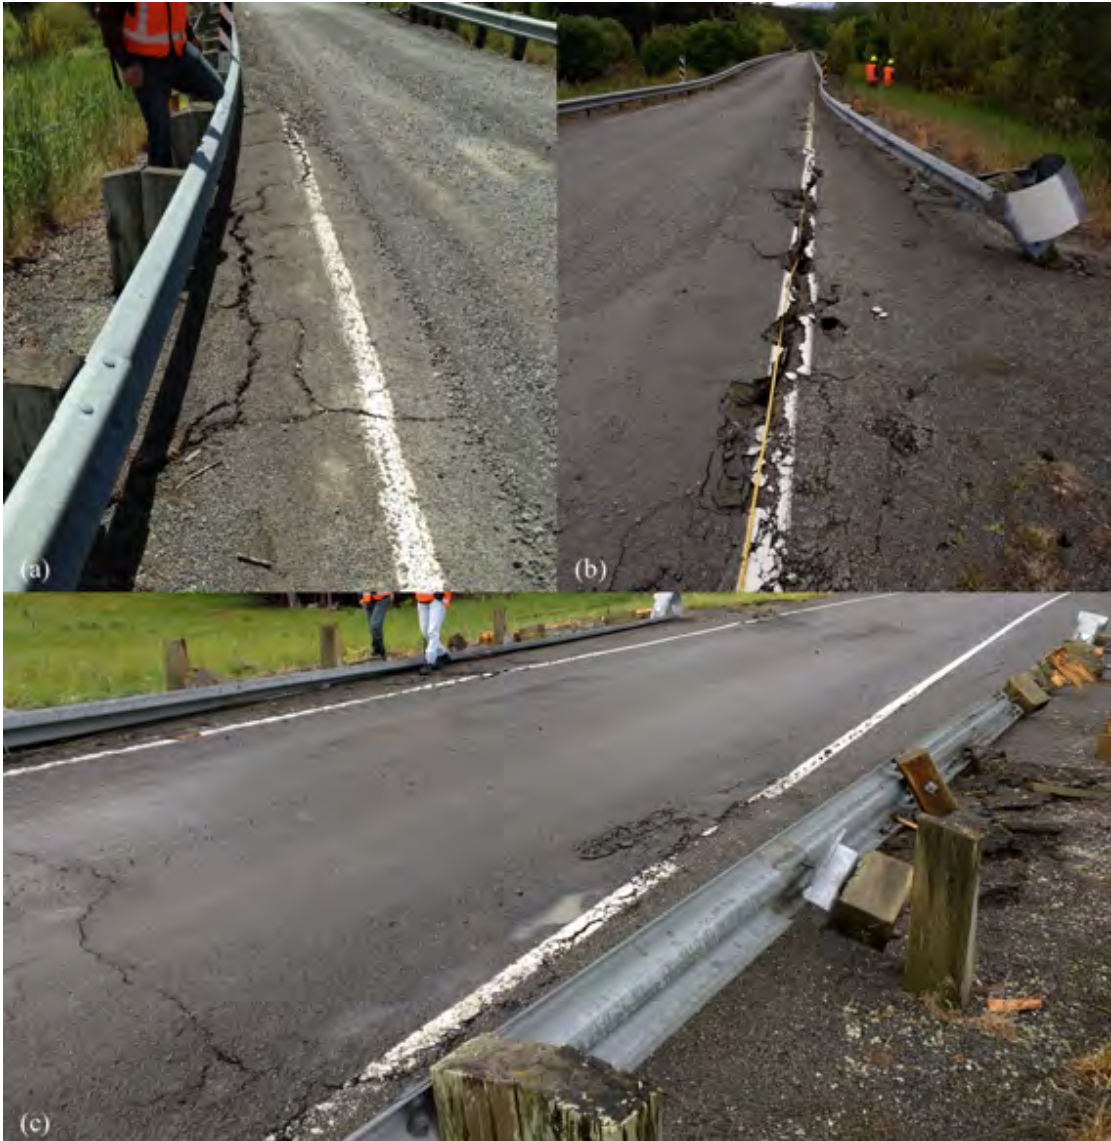
Figure 6.20: Cracking in approach roadways at Lower Mason Bridge: (a) Western side of south approach looking north [-42.6353, 173.0662]; (b) Eastern side of south approach looking north [-42.6353, 173.0662]; (c) North approach looking northwest across road [-42.6330, 173.0666].

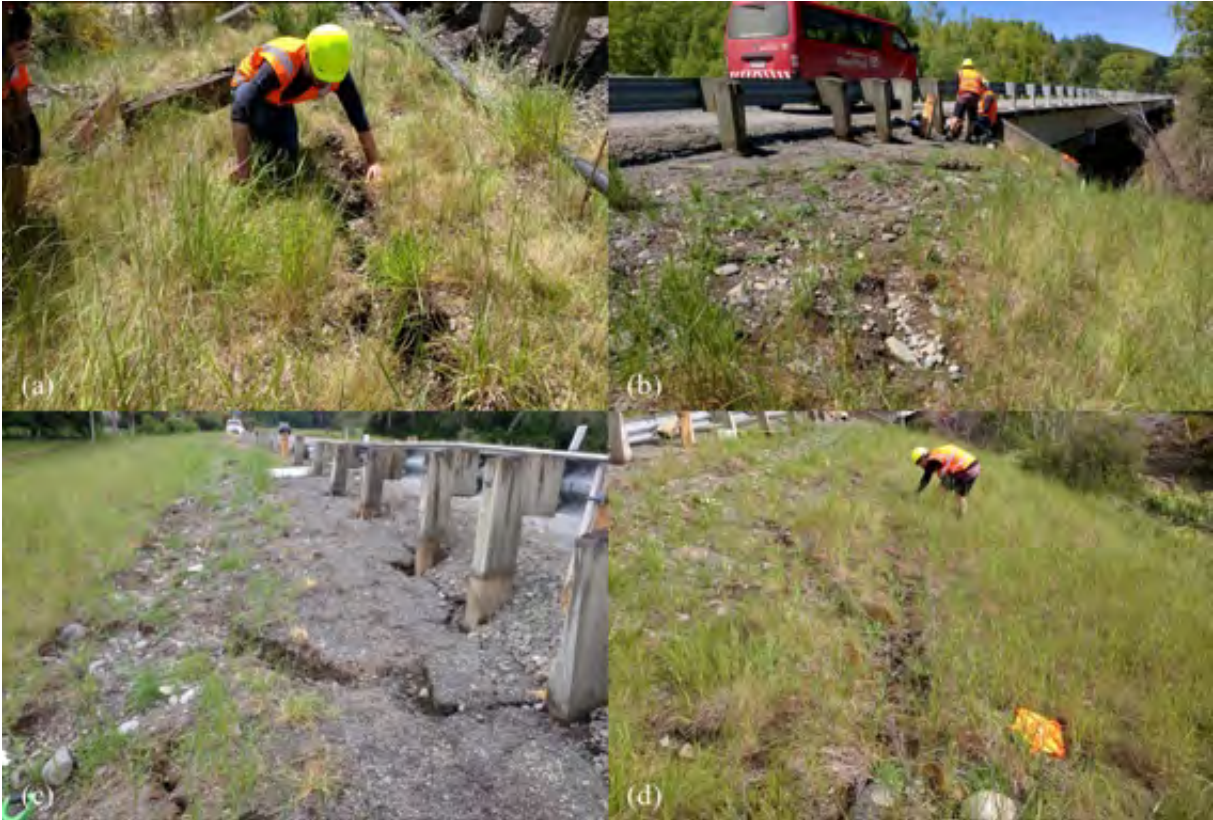
Figure 6.21: Cracking in sides of approach embankments at Lower Mason Bridge. (a) West side of south approach looking north [-42.6353, 173.0662]; (b) East side of south approach looking north [-42.6353, 173.0662]; (c) and (d) West side of north approach looking north and south, respectively [-42.6330, 173.0666].
