# GEOTECHNICAL RECONNAISSANCE OF THE 2016 $M_w$ 7.8 KAIKOURA, NEW ZEALAND EARTHQUAKE

Version 1.0: 10 JUNE 2017

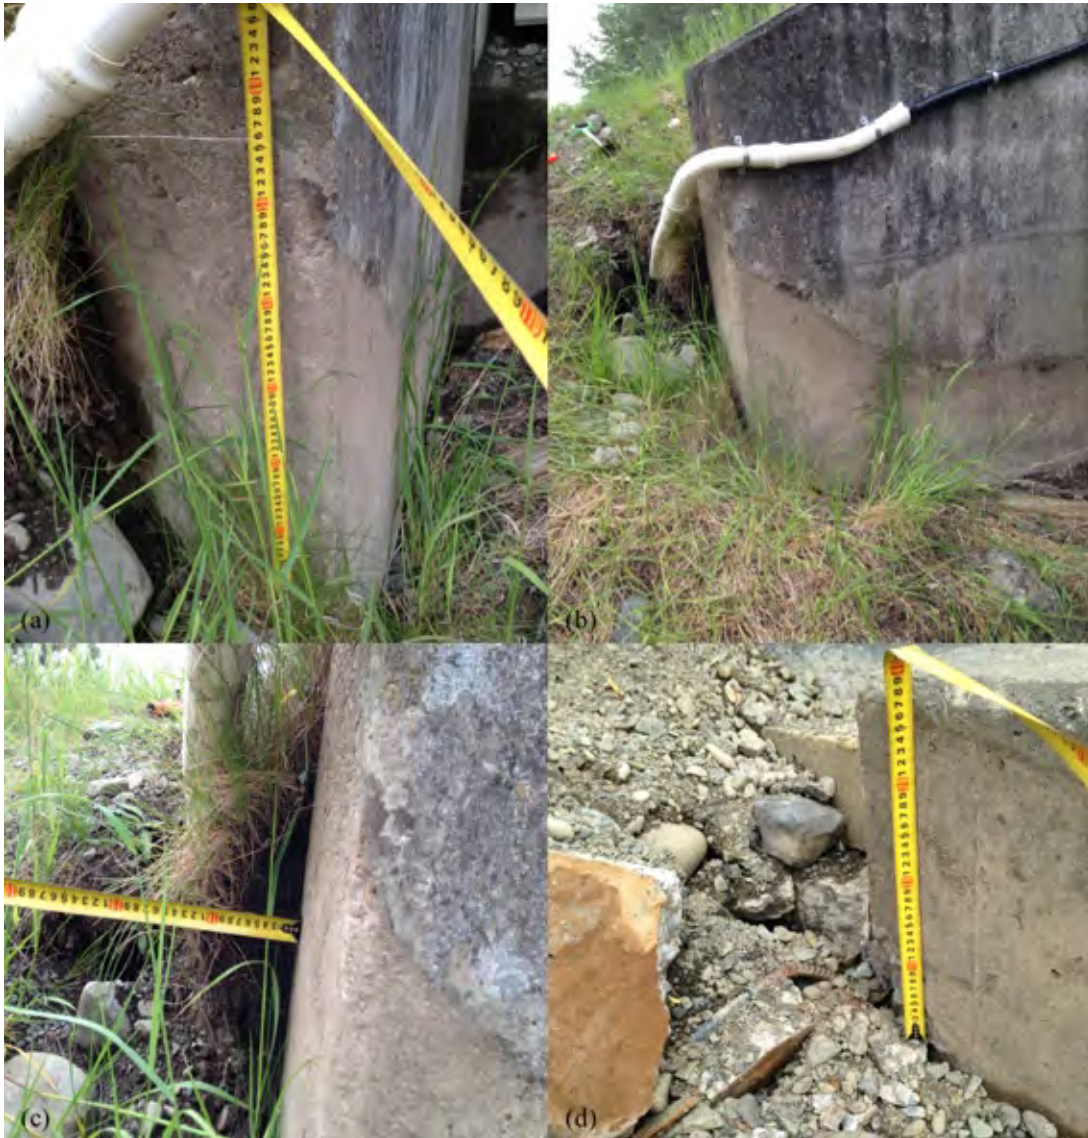
Figure 6.22: Settlement and outward movement at west side of north abutment to Lower Mason Bridge [-42.6334, 173.0666]: (a) Edge of abutment wall looking east; (b) Abutment wall looking north; (c) Edge of abutment wall looking north; (d) Embankment side of abutment wall near deck connection looking south.

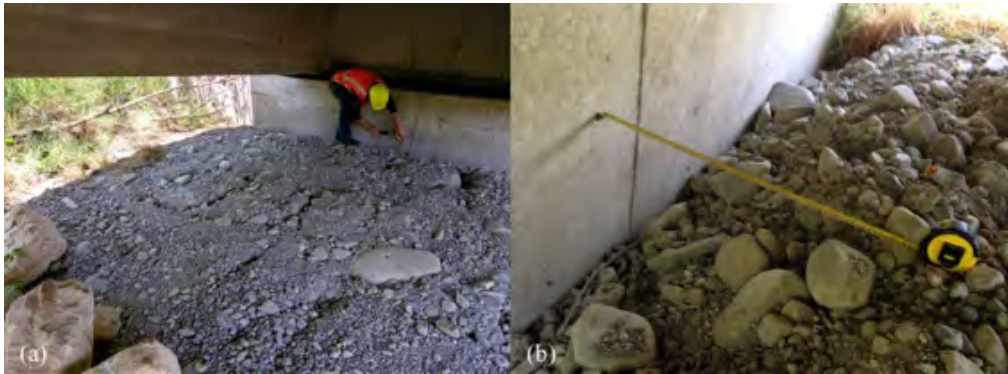
Figure 6.23: Cracking and gapping in fill below bridge deck at northern abutment to Lower Mason Bridge indicating riverward movement of the fill [-42.6334, 173.0666]: (a) Looking north; (b) 60 cm gap between wall and fill.

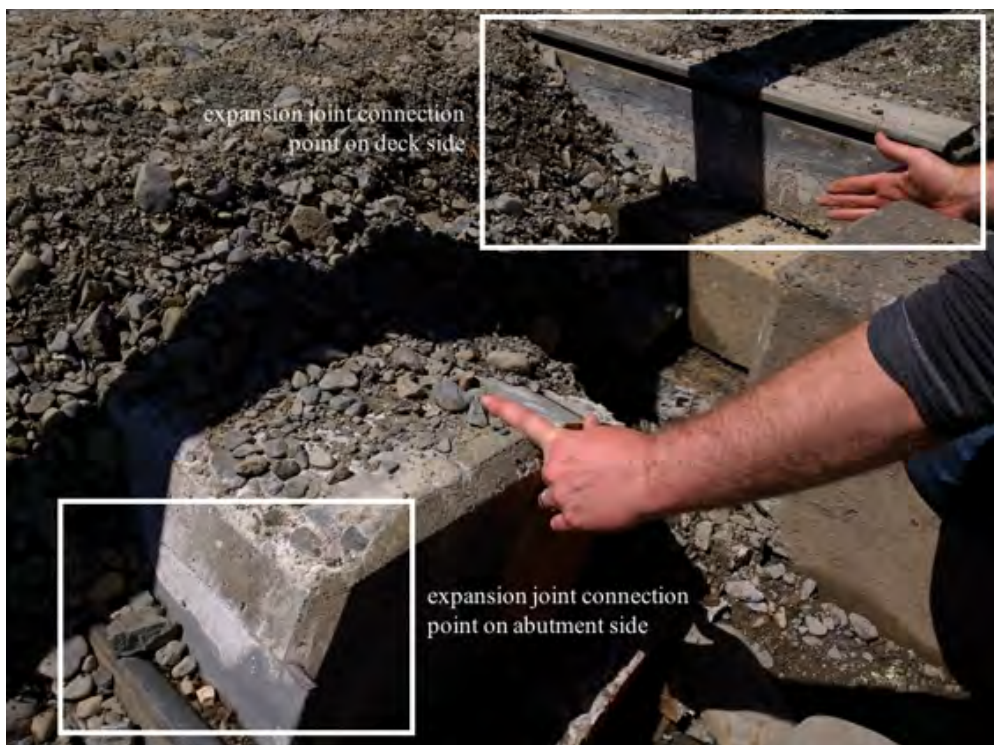
Figure 6.24: Damage to abutment-deck connection at Lower Mason Bridge due to relative movement of abutment wall and deck. The breakaway member to the left was pushed back away from the deck and rotated 180° such that the connection point for the expansion joint faces away from the deck [-42.6334, 173.0666].

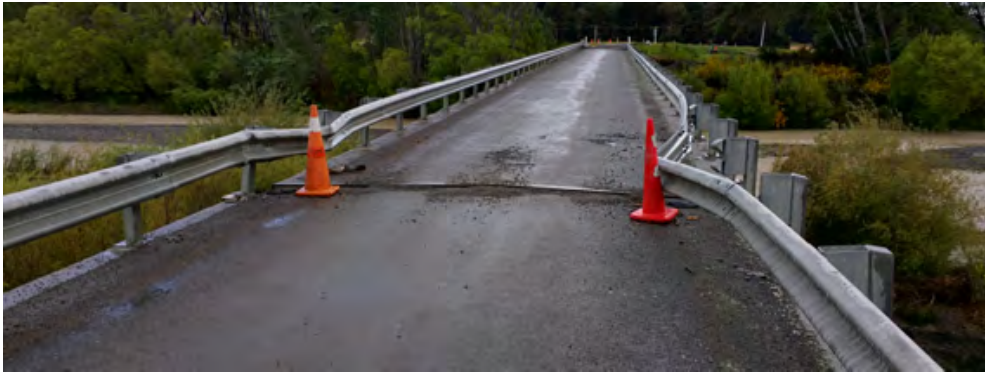
Figure 6.25: Buckling of guard rails at centre expansion joint of Lower Mason Bridge indicating that the two main deck sections have undergone permanent inward deformation. Photo facing south [-42.6343, 173.0664].

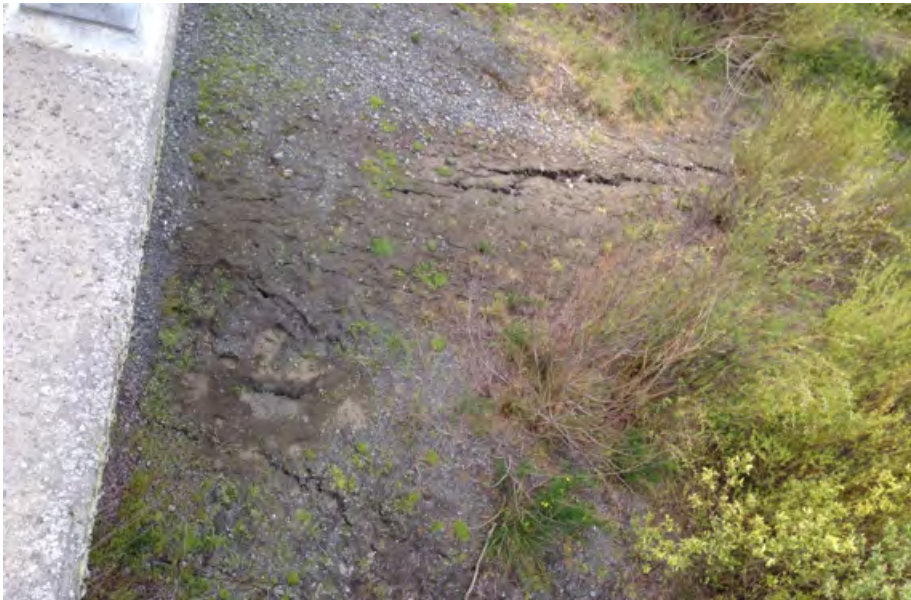
Figure 6.26: Cracks in northern river bank on eastern side of bridge. Photo taken from bridge deck. Riverward direction is down for this orientation [-42.6342, 173.0665].

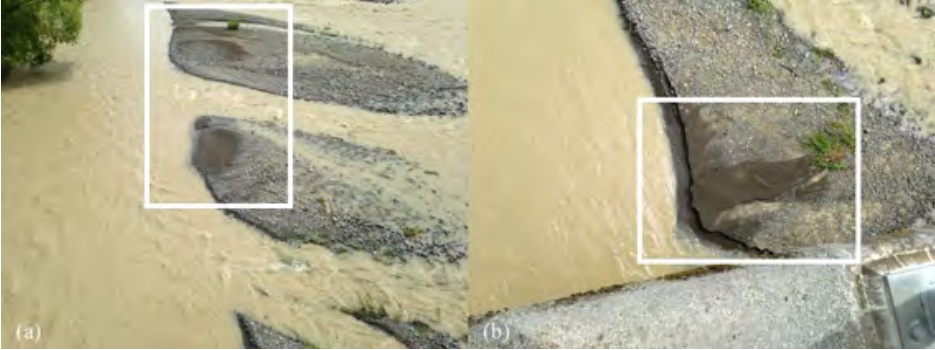
Figure 6.27: Liquefaction ejecta on west side of bridge (looking west). [-42.6345, 173.0657].

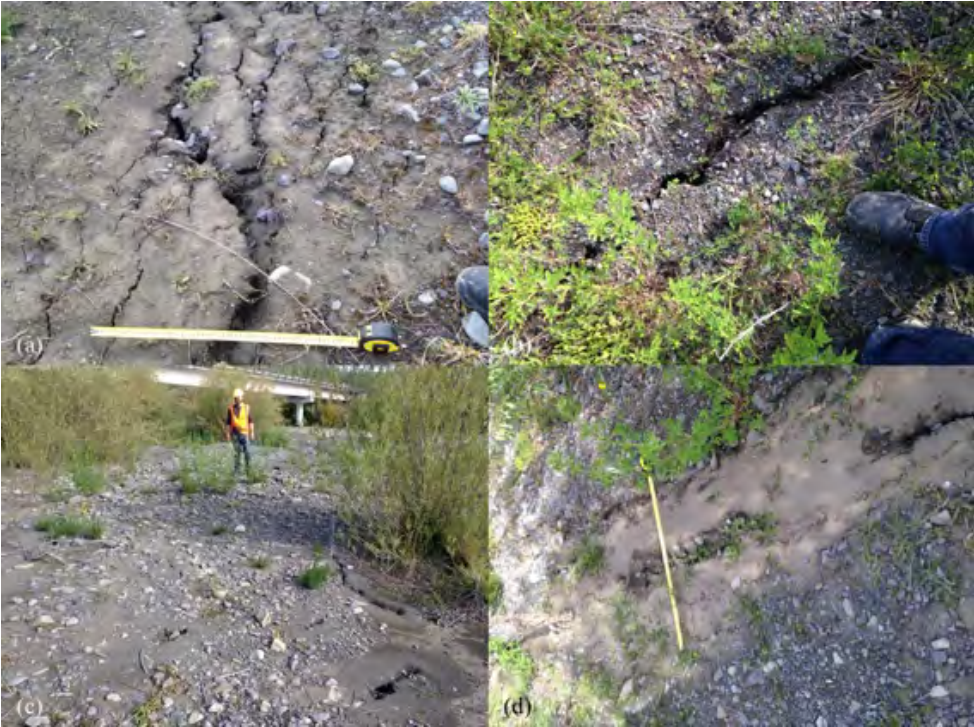
Figure 6.28: Representative photos of the lateral spreading cracking and liquefaction ejecta observed on the Northern river bank near the bridge in the areas indicated by Figure 6.19.

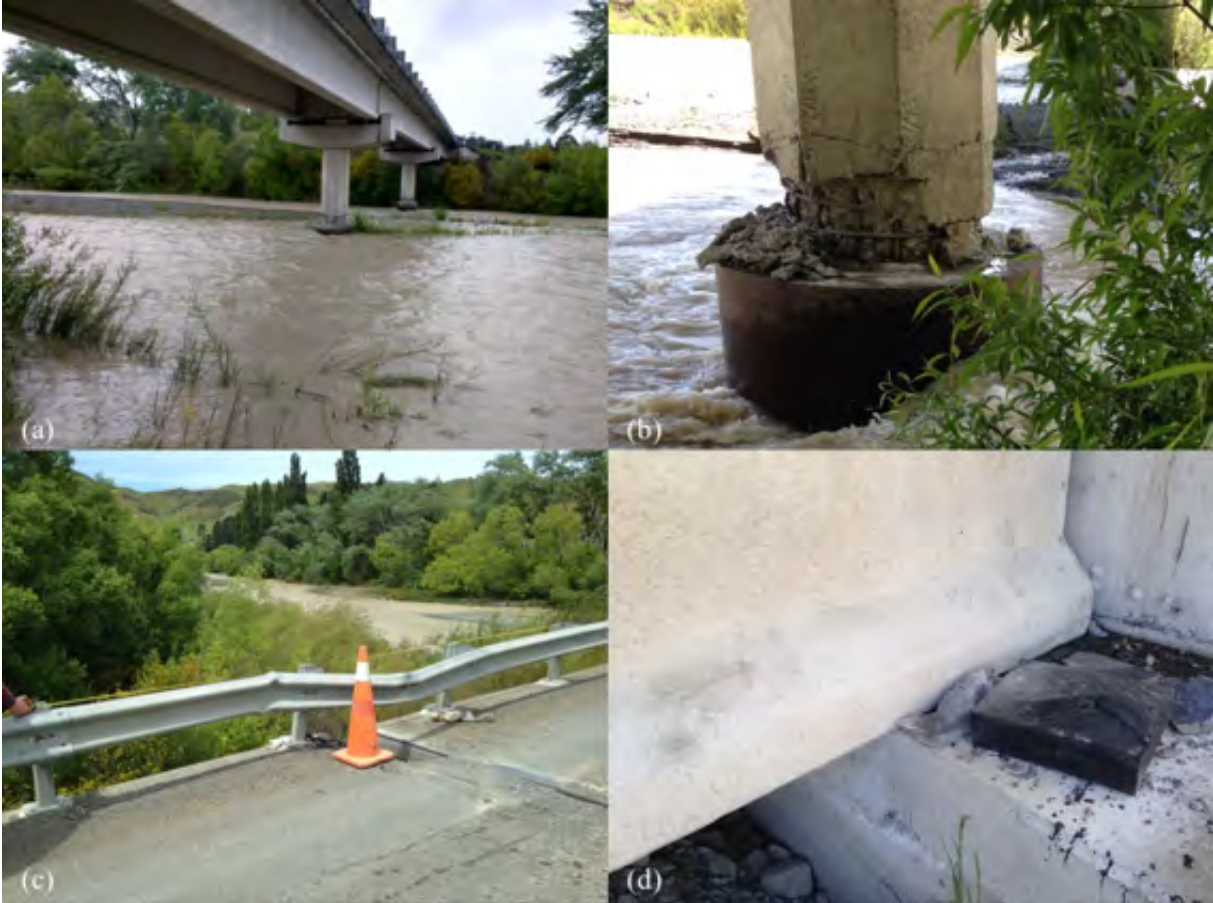
Figure 6.29: Structural damage at Lower Mason Bridge [-42.6343, 173.0664]. (a) Damage at base of piers looking south; (b) Base of southern-most pier looking north; (c) Deformation at central expansion joint looking southeast; (d) Girder unseated from bearing pad.

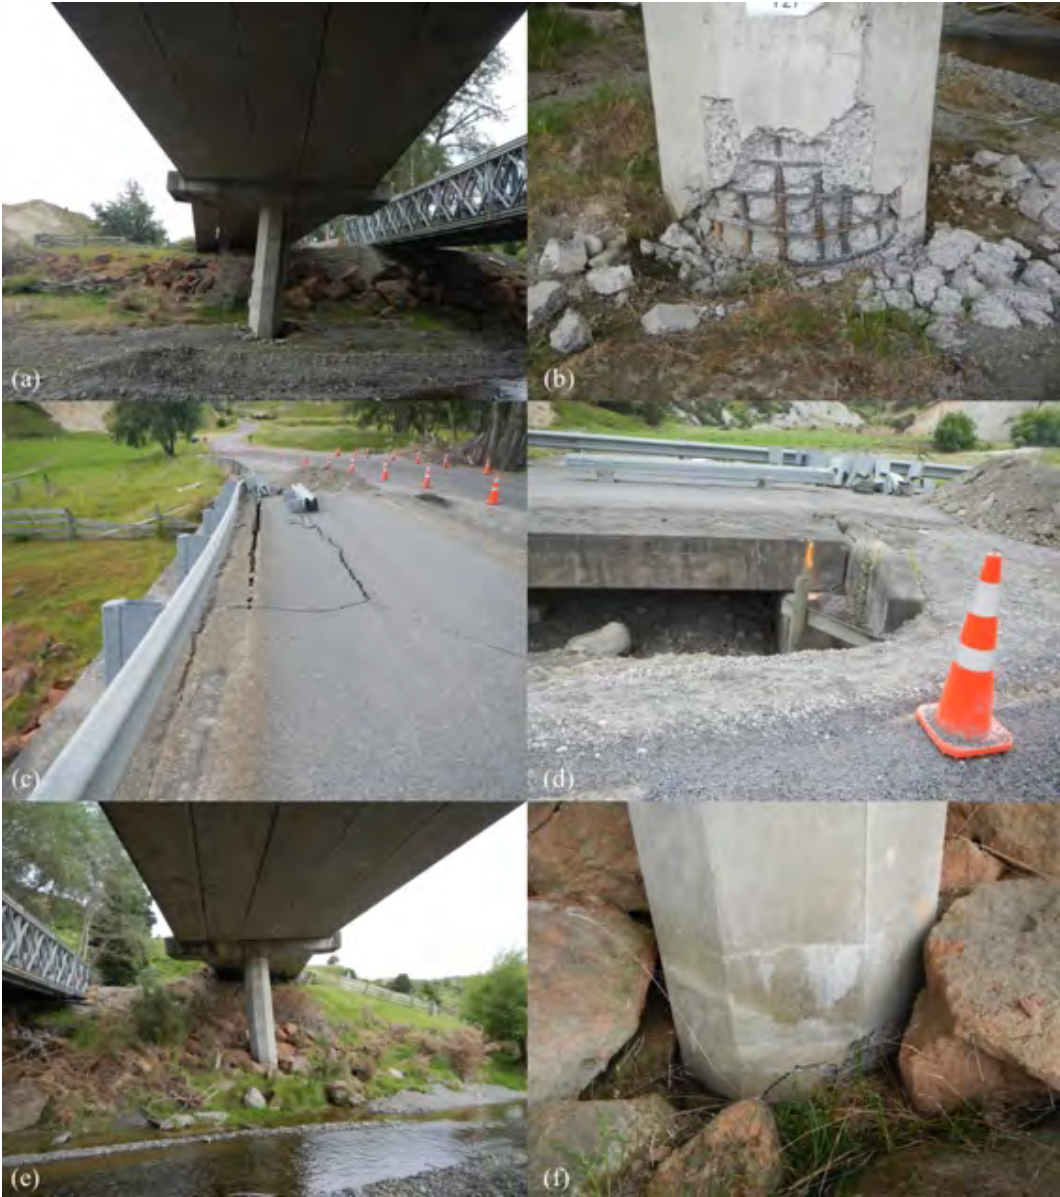
Figure 6.30: Structural damage to Wandle Bridge [-42.5864, 173.1003]: (a) South approach from under bridge; (b) Plastic hinging on pier near south approach; (c) Deck at southern end; (d) South abutment; (e) North approach from under bridge; (f) Minor hinging on pier near north abutment.

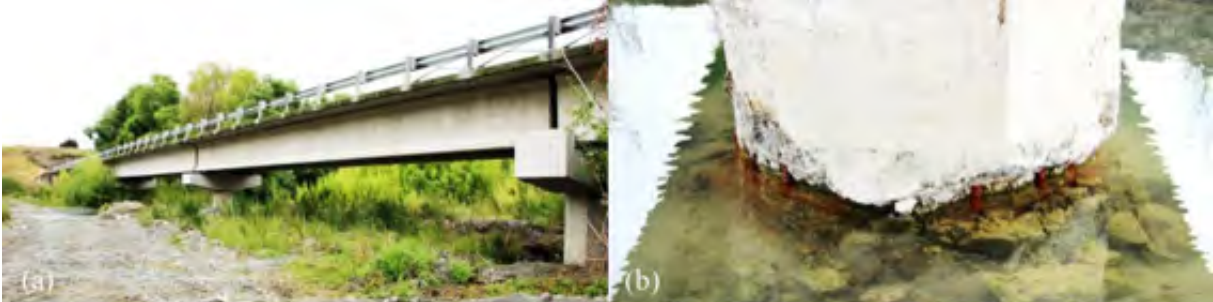
Figure 6.31: Lottery River Bridge [-42.6097, 173.0854]: (a) General layout; (b) Plastic hinge damage at base of pier.

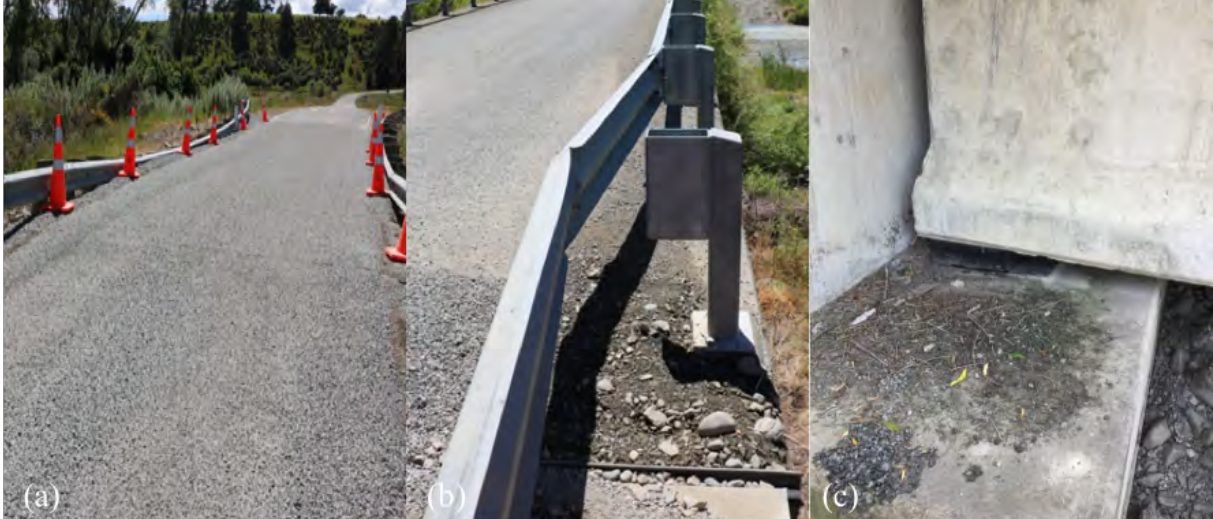
Figure 6.32: Damage at Lottery River Bridge [-42.6097, 173.0854]: (a) Gravel in-fill due to settlement and guardrail damage at northeast approach looking northeast; (b) Residual transverse offset of deck and abutment at northeast abutment looking southwest; (c) Residual displacement of bearing pad at southwest abutment looking west.

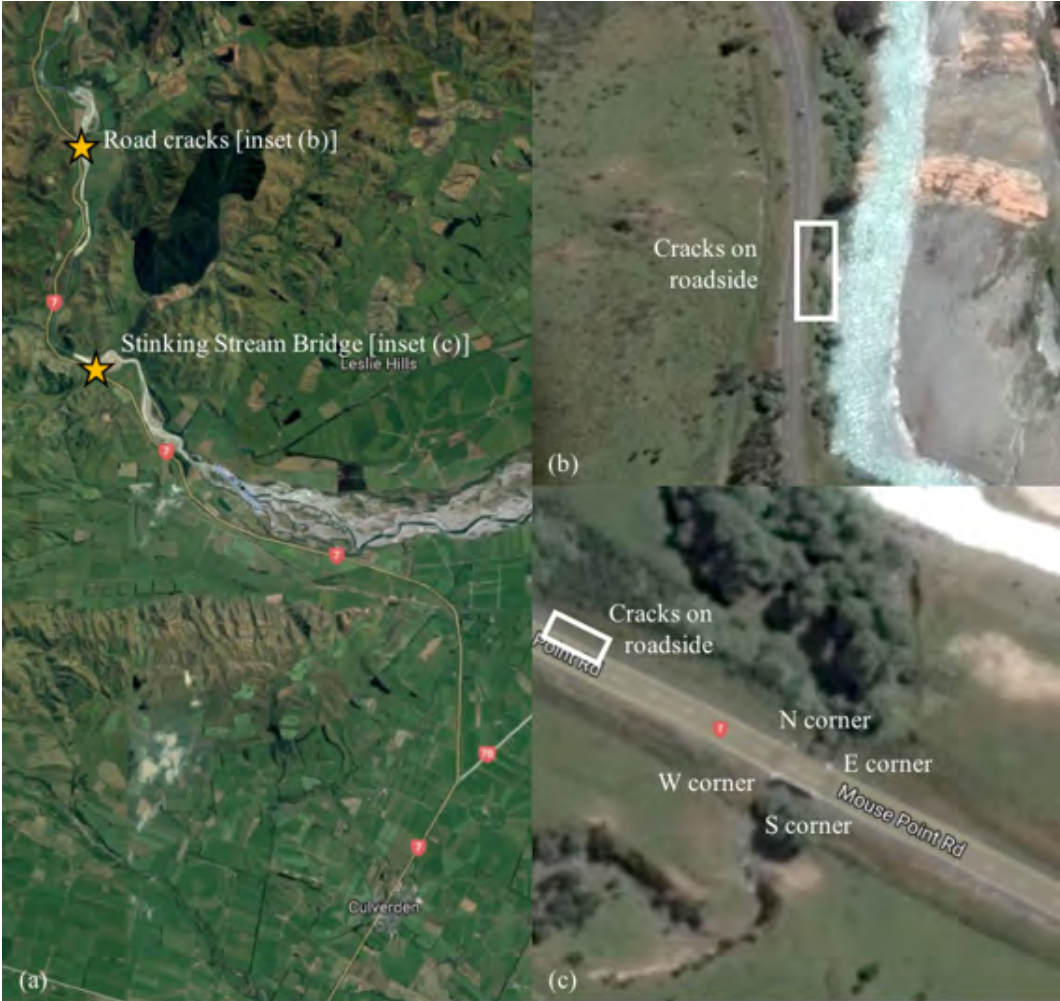
Figure 6.33: Highway 7 area: (a) Site locations for areas of interest; (b) Road crack site layout [-42.6310, 172.7718]; (c) Stinking Stream Bridge site layout [-42.6724, 172.7748].

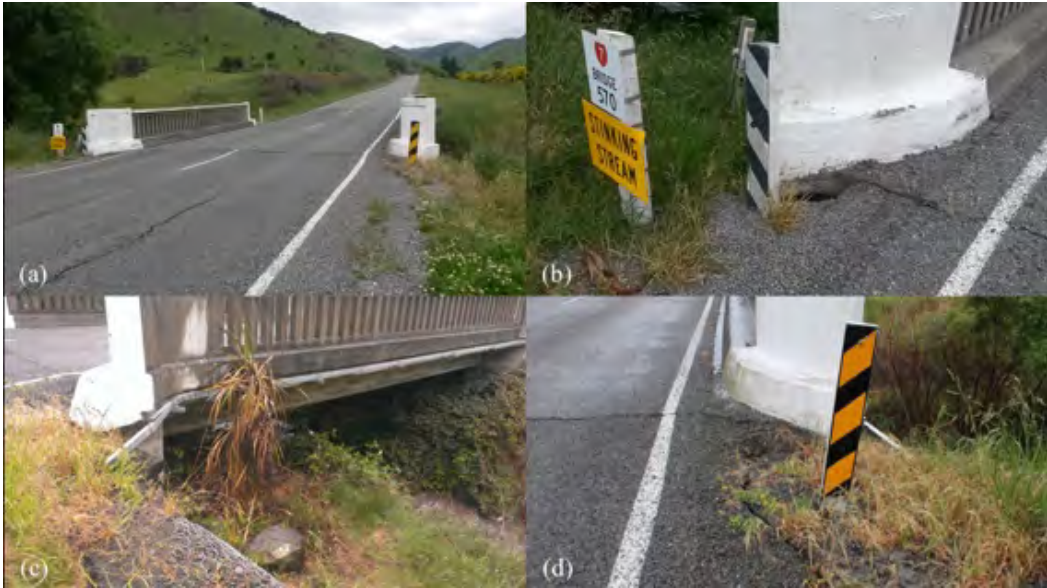
Figure 6.34: Stinking Stream Bridge [-42.6724, 172.7748]: (a) Looking north on 14 November; (b) Southern corner on 14 November; (c) and (d) Eastern corner on 17 November.

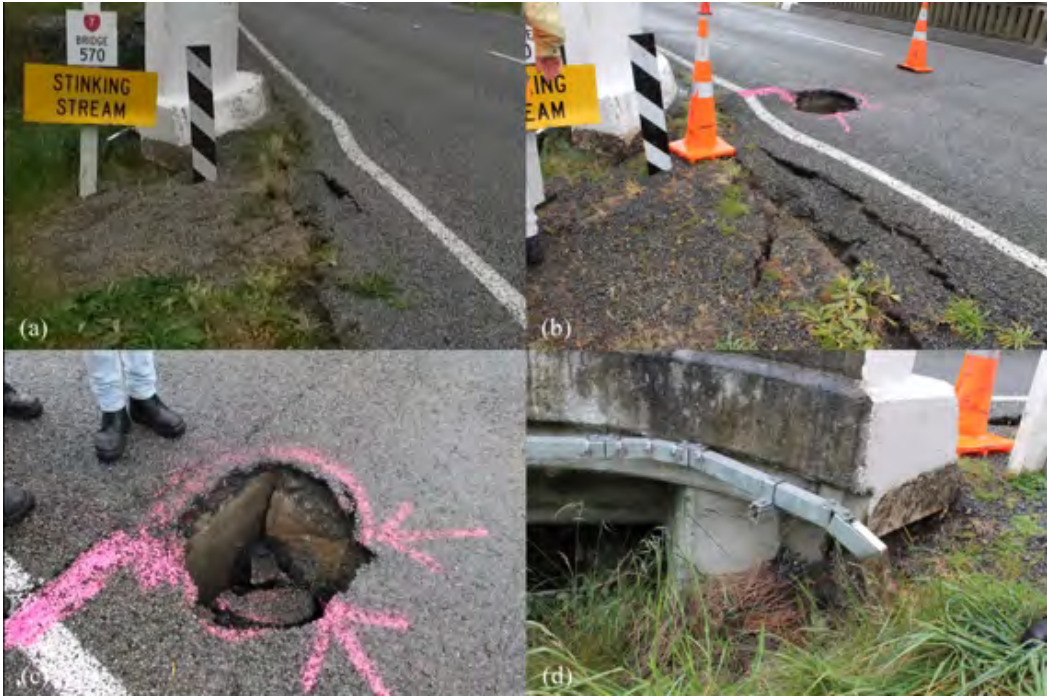
Figure 6.35: Northern corner of Stinking Stream Bridge [-42.6724, 172.7748]. (a) Looking south on 14 November; (b) Looking south on 17 November; (c) Hole in roadway; (d) Settlement on 17 November.

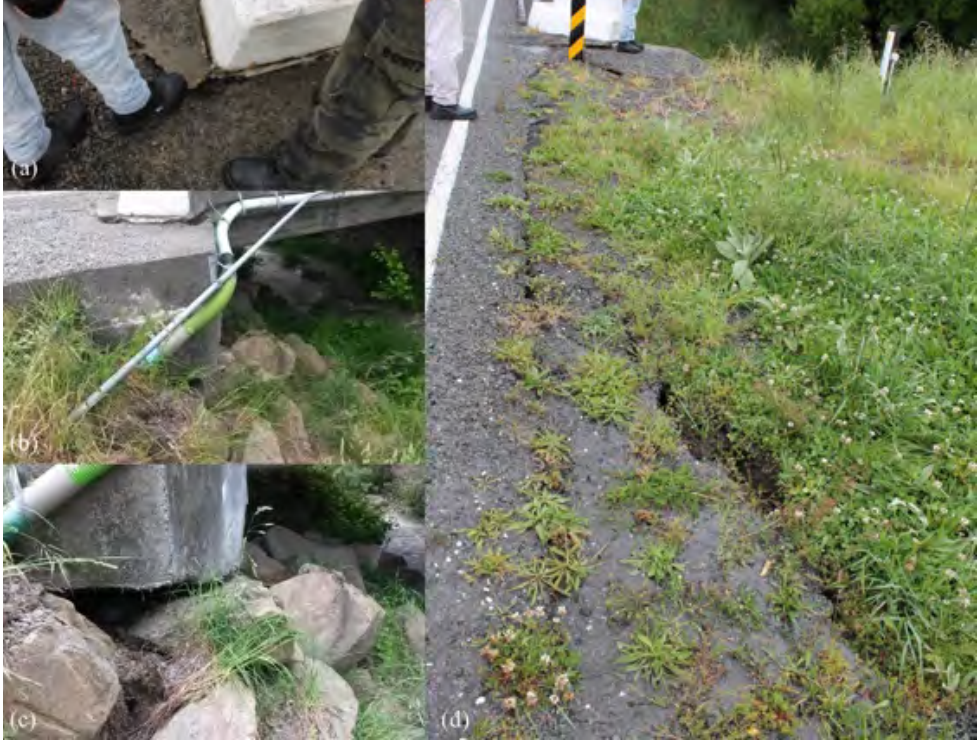
Figure 6.36: West corner of Stinking Stream Bridge [-42.672427, 172.774764]: (a) Settlement and cracking at abutment; (b) Settlement looking east; (c) Rip-rap movement away from the abutment base; (d) Cracking in approach.

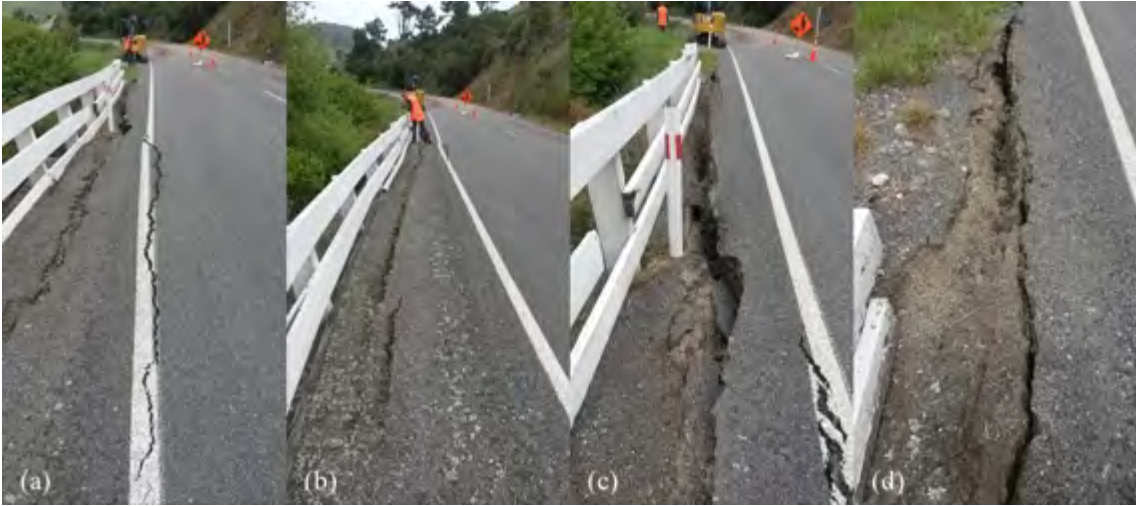
Figure 6.37: Cracks on free-face side of roadway on Highway 7 looking south [-42.6310, 172.7718]. Location and site layout shown in Figure 6.33.

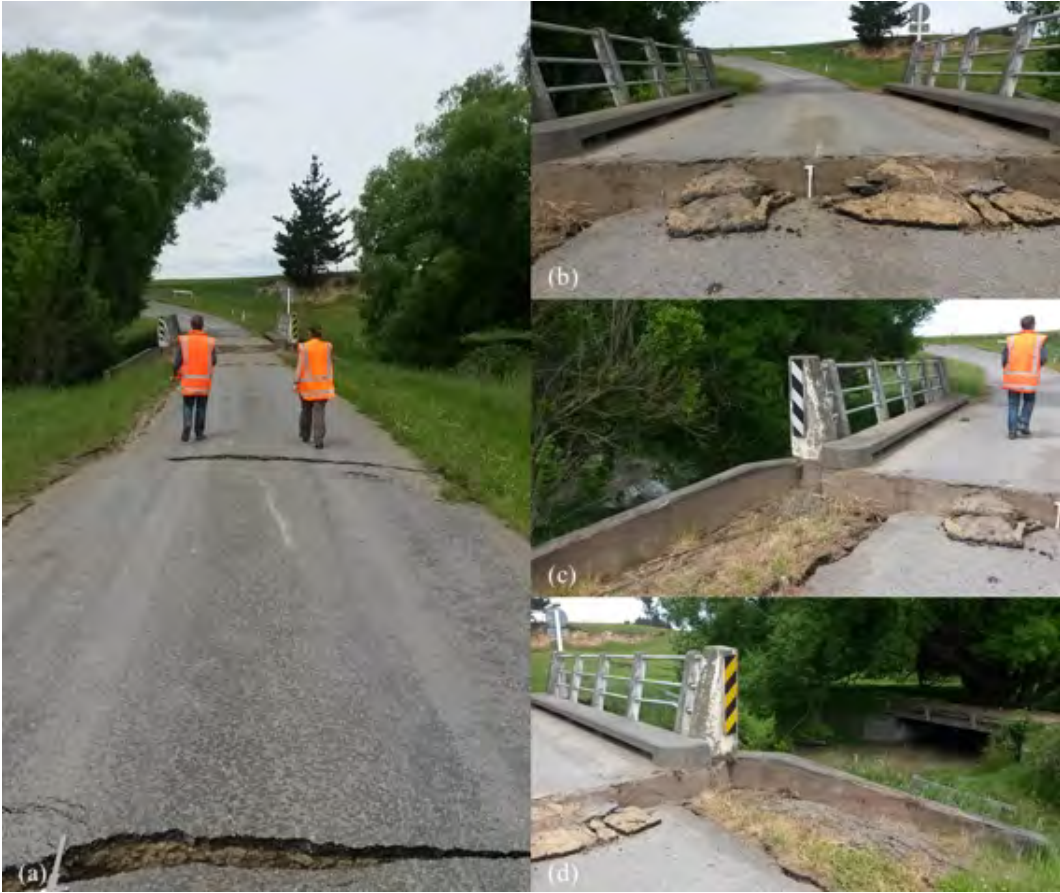
Figure 6.38: Home Creek Bridge [-42.6323, 172.9528]: (a) Roadway cracks in western approach; (b), (c), and (d) Settlement at western abutment.

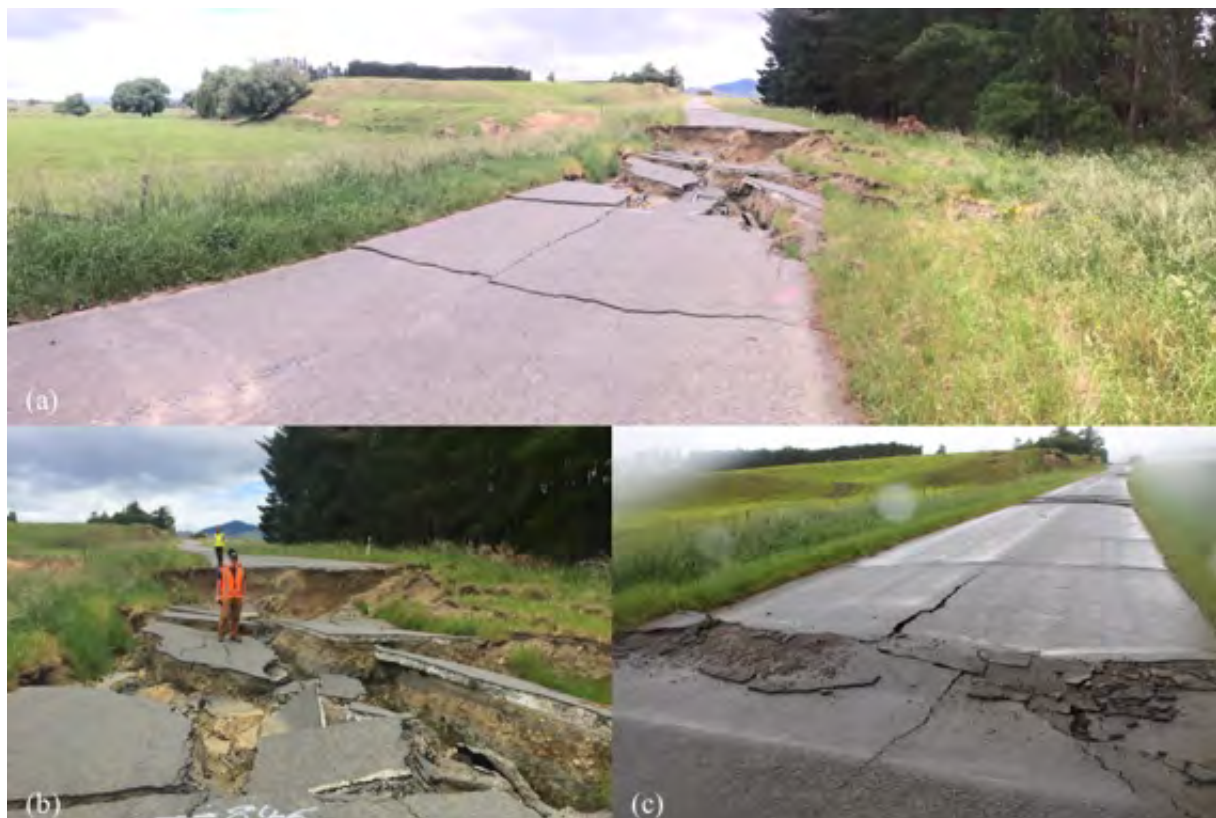
Figure 6.39: Failure and severe cracking on Leslie Hills Road (photos all taken looking west) [-42.6306,172.9895]: (a) Overview of major failure area; (b) Closer view of failure area; (c) Cracking to west of failure area.

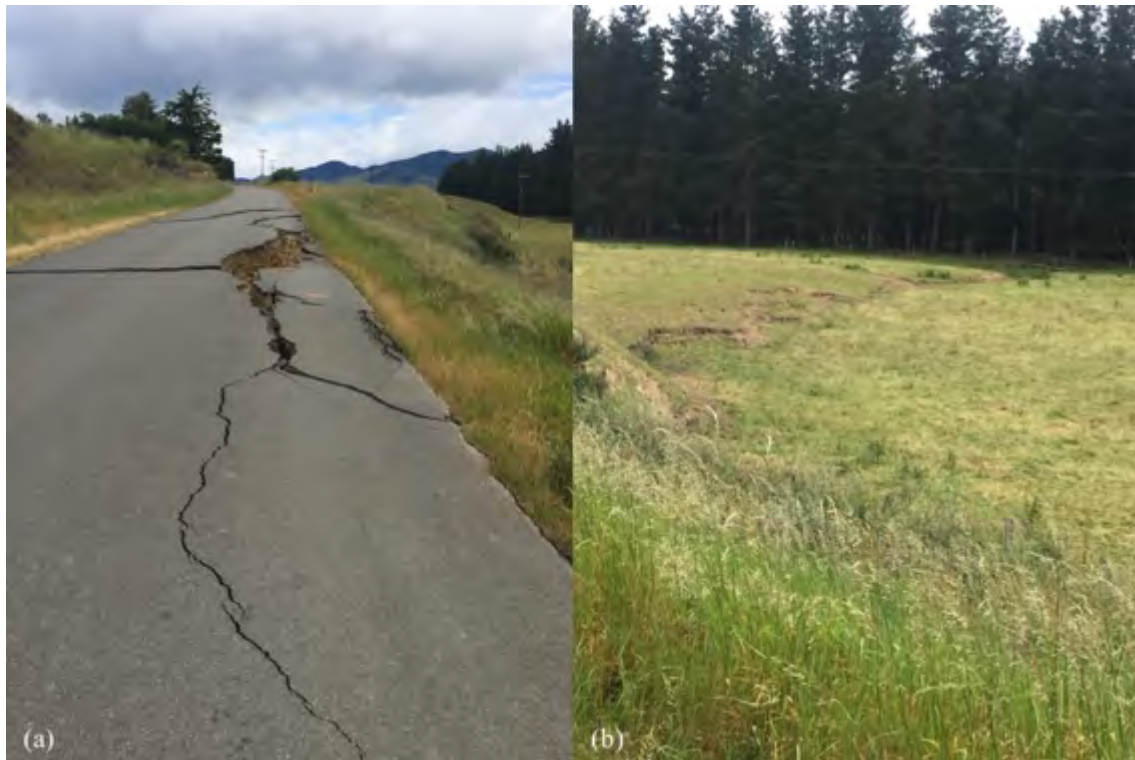
Figure 6.40: Damage west of failure area on Leslie Hills Road (both photos taken looking west) [-42.6306,172.9895]: (a) Cracking and failure of the road on free face of embankment; (b) Adjacent cracking through paddock.

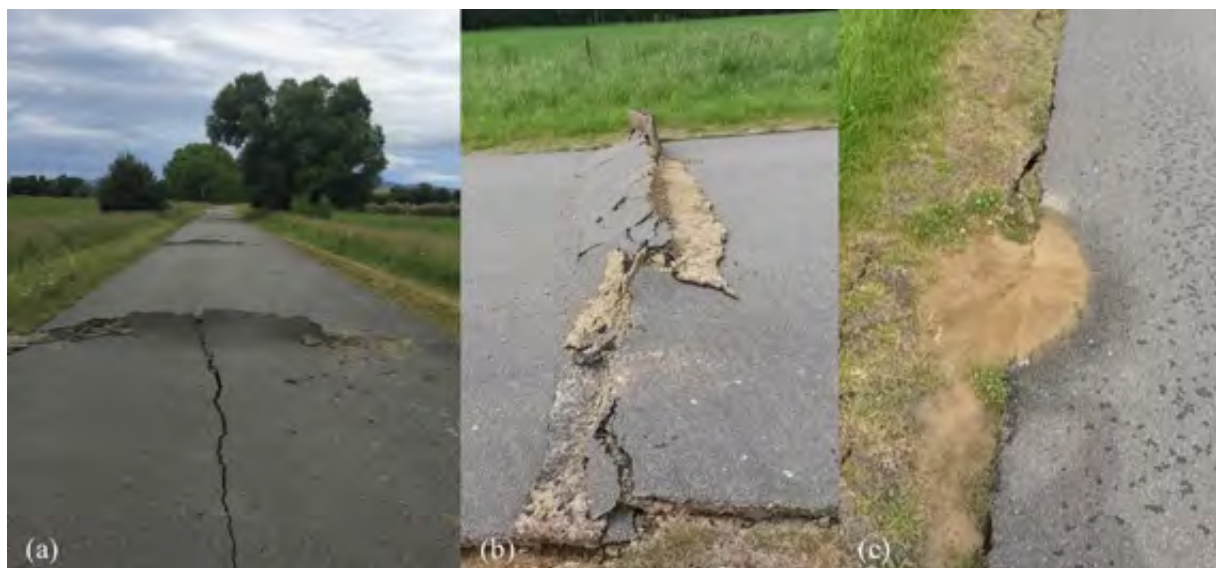
Figure 6.41: Damage observations east of Leslie Hills Road failure area [-42.6306,172.9895]: (a) Compression ridging in pavement material; (b) Side view of compression ridge; (c) Minor liquefaction ejecta.

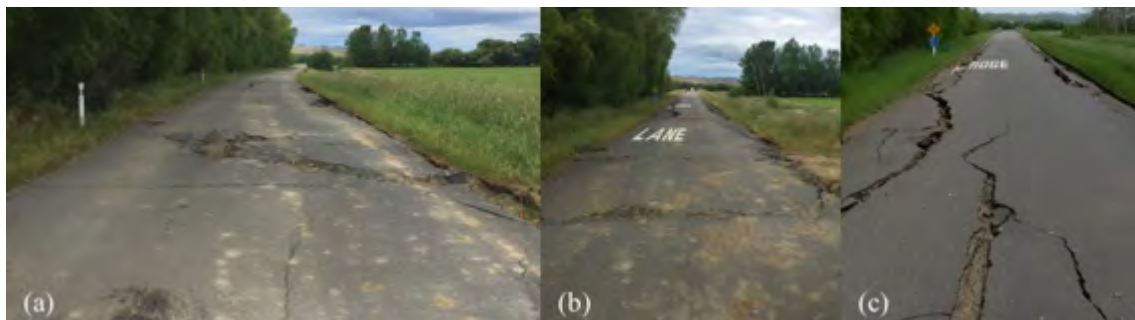
Figure 6.42: Cracking in roadway approaching Mt Paul Bridge from the north along Leslie Hills Road [-42.6355, 172.9924].

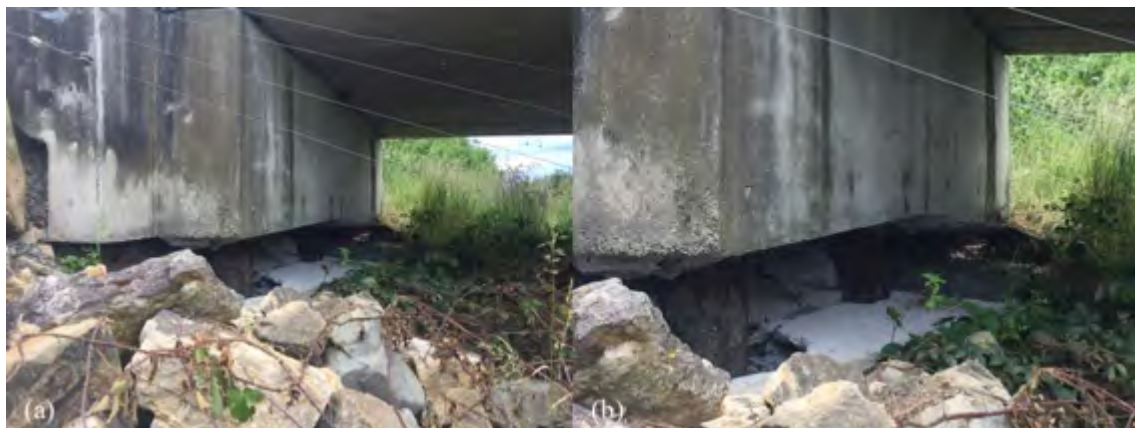
Figure 6.43: Settlement below abutment at Mt Paul Bridge [-42.6355, 172.9923].

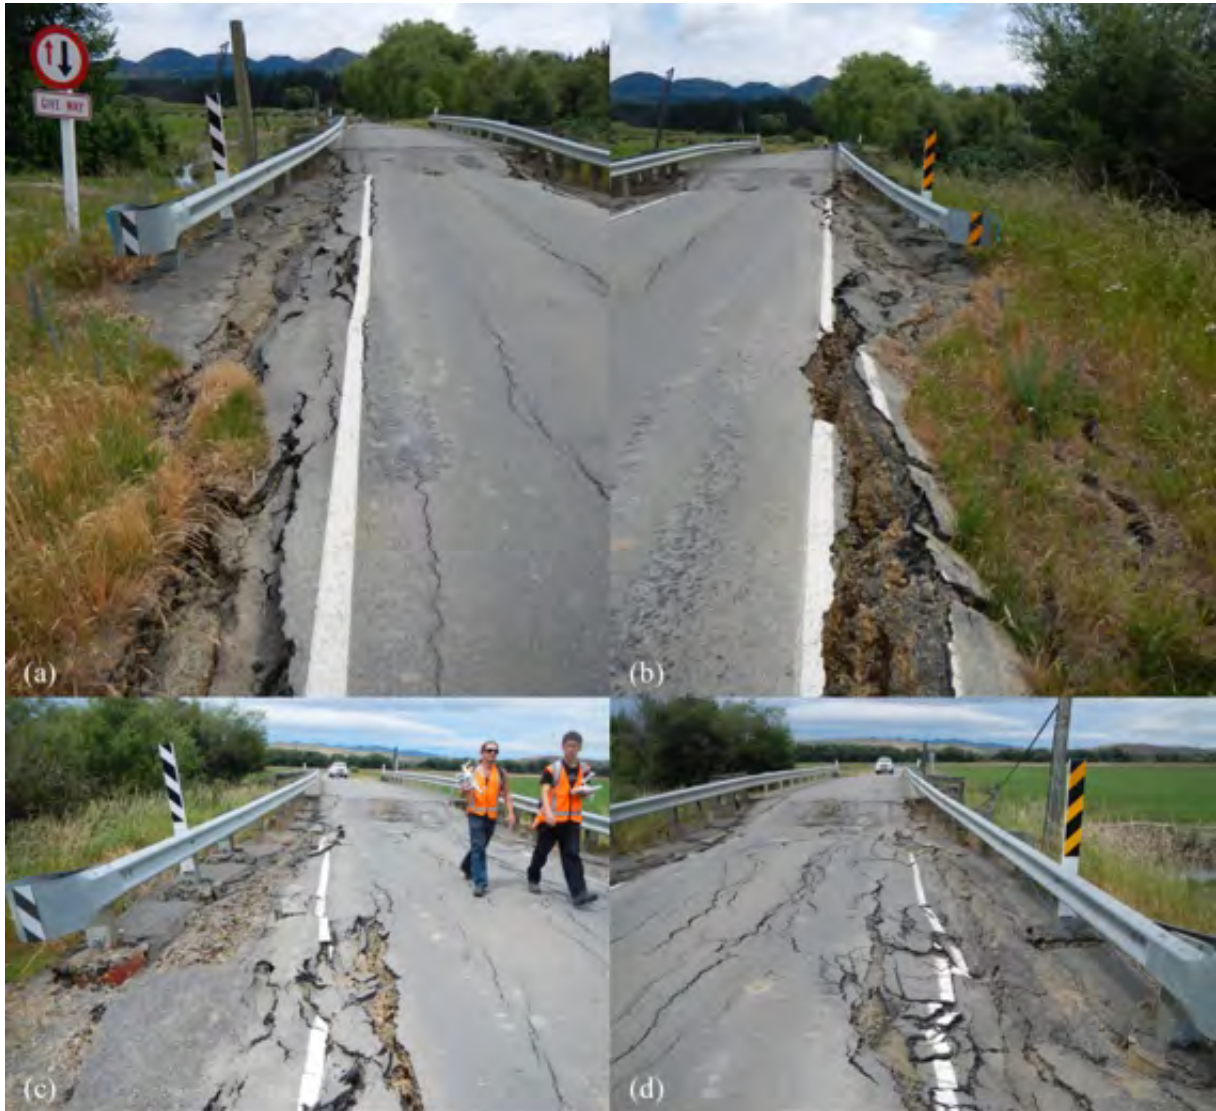
Figure 6.44: Settlement and cracking in approaches to Mt Paul Bridge [-42.6355, 172.9924]: (a) Southwest corner; (b) Southeast corner; (c) Northeast corner; (d) Northwest corner.

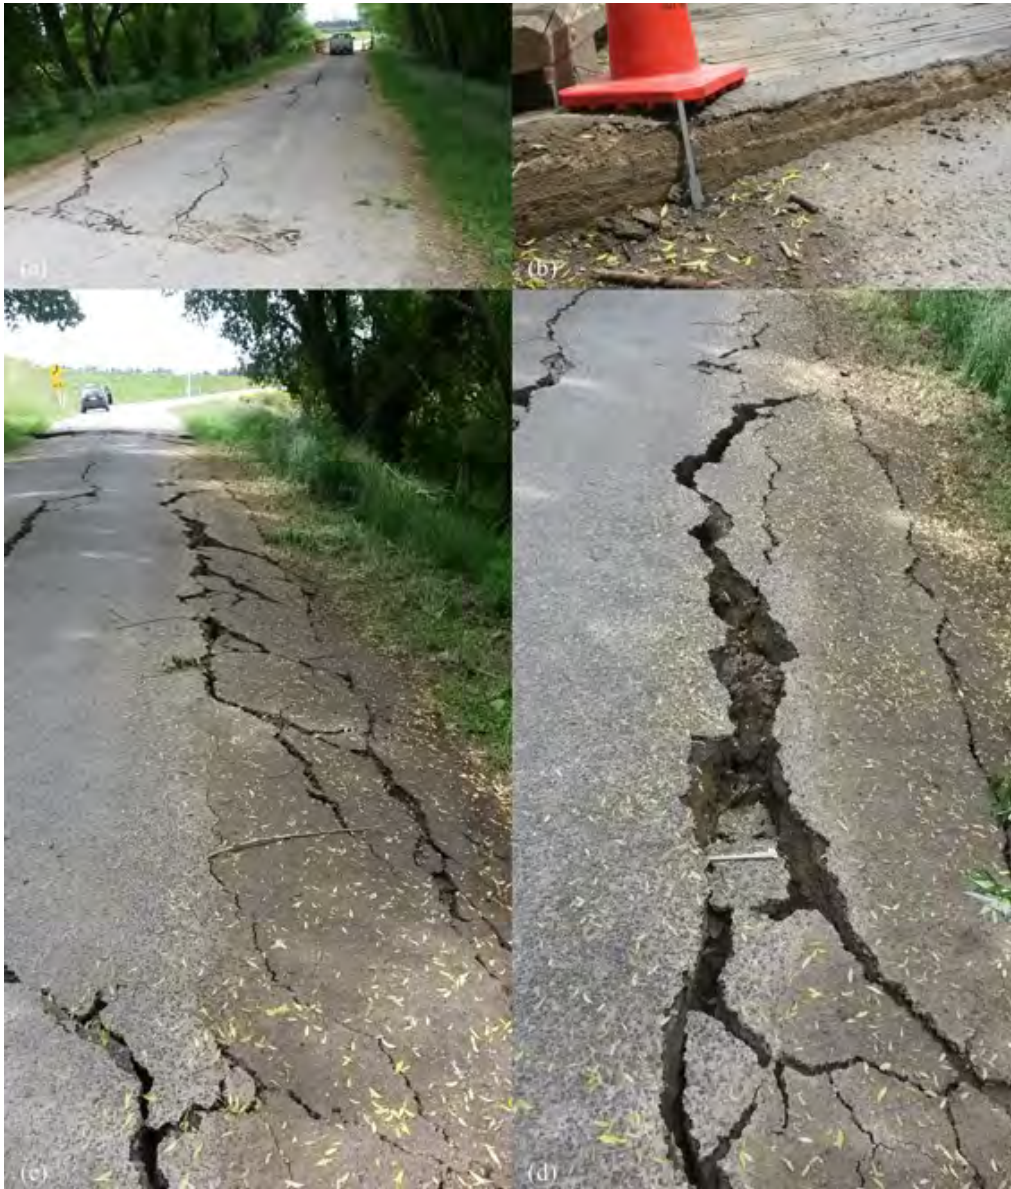
Figure 6.45: Damage at Emu Plains Bridge [-42.6394, 172.9149]: (a) Roadway damage looking west towards bridge; (b) Settlement at eastern abutment; (c) and (d) Significant cracking in roadway on eastern side of bridge (photos taken facing east away from bridge).

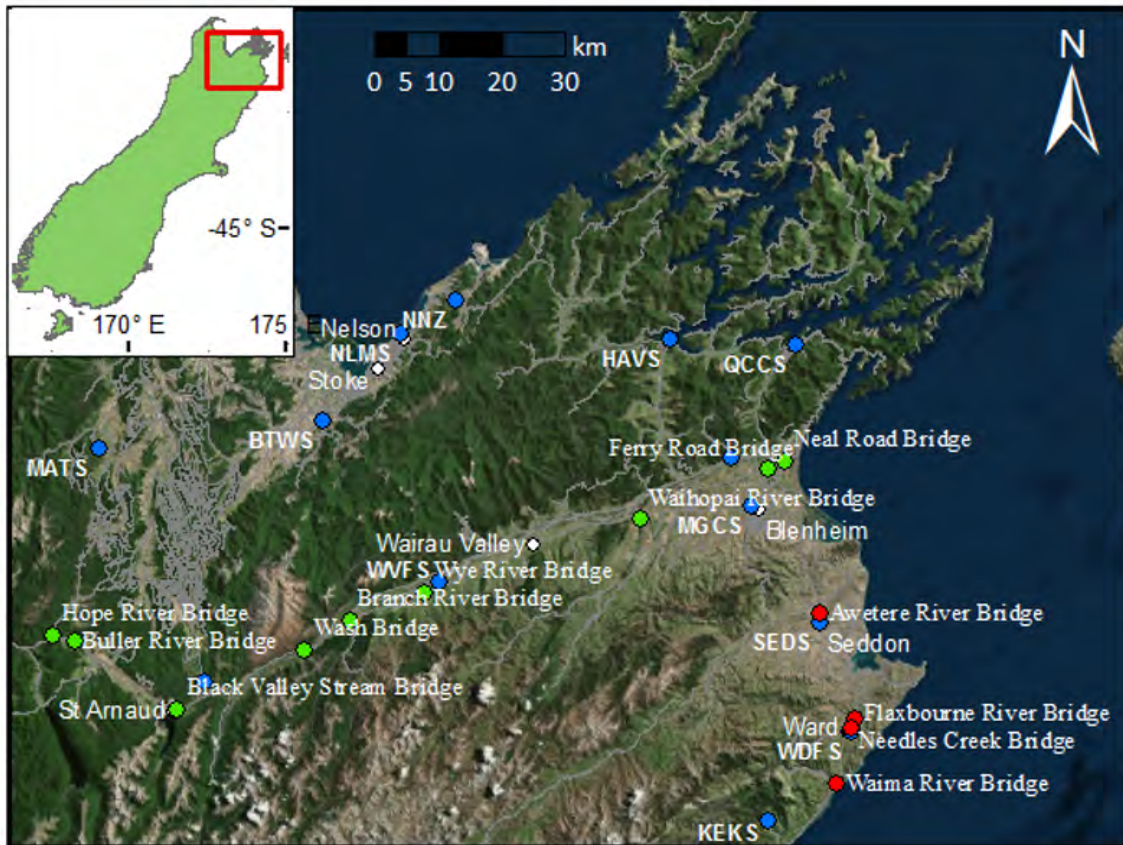
Figure 6.46: Bridge sites surveyed in the Marlborough District. Green markers indicate bridges with minor or no damage observations. Red markers indicate sites with moderate to severe damage observations. Blue markers indicate strong motion stations.

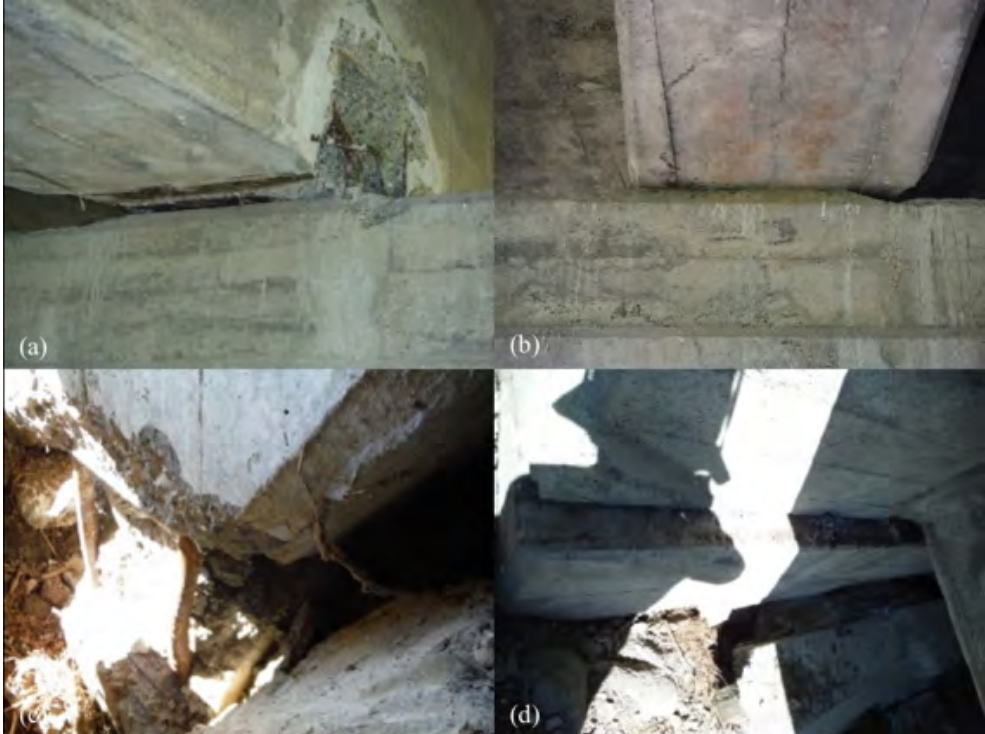
Figure 6.47: Damage at Flaxbourne River Bridge [-41.8085, 174.1458]: (a) Damage at deck-pier connection; (b) Residual transverse deck displacement; (c) Exposed and buckled reinforcement in abutment columns; (d) Residual longitudinal deck displacement.

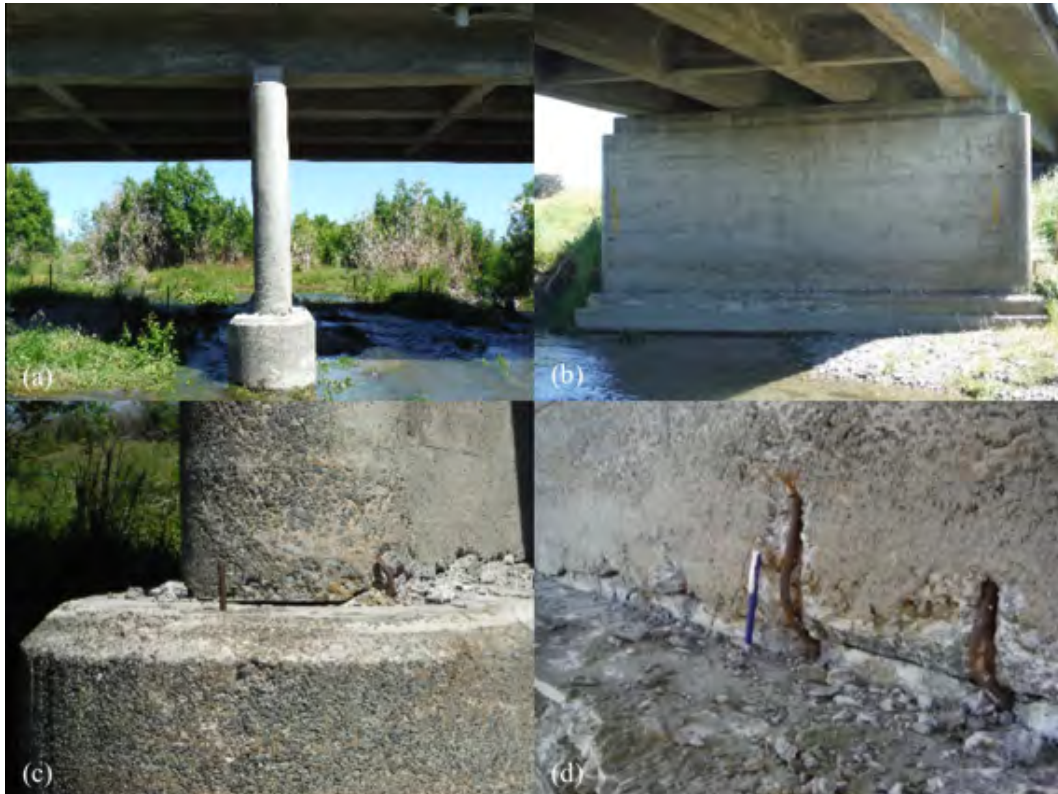
Figure 6.48: Substructure damage at Flaxbourne River Bridge [-41.8085, 174.1458]: (a) Tilted pier; (b) Cracking at pier base; (c) and (d) Cracking and exposed reinforcement at base of piers.

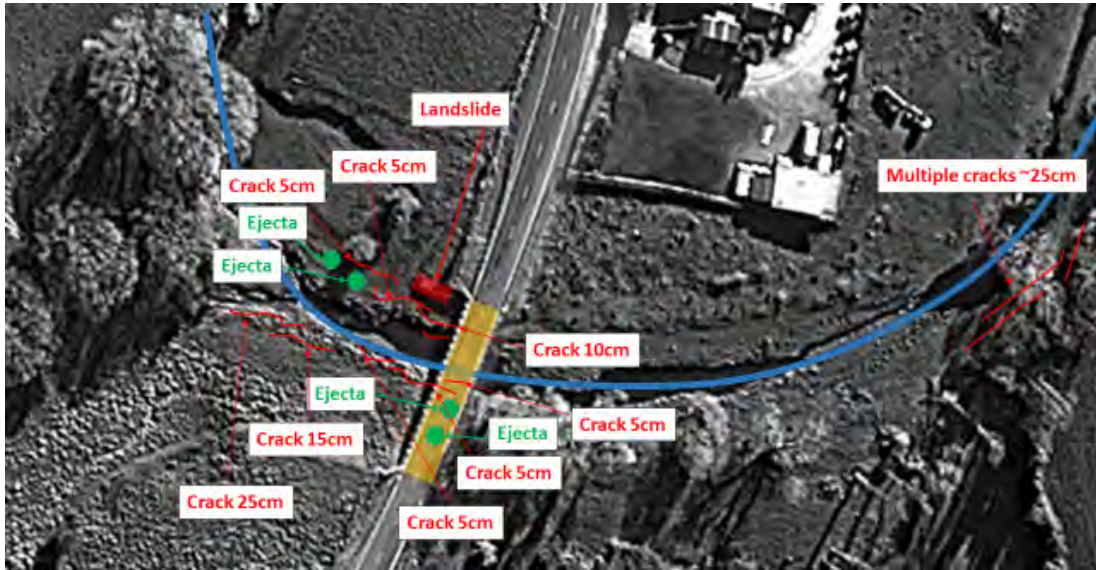
Figure 6.50: Overview of Needles Creek Bridge site with indications of ground damage. Orange area is the bridge deck, red lines indicate cracks, and the green markers indicate sand boils. The blue line indicates the creek bed.
