# GEOTECHNICAL RECONNAISSANCE OF THE 2016 $M_w$ 7.8 KAIKOURA, NEW ZEALAND EARTHQUAKE

Version 1.0: 10 JUNE 2017

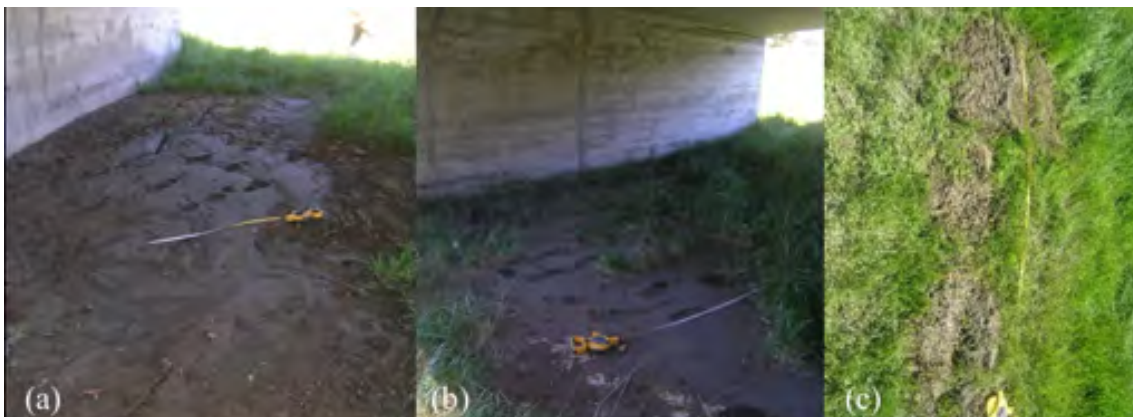
Figure 6.51: Liquefaction ejecta at Needles Creek Bridge site [-41.8217, 174.1370]: (a) Ejecta between piers 1 and 2; (b) Ejecta between piers 3 and 4; (c) Ejecta in free field west of bridge.

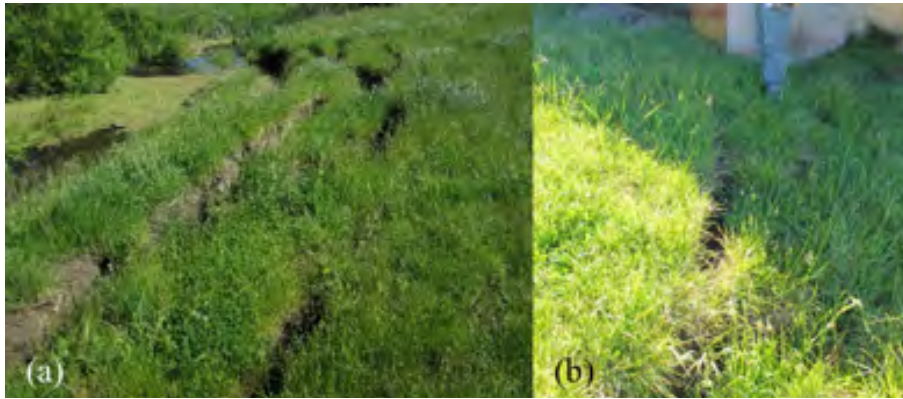
Figure 6.52: Free field lateral spreading cracks at Needles Creek Bridge site [-41.8217, 174.1370]: (a) Cracks along free face of the river; (b) Cracking near bridge pier.

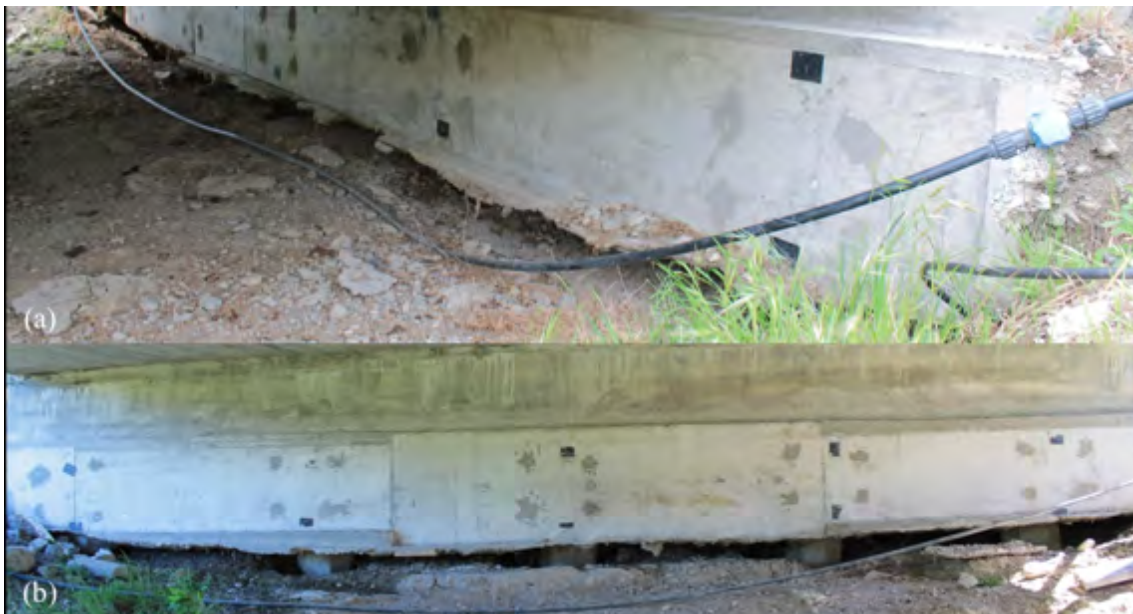
Figure 6.53: Soil subsidence below abutments at Needles Creek Bridge [-41.8217, 174.1370]: (a) North abutment wall looking northwest; (b) South abutment wall looking south.

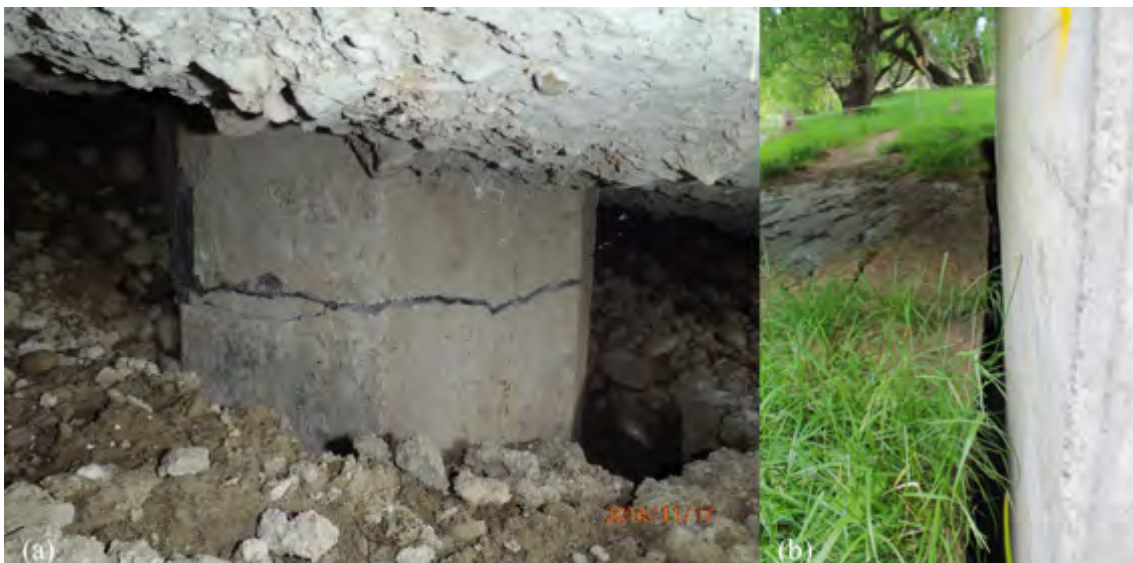
Figure 6.54: Pile and footing damage at Needles Creek Bridge [-41.8217, 174.1370]: (a) Crack in pile for south abutment; (b) Soil-footing gapping at pier 3.

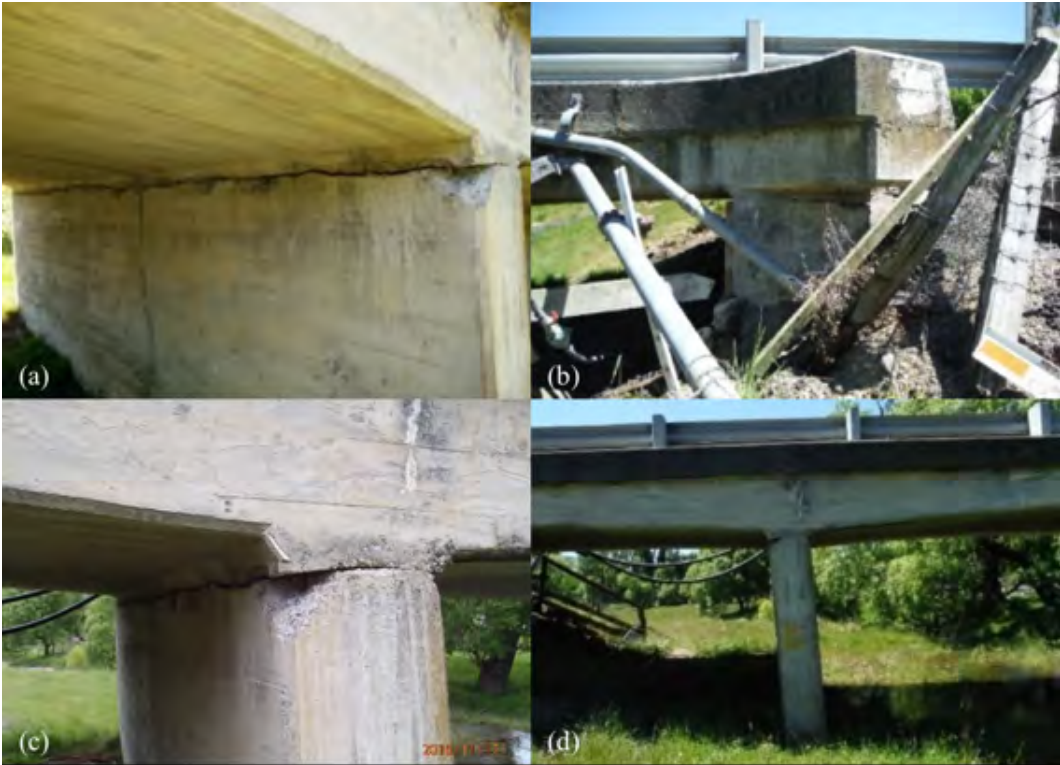
Figure 6.55: Structural damage at Needles Creek Bridge [-41.8217, 174.1370]: (a) Cracking across length of pier 1 looking south; (b) Deck sheared off of abutment 1 facing west; (c) Cracking at pier 1 facing east; (d) Tilting of pier 1 facing east.

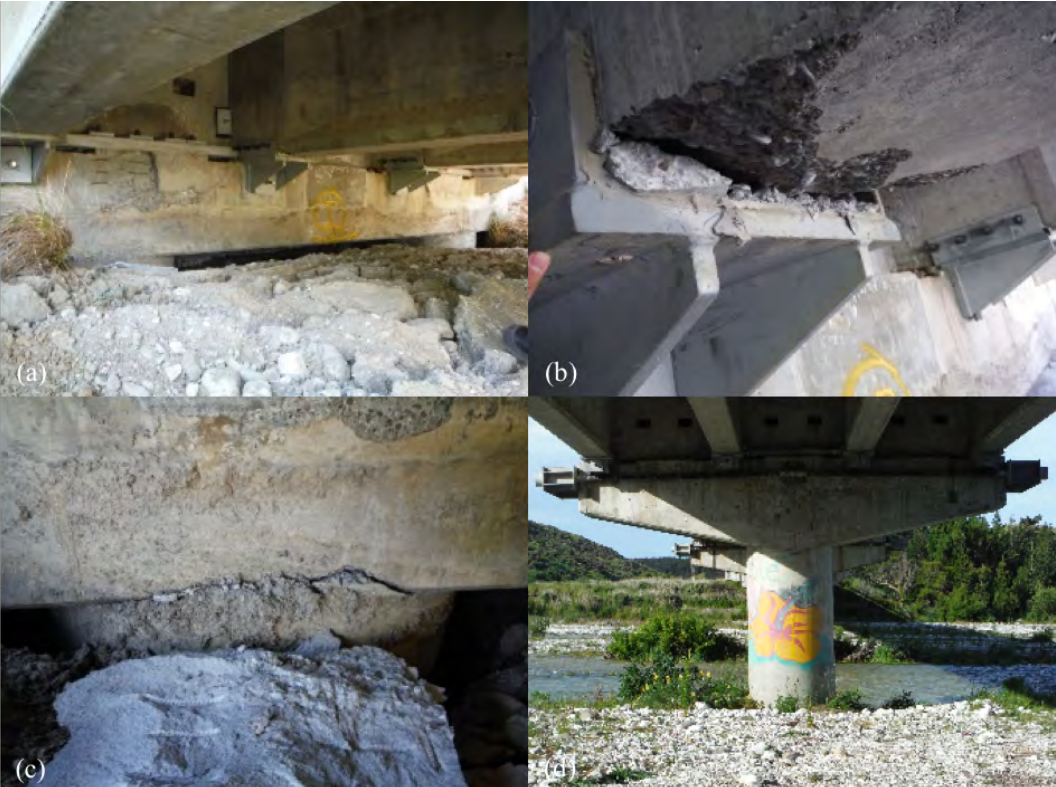
Figure 6.56: Damage at Waima River Bridge [-41.9021, 174.1122]: (a) South abutment facing south; (b) Damage to concrete beams around retrofit brackets; (c) Cracking at top of abutment pile; (d) Tilt of southernmost pier facing north.

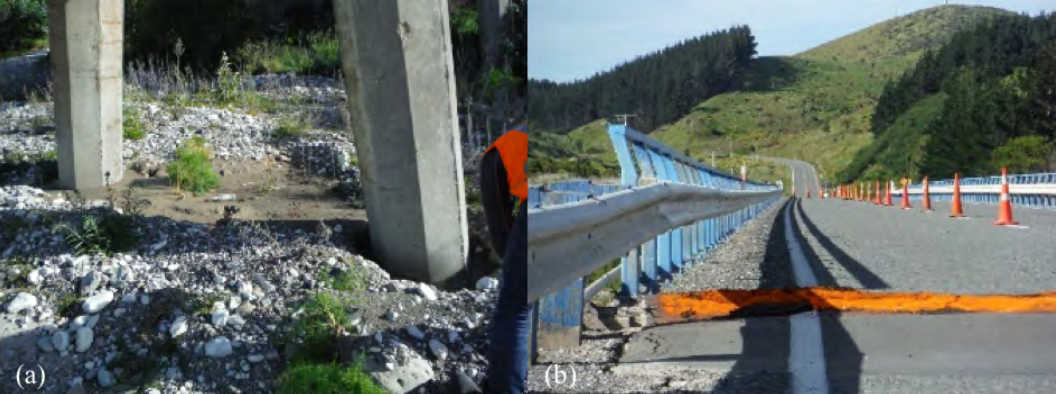
Figure 6.57: Geotechnical damage at Waima River Bridge site [-41.9021, 174.1122]; (a) Ejecta at piers of railroad bridge 50 m upstream; (b) Settlement at south approach looking north.

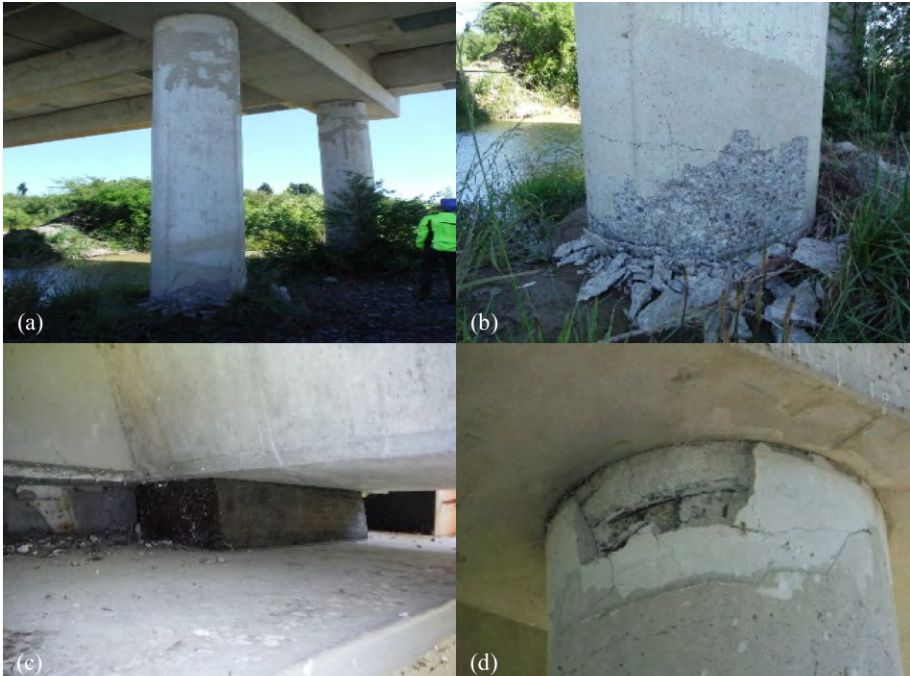
Figure 6.58: Damage at Awatere River Bridge [-41.6585, 174.077]: (a) Flexural damage at top and bottom of pier column near middle of bridge facing west; (b) Spalling of concrete at base of pier column; (c) Residual displacement in bearing pad at southern abutment; (d) Damage to previously grouted area.

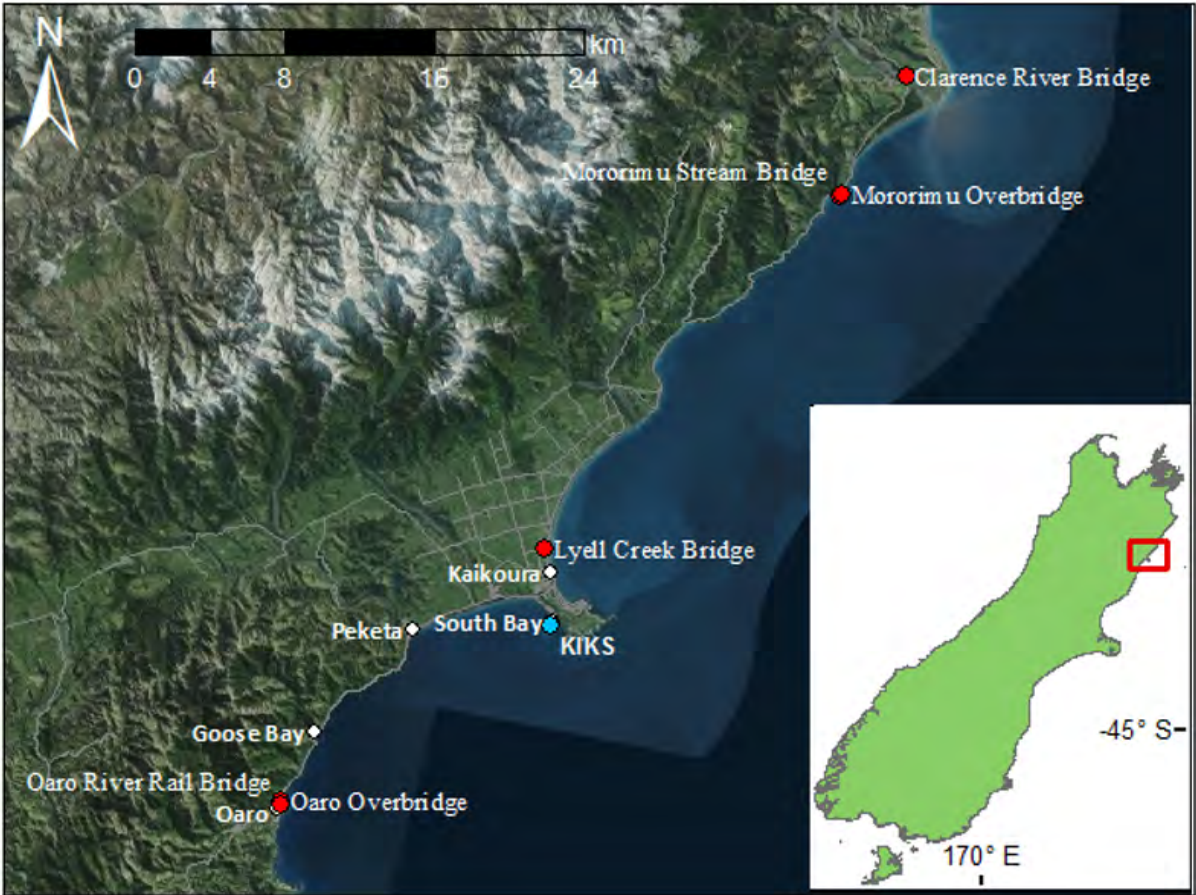
Figure 6.59: Bridge sites in the Kaikoura District with observations of moderate to severe damage. Red markers indicate bridge sites. Blue markers indicate strong motion stations.

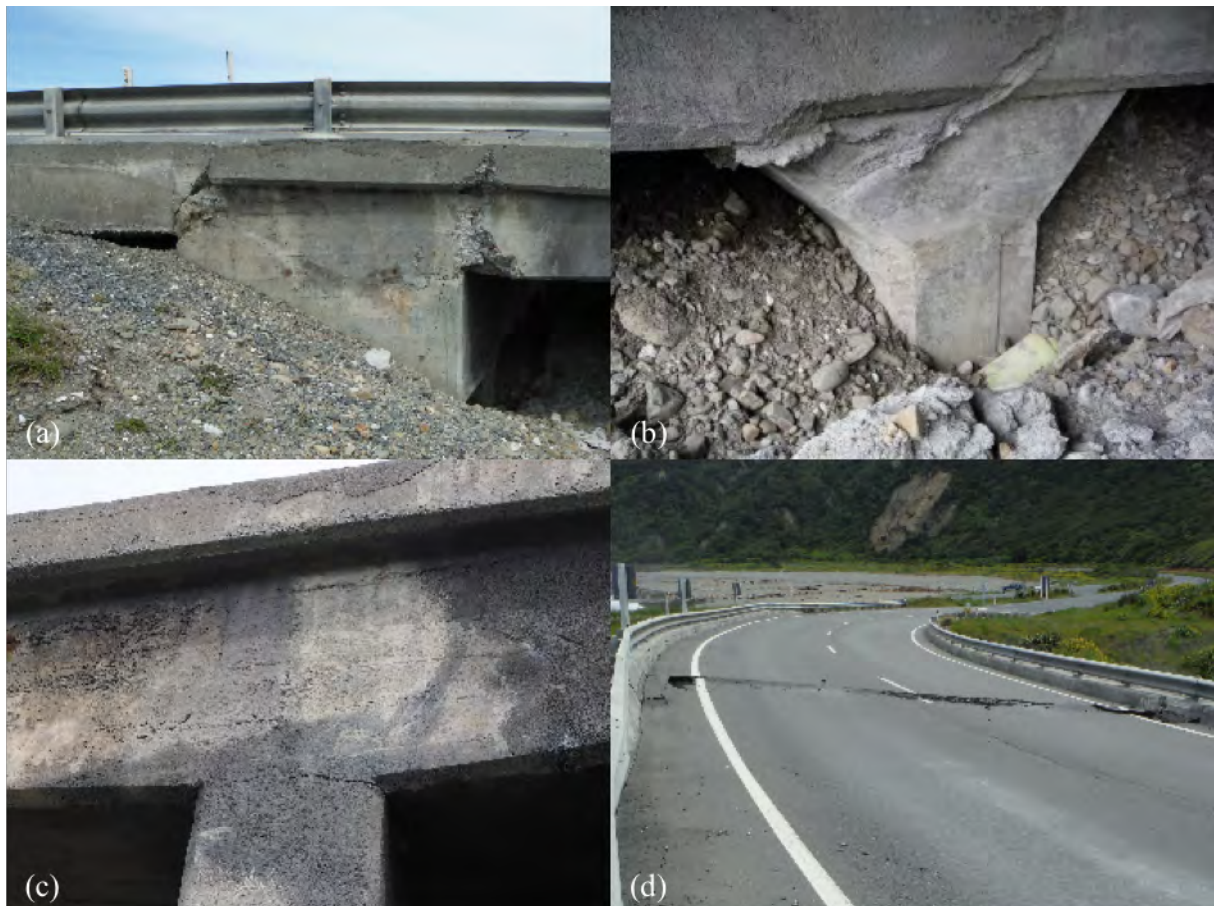
Figure 6.60: Damage observed at Mororimu Stream Bridge [-42.2173, 173.8673]: (a) Cracking in eastern abutment looking south; (b) Abutment column cracking; (c) Cracking at top of pier; (d) Settlement of eastern approach looking west.

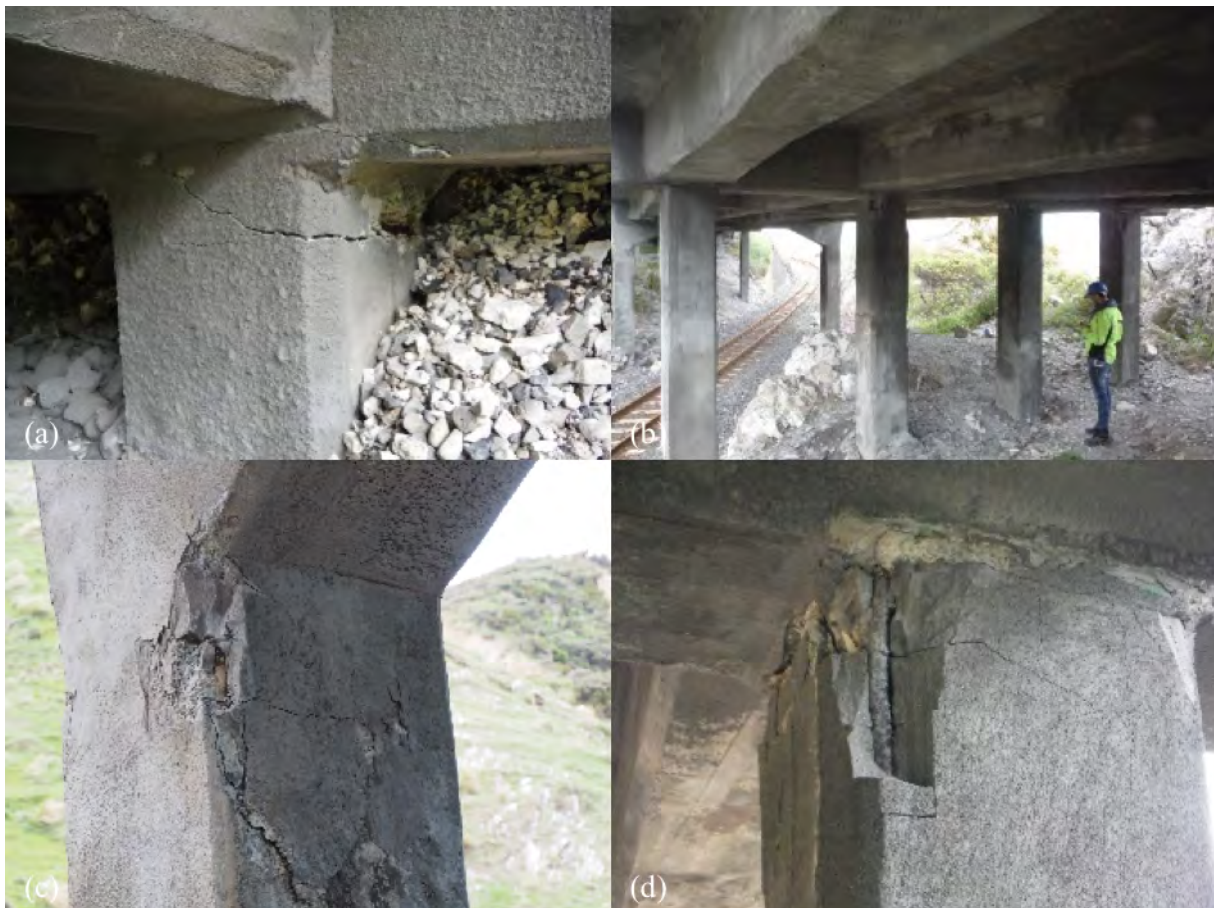
Figure 6.61: Structural damage observations at the Mororimu Overbridge [-42.2166, 173.8686]: (a) Abutment column cracking; (b) Damage to pier columns; (c) Cracking below knee joint of central pier column; (d) Exposed reinforcement at top of pier column.

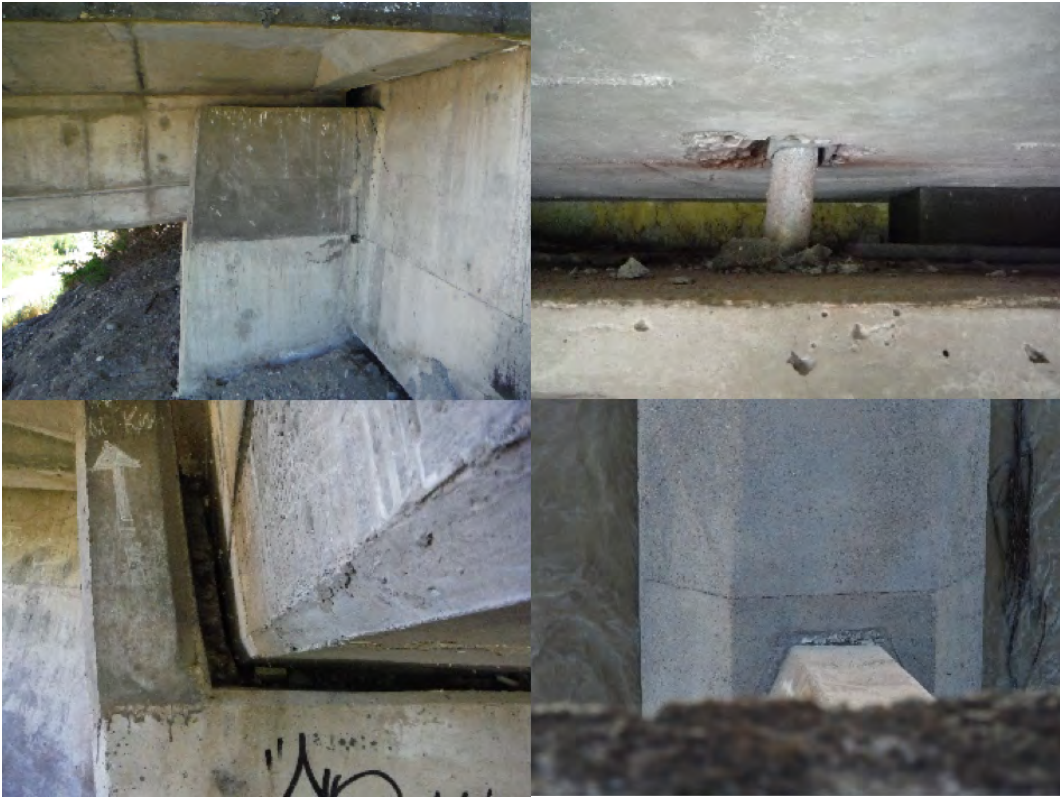
Figure 6.62: Structural damage at Clarence River Bridge [-42.1592, 173.9103]: (a) Cracking in transverse abutment wall; (b) Residual deformation in hold down rod securing deck to abutment; (c) Deck settlement at abutment; (d) Concrete spalling at base of pier.

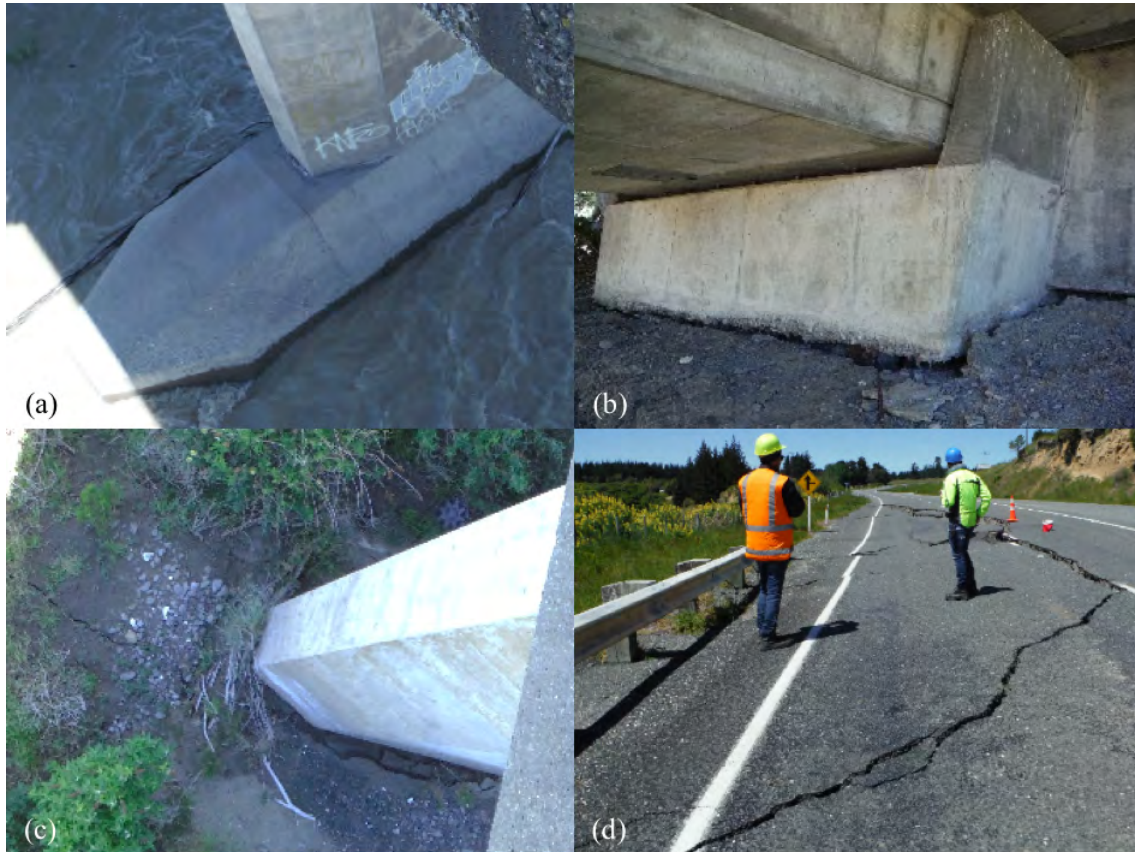
Figure 6.63: Damage at Clarence River Bridge [-42.1592, 173.9103]: (a) Cracking in top of footing; (b) Settlement of fill ahead of abutment; (c) Soil gapping at base of pier; (d) Spreading cracks in roadway at southern approach looking south.

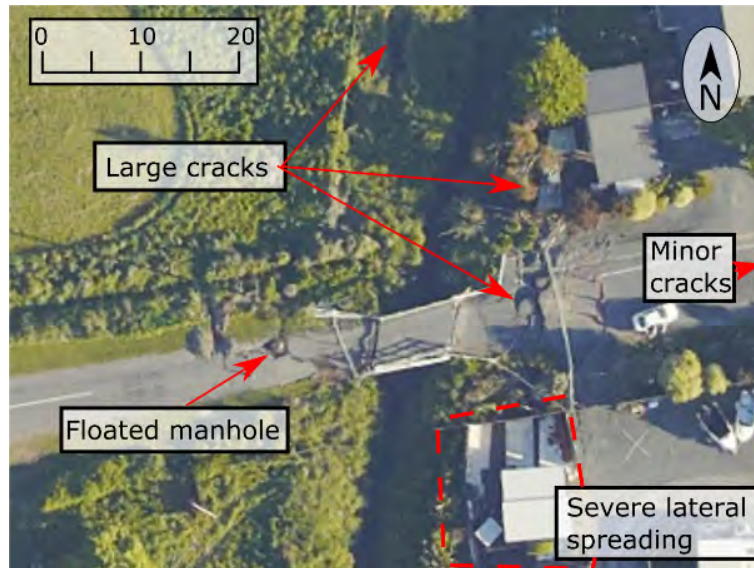
Figure 6.64: Site layout and features of interest at Lyell Creek Bridge [-42.3892, 173.6773].

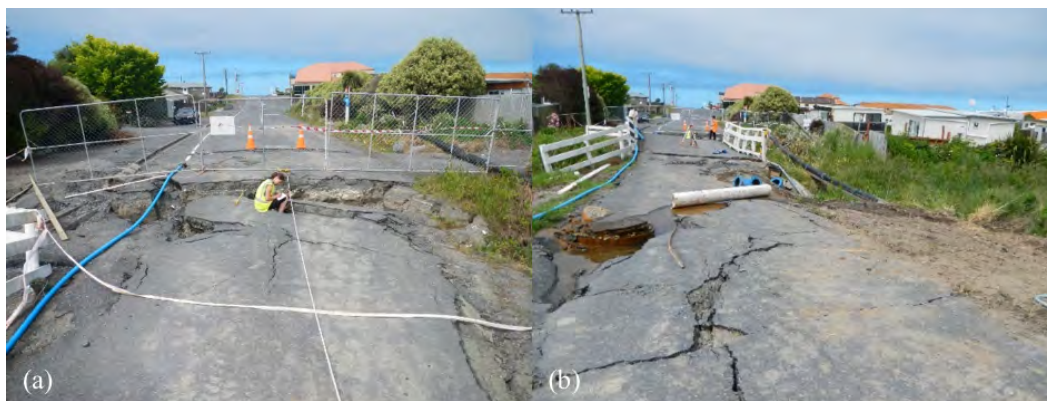
Figure 6.65: Approach cracking at Lyell Creek Bridge [-42.3892, 173.6773]: (a) Eastern approach looking east; Note: crack at 9, from the bridge abutment (location of field member) was 50 cm wide, and had a vertical offset of 30 cm. (b) Western approach looking east.

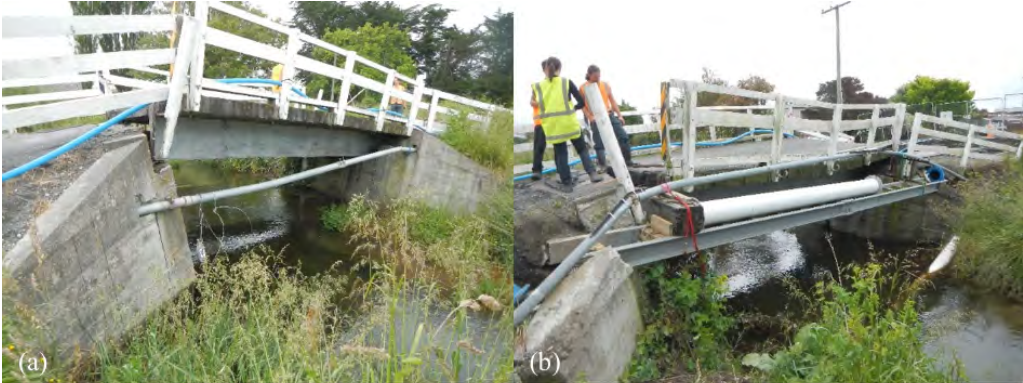
Figure 6.66: Back rotation of east and west abutments at Lyell Creek Bridge [-42.3892, 173.6773]: (a) Looking south at bridge; (b) Looking north at bridge.

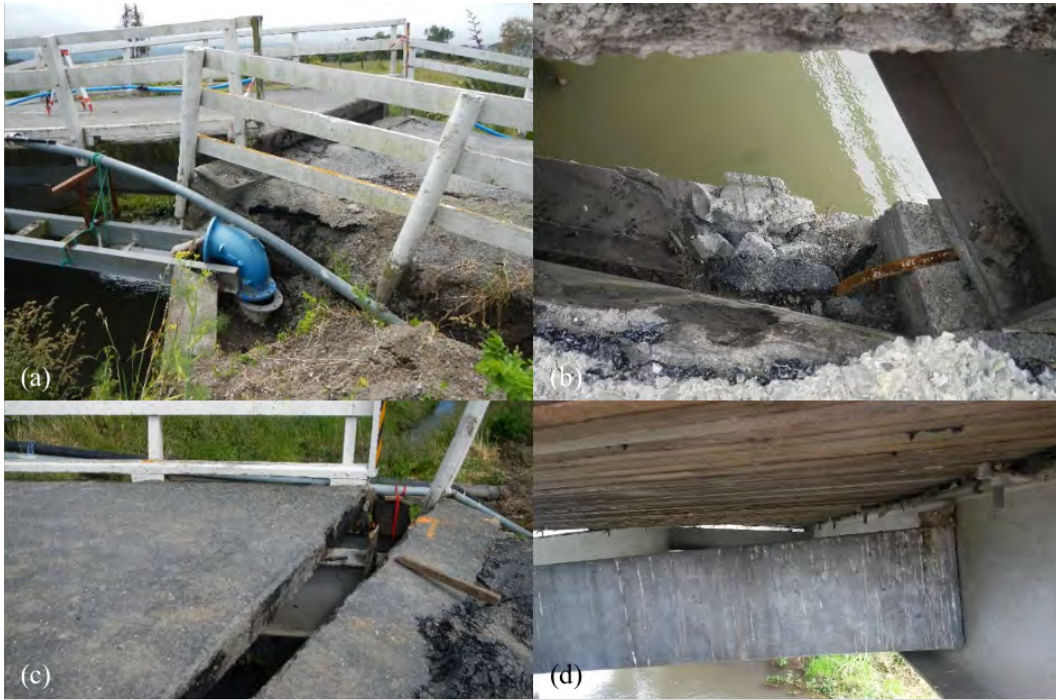
Figure 6.68: Damage at Lyell Creek Bridge [-42.3892, 173.6773]: (a) Eastern end of bridge looking north; (b) Bent anchor bars at east abutment-deck connection; (c) Gap between deck and west abutment looking south; (d) Twisting of deck beams.

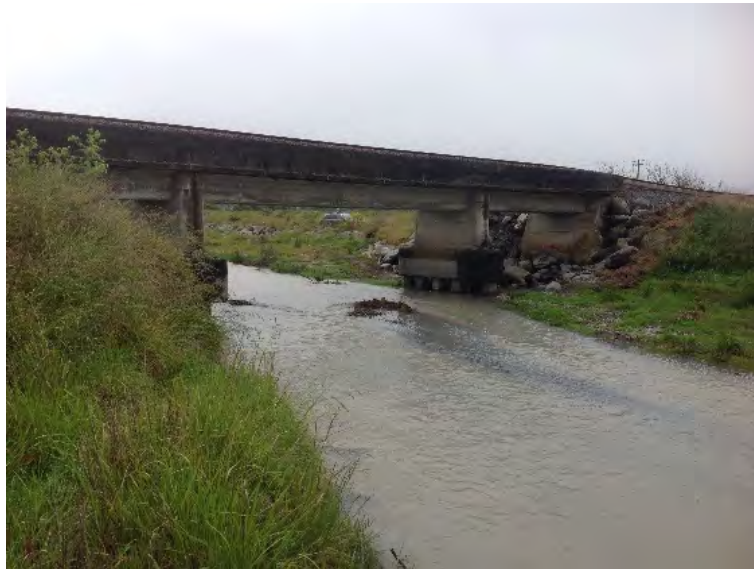
Figure 6.69: Middle Creek Railway Bridge (facing northwest) [-42.3672, 173.6862].

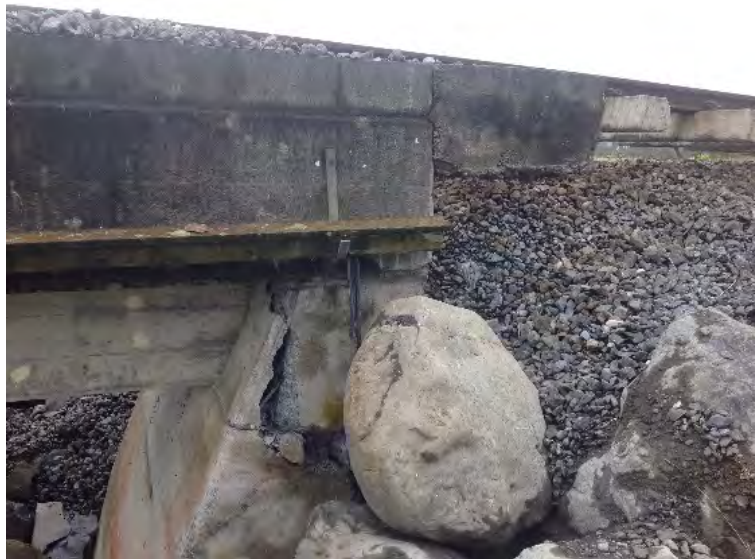
Figure 6.72: Damage to the north abutment of the Middle Creek Railway Bridge facing northwest [-42.3670, 173.6861].

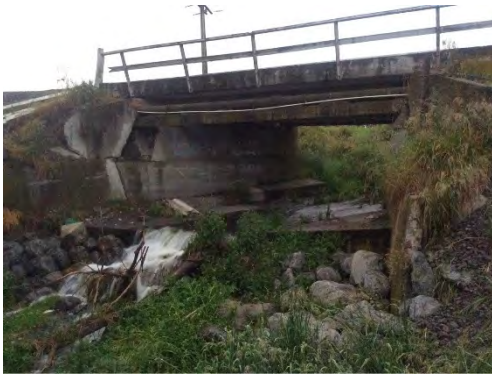
An ~9.5-m long, single lane bridge that crosses Middle Creek on Mt Fyffe Road also experienced damage, as shown in Figure 6.73 through Figure 6.76. As shown in Figure 6.73(b), fill was placed to compensate for subsidence of the both the north and south approaches and the barriers on the northern approach rotated outward. Also, both the reinforced concrete north and south abutments to the bridge experienced cracking (Figure 6.74-Figure 6.76).

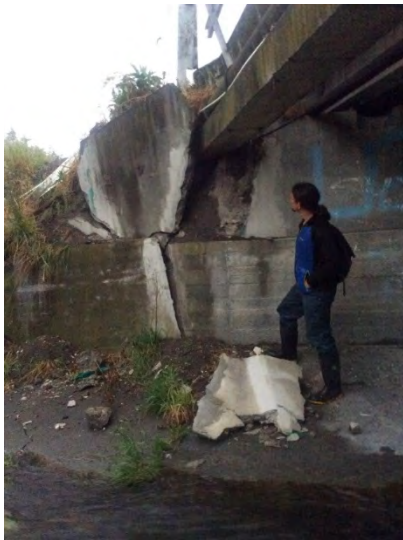
Figure 6.74: Damage to the south abutment on the east side of the bridge (8 Dec 2016, facing south) [-42.3692, 173.6547].

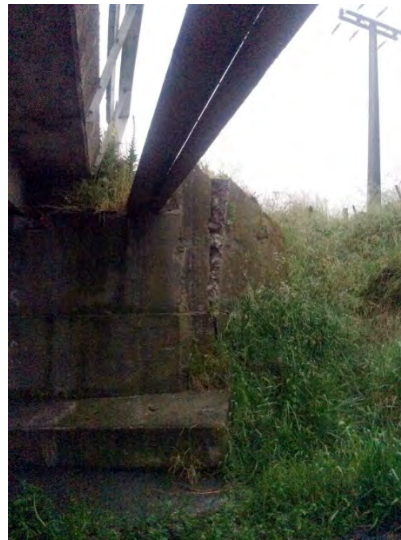
Figure 6.75: Damage to the north abutment on the east side of the bridge (8 Dec 2016, facing north) [-42.3692, 173.6549].

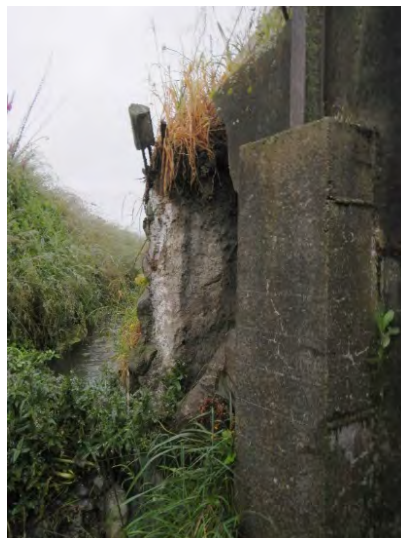
Figure 6.76: Damage to the north abutment on the west side of the bridge (8 Dec 2016, facing north) [-42.3692, 173.6547].

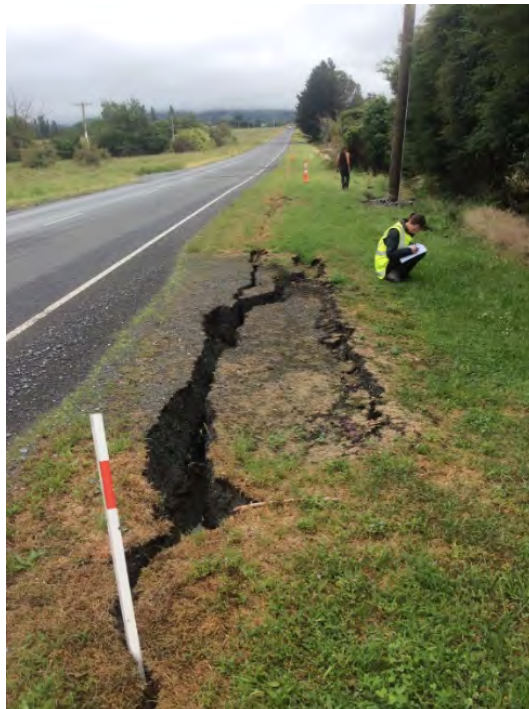
Figure 6.77: Lateral spreading cracks at the side of Athelney Road (9 Dec 2016, facing north) [-42.3598, 173.6765]. Note the drainage ditch to the right of the photo.

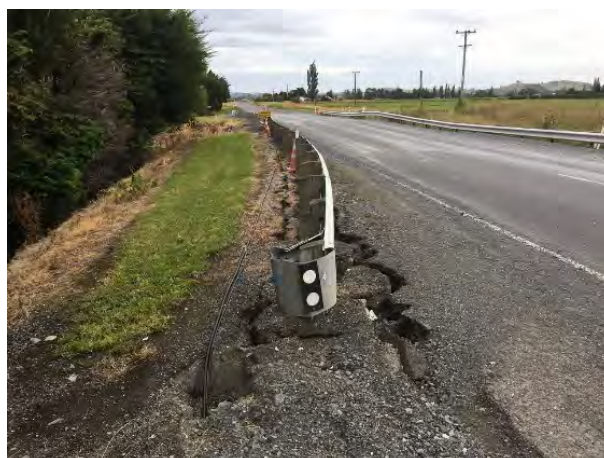
Figure 6.78: Cracking on the north-side of the Waimagarara culvert on Athelney Road (9 Dec 2016, facing south) [-42.3599, 173.6765].

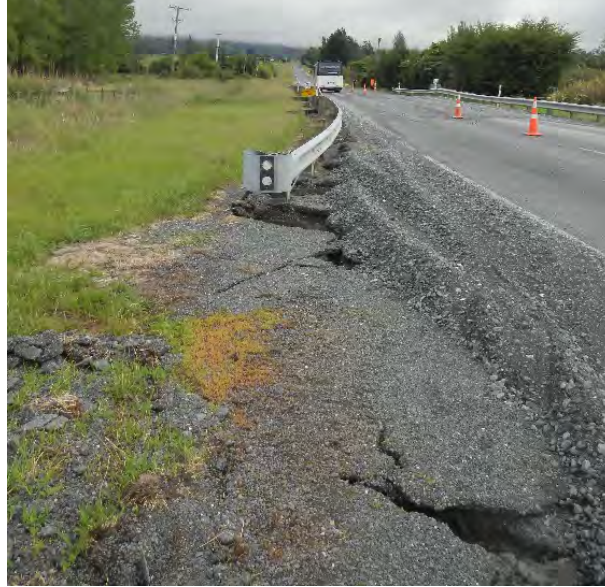
Figure 6.79: Cracking on the south side of the Waimagarara culvert on Athelney Road (9 Dec 2016, facing north) [-42.3606, 173.6765].

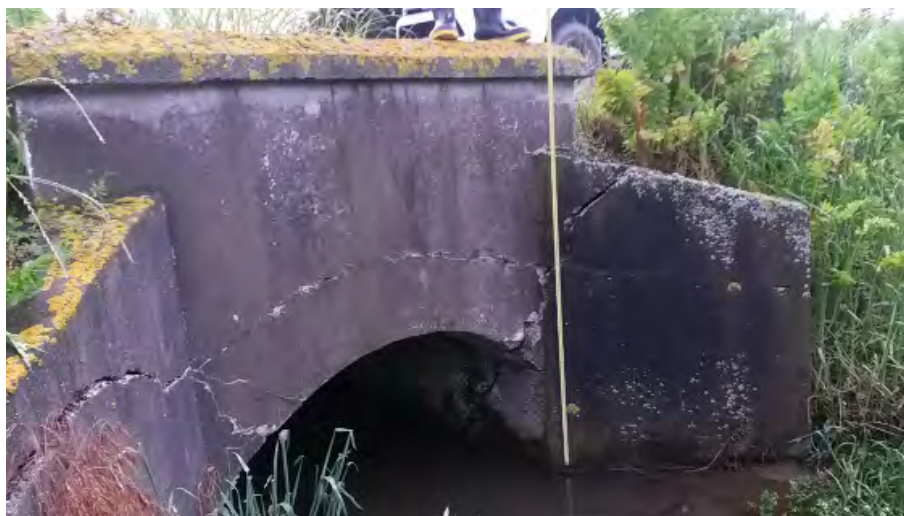
Figure 6.81: Cracking in the concrete at Hawthorne Road culvert (8 Dec 2016, facing northwest) [-42.3900, 173.6675].

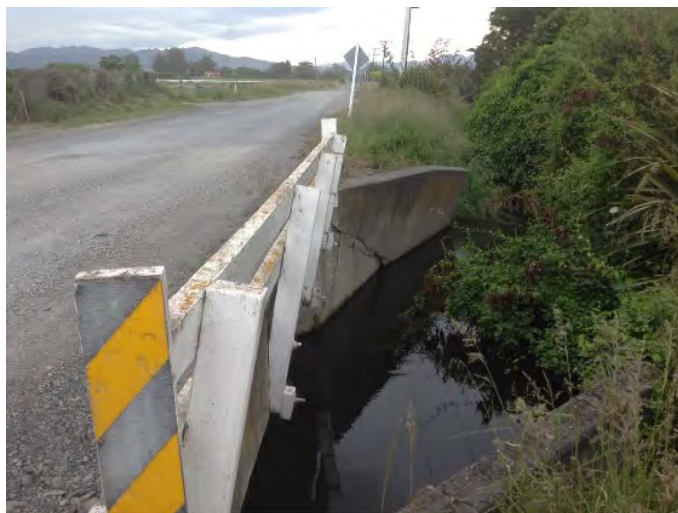
Figure 6.82: Failure of the northwest wingwall of the Lyell Creek culvert on Mill Road (8 Dec 2016, facing west) [-42.3765, 173.6788].

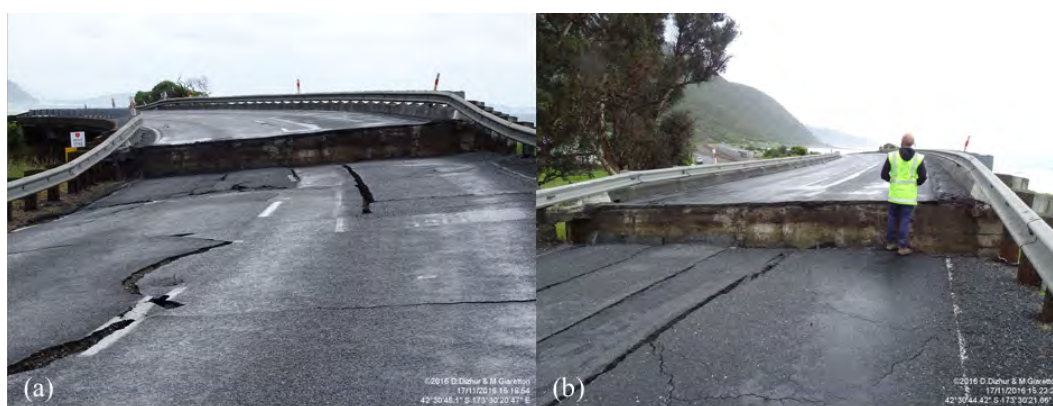
Figure 6.83: Settlement and severe approach roadway cracking at southern abutment to Oaro Overbridge [-42.5121, 173.5063] looking north. Photos by D. Dizhur and M. Giaretton.

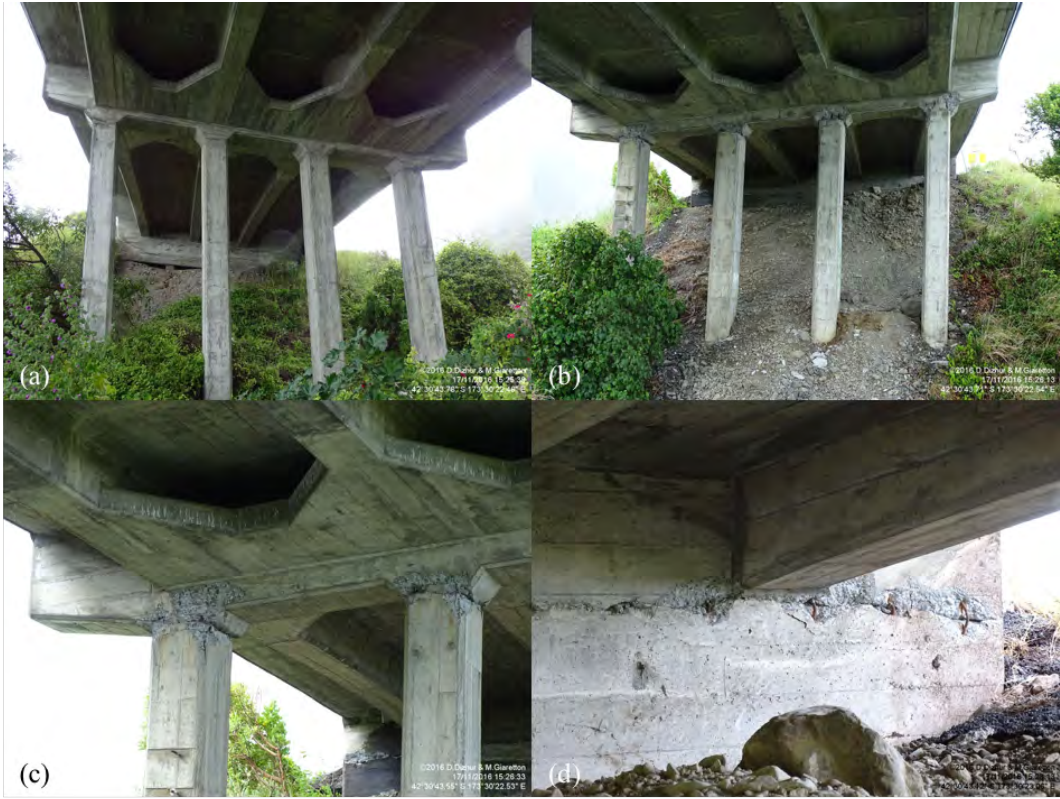
Figure 6.84: Damage at Oaro Overbridge [-42.5121, 173.5063]: (a) Settlement of fill ahead of southern abutment and cracking at top of pier columns looking south; (b) Cracking in fill ahead of northern abutment and plastic hinging at top of pier columns looking north; (c) Closer view of damage at top of pier columns in northernmost pier looking north; (d) Cracking across face of northern abutment wall, just below deck beams looking north. Photos courtesy of D. Dizhur and M. Giaretton.

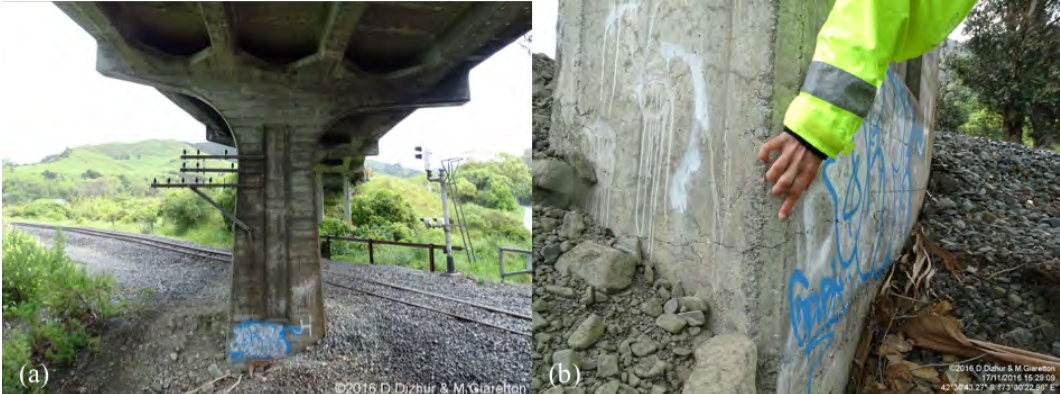
Figure 6.85: Damage at Oaro Overbridge [-42.512089, 173.506345]: (a) Northernmost central hammerhead pier looking south; (b) Flexural cracking at base of northernmost hammerhead pier. Photos courtesy of D. Dizhur and M. Giaretton.

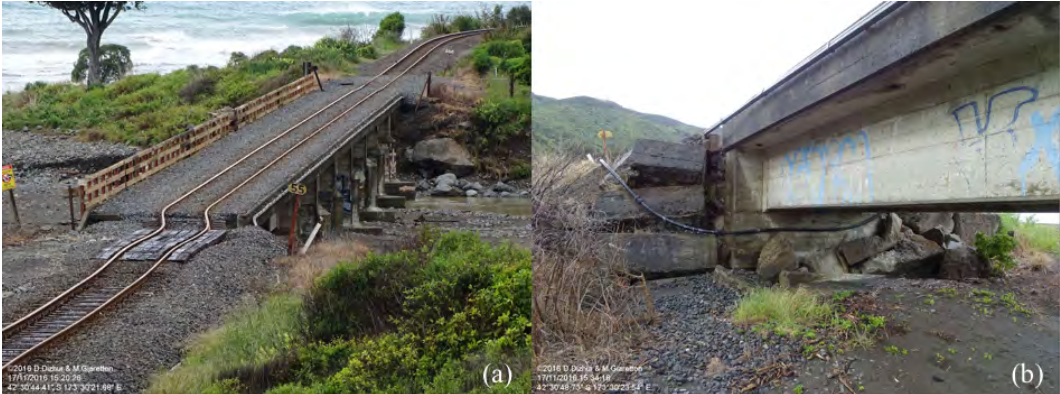
Figure 6.86: Damage at Oaro River Rail Bridge [-42.514025, 173.50682]: (a) Residual lateral deformation towards the east at the northern abutment has bent the tracks (photo looking south); (b) Northern abutment looking north. Photos courtesy of D. Dizhur and M. Giaretton.
