Seismological and Engineering Effects of the M 7.0 Samos Island (Aegean Sea) Earthquake

Hellenic Association of Earthquake Engineering: Report 2020/02

Geotechnical Extreme Events Reconnaissance Association: Report GEER-069

December 31, 2020

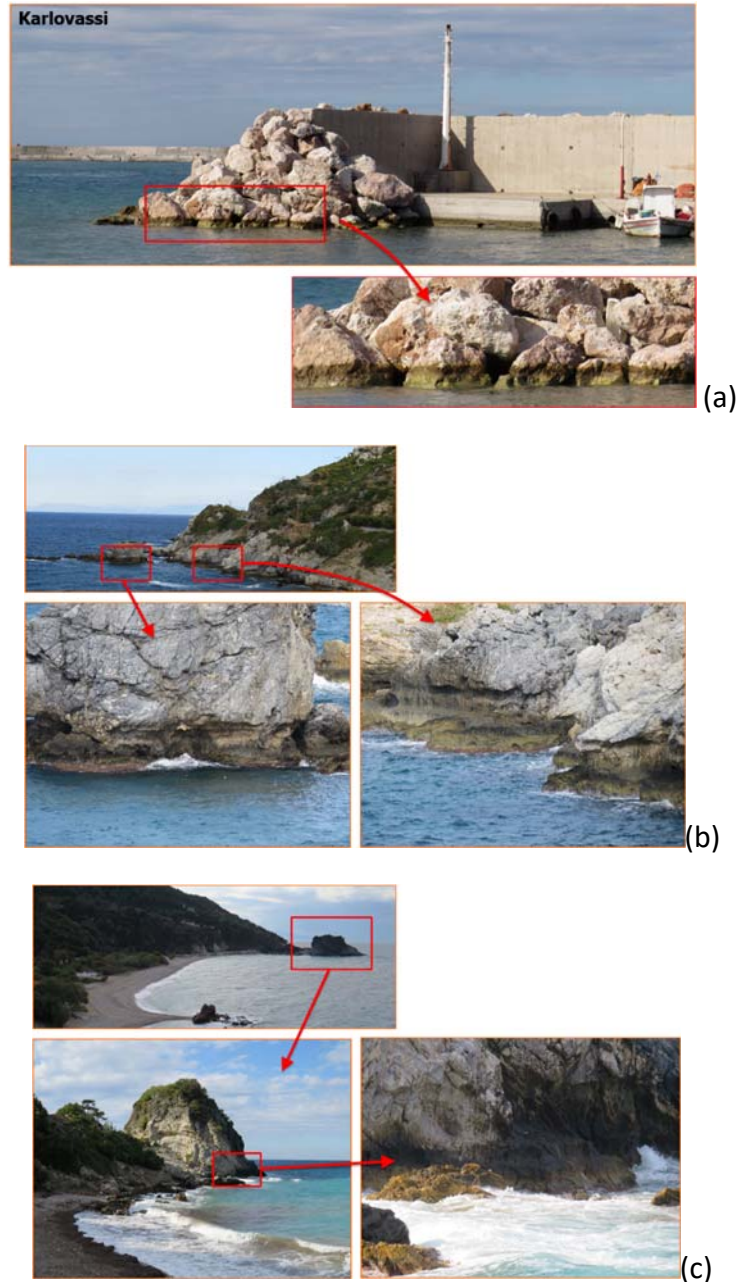
Figure 1.32. Permanent uplift (a) in the Karlovasi coastal area, imprinted not only on protection boulders, but also on the concrete jetty; (b) in the area west of the Karlovasi port imprinted on marbles of the Kerketeas nappe along the rocky promontory in Potami area; c) in the area west of the Karlovasi port imprinted on marbles of the Kerketeas nappe along Punta Promontory.

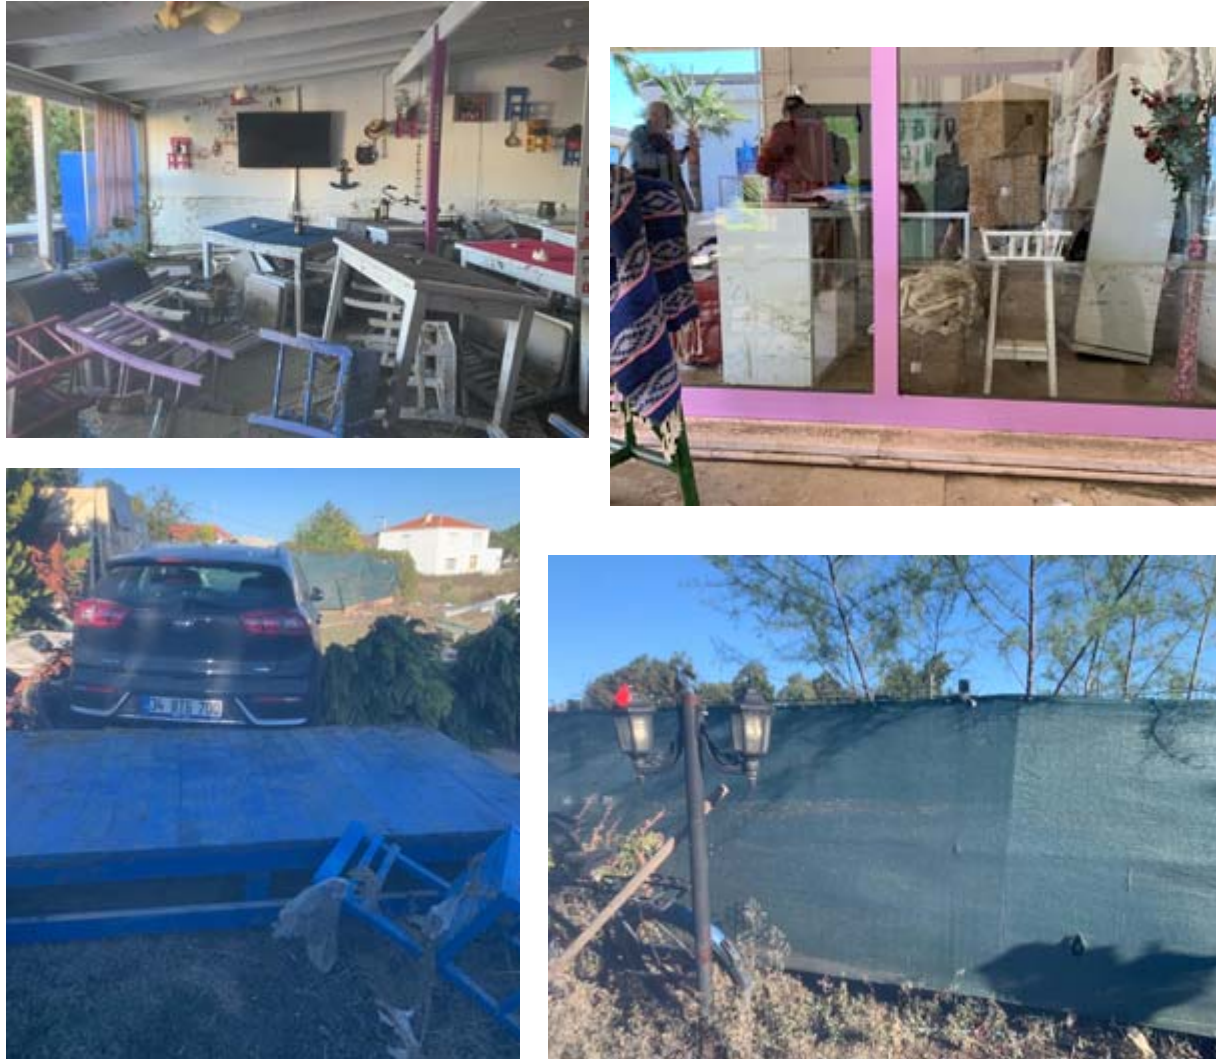
Figure 2.15. Damage on properties and tsunami traces in cafes and shops in Sigacik.

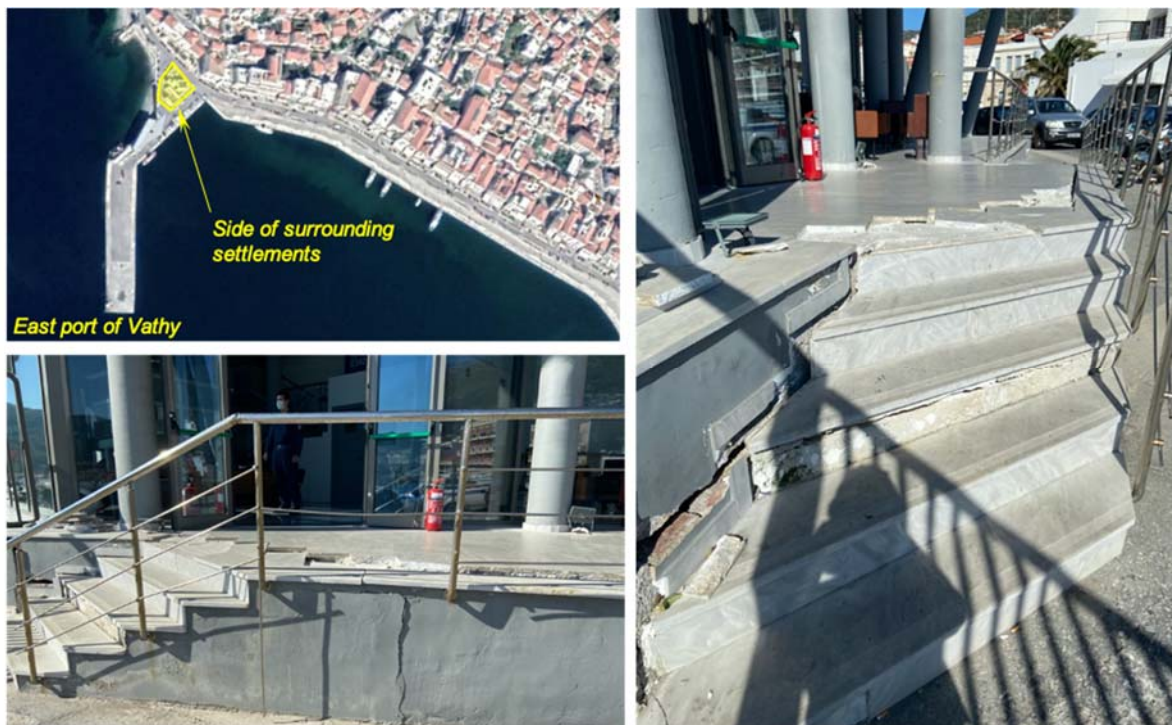
Figure 5.5. Damage observed around the Port authority building in Vathy, Samos (location: 37°45'27.0"N 26°58'15.4"E). The cracks indicate soil settlement/distortion around the building which remained intact and functioning 8 days after the earthquake (8th November 2020) [photos taken by the HAEE reconnaissance team]

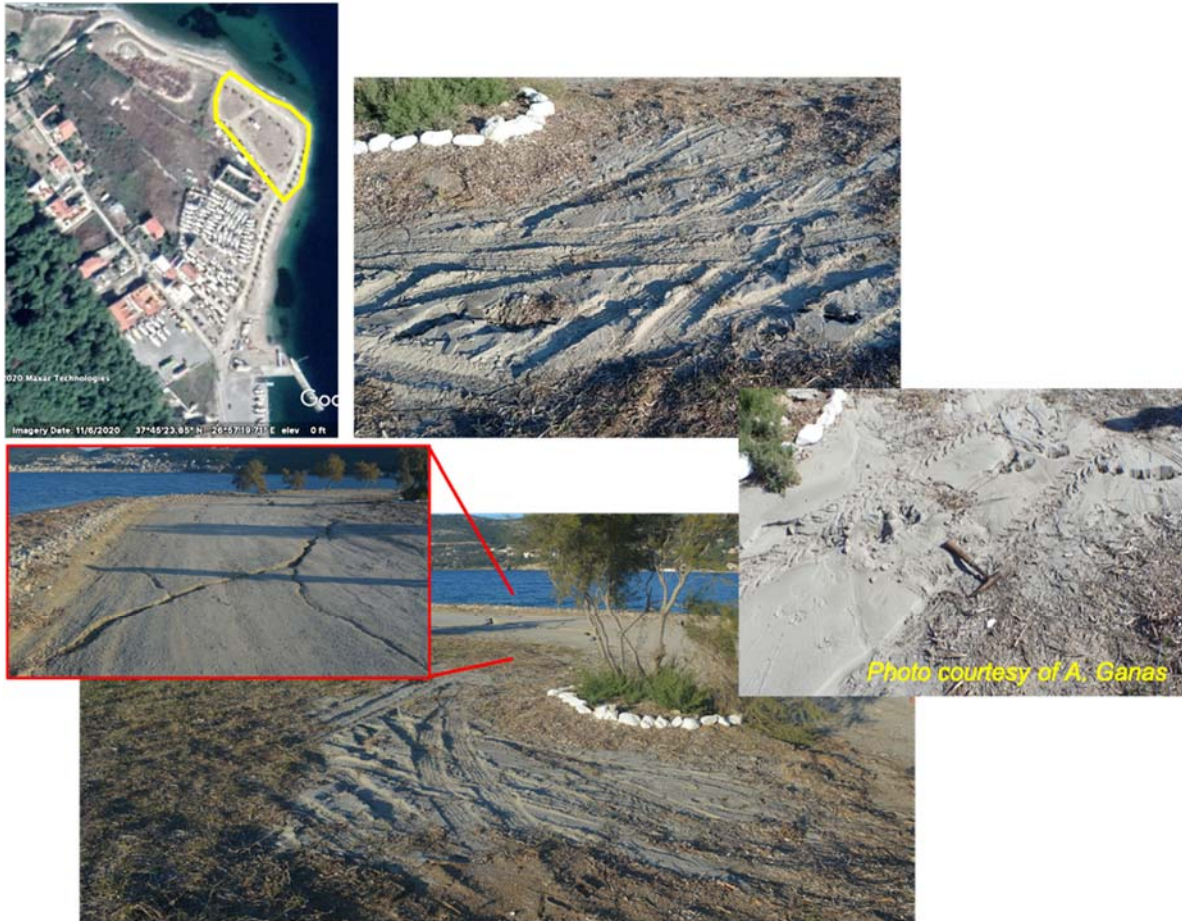
Figure 5.14. Surface manifestations of earthquake-induced soil liquefaction in the form of sand boils in Malagari (location: 37°45'24.6"N 26°57'28.8"E) [photos taken by the HAAE reconnaissance team and Dr. A. Ganas from NOA]

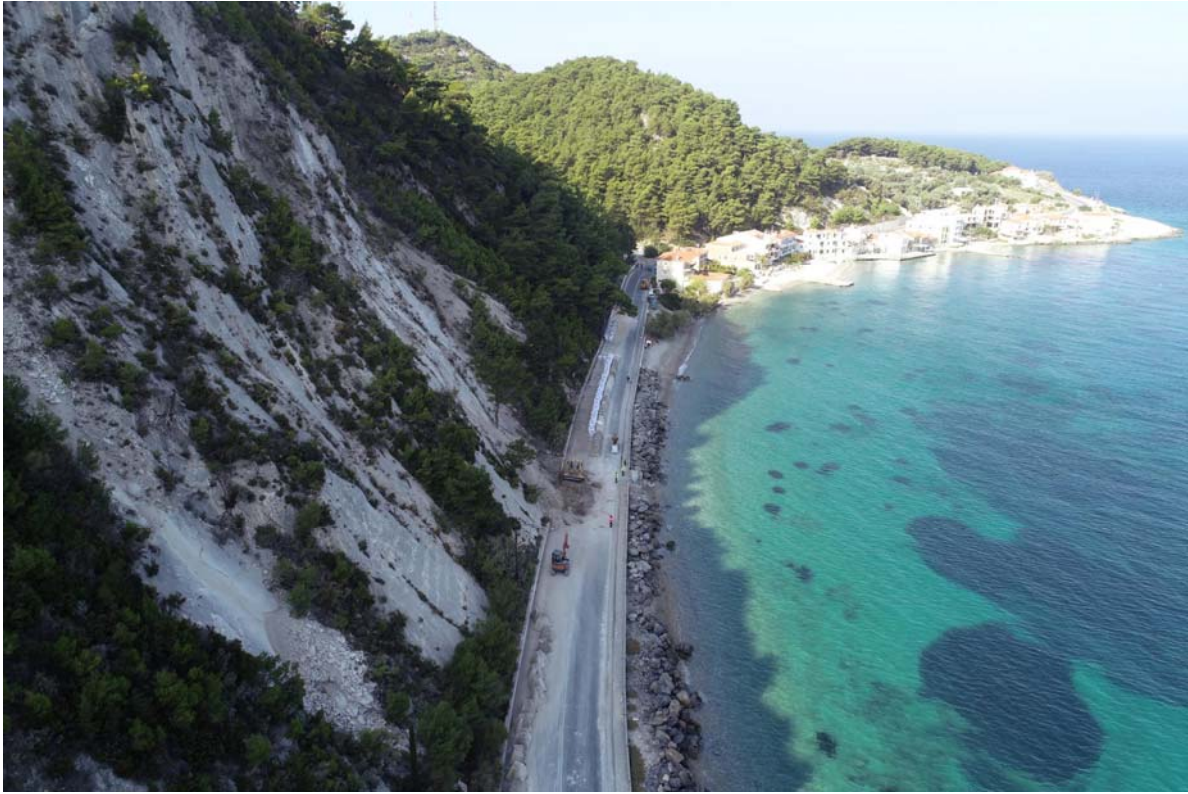
Figure 5.25. Up: A rock slide close to Avlakia region (aerial photograph courtesy of I.N. Spyrou and Prof. K. Ziotopoulou – *to not be reproduced without permission from Prof. Ziotopoulou, 37°47'48.0"N, 26°51'27.7"E*), Bottom – left: a closer view of the above rockslide reported illustrating the rock formation more clearly (picture by HAEE reconnaissance team), Bottom – right: Snapshot from a video recorded during the failure (source: <https://www.cnn.gr/ellada/story/240726/seismos-samos-vinteo-apo-katolisthisi-sta-aylakia>)

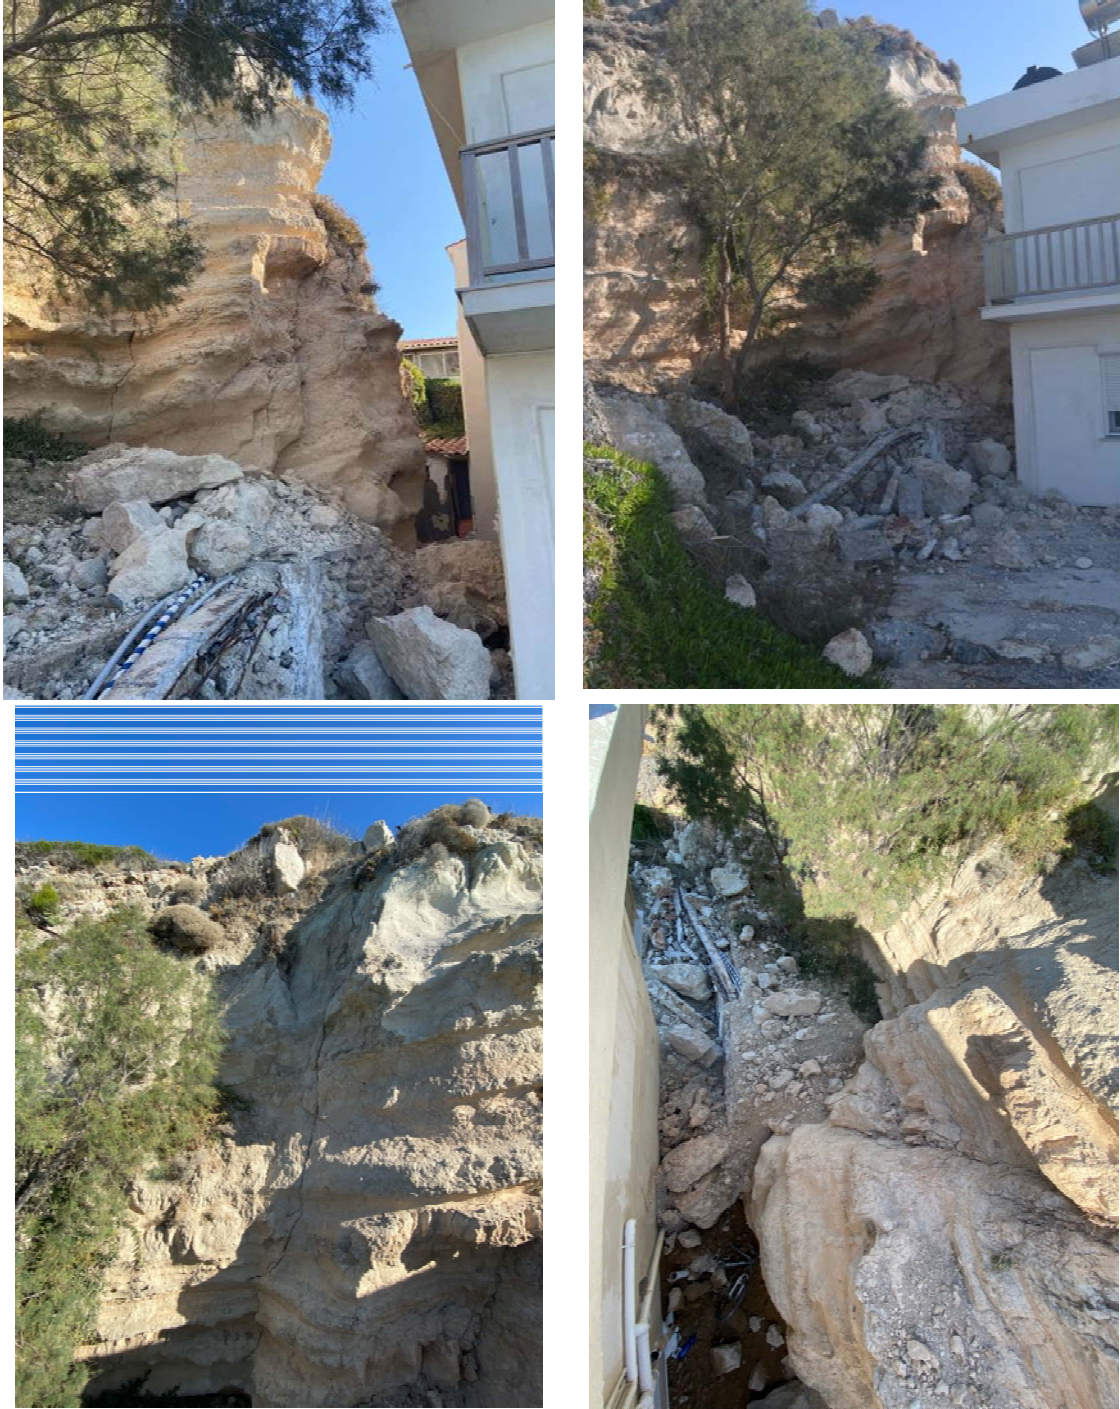
Figure 5.26. Detachment of sandy marls and marly limestones recorded very close to a residential building in the Kokkari region (photos taken by the HAEE reconnaissance team, 37°46'49.9"N, 26°53'35.0"E). Vertical open cracks are visible, clearly susceptible to detachment and overturning.

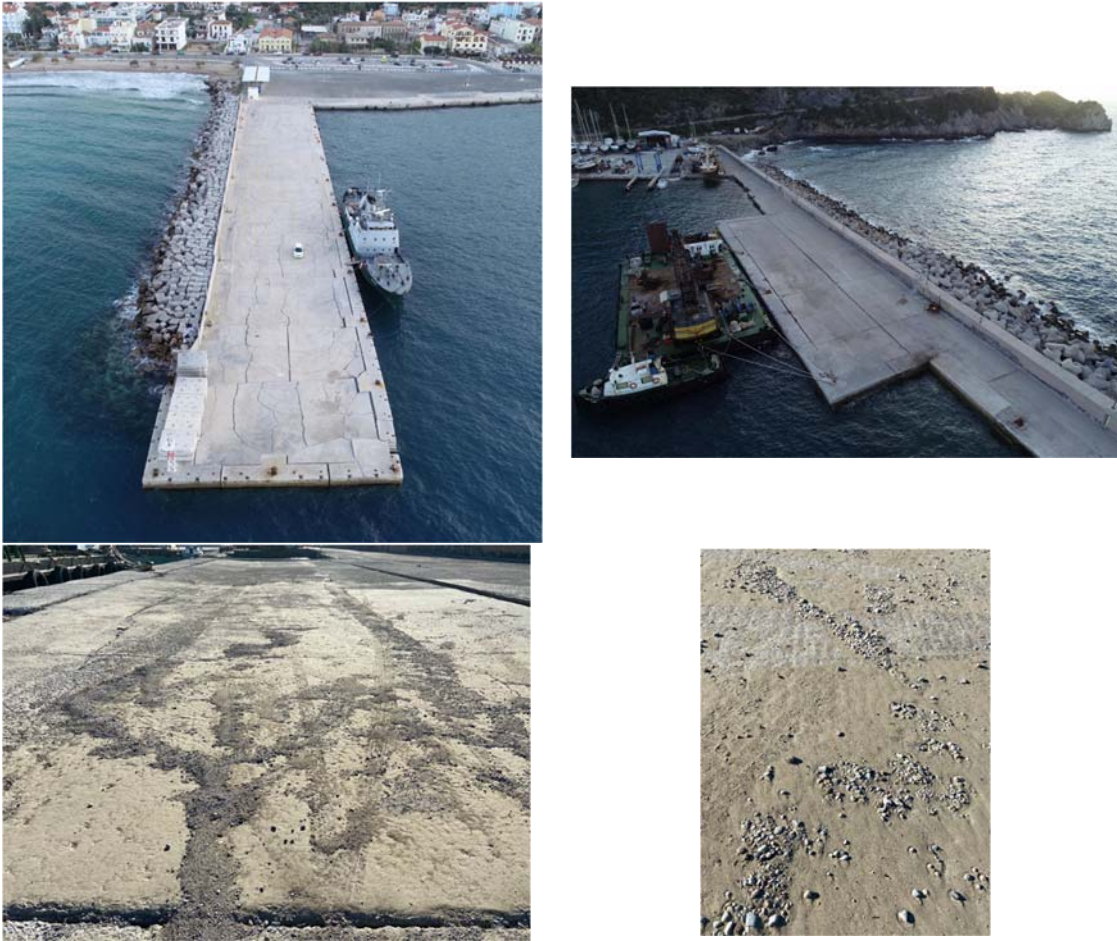
Figure 5.48. (top left) east quay wall of Karlovasi port, (top right) west quay wall of Karlovasi port, (bottom left) ejecta on the west quay wall, presumably product of liquefaction occurrence, and (bottom right) a detailed view of the ejecta, brownish to grey color, mostly sandy and silty with some gravels (aerial photographs courtesy of I.N. Spyrou and Prof. K. Ziotopoulou – *to not be reproduced without permission from Prof. Ziotopoulou*).

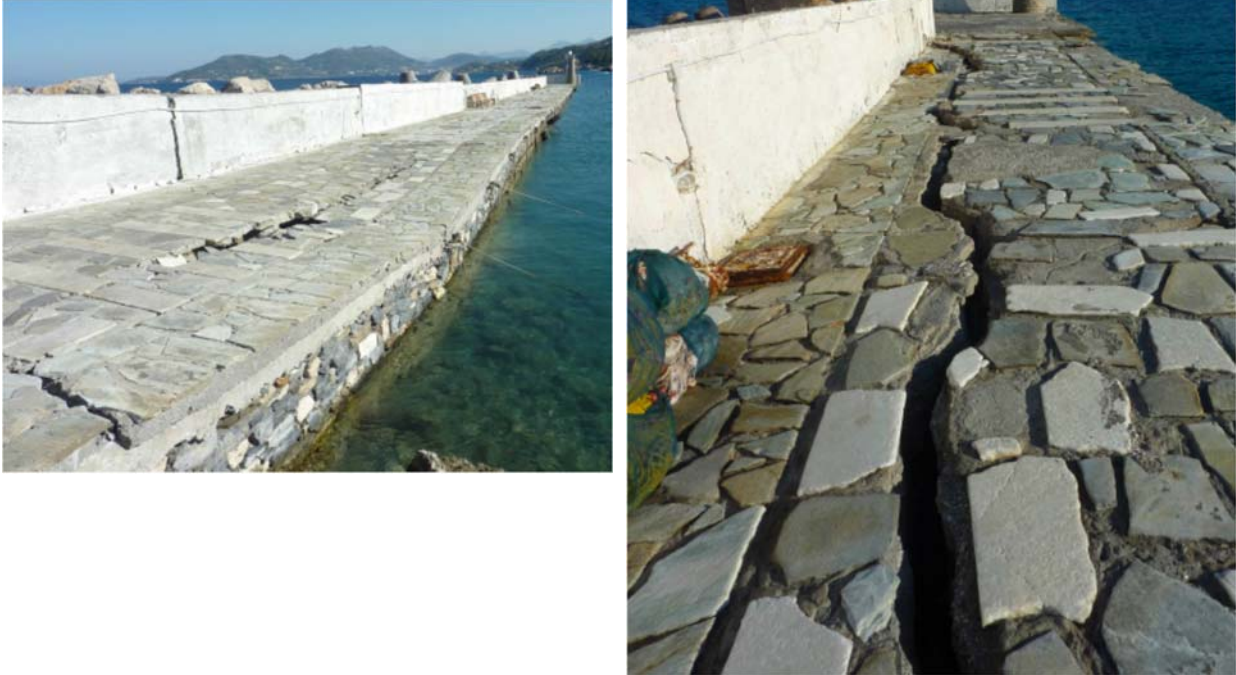
Figure 5.49. (left) clear trends of differential subsidence of the quay wall of Kokkari port with wide open cracks alongside and transversely, (right) close view of an open crack of 10 to 15cm alongside the sea front (HAEE reconnaissance report, 2020).

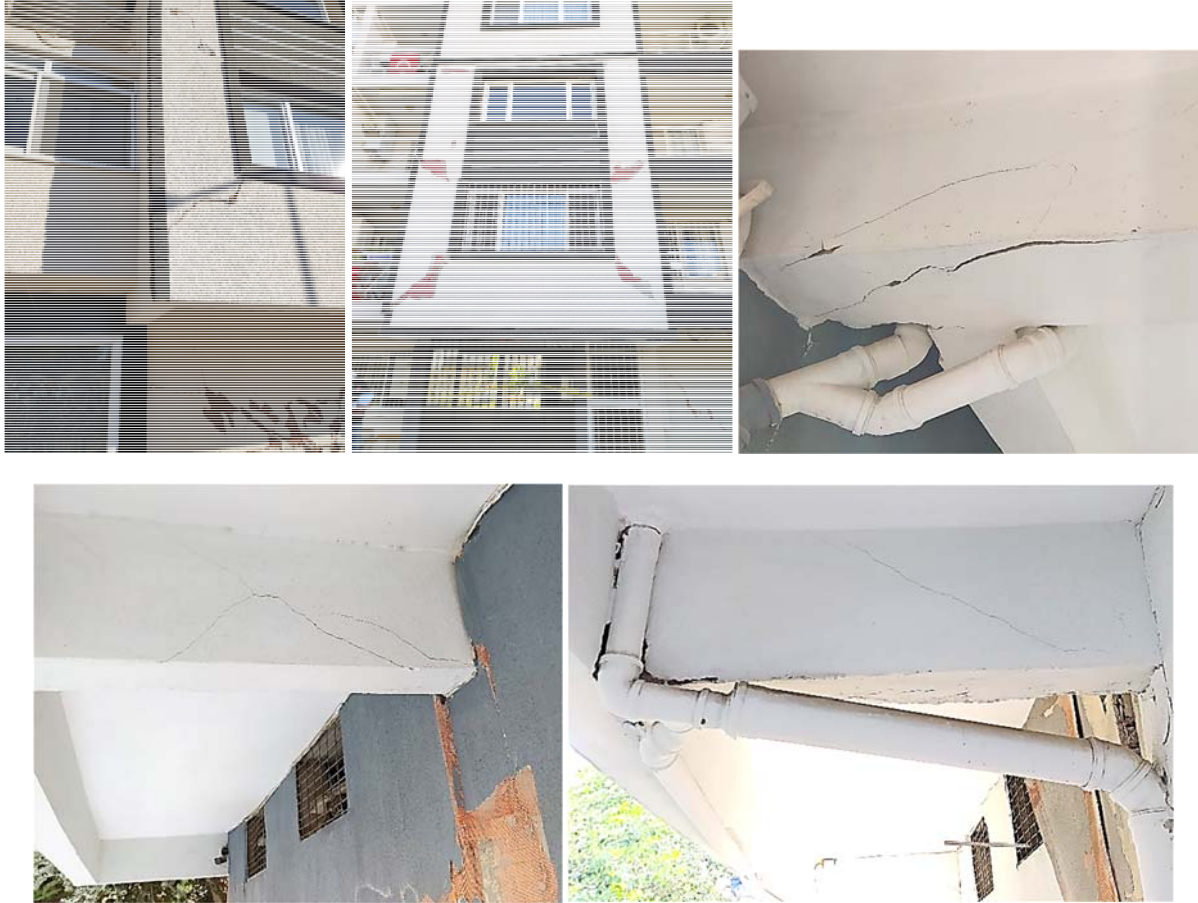
Figure 7.14. Overhang damages

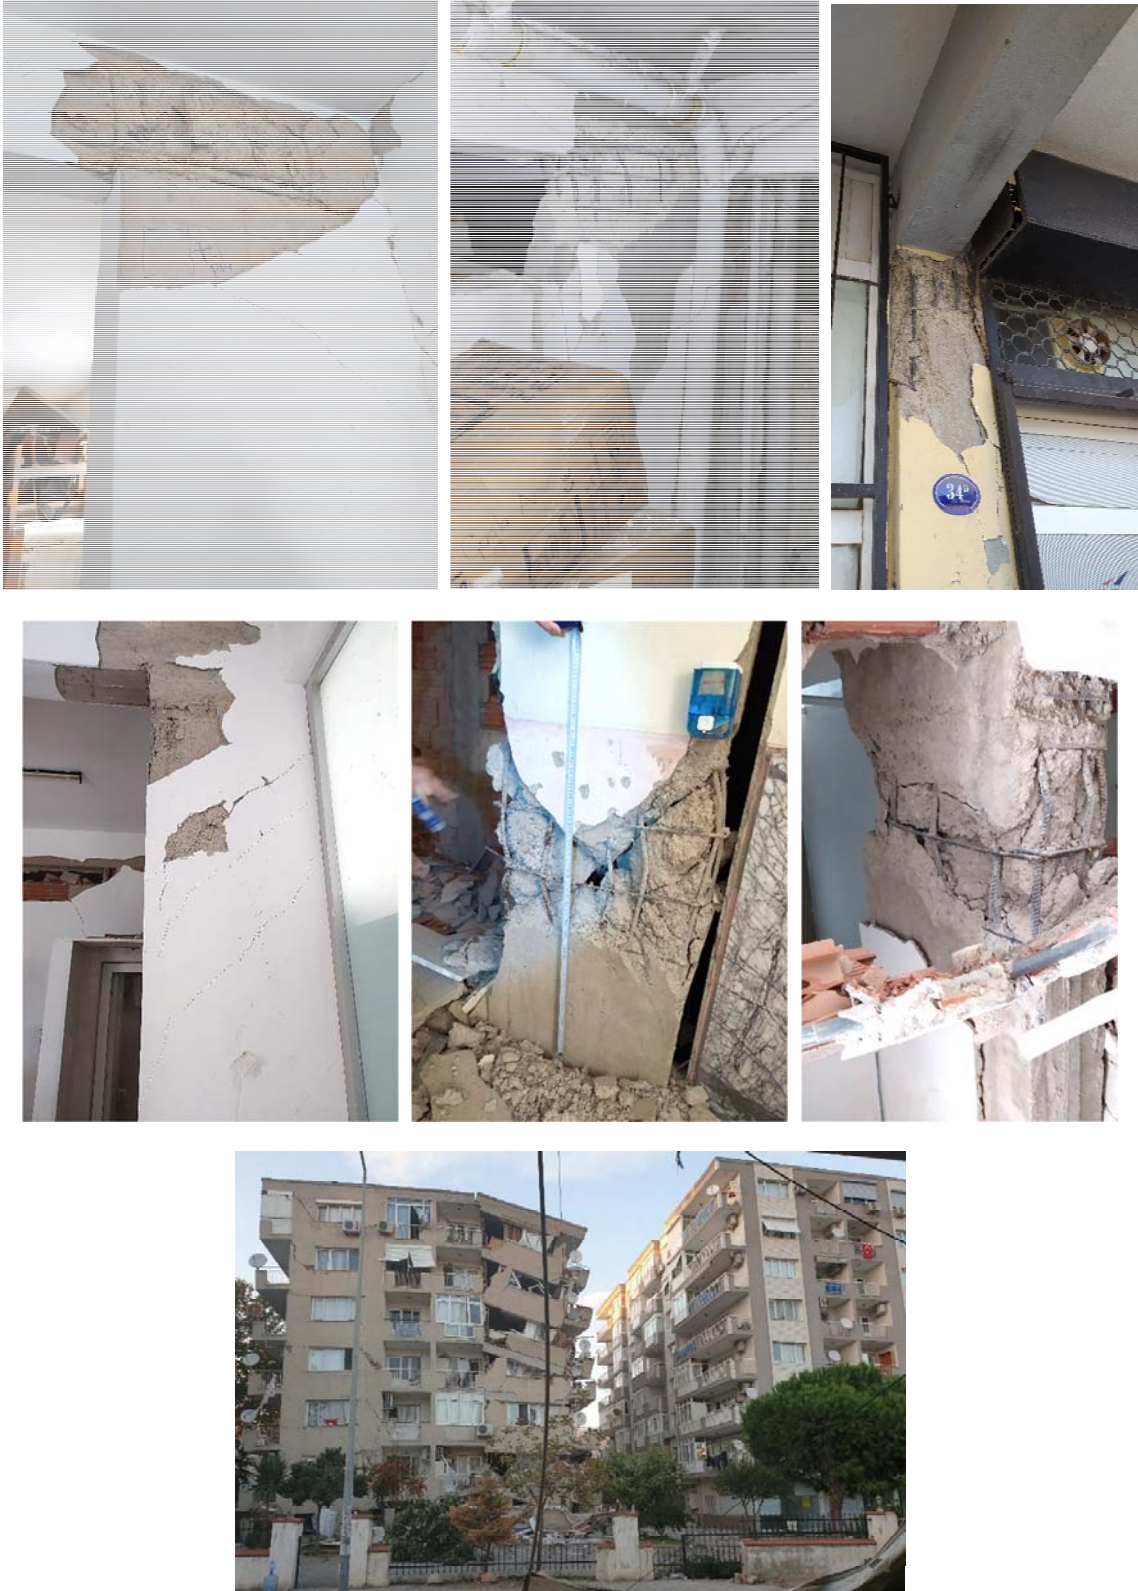
Figure 7.15. Severe column damages

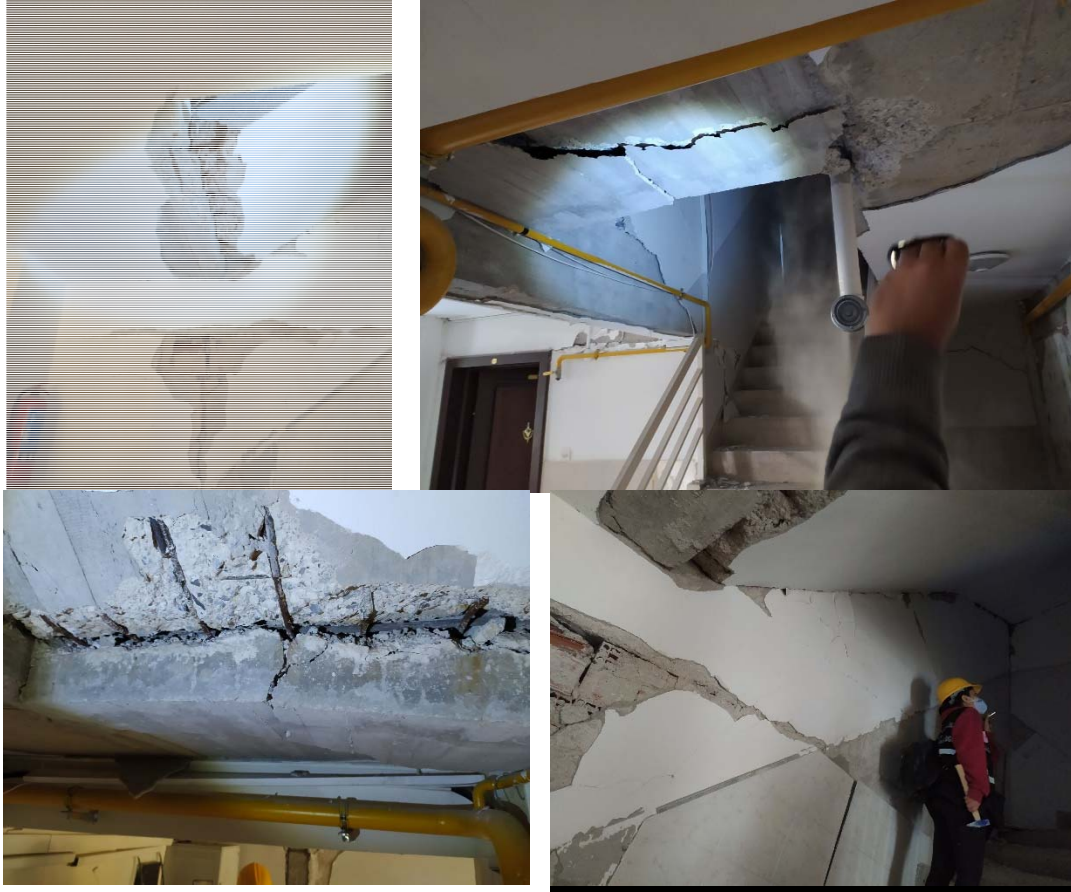
Figure 7.18. Observed staircase damages

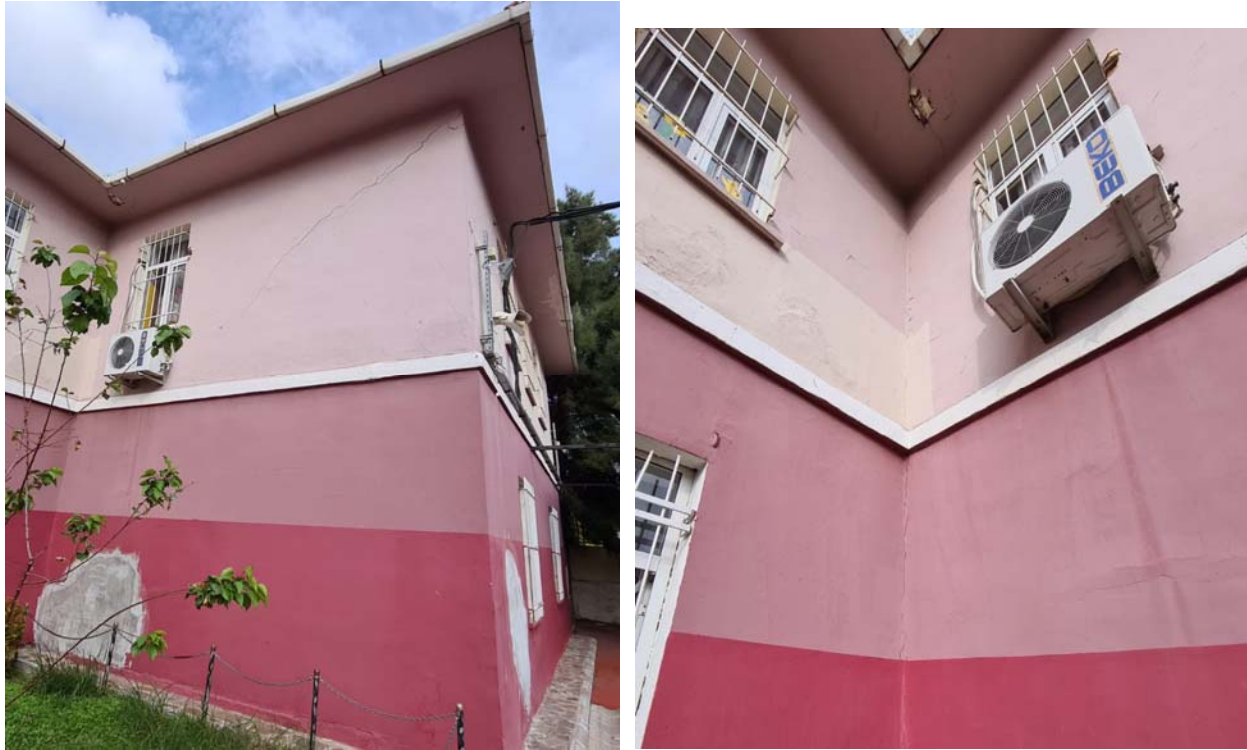
Figure 7.24. Perimeter wall damages in the school building

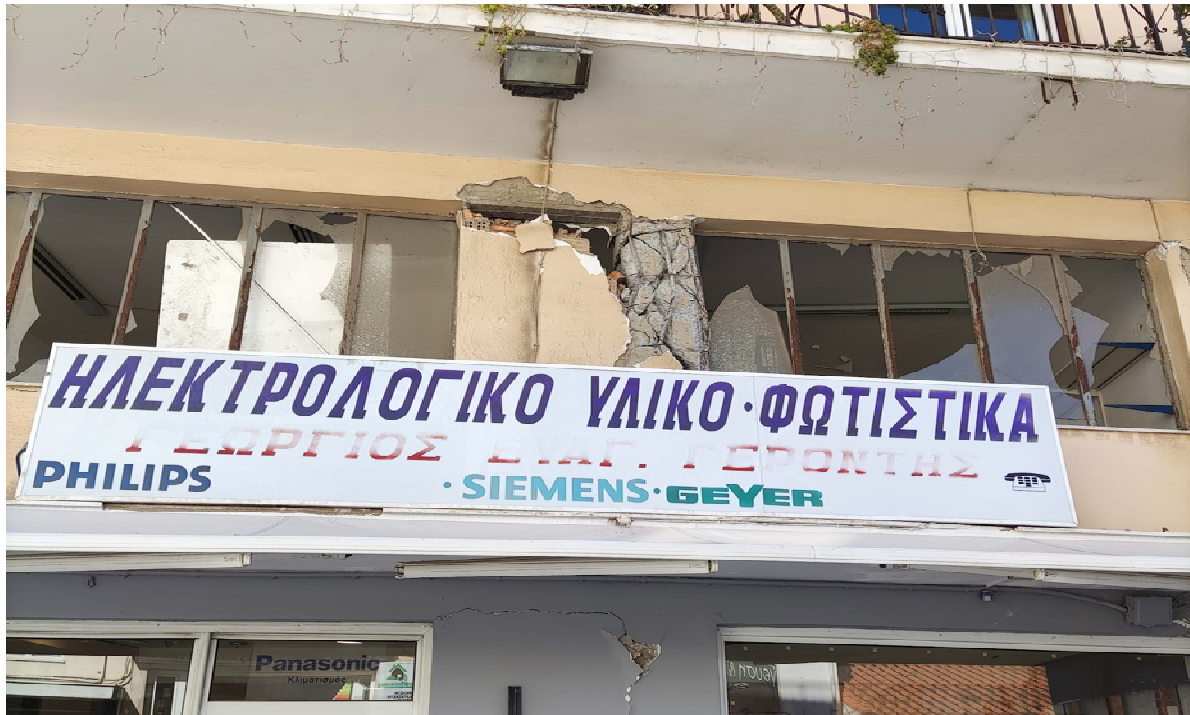
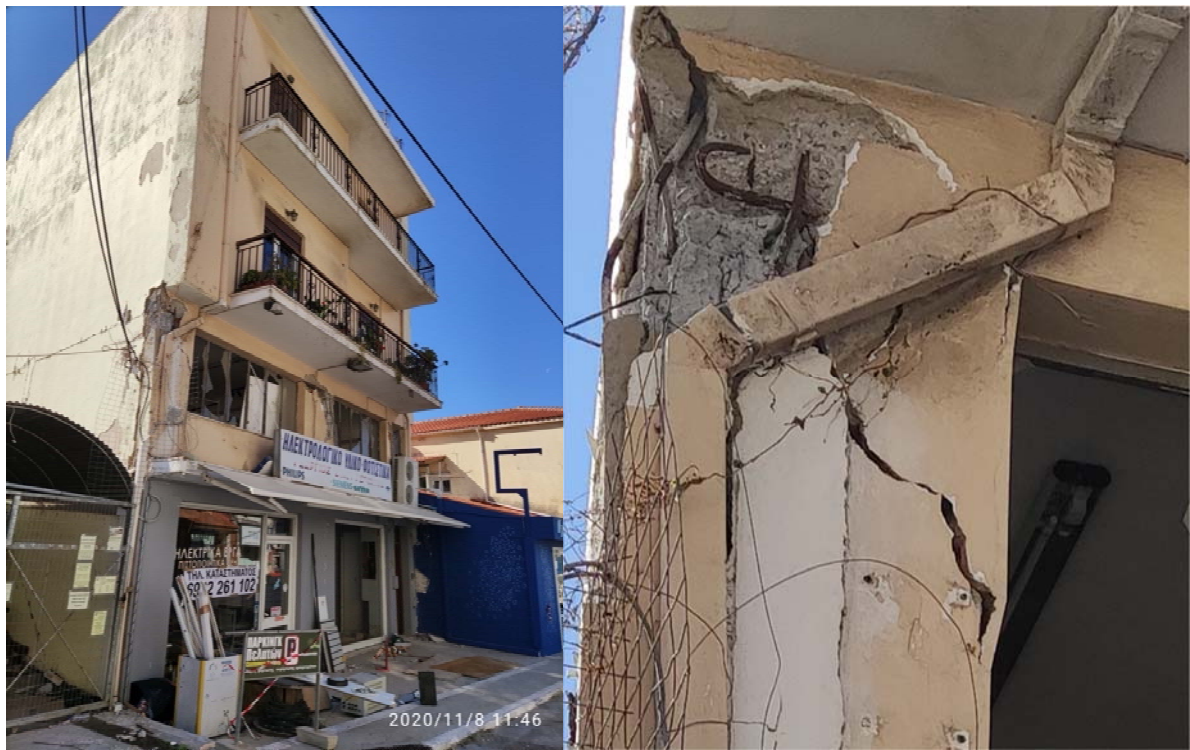
Figure 7.60. Short column (top) and beam-column joint failure of a 4-story building.

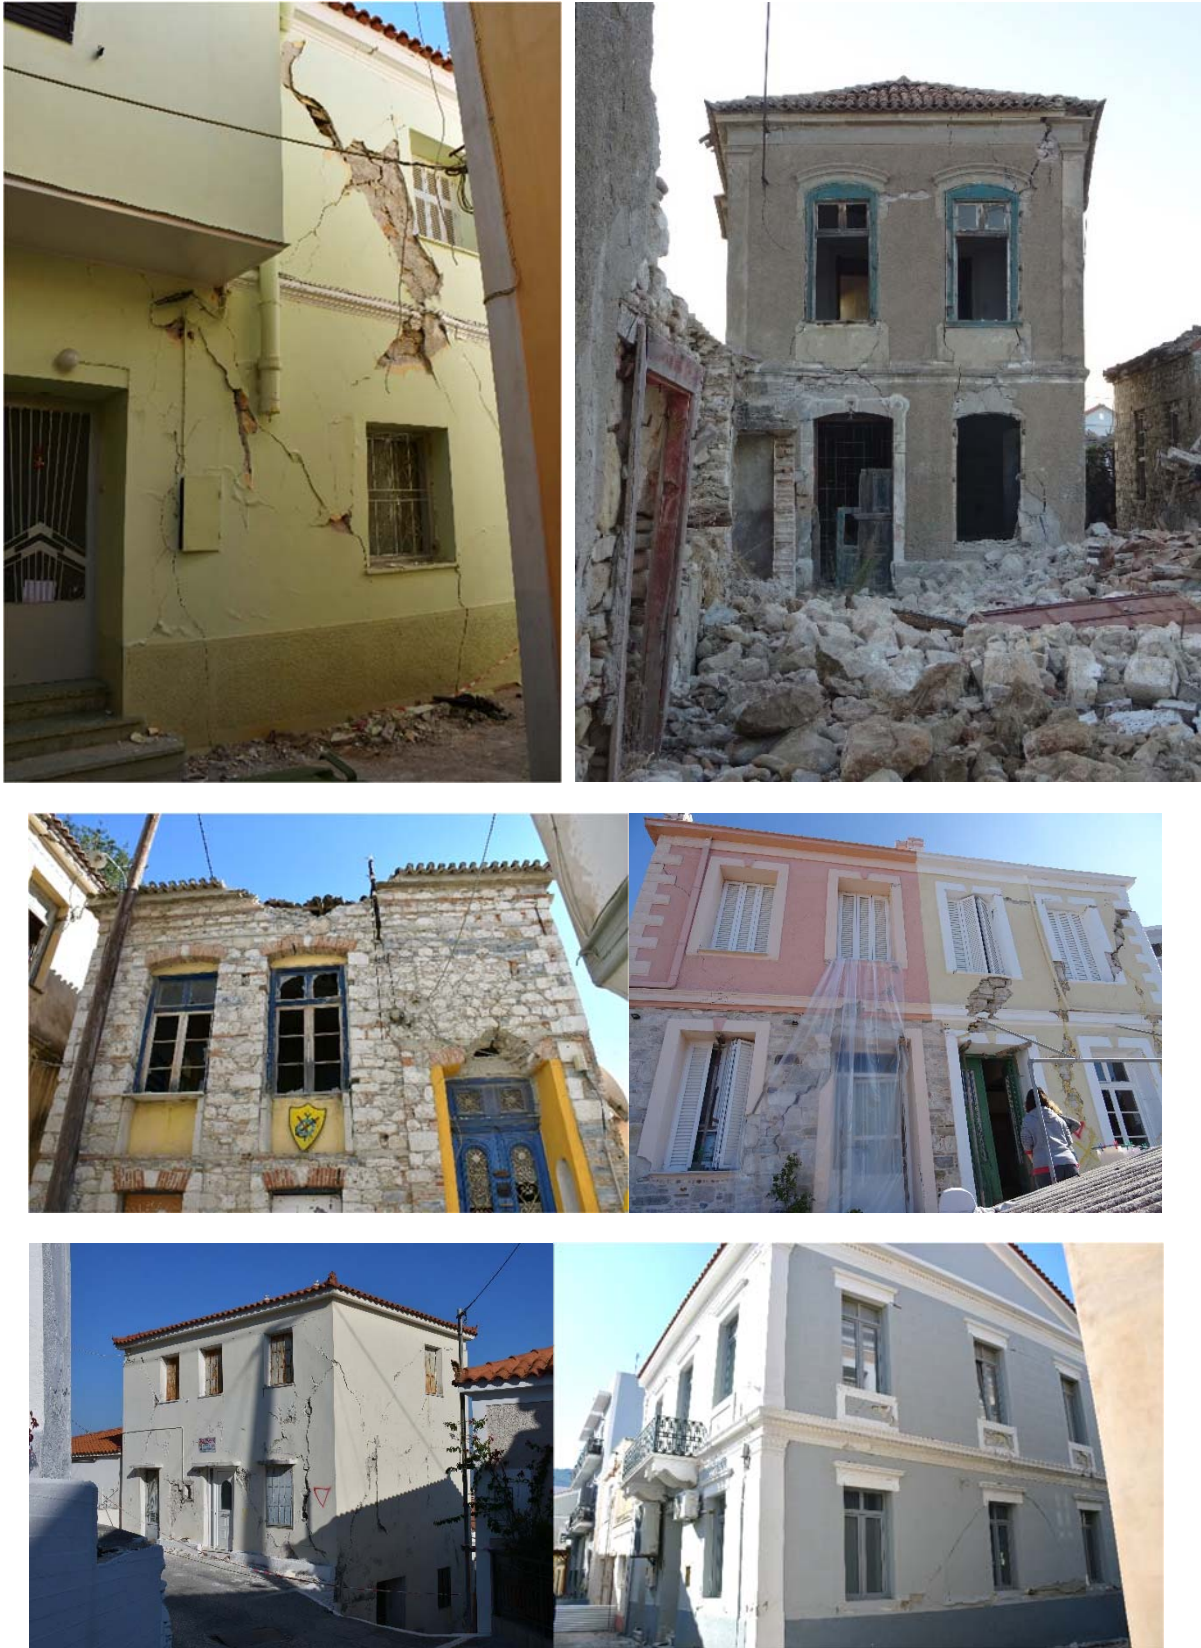
Figure 7.69. In-plane shear damage to walls and lintels.

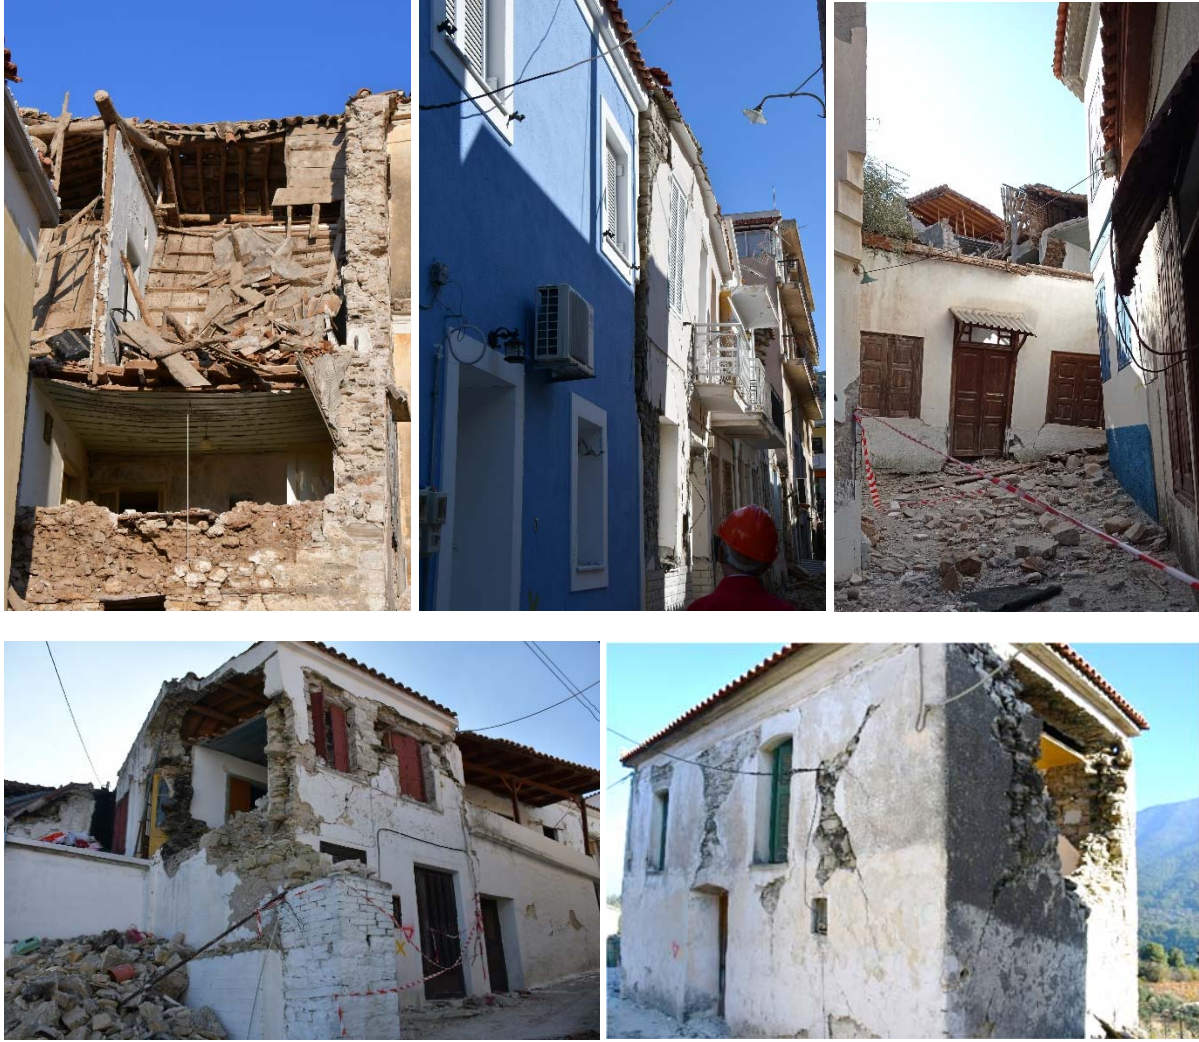
Figure 7.71. Partial collapse of residential masonry buildings.

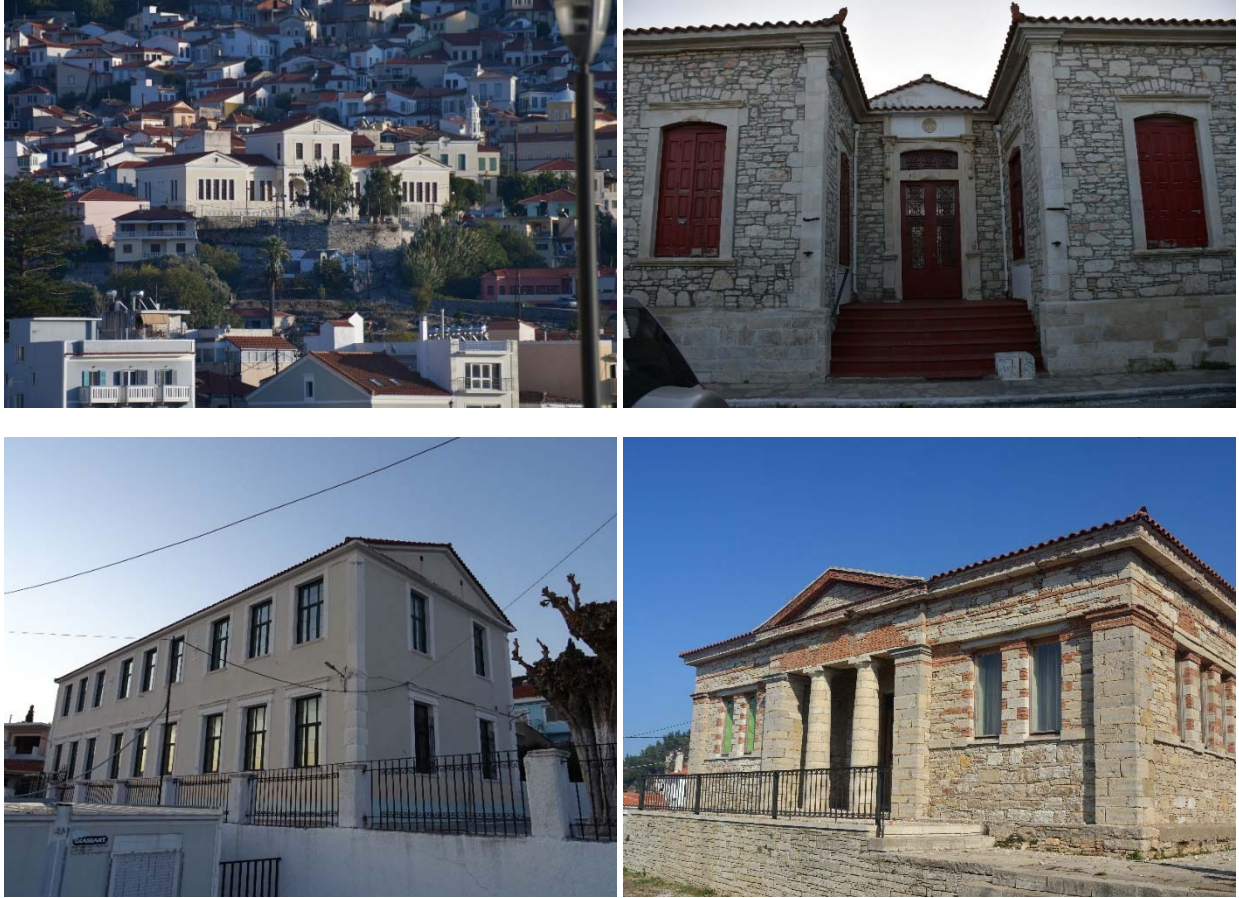
Figure 7.74. School buildings at Vathy. Limited damage was observed.

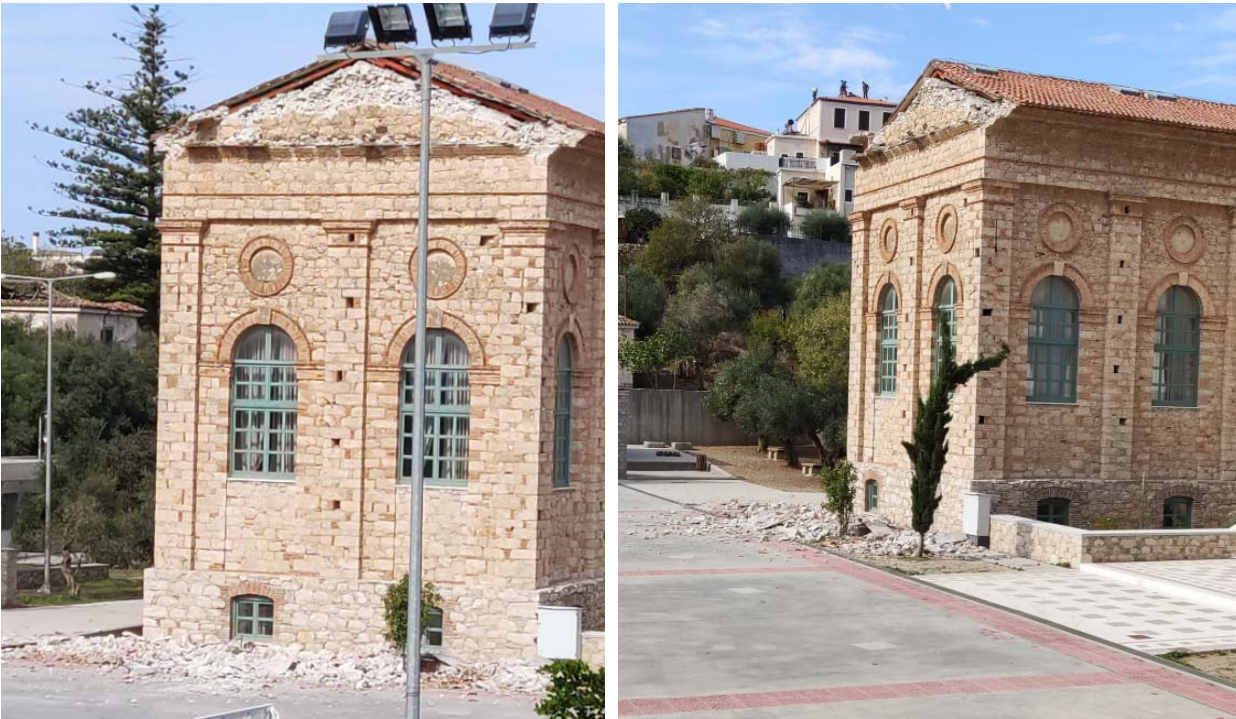
Figure 7.78. Primary school at Karlovassi (Porphyrriad School): damage to the triangular metope and the perimeter eaves, damage to the roof, and cracks inside the building.

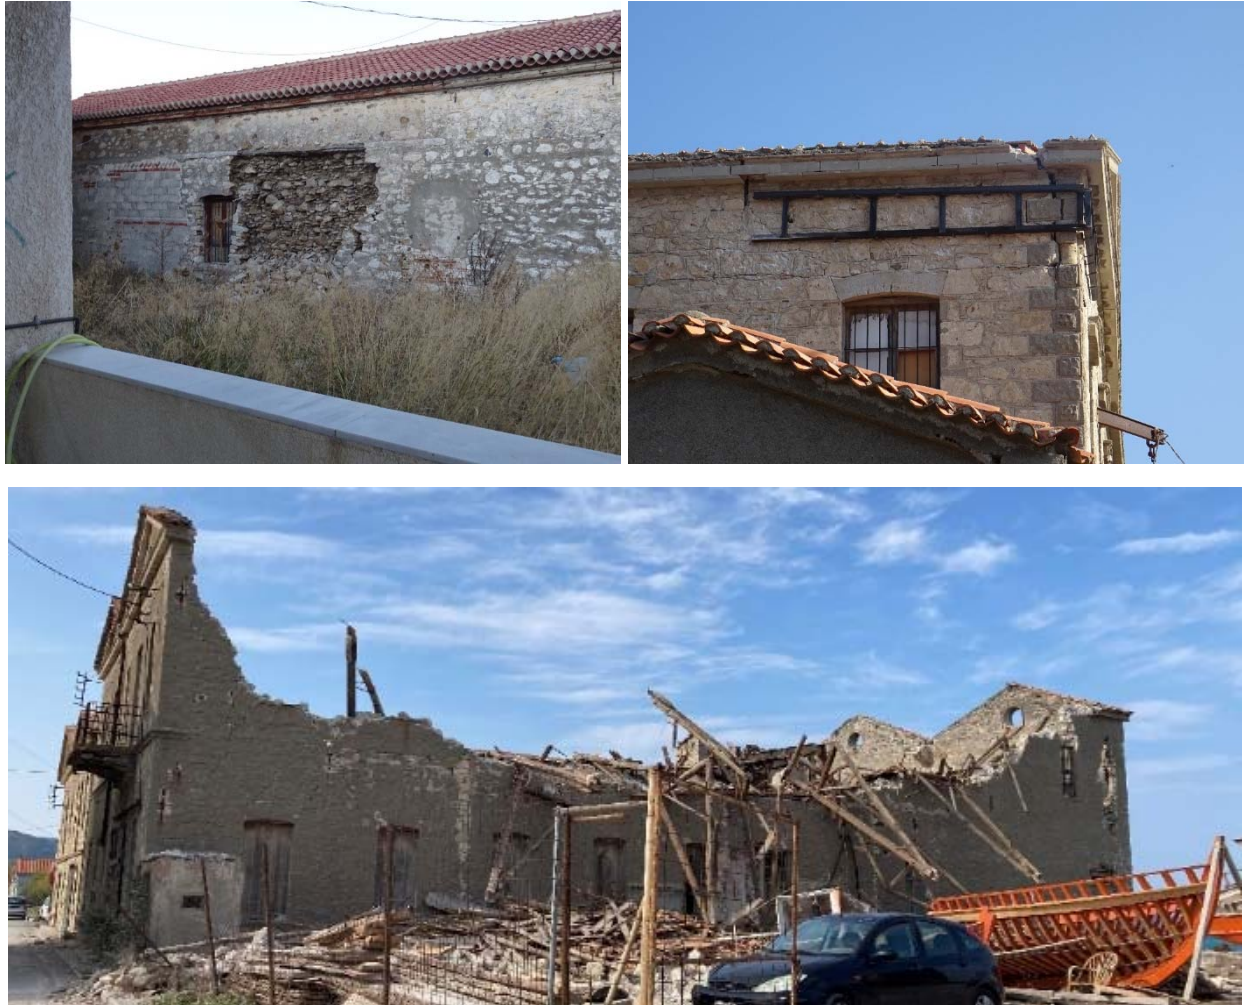
Figure 7.81. Typical damage in tannery buildings at Karlovassi.
