The Corps of Engineers and ERDC Geotechnical related activities during Earthquakes

Richard S. Olsen, PhD, PE

U.S. Army Engineer Research and Development Center (ERDC)

October 7, 2004

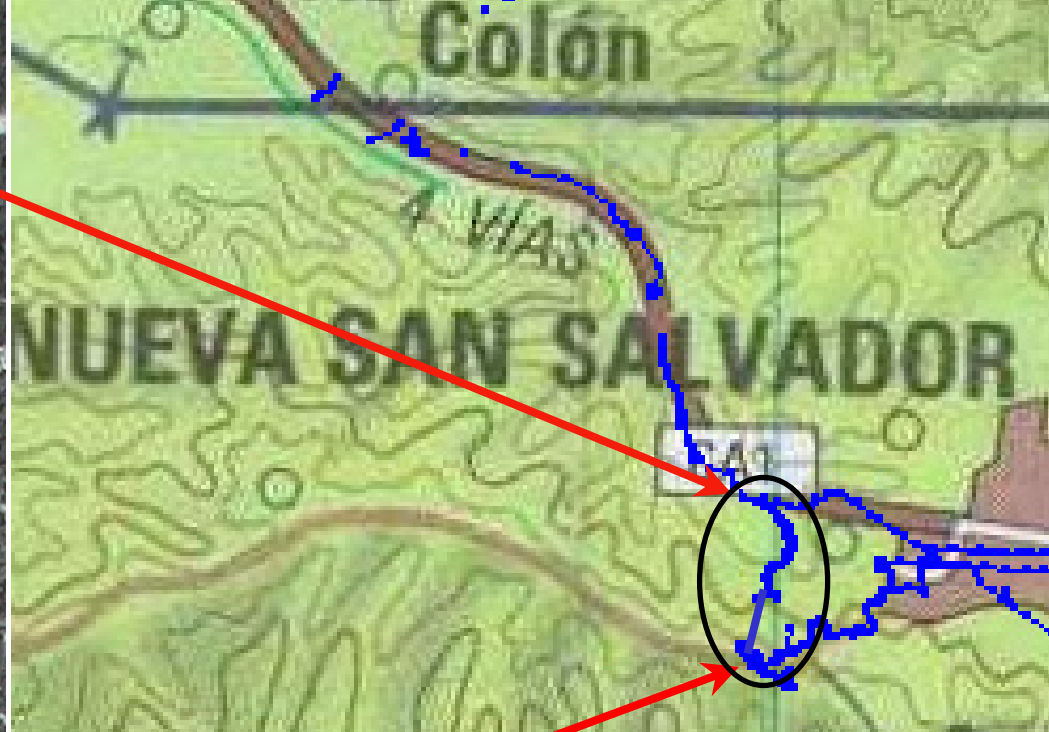
The main landslide was triggered because of a 20 year old dirt road. The initial failure jumped the road and started the debris chute slide.

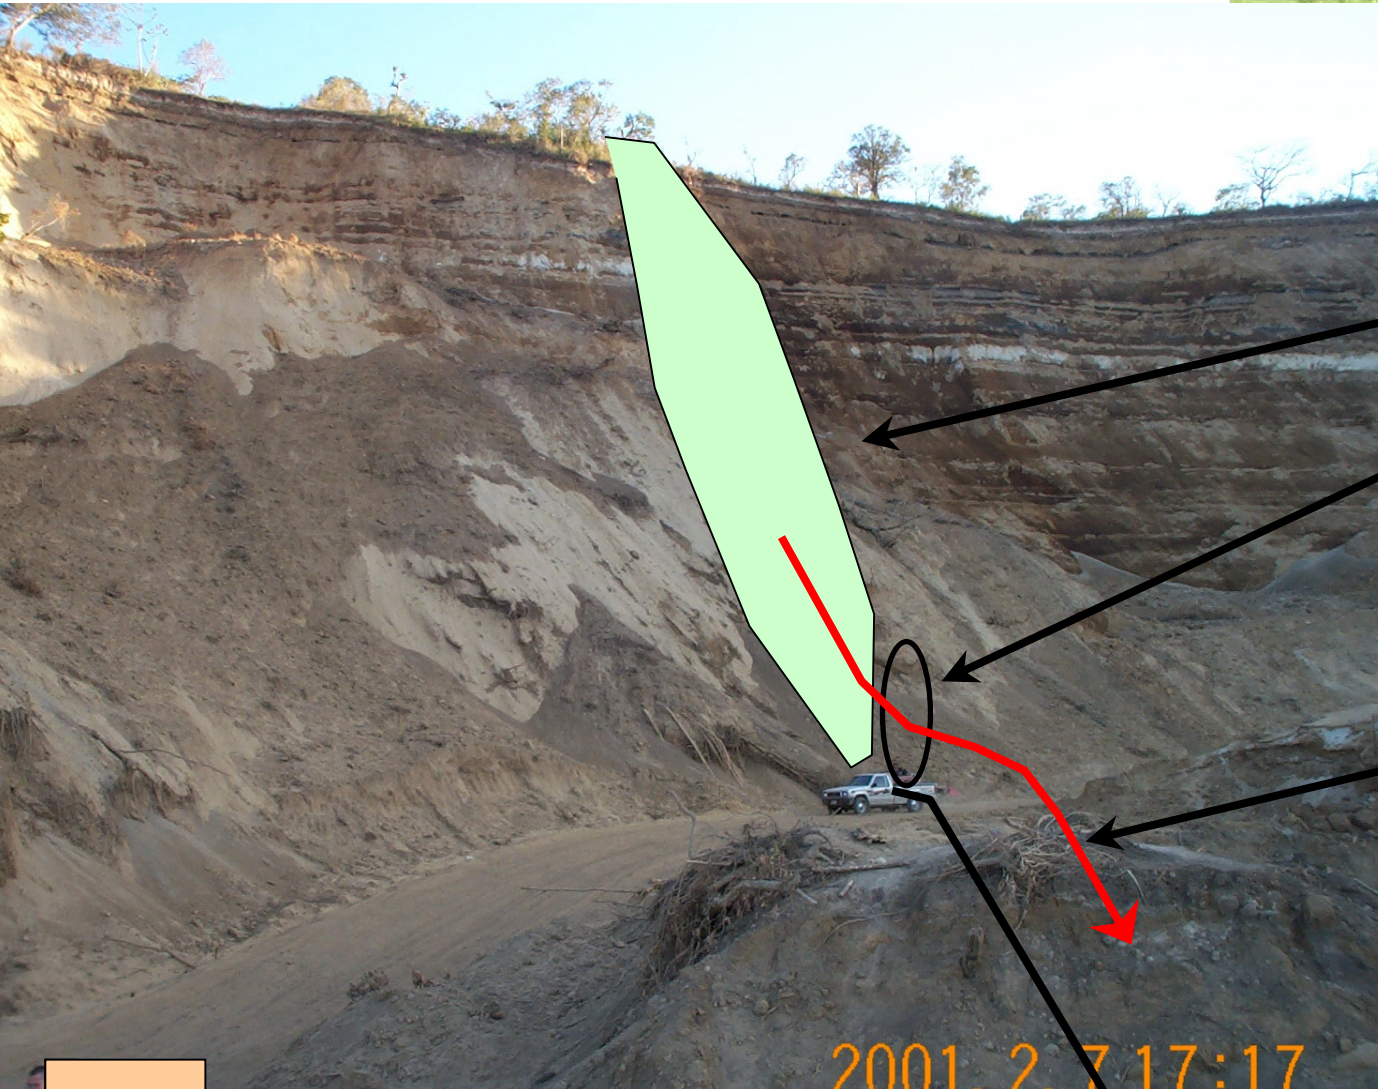
Los Chorros "Chute" Landslide

Road cut (40 years ago) removed the toe from the future landslide

The landslide, triggered by the earthquake "jumped" the road

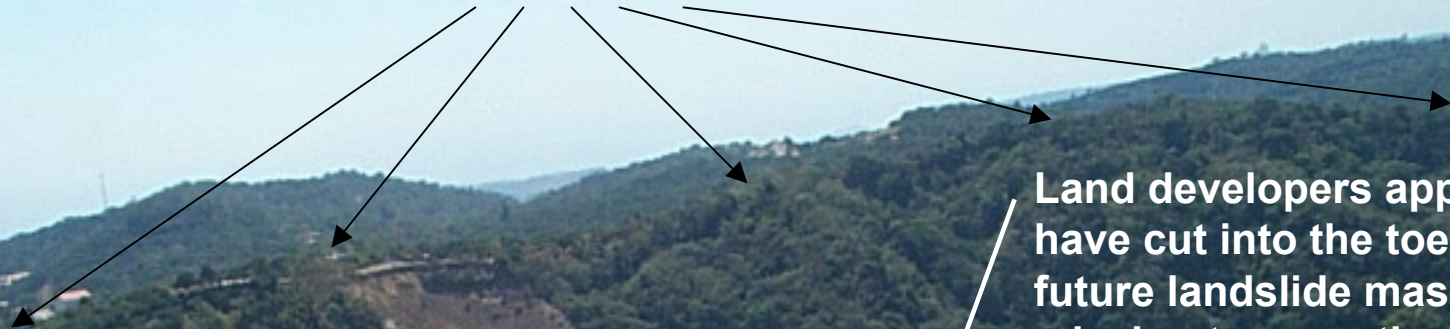
Santa Tecla Landslide

Cracks were measured along the total length of the hill by a another agency

Land developers appeared to have cut into the toe of this future landslide mass. The missing toe was the main ingredient that triggered this devastating landslide
THE TRIGGER

500 deaths – 300 homes destroyed

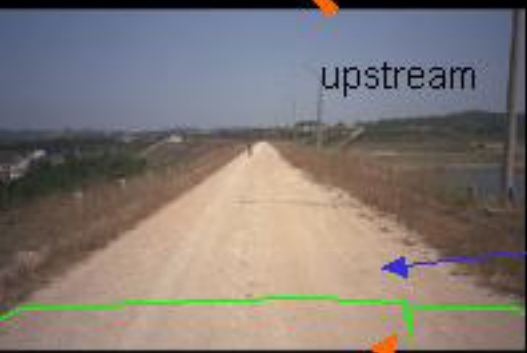
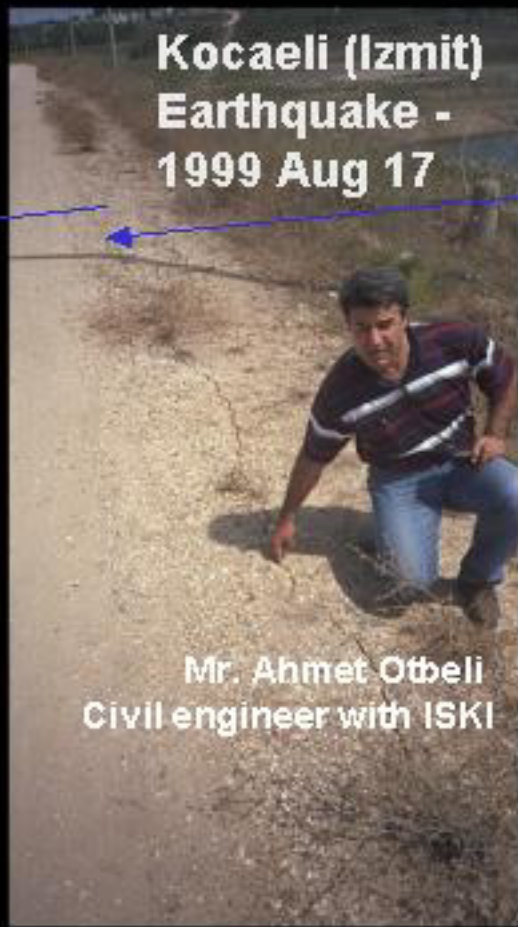
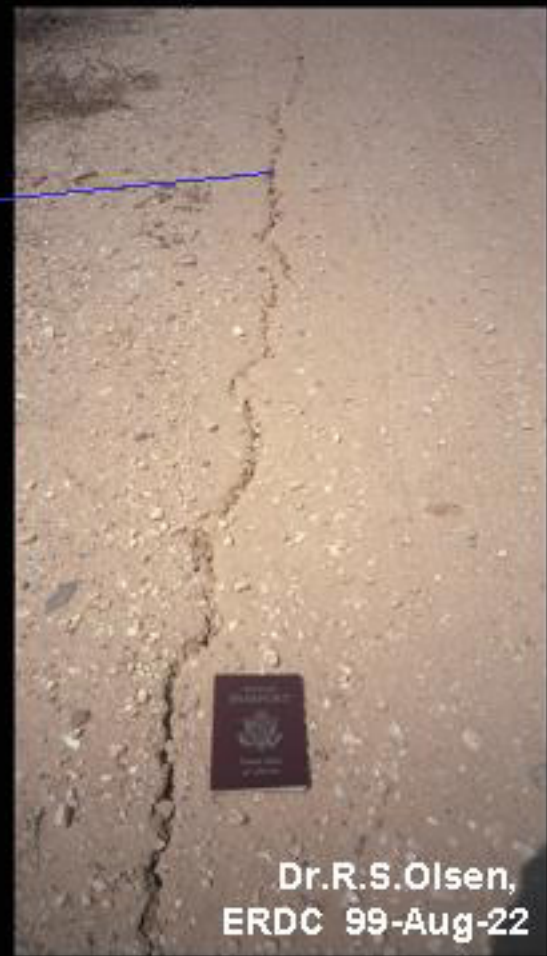
➔ **Gokce Dam, 30m earth/rock dam - views from the gravel crest road**

A single 9 mm wide crack the length of the dam was observed on the upstream side of the crest gravel road. The upstream side of this crack was 2 mm lower than the downstream side.

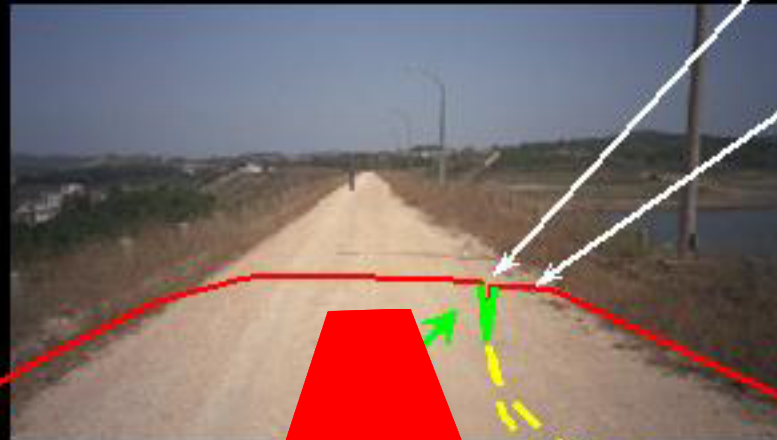
Gokce Dam
30m high earth/rock dam

A single 9 mm wide crack the length of the dam

The upstream side of this crack was 2 mm lower than the downstream side.

A 7mm wide crack (and 2mm drop) over a potential 150 m slip length represents 0.005% slippage. This dam experienced minor elastic based movement to reestablish the static strength – excellent performance.

This type of crack and crack width should be expected for a magnitude 7+ earthquake event because a stiffer compacted dam is bad for many other reasons.

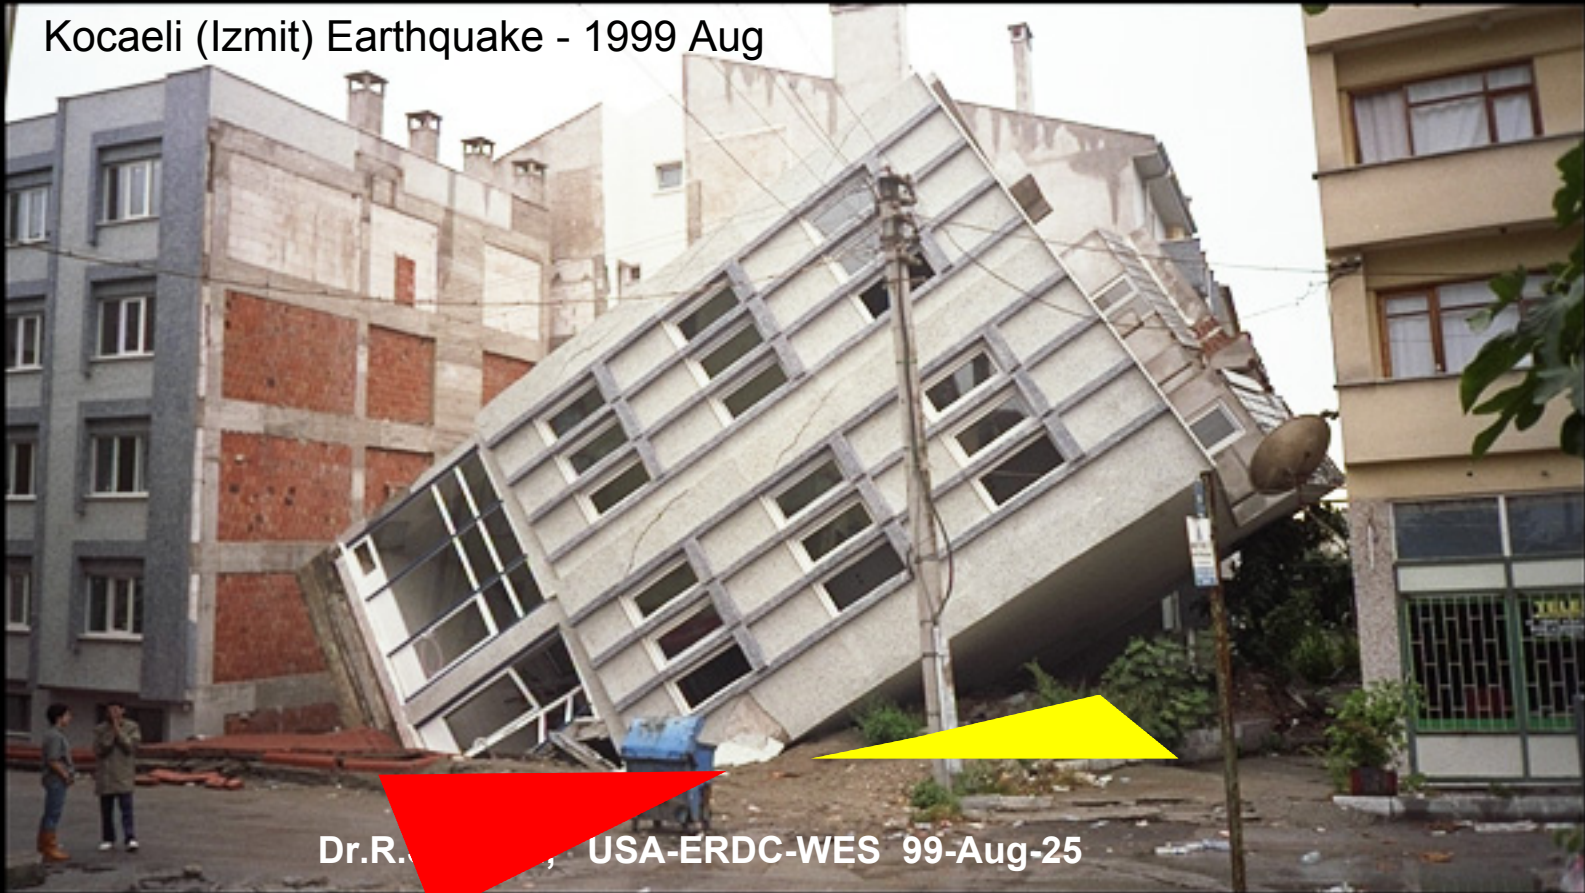
N40.775 E30.4045
City of Adapazari, Turkey

**Silt liquefaction caused bearing failure
(no liquefaction boils were observed)**

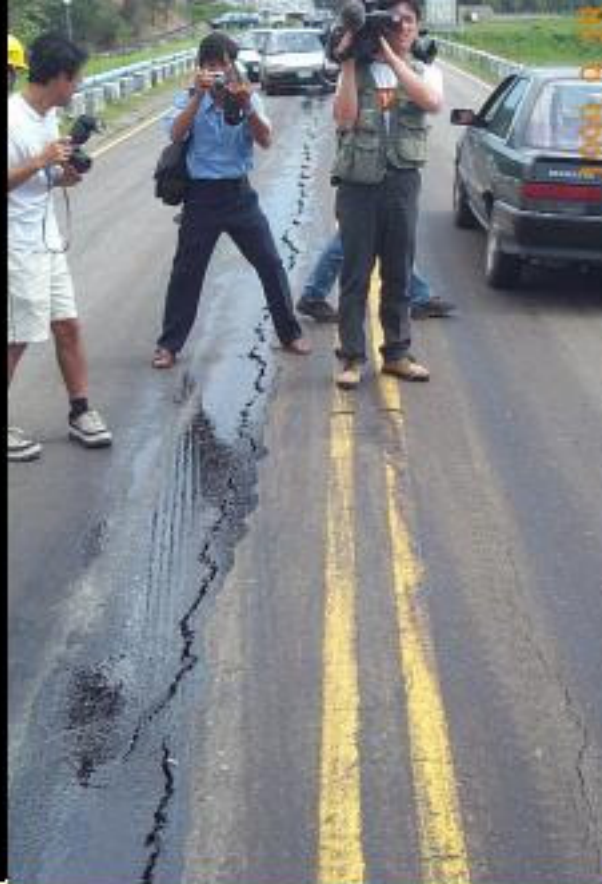
Shuishih Dam

Shuishin dam, build in 1934, experienced 30 cm of settlement within the shell during the Chi Chi earthquake. This shell settlement caused the shell to move away from the concrete cutoff wall resulting in reflection cracks, as shown.

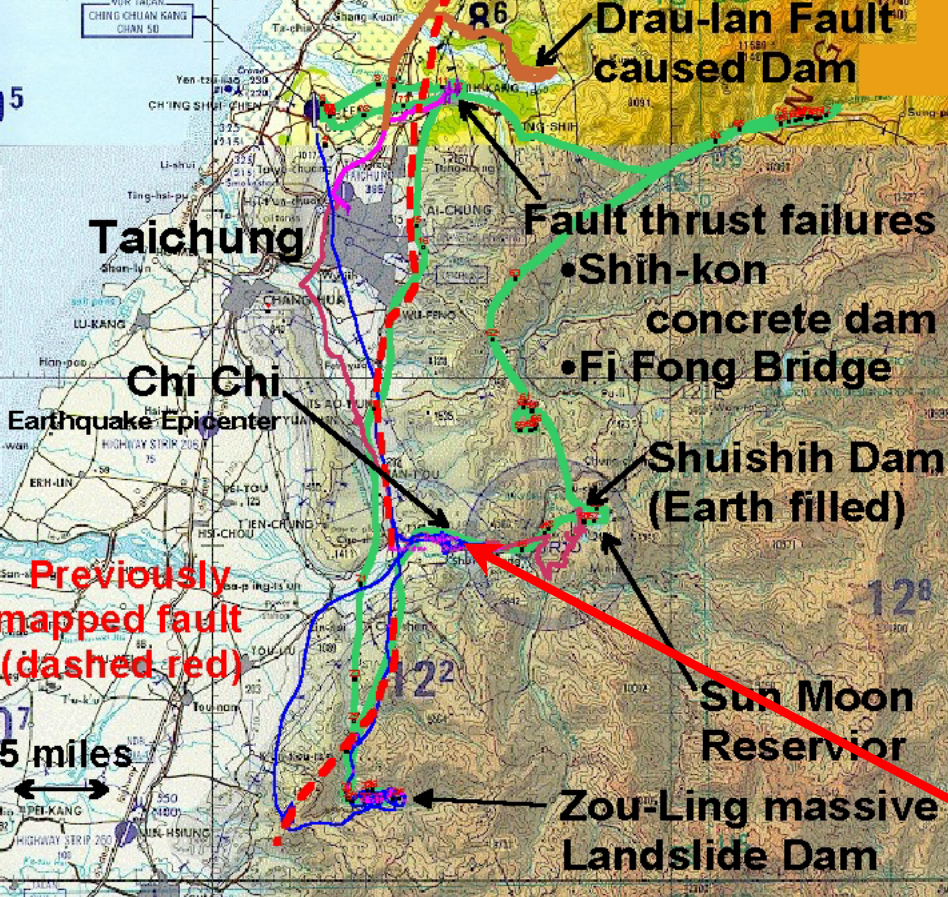
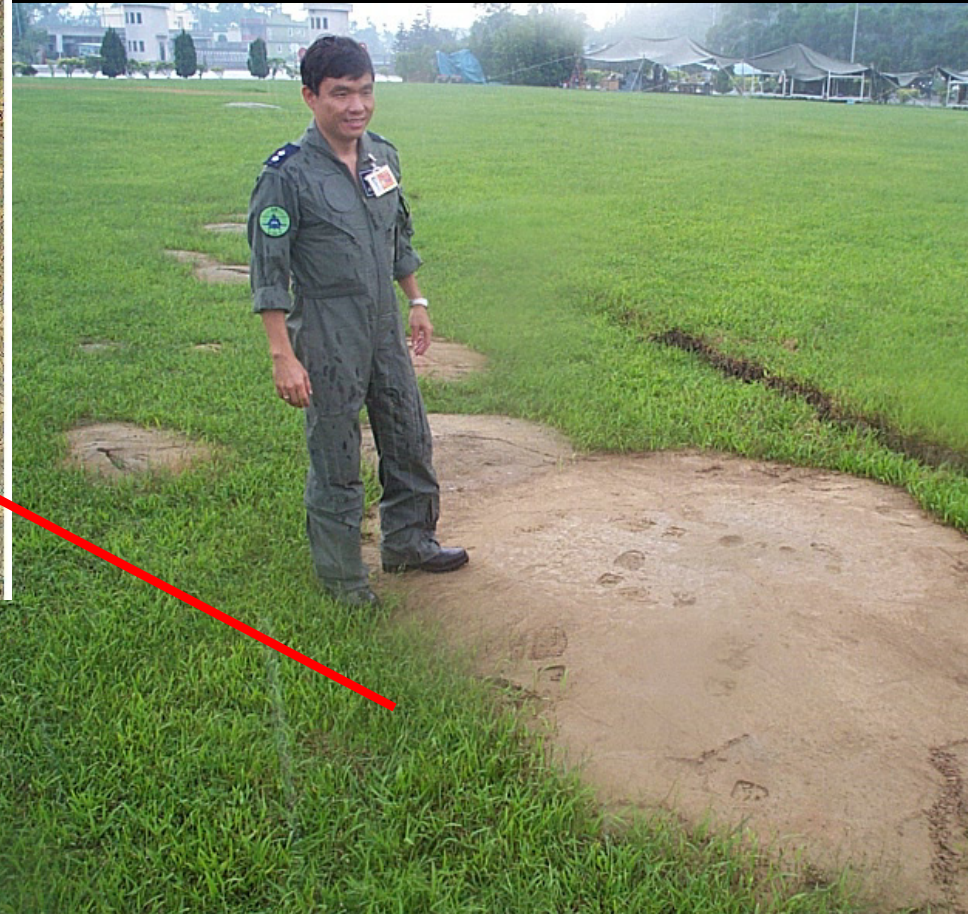
Taiwan Army base near the town of Chi Chi

Liquefaction and lateral spreading were observed

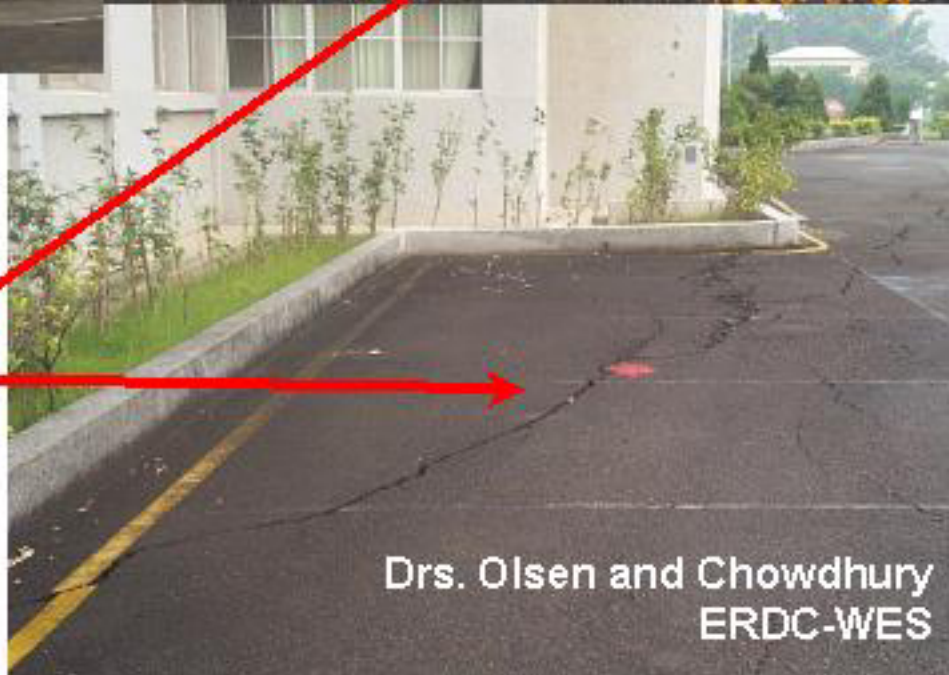
The wings of this building complex differentially settled due to liquefaction

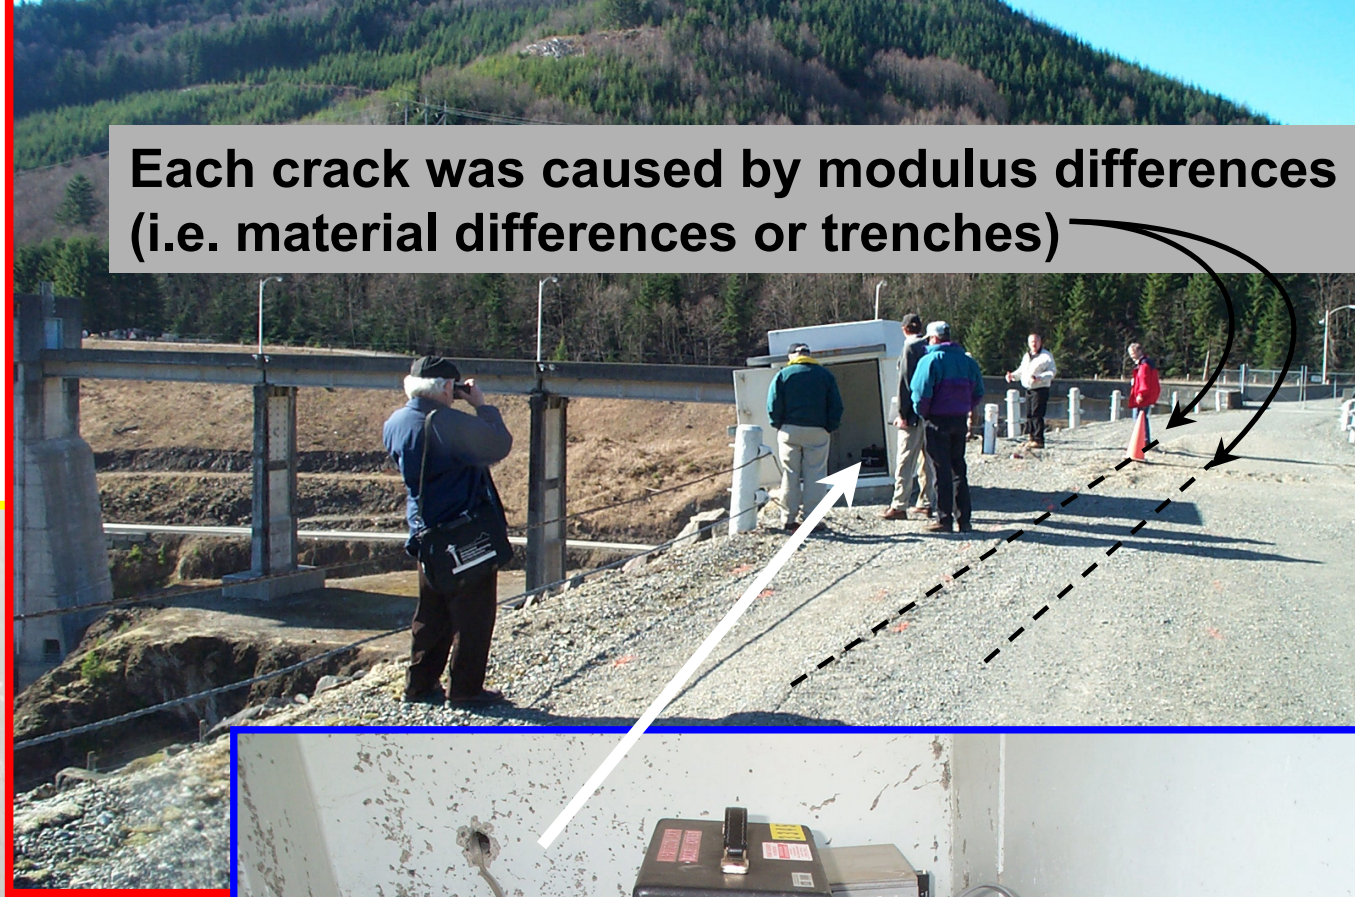
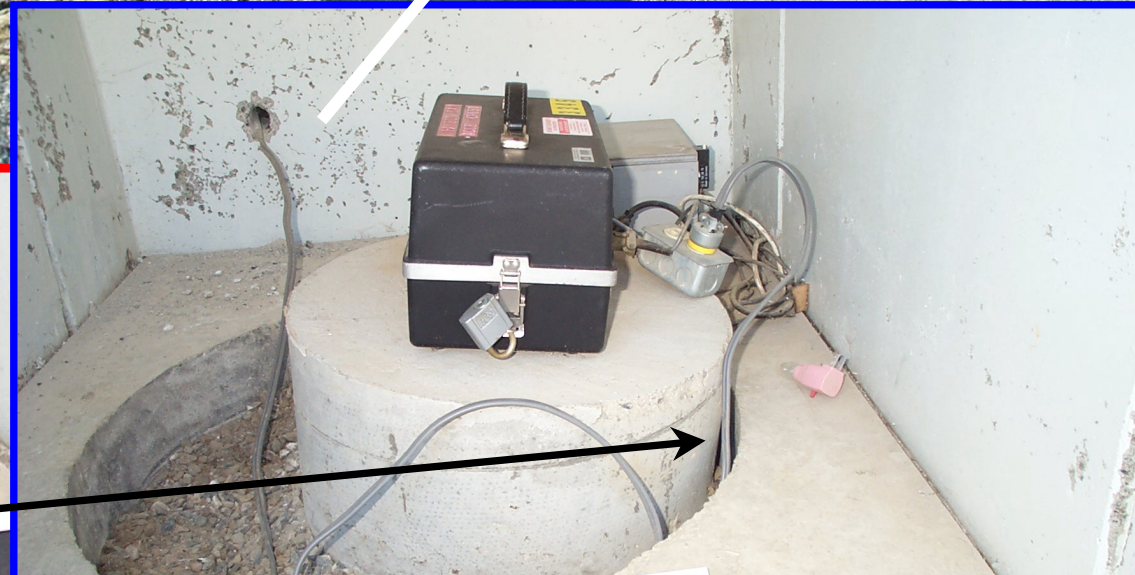
Howard Hanson Dam

Each crack was caused by modulus differences (i.e. material differences or trenches)

Gravel was not crushed – thus the pier did not repeatedly hit the slab during the earthquake

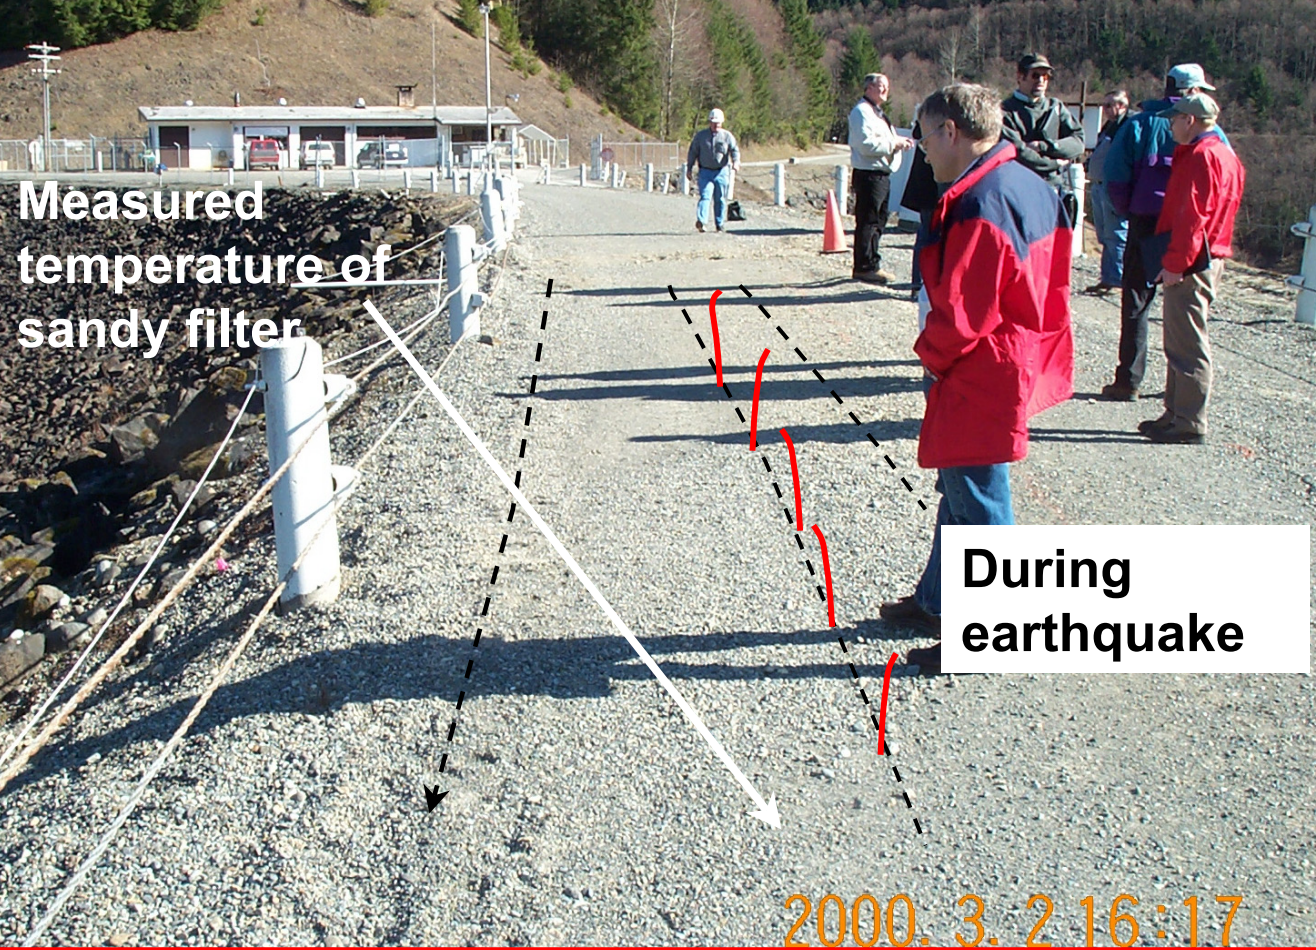
Howard Hanson Dam Seattle Earthquake 2001 *Damage Recon*

Each crack was
caused by modulus
differences (i.e.
material differences
or trenches)

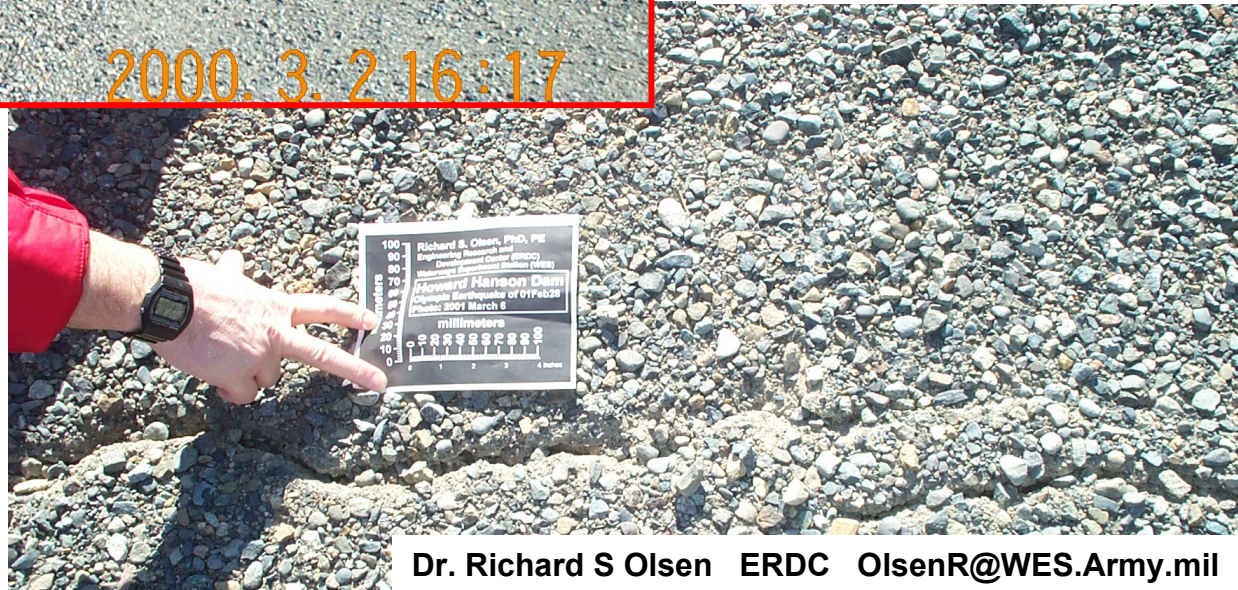
Also, measured
temperatures and pore
pressures in the shell
of the dam reflected
dilative behavior
