“Turning Disaster into Knowledge”

The M8.0 Pisco, Peru Earthquake of August 15, 2007

NSF-Sponsored GEER Workshop: Berkeley, CA; May 18-19, 2009

GEER Field-Team Members

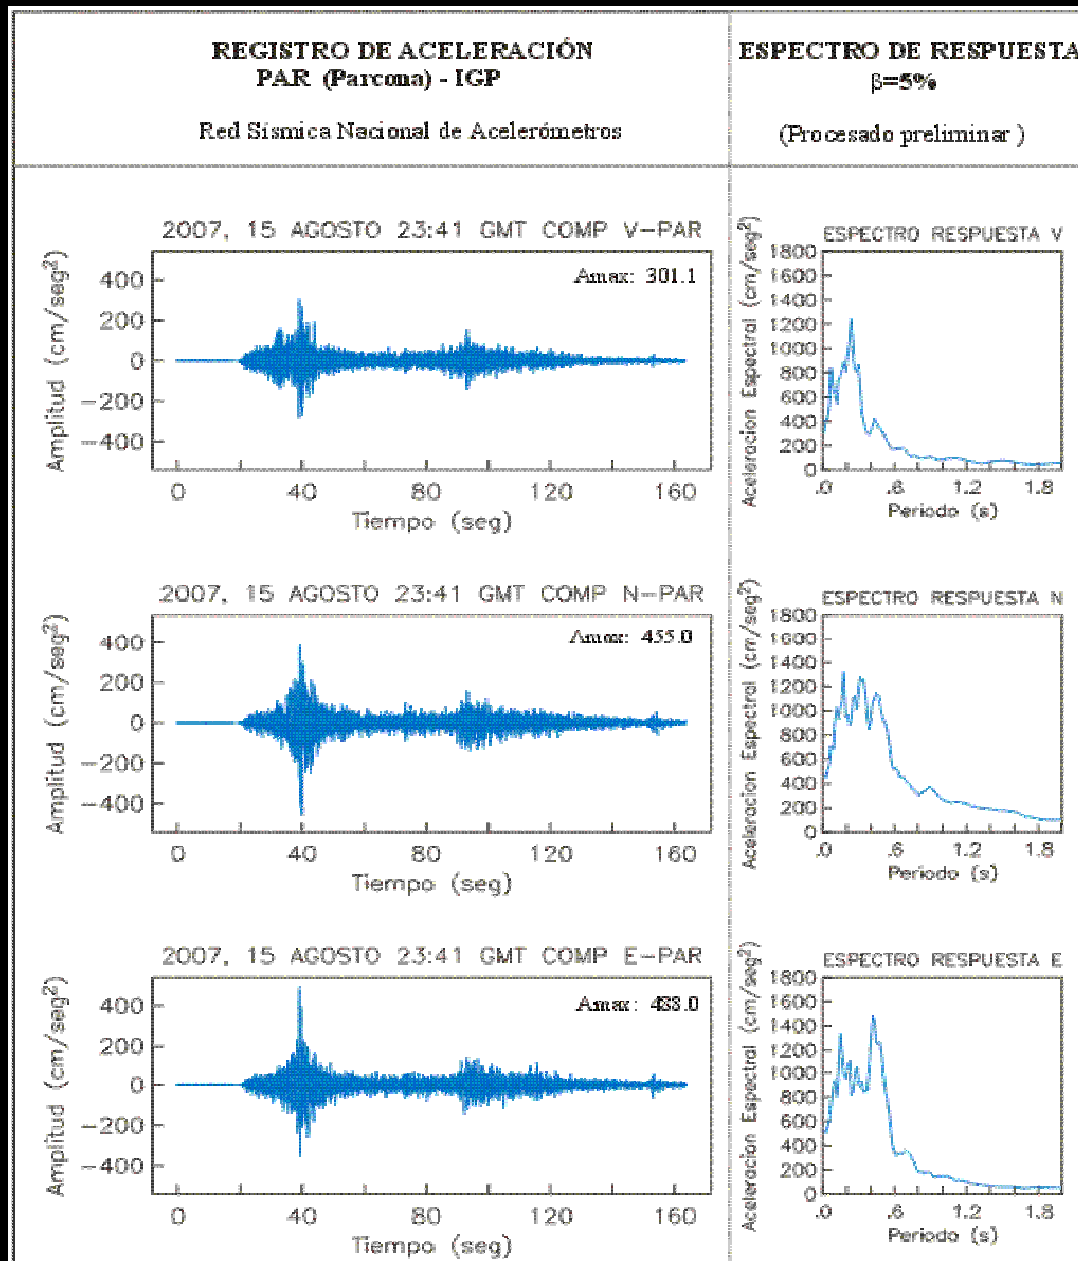
Parcona Record (Ica)

- Distance = 39 km
- Instrument on soil
- PGA = 0.49 g
- Two distinct phases of shaking
- Duration > 2 min

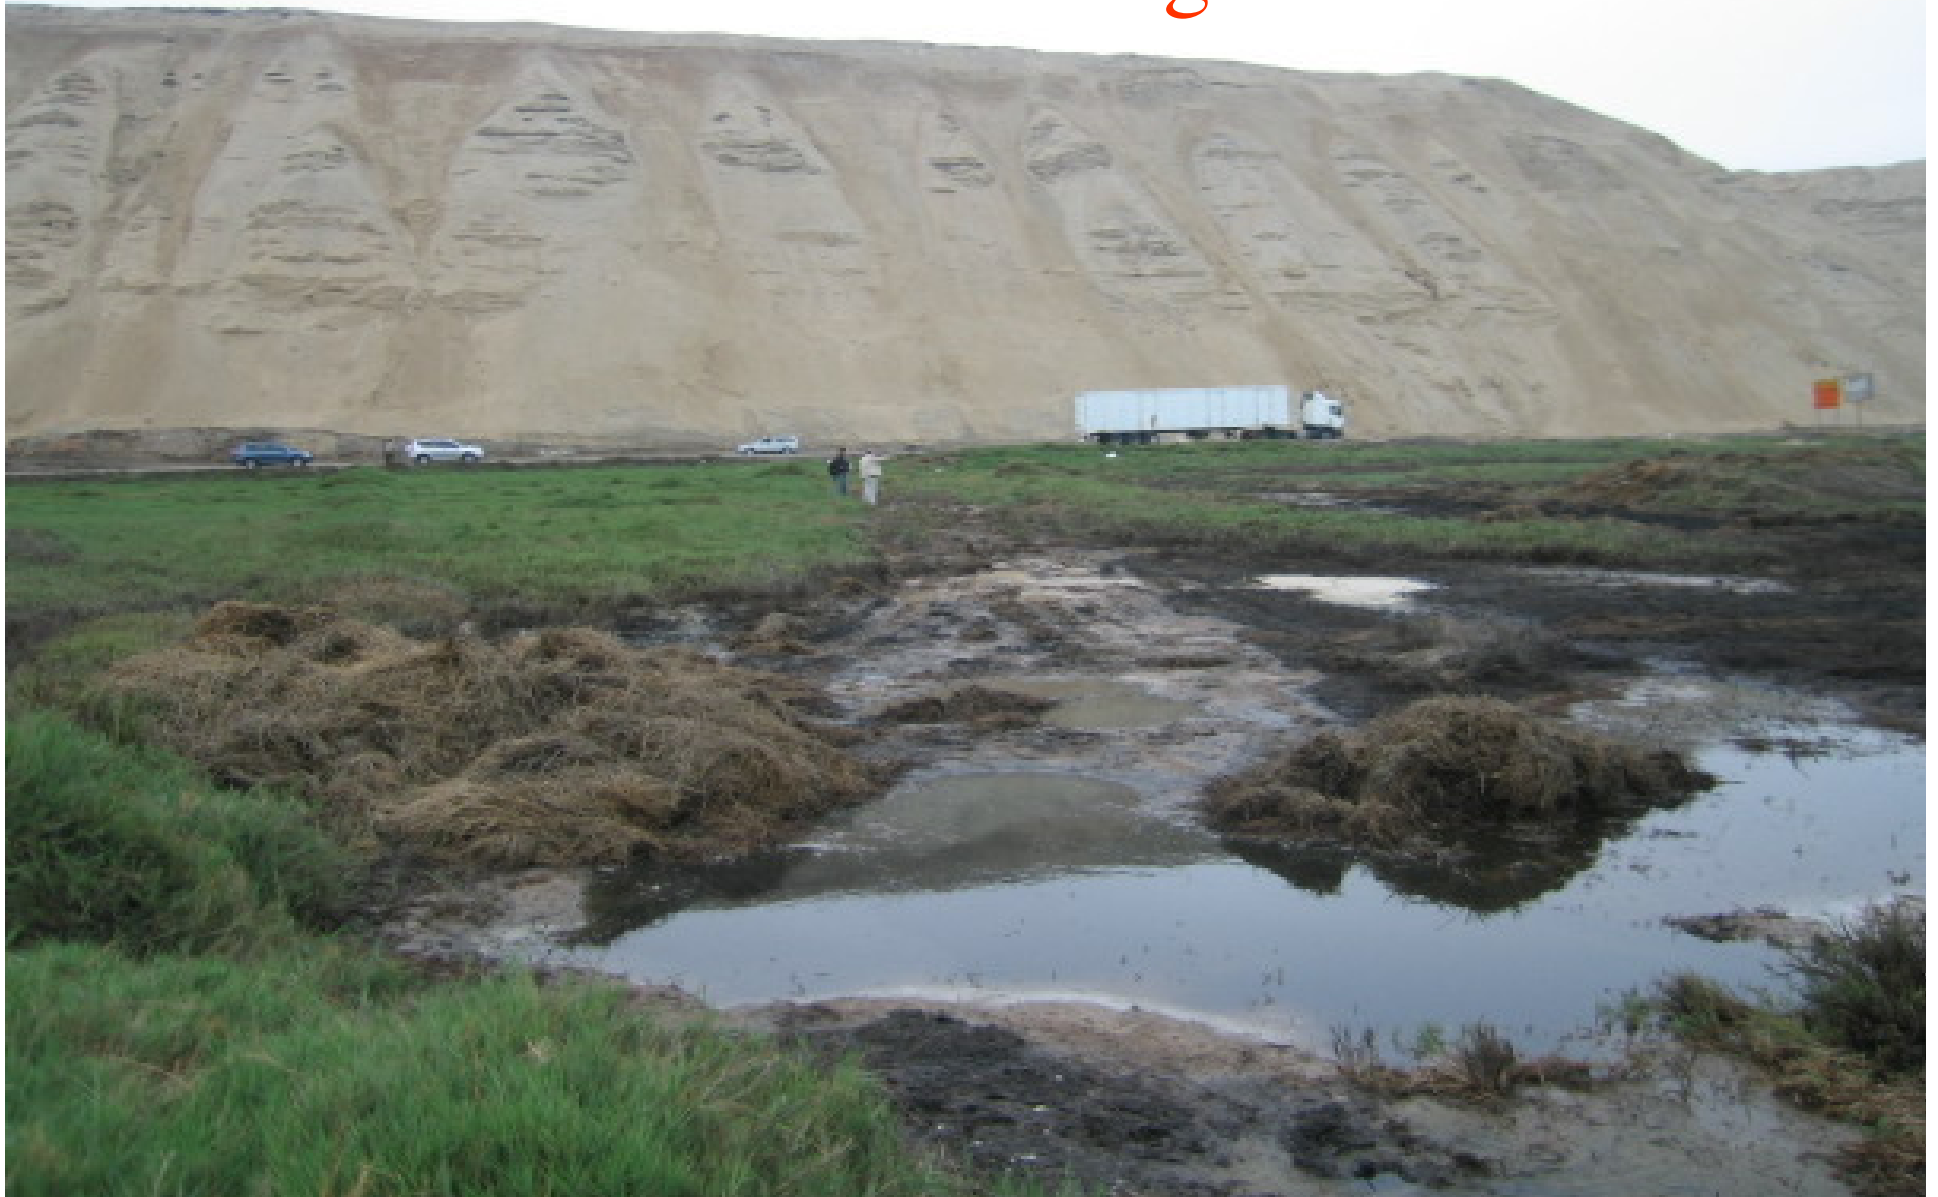
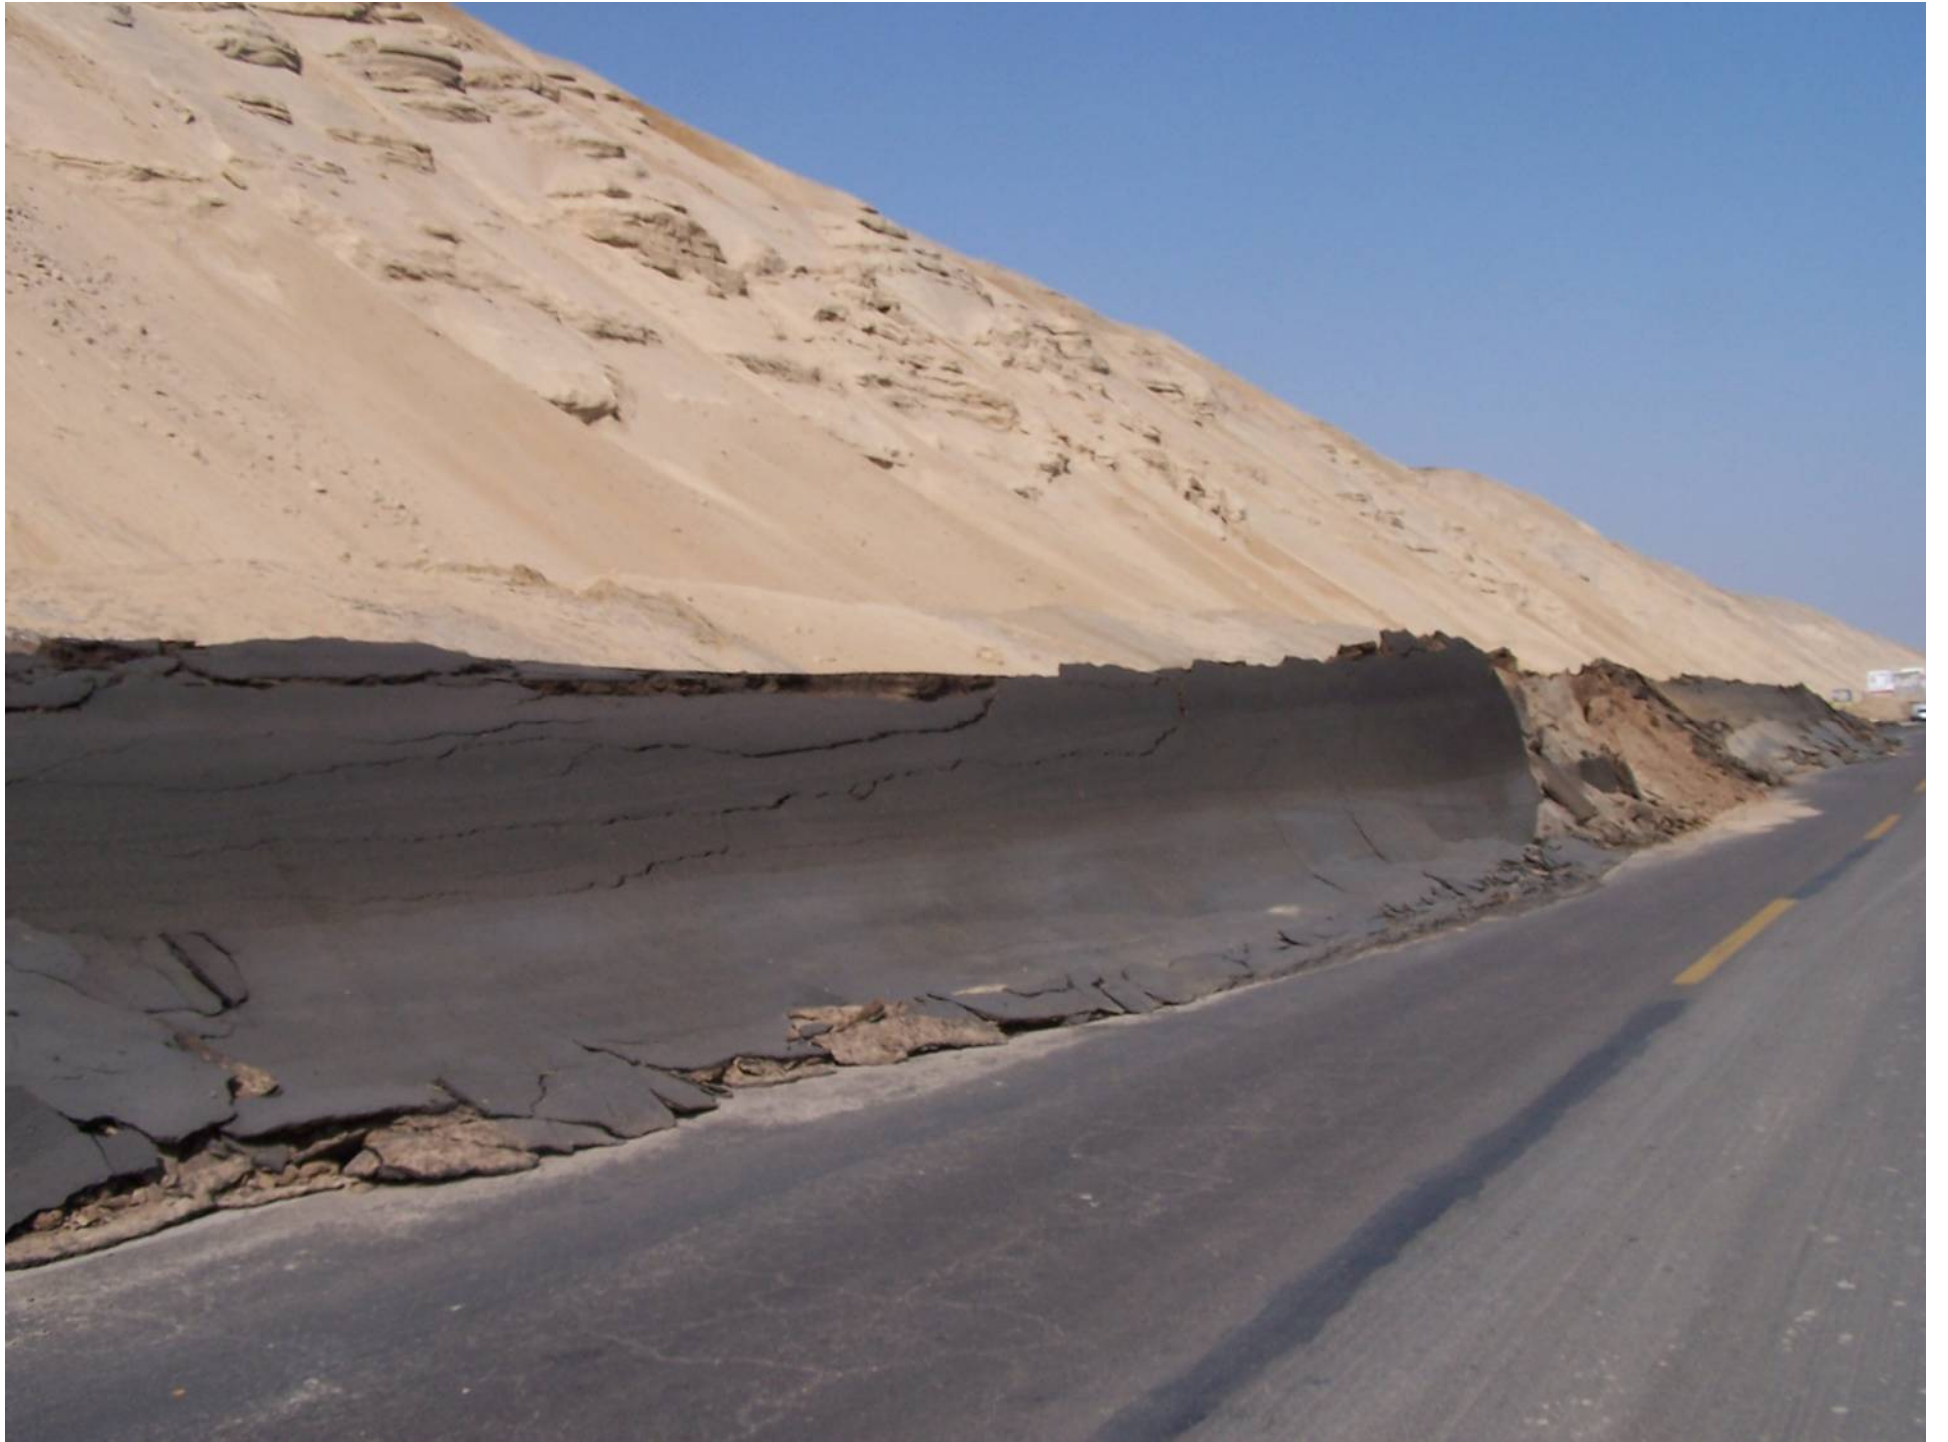
Jahuay Slope Failure + 400-m long

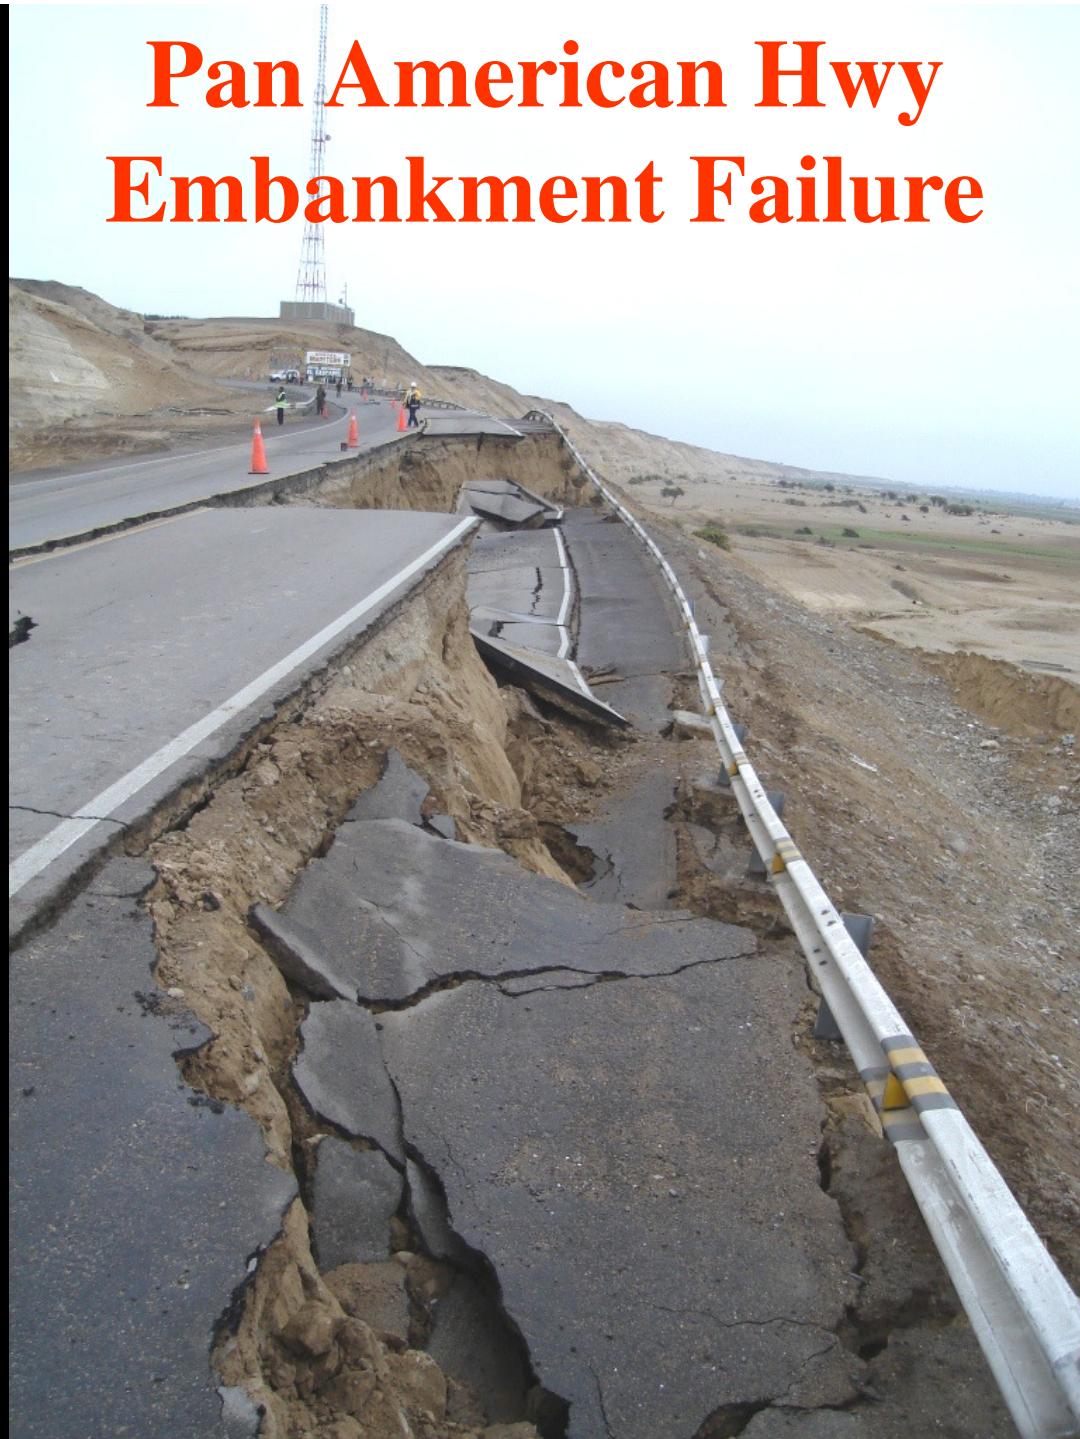
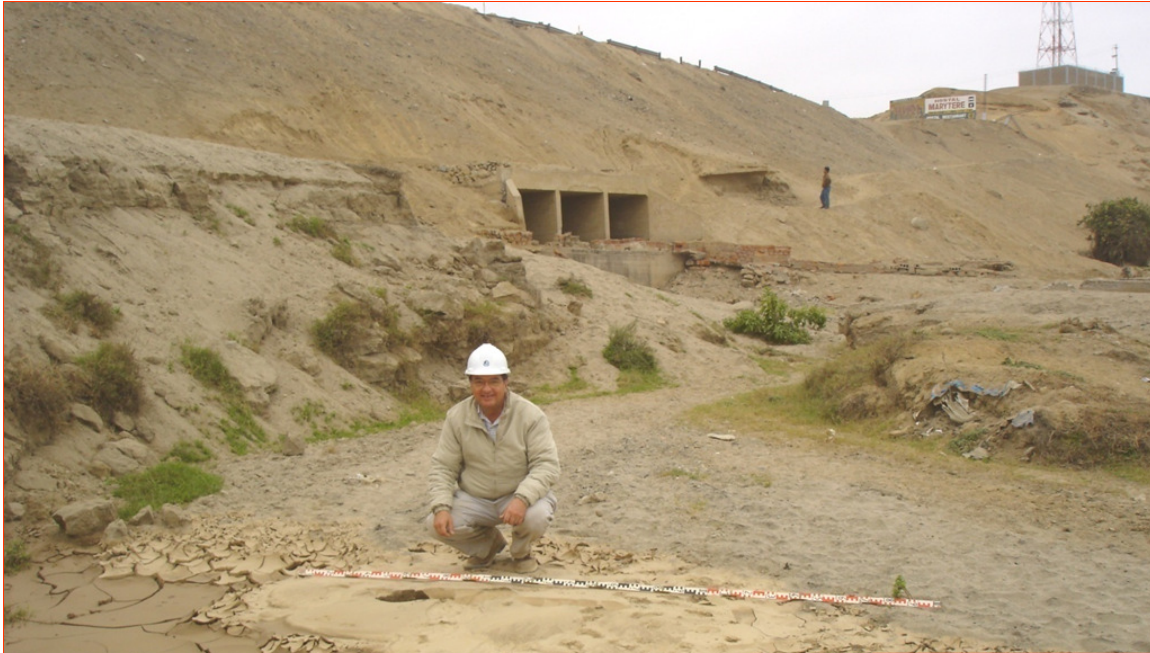
Pan American Hwy Embankment Failure

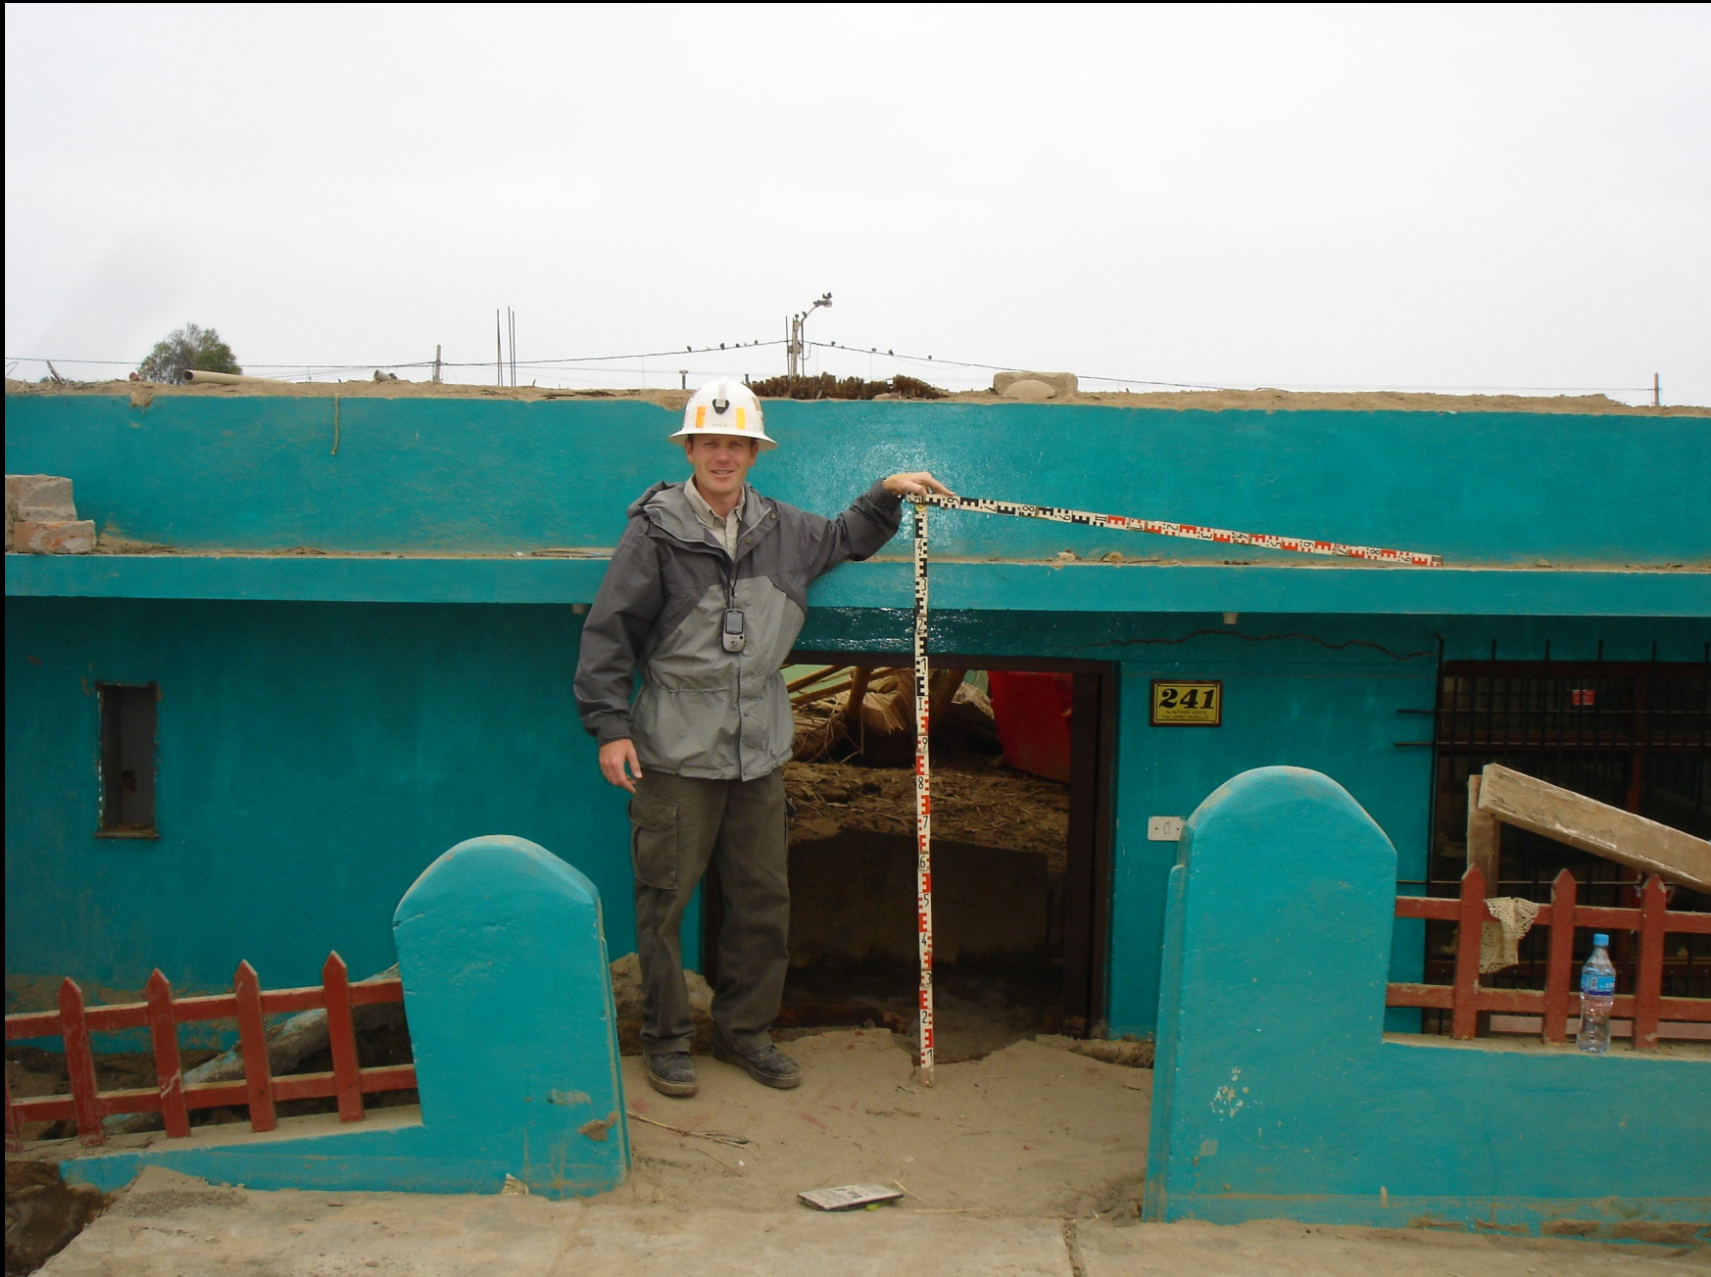
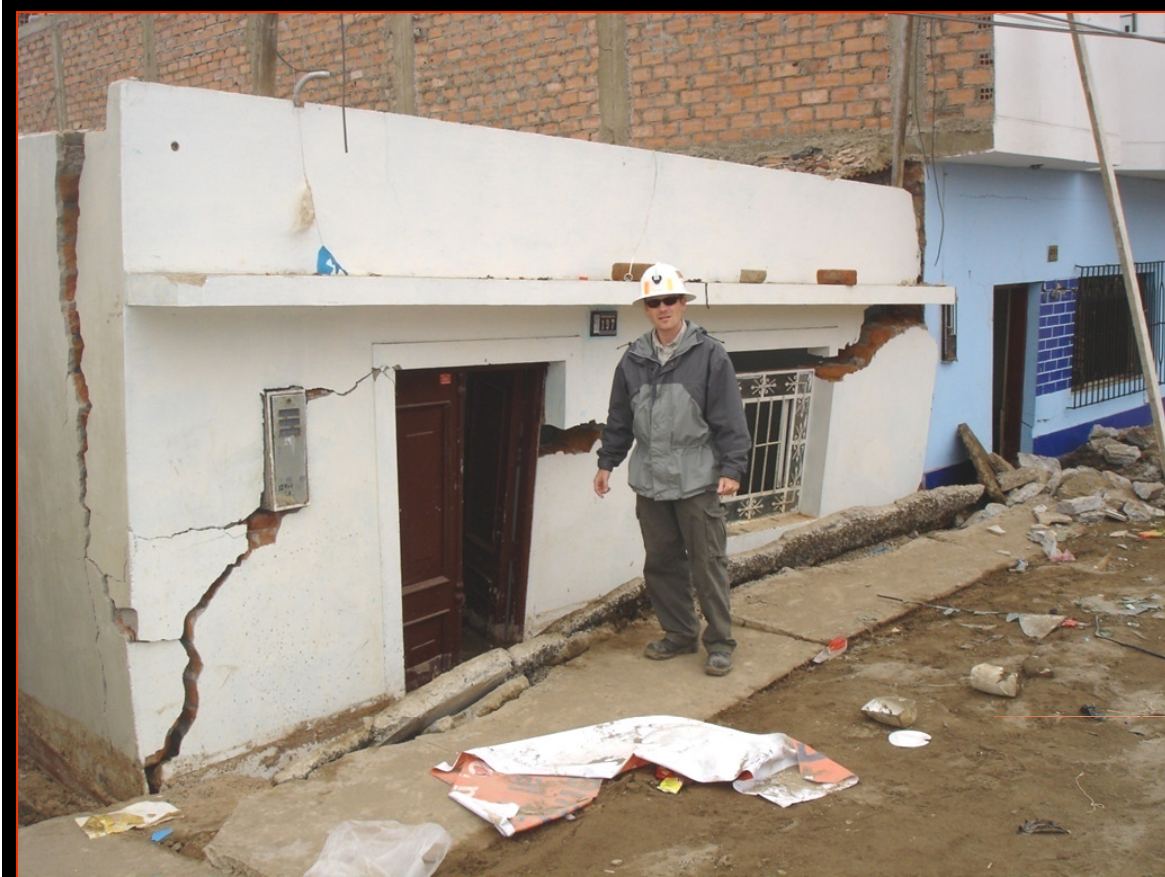
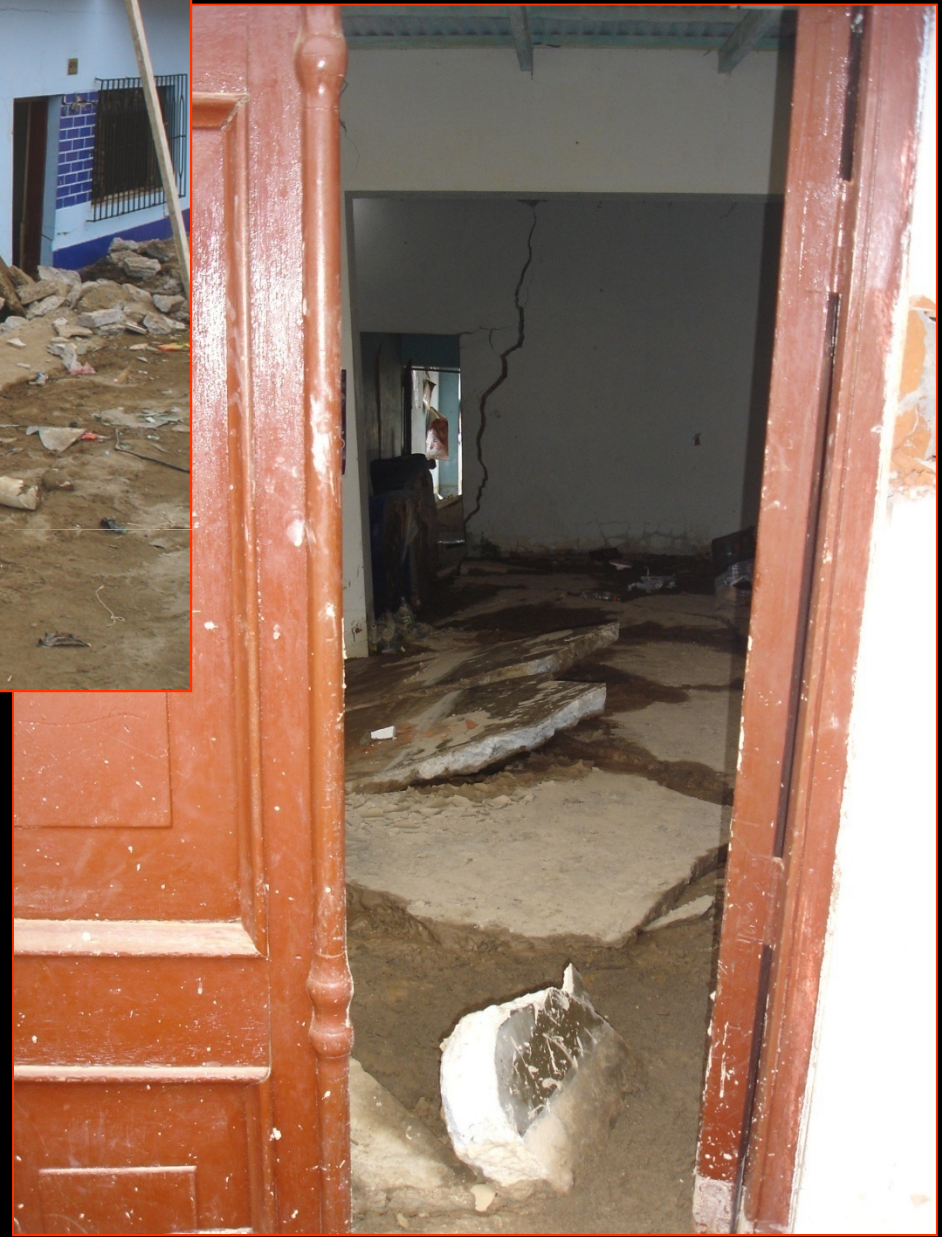
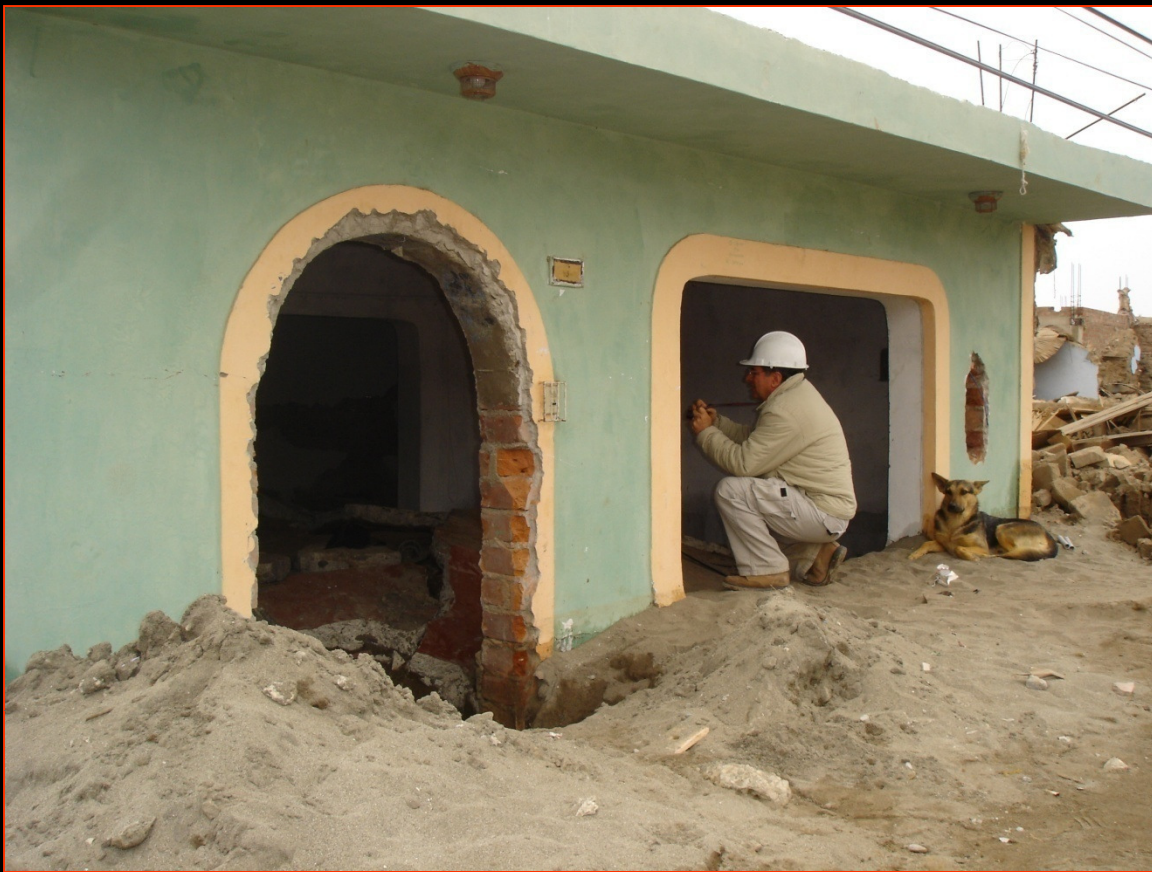
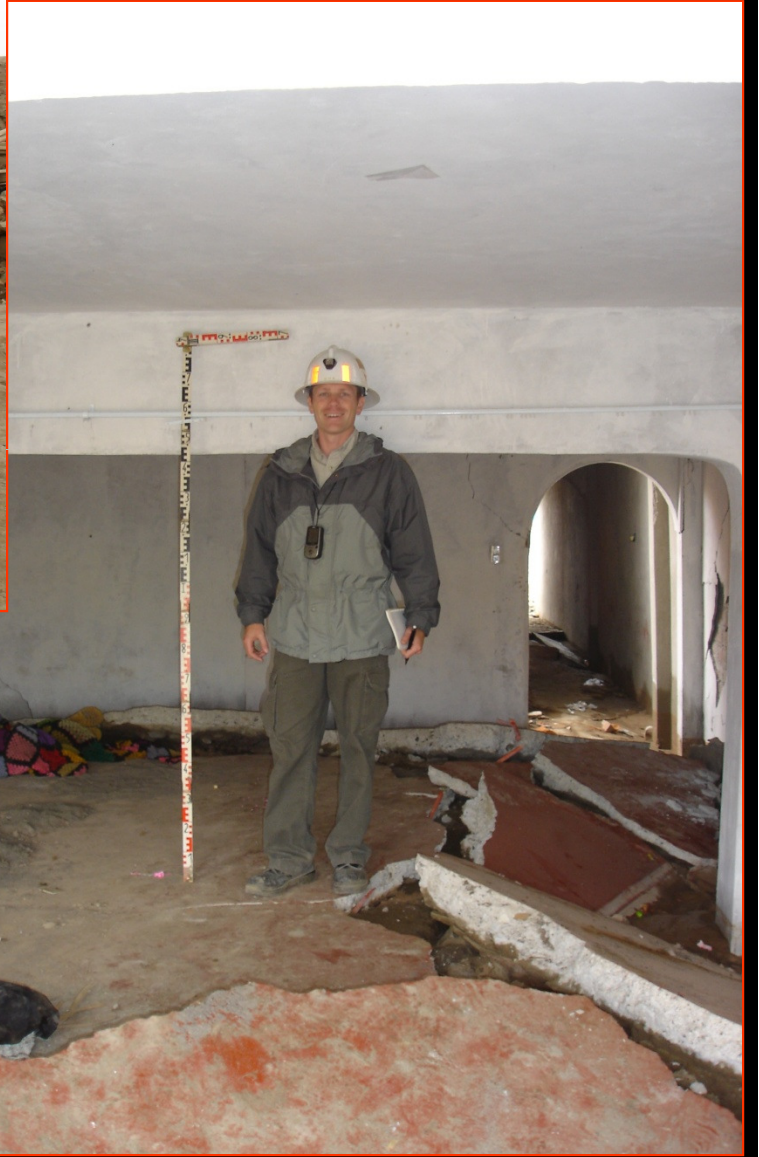
Tambo de Mora Liquefaction Damage

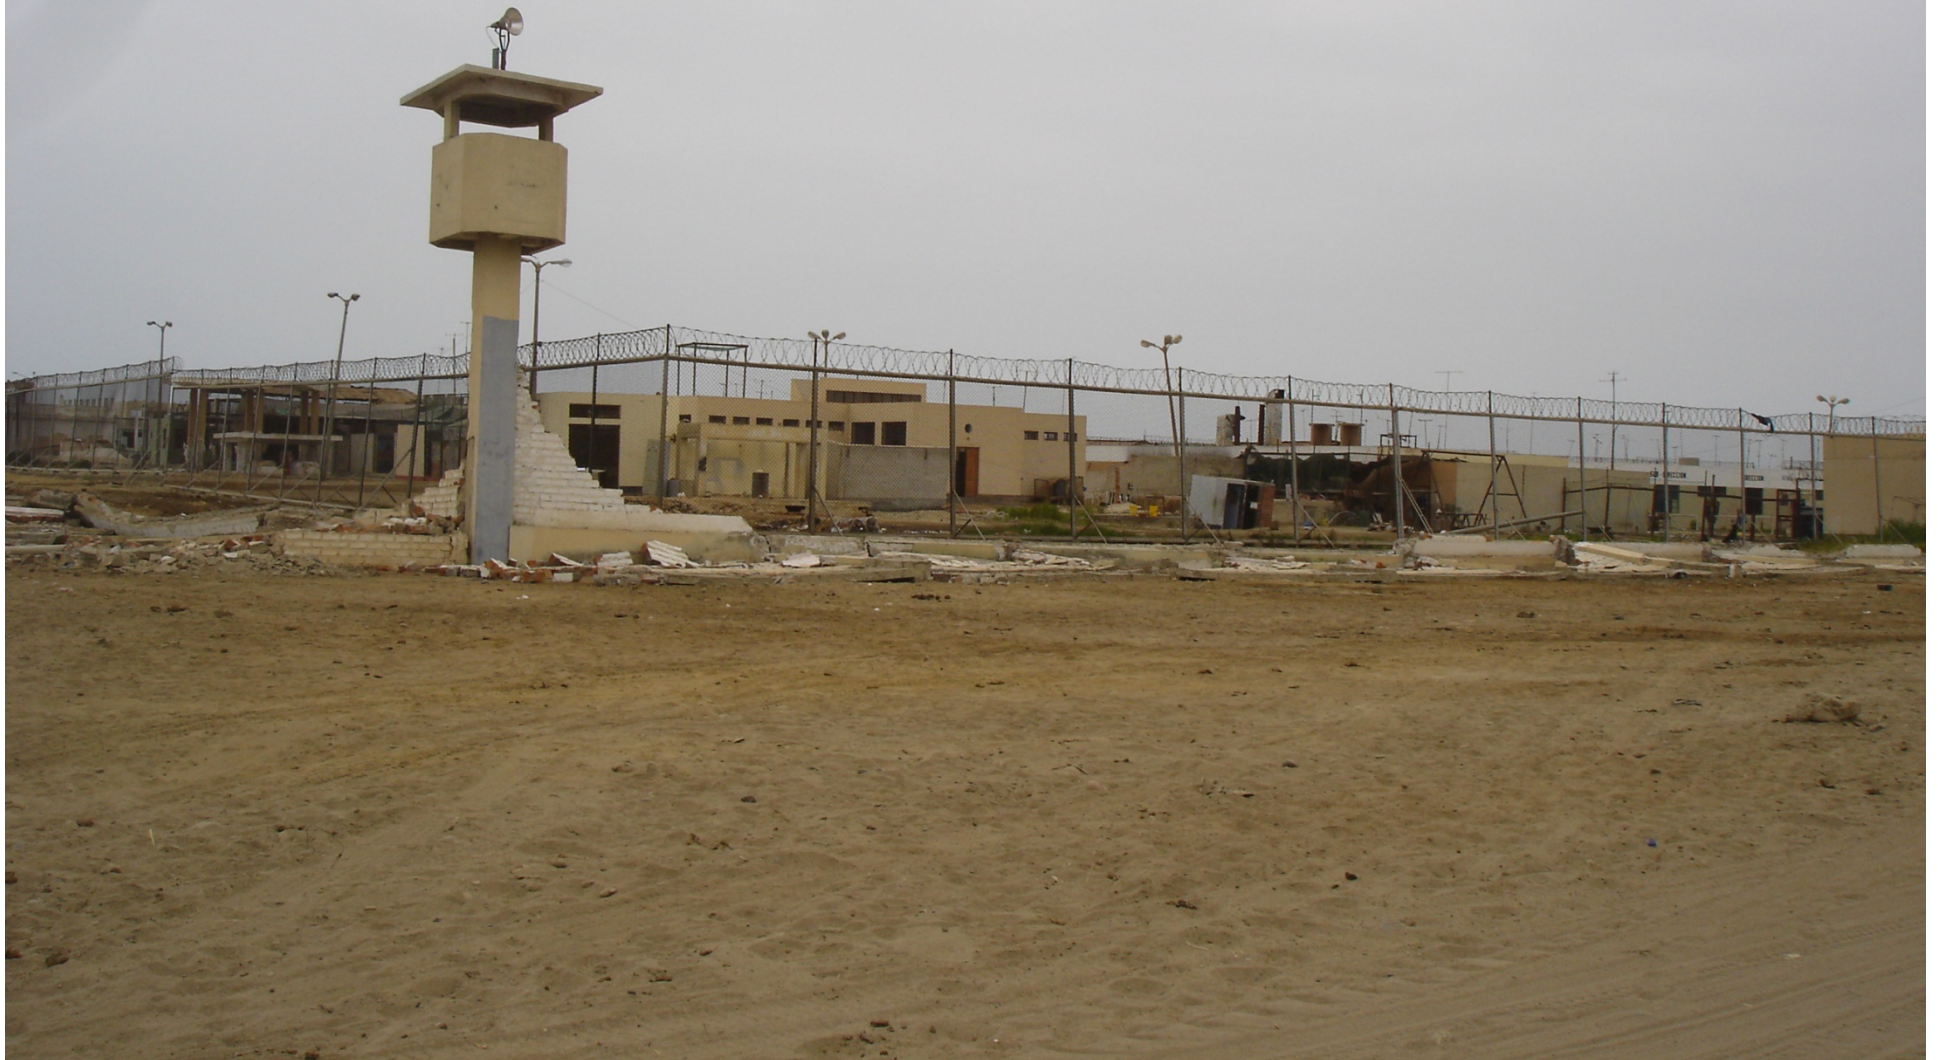
Chincha Prison

600 + Prisoners Escaped

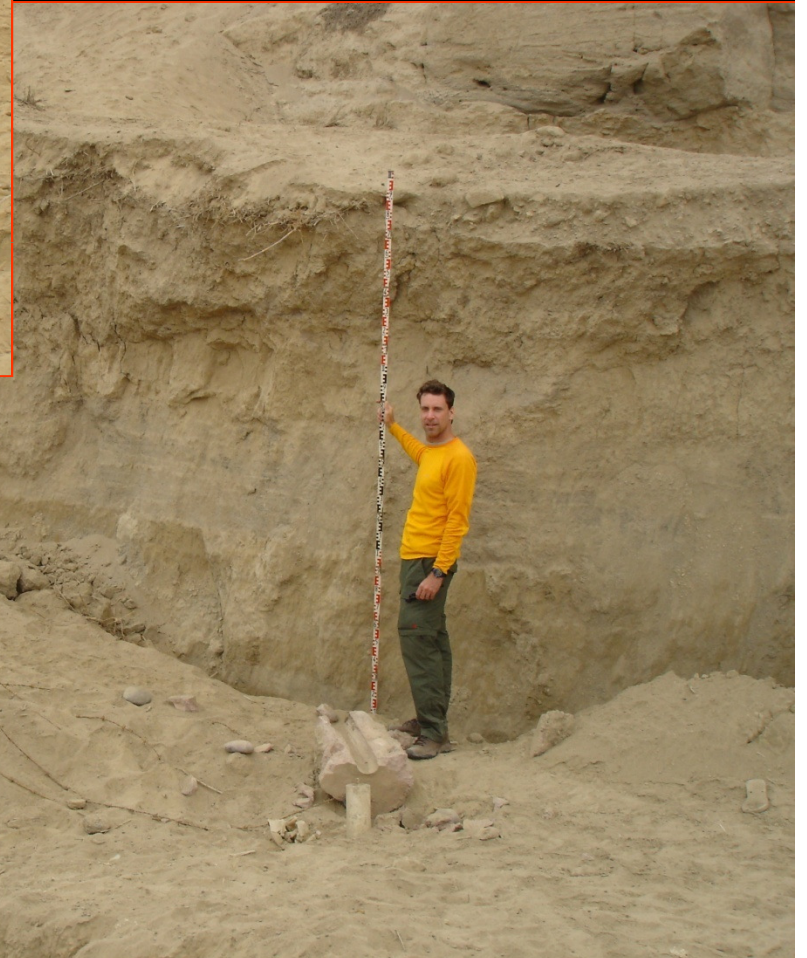
3-m High Head Scarp

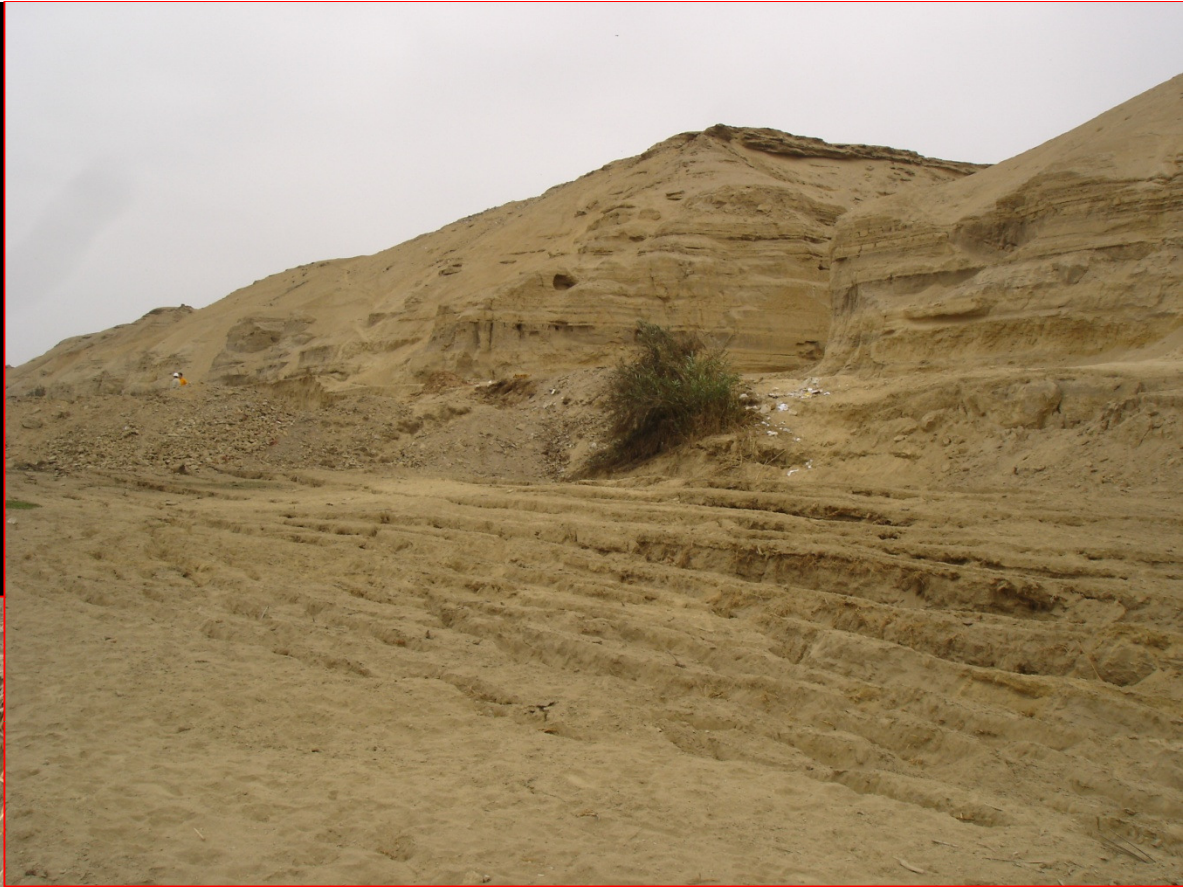
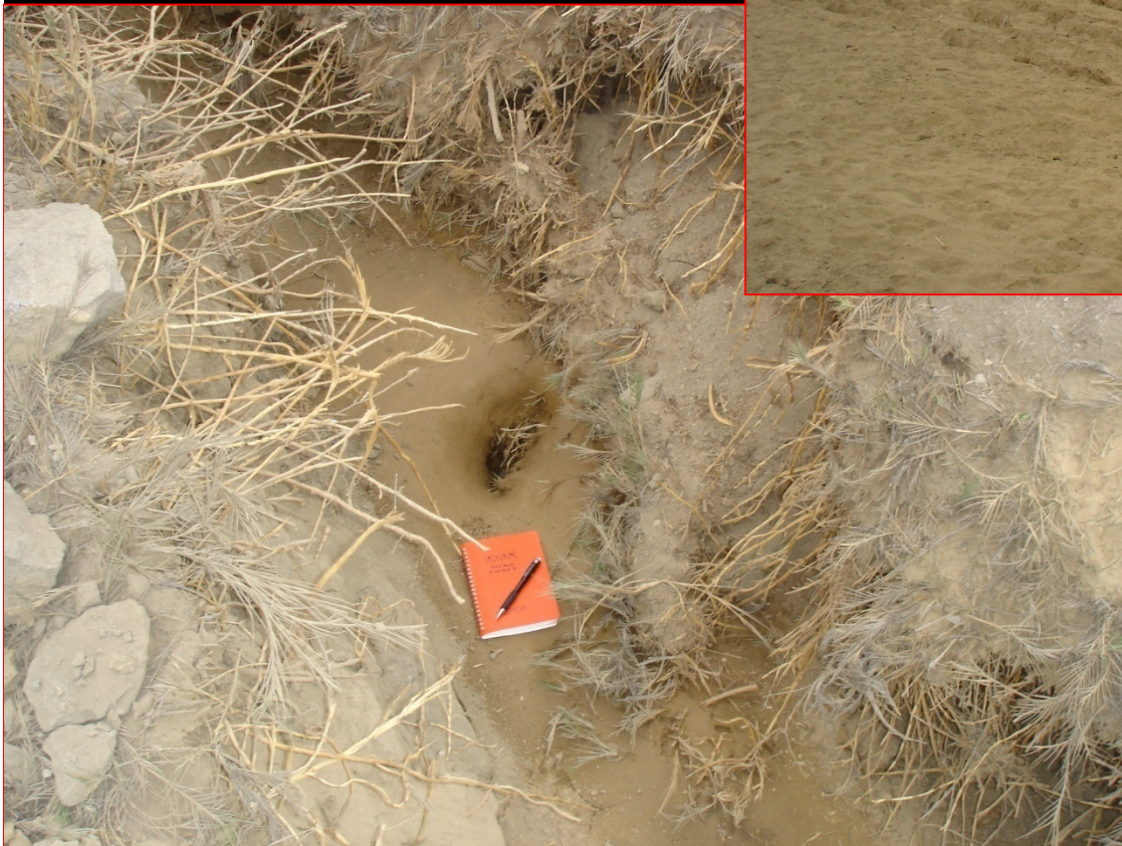
**Tension Cracks Filled
with Liquefaction
Ejecta**

Along Geologic Interface
