“Turning Disaster into Knowledge”

The M8.0 Pisco, Peru Earthquake of August 15, 2007

NSF-Sponsored GEER Workshop: Berkeley, CA; May 18-19, 2009

GEER Field-Team Members

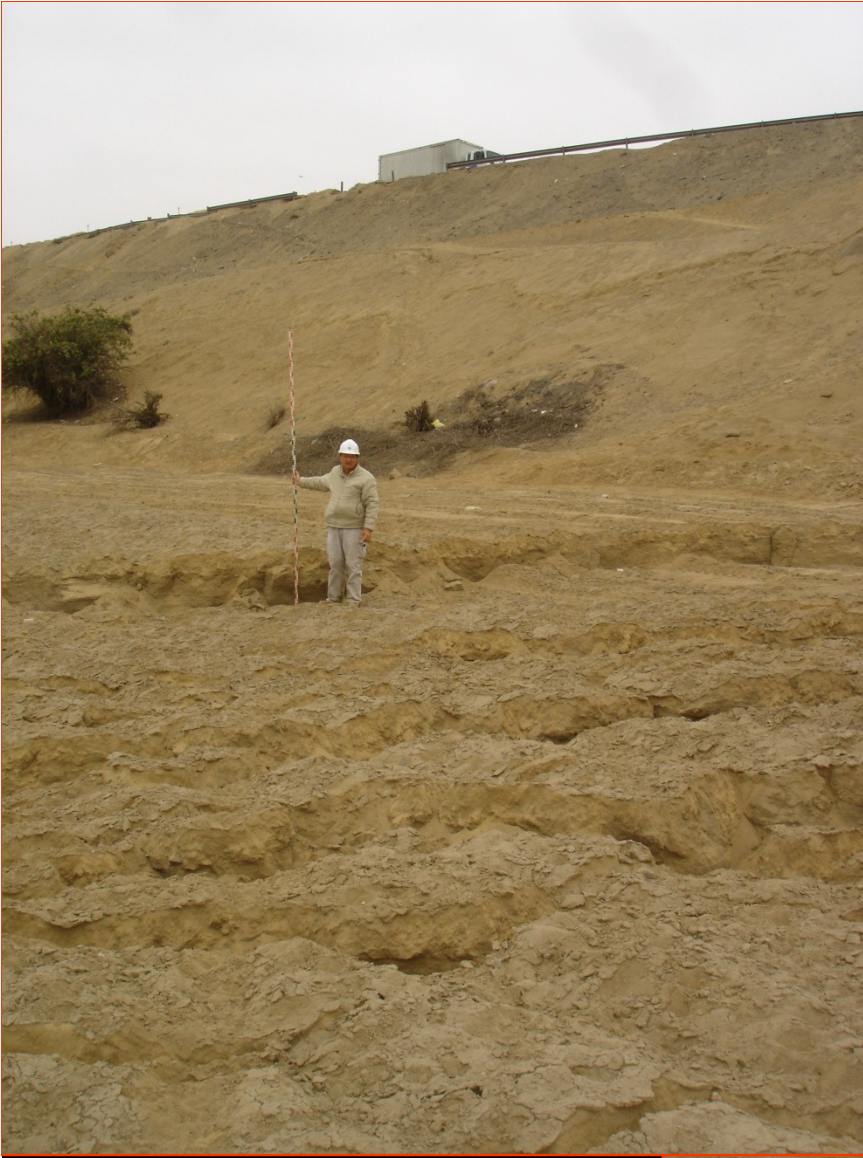
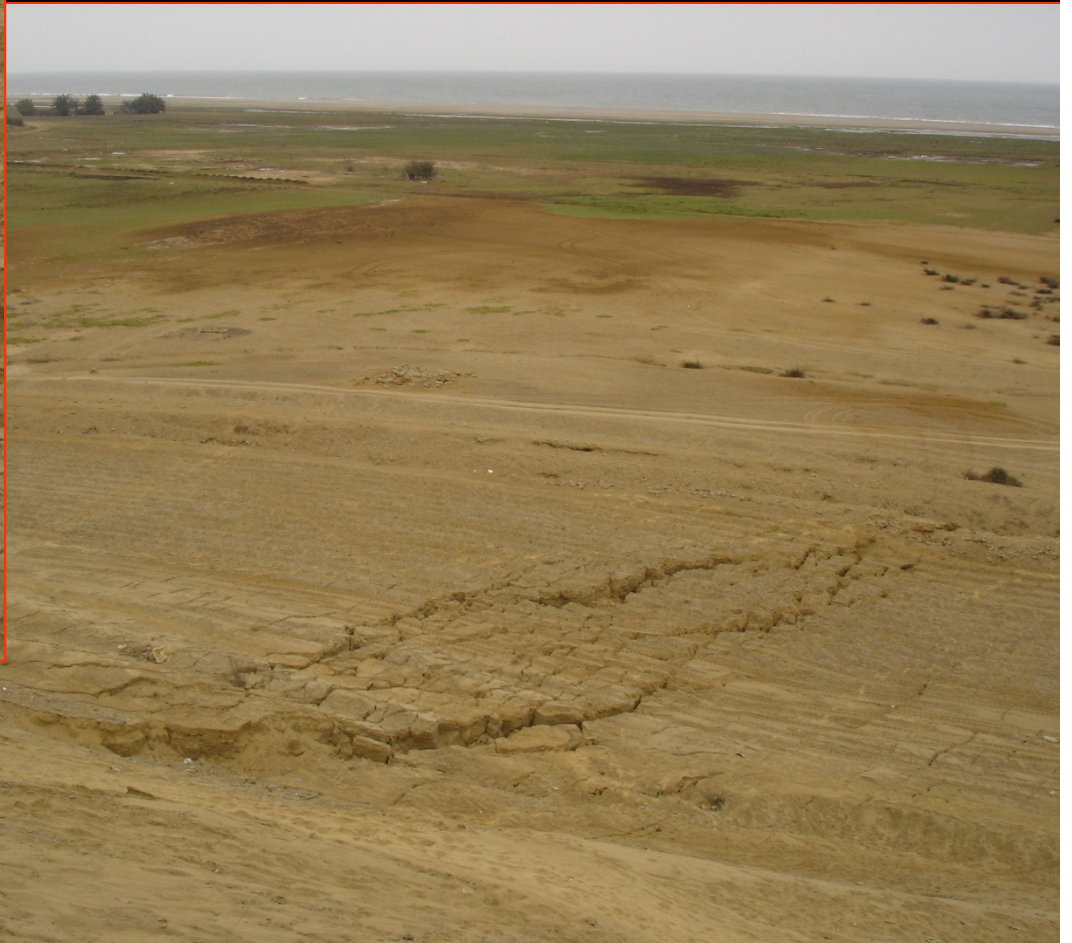
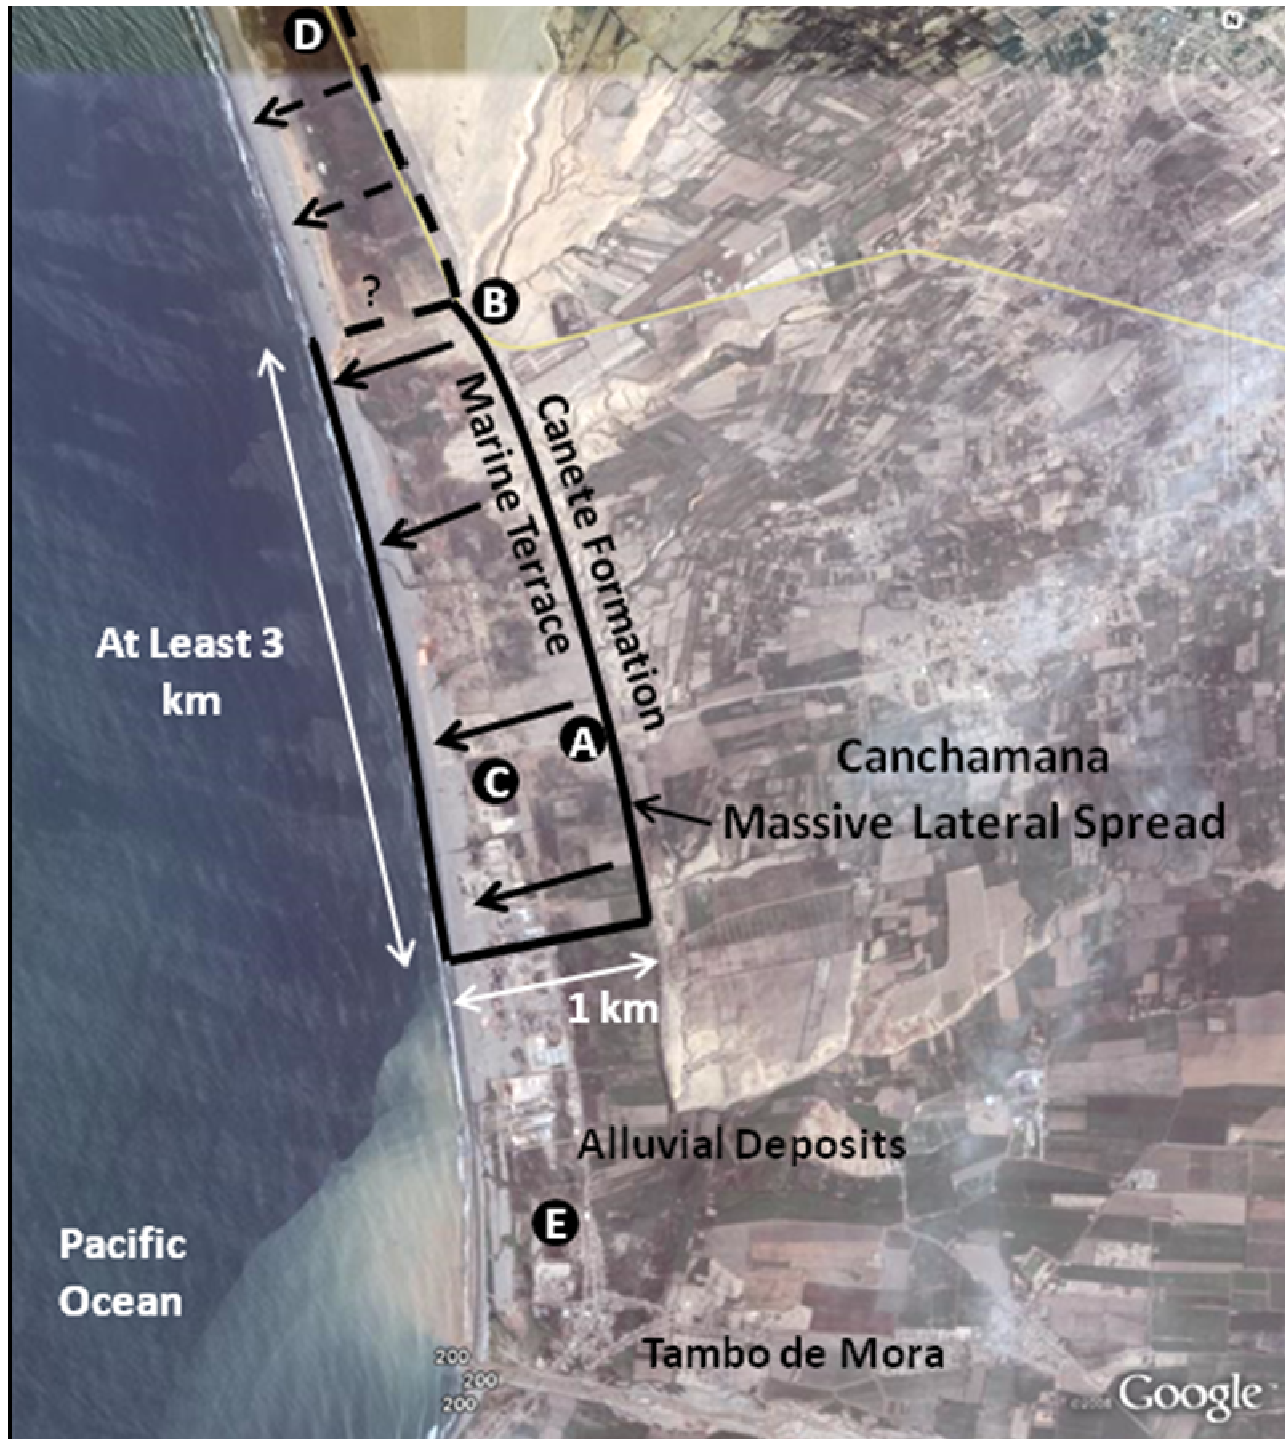
Large Tension Cracks Below Failed Embankment

Lateral displacement of +5 m from adding up the widths of tension cracks

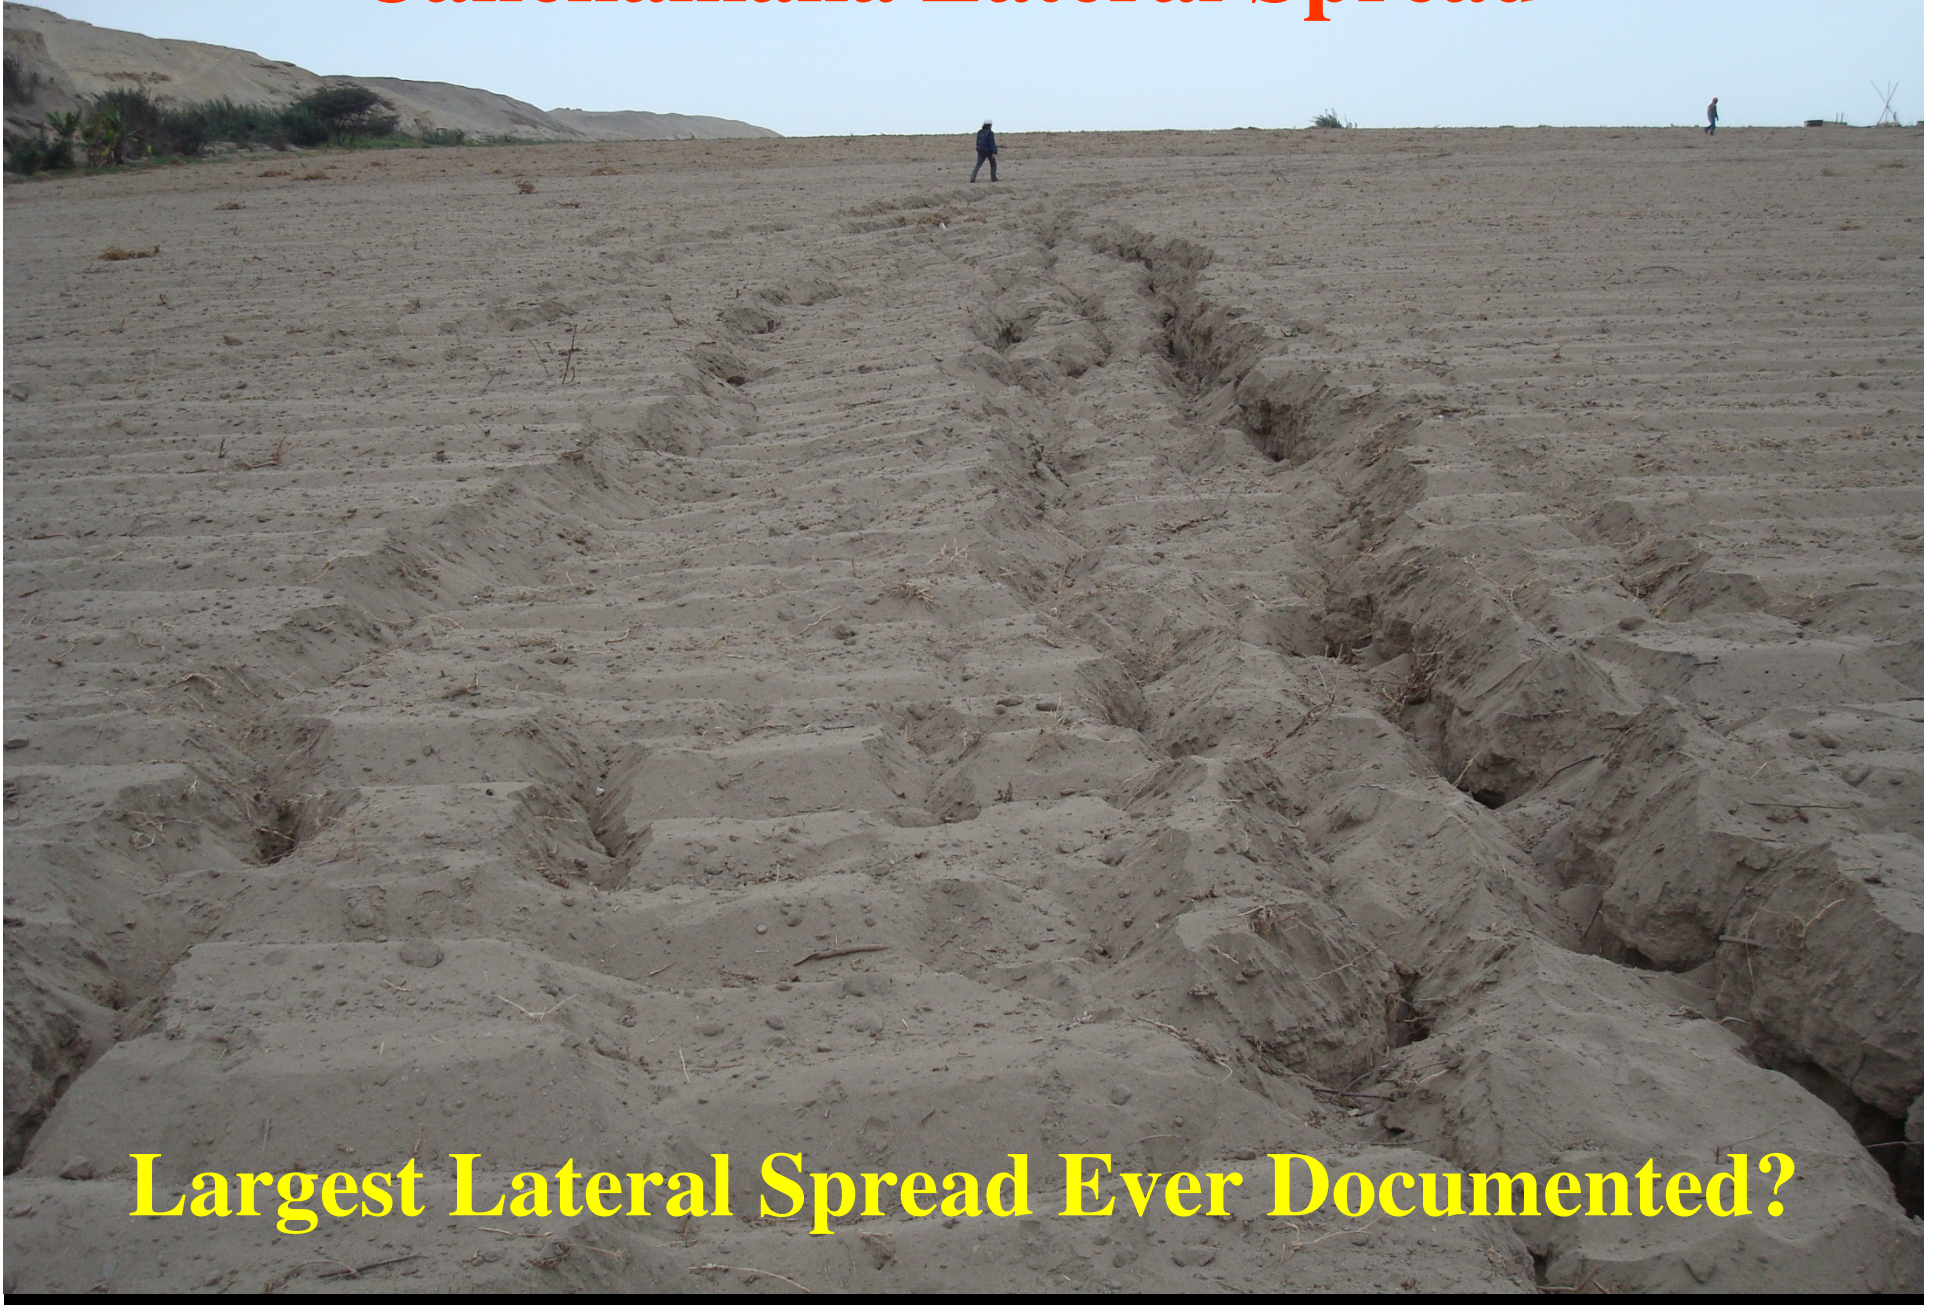
Canchamaná Lateral Spread

Largest Lateral Spread Ever Documented?

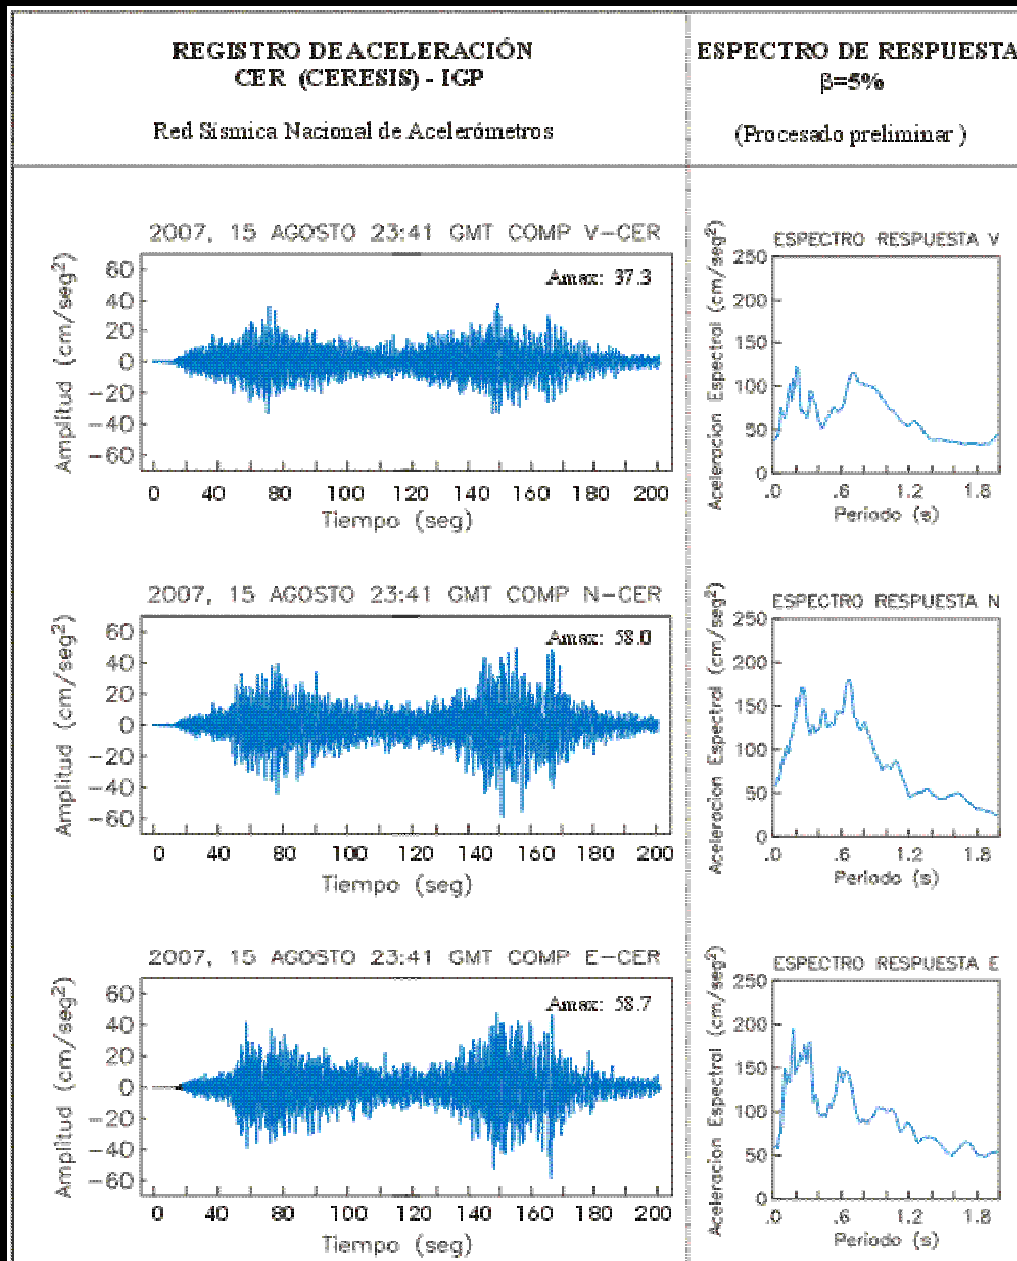
CERESIS Record (Lima)

- Distance = 102 km
- Instrument on stiff soil
- PGA = .06 g
