# GEOTECHNICAL IMPACTS OF HURRICANE MARIA IN PUERTO RICO

Event Date: September 20, 2017

**Geotechnical Extreme Events Reconnaissance**

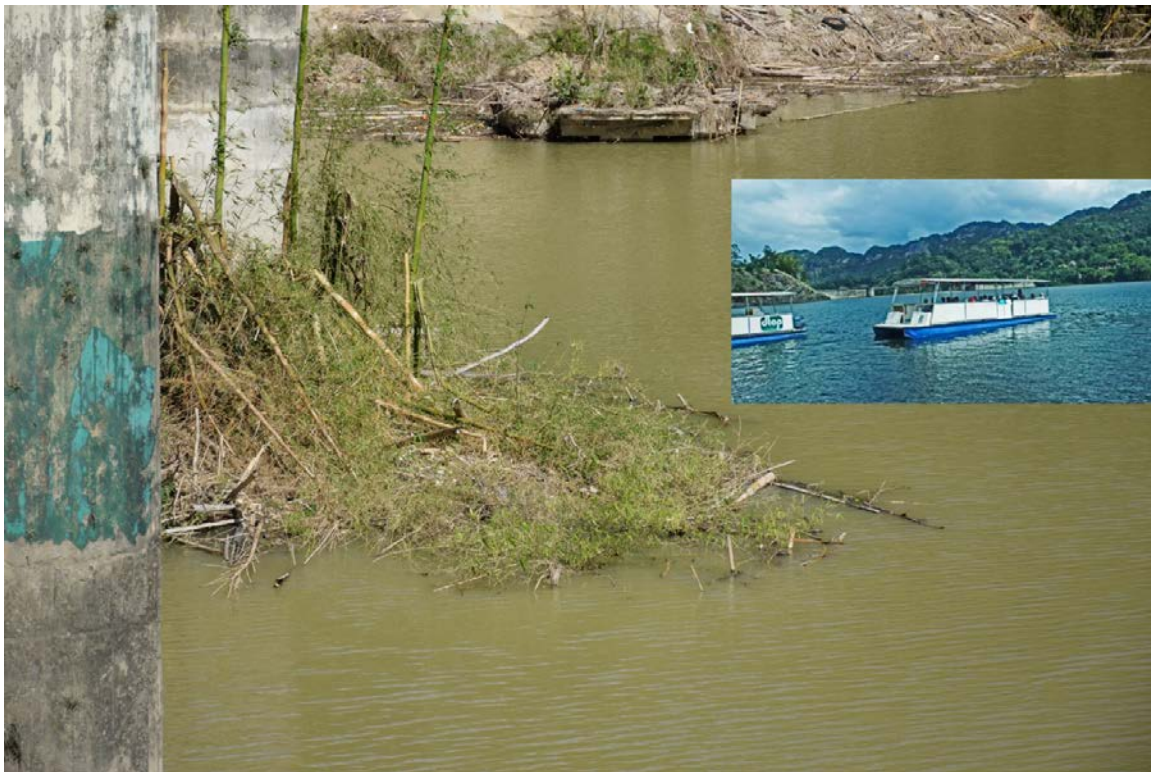
**Figure 3-1: Debris along the upstream face of the gravity dam at Lago Dos Bocas. Compare the dark brown color of the water in the reservoir to the historical blue color (before Maria) (Lat: +18.27691, Lon: -66.6561).**

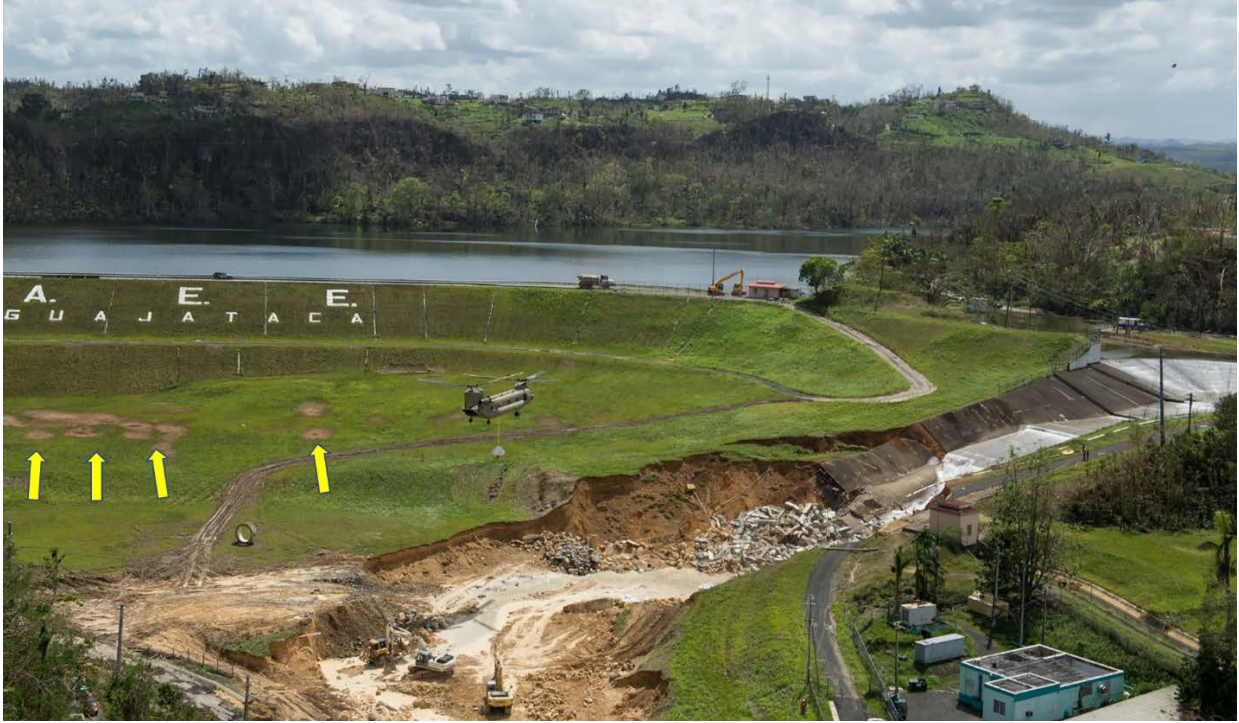
Note: Yellow arrows show location of sand boils downstream of the dam toe.

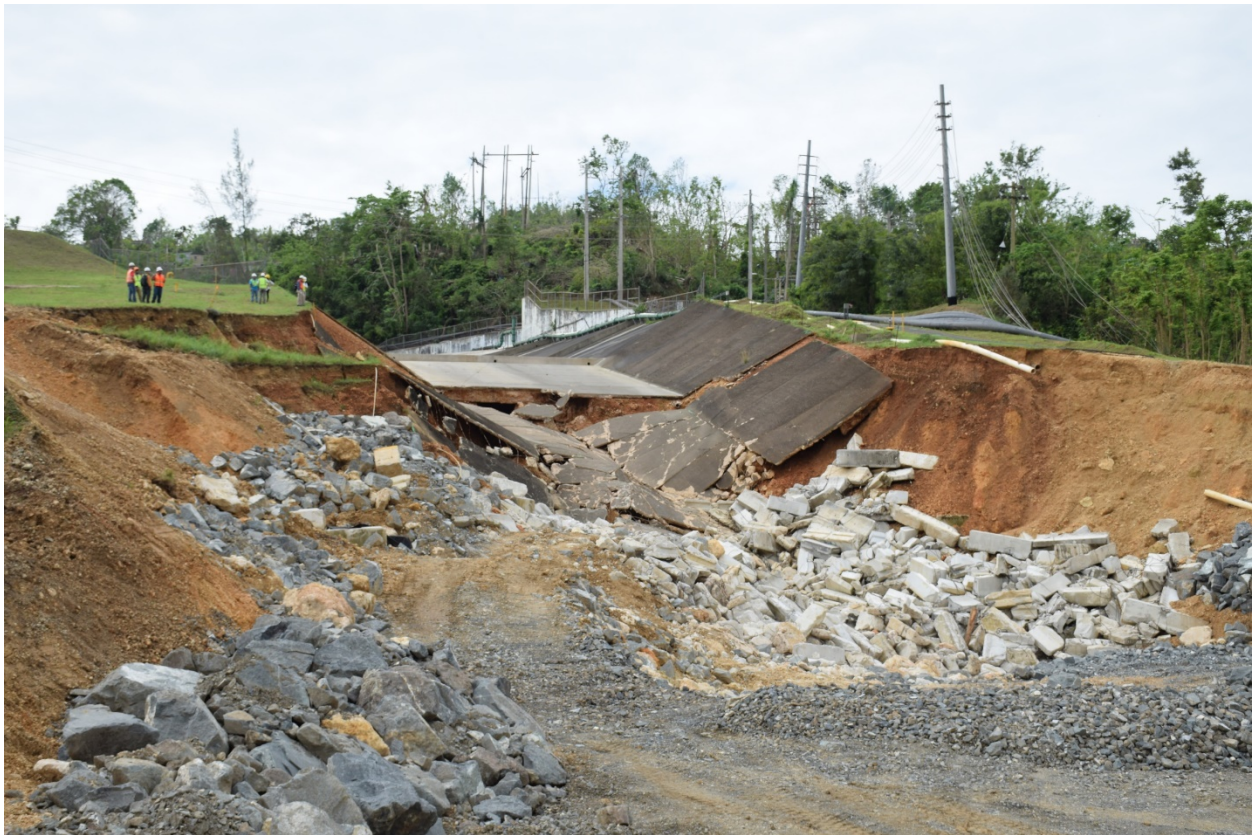
Figure 3-13: Damaged spillway (Lat: +18.39724, Lon: -66.92554).

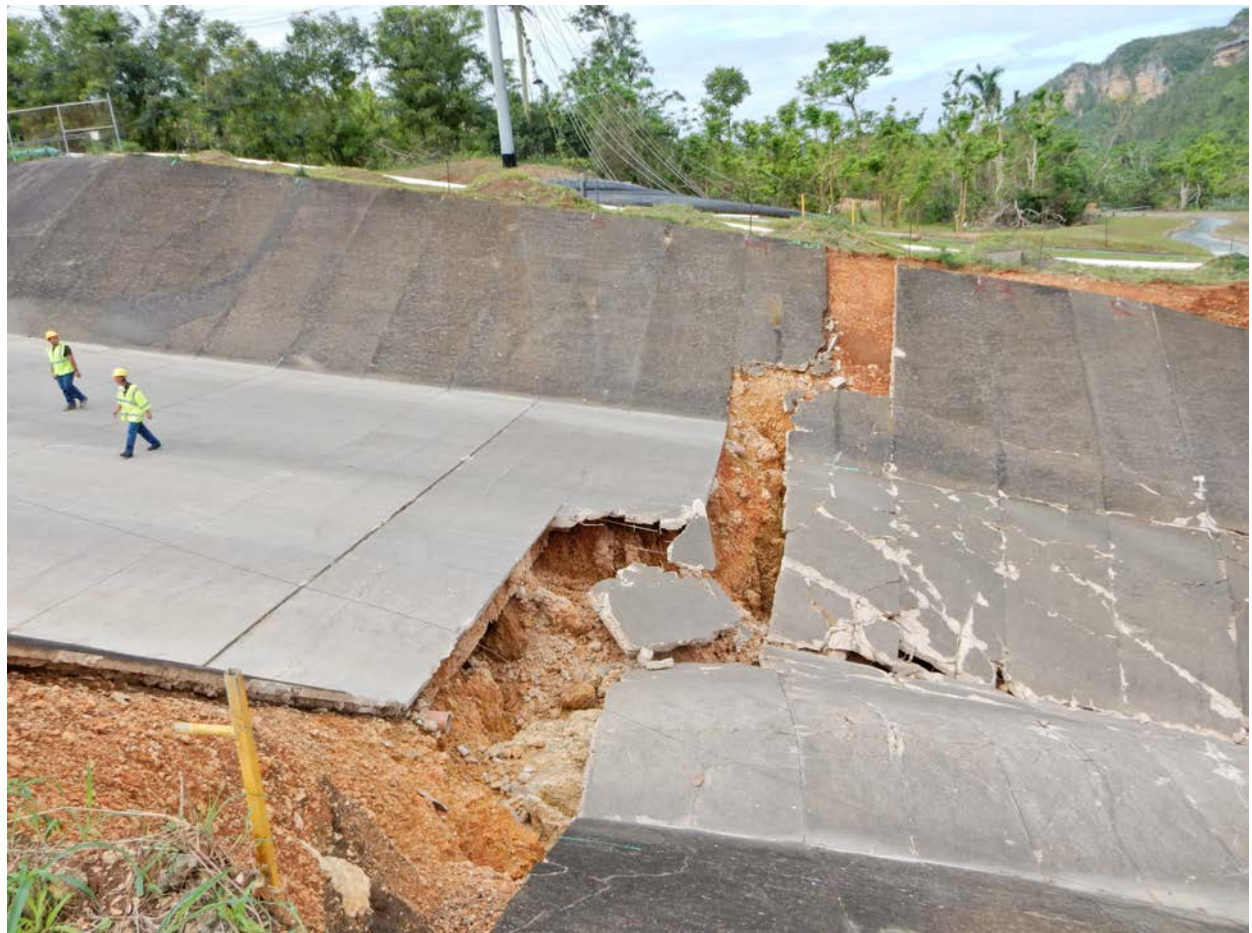
Figure 3-15: Displaced and damaged spillway (Lat: +18.39707, Lon: -66.92535).

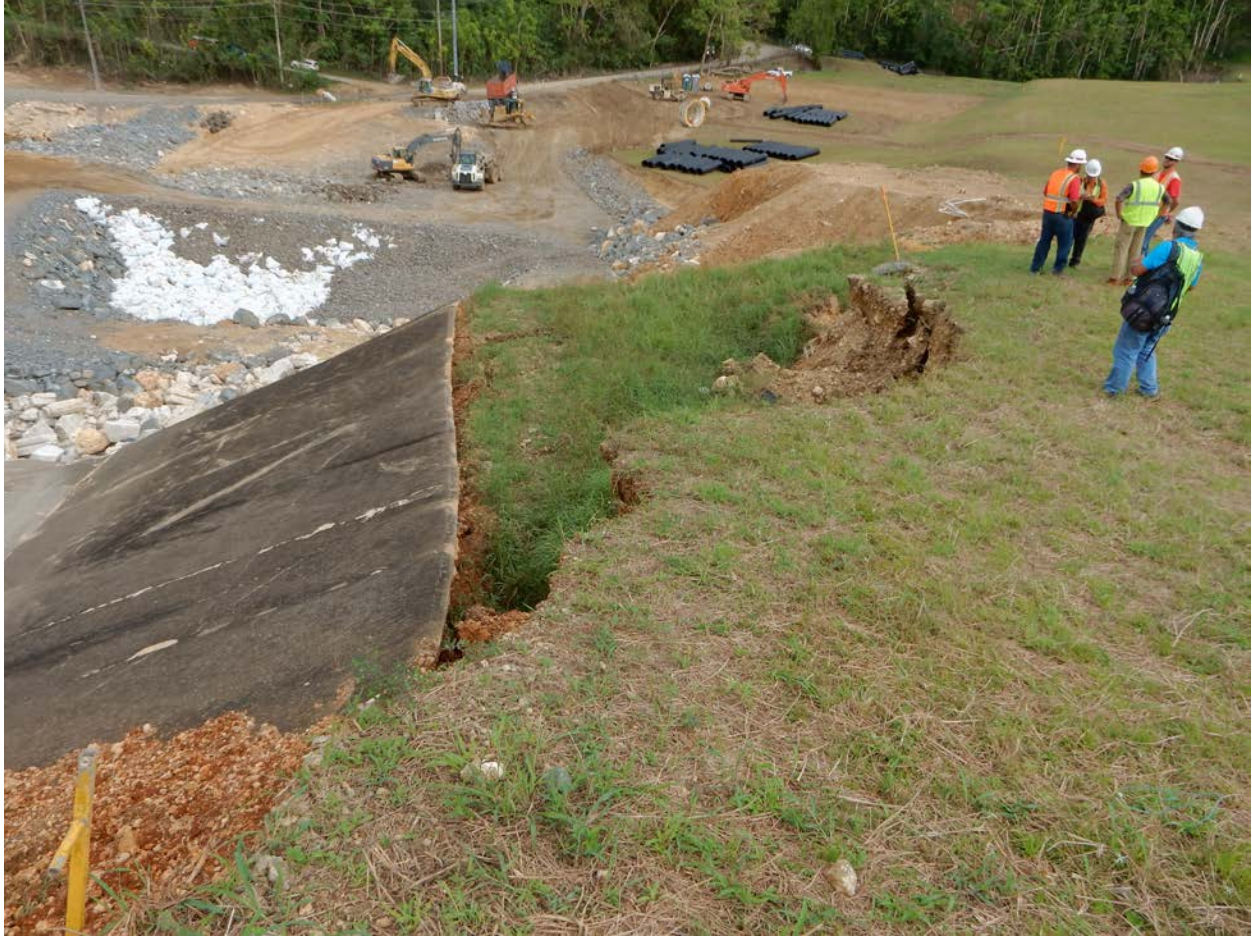
Figure 3-16: Scarp adjacent to the spillway (Lat: +18.39702, Lon: -66.92540).

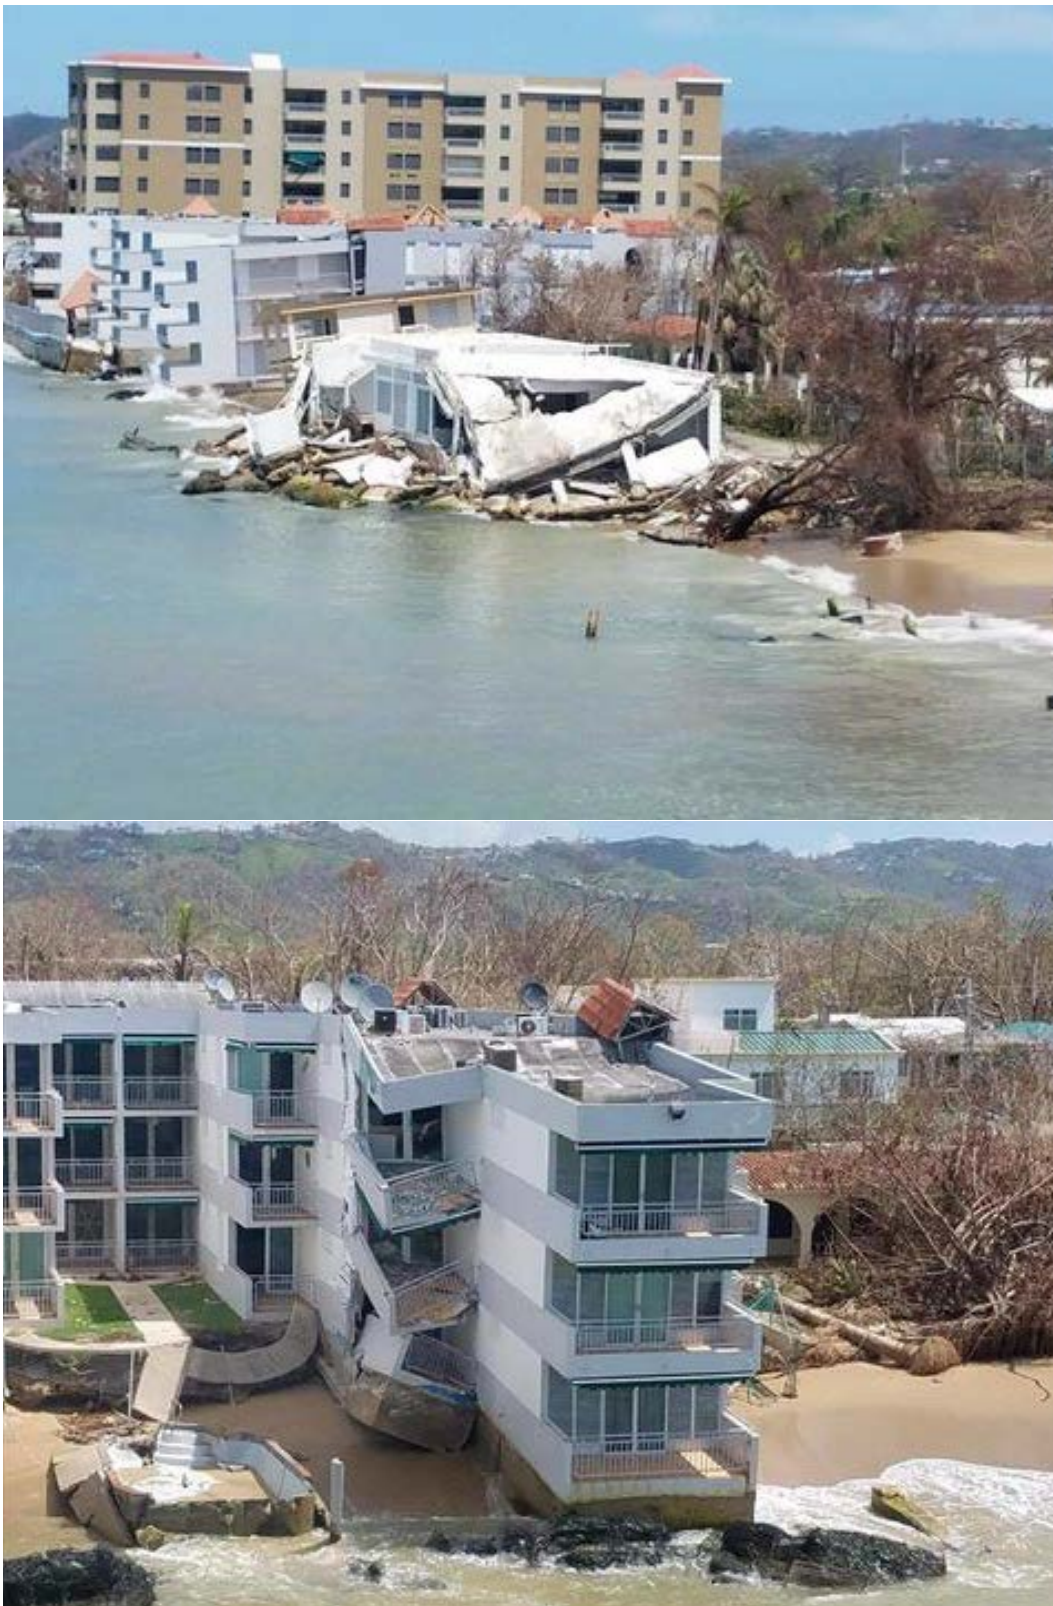
Extensive damage of the three-story building, supported by shallow footings, of Rincón Ocean Club I, and the common areas of the terrace and swimming pool can be seen in Figure 4-14. A high volume of soil was eroded from the front of the buildings and from underneath the swimming pool. Footings and a connecting grade beams supporting the terrace were exposed and sheared off from the building foundation, as shown in Figure 4-15 (c) and Figure 4-15 (d).

Notes: Top: multiple buildings damaged; Bottom: Rincón Ocean Club II (Source: <http://www.noticel.com/english/condo-in-rincon-collapses-due-to-hurricane-maria/638463446>)

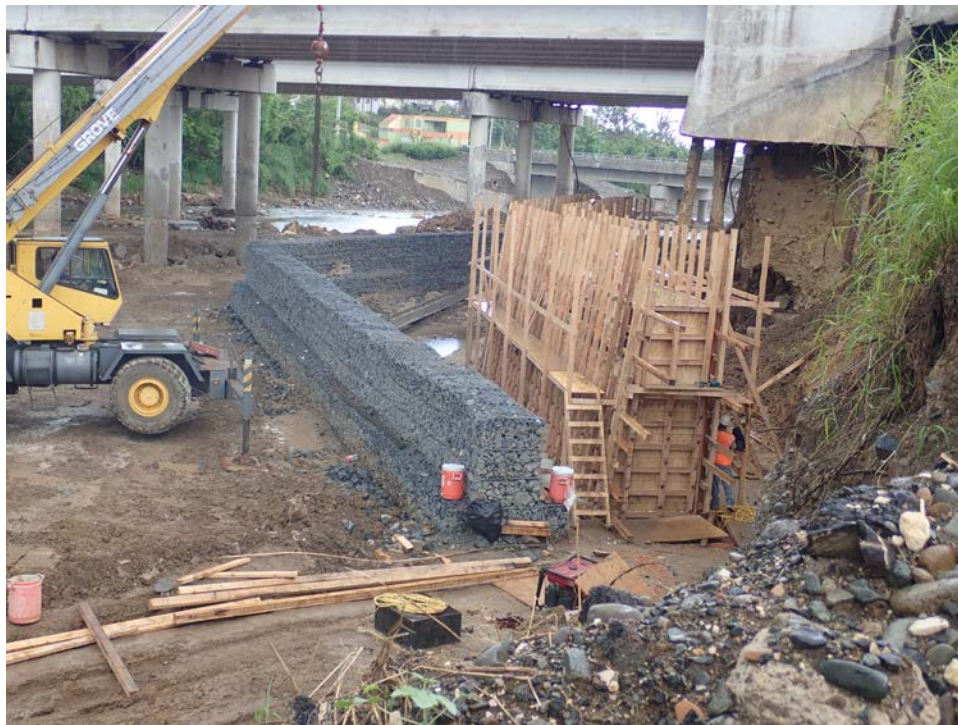
On October 31, 2017, the GEER team visited a river erosion site involving scour and erosion of a pier and abutment foundations of the bridges of Highway 52 over the Inabón River. This bridge is just east of the city of Ponce. Select photos of the site visit are shown on Figure 4-31 through Figure 4-34. These photos show ongoing work to repair the abutment. Figure 4-31 shows several exposed abutment H-piles and ongoing emergency work including erection of formwork for abutment repair and a temporary protection gabion wall; the gabion wall is to protect the abutment and reinforced concrete that will be installed in the area where the original piles are exposed. Additional photos appear in Appendix C. Figure 4-33 shows erosion that exposed several original abutment H-piles and the ongoing emergency repair works.

Figure 4-31: West abutment of westbound Highway 52 bridge over the Inabón River (Lat: +18.04003, Lon: -66.53795, October 31, 2017).

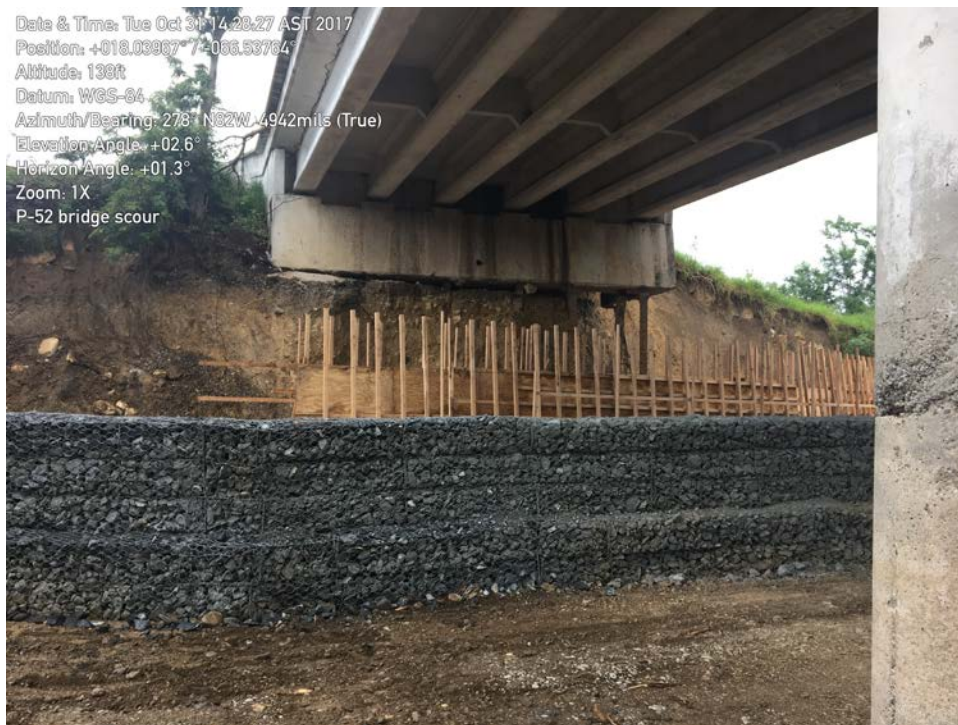
Figure 4-32: West abutment of westbound Highway 52 bridge over Inabón river (October 31, 2017). Photo shows erosion along this abutment and ongoing emergency repair work (Lat: +18.03967, Lon: -66.53764).

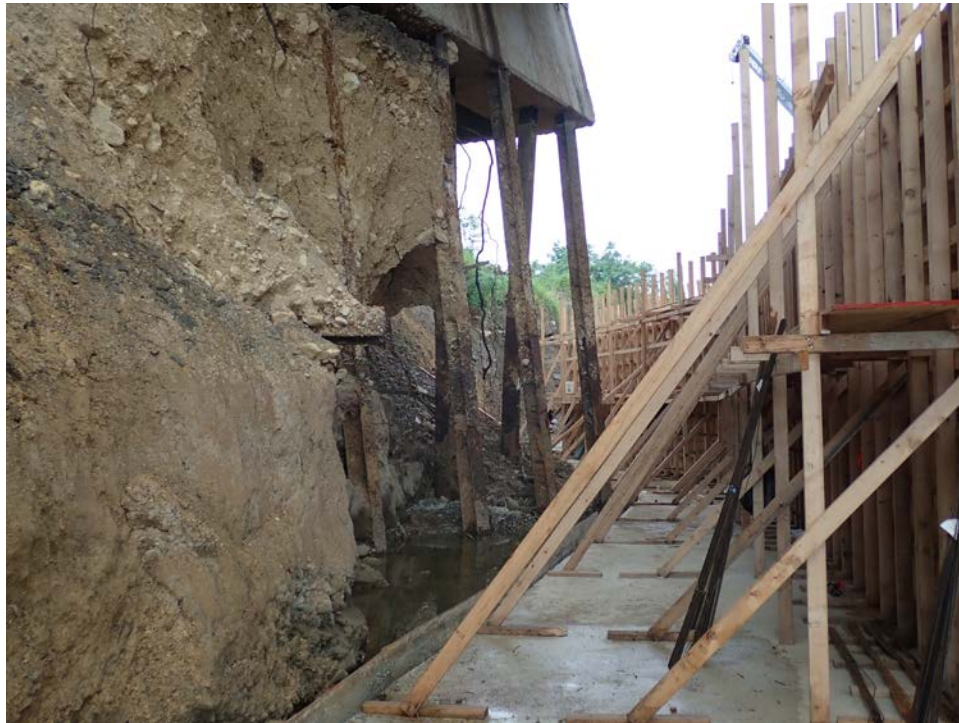
**Figure 4-33: Erosion damage at west abutment of westbound Highway 52 bridge over the Inabón River (Lat: +18.03962, Lon: -66.53767, October 31, 2017).**

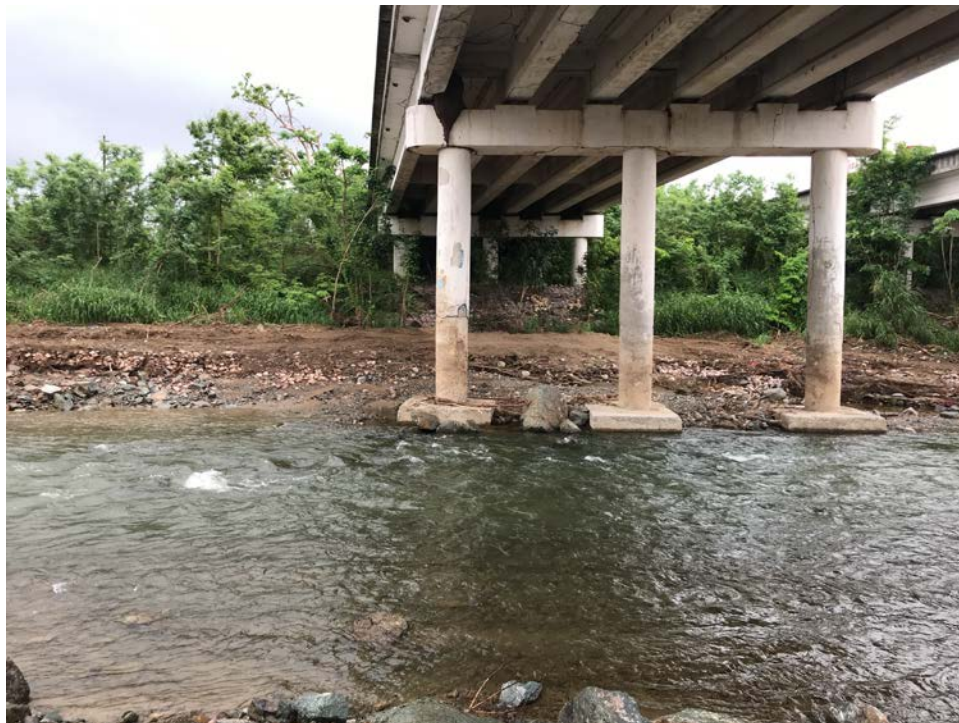
**Figure 4-34: Erosion along pier foundation of westbound Highway 52 bridge over the Inabón River (Lat: +18.03992, Lon: -66.53754, October 31, 2017).**

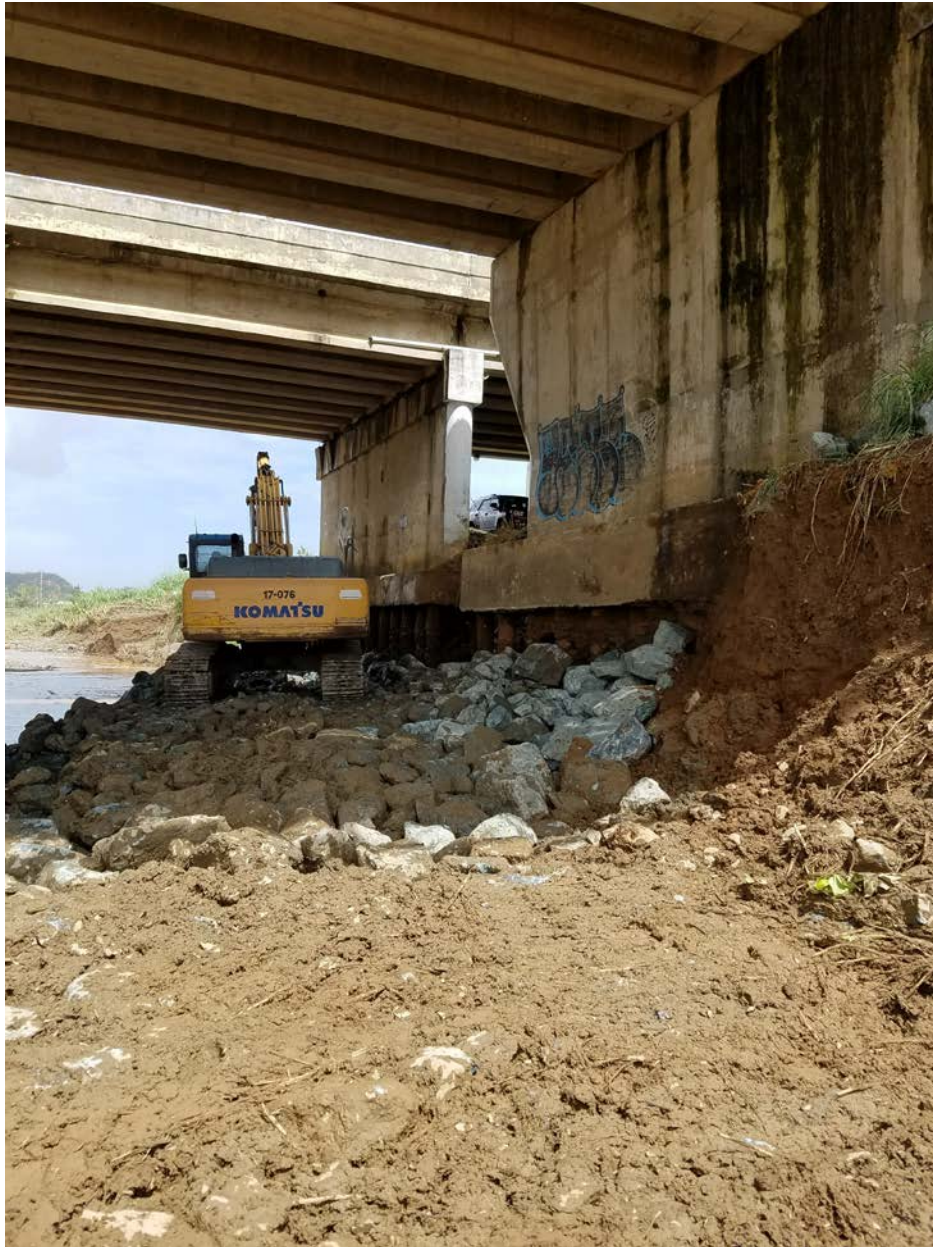
Figure 4-35: Erosion along pier foundation of bridges of Highway PR-177 in Bayamón, PR (Photo by Geo-Cim) (Lat: +18.38384, Lon: -66.13571).

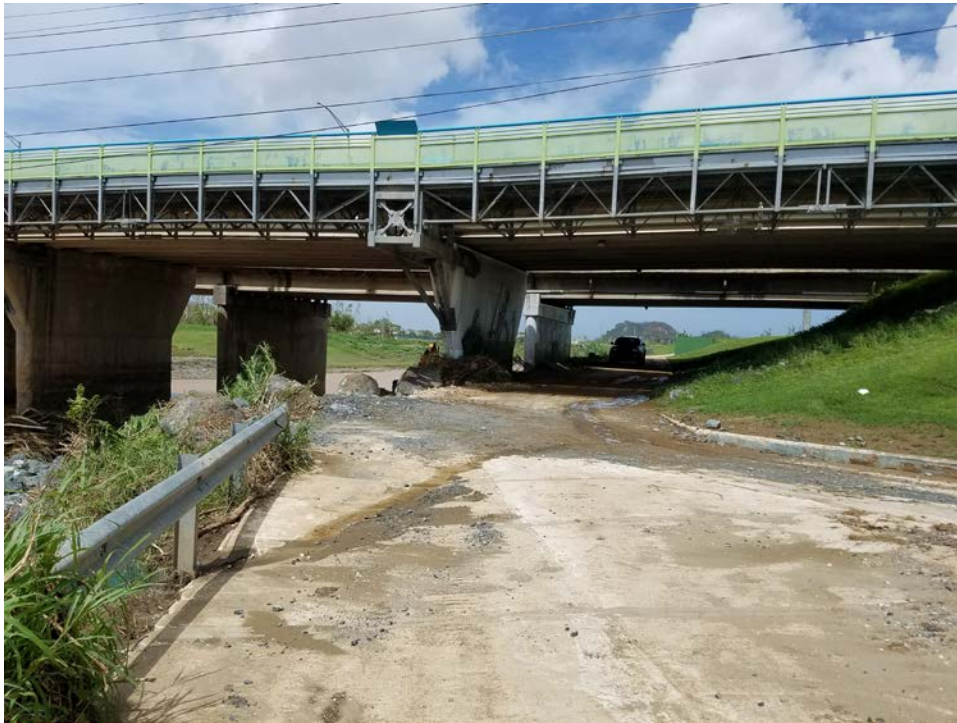
**Figure 4-36: Erosion along pier foundation of bridges of Highway PR-177 in Bayamón, PR (Photo by Geo-Cim) (Lat: +18.3838, Lon: -66.13557).**

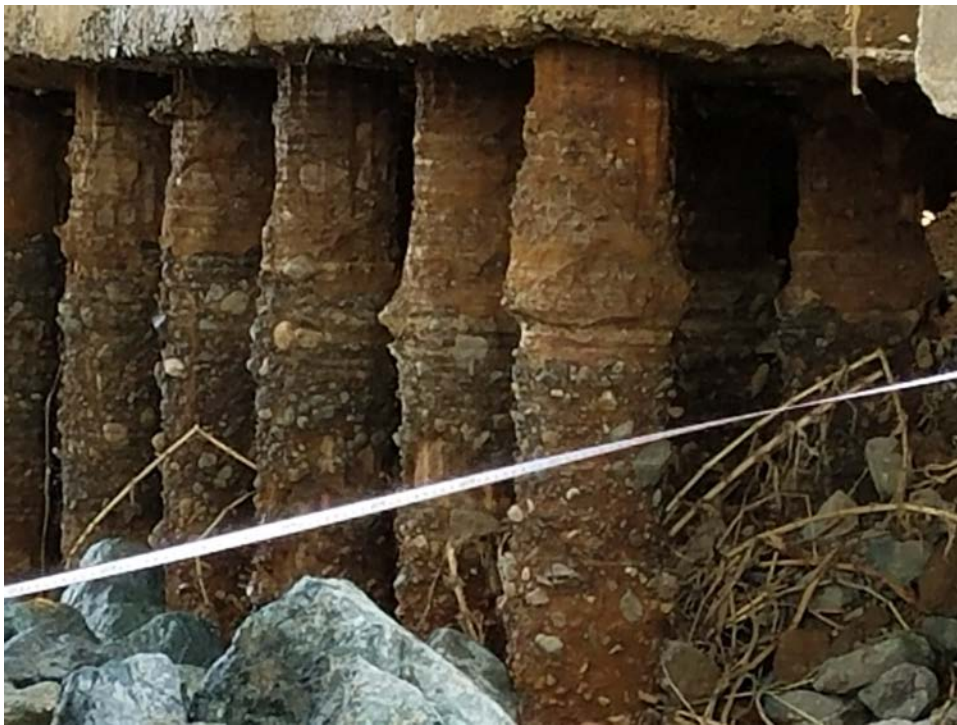
**Figure 4-37: Erosion along pier foundation of bridges of Highway PR-177 in Bayamón, PR (Photo by Geo-Cim) (Lat: +18.38389, Lon: -66.135562).**

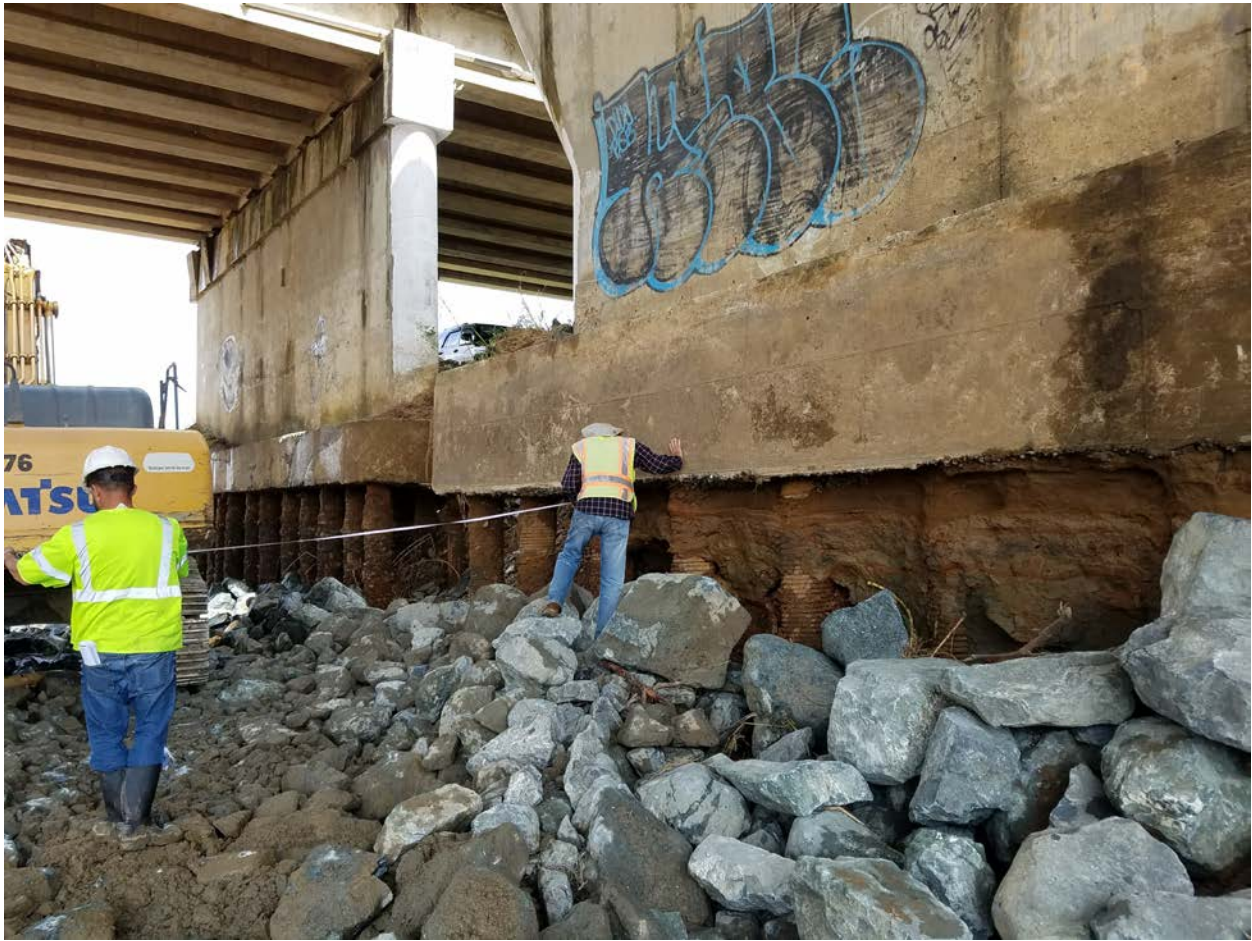
**Figure 4-38: Erosion along pier foundation of bridges of Highway PR-177 in Bayamón, PR (Photo by Geo-Cim) (Lat: +18.38392, Lon: -66.13581).**

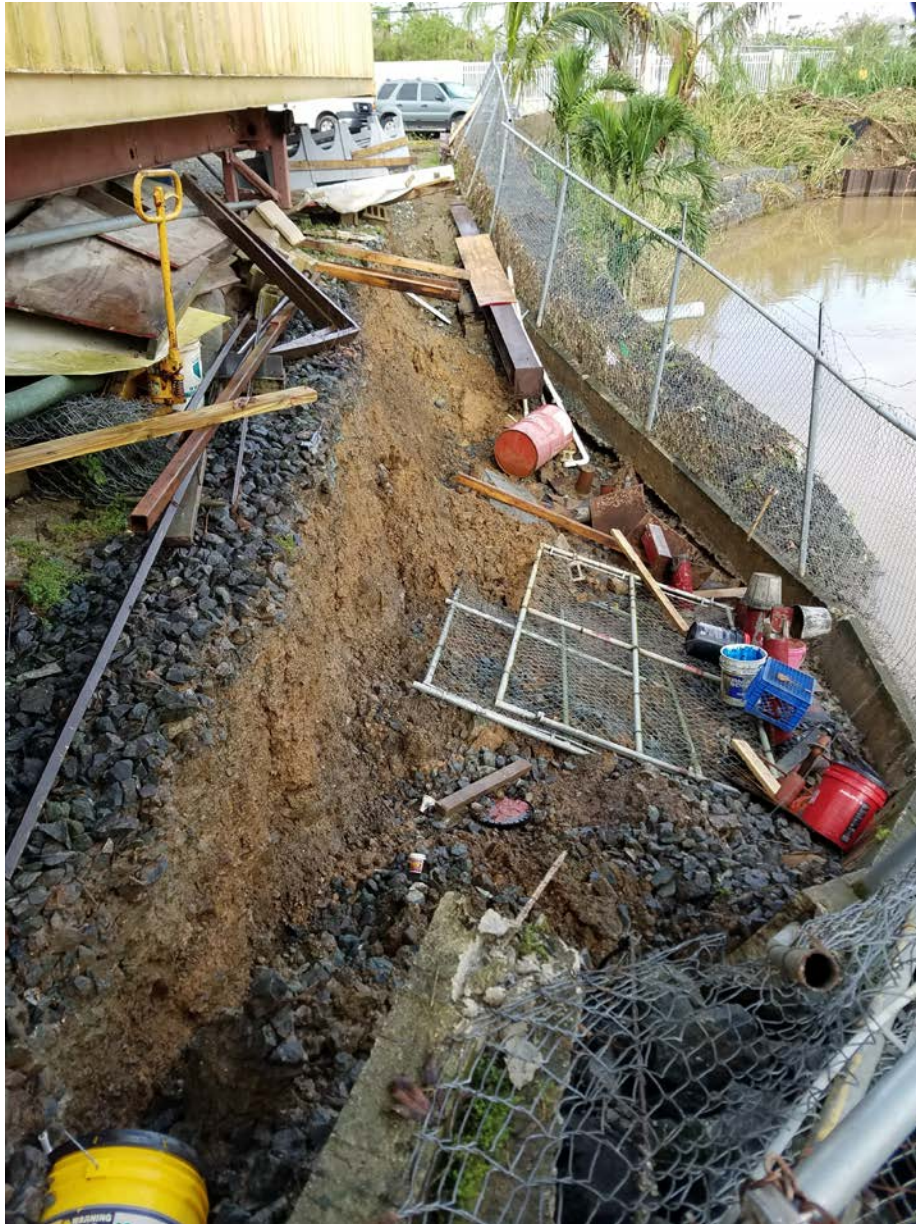
Figure 4-39: River bank erosion failure of Guaynabo River at Site RE3 (Photo by Geo-Cim) (Lat: +18.37306, Lon: -66.13248).

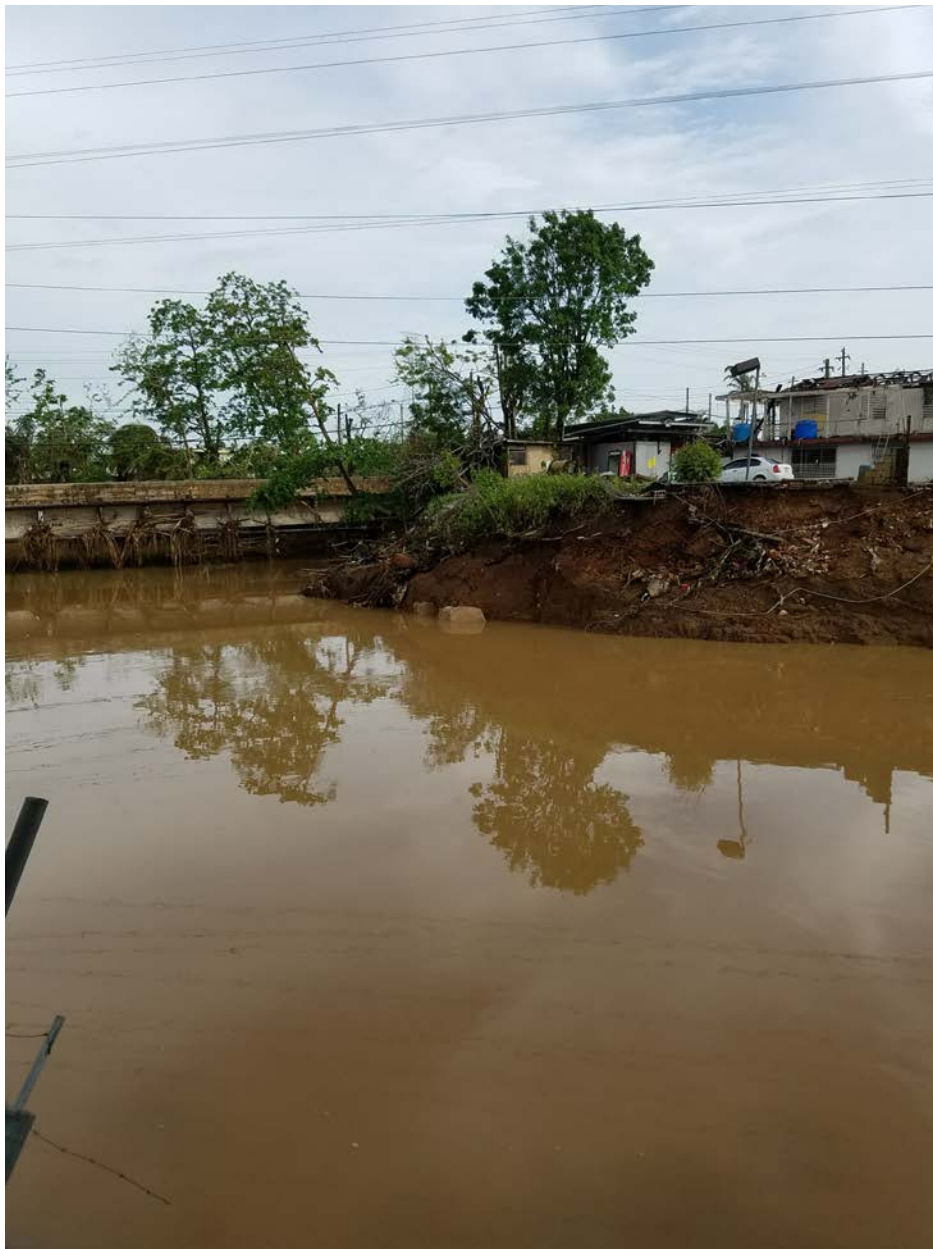
**Figure 4-40: River bank erosion failure of Guaynabo River at Site RE3 (Photo by Geo-Cim) (Lat: +18.37307, Lon: -66.13248).**

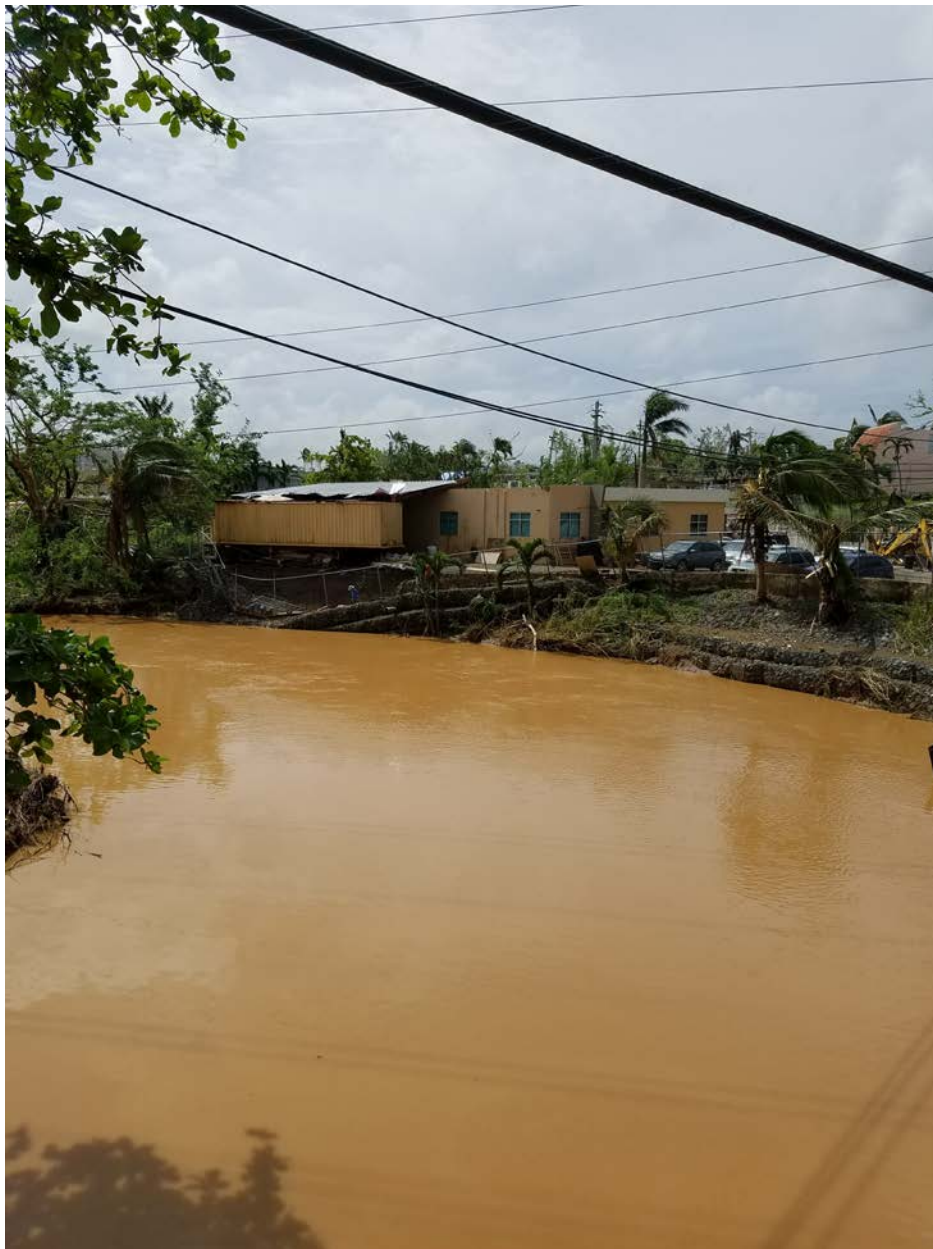
**Figure 4-41: River bank erosion failure of Guaynabo River at Site RE3 (Photo by Geo-Cim) (Lat: +18.37356, Lon: -66.13253).**

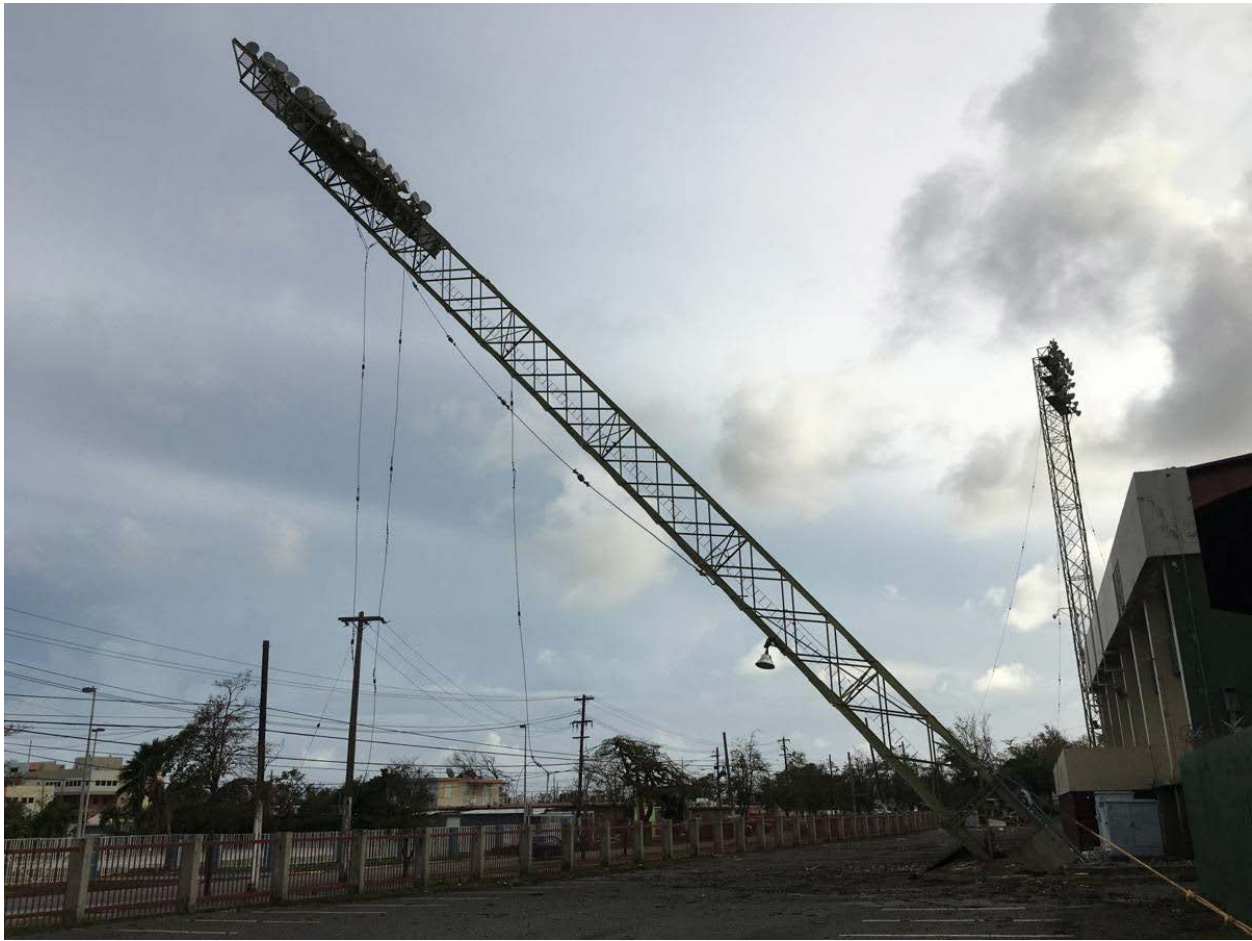
**Figure 6-11: Photo of failed tower published by El Vocero 9/27/17 (Photo from Bartolomei, 2017) (Lat: +18.002275, Lon: -66.630714).**

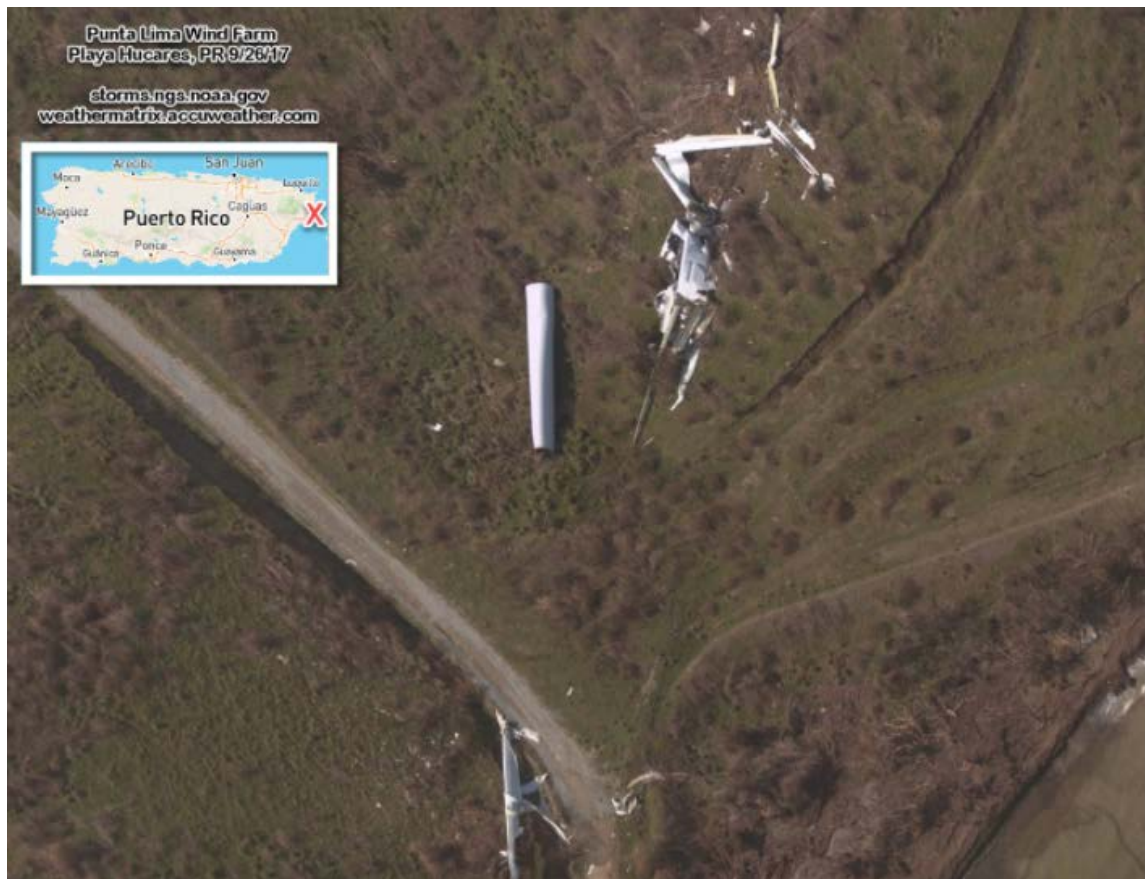
**Figure 7-2: Destroyed wind turbine at Punta Lima Wind Farm, PR (Lat: +18.181809, Lon: -65.694291).**

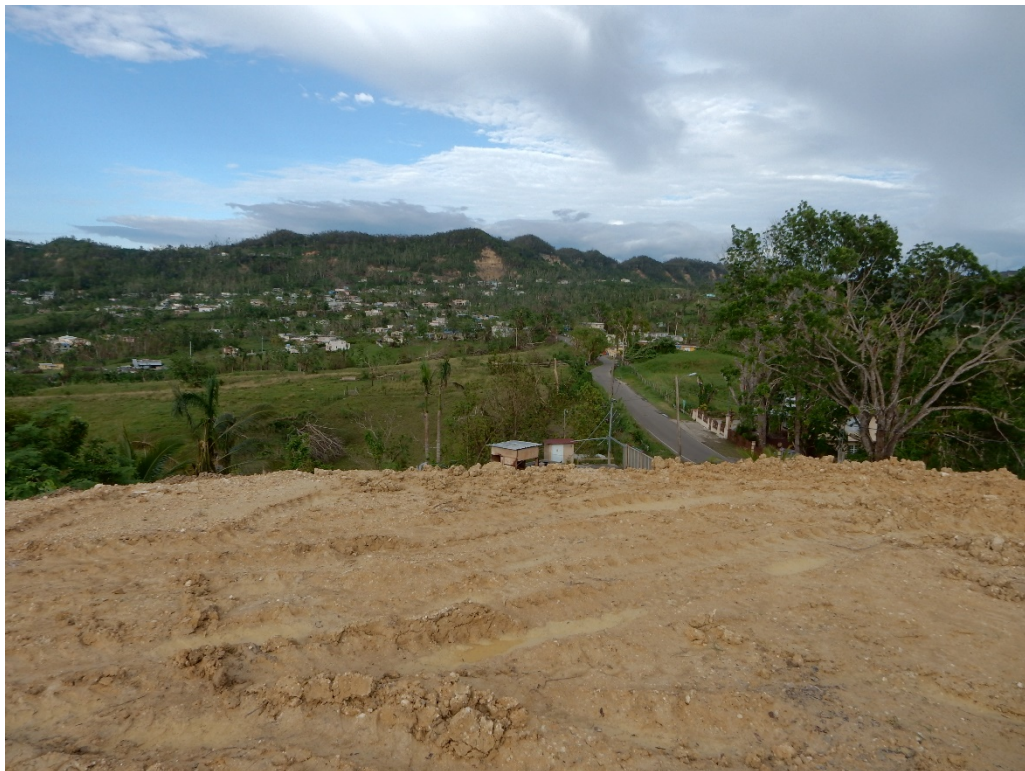
**Figure A-9: Moca, PR-110 failures from a distance; Lat: +18.38861, Lon: -67.07504; 2017.10.29; #3305.**

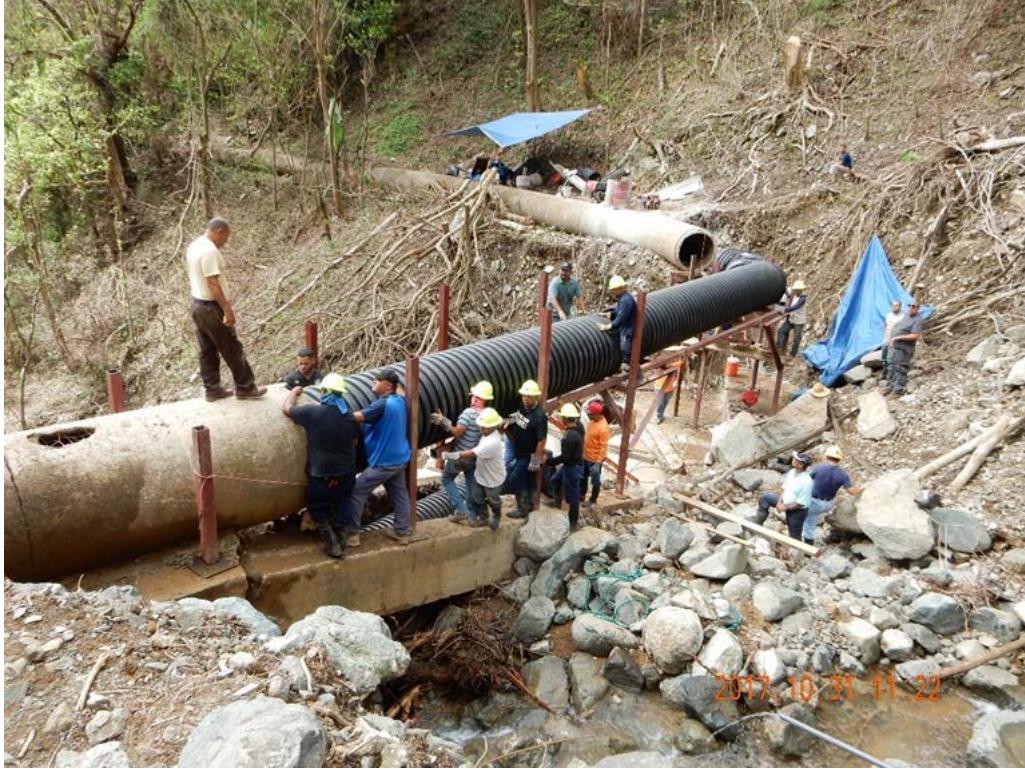
Figure A-16: Temporary repairs; Lat: +18.15865, Lon: -66.49810; 2017.10.31; #3506.

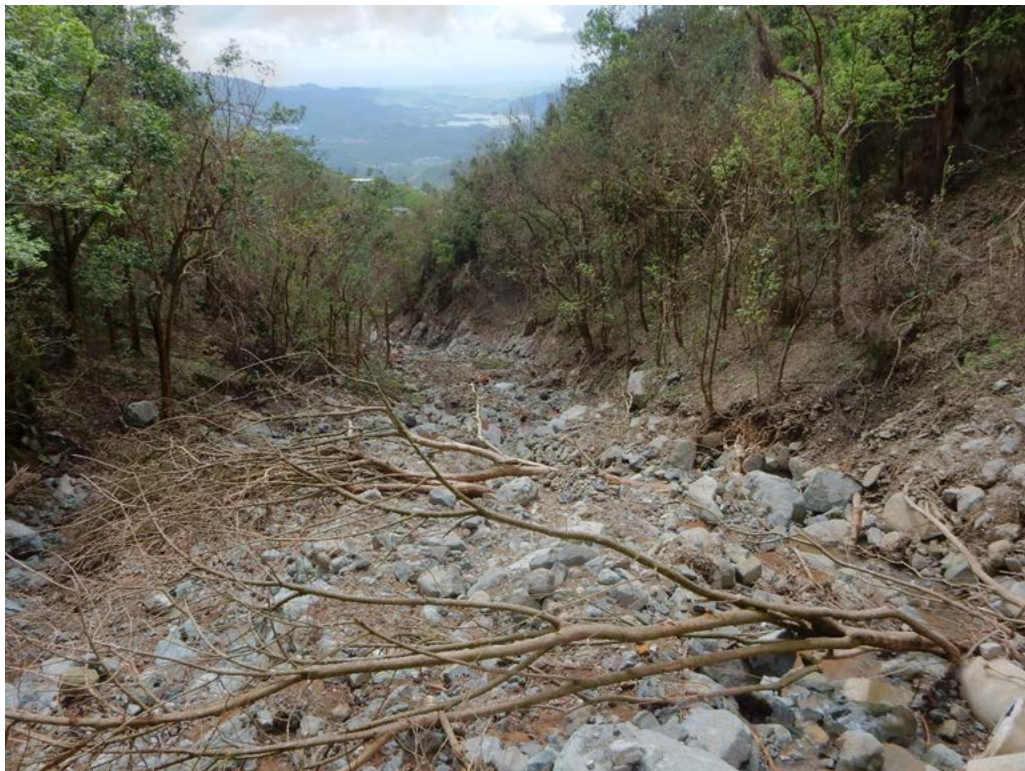
Figure A-17: Downstream of raw water line break, Carillo, Villalba, PR-149, Km 59.1; Lat: +18.15849, Lon: -66.49821; 2017.10.31; #3515.
