# GEOTECHNICAL IMPACTS OF HURRICANE MARIA IN PUERTO RICO

Event Date: September 20, 2017

**Geotechnical Extreme Events Reconnaissance**

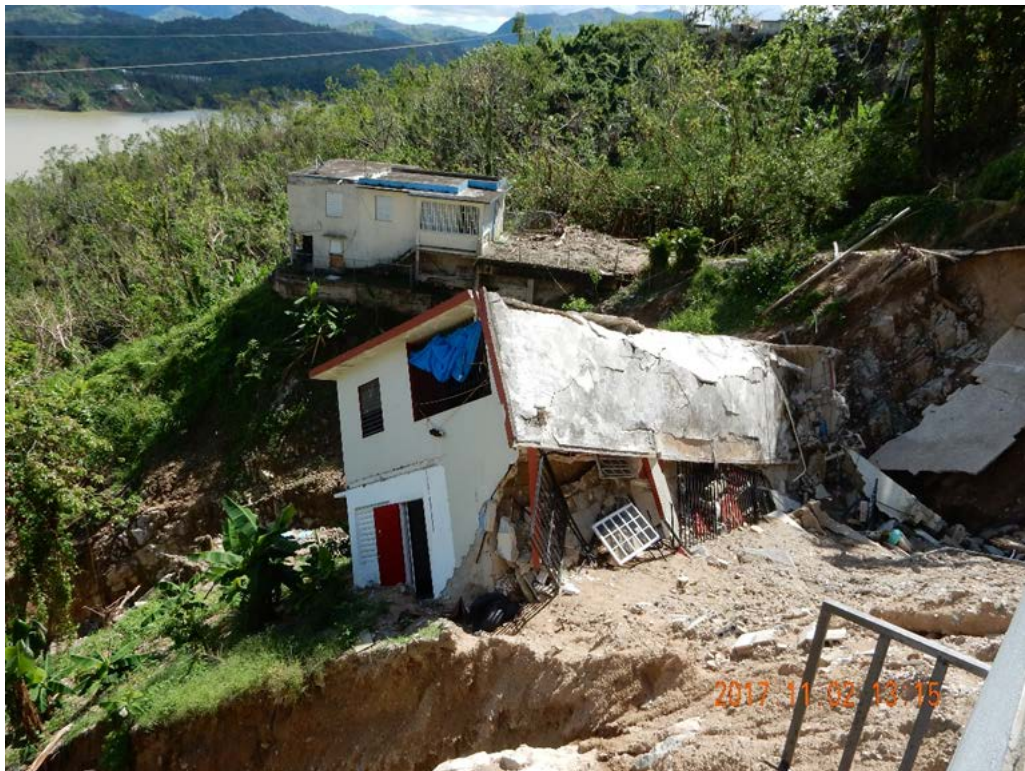
Figure A-28: Utuado, PR-140, Km 26.1, rusty cast iron pipe at head scarp; Lat: +18.26700333, Lon: - 66.66004833; 2017.11.02; #3876.

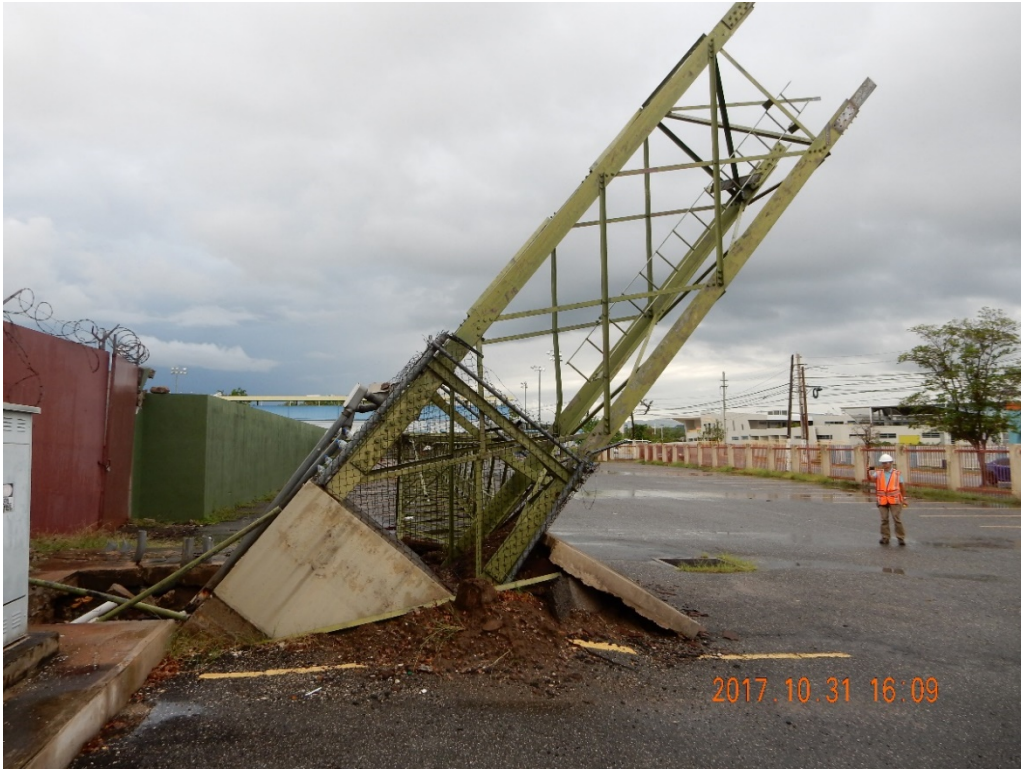
Figure E-4: Photo of foundation failure of illumination tower at Site F4 (Lat: +18.00207, Lon: -66.63098; 2017.10.31).

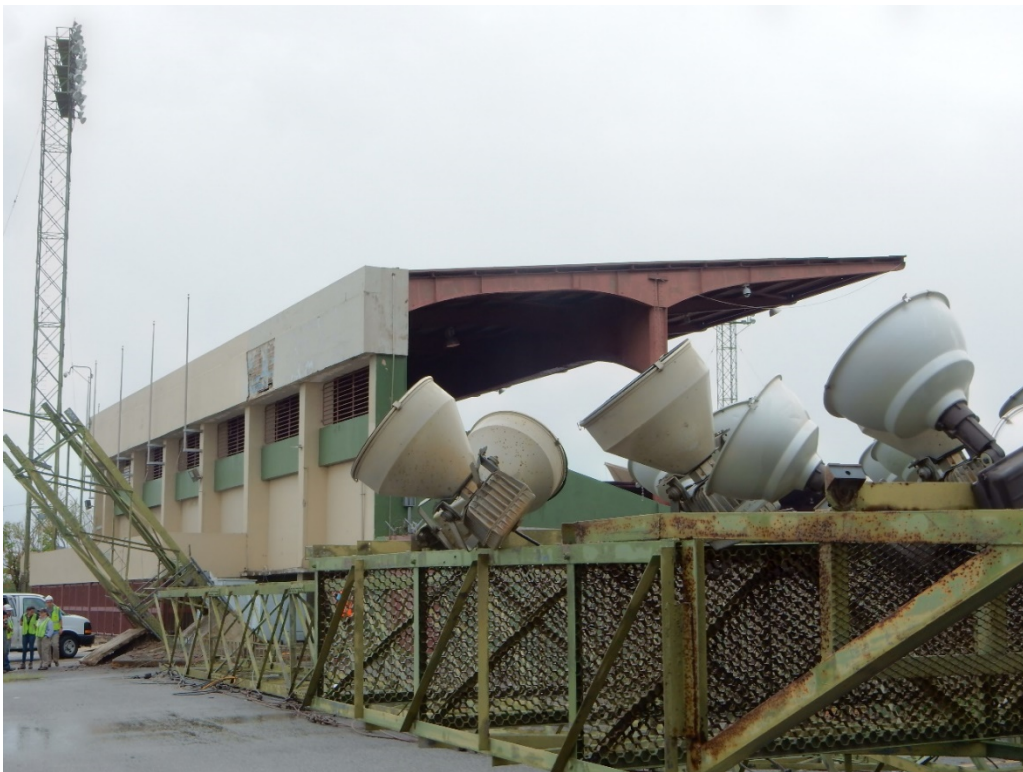
Figure E-8: Photo of portion of the structure of the failed illumination tower (Lat: +18.00207, Lon: -66.63098; 2017.10.31).

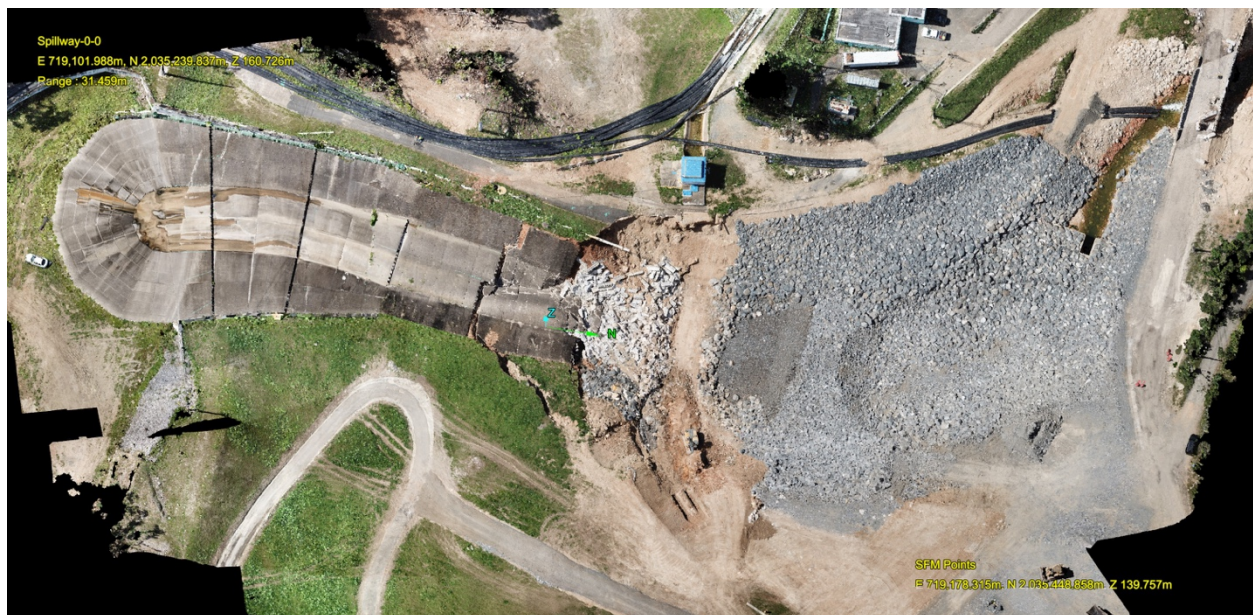
Figure G-1: The orthomosaic of the damaged spillway at Guajataca dam from a hybridized model of SFM imagery analysis and TLS LIDAR data.

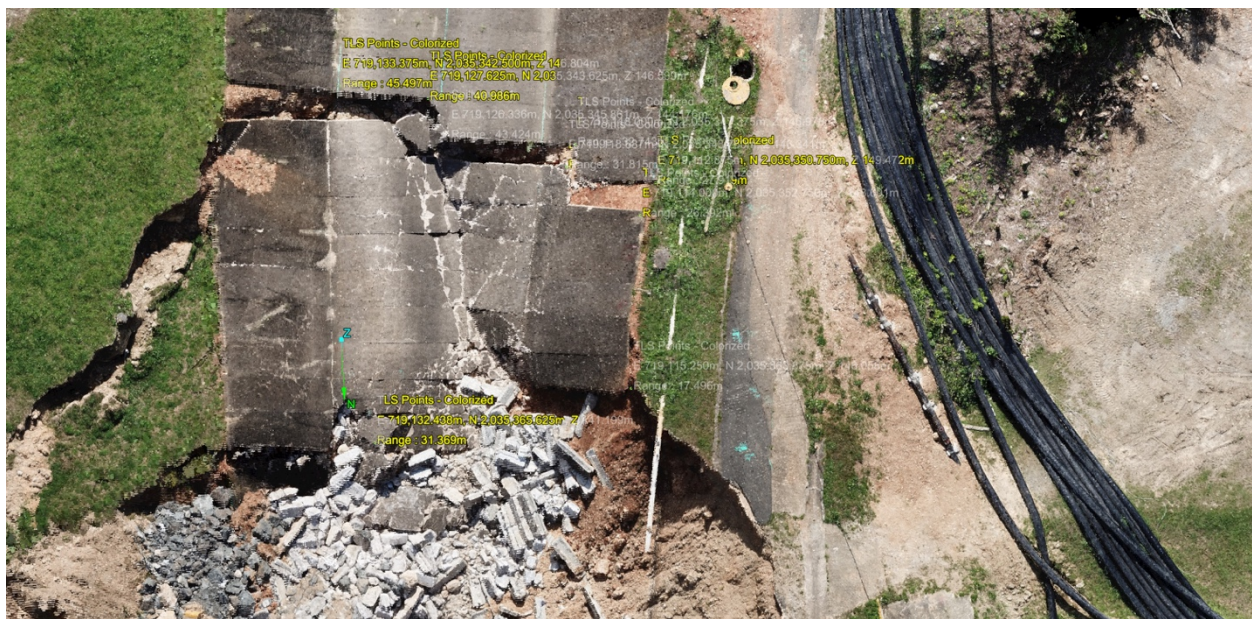
Figure G-3: Plan view of the damaged section D of the spillway.

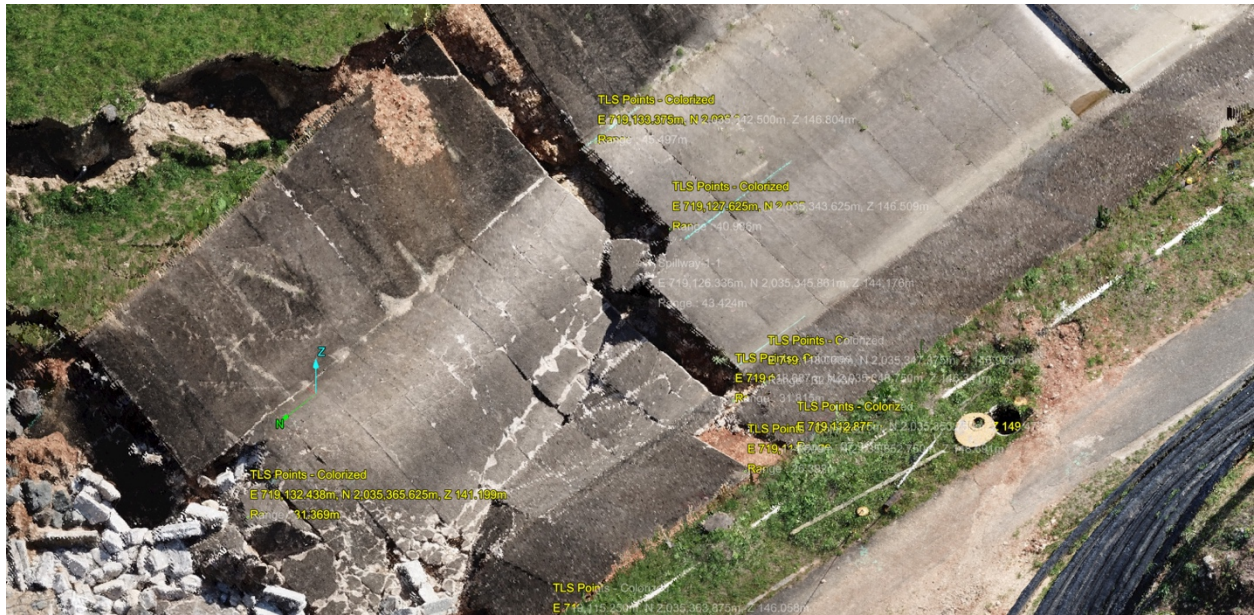
Figure G-4: Oblique view of the damaged section D of the spillway.

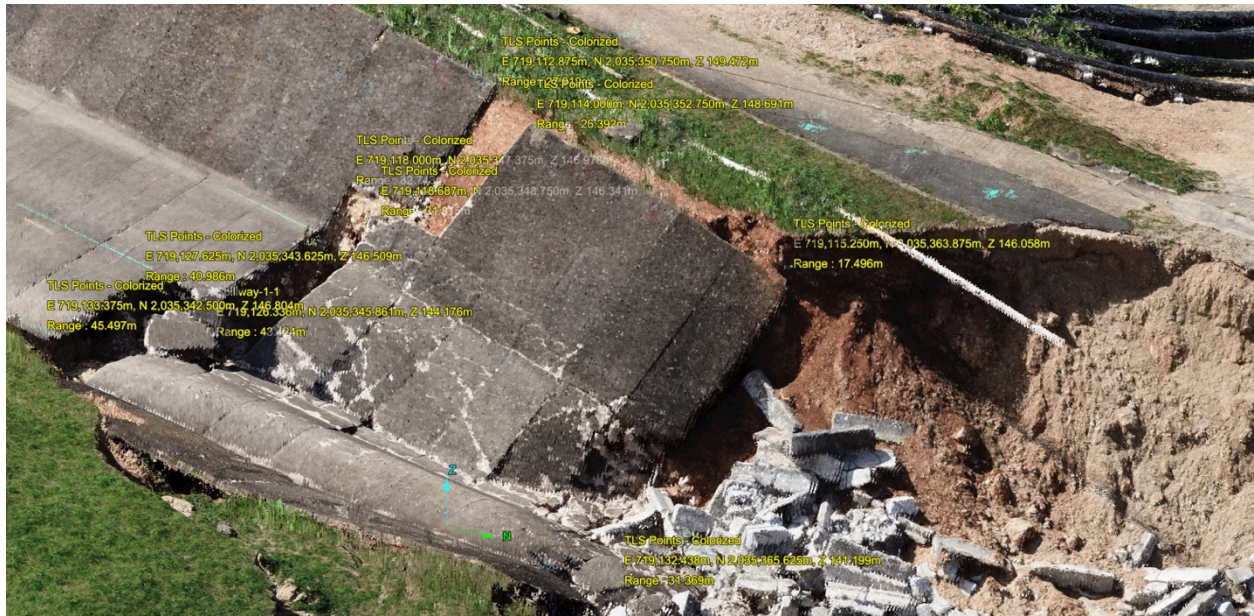
Figure G-5: Oblique view of the damaged section D of the spillway.

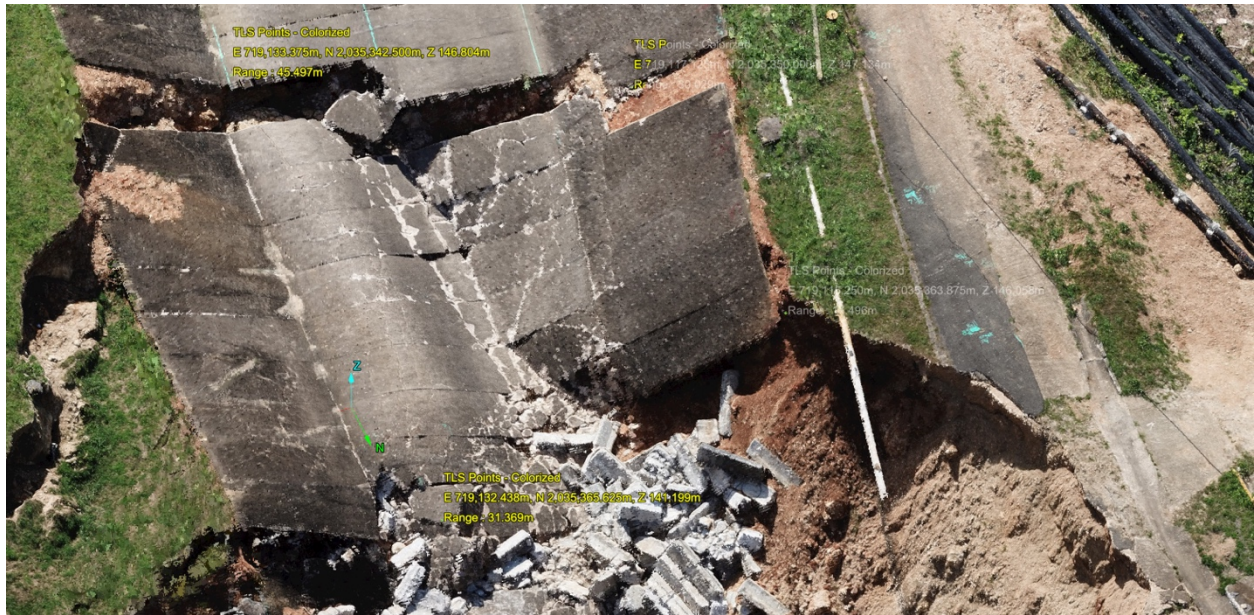
Figure G-6: Oblique view of the damaged section D of the spillway.
