**Geo-Engineering Earthquake  
Reconnaissance (GEER) Association**

**GEOLOGICAL ENGINEERING RECONNAISSANCE OF  
DAMAGE RESULTING FROM THE OCTOBER 15, 2006  
EARTHQUAKES, ISLAND OF HAWAII, HAWAII, USA**

***Dr. Edmund W. Medley, PE, CEG, F.ASCE***

15 December 2006

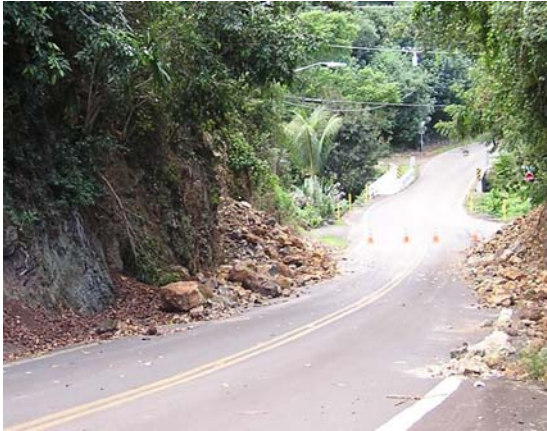
**Figure 4: Hwy 270, near Keokea Bay Beach Park access road: Highway blocked by rock fall.**

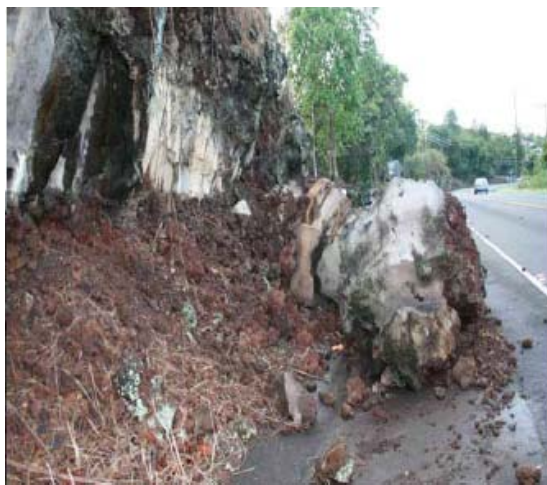
**Figure 5: Failed rock cut: massive a'a block undermined by raveled a'a clinker (Chock, 2006; after Robertson et al, 2006)**

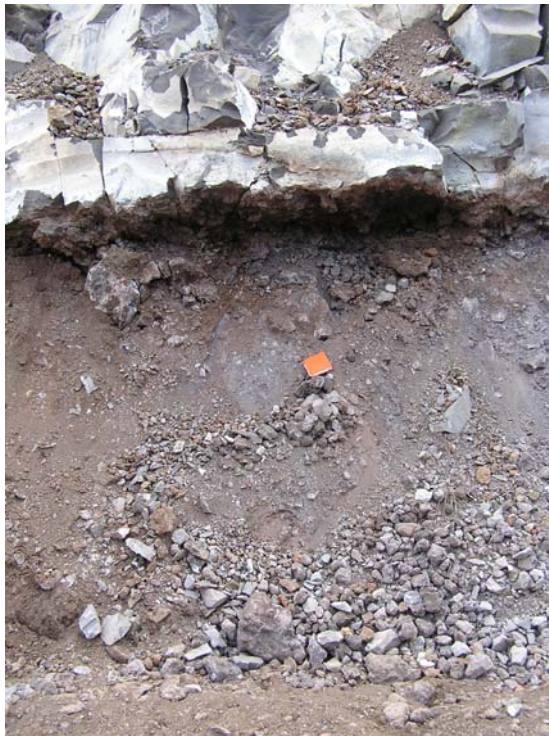
**Figure 8: Location 25, Hwy 270 north of Kawaihae. Cantilevered block of massive *a'a* basalt, undermined by raveled clinker**

blocks are capable of sustained significant cantilevers. However, with the removal of raveled supporting clinker, many overhanging blocks failed during the earthquakes (Figure 8). It was these large and heavy blocks, rather than the soil-like clinker, that represented the greater hazard to traffic.

1. The failure of road cut rock slopes was much influenced by the presence of a'a clinker. Where clinker underlay massive basalt blocks, there was a tendency for the loose clinker to translate, rotate and ravel downslope, thereby undermining the blocks. Where the massive blocks could not sustain a critical cantilever, they dislodged as well. Even if the blocks did not fail, their overhang is a future traffic hazard and they should be reviewed by an engineering geologist (or geotechnical engineer knowledgeable in rock engineering) and removed if necessary;

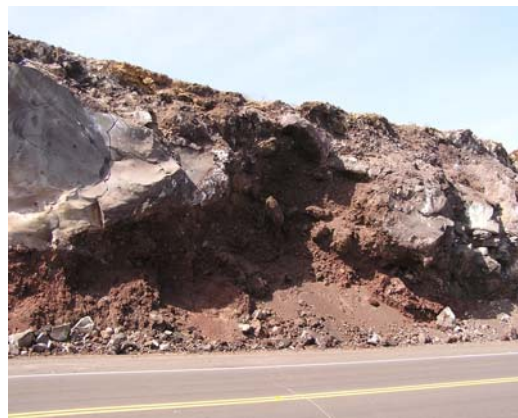
**Figure 9: Location 32, Hwy 11. Failure of massive basalt rock overlying weaker weathered rock (baked zone).**

soils failed, undermining the stronger rock above, in a fashion similar to that above described for aa/massive basalt sequences (Figure 9 and Figure 10).

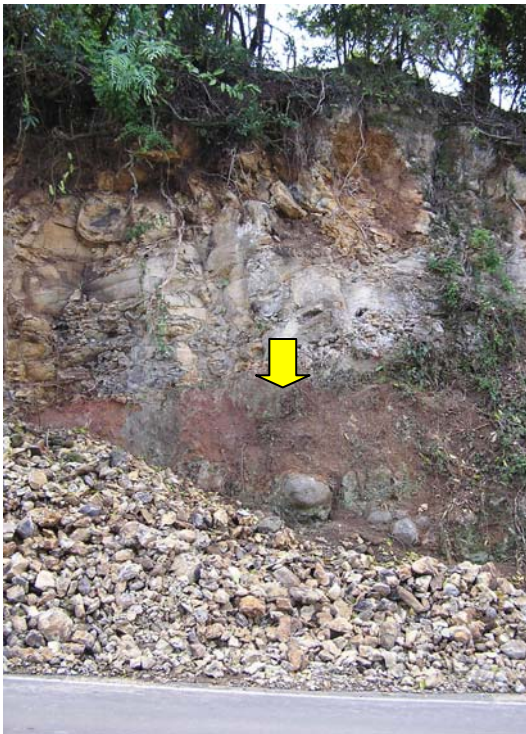
**Figure 10: Location 18, Hwy 270 at Makapala. Failure of stronger rock underlain by baked zone soil, with weathered boulders (arrow).**

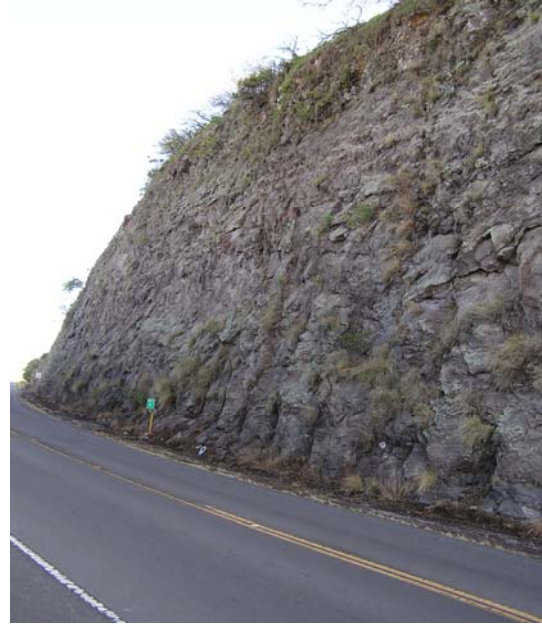
At Location 13 on Hwy 250, (Milepost 8, Kohala Mountain Road) a very high and steep road cut appeared to have sustained little distress during the earthquake

**Figure 14: Location 12, Milepost 8, Hwy 250. Stable steep and high road cut.**

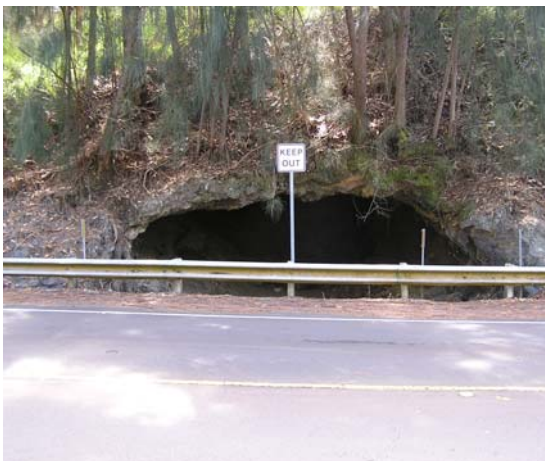
Lava tubes are common in pāhoehoe. One lava tube beside Highway 240 (Figure 16) showed remarkably little apparent disruption of wall and roof rock mass, despite a span of several meters and fractured rock exposed at the cave surfaces. The degree of rockmass failures in caves and tunnels due to the earthquake is unknown. The vulnerability of tunnels to rockfall during large earthquakes is an important lifeline issue given that Statewide, many water supply routes occupy tunnels. Water supply to the Waipio area was interrupted by collapse of a major ditch in the Kohala area (according to news reports).

**Figure 16: Location 7, Hwy 240, near Kapulena, north of Honokaa. Lava tube, with apparently little rockfall from roof and walls.**

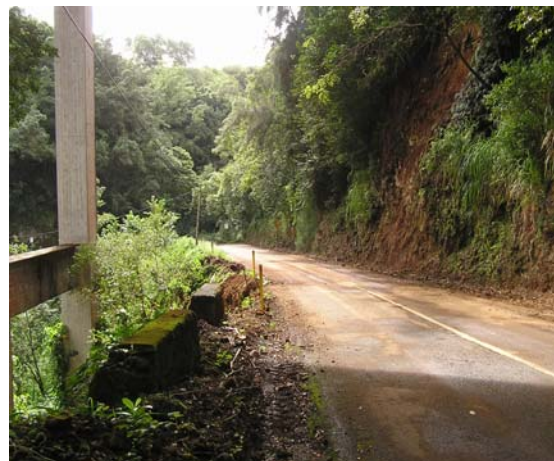
**Figure 17: Location 4, old Hwy 11 near Ookala, Modern Hwy 11 viaduct above. Soil slide in very steep road cut in vicinity of abutment of viaduct, typical of many slides along this road.**

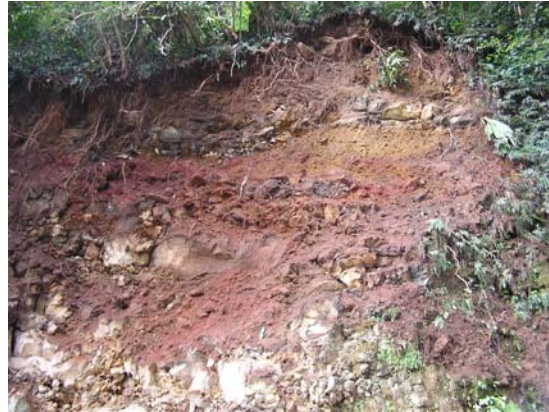
Fresh to moderately weathered rocks, in which hard blocks of rock are surrounded by weaker soil (Figure 10 and Figure 18); or rock masses composed of massive blocks of basalt within an a'ā clinker matrix (Figure 9) are complex geological mixtures. As shown by Wakabayashi and Medley (2004)<sup>5</sup> such rock/soil mixtures have a *block-in-matrix*

**Figure 18: Location 4: old Hwy 11 near Ookala. Failure of soil above rock. Note inclusions of rock within soil.**

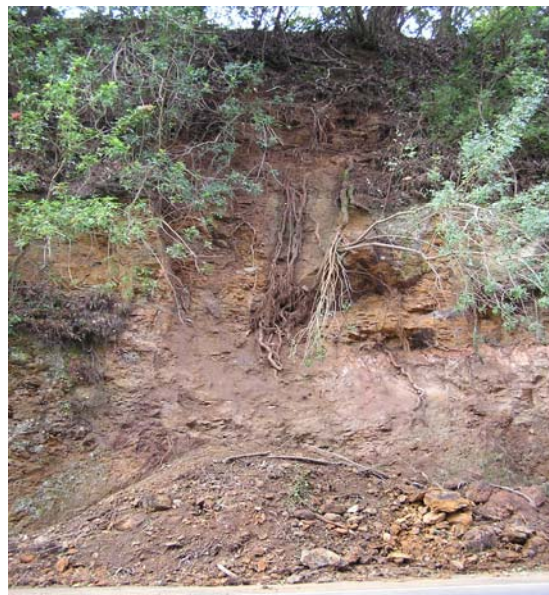
**Figure 19: Location 16, Near Kapaau (Kohala), Hwy 270. Tree roots within fractures influenced instability in road cuts in soil.**

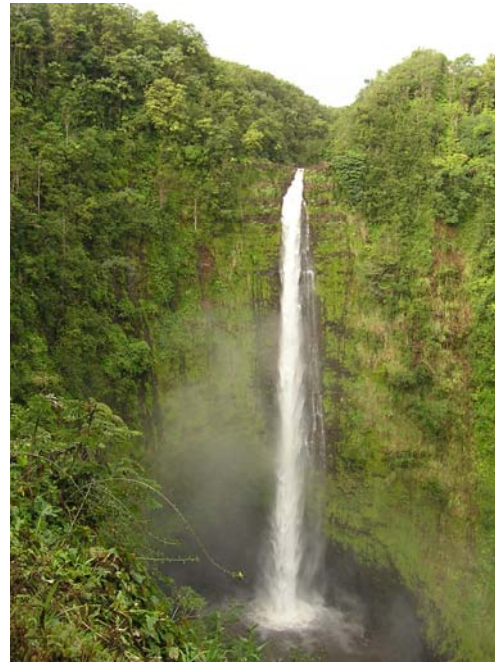
**Figure 20: Location 2, Akaka Falls, Hamakua Coast. Bald scars in the cliff face may not all be attributable to the earthquake.**

Apparently recent slides were observed on the cliff face of the Akaka Falls (Figure 20). Other earthquake effects at the State Park property were apparently limited to fallen trees and damaged hand railings. At Waipio Valley, the coastal cliffs show evidence of older landslides which have deposited debris that is at least 35 years old<sup>7</sup> (Figure 21). However, prominent large scars may not be a result of the earthquake since at the time of the reconnaissance, the water at the toe of the cliff was not muddy. The alignment of the failed cliffs in Figure 21 suggests a mega-landslide head scarp or a fault scarp, although the faceted spurs may also be due to erosion.

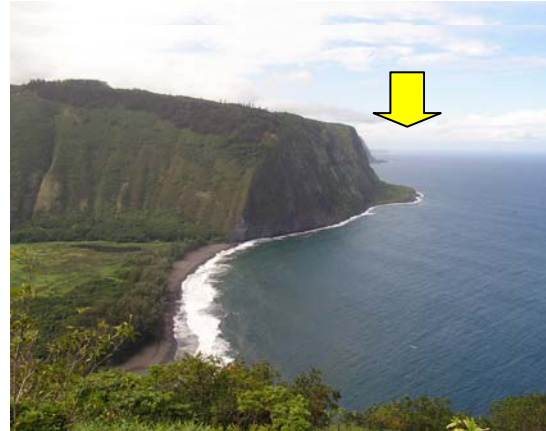
**Figure 21: Location 8, Waipio Valley cliffs. Debris from an older slide (arrowed) in the background. Apparently recent scar in the closer truncated spur is not a result of the earthquakes since the water is not muddy.**

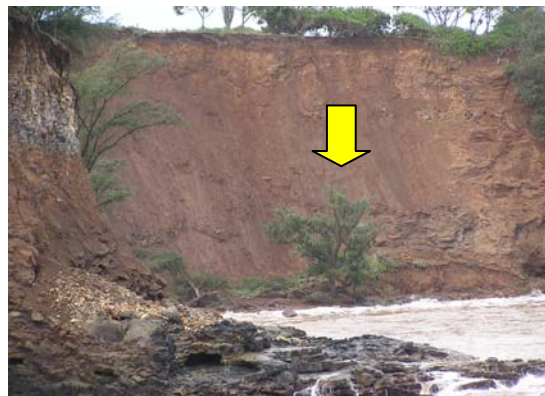
**Figure 22: Location 19, Keokea Bay. Cliffs failed during the earthquake: Note displaced trees (arrow) and slide scars.**

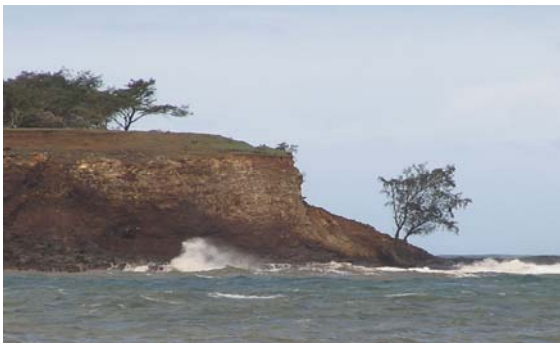
**Figure 23:** Headland to the northwest of Location 19, Keokea Bay. Cliff top slid into the ocean, indicated by the displaced tree and the almost submerged toe debris.

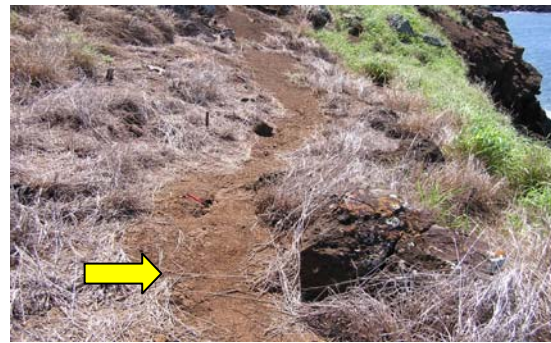
Closer to the epicenters, the seismic activity resulted in landslides and tension cracks several feet from the cliff top along the trail between Honoipu Landing and Puakea Ranch (Figure 24 and Figure 25). The cliff failures also damaged the dry stacked rock wall structure supporting

**Figure 25:** Location 23, Kuakini Trail. Tension cracks behind cliff top (arrow).

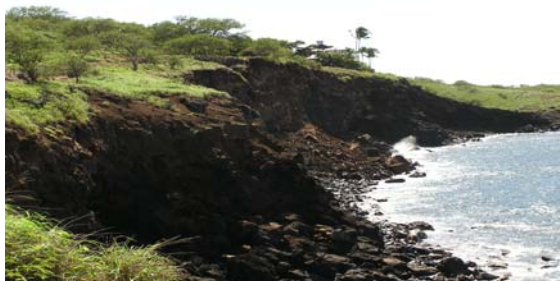
**Figure 24:** Location 23, failed cliff south of Honoipu Landing (Kuakini Trail).

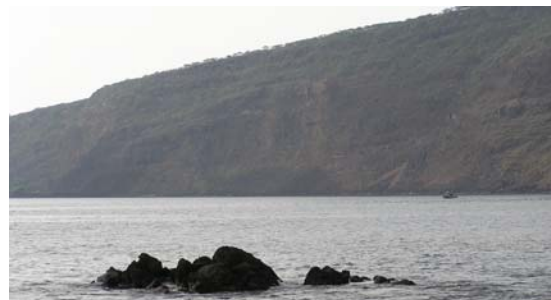
A dramatic earthquake-triggered landslide occurred at Kealakekua Bay (Figure 26), south of Kailua-Kona from the Pali Kapu o Keōua, a fault trace and the head scarp of the Alike mega-landslide that occurred about 100,000 years ago. The area seaward and landward of the cliffs was closed by the State and so was not investigated during the reconnaissance.

**Figure 26:** Location 36, Napo'opo'o, facing the Pali Kapu o Keōua, a fault/mega-landslide scarp.

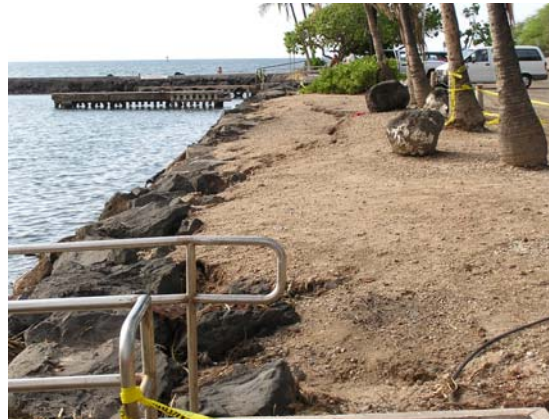
**Figure 27: Location 27, Kawaihae Small Boat Harbor, showing ground crack resulting from lateral spreading.**

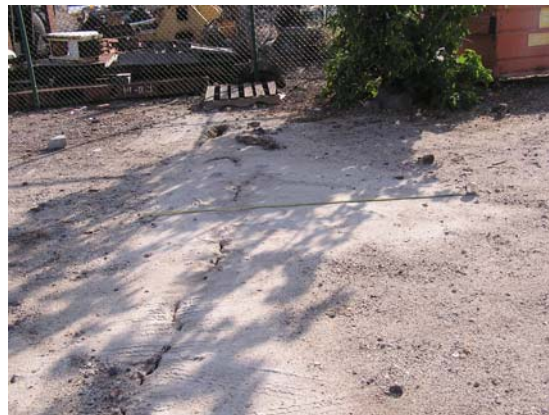
**Figure 28: Location 27, Kawaihae Small Boat Harbor parking lot, adjacent boat yard at south side. Liquefied (white) sand was ejected from ground crack.**

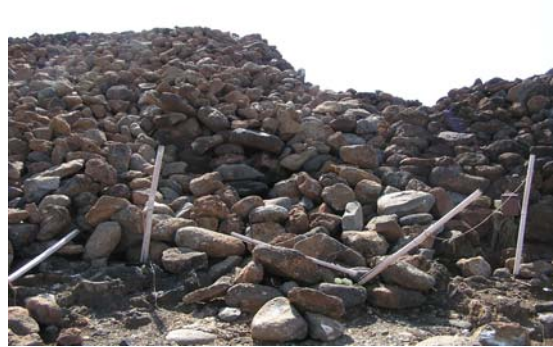
The Pu'ukoholā heiau and the neighboring older Mailekini heiau (Figure 31 and Figure 32) were both badly damaged by the earthquakes. The worst damage at the Pu'ukoholā heiau was to the access steps on the north side (Figure 32). At the Mailekini heiau, much of the interior face of the east wall slumped and raveled (Figure 33).

**Figure 32: Location 29, Pu'ukoholā heiau, north side: Earthquake caused collapse of access step structure.**

4. Although many stacked rock walls likely will be repaired relatively easily, some historical and cultural structures (such as the Pu'ukoholā and Mailekini heiaus) will require detailed, culturally-sensitive and interdisciplinary assessments of damage and scope of repairs. Initial non-intrusive damage surveys could be performed using LiDAR and/or photogrammetric surveying using terrestrial stereo-photography.

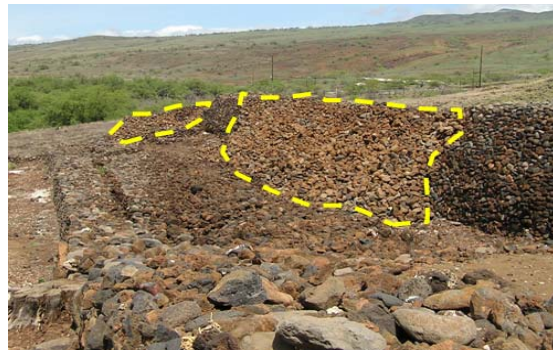
**Figure 33: Location 29, Mailekini heiau. Significant raveling and slumping of interior face of the eastern wall (outlined).**

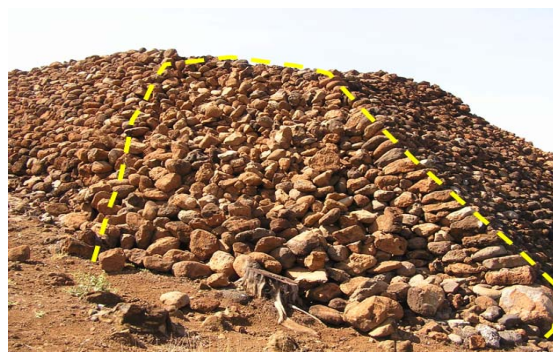
Earthquake damage was in the form of slumps and ravel of the wall faces (Figure 34 and Figure 35). The unfailed side slopes are inclined at about 40 to 50 degrees (Figure 34). The angle of repose for the slumps was about 30 degrees, with run-outs extending to 5 m and greater from the original toes of the inclined walls. Many wall bulges were observed where the slopes approached vertical (Figure 35), which suggests vulnerabilities to increased rock face instability and eventual collapse from future earthquakes or creep deformation.

**Figure 34: Location 29, Pu'ukoholā heiau, northeast corner. Dashed lines indicate boundary of ravel zone.**

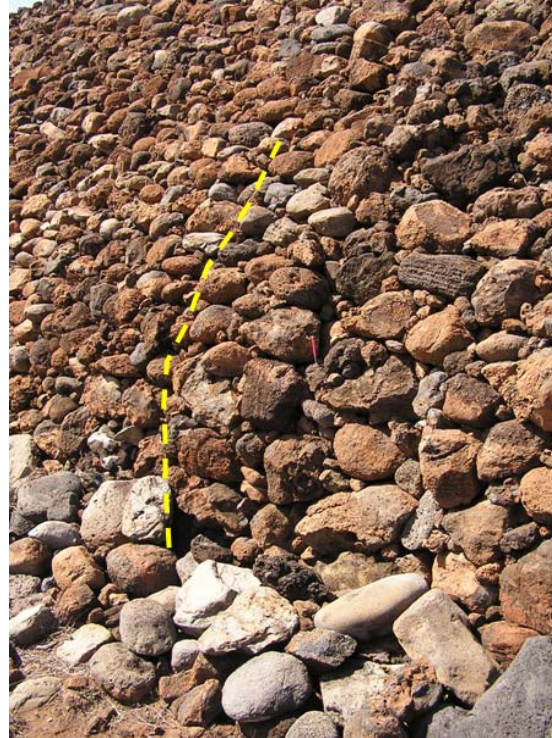
**Figure 35: Location 29, NE corner Puukohola Heiau. Bulging of rock face approaches 90 degree inclination as indicated by yellow line. Bulge is clearly seen in stereo (see Appendix).**

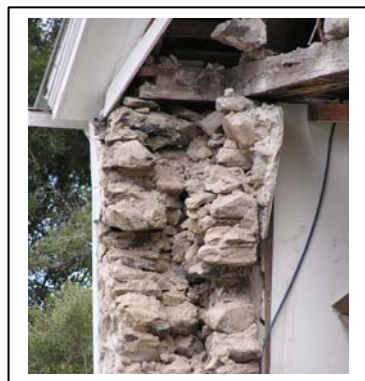
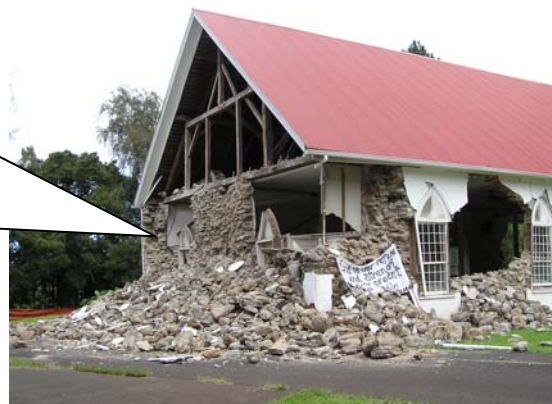
As reported by Robertson et al (2006), dramatic damage occurred at the Kalāhikiola Congregational Church in Kapa’au, which was largely constructed of weakly grouted stacked rock (Figure 36).

**Figure 36: Location 21, Kalāhikiola Congregational Church, Kapa’au. Weakly cemented stacked rock walls failed dramatically.**

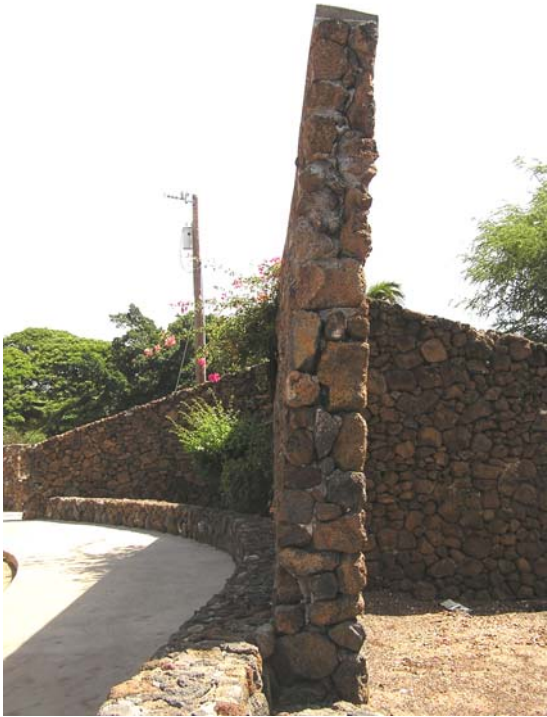
At Spencer Beach Park, south of Kawaihae, a tall free-standing grouted stacked rock wall appeared to have accommodated earthquake-related deformation (Figure 37). No other walls at the park showed damage, although none seemed unrestrained like the one pictured.

**Figure 37: Location 30, Spencer Beach Park, south of Kawaihae. Apparent earthquake damage of partially mortared rock wall.**

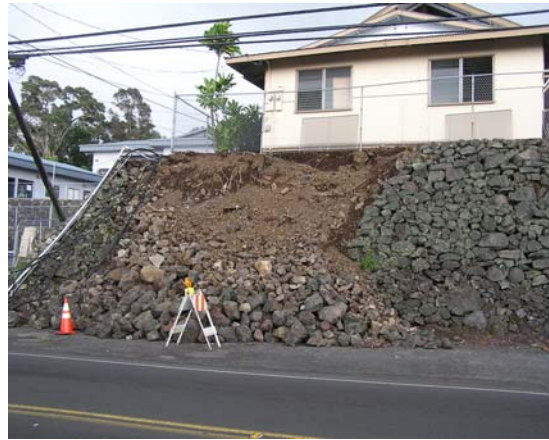
Failed stacked rock retaining walls were observed in several locations, such as that shown in Figure 38 in Captain Cook, on Hwy 11 south of Kailua-Kona. Virtually no stacked rock wall (or road cut) failures were observed on Hwy 11 between Captain Cook and Hilo. Only minor damage to trails was reported at Hawaii Volcanoes National Park (Location A, Figure 1).

**Figure 38: Location 35, Captain Cook. Failed stacked rock retaining wall.**

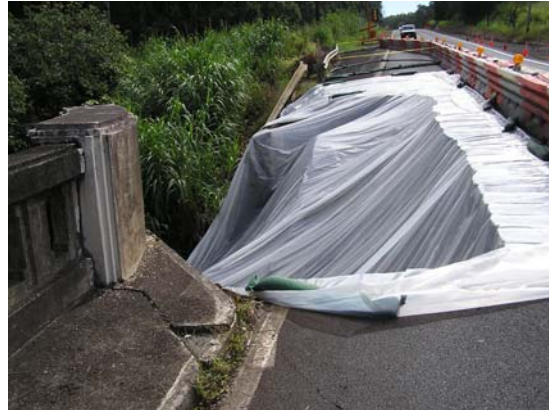
At Mile Post 35 on Hwy 11, near Pa’auilo, an embankment for the southern approach failed (Figure 39).

**Figure 39: Location 6, Mile Post 35, Hwy 11 near Pa’auilo. Failure of fill at makai (east) side of southern approach to bridge.**

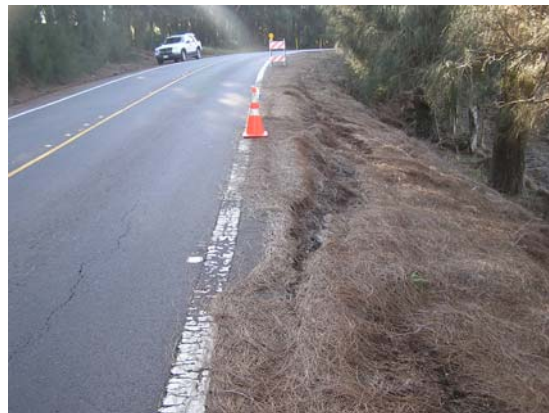
At Mile Post 9.4 on Hwy 250 (Kohala Mountain Rd), the makai (west) side embankment failed at several locations over several hundred meters (Figure 40). There is a narrow shoulder for this road, and the bridge itself is single-lane. The road was closed at this location after the earthquake. Since Hwy 270 was also closed, there was no route open for traffic in or out of Kohala.

**Figure 40: Location 15, north of Mile Post 9.4 Hwy 250. Slump failure of embankment on makai (west) side road.**

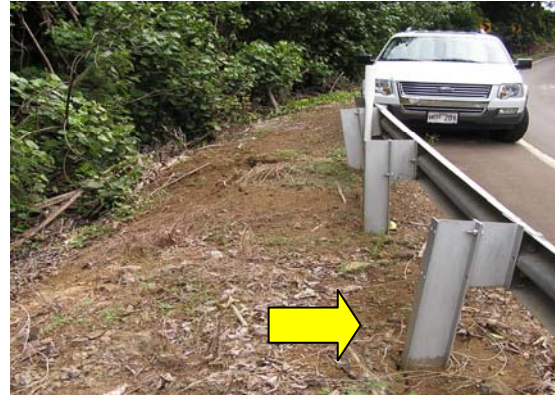
At the crest of a steep embankment near Makapala on Hwy 270, tension cracks and a head scarp about 0.3 m high were observed (Figure 41). The high embankment was on the makai (north) side of the road, and had side slopes of greater than 45 degrees.

**Figure 41:** Location 18, Hwy 270 near Makapala, makai side. Arrow indicates tension cracks and short head scarp (12 inches) at crest of steep and high fill slope.

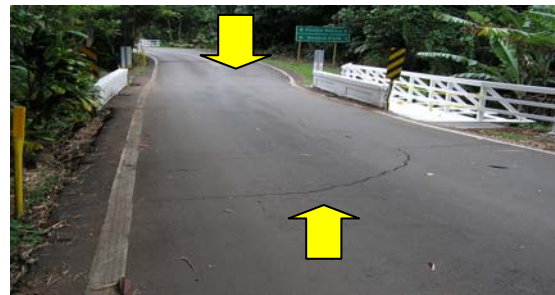
surface appeared to match the locations of the cut/fill transitions of underlying subgrade (Figure 42). At one location, cracked asphalt concrete pavement was thrust over adjacent pavement (Figure 43). The west bridge abutment headwall had suffered some spalling at apparent pre-existing cracks (Figure 44).

**Figure 42:** Location 20, bridge at approximately MP 28, Hwy 270. AC pavement cracked at approximately the cut/fill transition lines of underlying subgrade (cracks in AC).

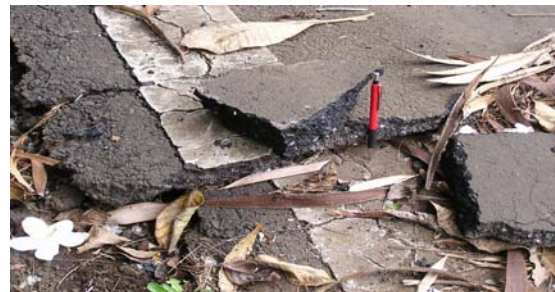
**Figure 43:** Location 20, bridge at approximately MP 28, Hwy 270. Thrusting of AC pavement.

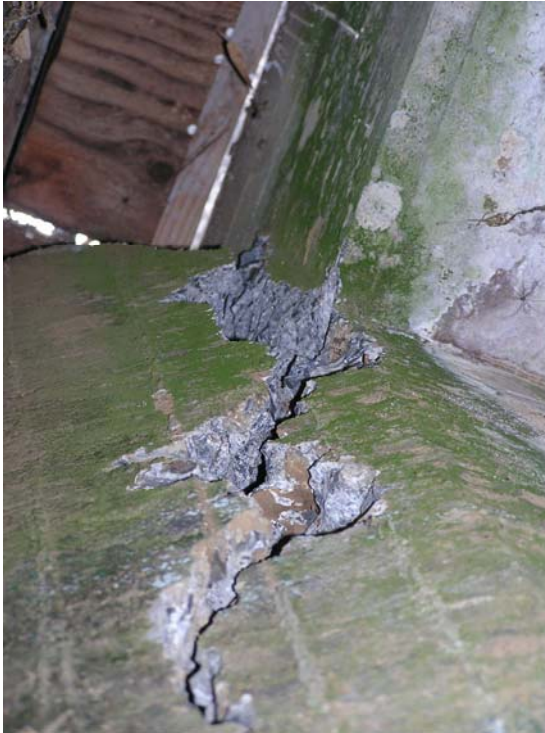
**Figure 44: Location 20, bridge at approximately MP 28, Hwy 270. At SW corner of bridge, looking upward. Wooden plank sidewalk above. Significant spalling of bridge abutment headwall.**

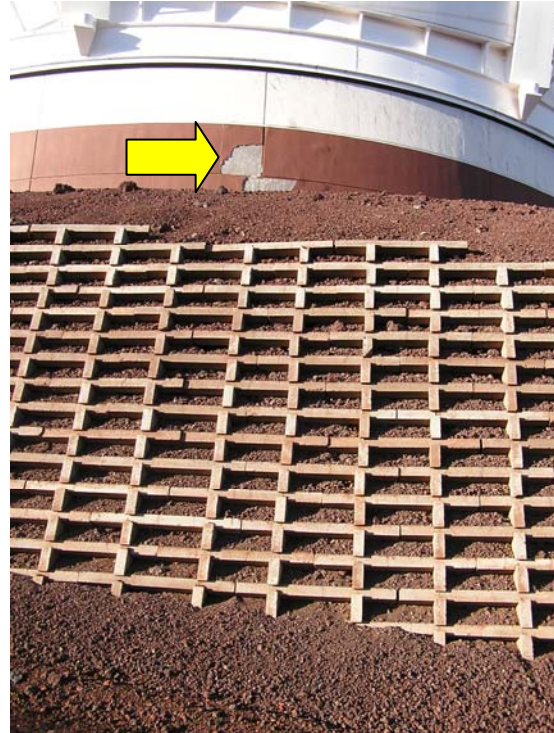
At the Mauna Kea Observatories complex at the summit of Mauna Kea, (about 4,260 m elevation), no apparent distress was observed at the high earthwork embankment adjacent the Keck Observatory building, although recent spalling had occurred at the exterior (Figure 45).

**Figure 45: Location 28, Keck Observatory, Mauna Kea summit. No apparent distress to high embankment beside the observatory. Spalled stucco evident at two places on the exterior wall of the building (one arrowed).**

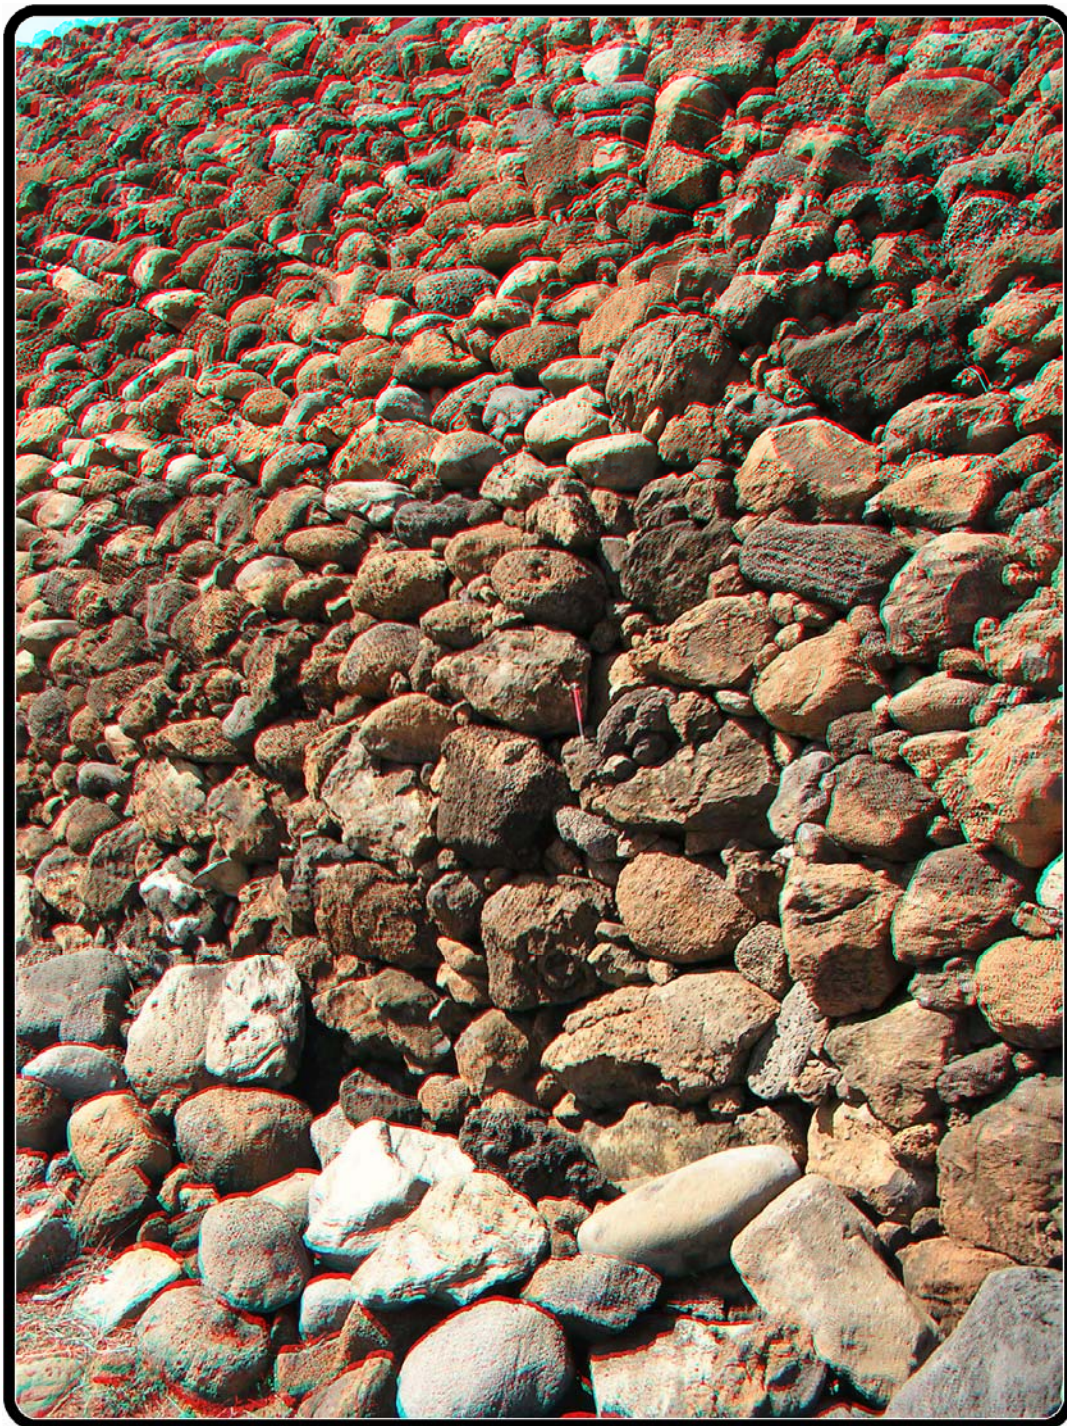
**Figure S2: Location 29: Puukohola Heiau. Bulge at NE corner.**

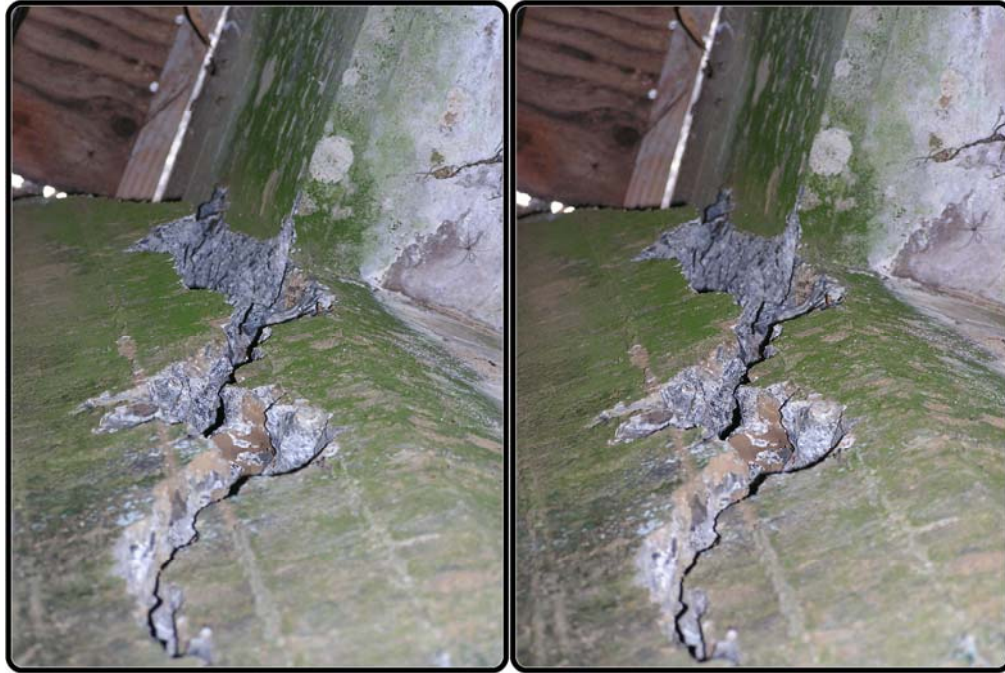
**Figure S5: Location 20. Bridge at MP 28, Hwy 270. Looking upward at spalled concrete structure.**

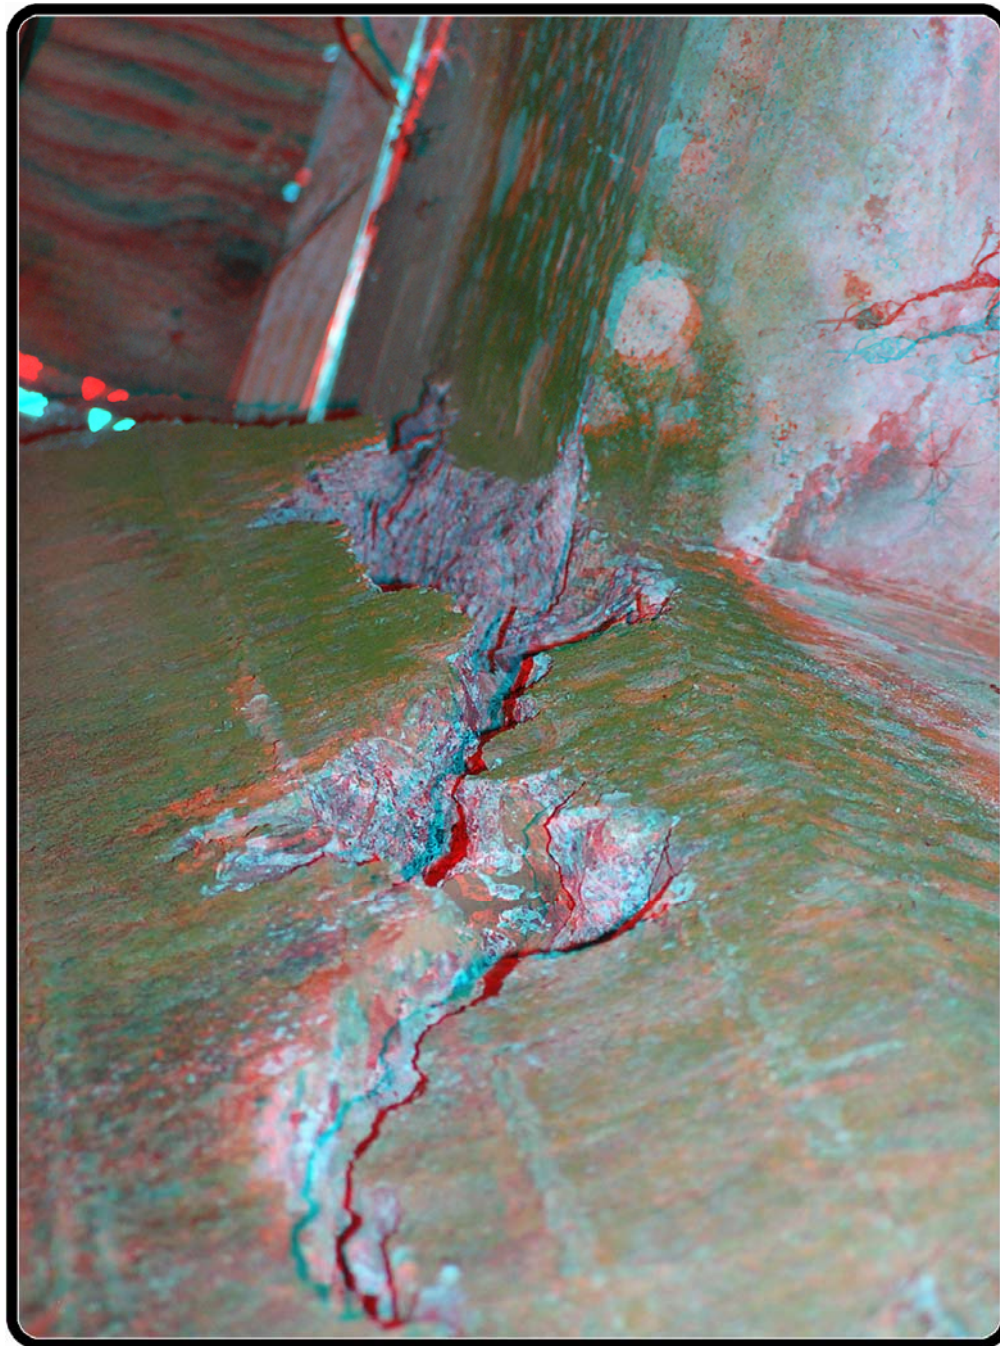
**Figure S6: Location 20. Bridge at MP 28, Hwy 270. Looking upward at spalled structure.**
