GEOTECHNICAL ASPECTS OF SEPT. 5, 2012 M7.6 SAMARA, COSTA RICA EARTHQUAKE

Version 1.0

January 30, 2013

Prepared by

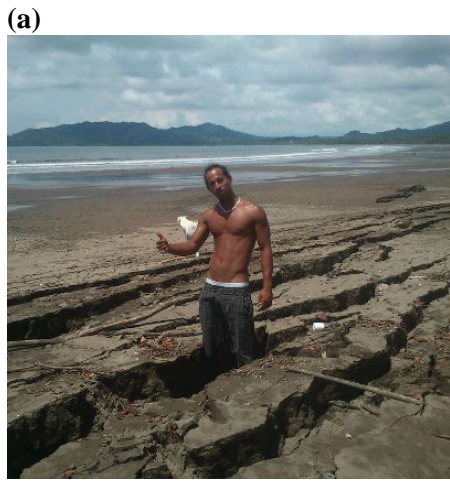
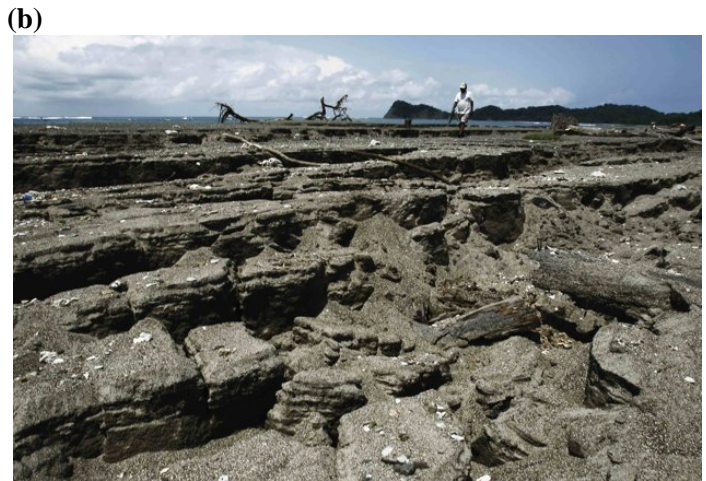
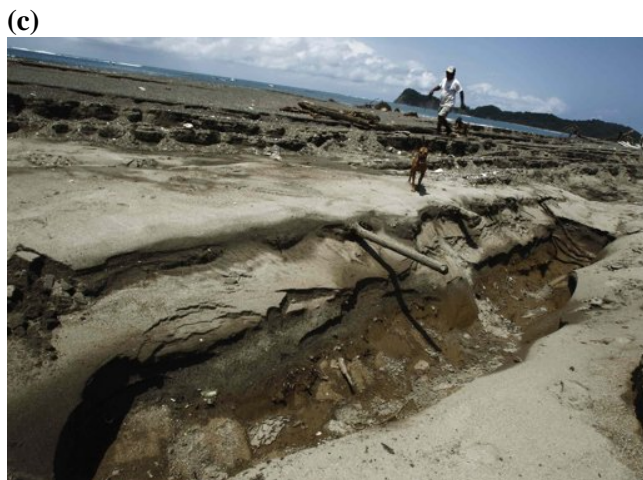
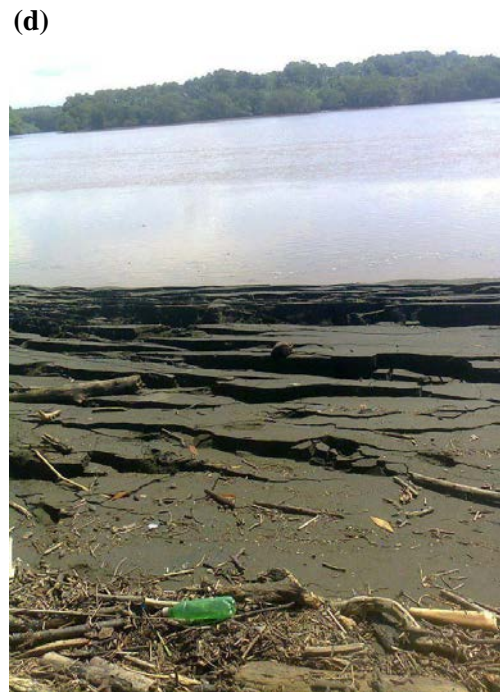
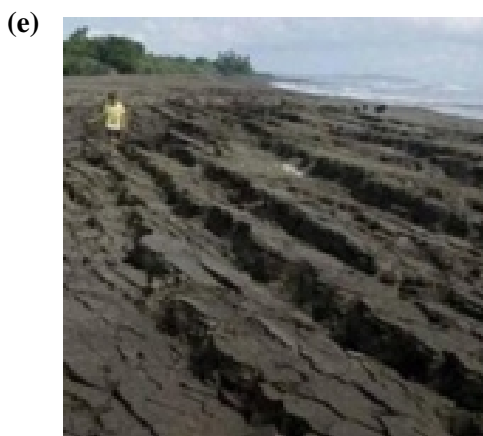
Fig. 2.3 - Liquefaction features at beaches in the 2012 Samara Earthquake. (a) man standing in lateral spreading cracks Playa Pochote (Alvarez, 2012) (b) lateral spreading cracks at Playa Garza (Reuters, 2012a) (c) sand blow at Playa Ostional, (d) Cracks at Playa Tivives (Edodes, 2012) (e) Cracks, up to 5 ft deep, at Ostional beach (Cotza Rica, 2012)

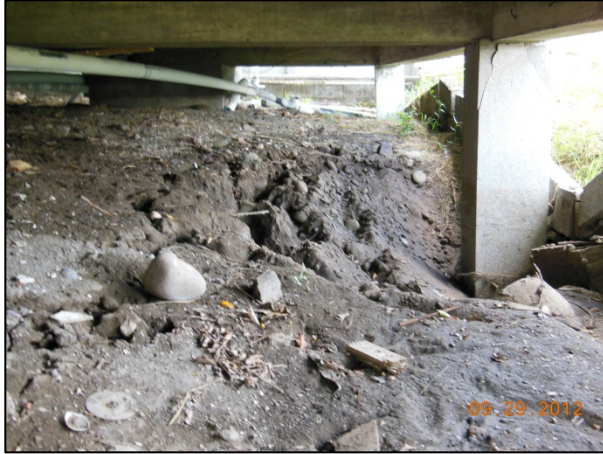
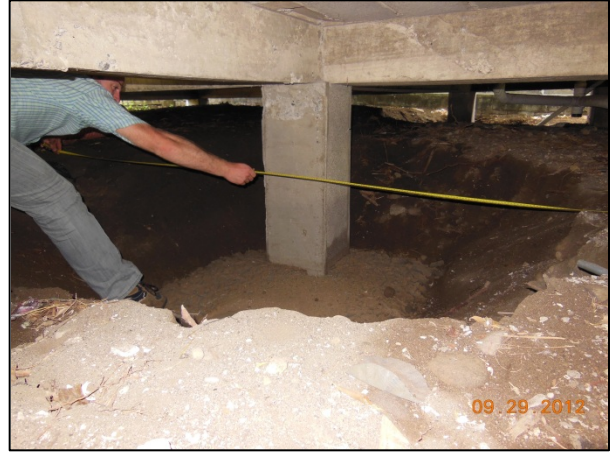
Liquefaction damage was observed at a site in Puntarenas, a relatively thin barrier peninsula within the Gulf of Nicoya. This city is one of the largest along the Pacific coast and several other port facilities are located nearby. Port services are available within this city and on the north side of the peninsula there is a small office for port security and fisheries. The Capitanía is a port of entry office in charge of security and shipments. This building is a relatively small structure built on concrete pedestals or stilts supported on shallow foundations. The structure was recently renovated (6 months previously) and a handicapped ramp was installed. The entire structure rotated as a monolith during the earthquake when the foundation soils liquefied. The foundations punched through the liquefied ground at different rates to produce the tilting and failure of some of the reinforced 12-inch square concrete stilts (see Fig. 2.4). It is estimated that the building sank about 50 to 75 cm. The building was supported on nine (9) 30cm square concrete stilts. Each column foundation had a clear crater developed around the footing. The center stilt developed a crater of about 2.6 meters wide and 0.6 m deep.

Fig. 2.5 – Foundations Punching through liquefied ground (a) exterior column, north side; (b) interior column, left behind a 60cm crater.

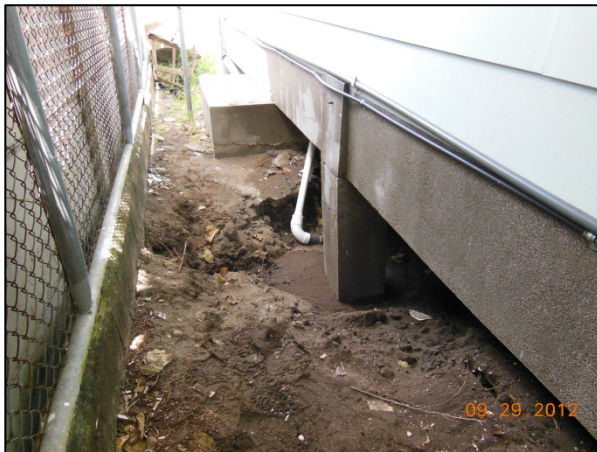
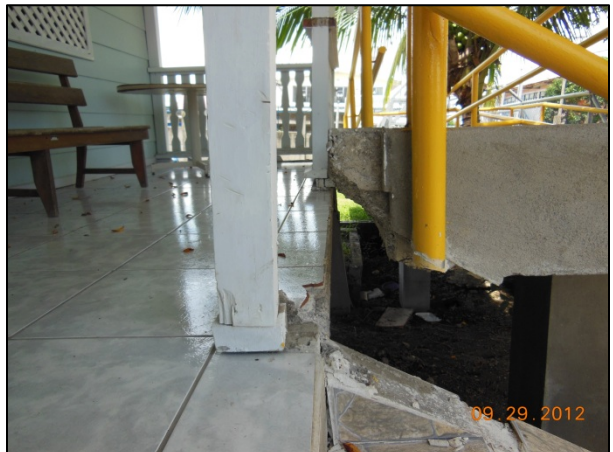
Fig. 2.6 – Structure tilted toward the west side (a) west side bottomed out at the top of the water tank; (b) new handicapped ramp detached from building front porch.

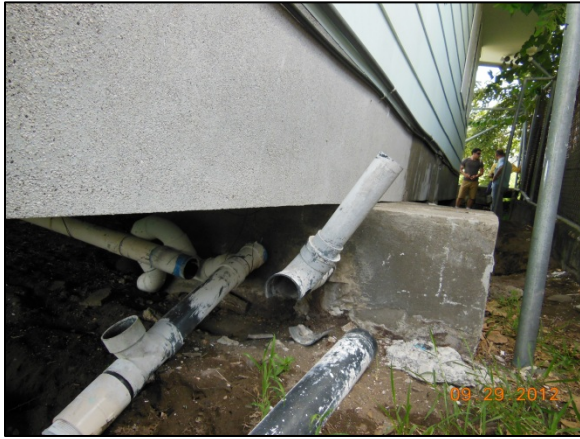
Damaged water and sewer utilities that served the Capitanía building office.

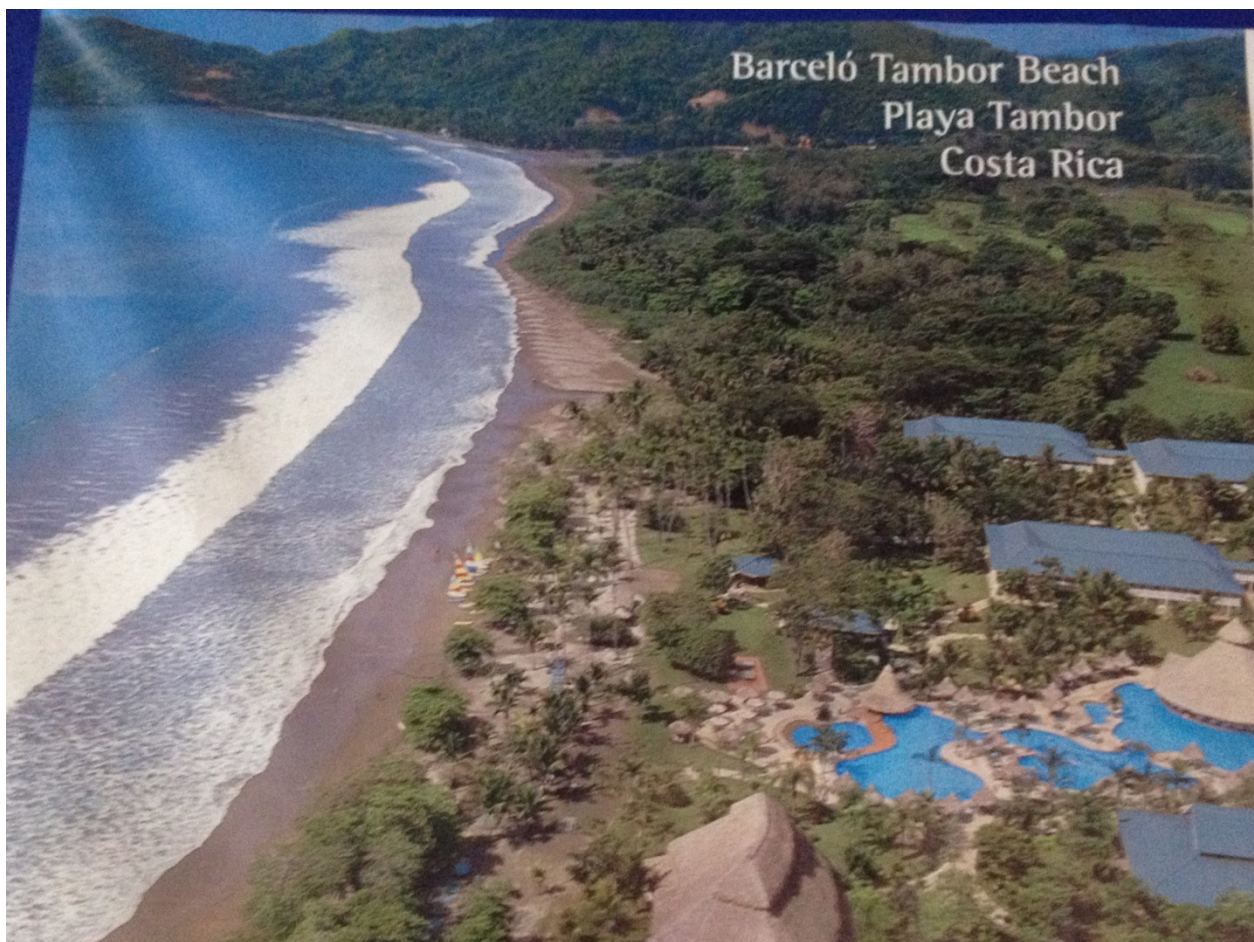
A 200+ room hotel at Tambor beach experienced significant damage during the earthquake. Although the hotel remained open to accommodate some guests after the earthquake, the damage was sufficient that the hotel stopped accepting guests and had to close several months for repairs to the hotel buildings and swimming pool areas. The GEER team drove to this hotel, shown in Fig. 2.8, but was not permitted to enter the grounds. Given the proximity of the hotel to the sandy beach area and the liquefaction observed at other similar beach locations along the coast of the Nicoya peninsula, it is likely that liquefaction played a role in the damage to the hotel.

Fig. 2.8 Hotel at Tambor Beach which sustained significant damage and was closed for several months to undertake repairs to the hotel and swimming pool areas. Given proximity of sandy soils, liquefaction likely played a role in the damage.

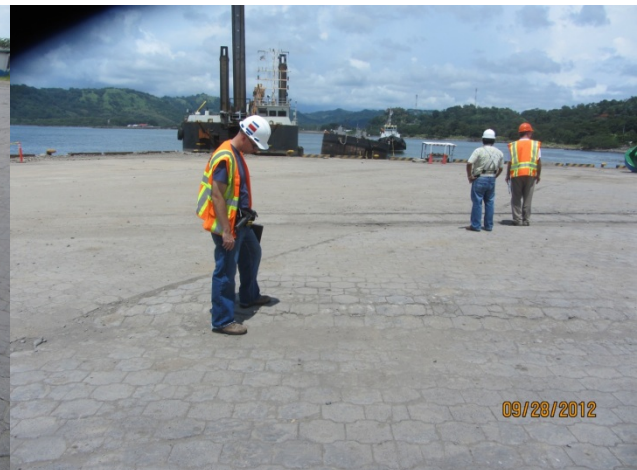
Fig. 3.3 - Apparent heave of rectangular area on the (a) west (9.91170° N 84.72194° W) and (b) east (9.91246° N 84.71811° W) ends of the port.

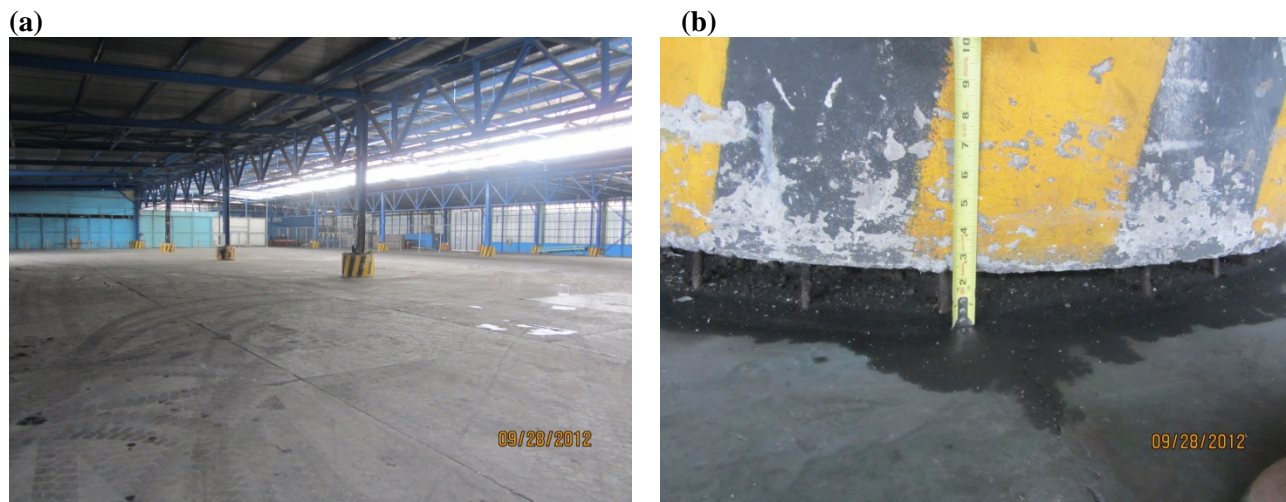
As indicated by the photo in Fig. 3.4, the wharf did not show any signs of lateral spreading or outward deformation. Differential settlement of the floor slab in the cruise passenger waiting area was sufficient to cause cracks in the tile floor in two directions. At the time of our visit the damaged tile had been removed, the slab leveled and tile was being replaced. In an adjacent warehouse facility the columns were all supported by piles which did not settle. Most of the columns had been protected from impact damage by forming a circular concrete column around the steel column. In most instances, the concrete floor slab remained flush with the bases of these concrete columns. However, in several cases, the base slab settled between 70 mm and 100 mm (2.5 to 4 inches) relative to column base as shown in photograph in Fig. 3.4. Settlement of this magnitude in saturated fill material suggests liquefaction; however, the floor slabs were able to accommodate this settlement without cracking and there was no indication of sand boils at the port.

Fig. 3.4 - (a) Concrete cylinders protecting pile-supported columns in warehouse adjacent to wharf and (b) earthquake induced settlement of the ground around the column relative to the pile-supported column. (9.91192° N 84.72003° W

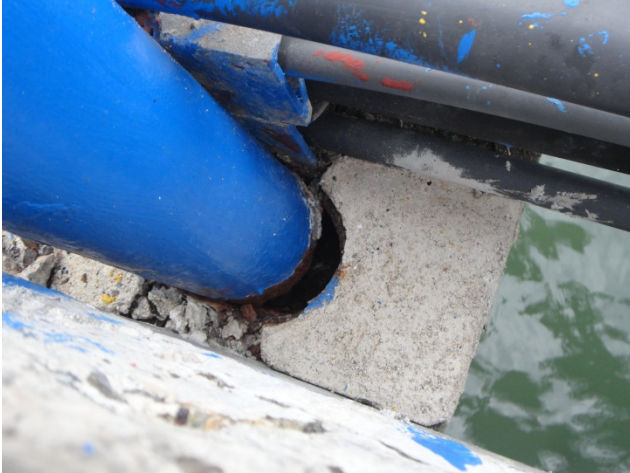
Fig. 3.10 - Damaged connection between a guardrail post and the pier (9.97213° N 84.83079° W).

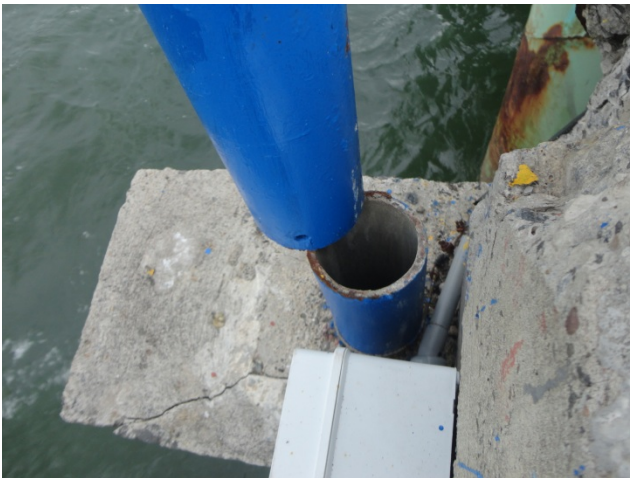
Fig. 3.11 - Sheared weld on a damaged guardrail post. Similar damage was observed on nearly every post (9.97214° N 84.83070° W).

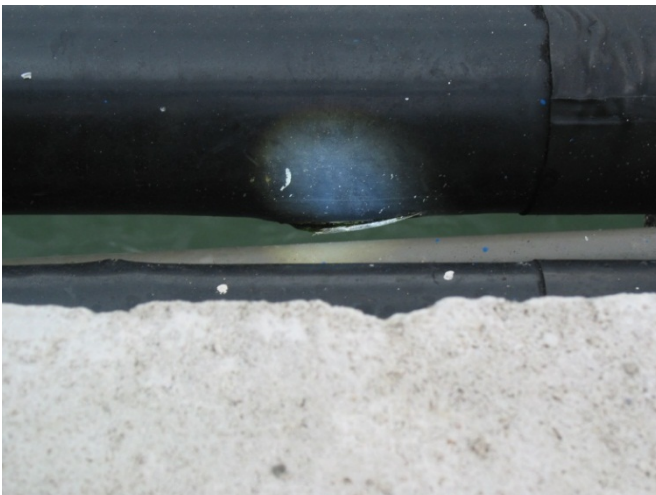
Fig. 3.12 - Damaged water pipe adjacent to pier (9.97190° N 84.83075° W).

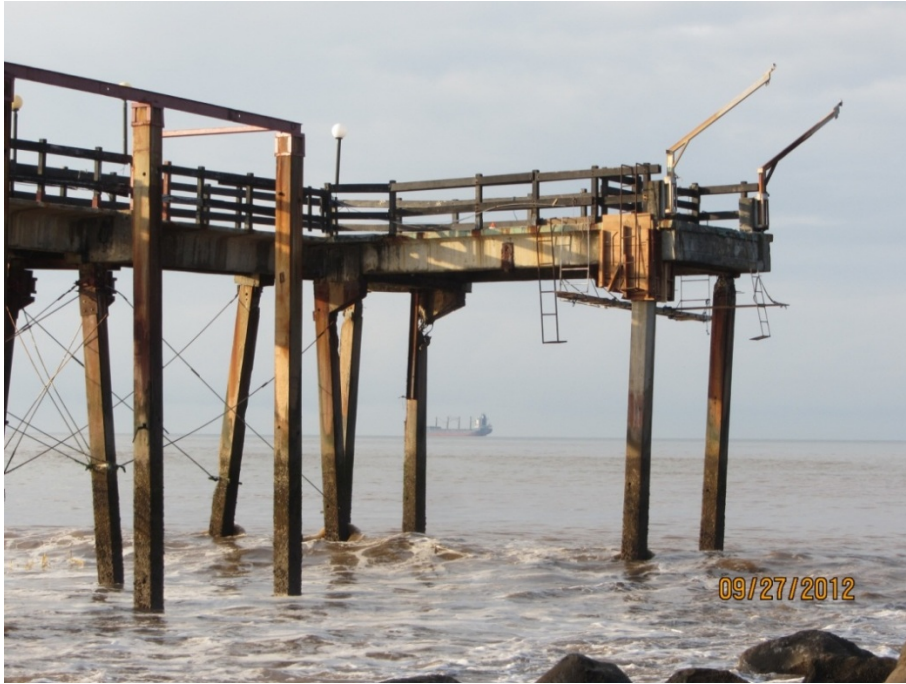
Based on nearby seismograph stations, the pier was subjected to peak acceleration values of approximately 0.2g during the earthquake. As a result of the shaking, the pile to pier connection failed at four of the piles near the end of the pier as shown in Fig. 3.14. In addition, two of the piles apparently rotated about 10° from their original vertical position as shown in Fig. 3.14. To provide lateral stability to the pier, three steel H-piles were driven as shown in Fig. 3.14 and 3.15 and lateral bracing put in place. In addition, the connections between the deck and the support piles was repaired.

Fig. 3.14 - Failure of the pile to deck connection at four piles near end of pier. (9.96779° N 84.74181° W).

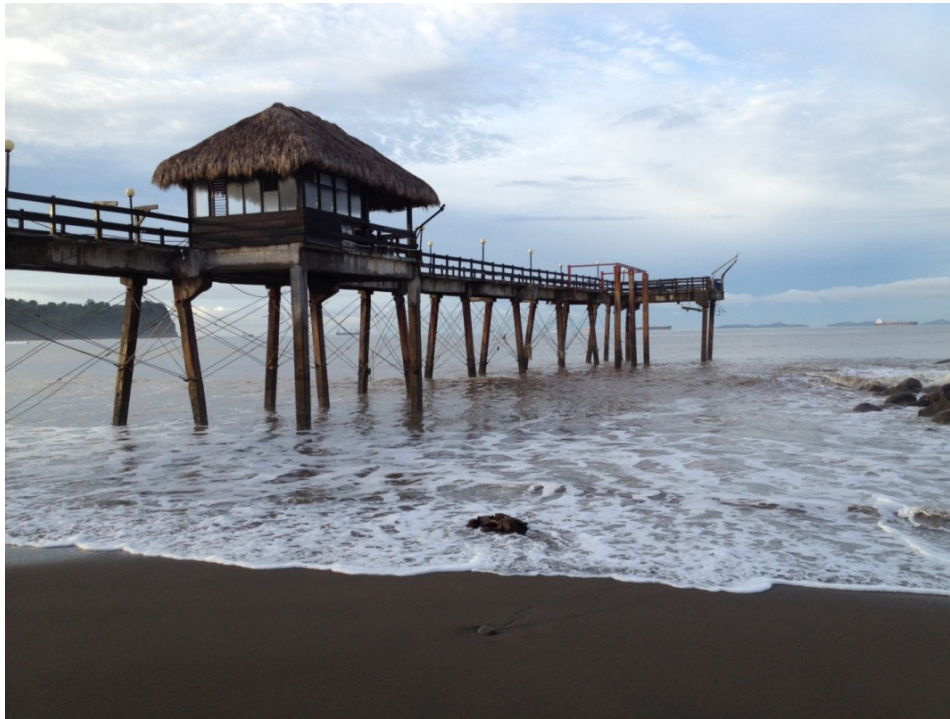
Fig. 3.15 - Pier with additional support piles to stabilize the pier during repairs. (9.96812° N 84.74150° W).

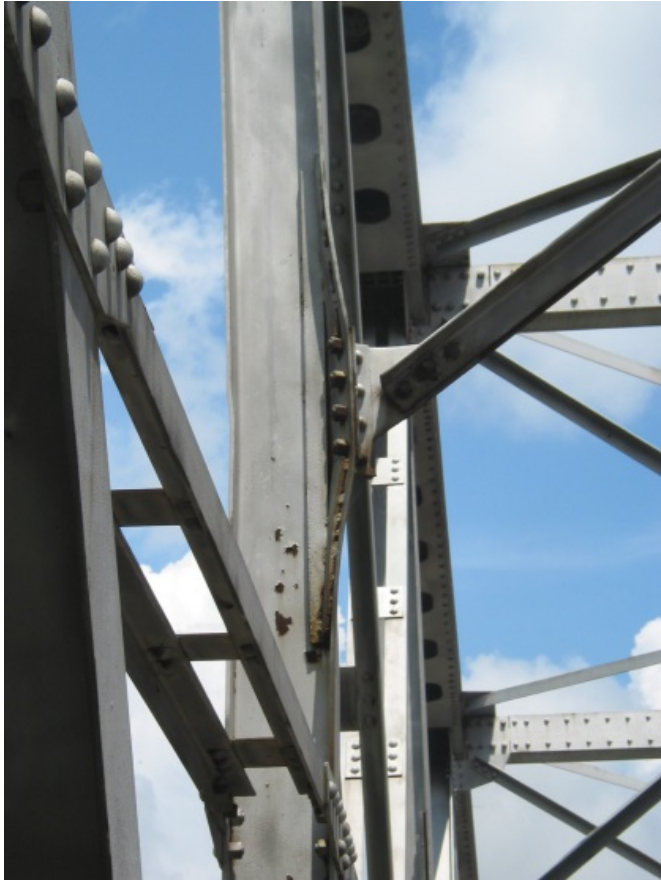
The Costa Rican Ministry of Transportation inspected the bridge just a few days after the September 5 event, and identified it as having sustained damage from the earthquake. The Ministry's investigation identified torsional buckling in a few members of the truss. Our investigation confirmed the torsional buckling in the truss (Fig. 4.3), though it is not immediately clear whether the earthquake caused the distress. Rust spots were visible in distressed areas due to the torsional buckling, suggesting that the damage may have occurred prior to the September 5 earthquake. In addition to the buckling, our inspection of the bent-supported section of the bridge showed that the connection plates and fasteners between the bridge and the bent on the southern part of the bridge appeared to have been pulled out of the concrete approximately 25-50 mm (1-2 inches), as shown in Fig. 4.4.. Two water pipelines approximately 0.5 m (20 inches) in diameter were observed to run parallel to the bridge deck on both sides of the bridge. Inspection of the pipeline on the south side of the bridge identified what appeared to be possible evidence of compression of the pipe due to a slightly crooked alignment (Fig. 4.5). However, no evidence of compression in the bridge deck was apparent. The pipeline on the north side of the bridge did not show the same crooked alignment as the southern pipeline; however, significant leakage was observed at one of the collared joints near the west abutment of the bridge.

Fig.4.3 - Torsional buckling in certain members of the truss bridge (9.99704° N 84.69480° W).

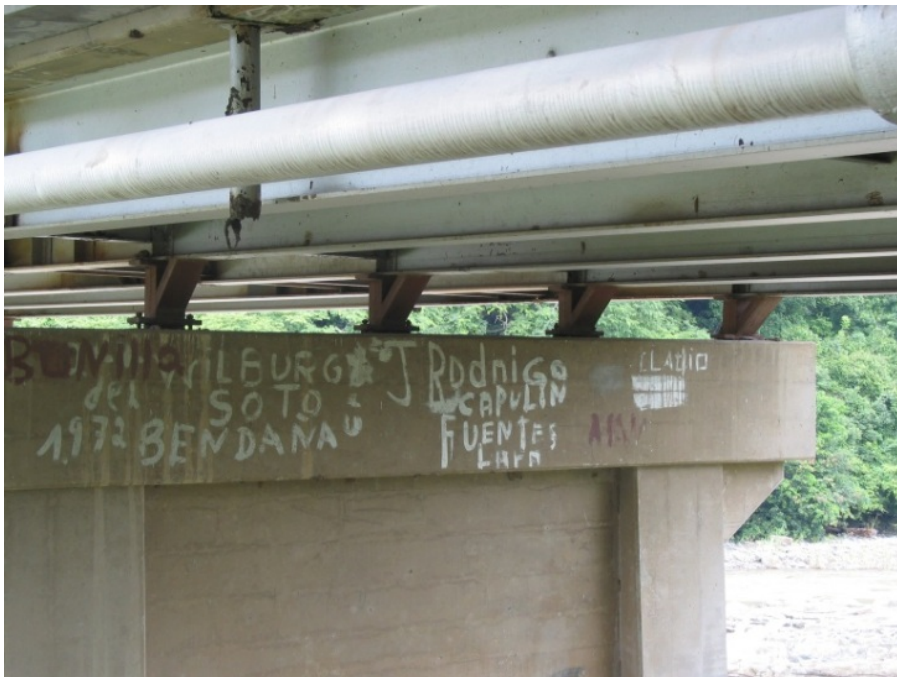
Fig.4.4 - Pull-out of the connections between the deck and the bent on the southern half of the bridge (9.99706° N 84.69436° W).

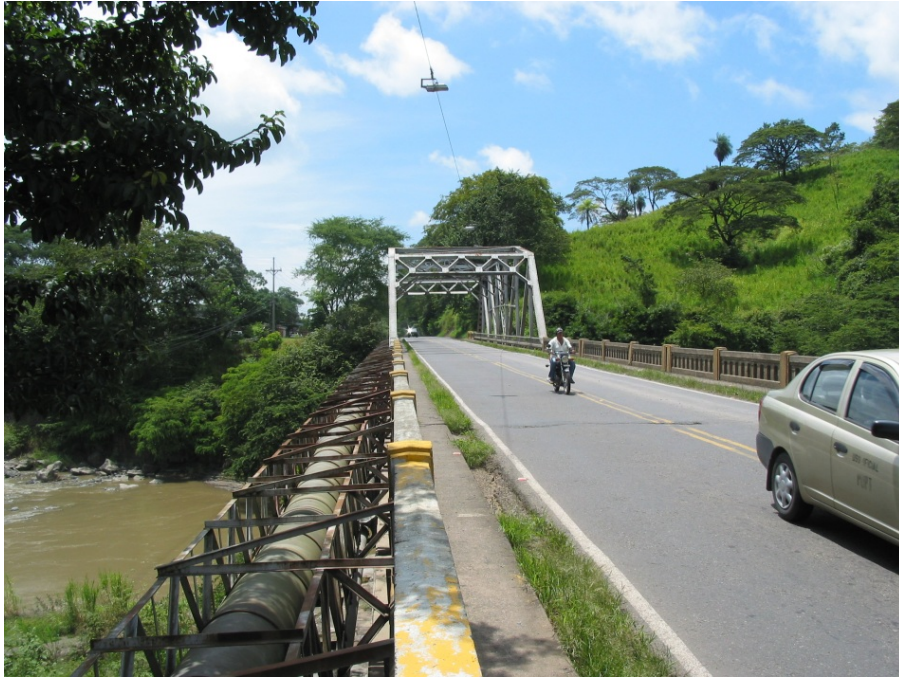
Fig. 4.5 - Crooked water pipe adjacent to the south side of the bridge (9.99705° N 84.69412° W).

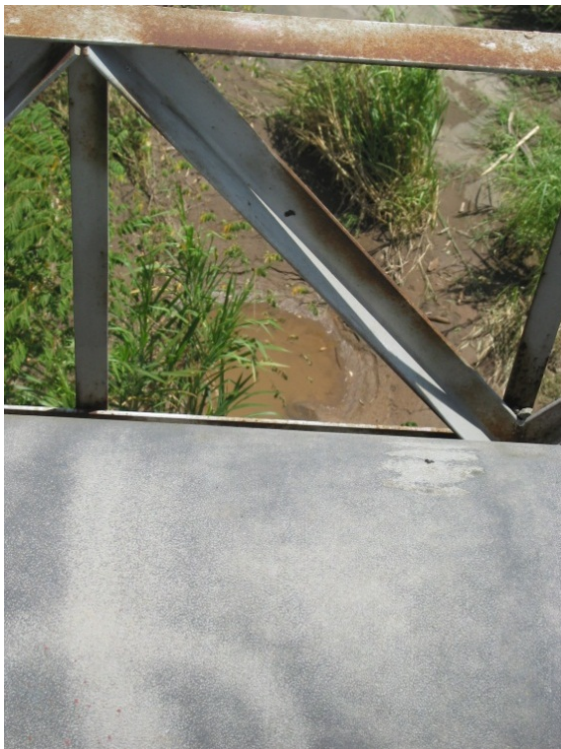
The GEER reconnaissance team identified possible evidence of liquefaction along the east bank of the river immediately south of the bridge. Remnants of what appeared to be subsided sand boil approximately 1.5 meters (5 feet) in diameter were visible, along with traces of what appeared to be residual runoff sand that had flowed towards the river Fig. 4.6 and 4.7). However, we could find no strong visible evidence that liquefaction had caused damage to the Rio Barranca Bridge.

Fig. 4.6 - Evidence of a subsided sand boil due to liquefaction (9.99688° N 84.69438° W).

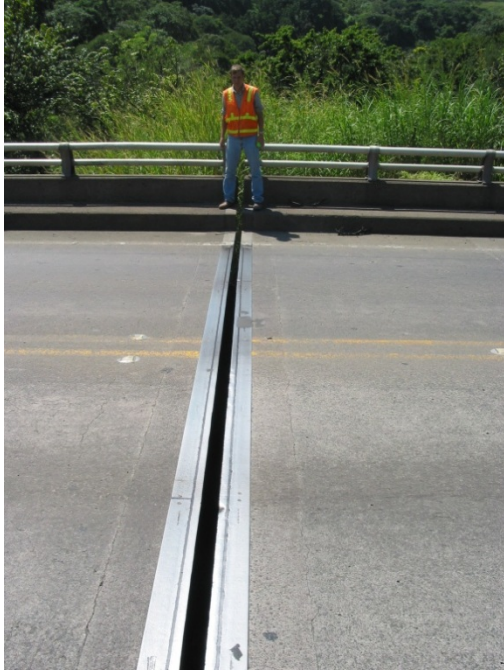
The Costa Rican Ministry of Transportation inspected the bridge just a few days after the September 5 event, and identified it as having sustained damage from the earthquake. While our reconnaissance team confirmed this report, the damage we observed appeared relatively minor. Investigation of the bridge deck at the abutments revealed an offset of 76 mm (3 inch) at the west abutment (Figs. 4.10 and 4.11) and an offset of 25 mm (1 inch) at the east abutment (Fig. 4.12). According to the Costa Rican Ministry of Transportation, the bridge deck was designed to have offsets of approximately 25-50 mm (1-2 inches) at the abutments. In addition, vertical offsets of

Fig. 4.10 - Longitudinal offset at the west abutment (10.00188° N 84.31129° W).

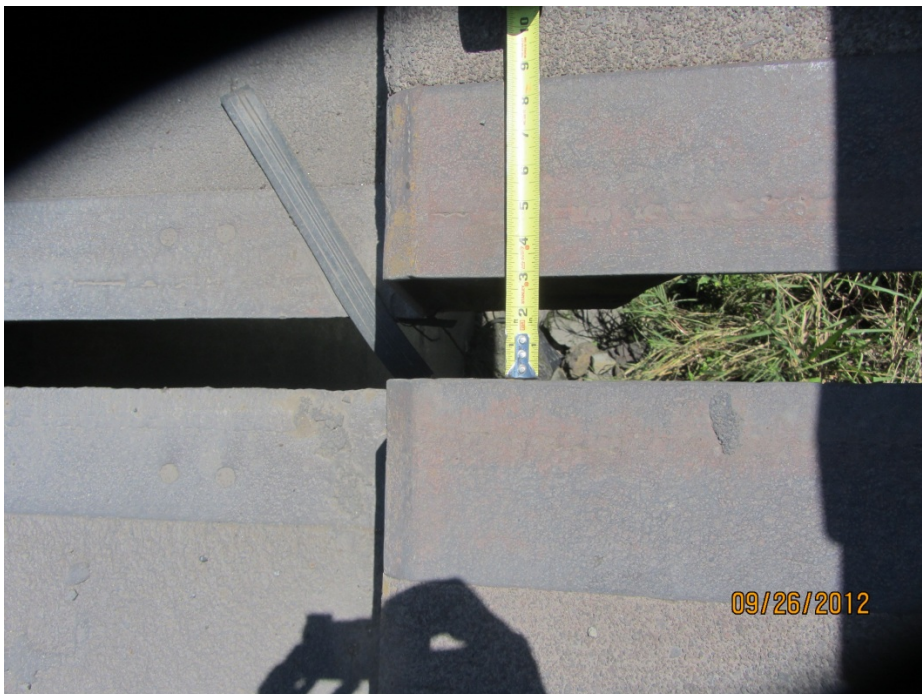
Fig. 4.11 - Longitudinal offset of about 76 mm (3 inches) at the west abutment.

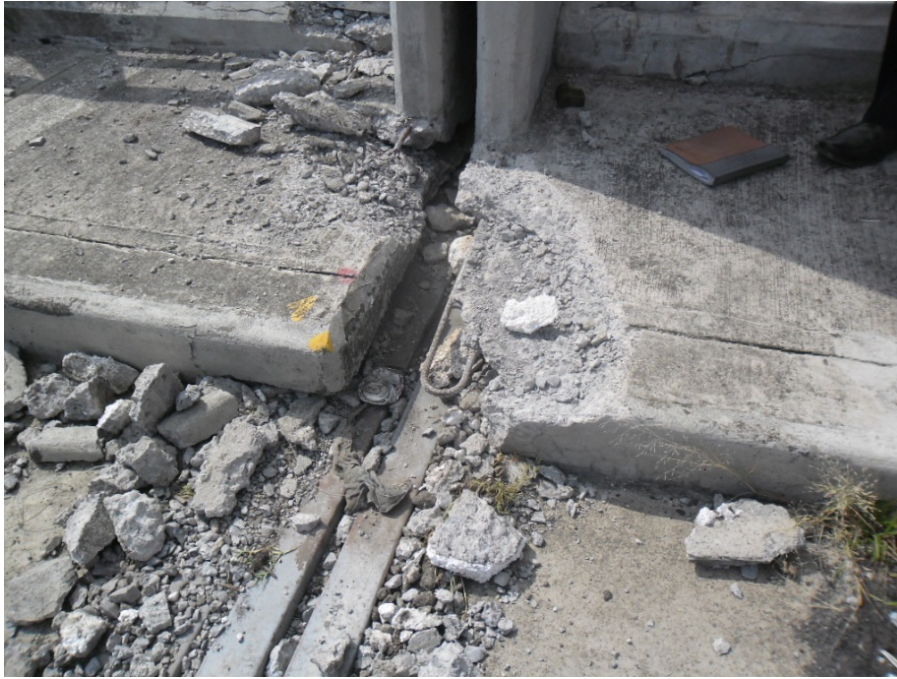
The Costa Rican Ministry of Transportation inspected the bridge just a few days after the September 5 event, and identified it as having sustained damage from the earthquake. Reported damage was generally limited to concrete spalling at the joint between the cable-stayed bridge and the box girder bridge due to pounding (Fig. 4.17). Our investigation confirmed that spalling in the concrete had occurred at the joint between the two bridges (Fig. 4.18), resulting in the exposure of steel rebar in a few locations. We measured a gap of approximately 25 mm (1 inch) at the joint between the two bridge sections (Fig. 4.19). Investigation of the east abutment of the bridge revealed a large crack about 25 mm (1 inch) in width spanning the width of the abutment slab, as shown in Fig. 4.20. This crack appeared to have been caused by differential settlement or slope movement beneath the slab. It is unclear whether these settlements or movements occurred as a result of the September 5 earthquake or prior to it. Visual inspection of the bents from the east abutment showed no evidence of tilting or other damage. No evidence of liquefaction was observed in the vicinity of the bridge abutments.

Fig. 4.17 - Spalled concrete and exposed rebar due to pounding between the cable-stayed bridge and the box girder bridge (courtesy of the Costa Rica Ministry of Transportation) (10.24678° N 85.24685° W).

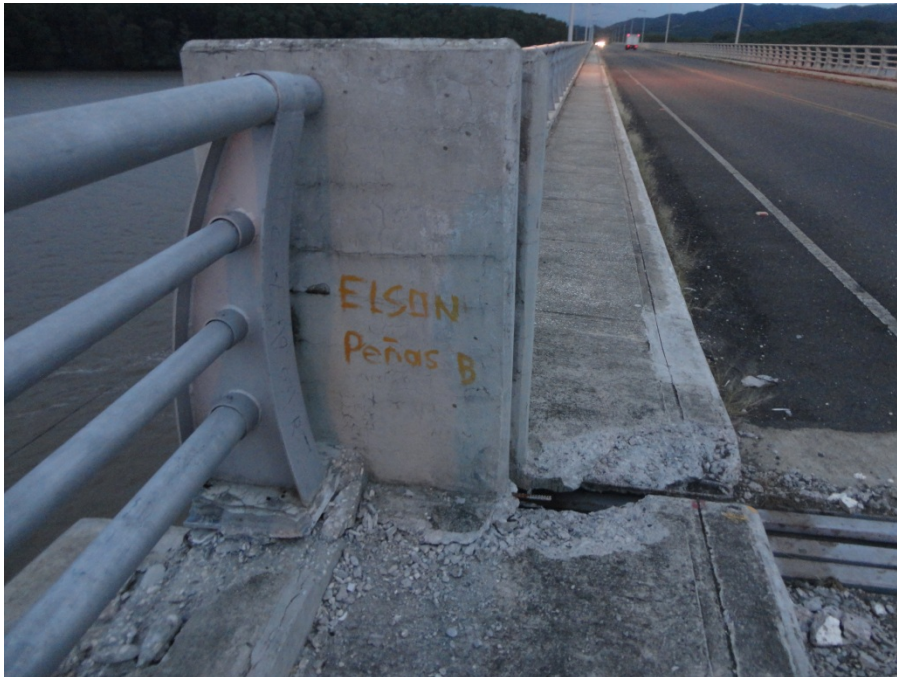
Fig. 4.18 - Evidence of pounding observed by the reconnaissance team at the joint between the box girder section and the cable-stayed section of the bridge (10.24678° N 85.24685° W).

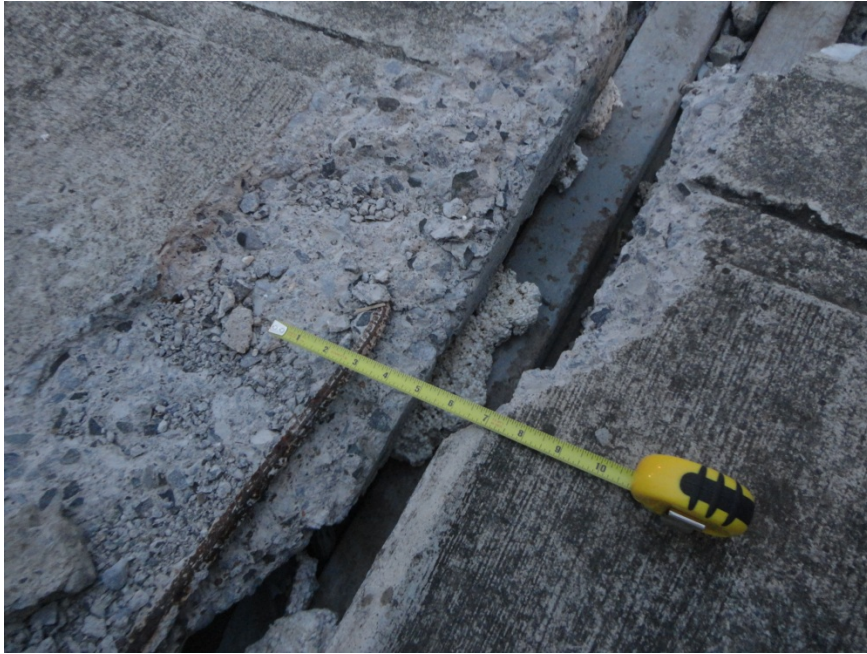
Fig. 4.19 - Gap of approximately 25 mm (1 inch) between the box girder and cable-stayed sections (10.24670° N 85.24682° W).

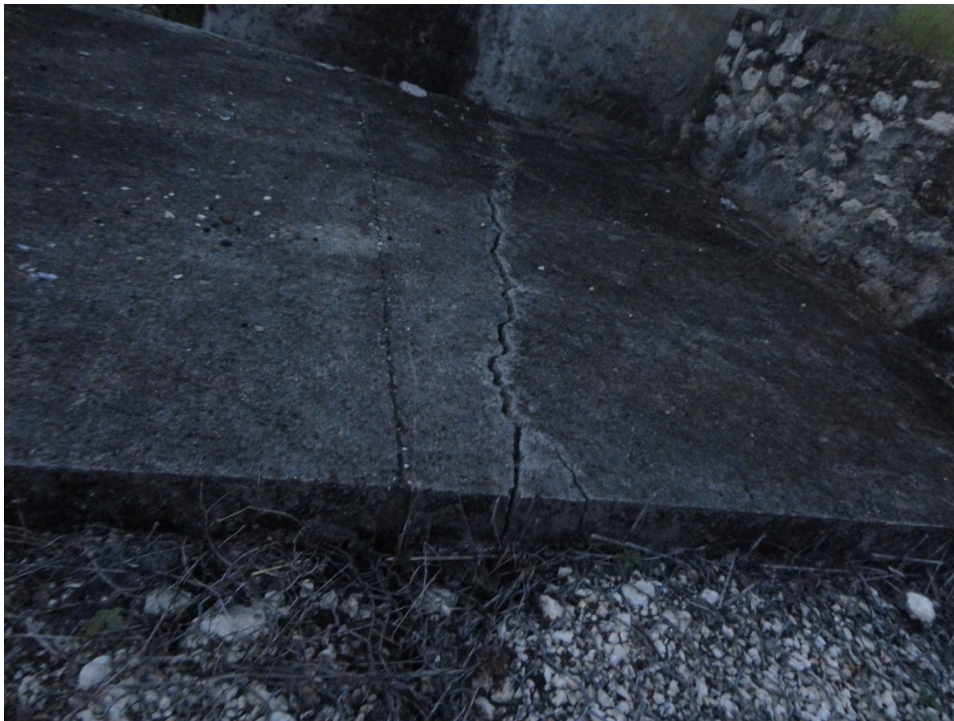
Fig. 4.20 - Transverse crack observed across the abutment slab at the east abutment (10.24889° N 85.24262° W).

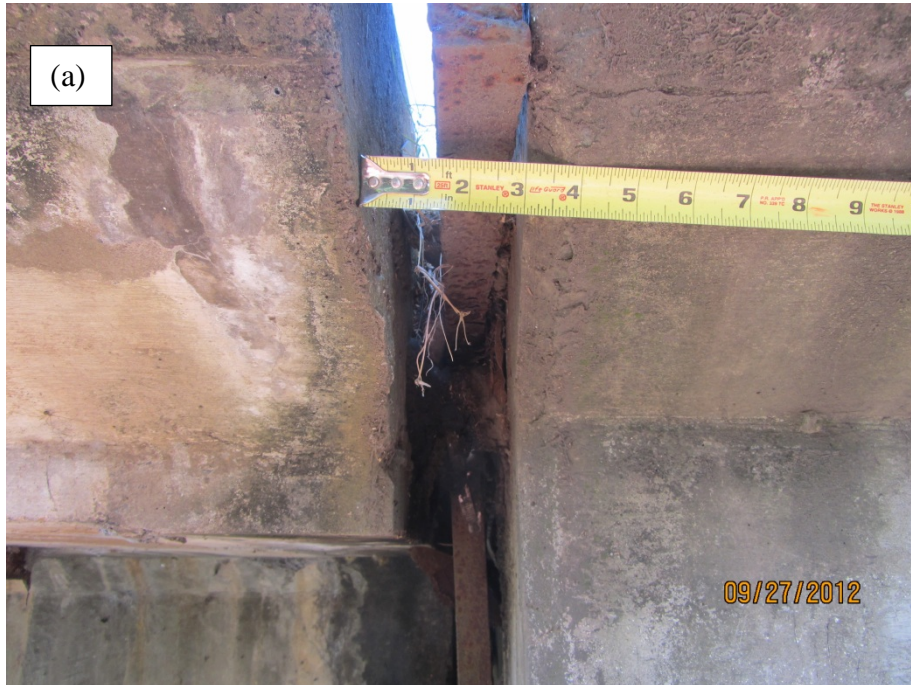
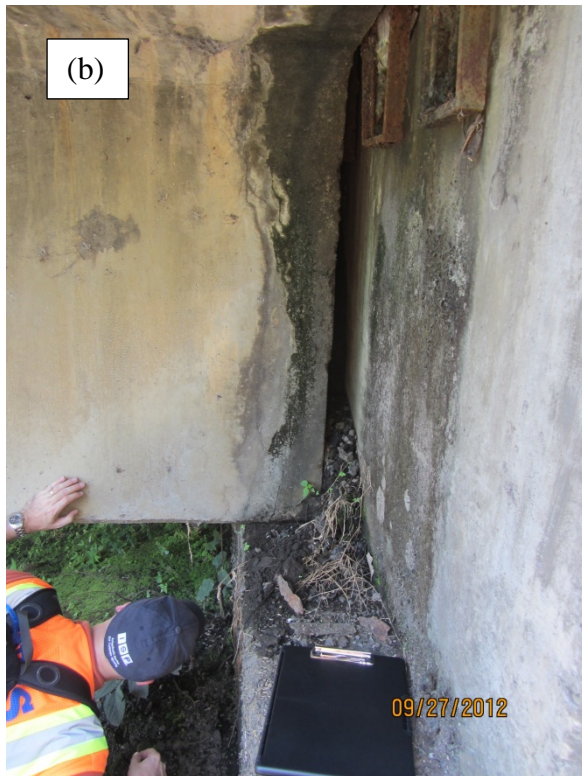
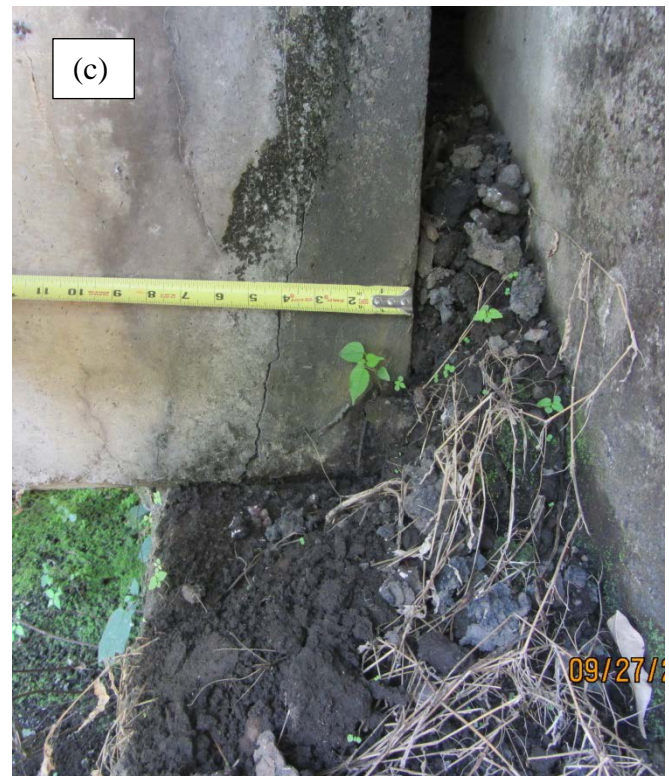
Overall the bridge performance following the Nicoya earthquake was good, with no noticeable cracking or excessive separation between bridge segments. However, the Costa Rican Ministry of Transportation inspected the bridge a few days after the earthquake and identified some potential problems owing to the offset between the bridge and the abutment. The GEER team observed that the gap between the bridge and the southeast abutment had increased by about 1.5 inches from its original position as shown in Fig. 4.25 (a) and (b). This offset had caused the metal sheathing around two of the cables to be pulled apart so that the steel wire cables were exposed to the atmosphere. Although this does not pose any immediate threat to the safety of the bridge, the potential for accelerated corrosion is significantly increased. In addition, the movement of the bridge in the northwest direction has reduced the seat length on the abutment to only about 7 inches (see Fig. 4.25(c)).

Fig. 4.25 Offset of bridge relative to abutment at Iglesias bridge of about 1.5 inches. The offset ruptured the metallic sheath surround the tension cable exposing them to increased corrosion and reduced the seat distance for the abutment. (10.02801° N 84.36015° W)

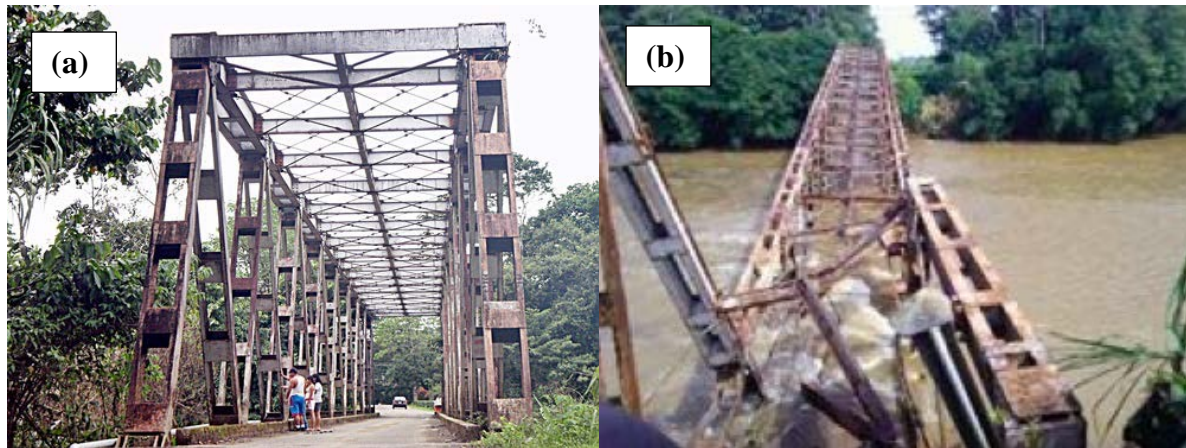
Photographs looking along the longitudinal axis of the bridge from one abutment (a) before and (b) after the earthquake are shown in Fig.4.28. The bridge appears to be a 1930s vintage bridge with built-up sections to form the truss members. The bridge had been demolished prior to the arrival of the GEER team and new pile foundations were being driven to support a replacement bridge. Given that the bridge was relatively old and the ground motions were quite low, it seems likely that the bridge failed by falling off the support on one side which led to a failure of the top truss. A similar failure occurred to a steel girder bridge at Rio Estella during the 1991 Limon Cost Rica earthquake. A newer, well constructed bridge would have survived this low acceleration level with little problem.

Fig. 4.28 – Photographs in the longitudinal direction of the De Hierro Sobre bridge over the Sarapiquí river (a) before and (b) after the earthquake. The bridge collapsed into the river during the earthquake despite relatively low acceleration level. (photos courtesy of Yamil Herrera) (10.39000° N 84.13736° W)

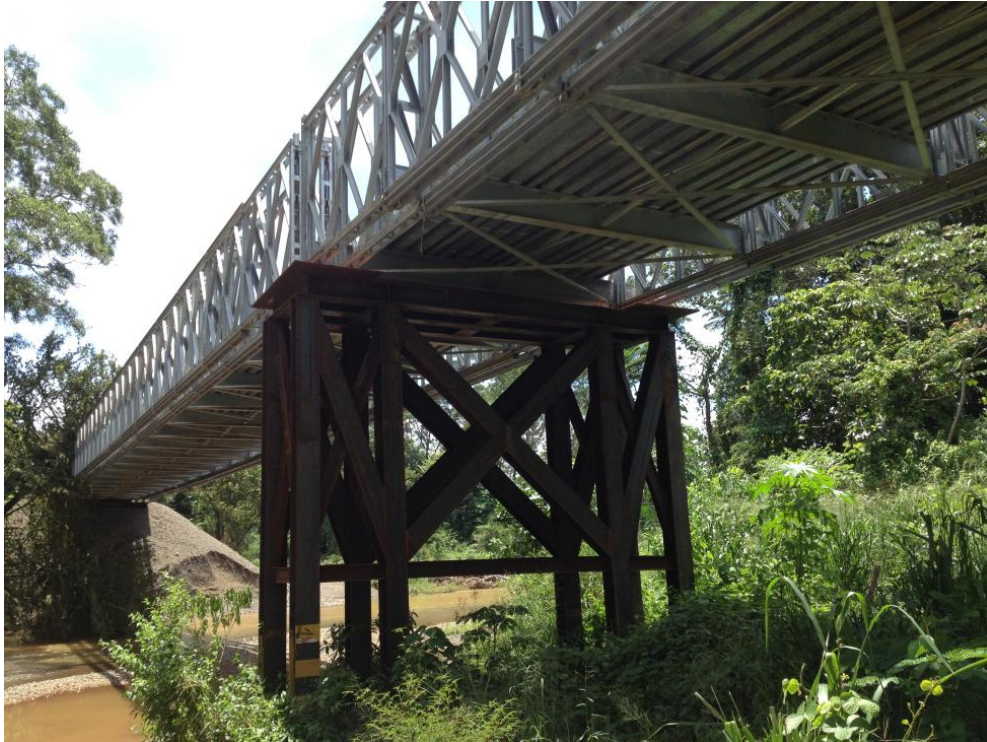
In contrast to the poor performance of the truss bridge over the Sarapiquí river, this two span bridge at Nosara (≈ 70 m length) shown in Fig. 4.29 weathered the earthquake with no apparent damage with the exception of some sloughing of the steeply inclined approach fill. The abutments and center pier, shown in Fig. 4.29, were supported by a framework consisting of eight steel H piles (HP12x63) driven 8 m into the underlying soil profile. The bridge was attached with a pin connection to a plate section which was welded atop the eight H piles as shown in Fig. 4.30. A recording station in Nosara about 2 km from the bridge recorded a peak acceleration of 1.38 g. This case history points to the fact that well-constructed bridge can perform very well despite strong ground shaking, particularly if the bridge support seats are adequate.

Fig. 4.29 Single span steel bridge in Nosara which performed without damage despite peak ground accelerations of 1.38g in the vicinity owing to the proximity to the fault rupture. Pile foundations at the abutment were in the same configuration as for this central pier.

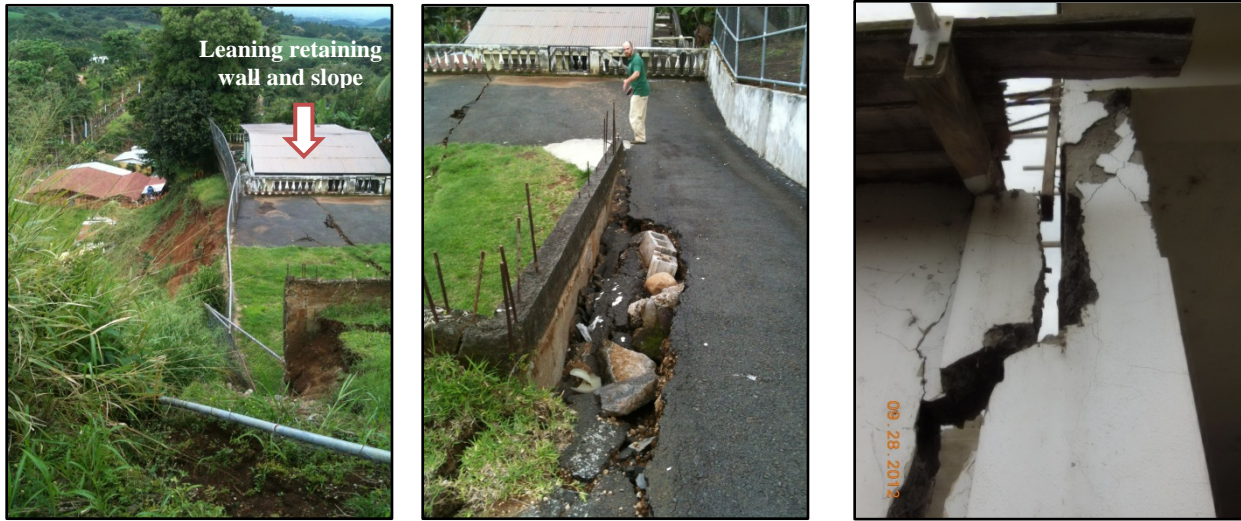
Fig. 5.4 – Construction near steep slopes: retaining walls and slope failure (a) Leaning retaining wall and large deformations caused evacuations; (b) Large crack openings parallel to the alignment of wall, (c) detached stairwell of structure built near a slope, minor reinforcement.

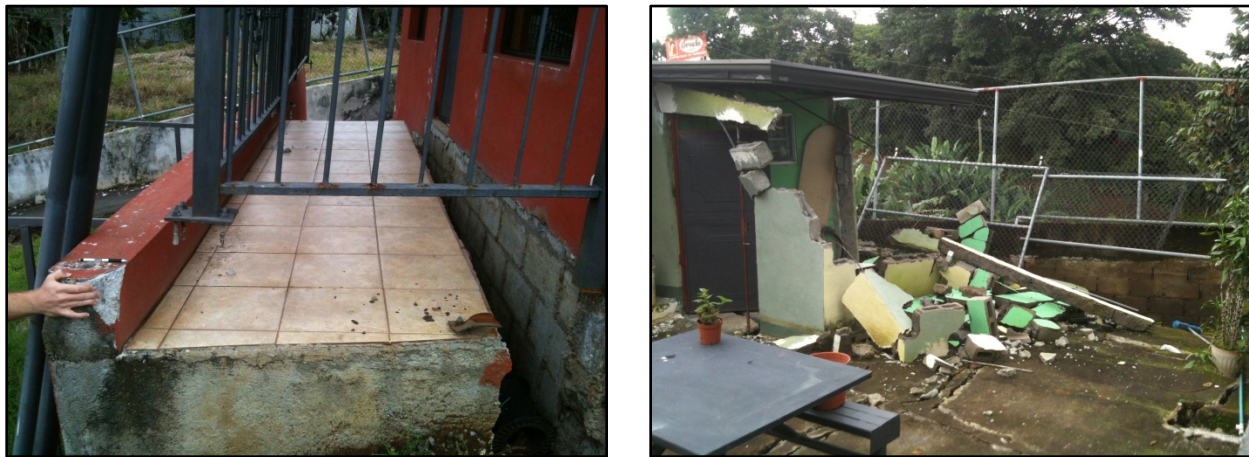
Fig. 5.5 – Structures became inhabitable. (a) Rear access porch became detached from structure, no apparent structural tie of porch to structure; (b) The shear displacement near retaining wall caused masonry construction to collapse in back patio of lower house.

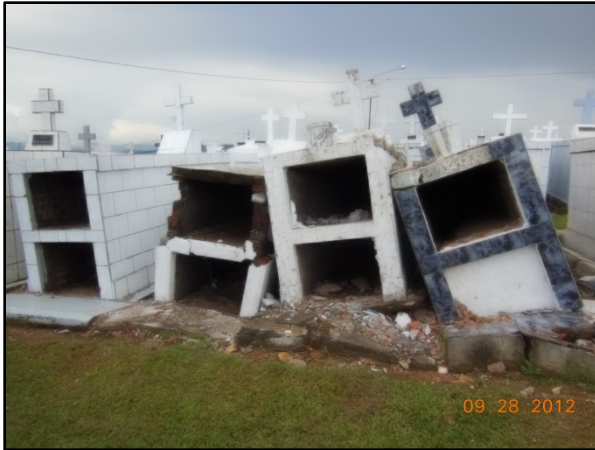
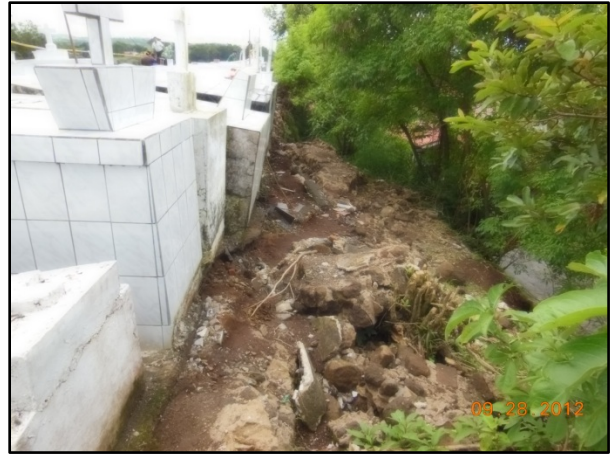
Fig. 5.6 – Cemetery damage in the town of Grecia (a) Excessive tilting, subsidence, and bearing capacity failures; likely due to construction over old underground burial sites; (b) Perimeter gravity retaining wall failed at different locations.

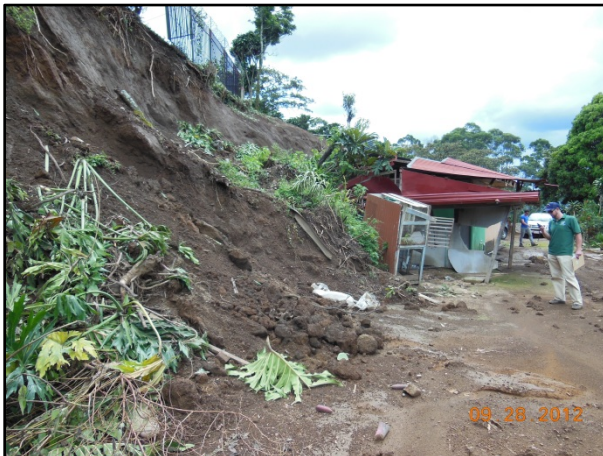
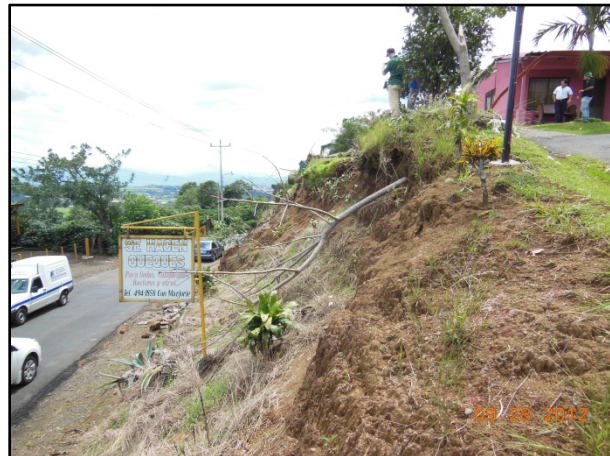
Fig. 5.7 – Slope failures near built dwellings and roads. (a) Collapse of steep bank on to small house; (b) Light construction single story and carports built on top of steep slope with water utilities located a toe of slope, likely contributed to the slope failure.
