Prepared by:
GEER Association
geerassociation.org
Hokkaido-Iburi Earthquake
Version 1.0
February 2019

Seismological, Geological, and Geotechnical Engineering Aspects of the 2018 M_w 6.6 Hokkaido Eastern Iburi Earthquake

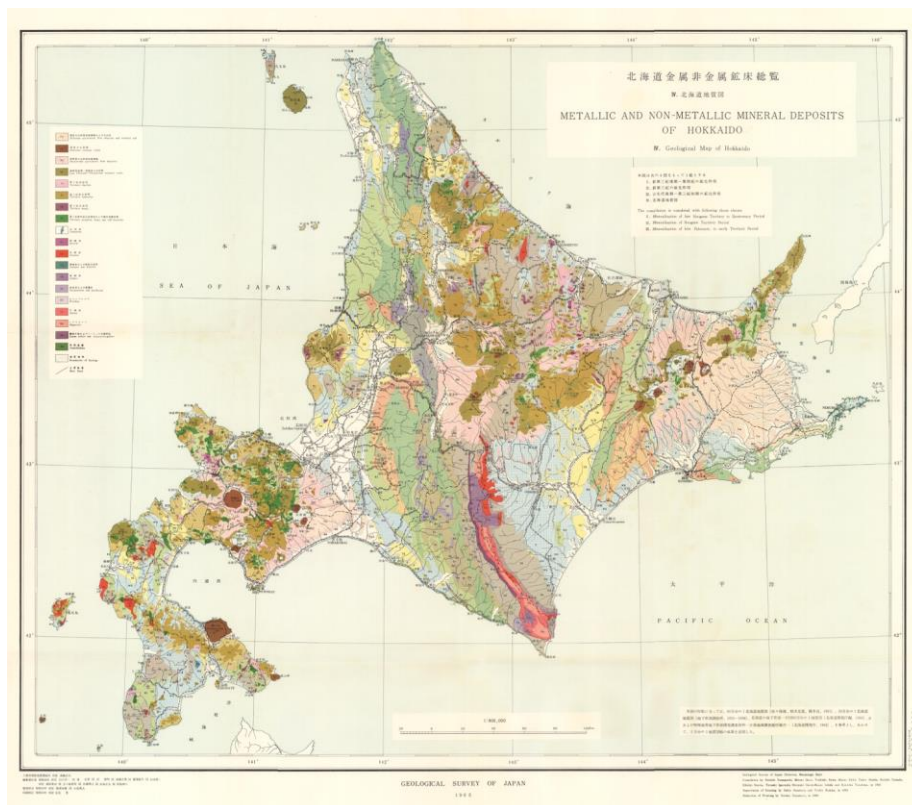
Figure 3-1. 1:800,000 scale geologic map of Hokkaido by the Geologic Survey of Japan (1967). Earthquake effects, and reconnaissance were focused in the constriction of midwestern Hokkaido near Sapporo and Chitose, primarily in late Pleistocene to Holocene volcanic or alluvial soils and Miocene age sedimentary units (primarily sand and mudstone), light blue and green in the above along the southern sections of the 142° Meridian.

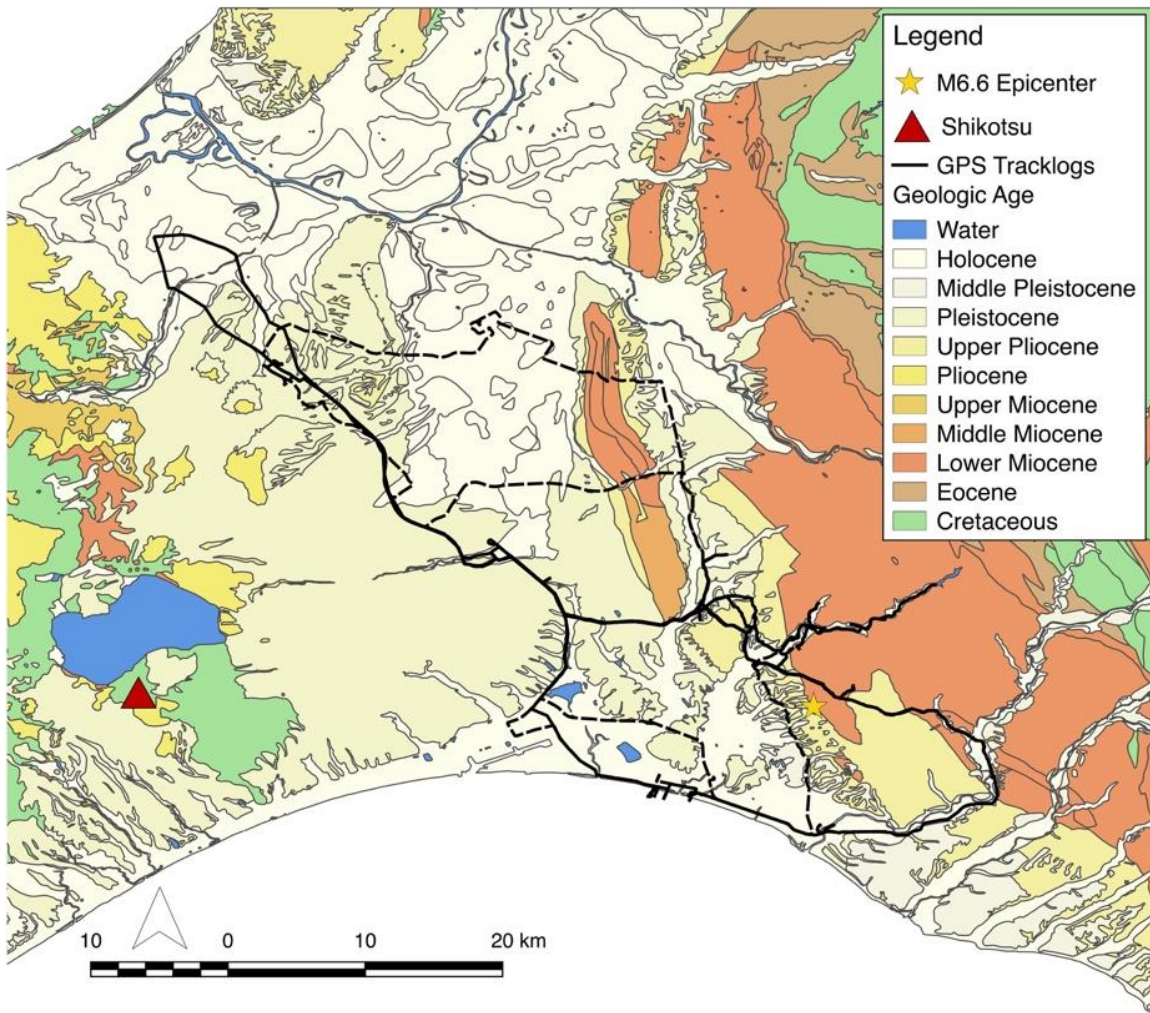
Figure 3-2. Simplified geologic ages (from 1:200,000 scale mapping, GSJ) within the reconnaissance study region, GPS tracklogs of the reconnaissance teams shown in black lines. Surficial deposits are primarily Miocene or Pleistocene in age, including extensive Shikotsu-1 pumice and scoria deposits (Pleistocene).

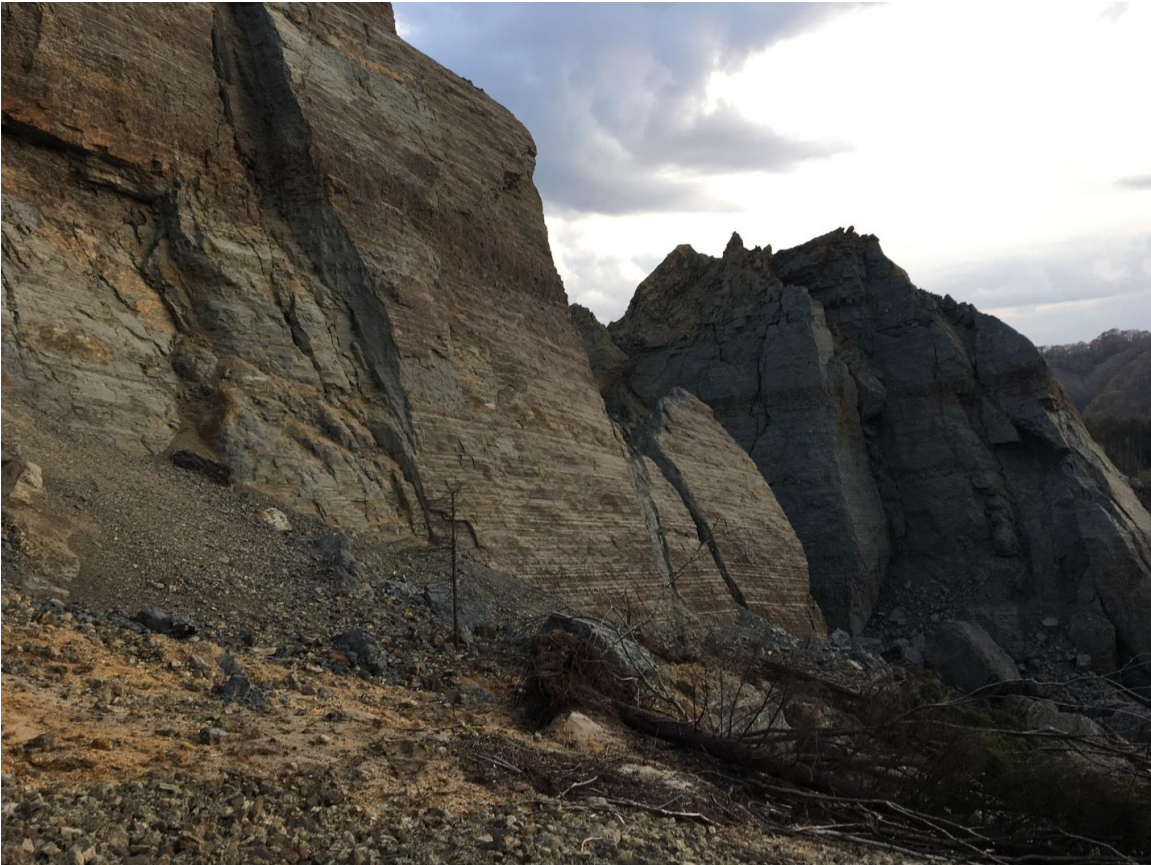
Figure 3-3. Exposure of the Kawabata formation within a deep-seated translational rock slide, image from Jeff Bachhuber 42.736835°, 142.005206.

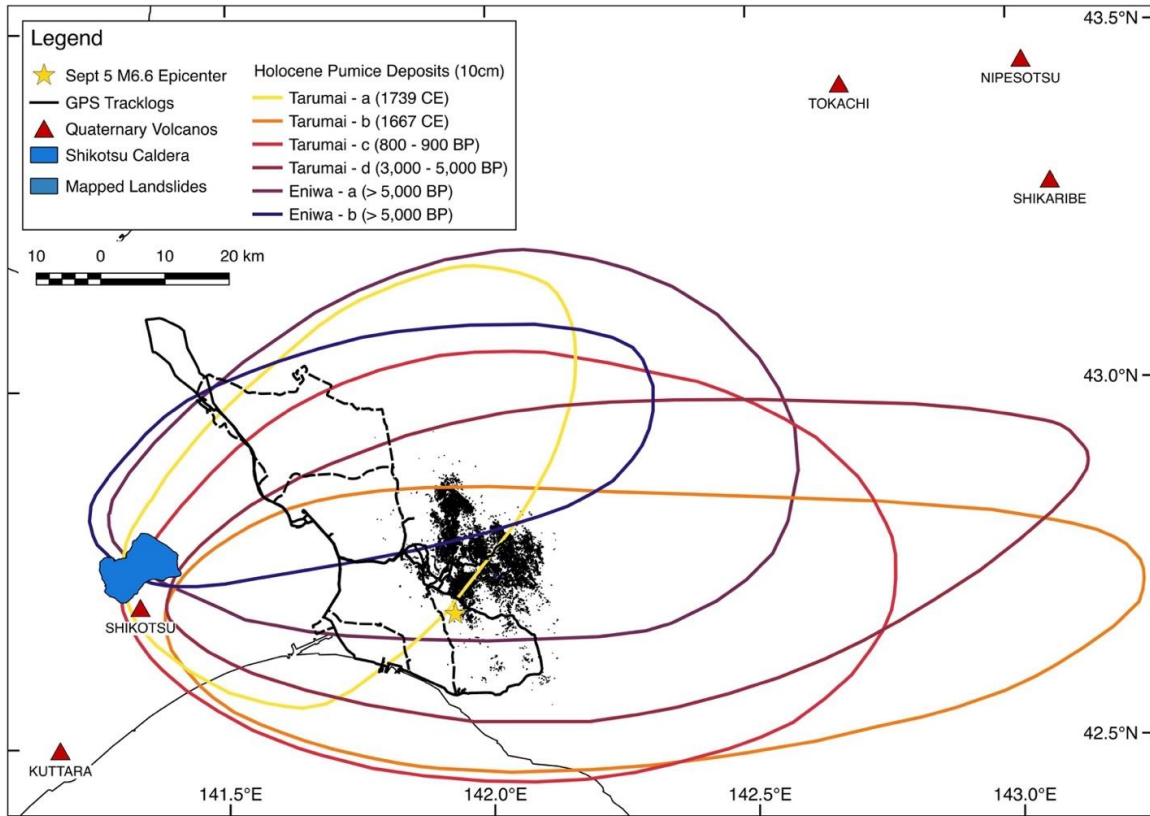
Figure 3-4. Pumice-fall contours (10cm) of significant eruptions of the Shikotsu volcano. All triggered landslides are within the 100cm deposition of Shitoksu pumice (20 - 40ka). Mapped from Ishii (1963).

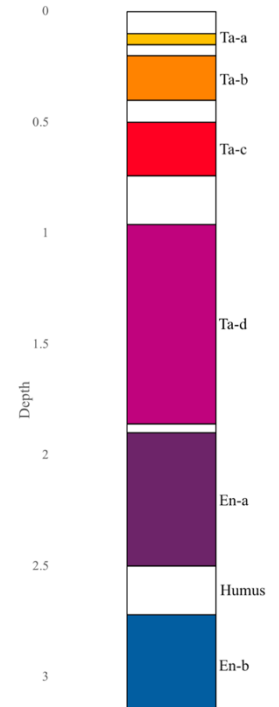
Deposit		Index	Age	Approx. Thickness at Hayakita (cm)
Holocene	Tarumai a	Ta-a	1739 CE	5
	Tarumai b	Ta-b	1667 CE	20
	Tarumai c	Ta-c	800 – 900 BP	25
	Tarumai d	Ta-d	3,000 – 5,000 BP	90
	Eniwa a	En-a	> 5,000 BP	60
	Eniwa b	En-b	> 5,000 BP	40
Pleistocene	Shikotsu 1		20 – 40 ka	>100

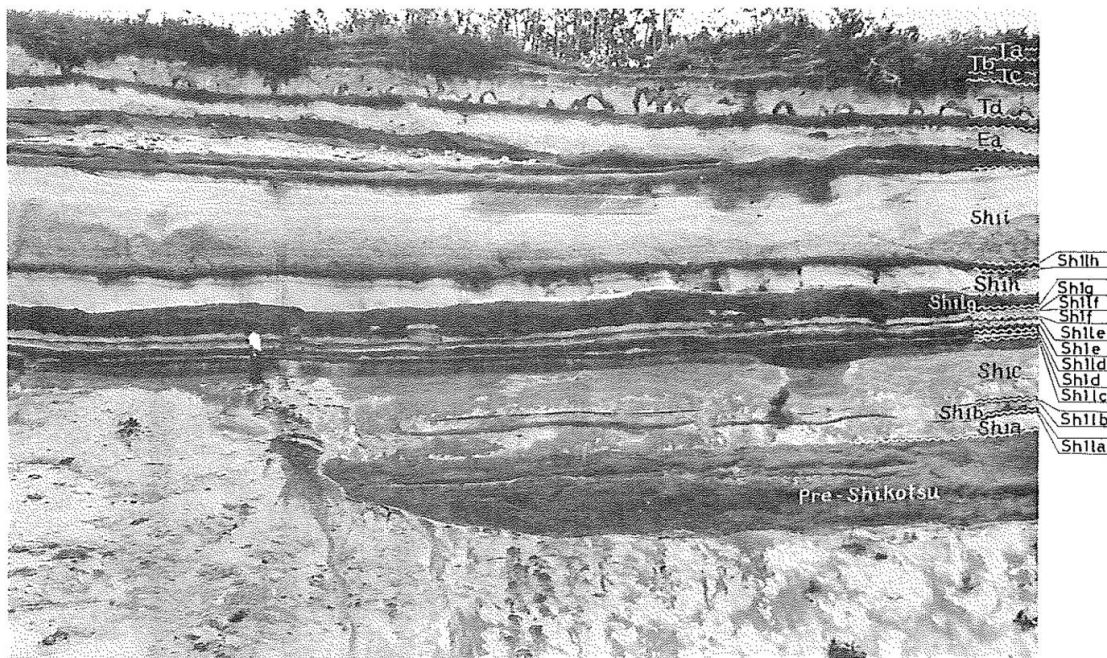
Figure 3-5. Hayakita pyroclastic type section from Minato et al. (1972). Note person for scale in left-center of image. During reconnaissance only the top 1 – 2m of pyroclastic deposits were observed, locally less than 1m resting directly on bedrock (often slopes >20°).

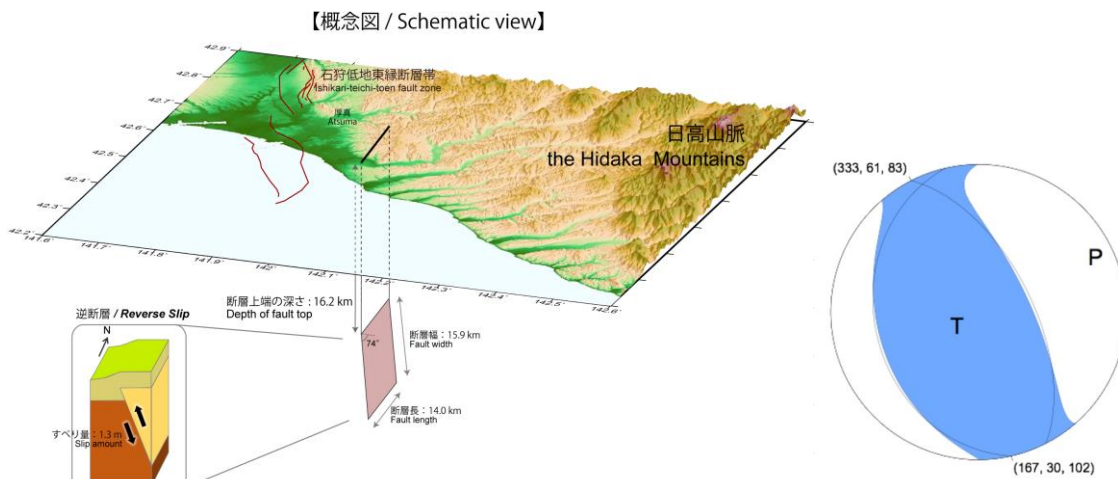
Figure 3-8. Source solutions for the M6.6 Sept 5, Tomakomai earthquake. Left, GSI fault plane solution from InSAR analyses. Right, USGS-NEIC moment tensor solution.

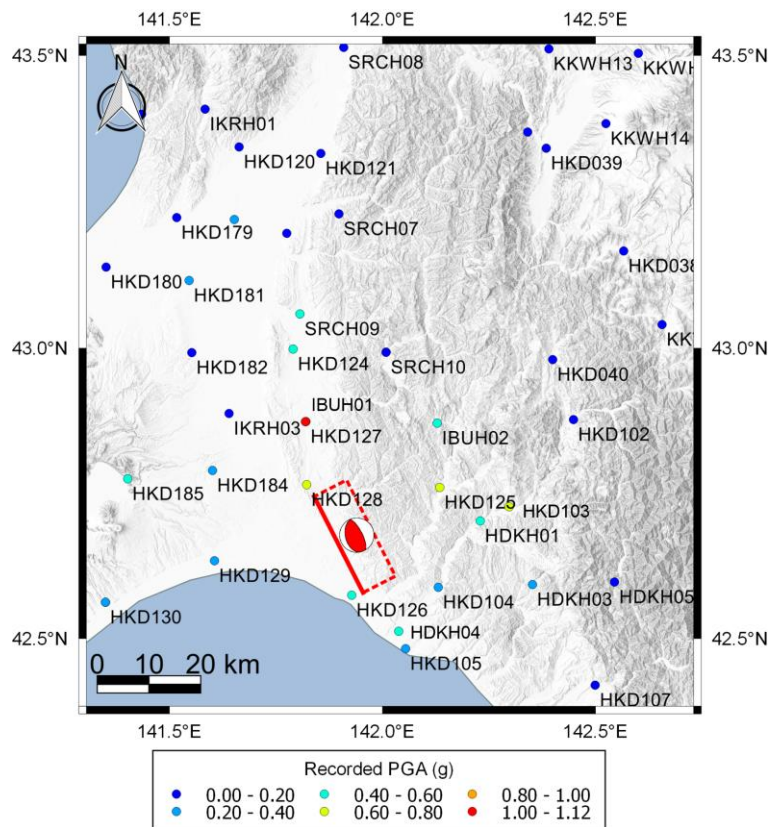
Figure 4-1. Overview of available recording stations in the epicentral area and recorded PGA.

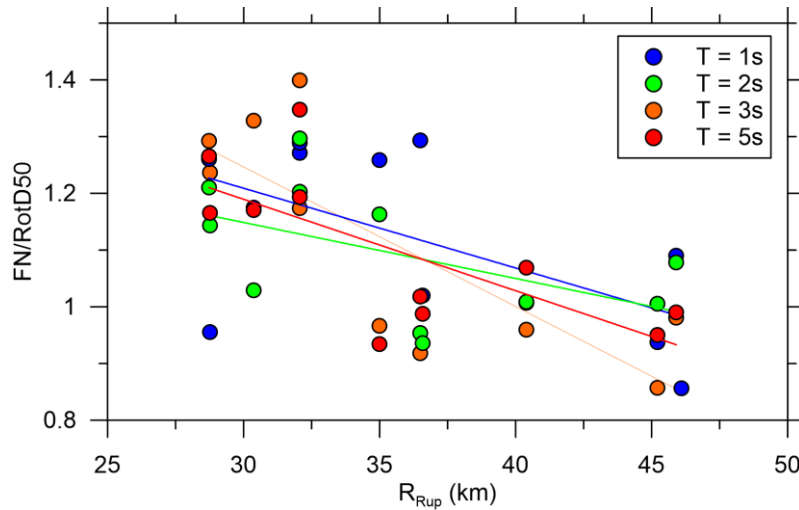
Figure 4-3. FN/RotD50 ratios versus rupture distance for stations in the updip direction for various periods ($T = 1s, 2s, 3s,$ and $5s$).

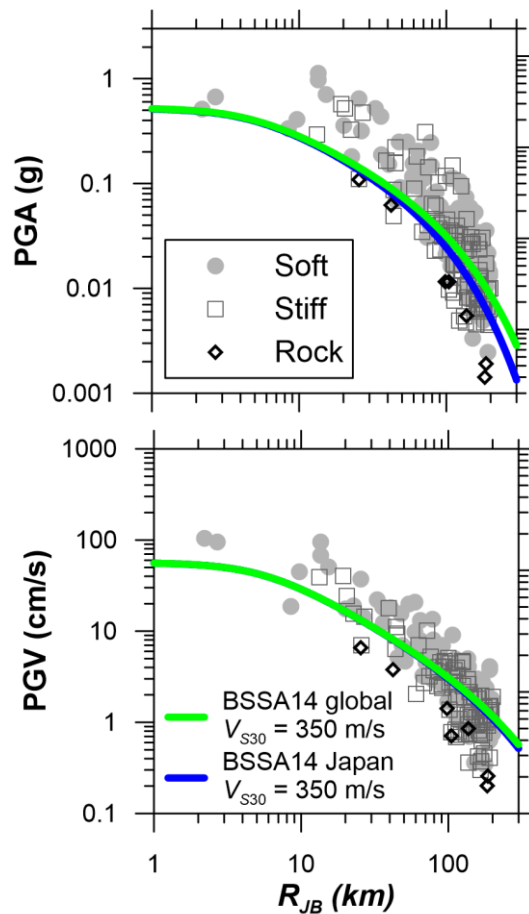
Figure 4-4. Variation of PGA and PGV with R_{JB} for rock, stiff, and soft soil.

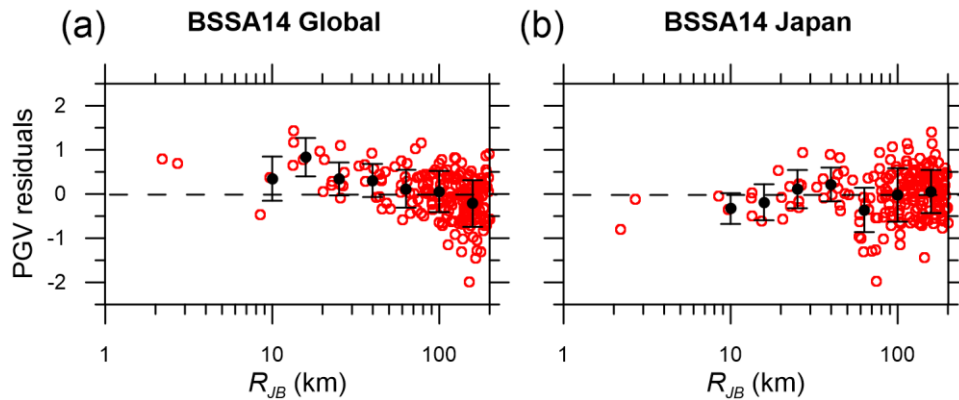
Figure 4-6. Within-event residuals of PGV from recorded ground motions relative to predictions of the (a) BSSA14 global model, and (b) the BSSA14 model with regional adjustment for Japan. Binned means shown with +/- one standard deviation.

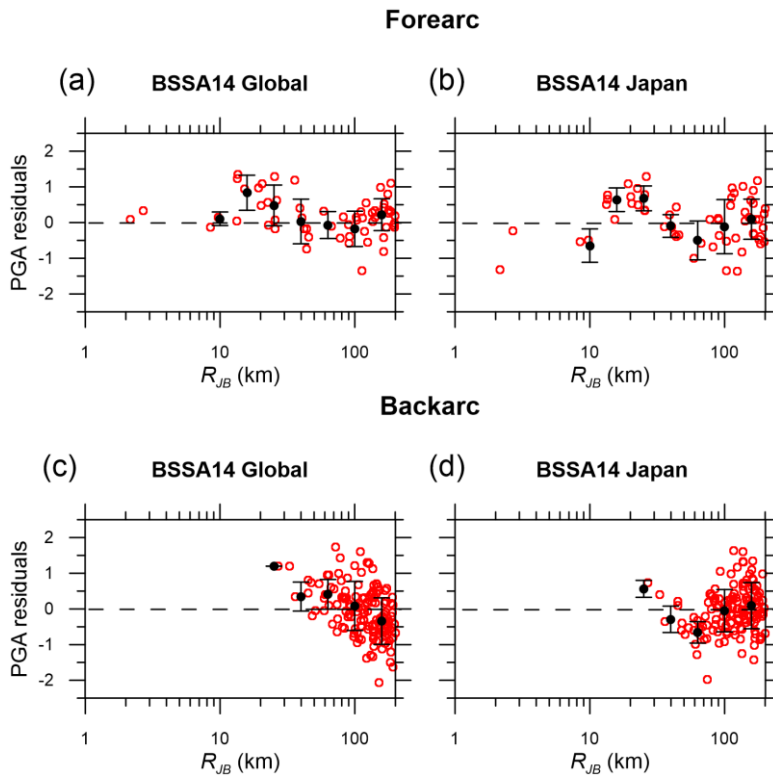
Figure 4-7. Within-event residuals of PGA from recorded ground motions relative to predictions of: (a) the BSSA14 global model in the forearc region, (b) the BSSA14 model with regional adjustment for Japan in the forearc region, (c) the BSSA14 global model in the backarc region, (d) the BSSA14 model with regional adjustment for Japan in the backarc region. Binned means shown with +/- one standard deviation.

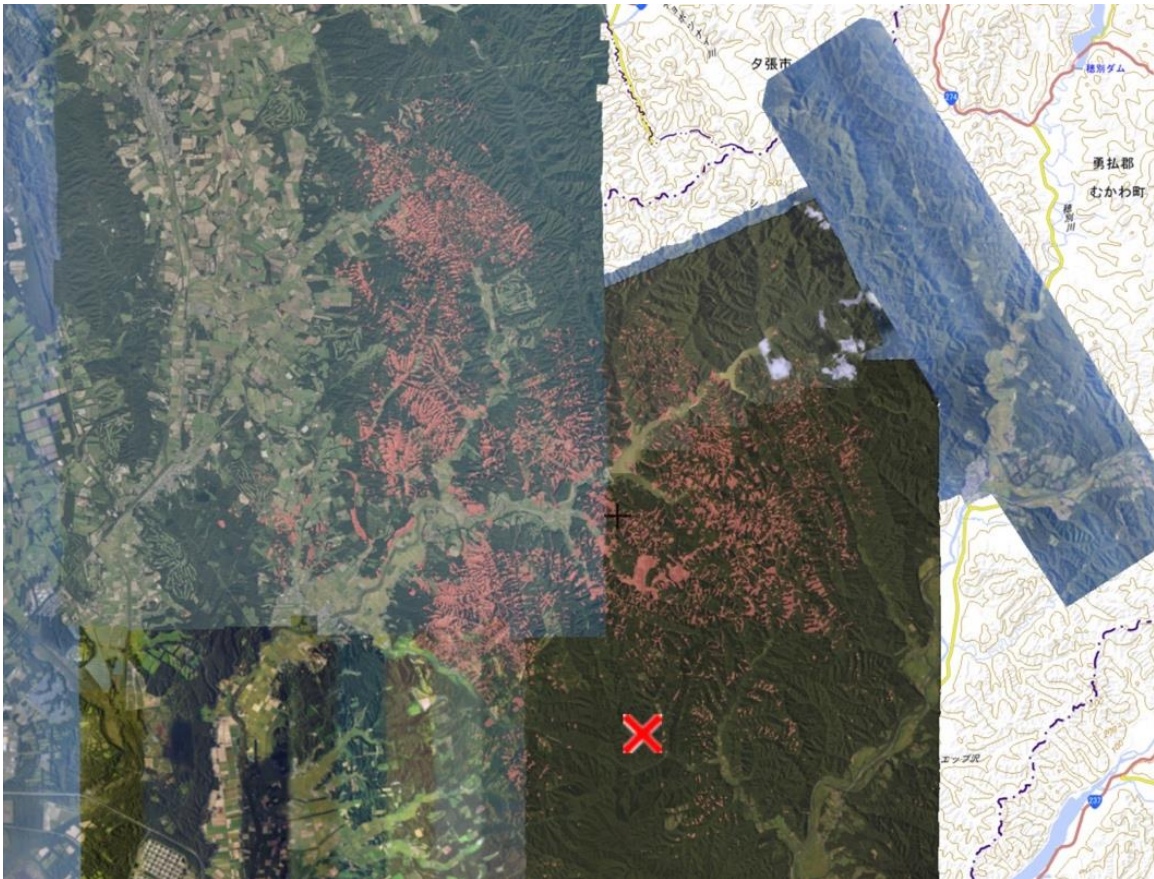
Figure 5-1. Post-earthquake aerial photos collected Sept 6 – 11 and coseismic landslides mapped by the Japanese Geographical Survey Institute (<http://www.gsi.go.jp/BOUSAI/H30-hokkaidoiburi-east-earthquake-index.html#10>, last accessed Oct, 2018). M6.6 epicenter [GSI] marked by red 'X', landslides shown as pink polygons

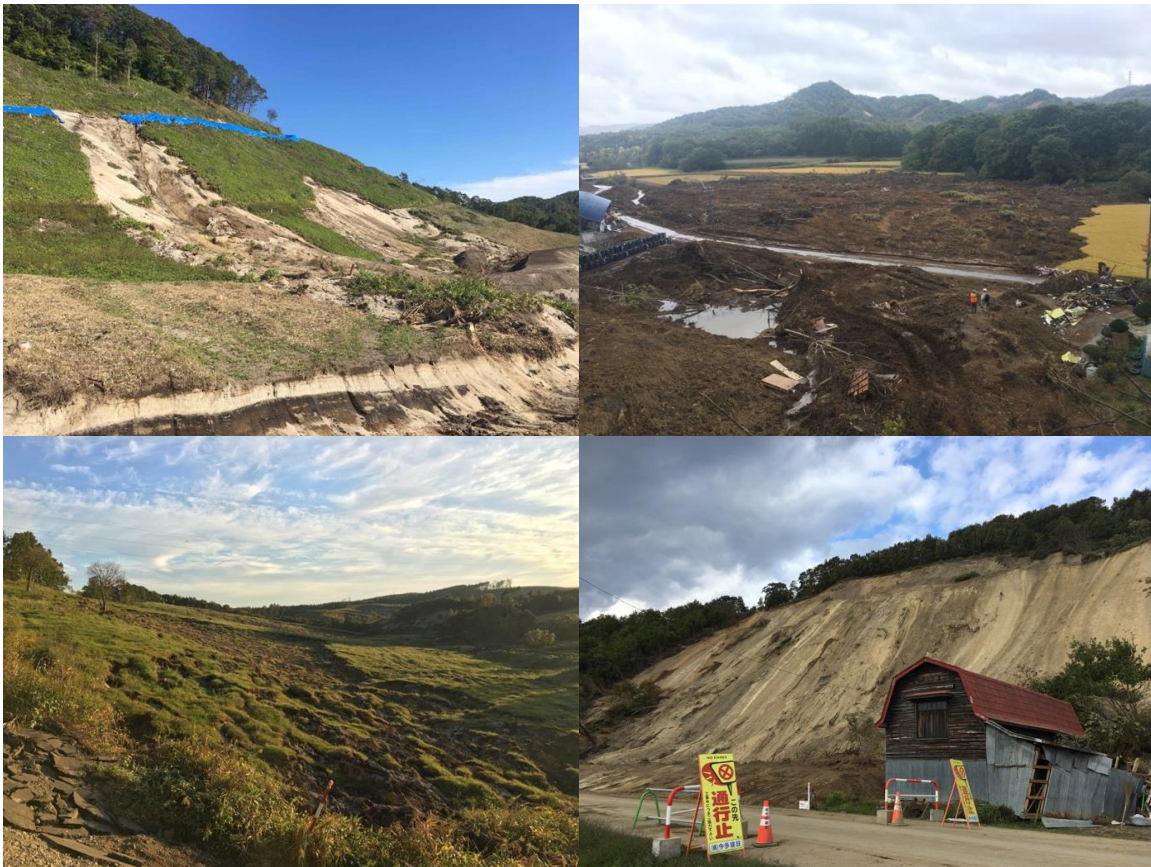
Figure 5-2. Typical landslides observed following the 2018 earthquake. A. shallow flowslide along pumice failure surface along Rt. 59. B. Low angle planar soil slide along pumice failure plane (cow-slide). C. Fluidized runout of a highly destructive flowslide along Rt 1065. D. Shallow debris slides at Horonai, failure depths limited by near-surface Kawabata formation that did not appear to slide.

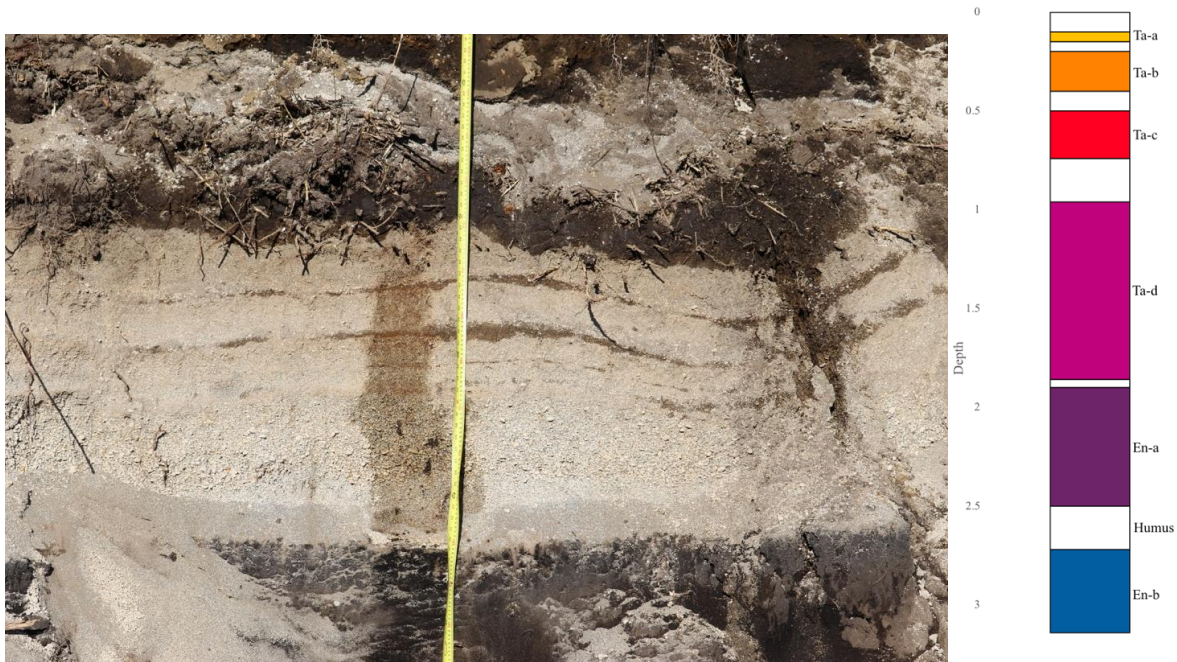
Figure 5-3. Pumice exposed by reconstruction work in the toe of Landslides along Route 59. Right, cartoon of the near-surface pumice stratigraphy at Hayakita after Ishii (1963). 70cm Pumice deposit (left) likely from Ta-b and Ta-c eruptions, possibly resting on organic soils derived from Ta-d. Image and soil column figure reflect data collected 13km apart.

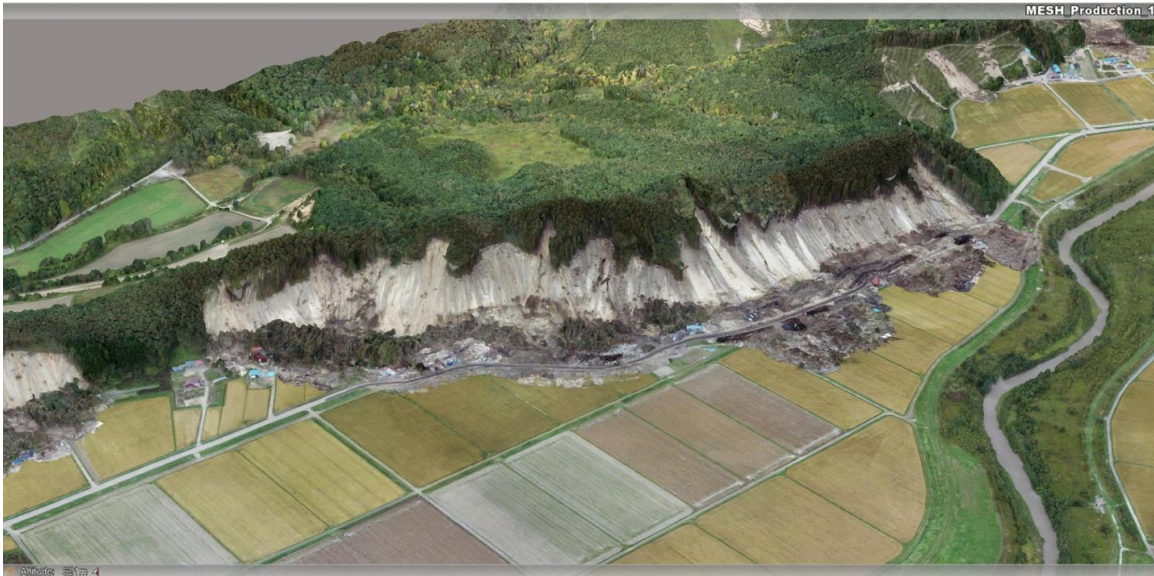
Figure 5-4. UAV SfM model of the Yoshino landslide complex. Landslide failure was along a shallow, approximately planar, surface of pumice (Ta-b/c?) causing complete destruction of the community at the toe of these slopes and running into the adjacent rice fields. Failed slope angles $\sim 30^\circ$ (141.91, 42.74858).

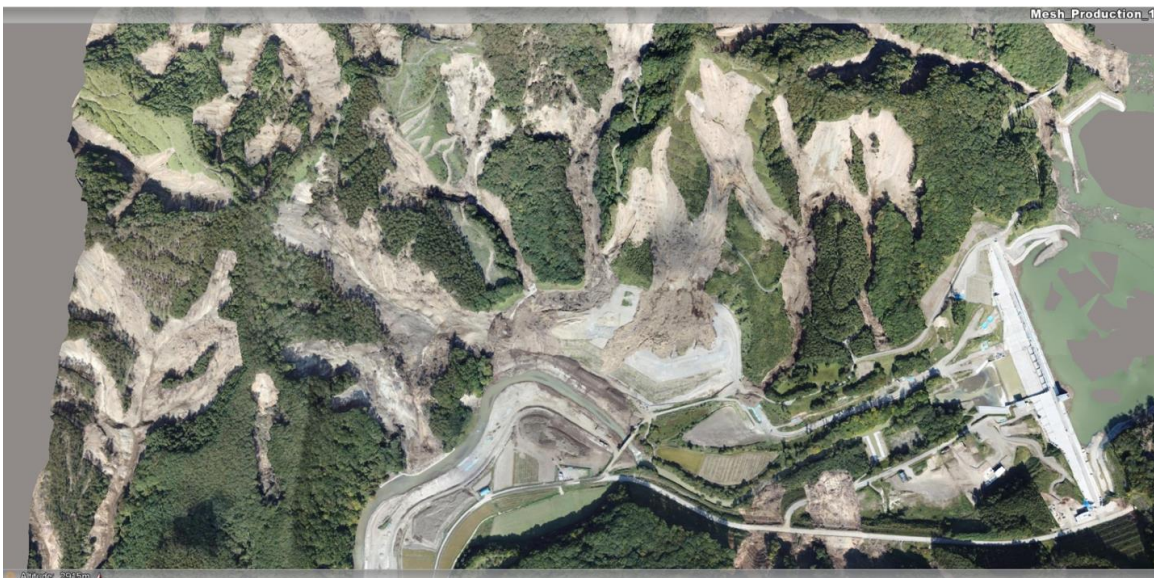
Figure 5-5. Extensive landslide triggering near Atsuhoro Dam. Long runout flowslides occurred in most hillslope concavities, coalescing and completely inundating side-channels throughout the landscape (e.g., left edge of this image). Landslides occurred in hillslopes of various ages of logging production / tree-cover. Dam crest is $\sim 515\text{m}$ long for scale (141.9936, 42.76631).

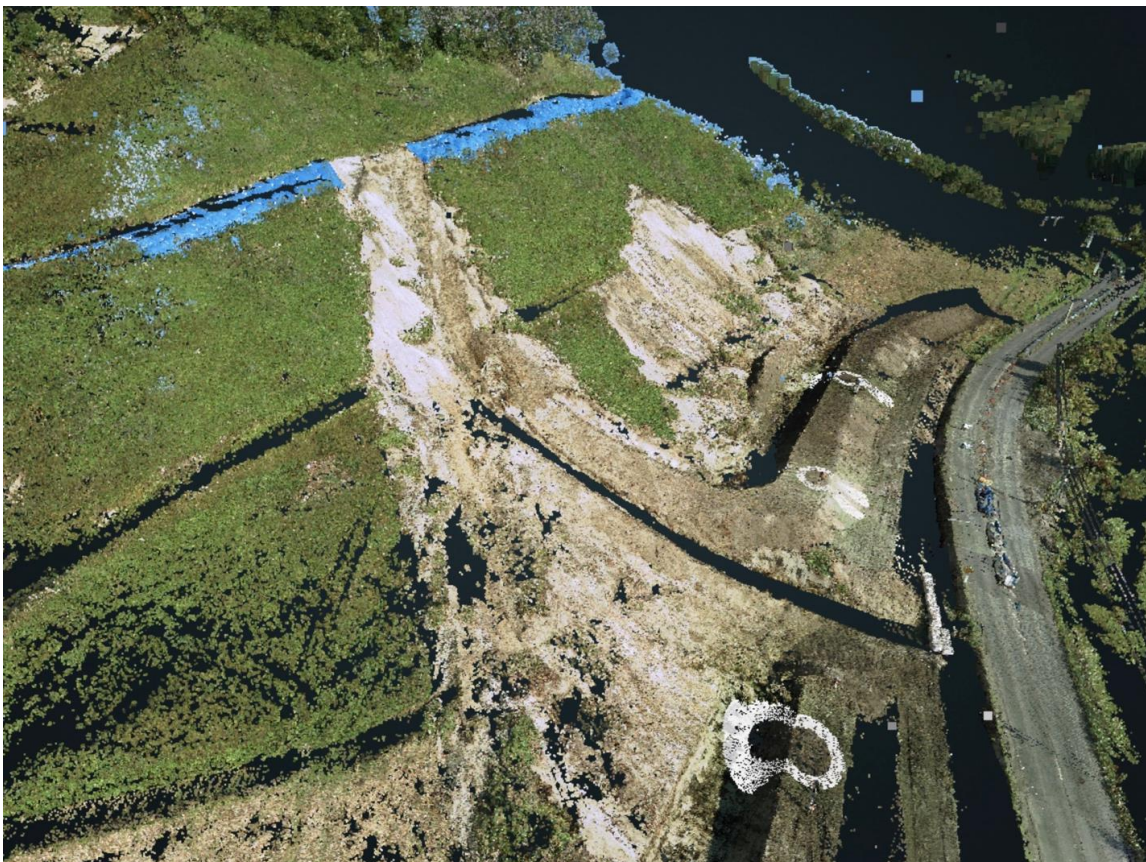
Figure 5-6. Terrestrial lidar point cloud of shallow landslides along Route 59. The foreground landslide as observed was over 130m long, and considerable reworking (e.g. earthen berm) of the runout deposits had previously occurred. Distal slide never greater than 1m in thickness 42.6974, 141.9471.

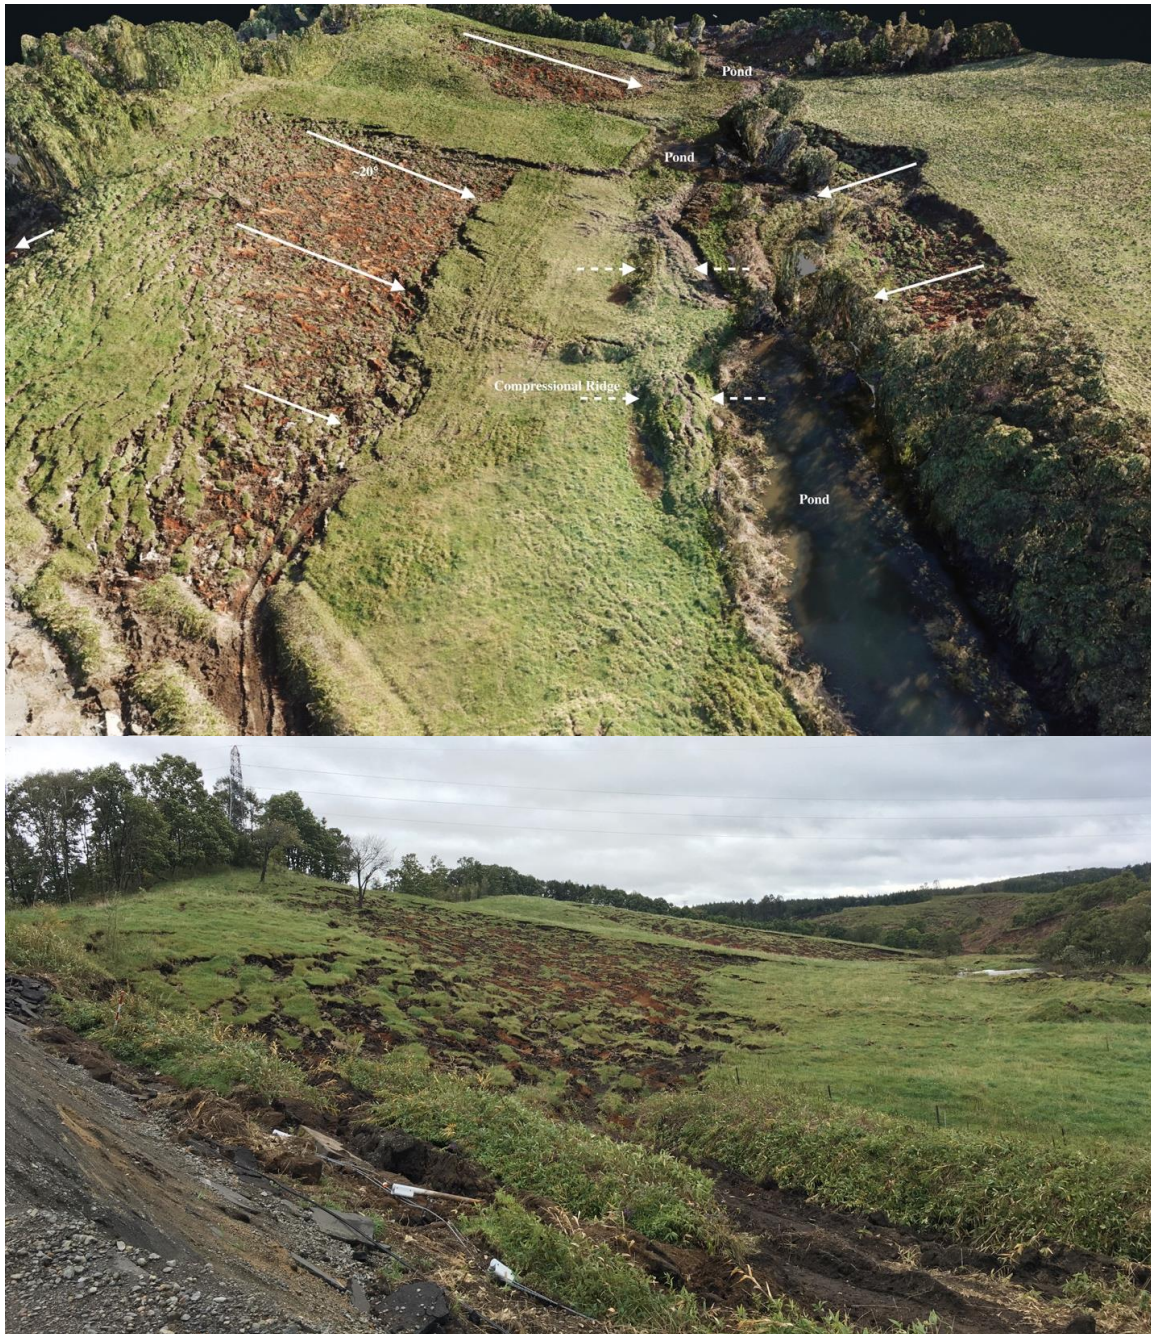
Figure 5-7. Top. UAV-SfM model of the multiple dam-forming 'Cow slides' near Atsuma [42.7568°, 141.8702°]. Bottom. Image looking across the face of the landslide. Surficial turf and organic soils failed as a coherent mat, displacing upwards of 70m downslope damming the central irrigation ditch. Principal failures moving left to right (white arrows) along slopes of ~20°, and included highly complex head and side cracking systems and compressional ridge of displaced turf and soil at the toe. Landslide failure was nearly continuous over the left ridge into a steeper slope severely damaging a residential structure, and right to the adjacent slope also failing towards the irrigation channel.

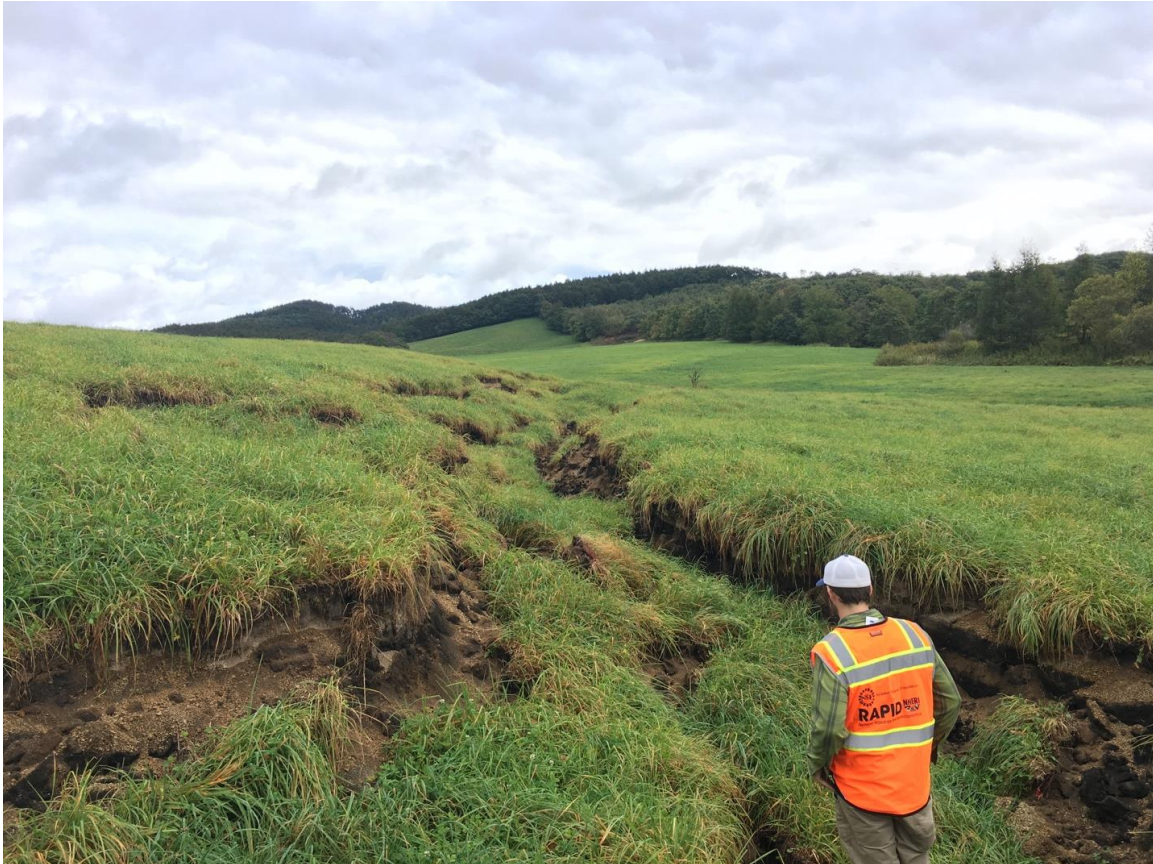
Figure 5-8. 'Low-angle' slide along a $\sim 12^\circ$ slope within pastureland near Atsuma 42.7644° , 141.8778°]. Sliding plane ~ 1.5 - 2 m in depth, with relatively intact sliding of the failed mass. A smaller failure along the facing hillslope (right of this image) with little permanent deformation was also observed. These landslides were not mapped by the GSI from aerial images.

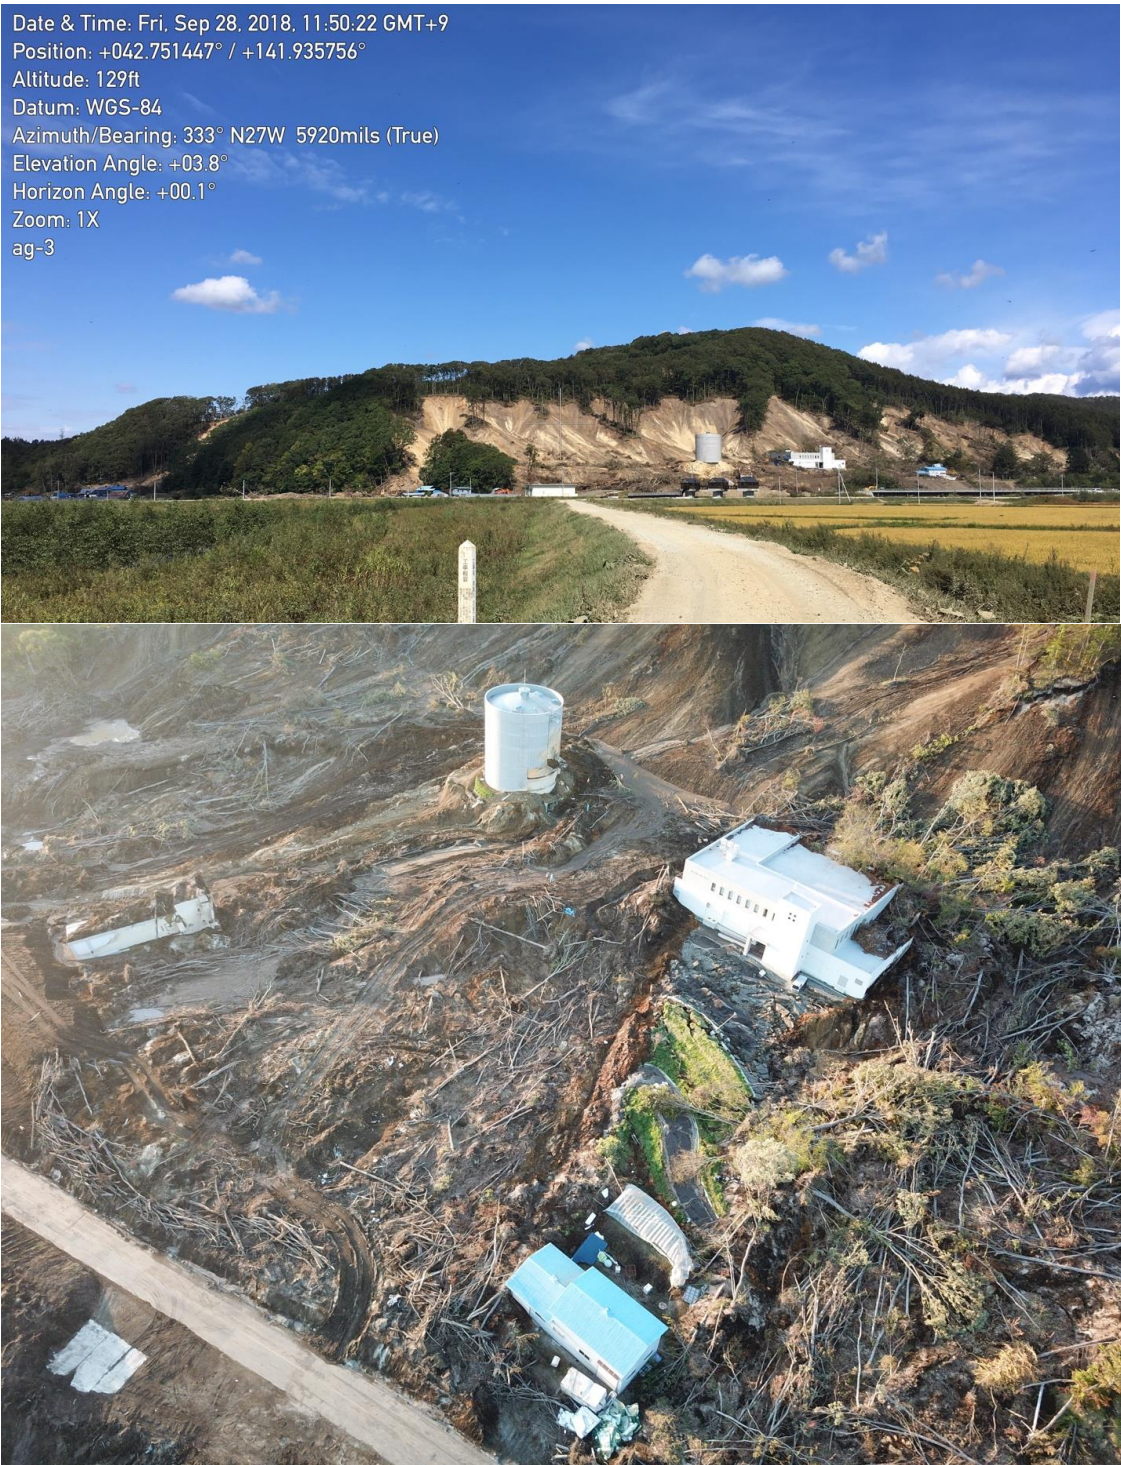
Figure 5-9. Landslide damages at the Tomisato Water Treatment Plant. Top, overview of slope failure. Bottom, UAV-image showing the displaced stairway (left) and protected shadow zone by the surviving main-building. Both water tower and main building are founded on deep piles

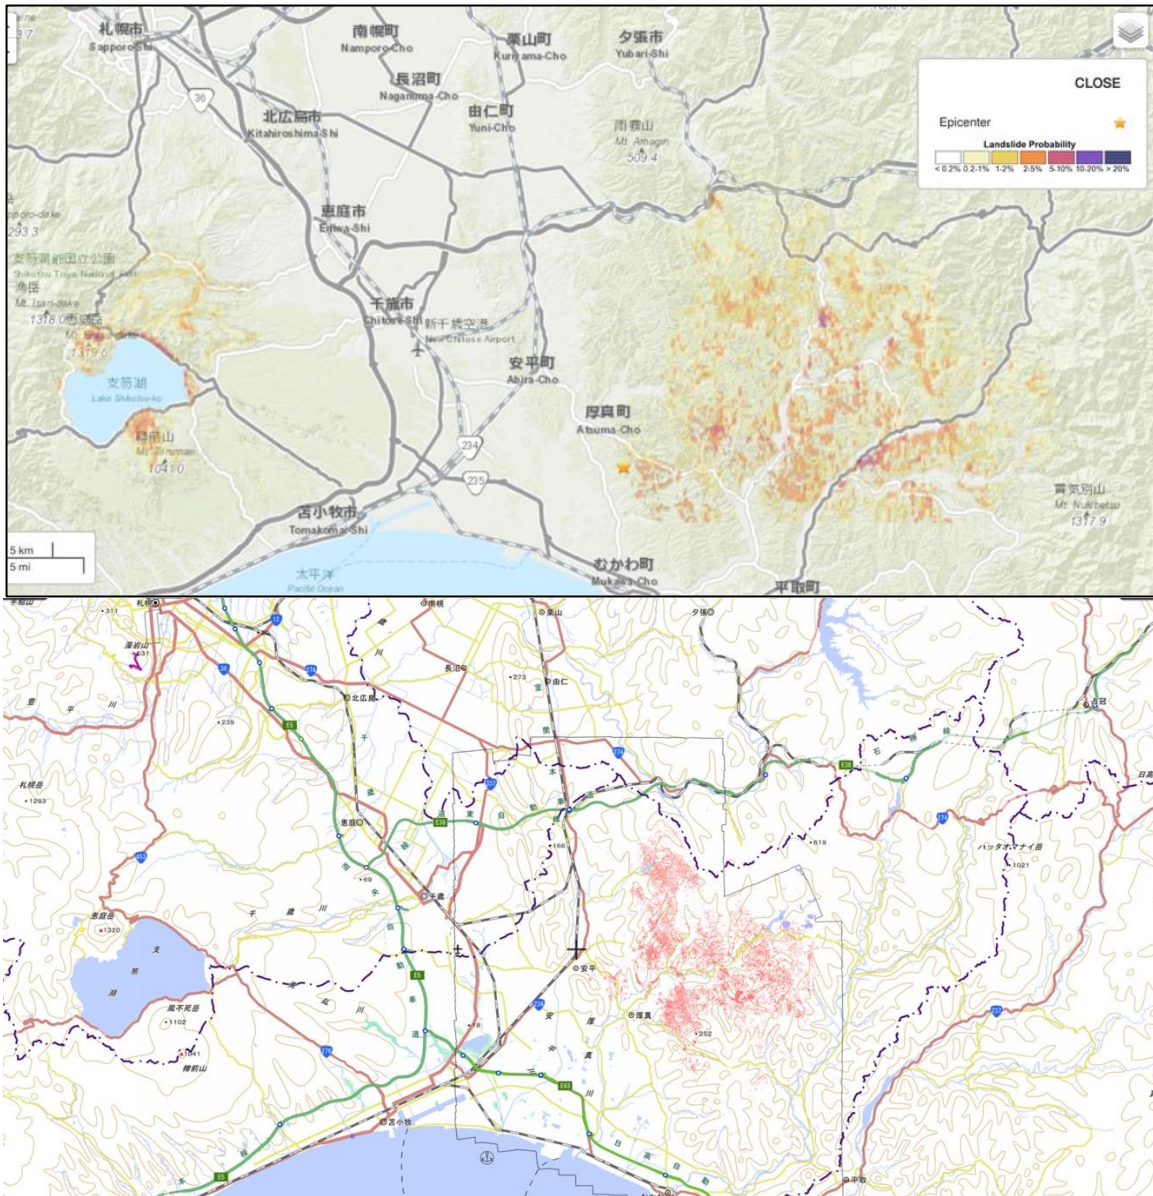
Figure 5-10. Comparison of USGS Landslide Probability prediction (top) and mapped landslides (bottom).

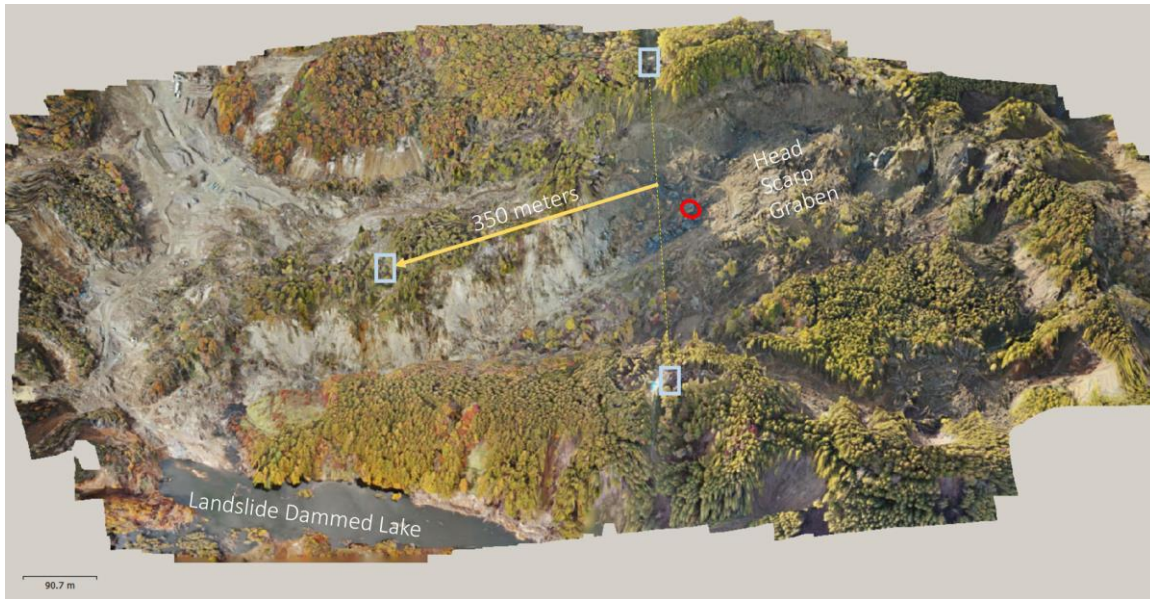
Figure 5-11. Drone composite image showing Horonai megaslide with offset (solid yellow line) of electrical tower relative to original electrical alignment (yellow dashed line). Tower locations are shown as white boxes. Approximate center point of composite image: 42.736835°, 142.005206°

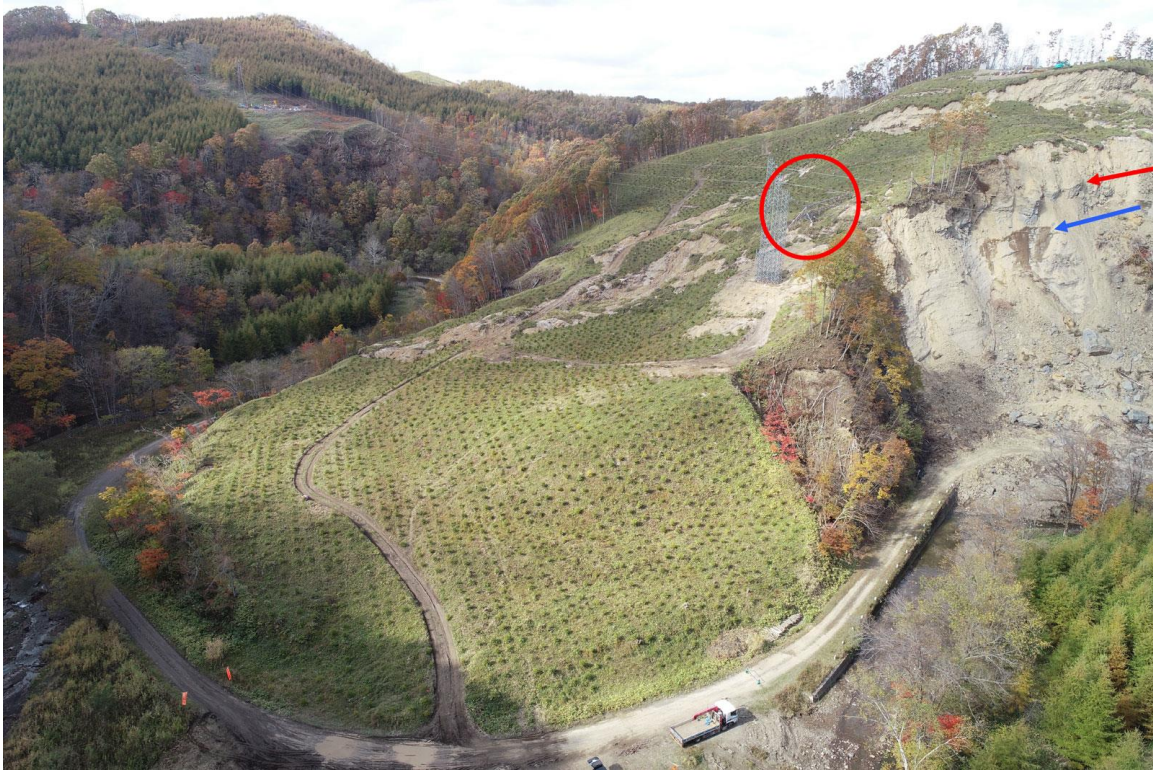
Figure 5-12. Drone image with view to northeast showing Hobetsuizumi megaslide with offset of electrical tower (within red circle). Water seepage visible at location indicated by blue arrow with red arrow showing upper inset slide plane. Photo location: 42.718279°, 142.151628°.

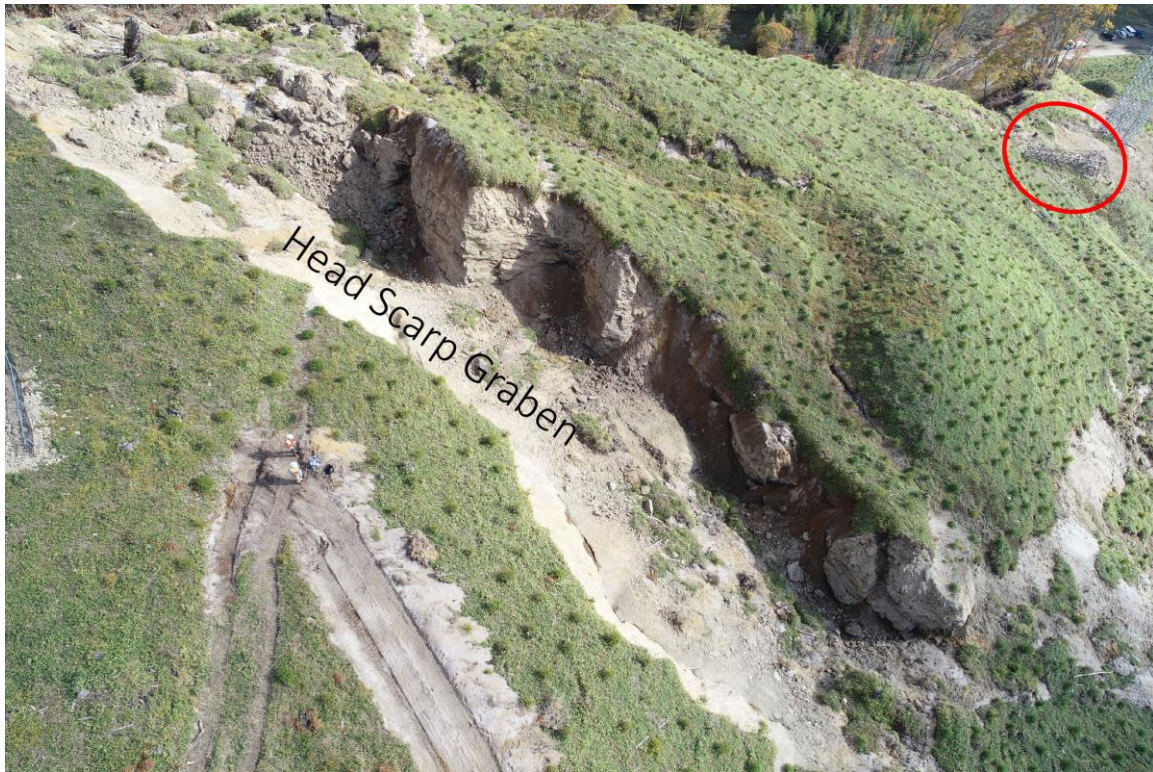
Figure 5-13. Drone image of the upper graben within the headscarp of the Hobetsuizumi megaslide. Note collapsed electrical tower (within red circle). 42.719687°, 142.151401°.
