Prepared by:
GEER Association
geerassociation.org
Hokkaido-Iburi Earthquake
Version 1.0
February 2019

Seismological, Geological, and Geotechnical Engineering Aspects of the 2018 M_w 6.6 Hokkaido Eastern Iburi Earthquake

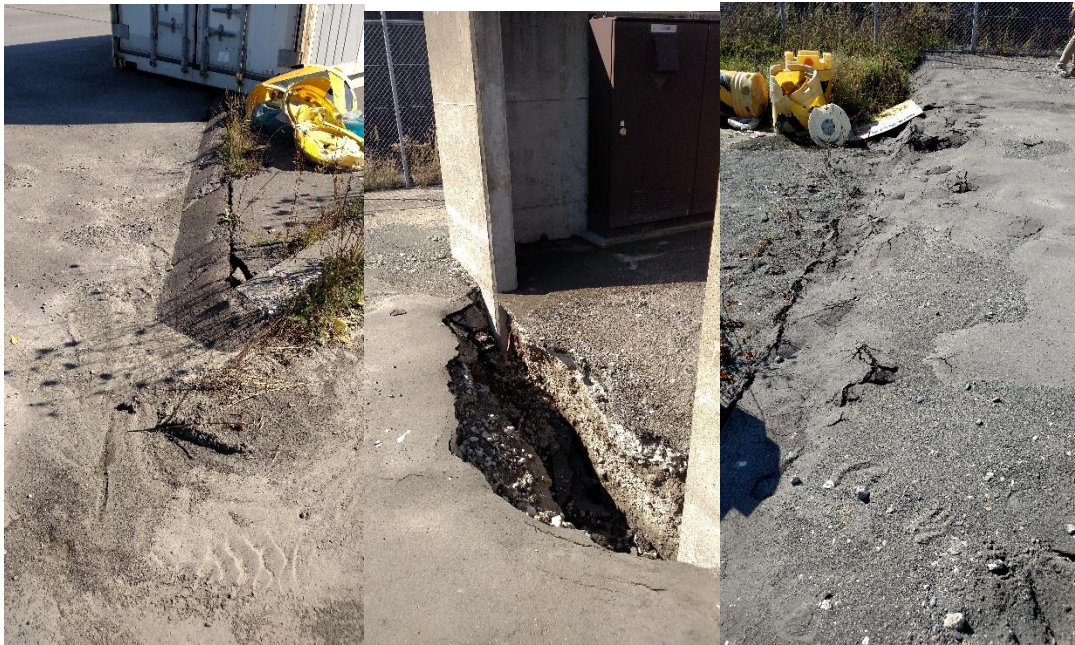
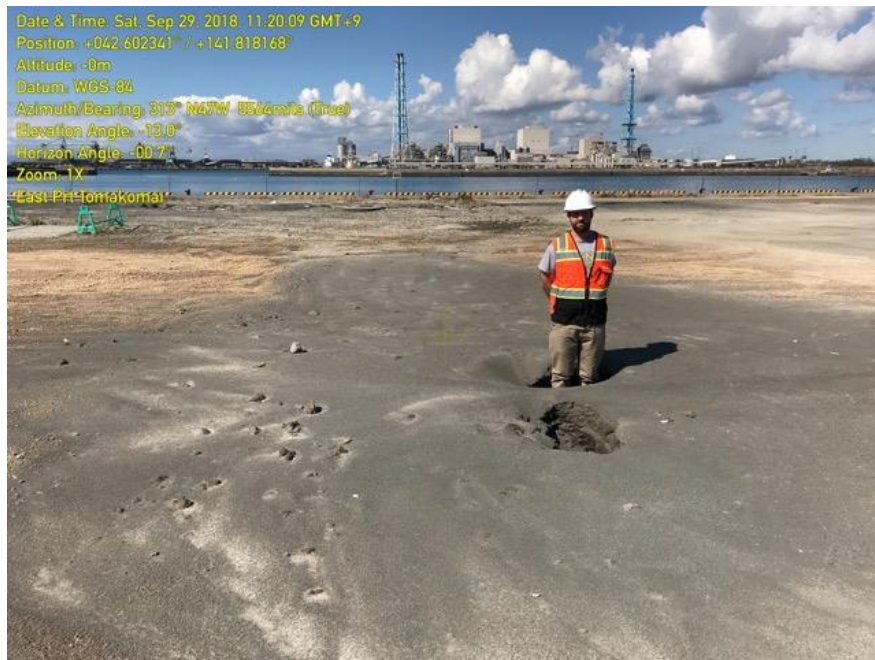
Figure 6-1. Sand boils surrounding a light tower at southern edge of the Tomakomai port. Sand boils were observed near the southern seawall and in the container back-yard at the port and in undeveloped areas of the port between the marine container facility and the HEPCO coal plant. 42°36'23.7"N 141°47'00.7"E.°

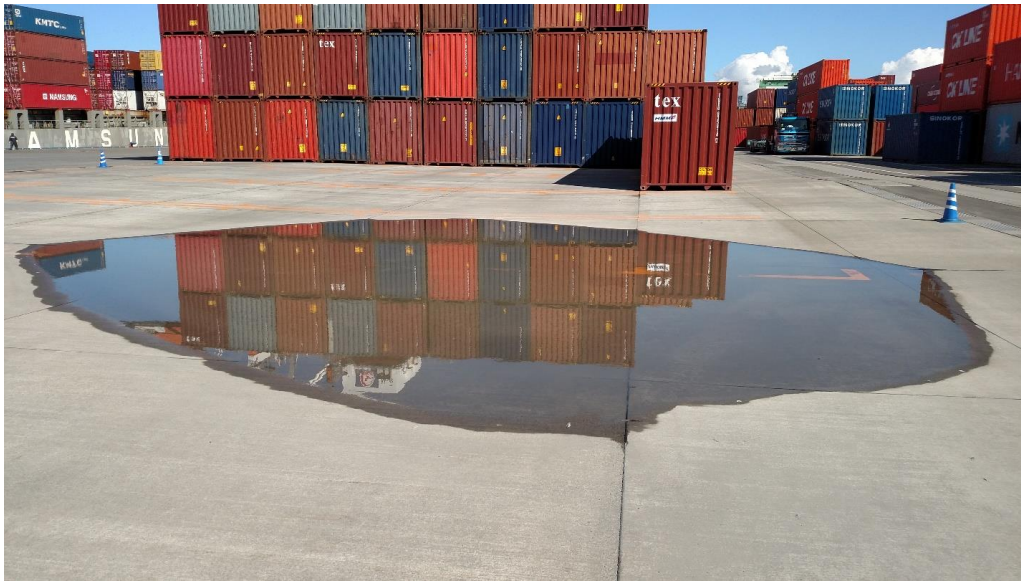
Figure 6-2. Minor settlement of concrete slabs and the ponding of water. Truck traffic was directed around these locations but were otherwise not hindered. 42° 36' 24.6" N 141° 46' 60.0" E.

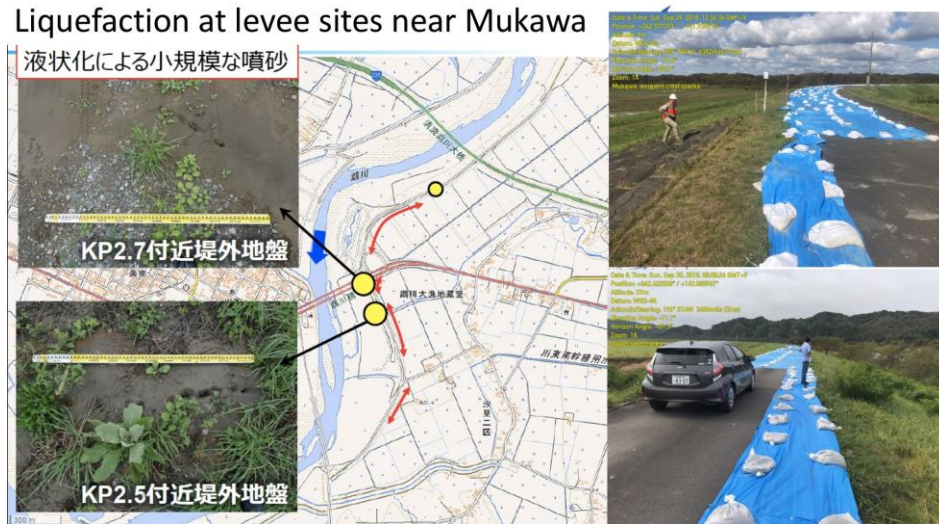
Figure 6-4. Sand boils observed by Japanese researchers (left), Map of Mukawa river locations near coast highway 235 (center), examples of blue tarp covered crest settlements of flood control levees along the Mukawa river (right). Japanese researchers identified liquefaction features (yellow circles) along the riverward side of the levee embankment. 42°34'30.2"N 141°56'23.0"E.

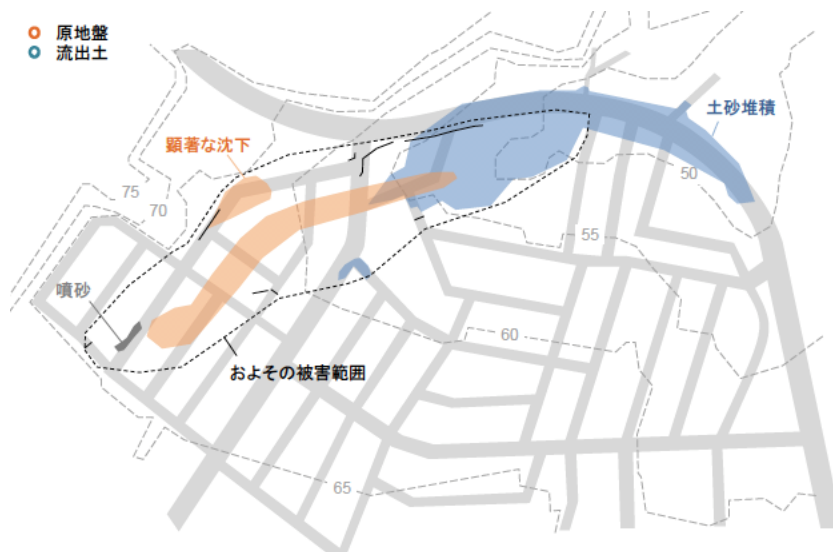
Figure 6-5. Overview of the Satozuka flow-failure. Orange – loss of material, Blue – deposition. Dashed grey lines show modern topography of the area, linear orange zones of loss reveal a former channel that was backfilled with pumice.

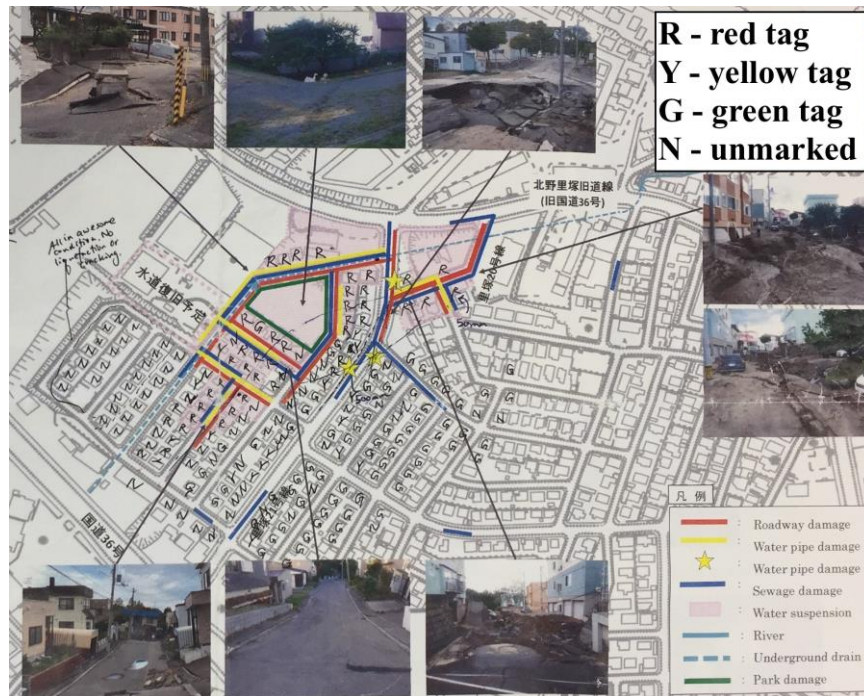
Figure 6-6. Distribution of structural tags due to flow-failure damage. Damages were most concentrated around the community park (green pentagon) and along a single street in the upslope direction (lower-left) following the former river channel where pumice backfill was locally thickest. Note adjacent structures tagged 'Red' and 'Green' likely due to foundation differences (e.g., Fig 6.10) Background image modified from data provided by the Sapporo City Waterworks Bureau.

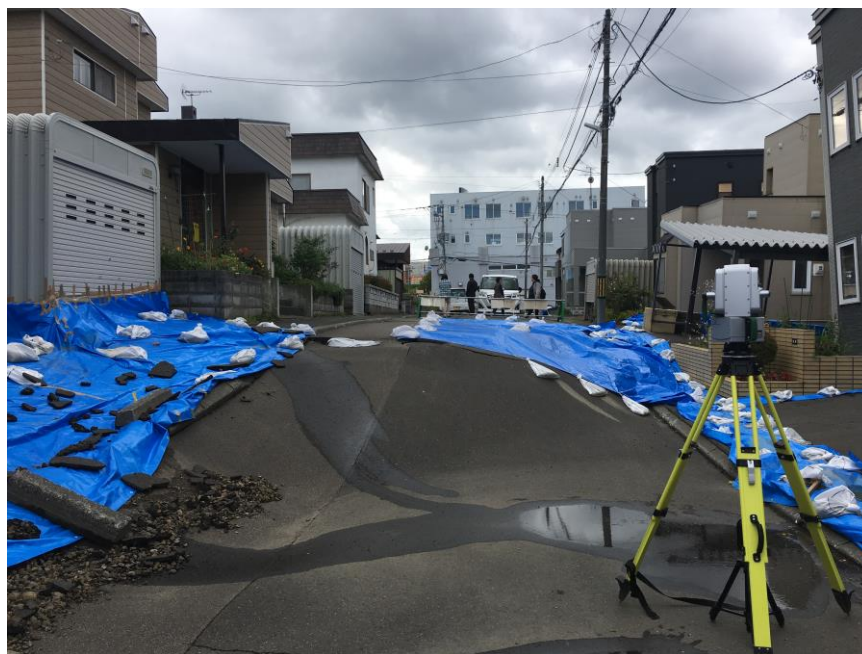
Figure 6-7. Head scarp of the Satozuka flow-failure. The full extent of cracking and potential damages was obscured by tarping and ongoing repairs, vertical offset at this location ~4ft (1.22m).

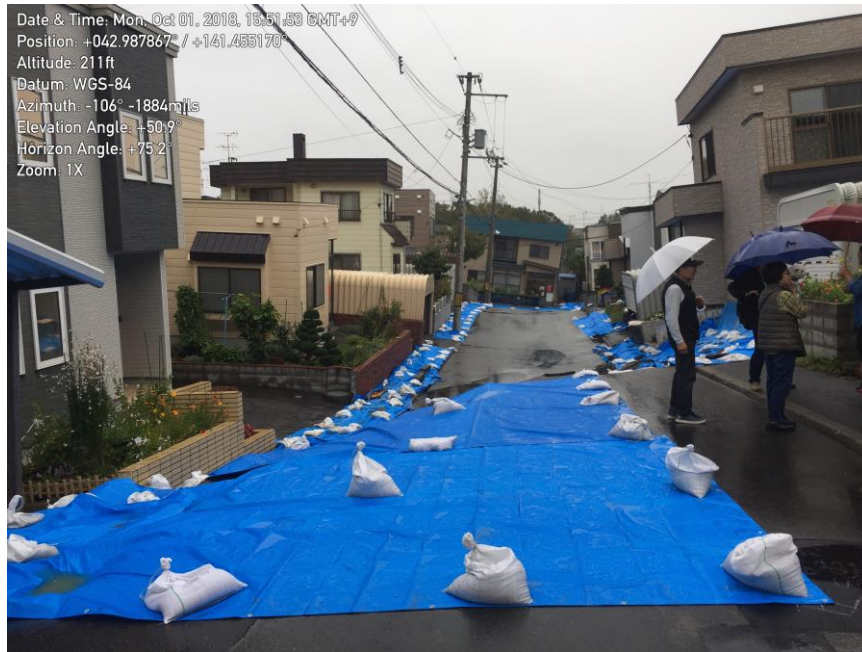
Figure 6-8. Looking down-slide from above the head scarp. Tilt of structure at end of street typical.

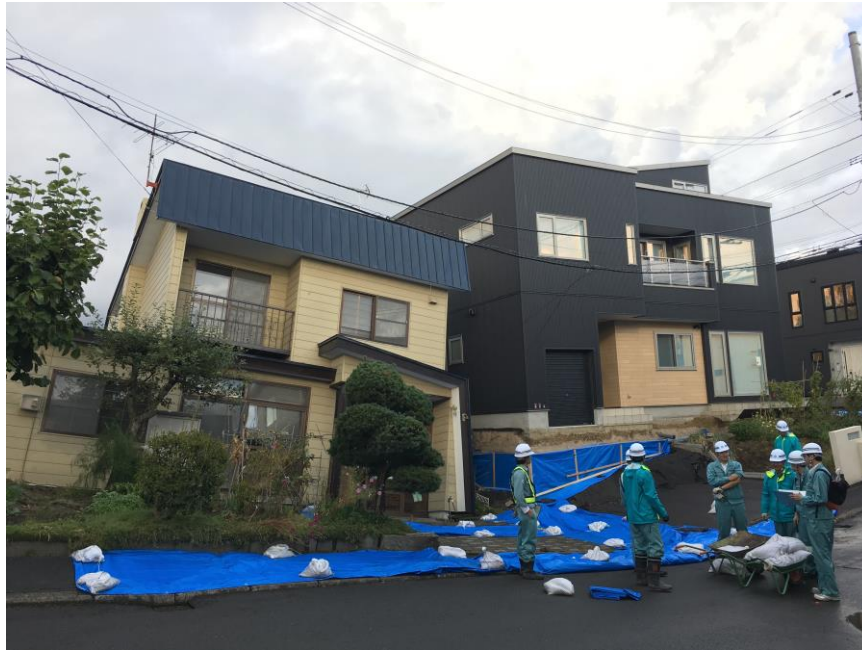
Figure 6-10. Contrasting building ages and foundations showing significantly different performance during the Satozuka flow-failure (main channel of deformation passes through these homes). Left, older mat foundation home with significant rotation and differential settlement. Right, contemporary home on piles, structure stable relative to down dropped surface (~2m).

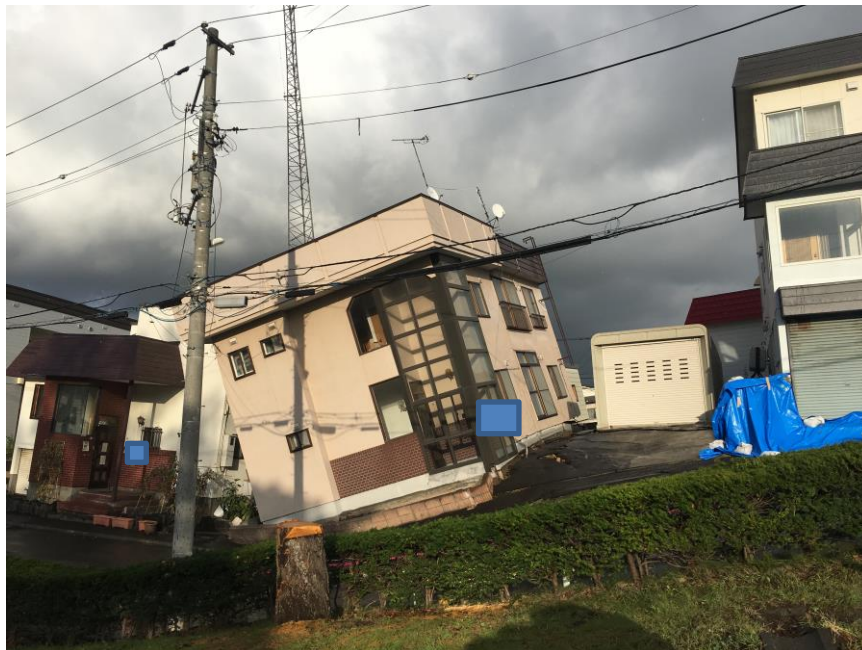
Figure 6-11. Significant rotation of a residential structure due to flow-failure-induced differential settlement

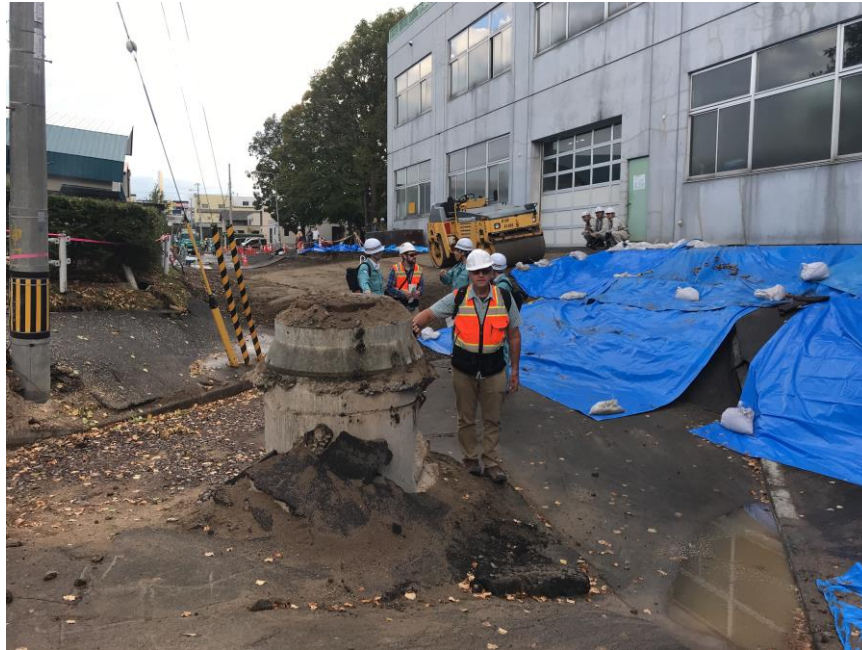
Figure 6-12. Manhole, founded on native non-liquefiable material at 10m depth. Surrounding pumice fill evacuated during flow-failure leading to significant vertical deformation shown here.

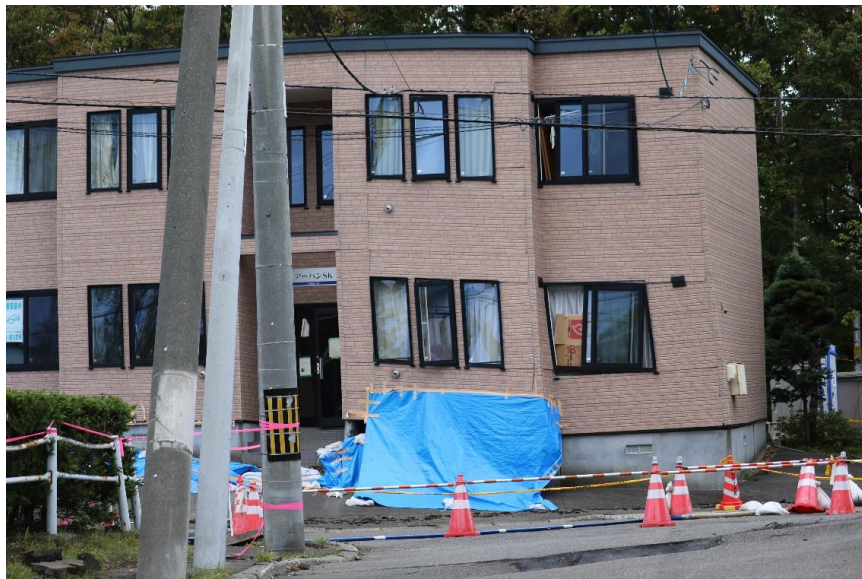
Figure 6-13. Modern apartment building with severe structural damage due to flow liquefaction. 42°59'21.3"N 141°27'22.6E.

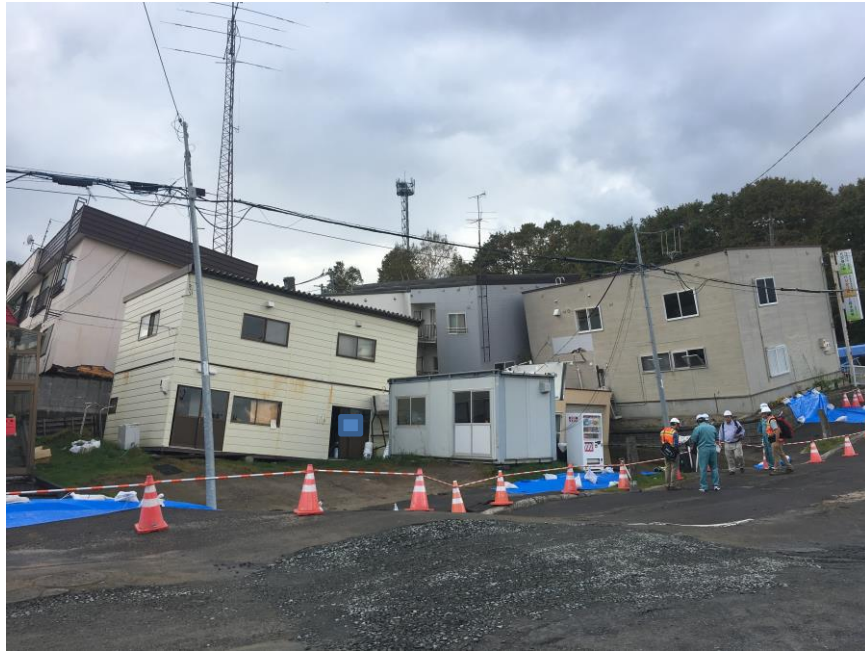
Figure 6-14. Lower Satozuka flow slide, differential settlement highlighted by severely tilted structures towards the central flow path. Deposition zone off-camera to the right. $42^{\circ}59'20.1''\text{N } 141^{\circ}27'24.6''\text{E}$.

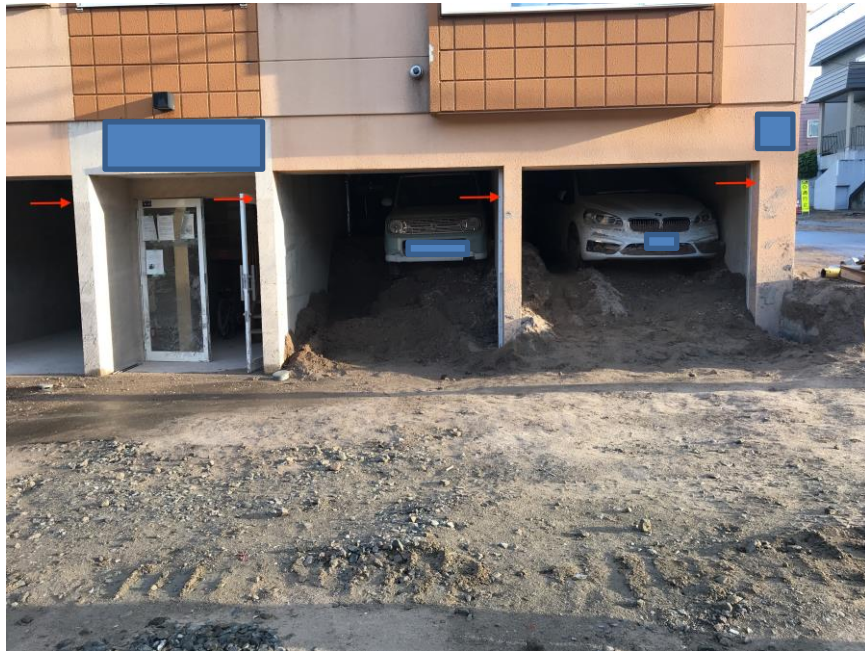
Figure 6-15. Deposition zone of the Satozuka flow-failure slide. Nearly all depositional material was removed prior to reconnaissance (red arrows indicate deposit highpoints). Rafted cars originally in closed garage bays that were damaged and filled with pumice.

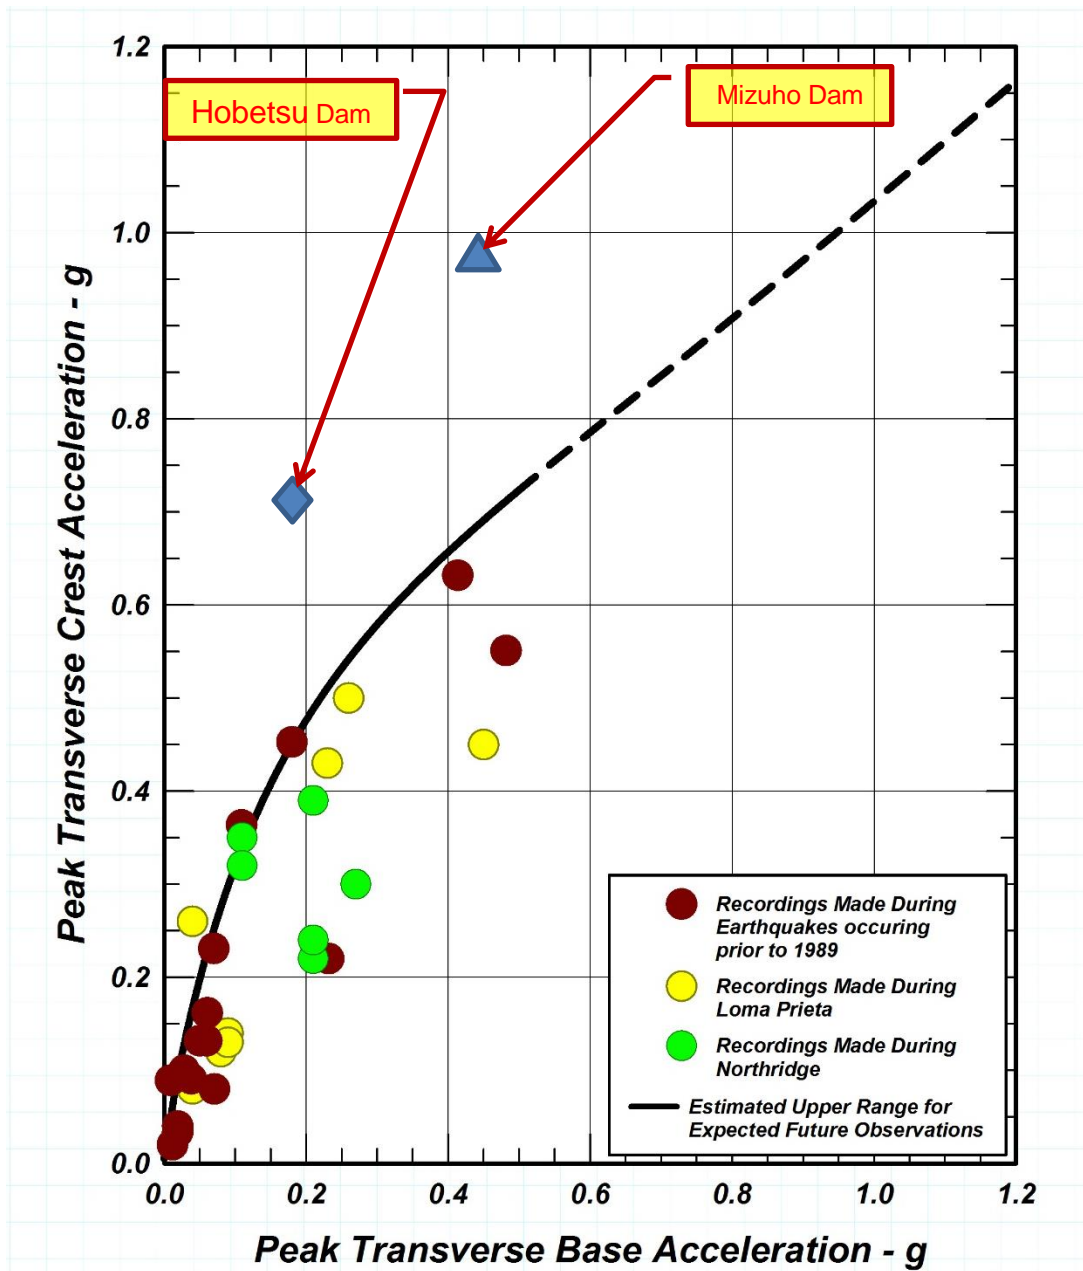
Fig. Variations of Recorded Peak Crest Accelerations With Those Recorded at the Base of Earth- & Rockfill Dams
 (source of recorded values from Loma Prieta & prior earthquakes: Harder, 1993)

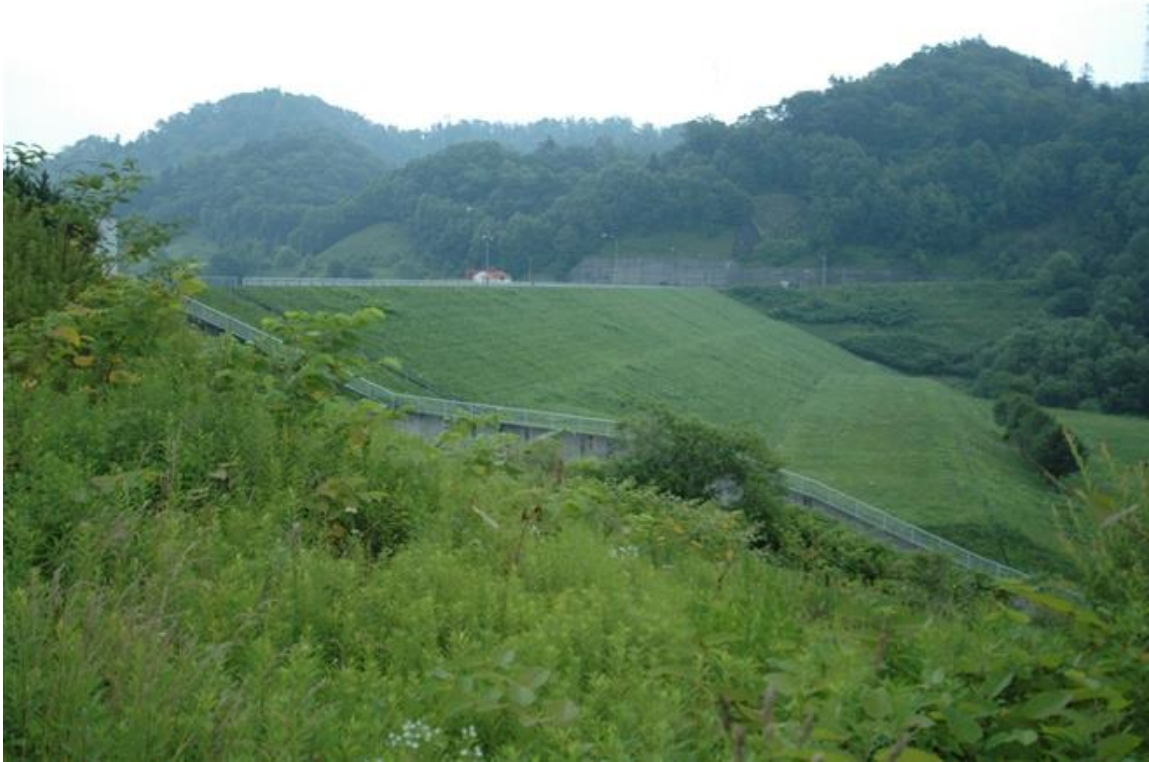
Figure 7-3. Downstream view of Hobetsu Dam from right abutment (Image from the Japan Dam Foundation <http://damnet.or.jp/cgi-bin/binran/enPAL.cgi?idm=9645>). 42.885648, 142.179387,

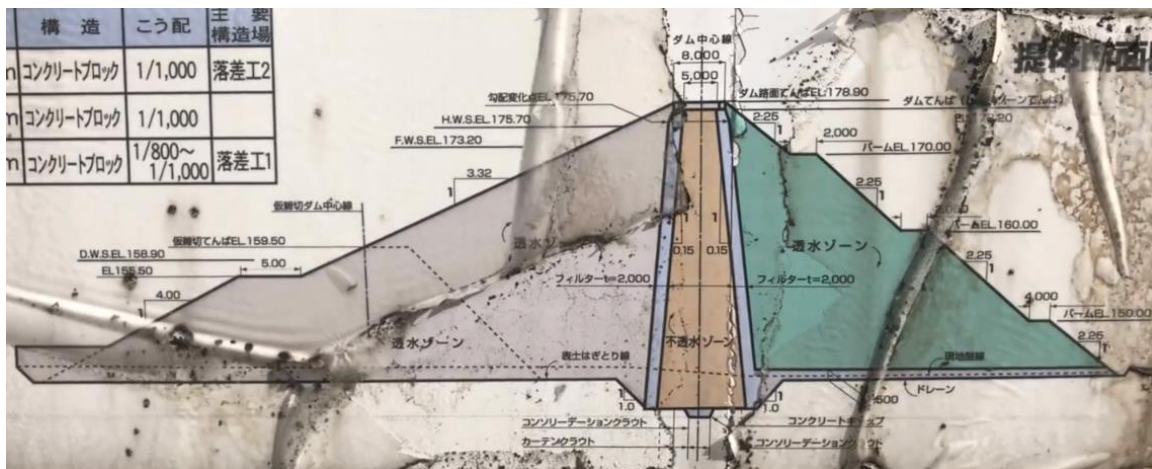
Figure 7-4. Section drawing of Hobetsu Dam posted onsite.

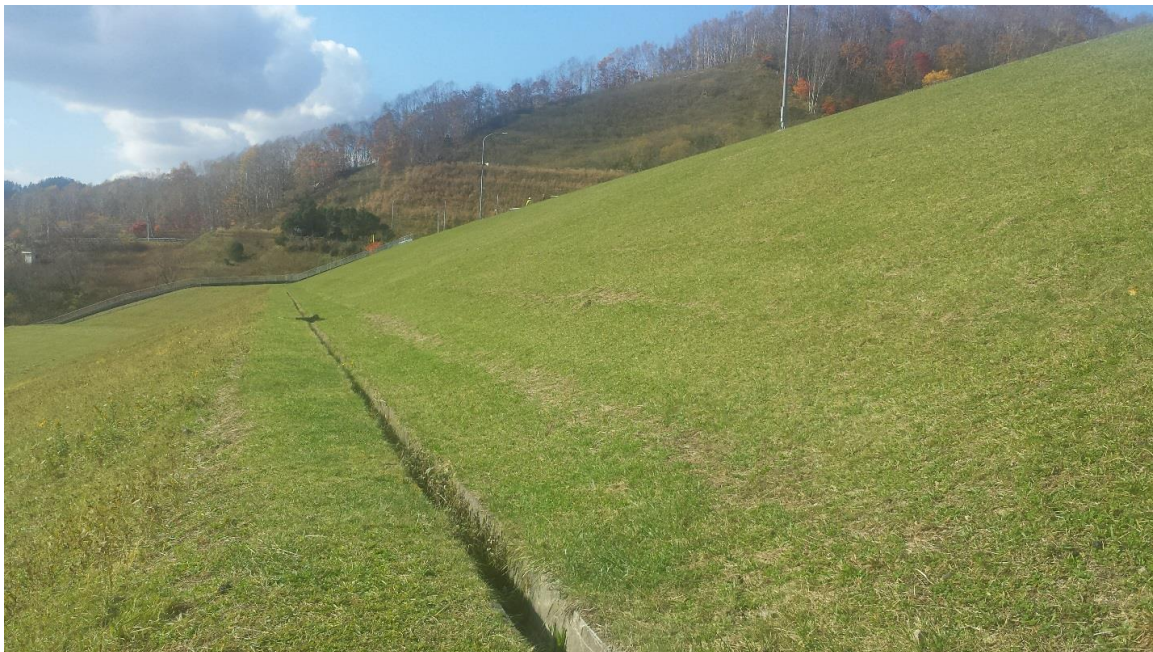
Figure 7-8. Surface drain on downstream slope of Hobetsu Dam. No damage or deformation of the drains was observed. 42.885648, 142.179387,

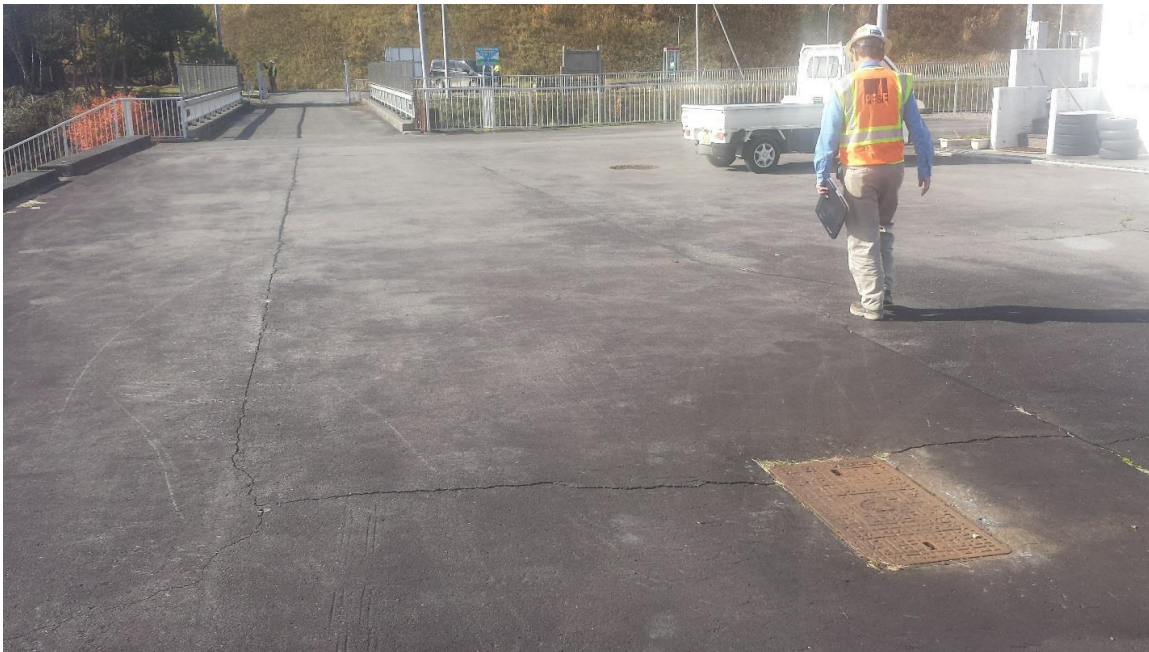
Figure 7-9. Fresh crack in crest pavement noted near contact between right abutment and spillway channel. 42.885648, 142.179387,

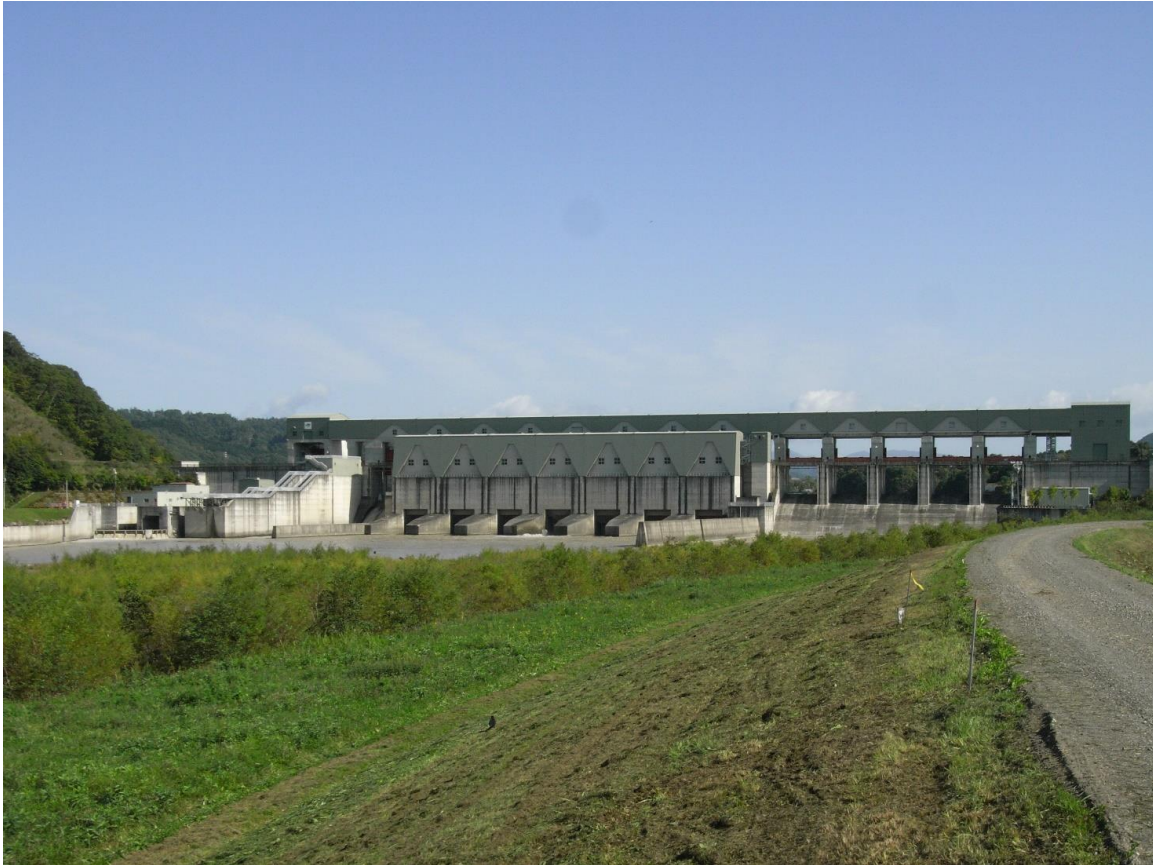
Figure 7-10. Downstream view of the Nibutani Dam from upstream right abutment 42.629302, 142.148654.

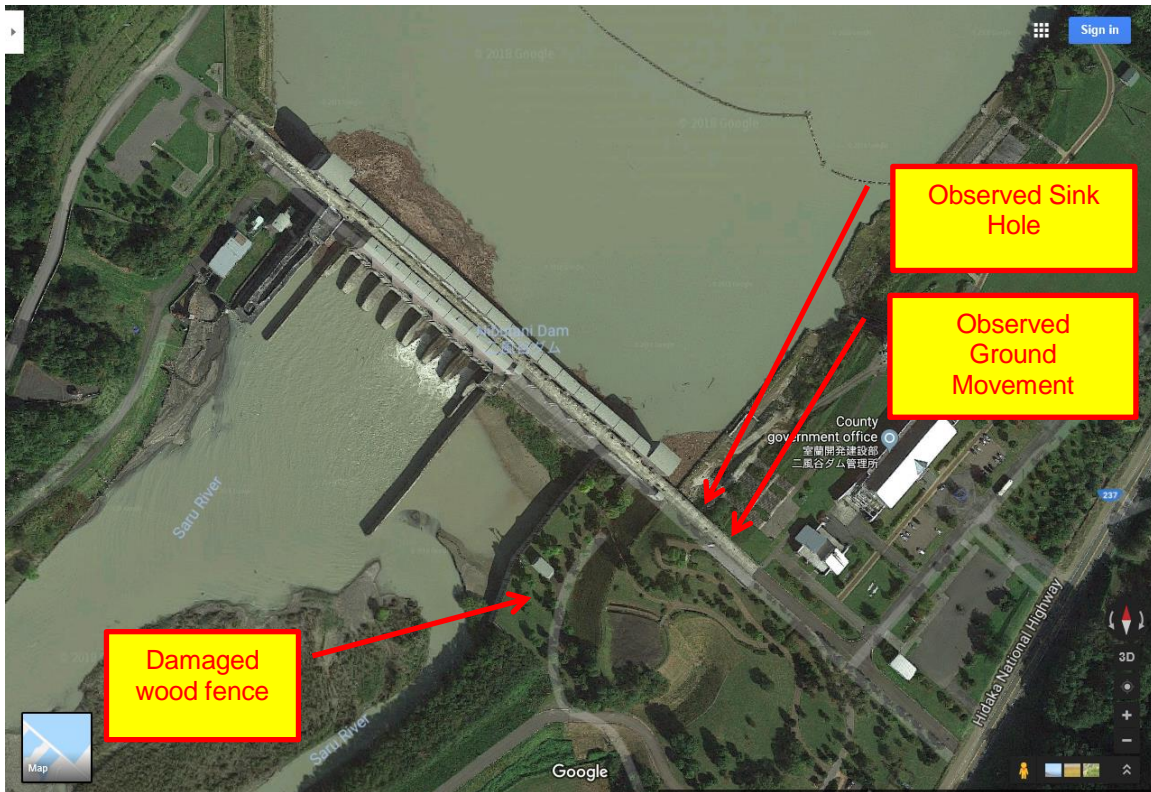
Figure 7-14. Plan view of Nibutani Dam and location of observed damage

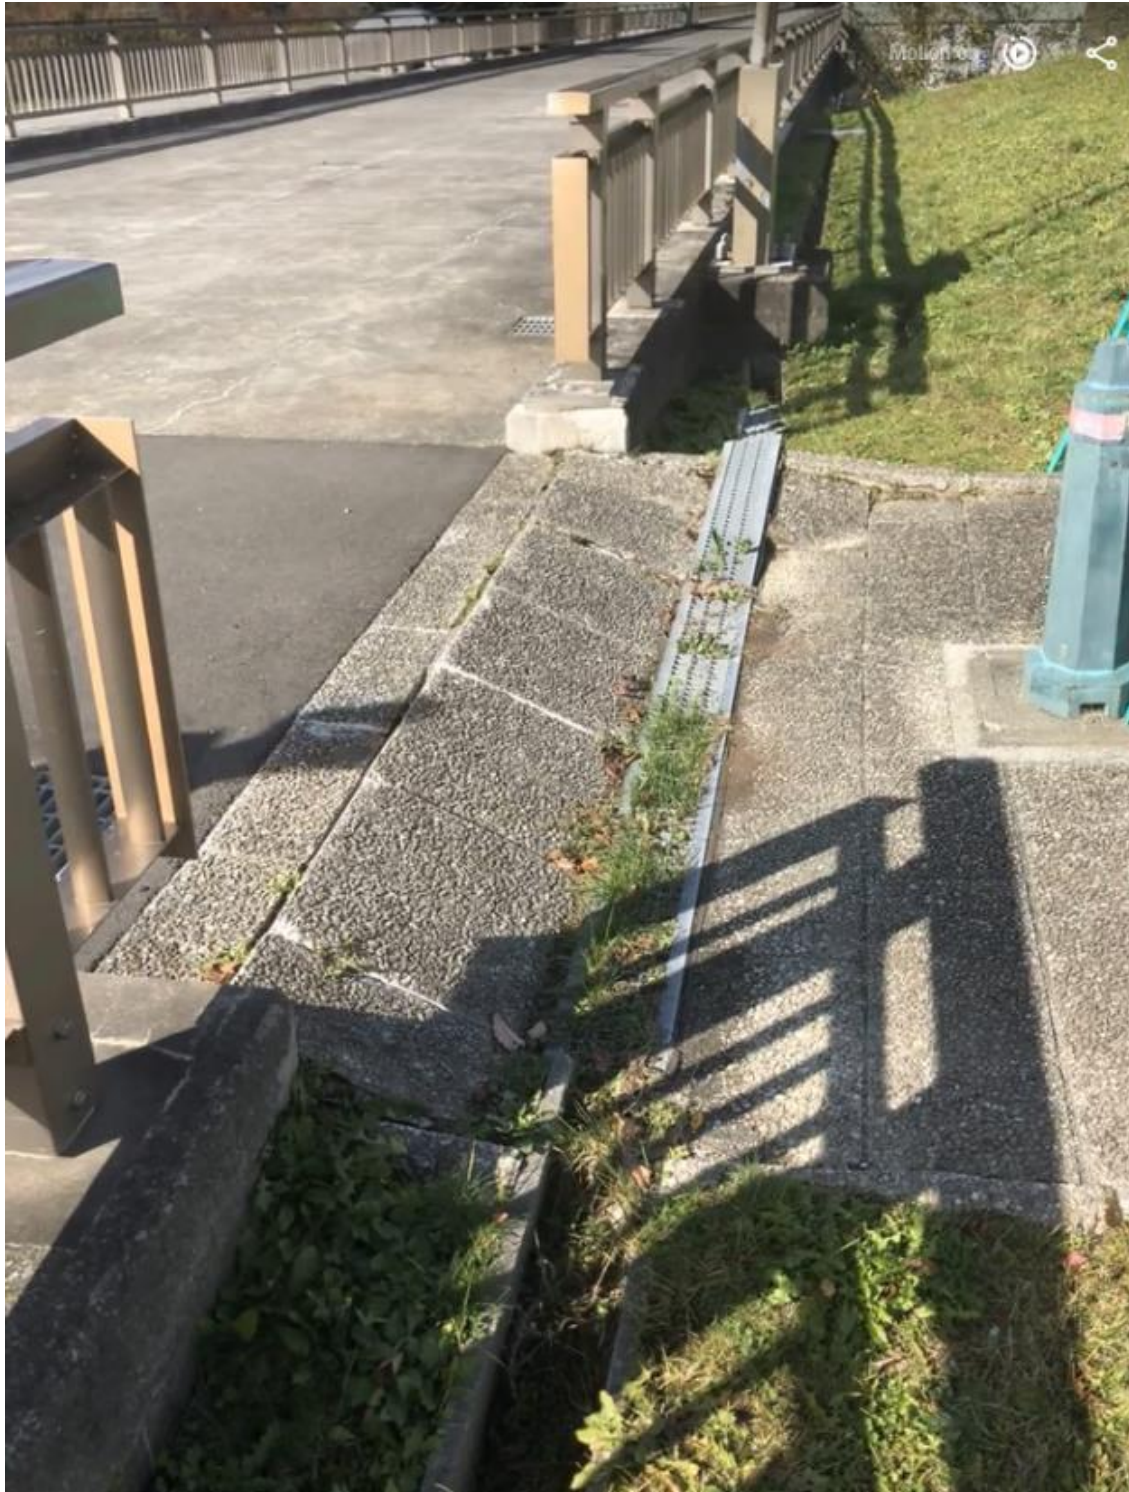
Figure 7-15. Differential settlement of bridge approach and adjacent fill area 42.629302, 142.148654

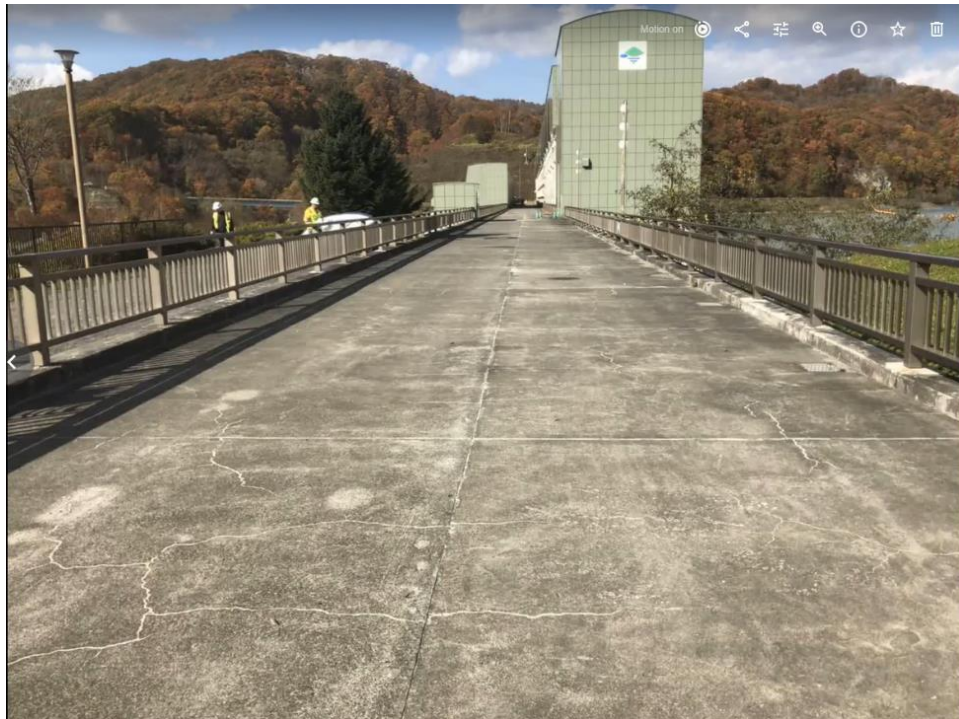
Figure 7-16. No damage to the deep foundation support bridge deck connect to the gates 42.629302, 142.148654

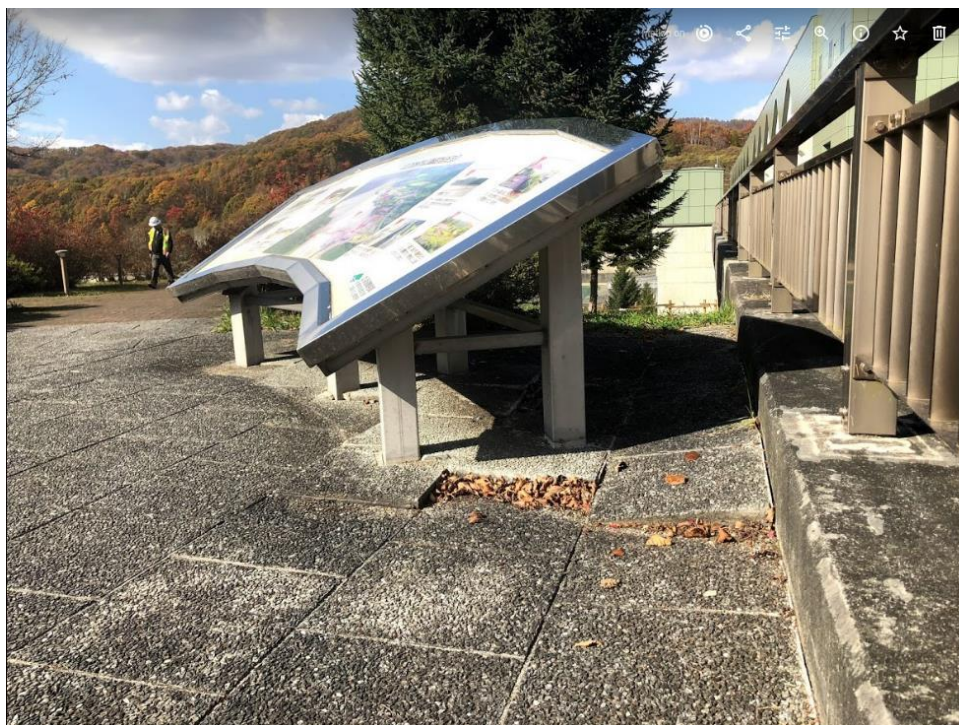
Figure 7-17. Differential settlement of the fill area 42.629302, 142.148654

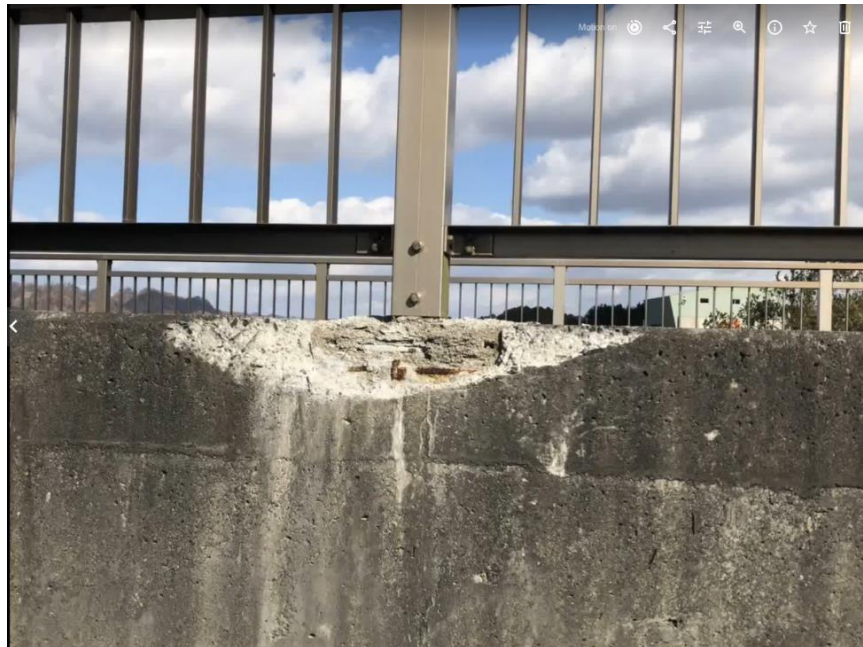
Figure 7-20. Damage of hand rail 42.629302, 142.148654

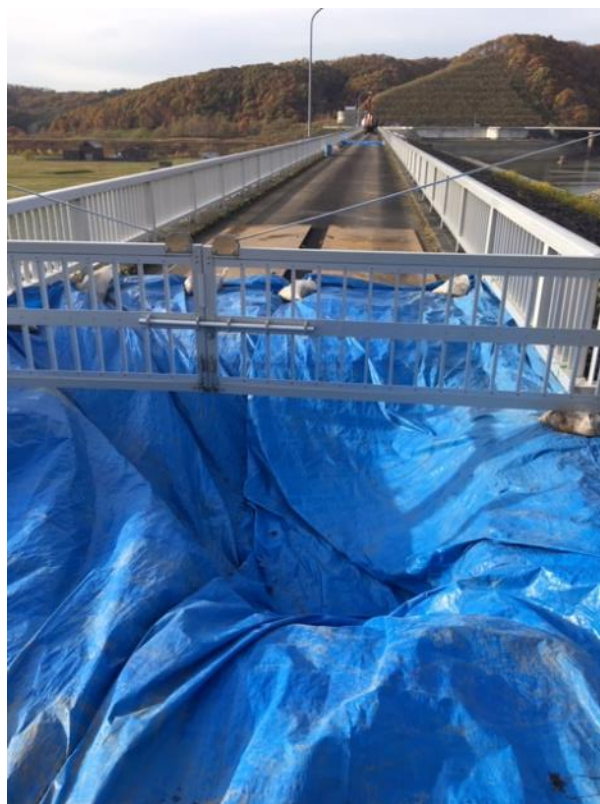
Figure 7-21. Sink hole near abutment bridge contact 42.629302, 142.148654

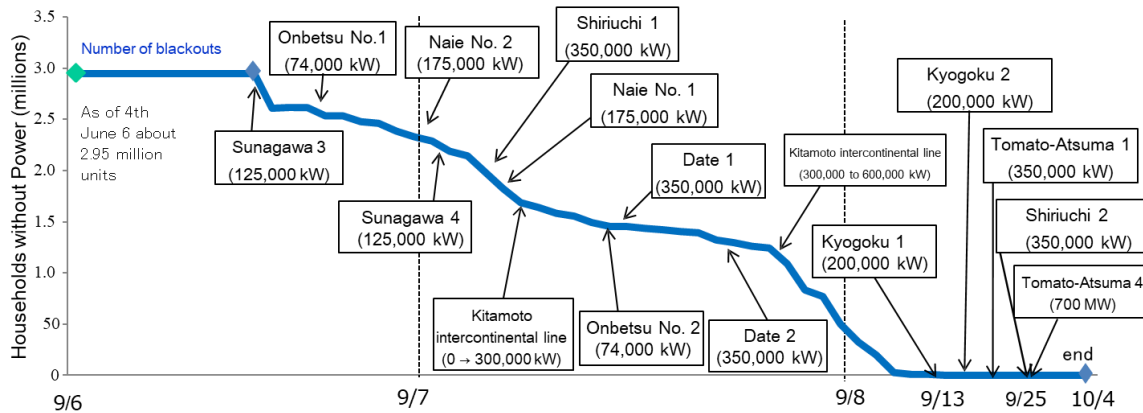
Figure 8-1. Households without power vs. time following 9/6 earthquake and progression of thermal power plant restart (HEPCO, 2018)

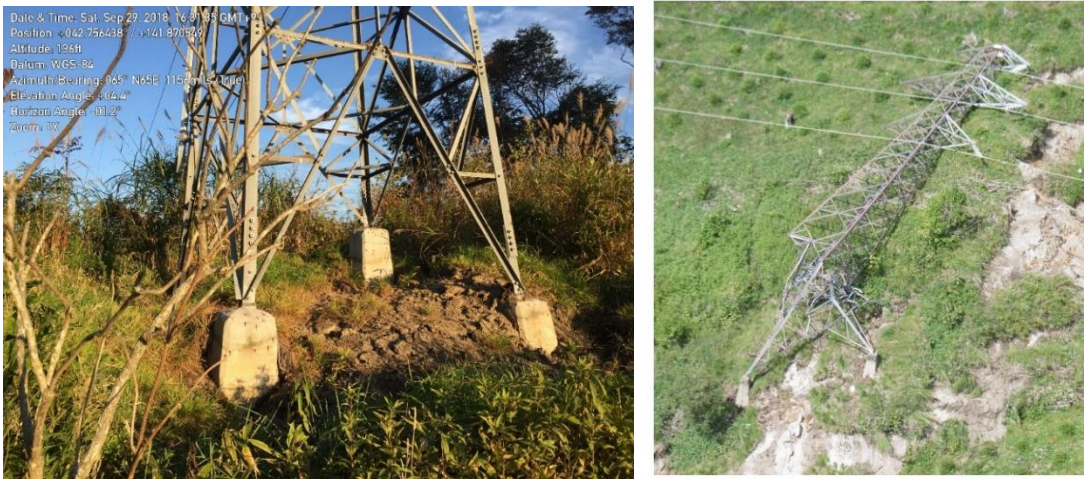
Figure 8-2. Electric power tower (a) at top of translational slide (Cow Slide) with no observable damage to foundation elements. Settlements at concrete footings range from 20-40 cm. (b) collapsed Iwachishi Line (66 kV) (November, 1, 2018 HEPCO report)

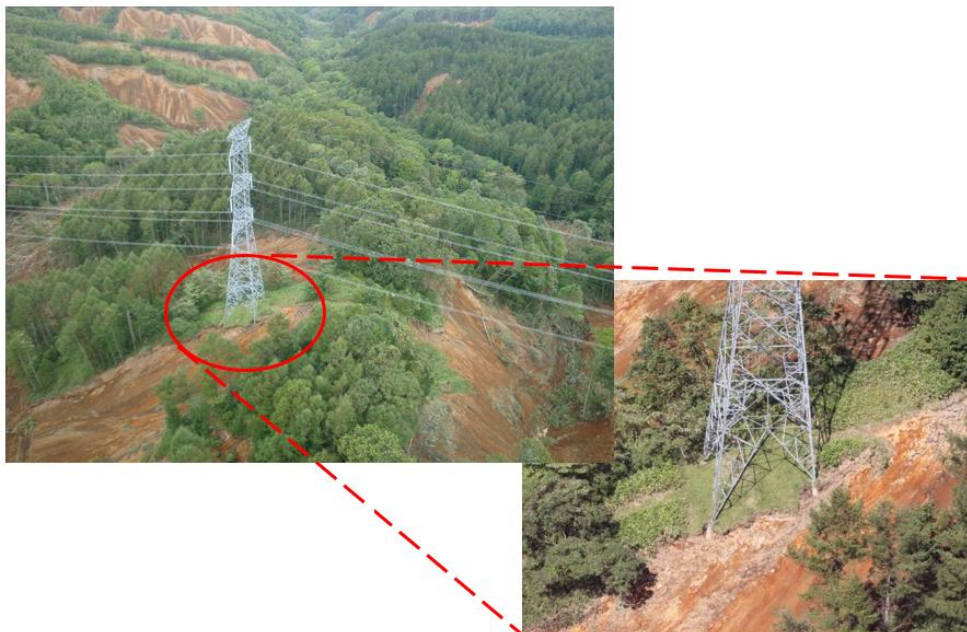
Figure 8-3. High capacity electric transmission tower narrowly avoiding significant damage due to nearby landsliding (Source: <http://wwwa.hepco.co.jp/pdf/18091601.pdf>)

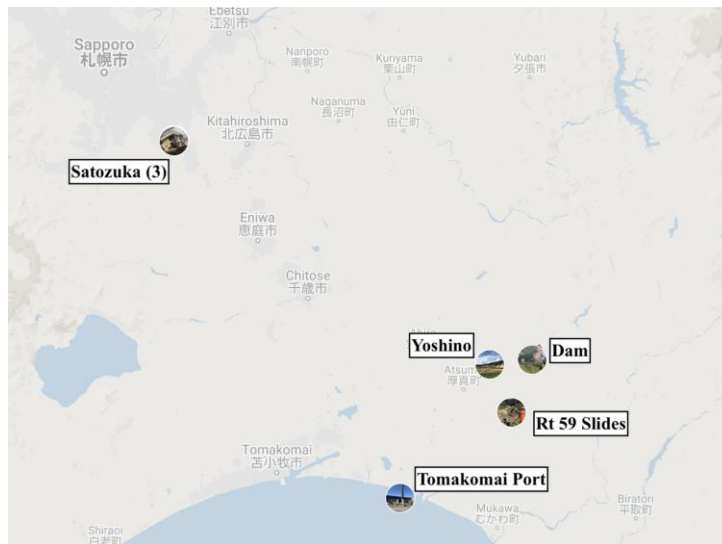
Figure 9-1. Map of the epicentral region showing locations of each terrestrial lidar scan location. The three sets of scans at Satozuka have been merged into a single model following reconnaissance effort.

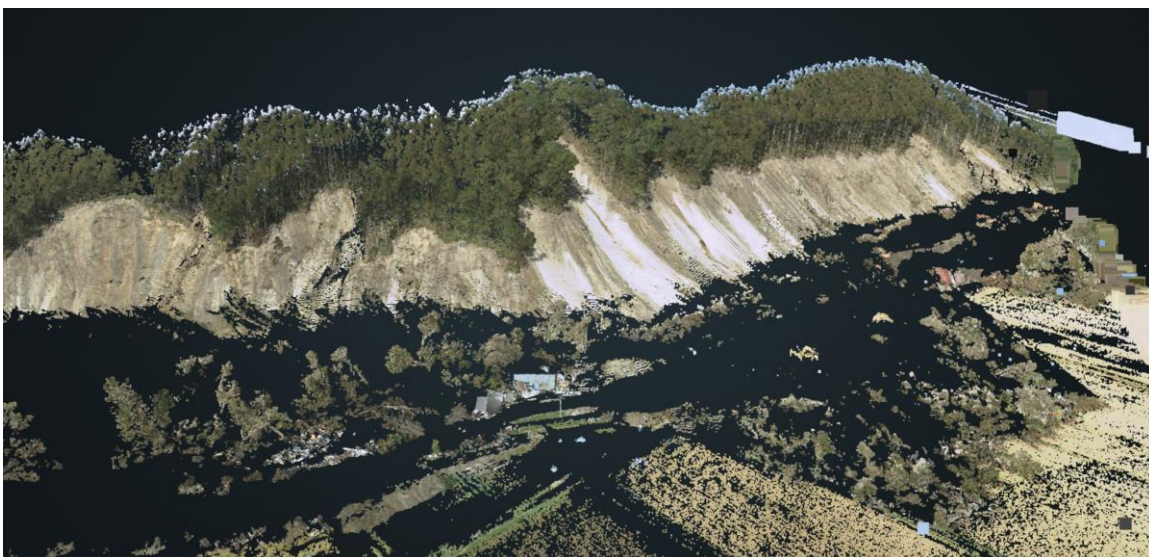
Figure 9-2. Yoshino Landslides. Six merged long range (0.5 – 1.6km) scans collected from two vantagepoints towards the highly destructive Yoshino landslide complex. Many buried homes observed but poorly constrained by data below landslide deposits. Large data gaps (dark zones at toe of slides) due to poor vantage points and active construction along the entire site to rebuild the roadway and clear debris.

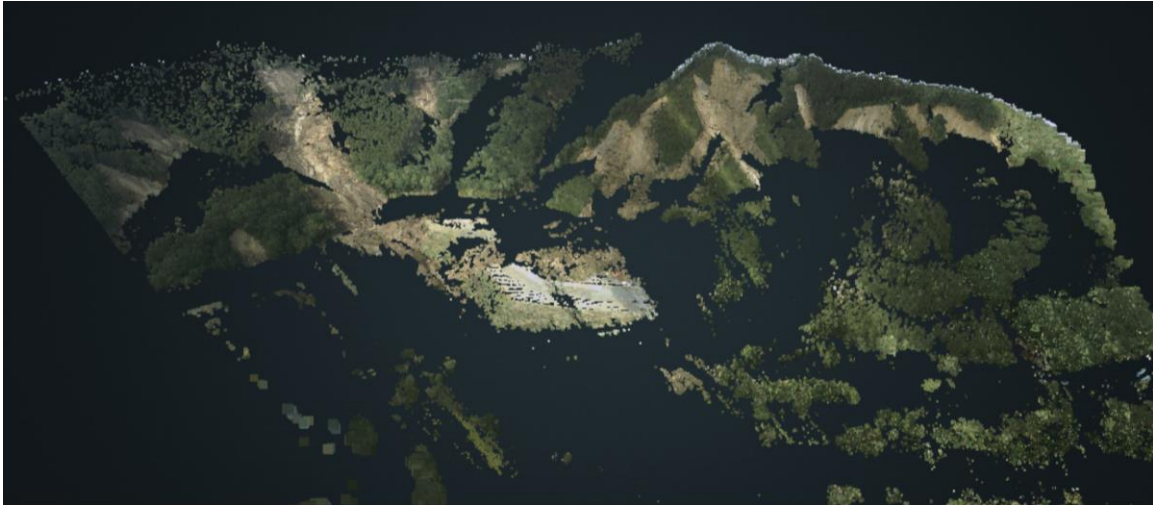
Figure 9-3. Point cloud data for the dam abutment landslides. Limited vantage-points limited the coverage of scans at this location but overall landslide behavior is preserved.
