Prepared by:
GEER Association
geerassociation.org
Hokkaido-Iburi Earthquake
Version 1.0
February 2019

Seismological, Geological, and Geotechnical Engineering Aspects of the 2018 M_w 6.6 Hokkaido Eastern Iburi Earthquake

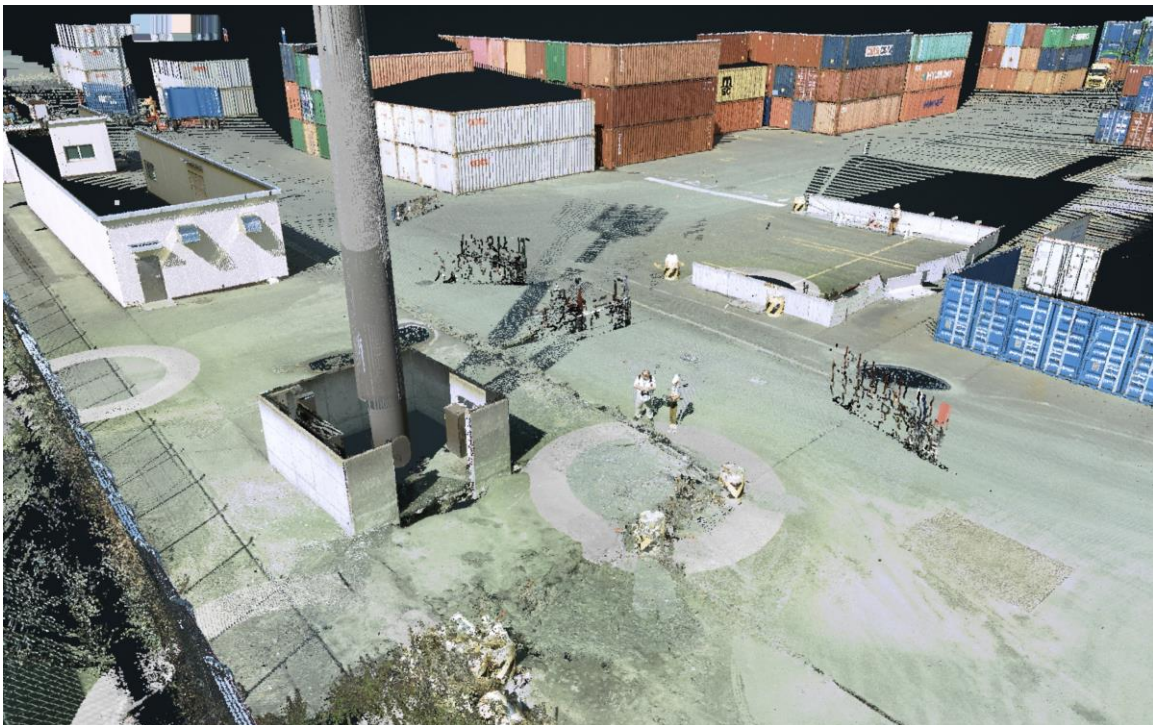
Figure 9-4. East Port of Tomakomai lidar scan. Note multiple noise chirps due to passing trucks along the active port facility road. Scans preserve small vertical settlements along light-post and adjacent structures (left) as well as minor roadway cracks due to liquefaction.

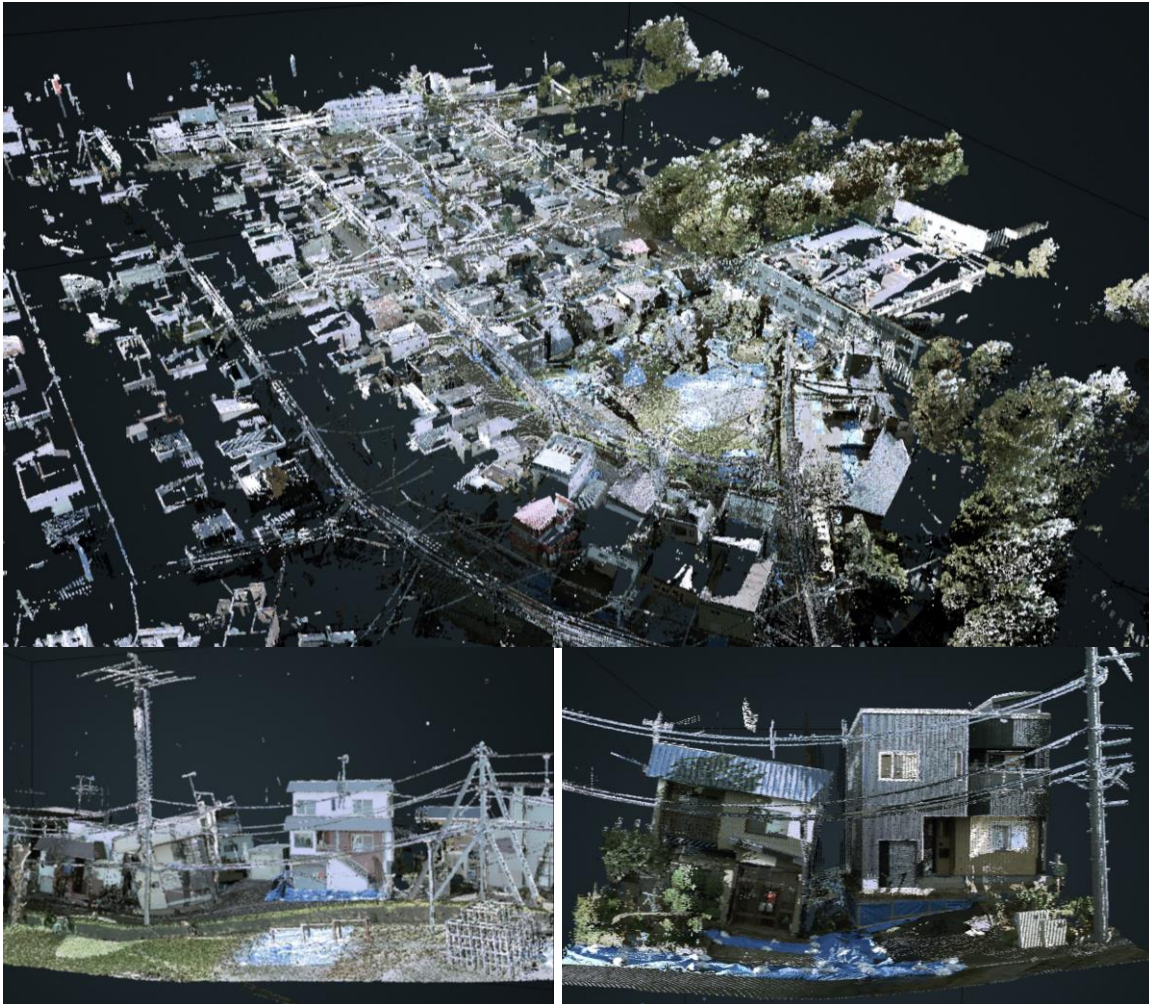
Figure 9-5. Scans collected from Satozuka. top, overview of the complete model from 38 individual TLS scans, flow-failure runs from upper left to lower right along the zone of highest data density. Bottom, example sections from within the data showing damaged and undamaged structures.

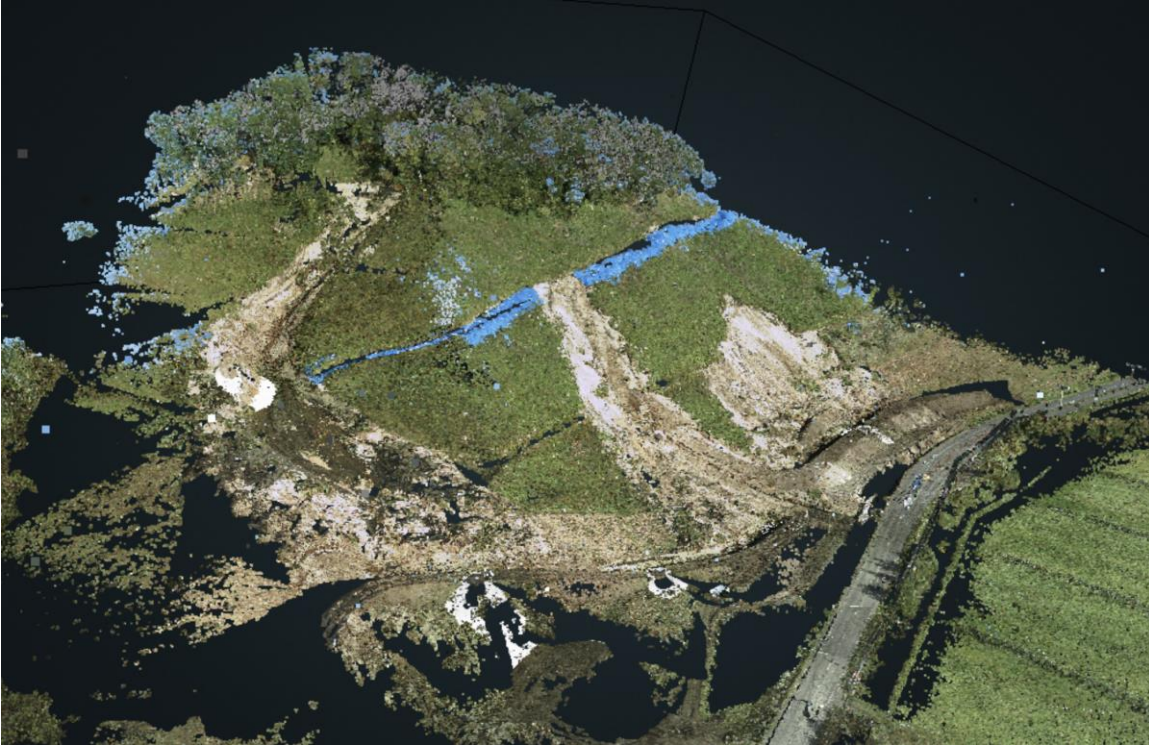
Figure 9-6. Route 59 landslides TLS scans. Three large landslides observed at this site, including one that turns sharply mid-runout. Landslide deposits had been considerably reworked but likely impacted highway below. Adjacent unfailed deposits clearly showed the layered pumice-organic soil mantle involved in nearly all landslides observed during our reconnaissance.
