# Geotechnical Reconnaissance and Engineering Effects of the December 29, 2020, M6.4 Petrinja, Croatia Earthquake, and Associated Seismic Sequence

A report to the NSF-Sponsored Geotechnical Extreme Event Reconnaissance (GEER) Association<sub>1</sub>

Report GEER-072: <https://doi.org/10.18118/G63T0S>  
August 3<sup>rd</sup>, 2021

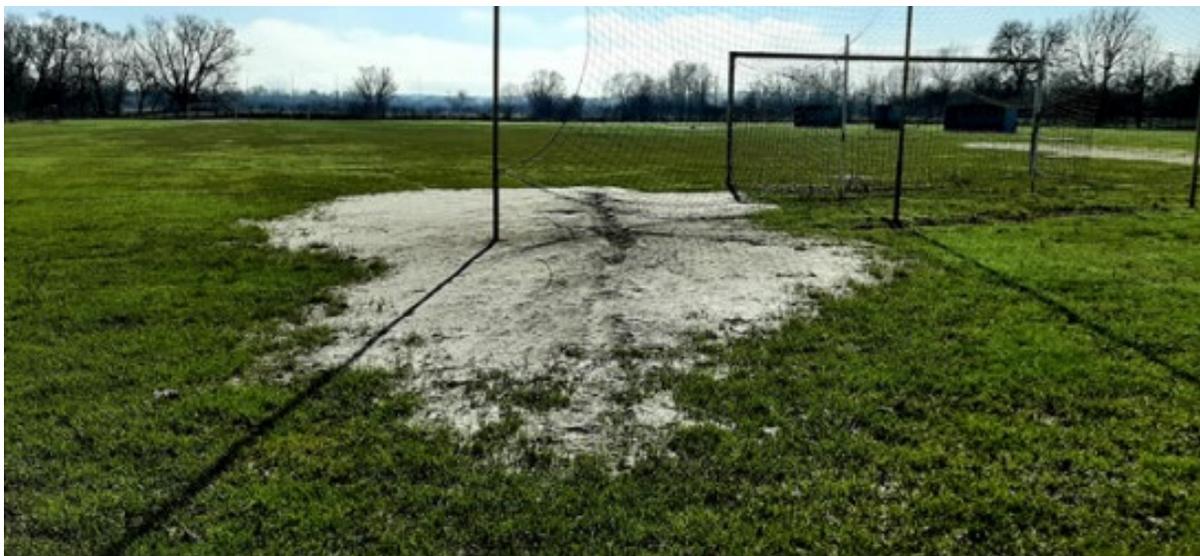
**Figure 7.12** Ejecta in a football field near Letovanić (45.506095N, 16.198165E).

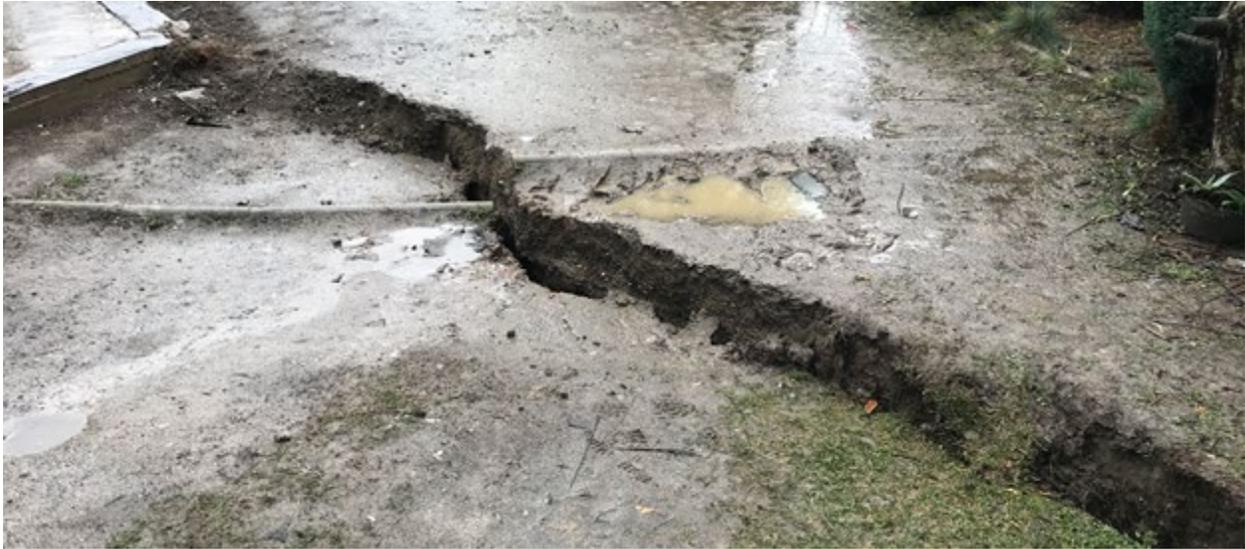
**Figure 7.16** Cracks in the driveway of one of the residences in Bok Palanječki (45.510058N, 16.410803E).

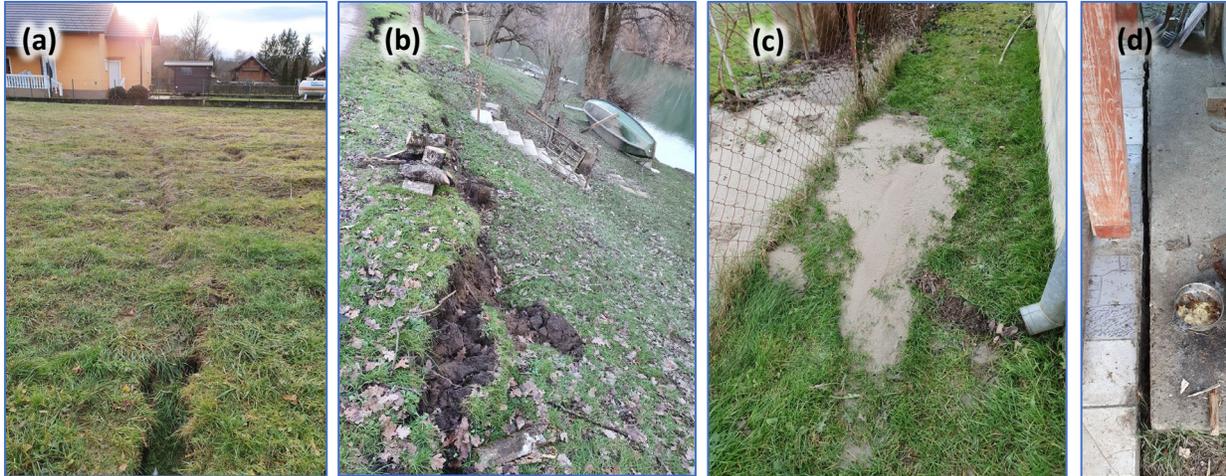
**Figure 7.18** (a) Crack in the yard west from the house, (b) crack along the riverbank, (c) sand ejecta around the house, and (d) crack due to settlement of the terrace, at 97 Ižišća Street, Stari Brod (45.4801N, 16.1841E) (Taus 2021e). The cracks are parallel with the riverbank.

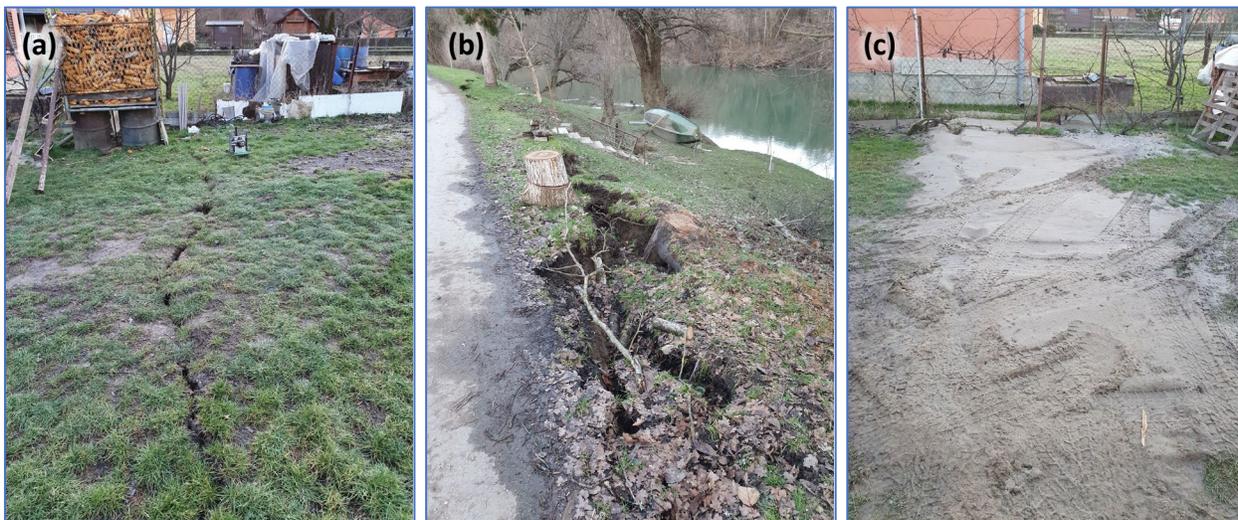
**Figure 7.19** (a) Crack in the yard west from the house, (b) crack along the bank, and (c) sand ejecta around the house at 98 Ižišća Street, Stari Brod (45.480158N, 16.184210E) (Taus 2021f). The cracks are parallel with the riverbank.

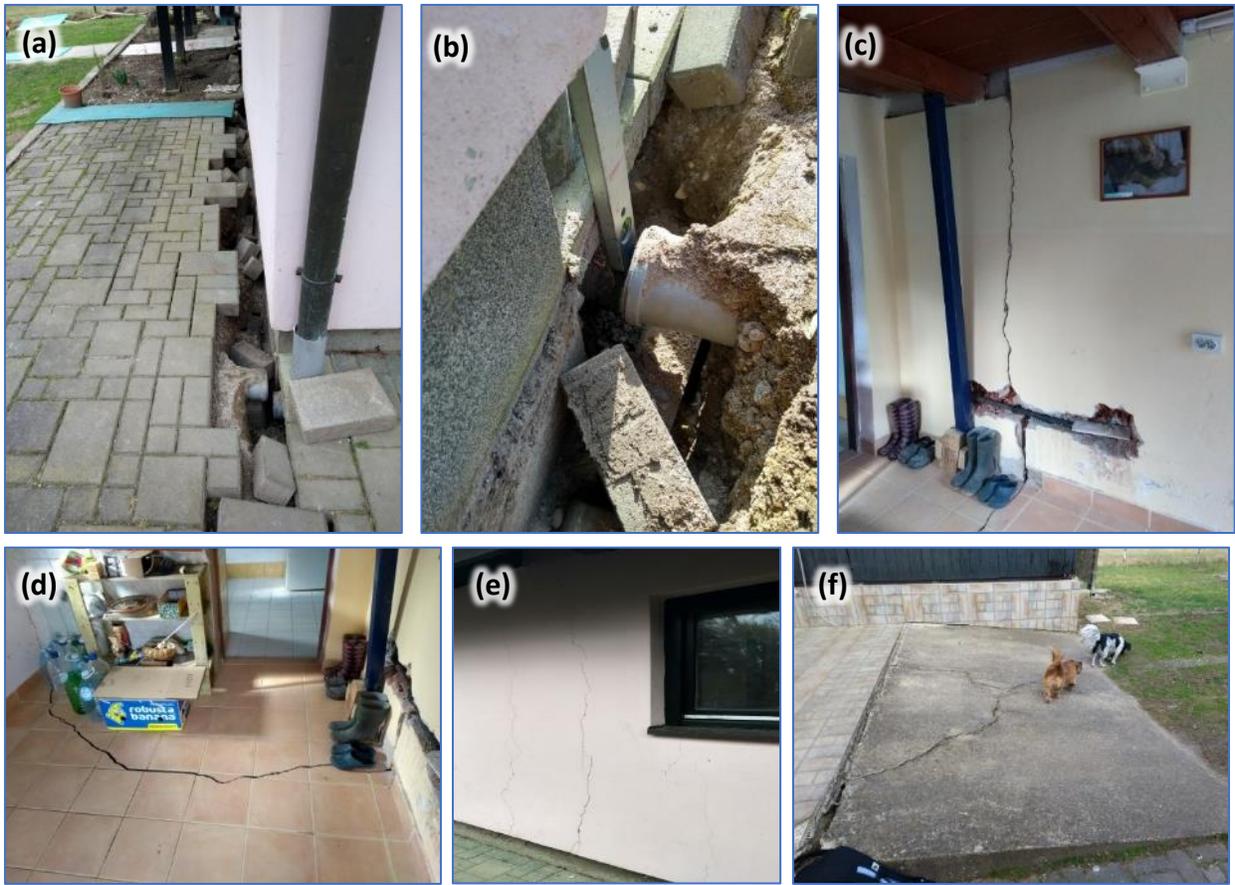
**Figure 7.22** (a, b) Western corner of the house at 99 Ižišća Street (45.480248N, 16.184285E) in Stari Brod with pavement heave of 8 cm and rupture of the roof drainage pipe, marked (2) in Figure 7.23. (c, d) Water pipe rupture caused by vertical crack in the wall and crack on the garage floor between the terrace and house foundation on the line marked (3) in Figure 7.23 and (e) corresponding crack on the outside. (f) Cracks on the pavement at the garage entrance marked (4) in Figure 7.23.

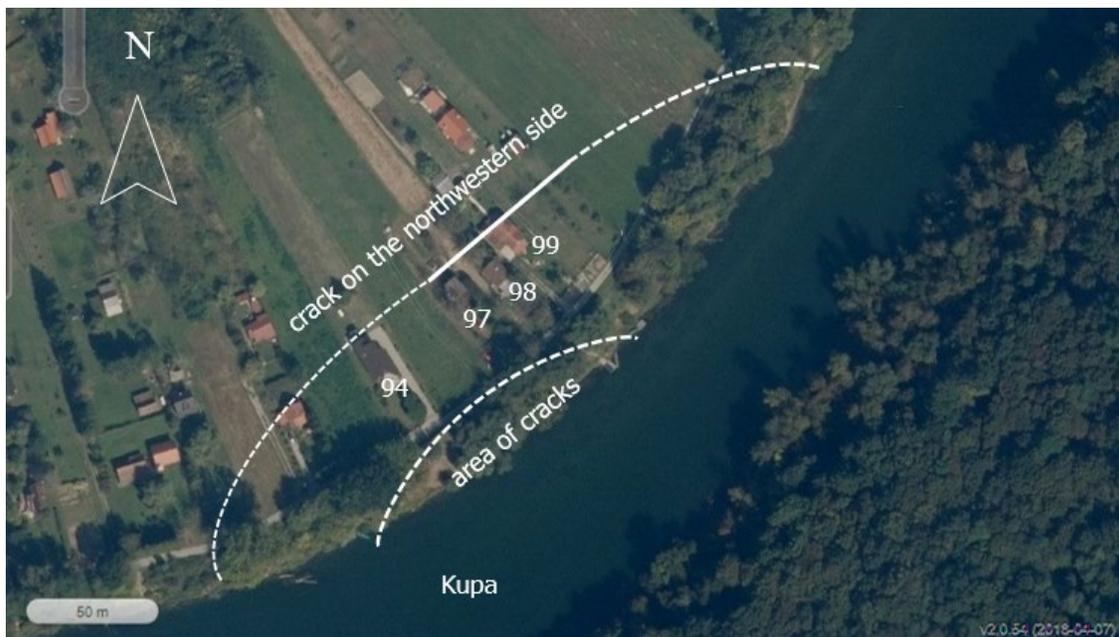
**Figure 7.24** Position of the cracks mapped at 97, 98, 99, 99 Ižišće Street in Stari Brod due to lateral spreading along the Kupa River (45.480N, 16.183E; Geoportal, <https://geoportal.dgu.hr/>).

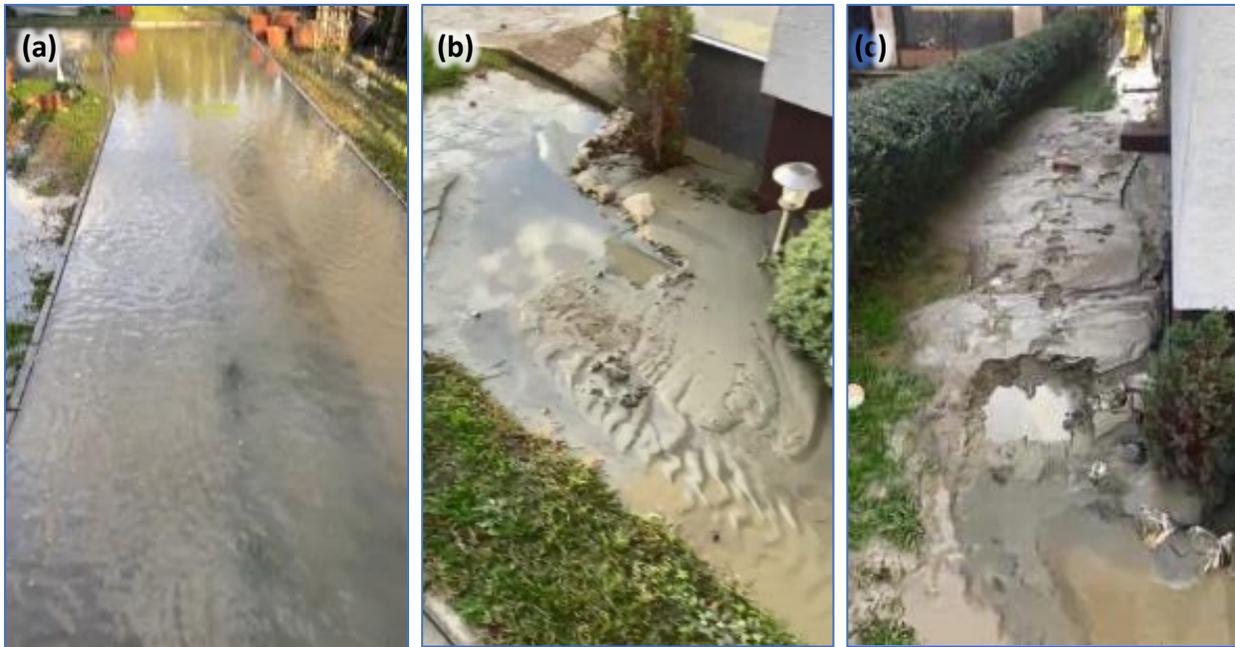
**Figure 7.28** (a) Flooding groundwater and sediment ejecta: (b) south corner, (c) northwest side around the house at 11 Milana Makanca Street, Petrinja (45.436061N, 16.262898E), recorded by the owner, Tomislav Zorčić, minutes after the Mw 6.4 earthquake.

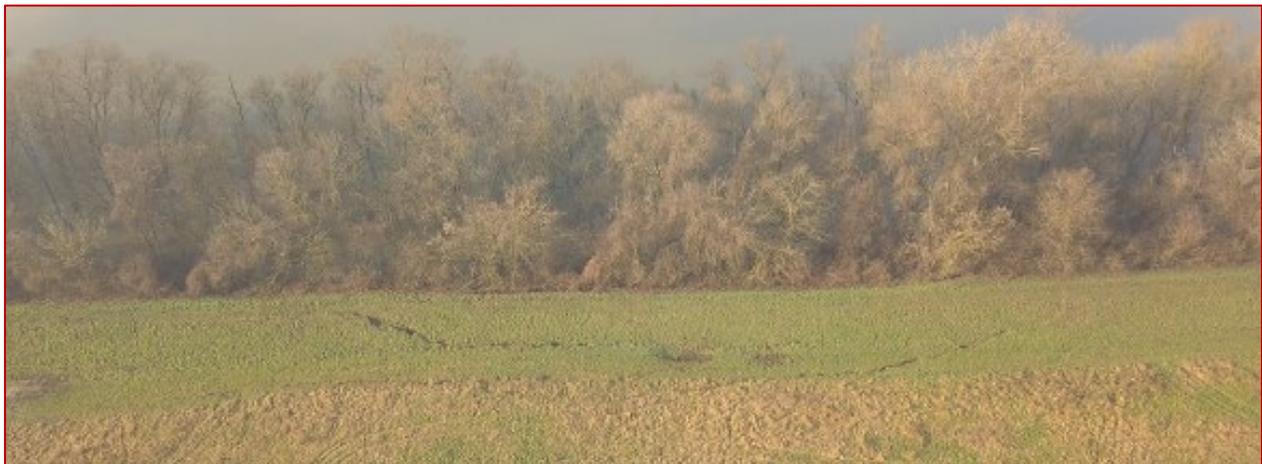
**Figure 8.4** Cracks across and along the levee (Photo documentation: Geokon – Zagreb LLD, January 7, 2021, 45.4614N, 16.3358E).

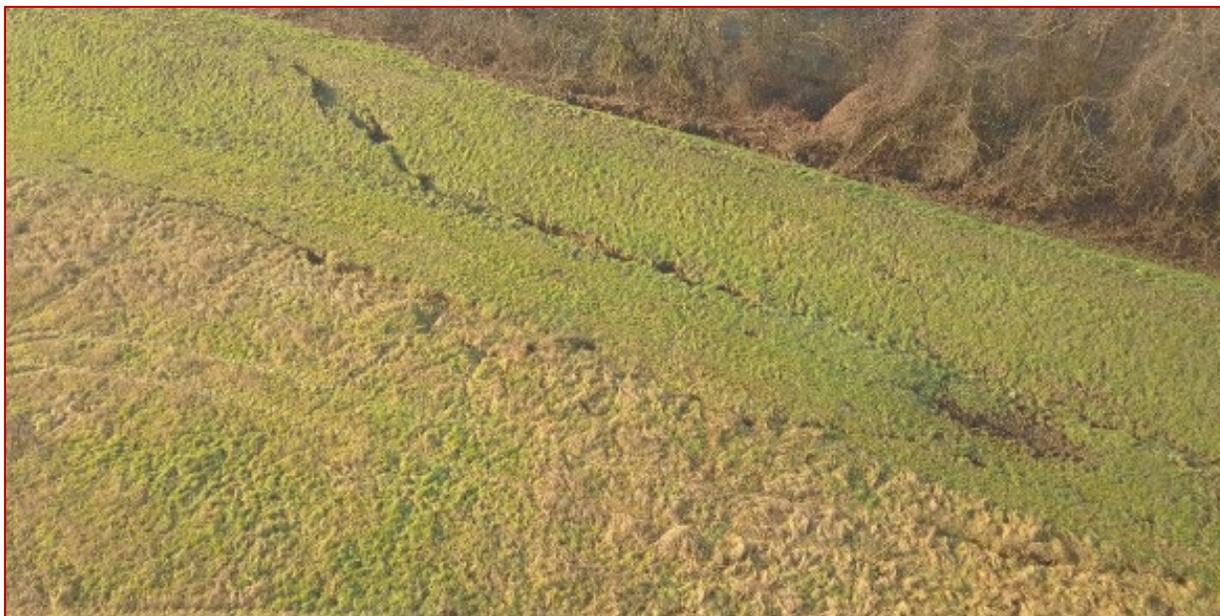
**Figure 8.5** Cracks across and along the levee (Photo documentation Geokon – Zagreb LLD, January 7, 2021, 45.4614N, 16.3358E).

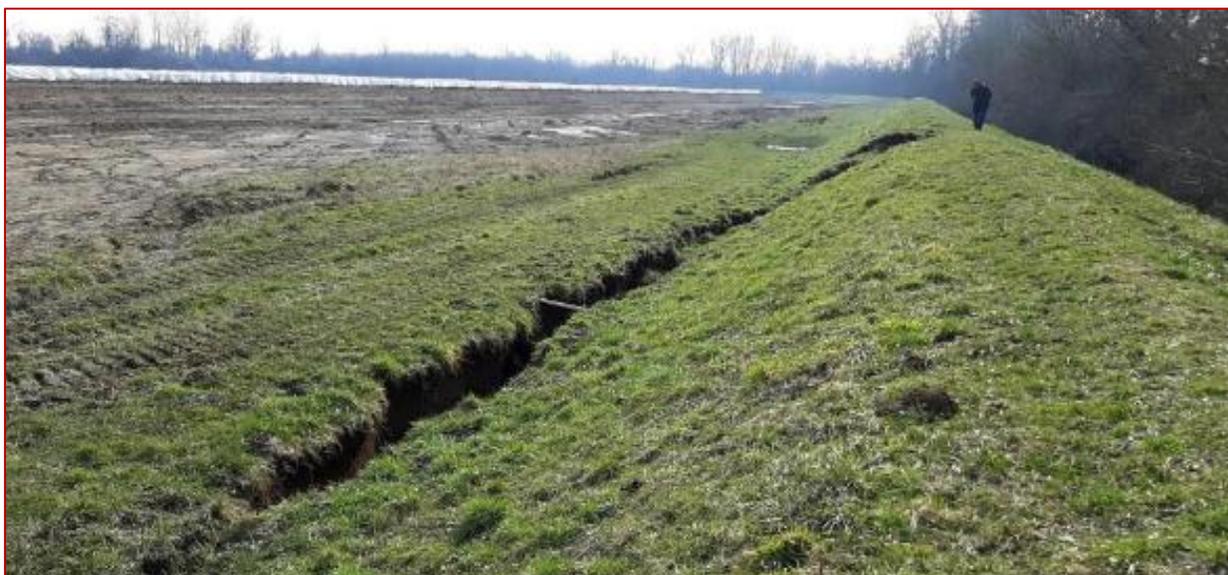
**Figure 8.6** Crack across and along the levee (21.2.2021.; 45.46142N, 16.33580E). Secondary levee is visible in the distance.

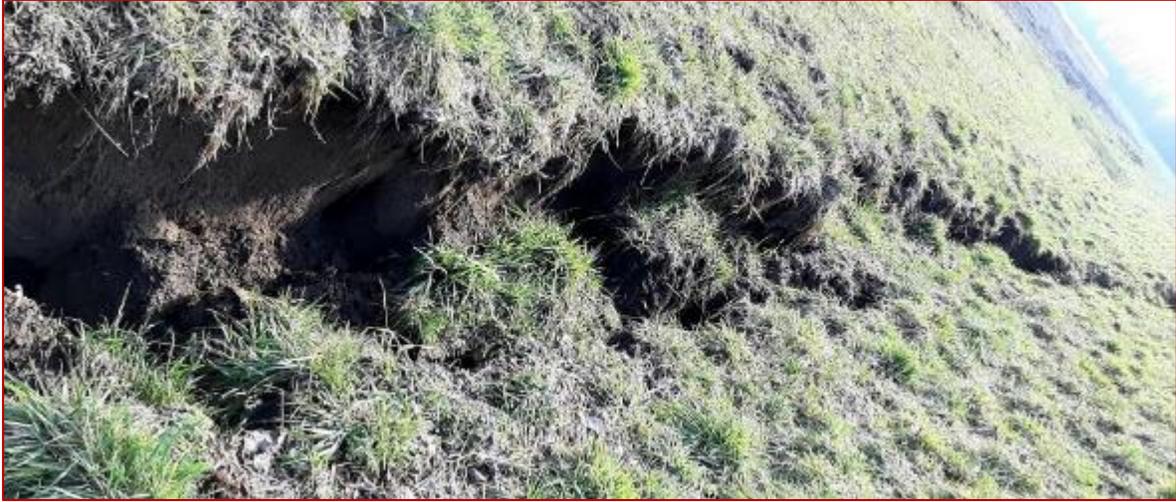
**Figure 8.7** Crack across and along the levee (21.2.2021.; 45.46130N, 16.33592E).

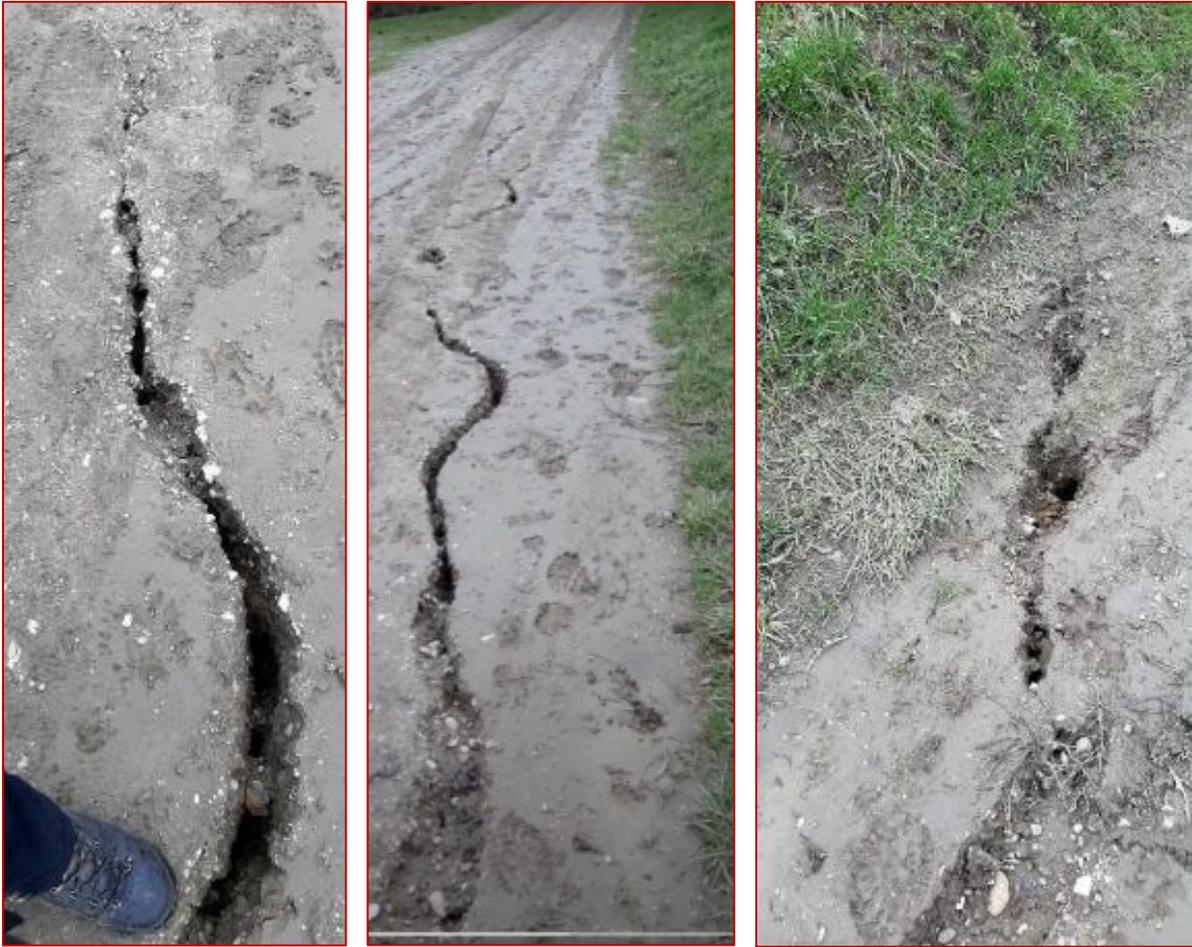
**Figure 8.13** Typical cracks near the levee toe (6 February 6, 2021; 45.4450N, 16.2660E).

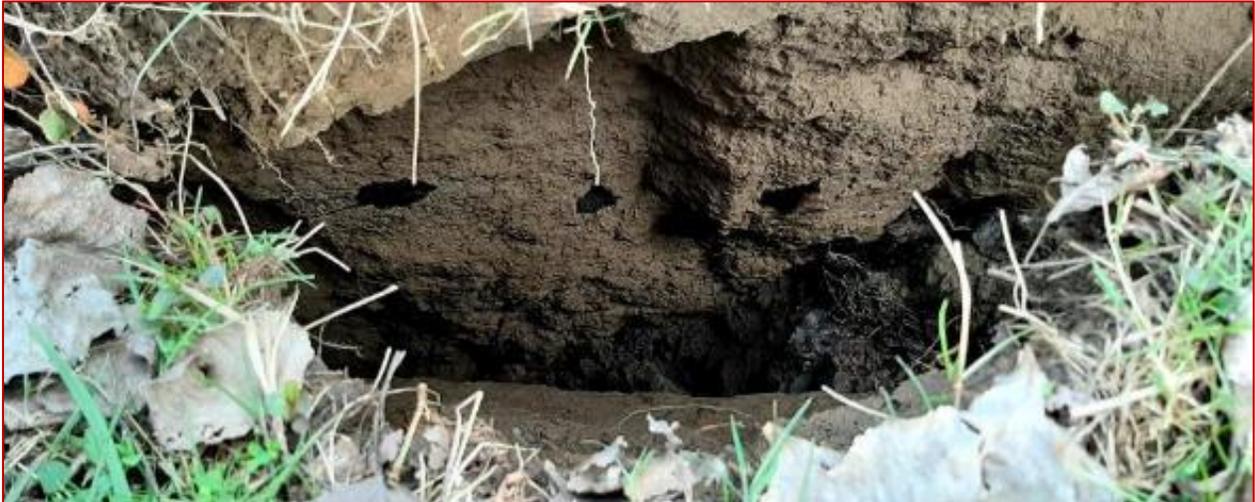
**Figure 8.15** One of the deep cracks in the levee north of Petrinja (February 19, 2021; 45.4593N, 16.2738E).

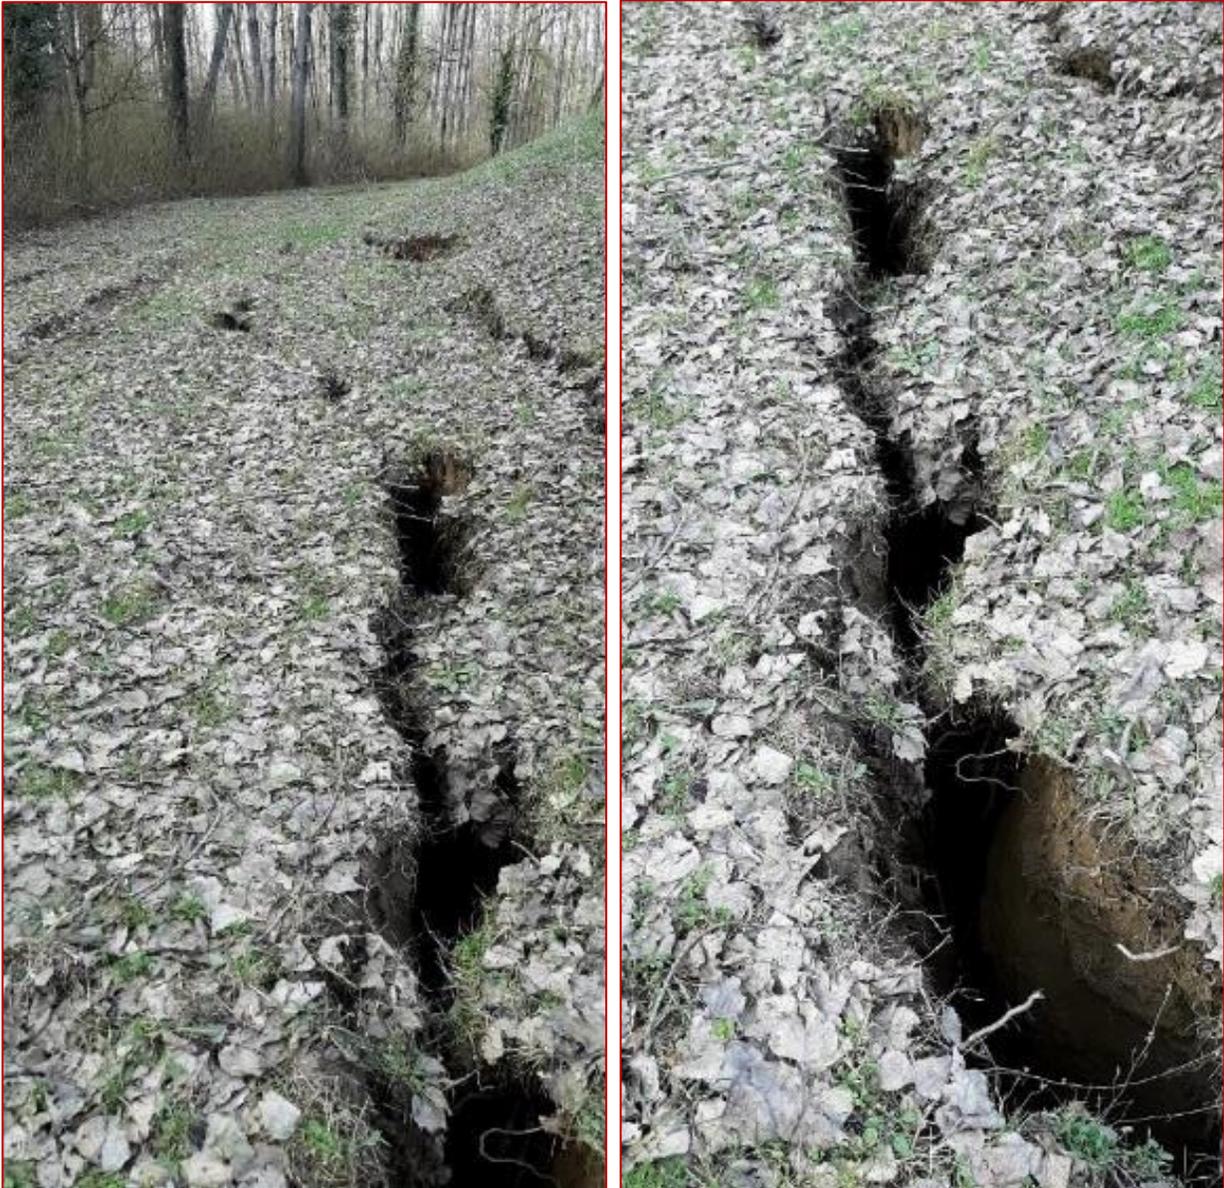
**Figure 8.16** Typical cracks on the river Kupa side of the levee north from Petrinja (19 February 2021; 45.4591N, 16.2739E)

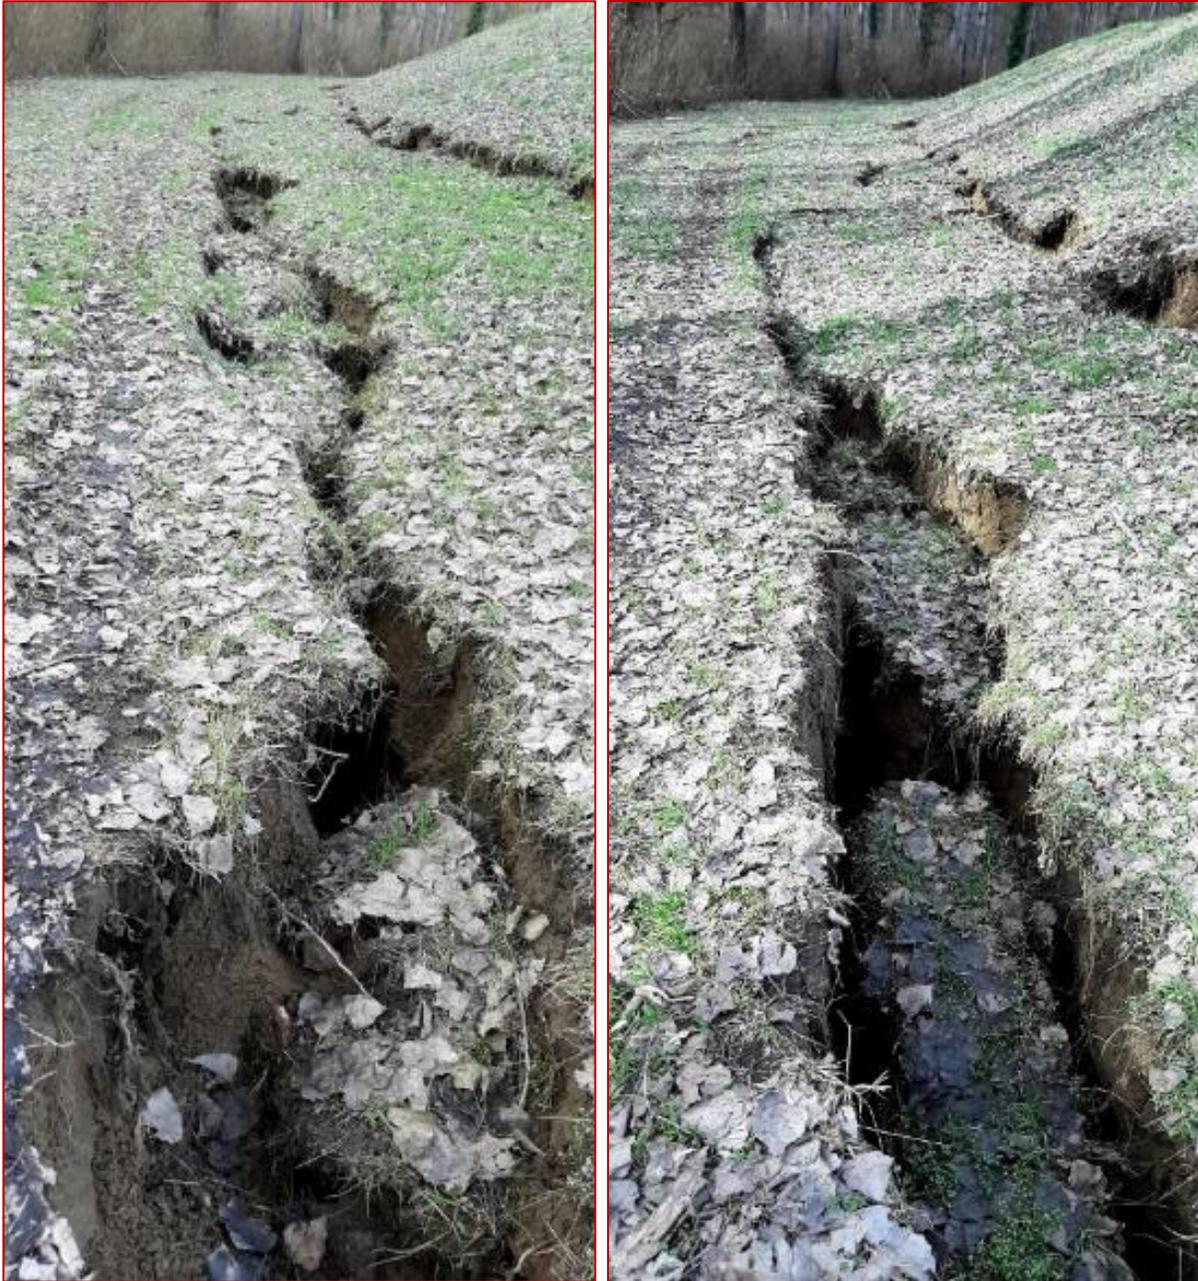
**Figure 8.17** Typical cracks on the river Kupa side of the levee north from Petrinja (February 19, 2021; 45.4592N, 16.2740E).

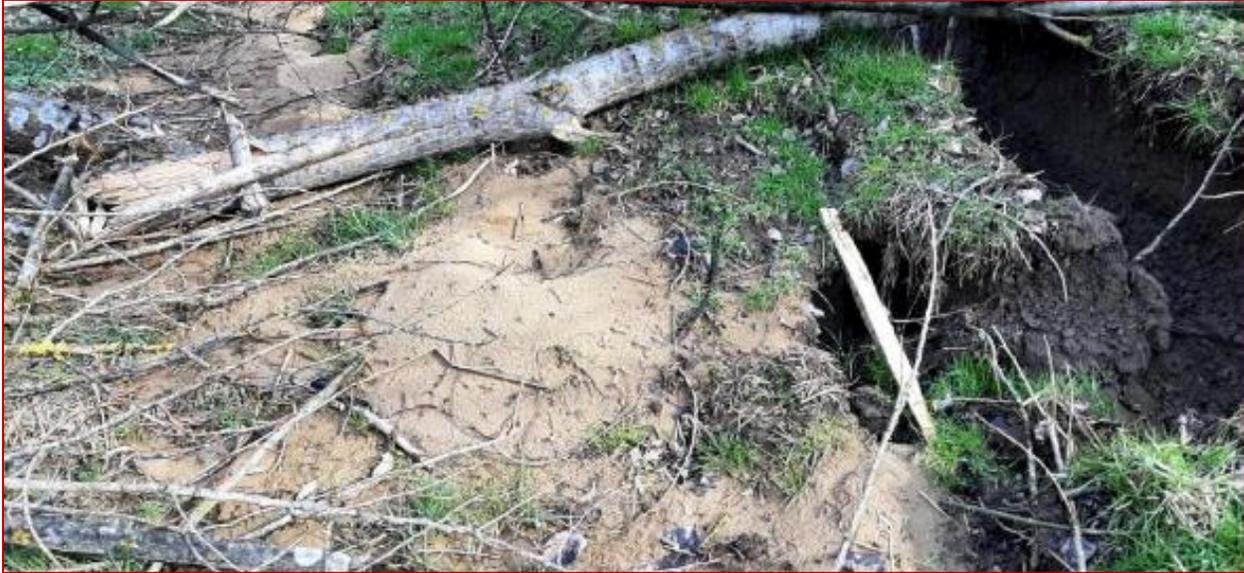
**Figure 8.18** Typical crack on the field side of the levee north from Petrinja with liquefied sand ejecta (19 February 2021; 45.4613N, 16.2748E)

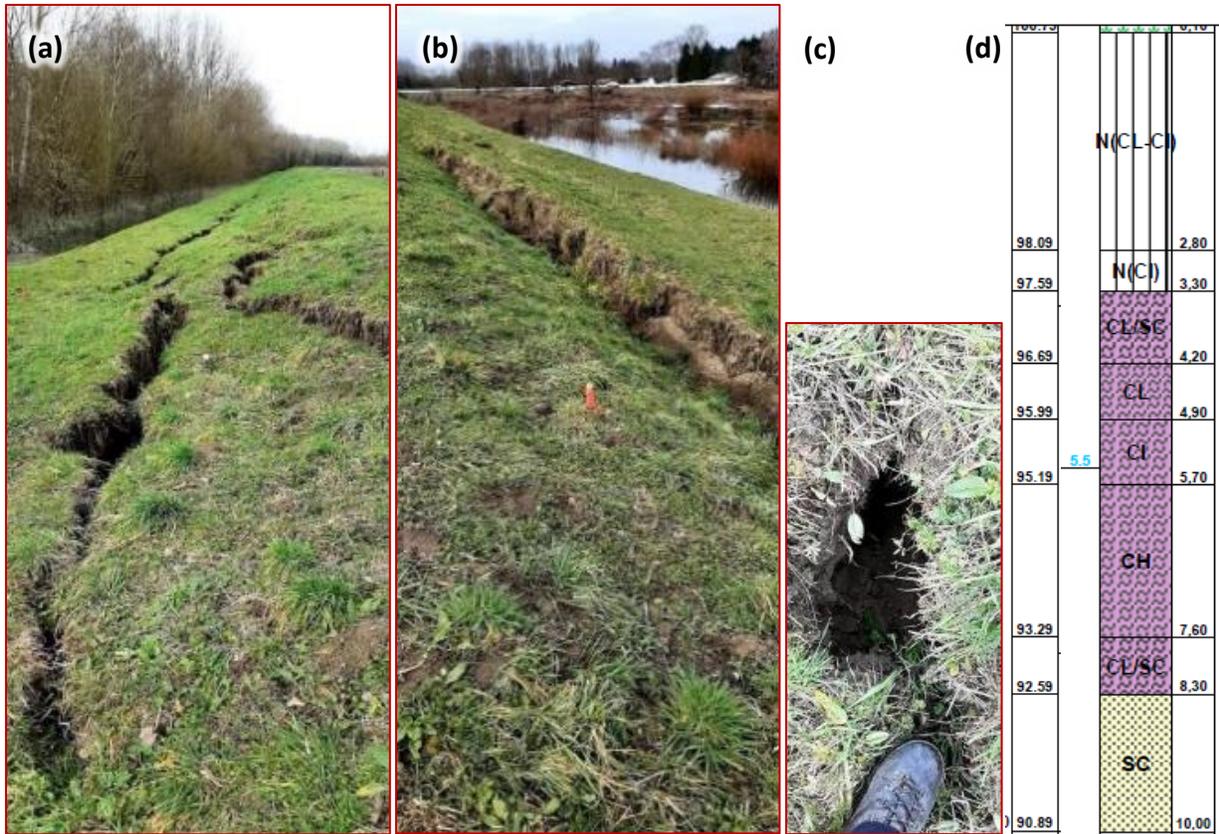
**Figure 8.21** (a) Some of the cracks at the river side of the levee (45.4704728N,16.3957025E), and (b) on the opposite side (45.47059N,16.3954E), (c) typical crack (45.4705N,16.3957E). (d) Borehole done in the year 2017 (Geokon-Zagreb LLD 2021) on a nearby location shows the presence of clayey sand at the depth of around 5 m below the ground surface – the upper 3.3 m represent the levee.

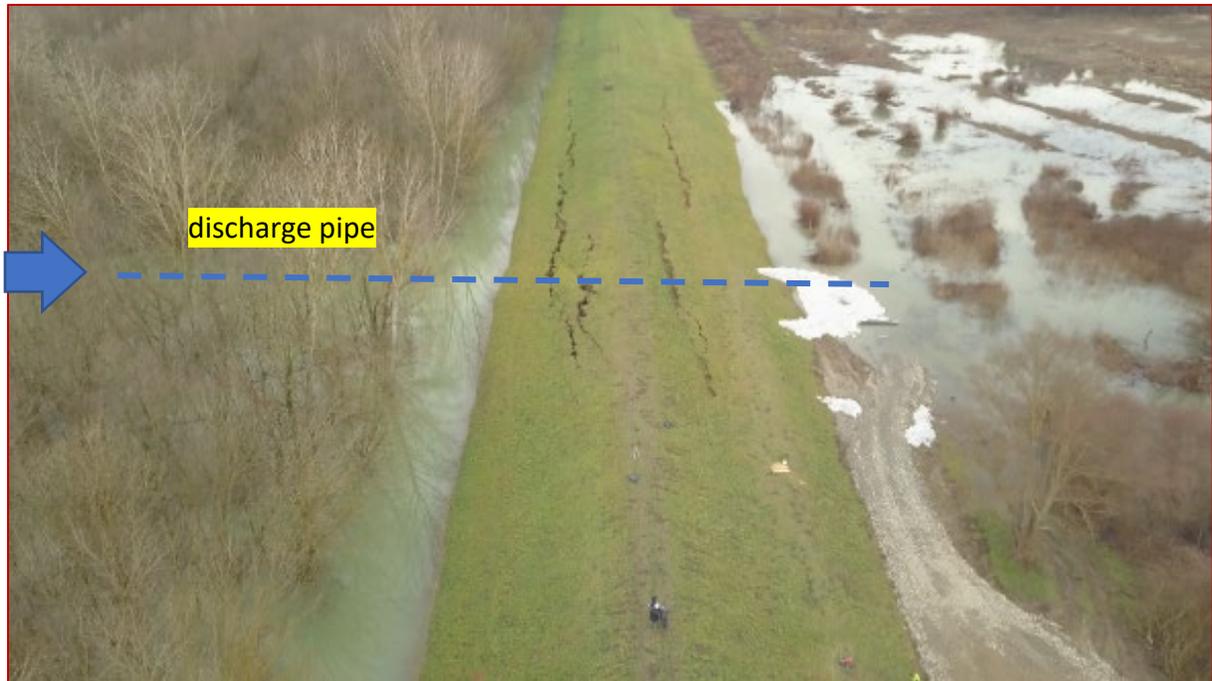
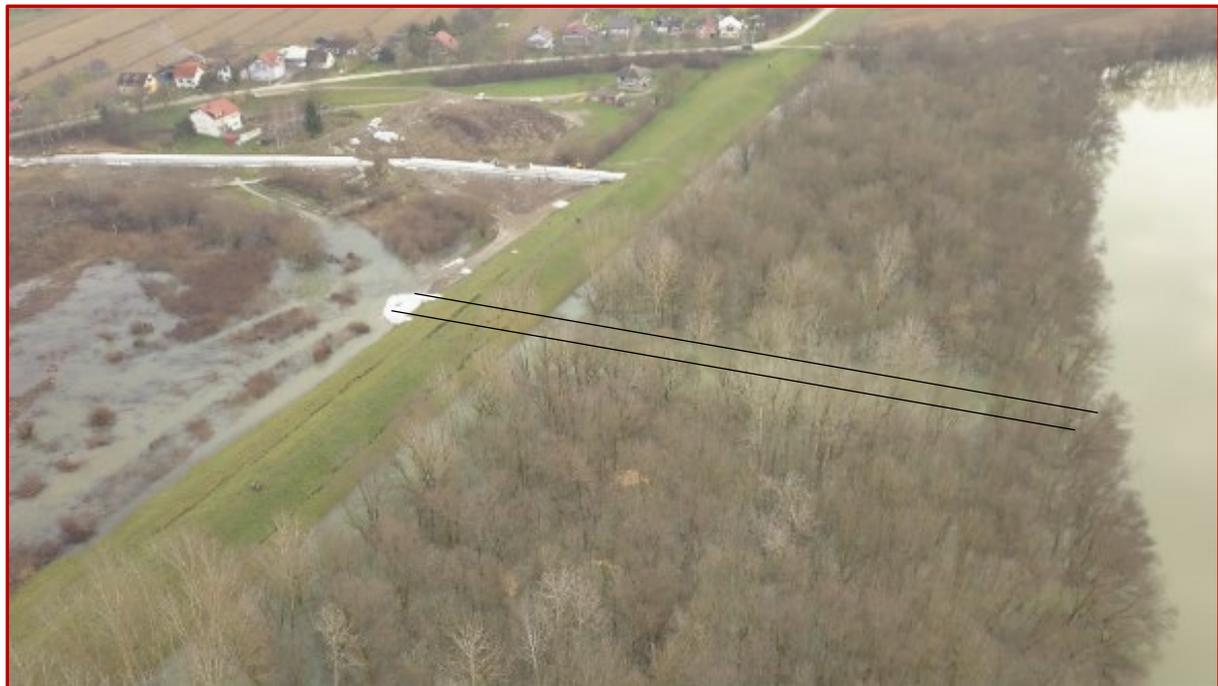
**Figure 8.22** Two air views of the southern part of the damaged levee with a high level of the Sava river. The white sandbags were installed right after the earthquake on the discharge pipe location, also the secondary levee was built. (Photo documentation of Geokon – Zagreb LLD, 45.4708 16.3952).

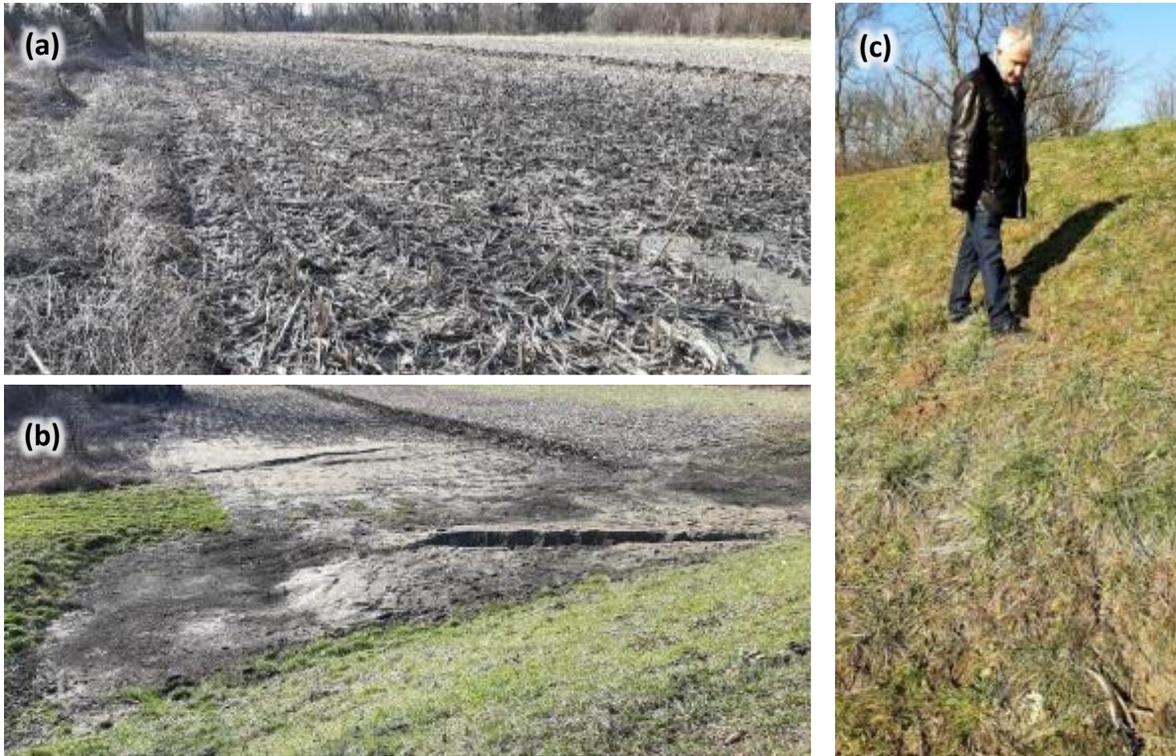
**Figure 8.27** (a, b) Liquefied sand on the river side of the levee near Hrastelnica from the levee toe to the distance of 40 m, and cracks on the levee (45.5007N, 16.4162E).

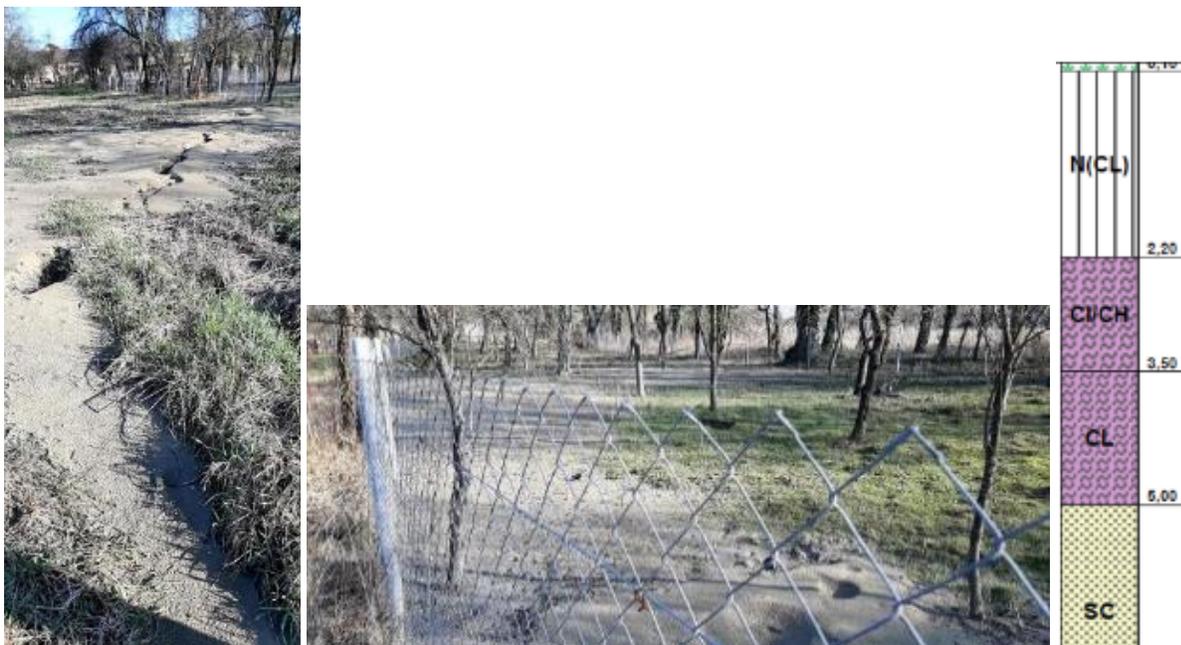
**Figure 8.28** Liquefied sand on the dry side of the levee near Hrastelnica (45.5015N, 16.4163E). Borehole from 2017 (Geokon-Zagreb 2021) on a nearby location shows the presence of clayey sand at the depth of around 5 m below the ground surface.

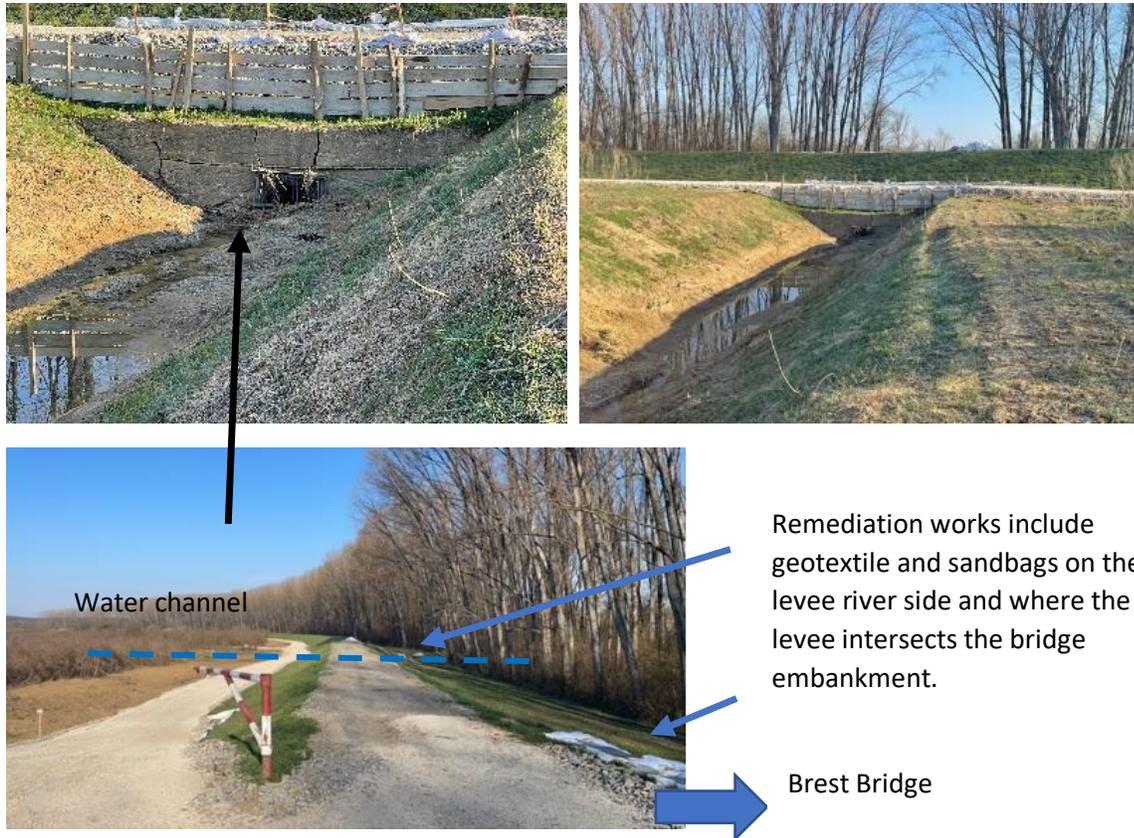
**Figure 8.30** Levee damage and remediation works on the south bank Kupa river levee near the Brest Bridge in Petrinja (45.4478N, 16.2583E; 45.4475N, 16.2595E) (source: Ingrid Tomac).

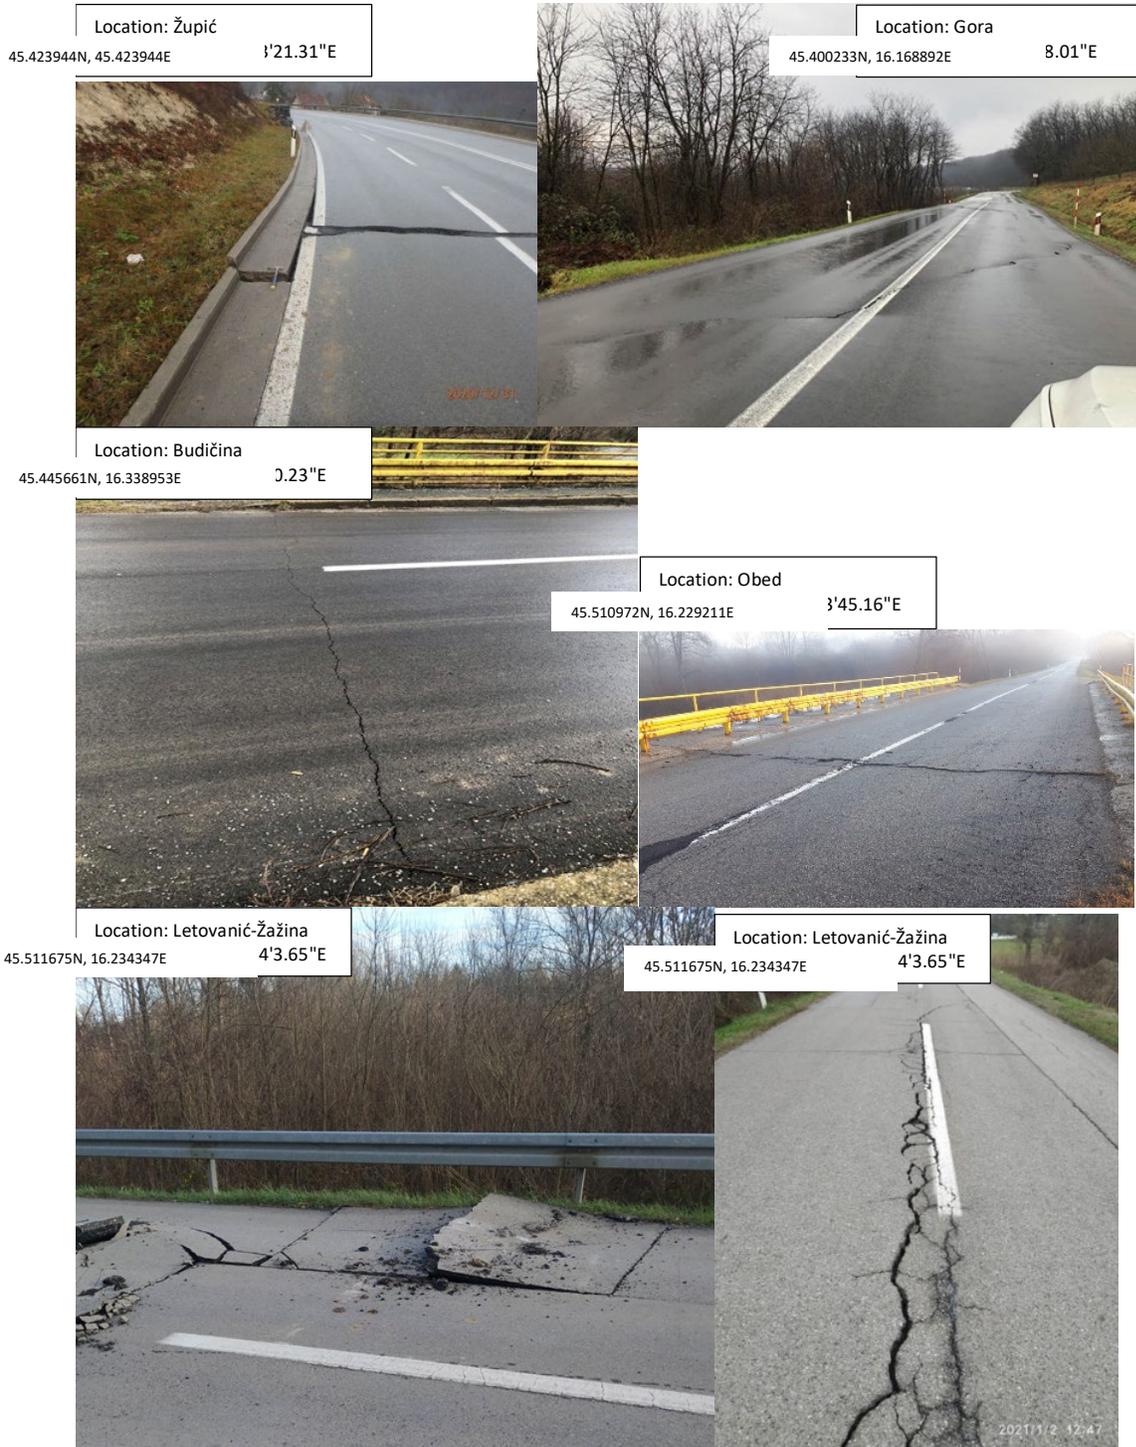
**Figure 9.3** Horizontal and vertical displacement cracks in asphalt perpendicular, parallel, or inclined towards the road axis in several locations (Source: Croatian Roads – Hrvatske ceste).

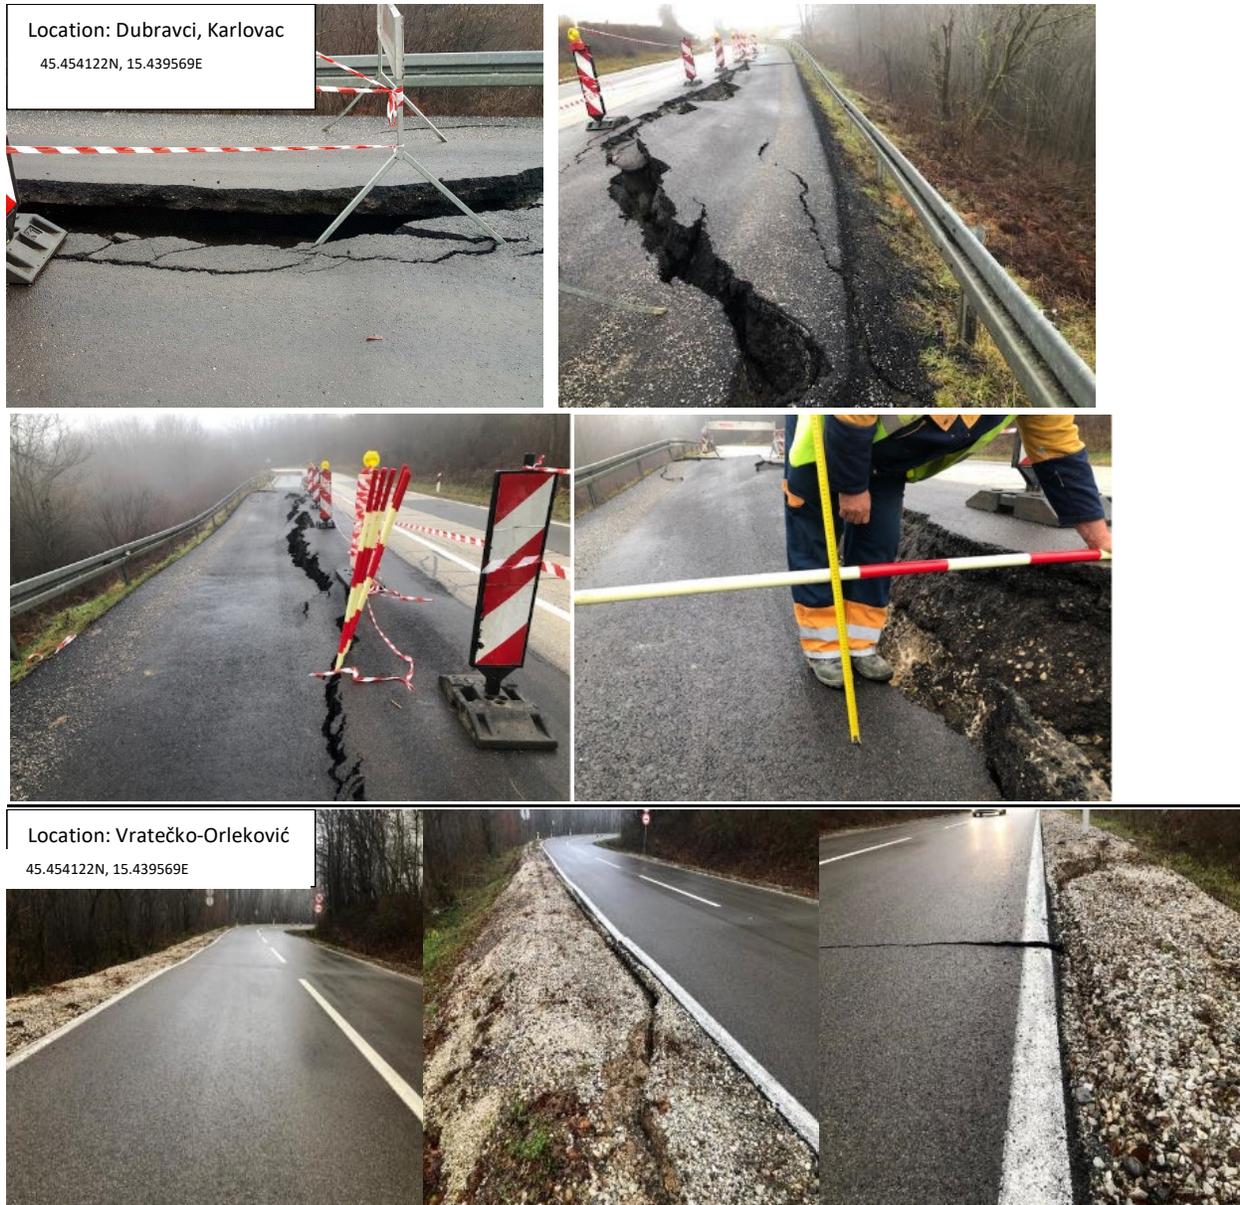
**Figure 9.4** Road damage accompanied with adjacent slope instability.
