# Geotechnical Reconnaissance and Engineering Effects of the December 29, 2020, M6.4 Petrinja, Croatia Earthquake, and Associated Seismic Sequence

A report to the NSF-Sponsored Geotechnical Extreme Event Reconnaissance (GEER) Association<sub>1</sub>

Report GEER-072: <https://doi.org/10.18118/G63T0S>  
August 3<sup>rd</sup>, 2021

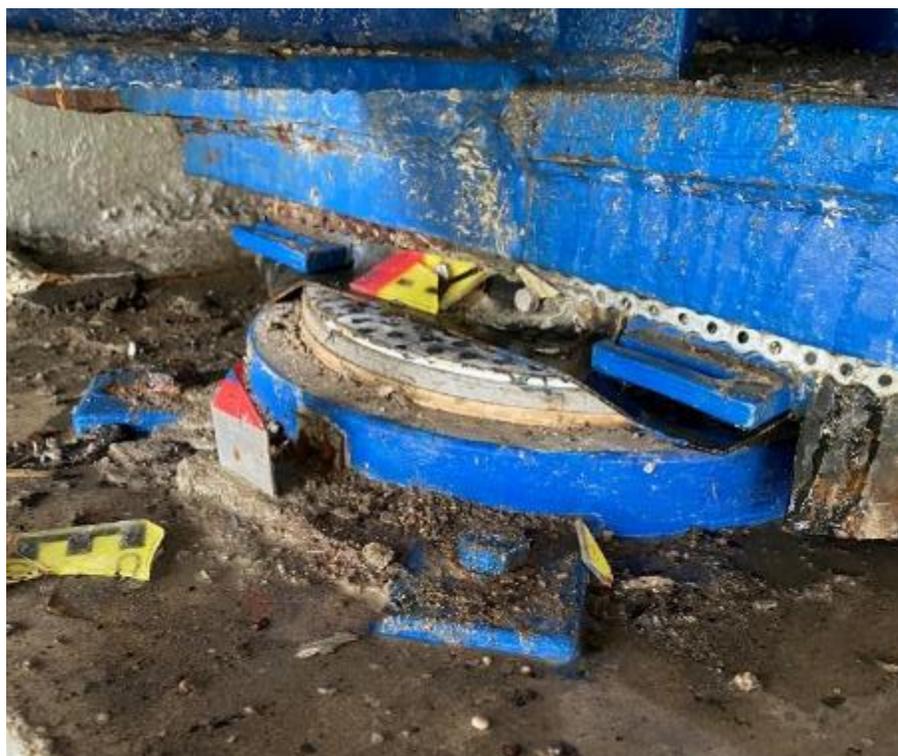
**Figure 9.11** Galdovo Bridge, damaged bearing on the east abutment (45.4790N, 16.3854E).

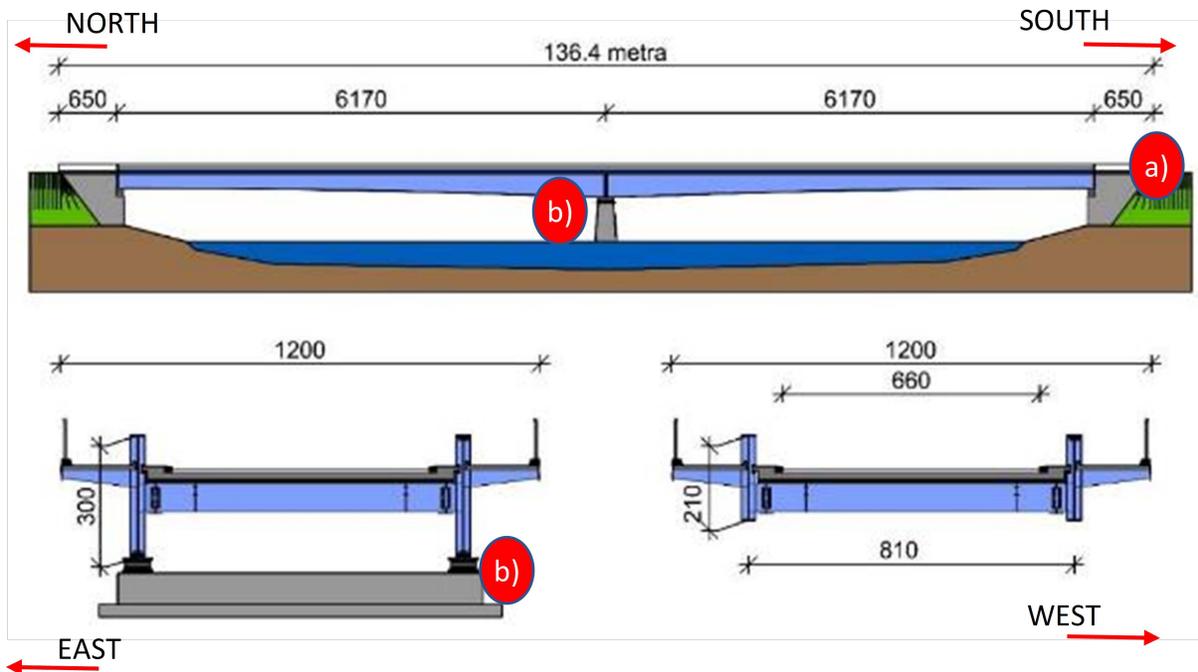
**Figure 9.20** Brest Bridge damage indicated in longitudinal and cross-section of the bridge (from Radić et al., 2007): a) settlement of the sidewalk before the abutment, b) damage to the bearing pedestal on the column (right).

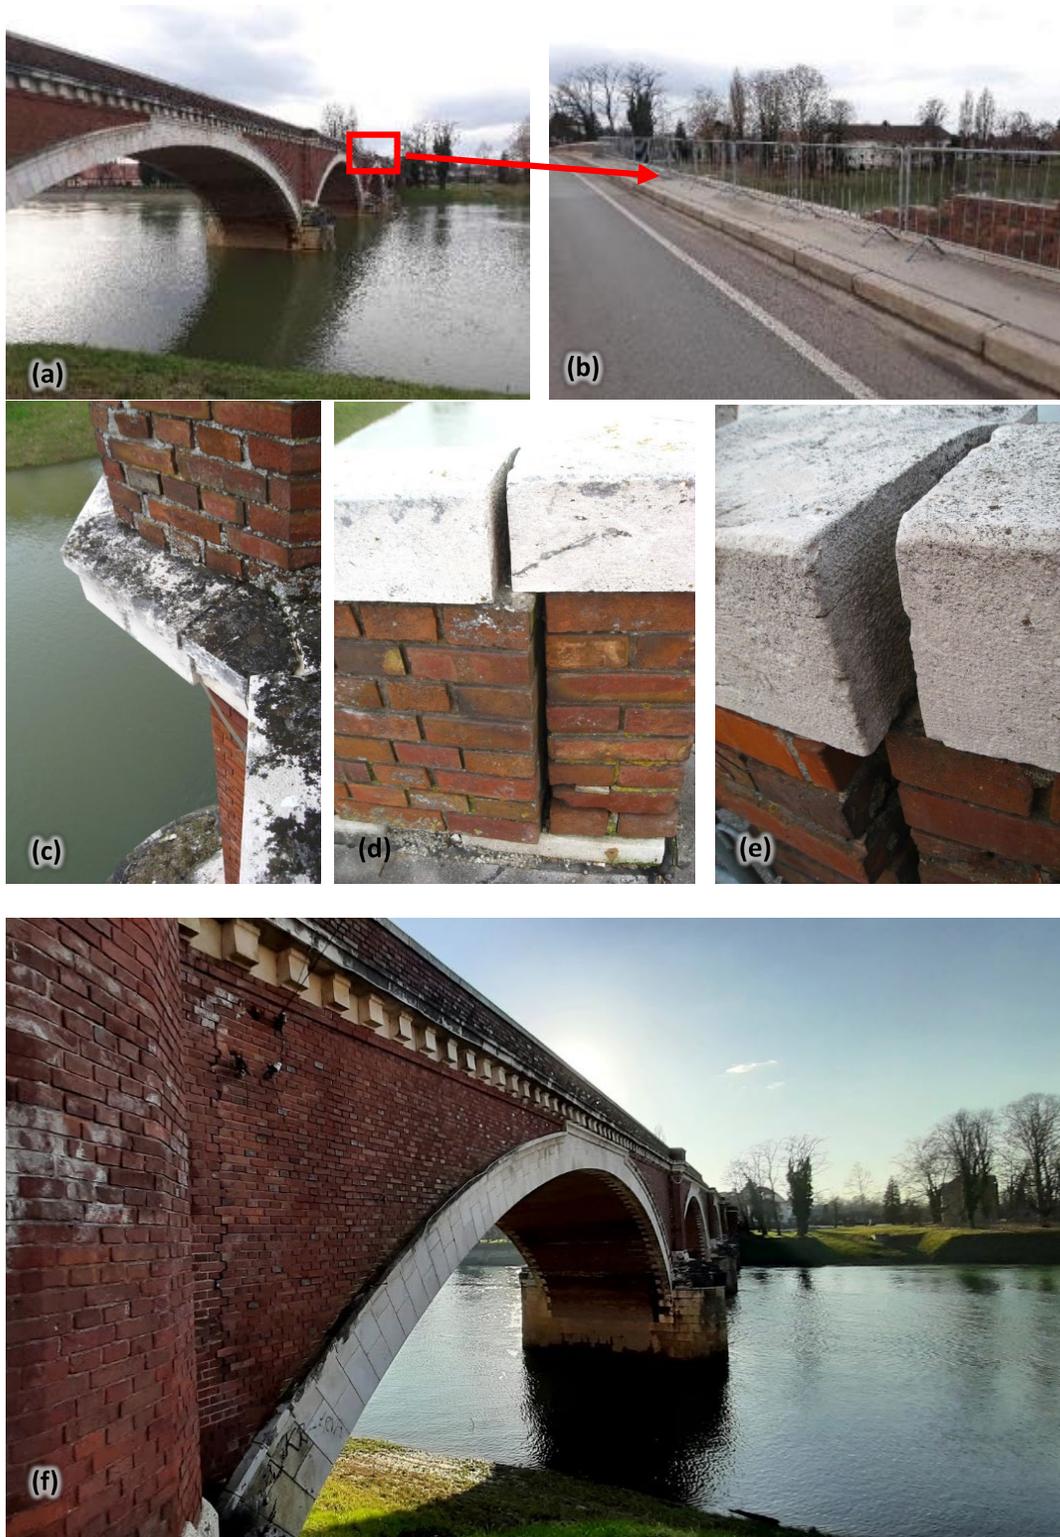
**Figure 9.21** Damage to the pedestrian railing of the Old Bridge in Sisak: a (45.483N, 16.371E), b (45.4829N, 16.3705E), c (45.4829N, 16.3707E), d (45.4829N, 16.3707E), e (45.4830N, 16.3707E), f (45.4825N, 16.3692E).
