Turning Disaster into Knowledge

**GEOLOGICAL AND GEOTECHNICAL ENGINEERING
RECONNAISSANCE OF THE SEPTEMBER 19, 2022,
MICHUACAN EARTHQUAKE, MEXICO**

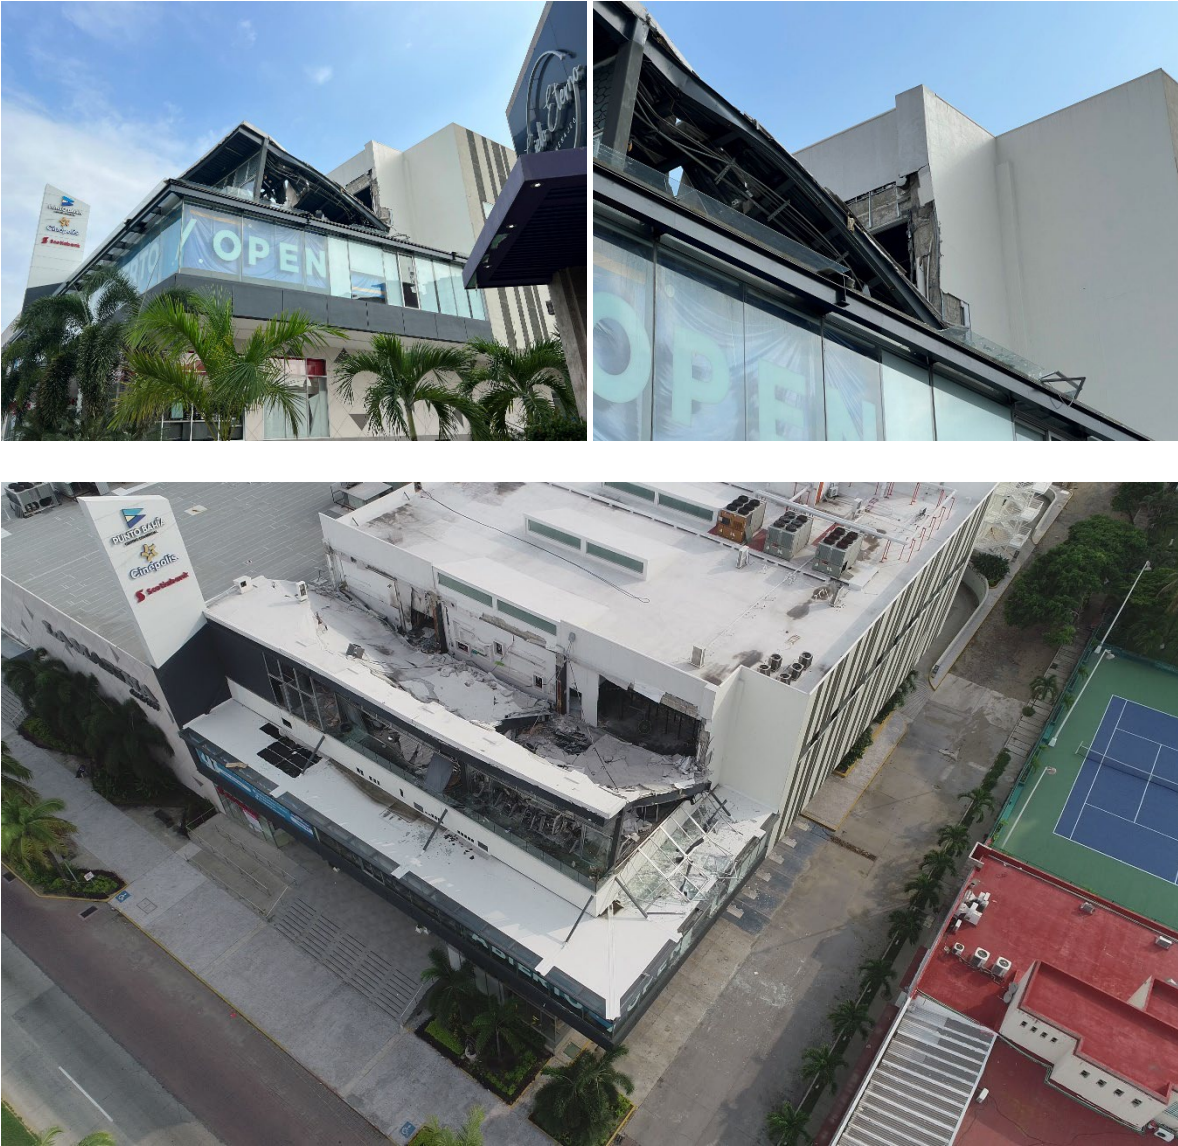
Partial collapse of a roof top housing a gym in a four-story mall (Figure 9), occurred in Manzanillo, Colima. According to the National Emergency Committee, one person was killed in this building from the roof collapse. An adjacent building was affected as well but with minor damage. Two km away from this mall, collapse of masonry walls of a Coppel store were observed (Figure 10); apparently no punching or settlement occurred. A second story balcony failed near the harbor in Manzanillo (Figure 11). Additionally, damage to several perimeter masonry walls in Manzanillo were observed (some experienced total collapse and some tilting between 10-15°, see Figures 12 to 14). In the small towns further south, the number of damaged structures as well as their severity increased as they approached the epicentral area. A variety of structures were damaged by the earthquake but most damage appeared to be in taller buildings including hospitals, single-family buildings, hotels, and churches, which can be seen in Figures 15 to 27.

Figure 9. Collapse of roof in mall, Manzanillo, Colima, Waypoint Station 7 (Coordinates: 19.100552°, -104.325525°)

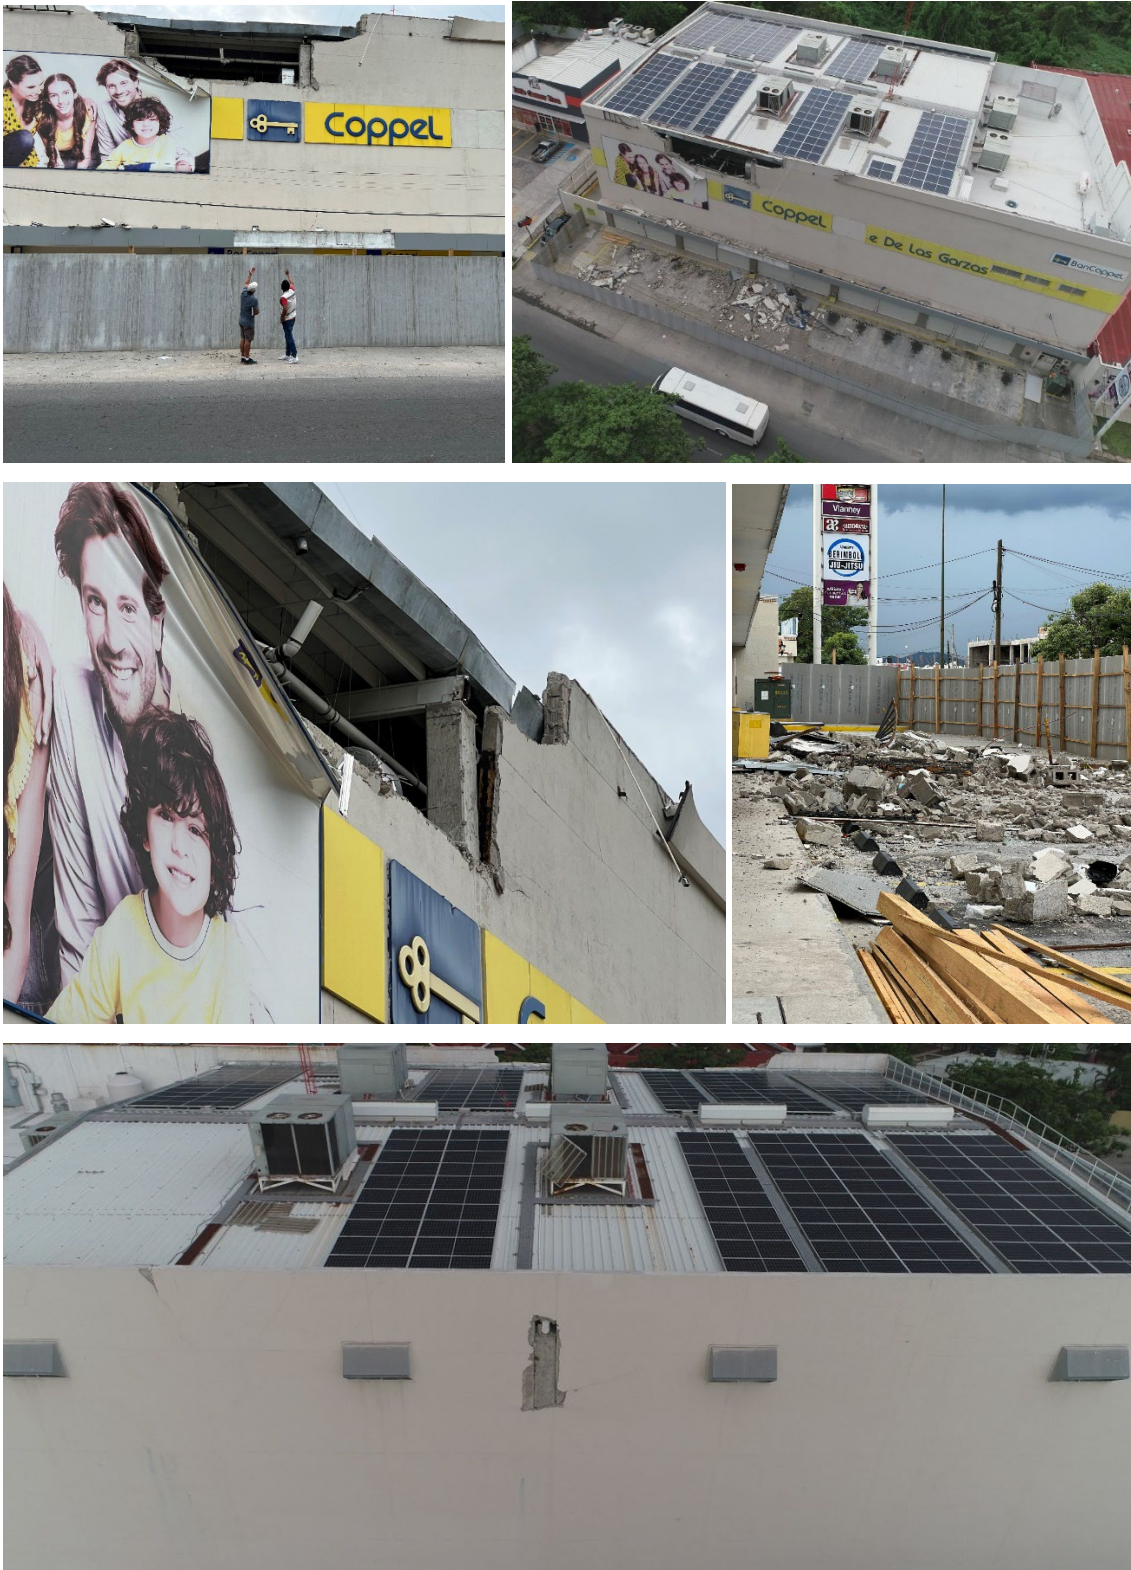
Figure 10. Collapse of third floor masonry walls of Coppel store, Manzanillo, Colima Waypoint Station 8 (Coordinates: 19.095606°, -104.302863°)

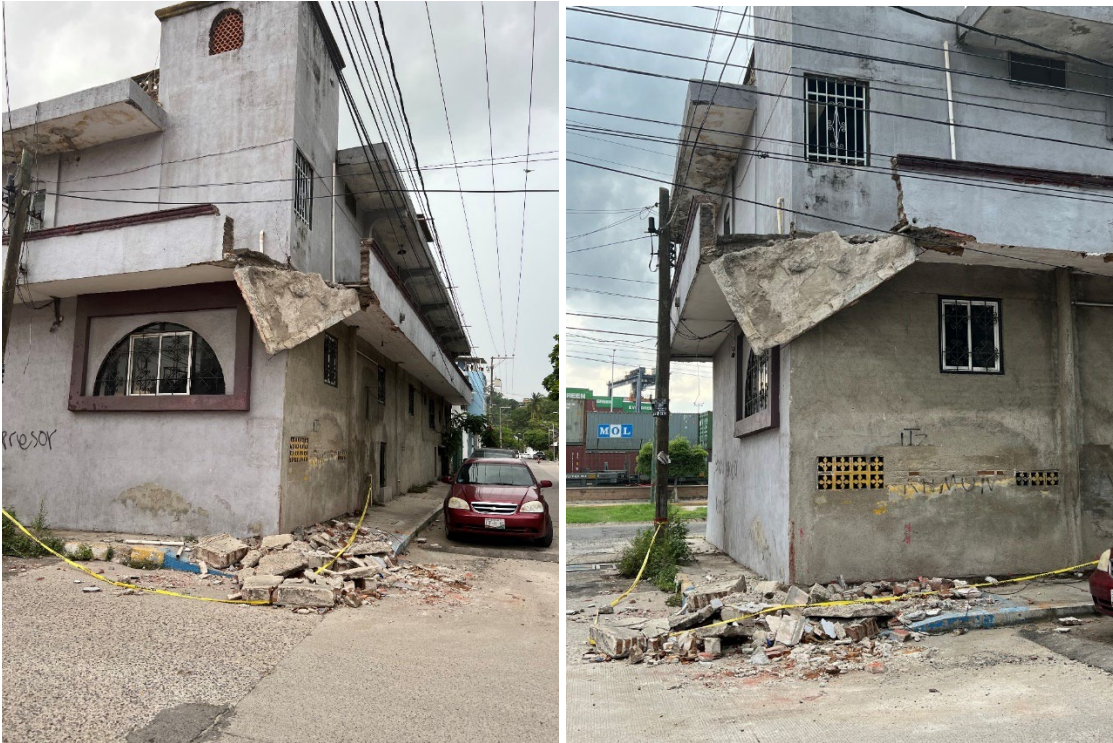
Figure 11. Partial collapse of balcony, Manzanillo, Colima
Waypoint Station 9 (Coordinates: 19.058136°, -104.290446°)

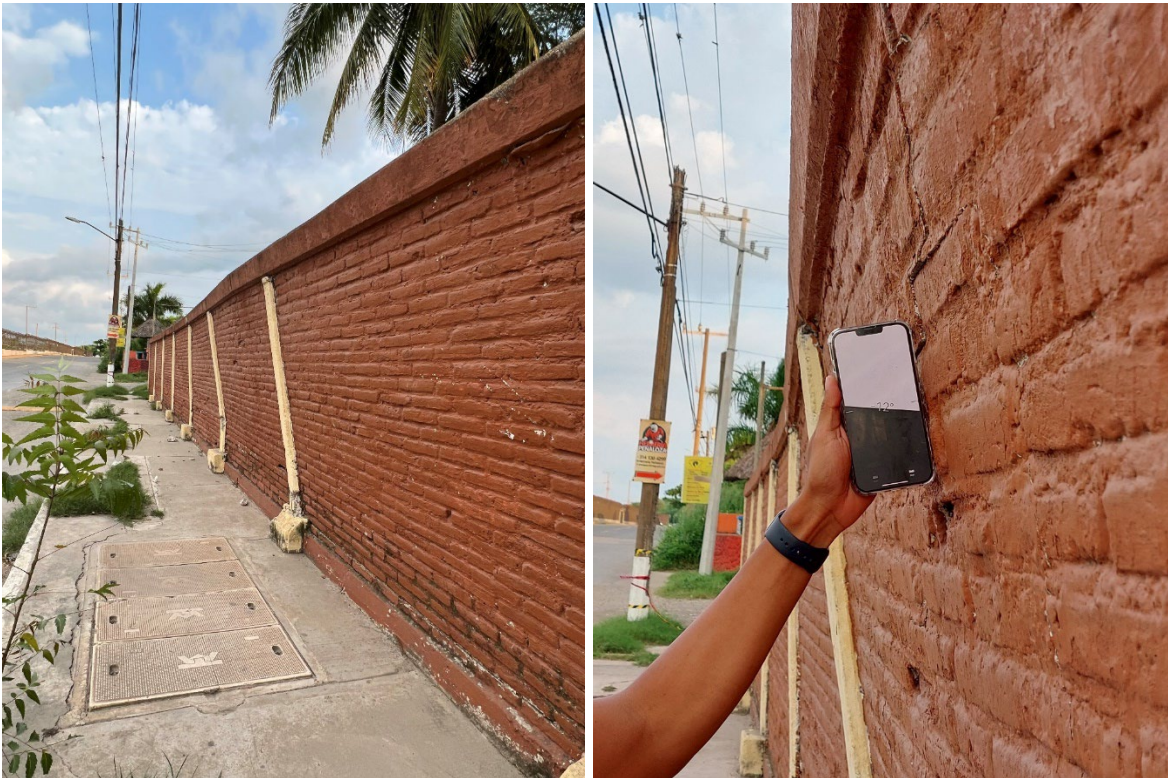
Figure 12. Column failures of perimeter walls of school, Manzanillo, Colima
Waypoint Station 10 (Coordinates: 19.024016°, -104.322869°)

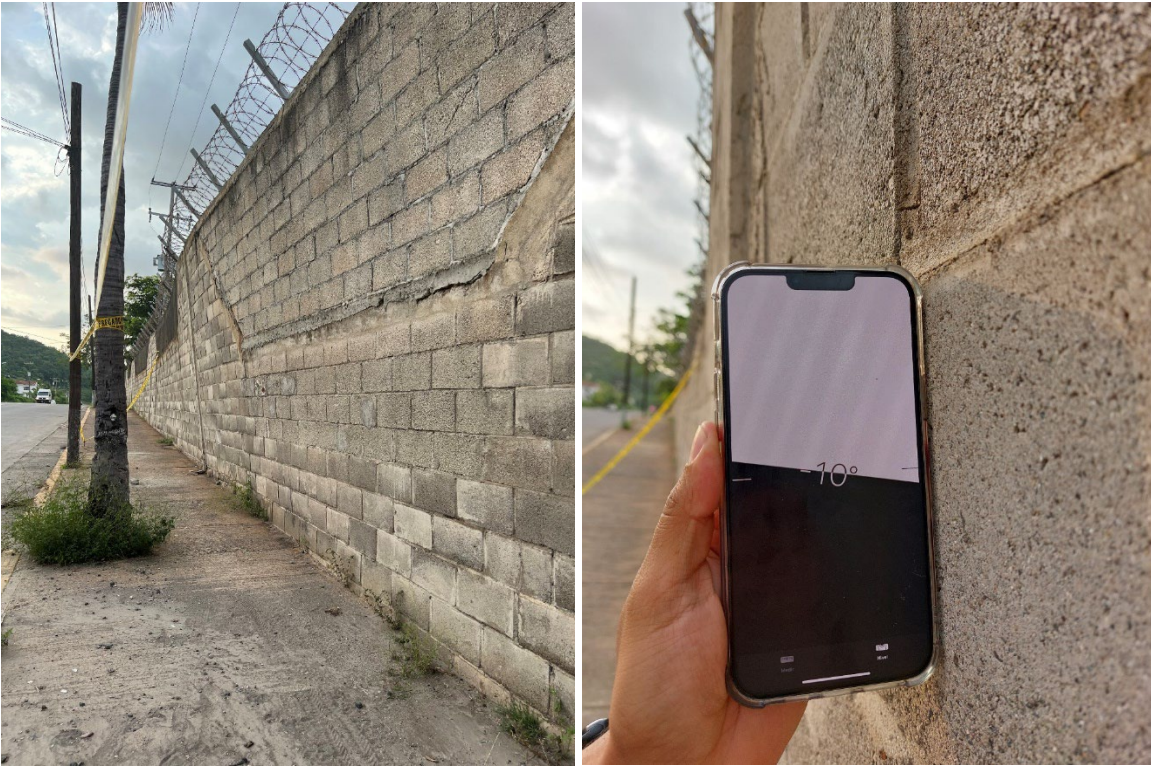
Figure 13. Columns failure of perimeter walls of thermal power station, Manzanillo, Colima, Waypoint Station 11 (Coordinates: 19.024788°, -104.323969°)

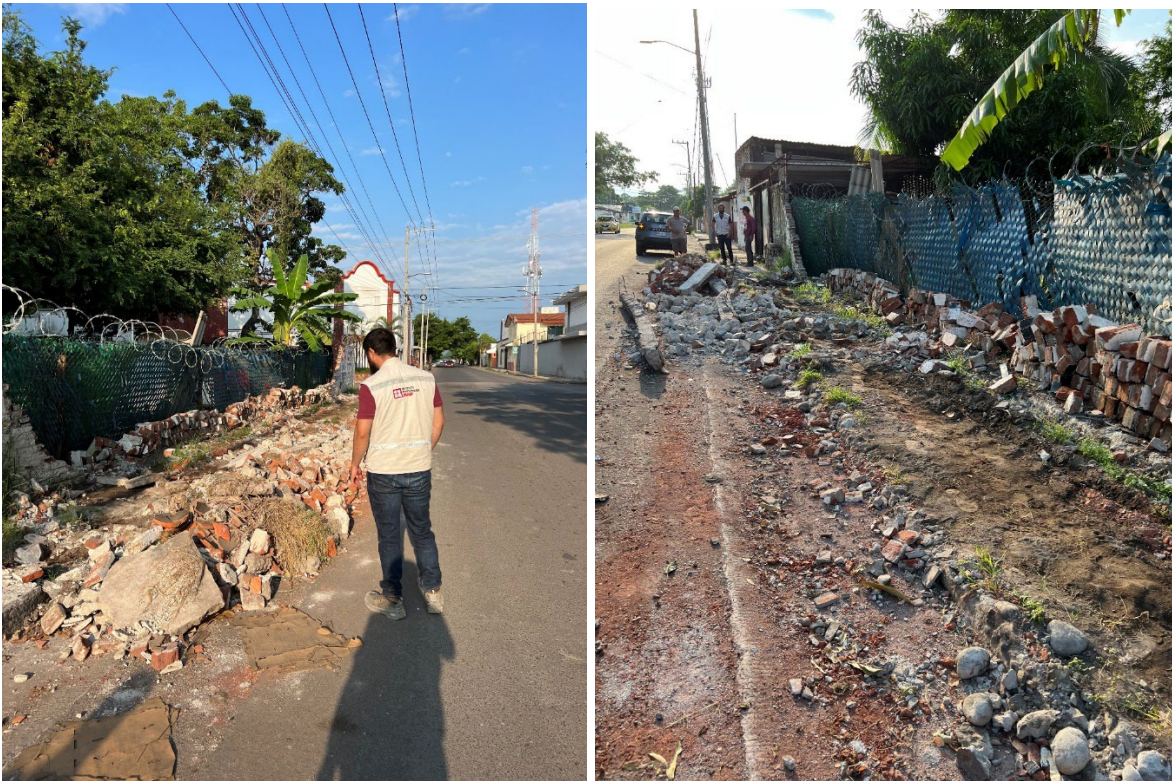
Figure 14. Collapse of perimeter wall of automobile workshop, Tecoman, Colima, Waypoint Station 12 (Coordinates: 18.918219°, -103.870195°)

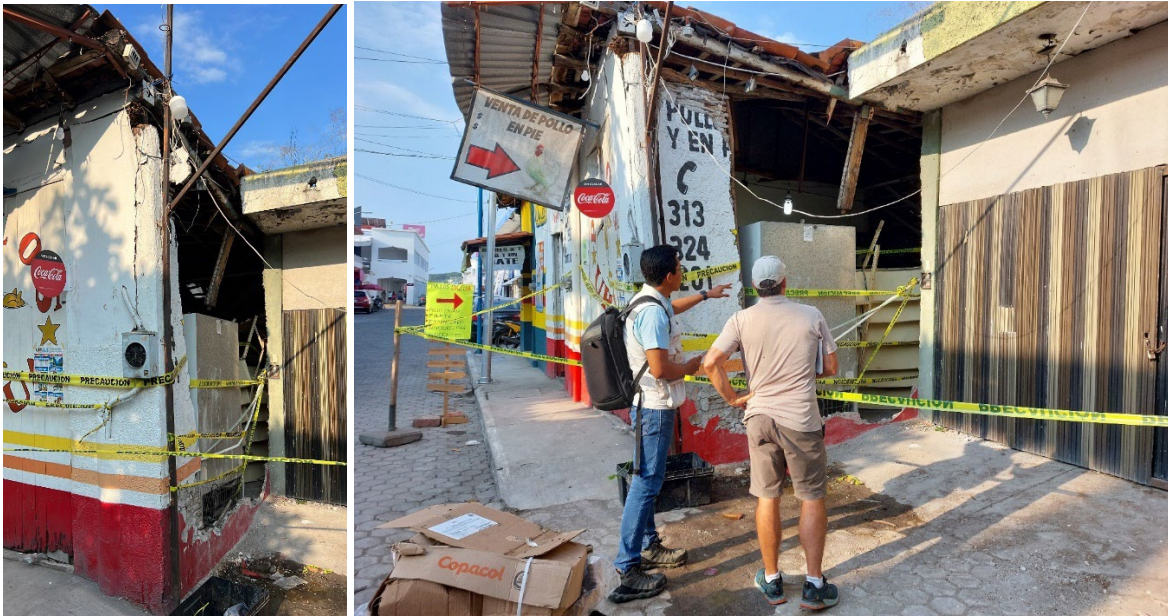
Figure 15. Collapse of local grocery store, Tecoman, Colima
Waypoint Station 13 (Coordinates: 18.911143°, -103.871476°)

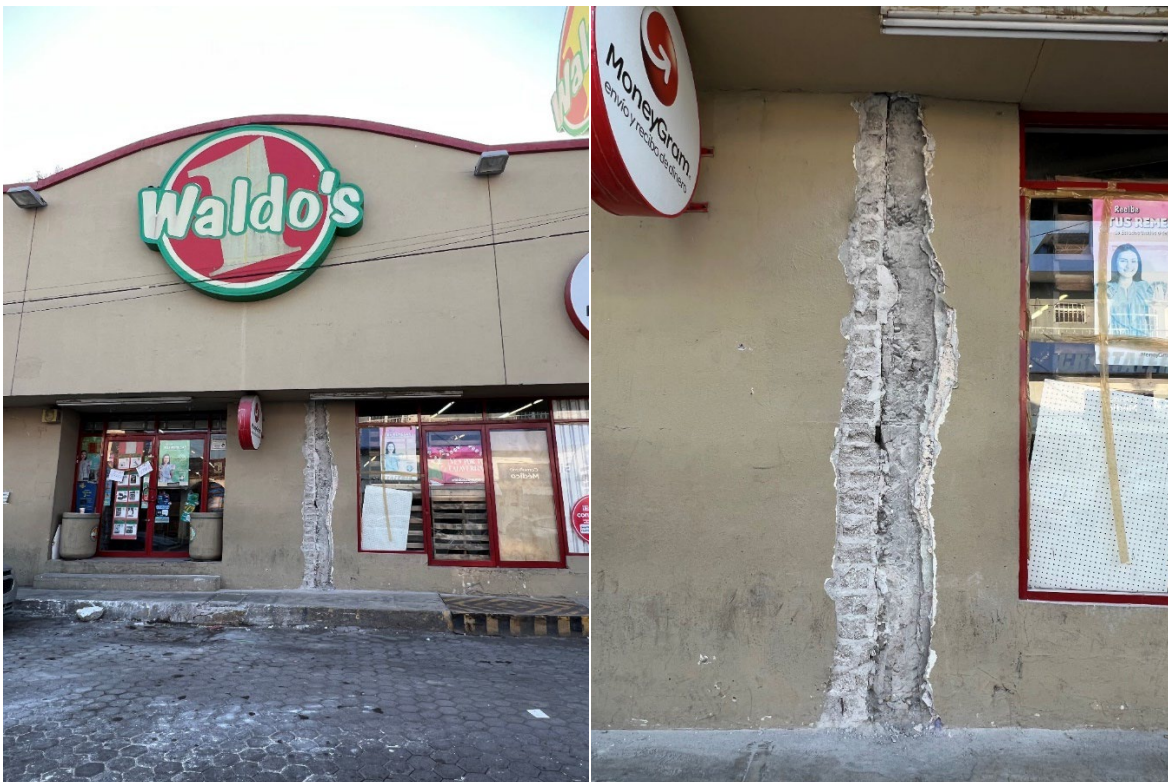
Figure 16. Column damage of supermarket, Tecoman, Colima
Waypoint Station 14 (Coordinates: 18.910863°, -103.871611°)

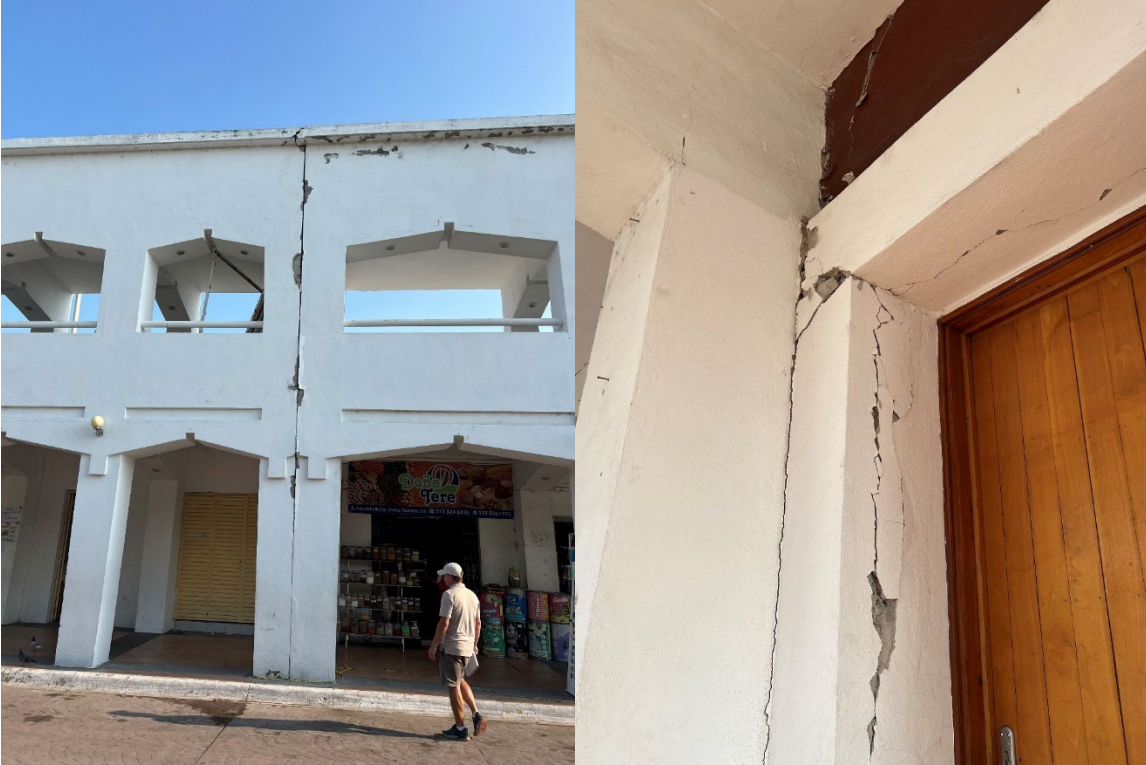
Figure 17. Damage in door frames and between structures, Tecoman, Colima
Waypoint Station 15 (Coordinates: 18.910531°, -103.87186°)

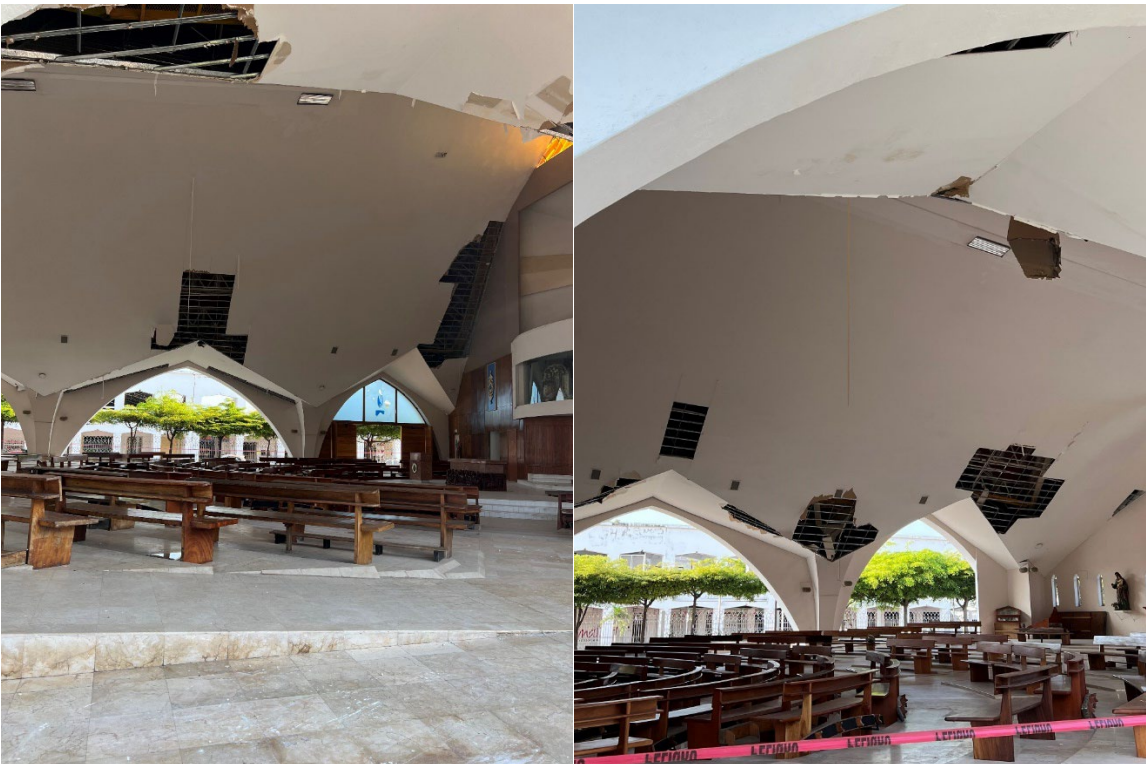
Figure 18. Damage to nonstructural elements in church, Tecoman, Colima
Waypoint Station 16 (Coordinates: 18.910498°, -103.87244°)

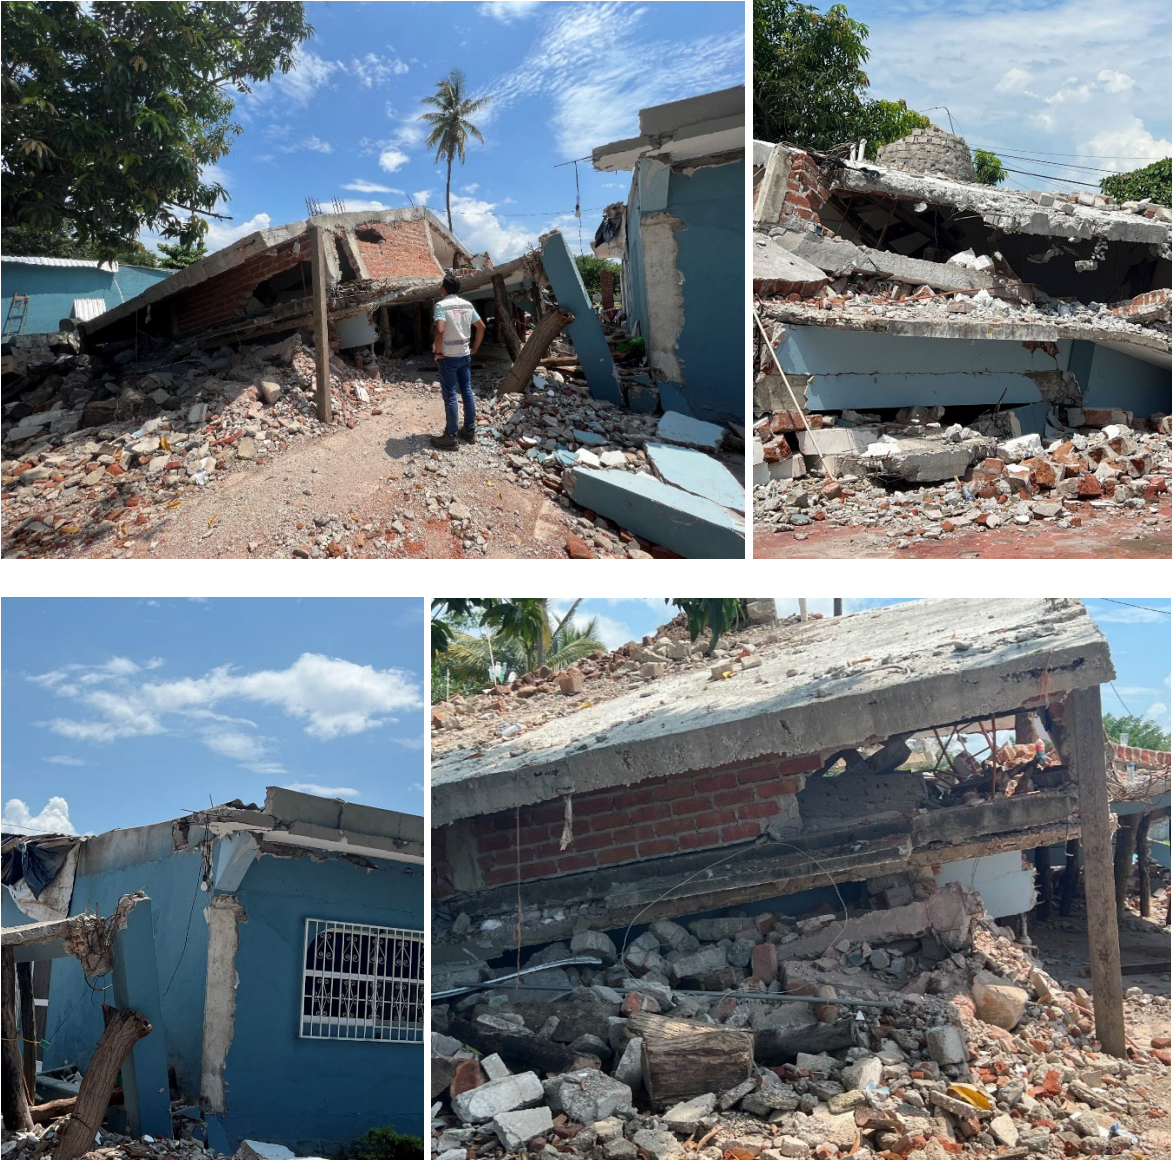
Figure 19. Total collapse of a two-story house with soft first floor, Coahuayana, Michoacan, Waypoint Station 22 (Coordinates: 18.728643°, -103.687277°)

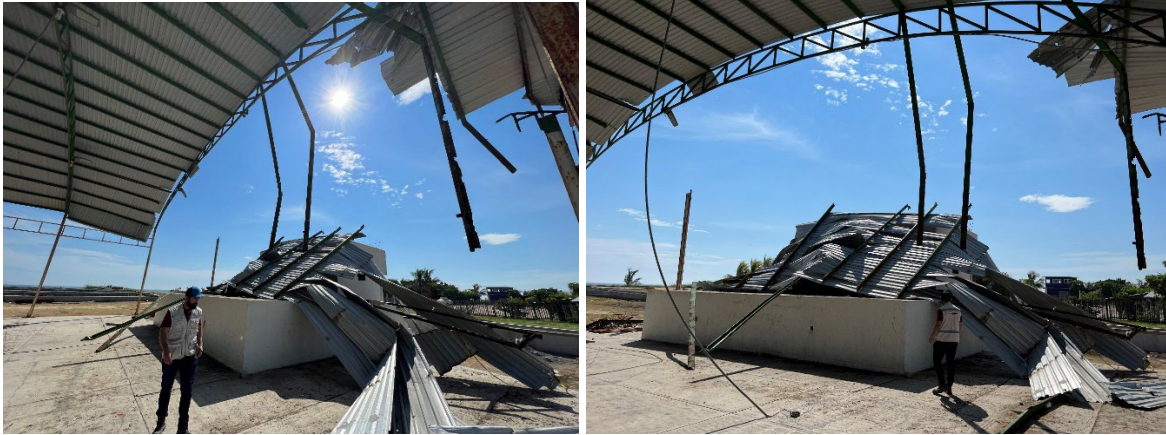
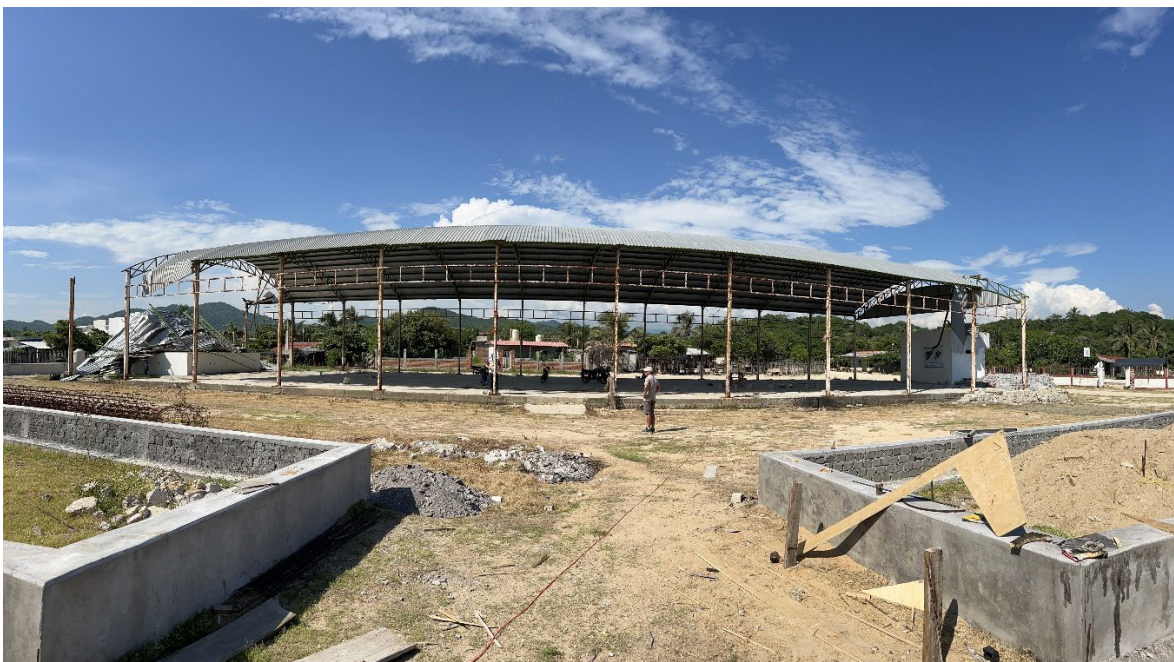
Figure 20. Partial collapse of a court cover roof. Structure had evidence of severe rust, Colola, Michoacan. Waypoint Station 26 (Coordinates: 18.298116°, -103.412856°)

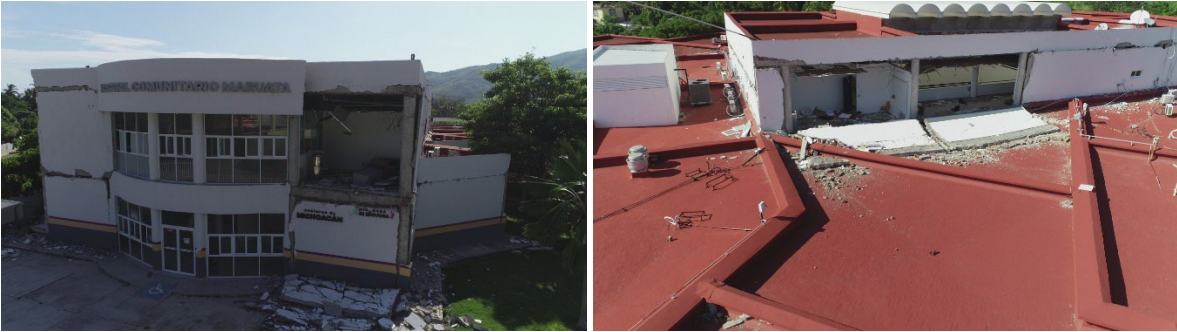
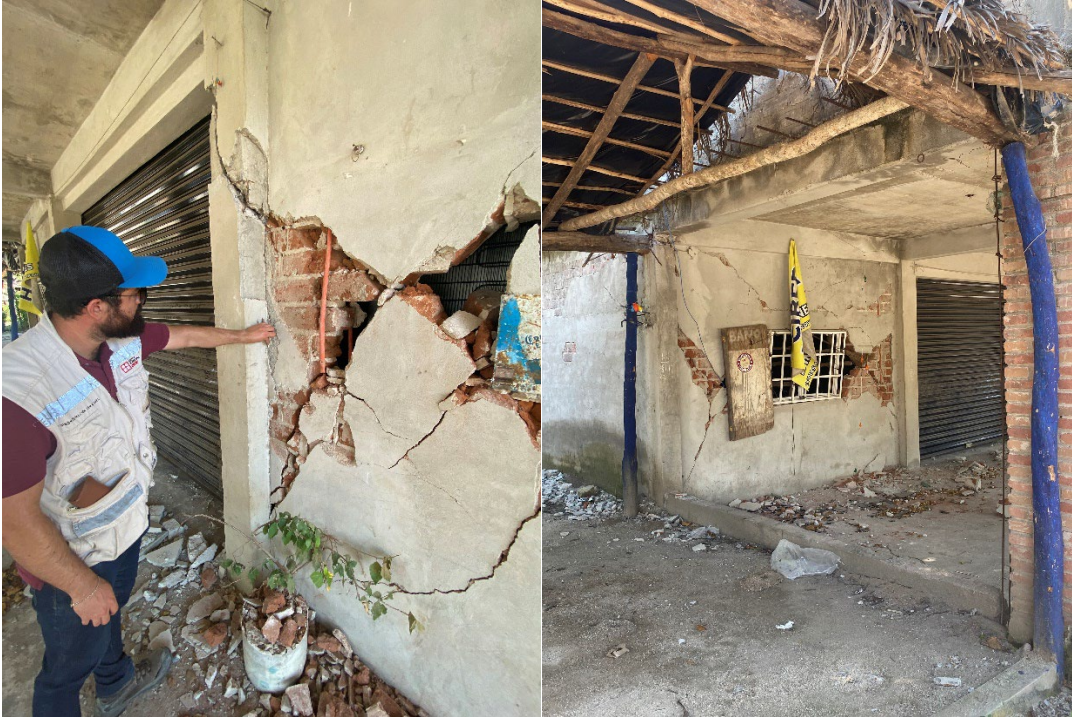
Figure 21. Collapse of masonry walls and damage to structural elements in community hospital and damaged column and wall of nearby masonry two story building, Maruata, Michoacan. Waypoint Station 28 (Coordinates: 18.27409°, -103.348231°)

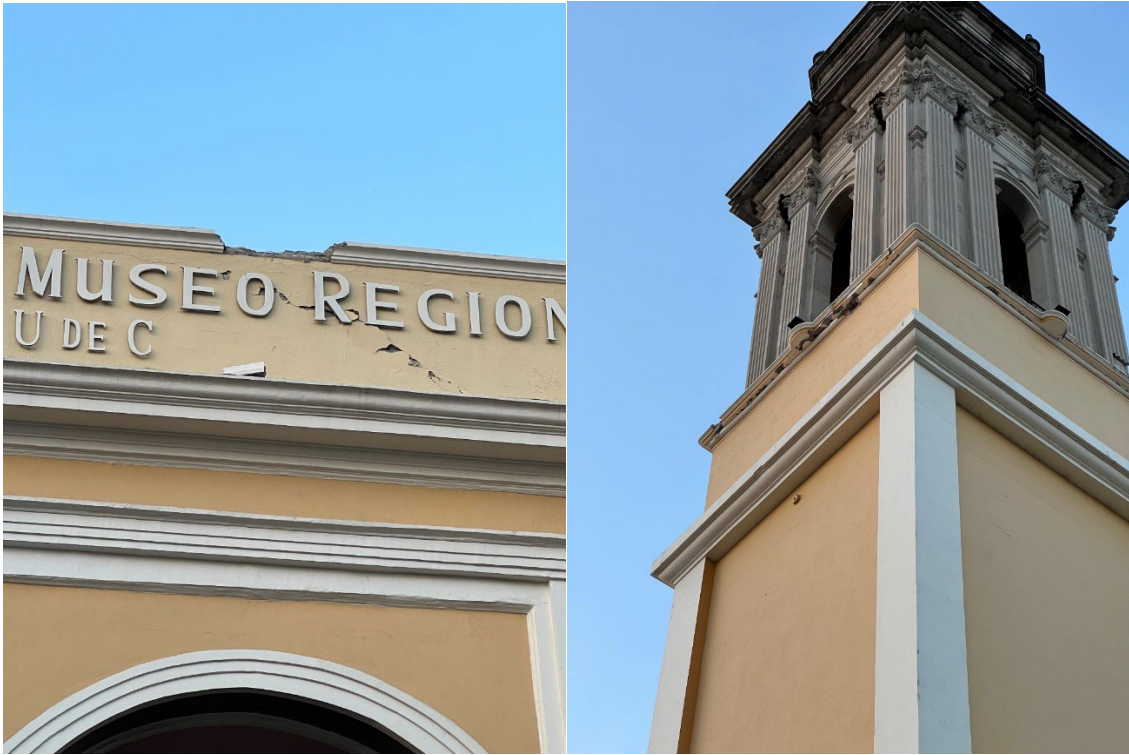
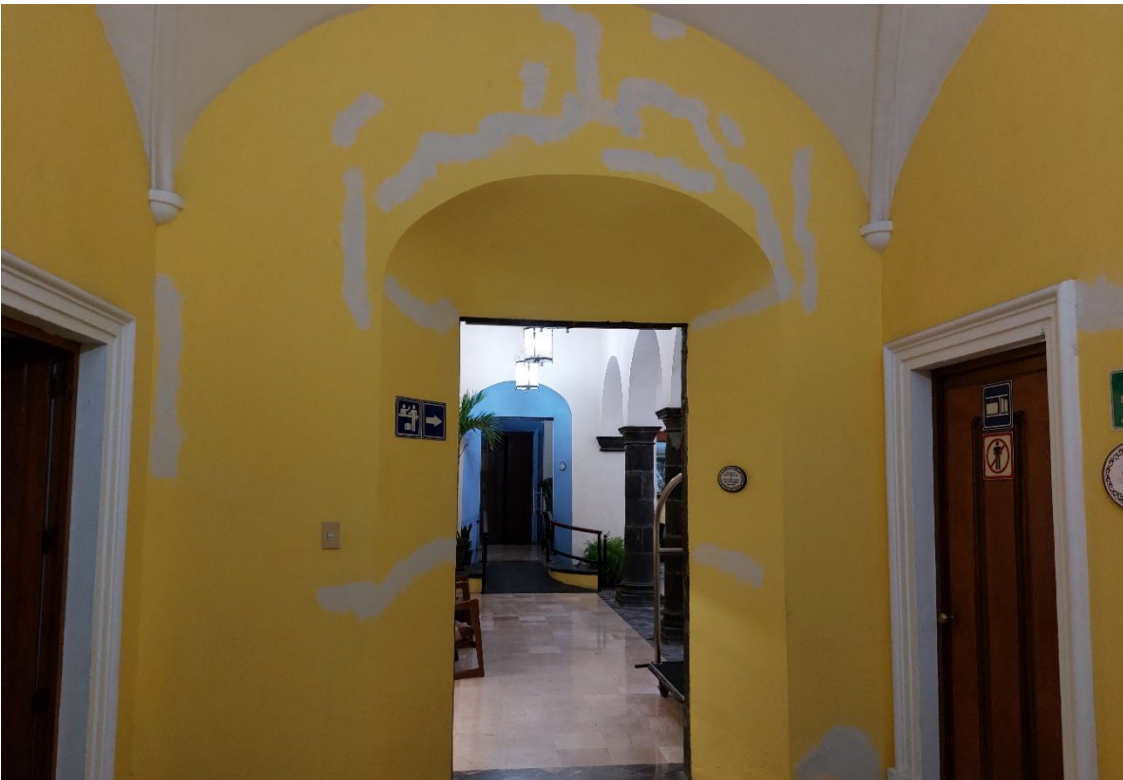
Figure 22. Damage and slight cracking in non-structural elements of multiple buildings in the center of the city, Colima, Colima. Waypoint Station 30 (Coordinates: 19.243584°, -103.728062°)

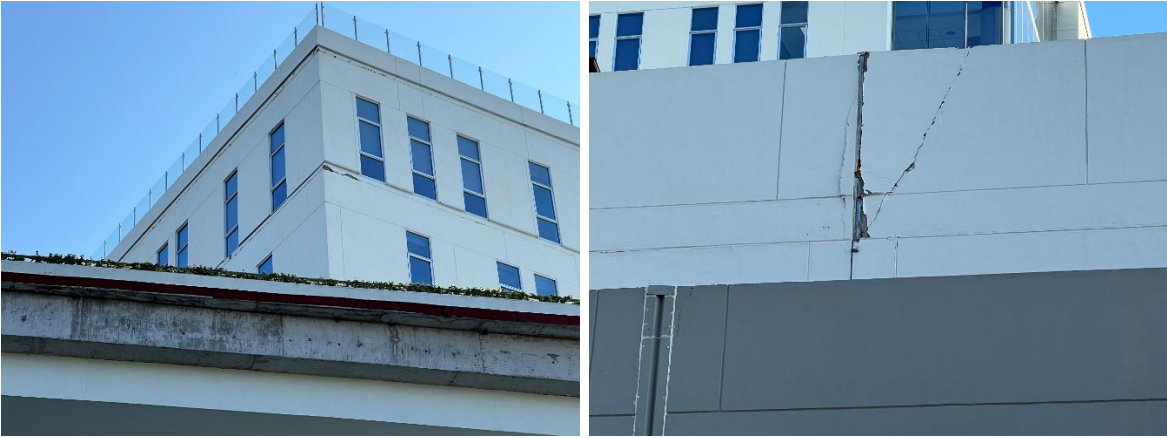
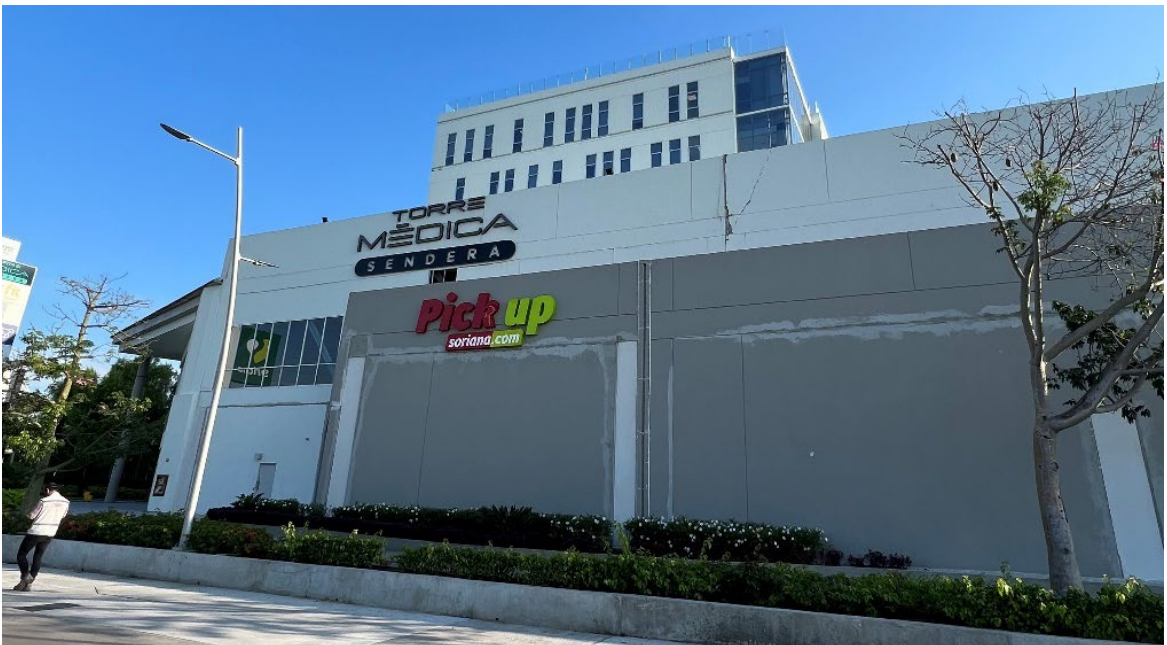
Figure 23. Cracking on non-structural elements with damage on the corner columns, Colima, Colima. Waypoint Station 32 (Coordinates: 19.275421°, -103.716969°)

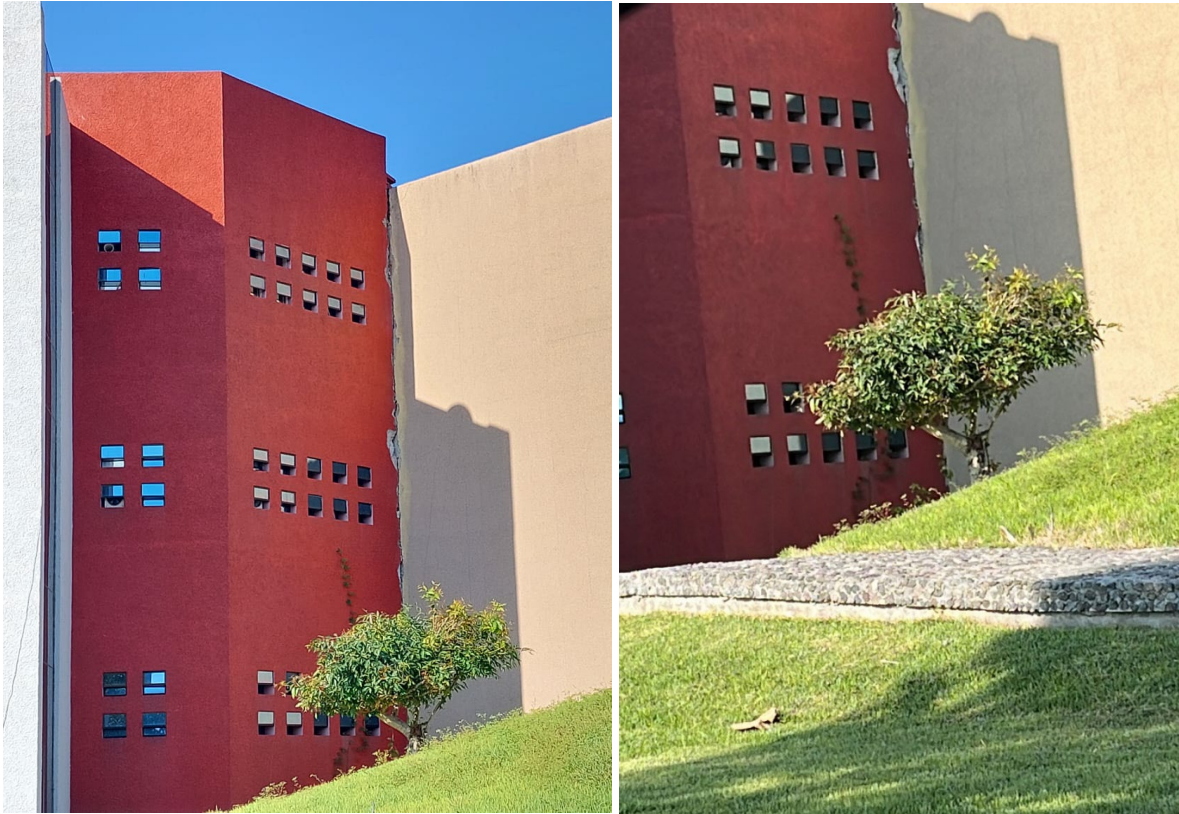
Figure 24. Vertical cracking in building, Colima, Colima.
Waypoint Station 33 (Coordinates: 19.255976°, -103.687608°)

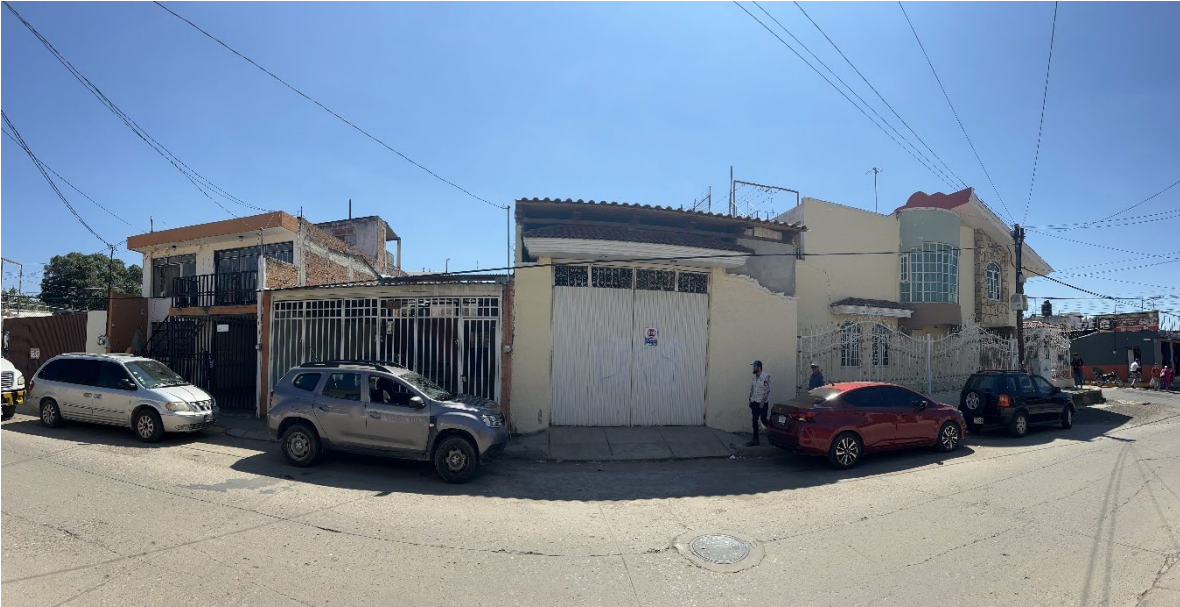
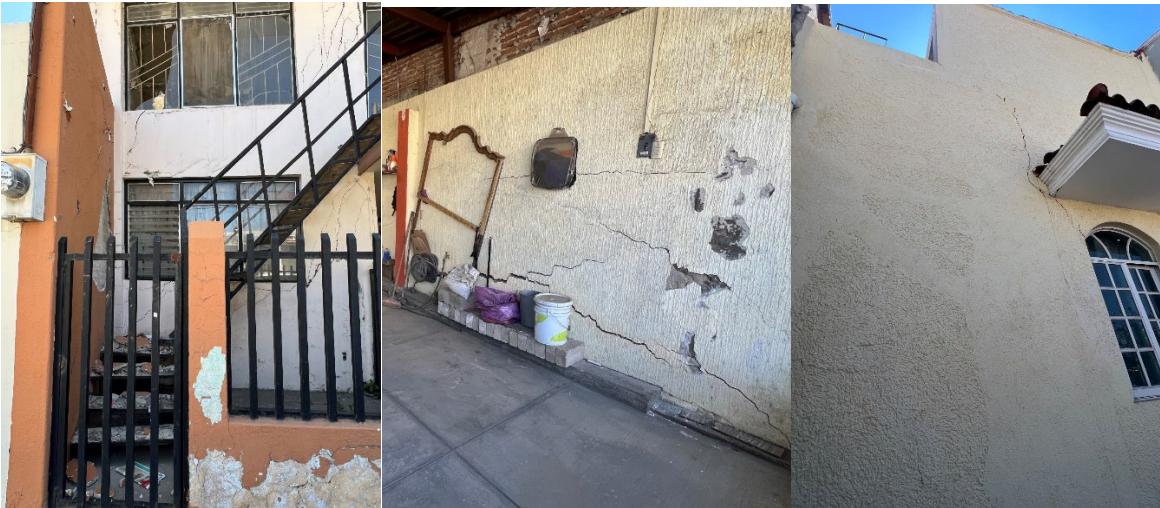
Figure 25. Severe damage in three continuous houses with extensive cracking on walls, floor lifting, and tilt of columns, Ciudad Guzman, Jalisco.
Waypoint Station 36 (Coordinates: 19.709474°, -103.467275°)

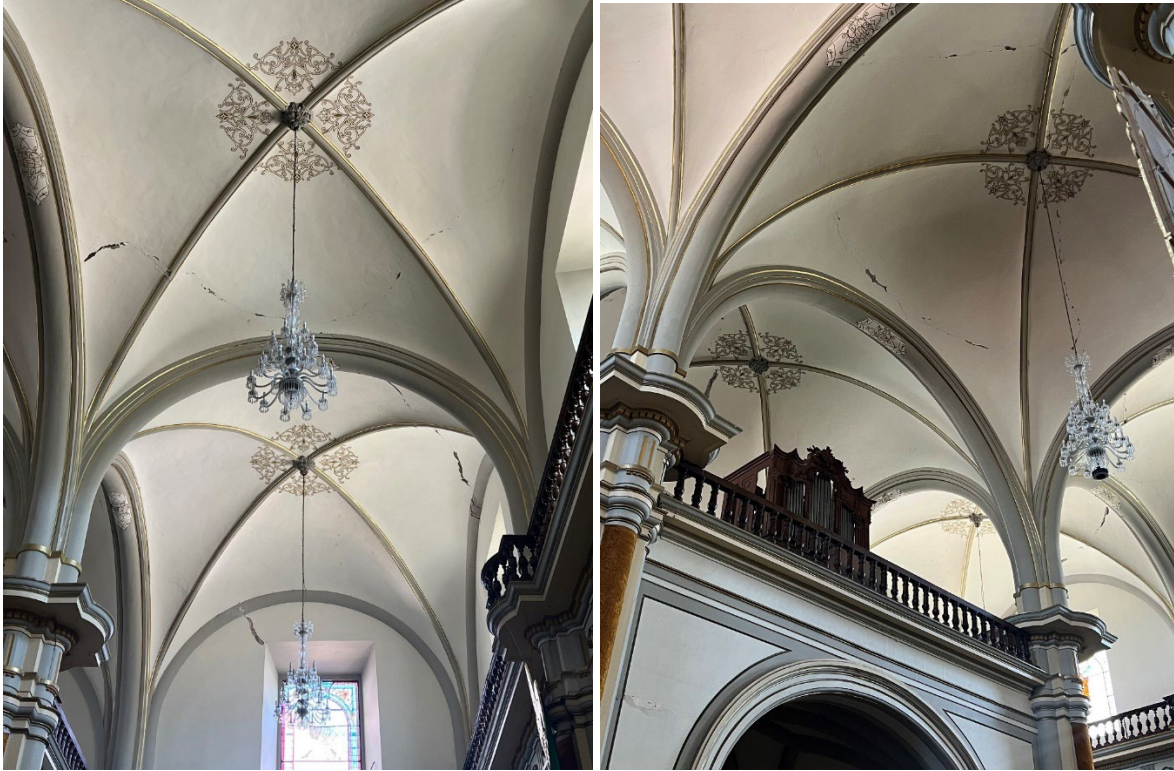
Figure 26. Roof cracking on church, Ciudad Guzman, Jalisco. Waypoint Station 37 (Coordinates: 19.703666°, -103.463191°)

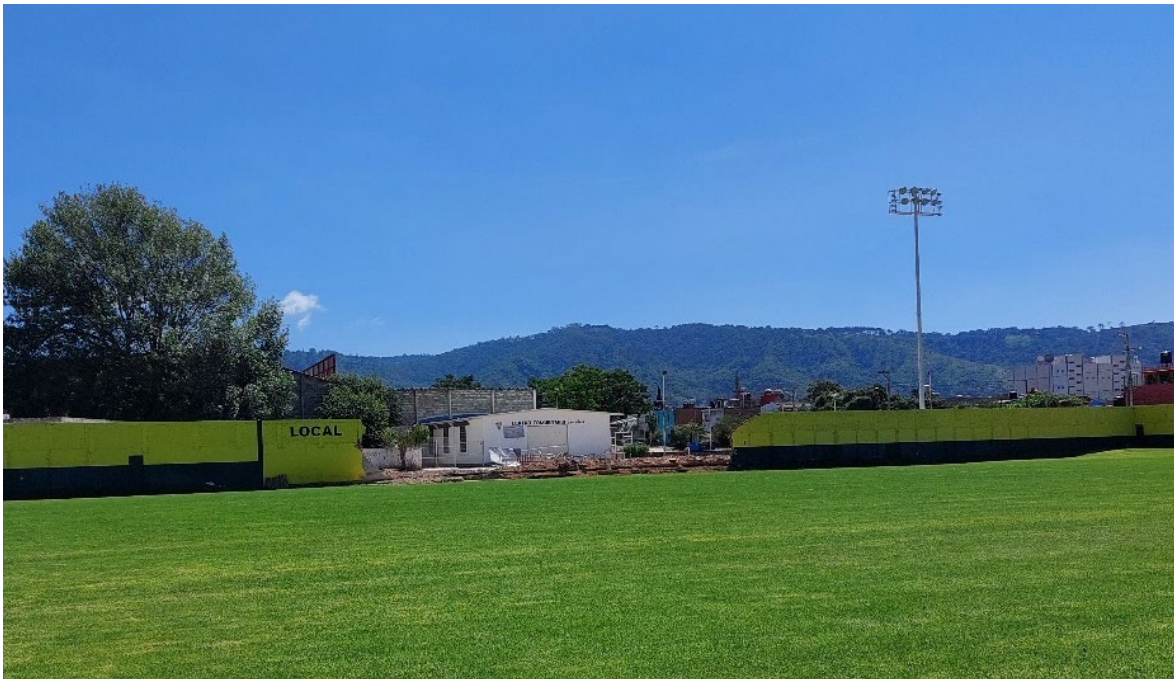
Figure 27. Partial collapse and cracking of perimeter wall of local stadium, Ciudad Guzman, Jalisco. Waypoint Station 38 (Coordinates: 19.702541°, -103.471109°)
