Turning Disaster into Knowledge

**GEOLOGICAL AND GEOTECHNICAL ENGINEERING
RECONNAISSANCE OF THE SEPTEMBER 19, 2022,
MICHUACAN EARTHQUAKE, MEXICO**

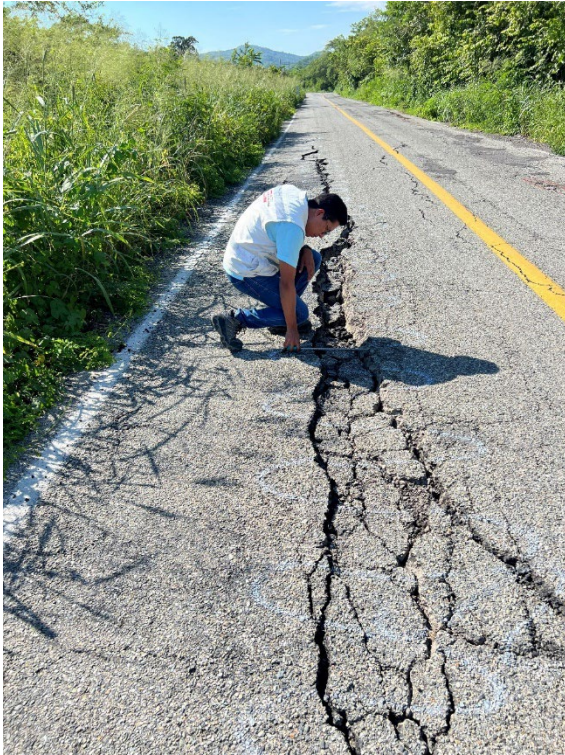
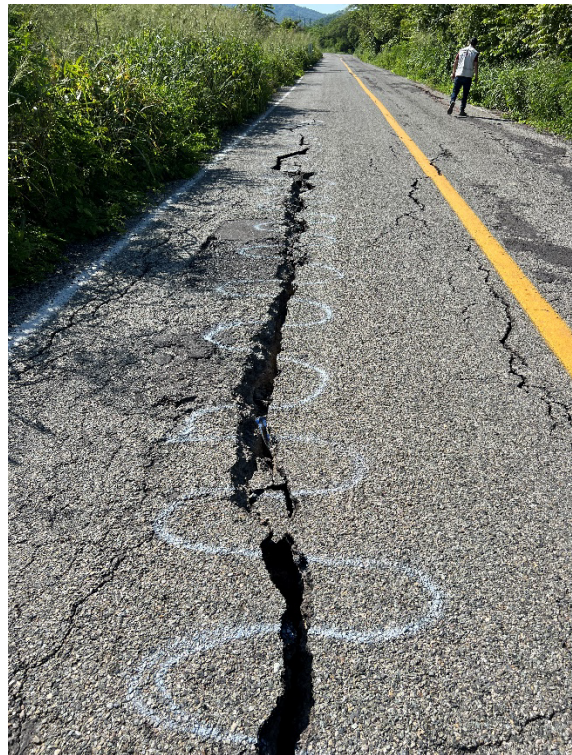
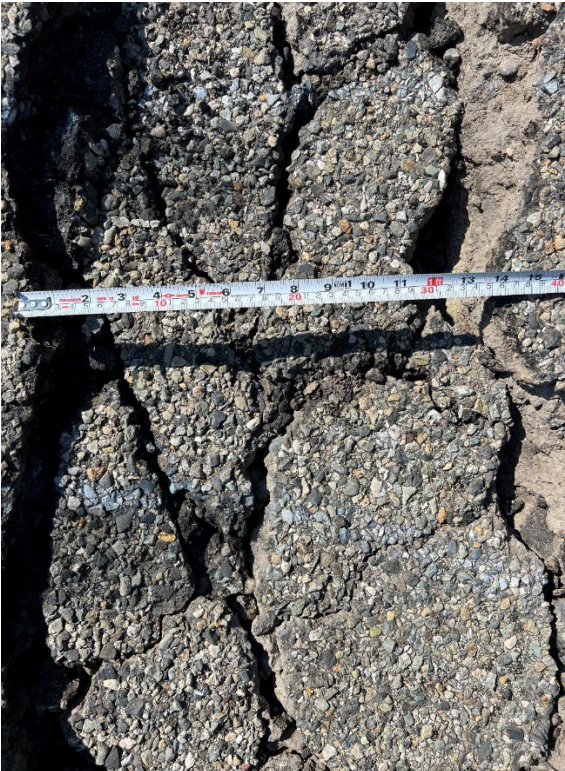
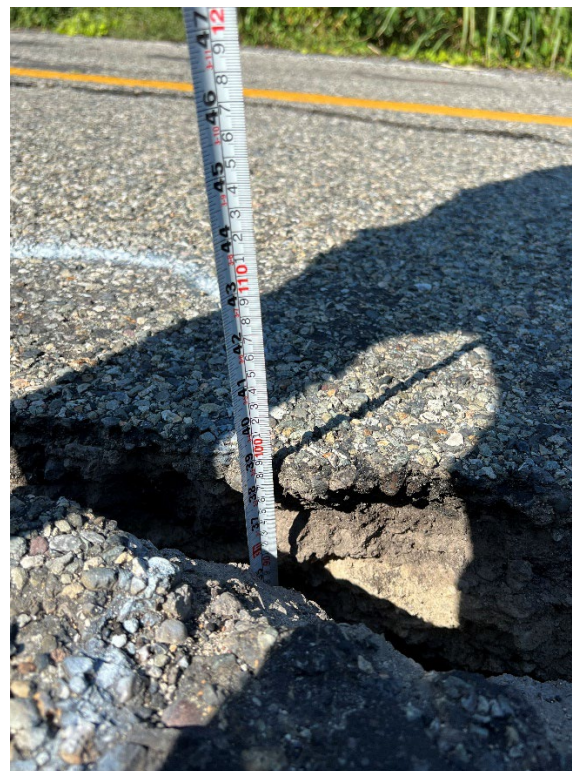
Minor damage in the form of cracking was noted along roads and highways within 50 km of the epicenter. Near the epicenter in Maruata, Michoacan, severe longitudinal cracking was detected on the road due to lateral movement. On average, the observed cracks were 6 m long, 38 cm wide, and 100 cm deep. Figure 28a depicts the road conditions before the earthquake; Figure 28b shows the conditions observed by the reconnaissance team.

Figure 28b. Severe longitudinal cracking on road due to lateral expansion, Maruata, Michoacan. Waypoint Station 27 (Coordinates: 18.282195°, -103.358294°)

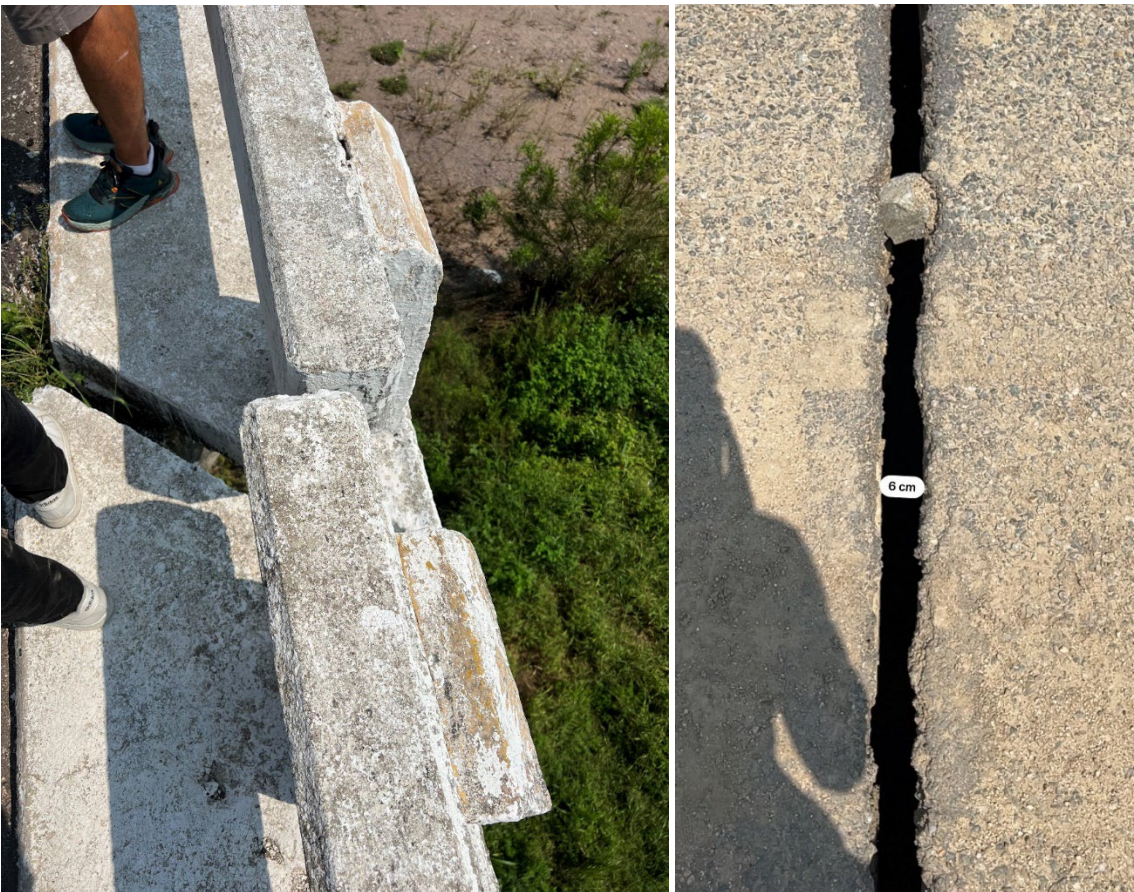
Figure 29. Gap of joints in decks of the bridge and lateral displacements, Campo Acosta, Jalisco.

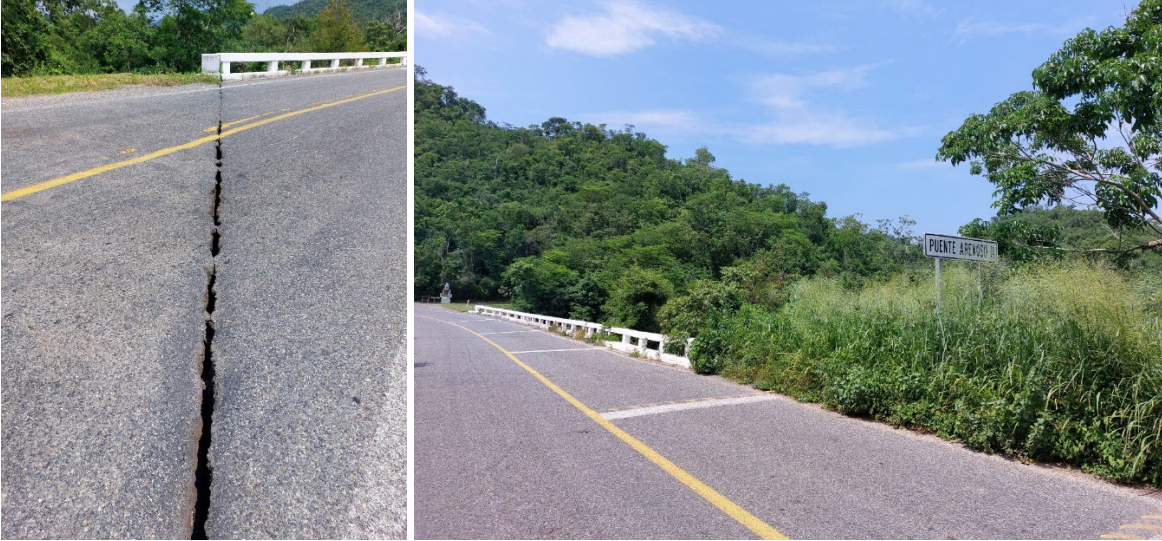
Figure 30. Gap of joints in decks of the bridge, Boca de Iguanas, Jalisco.
Waypoint Station 4 (Coordinates: 19.321026° , -104.817072°)

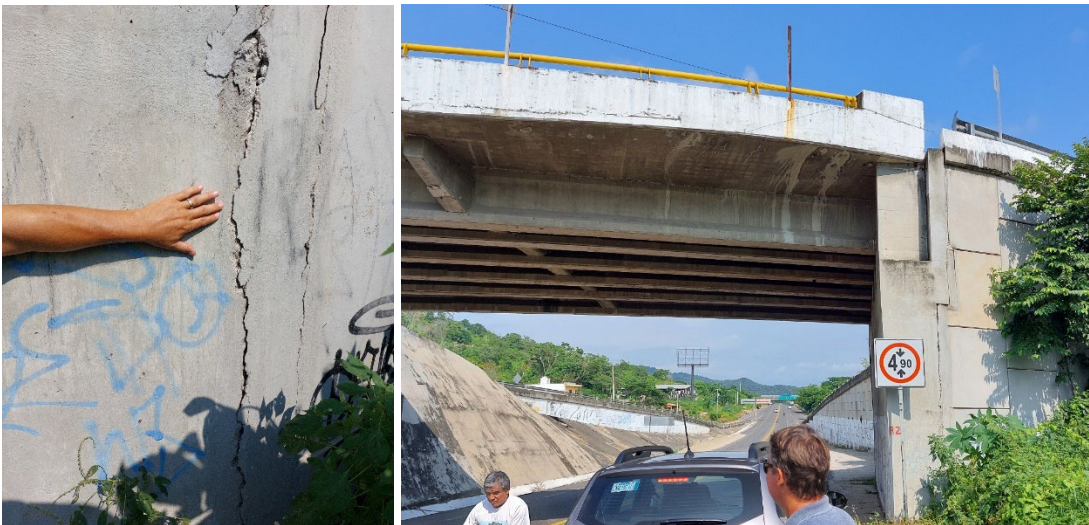
Figure 31. Vertical cracking in abutment of bridge, Boca de Iguanas, Jalisco.
Waypoint Station 6 (Coordinates: 19.125082° , -104.407973°)

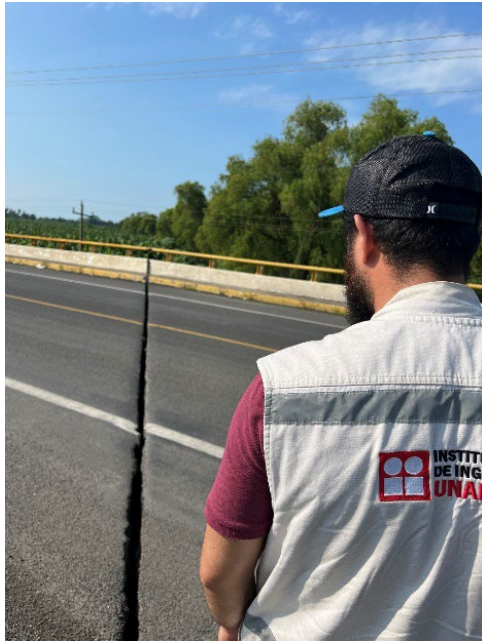
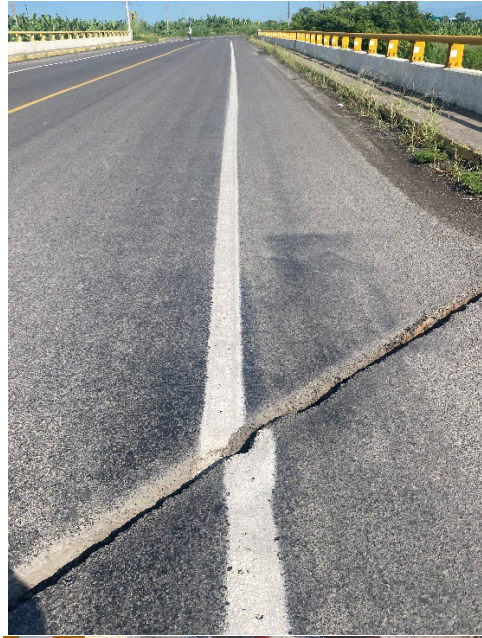
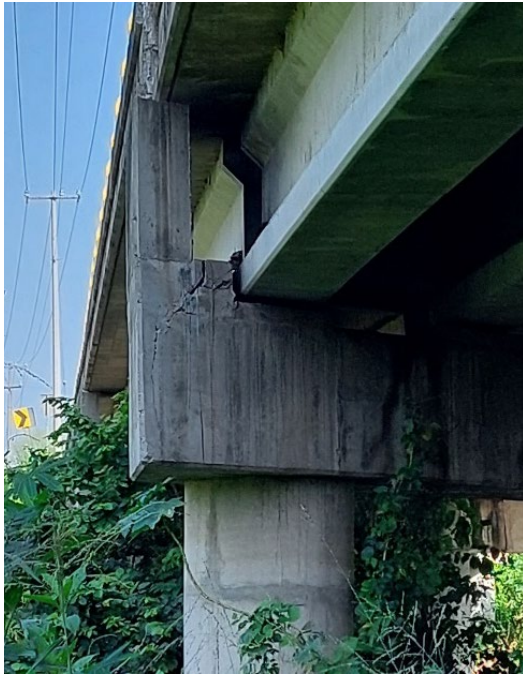
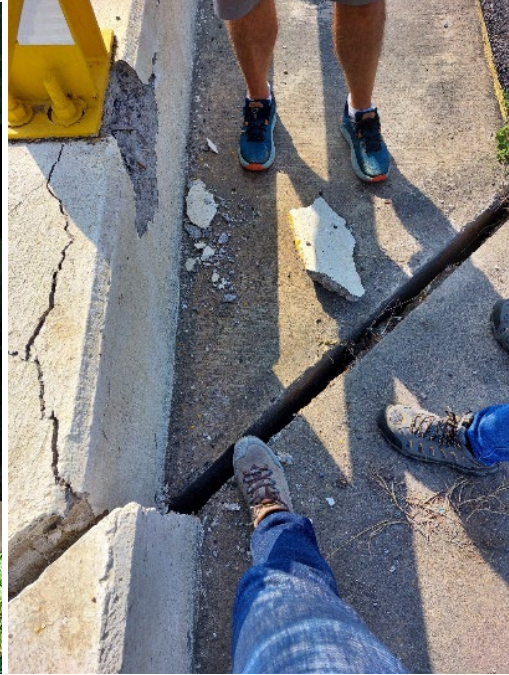
Figure 32. Lateral displacements of decks and damage in pier caps of bridge, Arturo Noriega Pizano, Colima. Waypoint Station 17 (Coordinates: 18.72438°, -103.722248°)

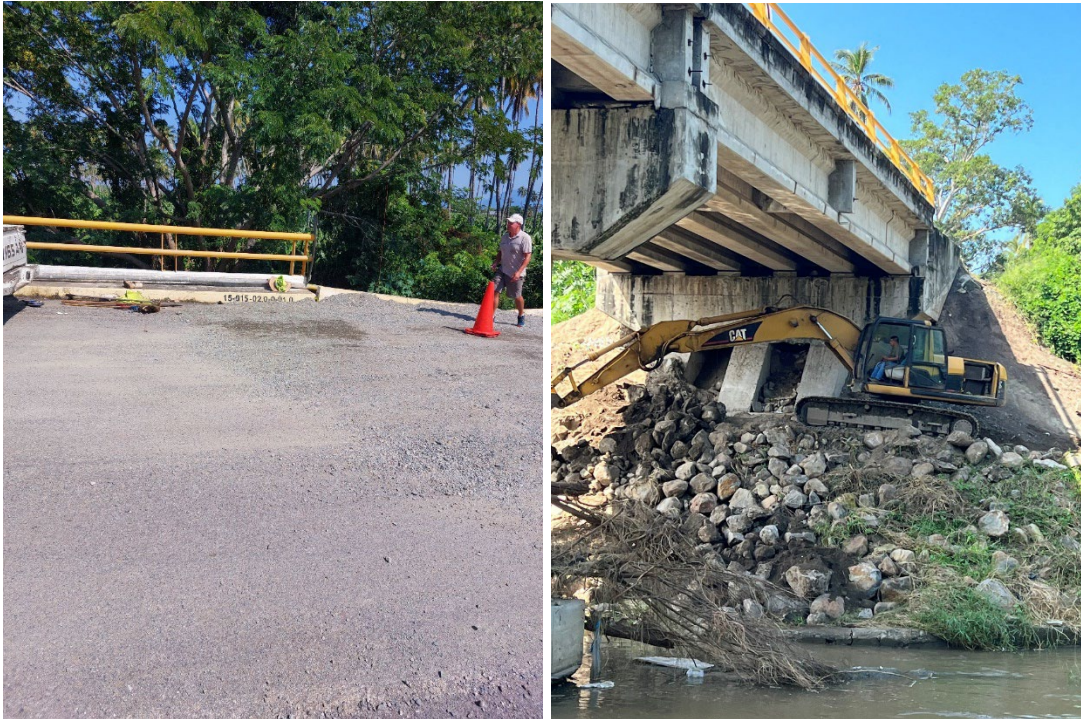
Figure 33. Lateral displacements of decks with damage in pier caps of the bridge and rotational failure of abutment, El Ticuiz, Michoacan. Waypoint Station 19 (Coordinates: 18.670031°, -103.681472°)

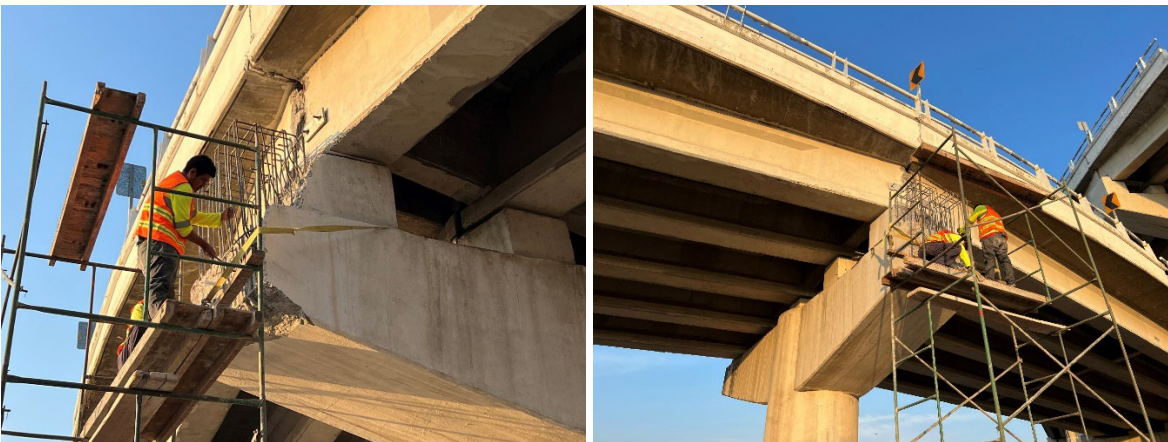
Figure 34. Lateral displacements of decks and damage in pier caps of bridge, Colima, Colima. Waypoint Station 31 (Coordinates: 19.213032°, -103.739473°)

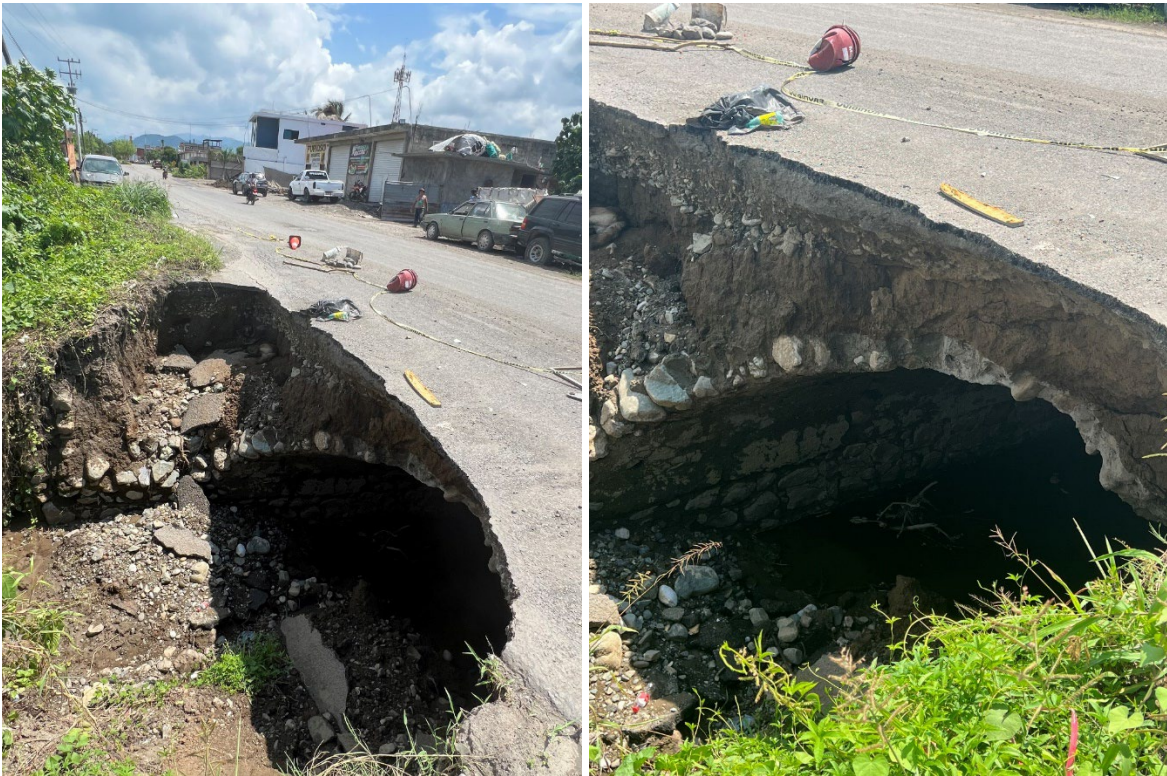
Damage to the sewer culvert, shown in Figure 35, was observed in Coahuayana, Michoacan. The damaged culvert was made of stones in mortar packed with fine materials. On average, the culvert was 8 m long, 4 m wide, and exhibited an artificial fill cover of approximately 1 m. The partial collapse of the entrance of the culvert affected the road to the center of town.

Figure 35. Collapse of the entrance of culvert made of masonry, Coahuayana, Michoacan. Waypoint Station 21 (Coordinates: 18.684114°, -103.669303°)

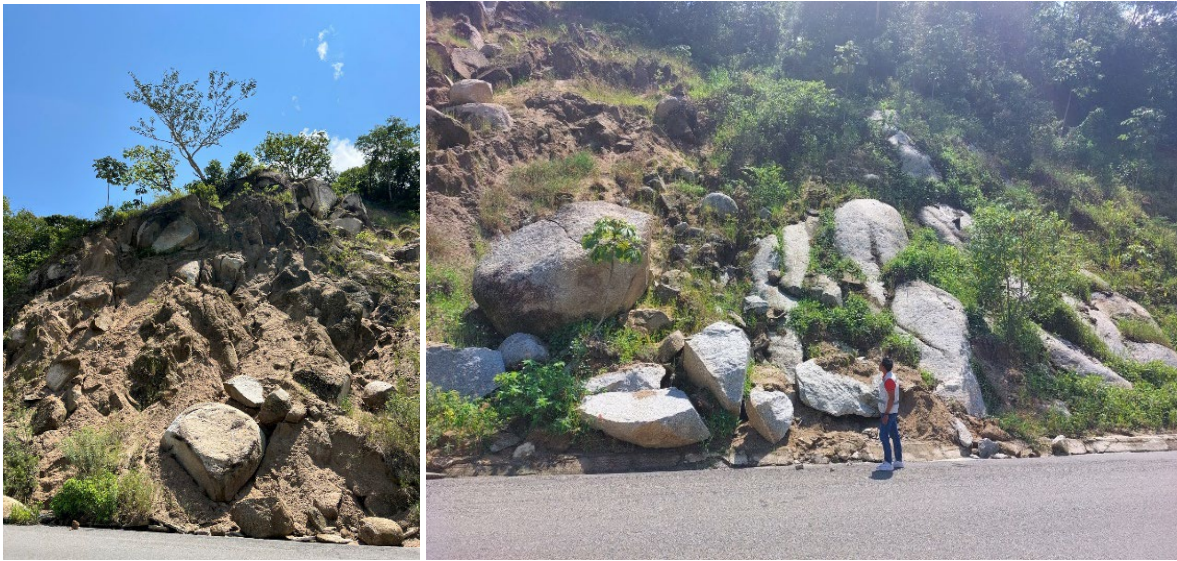
Figure 36. Rockfalls on cutting slope along the road, El Cono, Jalisco.
Waypoint Station 1 (Coordinates: 20.240086°, -105.320644°)

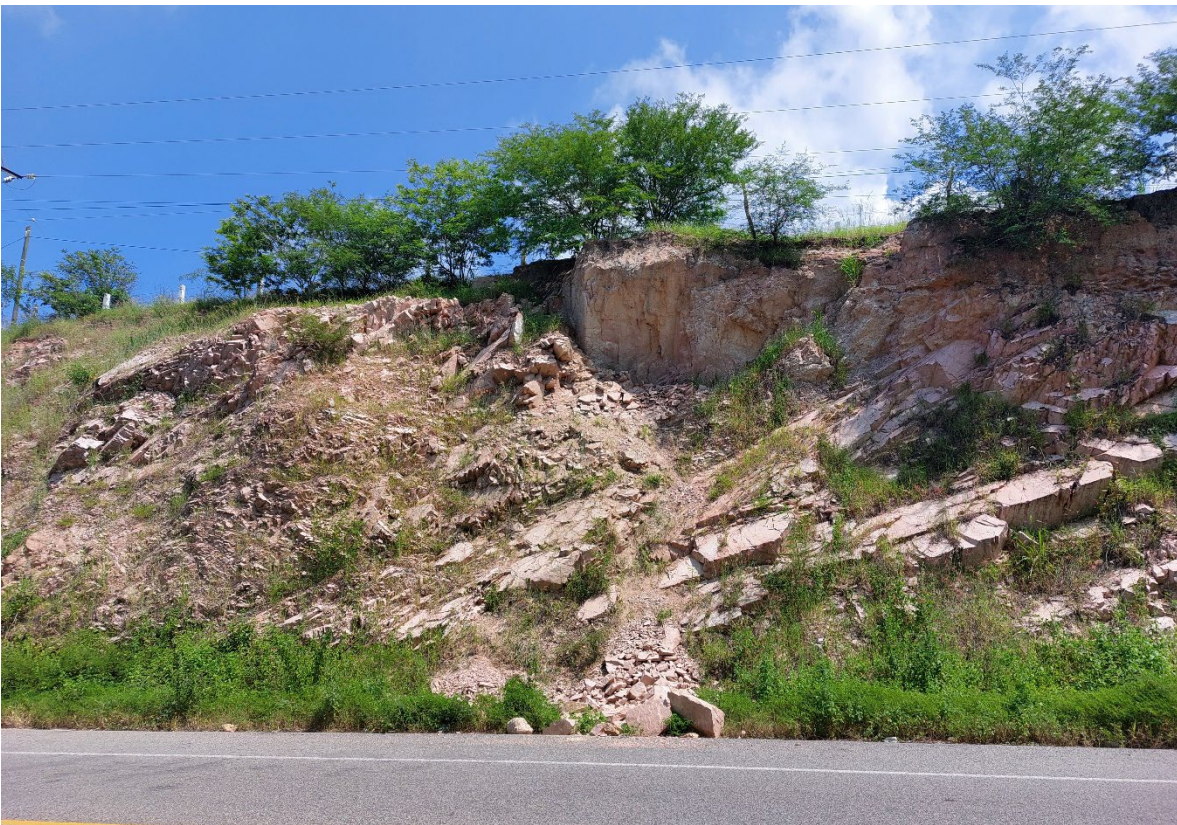
Figure 37. Rock wedge failure on cutting slope along the road, La Cumbre, Jalisco.
Waypoint Station 2 (Coordinates: 19.860358°, -105.323112°)

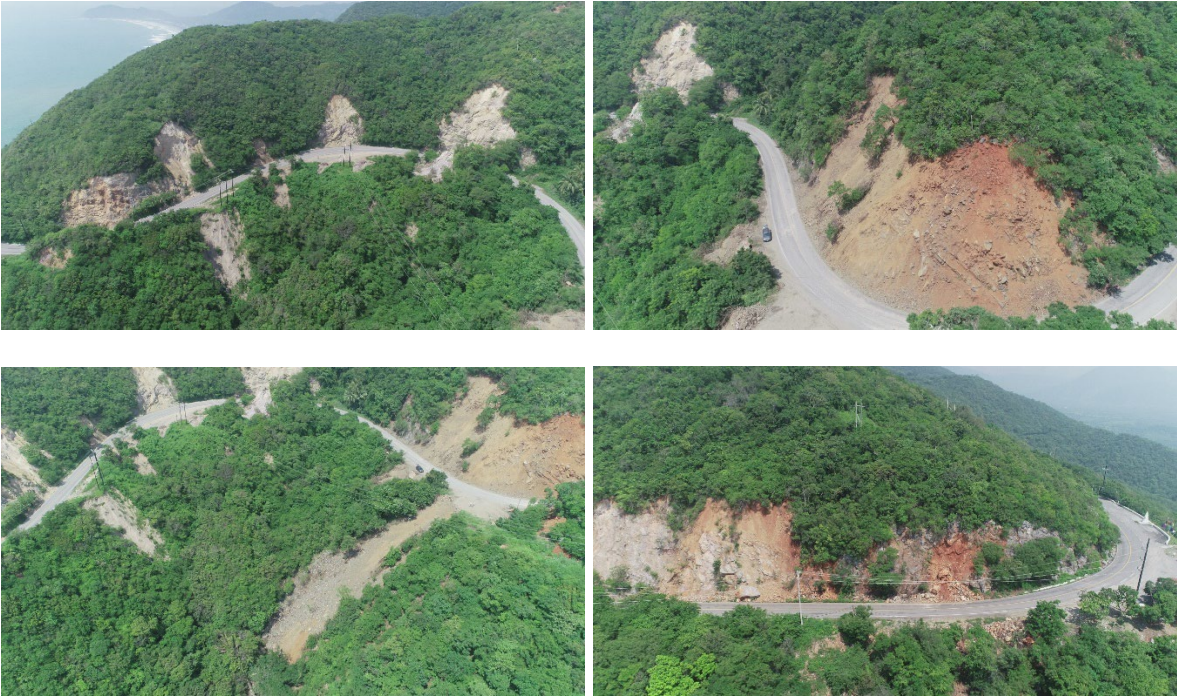
Figure 38. Multiple rockfalls and landslides on cutting slopes along the road, Las Brisas, Michoacan. Waypoint Station 23 (Coordinates: 18.566463°, -103.65394°)

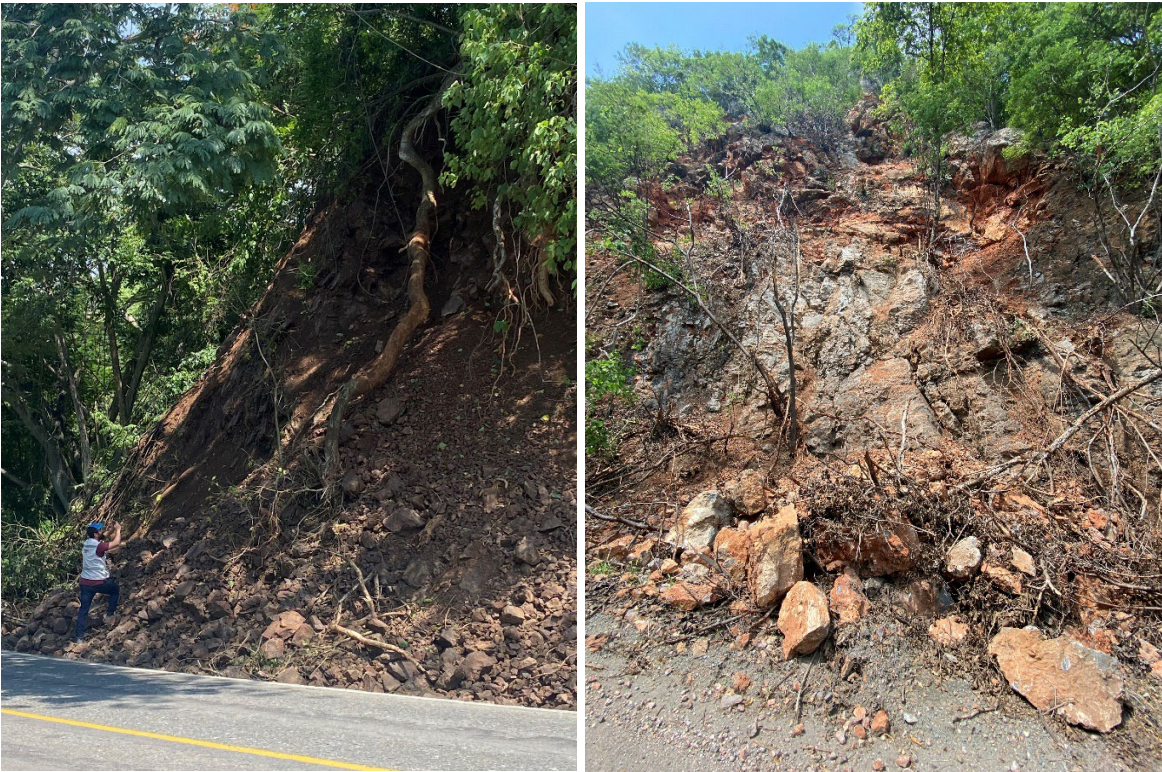
Figure 39. Rockfalls near Las Brisas, Michoacan. Waypoint Station 24 (Coordinates: 18.563754°, -103.646552°)

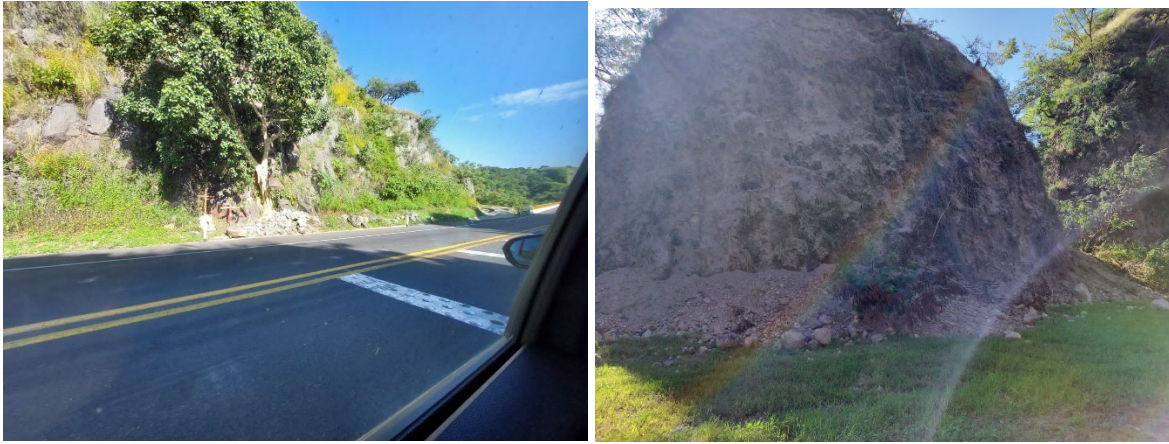
Figure 40. Rockfalls on cut slope along the road, Pialla, Jalisco. Waypoint Station 34 (Coordinates: 19.452558°, -103.469476°)

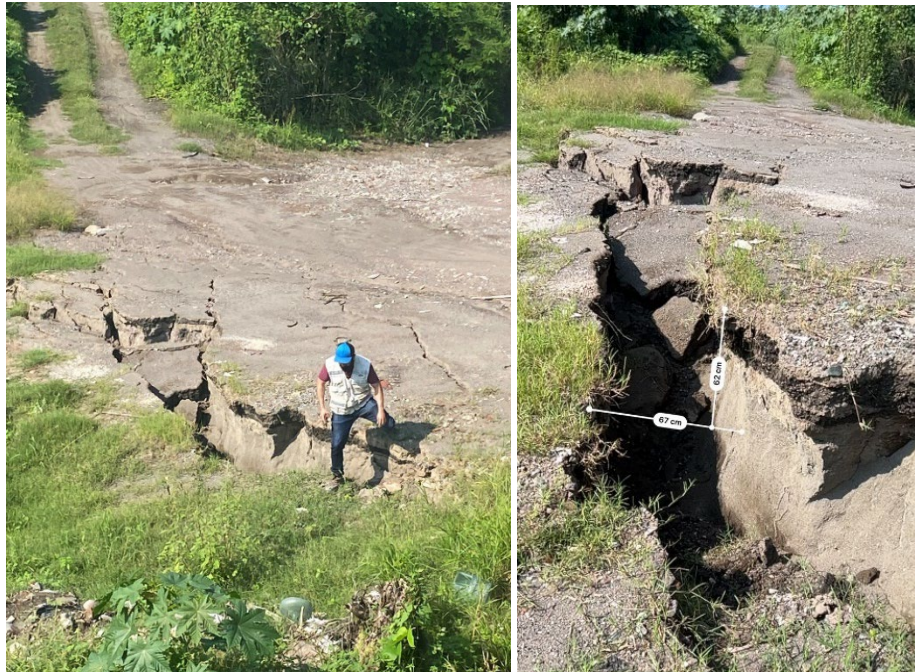
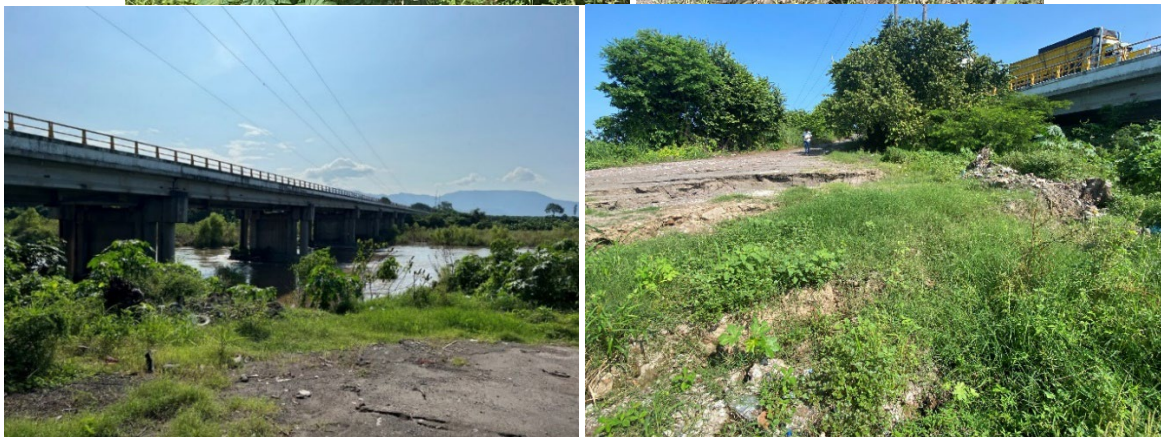
Evidence of liquefaction was noted in La Zapotera, El Ticuiz, Ixtapilla, and Maruata in the states of Colima and Michoacan. Liquefaction was demonstrated by lateral spreading features as well as sand boils and sand blows along open fissures. These effects are shown in Figures 41 to 44. The liquefaction was preceded near the coast in beach sands, along riverbeds, and natural levees. Lateral spreading occurred at sites with a natural slope or a nearby free face. A social media (Twitter, 2022) video was posted immediately after the earthquake in Coahuayana, Michoacan, about 50 km northeast of the epicenter, where a beach had been shattered into numerous elongate fractures and fissures stretching several hundred meters parallel to the coast (Figure 46). The feature was interpreted as caused by lateral spreading of the beach sands. The reconnaissance team used the UAV to look along the stretch of beach where the failure occurred, but these perishable features had been eroded by the incoming tides and waves prior to our visit. However, numerous other lateral spread features were observed further south along the same beach (Figure 43). Failure of a natural levee due to lateral spreading was found in La Zapotera, Colima (Figures 41 and 42). The lateral extent of the affected area is shown on Figure 42, in which red hash marks cracks and lateral displacement. The lateral displacement created an open graben near the head of the failure that had a lateral displacement of about 67 cm and vertical displacement of around 60 cm.

The cumulative lateral displacement of the slope was on the order of two meters. The lateral spread did not appear to affect the nearby bridge.

Figure 41. Lateral spread feature affecting a road along a natural levee, La Zapotera, Colima. Waypoint Station 18 (Coordinates: 18.717472°, -103.716876°)

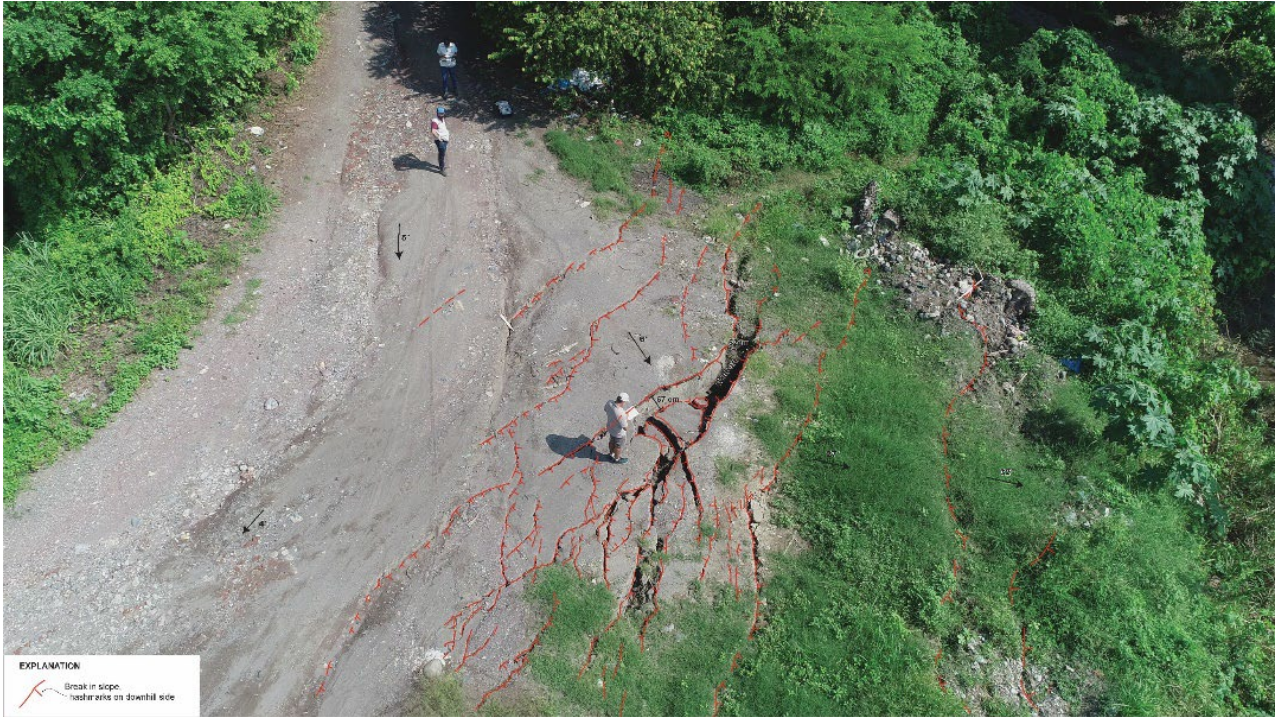
Figure 42. Lateral spread feature from Figure 41, La Zapotera, Colima. Red hash marks note cracks and lateral displacement of affected area. Waypoint Station 18 (Coordinates: 18.717472°, -103.716876°)

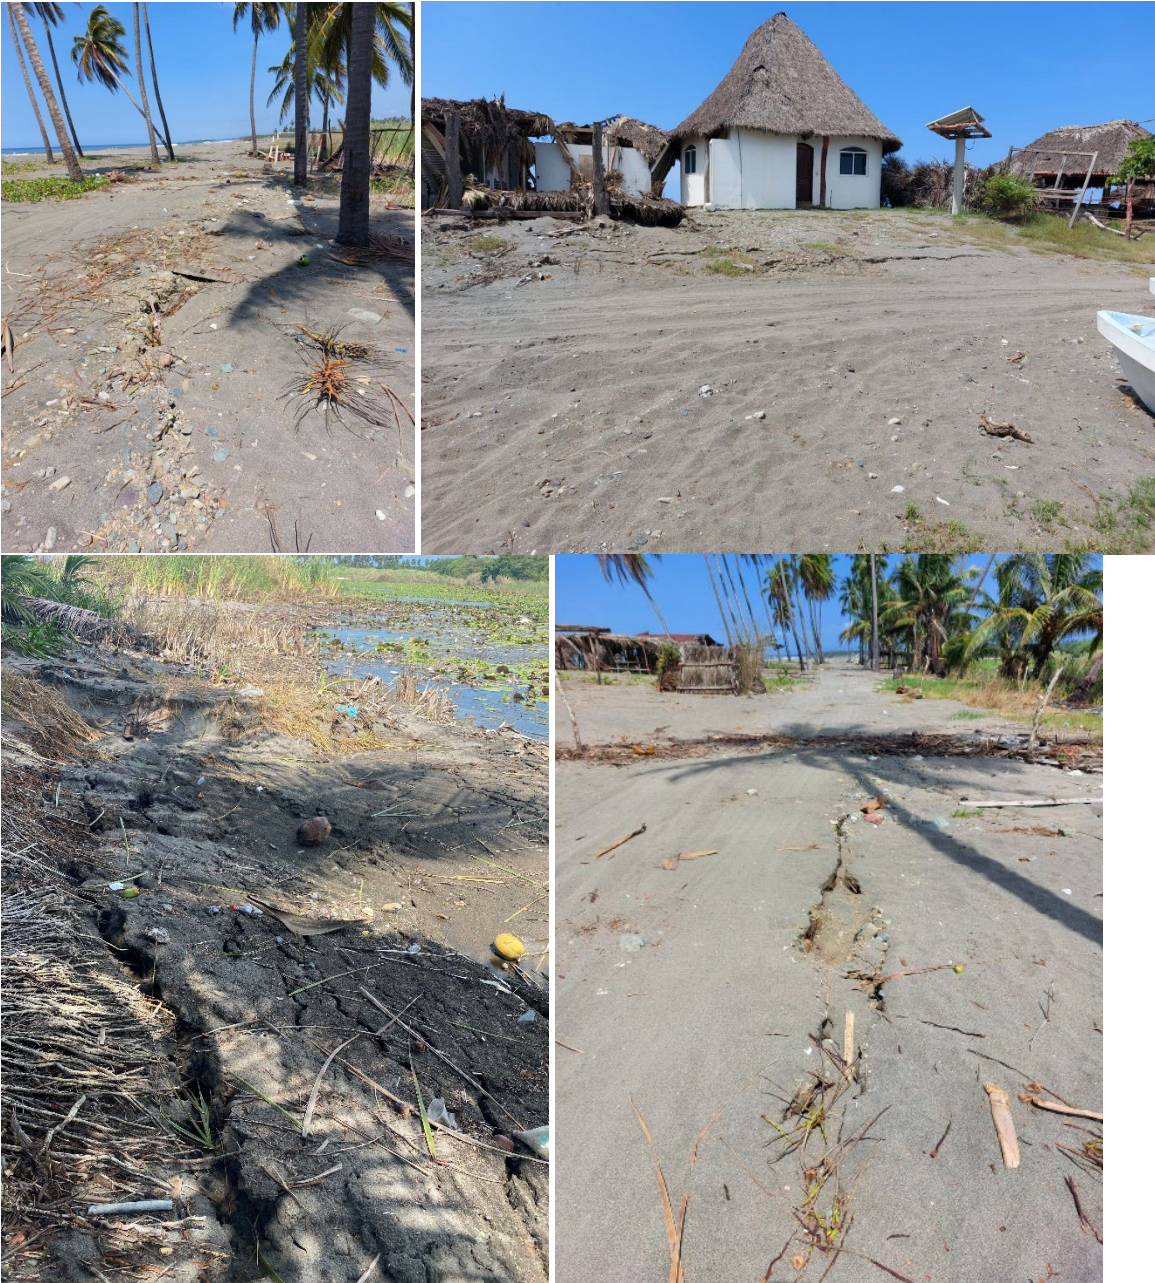
Figure 43. Lateral spreading in beach sands due to liquefaction, El Ticuiz, Michoacan. Waypoint Station 20 (Coordinates: 18.653076°, -103.700458°)

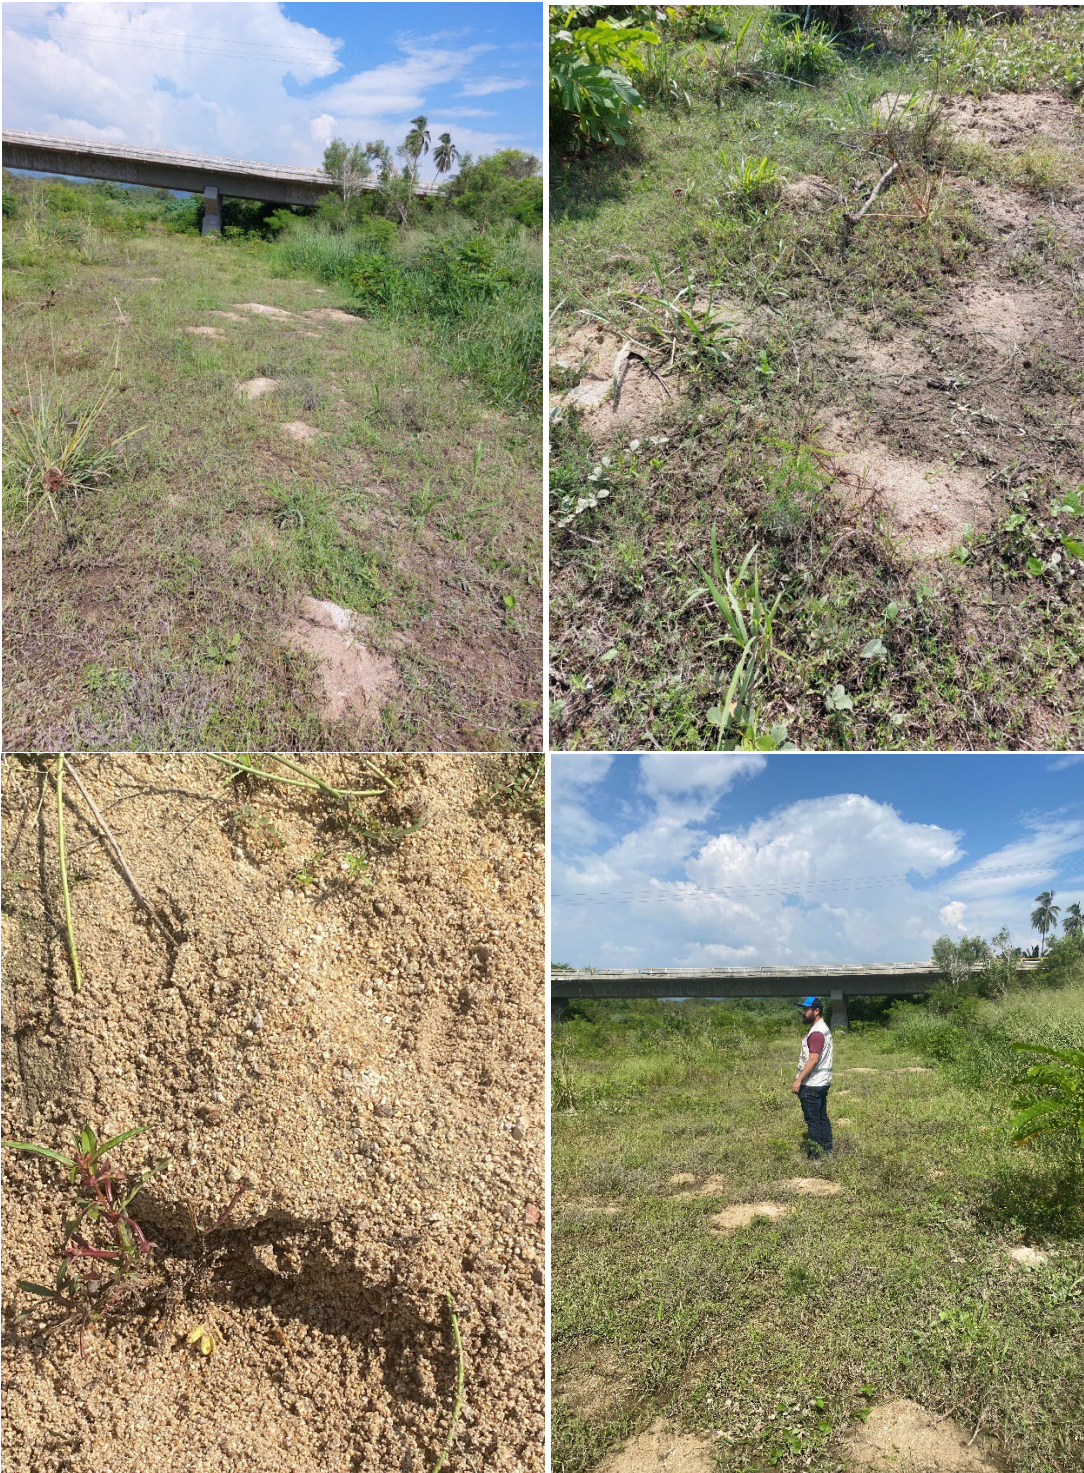
Sand boils or sand volcanoes were observed in a riverbed levee near Ixtapilla, Michoacan (Figure 44). The sand was ejected from points along a linear natural levee and buried nearby vegetation. There were over a dozen sand boils total, all with similar volumes of ejecta (<1 cubic meter). Fissures were evident near the sand boils but no ejecta from the fissures was observed.

Figure 44. Sand boils (sand volcanoes) in a riverbed. The sand was ejected from points along a linear natural levee and buried nearby vegetation, Ixtapilla, Michoacan. Waypoint Station 25 (Coordinates: 18.41615°, -103.532373°)

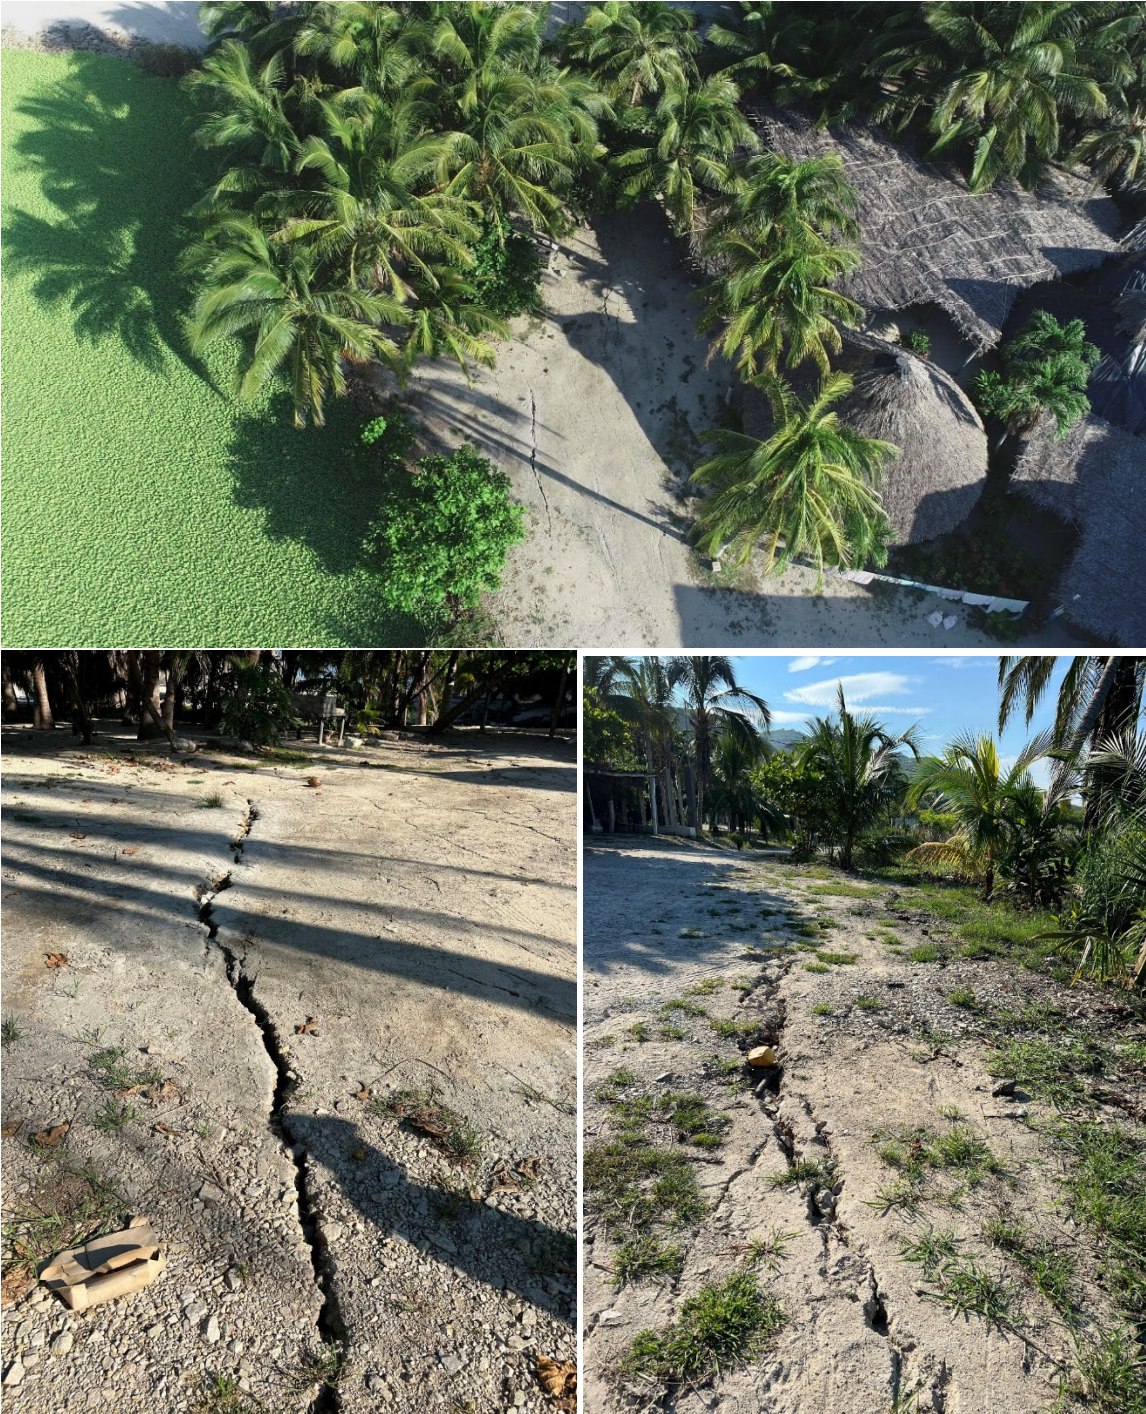
Sand blows along fissures were observed along a back beach in Maruata, Michoacan (Figure 45). The fissures covered an area of approximately 200 sq. m and were on the order of 5 to 10 m long with lateral displacements of 5 to 15 cm. Sand ejecta was noted as having flowed from several of the fissures. Locals reported sand ejecta spouting as high as 1-2 m and continuing well beyond the duration of earthquake shaking.

Figure 45. Lateral spreading and cracking in rural roads due to liquefaction, Maruata, Michoacan.

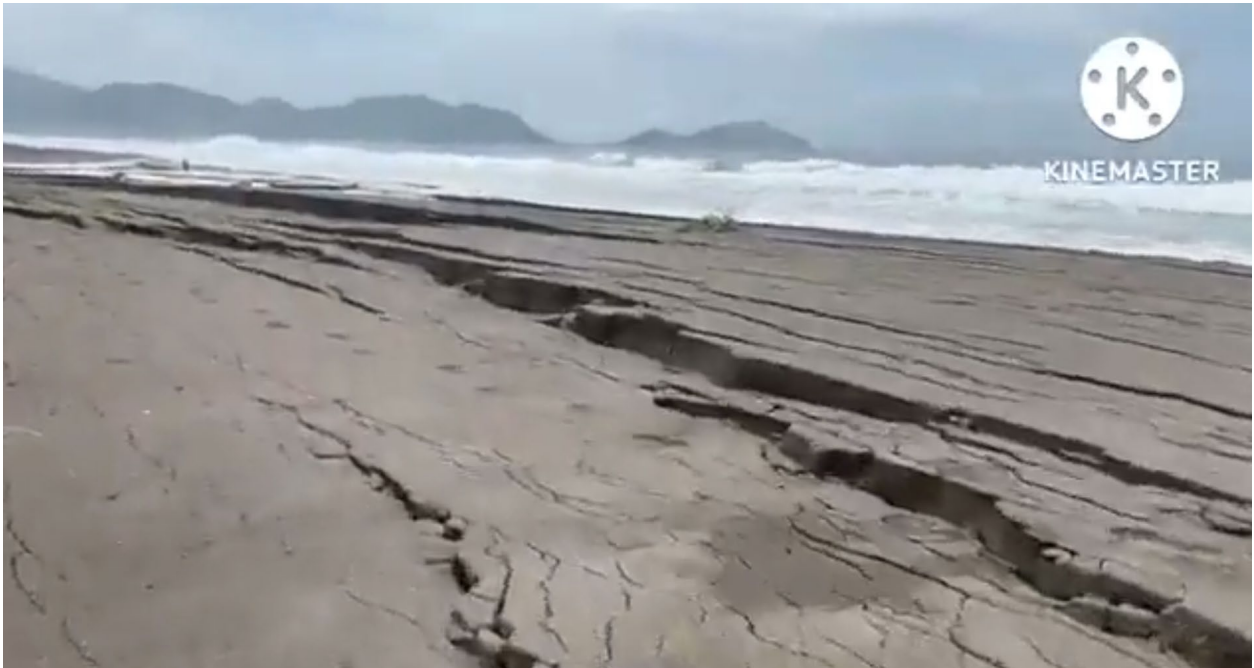
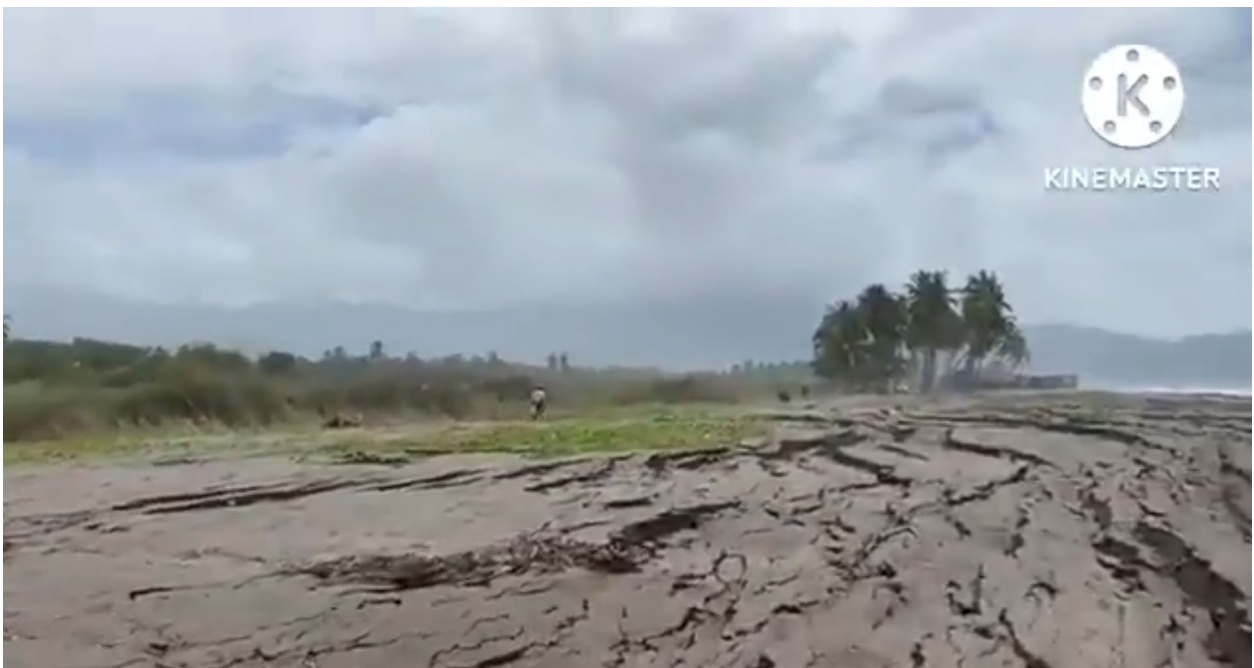
Figure 46. Lateral spreading in beach deposits near Coahuayana, Michoacan immediately after the earthquake (Twitter, 2022). These perishable features were eroded by the tide and waves prior to our visit.
