**THE GEOTECHNICAL ASPECTS OF THE
CENTRAL TEXAS FLOODS OF MAY 23-25, 2015**

Report of the NSF Sponsored GEER Association Team

GEER Association Report No. GEER-039

Version 1: June 12, 2015

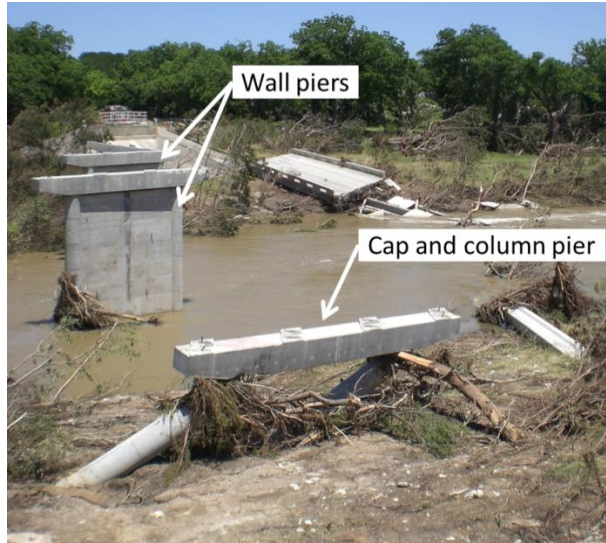
The county-maintained Fischer Store Road/CR 181 Bridge crosses the Blanco River approximately 5 miles northeast of Fischer, TX (Figure 2, 30.000530°N, -98.200038°W). The entire five-span bridge superstructure was displaced off of the supports, and portions of the superstructure settled on the river banks just downstream from the supports (Figure 3). The bridge was supported by two wall piers in the middle of the river channel, and two cap and column piers located on the embankments along the river channel. The superstructure rested on elastomeric bearing pads, many of which were washed away during the flood. Lateral forces in the superstructure were transferred to the substructure via shear pins, located only at the exterior girder supports. Significant plastic deformation of the shear pins was observed. There was no apparent mechanism provided to accommodate uplift force transfer between the super- and sub-structures.

Figure 3. Fischer Store Road/CR181 Bridge (view from west abutment)

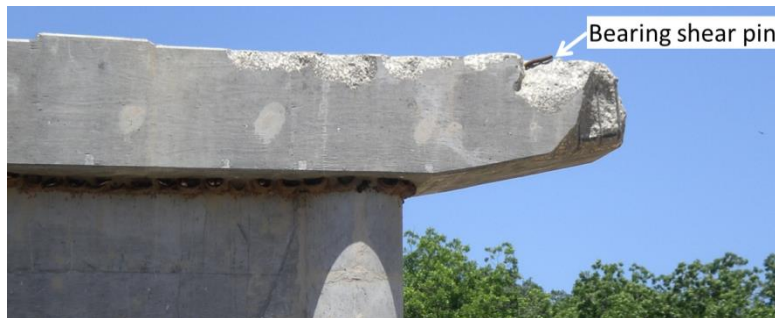
The wall piers appeared to have minimal damage. Damage was primarily observed in the cover concrete along the downstream edge of the pier cap (Figure 4) and is believed to have occurred as the girders were being pulled off the supports. Both cap and column piers were severely damaged, with the most severe damage being in the western bent. Hinging and complete section failures were observed at the construction joints between the columns and the bent cap, as indicated by the smooth surface in the failed cross-section (Figure 5a). The longitudinal bars in the column partially pulled out of the bent cap. In the downstream column in the western bent, several of the longitudinal bars fractured. The base of the columns/top of drilled shafts appeared to have rotated rigidly due to soil failure (Figure 5b). Soil was removed near the top of the foundation, and no signs of hinging were observed in the few feet of the drilled shaft just below the soil surface.

Figure 4. Damage to wall piers

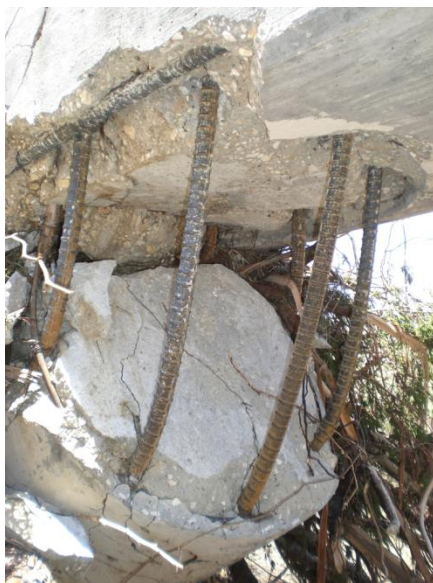
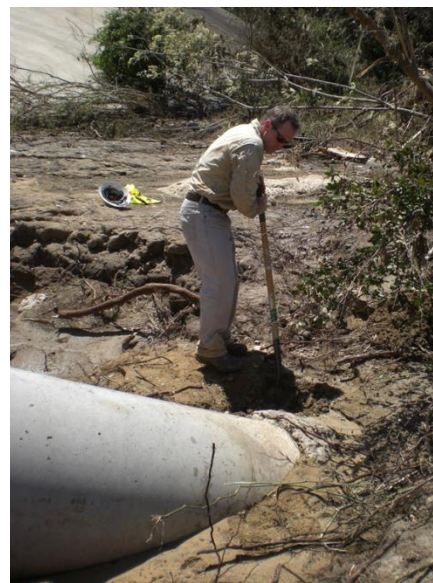
Figure 5. Damage to western bent: (a) hinging at top of upstream column and (b) rigid body rotation at foundation

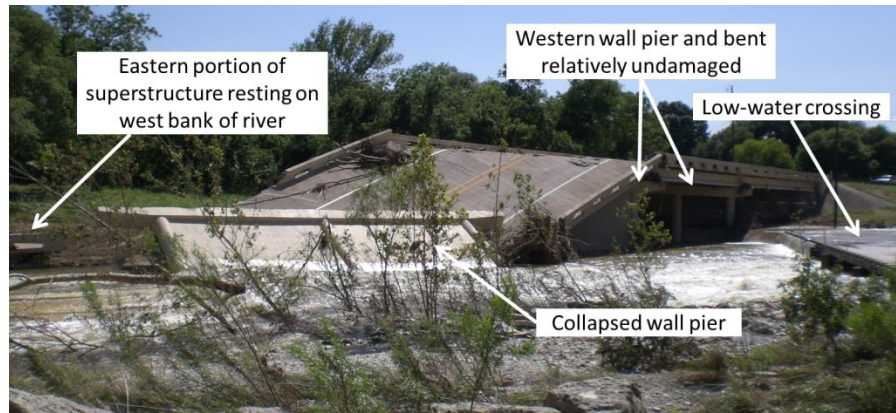
During the flooding, the superstructure along the eastern portion of the bridge was carried downstream a short distance and the three wall piers under this section of the bridge collapsed (Figure 7). One of the wall piers was resting on the collapsed superstructure (Figure 7), so it appears that the superstructure collapsed before the piers. The failure at the eastern-most wall pier was observed to be net section failure along the base of the pier (Figure 8a). The piers were placed on drilled shaft constructed directly in limestone. The web regions of the walls did not appear to have any reinforcement embedded in the limestone, whereas longitudinal bars from the drilled shafts were embedded in the pier columns above. All of the bars passing through the column-to-pile interface were fractured. As shown in Figure 8b, the column longitudinal bars appear to have been spliced just above the foundation interface, which may have contributed to the failure of the critical section at the foundation interface. Although the other collapsed wall piers were still under water at the time of observation, they are believed to have failed in a similar manner. The two westernmost-bridge spans did not collapse but the girders comprising these spans were noticeably shifted from their original support locations (Figure 9). The rotations of these girders suggests that the shifting was associated with the washed out portion of the superstructure pulling the remaining portion of the superstructure as it traveled downstream.

Figure 7. View of RM 165 Bridge from the east

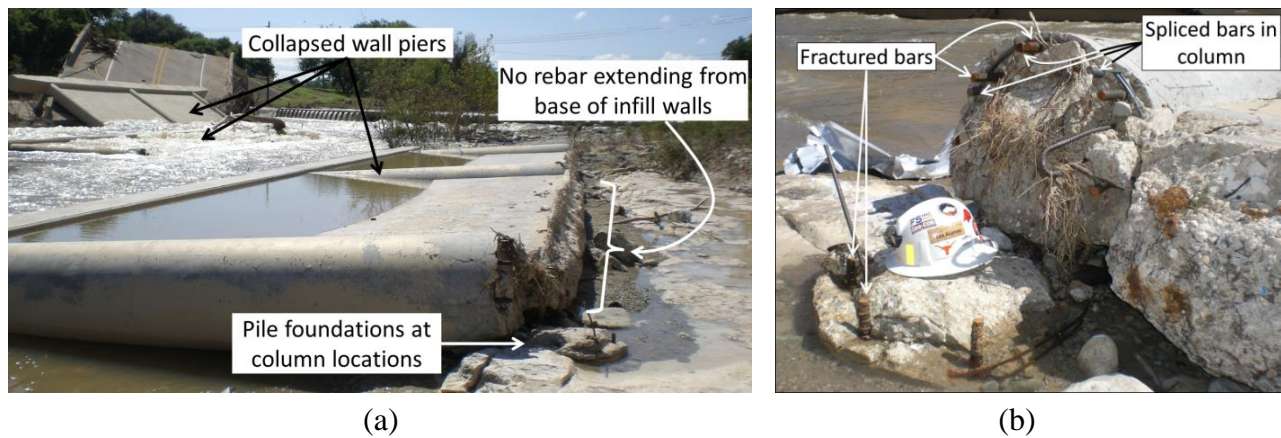
Figure 8. Collapsed wall piers. (a) section failure at base and (b) splice at base of pier columns

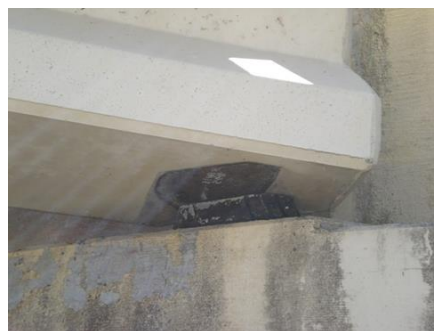
Figure 9. Shifting of girders at west abutment

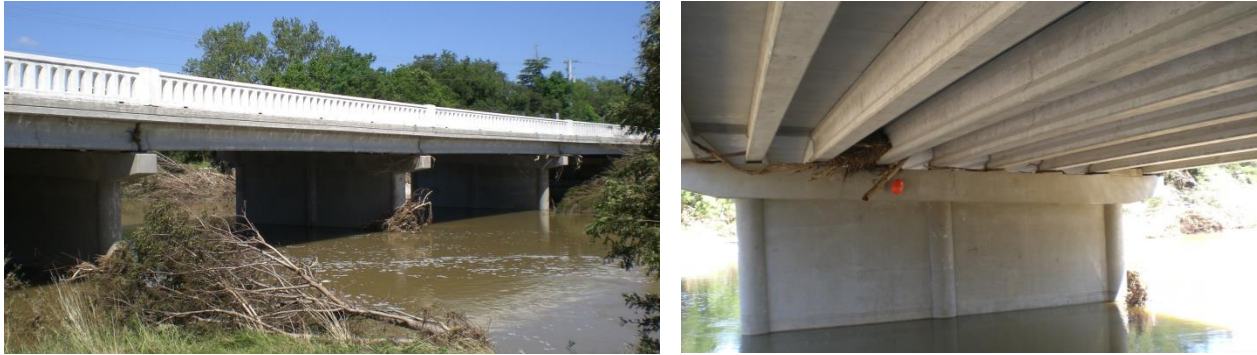
The LP 163 Bridge, built in 2002, was a little over 1 river-mile upstream from the RM 165 Bridge (Figure 2, 30.096229°N, -98.418153°W). The bridge was supported by three wall piers in the river channel (Figure 10). According to witnesses on site at the time of flooding, the bridge was completely overtopped during the flood; however, no significant post-event damage was observed.

Figure 10. LP 163 Bridge relatively undamaged

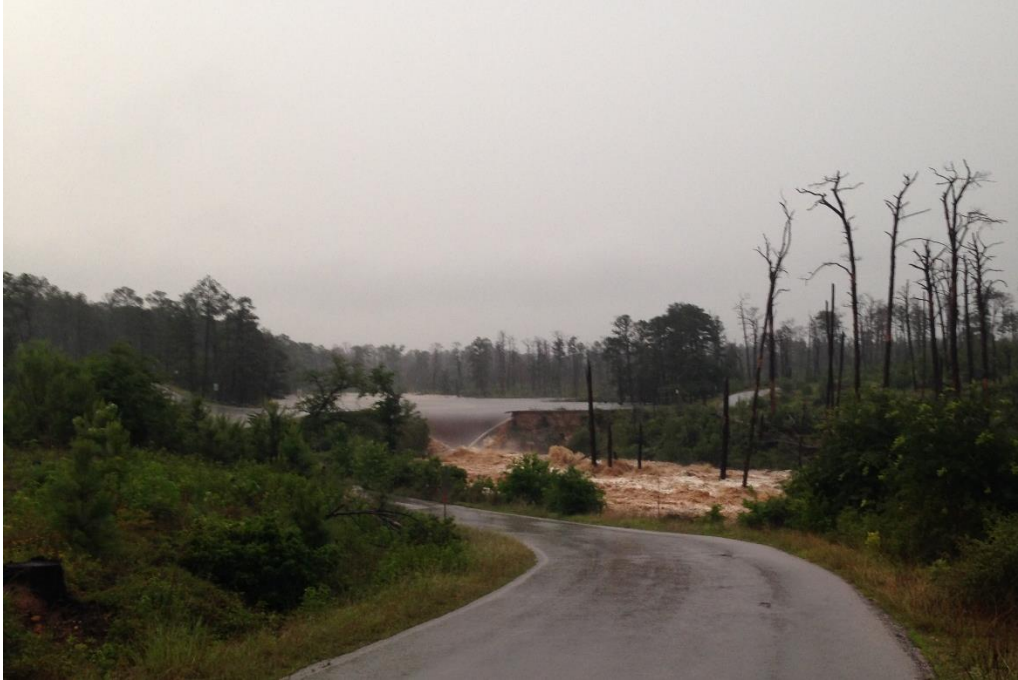
Figure 13. Water over-topping the dam at 6:48 PM on May 25, 2015
(photo from Greg Creacy, TPWD).

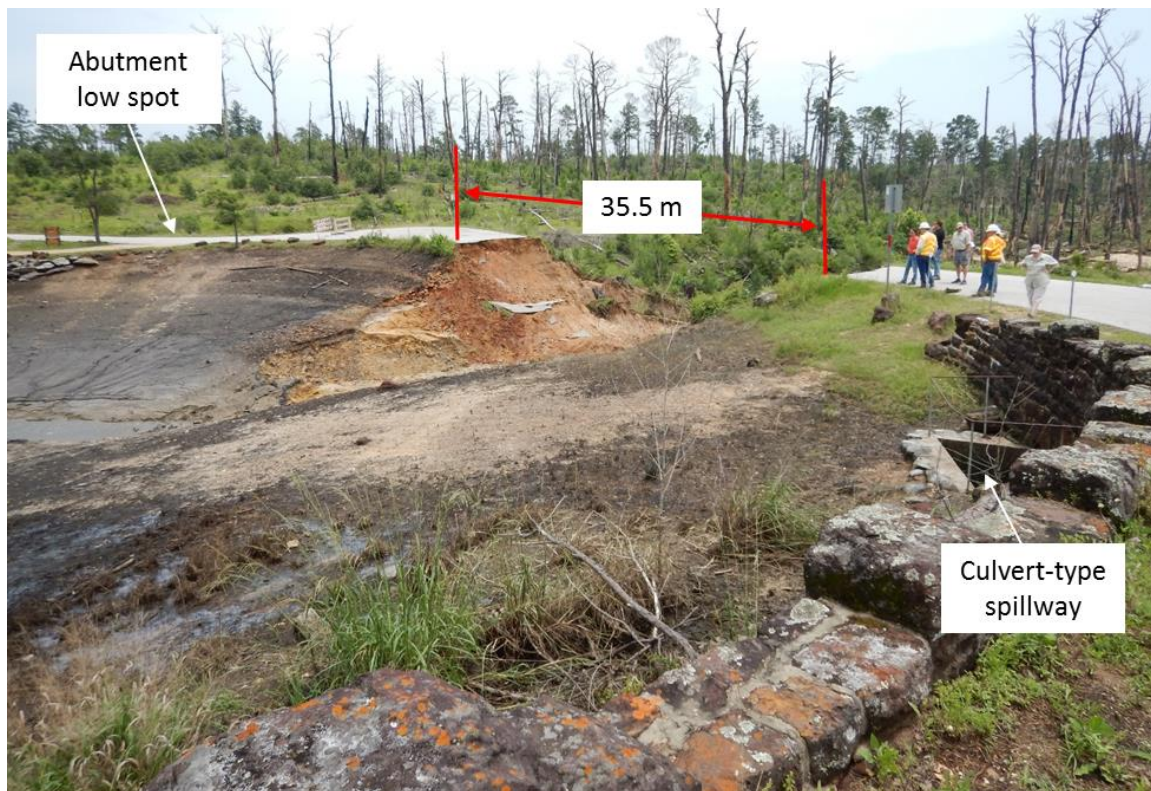
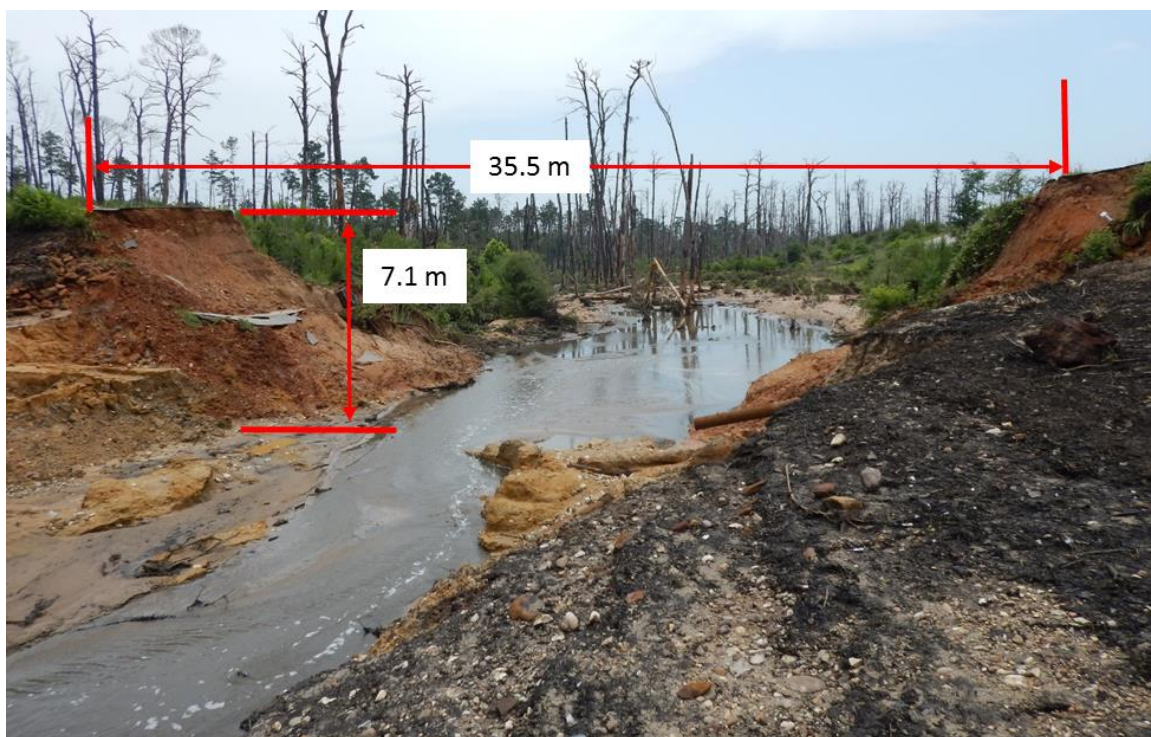
1. A section of the dam approximately 35.5 m wide was washed out during the flood. The depth of the failure was approximately 7.1 m (Figures 14 and 15). The three-dimensional geometry of the site on May 29 and a cross-section through the remaining section of dam on the east abutment are shown in Figure 16.

Figure 14. View of dam failure from upstream of the west abutment.

Figure 15. View of dam from upstream in the middle of the former lake.

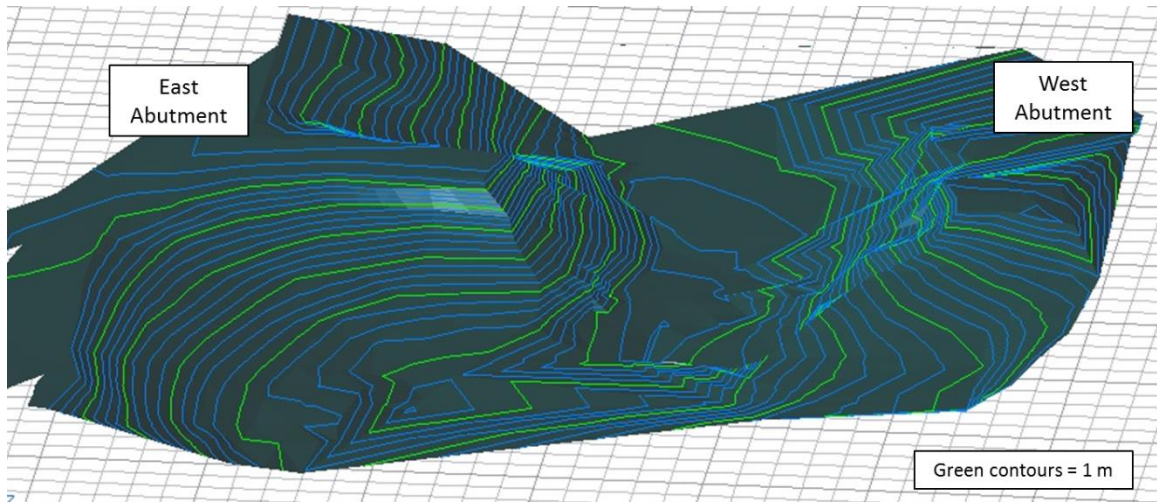
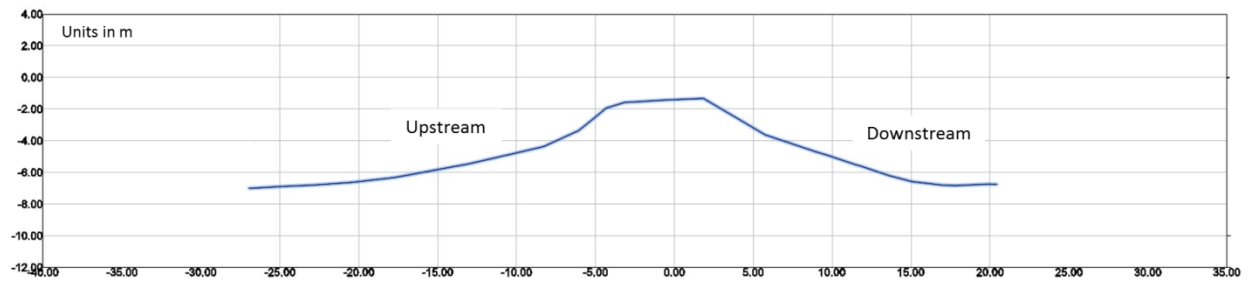
Figure 16. (a) 3D geometry of dam site after failure and (b) cross-section through east abutment.

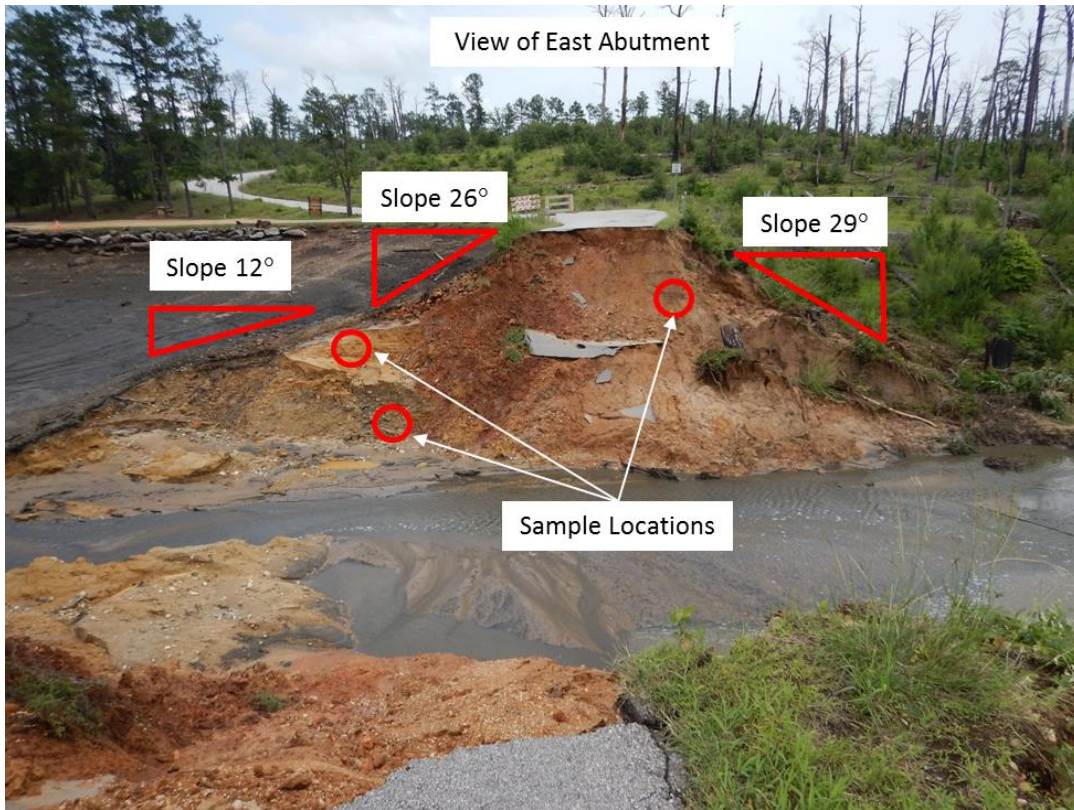
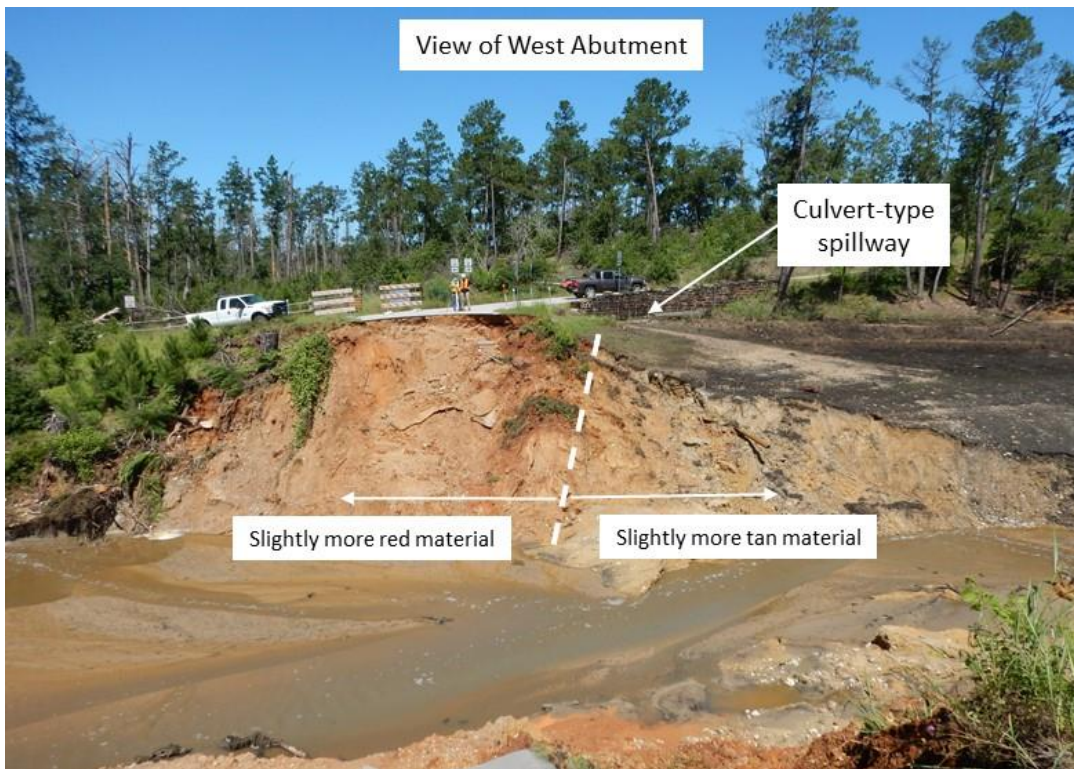
2. The topographic survey indicated that the remaining segments of the dam had an upstream slope of approximately 26 degrees near the crest and 12 degrees closer to the exposed lakebed. The downstream slope was approximately 29 degrees (Figure 17a). Halff Associates (2013) reported that both upstream and downstream faces were 1.7H:1V (30.5°), as inferred from a LIDAR survey performed in 2008.

3. There appeared to be no clear evidence of a clay/fine-grained core. Rather, the dam appeared to be constructed of clayey-sand soils that were only slightly different in color from one another: a slightly more tan material on the upstream slope, and a slightly more red material on the downstream slope (Figure 17b). At first glance, the east abutment appeared to have a third type of dark red soil in the middle of the dam (Figure 17a). However, this dark red soil was determined to have slumped into the core area of the dam from the near-surface material at the time of failure, as it only existed at the surface of the failure scarp.

4. Three bulk soil samples were taken from the east abutment at the approximate locations indicated in Figure 17a. All of these soil samples classified as clayey sand with between

Figure 17. (a) View of west abutment and (b) view of west abutment.

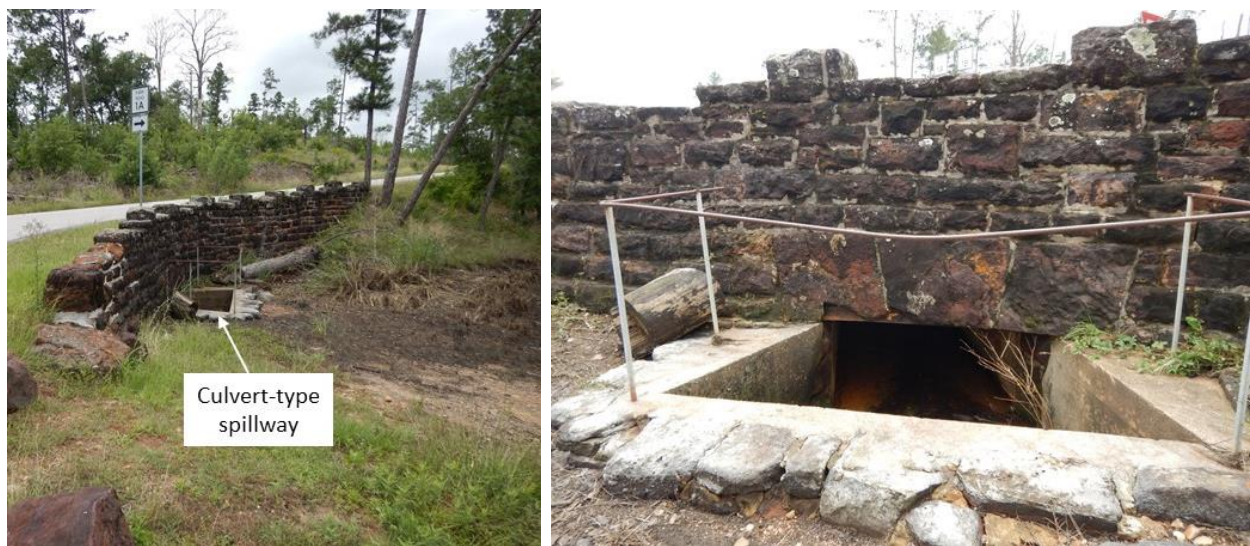
5. The culvert-type spillway was small (approximately 1 m x 1 m), but not plugged by debris at the time of our visit (Figure 18). TPWD indicates that that the culvert was not cleared of debris prior to our visit.

Figure 18. Culvert-type spillway on west abutment

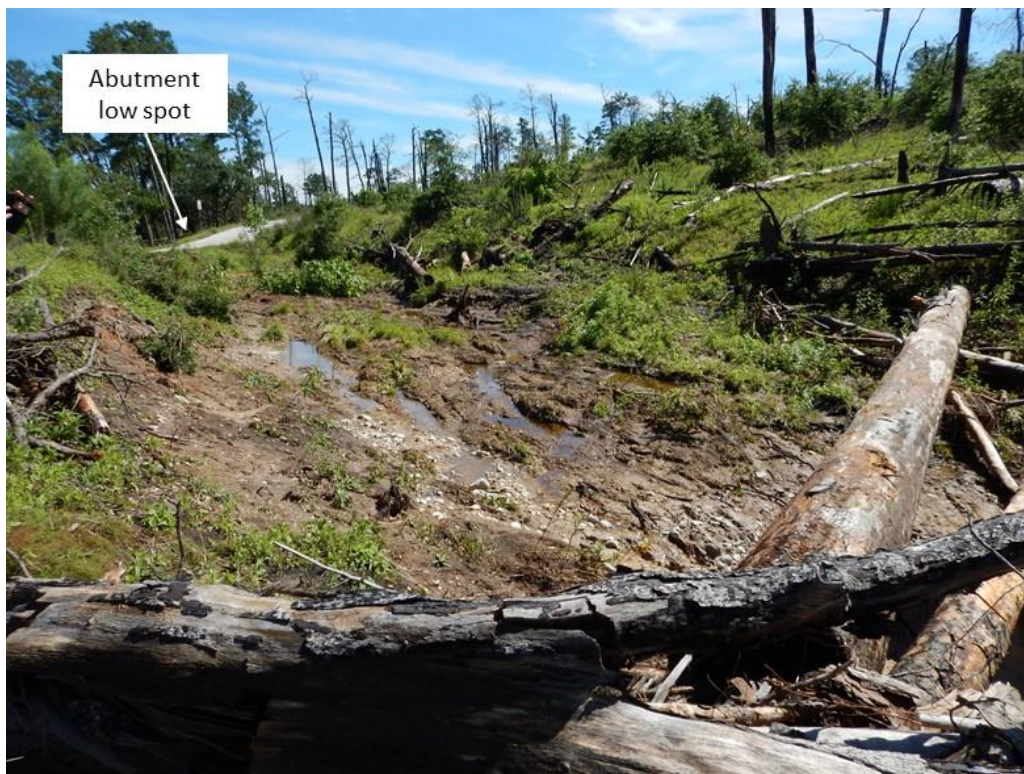
6. A significant amount of water clearly flowed over the low spot on the east abutment (Figure 19). This flow had not eroded the native material immediately downstream from the road to a significant degree. However, approximately 70 m downstream from the low spot in the pavement a significant crevasse had opened up and was eroded by the running water (Figure 20). This crevasse apparently first developed during the 2012 flood when the water overtopped the low spot in the abutment (personal communication, Greg Creacy, TPWD). The erosion did not appear to exacerbate the actual dam failure. Rather, it probably served to extend the life of the dam as water overtopped this location first.

Figure 19. View of erosional channel just downstream from the low spot in the east abutment.

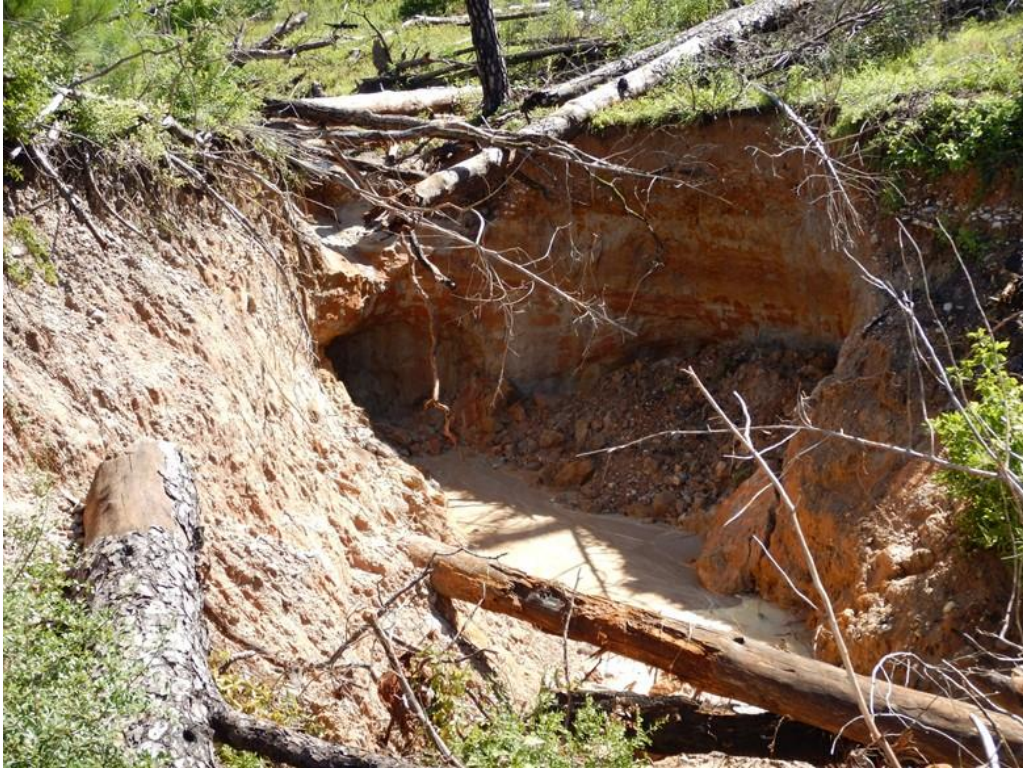
Figure 20. View of erosional crevasse about 70 m downstream from the low spot on the east abutment.
