Site Visit and Drone Based Reconnaissance Study of the Severely Affected Infrastructure by February 7th, 2021, Chamoli Rock-Ice Avalanche Disaster, Uttarakhand, India

Barrage of Tapovan Vishnugad hydroelectric project

GEER – 074
doi:10.18118/G6V95B

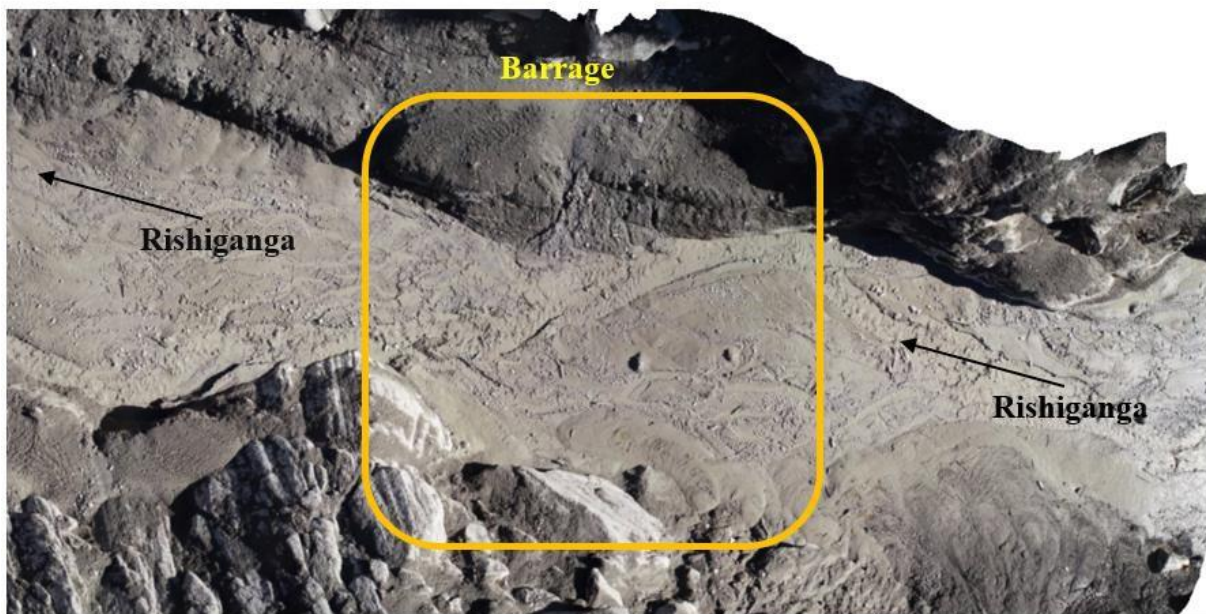
The barrage of the powerhouse was partially washed away and partially submerged under the debris, as shown in Figure 3.17. Similarly, damage to the other supporting structures such as water impounding and intake zone for the headrace tunnel was exceptionally severe, as shown in Figures 3.18 - 3.20.

Figure 3.17 Barrage region, 30°28'42.68"N 79°42'0.50" E (Dated: 11/2/2021)

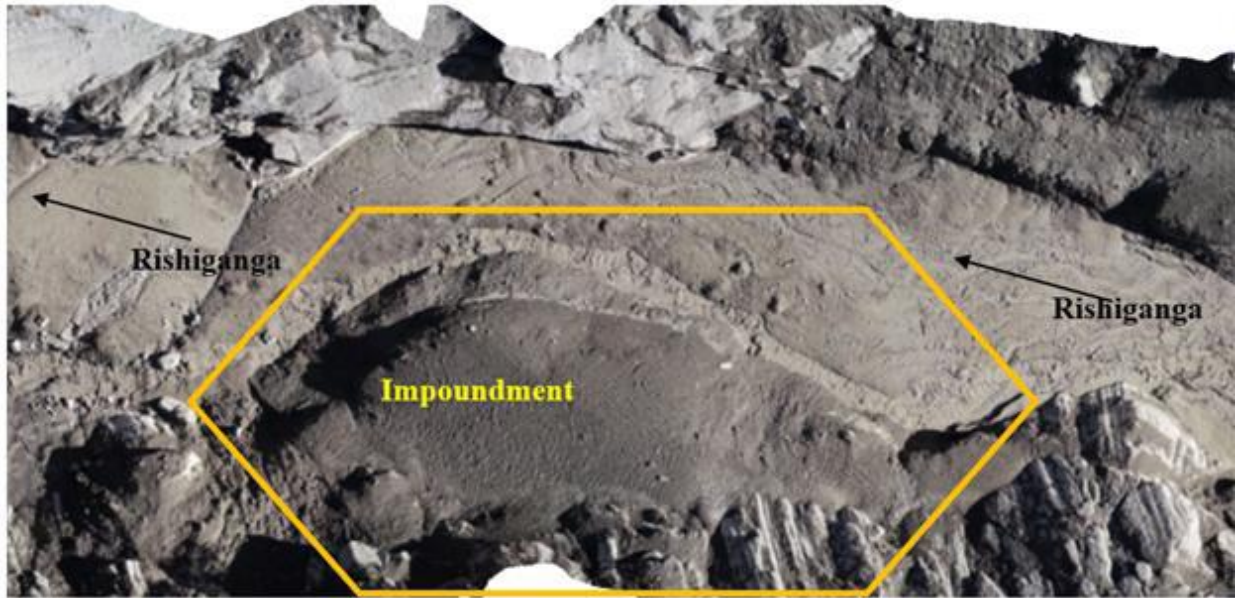
Figure 3.18 Marks of impoundment region @ 30°28'45.39"N 79°41'53.46" E (Dated:11/02/2021)

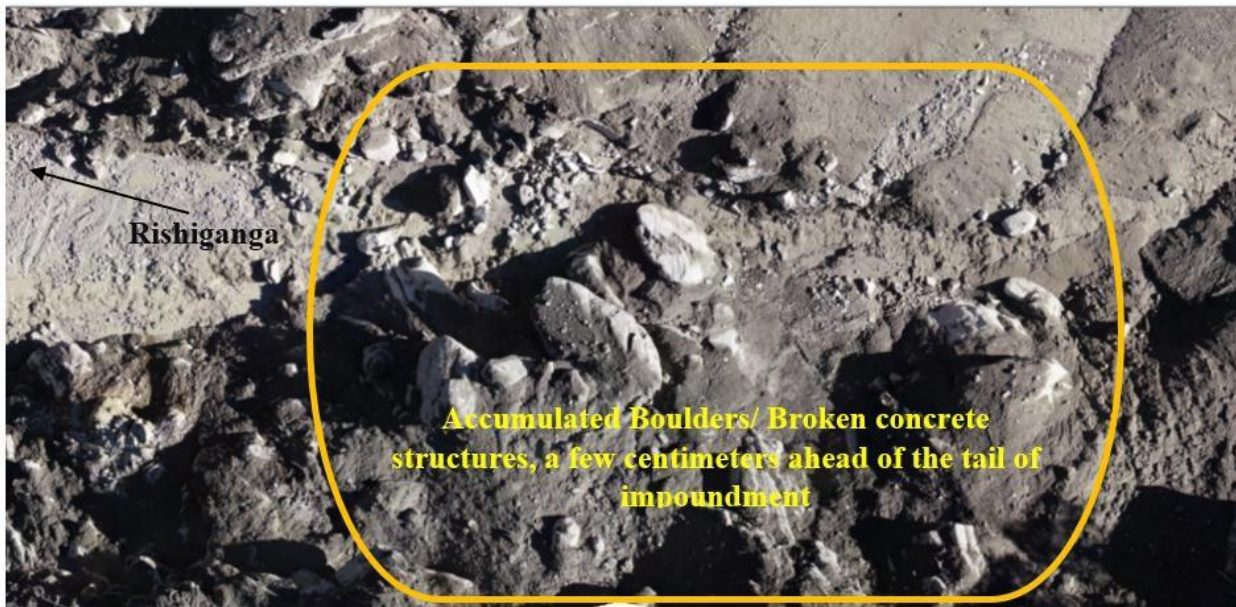
Figure 3.19 Accumulated Boulders/ Broken concrete structures, a few centimeters ahead of the tail of impoundment @ 30°28'47.40"N 79°41'53.25"E (Dated:11/02/2021)

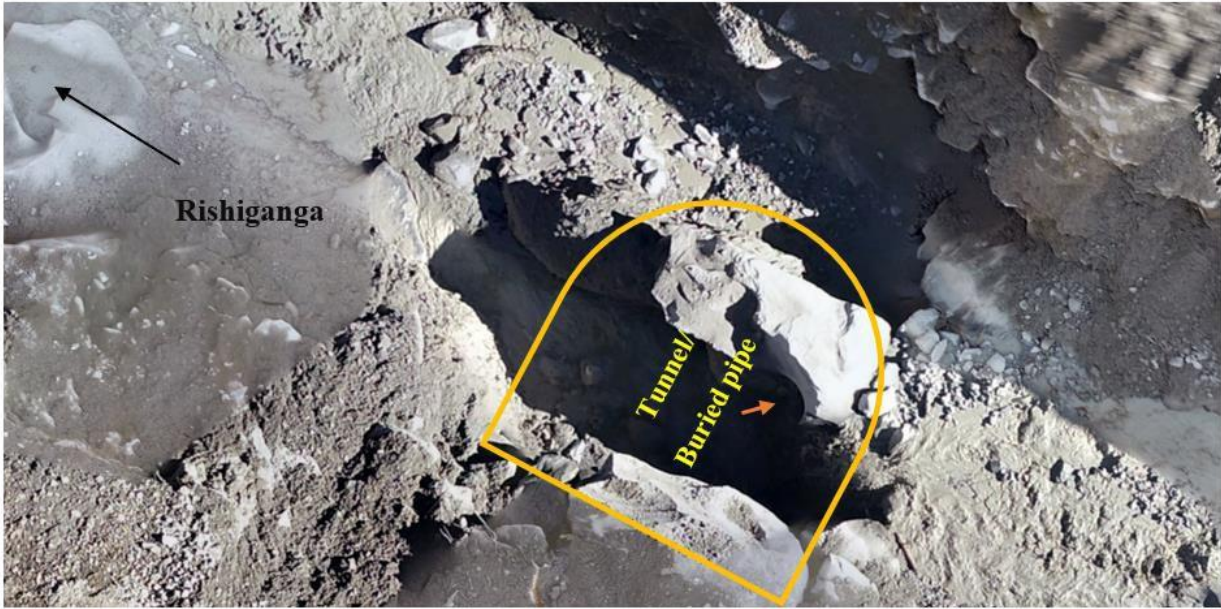
Figure 3.20 Buried pipe/tunnel structure@ 30°28'56.39"N 79°41'49.20" E

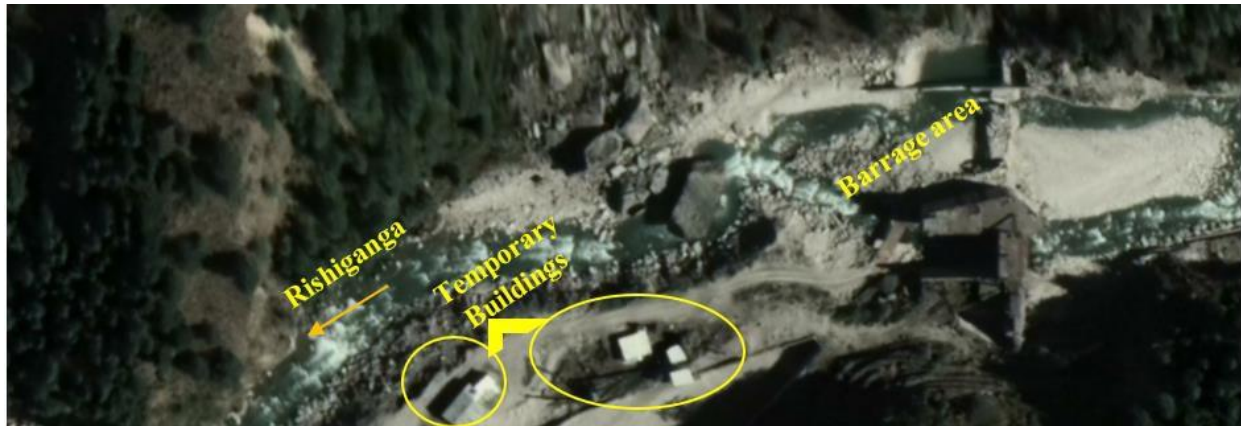
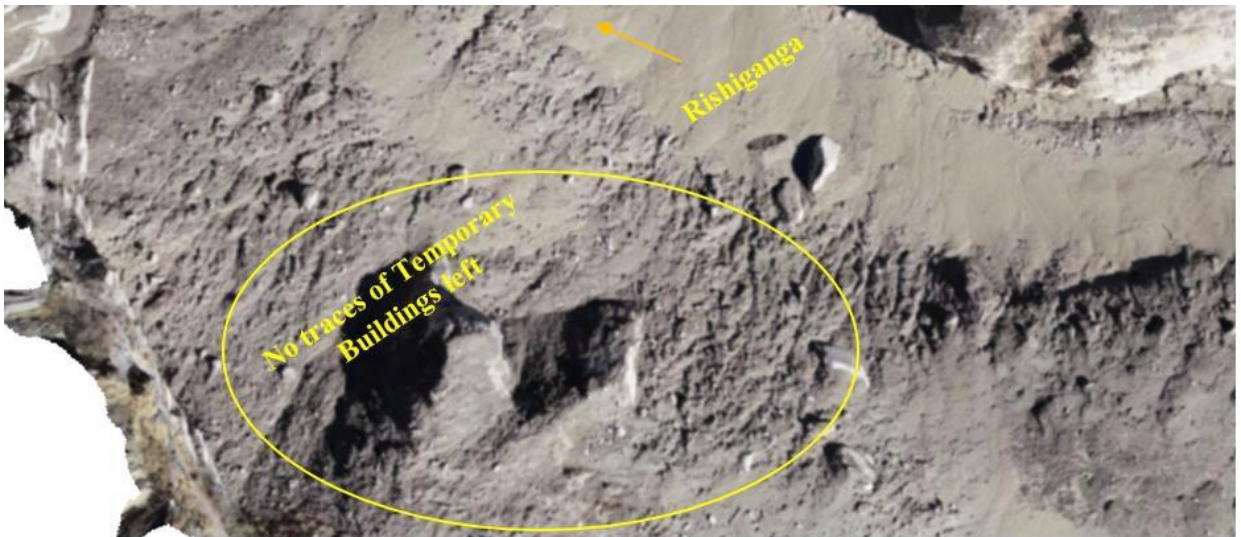
Figure 3.21a shows the pre-event imagery of November 17th, 2018 obtained from Google Earth. This image highlights the temporary buildings near the downstream of the barrage, whereas 3.21b gives a post-event close-up view of the same location, filled with debris and giant boulders.

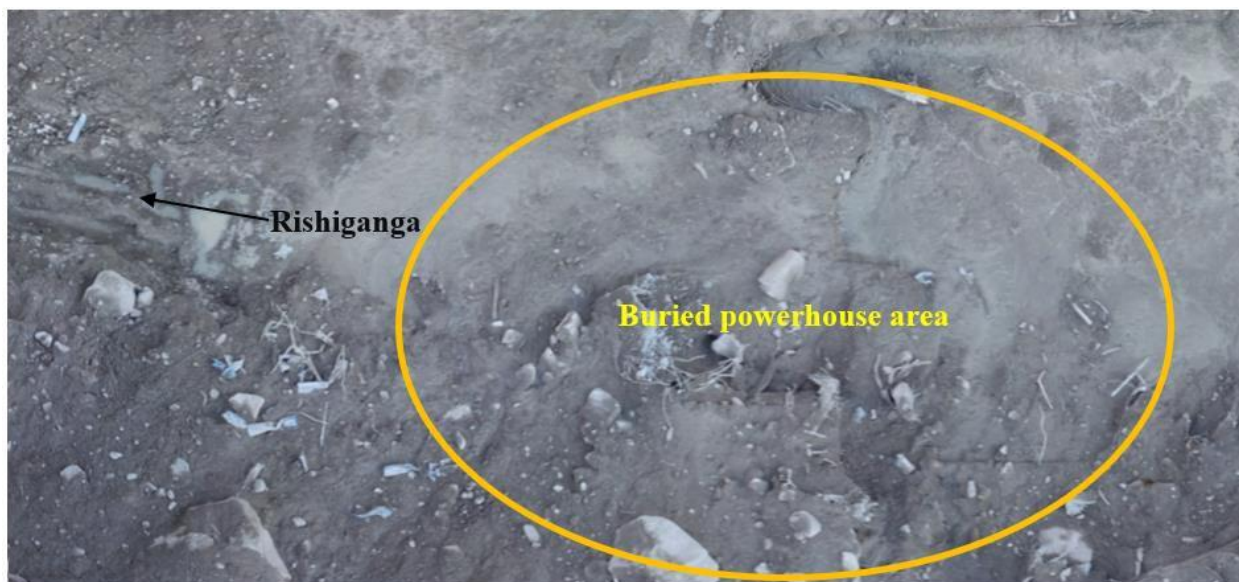
The powerhouse site also experienced similar damage. Figures 3.22 and 3.23 show that the multi-story building, powerhouse, and utility structures were washed away from their locations. The extent of the damage caused by the flash flood at the penstock location can be seen clearly in the images in Figure 3.24. The debris mark (solid red line), as shown in Figure 3.24a, indicates the height the flood reached up to the of the penstock, which is at an elevation of about 1986 m MSL, causing damage to the penstock support system (steel bars are exposed) and burying the turbine with debris.

Figure 3.22 Buried powerhouse region @30°29'5.11"N 79°41'40.46" E (Dated: 11/02/2021)

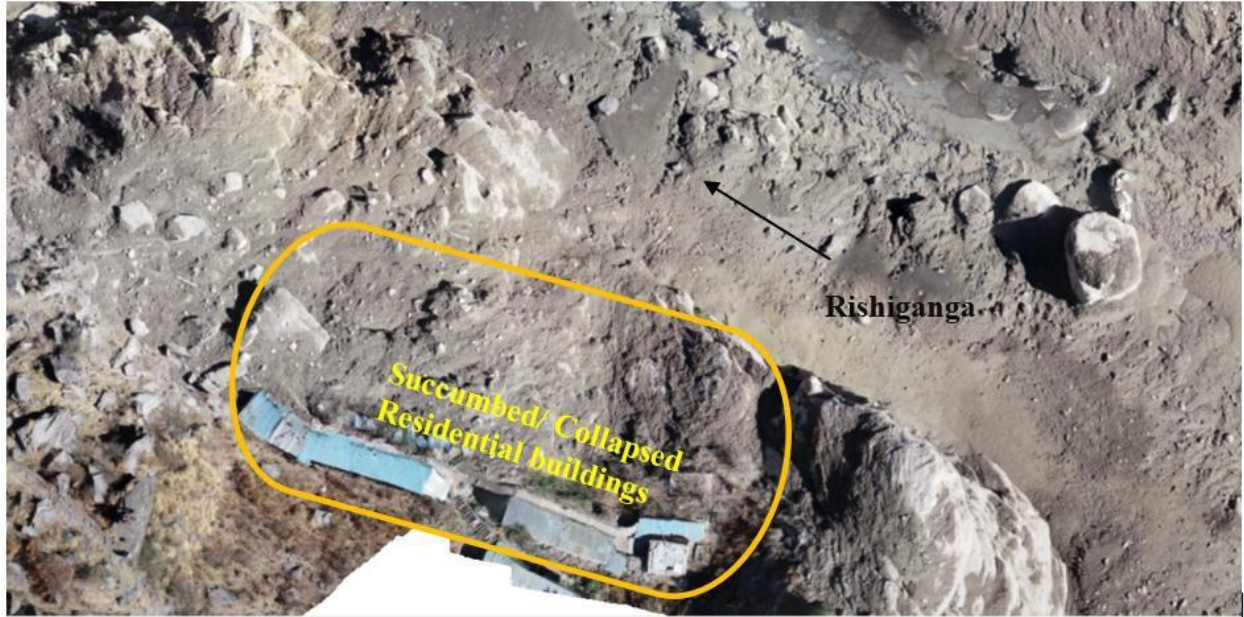
Figure 3.23 Damaged/Buried Residential Houses@ 30°28'51.83"N 79°41'49.93"E(Dated: 11/02/2021)

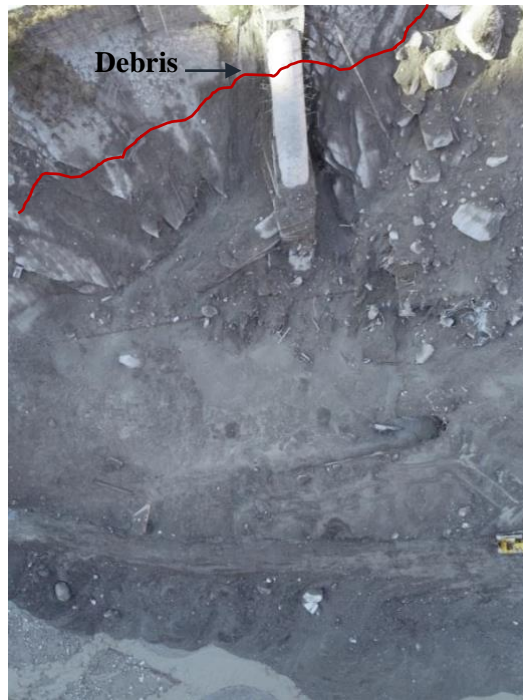
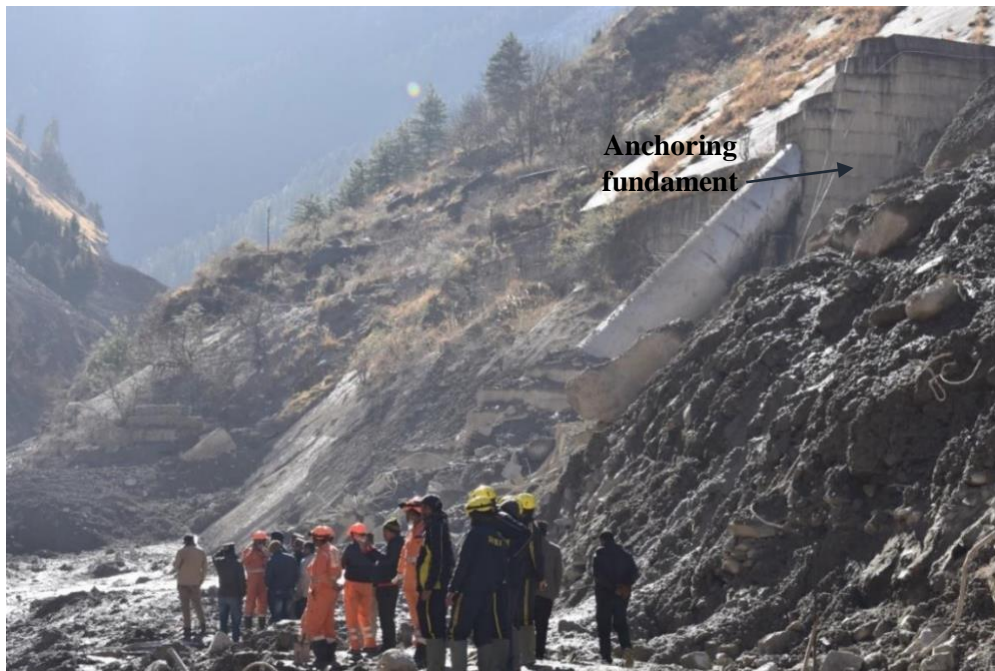
Figure 3.24 Post-event images at the location of the penstock illustrate the damage caused, exposed reinforcement, and deposition of debris covering the penstock a) top view ($30^{\circ}29'2.57''N$ $79^{\circ}41'40.91''E$) b) side view. (Dated: February 11th, 2021)

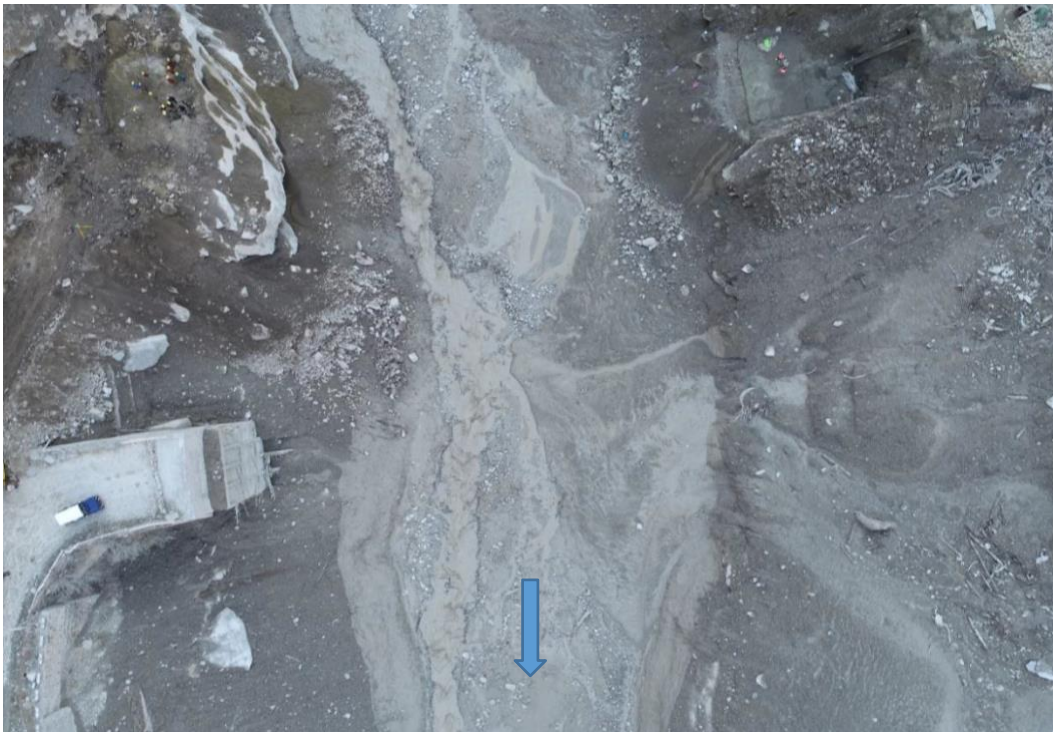
The right bank abutment and the approach slab of the RCC bridge were severely damaged and buried under the muddy deposits, in contrast to the left bank abutment and approaching slab, as shown in Figure 3.25. It also clearly shows the bridge superstructure at an elevation of 1973 MSL was completely washed away by flash floods.

Figure 3.25 Damaged Raini bridge across the bank of Rishiganga River with only leftabutment and no decks. (30°29'7.95"N, 79°41'39.56"E) (Dated: February 11th, 2021)

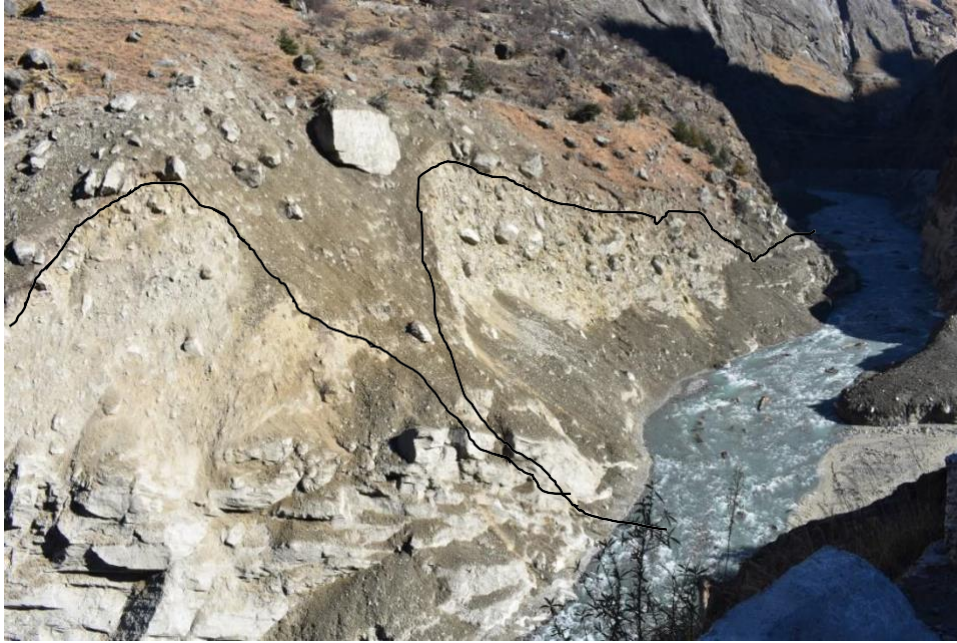
The debris flow moving with extremely high velocity and kinetic energy crashed with the mountain face at the Dhauliganga and Rishiganga confluence and formed craters on the face, as shown in Figure 3.26 in solid black lines. The mountain on the right bank of Dhauliganga acted like a barrier in the path of incoming massive debris flow from Rishiganga and created a temporary blockage. It resembles the "water hammer" phenomenon in the dam when gates behind penstocks are closed abruptly. The temporary blockage at the confluence resulted in impounding and raising the water level upstream of the Dhauliganga, evident from the debris mark highlighted in the solid blue line in Figure 3.27.

Figure 3.26 Crater formation at mountain face from the collision of debris flow with the hill (N30°29'11.30", E79°41'29.65", Elevation-1989 m). (Dated: February 11th, 2021)

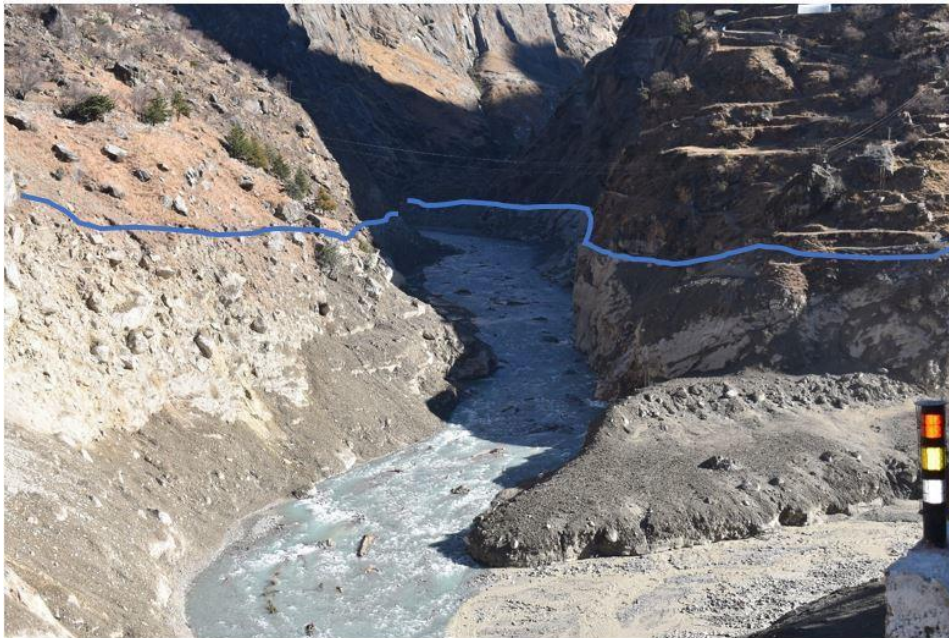
Figure 3.27 Raised watermarks upstream of Dhauliganga as proof of temporary blockage of the main river and debris throwback after the impact with the hill. (N 30°29'11.30" E079°41'29.65", Elevation-1989 m) (Dated: February 11th, 2021)

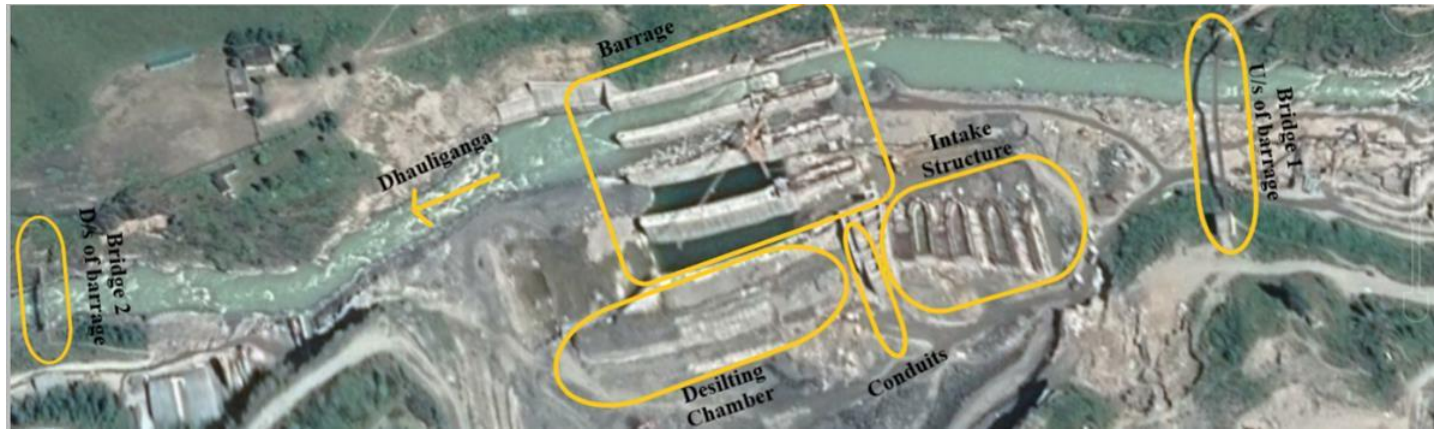
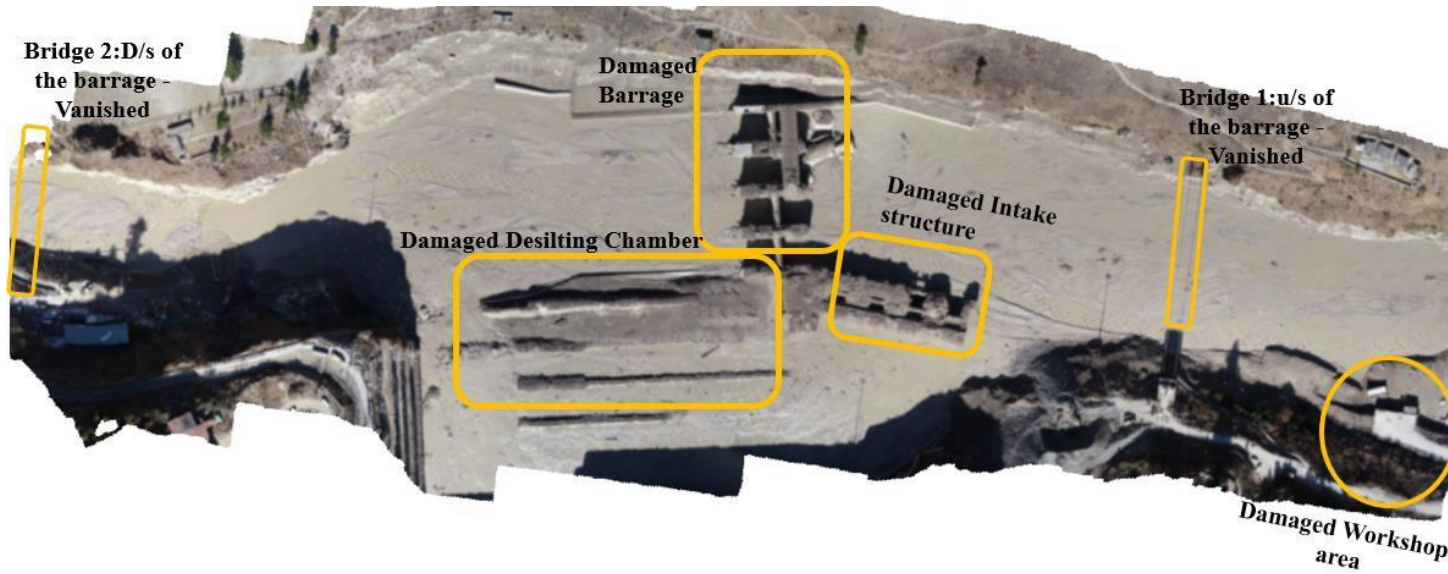
The pre and post-event visuals of the TV-HEP are presented in Figures 3.29a and 3.29b, respectively. The pre-event visual was obtained from the Google imagery of 2017, and the post-event was a digital ortho mosaic generated from the drone survey. It is evident from these figures that Tapovan HEP was severely affected by the flash floods and heavily deposited with debris, including soil and boulders of different sizes.

Figure 3.29 Tapovan HEP area (a) pre and (b) post-event orthophoto data showing the collapsed bridges, damaged structures, accumulated boulders, muddy water and, affected barrage gates @ 30°32'7.84"N 79°31'10.71" E

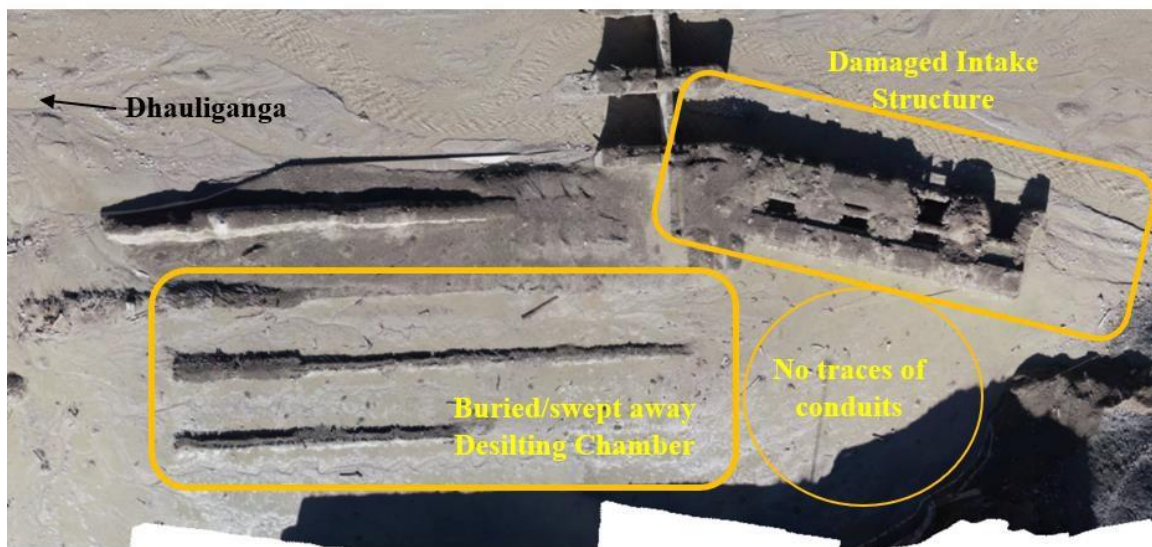
The piers of the barrage and intake structures suffered massive damage, and large debris deposits were observed over them. The conduits and the desilting chamber, as shown in Figure 3.28, are missing in Figure 3.34, and are probably buried by the debris deposition. Figure 3.35 shows a detailed view of the damaged intake structure with a visible layer of deposits, whereas, Figure 3.36 shows the broken and exposed steel bars at the tail of the intake structure (downstream of barrage).

Figure 3.34 *Aftermath marks of the Intake structure, desilting chamber, and conduits@ 30°29'35.89"N 79°37'41.67"E (Dated:11/02/2021)*

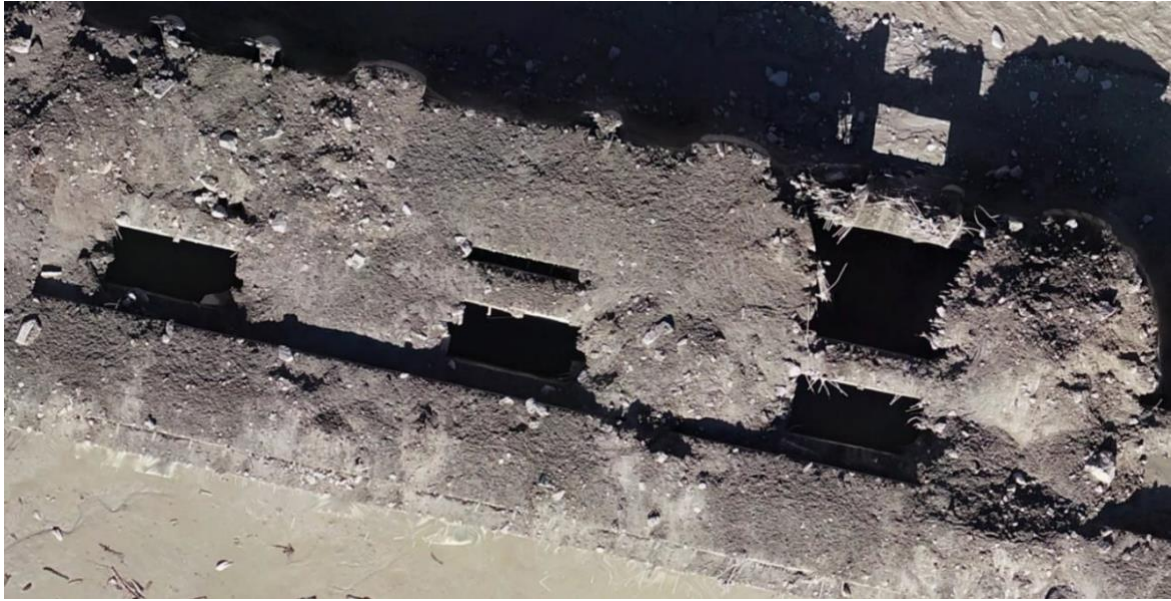
**Figure 3.35 Close-up view of the Intake structure@ 30°29'35.89"N 79°37'41.67"E
(Dated:11/02/2021)**

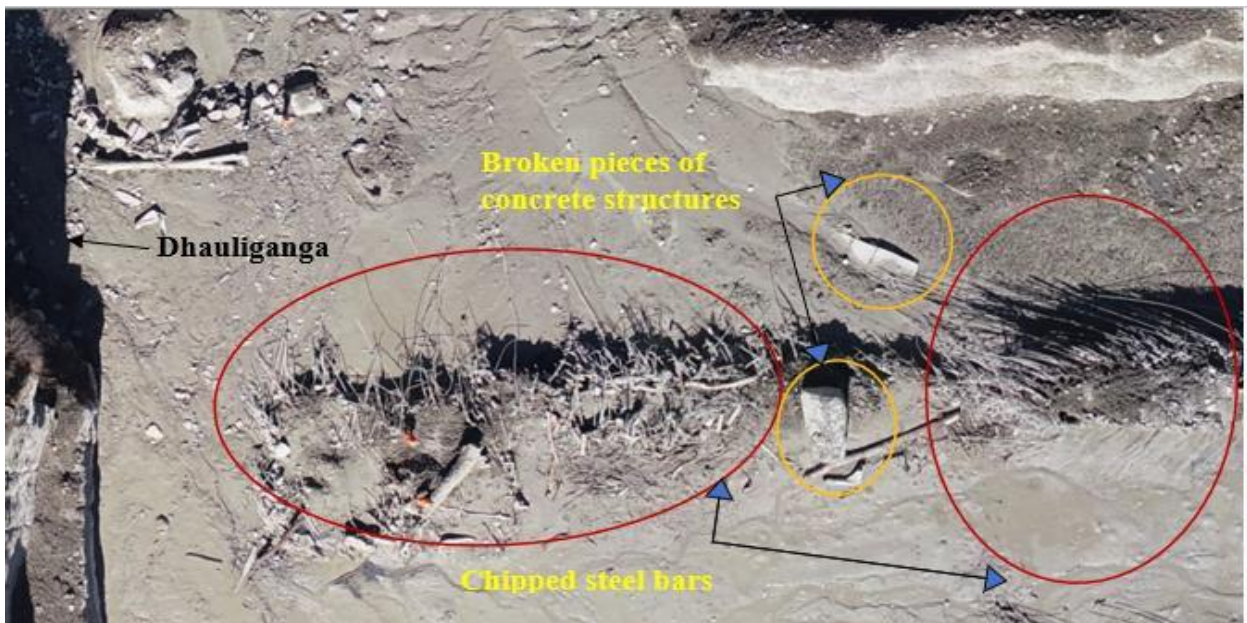
**Figure 3.36 Distorted steel bars at the tail of intake structure @ 30°29'35.89"N 79°37'41.67"E
(Dated:11/02/2021)**

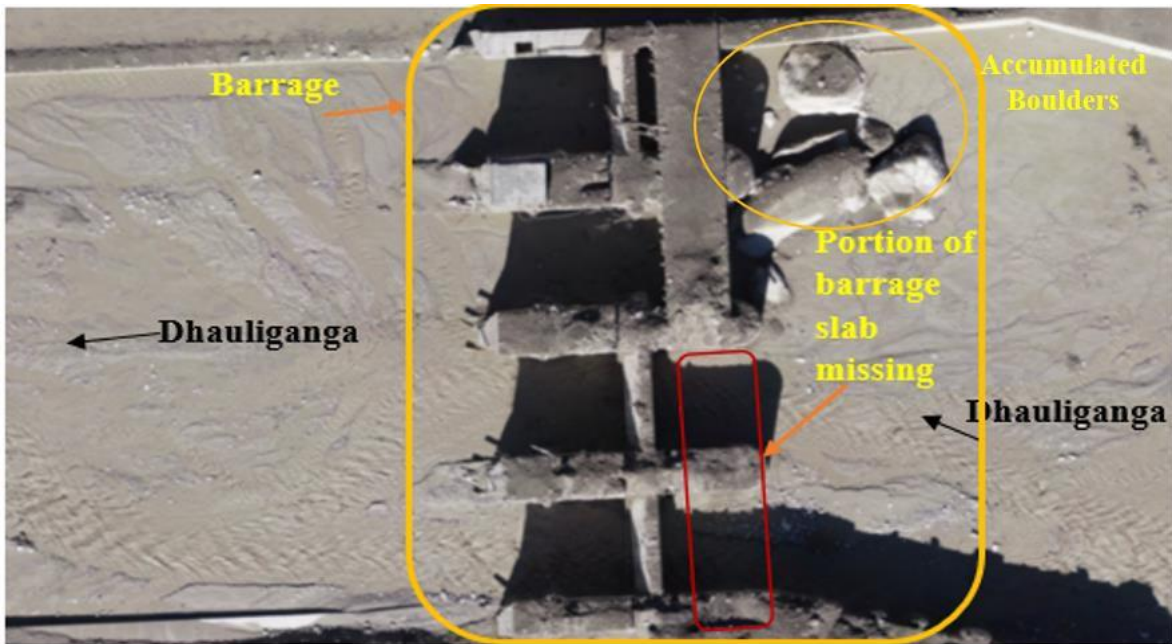
Almost half of the breast wall over the barrage top was washed away, as shown in Figure 3.37. Huge boulders of different sizes were carried by the floods are retained by the piers of the barrage, as illustrated in Figure 3.37.

Figure 3.37 View of Tapovan barrage @ 30°29'35.89"N 79°37'41.67"E (Dated:11/02/2021)

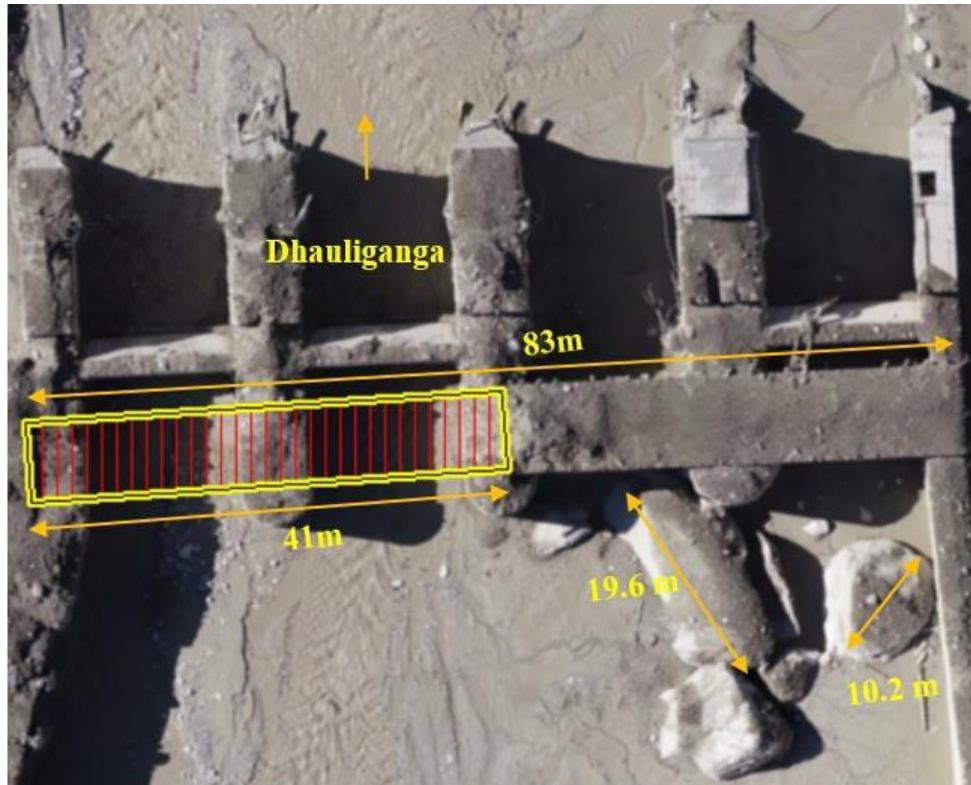
The post-event orthophoto and Global Mapper were used to estimate the dimensions of the damaged barrage, breast walls, and the boulders behind the barrage piers. The total length of the breast wall over the barrage before the event was about 83 m long, whereas post-event, about 41 m length of this breast wall had been washed away, as shown in Figure 3.38. The approximate length of the boulders came out 10.2 m and 19.6 m which is 1/8th and 1/4th of the calculated total length of the breast wall, which indicates that the flow velocity must have been sufficiently high, which led to the accumulation of huge boulders near the gates.

Figure 3.38 Dimensions of the existing and vanished portion of the breast wall (highlighted with red strips) along with the accumulated boulders. @ 30°29'35.89"N 79°37'41.67"E (Dated:11/02/2021)

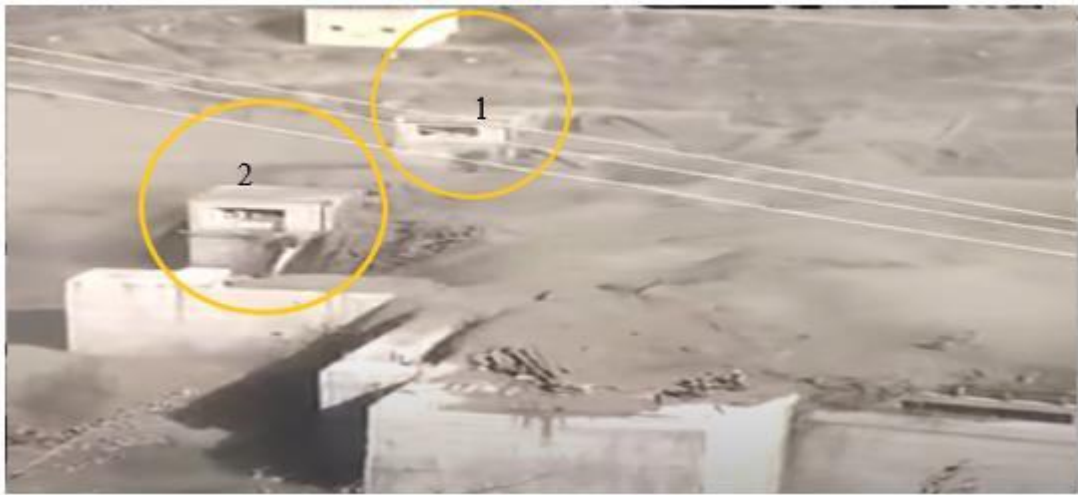
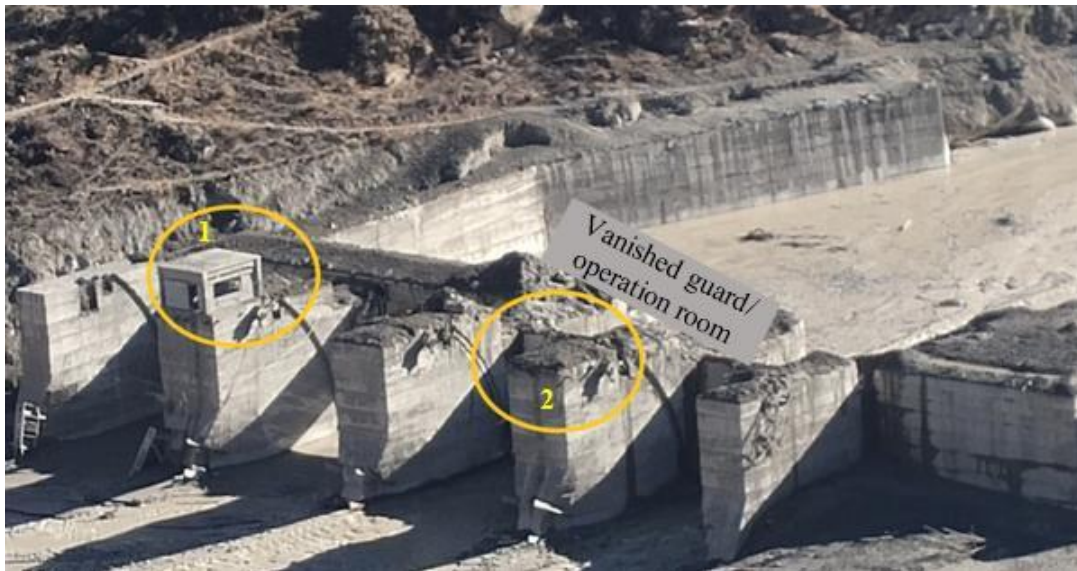
Figure 3.40 presents the status of guard/operation rooms constructed on top of the barrage. Figure 3.40a shows that the flood has reached to top level of the barrage piers to reach the guardroom during the event and wash away one of the guardrooms, as shown in Figure 3.40b.

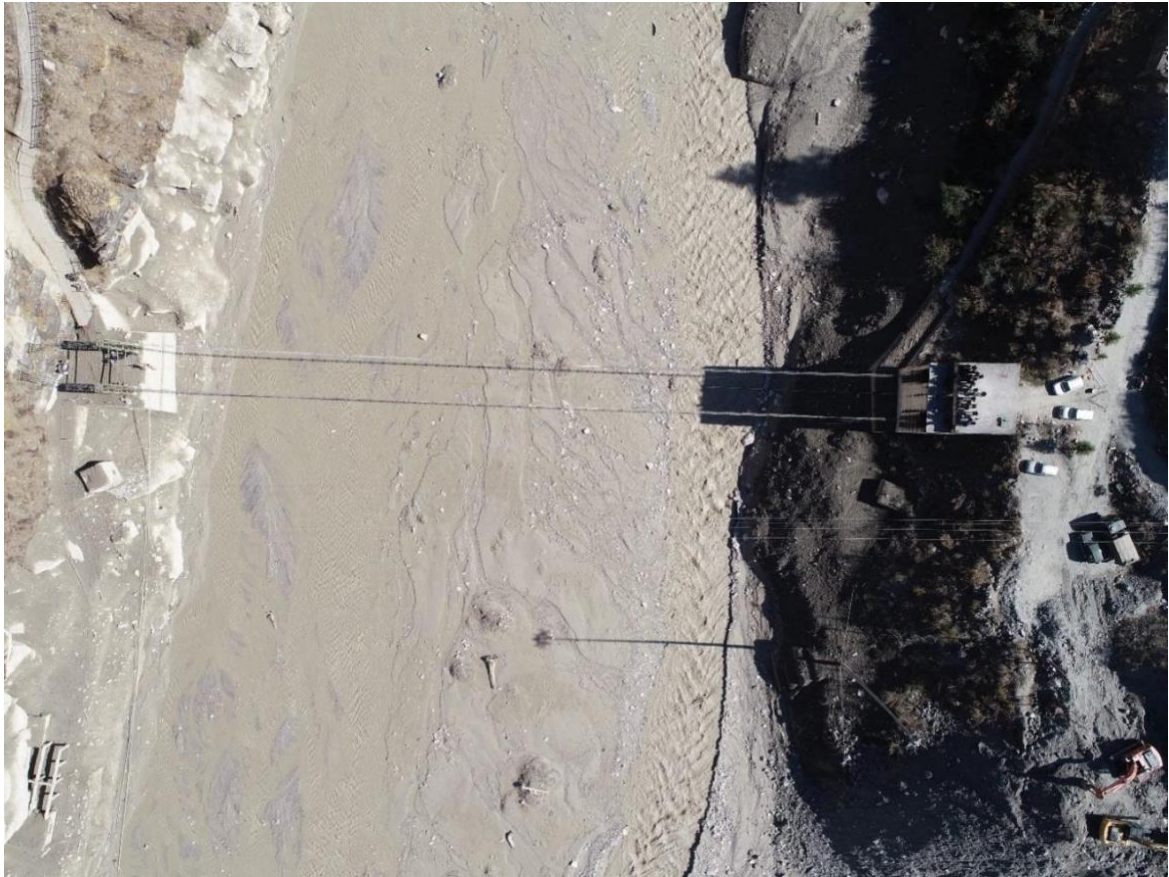
Two bridges at the entrance of Malari valley and near Tapovan have washed away. Bridge 1 was located at the upstream side of the barrage, whereas bridge-2 was downstream of the barrage. The reconnaissance team observed during the field survey that the deck portion of both the bridges had vanished, but their piers were intact. Figure 3.41 depicts the close-up of one of the collapsed bridges near the upstream of the affected site.

***Figure 3.41: Close-up of collapsed bridge-1 U/s of Tapovan Barrage site(dated 11/2/21)@
30°29'34.41"N 79°37'47.92"E***
