Geotechnical Reconnaissance and Engineering Effects of the December 29, 2020, M6.4 Petrinja, Croatia Earthquake, and Associated Seismic Sequence

Chapter 9: Infrastructure Damage

Authors: Jelena Bleiziffer, Igor Gukov, Ingrid Tomac, Sonja Zlatović, Petar Krešimir Žderić, Zvonimir Vlahović

9. Infrastructure Damage

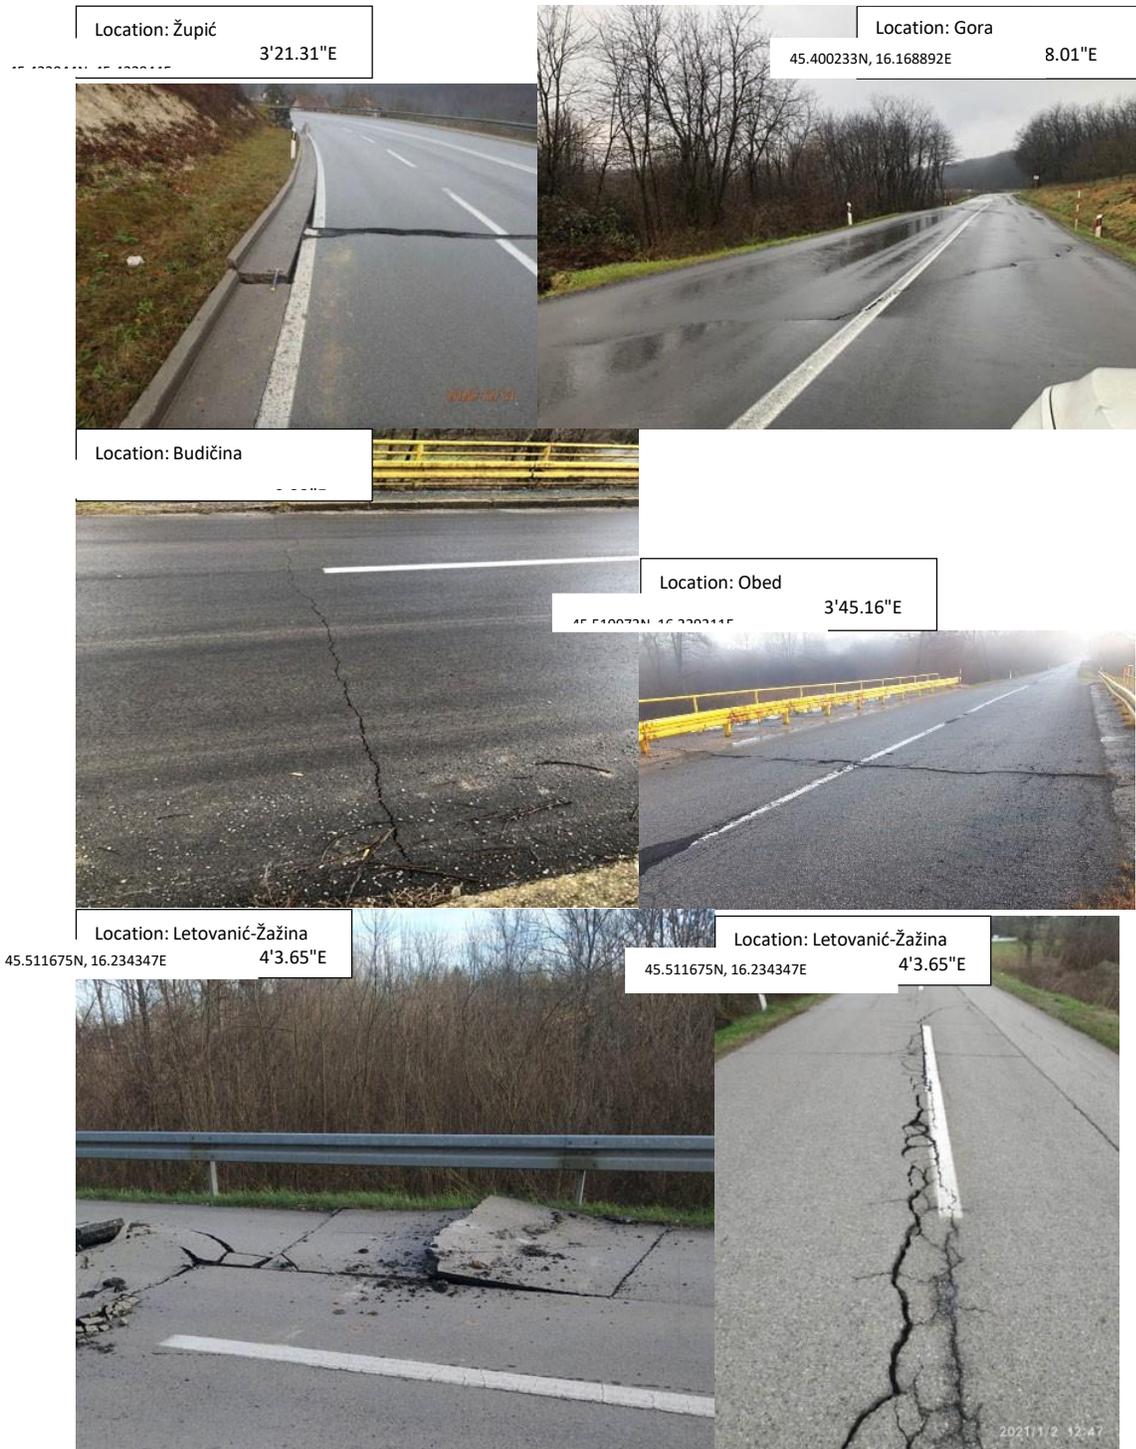
Asphalt and subgrade cracking occurred on roads from which roughly 95% are in Sisak-Moslavina County. Asphalt damage in perpendicular, parallel, or inclined direction from the road axes occurred as opening cracks and, in several instances, accompanied with vertical displacements, as shown in **Figure 9.3**.

Figure 9.3 Horizontal and vertical displacement cracks in asphalt perpendicular, parallel, or inclined towards the road axis in several locations (Source: Croatian Roads – Hrvatske ceste).

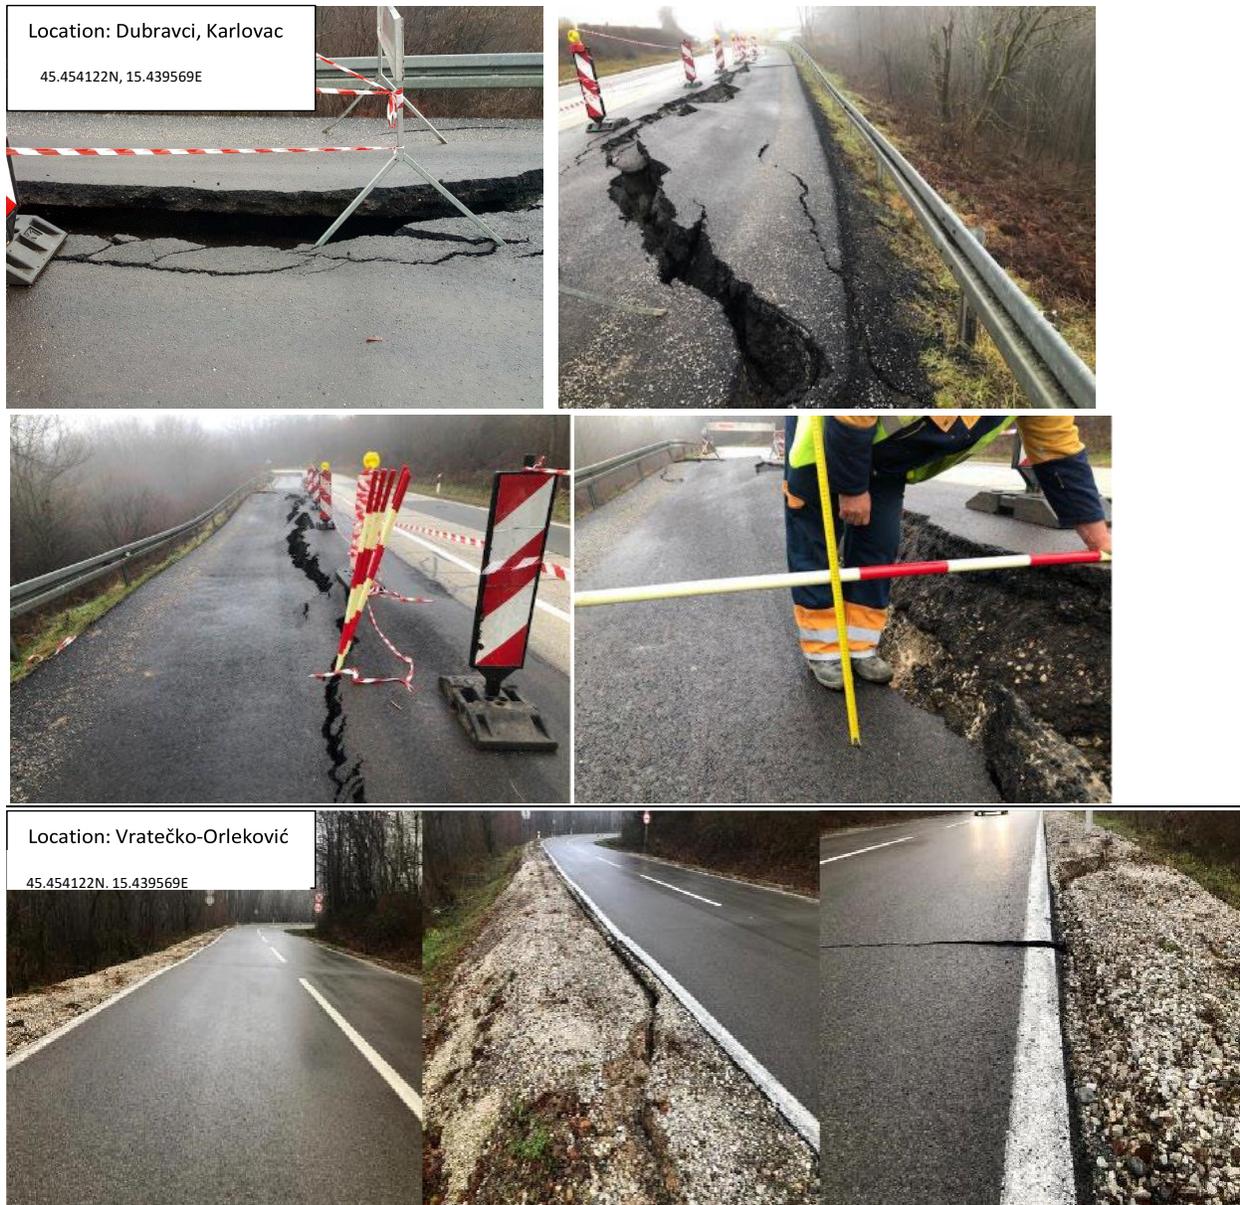
Road damage was associated with an adjacent slope stability failure, either as a road embankment loss of stability or as re-activation of previously known landslides. Croatian Roads report a series of reactivated landslides with referral to previous road repair works, pointing that

the slopes deformed additionally during the earthquake causing different levels of severity of road damage. Demonstrated effects span from thin asphalt cracks to cm-scale displacements, subgrade failure, and displacement and terrain slope displacement. Reported landslides are Landslide Župić, Landslide Gora, Landslide Jošavica, Landslide Vratečko-Orleković, Landslide Vratnik, Landslide Klasnić, Landslide Žirovac, 10 landslides on the state road DC31, landslide on the state road DC36, the state road DC1 near Brebornica, and the state road DC3 near Dubravci. **Figure 9.4** shows selected examples of a few severe sliding-related road damage as reported by Croatian Roads (2021).

Figure 9.4 Road damage accompanied with adjacent slope instability.

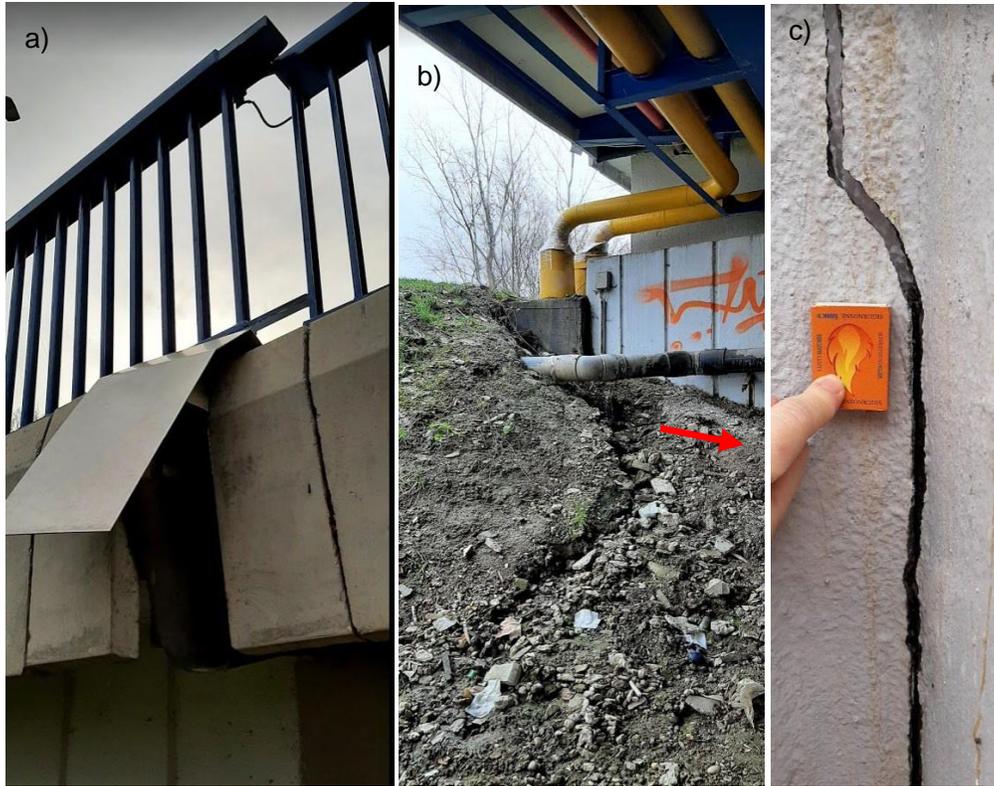
Figure 9.6 Left Sava riverbank, east bridge abutment a) north face, upstream, b) north face, upstream and c) south face, downstream (45.4790N, 16.3854E).

Damage suggests that the roadway slab rotated clockwise, where the western bridge portion displaced towards the north and the east towards the south. This can particularly be observed at

- There was a longitudinal displacement during the earthquake of at least 8 cm (**Figures 9.6 – 9.10**) – evidenced by pulling out of the railing at its expansion joint, and misalignment of the bridge finger expansion joint,
- There was a failure of transversally unmovable bridge bearing on the east abutment, and permanent 15-cm transverse displacement of the bridge (**Figures 9.6 and 9.9**). The bearings on the columns also suffered damage due to the bridge rotation.

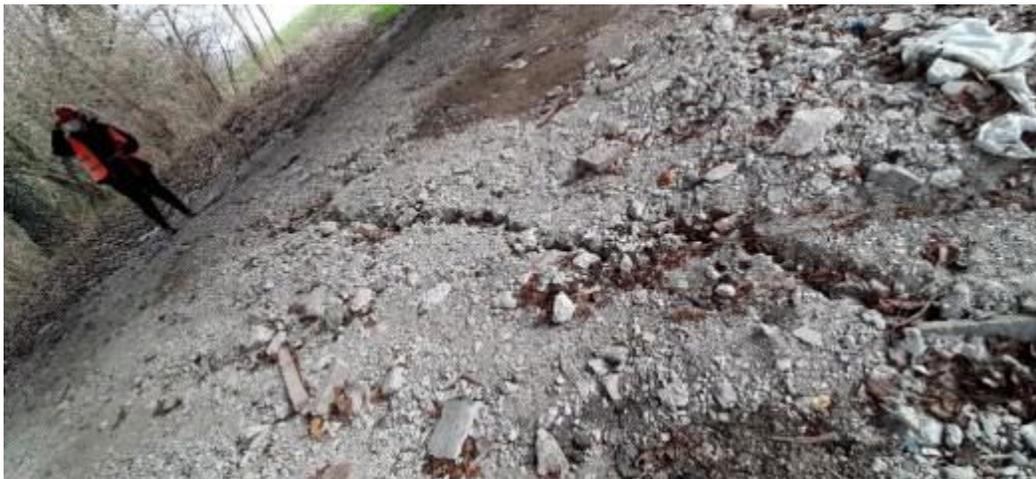
Figure 9.7 Left bank of Sava, soil cracks between the abutment and the adjacent column (45.4790N, 16.3854E).

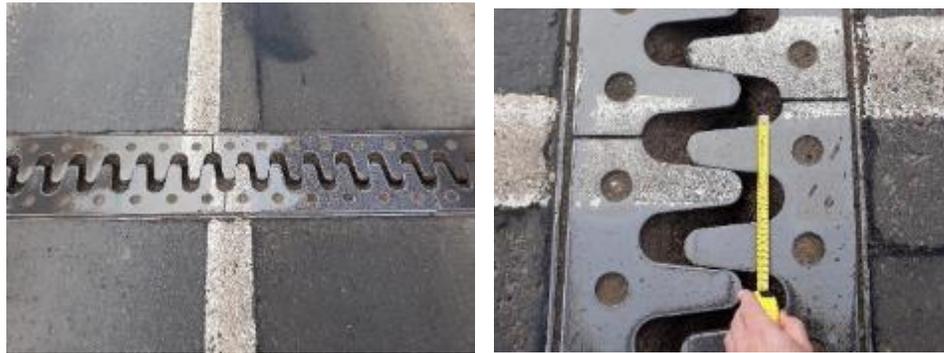
Figure 9.8 Galdovo Bridge, displacement of the bridge expansion joint on the east abutment (45.4790N, 16.3854E).

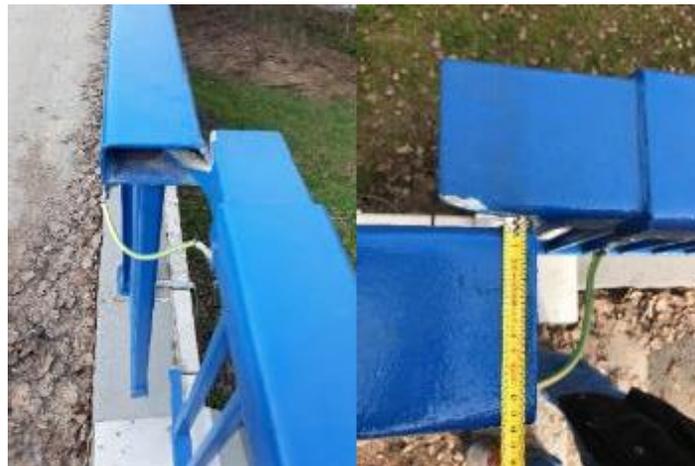
Figure 9.9 Galdovo Bridge, 15-cm transverse displacement of the bridge railing (45.4790N, 16.3854E).

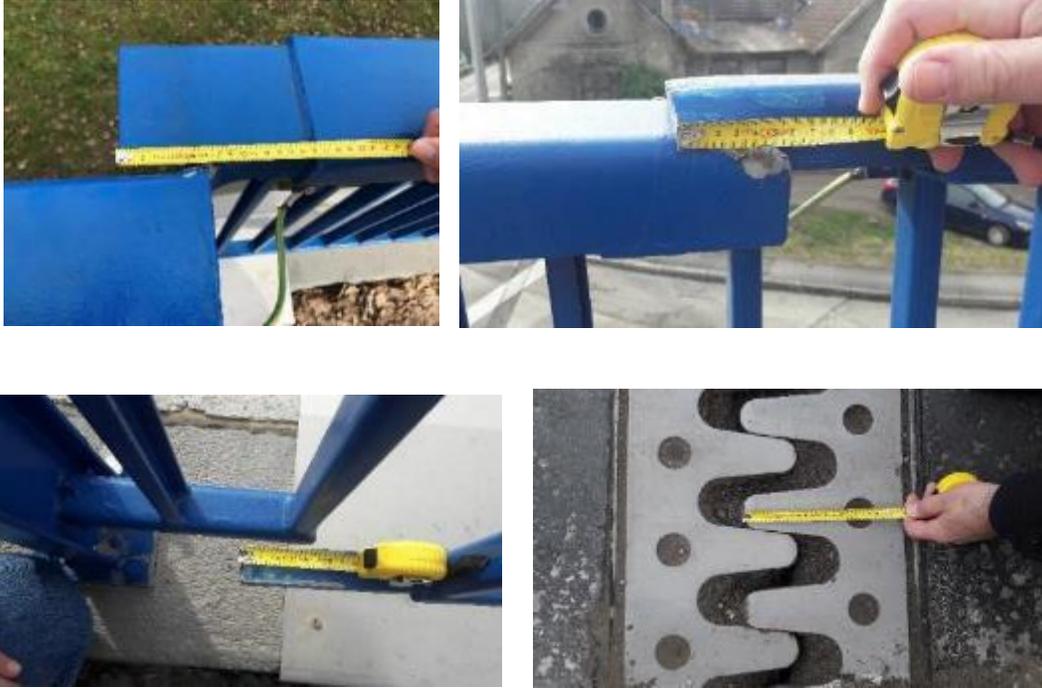
Figure 9.10. Galdovo Bridge, measuring longitudinal displacement on railing and expansion joint (45.4790N, 16.3854E).

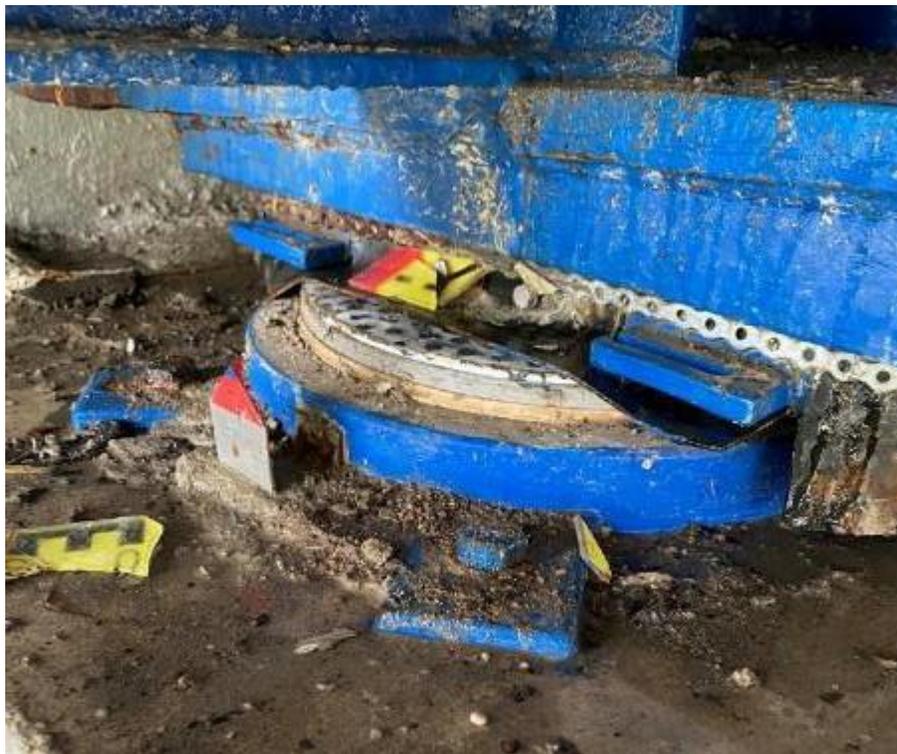
Figure 9.11 Galdovo Bridge, damaged bearing on the east abutment (45.4790N, 16.3854E).

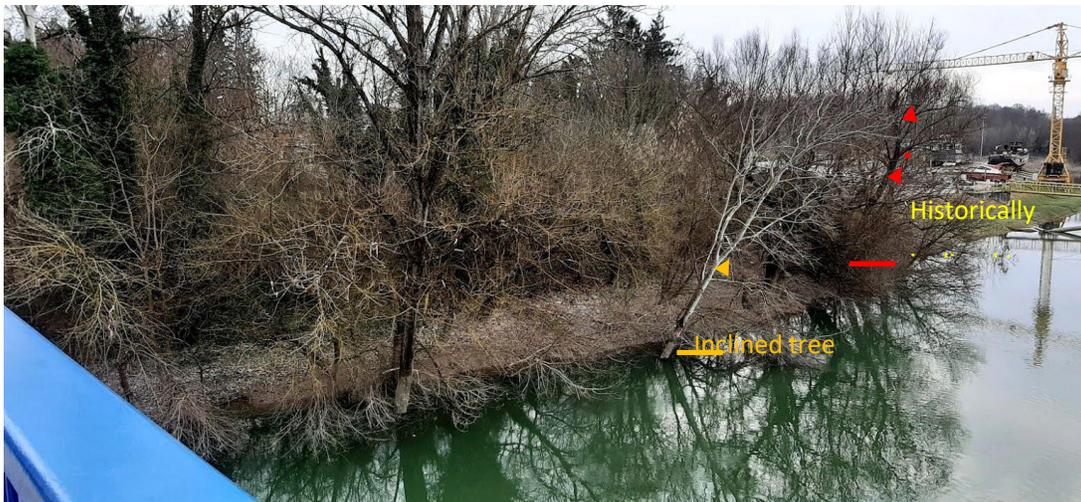
Figure 9.12 shows inclined trees on the riverbank, which typically indicate recent or historical slope instability. An absence of images and information before an earthquake makes it difficult to draw any conclusions about earthquake effects.

Figure 9.12 Inclined trees on the left bank of Sava river, the eastern side of the bridge, view towards the south (45.479N,16.385E).

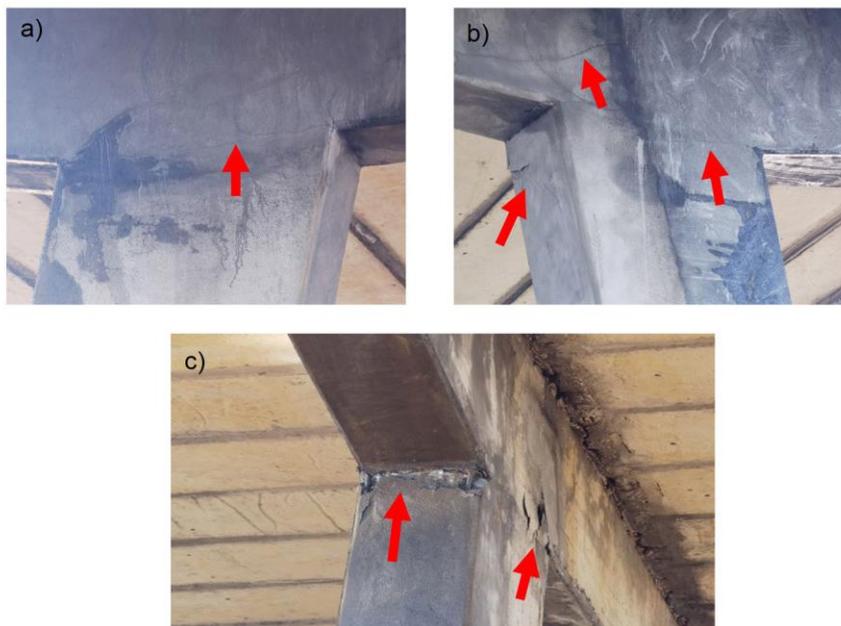
Damage was detected after the earthquake on columns S4, S7, and S20 at the column-cap beam joint. On S4 (**Figure 9.16a**), the west column has horizontal cracks on the side facing south. On S7 (**Figure 9.156b**) the east column also has horizontal cracks on the south-facing side. On S20 (**Figure 9.16c**), the east column, the eastern and southern face at the top of the column show surface cracks.

Figure 9.16. a) damage at S4, b) damage at S7 and c) damage at S20. (source: Earthquake Petrinja 29 12 2021 GP HC_Road and bridge damage report”, in Croatian).

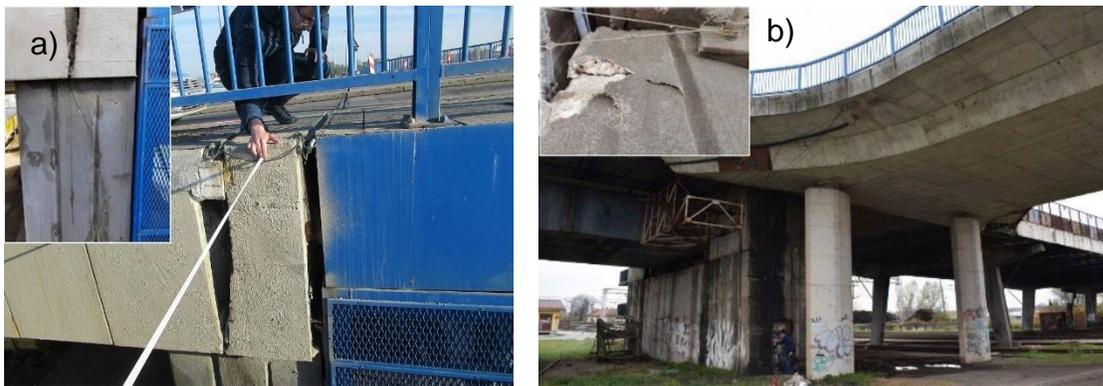
Column at S13 is the edge column under the steel span on the northern side (**Figure 9.17**). Previously existing crack was repaired with concrete anchors during the retrofit in 2019. **Figure 9.17 b)** shows the side ramp as it was before the retrofit. The ramp is a reinforced concrete viaduct supported on elastomeric bearings, that suffered a visible crack on the asphalt along with the connection to the bridge and was sideways hitting the S13 column during the earthquake and caused local column damage, which is only superficial. **Figure 9.18** shows cracks on the soil surface between S4 and S5, which are in the east-west direction, perpendicular to the bridge longitudinal axis. To summarize, the damage on the Gromovi Bridge was detected on the columns and connections between columns and the roadway slab on the northern side of the Kupa river. The damage suggests a lateral spread of the northern embankment. It is interesting to note that most of the damage occurred on the parts of the bridge with shallow foundations, while the deep-founded bridge supports were not damaged. **Figure 9.19** links an aerial image obtained after the earthquake where liquefaction was detected on a wider area of the city of Sisak, including both sides of the Gromovi Bridge. The approximate position of identified damage is also shown.

Figure 9.17 a) reinforced pre-existing crack and dilation above on the column S13 on the northern side of the Kupa river and b) side ramp. (Source: Metal Projekt Ltd).

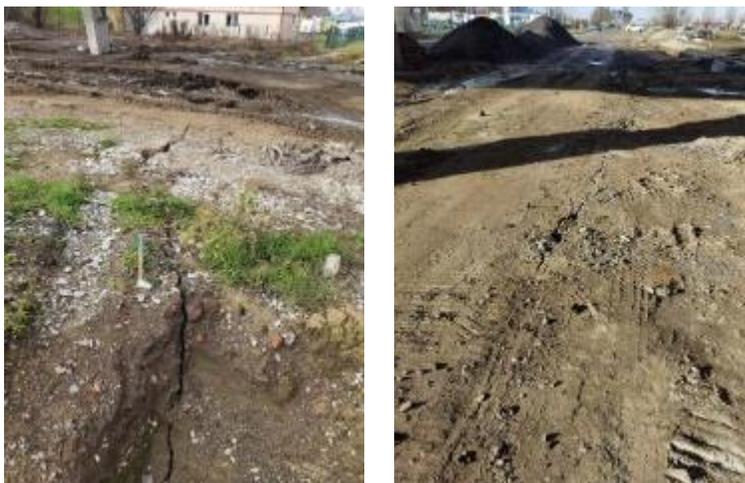
Figure 9.18 Cracks in soil between S4 and S5 (source: Hrvatske ceste 2021).

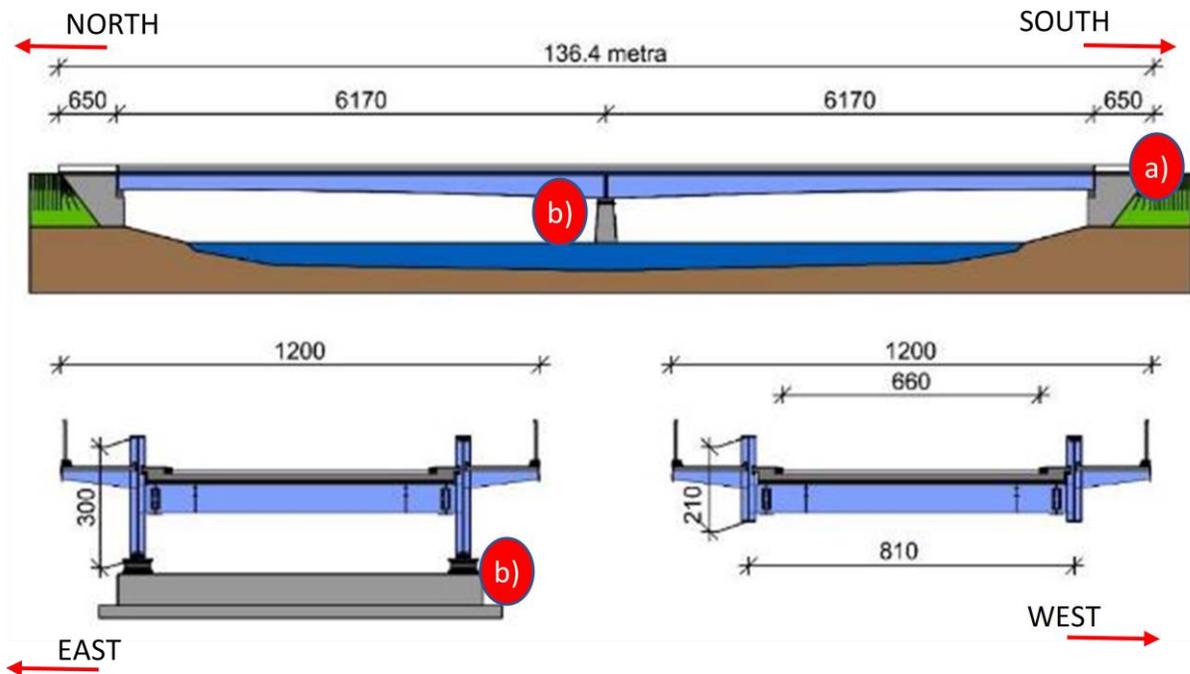
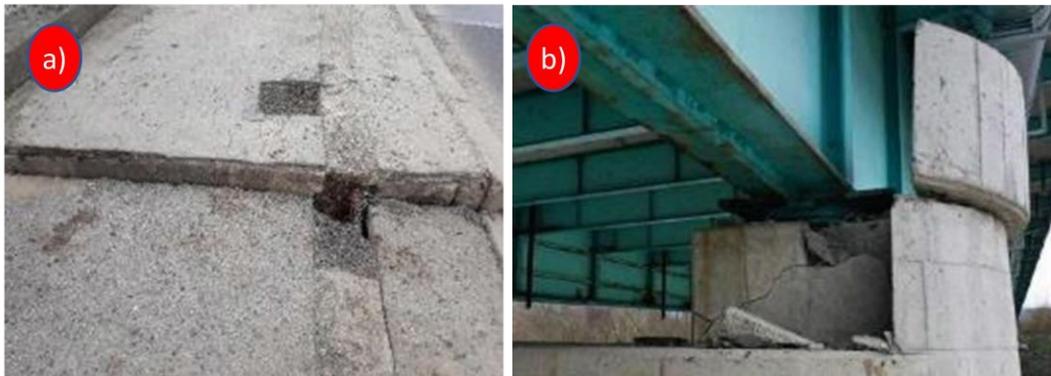
The column and abutments were constructed of cut stone filled with lean concrete and founded on 12-18 m deep caissons (Lazić, 1998). Fixed pot bearings (6000 kN) are installed on the central pier, while the pot bearings on the abutments (2000 kN) are movable in one direction (Lazić, 1998). Expansion joints KT-160 are installed at both abutments (Lazić, 1998). Damage observed includes settlement and damage to bridge embankment and asphalt layer just before the bridge, and damage to the bridge bearing and bearing pedestal on the column, as shown on **Figure 9.20**.

Figure 9.20 Brest Bridge damage indicated in longitudinal and cross-section of the bridge (from Radić et al., 2007): a) settlement of the sidewalk before the abutment, b) damage to the bearing pedestal on the column (right).

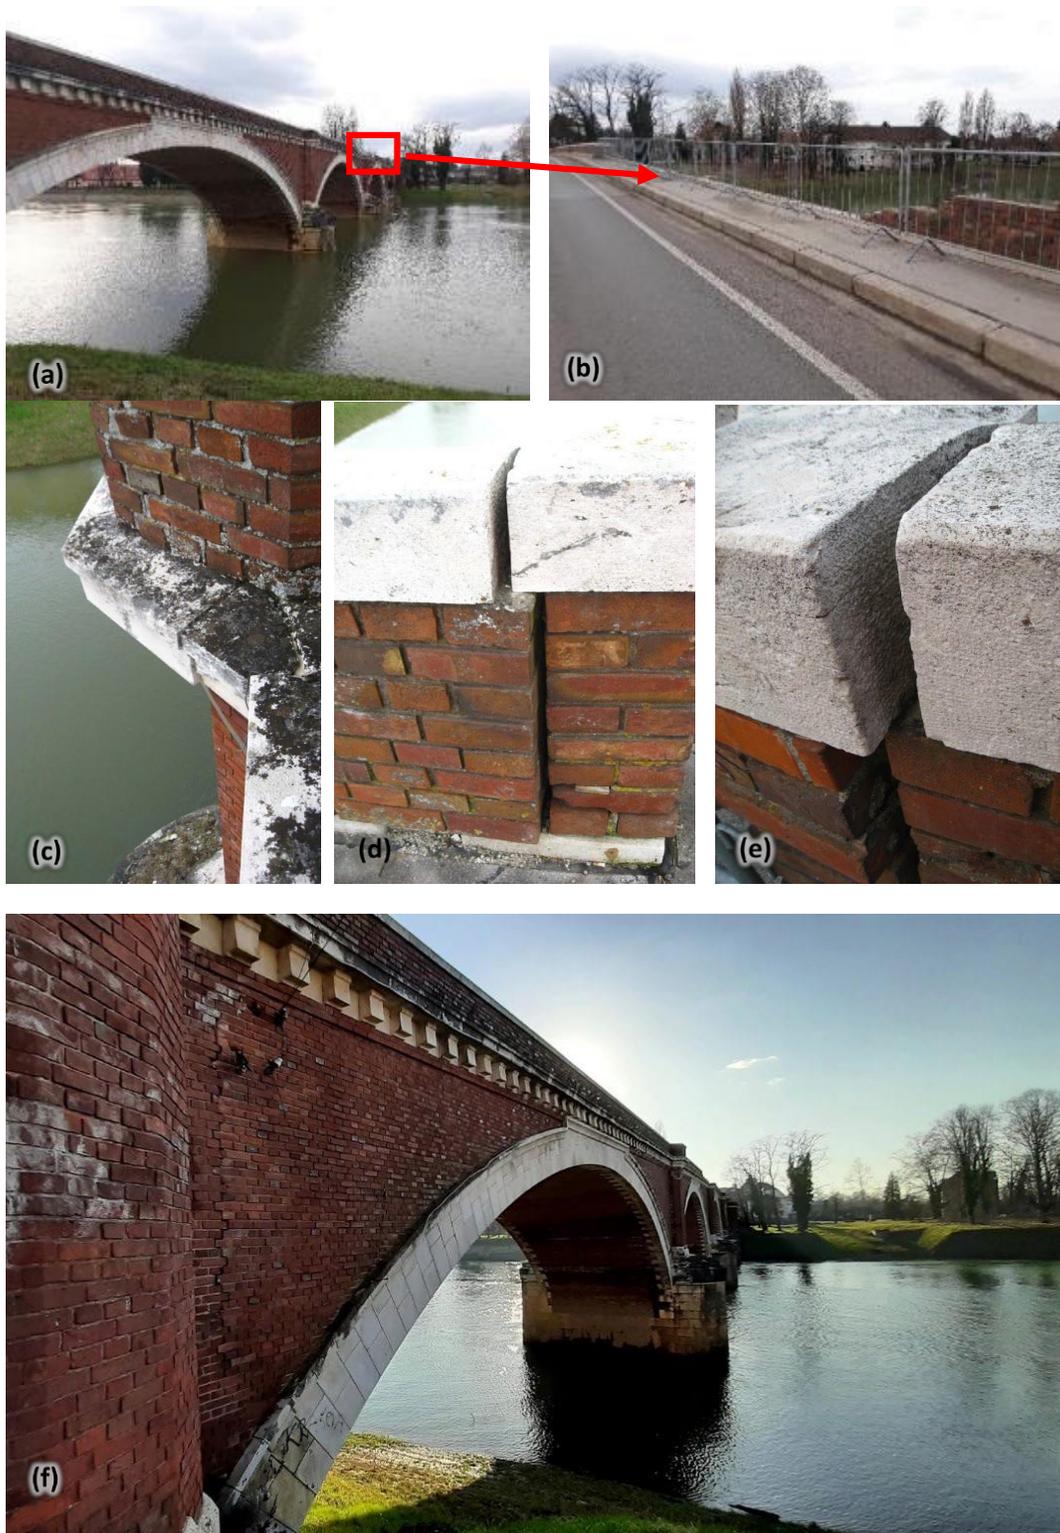
The Old Bridge in Sisak is an arch bridge across the Kupa river from 1934. A portion of its brick railing fell during the earthquake as illustrated in **Figure 9.21 (a&b)**. Some other railing portions were displaced (**Figure 9.21 c,d&e**), but according to an article (siscia.hr, 2018) they were damaged even before the earthquake. Some damage is visible in masonry above the arch, close to an abutment.

Figure 9.21 Damage to the pedestrian railing of the Old Bridge in Sisak: a (45.483N, 16.371E), b (45.4829N, 16.3705E), c (45.4829N, 16.3707E), d (45.4829N, 16.3707E), e (45.4830N, 16.3707E), f (45.4825N, 16.3692E).
