Geotechnical Reconnaissance and Engineering Effects of the December 29, 2020, M6.4 Petrinja, Croatia Earthquake, and Associated Seismic Sequence

Chapter 6: Cover-Collapse Sinkholes

Authors: Ingrid Tomac, Igor Vlahović, Jelena Parlov, Bojan Matoš, Darko Matešić, Ivan Kosović, Ivica Pavičić, Tihomir Frangen, Josip Terzić, Davor Pavelić, Nguyen Pham

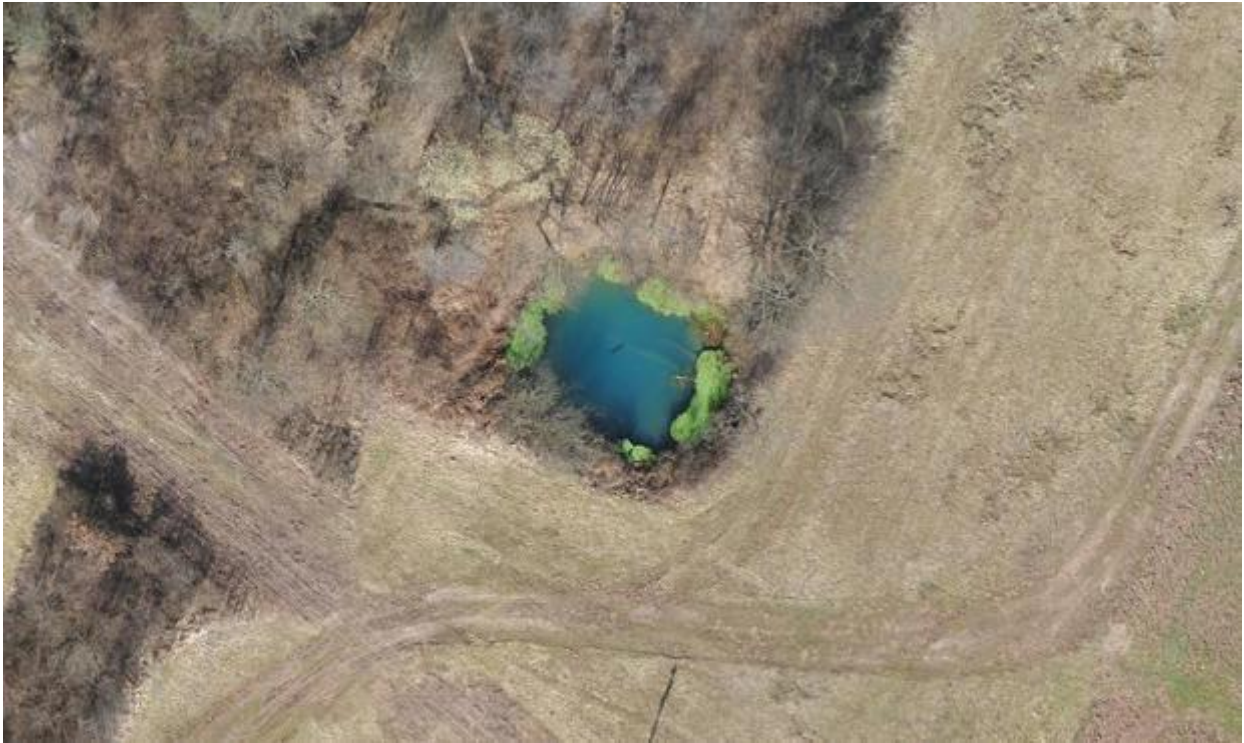
Figure 6.4 Sinkhole S069, with the largest diameter of 16.8 m, is a fossil cover-collapse sinkhole representing a freshwater spring (45.28696N, 16.42630E).

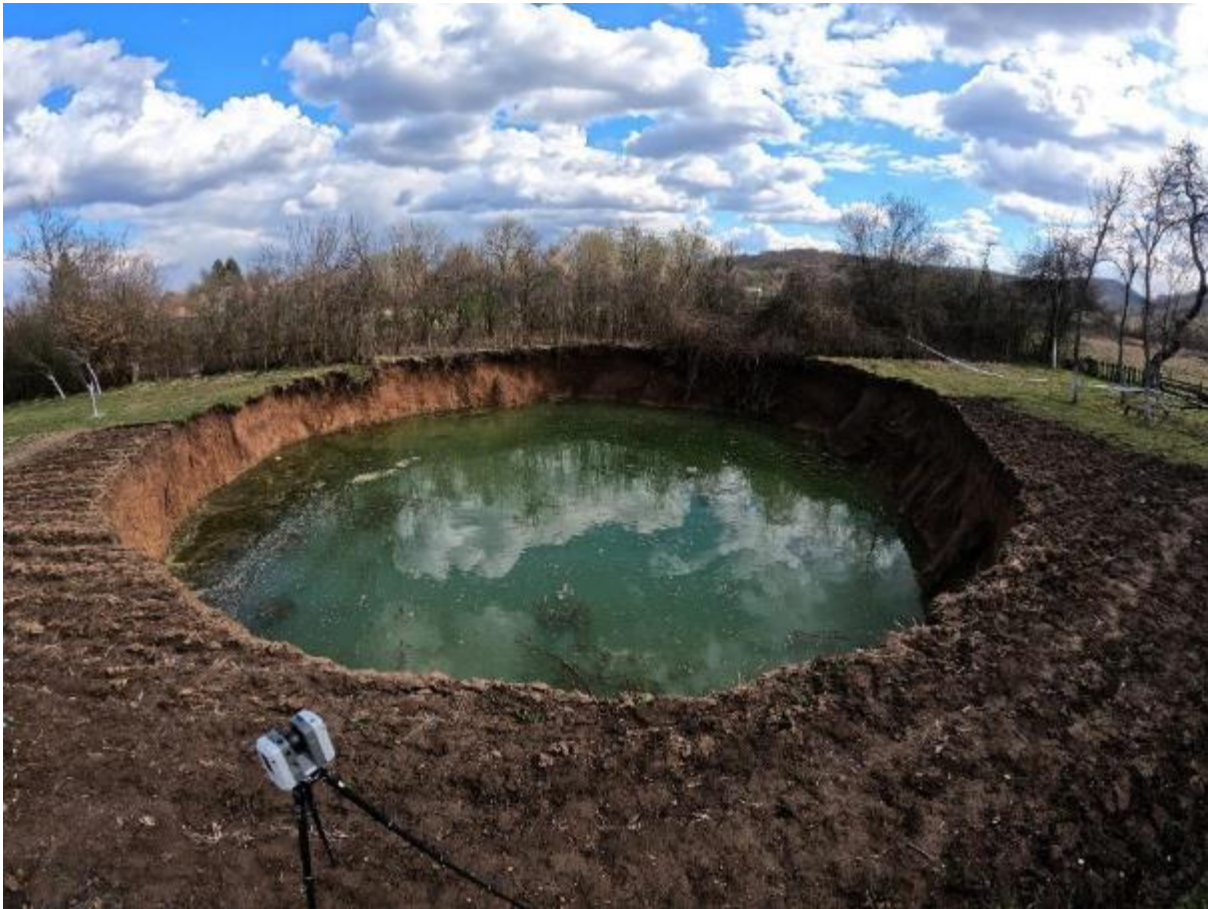
The largest sinkhole, S001 (**Figure 6.17**) collapsed in Mečenčani between the January 4, 2021 afternoon and 13:00 h of January 5, more than 30 hours before the main aftershock, which took place at 18:01 on January 6 (M 4.9). The first subtle subsidence of the area was noticed by land-owners on January 4 afternoon. Two major foreshocks on December 28 (M 5.2 and M 4.7) and the main earthquake of December 29, 2020 (M 6.4) preceded a week before the S001 collapse. The surface soil collapsed at once into S001, forming a sinkhole about 15 m in diameter, followed by minor adjustments and collapses of walls, which remained sub-vertical. **Figure 6.18** shows snapshots from the video recorded on January 6, where the walls are collapsing with an unstable, brittle clay block of approximately 2–3 m, and S001 is widening (Vidić, 2021. Available at: <https://www.youtube.com/watch?v=br-ocSaXIDgwww>).

Figure 6.17 A giant sinkhole (S001) in the Mečenčani. The photograph was taken on March 15, 2021, during lidar imaging (45.283243N, 16.425887E).

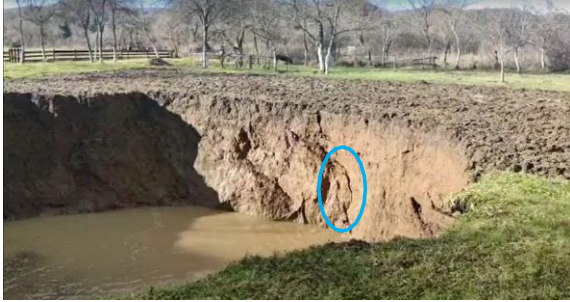
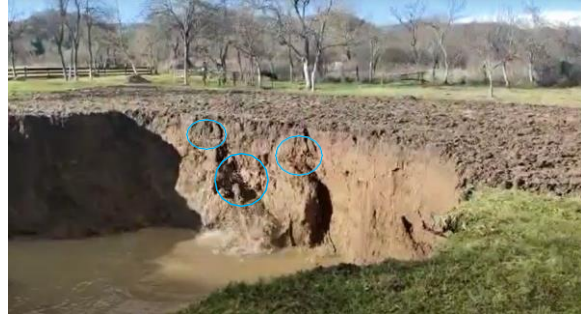
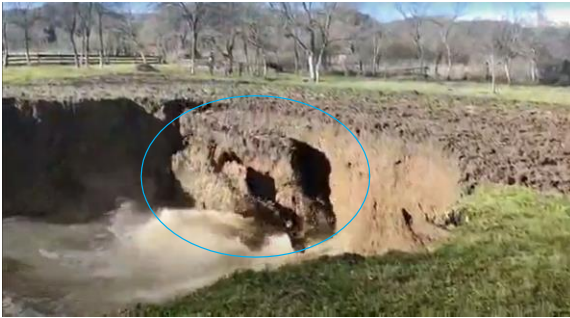
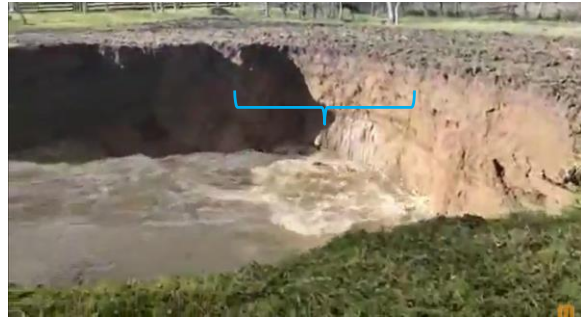
a) The collapse of the edge of a larger unstable clay block.

b) Upper portions of the block are falling.

c) Large block collapse.

d) Material sinks under the water

Figure 6.18. S001 brittle wall collapse sequence on January 6, 2021 (45.2833444N, 16.4259639E) (Vidić, 2021. Available at <https://www.youtube.com/watch?v=br-ocSaXIDgwww>).

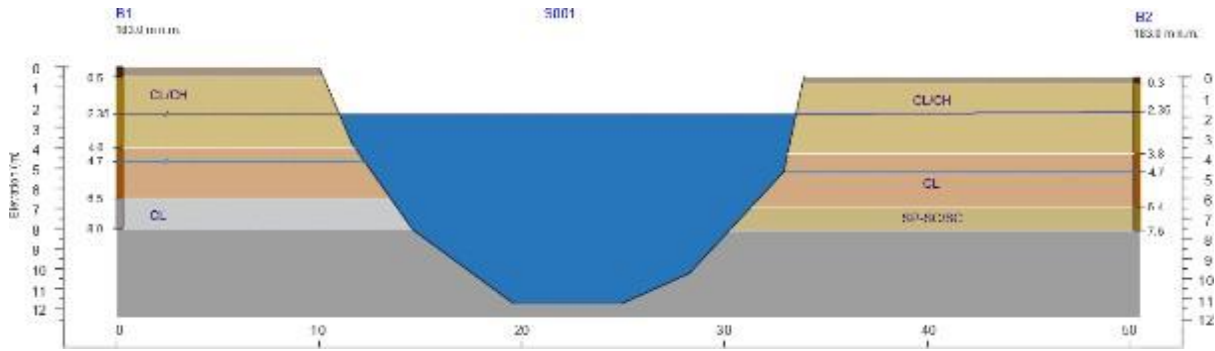
Insight into two geotechnical boreholes reveals that soil consists of 0.5 of fill, 3.5 of sandy lean, and fat clay that is firm to stiff, containing sparse traces of limestone particles up to 20 mm in diameter, with sharp edges (**Figure 6.25**). Limestone particles are distinct and white. Below is stiff to very stiff clay, interlayered by very moist clay with gravel. Boreholes were drilled without heavy machinery and stopped where the equipment could not penetrate stiffer layers at approximately 8,0 m depth. Lower layers are in B-1 gray lean marly clay, with low plasticity and high stiffness. Bedrock or cobbles appeared below 8 m, where also the Standard Penetration Test equipment bounced off without penetration.

Figure 6.25 Soil profile around S001, dimensions are given in mm (45.2833444N, 16.4259639E).

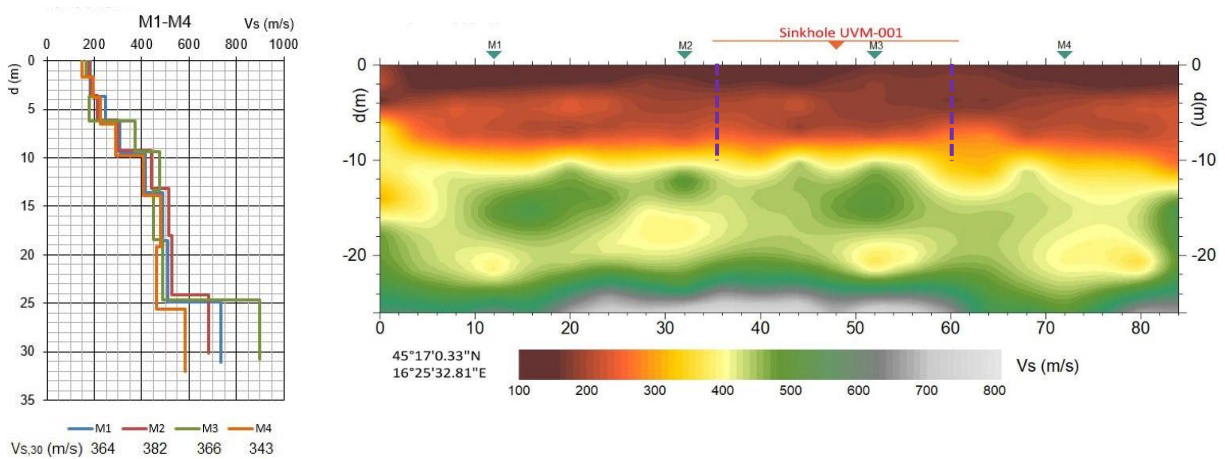
Multichannel Analysis of Surface Waves (MASW) has been performed just along the edge of S001. **Figure 6.26** shows a two-dimensional interpretation of the MASW profile near S001, where lower shear wave velocities of 180–220 m/s occur until 5–6 m depth, under which are slightly higher velocities 300–400 m/s between 6 and 10 m. Relatively uniform strata down to 25 m are shown in green and yellow colors, which has heterogeneous 400–500 m/s velocities. It can be concluded that the compact rock layer appears below 25 m, which is geologically characterized as karst. Comparing to MASW profiles, indeed, shear wave velocities increase at that depth. Detailed presentation of investigation works is in Chapter 10.

Figure 6.26 MASW profile with a sketch of S001 to the depth of 11.2 m (45.2833444N, 16.4259639E).

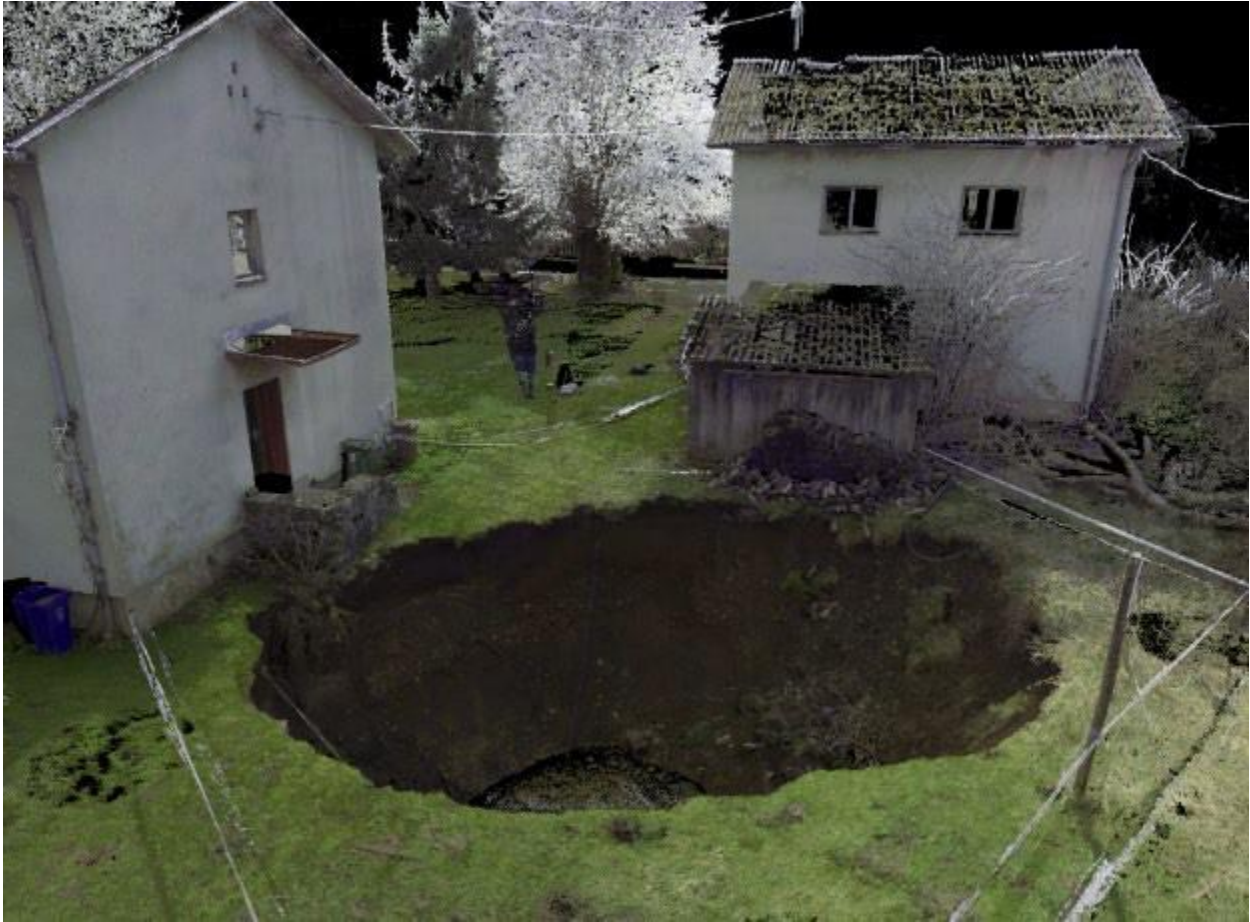
S015 collapsed on December 29, 2020, with the first subsidence noticed six hours after the main shock, followed by the opening of two cover-collapse structures (each about 1.5 m in diameter

and cca. 1 m deep) within the next three hours and further collapse and formation of united sinkhole until the morning of December 30. **Figure 6.27** shows a lidar bundle scan near a house, where **Figures 6.28** and **6.29** show measurements from point cloud data.

Figure 6.27 The lidar scan of S015 (45.282859N, 16.429841E).

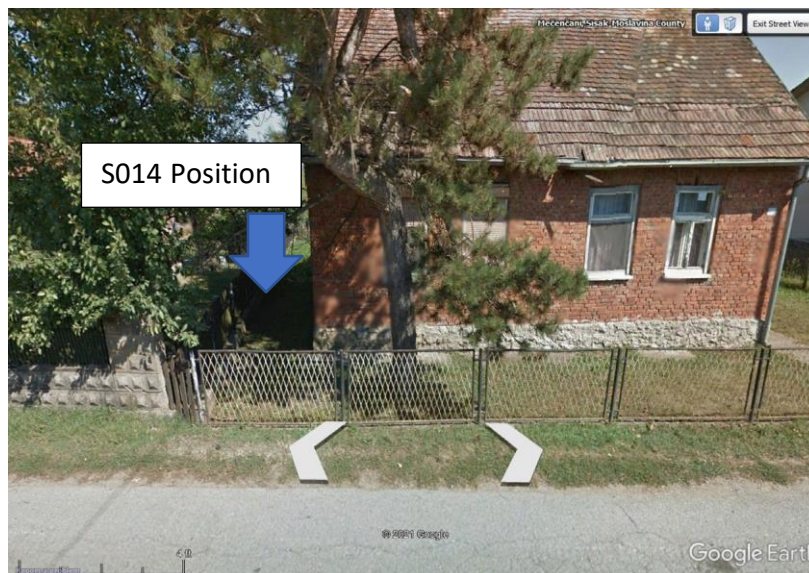
Sinkhole S014 collapsed on December 31, 2020, near a brick wall family house, as shown in **Figures 6.30** and **6.31**, and is full of water. S014 caused floor slab and house walls failure, whose materials then fell into the sinkhole.

Figure 6.30 Street view of the house and S014 position (45.282822N, 16.429389E).

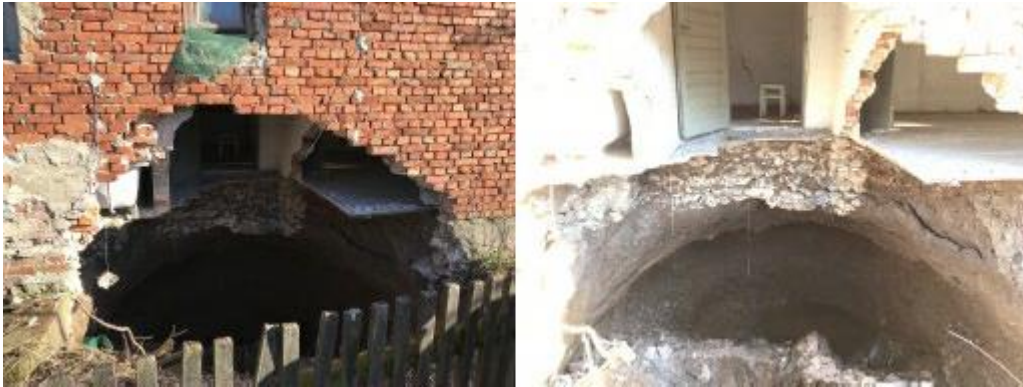
Figure 6.31 S014 images (45.282822N, 16.429389E).

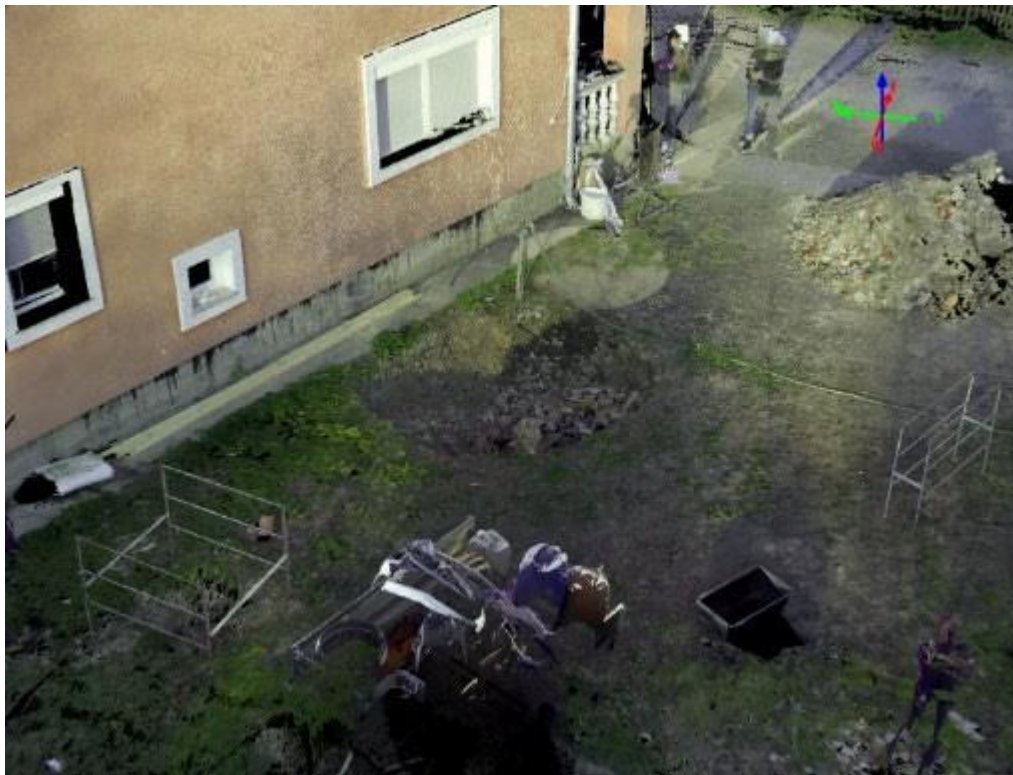
Sinkholes S053, S054, and S055 have a relatively small diameter, as shown in **Figures 6.32 to 6.38**. Three sinkholes collapsed within an agricultural family compound in Mečenčani. S053 was just next to the family house wall, as shown in **Figure 6.32**. S054 and S055 collapsed near greenhouses.

Figure 6.32 S053 bundle image (45.281270N, 16.431618E).
