Geotechnical Reconnaissance and Engineering Effects of the December 29, 2020, M6.4 Petrinja, Croatia Earthquake, and Associated Seismic Sequence

Chapter 8: Earthen Levee Systems

8. Earthen Levee Systems

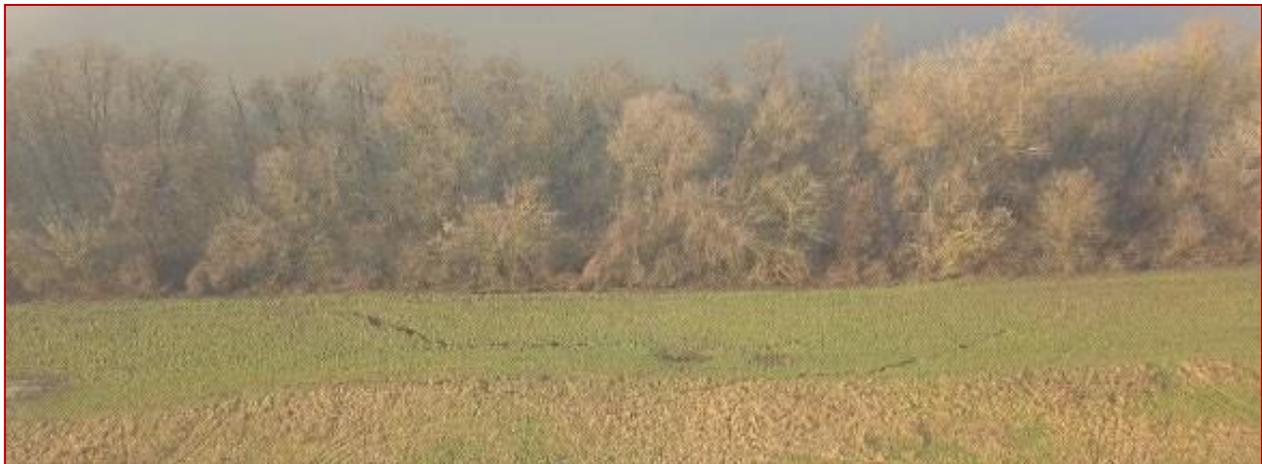
The crack which spreads across the crest and continues down the slope of the levee extending for about 30 m along both sides of the levee is shown in **Figure 8.4** and **Figure 8.5** from above, in **Figure 8.7** on the field side, and **Figure 8.8** and **Figure 8.9** on the river side. Cracks are vertical in general but irregular in shape, so a maximum depth of 2 m was measured.

Figure 8.4 Cracks across and along the levee (Photo documentation: Geokon – Zagreb LLD, January 7, 2021, 45.4614N, 16.3358E).

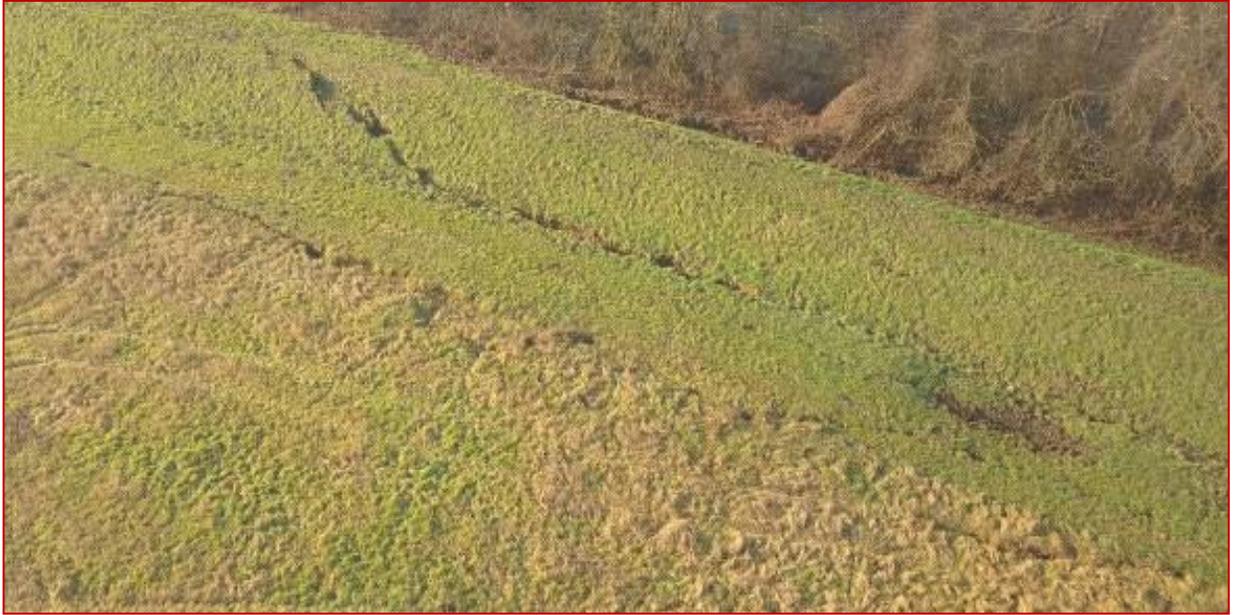
Figure 8.5 Cracks across and along the levee (Photo documentation Geokon – Zagreb LLD, January 7, 2021, 45.4614N, 16.3358E).

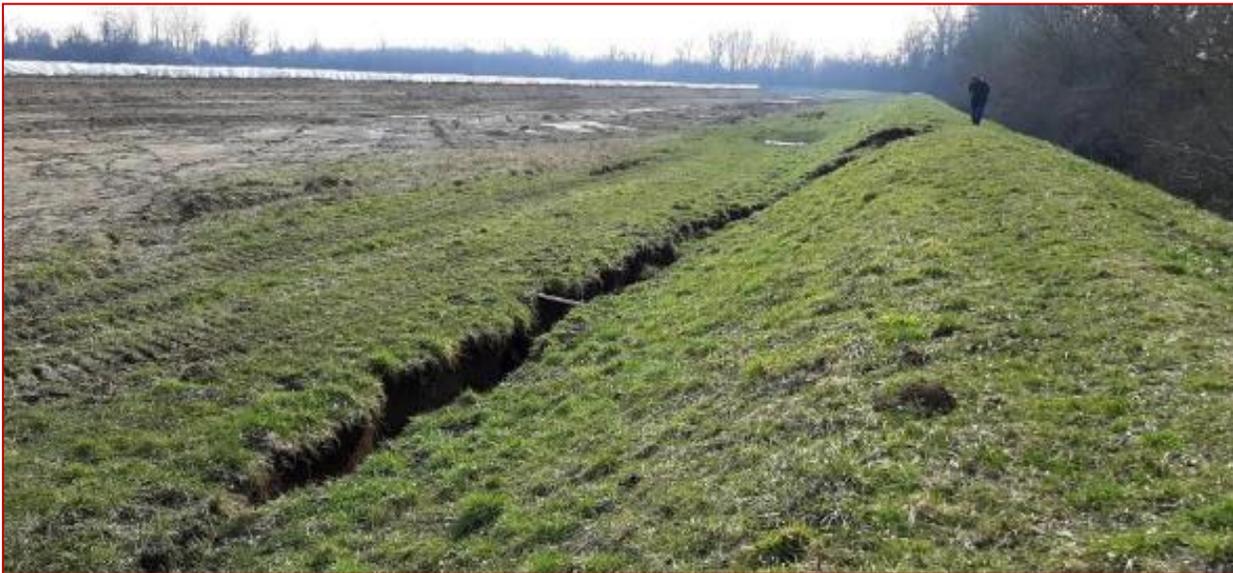
Figure 8.6 Crack across and along the levee (21.2.2021.; 45.46142N, 16.33580E). Secondary levee is visible in the distance.

In the first days after the earthquake, Croatian Waters started building a secondary levee far enough on the field side to prevent flooding. The cracks on the river side and the deformation of the slope towards the river make the riverbank unstable.

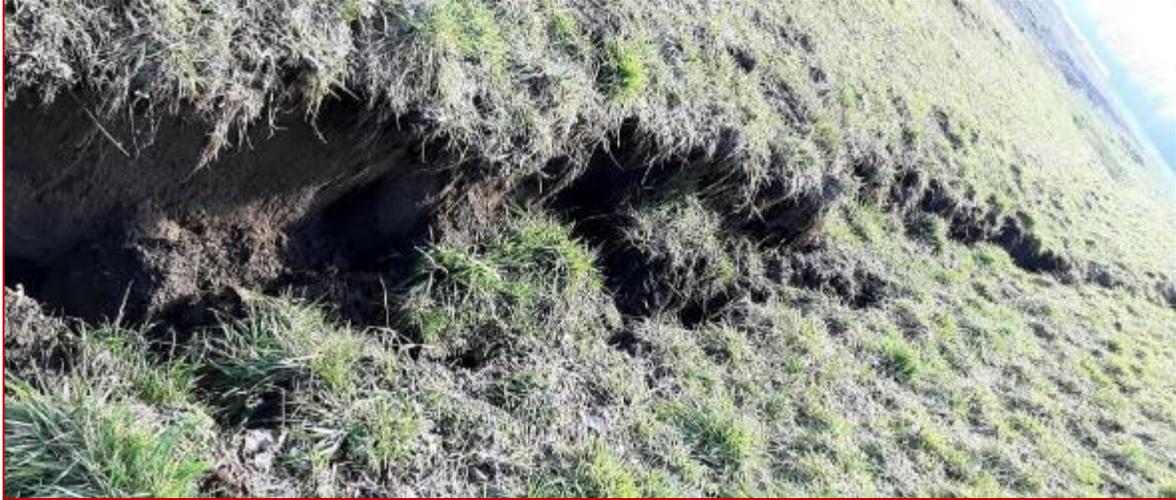
Figure 8.7 Crack across and along the levee (21.2.2021.; 45.46130N, 16.33592E).

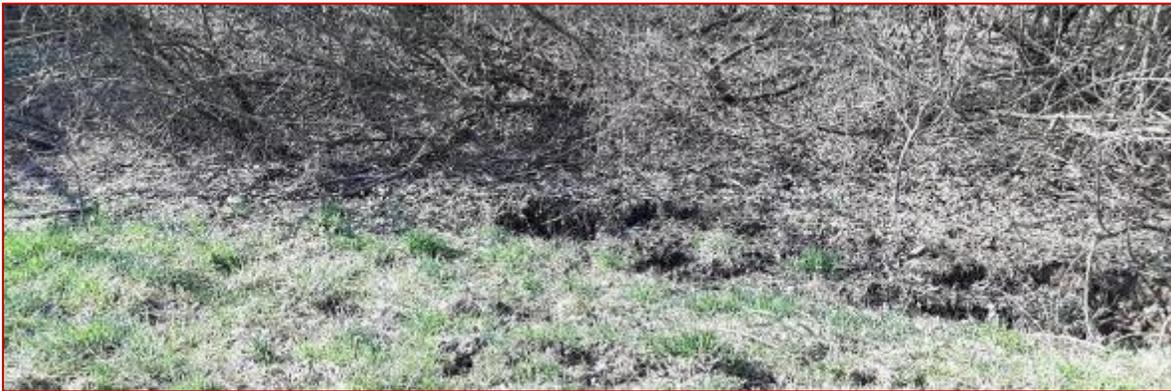
Figure 8.8 At the river side of the levee crack is 2 m deep (21.2.2021.; 45.4612192N, 16.3358308E).

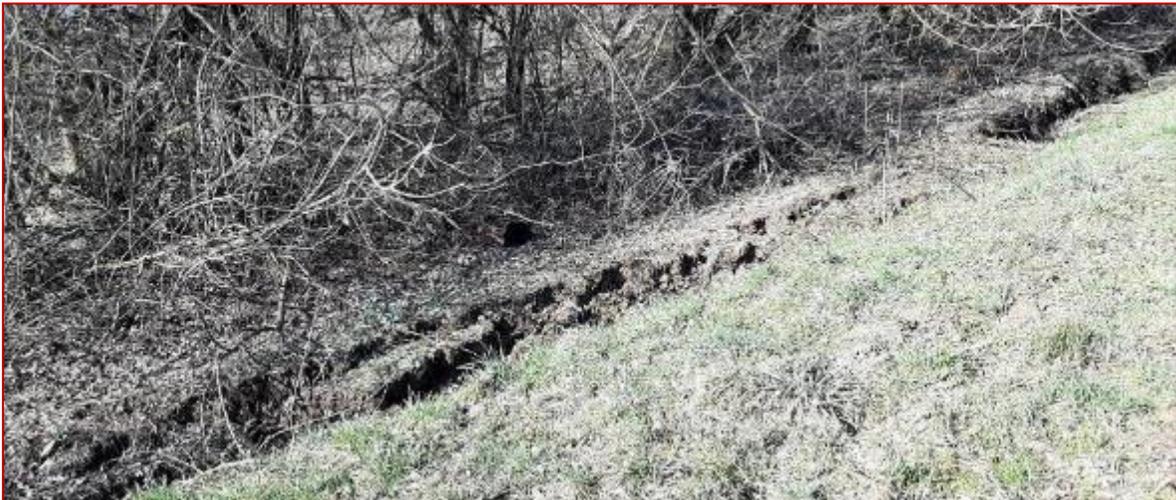
Figure 8.9 At the river side of the levee (21.2.2021.; 45.4612015N, 16.3358606E).

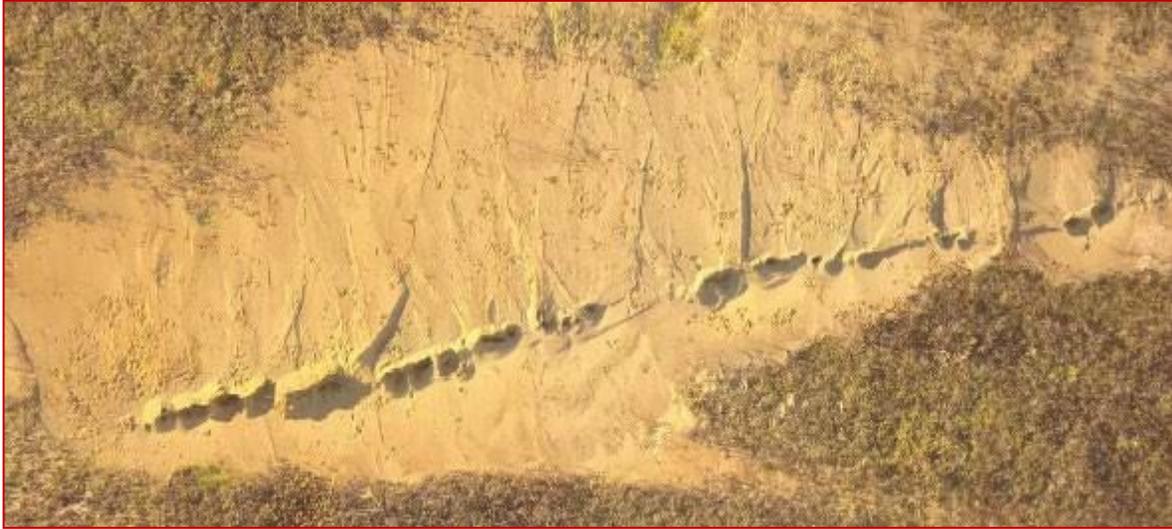
On both sides in the field irregular ejecta was found, the longest stretch being approximately 60 m long as seen in the air photo in **Figure 8.10**.

Figure 8.10 Ejecta in the field: length approximately 60m (Photodocumentation Geokon-Zagreb d.o.o.; January 7 2021; 45.46006N, 16.33759E).

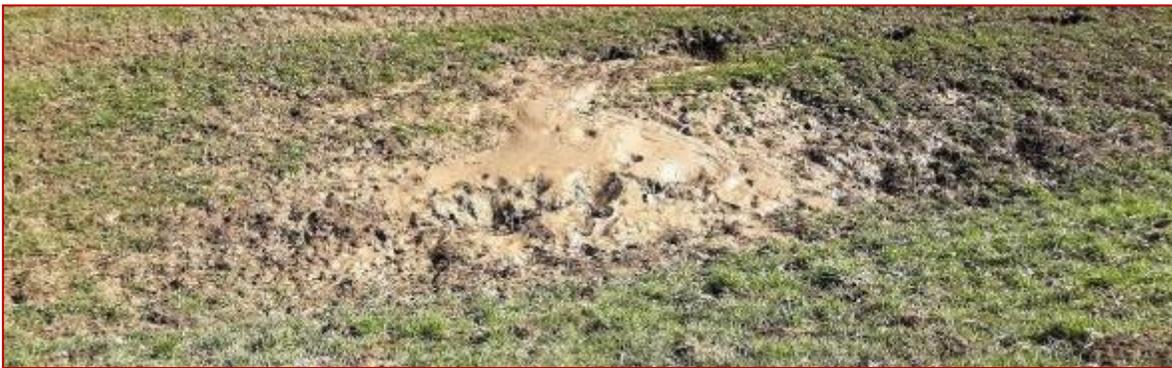
Figure 8.11 Ejecta in the field (21.2.2021.; 45.4611943N, 16.3358866E).

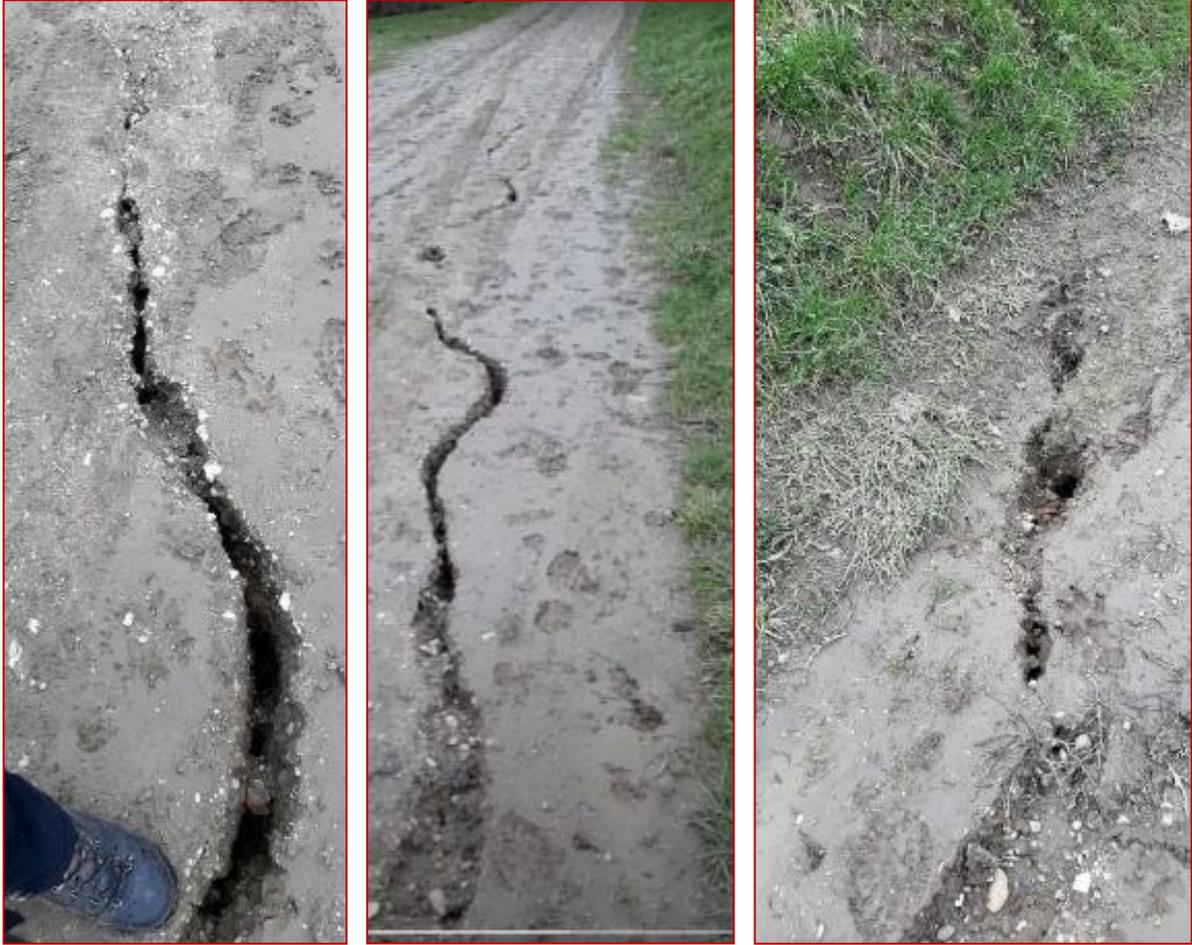
Along the levee from Bridge Brest downstream to the Beach, on the right (southern) bank, cracks have been found along with the tow as shown in Figure at the distance of about 1m and width up to 7 cm. Liquefied sand was ejected on the other side of the levee, in the fields. Previous geotechnical investigation (Geokon-Zagreb LLD, 2021) shows the presence of silty sand from the depth of about 2 to 4m to about 5.5 to 5.8m.

Figure 8.13 Typical cracks near the levee toe (6 February 6, 2021; 45.4450N, 16.2660E).

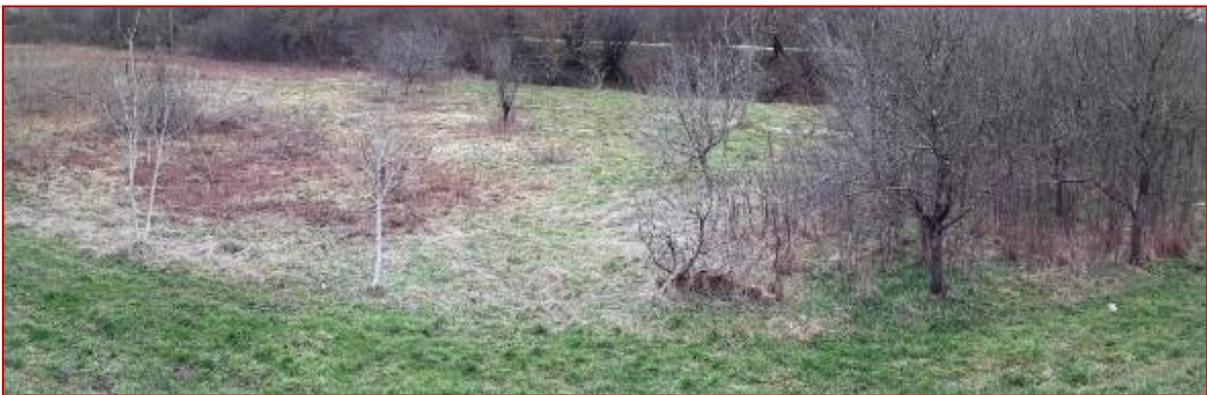
Figure 8.14 Liquefied sand ejecta on the field side of the levee (45.4453N, 16.2649E).

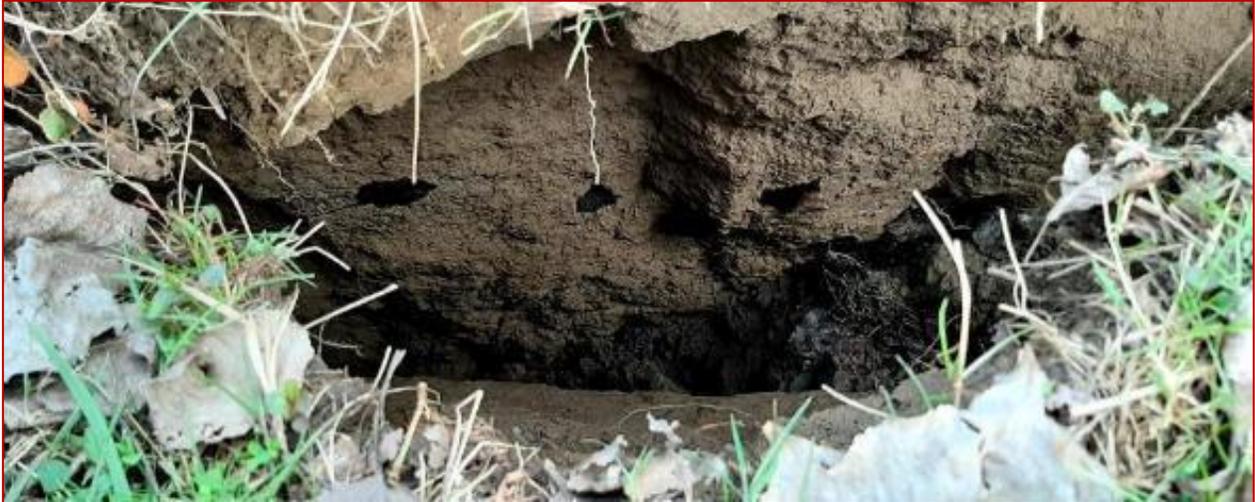
Along the levee from the Petrinja Beach, at a length of 4 km, cracks are visible on both sides the levees. Cracks are irregular in shape and the maximum measured depth is 2m. Typical cracks are shown in the **Figure 8.15-17**. In some locations, liquefied sand ejecta is found. **Figure 8-18** shows one of the cracks with liquefied sand. Croatian Waters in the first days after the earthquake started building secondary protection visible in **Figure 8-19**.

Figure 8.15 One of the deep cracks in the levee north of Petrinja (February 19, 2021; 45.4593N, 16.2738E).

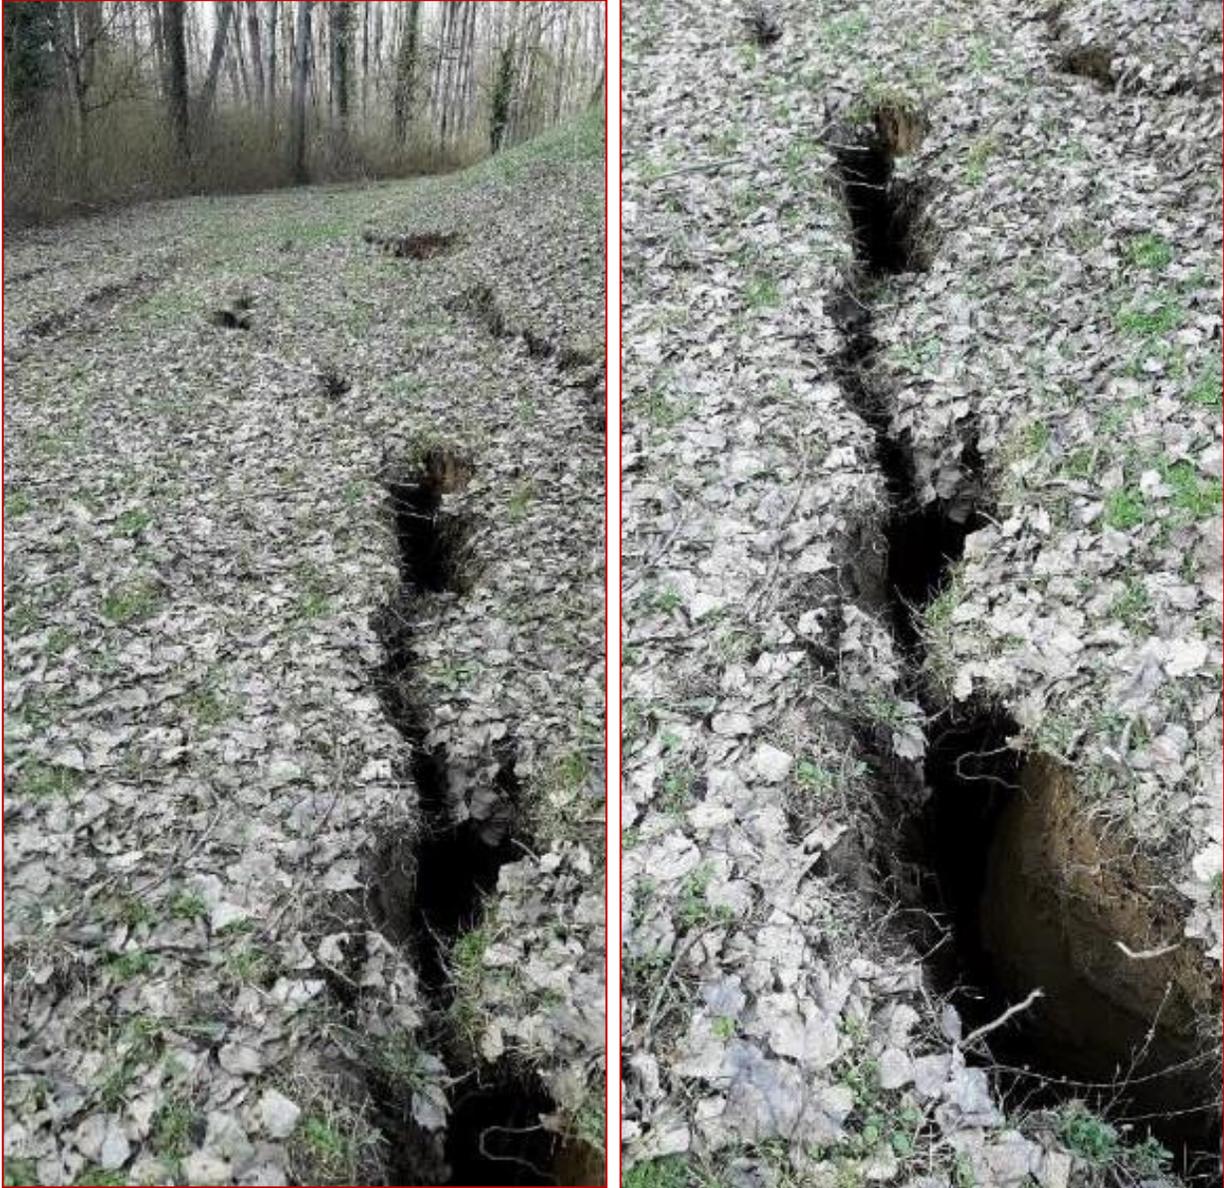
Figure 8.16 Typical cracks on the river Kupa side of the levee north from Petrinja (19 February 2021; 45.4591N, 16.2739E)

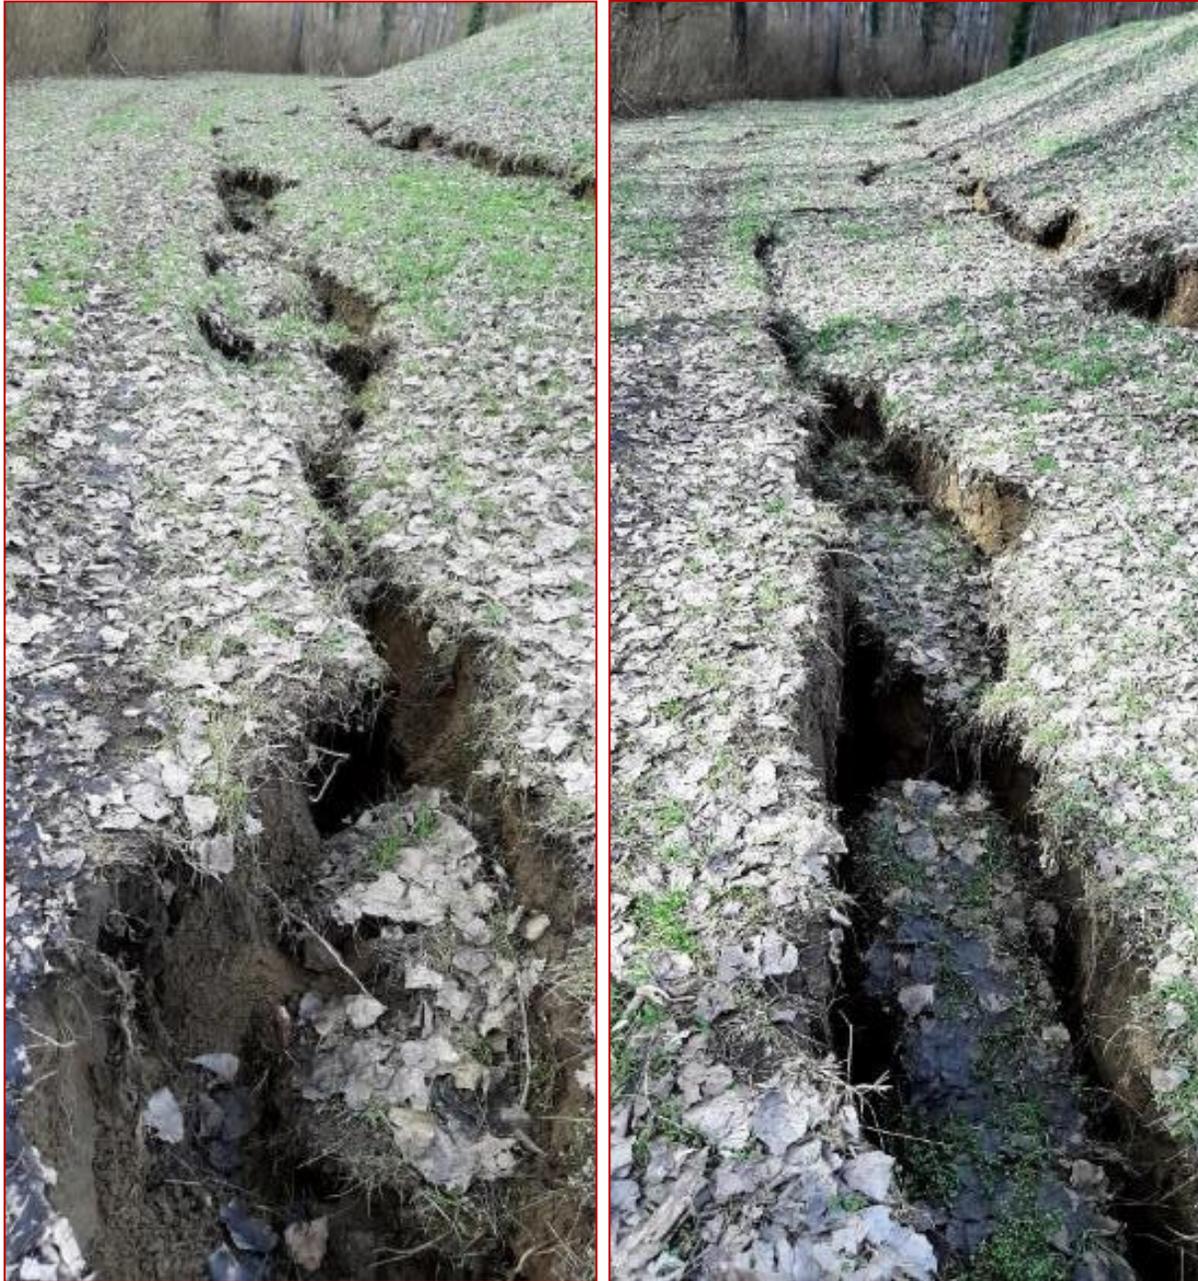
Figure 8.17 Typical cracks on the river Kupa side of the levee north from Petrinja (February 19, 2021; 45.4592N, 16.2740E).

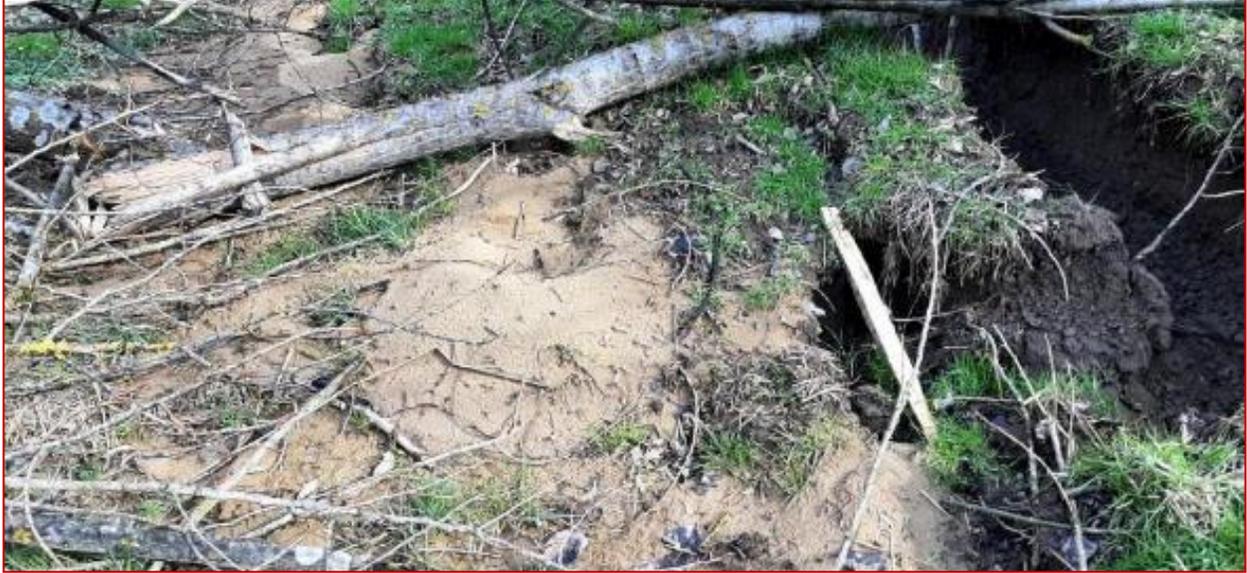
Figure 8.18 Typical crack on the field side of the levee north from Petrinja with liquefied sand ejecta (19 February 2021; 45.4613N, 16.2748E)

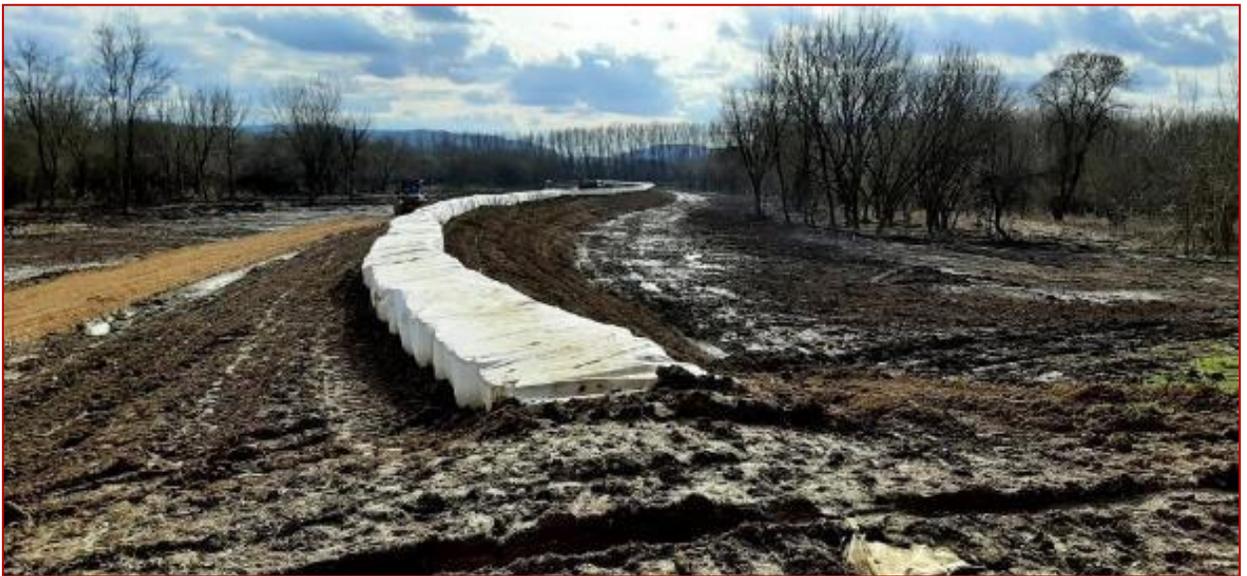
Figure 8.19 Secondary levee built by Croatian Waters (19 February 2021; 45.46180N, 16.2775E).

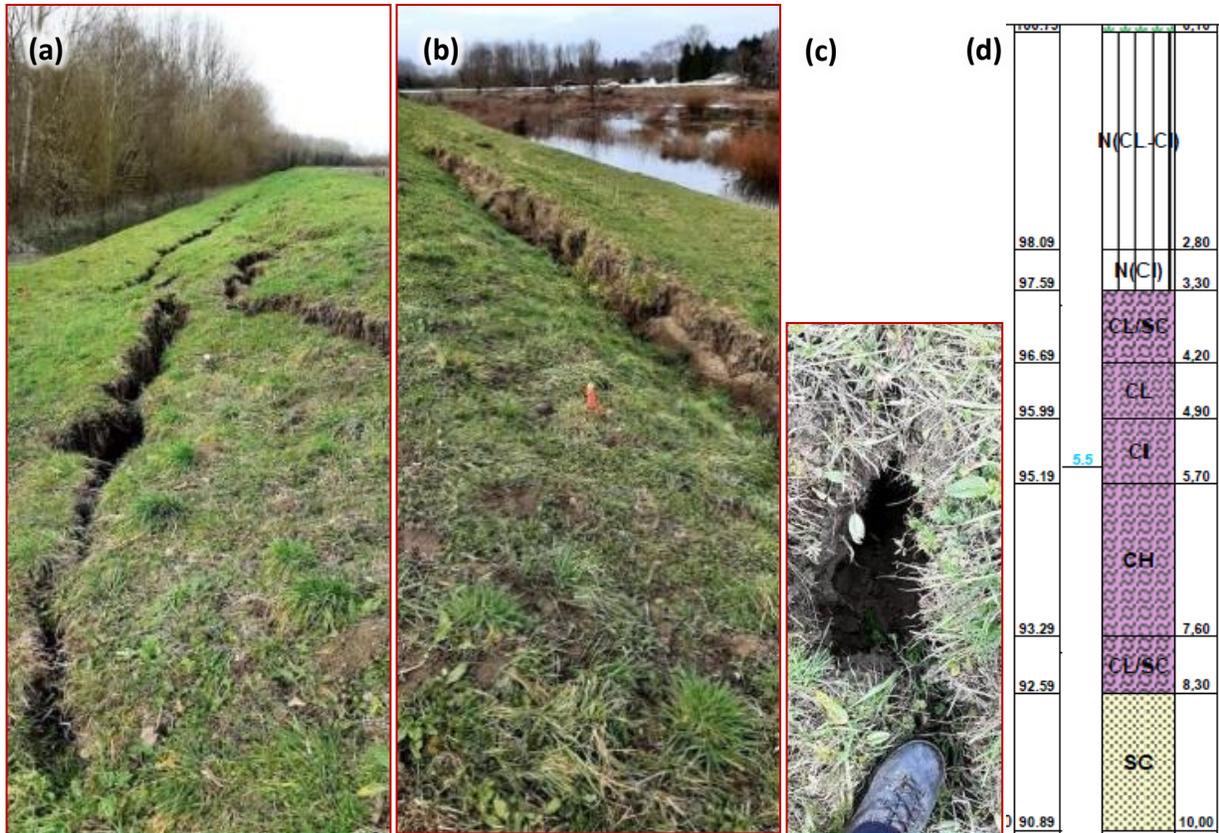
The longitudinal cracks are up to 50 cm wide and there is also vertical displacement observed as can be seen in **Figure 8.21 a-c**. A nearby boring from the year 2013. (Geokon-Zagreb LLD 2021) shows the presence of medium density sand at 5 m depth as shown in **Figure 8.21d**. Regarding the widespread liquefaction in the area, this could suggest that liquefaction may have played a role in the deformation of the levee and surrounding ground. Croatian Waters built a secondary levee to protect 800m of the primary levee. The densest are the cracks around the discharge pipe through the levee - where Croatian Waters built separate protection as seen in **Figure 8.22**.

Figure 8.21 (a) Some of the cracks at the river side of the levee (45.4704728N,16.3957025E), and (b) on the opposite side (45.47059N,16.3954E), (c) typical crack (45.4705N,16.3957E). (d) Borehole done in the year 2017 (Geokon-Zagreb LLD 2021) on a nearby location shows the presence of clayey sand at the depth of around 5 m below the ground surface – the upper 3.3 m represent the levee.

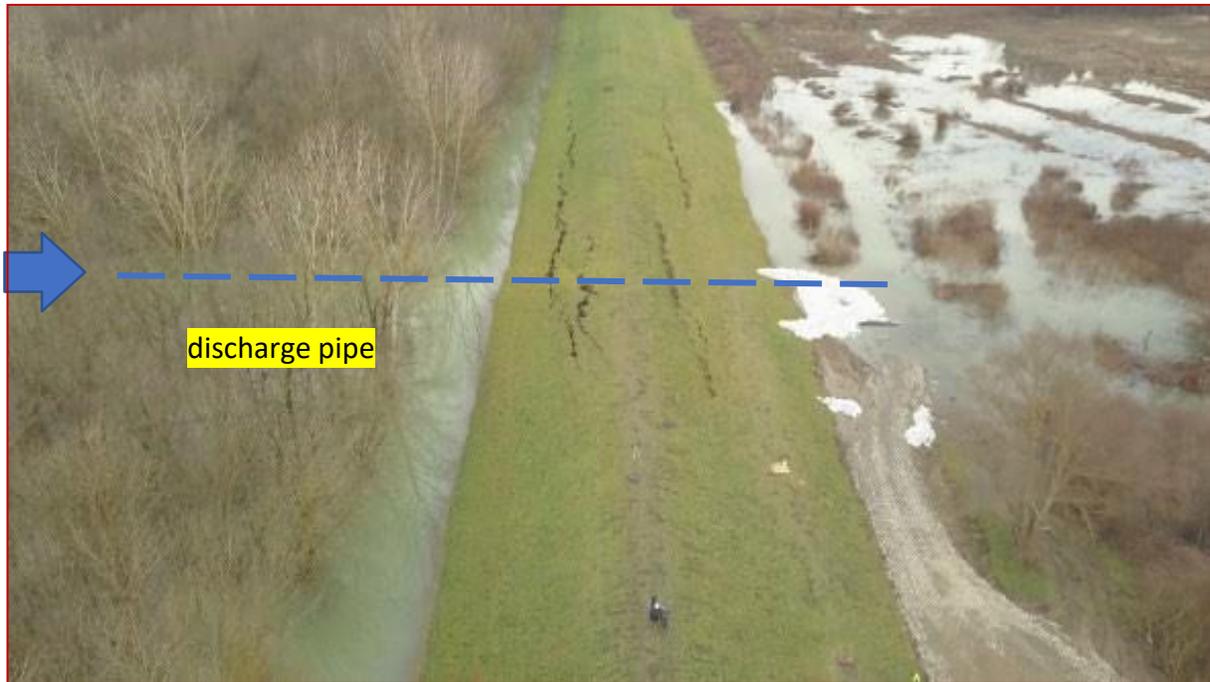
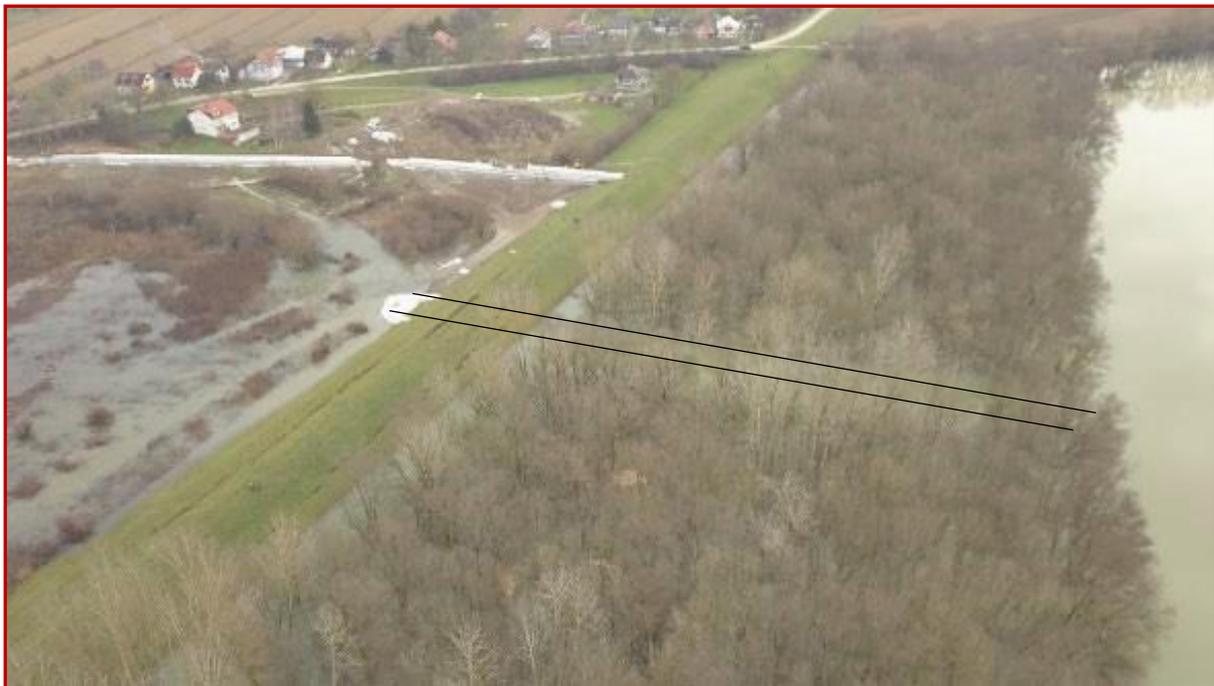
Figure 8.22 Two air views of the southern part of the damaged levee with a high level of the Sava river. The white sandbags were installed right after the earthquake on the discharge pipe location, also the secondary levee was built. (Photo documentation of Geokon – Zagreb LLD, 45.4708 16.3952).

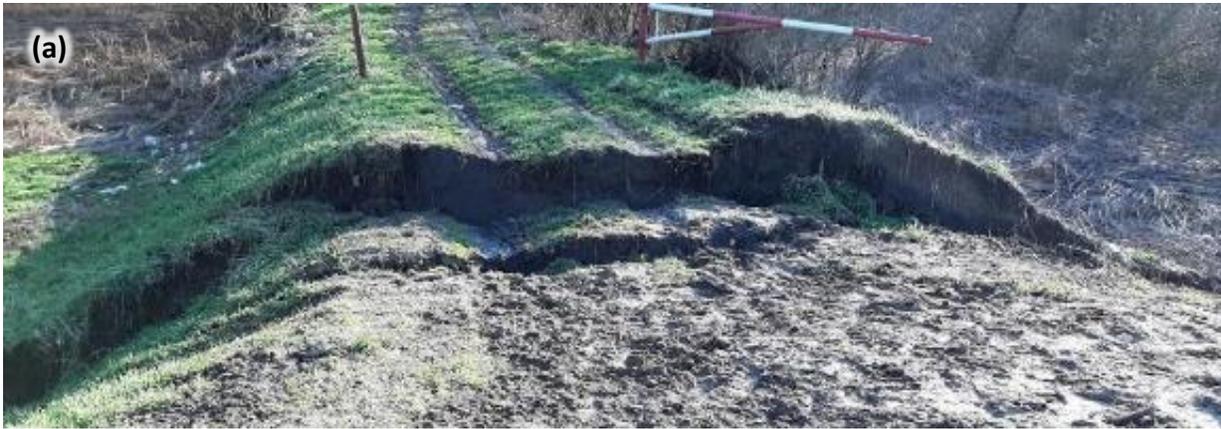
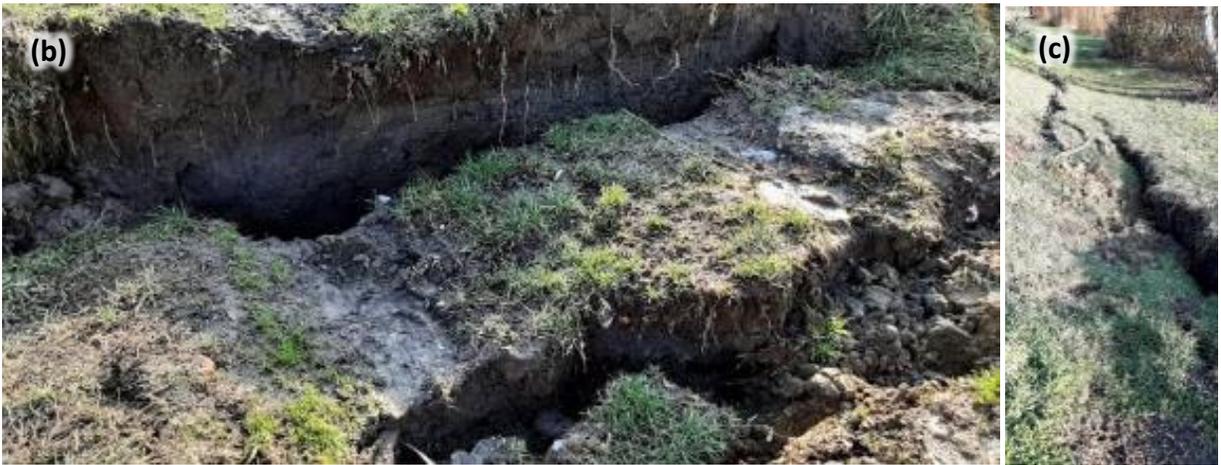
At a distance of 19.5 km from the epicenter, the levee on the left bank of the Sava river was damaged over a length of approximately 250m in the area shown in **Figure 8.23**. Transverse cracks followed by vertical displacement of about 50 cm occurred near the location where two levees meet as shown in **Figure 8.24**. Longitudinal cracks along the road and the toe are shown in **Figure 8.25**, together with some ejecta on the river side. On the field side, more sand was ejected to the surface as seen in **Figure 8.26a**. A sand layer was found at a depth of about 5m as shown in **Figure 8.26b**.

Figure 8.24 (a,b) Transverse cracks and settlement. (45.518732N, 16.4028826E), (c) longitudinal cracks along the levee toe on the eastern side.

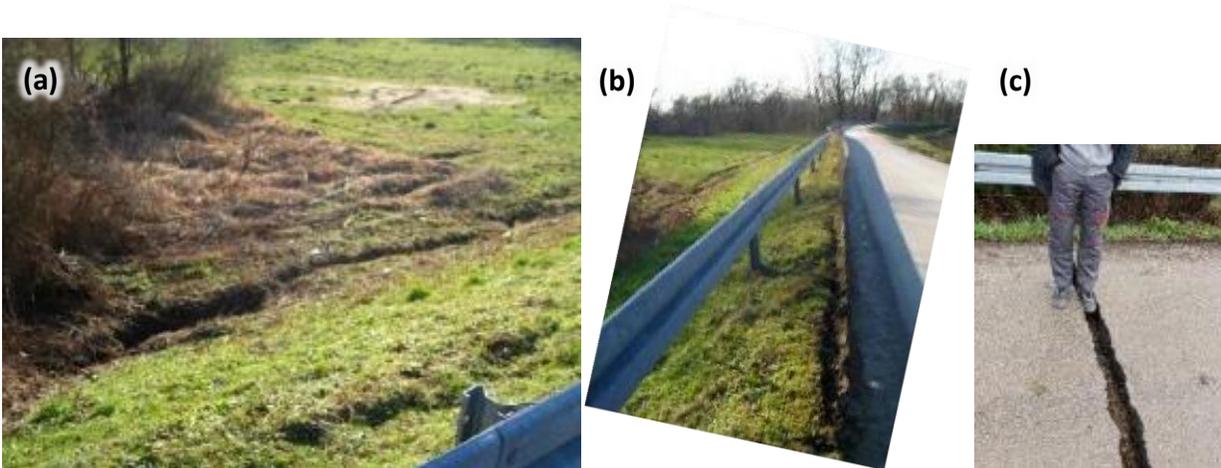
Figure 8.25 (a) Sand ejecta in the field, longitudinal cracks along the levee along the toe and (b) along the crest and settlement. (45.51874, 16.402). (c) Transverse crack on the road on the levee crest (Photo documentation Geokon – Zagreb LLD).

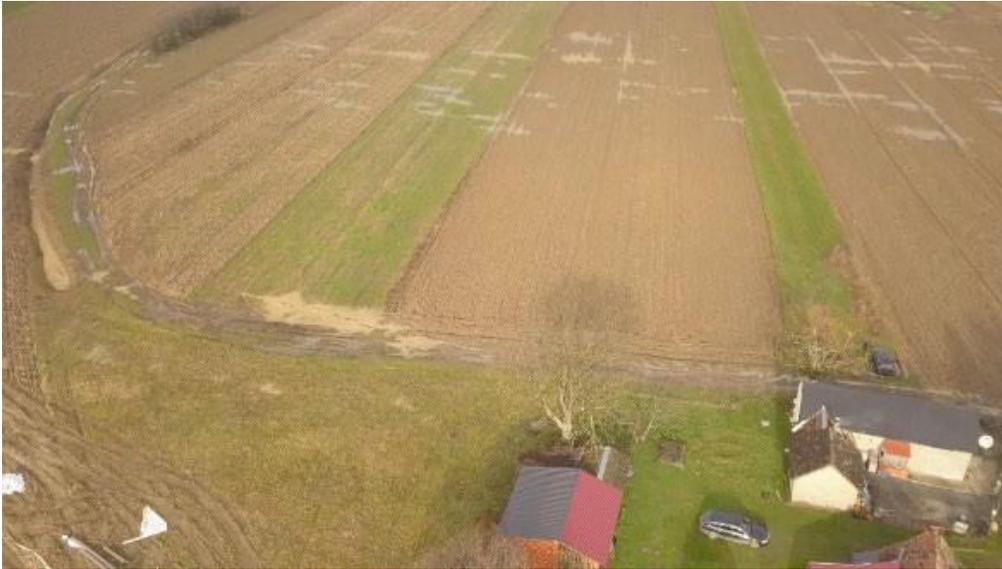
Figure 8.26 (a) Aerial view of the liquefaction in the field near Palanjek. (45.520N, 16.402E, Photo documentation Geokon – Zagreb LLD. (b) Borehole from 2013 (Geokon-Zagreb LLD 2021) on a nearby location shows the presence of clayey sand at the depth of around 5 m below the ground surface.

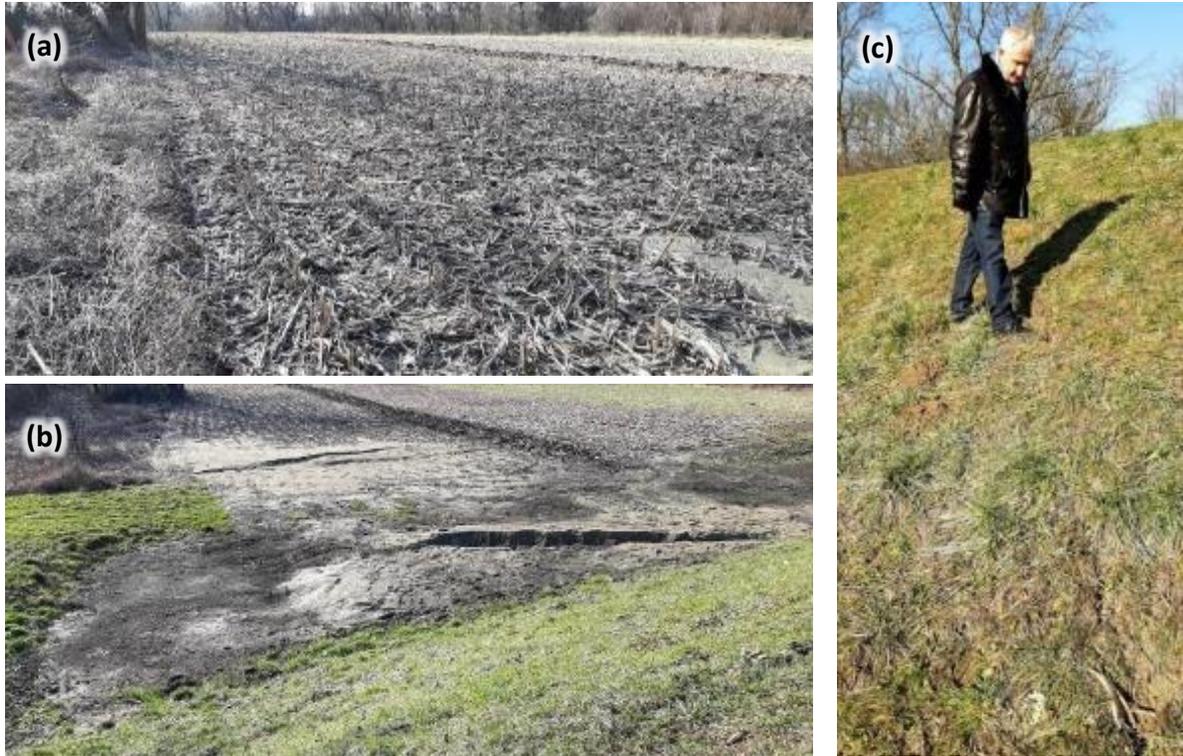
At a distance of 19km from the epicenter, along the section of the left bank of the Sava river, sand ejecta are visible on both sides of the levee, on the levee slopes, near the toe, and in the fields. In addition to some smaller areas, sand ejecta are visible on the river side in the field along the stretch of 40 m of the levee, and at a distance of 40 m or more as seen in **Figure 8.27**. A similar area is covered with sand on the opposite side as shown in **Figure 8.28**. A nearby borehole from 2017 (Geokon-Zagreb LLD 2021) shows the presence of a sand layer at a depth of 3 m (**Figure 8.28c**).

Figure 8.27 (a, b) Liquefied sand on the river side of the levee near Hrastelnica from the levee toe to the distance of 40 m, and cracks on the levee (45.5007N, 16.4162E).

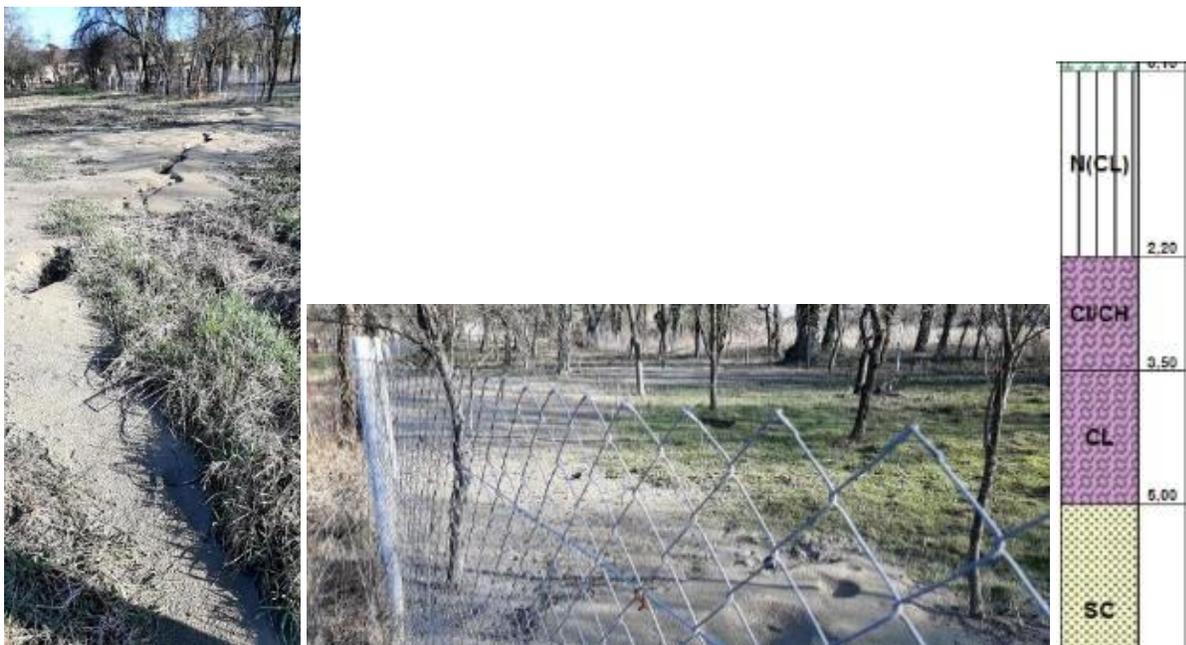
Figure 8.28 Liquefied sand on the dry side of the levee near Hrastelnica (45.5015N, 16.4163E). Borehole from 2017 (Geokon-Zagreb 2021) on a nearby location shows the presence of clayey sand at the depth of around 5 m below the ground surface.

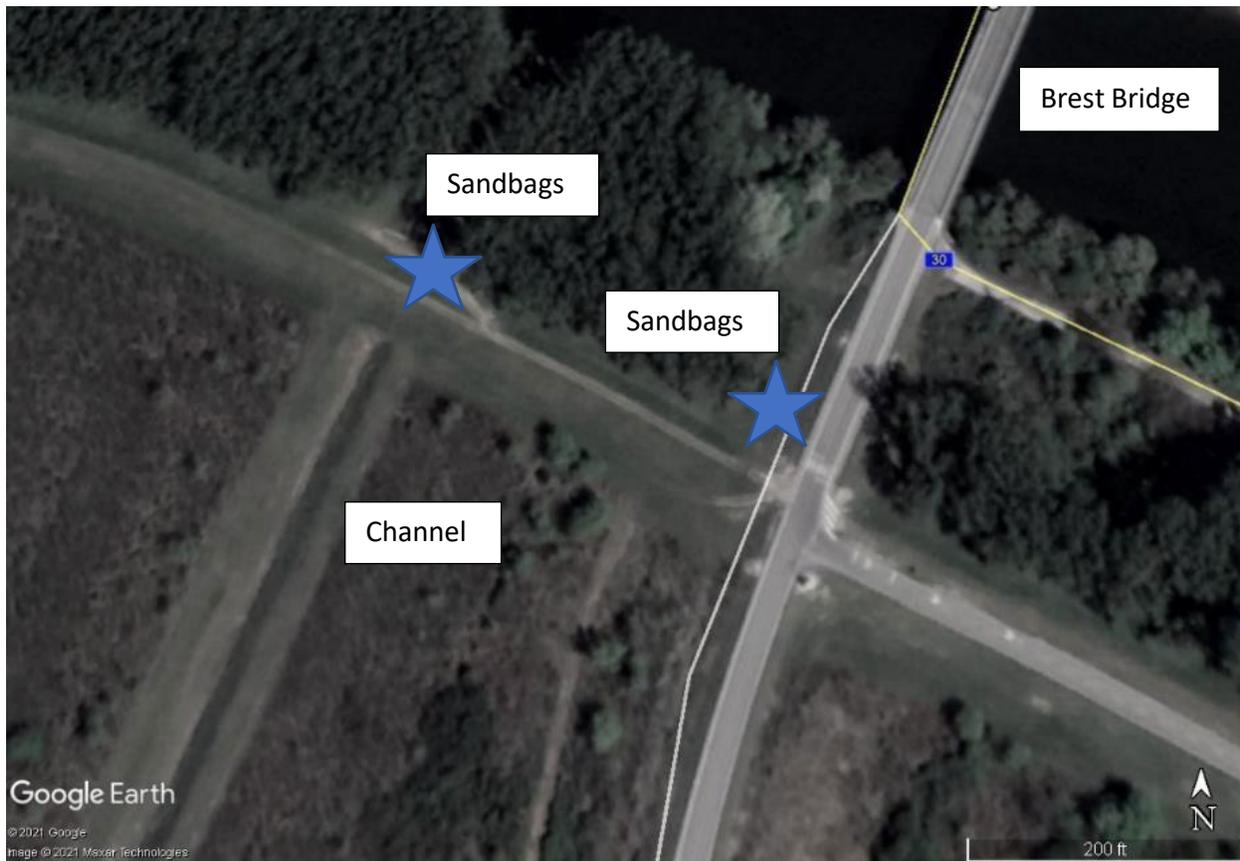
A levee south of Brest Bridge along the Kupa river was damaged in two locations. The first location is at the contact of the levee and the bridge embankment and the second is where a water channel perpendicularly crosses the levee. **Figure 8.29** shows the plan view and **Figure 8.30** damaged concrete channel under the levee and remediation works that were performed immediately after the earthquake. The images were taken on March 22nd, 2021.

Figure 8.29 Plan view of the Brest Bridge and levee damage in Brest Pokupski, near Petrinja (45.4476N, 16.259E) (source: Ingrid Tomac)

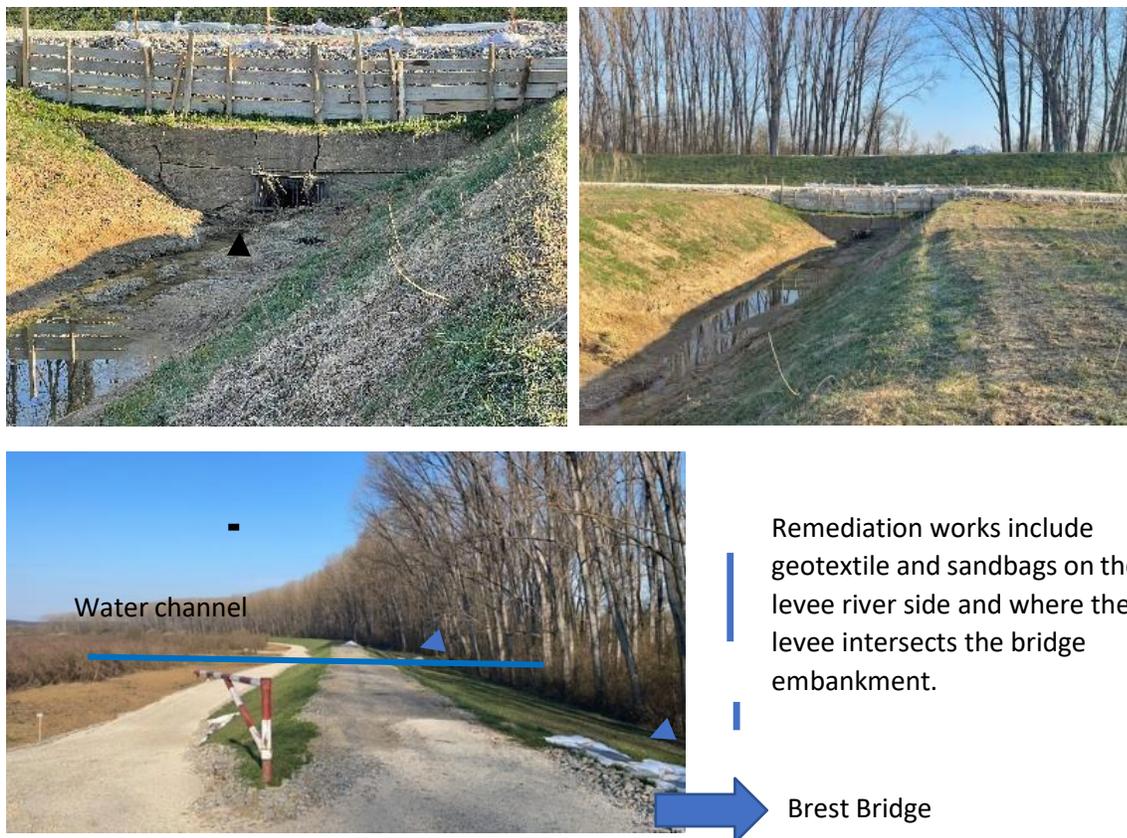
Figure 8.30 Levee damage and remediation works on the south bank Kupa river levee near the Brest Bridge in Petrinja (45.4478N, 16.2583E; 45.4475N, 16.2595E) (source: Ingrid Tomac).

Remediation works include geotextile and sandbags on the levee river side and where the levee intersects the bridge embankment.
