GEOTECHNICAL ENGINEERING RECONNAISSANCE OF THE 2022 CHIHSHANG EARTHQUAKE SEQUENCE

Version 1.0; April 2024

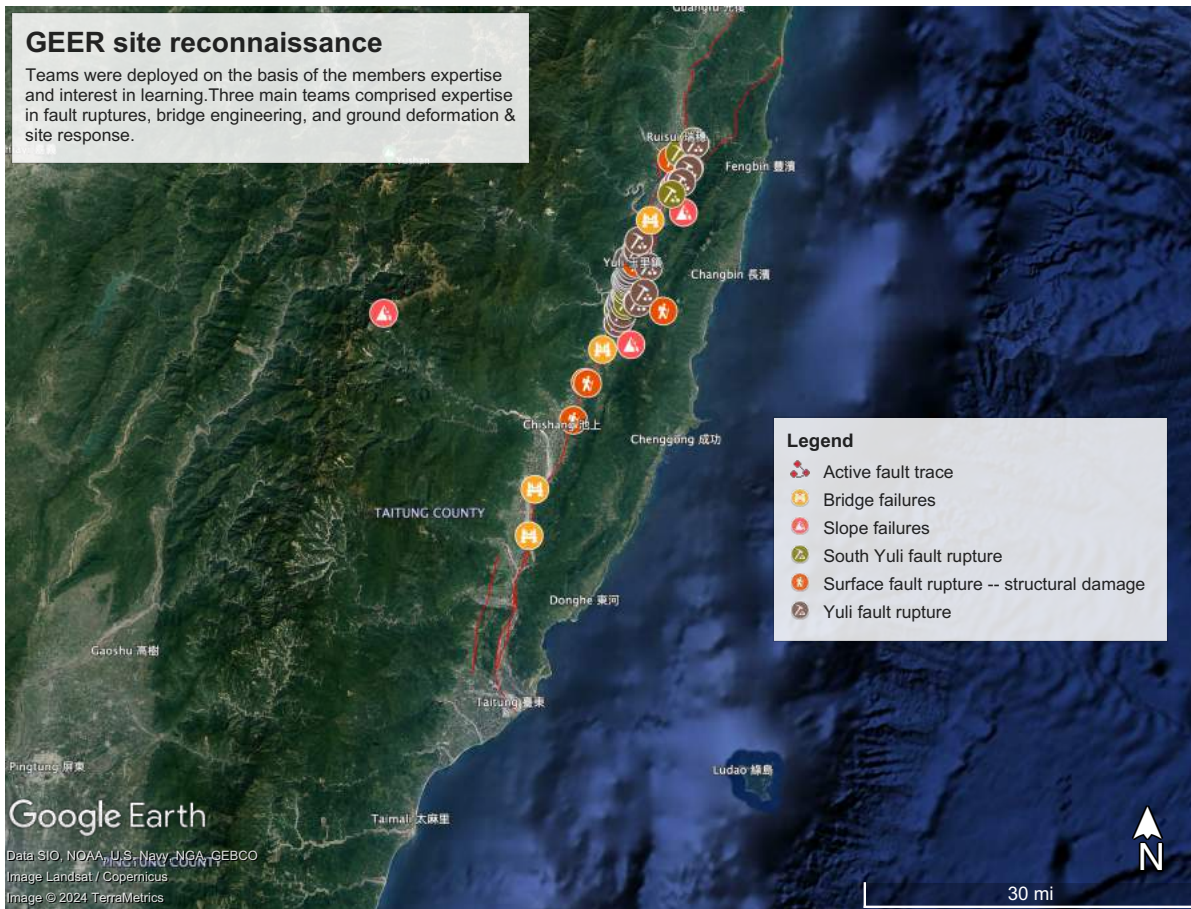
Figure 1.2 Bird’s eye view of the GEER mission, categorized by class of failures that we focused on.

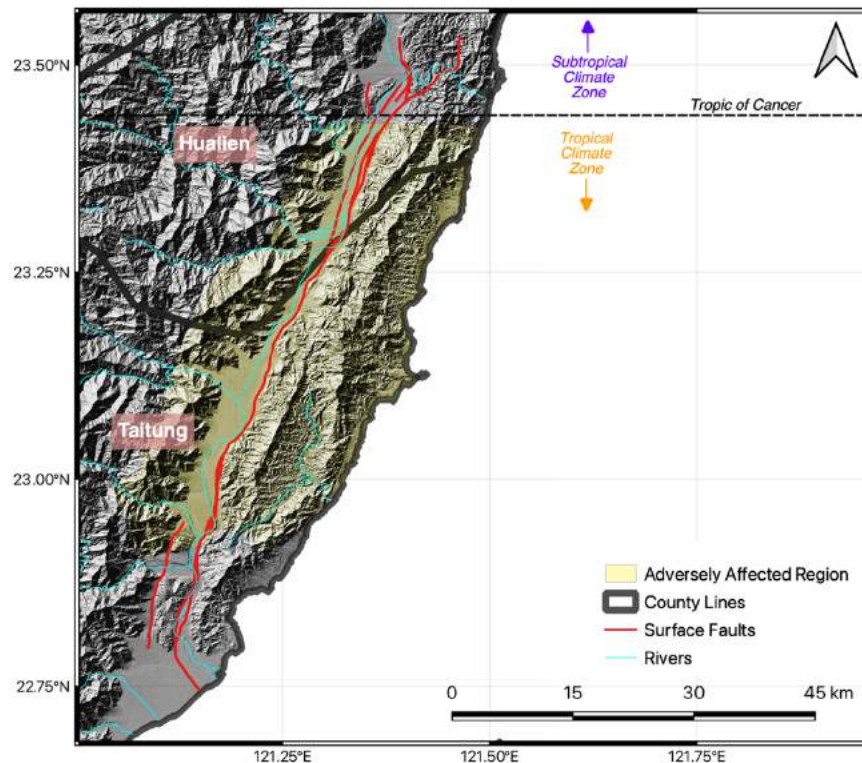
Figure 2.1 Summary map of region adversely affected by the **M6.9** and **M6.5** earthquakes, the counties, and known fault locations.

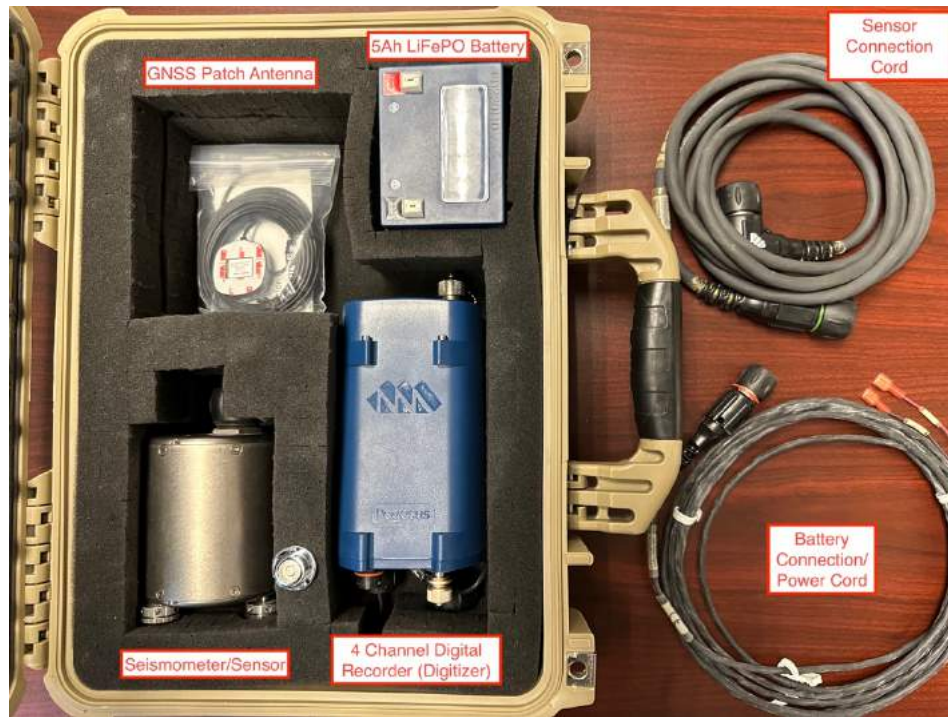
Figure 2.2. Necessary components/equipment for the operation of one seismometer

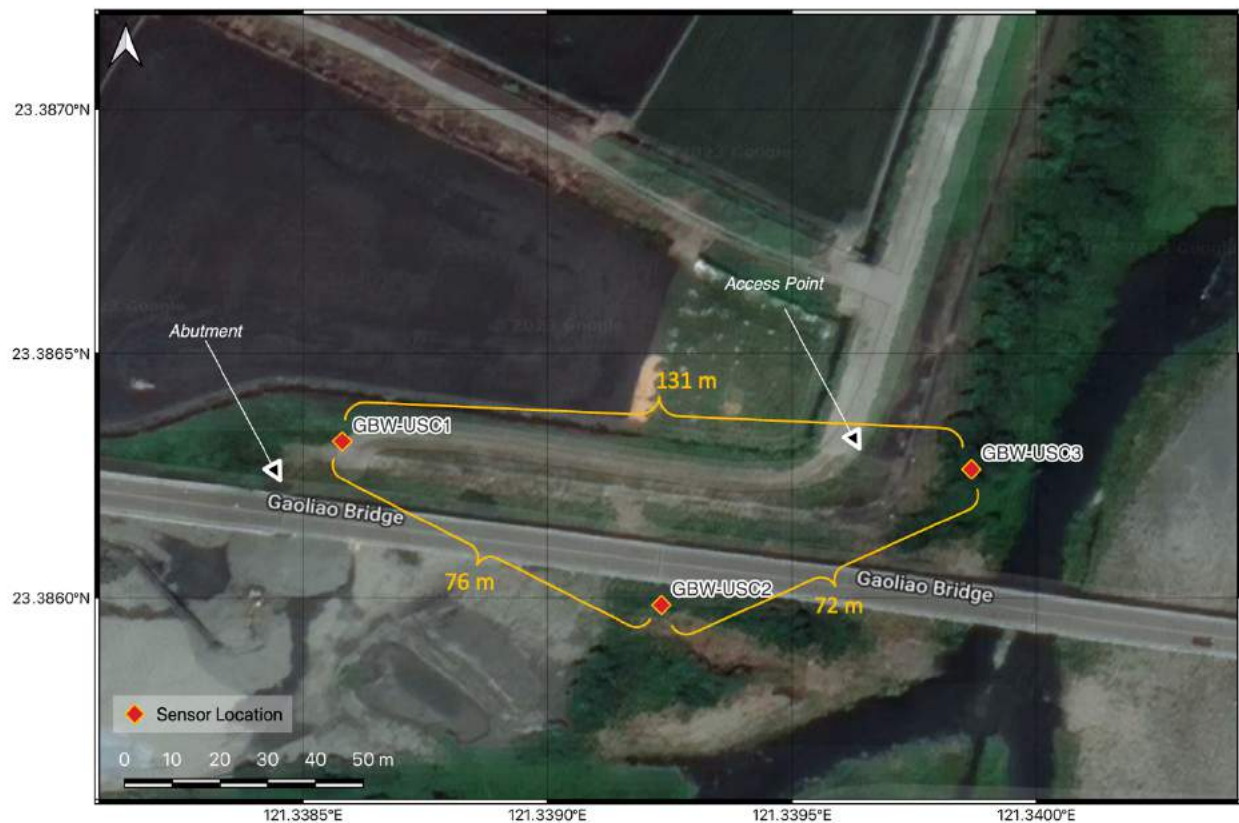
Figure 2.5. Layout of the temporary seismometer deployment at the western end of Gaoliao bridge. Shows the configuration of the semi-triangular array, highlighting the distances between the sensors, the location of the access point, the abutment, and the bridge.

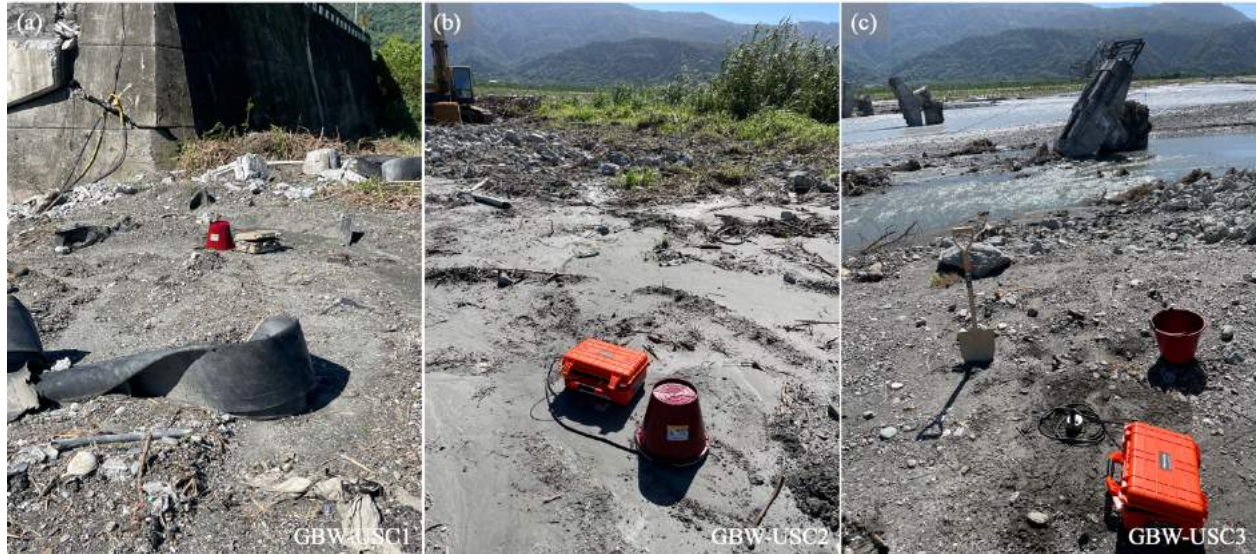
Figure 2.6. Photo of sensor setup at Gaoliao bridge (Western end). (a) GBW-USC1; (b) GBW-USC2; (c) GBW-USC3.

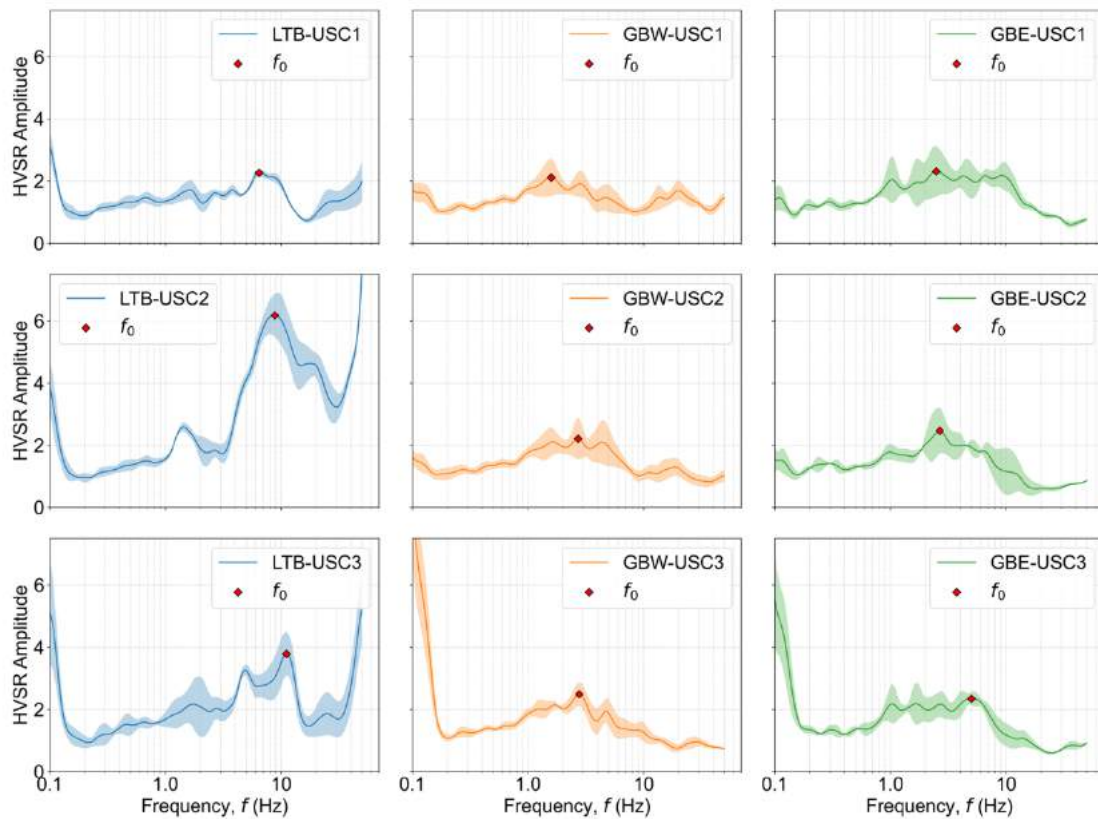
Figure 2.9. Plot of mean mHVSr curves derived from the recorded ambient vibrations at the bridge locations. The shaded regions around the mean curve (solid lines) represent ± 1 standard deviation. The red diamond indicates the estimated fundamental site frequency taken as the maximum amplitude peak within the range of 0.2 – 30 Hz.

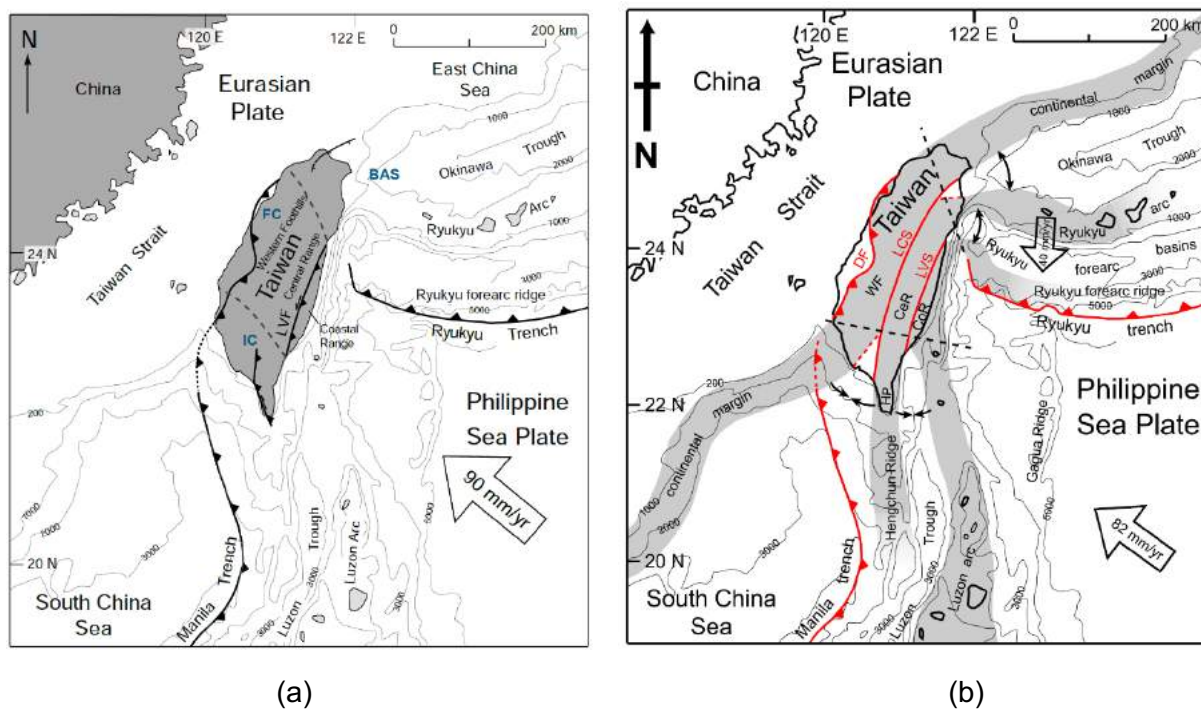
Figure 3.1 Tectonic map of Taiwan (a) modified and (b) directly from Shyu et al. (2005).

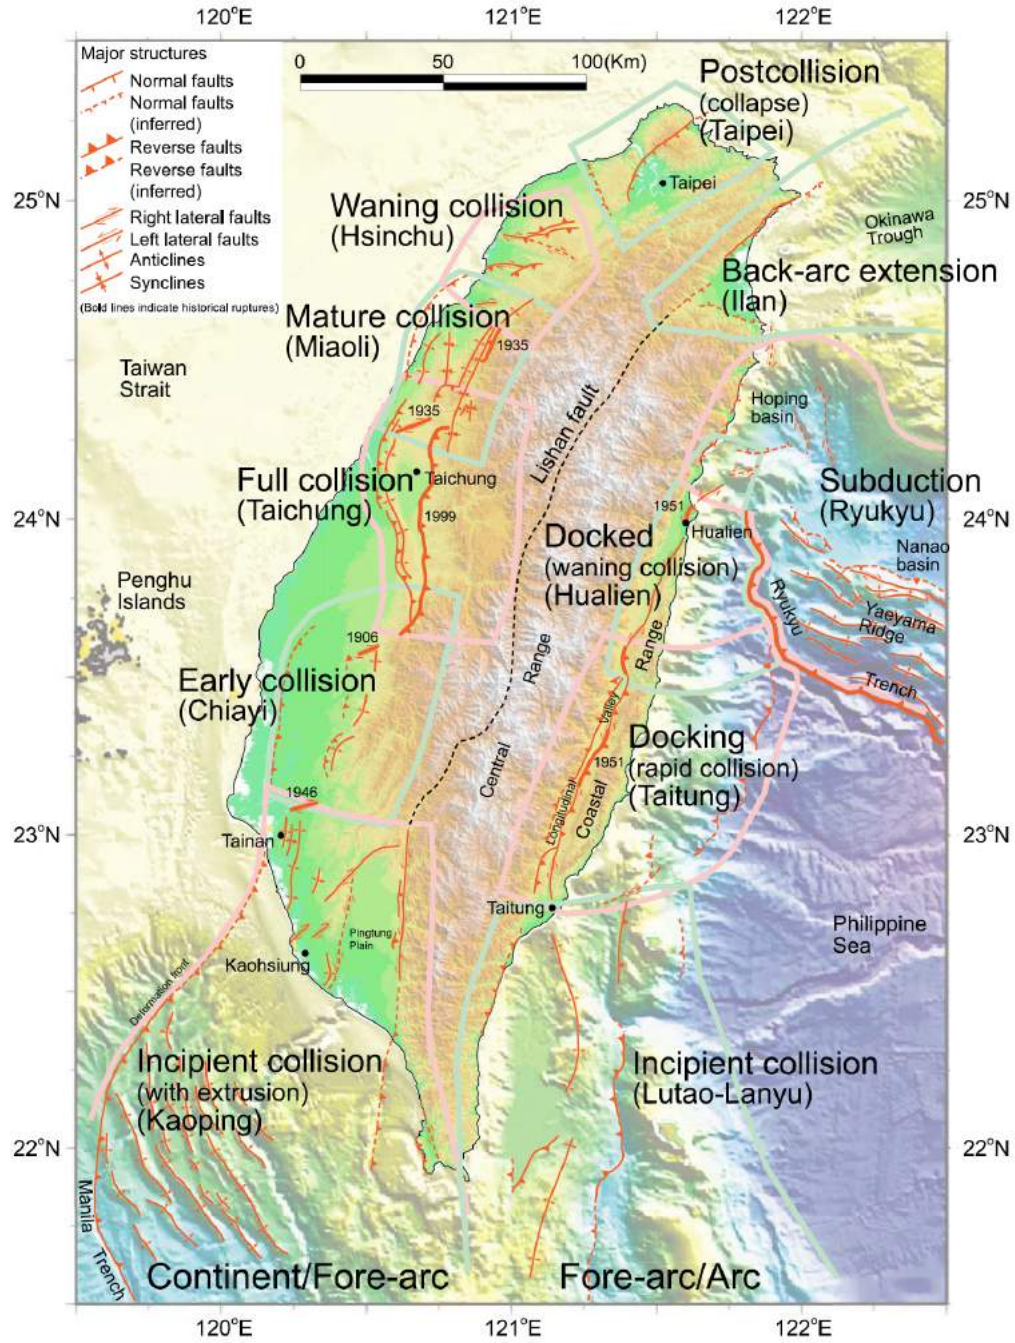
Figure 3.2 Taiwan fault structures, from Shyu et al. (2005).

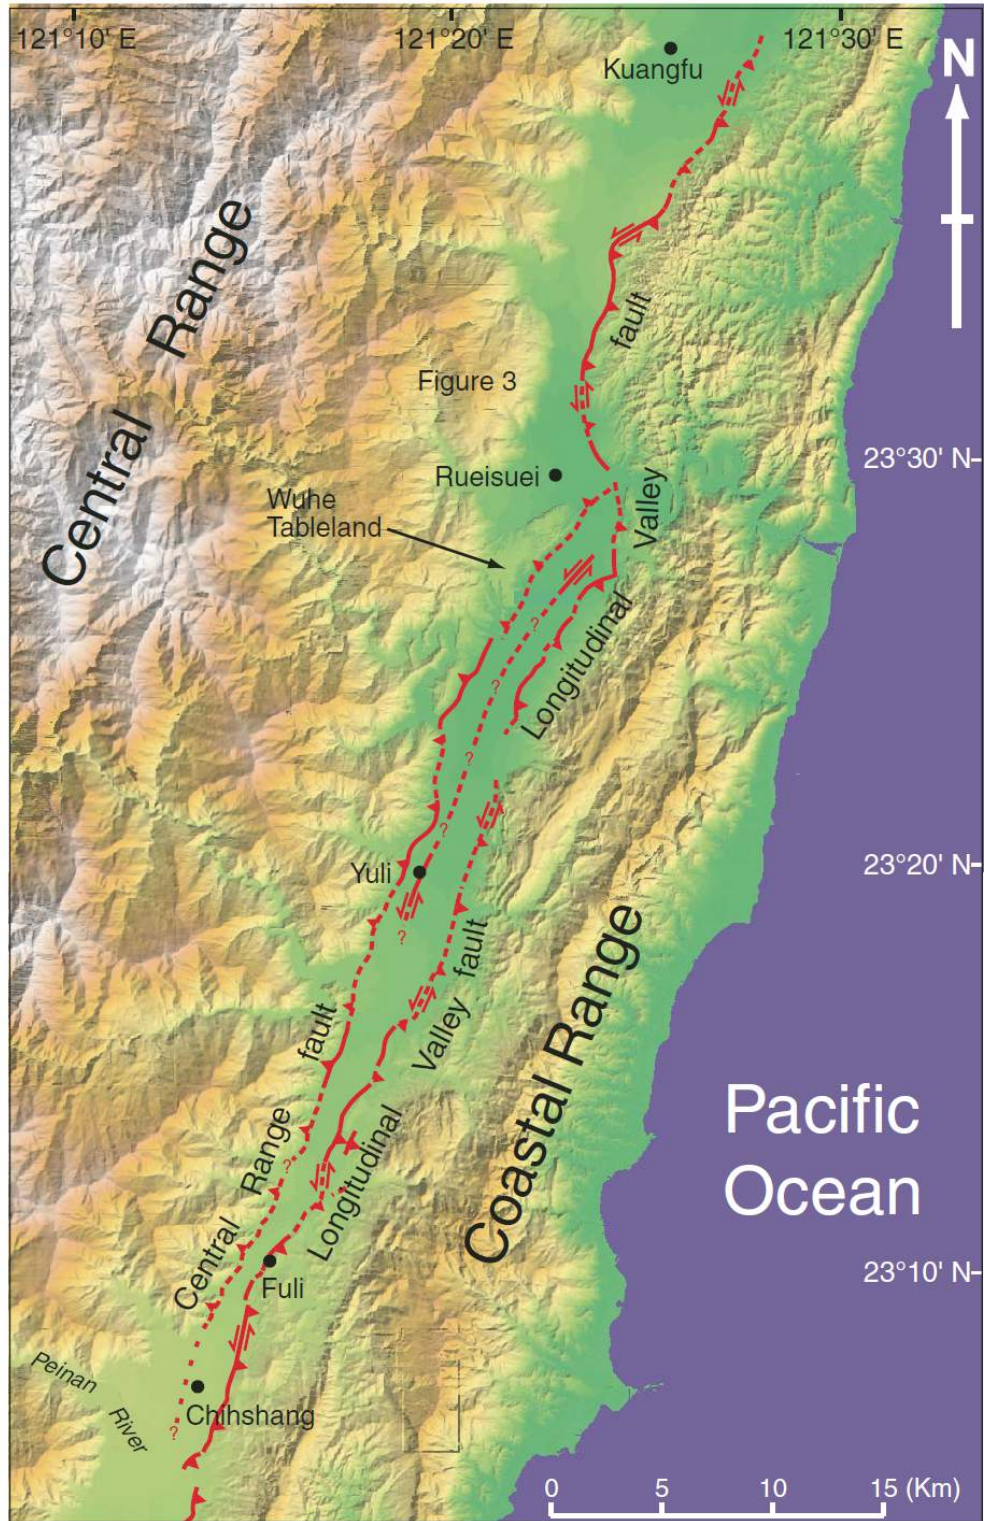
Figure 3.4 Tectonic map of Taiwan's Coastal Range (adapted from Shyu et al, 2006).

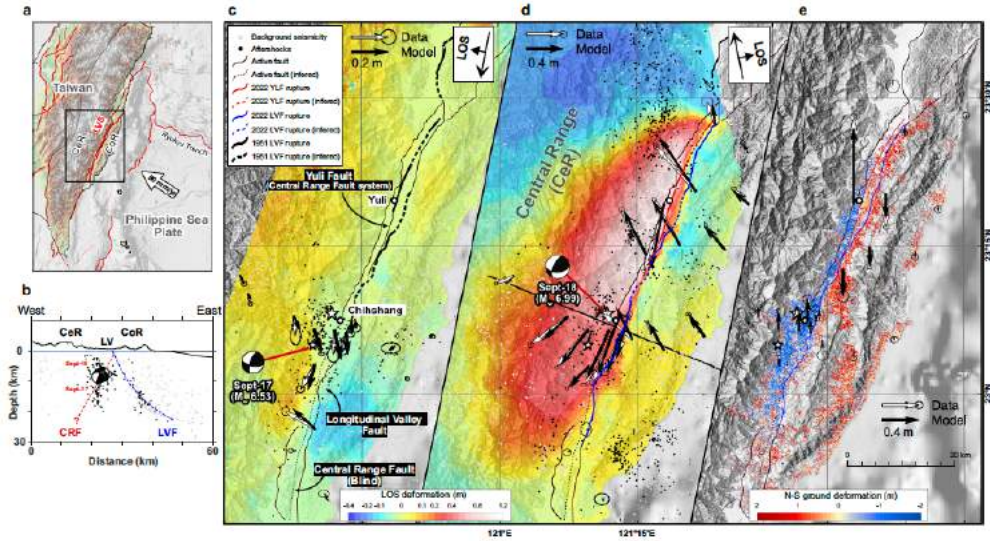
The consequence of the unique rupture mechanism from south to north manifested in strong evidence of forward directivity effects, with strong associated pulse-like velocity motions; as well as single-sided velocity pulses normal to the direction of rupture propagation that resulted from the accommodation of the tectonic slip of the complex normal-reverse rupture communication. Typical pulse like motions extracted by NAR Laboratories are shown in Figure 3.7 below for the **M6.9** mainshock and the **M6.5** foreshock.

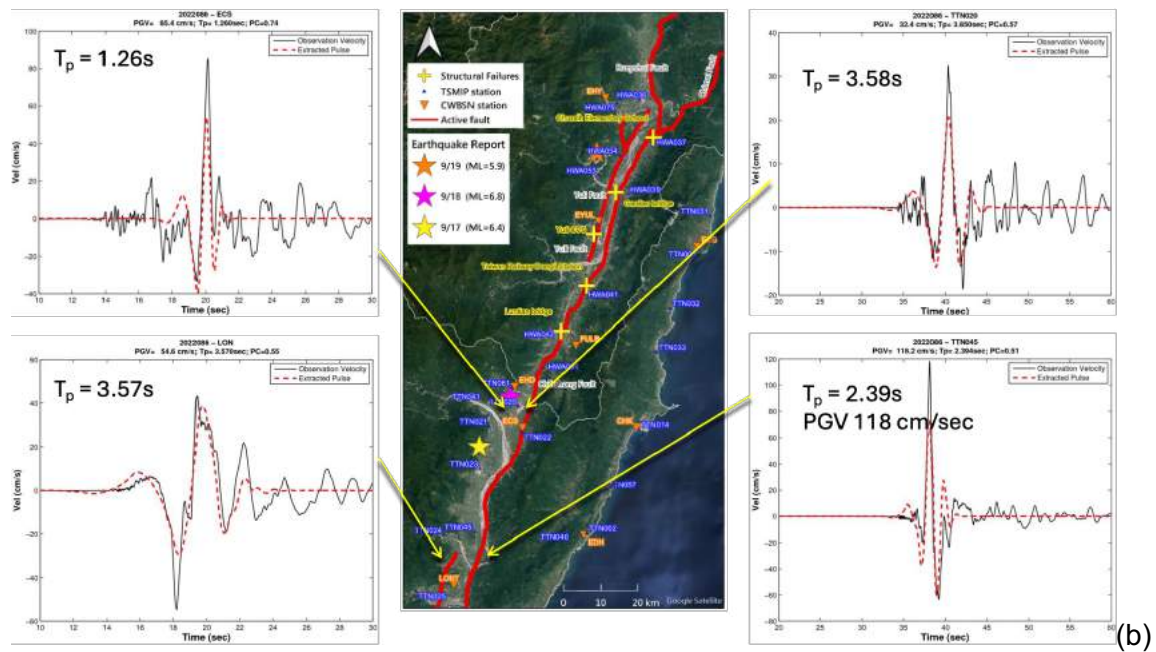
Figure 3.8. Pulse like motions extracted by NARLabs from the Chihshang mainshock (a) and the Guanshan foreshock (b); each ground motion time series depicts the extracted pulse-like motions, their period, and the peak ground velocity, where applicable.

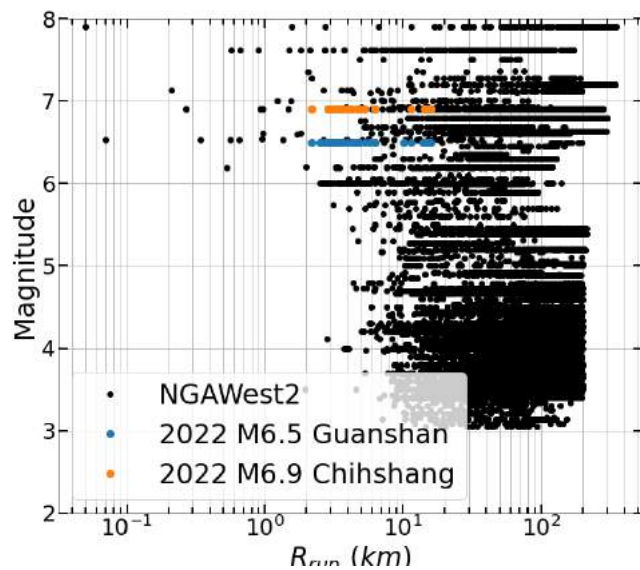
Figure 3.9 Distribution of magnitude-distance of the M6.5 Guanshan and M6.9 Chihshang events, plotted alongside the NGAWest2 database for reference.

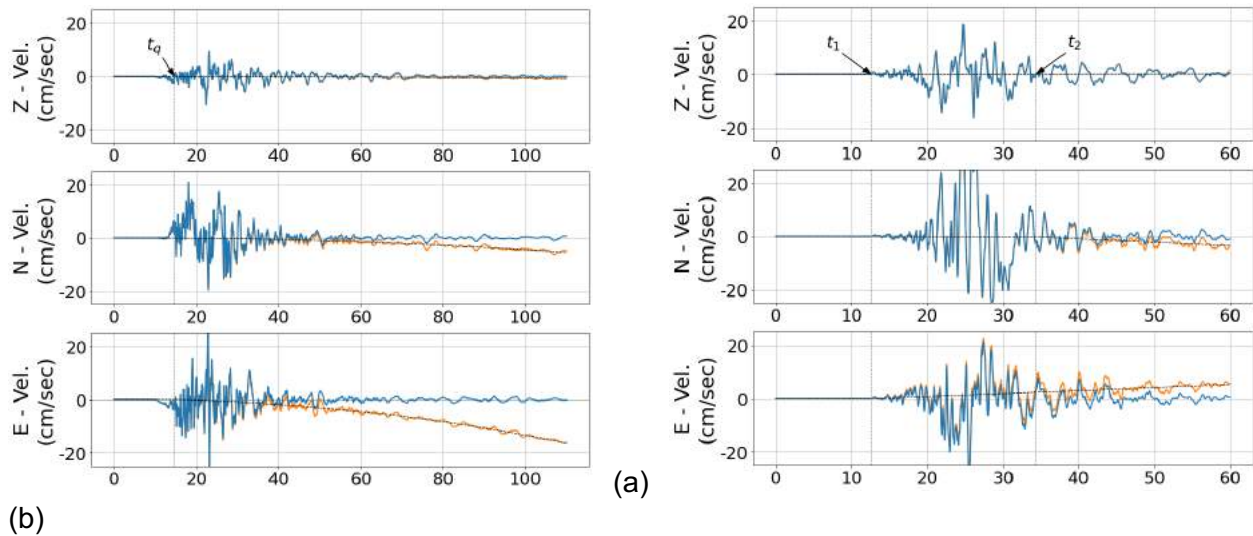
Figure 3.10 Instrument tilt correction simultaneously for all three components using the Boore (1999) quadratic baseline correction method (a) and the bilinear method (b).

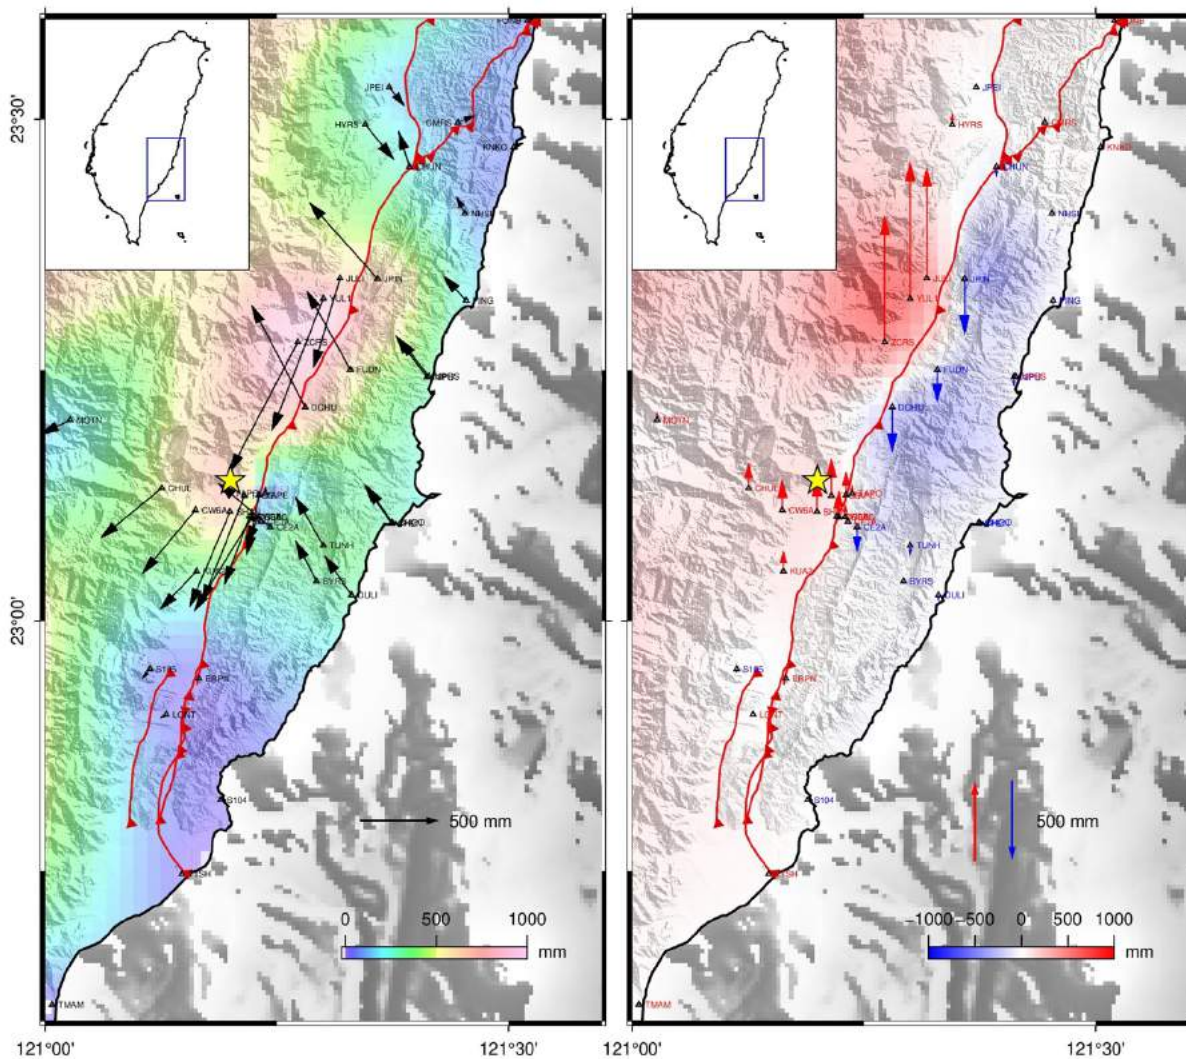
Figure 3.11 Horizontal and vertical permanent offset measured by the GNSS network in the vicinity of the M_w 6.9 Chihshang earthquake epicenter. The maximum horizontal displacement was measured in the GPS station ZCRS south of Yuli town, with displacement of 1000 mm, while station DYES north of Yuli measured the largest uplift, 1100 mm (<https://tgm.earth.sinica.edu.tw>)

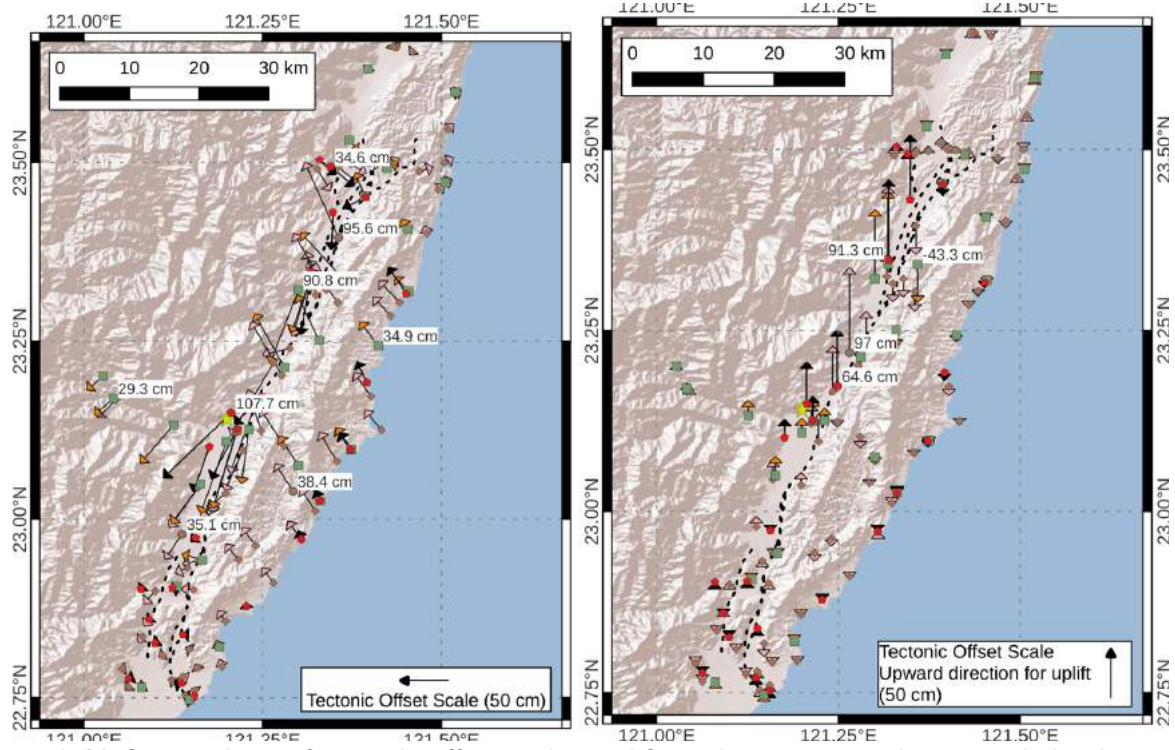
Figure 3.12 Comparison of tectonic offset estimated from the strong motion records by the GEER team (black arrows) and the GNSS stations (orange arrows). Recordings from the Mw6.9 Chihshang mainshock.

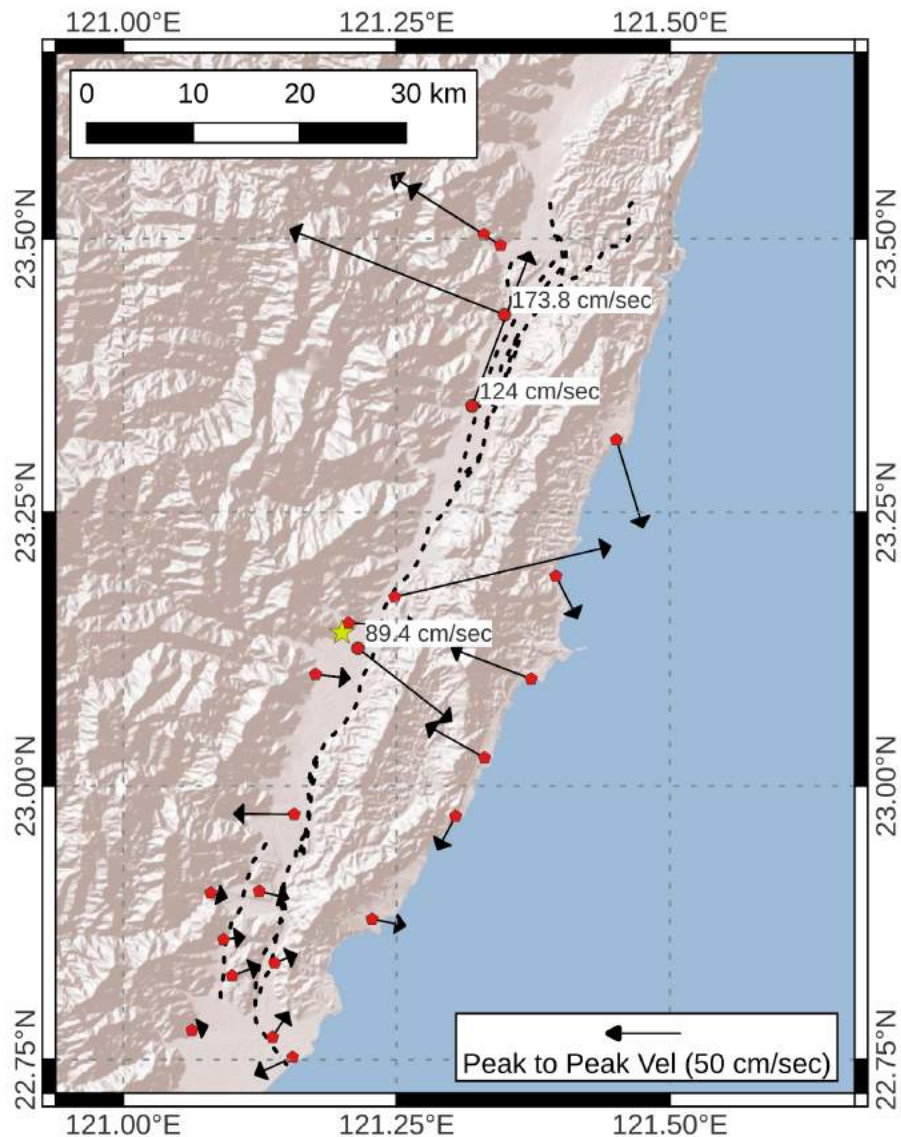
Figure 3.14 Peak-to-peak velocity vectors extracted from strong ground motion time series along the rupture (**M6.9 Chihshang mainshock**).

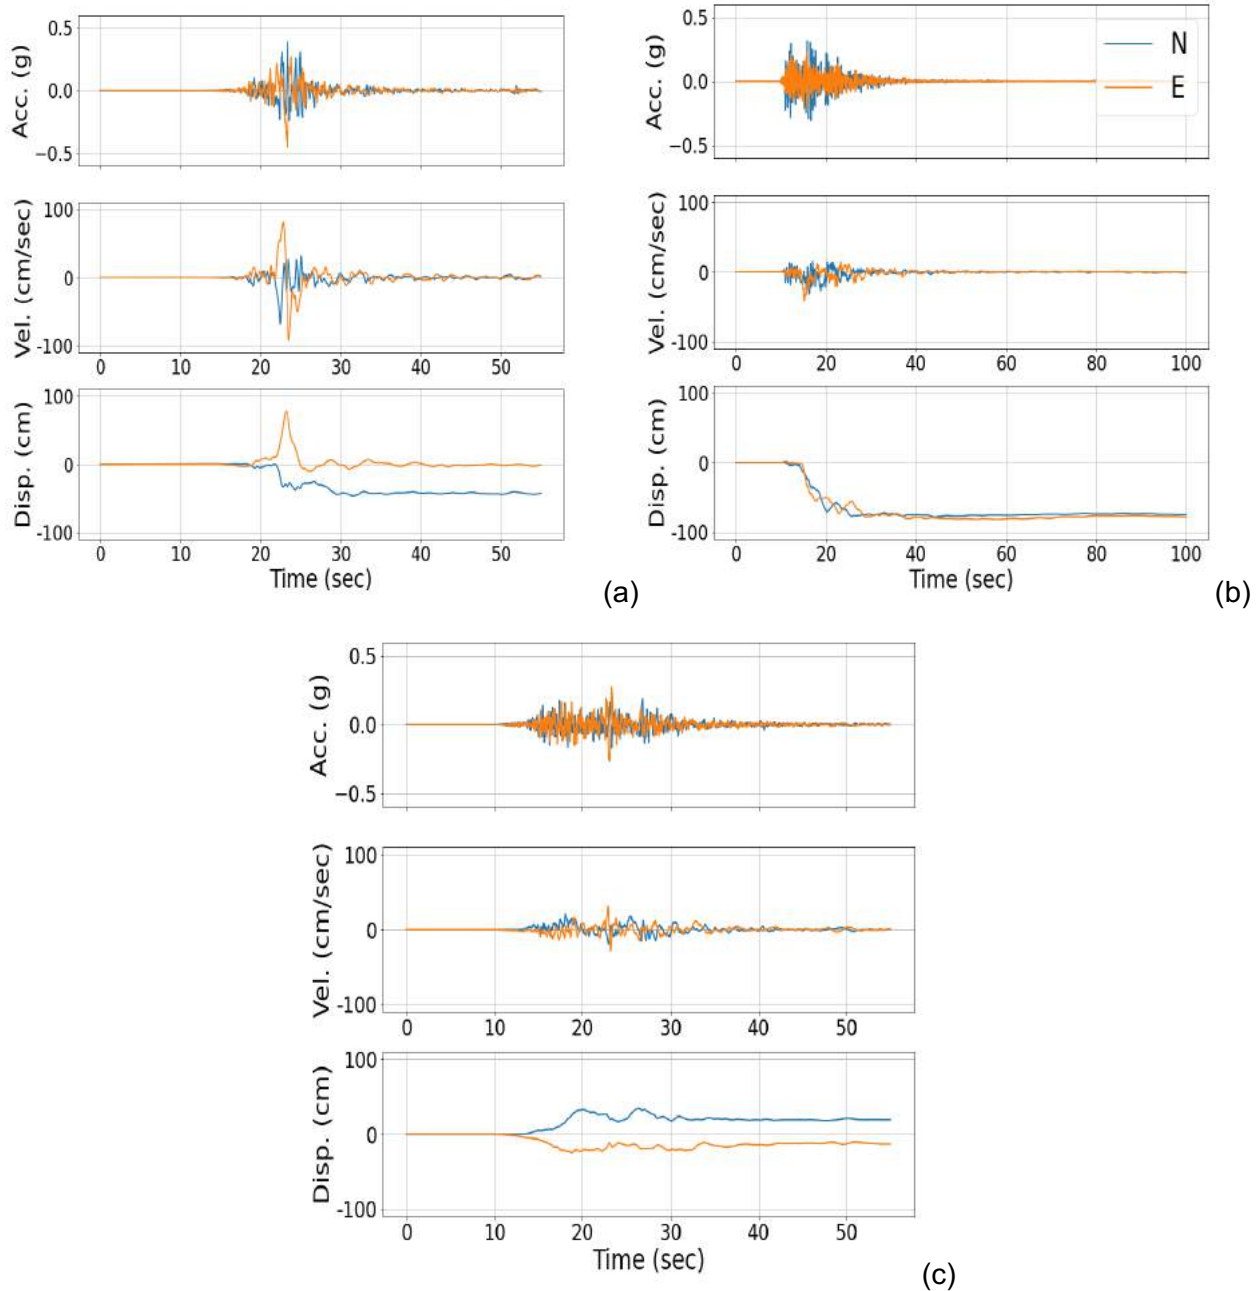
Figure 3.15 Examples of horizontal strong ground motions, processed by the modified Boore (1999, 2000) baseline correction to recover the tectonic offset. A second dataset that was not processed using the quadratic or bilinear baseline correction, was processed the NGA PEER processing protocols.

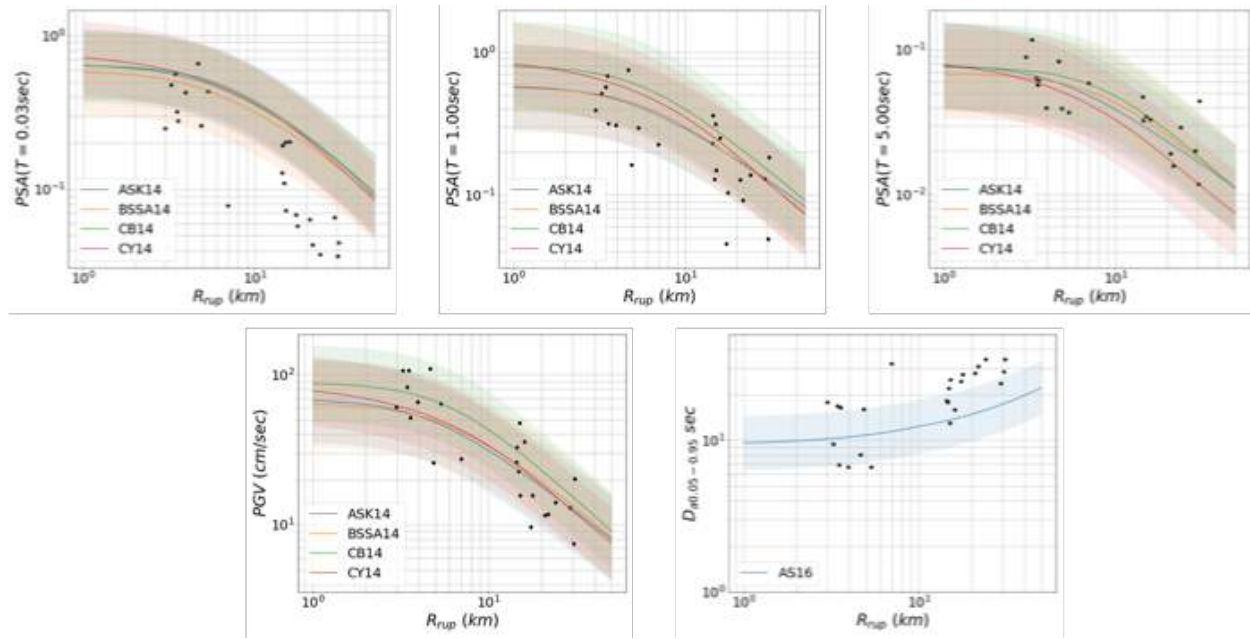
Figure 3.16 Ground motion scaling of the **M6.9** Chihshang strong ground motions.

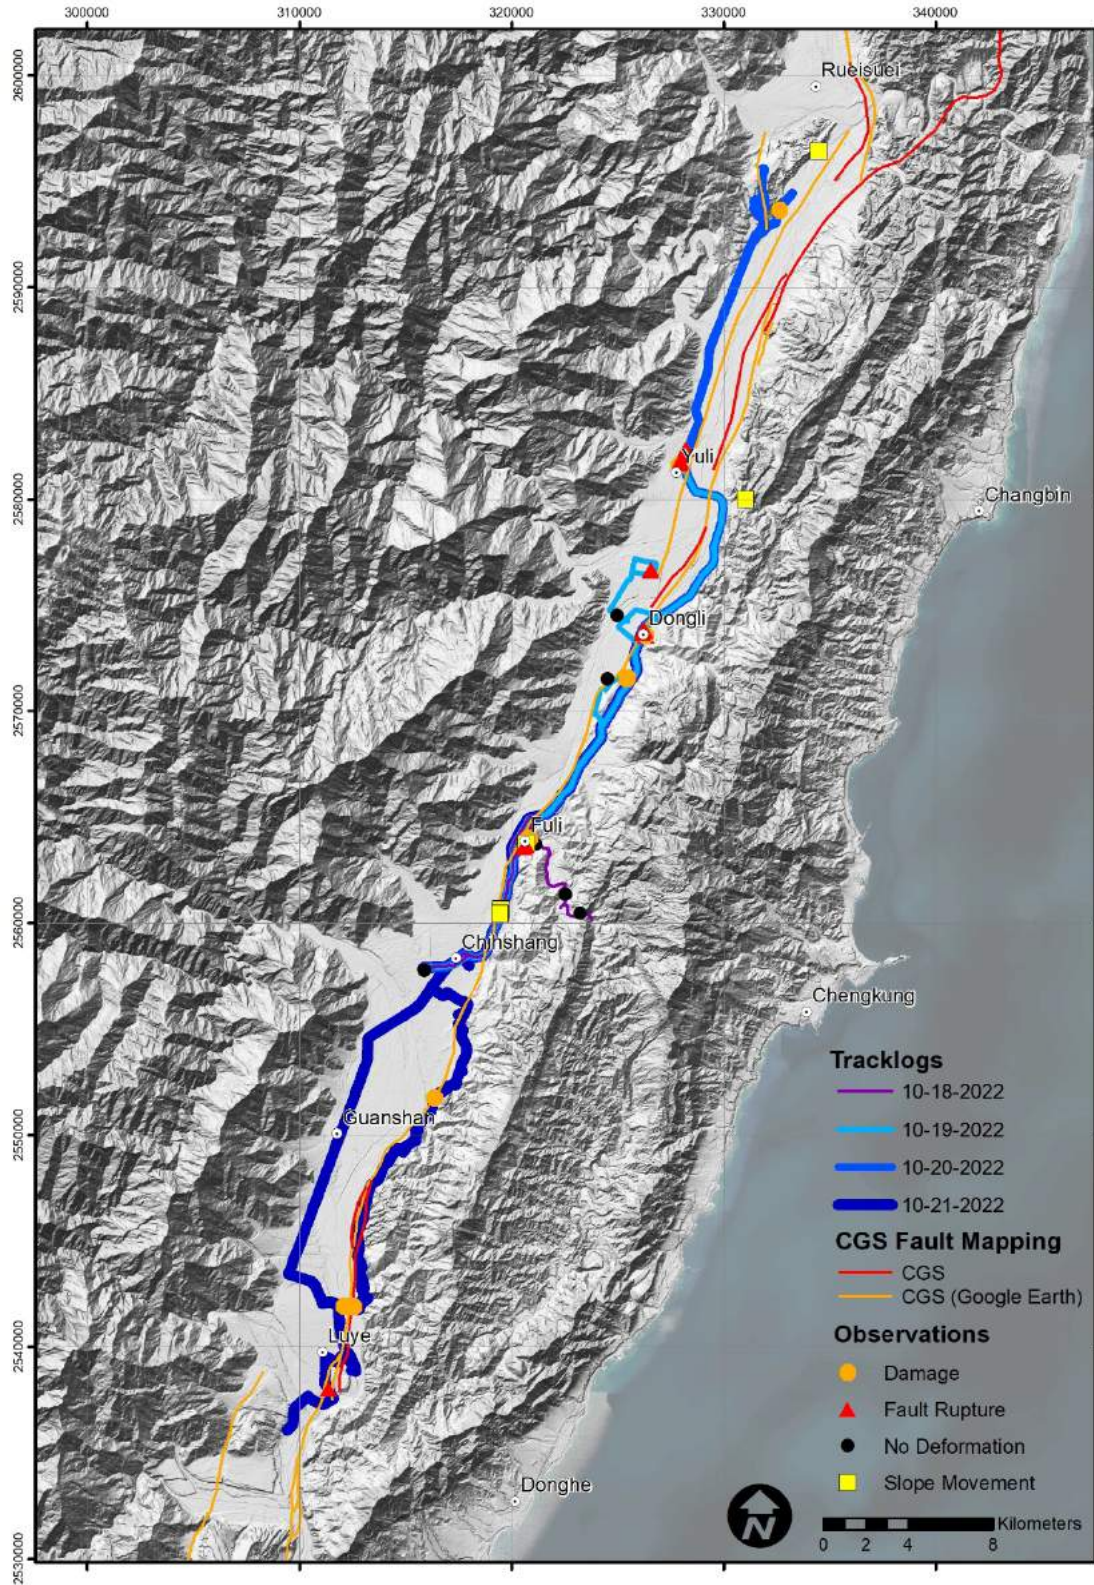
Figure 4.1: Tracklog and observation map from the surface fault rupture team.

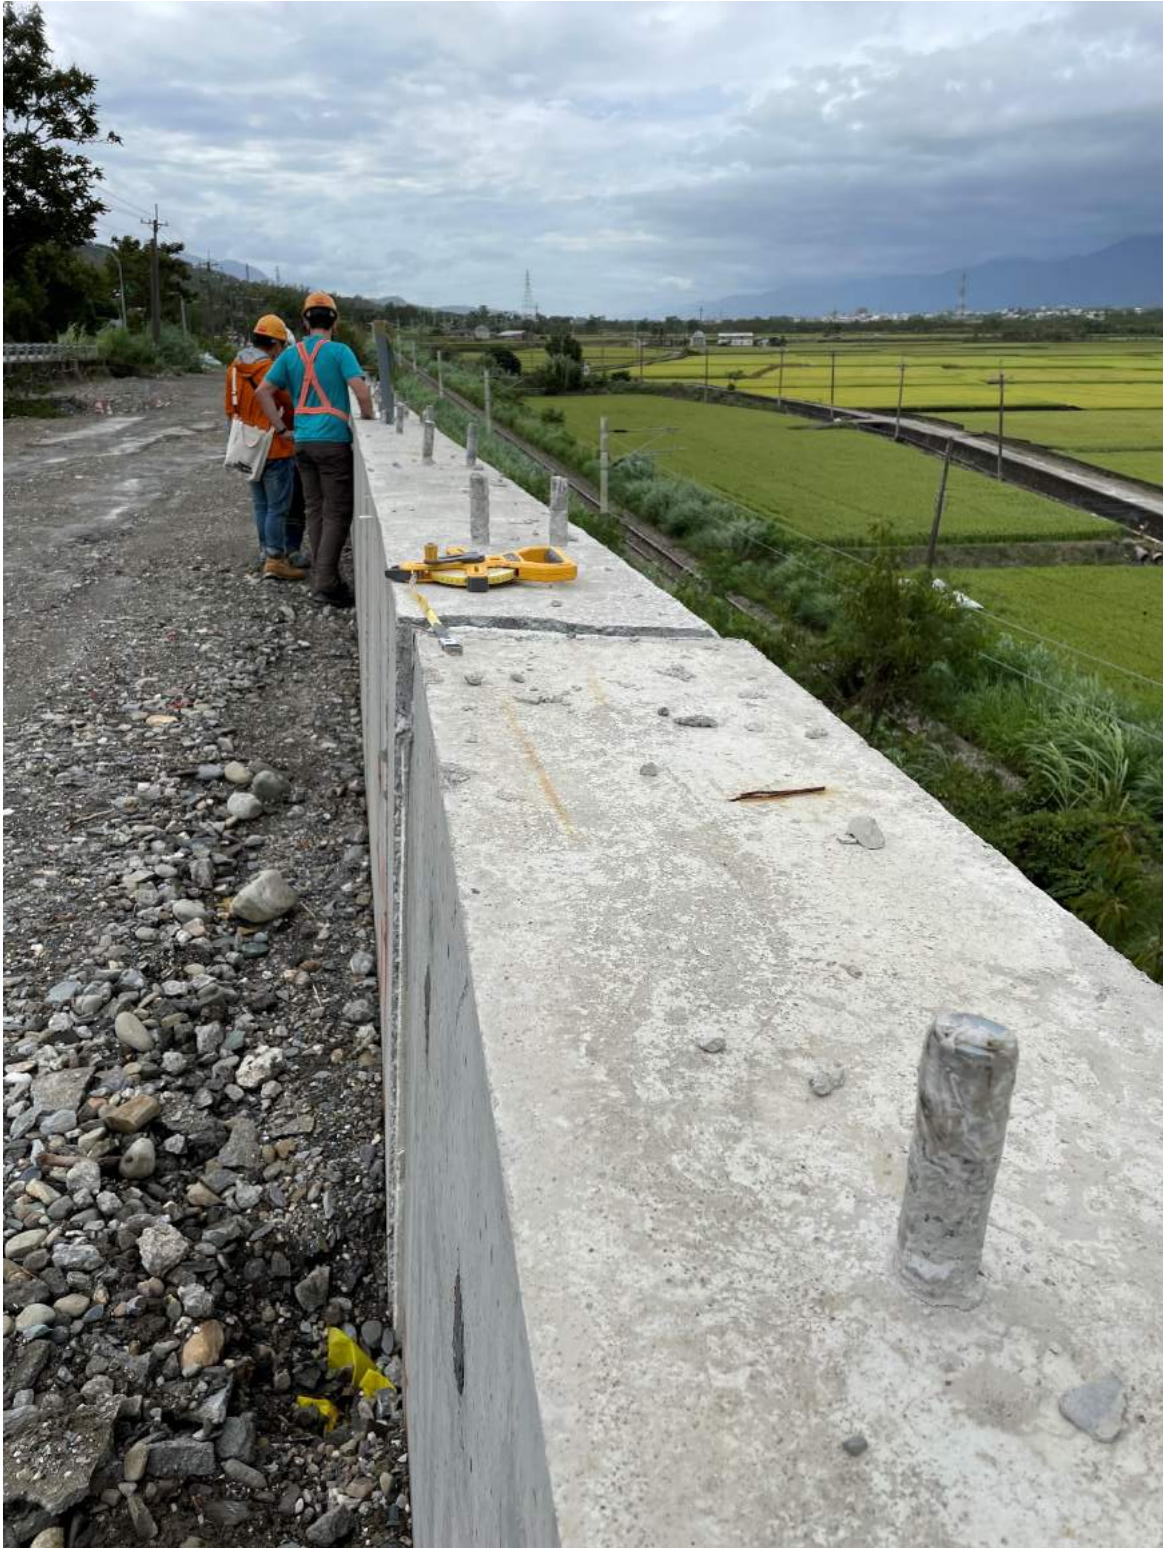
Figure 4.3: View looking south along retaining wall showing displacement of joint between 20-m wall sections. Backfill composed of river gravel, locally emplaced in lifts between geotextile. Lat: 23° 8' 43.47456", Lon: 121° 14' 13.727399".

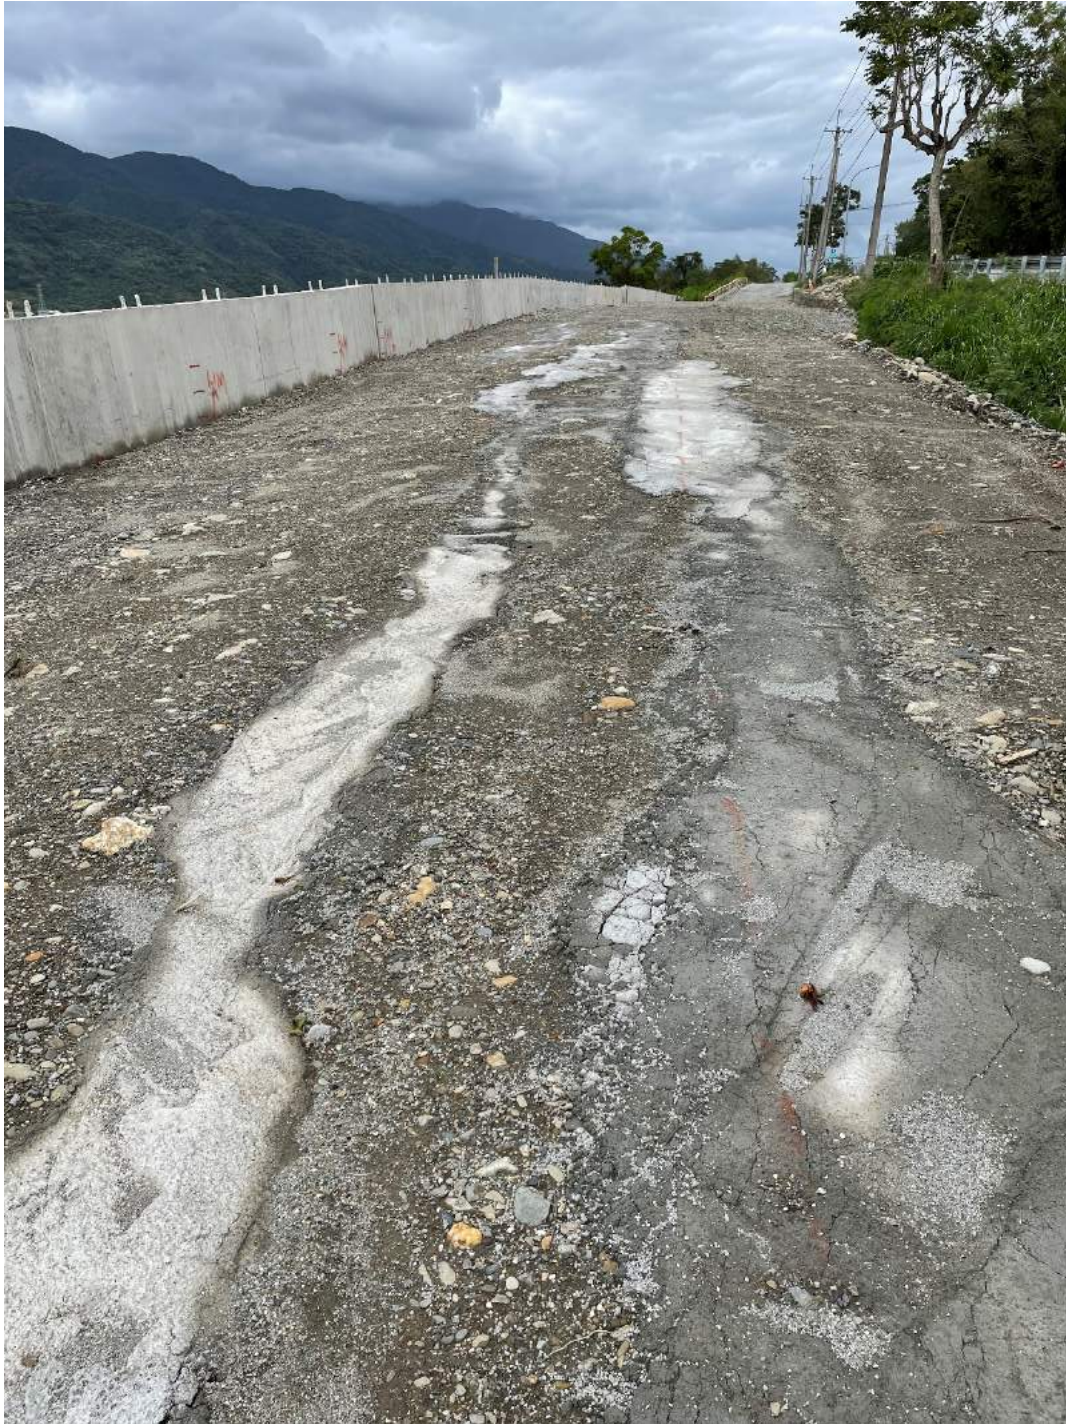
Figure 4.6: View looking north and ground cracking areas “repaired” with concrete. Failed retaining wall in upper left. Lat: 23° 8' 39.00048”, Lon: 121° 14' 12.52428”.
