GEOTECHNICAL ENGINEERING RECONNAISSANCE OF THE 2022 CHIHSHANG EARTHQUAKE SEQUENCE

Version 1.0; April 2024

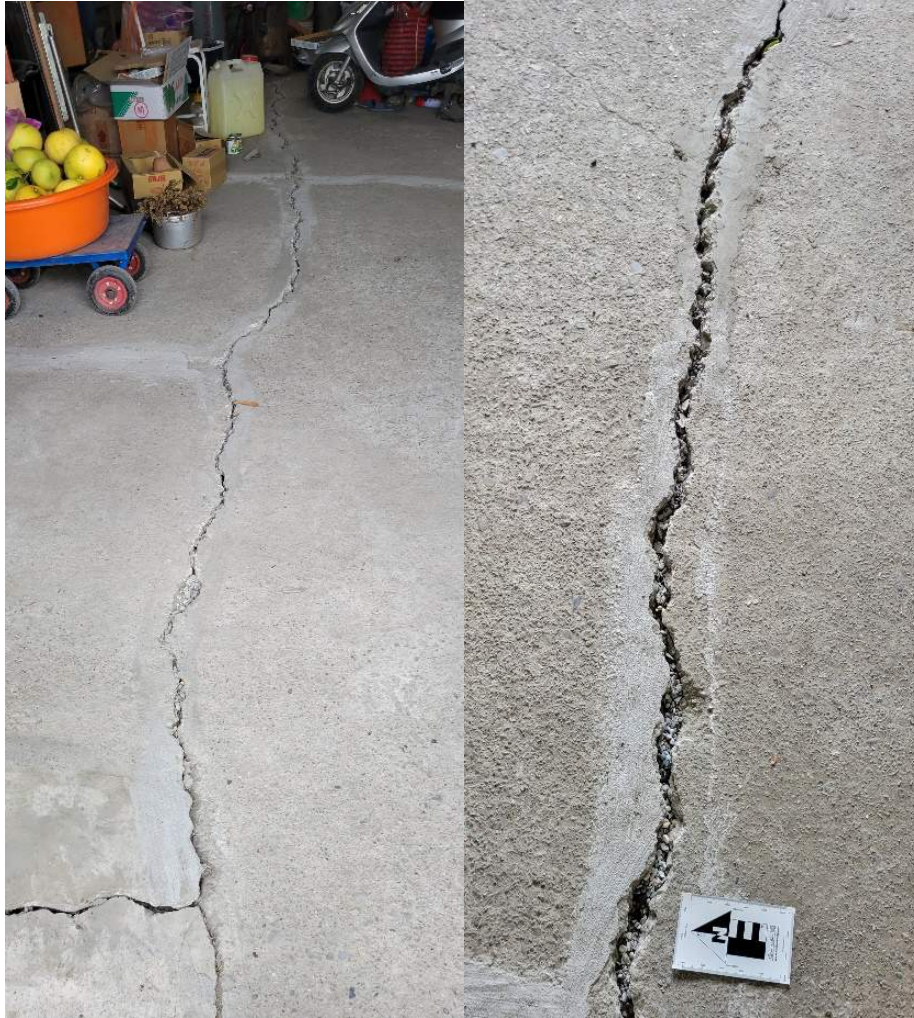
Figure 4.6: View looking north and ground cracking areas “repaired” with concrete. Failed retaining wall in upper left. Lat: 23° 8' 39.00048”, Lon: 121° 14' 12.52428”.

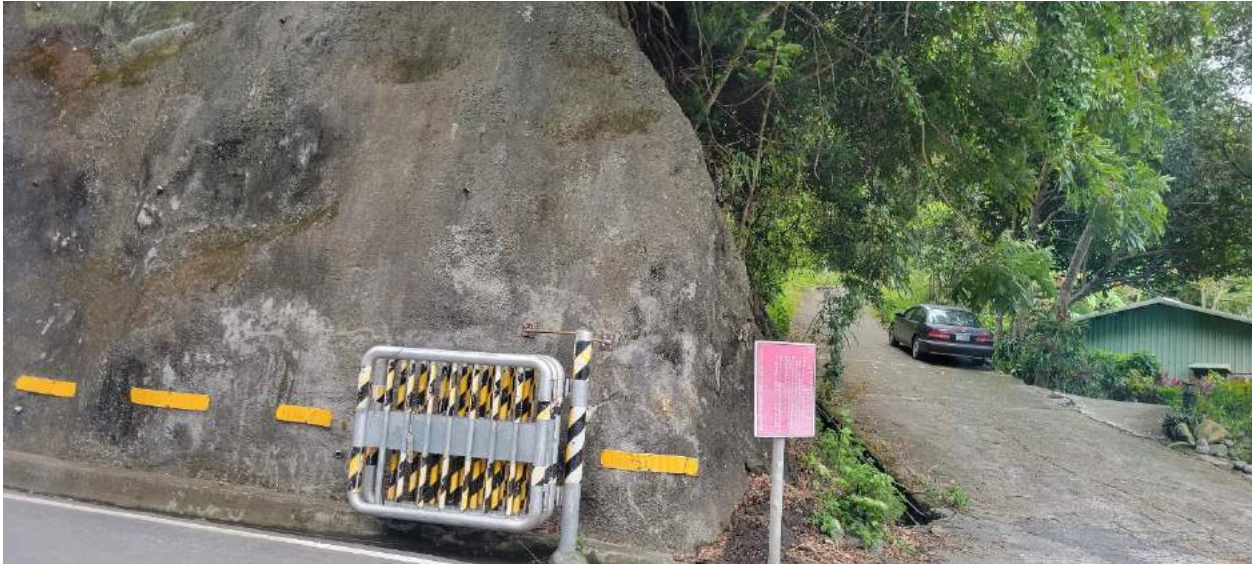
Figure 4.8: Roadside showing Tuluanshan volcanics.

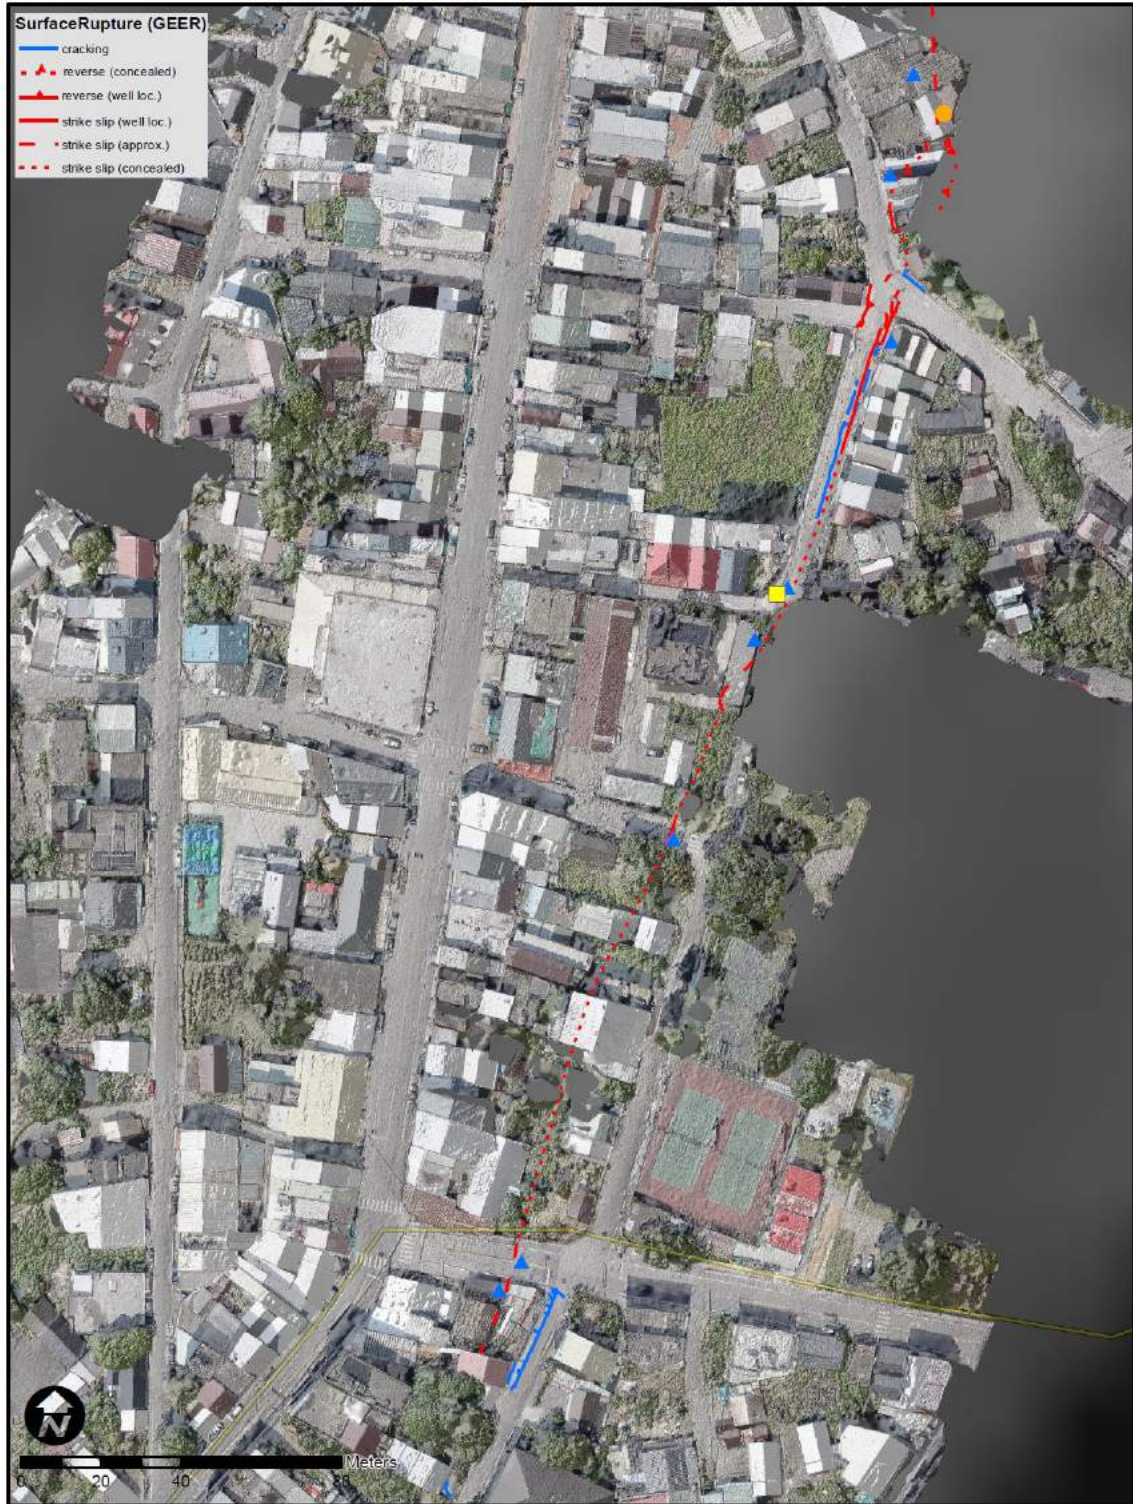
Figure 4.9: Rupture map in the town of Fuli.

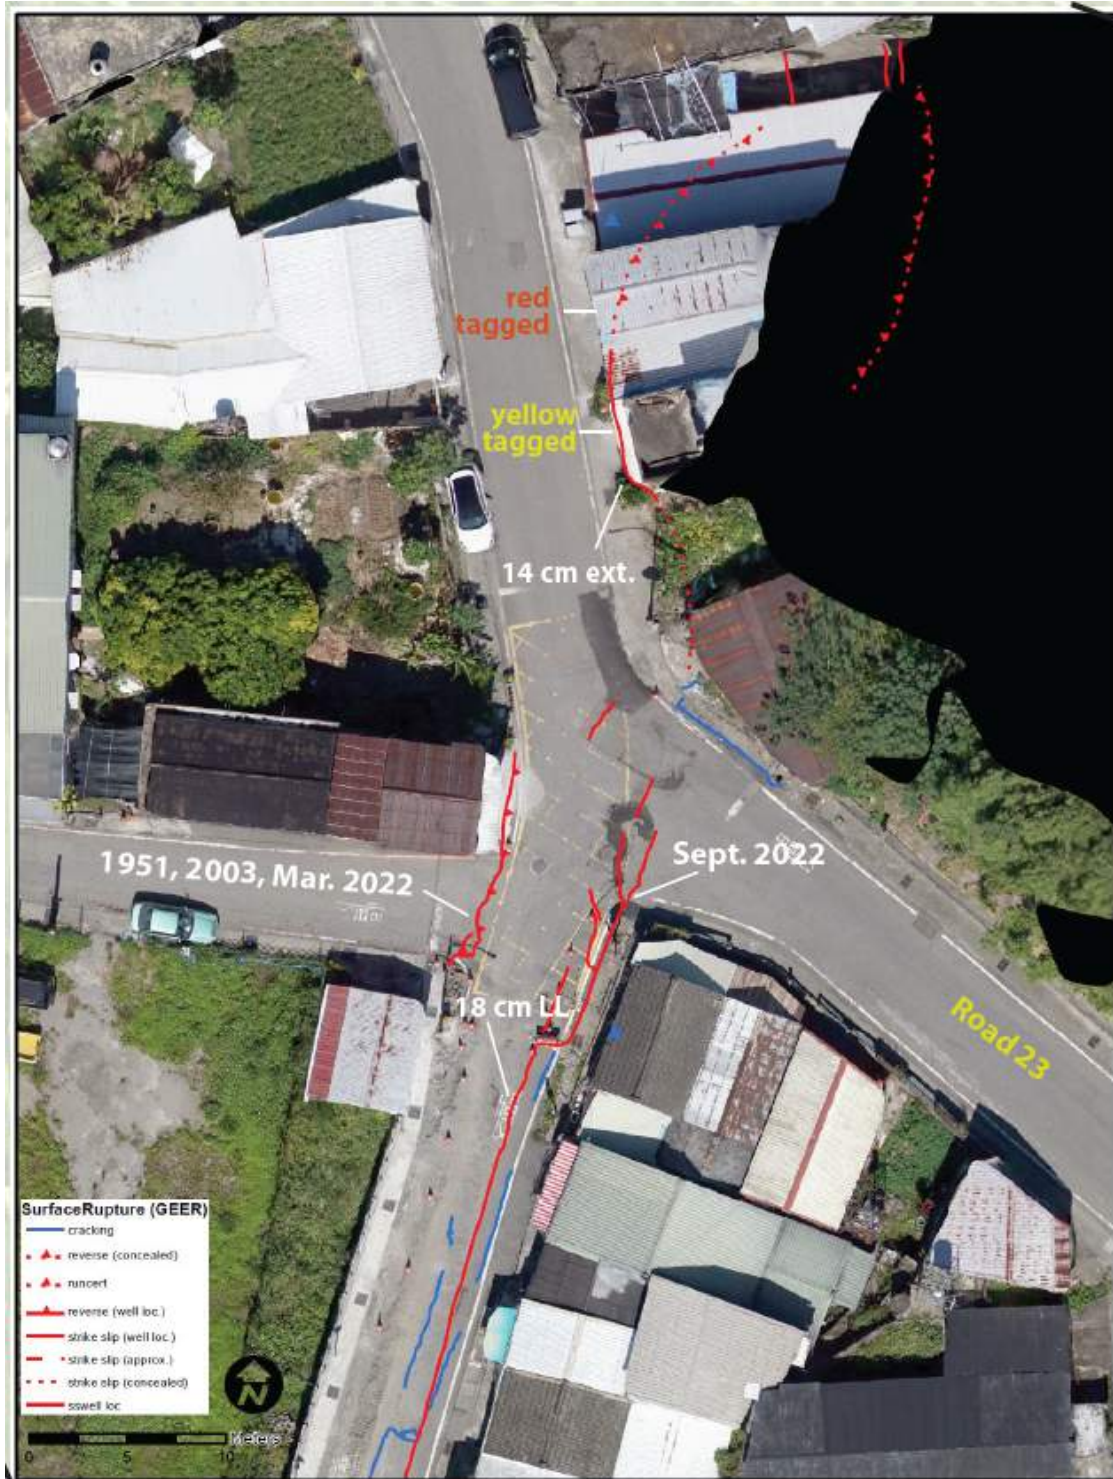
Figure 4.10: Detailed map of surface rupture at the Road 23 intersection in Fuli. Photos of structures north of the intersection are shown in figures below. Note position of September 2022 and prior surface ruptures at this location.

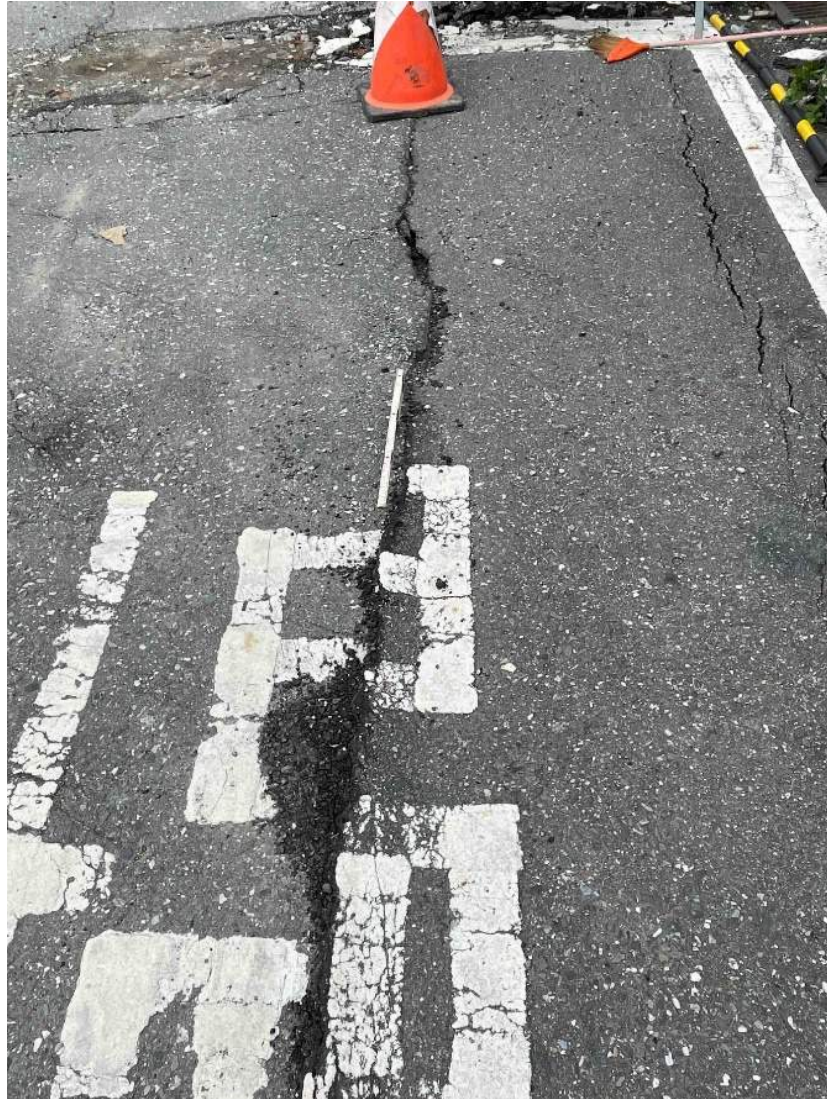
Figure 4.11: Surface rupture coincident with fault-parallel sewer line. Discrete LL offset is 18 cm. Lat: 23° 10' 24.693599", Lon: 121° 14' 54.185999"

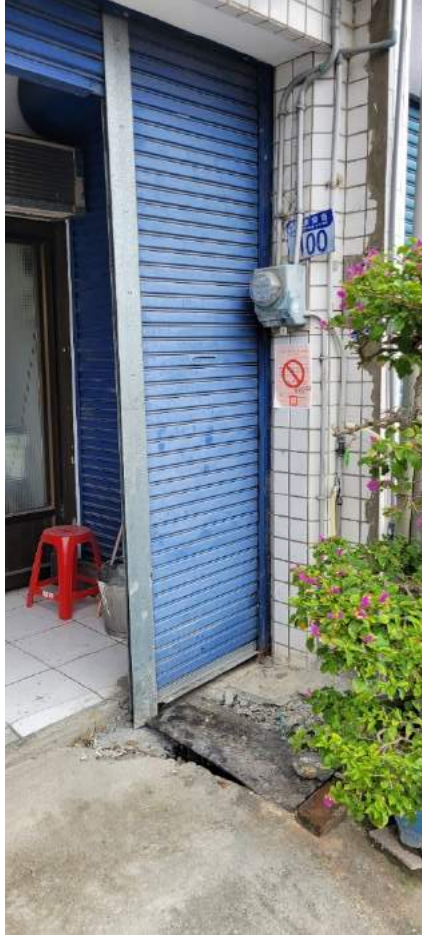
Figure 4.12: Fault rupture along a localized left (releasing) bend in the LVF. Rupture propagated around the foundation here but resulted in 14 cm of extension at the foundation corner. Lat: 23° 10' 25.973039", Lon: 121° 14' 54.221279"

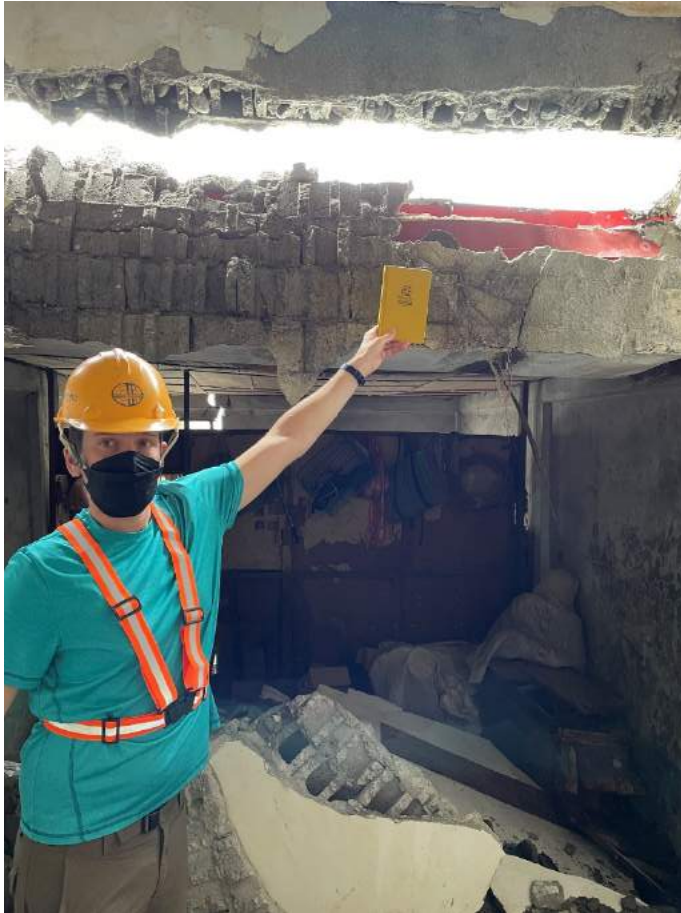
Figure 4.13: Fault rupture along a localized left (releasing) bend in the LVF. Fault rupture propagated along the edge of this foundation here, adjacent to the structure shown in Figure 4.12. Lat: 23° 10' 26.174639", Lon: 121° 14' 54.370679"

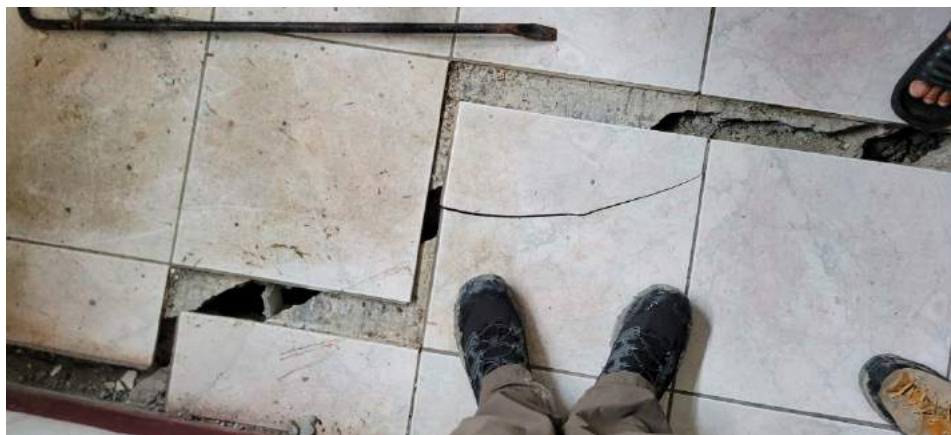
Figure 4.14: Partial collapse of URM structure along the LVF. Rupture propagated beneath the house. Lat: 23° 10' 26.201999", Lon: 121° 14' 54.605400"

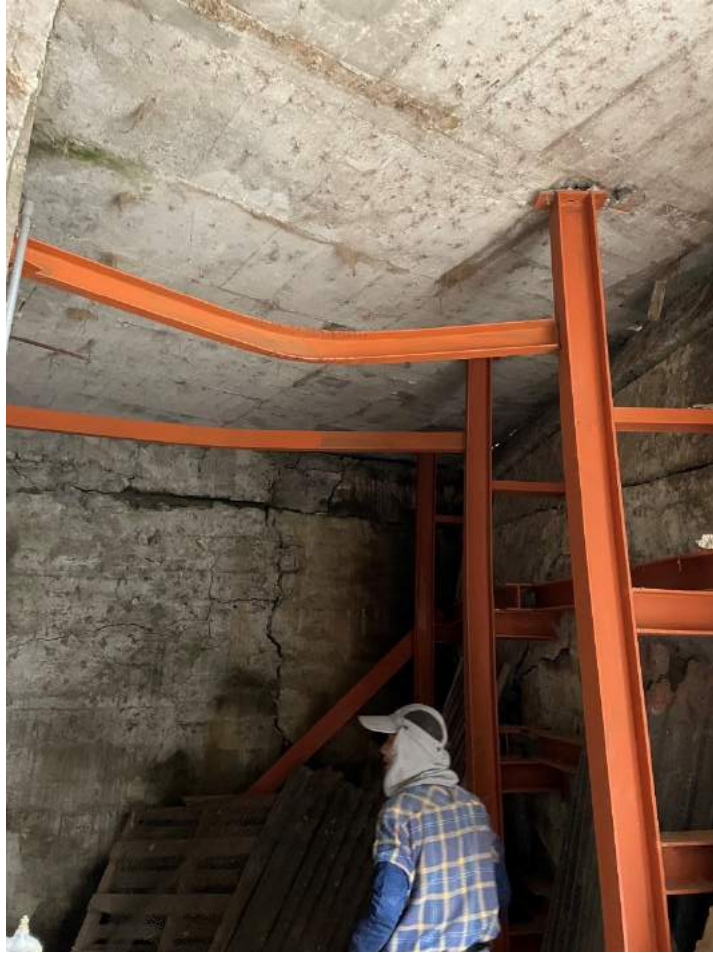
Figure 4.17: Deformation of braced concrete structure built into the LVF scarp. Deformation was largely coseismic based on owner's account. Lat: 23° 10' 27.884280", Lon: 121° 14' 54.895199"

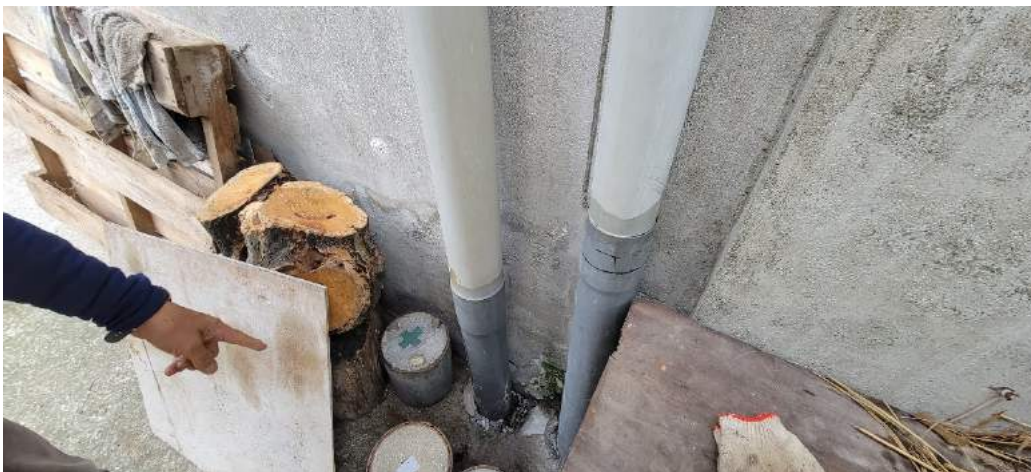
Figure 4.18 (a) Concrete damage due to relative foundation movement around water pipeline. Lat: 23° 10' 28.720199", Lon: 121° 14' 55.052159"

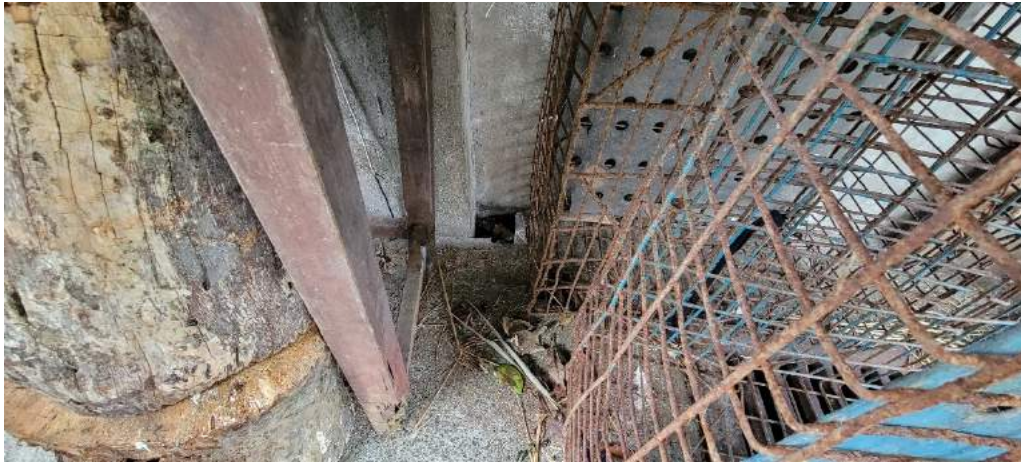
Figure 4.18 (b) Separation of concrete walls from foundation. Lat: $23^{\circ} 10' 28.626959''$, Lon: $121^{\circ} 14' 54.975479''$

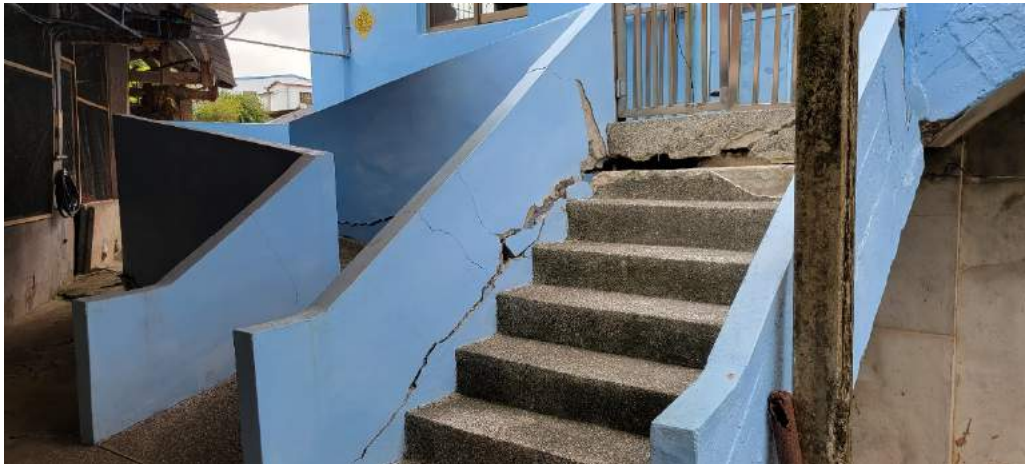
Figure 4.18 (c) Cracking in concrete stairs resulting from relative foundation displacement. Lat: $23^{\circ} 10' 28.512480''$, Lon: $121^{\circ} 14' 54.98628''$

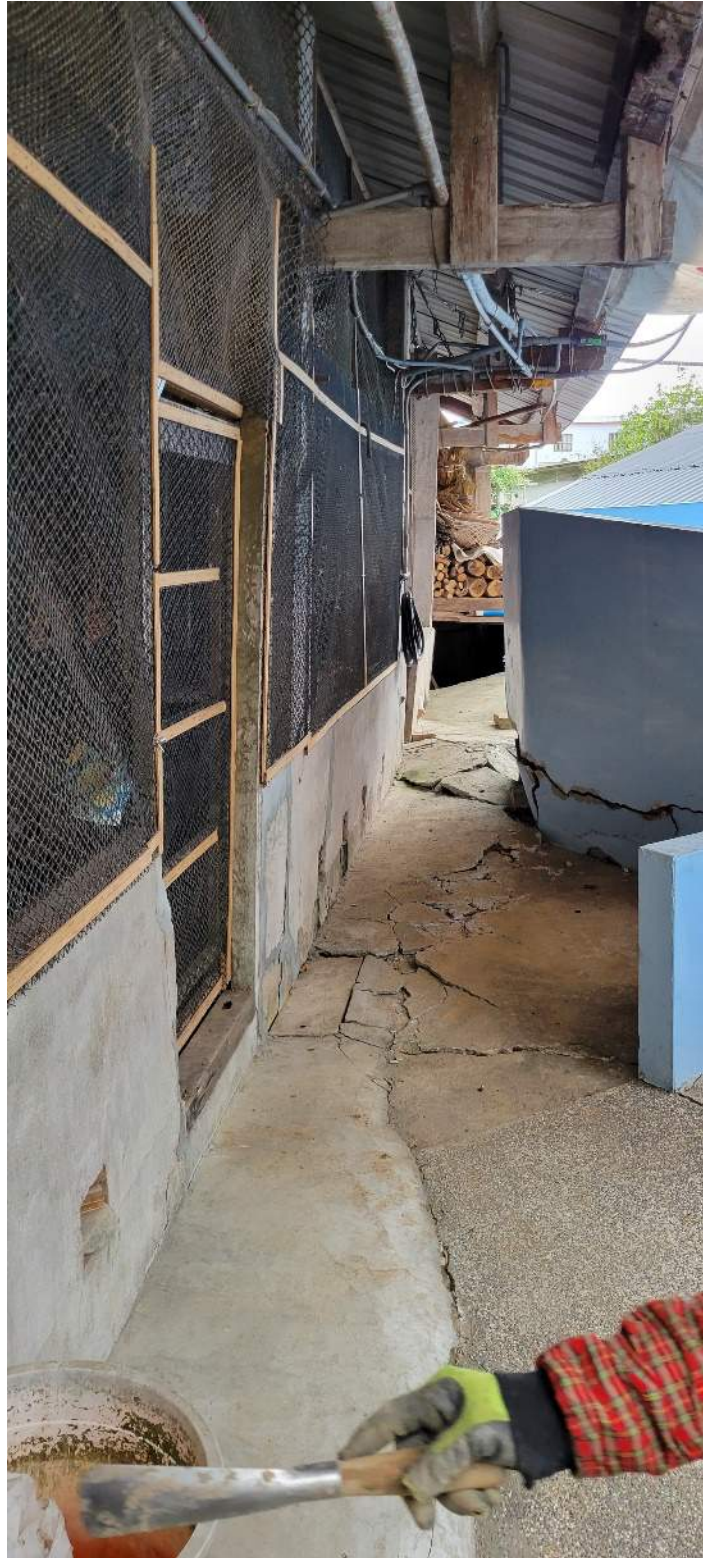
Figure 4.18 (d) Pavement buckling. Lat: 23° 10' 28.520039", Lon: 121° 14' 55.023719"

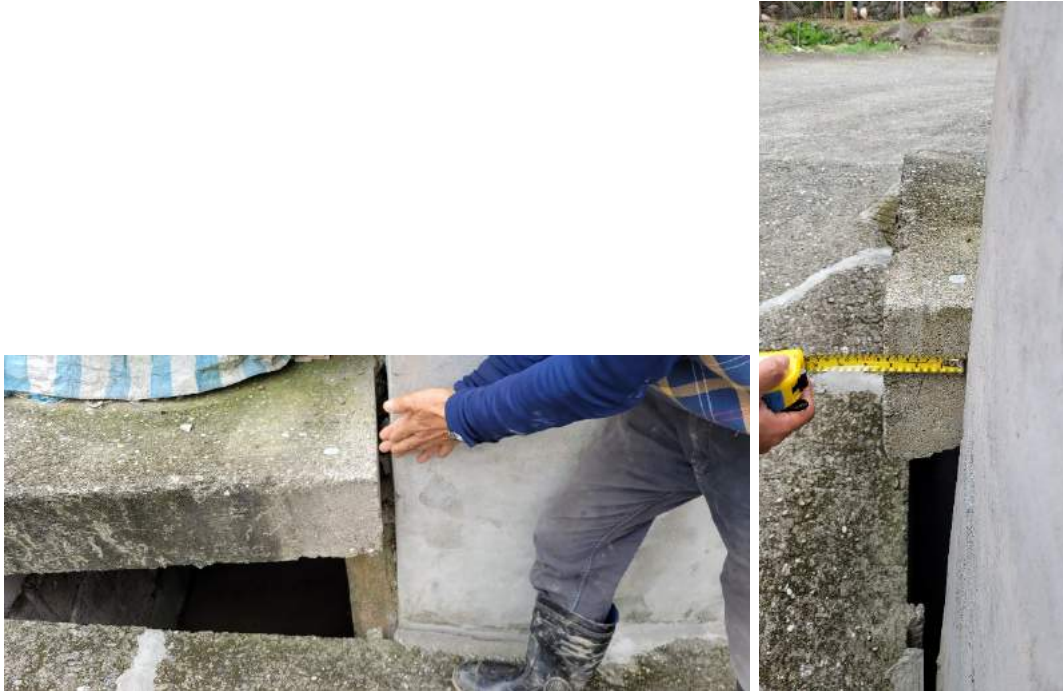
(e) Relative movement of foundation. Lat: 23° 10' 28.924320", Lon: 121° 14' 54.961080"

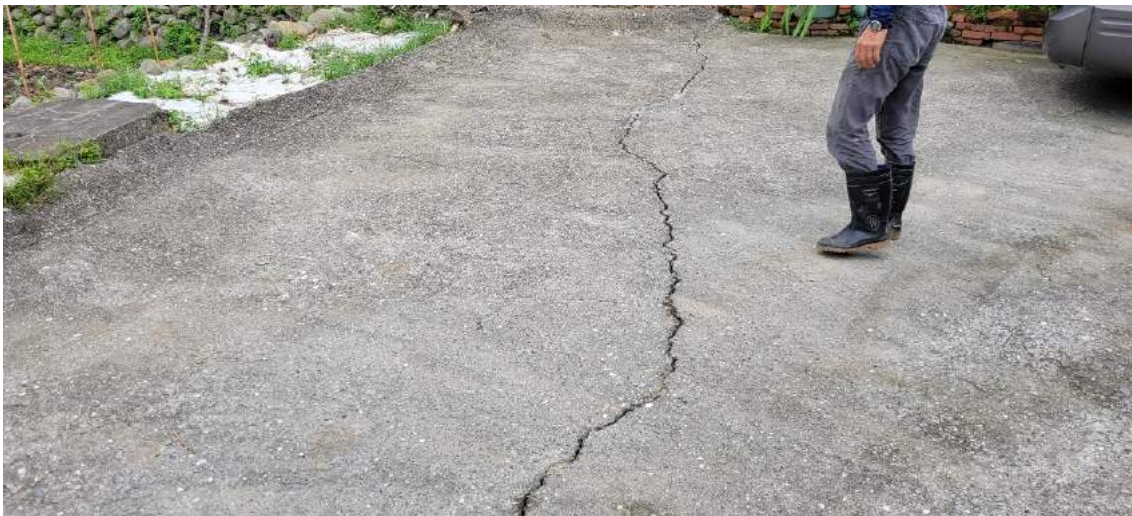
(a) Crack in pavement produced during mainshock. Lat: 23° 10' 28.945920", Lon: 121° 14' 54.936599"

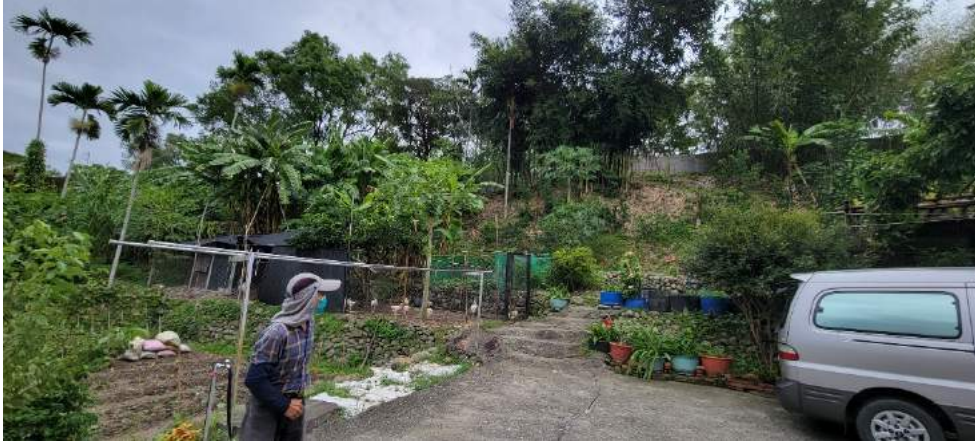
(b) View uphill following presumed trace of fault seen via cracks in pavement. Lat: 23° 10' 28.918199", Lon: 121° 14' 54.926159"

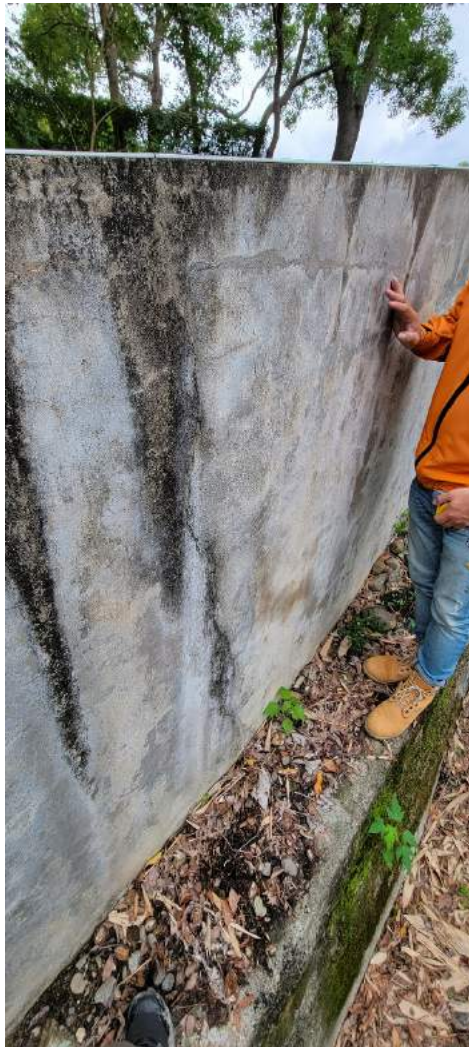
(c) Hairline fracture in concrete wall uphill from (b). Lat: 23° 10' 28.858440", Lon: 121° 14' 56.000759"

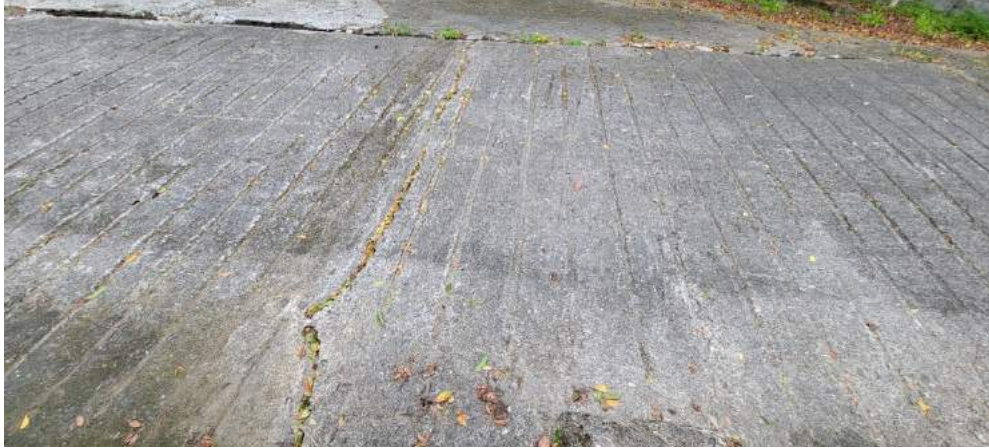
(d) Cracks in walkway between private property and Fuli Junior High School. Whether this crack was directly caused by the September 18 earthquake is uncertain. Lat: 23° 10' 28.848720", Lon: 121° 14' 56.038199"

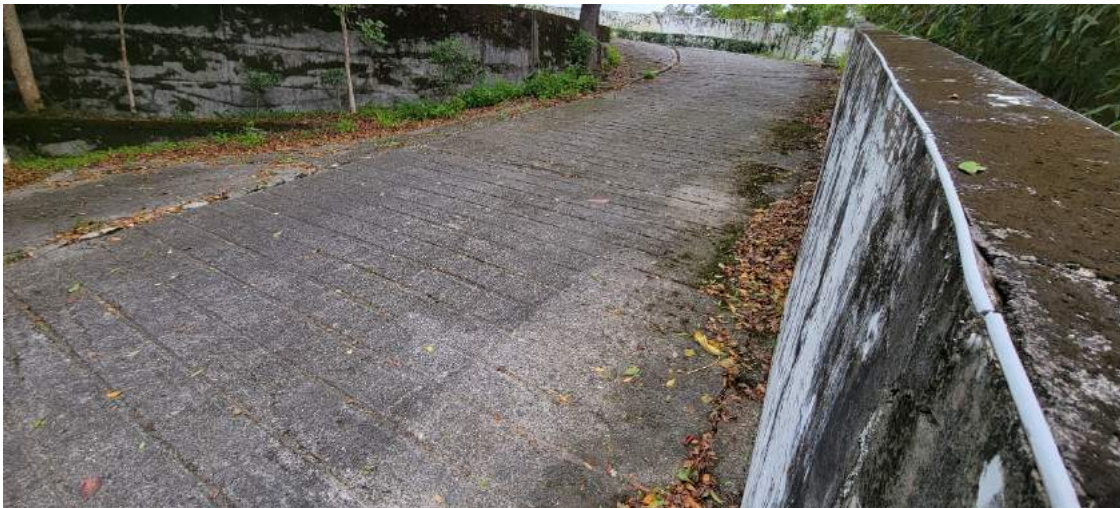
(e) View looking uphill from (d).

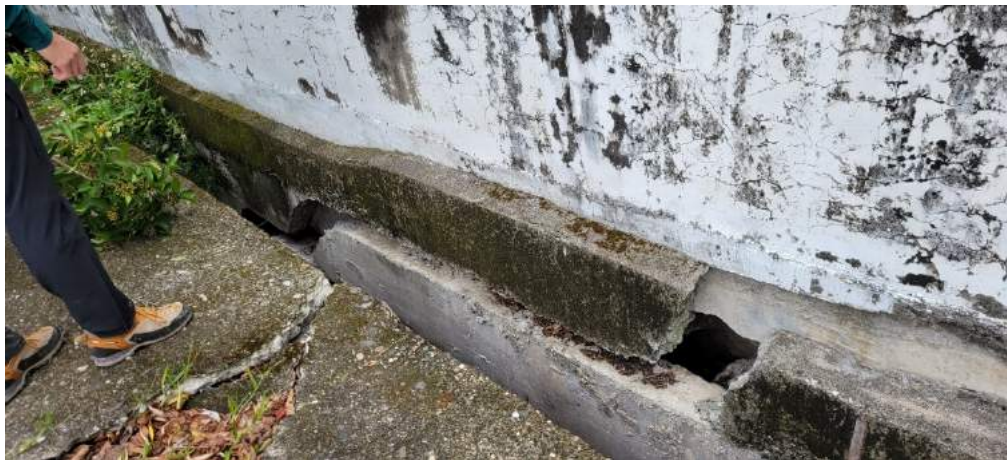
(f) Foundation offset with uncertain cause. Lat: 23° 10' 28.041599", Lon: 121° 14' 56.212440"

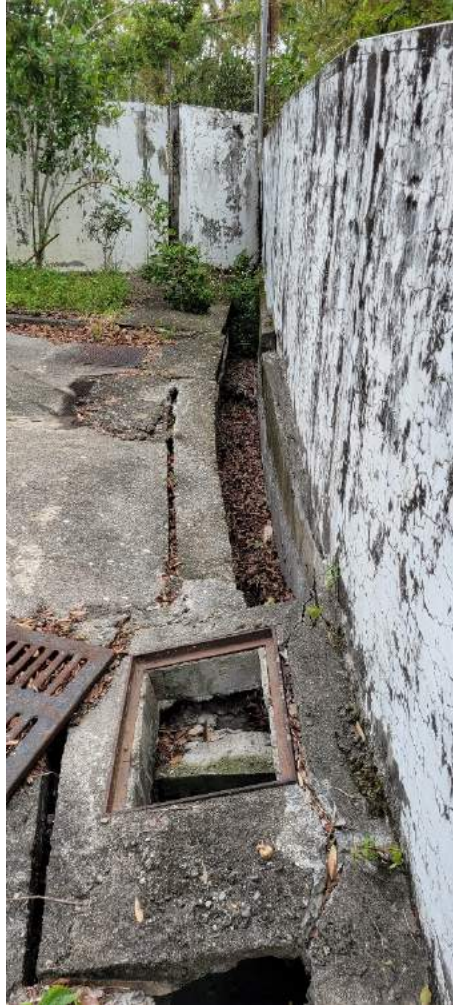
(g) Inward buckling of concrete wall. Uncertain as to whether this was a direct result of the September 18 earthquake. Lat: 23° 10' 28.223039", Lon: 121° 14' 56.014799"

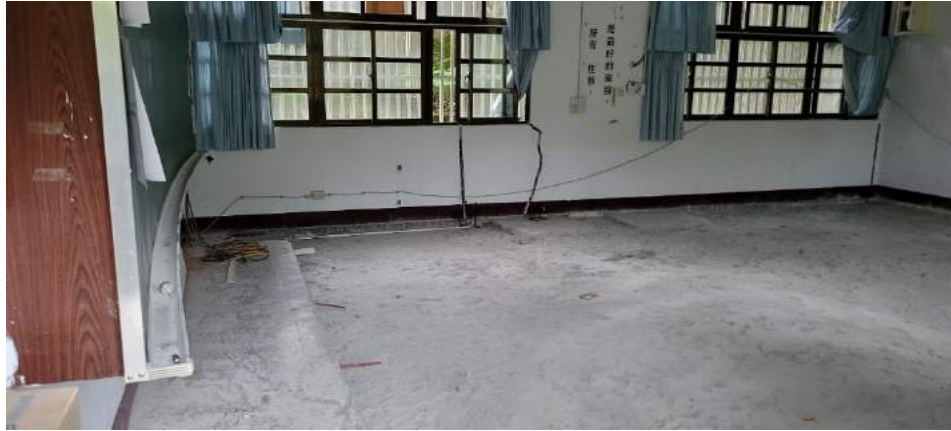
Figure 4.19 Possible continuation of fault rupture uphill from Figure 4.17 towards Fuli Junior High School.

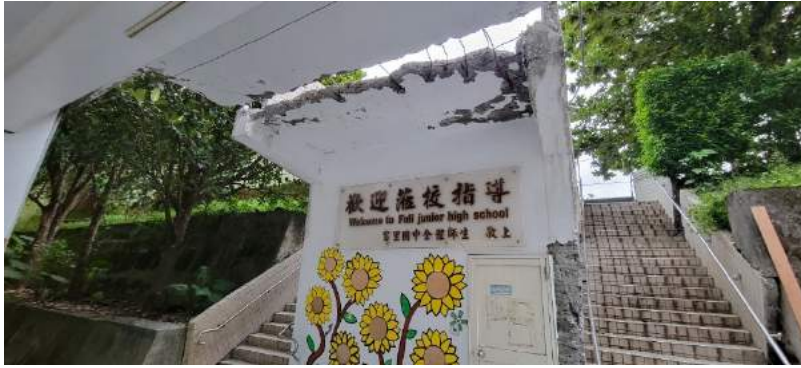
Figure 4.20: Diagonal cracks in walls of Fuli Junior High School classrooms presumed to have been caused by September 18 earthquake. Lat: 23° 10' 30.607680", Lon: 121° 14' 56.832000"

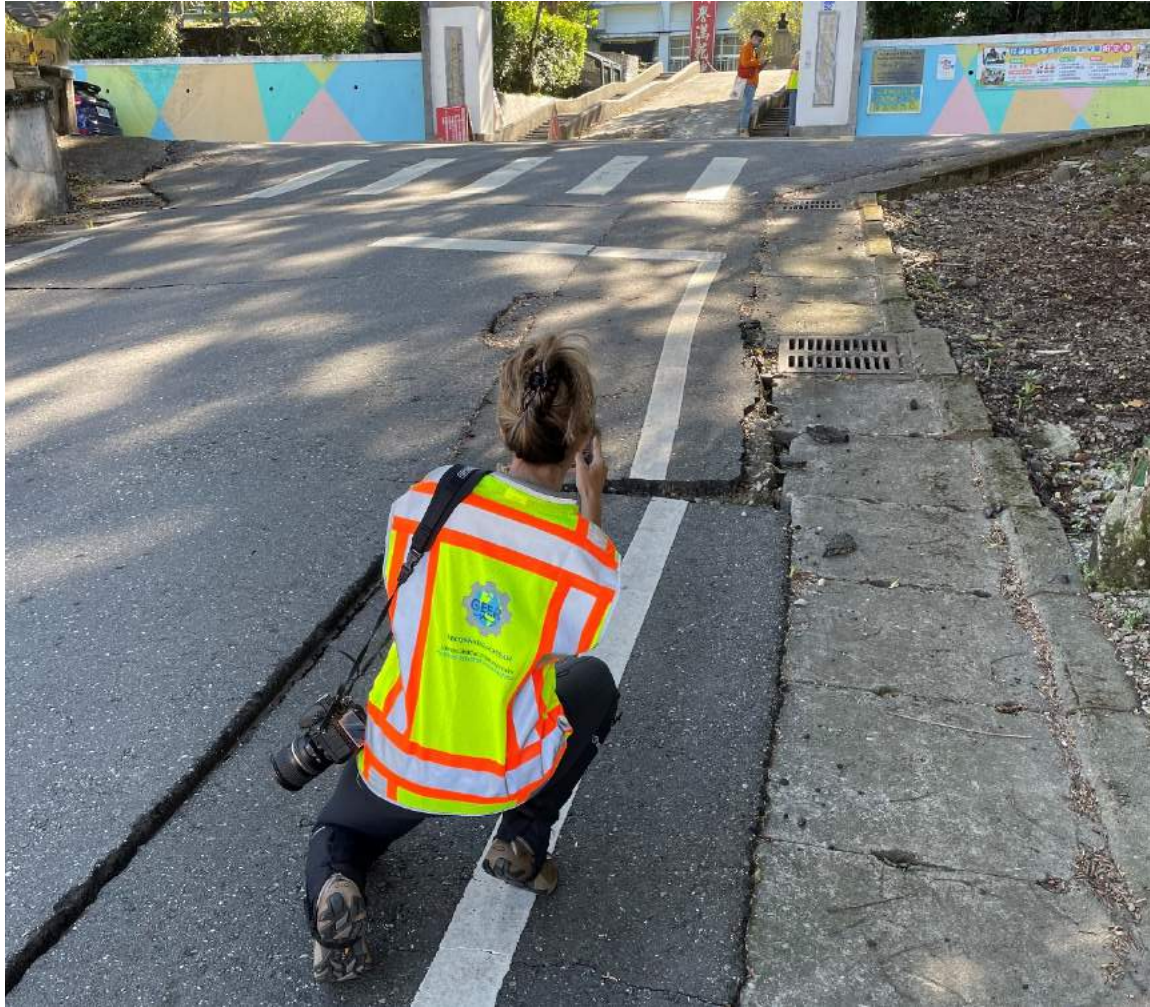
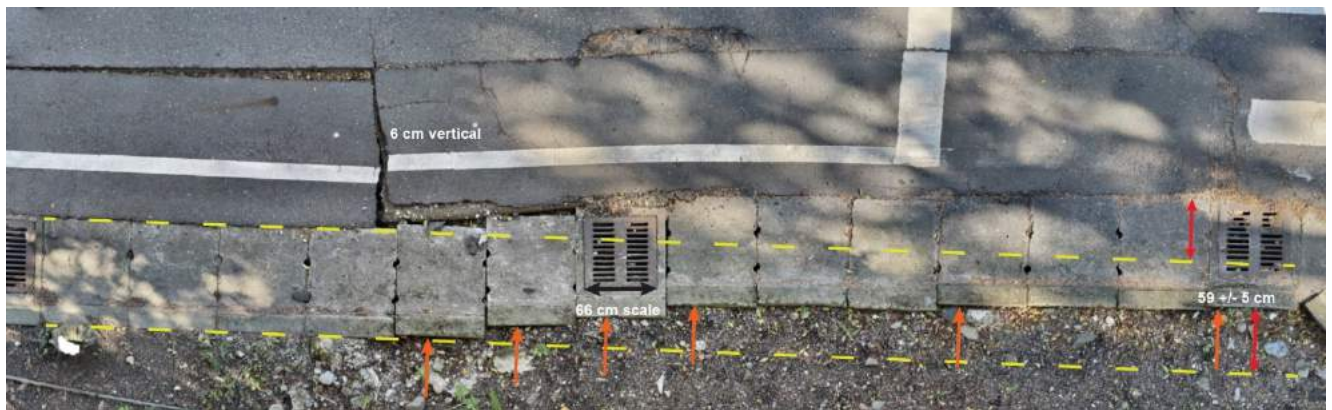
Figure 4.22: offset of sewer lateral in Fuli. The best estimate of total LL displacement is 59 cm, include possible pre-event creep and/or prior surface rupture on the LVF.

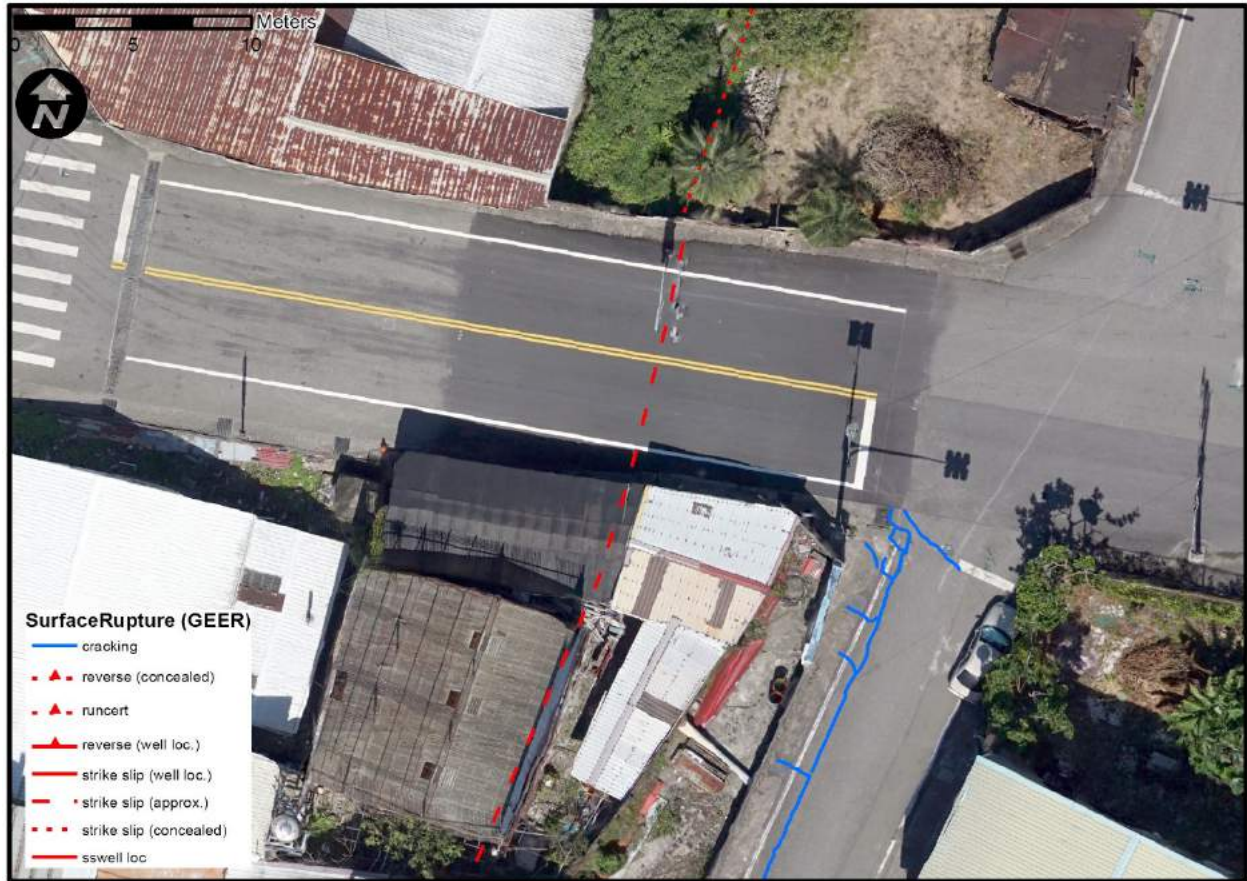
Figure 4.23: Map view of repaired intersection in Fuli. Sewer lateral and adjacent wall are sinistraly offset ~90 cm. Displacement may include pre-event creep and/or prior surface rupture on the LVF.

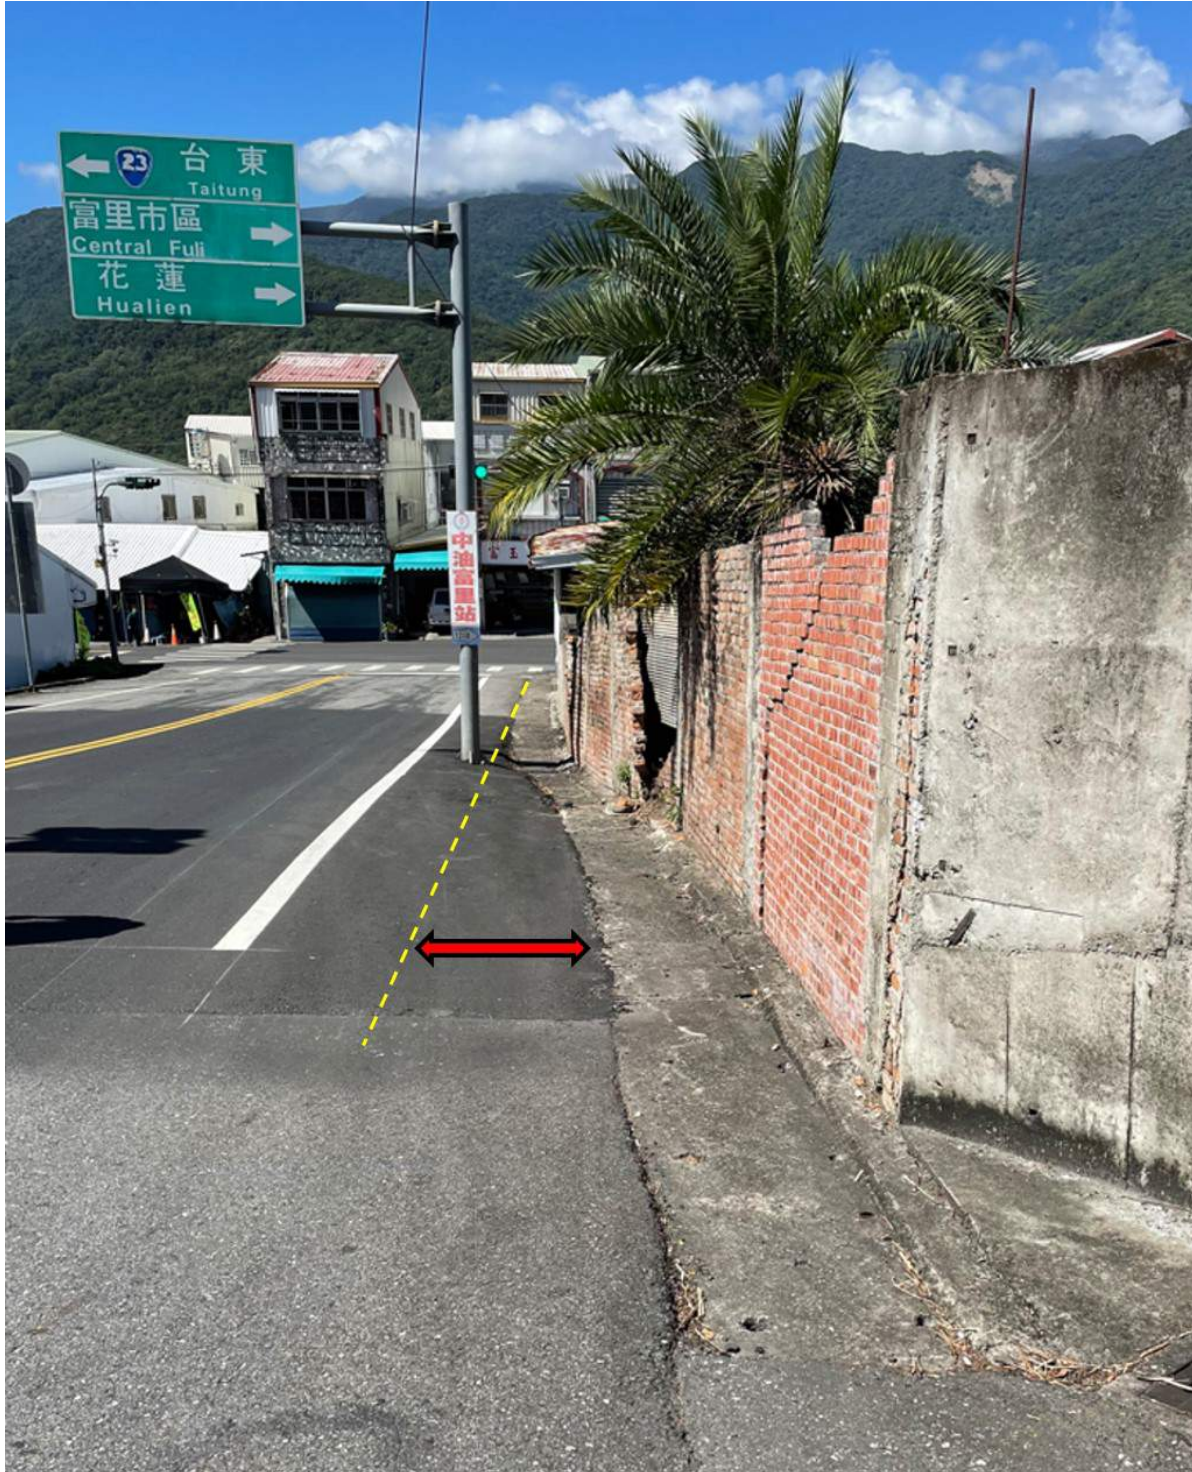
Figure 4.24: West-looking view of offset sewer lateral and brick wall. Total LL offset is ~90 cm, which may include creep and/or surface rupture on the LVF that occurred prior to the September earthquake.

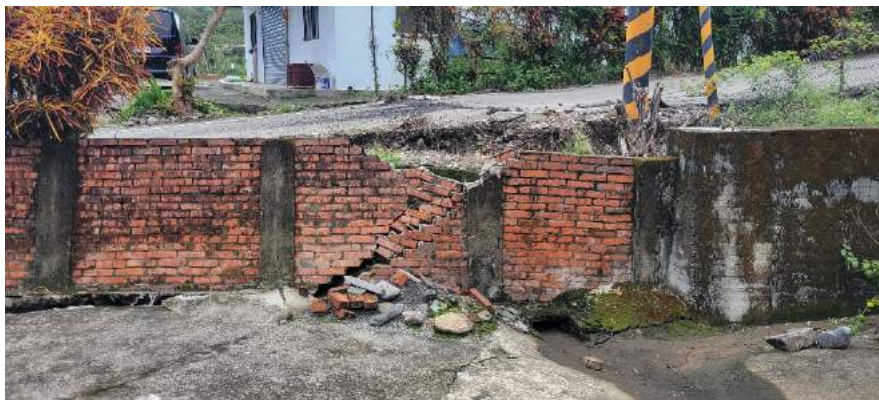
Figure 4.25: Views looking (a) uphill and (b) downhill along Dongning Street adjacent to properties exhibiting recent damage. Lat: 23° 14' 39.447239", Lon: 121° 17' 37.383720"

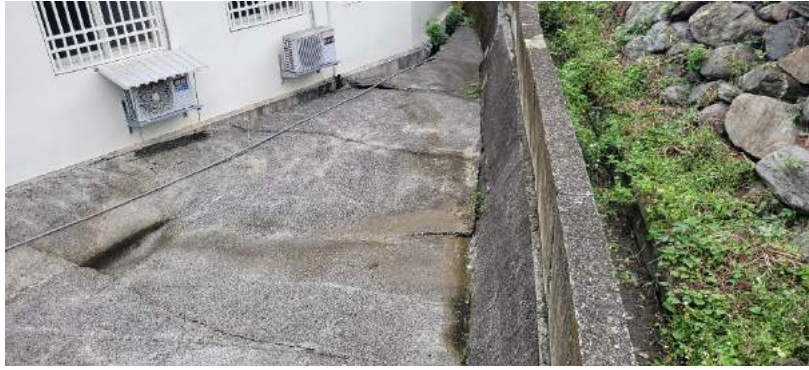
Figure 4.26: Damage associated with property on north side of Dongning Street. Lat: 23° 14' 39.136920", Lon: 121° 17' 38.056919"

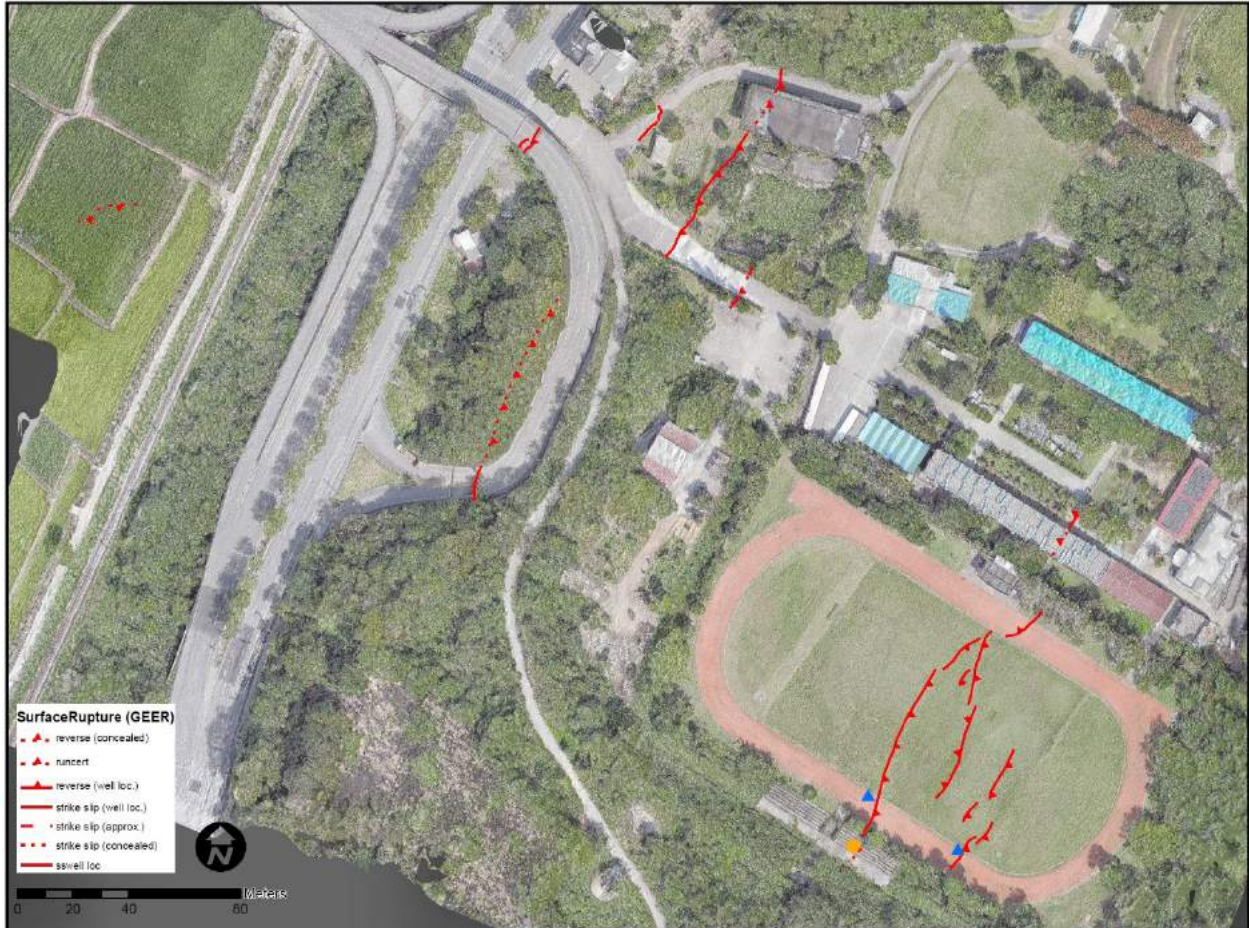
Figure 4.28: Surface Rupture Map at Dongli School
