GEOTECHNICAL ENGINEERING RECONNAISSANCE OF THE 2022 CHIHSHANG EARTHQUAKE SEQUENCE

Version 1.0; April 2024

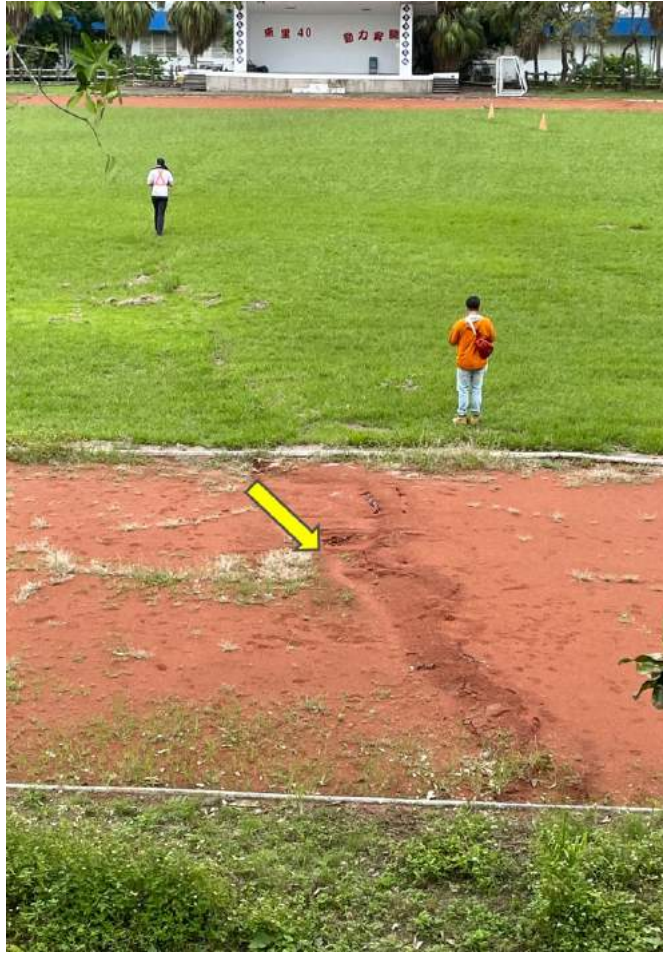
Figure 4.29: Reverse faults in the school athletic fault. Scarp height reaches a maximum of 13 across this strand, similar to others shown on the map above. Lat: $23^{\circ} 15' 44.124479''$, Lon: $121^{\circ} 18' 7.791120''$.

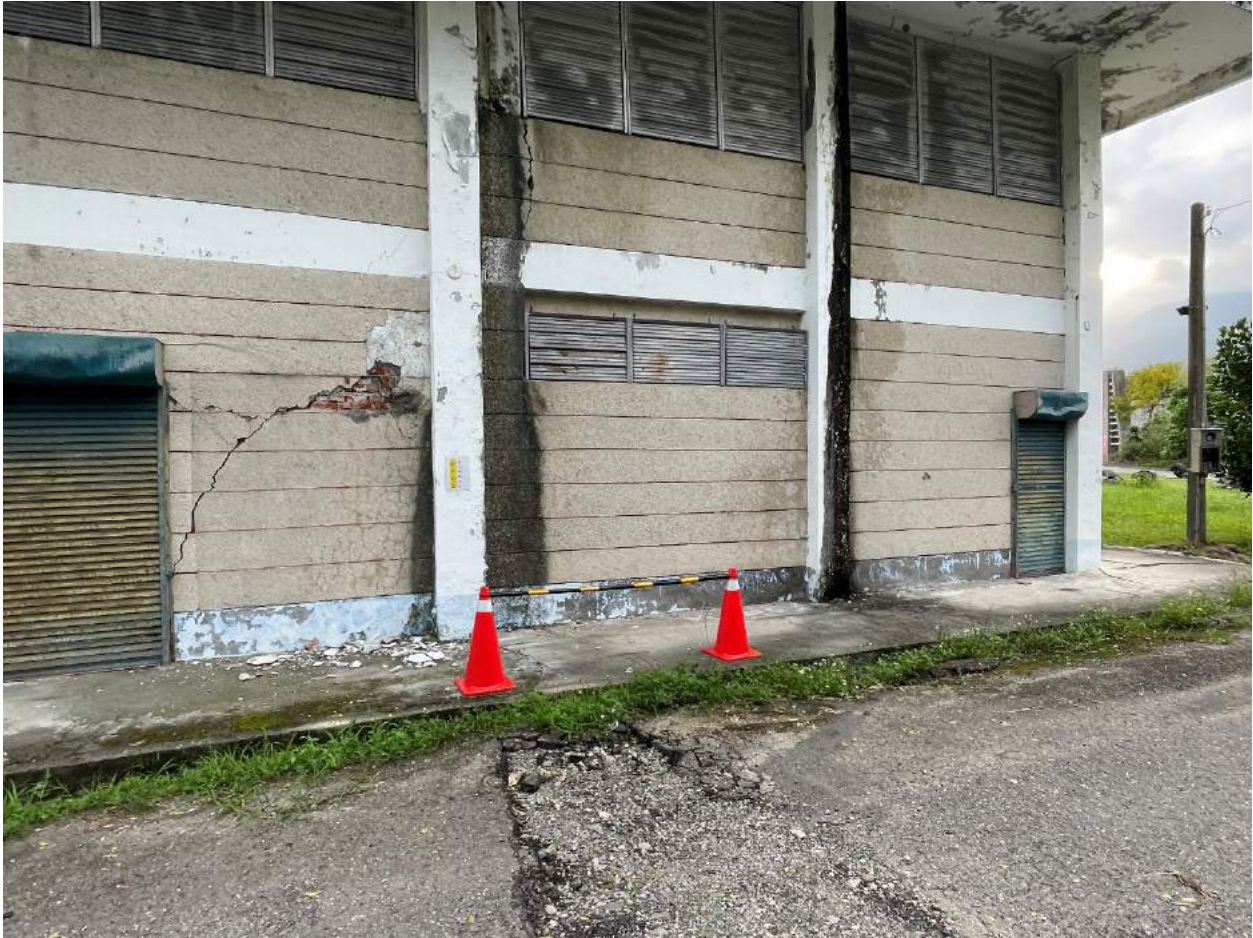
Figure 4.33: Damage to structure on the opposite side of the street from the retaining wall in the figure above. Cracking extends from the foundation to the roof, Lat: 23° 15' 46.403640", Lon: 121° 18' 9.362160"

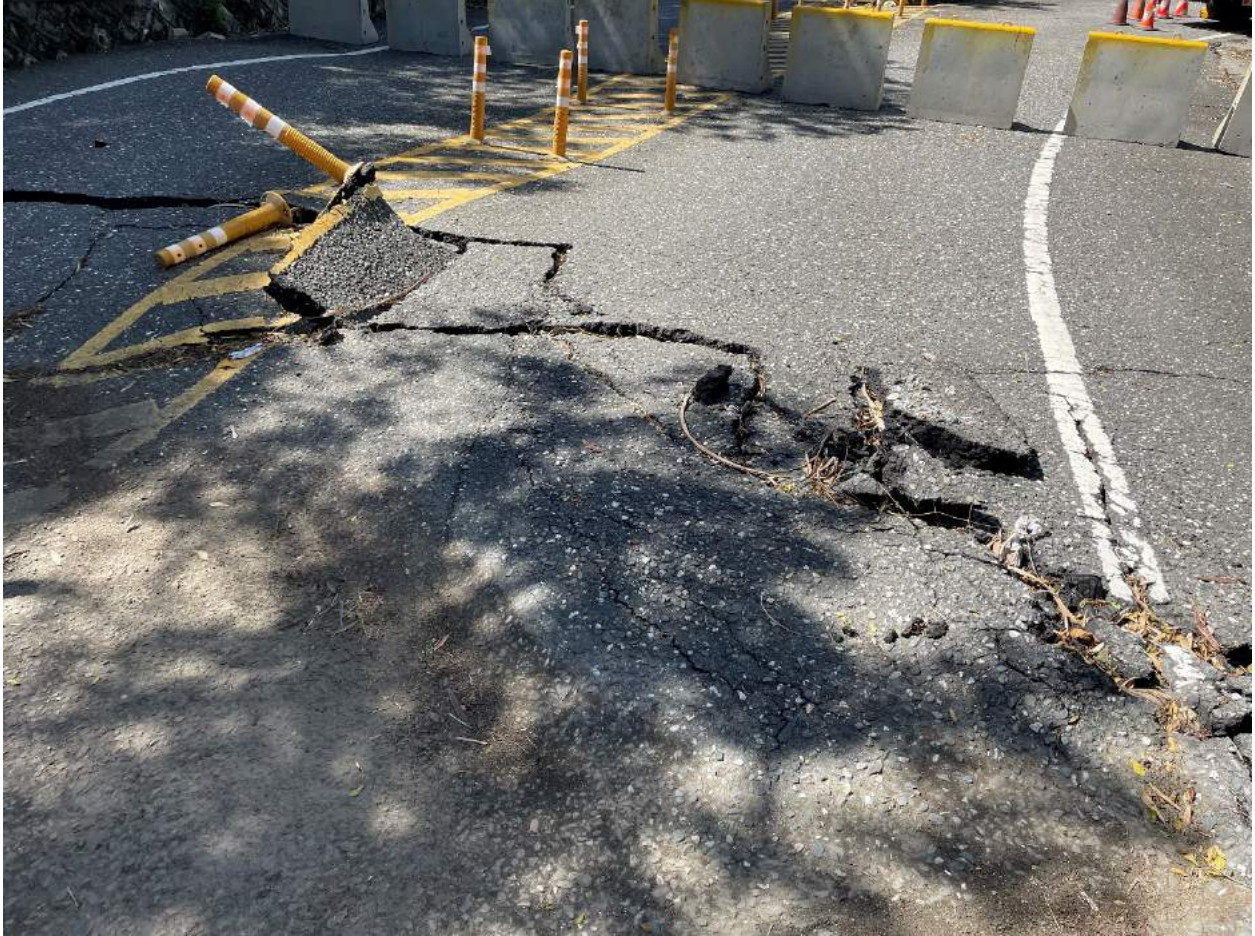
Figure 4.34: Surface rupture through the bridge approach near projected location of the LVF. Asphalt pavement buckled and locally detached. View looking southwest, Lat: 23° 15' 46.403640", Lon: 121° 18' 9.362160"

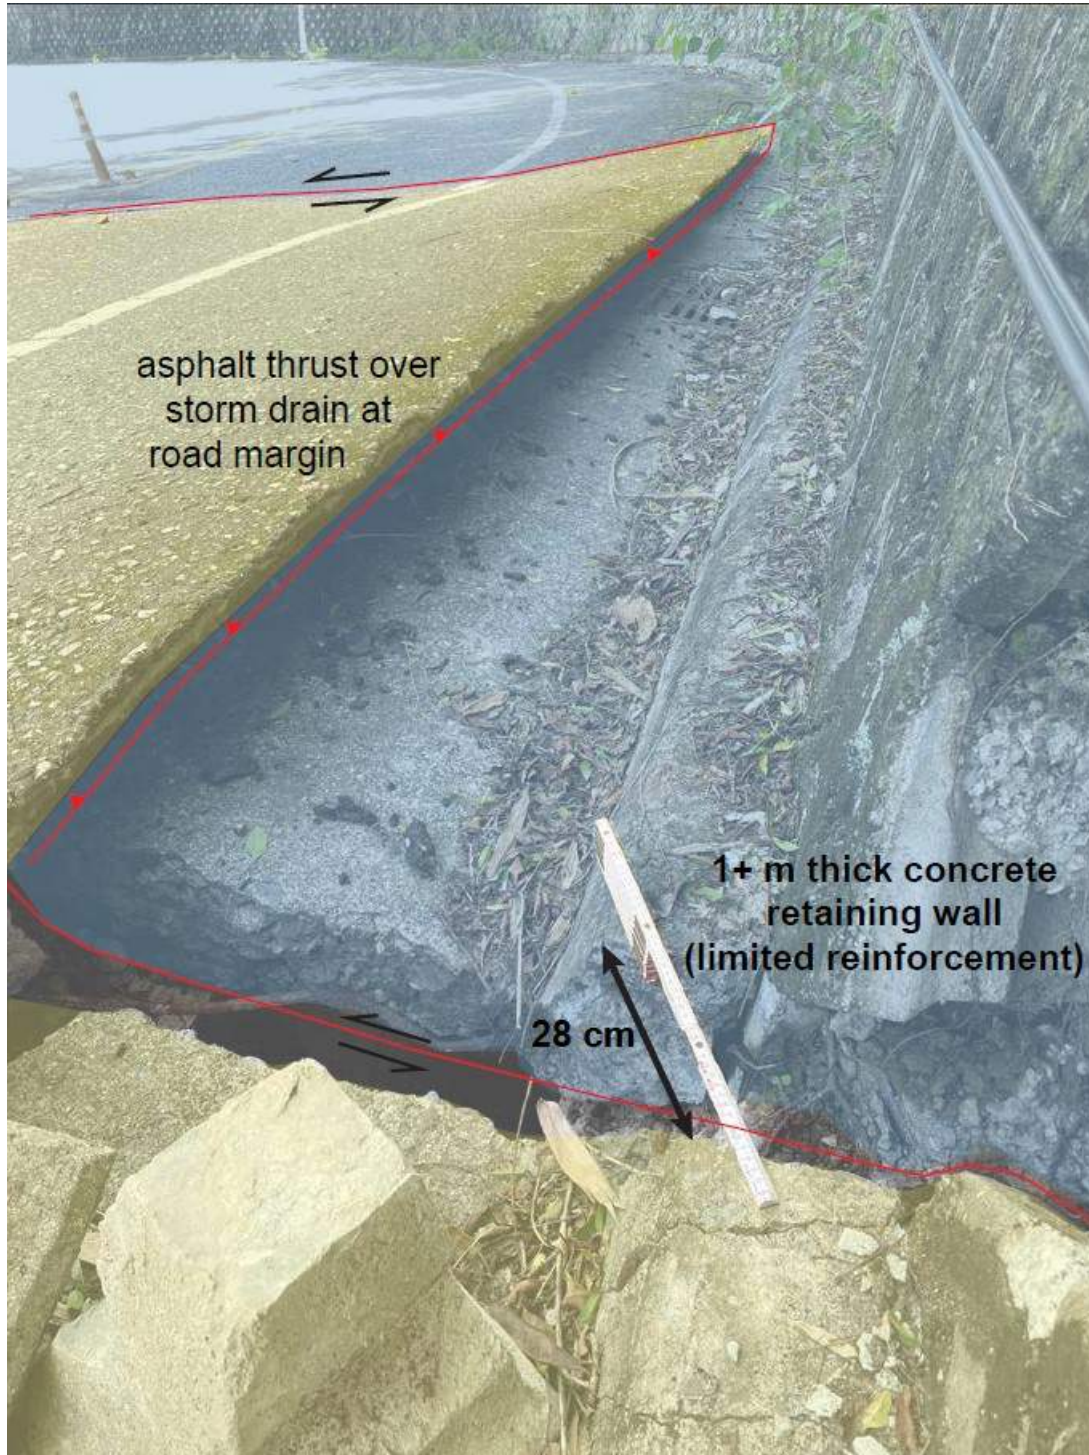
Figure 4.35: Annotated photo showing view of buckled pavement on bridge approach. Net horizontal displacement of the 1-m-thick concrete retaining wall (sparse reinforcement) was ~28 cm, Lat: 23° 15' 46.403640", Lon: 121° 18' 9.362160"

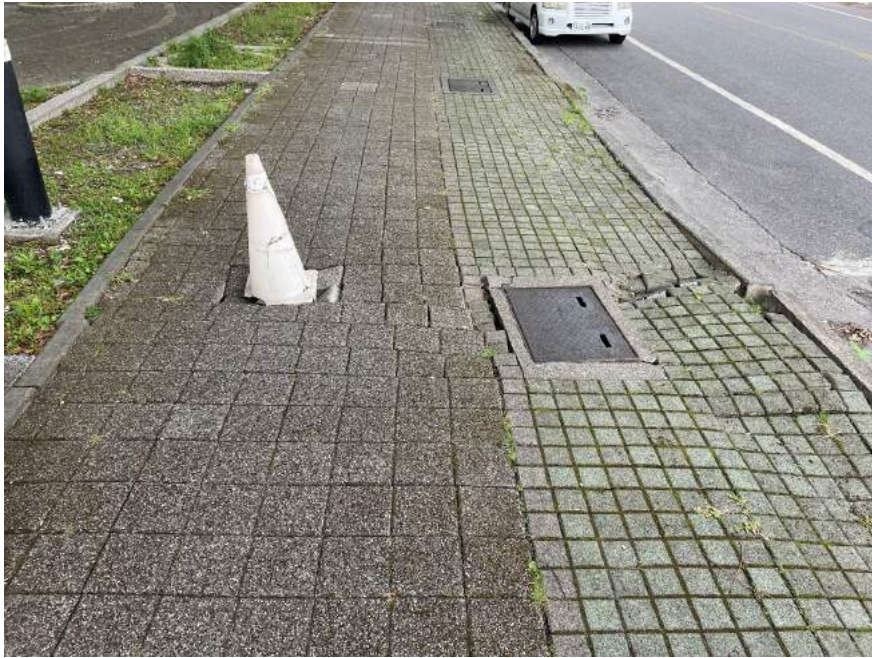
Figure 4.36: Minor (<10 cm) offset of storm drain across the Yuli fault. Location Roughly coincident with 1951 Rupture (Shyu et al., 2007). Lat: 23° 20' 10.720679", Lon: 121° 19' 1.702919"

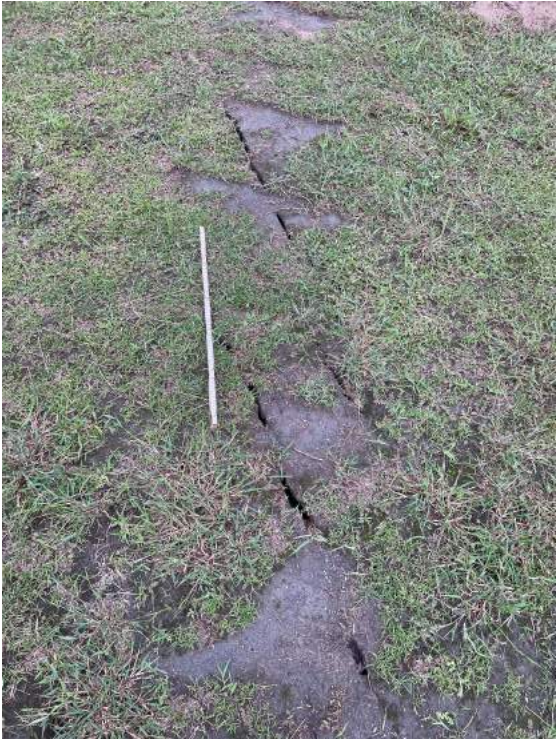
Figure 4.40: En-echelon tension cracks with apparent ejected sands at the Yuli High School athletic field. Lat: 23° 20' 31.165800", Lon: 121° 19' 11.031959"

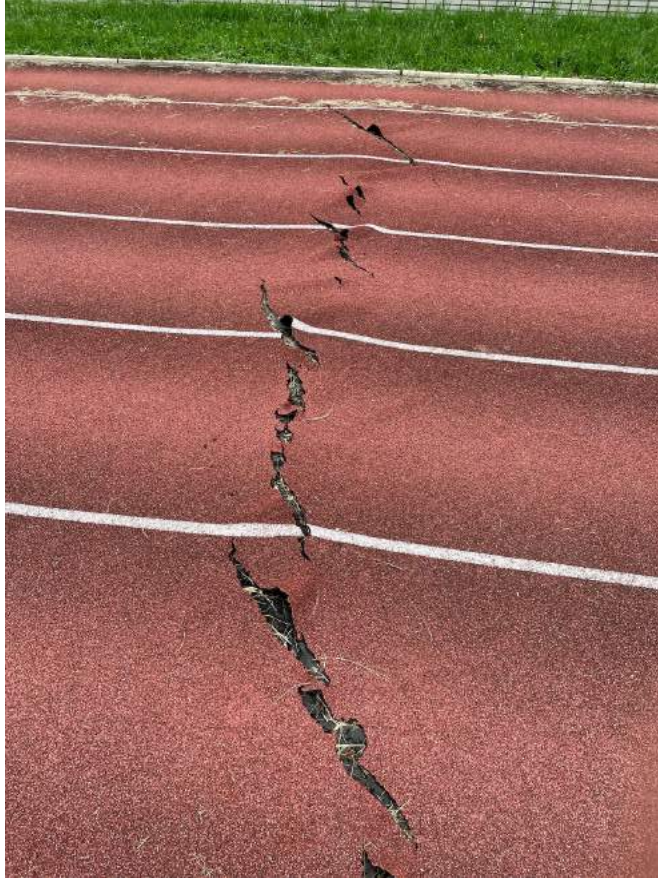
Figure 4.41: En-echelon tension cracks rupturing the track at the Yuli High School athletic field.
Lat: 23° 20' 31.715519", Lon: 121° 19' 11.219520"

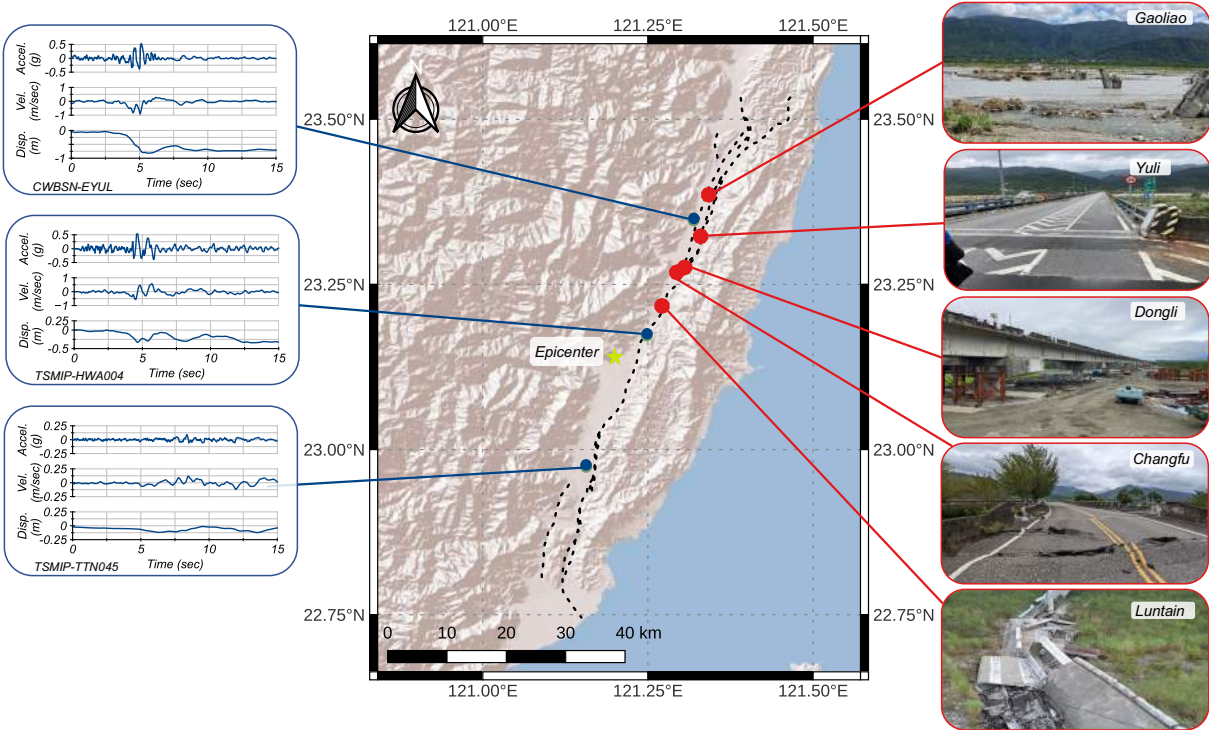
Figure 5.1. Locations of the five most heavily damaged bridges, the traces of the Longitudinal Valley Fault, the epicenter of the M6.9 earthquake, and select acceleration, velocity, and displacement time series from that event.

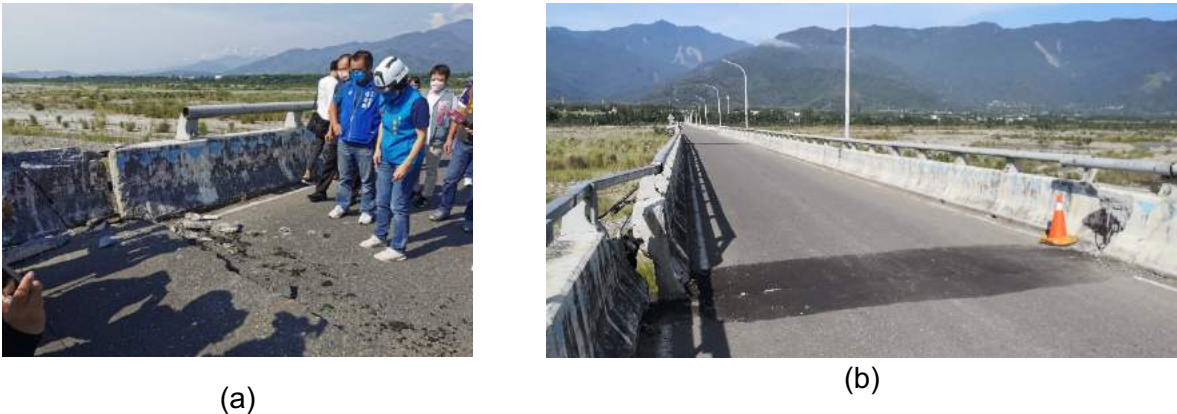
Figure 5.2. a) Damage between adjacent bridge spans buckling roadway, concrete barrier, and metal guardrail (United Daily News), looking south; b) repaired roadway and metal guardrail damage during GEER/NCREE visit looking northwest. (22.9748° 121.1702°)

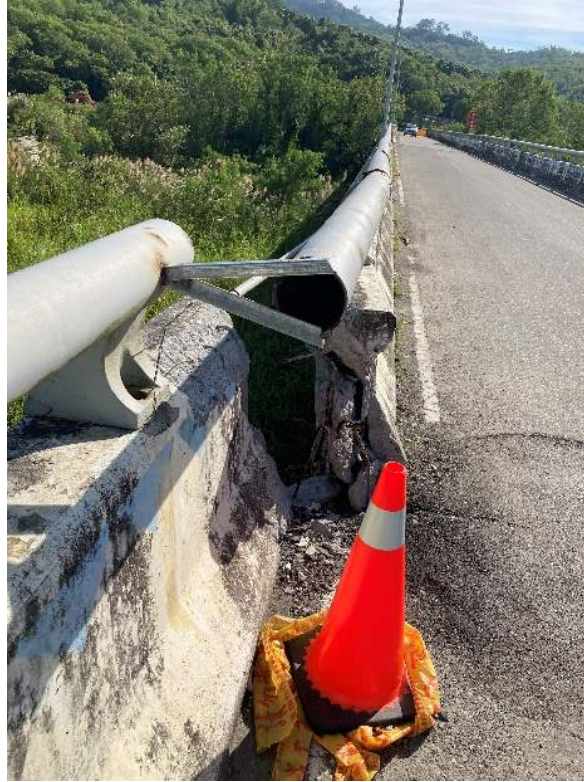
Figure 5.3. Lateral offset, looking towards the east abutment. (22.97484° 121.17017°)

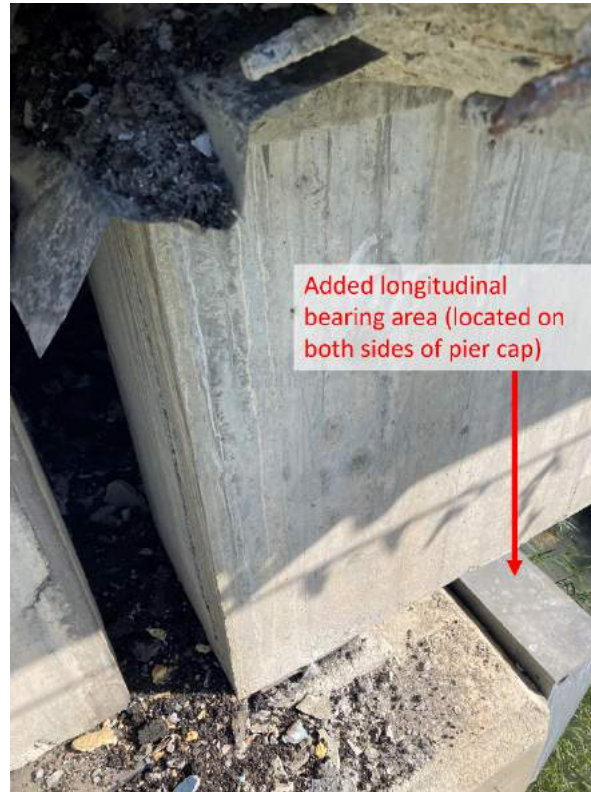
Figure 5.5. View of typical retrofit by adding additional bearing area to prevent longitudinal unseating (22.97479° 121.17059°)

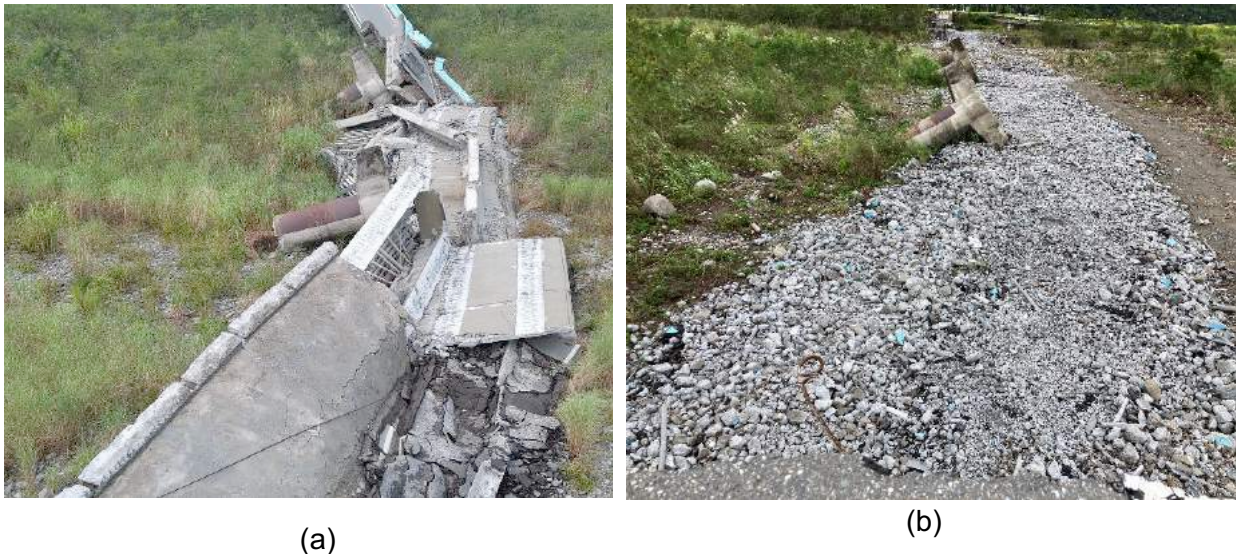
Figure 5.6. a) Failed spans and pier foundation supports at the Luntian Bridge (image curious of NCREE); b) view for concrete bridge piers after deck removal during GEER team visit in October 2022 (23.21726° 121.27172°)

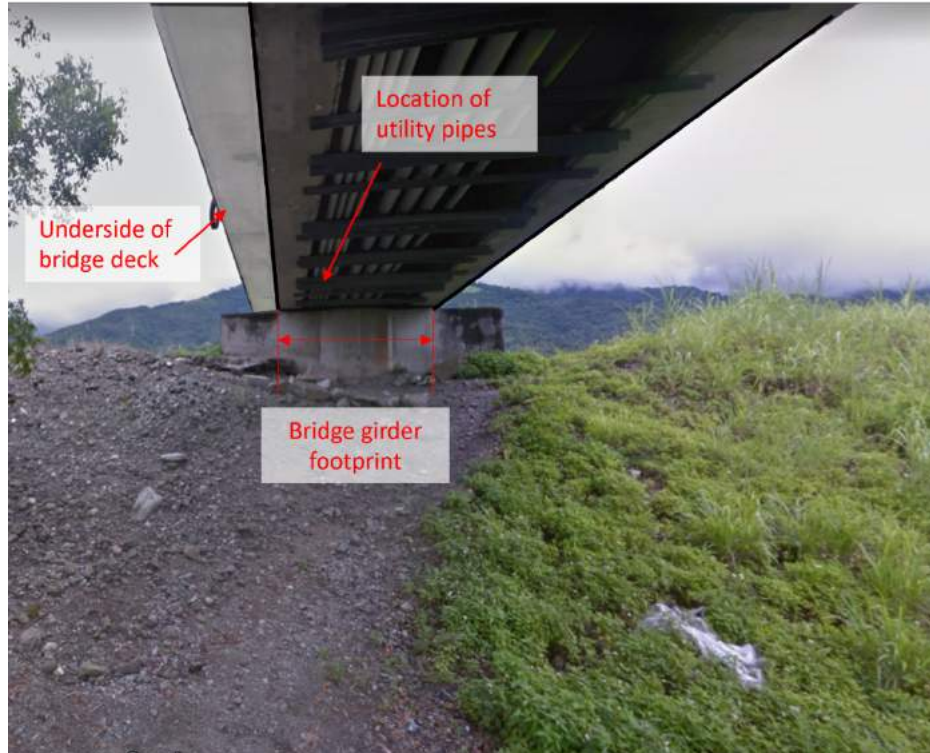
Figure 5.8. Looking west at the 2nd pier from the east abutment prior to the earthquake. Note the location of the utility pipes on the pier cap. Photo from Google Street View from 2012 (near 23.21457° 121.27268°)

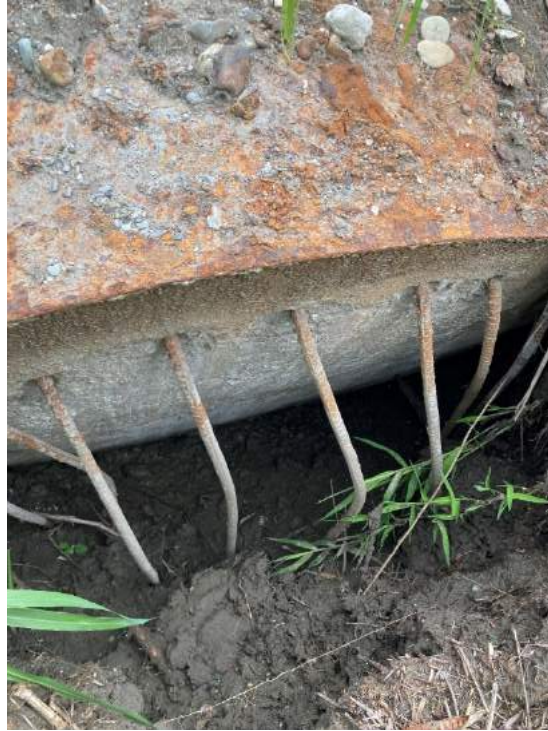
Figure 5.11. View from the bottom of one of the failed pier foundations. The longitudinal rebar yielded and relatively smooth base suggesting a cold joint (23.21753° 121.27116°)

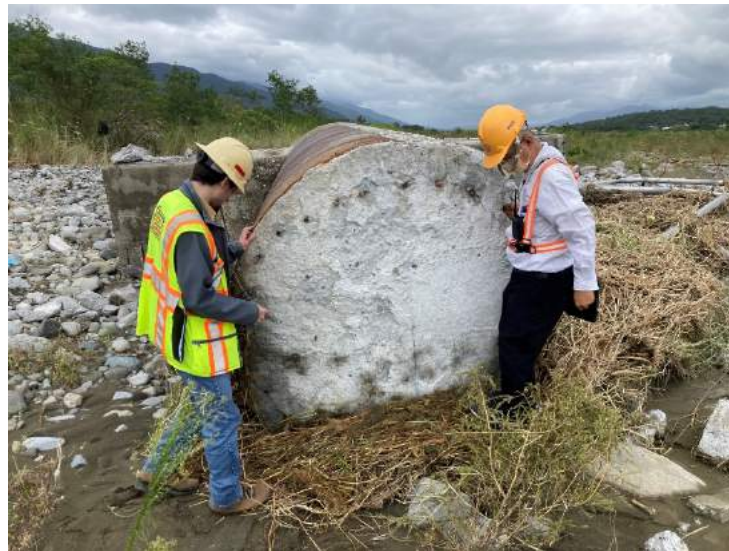
Figure 5.12. Typical view of one of the failed piers with irregular longitudinal rebar spacing. (23.21775° 121.27062°)

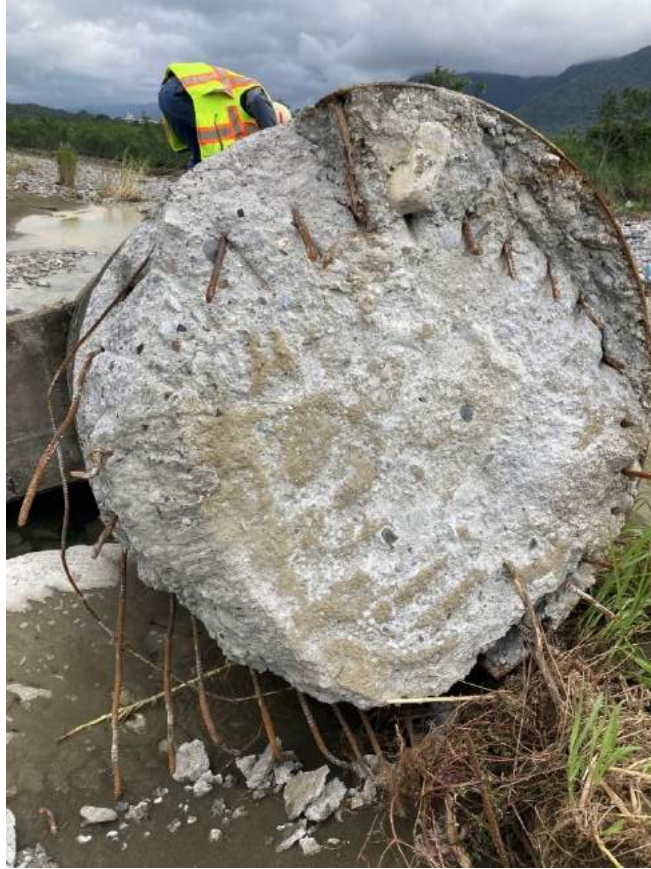
Figure 5.13. View of a failed pier with irregular longitudinal rebar spacing. Same pier as and concrete pad as Figure 5.14. (23.217653° 21.270928°)

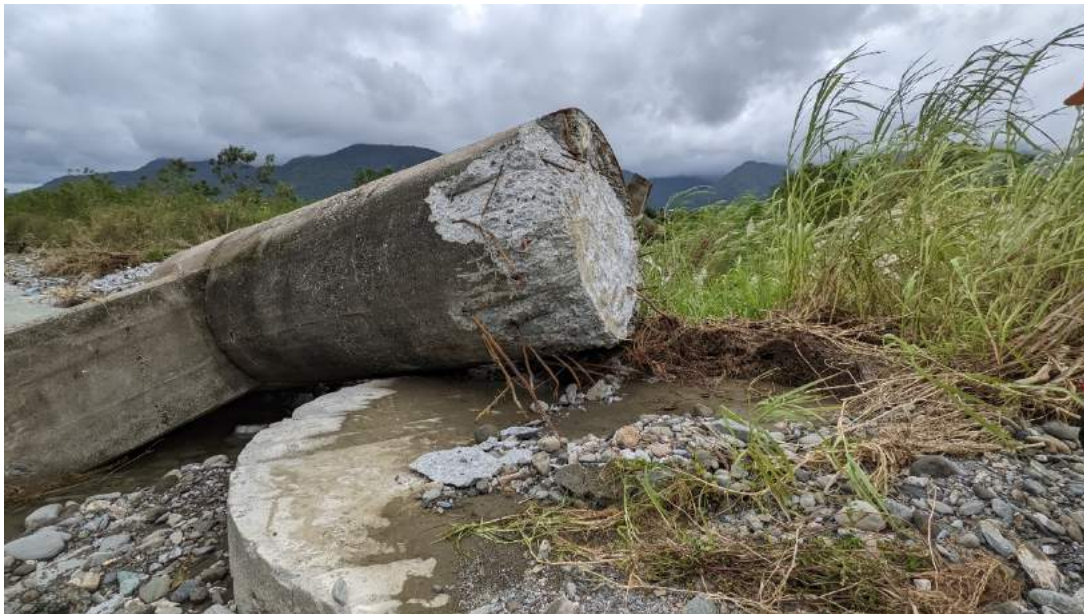
Figure 5.14. View of failed bridge pier and concrete pad. Note the yield longitudinal rebar connecting the pier to the concrete pad. (23.21771° 121.25425°)

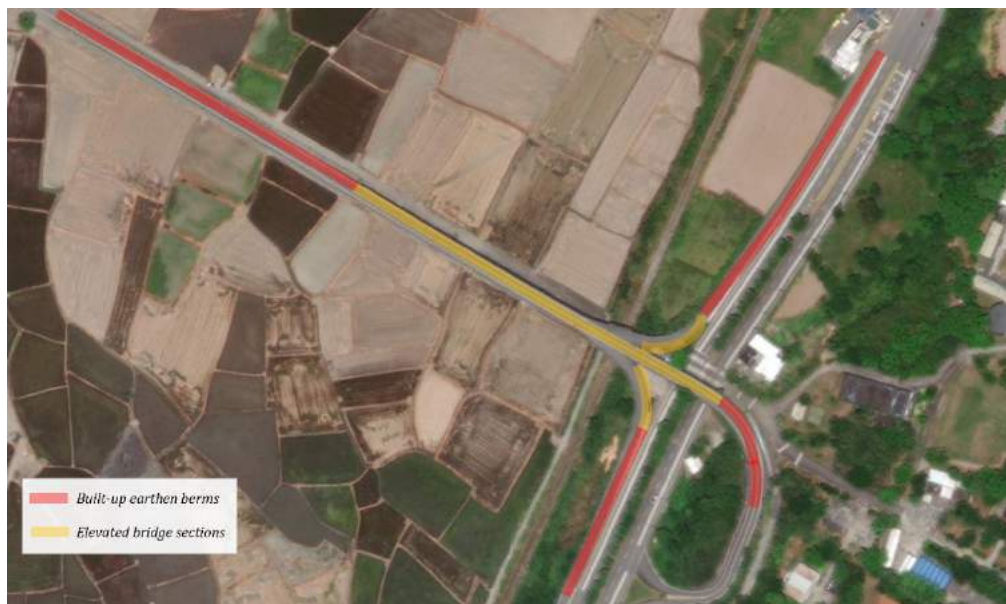
Figure 5.15. Google satellite view of the Changfu Bridge with the built-up earthen berms (red) and main-spans and approaches (yellow).

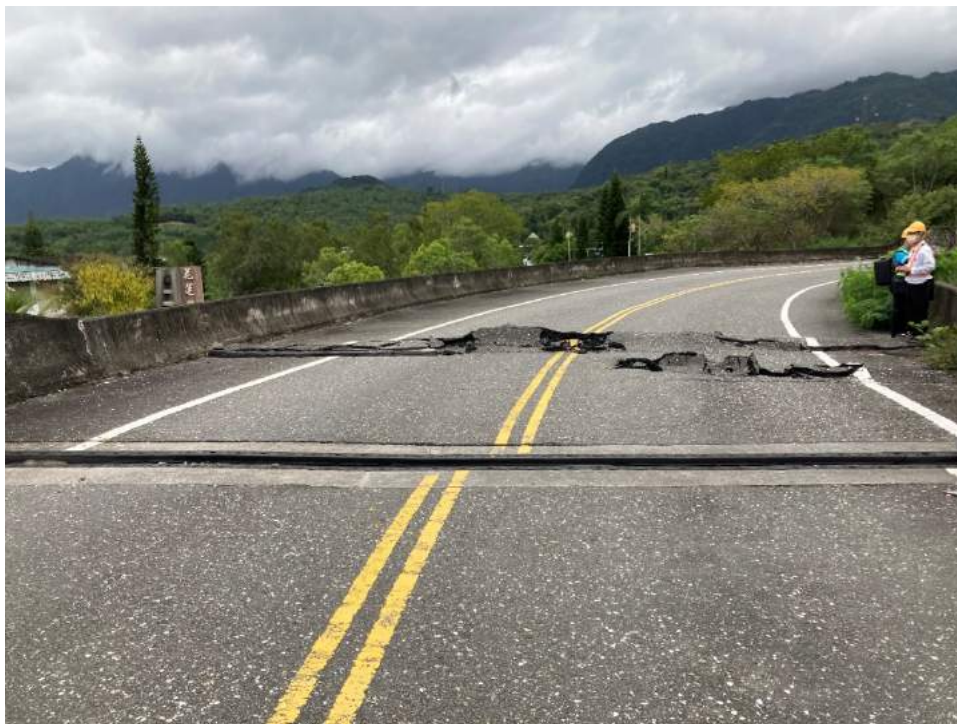
Figure 5.17. 41 cm lateral offset between bridge span and abutment. (Asphalt buckling due to surface fault rupture) (23.26452° 121.30089°)

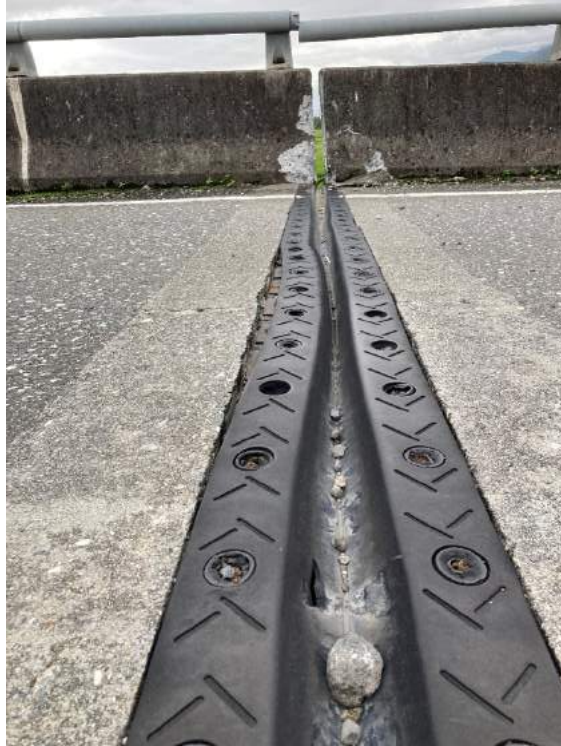
Figure 5.18. Damage to expansion joint, concrete and metal barriers (23.26557° 121.29901°)

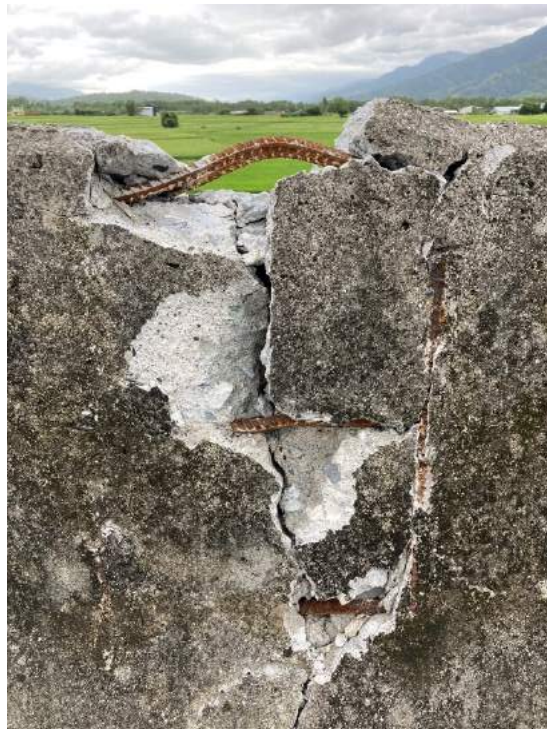
Figure 5.19. Compression buckling of concrete barrier steel reinforcement (23.26584° 121.29836°)

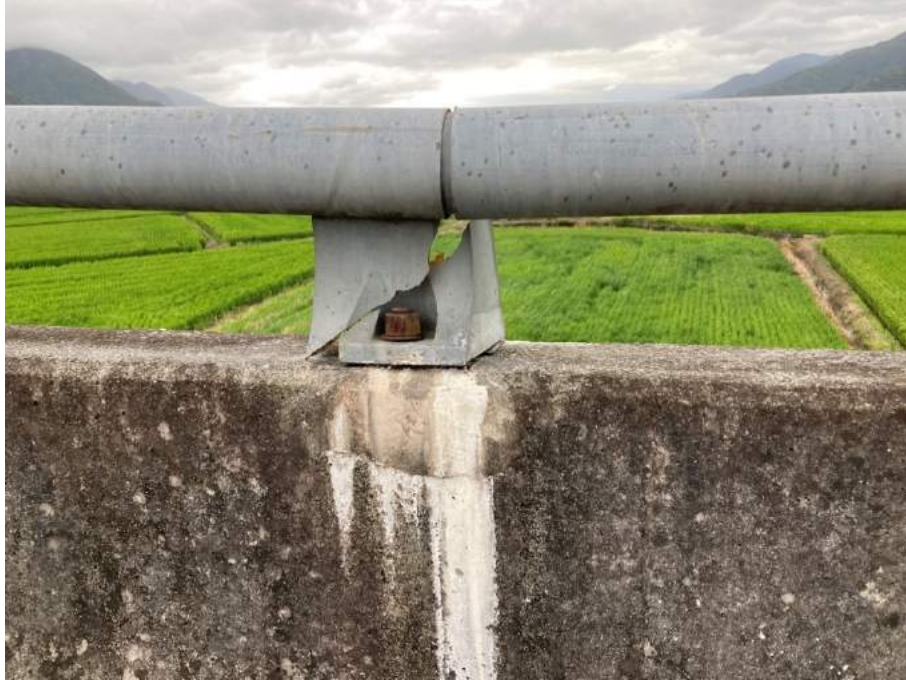
Figure 5.20. Shear failure in metal guardrail bracket caused by compressional loads. (The expansion joint preventing tensile loading) (23.26568° 121.29870°)

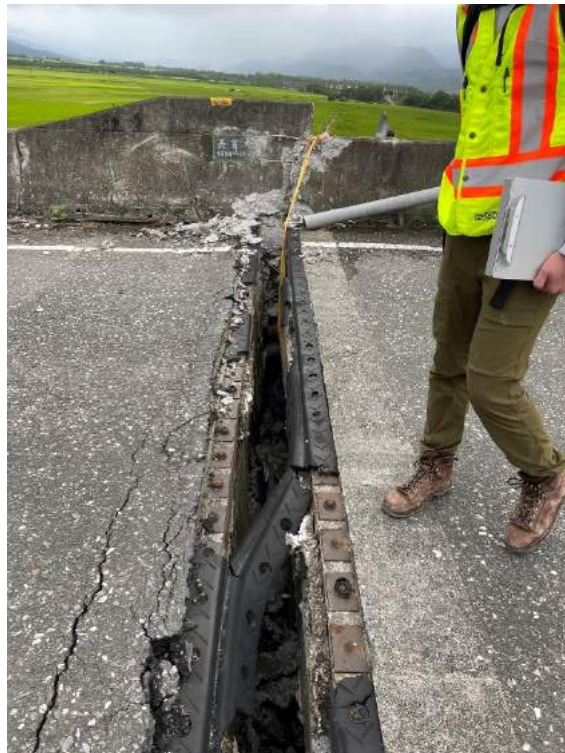
Figure 5.21. Extension of bridge joint at the west abutment. Gap approximately 25 cm. (23.26574° 121.29864°)

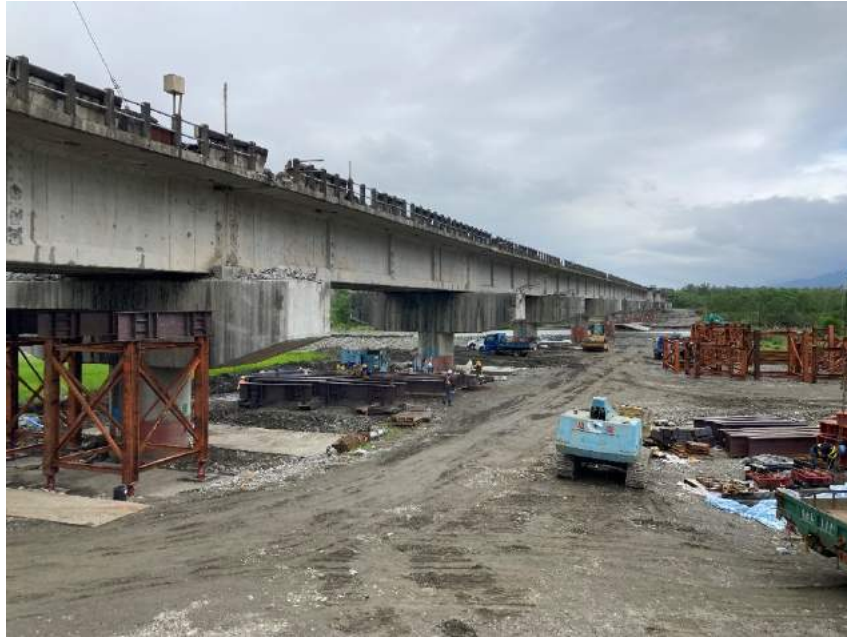
Figure 5.23. View of the Dongli Railroad Bridge during active repair operations. (23.27487° 121.30530°)

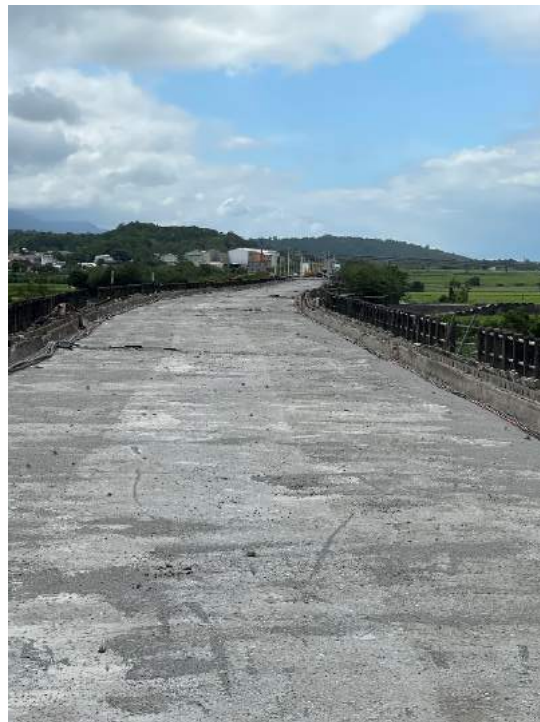
Figure 5.24. View from the bridge deck of the Dongli Railroad Bridge with the train rails removed. The twist in the deck was due to the lateral translation of the prestressed girders. (23.27829° 121.30669°)

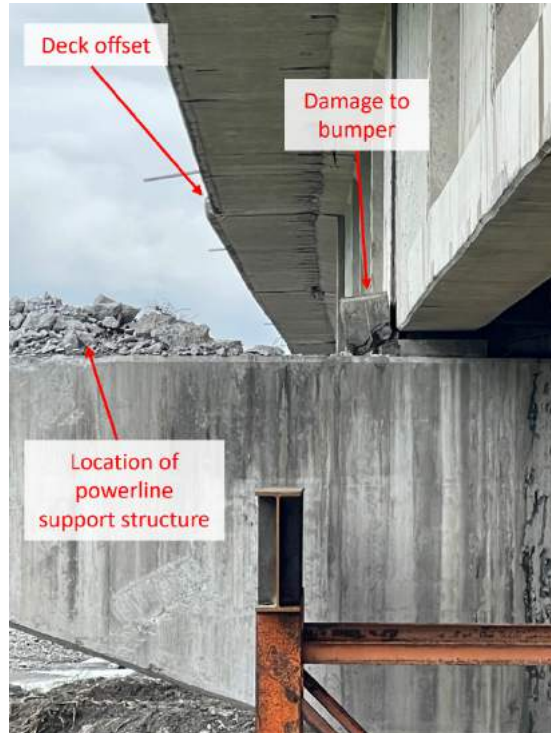
Figure 5.25. Typical damage to a concrete bumper shear key, offset of bridge deck, and location of concrete powerline support structure. (23.27481° 121.30502°)

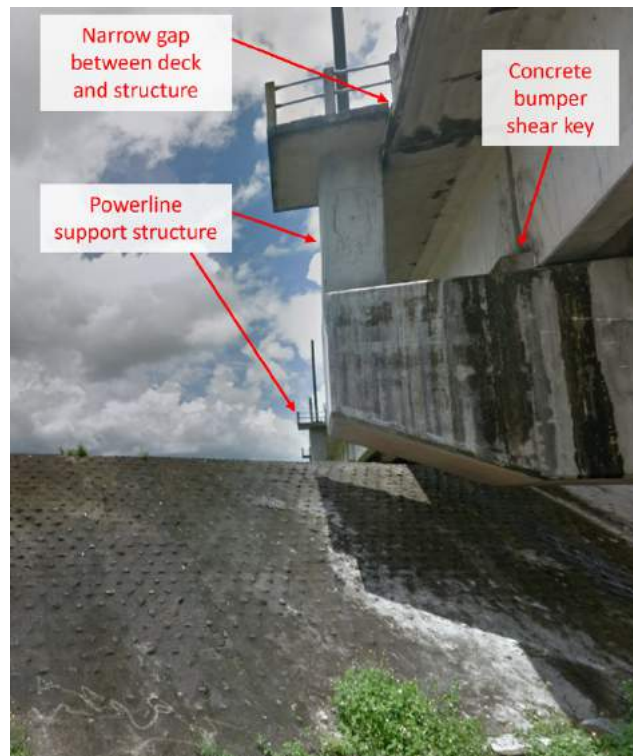
Figure 5.26. Google Street view from 2012 showing the intact powerline support structure and concrete bumper shear key (23.27468°, 121.30489°)

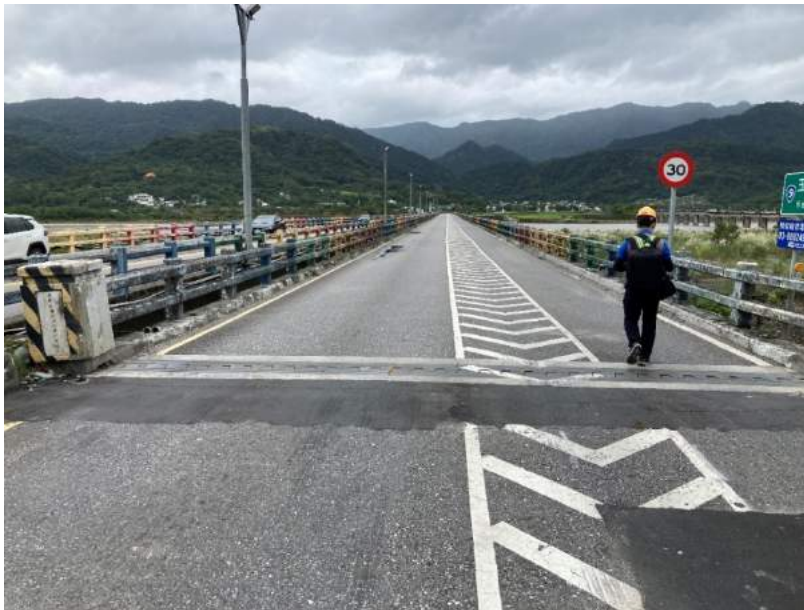
Figure 5.27. View from the west abutment of the south Yuli bridge. (23.32332° 121.32684°)

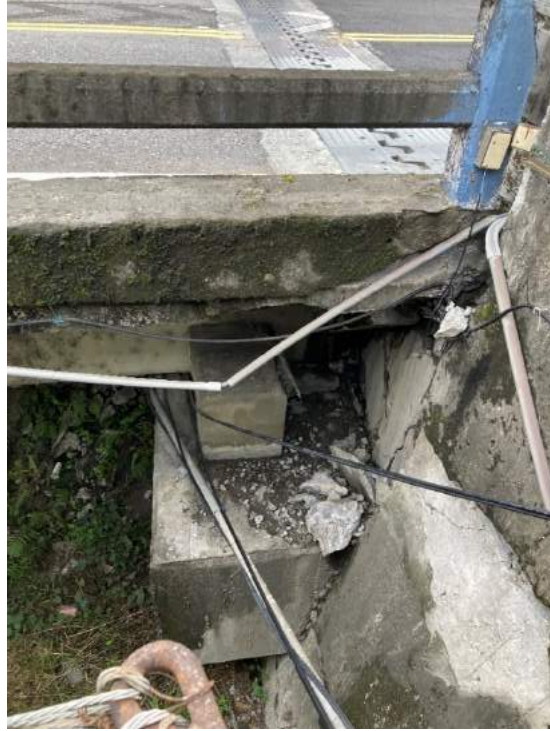
Figure 5.29. Damage to the North Yuli bridge east abutment and adjacent utility lines. (23.32233° 121.33240°)

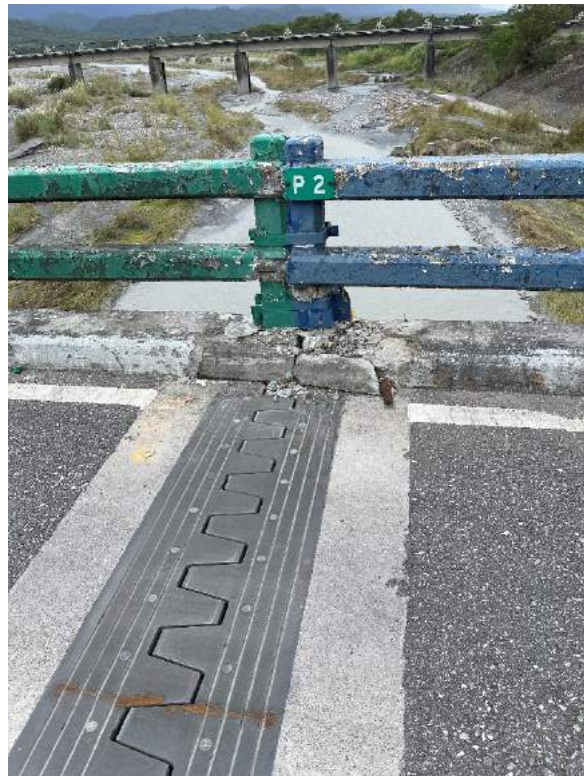
Figure 5.30. Typical damage in concrete railing at finger joints. (23.32317° 121.32758°)

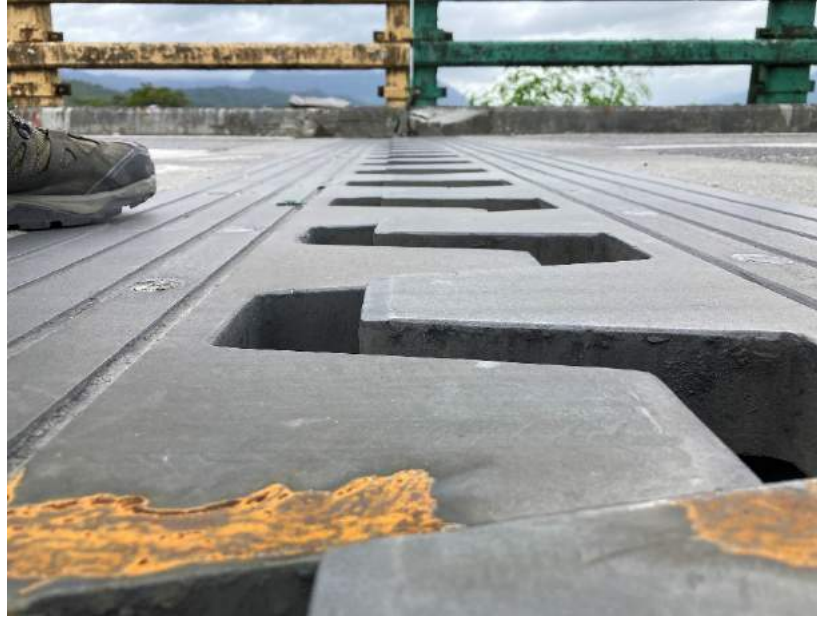
Figure 5.31. Typical differential movement at a Figure 5.joint. (23.32240°121.33194°)

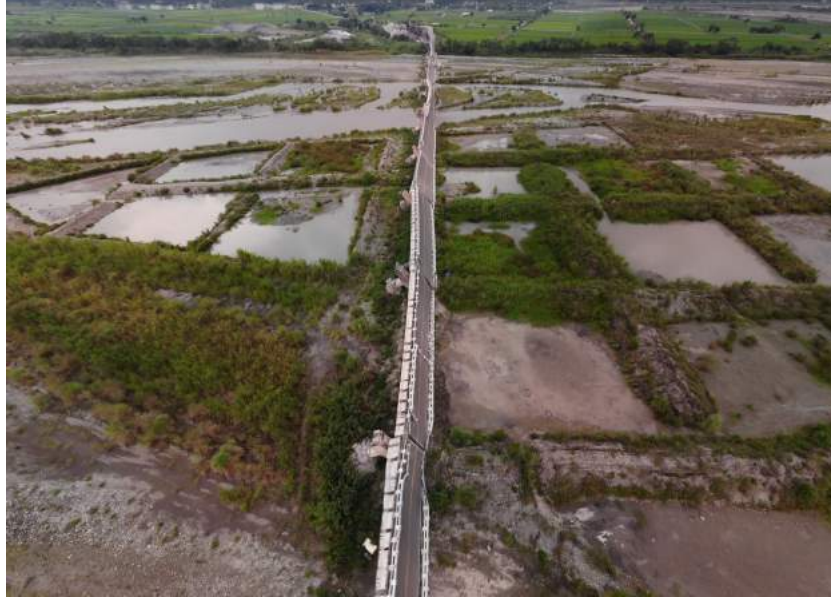
Figure 5.32. Failed spans of the Gaoliao bridge looking west (Image courteous of Zola Zhou, 23.38563° 121.34458°)

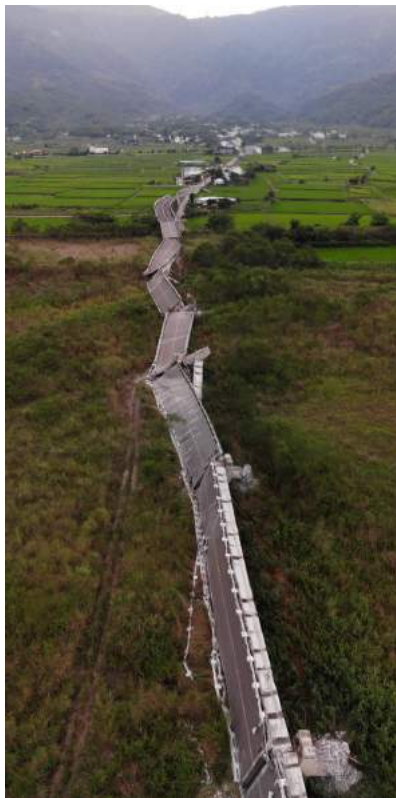
Figure 5.33. Failed spans of the Gaoliao bridge looking east (Image courteous of Zola Zhou, 23.38563° 121.34458°)

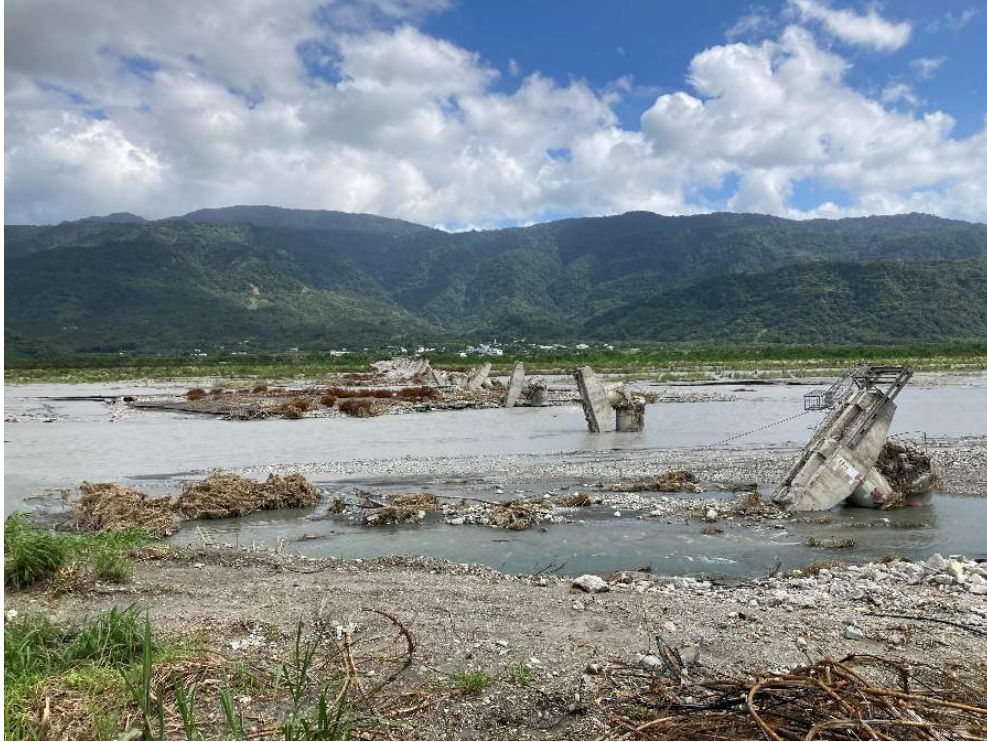
Figure 5.34. Looking towards the east abutment at the failed piers (23.38632° 121.33973°)

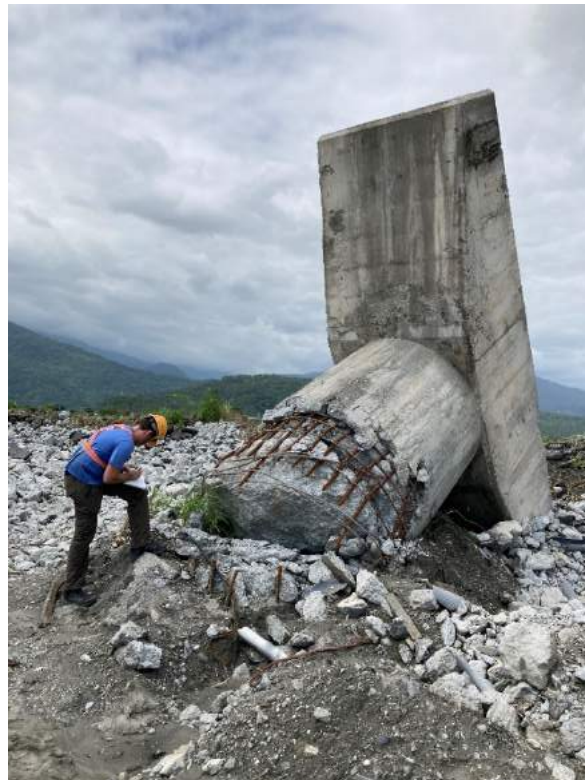
Figure 5.35. Typical view of the plastic hinges in the concrete piers (23.38630° 121.33930°)

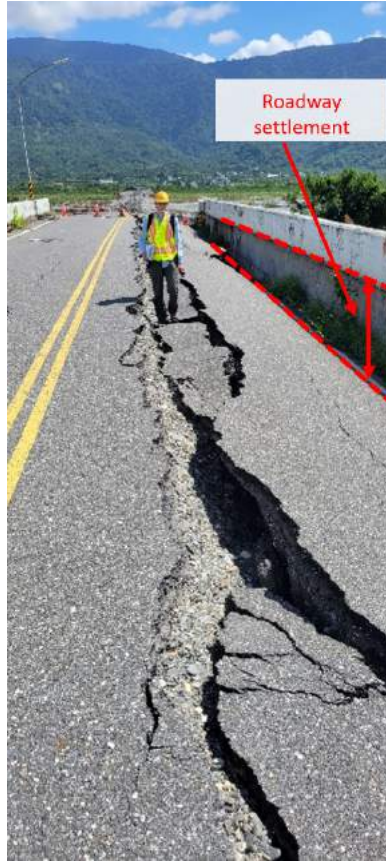
Figure 5.36. Roadway cracks and settlement in west abutment. Note (23.38625° 121.33806°)

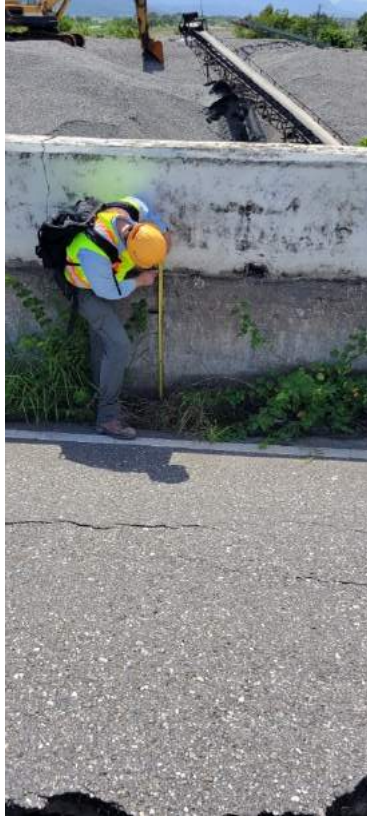
Figure 5.37. Roadway settlement at the south back-to-back concrete gravity wall in the west abutment (23.38629° 121.33811°)
