GEOTECHNICAL ENGINEERING RECONNAISSANCE OF THE 2022 CHIHSHANG EARTHQUAKE SEQUENCE

Version 1.0; April 2024

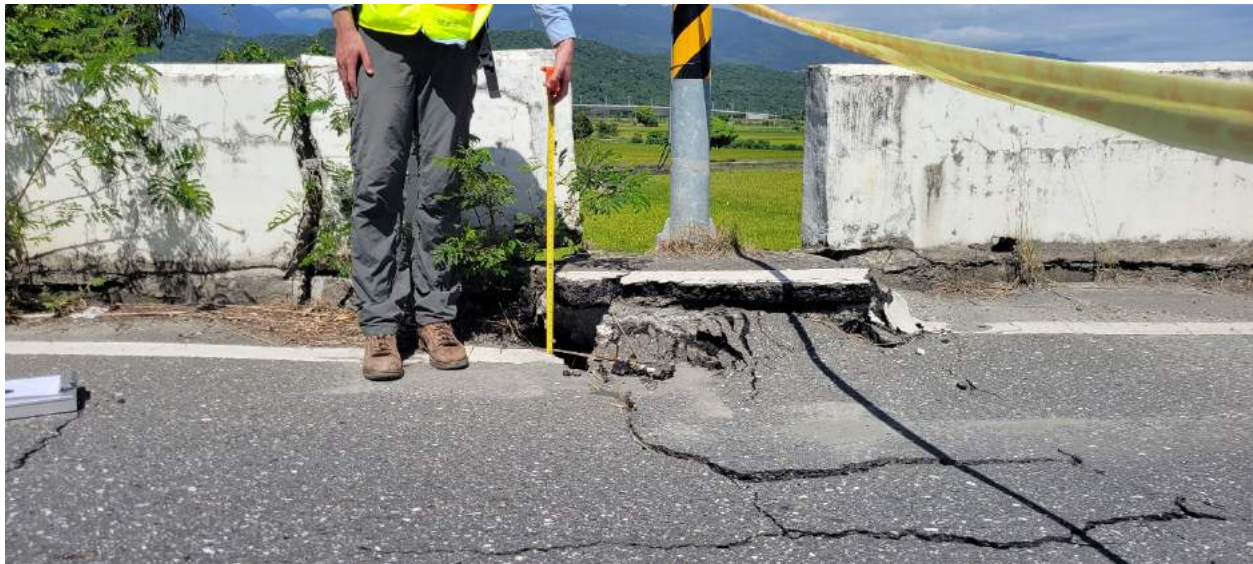
Figure 5.38. Settlement near the light post foundation in the east abutment (23.38617° 121.33741°)

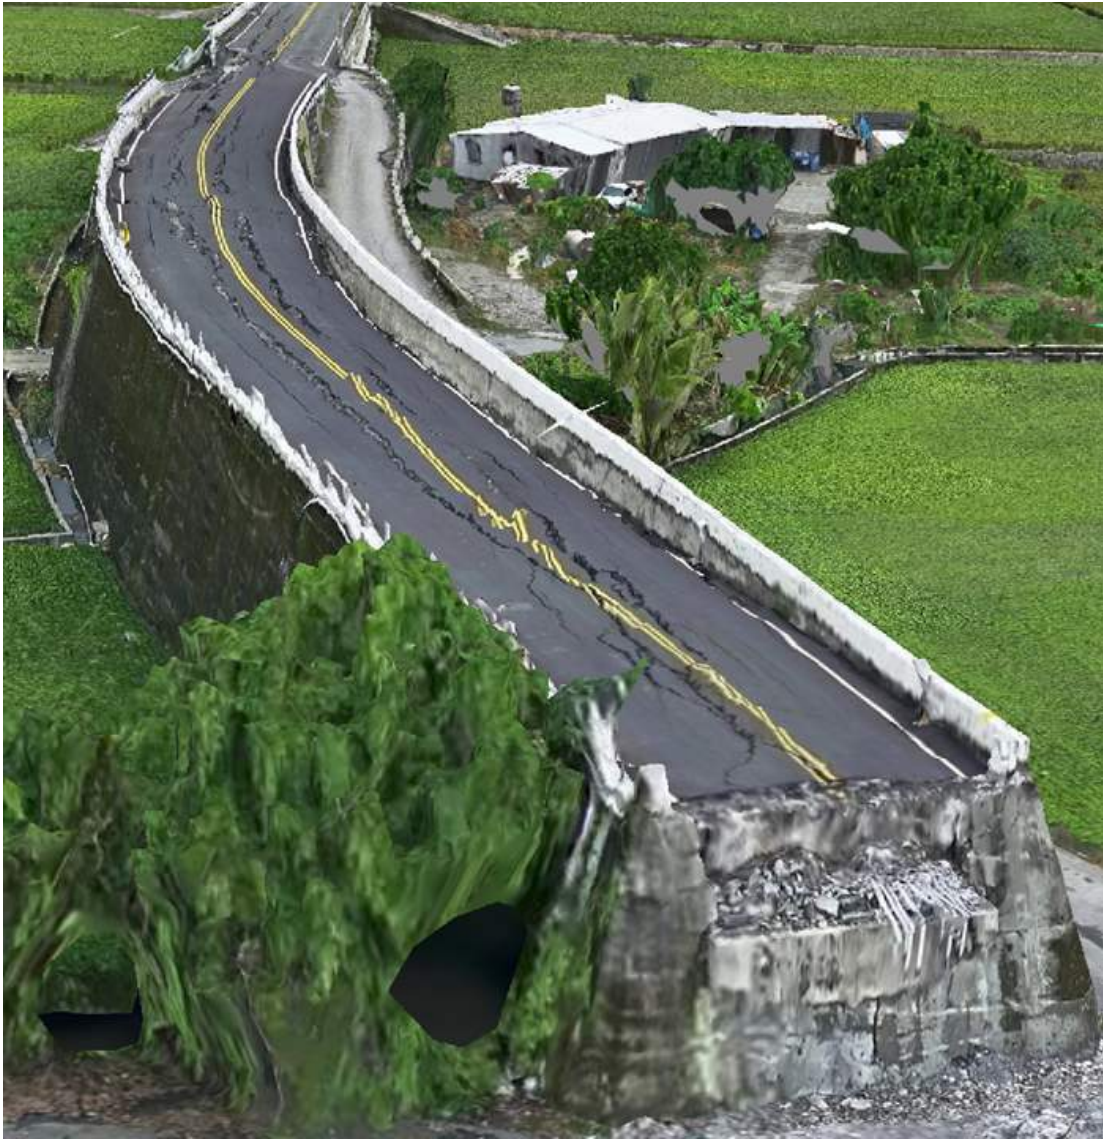
Figure 5.39. Drone view of the east abutment looking east (approx. 23.38522° 121.34690°)

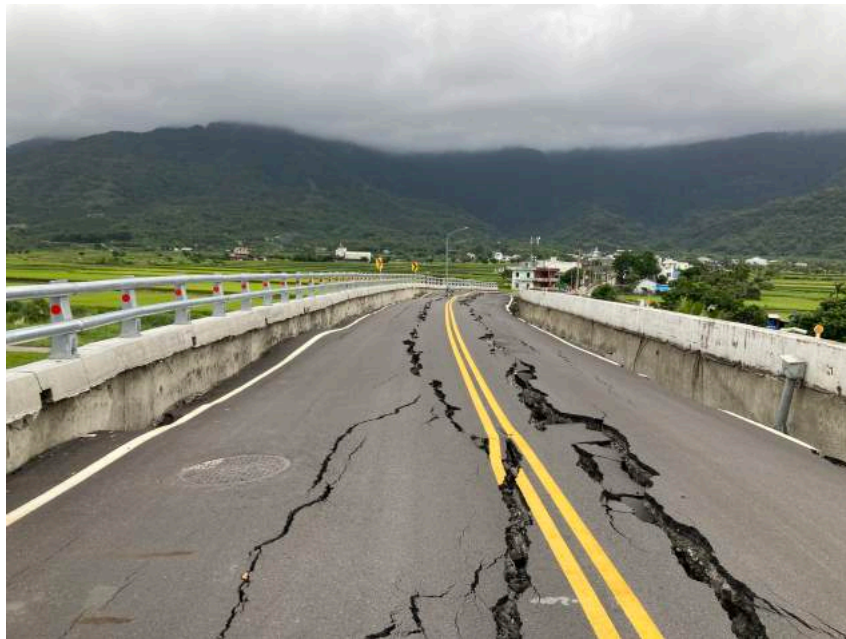
Figure 5.41. Roadway cracks and settlement in the east abutment looking east (23.38520° 121.34710°)

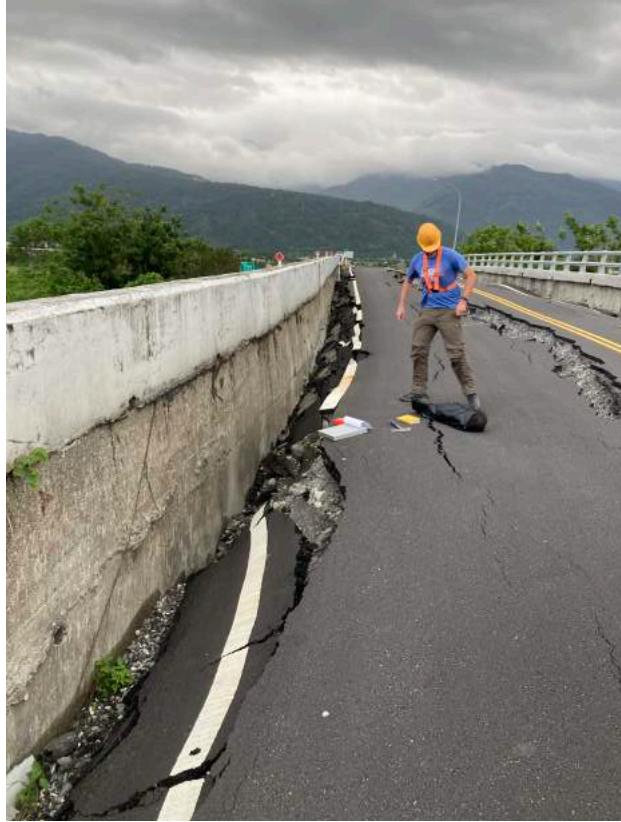
Figure 5.42. Roadway cracks and settlement in the east abutment looking west (23.38510°
 121.34767°)

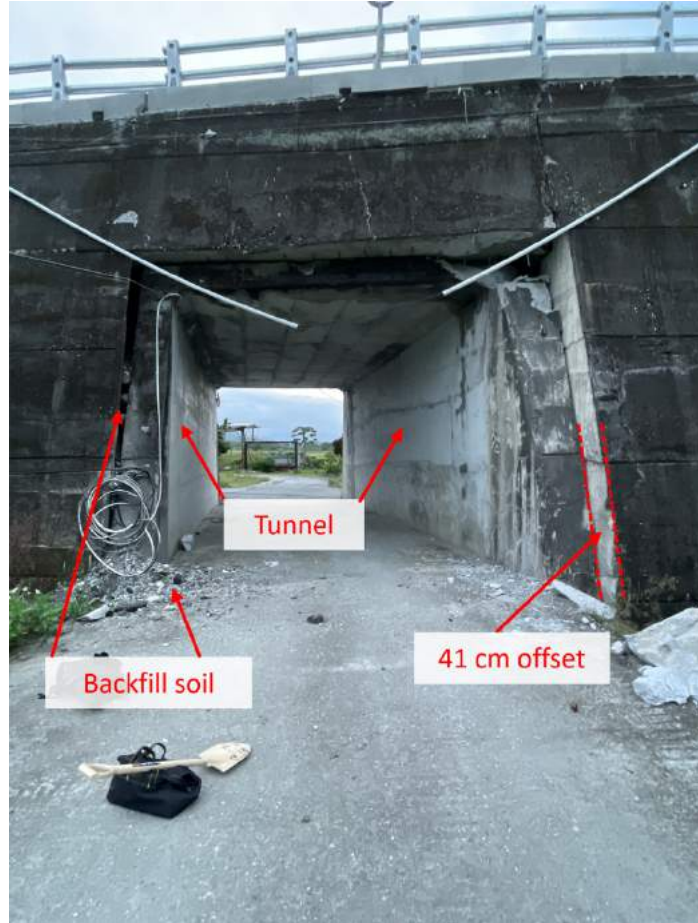
Figure 5.43. Tunnel beneath east bridge approach, 41 cm offset from gravity wall, and backfill soil that flowed from gap between the gravity wall and tunnel liner (23.38526° 121.34783°)
