# **Damage due to Liquefaction and Associated Lateral Flow during the 2024 Noto Peninsula Earthquake, Japan**

A report prepared by Kyushu University, Kawasaki Geological Engineering Co., Ltd, Tokyo City University, National Research Institute for Earth Science and Disaster Resilience, Shimizu Corporation, Geo Disaster Prevention Institute, Yoshimitsugumi Inc., Kyushu University, Toyama Prefectural University, Kanazawa University, Chuo University in cooperation with Geotechnical Extreme Event Reconnaissance Association

GEER Association Report 084

February 24, 2025

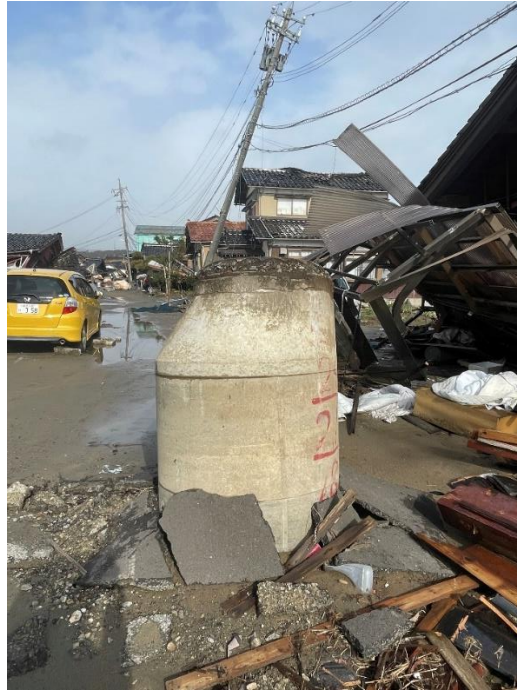
**Figure 5.2.** Liquefaction causes manholes lifting phenomenon (Suzu City, Ishikawa Prefecture). Lat: 37.40073°, Lon: 137.24304°

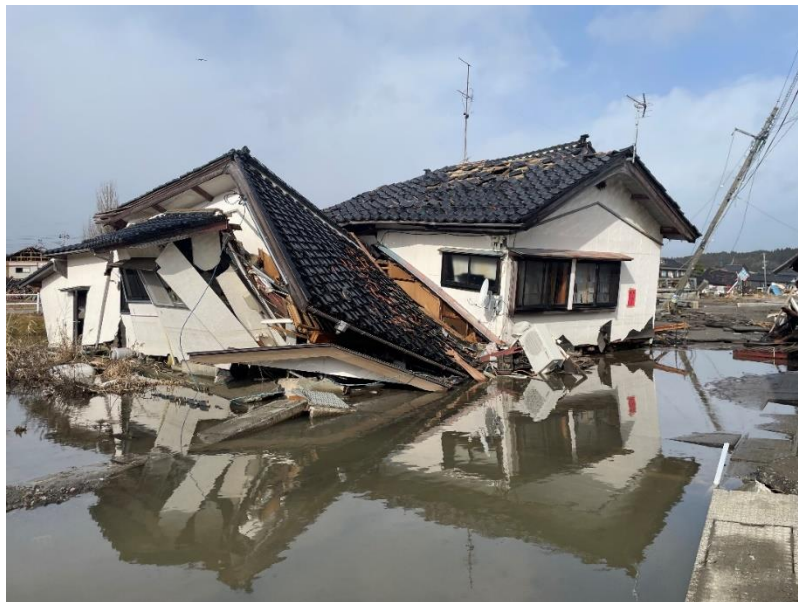
**Figure 5.3.** Detached house collapsed due to multiple factors (Suzu City, Ishikawa Prefecture). Lat: 37.40178°, Lon: 137.24284°

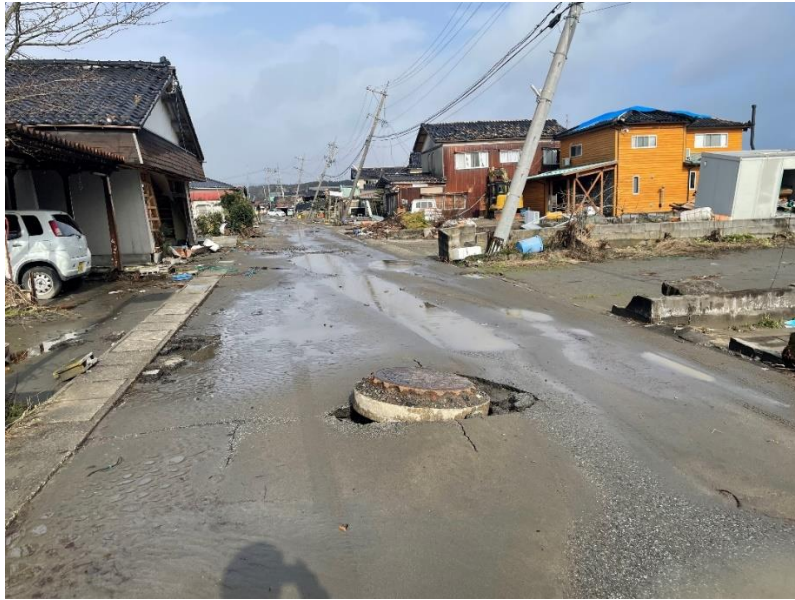
**Figure 5.4.** A utility pole leaning toward the sea (Suzu City, Ishikawa Prefecture). Lat: 37.39912°, Lon: 137.24358°

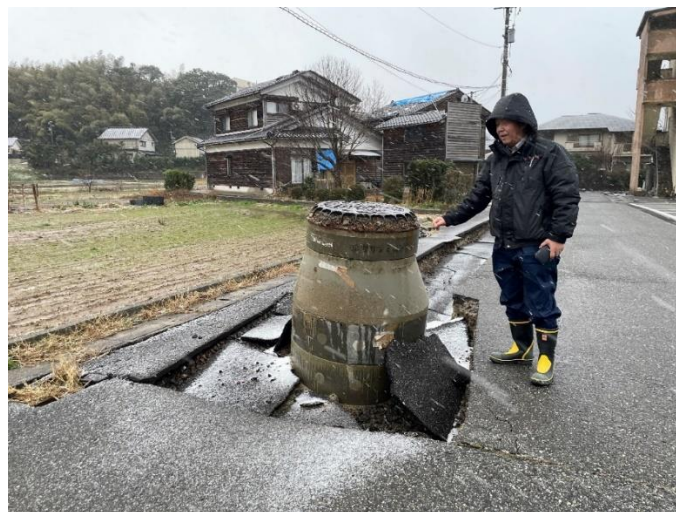
In contrast, in Wajima City, where the earthquake's magnitude was similar to that in Suzu City, liquefaction damage was not as severe. Similar to Pearl City, the shafts were raised by liquefaction, but the height of the shafts above the ground was approximately half the height of a human body, as shown in Figure 5.5. In Wajima City, damage also occurred due to the uplift of the seabed in the harbor and along the coastline, along with a fire at the morning market.

**Figure 5.5.** Liquefaction causes manholes lifting phenomenon (Wajima City, Ishikawa Prefecture). Lat: 37.39358°, Lon: 136.91582°

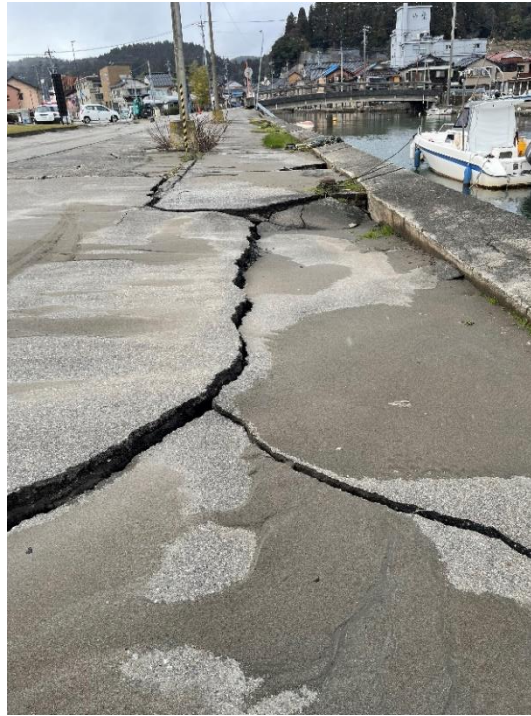
**Figure 5.6.** Liquefaction at the Port of Uitsu (Noto Town, Ishikawa Prefecture). Lat: 37.30639°, Lon: 137.15124°

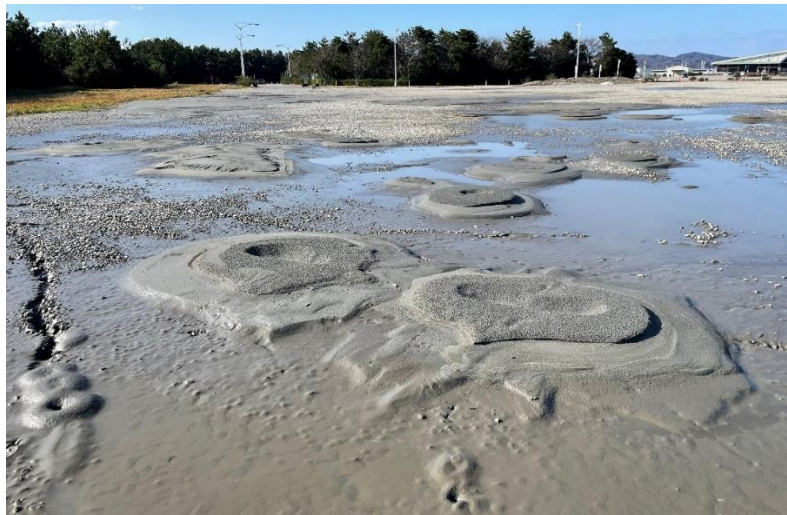
In Imizu City, extensive liquefaction was observed in the Shinminato area. Sand eruptions, ranging from 80 cm to 2 meters in diameter, were seen at multiple locations, as shown in Figure 5.8. Fountain marks, indicative of liquefaction, were also observed alongside the sand eruptions, as seen in Figure 5.9. At Shinminato Fishing Harbor, subsidence caused by liquefaction and other factors disrupted the functioning of the harbor, as shown in Figure 5.10. A similar situation occurred at Fushiki Port in Takaoka City, where substantial sand fountains emerged, and numerous instabilities due to liquefaction were observed, impairing logistics and daily activities, as depicted in Figure 5.11. In Takaoka City, liquefaction damage was widespread in both inland and coastal areas (Figure 5.12), with most damage believed to have occurred in the vicinity of the old river channel.

**Figure 5.8.** Sand eruption site in Shinminato, Toyama Prefecture, Japan (Imizu City, Toyama Prefecture). Lat: 36.78020°, Lon: 137.10301°

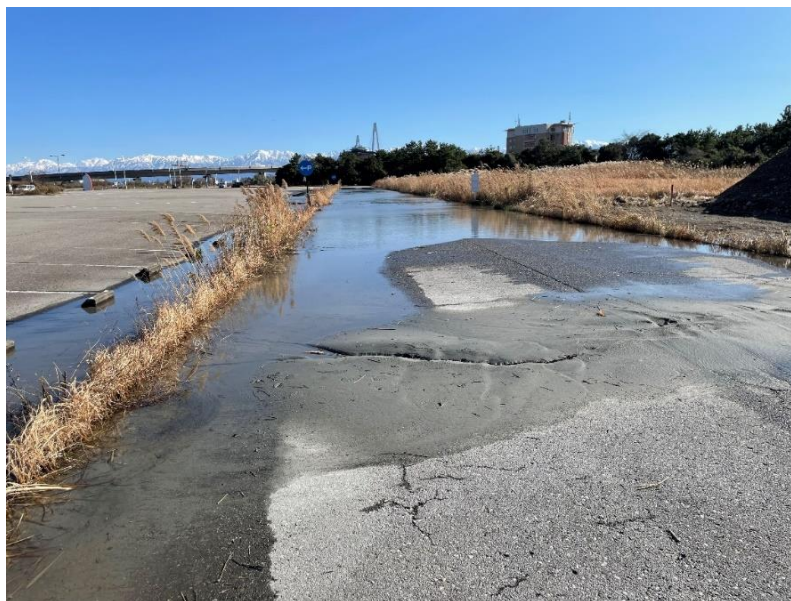
**Figure 5.9.** After fountain caused by liquefaction (Imizu City, Toyama Prefecture). Lat: 36.78097°, Lon: 137.09959°

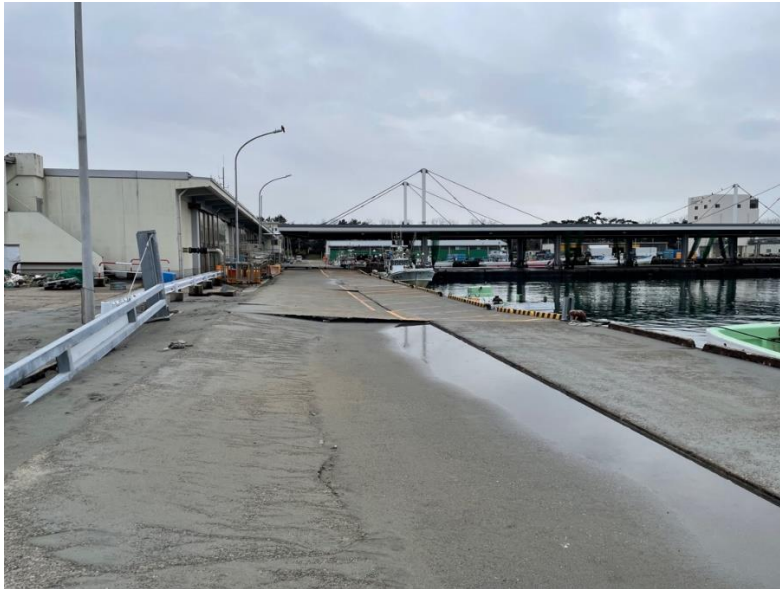
**Figure 5.10.** Damage to Shinminato Fishing Port due to liquefaction (Imizu City, Toyama Prefecture). Lat: 36.78250°, Lon: 137.09720°

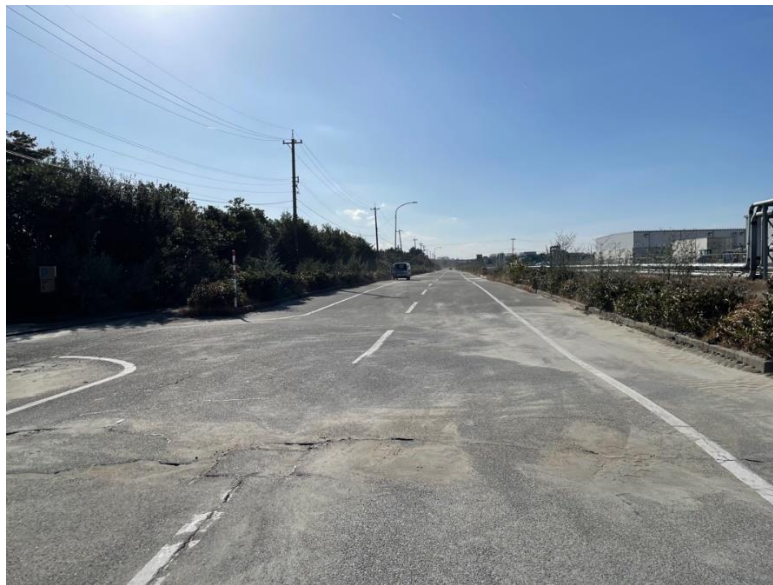
**Figure 5.11.** Liquefaction damage on a road in Toyama Fushiki Port (Takaoka City, Toyama Prefecture). Lat: 36.80089°, Lon: 137.06691°

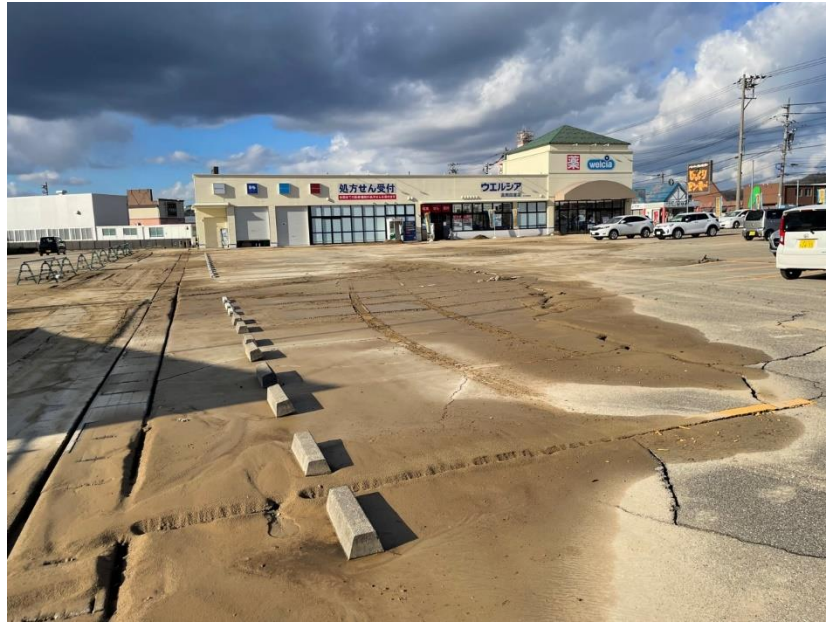
**Figure 5.12.** Liquefaction damage in old river channel (Takaoka City, Toyama Prefecture).  
Lat: 36.75944°, Lon: 137.00375°

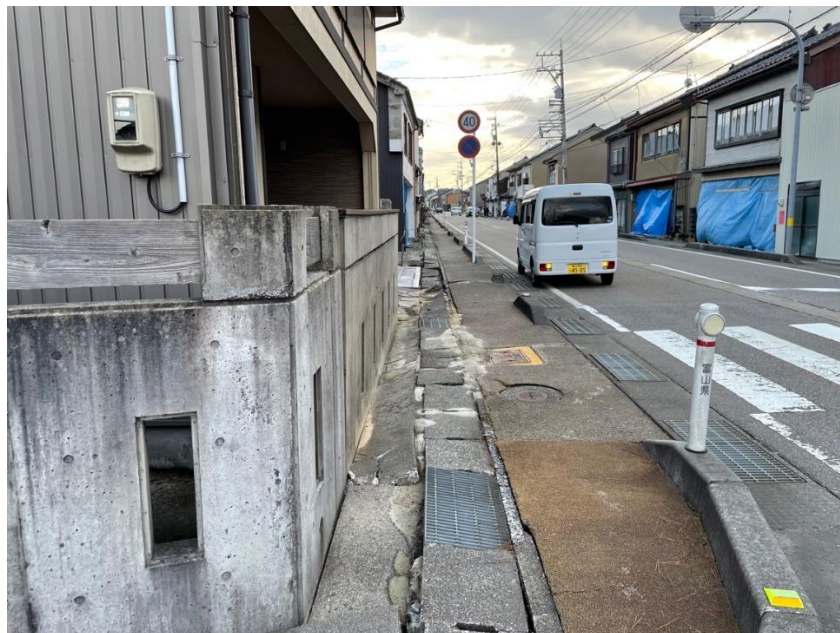
**Figure 5.13.** Damage to gutters due to liquefaction (Himi City, Toyama Prefecture). Lat:  
36.87181°, Lon: 136.98319°

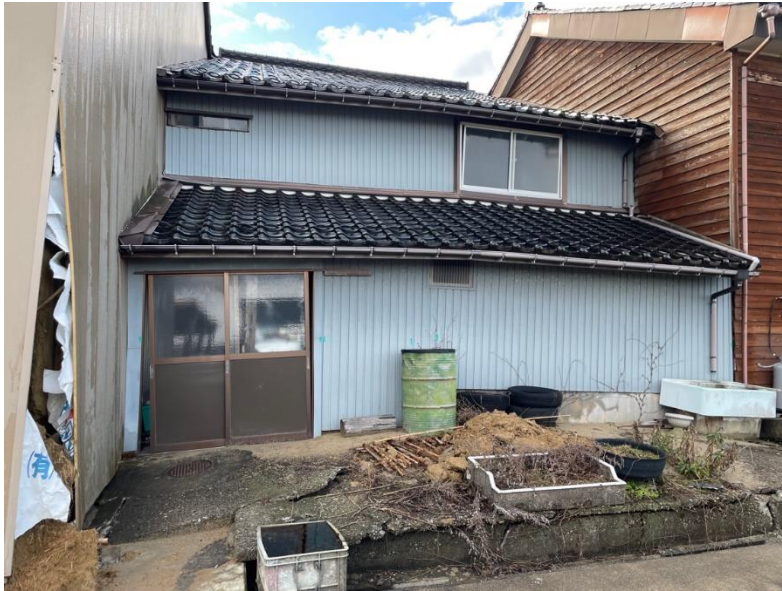
**Figure 5.14.** A house that deflects from side to side due to immobile subsidence caused by liquefaction (Himi City, Toyama Prefecture). Lat: 36.86425°, Lon: 136.98546°

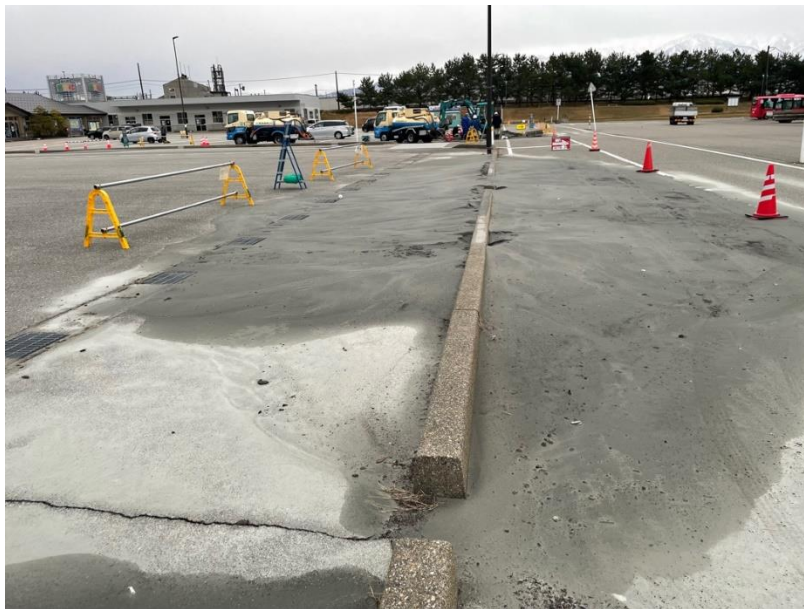
**Figure 5.15.** Sediment eruption at Uozu Fishing Port (Uozu City, Toyama Prefecture). Lat: 36.82440°, Lon: 137.39305°

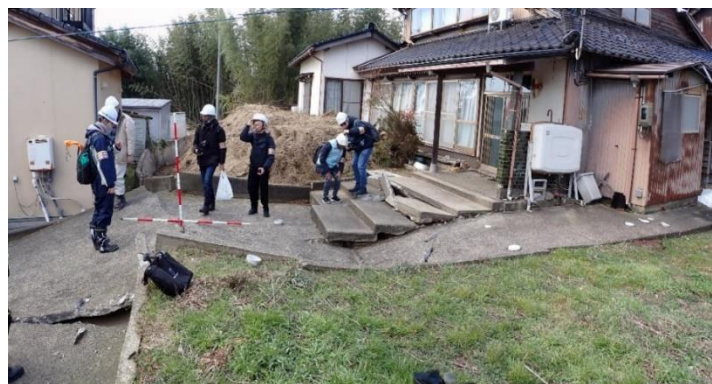
**Figure 5.17.** Damage in the Ohsaki area of Kahoku City (Uplift of road and lateral movement of houses). Lat: 36°42'23.62", Lon: 136°41'27.08"

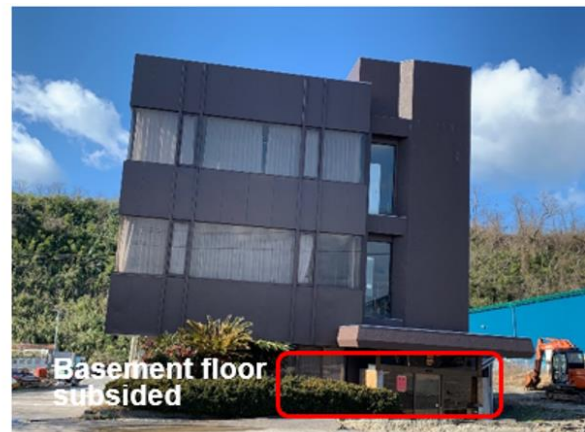
**Figure 5.19.** (a) Pile supported undamaged house in Muro. Lat:  $36^{\circ}41'31.58''$ , Lon:  $136^{\circ}40'50.06''$  (b) Differential settlement for a building with shallow foundation in Miyasaka. Lat:  $36.67329^{\circ}$ , Lon:  $136.66323^{\circ}$

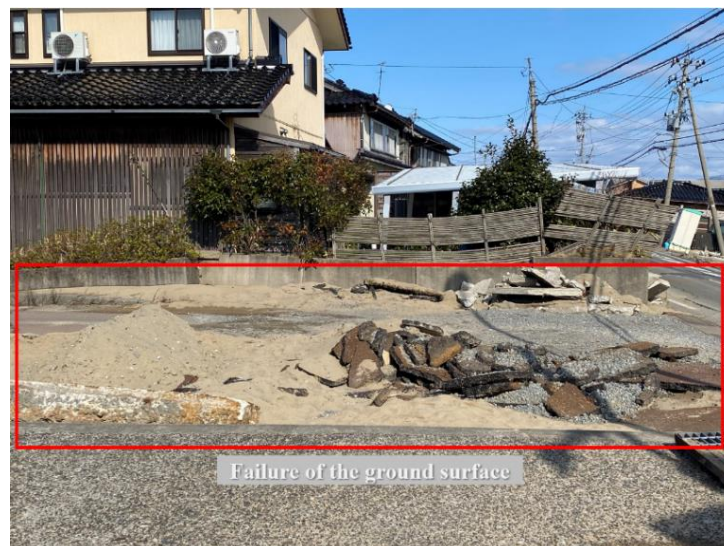
The preliminary reconnaissance survey conducted by the authors on February 3 and 4, 2024 (approximately one month after the disaster) revealed significant deformations in several geotechnical and structural systems in the Nishi Araya area, located south of Muro. The primary cause of these large deformations was liquefaction-induced lateral spreading, which resulted in widespread ground failure throughout the area, accompanied by the ejection of sand. Figure 5.22 illustrates a typical example of ground surface settlement caused by lateral spreading.

**Figure 5.22.** Settlement of the ground surface adjacent to the Prefectural Road 8. Lat:  $36^{\circ}40'41.70''$ , Lon:  $136^{\circ}40'4.36''$

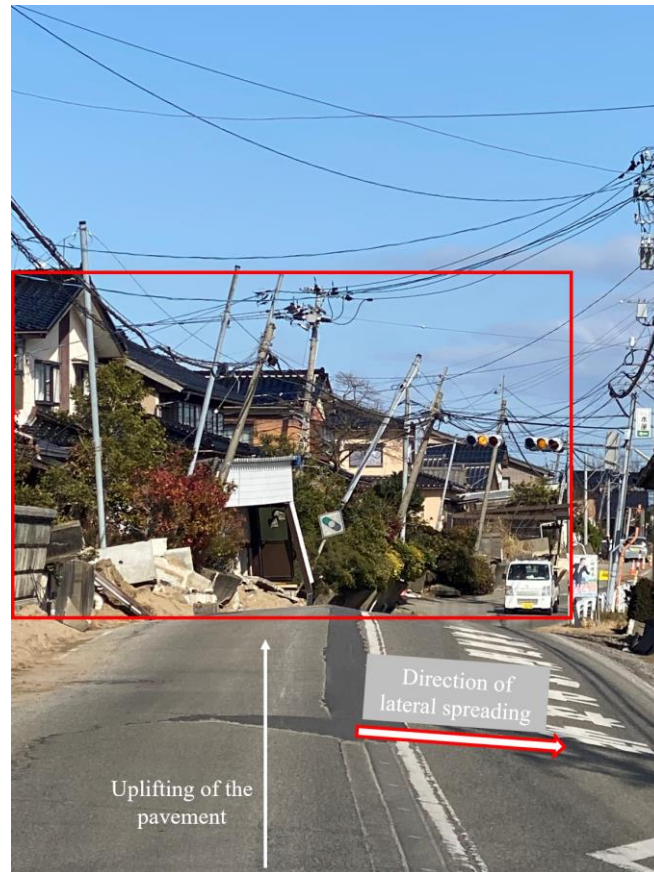
Our initial investigation revealed that the effects of liquefaction-induced lateral spreading were most pronounced on the lower side of the Uchinada sand dunes, toward Prefectural Road 8. Figure 5.23 provides a view of the damaged Prefectural Road 8, highlighting severely tilted utility poles and buildings.

**Figure 5.23.** Significant uplift of the left side of Prefectural Road 8 with tilted poles clearly visible. Lat: 36°40'41.64", Lon: 136°40'4.80"

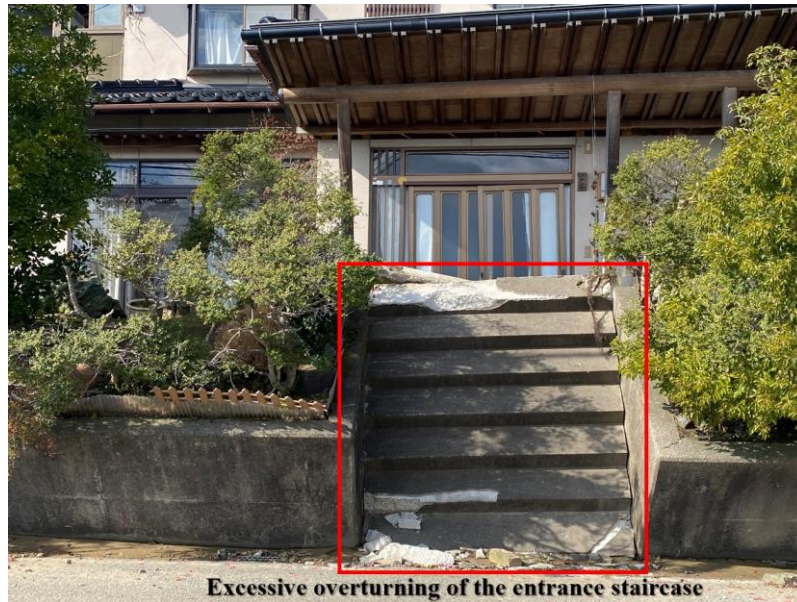
**Figure 5.25.** Significant tilting of the entrance staircase towards Prefectural Road 8. Lat: 36°40'43.99", Lon: 136°40'6.88"

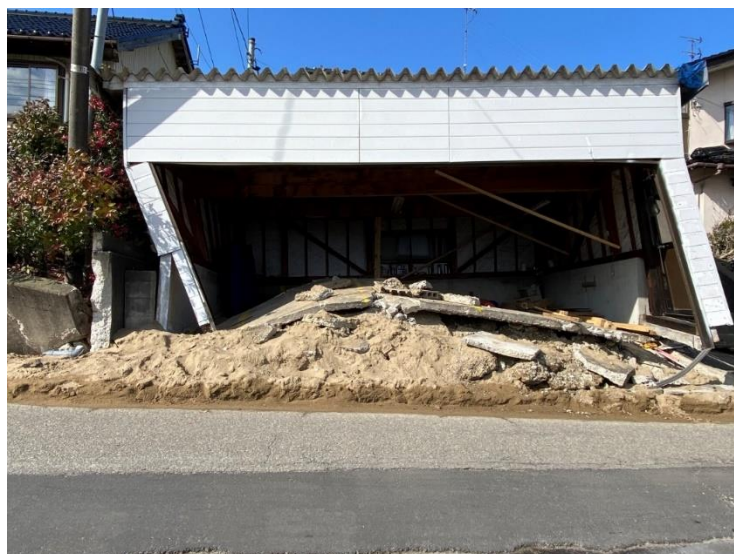
The uplift of the road pavement due to liquefaction-induced lateral spreading is clearly visible. The lateral spreading occurred in the direction of the reclaimed land, exerting a substantial lateral thrust on the utility poles, buildings, and other infrastructure in the vicinity, causing them to tilt significantly toward the reclaimed land. Figures 5.24 and 5.25 provide close-up views of two buildings that sustained severe damage, with the compound walls and staircases tilted toward Prefectural Road 8 as a result of the considerable lateral thrust applied. Figure 5.26 illustrates the collapse of a parking shed caused by lateral spreading, accompanied by notable sand ejecta.

**Figure 5.26.** Collapse of the parking shed. Lat: 36°40'43.62", Lon: 136°40'6.50"

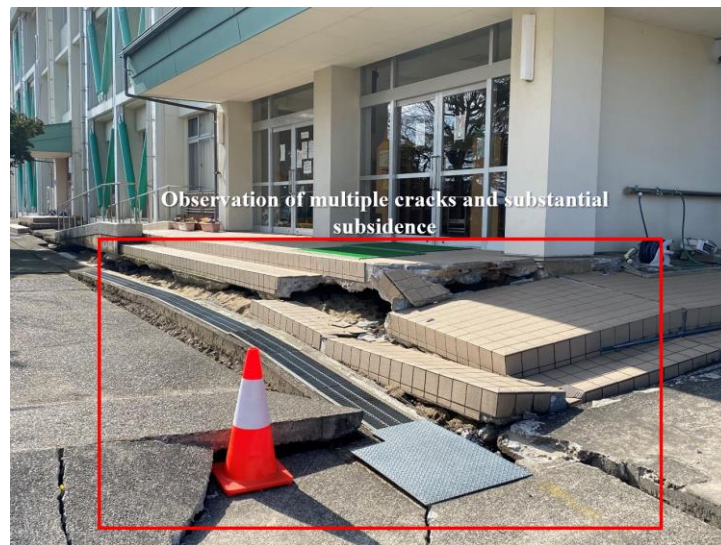
Figure 5.27 depicts the subsidence and multiple cracks observed at the entrance of Nishi Araya Elementary School. Additionally, the school's playground sustained significant damage, with a visible crack line leading to shear rupture of the ground, as shown in Figure 5.28.

**Figure 5.27.** Damage to the entrance of Nishi Araya elementary school. Lat: 36°40'42.25", Lon: 136°40'3.53"

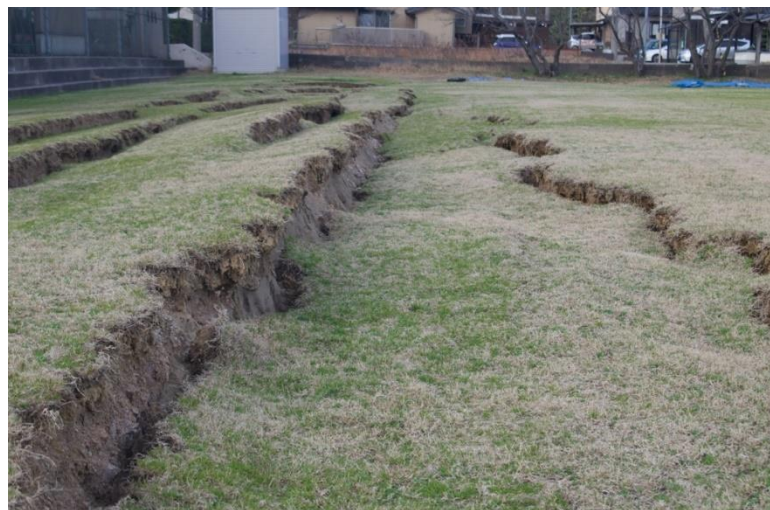
**Figure 5.28.** Observation of tension cracks at the playground of Nishi Araya elementary school. Lat: 36°40'44.83", Lon: 136°40'2.33"

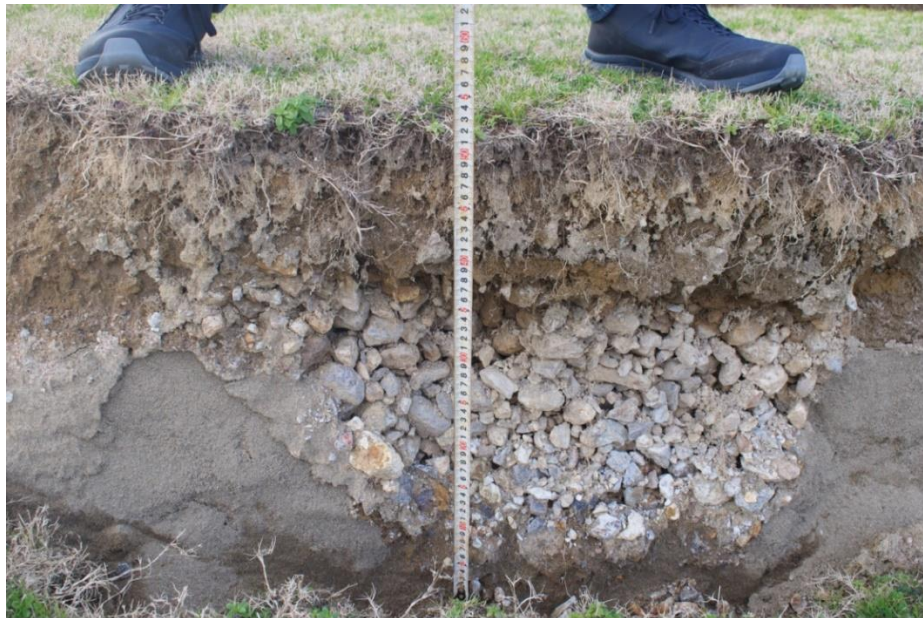
**Figure 5.29.** Formation of a vertical gap of 50 cm between the two ruptured parts of the ground. Lat: 36°40'44.64", Lon: 136°40'2.11"

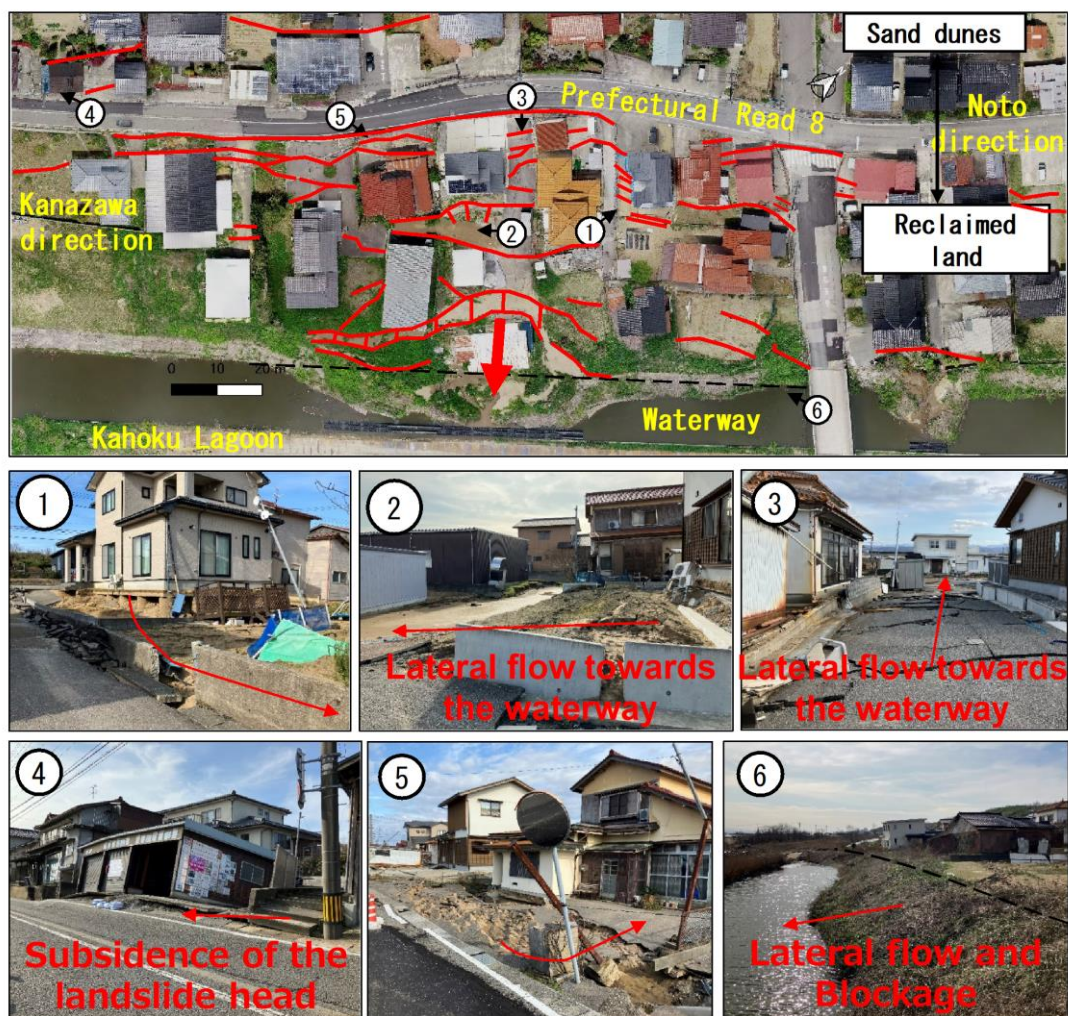
Figure 5.30 illustrates some of the lateral flow induced damage in the Muro district. On the gentle slope on the Kahoku lagoon side of Prefectural Road 8, lateral flow was observed, which resulted in the blockage of the waterway. In the vicinity of Prefectural Road 8, a subsidence zone developed, characterized by stepped subsidence and open cracks.

**Figure 5.30.** Lateral Flow induced damage in Muro district.

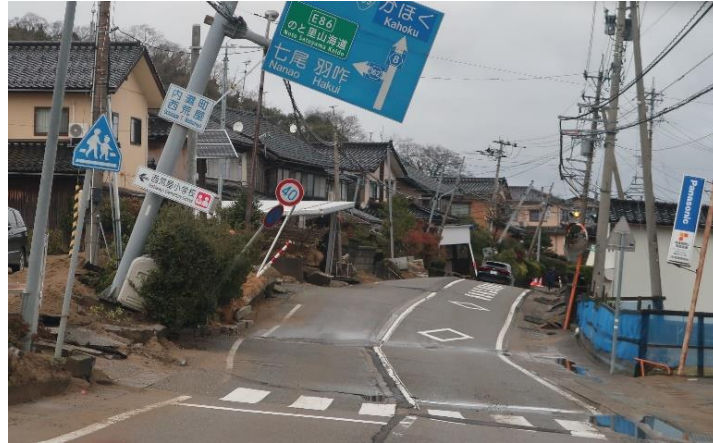
**Figure 10.6.** Compression and upliftment of prefectural road no. 8 (Near Nishi Araya area)
