2023 Turkey Earthquake Virtual Report on Geotechnical Impacts

Report Date: 2/09/2023

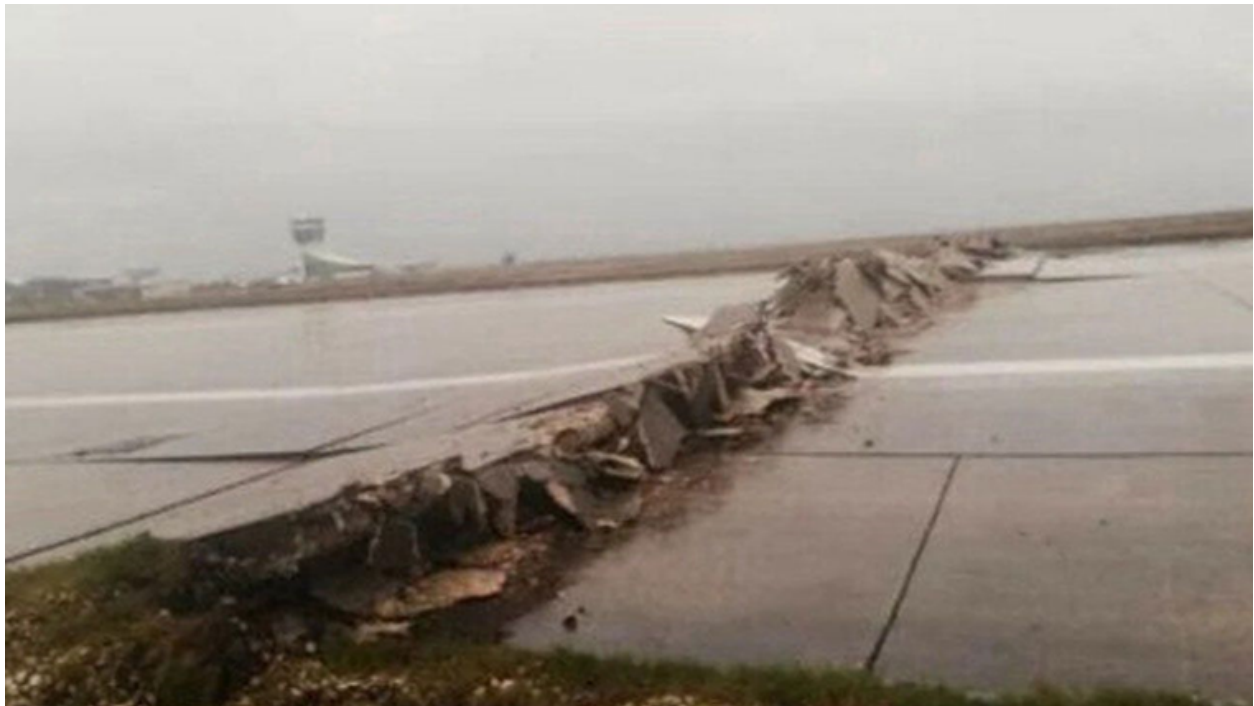
Figure 2: Damage to Hatay Airport runway

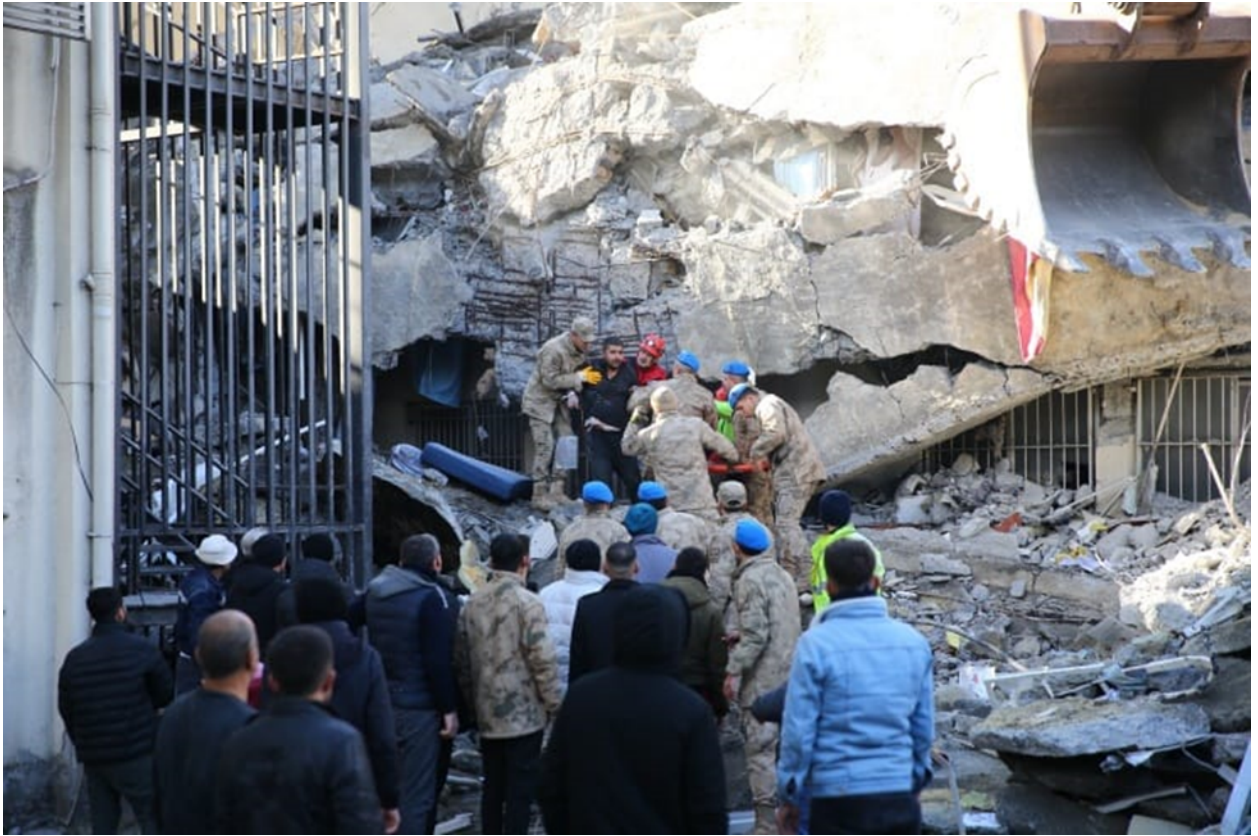
Figure 3: Collapsed state hospital in Iskenderun, Hatay
(<https://www.diken.com.tr/hastane-nasil-yikilir/>)

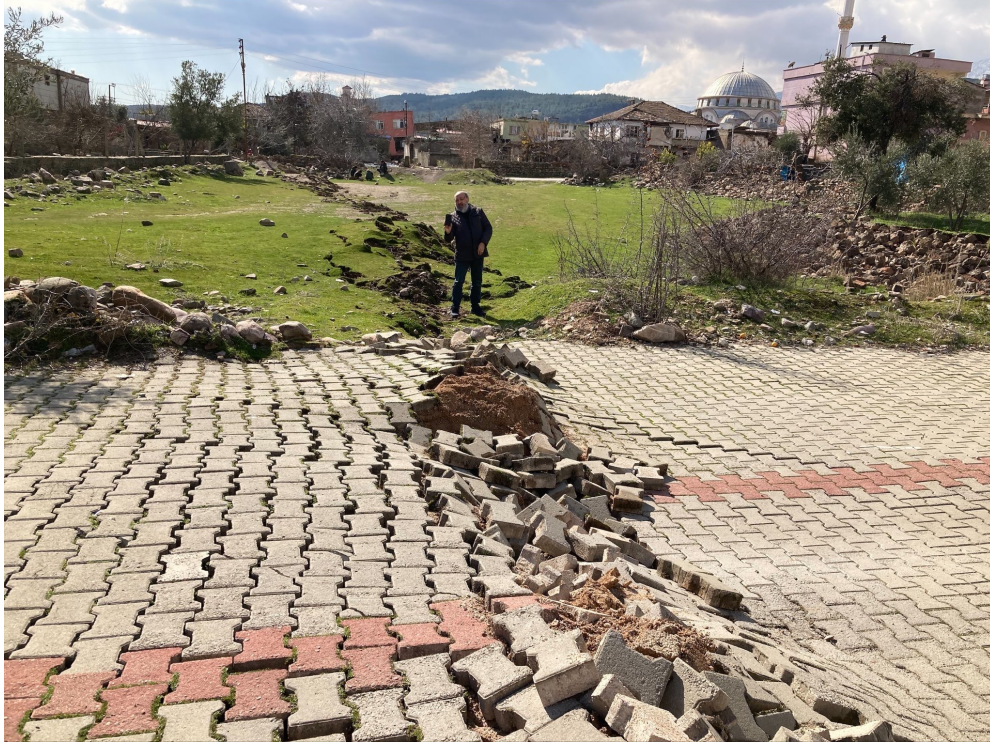
Figure 17: Surface rupture observed in residential neighborhood near Hessa (Source: <https://twitter.com/ziyadin/status/1623288689894871046/photo/1>)

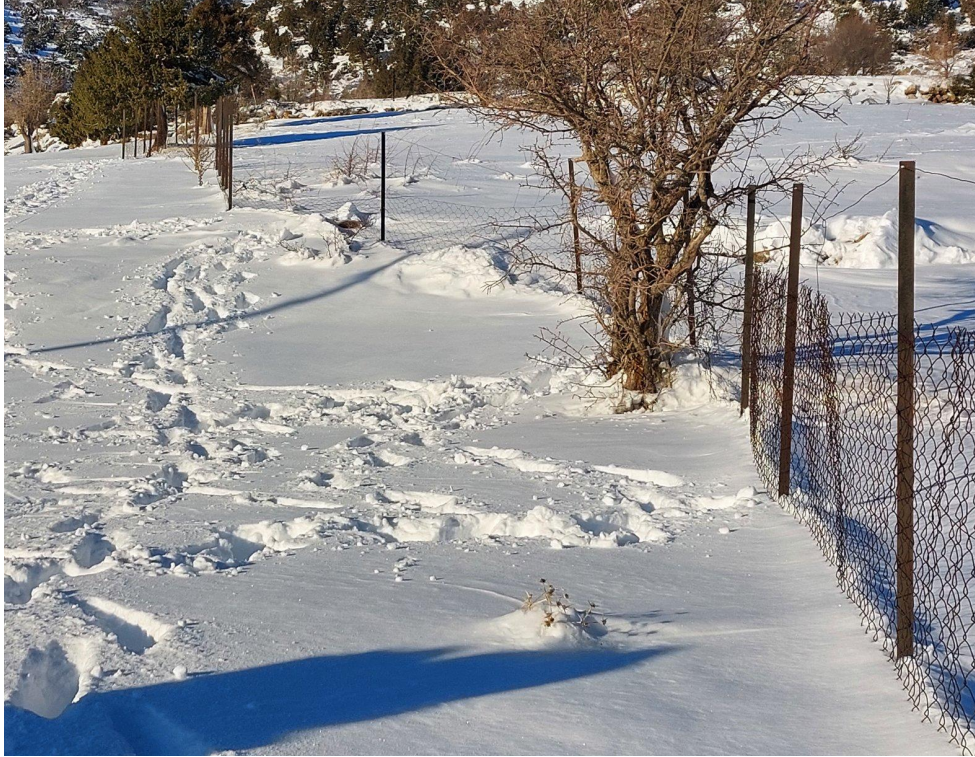
Figure 19: Ground displacement in Kahramanmaraş measured by fence offset of 6.7m
(Source: Twitter Taylan SANÇAR;
<https://twitter.com/tsancar/status/1623698495730339840/photo/1>)

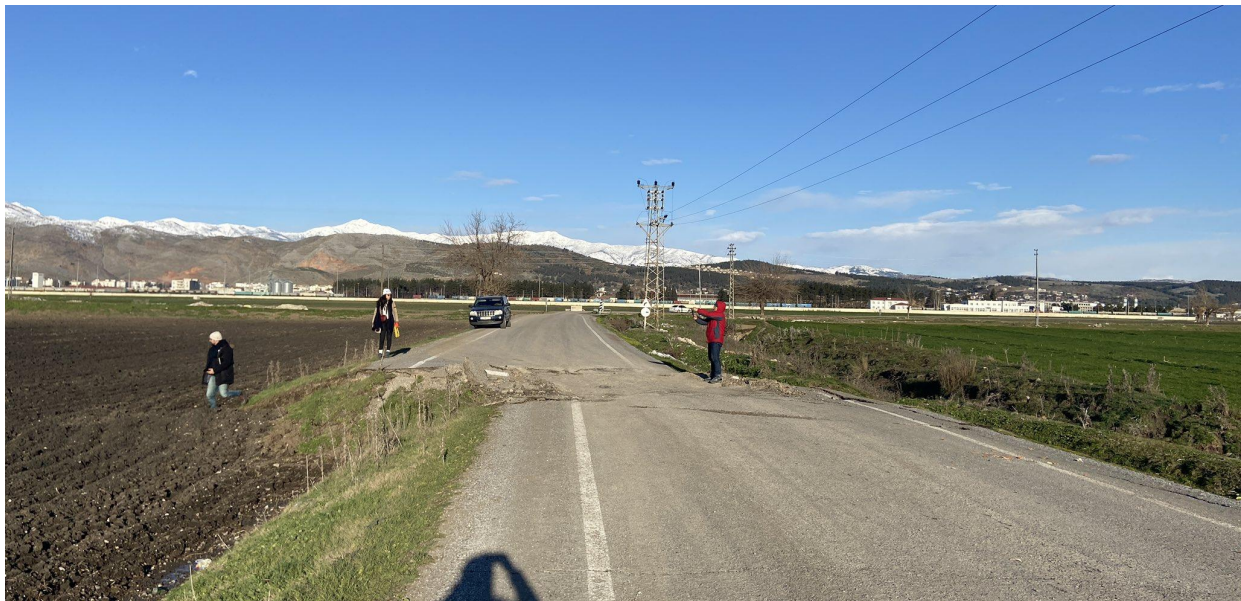
Figure 20: Road damage in Kahramanmaraş/Türkoğlu. 3.3m of displacement (Source: Twitter Cengiz Zabcı). <https://twitter.com/CengizZabcı/status/1623236487687929857/photo/1>

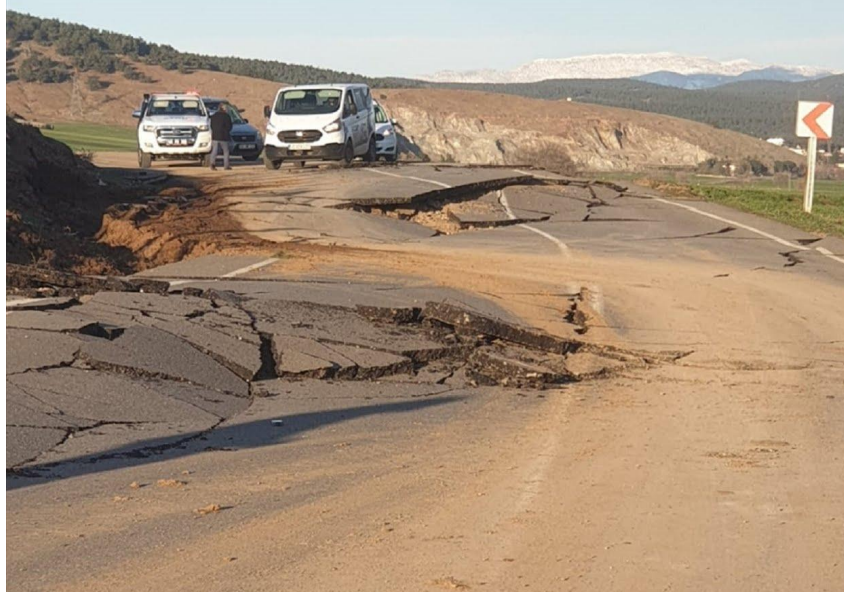
Figure 21: Road damage in Tevekkelli, Tevekkelli Village Road, 46090. (Source: Twitter Zeliş; https://twitter.com/Panthalassa_Z/status/1623237597752352769)

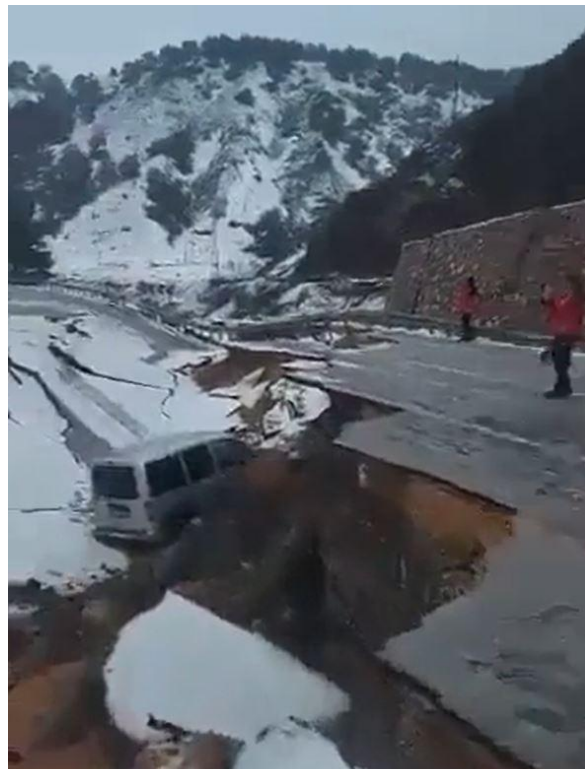
Figure 22: Lateral flow landslide on the road between Adana and Gaziantep (Source: Twitter video Sokagin Sesi Gazetesi; <https://twitter.com/sokaginsesigaz1/status/1622689001332215853>)

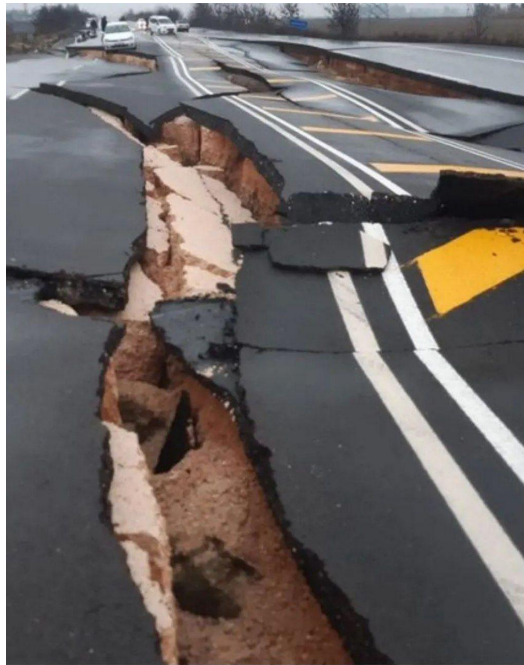
Figure 23: Road in Hatay, Turkey completely split open. (Source Video: Video <https://twitter.com/porcumali/status/1622594257176469506>)

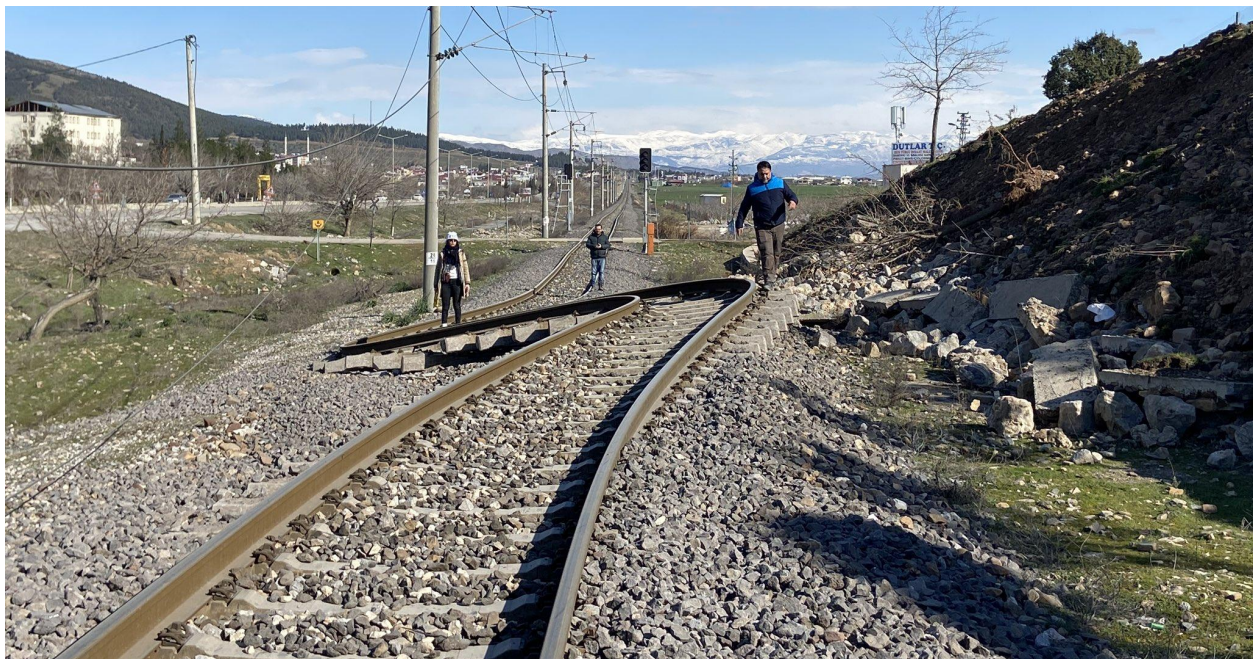
Figure 24: Surface displacement in Şekeroba highlighted by rail displacement (Source: Twitter Cengiz Zabci <https://twitter.com/CengizZabci/status/1623236454926229504/photo/1>)

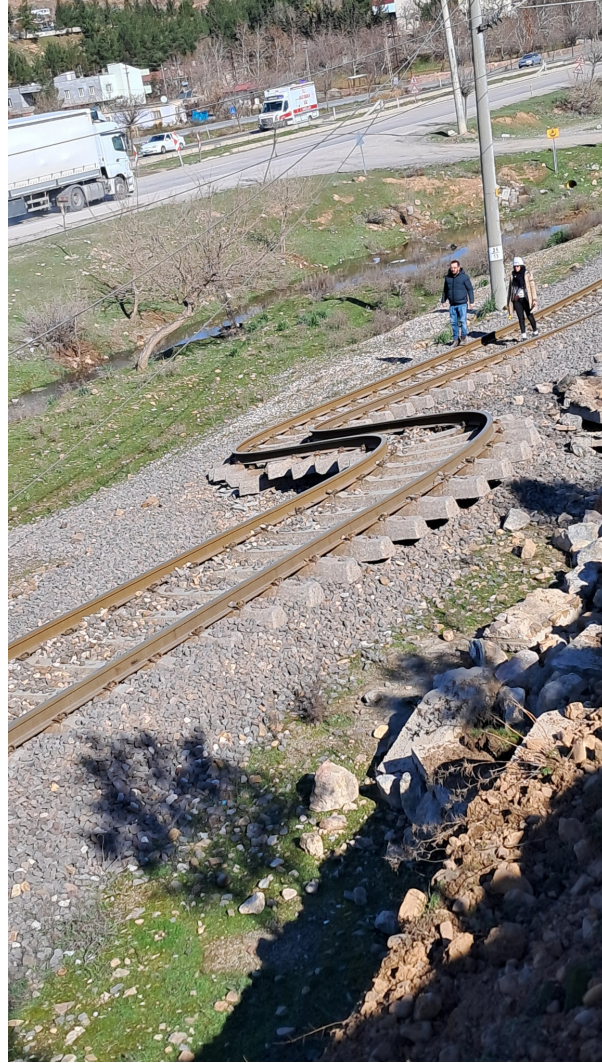
Figure 25: Surface displacement in Şekeroba highlighted by rail displacement (Source: @akyuz24 on Twitter)

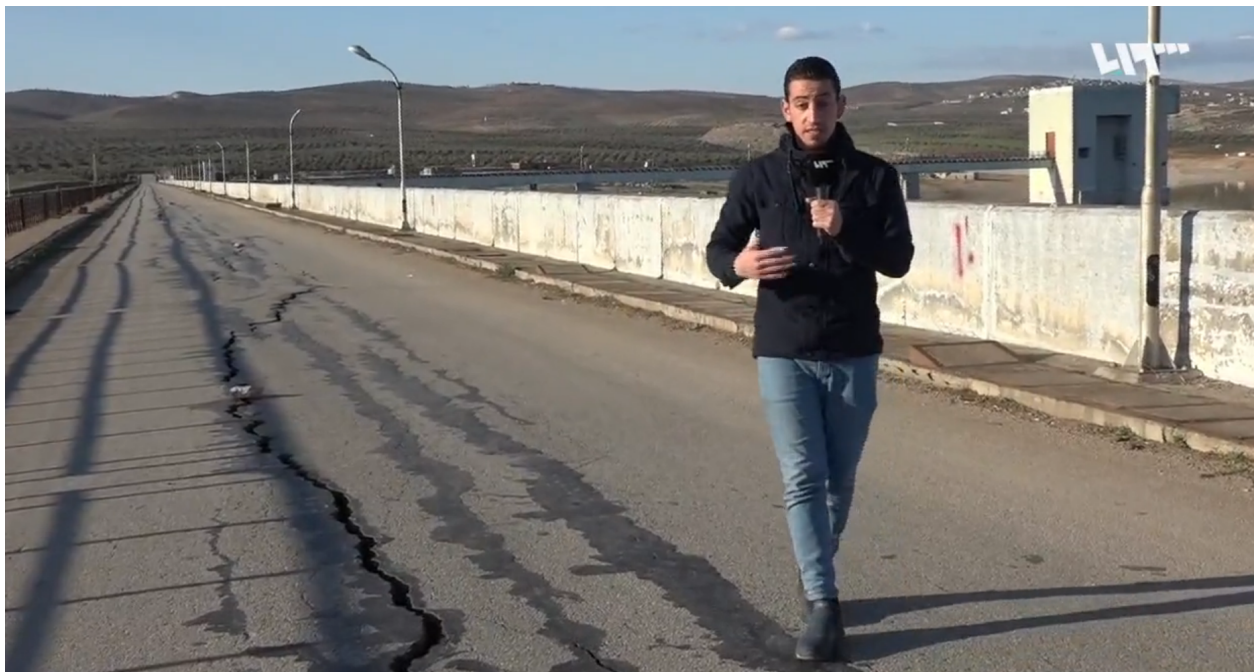
The Afrin Dam, also called the Maydanki Dam, is an earth-filled hydroelectric dam. Located on the Afrin River in northwest Syria, this dam provides drinking water for about 200,000 people. The earthquake sequence resulted in the cracking of the Afrin Dam, but has been determined to be stable with no need for evacuations or immediate repair. Cracking in the Sultansuyu Dam has also been observed, however no imminent threat of failure has been identified at this time. There have been no further reports of flooding or damage, and no evacuation notices have been sent. Additionally, the Ataturk dam, the third largest dam in the world, has been cleared of any damage or impacts resulting from the earthquakes. A mud dam just upstream of the Syrian village of al-Tlul failed as a result of the earthquake, flooding the town and prompting the evacuation of the dozens of families living there.

Figure 27: Cracking in the Afrin Dam (Source: <https://twitter.com/Hibakarm/status/1623723294686838784>)

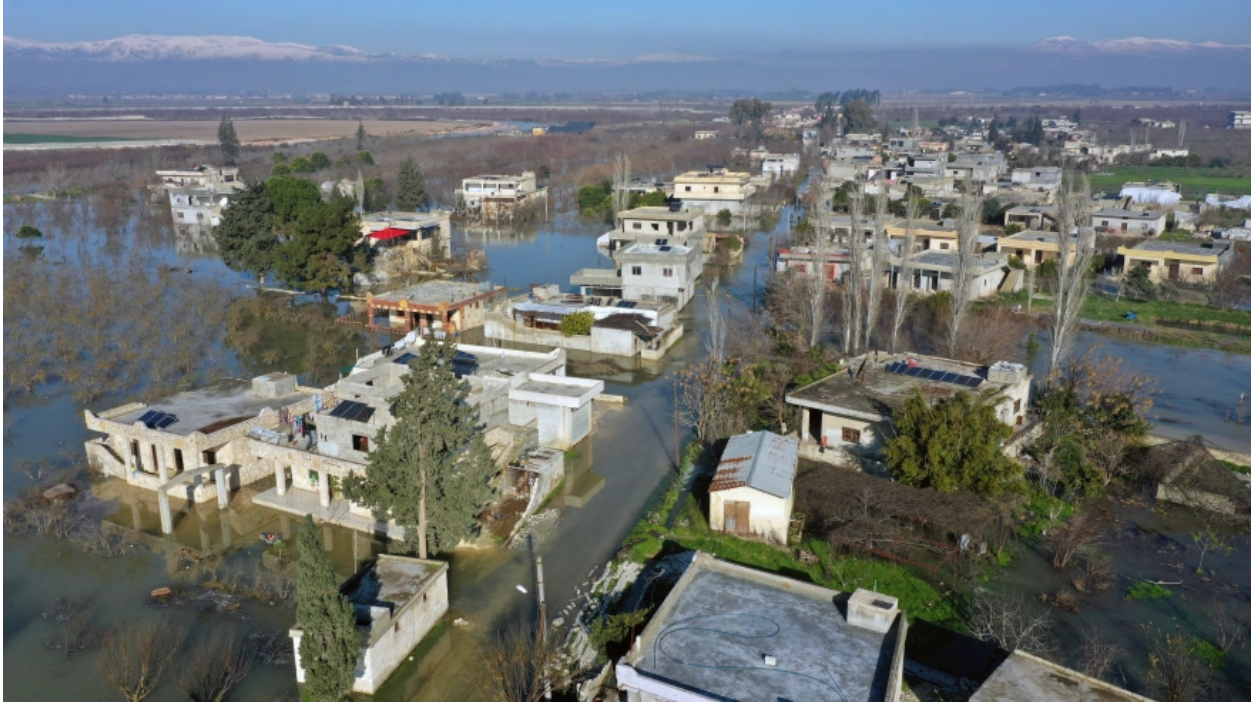
Figure 28: Aerial view of the al-Tlul village, where damage to the Afrin dam led to flooding (Photo Credit: AP Photo/Ghaith Alsayed).

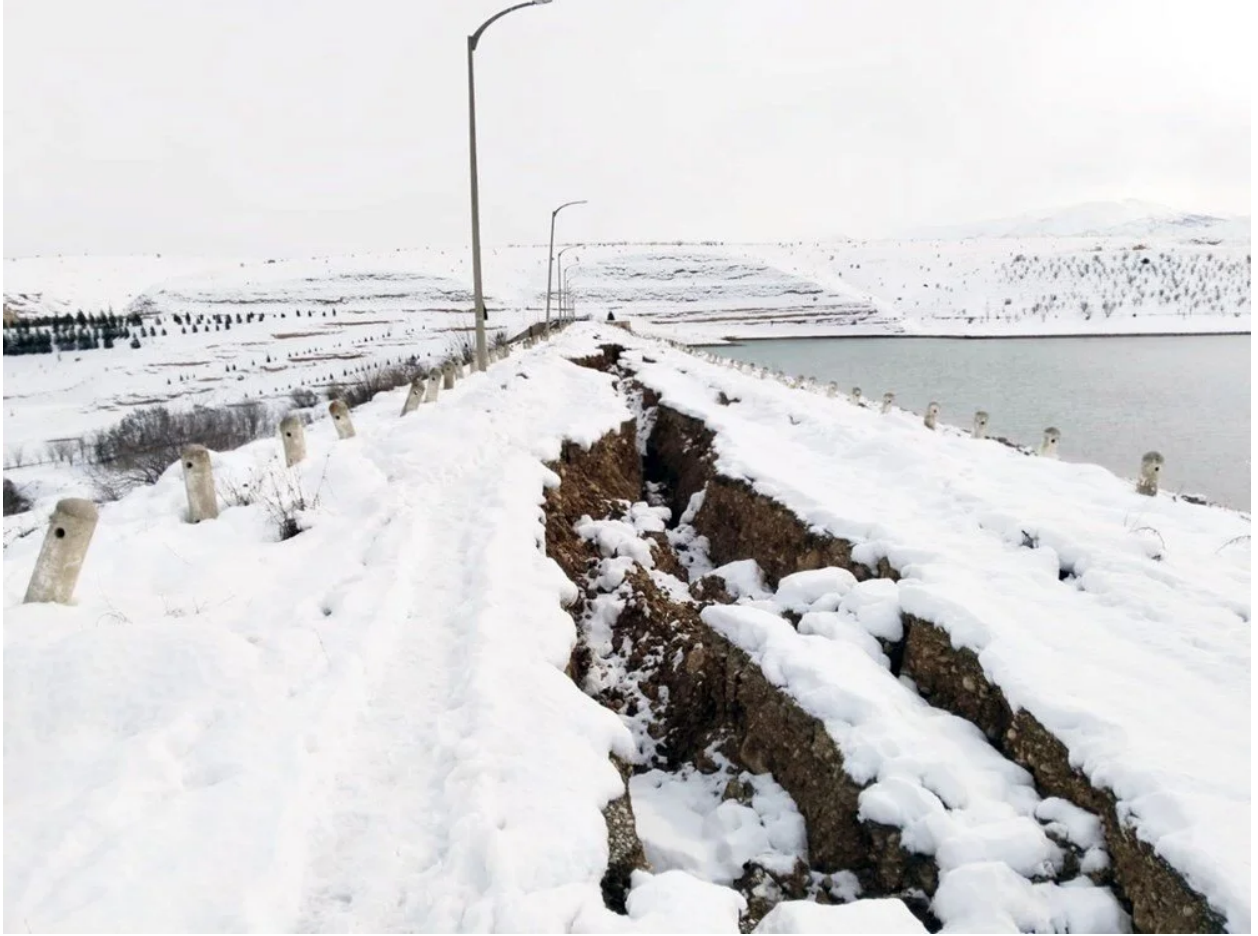
Figure 29: Cracking damage observed in the Sultansuyu Dam (Source: <https://www.ntv.com.tr/galeri/turkiye/govde-aksinda-catlaklar-olusan-malatyadaki-sultansuyu-baraji-tahliye-ediliyor,xxRN92Huy0iiG0tyCNU4fA/aimTJcX5X0egL7OUo5ez0Q>)
