Geotechnical Damage in Central and Northeastern Florida from Hurricane Irma

GEER Association Report No. GEER-056b

October 2017

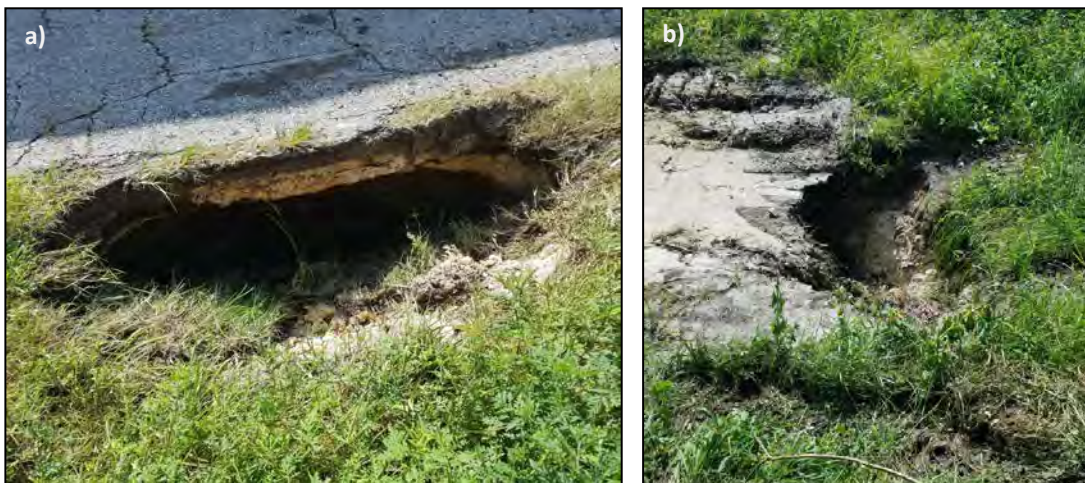
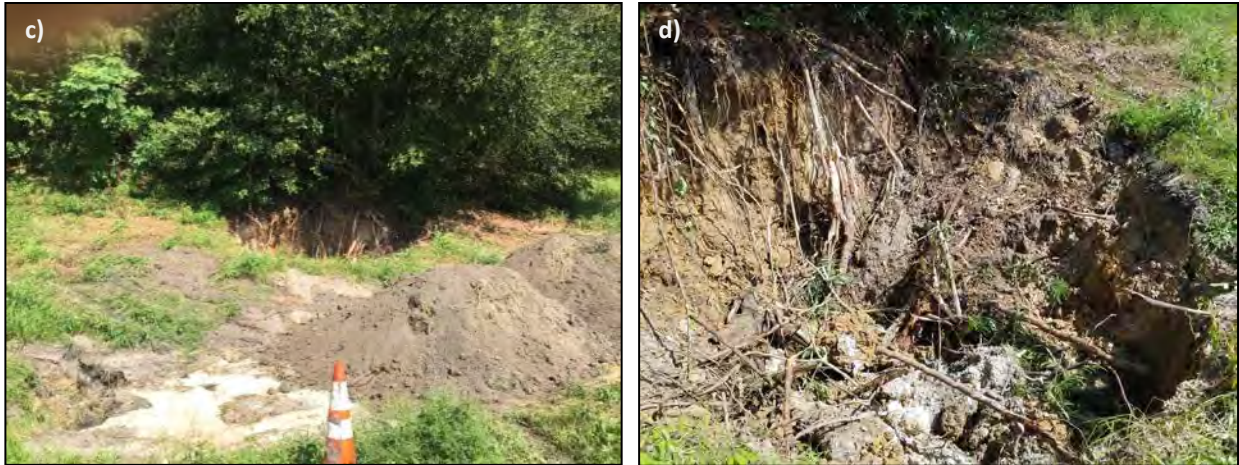
Figure 19: Images of the sinkholes that formed along I-75 northbound south of the SR 26 interchange: a) roadside sinkhole, b) drainage ditch sinkhole, c) sinkhole at the back slope of the drainage ditch, and d) contents of the back slope sinkhole (pers. comm. *Binay Prakash, FDOT*).

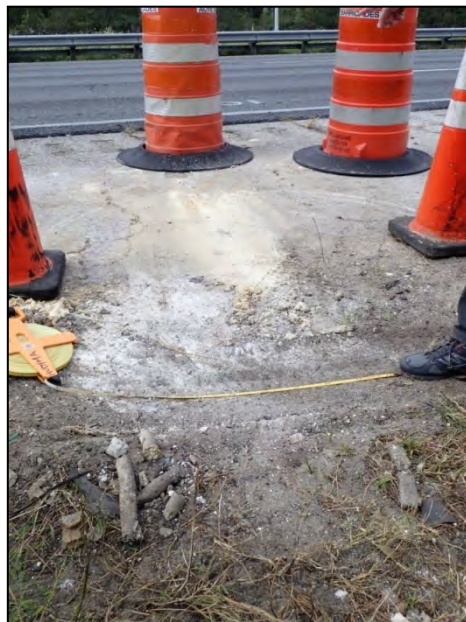
Figure 20 shows evidence of the repaired sinkhole that was encroaching on the I-75 northbound shoulder. During the site visit, the team witnessed geotechnical drilling operations whose purpose was to identify subsurface voids (Figure 21). The drilling data will be used to identify the geometry and extent of the sinkhole so that a grouting plan can be developed for the permanent repair of the sinkhole. Measurements indicate the length and width of the total distressed area are approximately 20 m by 20 m.

Figure 20: Distress from a repaired sinkhole approximately 1 m diameter at the roadway edge of the northbound lane of I-75 (Latitude 29°39'7.99"N / Longitude 82°24'44.00"W)

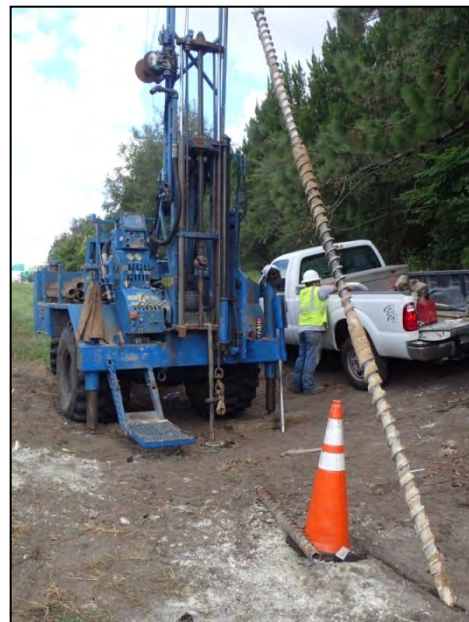
Figure 21: Repair activities for a sinkhole within the drainage ditch off the northbound lane of I-75 with fill and cement grout (Latitude 29°39'8.81"N / Longitude 82°24'45.00"W).

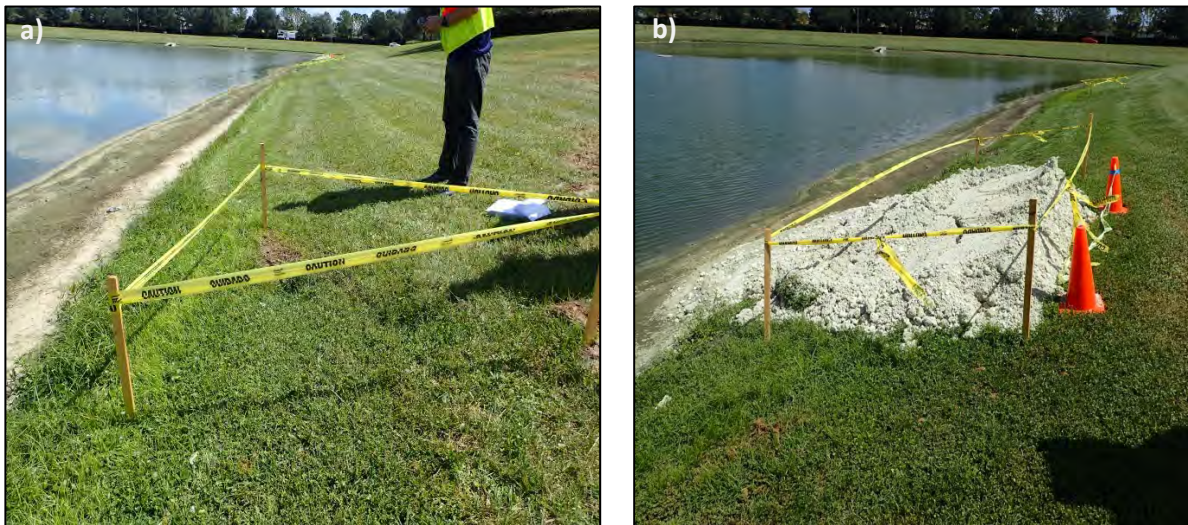
likely the largest sinkhole since it had been overfilled with granular soil. It is also the closest to the water level in the retention pond. The pond was most likely being drained so repairs could be made to the small sinkholes.

Figure 25. Sinkholes on the bank a) Site 1-1, b) Site 1-3 (Latitude 29° 8'47.98"N / Longitude 82°12'31.30"W).

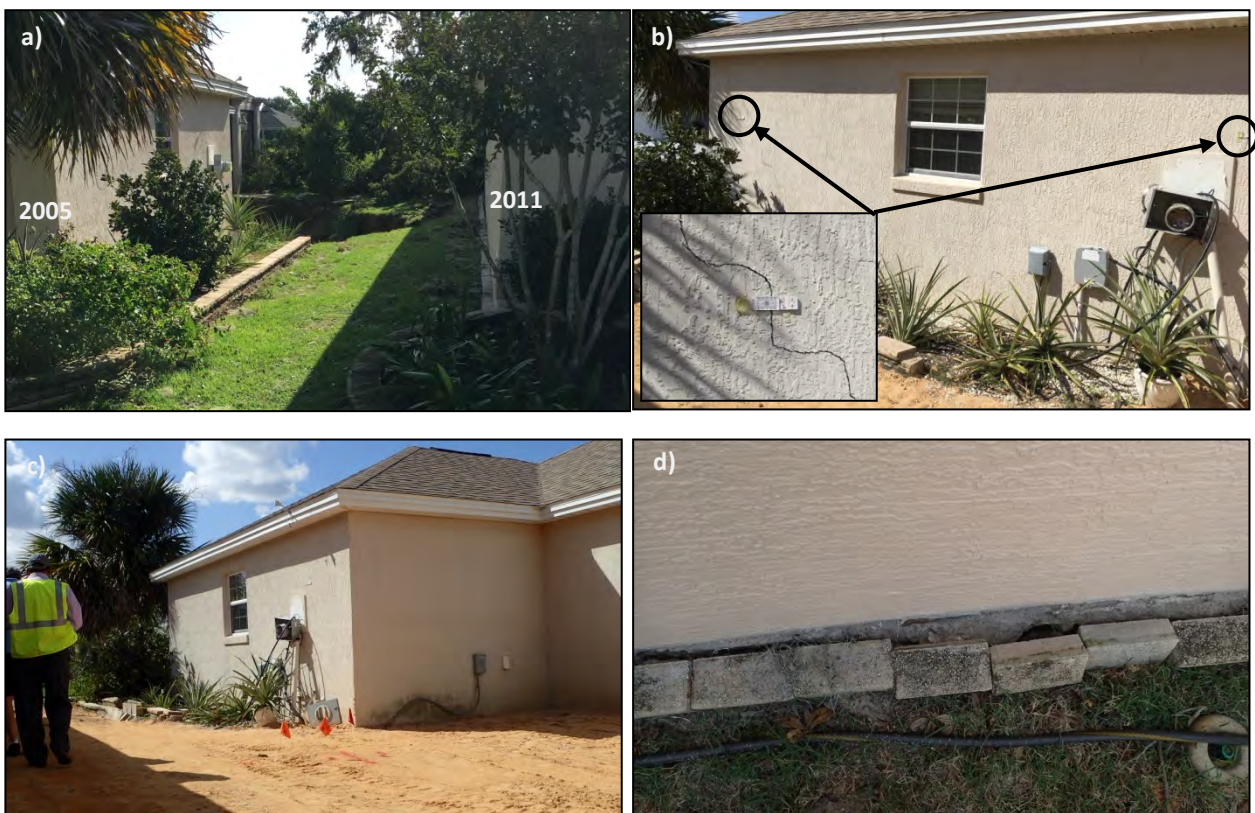
Figure 30: Documentation of a sinkhole that formed between homes at 2005 and 2011 Markridge Loop, The Villages, FL., including: a) the open sinkhole (dimensions unknown; pers. comm. Doug Wernicke); and b) cracks on the wall of 2005 Markridge Loop with crack gages; c) area between the two homes; and d) evidence of ground subsidence and an irrigation system at the wall of 2011 Markridge Loop after sinkhole backfilling. (Latitude 28°53'0.57"N / Longitude 82° 0'1.02"W).

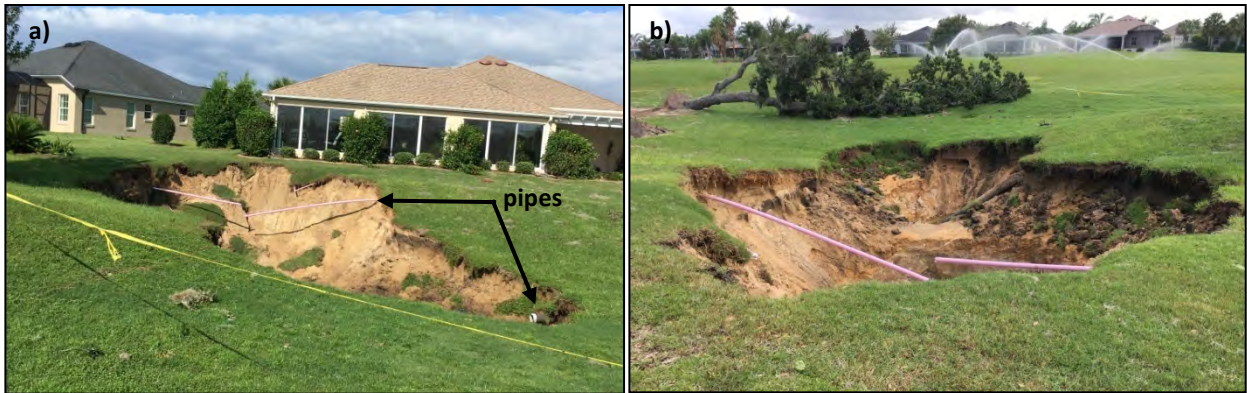
Figure 31: Images of a large sinkhole (dimensions unknown) that formed behind 2011 Markridge Loop, The Villages, FL. Note the small and large diameter pipes and large felled tree. (pers. comm. Doug Wernicke). (Latitude 28°52'59.95"N / Longitude 81°59'59.73"W).

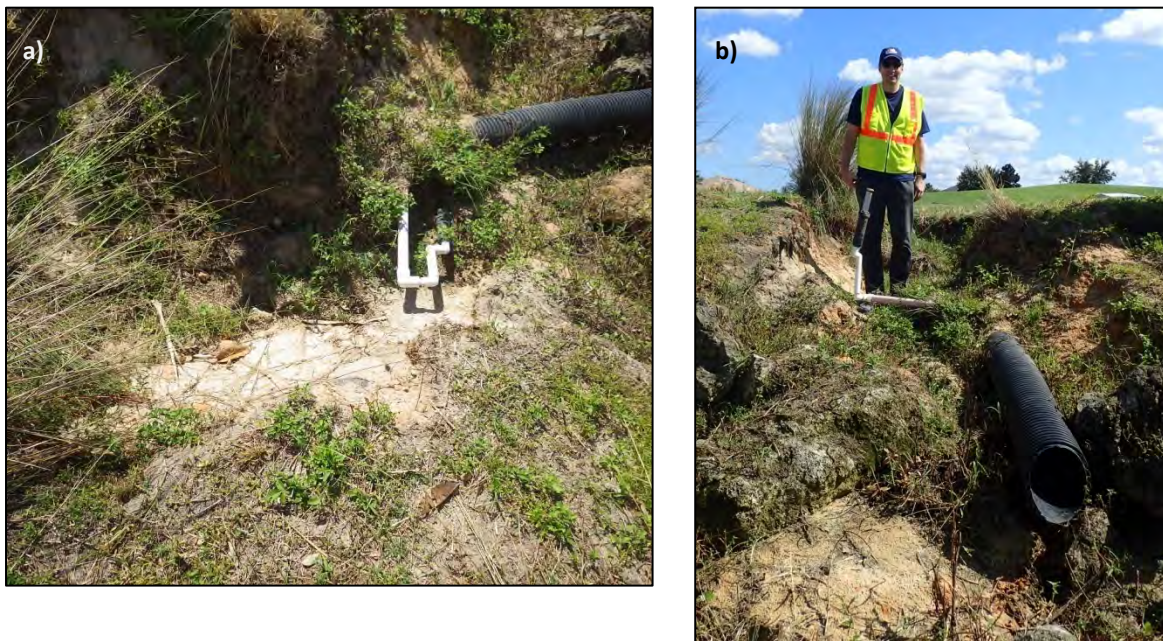
Figure 32: Documentation of a sinkhole and overland erosion that formed at edge of the golf course retention pond between Markridge Loop and Dover Hollow Run in The Villages, FL (Latitude 28°52'57.88"N / Longitude: 81°59'58.93"W).

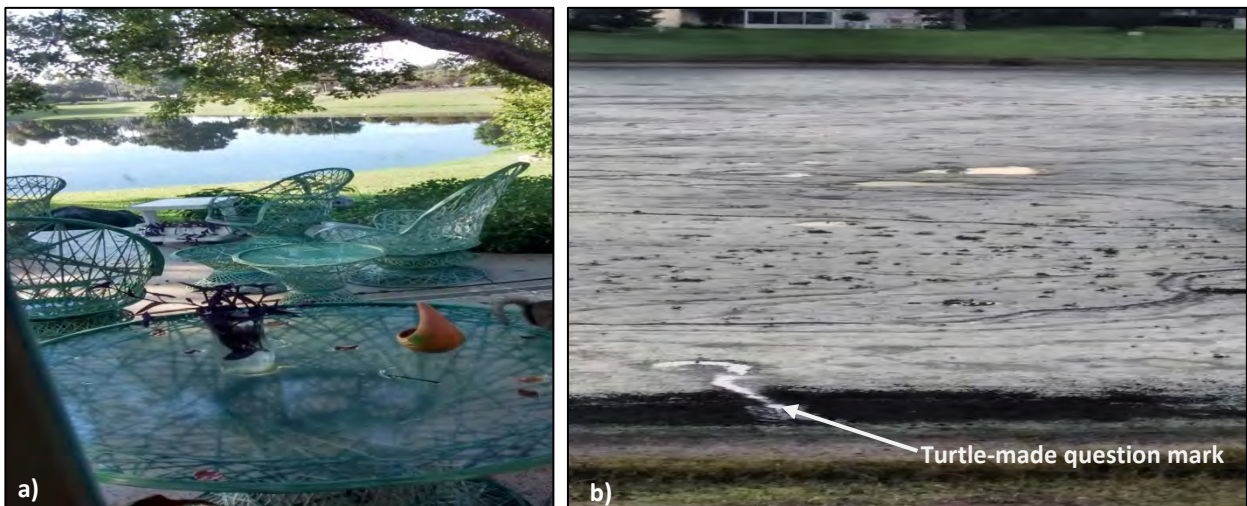
Figure 34. Images illustrating the retention pond a) prior to (Aug. 9 2017), and b) following (Sept. 18, 2017) Hurricane Irma and sinkhole formation where the view is from Alhambra Way. (Latitude 28°57'12.85"N / Longitude 81°59'36.36"W). Images courtesy of Dan Snyder and Sheila Huffman Dailey.

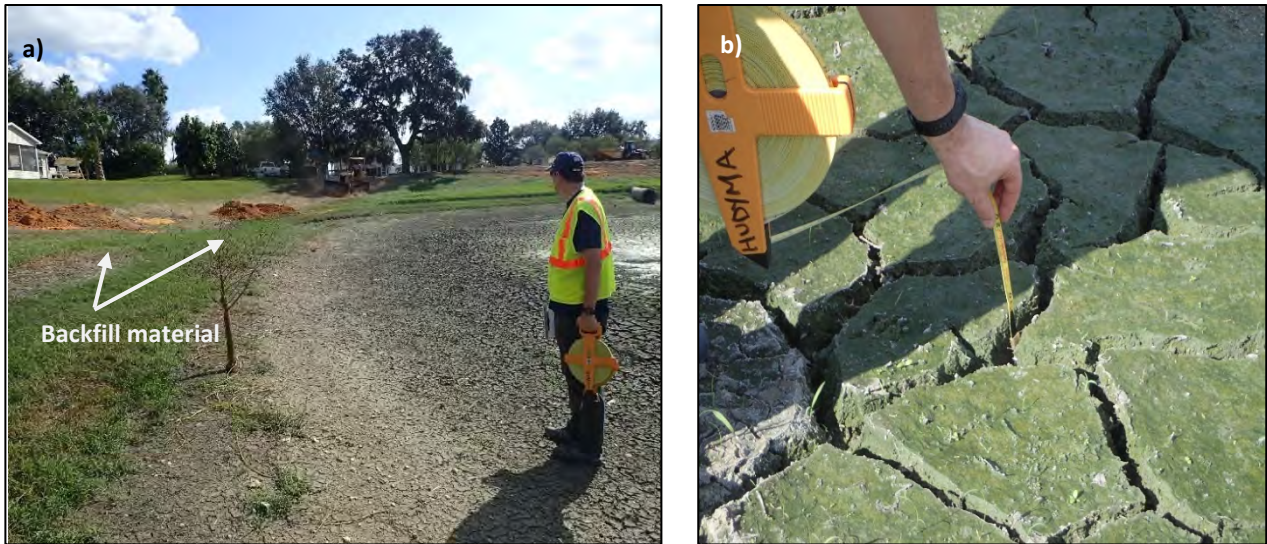
Figure 35. Retention pond between Alhambra Way and Botello Ave. (a) fully drained retention pond with fill material placed on the bank for backfilling sinkholes (Latitude 29°57'9.18"N / Longitude 81°59'31.5"W), and (b) 10 mm deep desiccation cracks in the pond bottom (Latitude 28°57'10.94"N / Longitude 81°59'36.67"W).

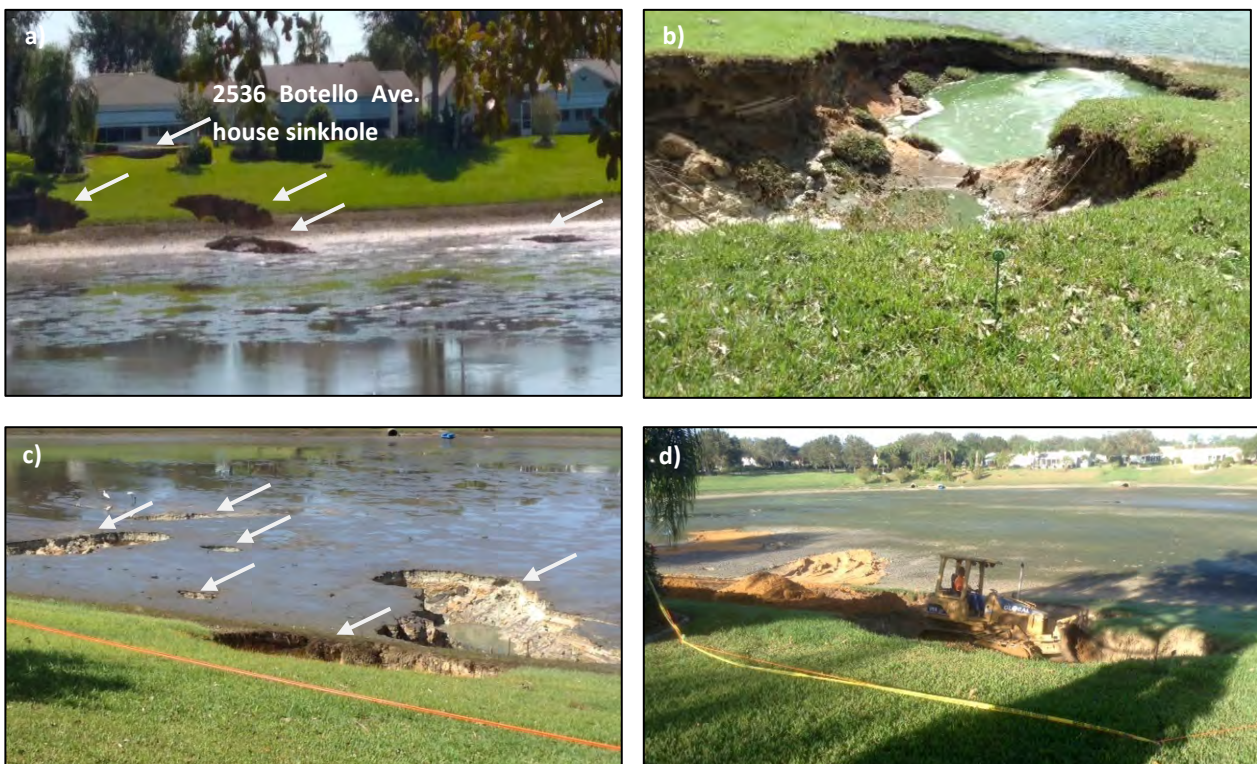
Figure 36. Sinkholes on the bank of, and within the retention pond between Alhambra Way and Botello Ave. (a, b, c), and under repair (d) (Latitude 28°57'11.92"N / Longitude 81°59'31.49"W) (images courtesy of local residents Sheila Huffman Dailey, Dan Snyder, and Barbara Beveridge).

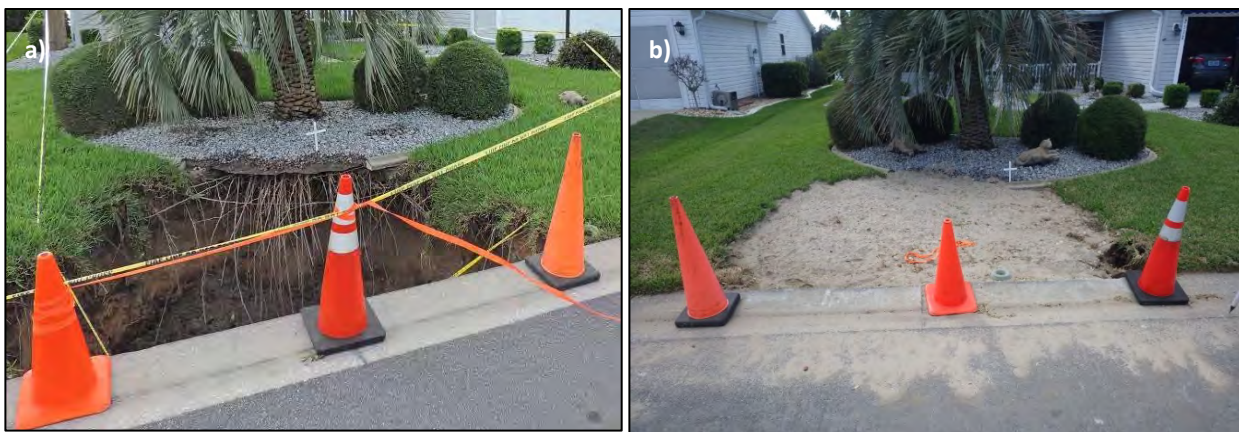
Figure 37. Sinkhole formed at 2532 Botello Avenue a) prior to repair¹⁹ and b) following repair (Latitude $28^{\circ}57'10.60''\text{N}$ / Longitude $81^{\circ}59'30.50''\text{W}$).

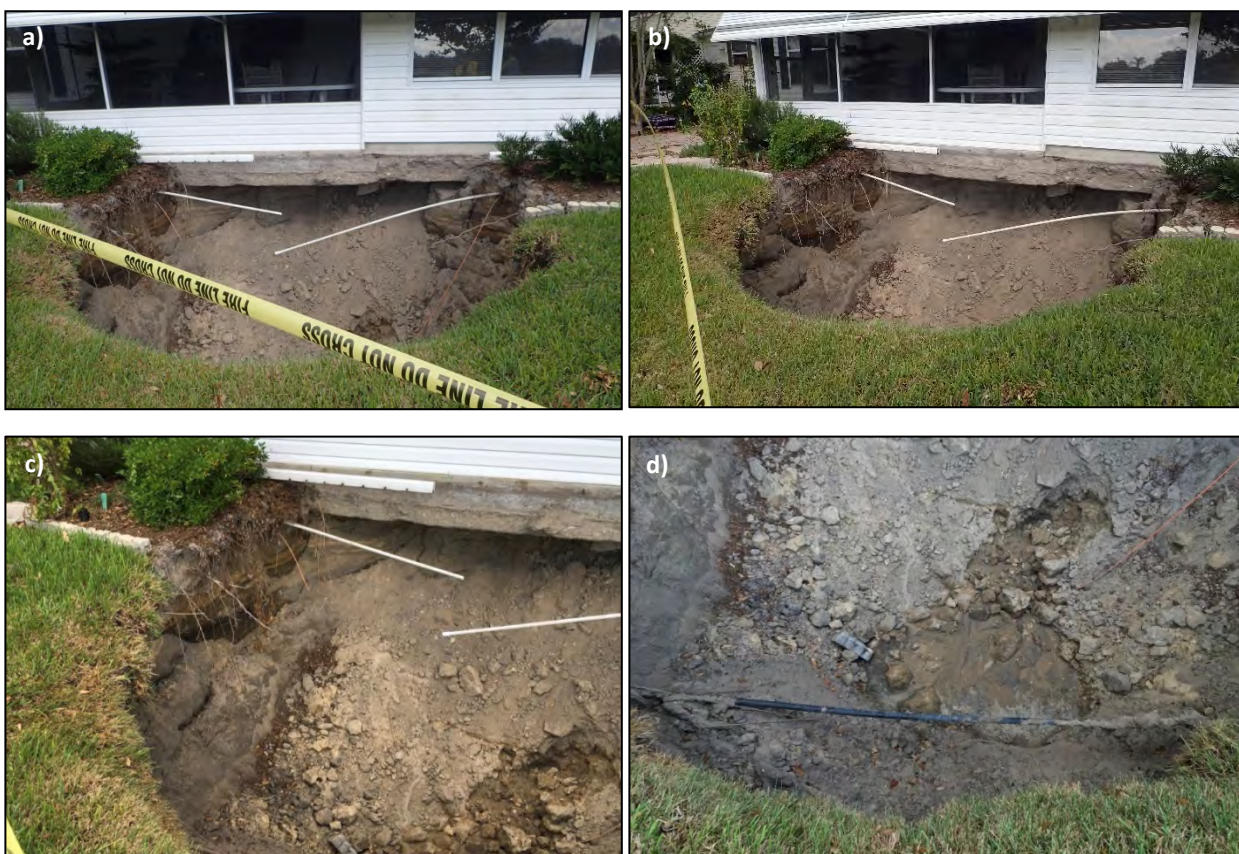
Figure 38. Sinkhole undercutting a foundation at 2536 Botello Rd. showing multiple front views (a, b, c,) and bottom of the sinkhole (d). (Latitude $28^{\circ}57'11.67''\text{N}$ / Longitude $81^{\circ}59'30.05''\text{W}$).

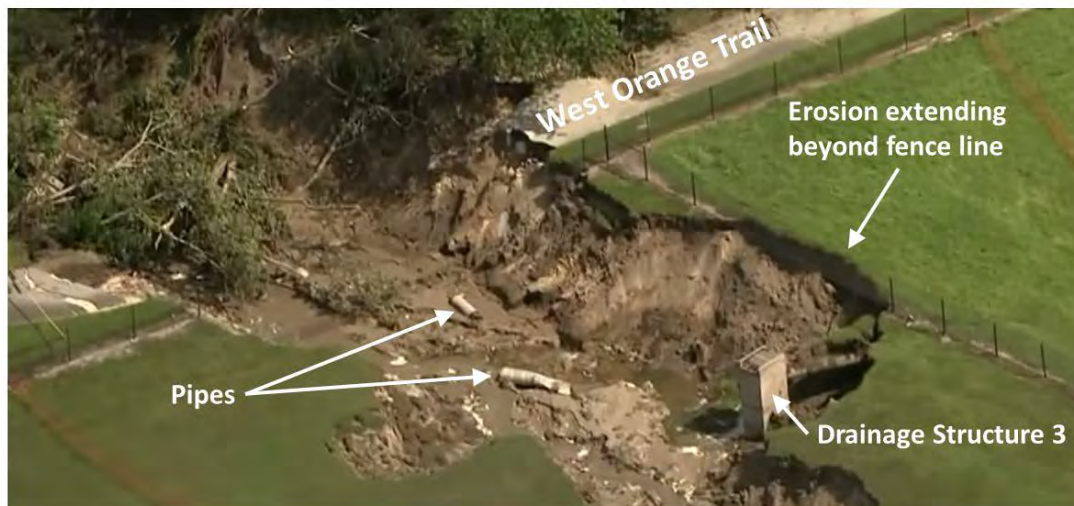
Figure 41: Aerial image of the Apopka erosion washout that bisected the West Orange Trail and damaged two large scale drainage structures²¹ (approximate location Latitude 28°41'8.68"N / Longitude 81°30'20.97"W).

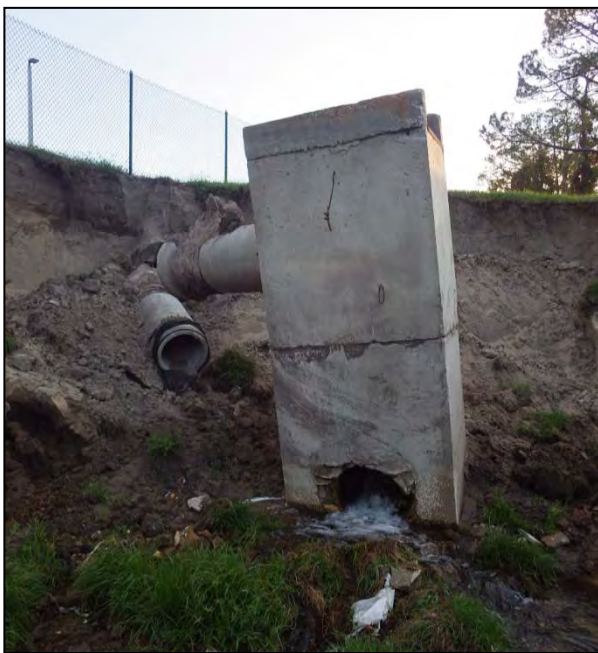
Figure 45. Damaged drainage structure 3 (Latitude 28°41'9.08"N / Longitude 81°30'22.39"W).

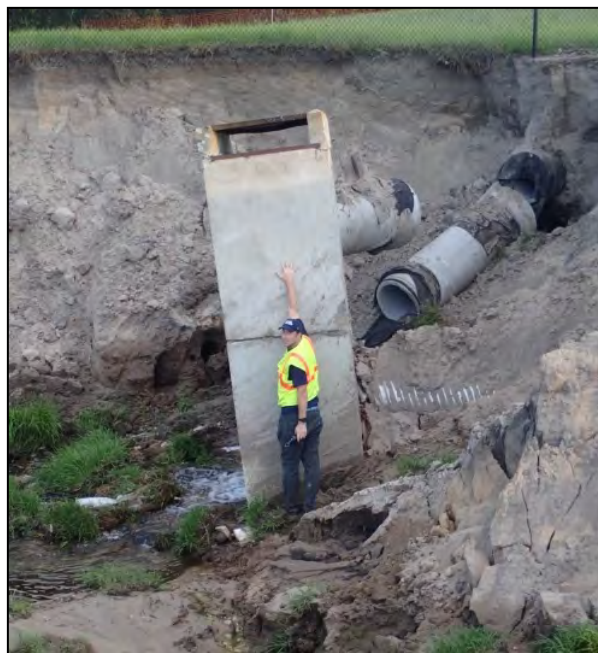
Figure 46. Damaged drainage structure 3, dimensioned by the investigators 2.4 m reach (Latitude 28°41'9.08"N / Longitude 81°30'22.39"W).

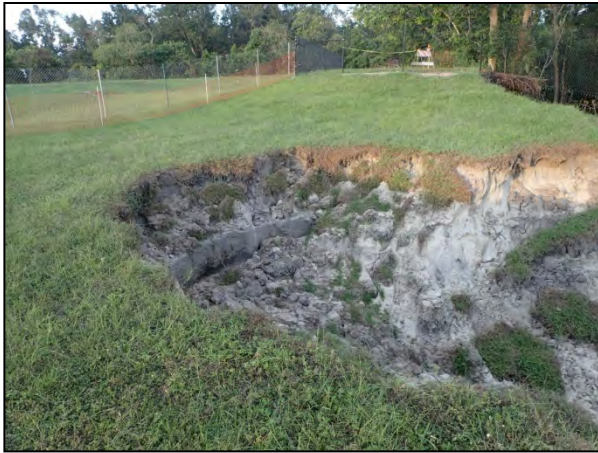
Figure 47. Erosion lateral to the main channel likely from failed drainage structure 3 (Latitude 28°41'9.15"N / Longitude 81°30'21.64"W).

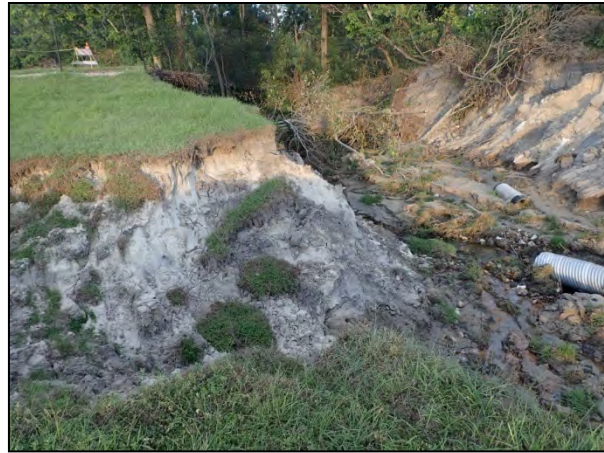
Figure 48. Erosion lateral to the main channel likely from failed drainage structure 3 (Latitude 28°41'9.15"N / Longitude 81°30'21.64"W).

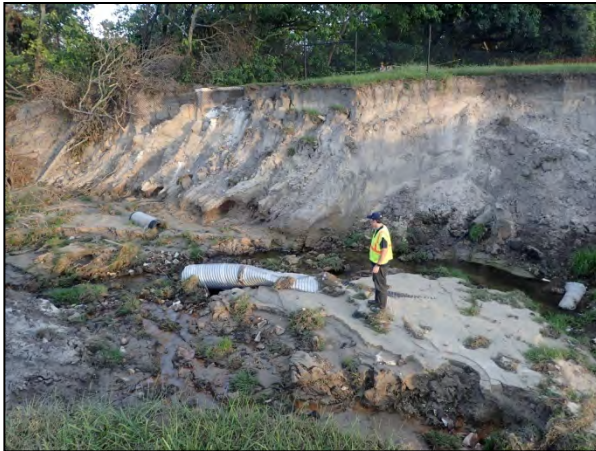
Figure 49. Damaged pipes, eroded West Orange Trail, and uprooted trees at drainage structure 3 area (Latitude 28°41'9.15"N / Longitude 81°30'21.64"W).

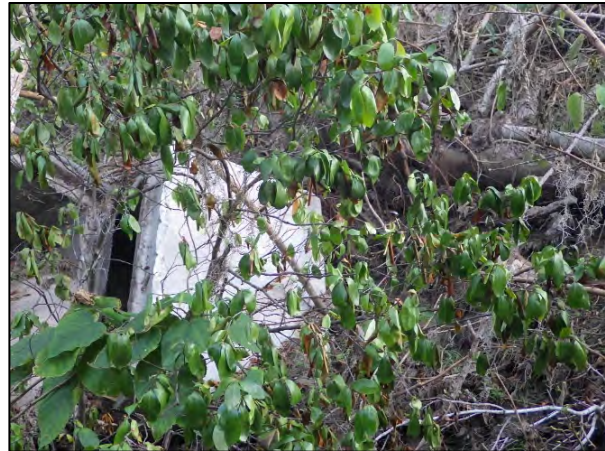
Figure 50. Fourth drainage structure buried under wooded debris east of the West Orange Trail. (Latitude 28°41'8.71"N / Longitude 81°30'20.57"W).

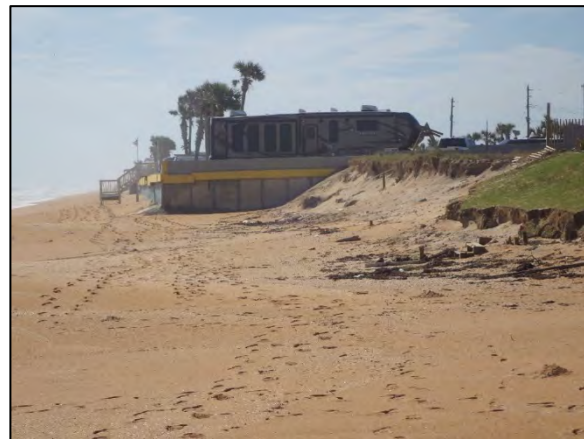
d) Scour on the north wing wall of the concrete seawall (Latitude 29°32'36.21"N / Longitude 81°9'30.17"W).

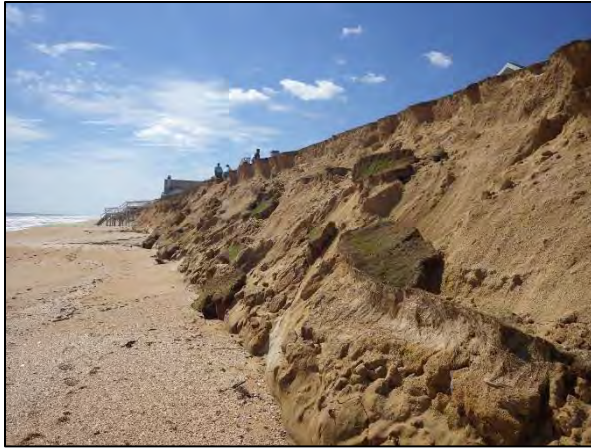
a) Extent of dune failure (photograph taken facing south, Latitude 29°32'35.83"N / Longitude 81°9'29.51"W).

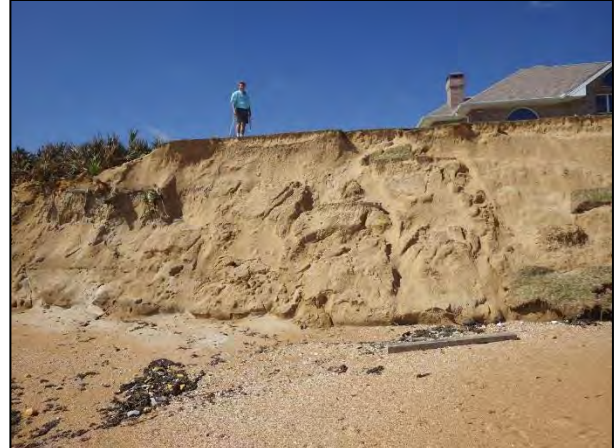
b) Location where failed dune slope height was measured (Latitude 29°32'35.34"N / Longitude 81°9'29.59"W).

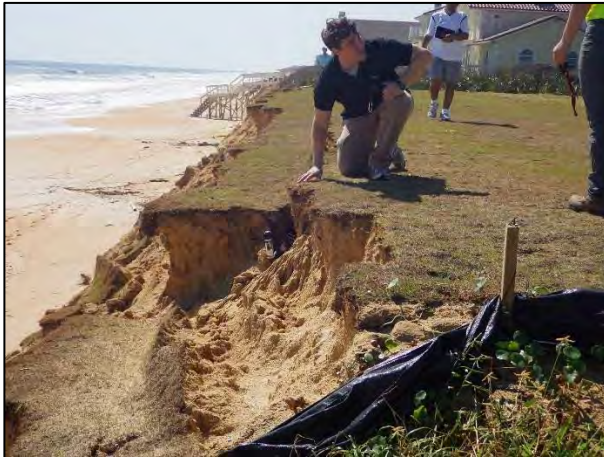
c) Close up of blocky nature of failed dune crest (Latitude 29°32'36.74"N / Longitude 81°9'29.95"W).

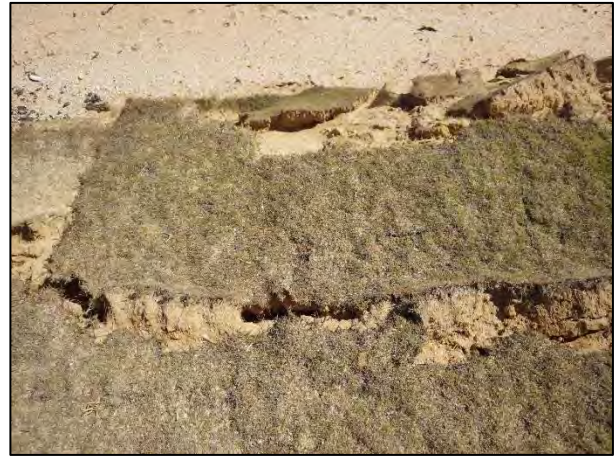
d) Close up of seam in sod where moisture most likely infiltrated into the dune (Latitude 29°32'35.83"N / Longitude 81°9'29.51"W).

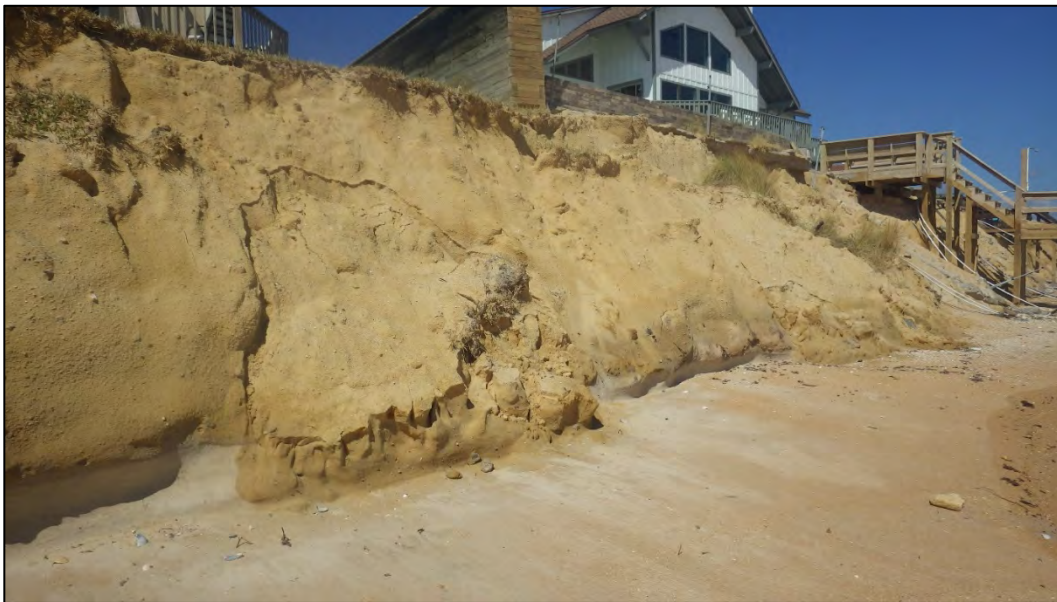
Figure 60. Eroded dune showing active sloughing, undercutting of deck, and potentially unstable timber beach staircase (Latitude 29°32'31.04"N / Longitude 81°9'27.05"W).

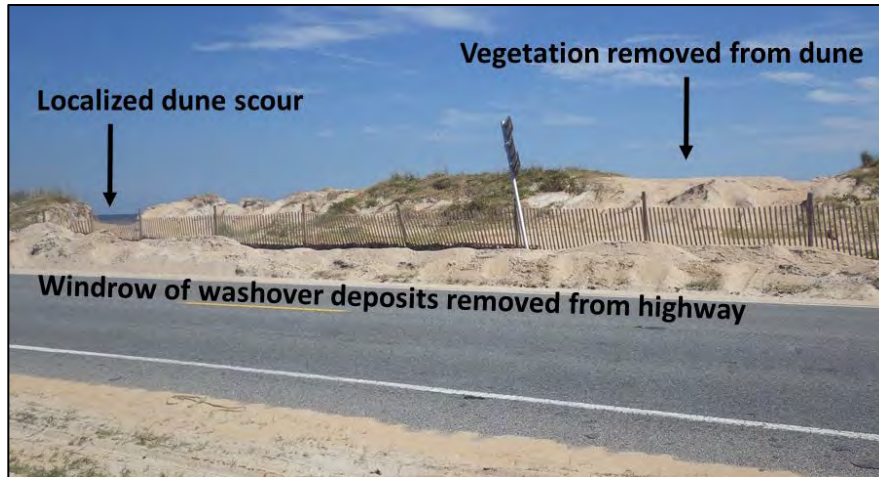
a) Overwash damage to dunes on the east side of Highway A1A (Latitude 29°40'14.09"N / Longitude 81°12'50.37"W).

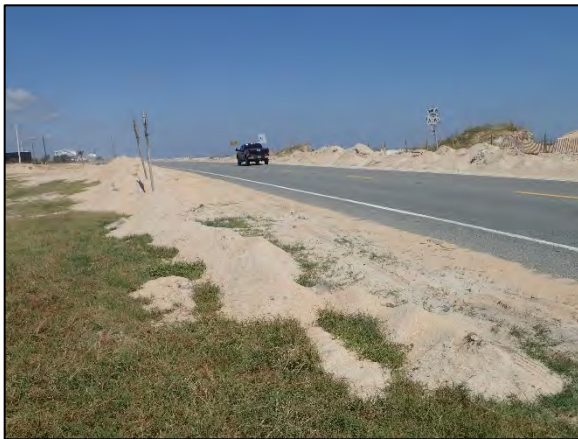
b) Windrows of washover deposits on west side of Highway A1A (Latitude 29°32'29.00"N / Longitude 81°9'25.0"W).

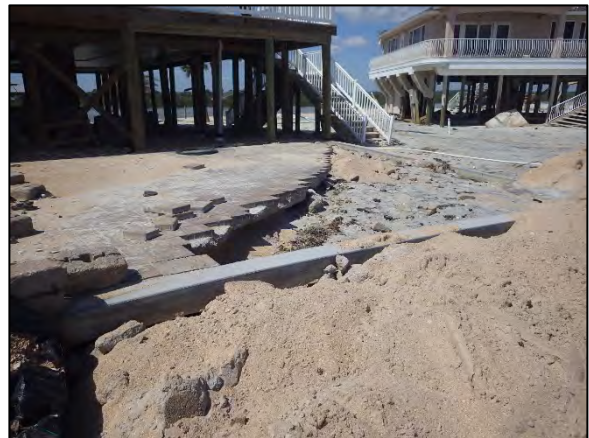
d) Scour under a deck constructed of brick pavers (Latitude 29°40'38.5"N / Longitude 81°12'58.24"W).

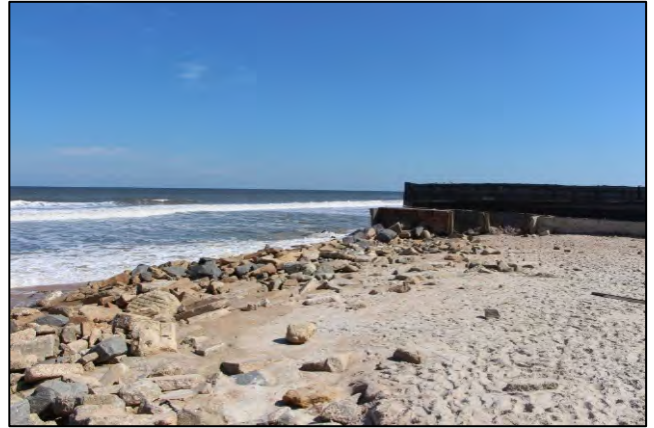
d) Overwash and unravelling of poorly constructed revetment (approximate location Latitude 29°51'34.61"N / Longitude 81°15'57.22"W).

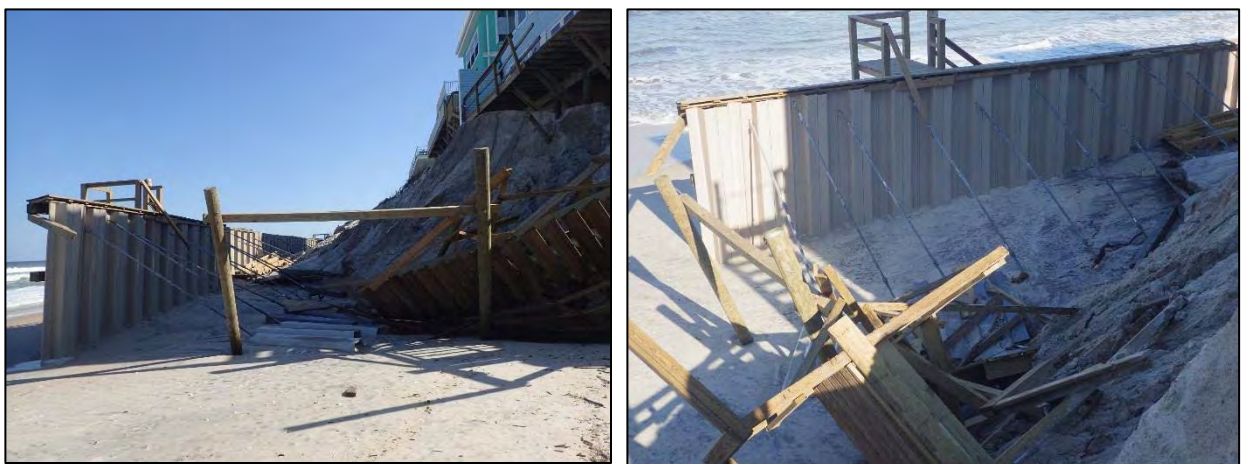
a) Scour exposing anchors and north wing wall is missing (Latitude 29°56'46.05"N / Longitude 81°18'7.5"W).

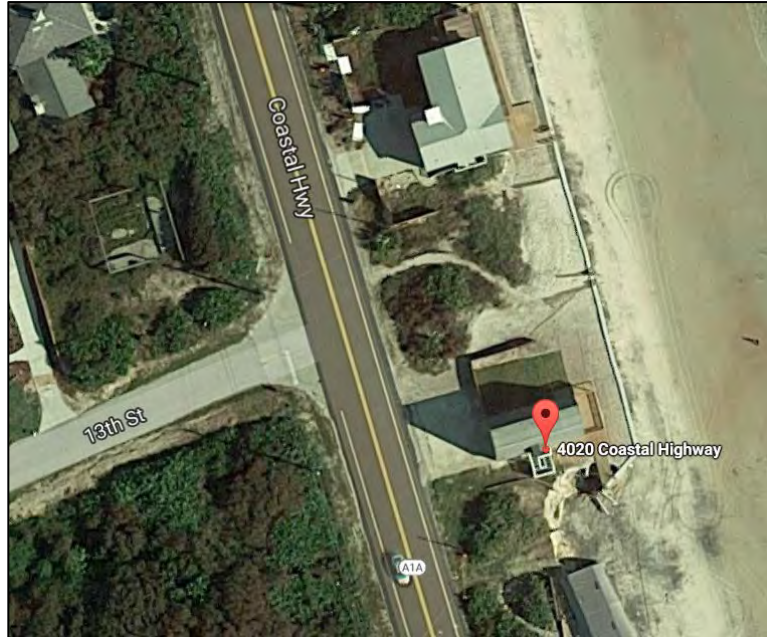
Figure 74. Aerial image of south wing wall damage at 4020 Coastal Highway, Vilano Beach, FL (Latitude 29°56'55.10"N / Longitude 81°18'11.25"W, from Google Earth, 2017).

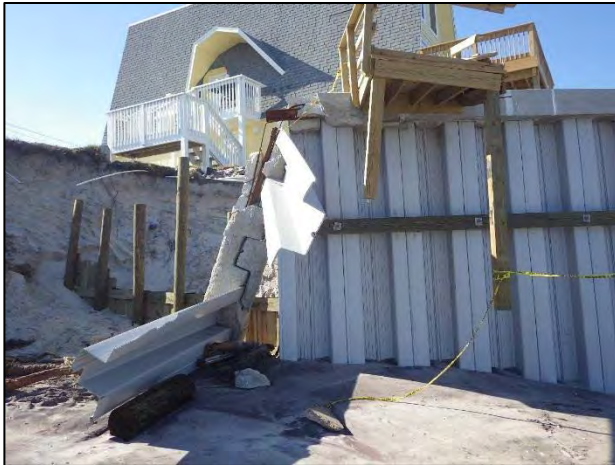
a) South wing wall destroyed.

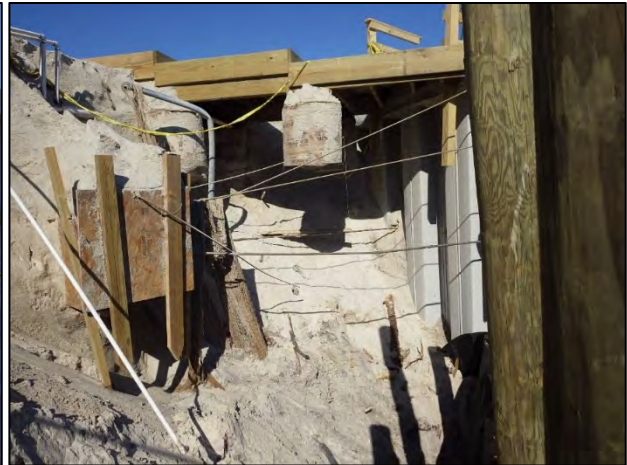
b) Damage behind the retaining structure.

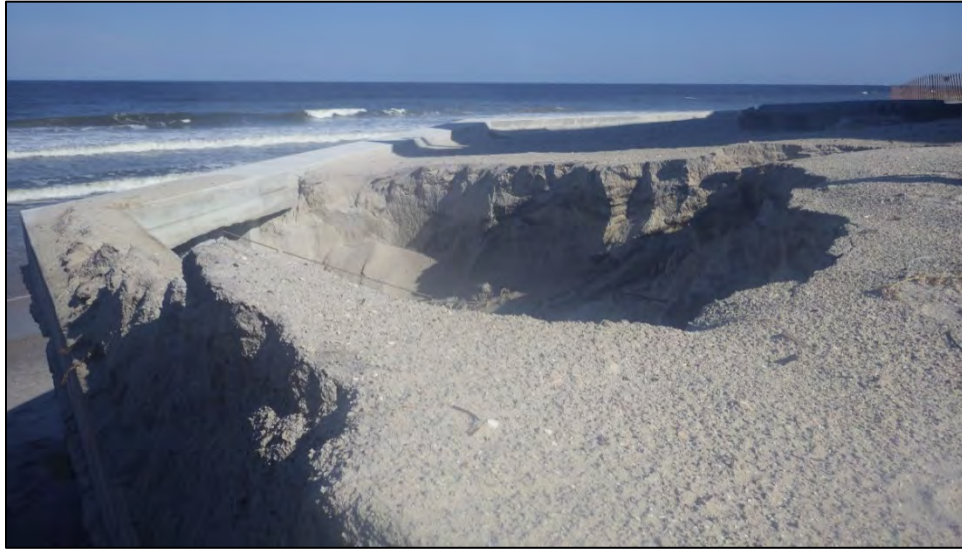
c) Ground loss behind sheet pile (Latitude 29°56'58.16"N / Longitude 81°18'11.96"W).

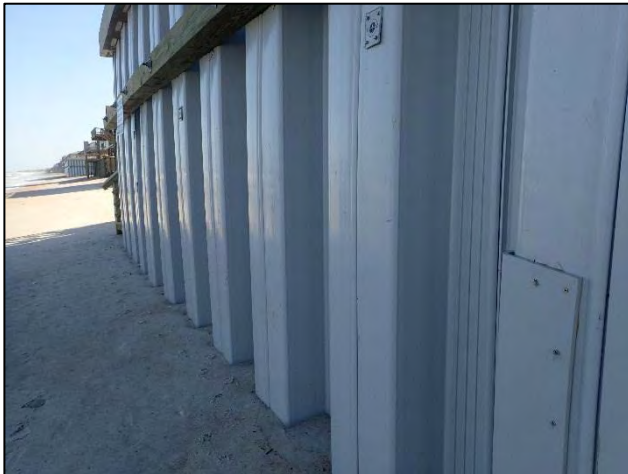
a) Wall bowing below wale and anchors (Latitude 29°57'46'1.08"N / Longitude 81°18'12.22"W).

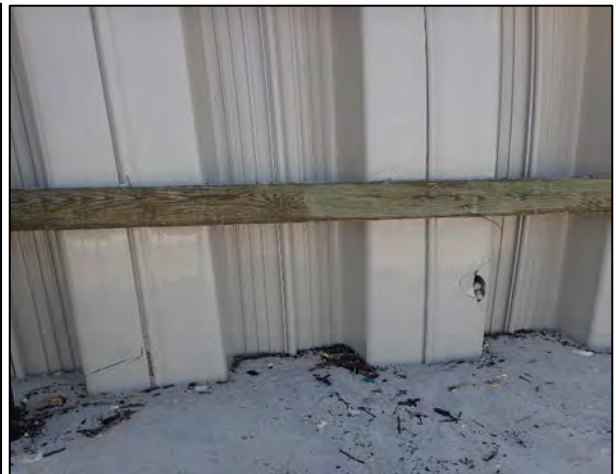
b) Cracking and hole in sheet pile material (Latitude 29°56'44.79"N / Longitude 81°18'7.05"W).

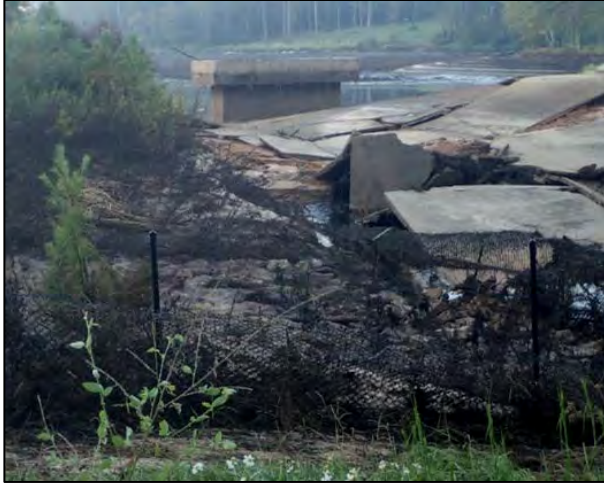
a) Failed dam showing concrete box weir intact
(Latitude 30°46'40.1"N / Longitude
81°58'13.0"W).

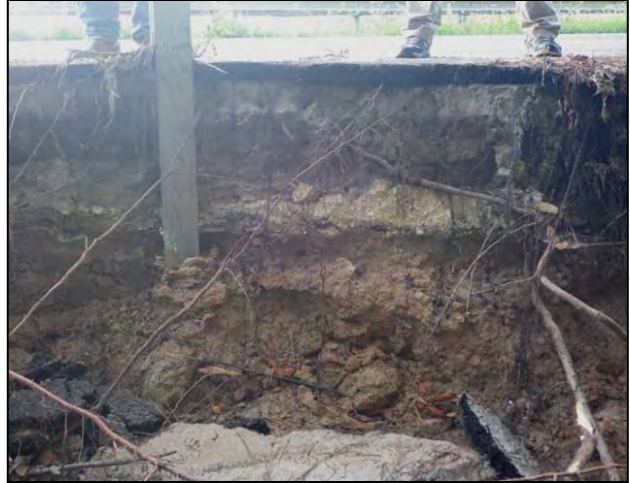
b) Scour at pavement edge on north shoulder of
Lake Hampton Road (Latitude 30°46'45.19"N /
Longitude 81°58'24.6"W).

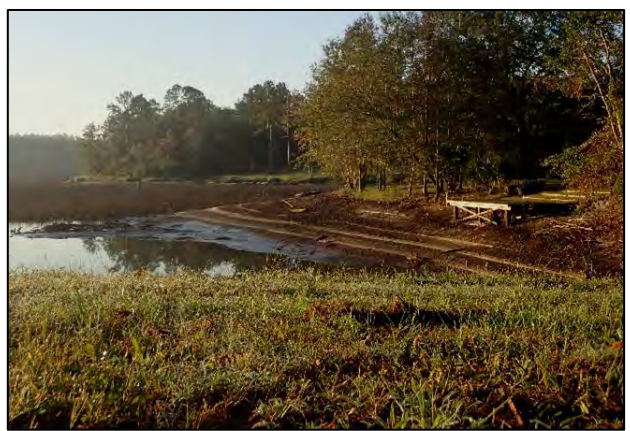
d) Lowered water levels in Lake Hampton
(Latitude 30°46'37.97"N / Longitude
81°58'14.27"W).

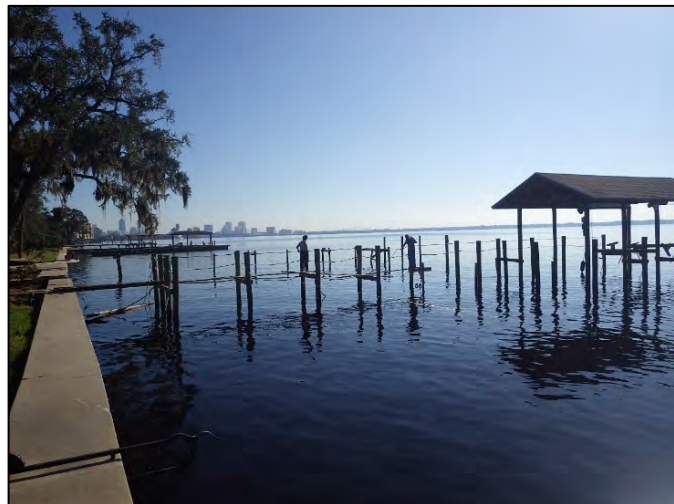
b) Damage to private dock.

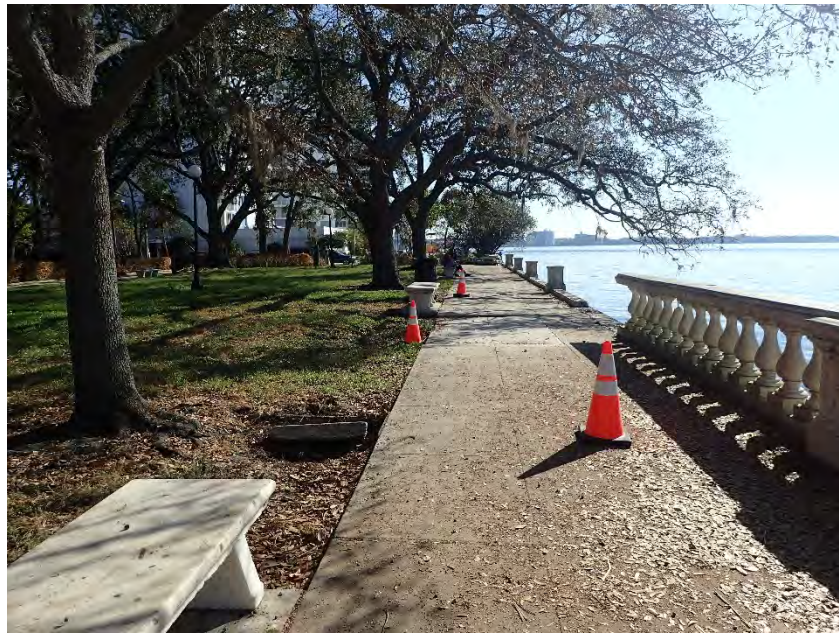
Figure 91. Photo showing sections of the broken decorative railing. Photograph taken looking north. (Latitude 30°18'36.11"N / Longitude 81°40'44.68"W).

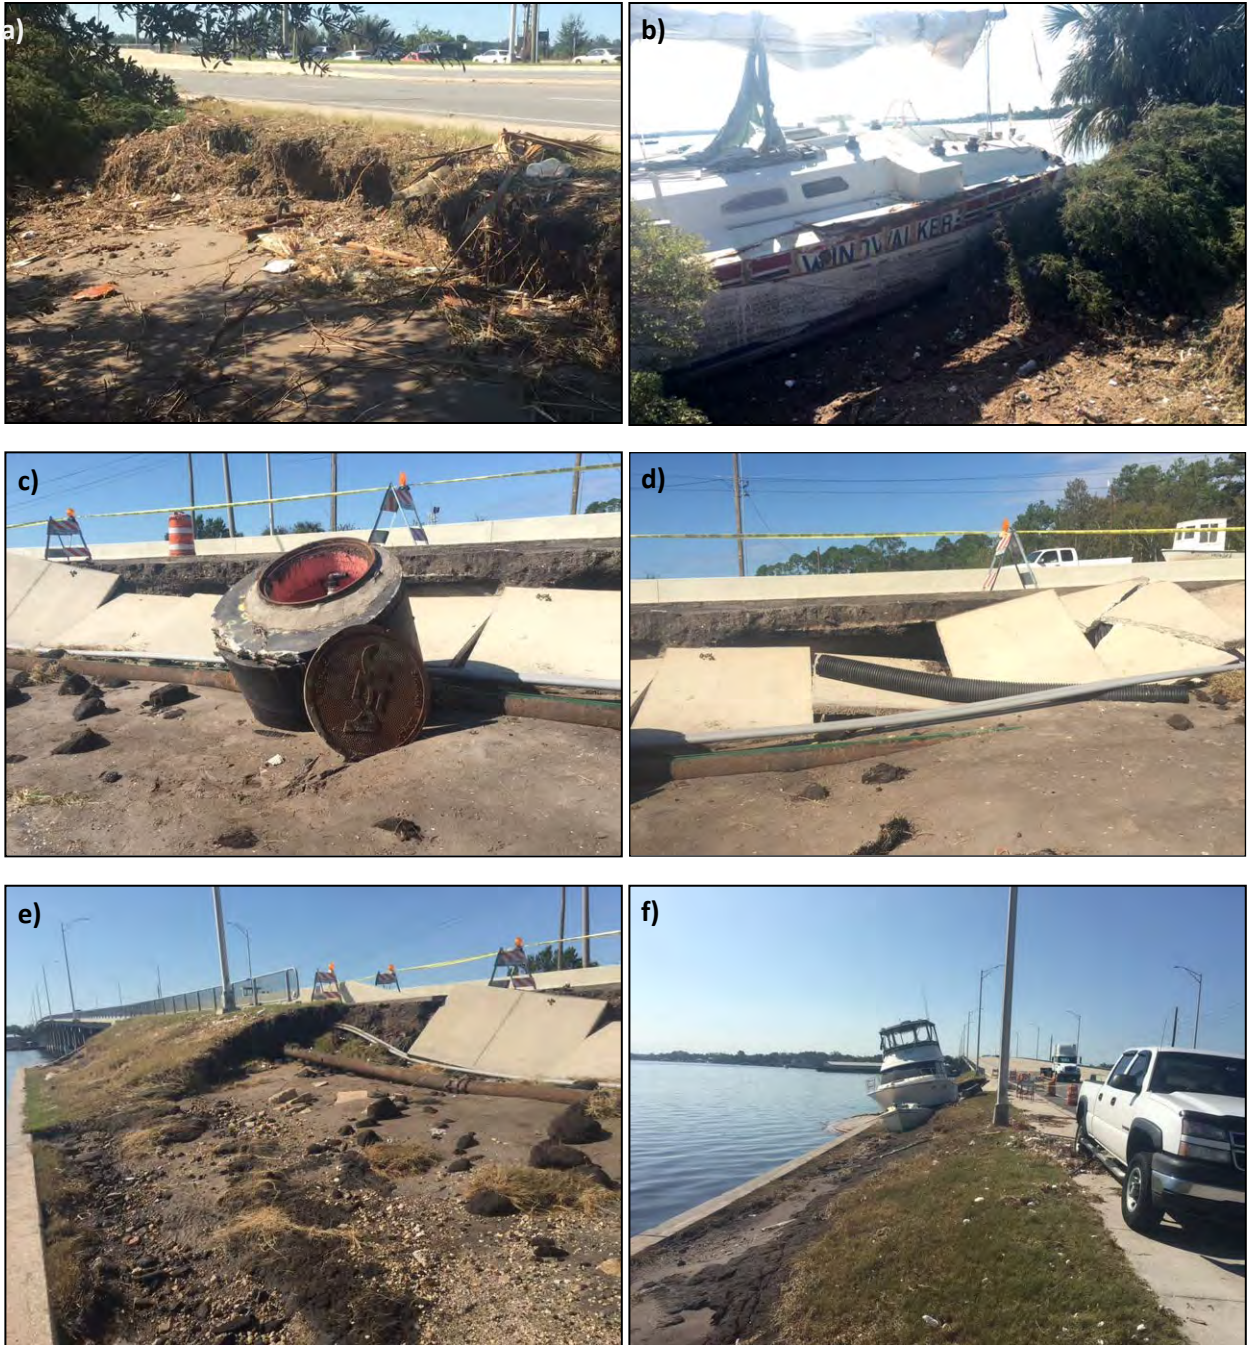
Figure 94. Scour damage along the northeast bridge embankment of the US 17 bridge over the Trout River, (Latitude 30°23'45.44"N / Longitude 81°38'53.95"W). Scour features are presented from north to south toward the concrete cover of the embankment that demonstrate erosion of soil below the road shoulder that resulted in broken pavement and exposed buried infrastructure that included: shallow roadside scour (a); boat washed ashore and scour pattern (b); an exposed sewer access structure and sewer pipe originally located 5 feet below finished grade (c); exposed sewer pipe and conduit for electrical service to light poles (d), and; the terminus of scour (e). Scour was likely caused by eddies and turbulence around two boats washed ashore (f).
