Geotechnical Damage in Central and Northeastern Florida from Hurricane Irma

GEER Association Report No. GEER-056b

October 2017

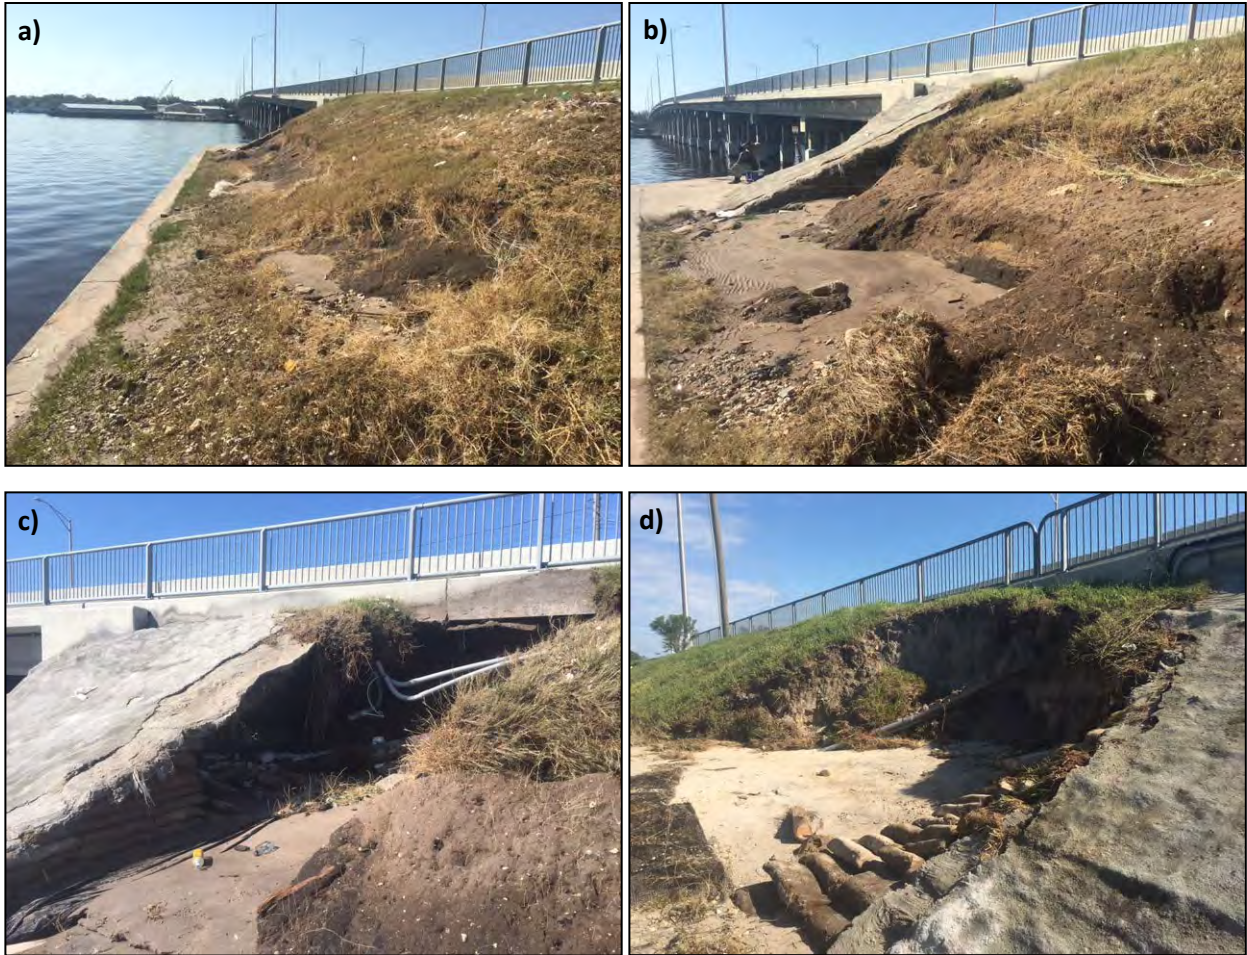
Figure 95. Scour damage along the northern bridge embankment of the US 17 bridge over the Trout River, (Latitude 30°23'44.43"N / Longitude 81°38'54.13"W). Scour features are presented from north east to north west near the concrete cover of the embankment that demonstrate erosion, which included: embankment soil erosion north of the bridge abutment (a, b), and erosion at the interface between the soil and concrete faced, stacked concrete sack wall at the east (c), and west (d) side of the north abutment.
