Geotechnical Extreme Events Reconnaissance

Geotechnical Damage in Central and Northeastern Florida from Hurricane Irma

GEER Association Report No. GEER-056b

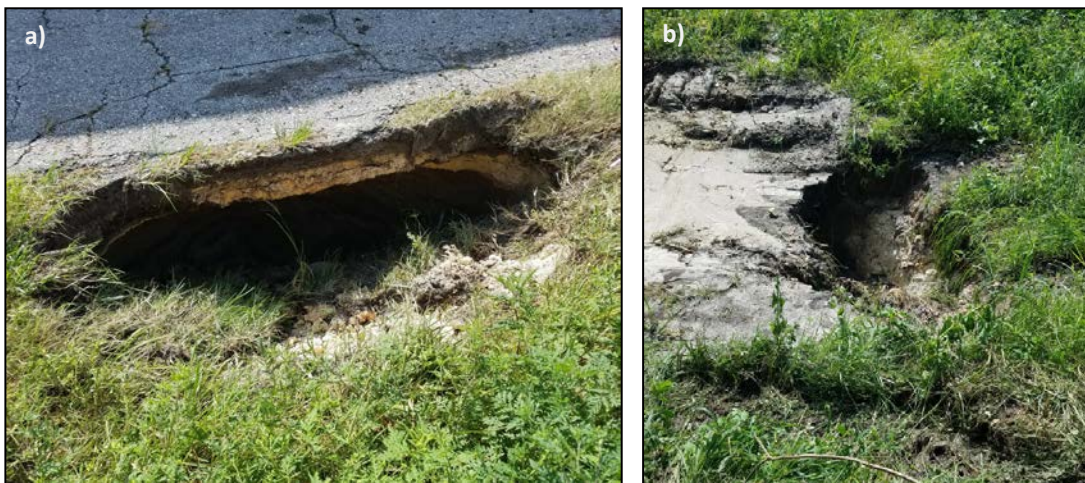
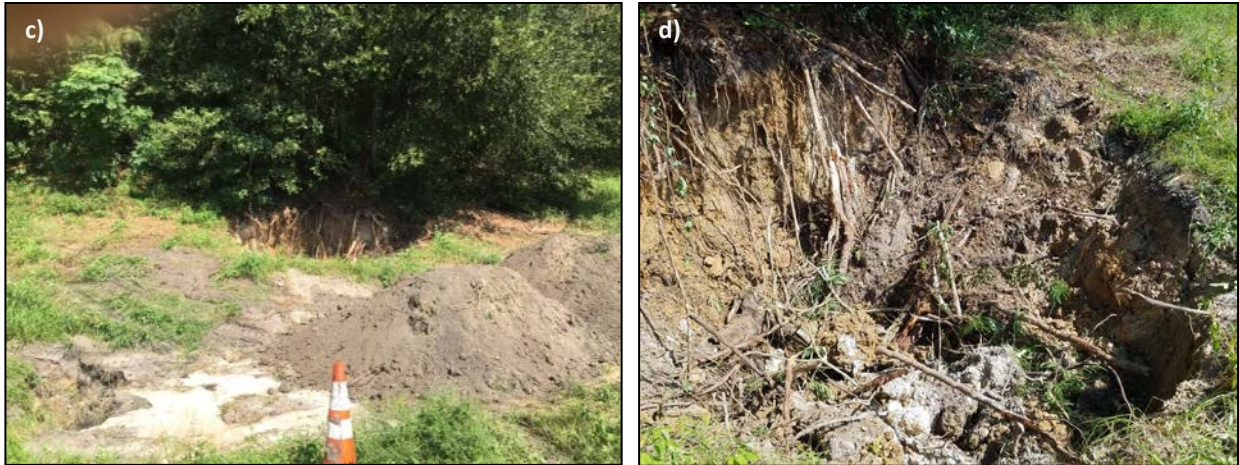
Figure 19: Images of the sinkholes that formed along I-75 northbound south of the SR 26 interchange: a) roadside sinkhole, b) drainage ditch sinkhole, c) sinkhole at the back slope of the drainage ditch, and d) contents of the back slope sinkhole (pers. comm. *Binay Prakash, FDOT*).

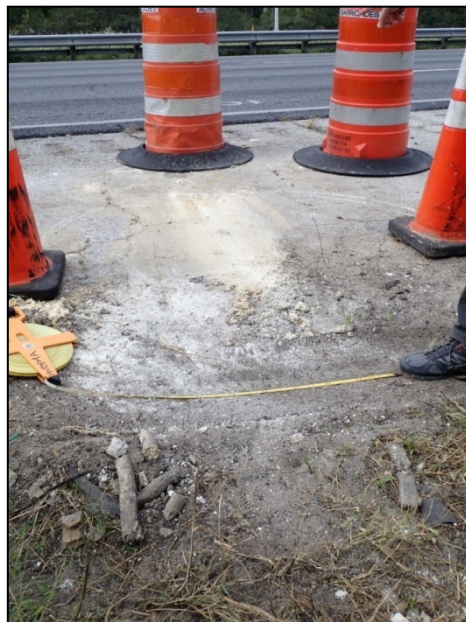
Figure 20 shows evidence of the repaired sinkhole that was encroaching on the I-75 northbound shoulder. During the site visit, the team witnessed geotechnical drilling operations whose purpose was to identify subsurface voids (Figure 21). The drilling data will be used to identify the geometry and extent of the sinkhole so that a grouting plan can be developed for the permanent repair of the sinkhole. Measurements indicate the length and width of the total distressed area are approximately 20 m by 20 m.

Figure 20: Distress from a repaired sinkhole approximately 1 m diameter at the roadway edge of the northbound lane of I-75 (Latitude 29°39'7.99"N / Longitude 82°24'44.00"W)

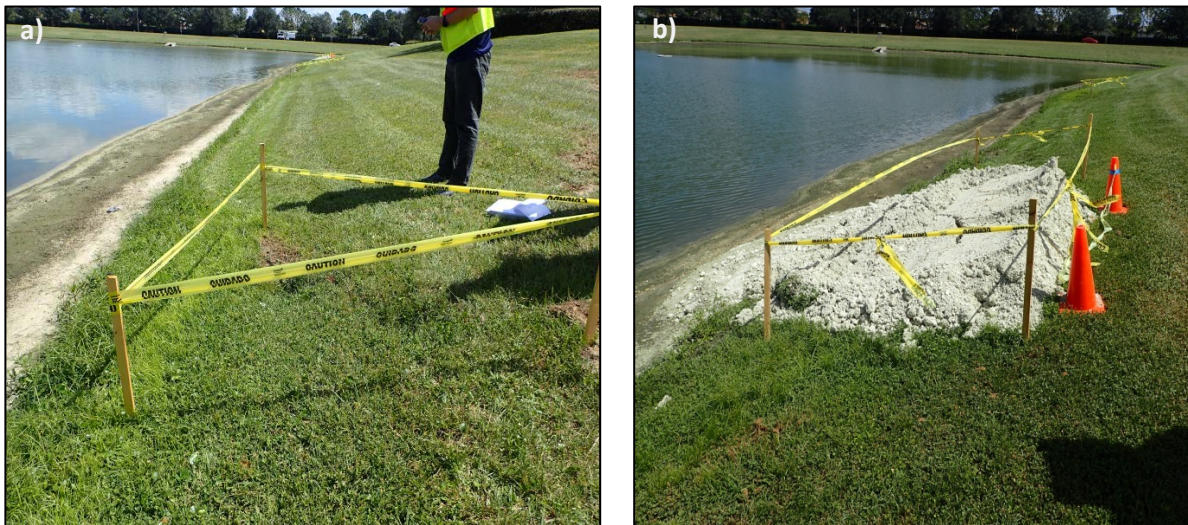
likely the largest sinkhole since it had been overfilled with granular soil. It is also the closest to the water level in the retention pond. The pond was most likely being drained so repairs could be made to the small sinkholes.

Figure 25. Sinkholes on the bank a) Site 1-1, b) Site 1-3 (Latitude 29° 8'47.98"N / Longitude 82°12'31.30"W).

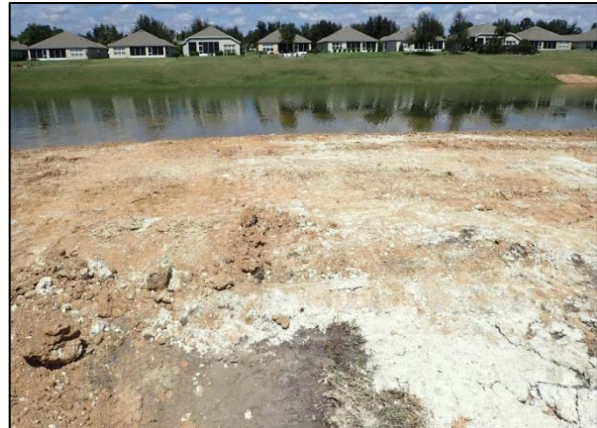
Repaired sinkhole E

Figure 27. Repaired sinkholes on the bank of the retention pond (Latitude 29° 8'48.30"N / Longitude 82°12'52.89"W).

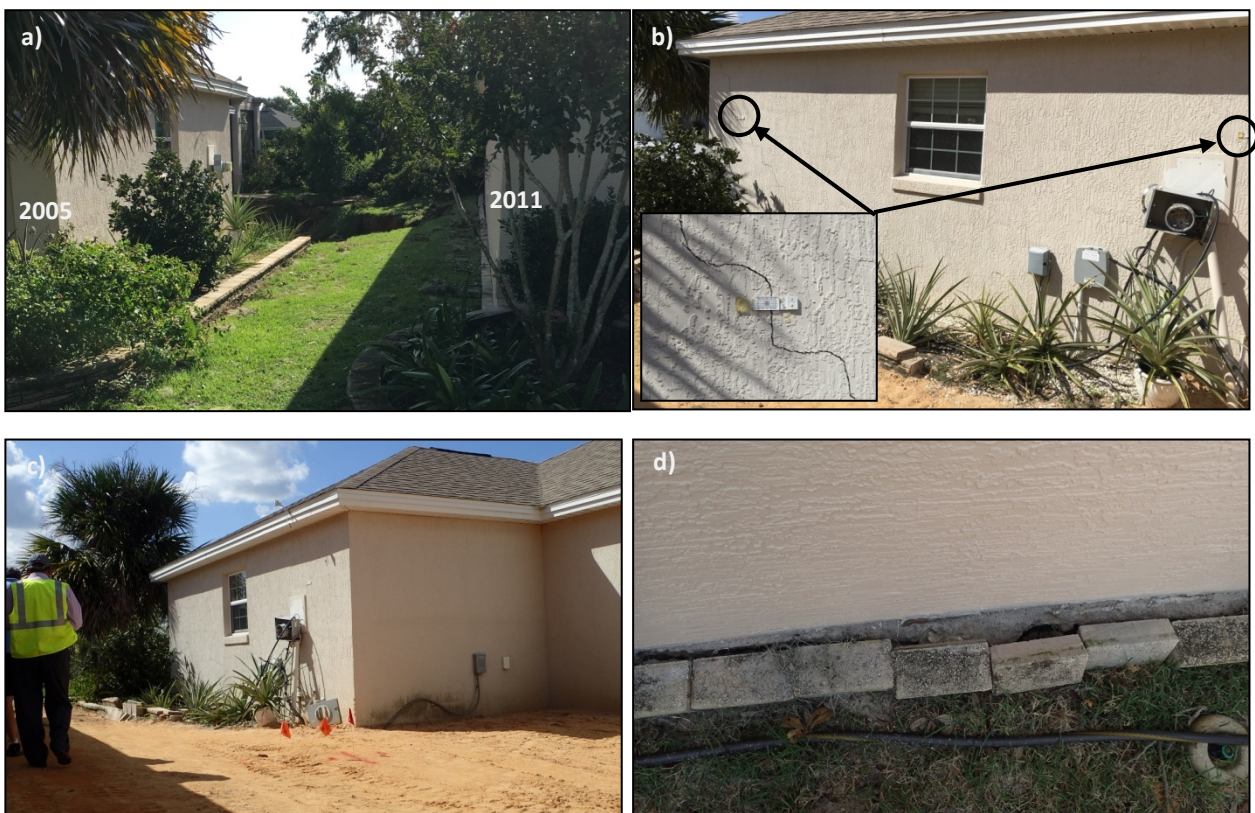
Figure 30: Documentation of a sinkhole that formed between homes at 2005 and 2011 Markridge Loop, The Villages, FL., including: a) the open sinkhole (dimensions unknown; pers. comm. Doug Wernicke); and b) cracks on the wall of 2005 Markridge Loop with crack gages; c) area between the two homes; and d) evidence of ground subsidence and an irrigation system at the wall of 2011 Markridge Loop after sinkhole backfilling. (Latitude 28°53'0.57"N / Longitude 82° 0'1.02"W).

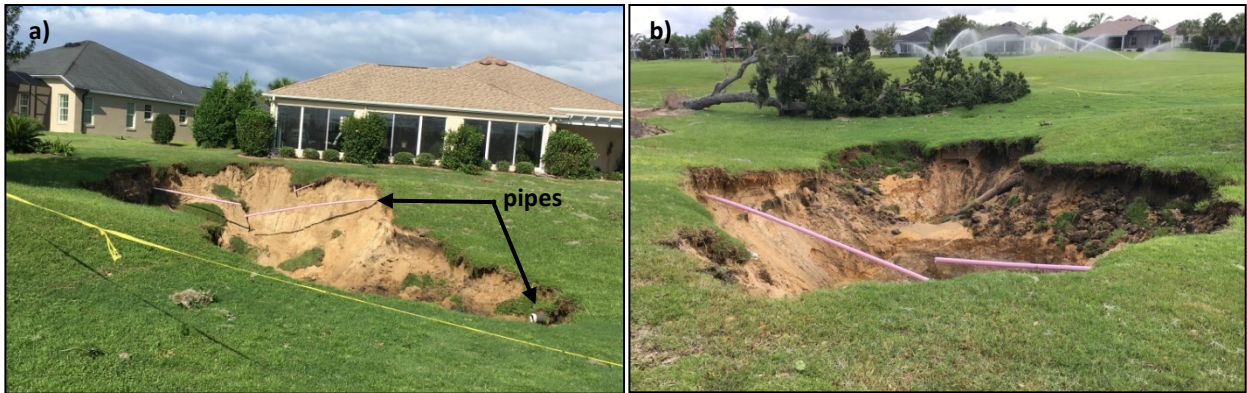
Figure 31: Images of a large sinkhole (dimensions unknown) that formed behind 2011 Markridge Loop, The Villages, FL. Note the small and large diameter pipes and large felled tree. (pers. comm. Doug Wernicke). (Latitude 28°52'59.95"N / Longitude 81°59'59.73"W).

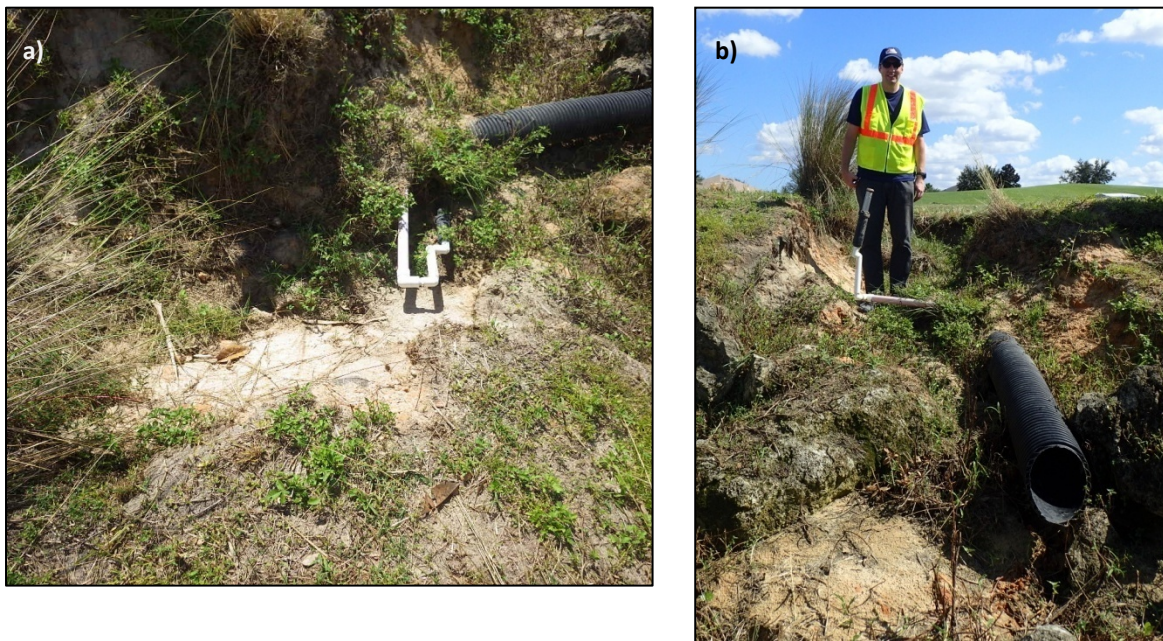
Figure 32: Documentation of a sinkhole and overland erosion that formed at edge of the golf course retention pond between Markridge Loop and Dover Hollow Run in The Villages, FL (Latitude 28°52'57.88"N / Longitude: 81°59'58.93"W).

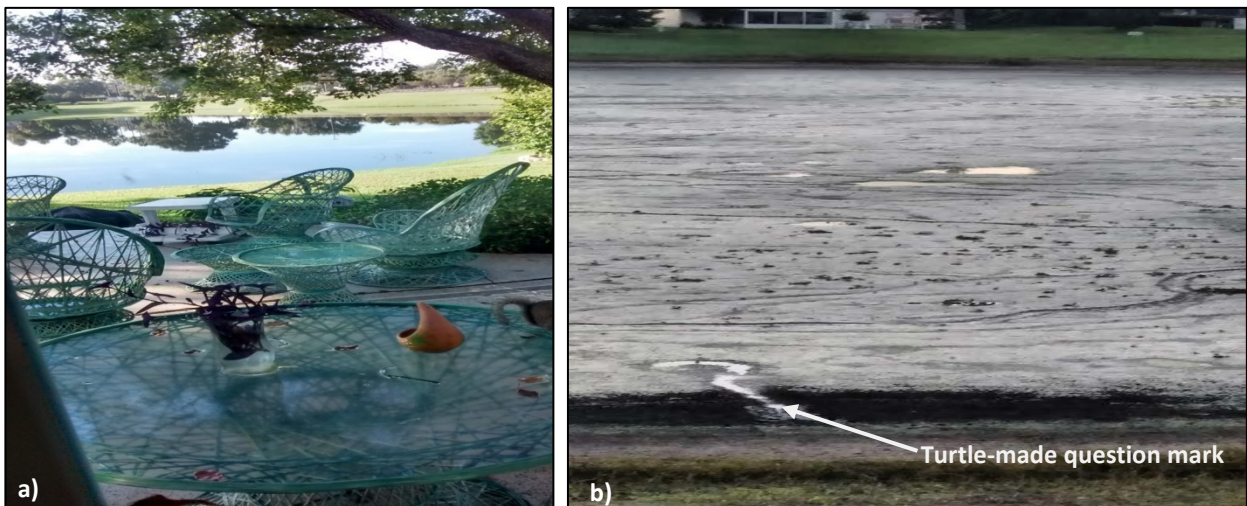
Figure 34. Images illustrating the retention pond a) prior to (Aug. 9 2017), and b) following (Sept. 18, 2017) Hurricane Irma and sinkhole formation where the view is from Alhambra Way. (Latitude 28°57'12.85"N / Longitude 81°59'36.36"W). Images courtesy of Dan Snyder and Sheila Huffman Dailey.

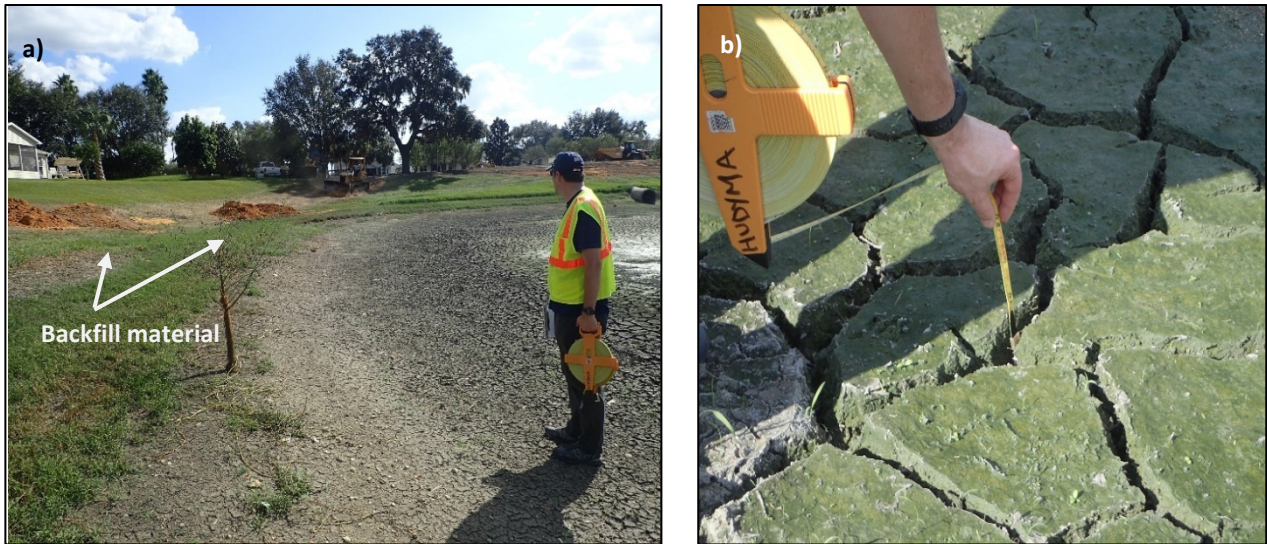
Figure 35. Retention pond between Alhambra Way and Botello Ave. (a) fully drained retention pond with fill material placed on the bank for backfilling sinkholes (Latitude 29°57'9.18"N / Longitude 81°59'31.5"W), and (b) 10 mm deep desiccation cracks in the pond bottom (Latitude 28°57'10.94"N / Longitude 81°59'36.67"W).

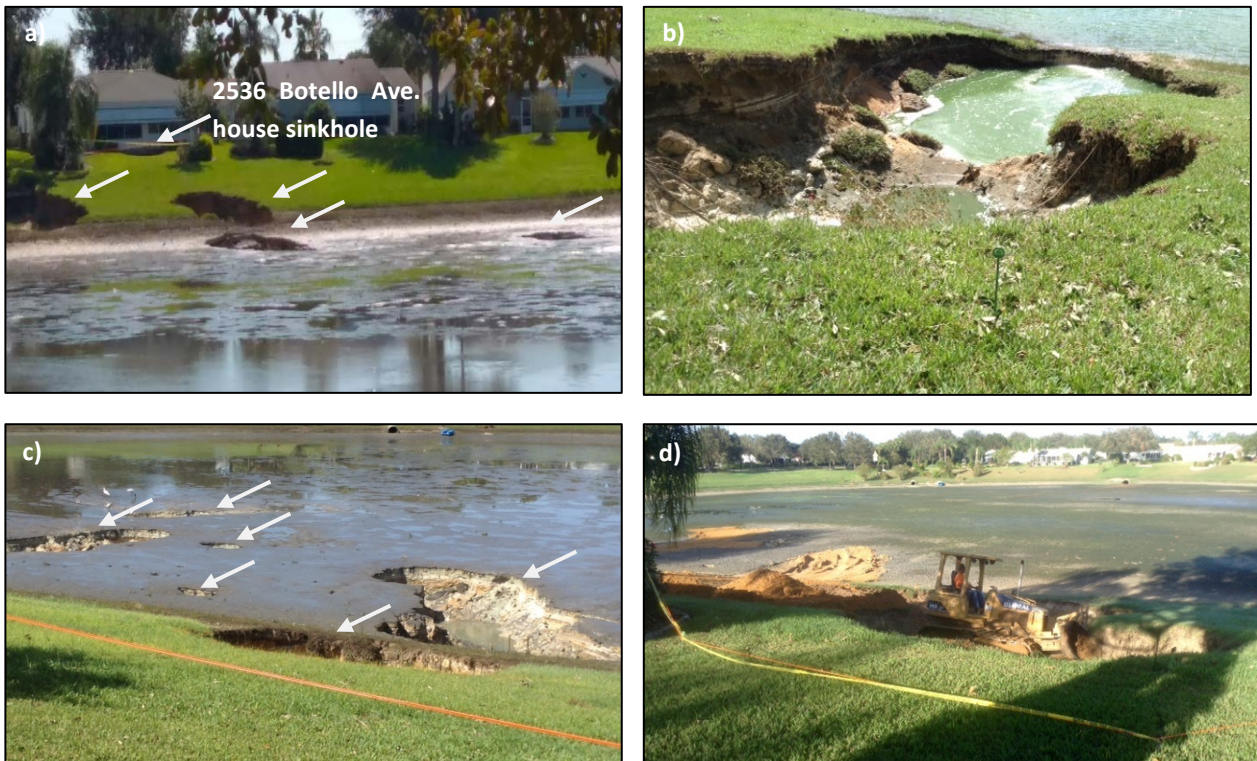
Figure 36. Sinkholes on the bank of, and within the retention pond between Alhambra Way and Botello Ave. (a, b, c), and under repair (d) (Latitude 28°57'11.92"N / Longitude 81°59'31.49"W) (images courtesy of local residents Sheila Huffman Dailey, Dan Snyder, and Barbara Beveridge).

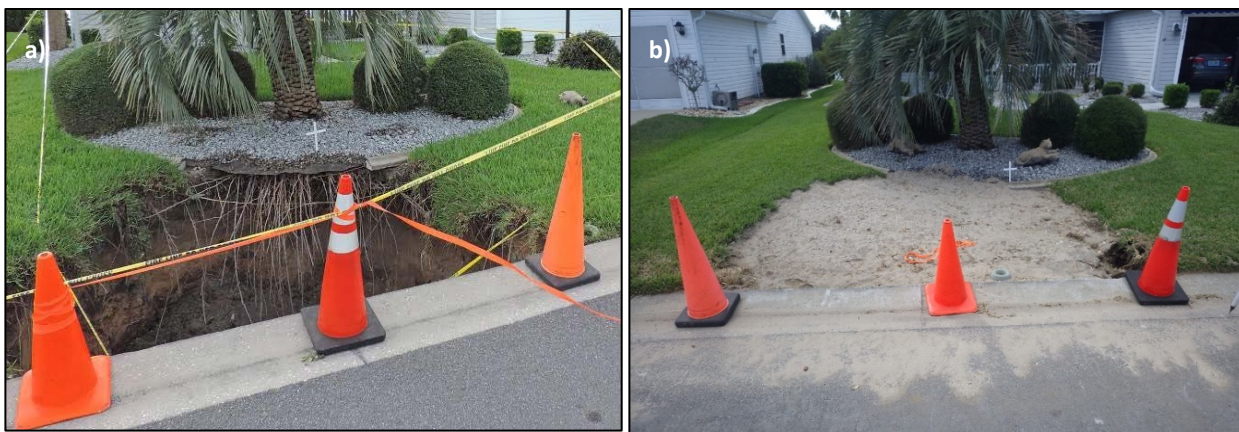
Figure 37. Sinkhole formed at 2532 Botello Avenue a) prior to repair¹⁹ and b) following repair (Latitude 28°57'10.60"N / Longitude 81°59'30.50"W).

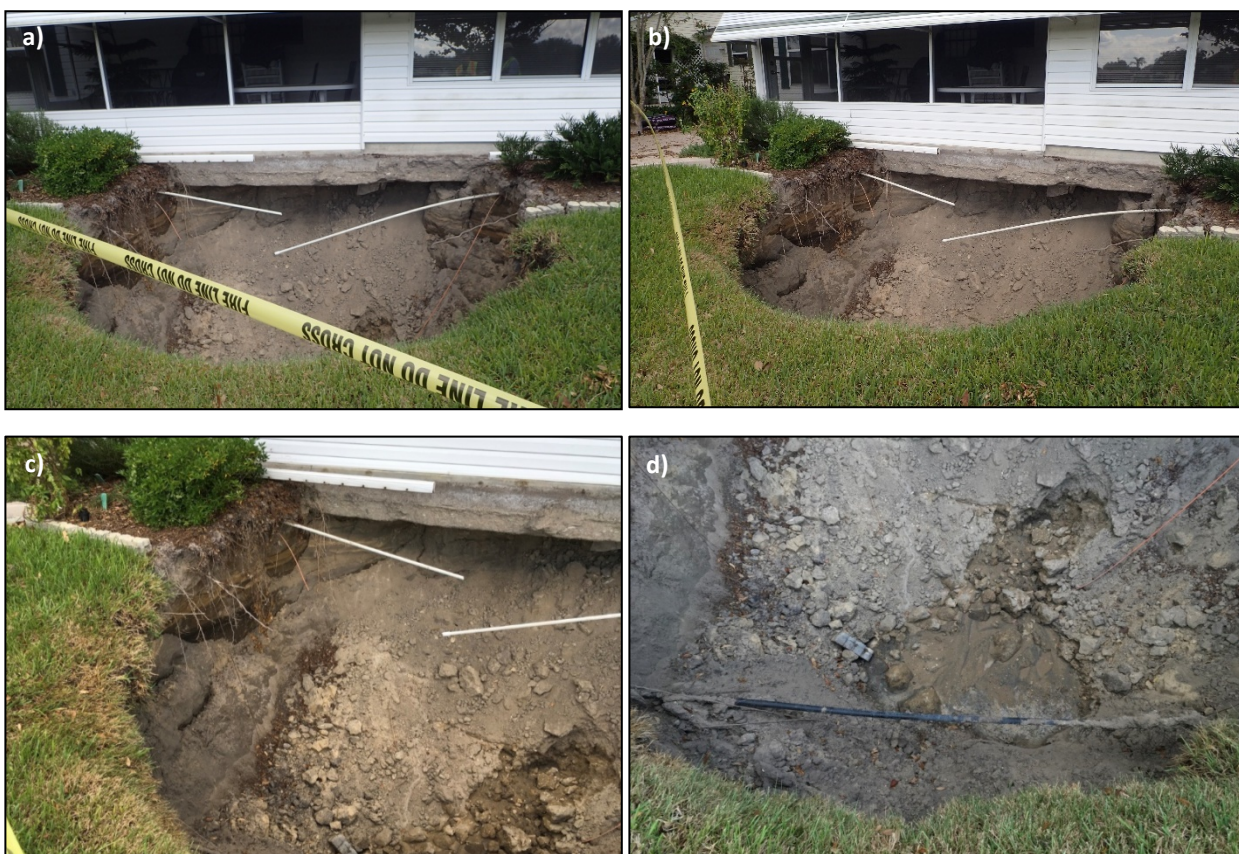
Figure 38. Sinkhole undercutting a foundation at 2536 Botello Rd. showing multiple front views (a, b, c,) and bottom of the sinkhole (d). (Latitude 28°57'11.67"N / Longitude 81°59'30.05"W).

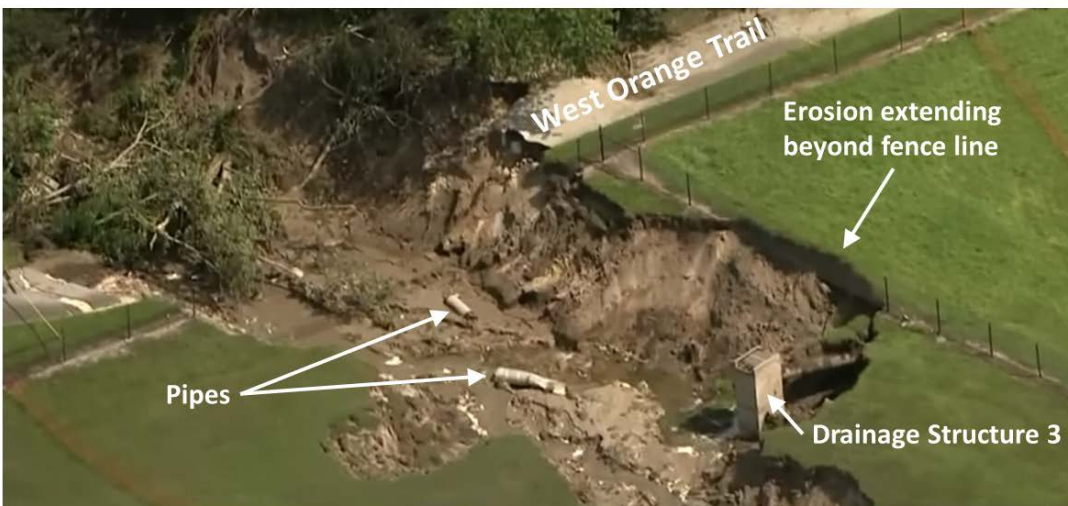
Figure 41: Aerial image of the Apopka erosion washout that bisected the West Orange Trail and damaged two large scale drainage structures²¹ (approximate location Latitude 28°41'8.68"N / Longitude 81°30'20.97"W).

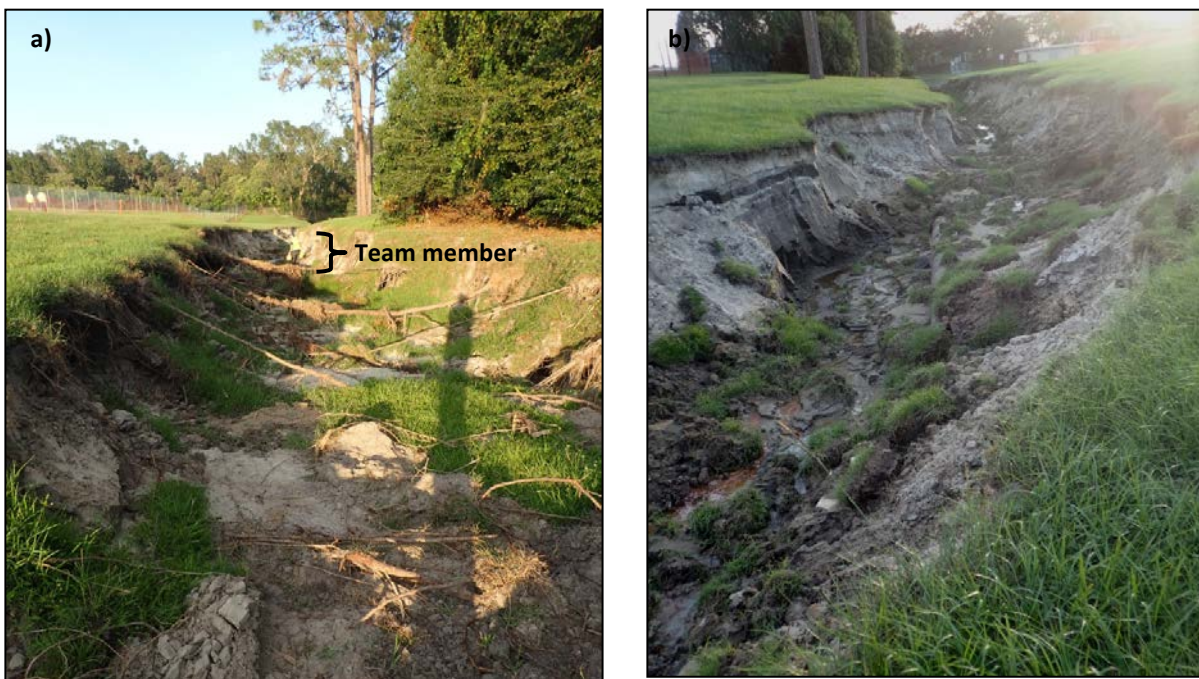
Figure 42: Images of the channel where the view is a) toward the east from the western portion of the channel (Latitude 28°41'7.87"N / Longitude 81°30'24.97"W), and b) toward the west from the channel (Latitude 28°41'8.70"N / Longitude 81°30'22.33"W).

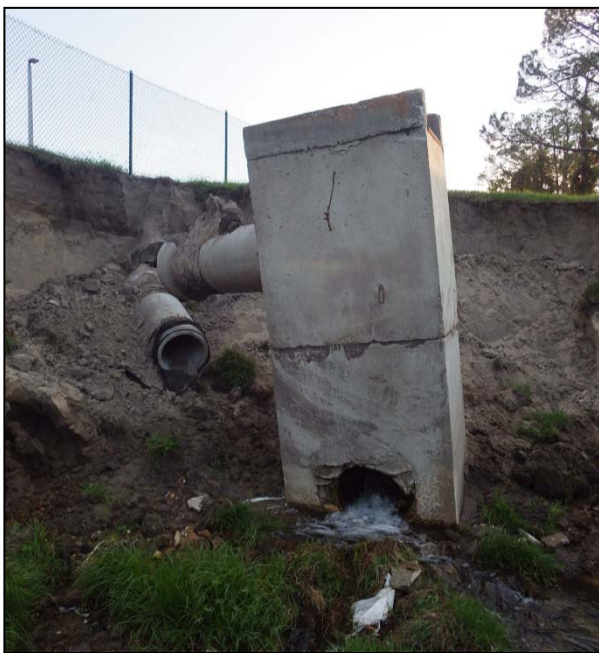
Figure 45. Damaged drainage structure 3 (Latitude 28°41'9.08"N / Longitude 81°30'22.39"W).

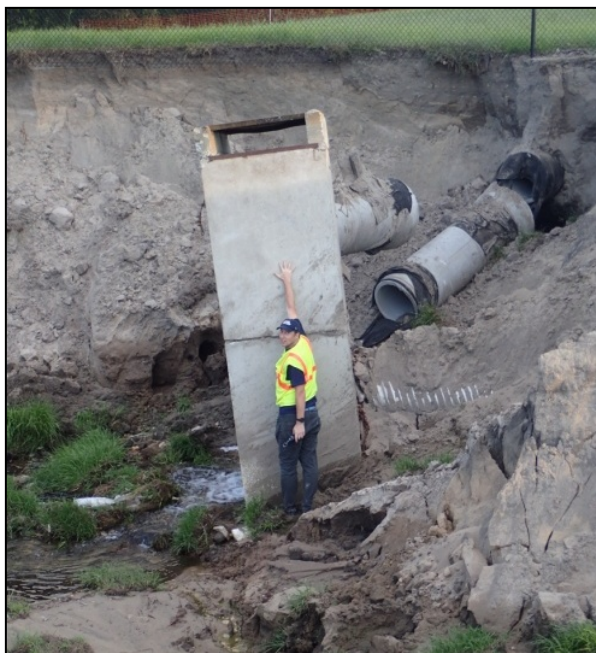
Figure 46. Damaged drainage structure 3, dimensioned by the investigators 2.4 m reach (Latitude 28°41'9.08"N / Longitude 81°30'22.39"W).

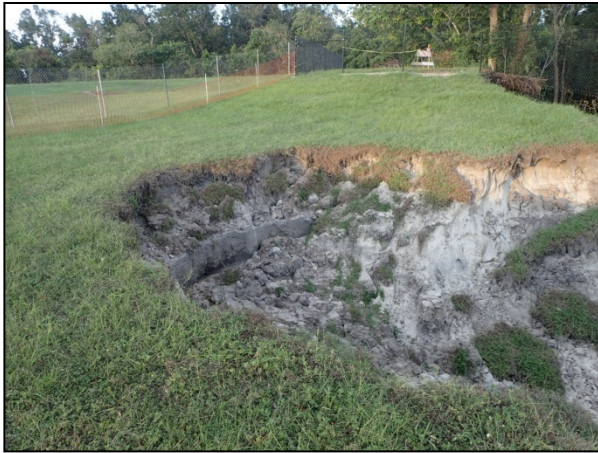
Figure 47. Erosion lateral to the main channel likely from failed drainage structure 3 (Latitude 28°41'9.15"N / Longitude 81°30'21.64"W).

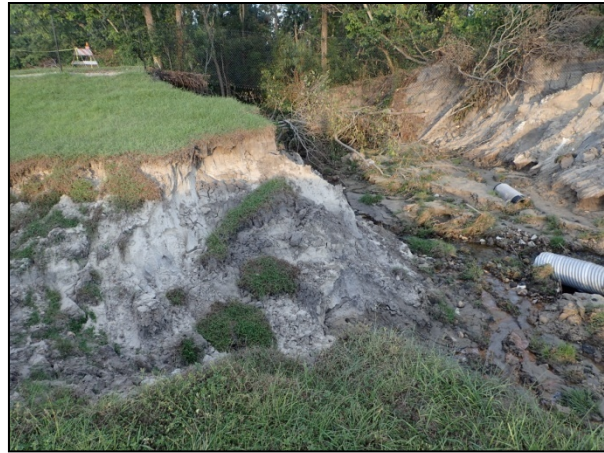
Figure 48. Erosion lateral to the main channel likely from failed drainage structure 3 (Latitude 28°41'9.15"N / Longitude 81°30'21.64"W).

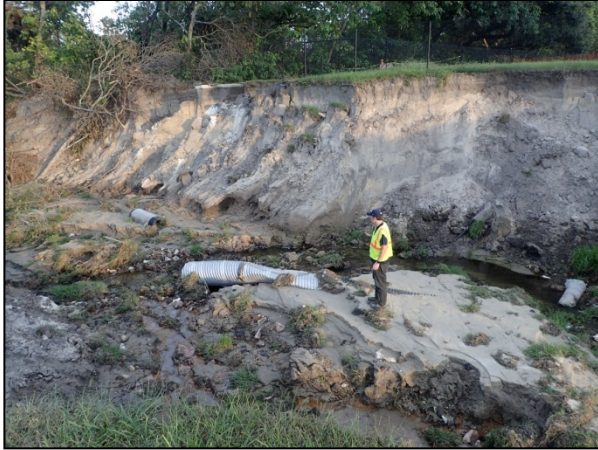
Figure 49. Damaged pipes, eroded West Orange Trail, and uprooted trees at drainage structure 3 area (Latitude 28°41'9.15"N / Longitude 81°30'21.64"W).

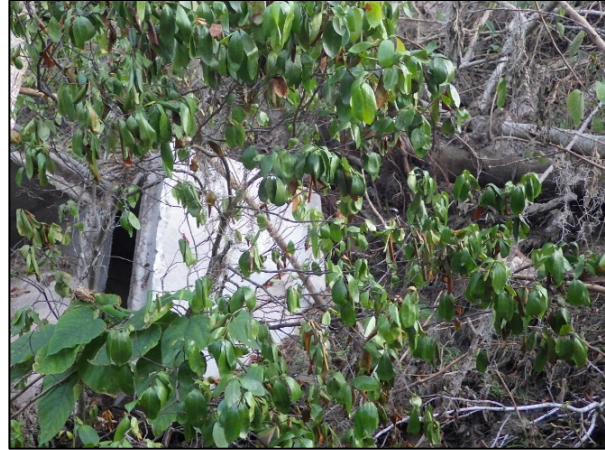
Figure 50. Fourth drainage structure buried under wooded debris east of the West Orange Trail. (Latitude 28°41'8.71"N / Longitude 81°30'20.57"W).

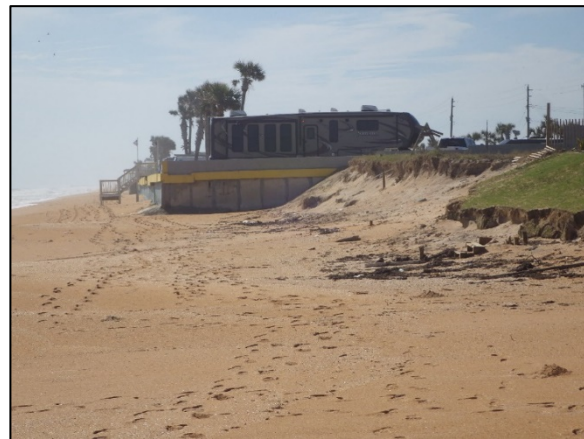
d) Scour on the north wing wall of the concrete seawall (Latitude 29°32'36.21"N / Longitude 81°9'30.17"W).

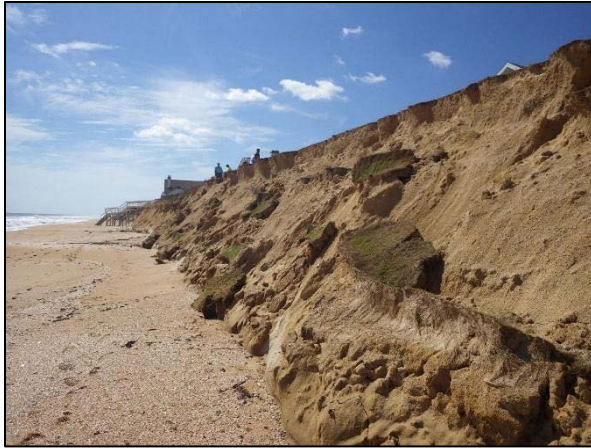
a) Extent of dune failure (photograph taken facing south, Latitude 29°32'35.83"N / Longitude 81°9'29.51"W).

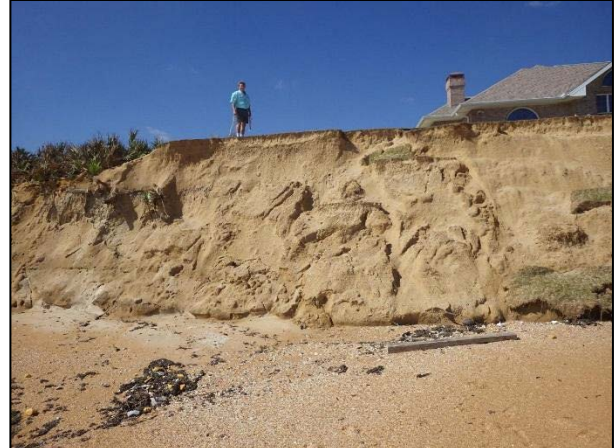
b) Location where failed dune slope height was measured (Latitude 29°32'35.34"N / Longitude 81°9'29.59"W).

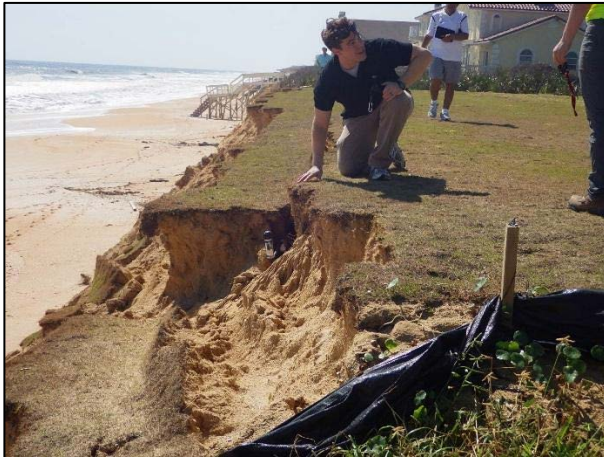
c) Close up of blocky nature of failed dune crest (Latitude 29°32'36.74"N / Longitude 81°9'29.95"W).

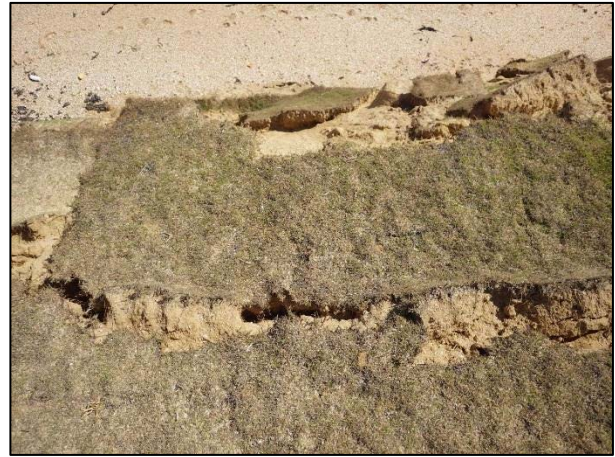
d) Close up of seam in sod where moisture most likely infiltrated into the dune (Latitude 29°32'35.83"N / Longitude 81°9'29.51"W).

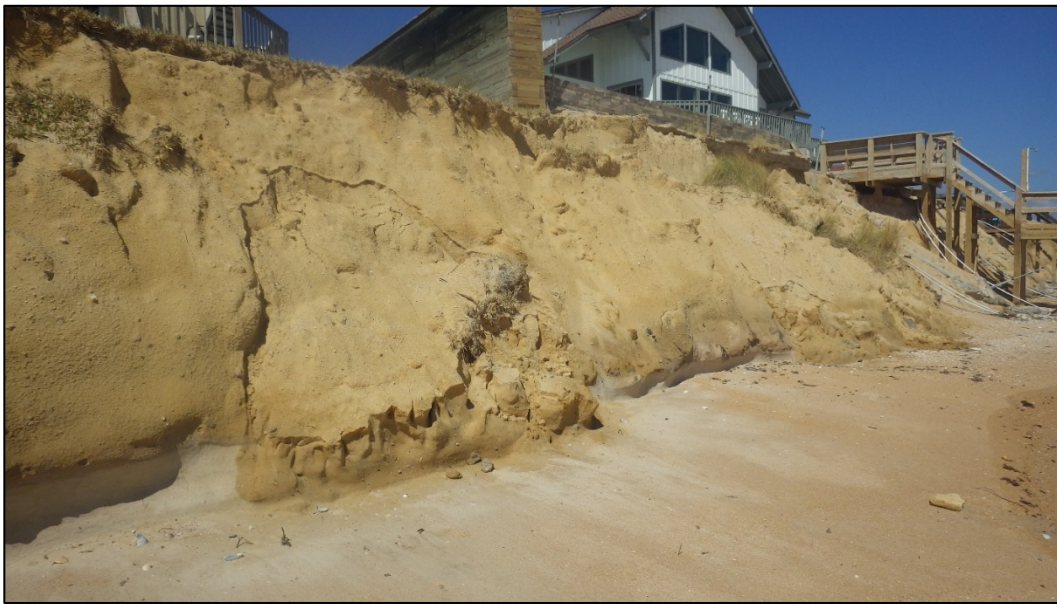
Figure 60. Eroded dune showing active sloughing, undercutting of deck, and potentially unstable timber beach staircase (Latitude 29°32'31.04"N / Longitude 81°9'27.05"W).

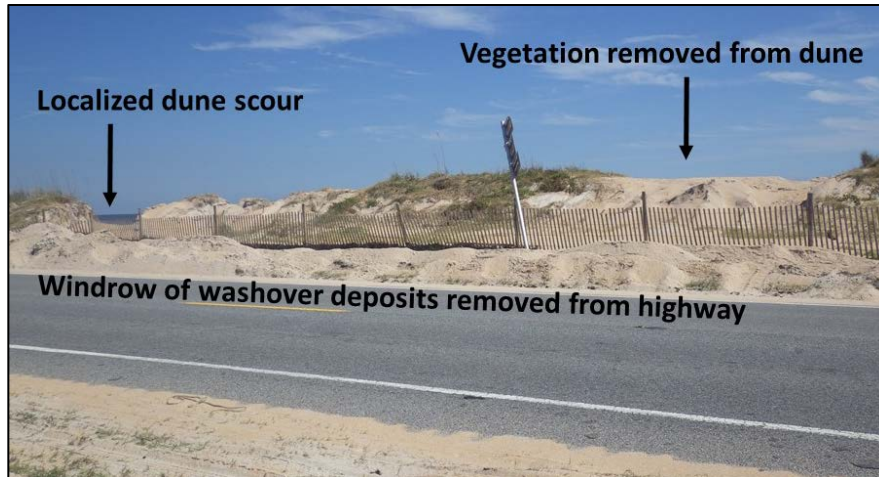
a) Overwash damage to dunes on the east side of Highway A1A (Latitude 29°40'14.09"N / Longitude 81°12'50.37"W).

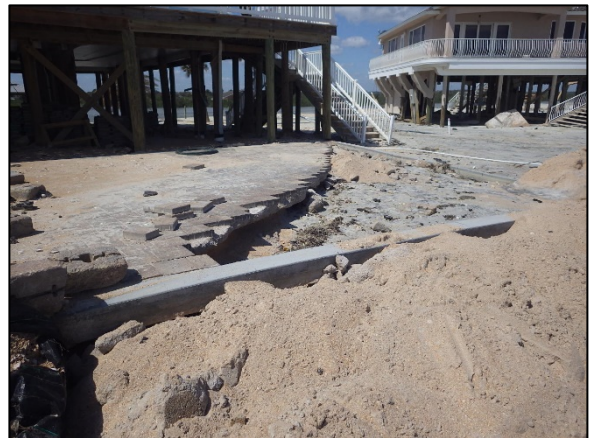
d) Scour under a deck constructed of brick pavers (Latitude 29°40'38.5"N / Longitude 81°12'58.24"W).

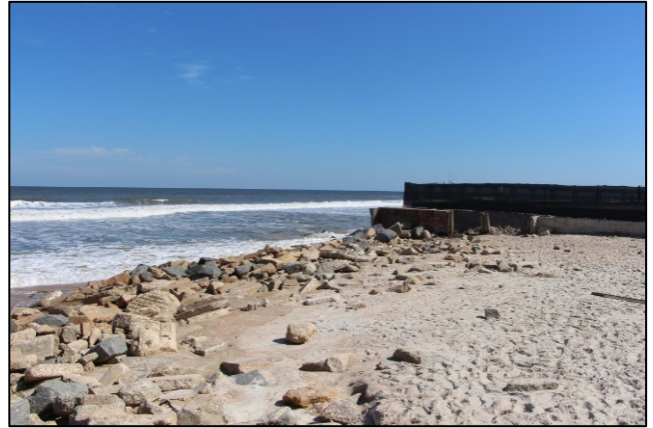
d) Overwash and unravelling of poorly constructed revetment (approximate location Latitude 29°51'34.61"N / Longitude 81°15'57.22"W).

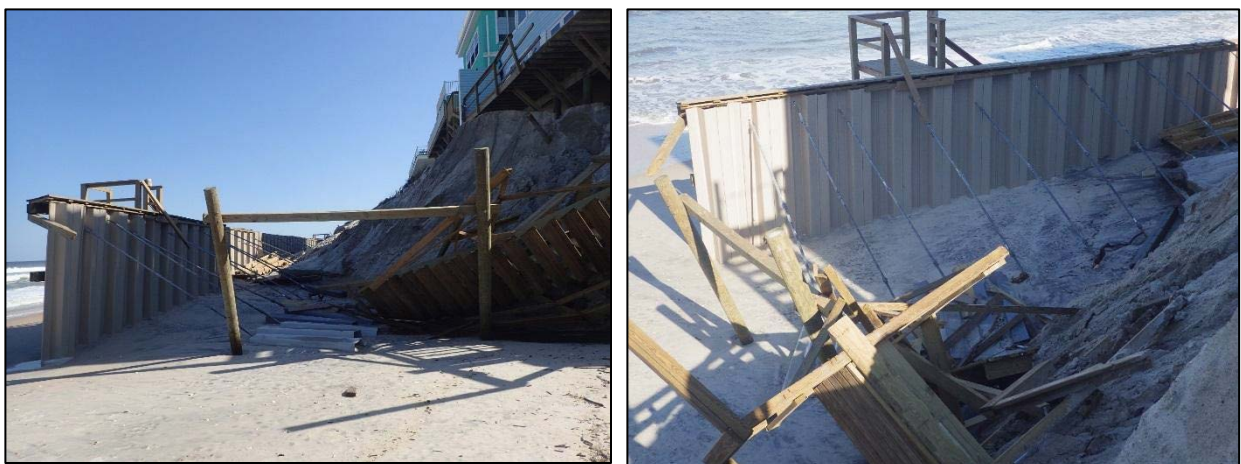
a) Scour exposing anchors and north wing wall is missing (Latitude 29°56'46.05"N / Longitude 81°18'7.5"W).

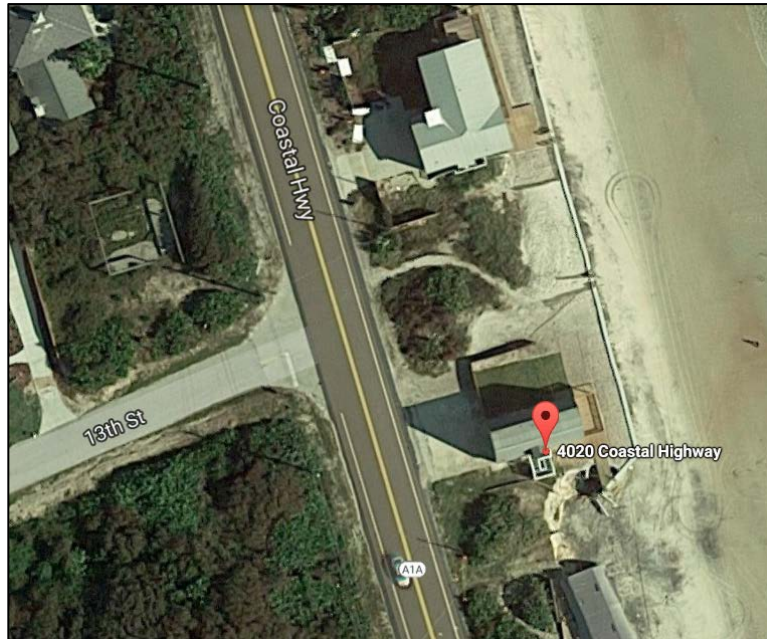
Figure 74. Aerial image of south wing wall damage at 4020 Coastal Highway, Vilano Beach, FL (Latitude 29°56'55.10"N / Longitude 81°18'11.25"W, from Google Earth, 2017).

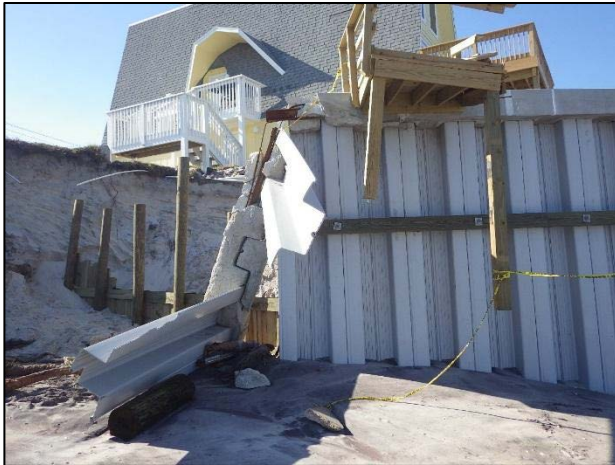
a) South wing wall destroyed.

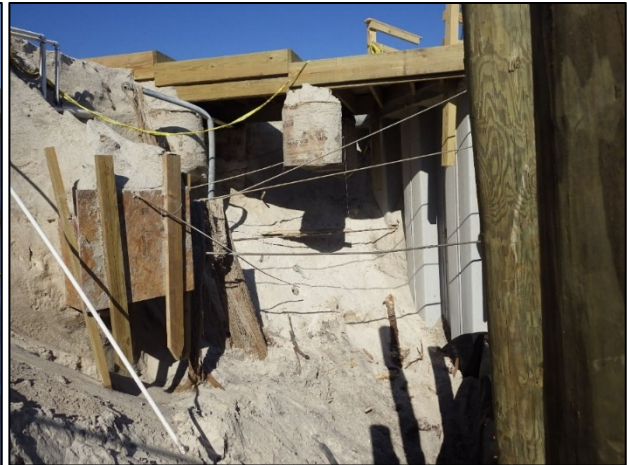
b) Damage behind the retaining structure.

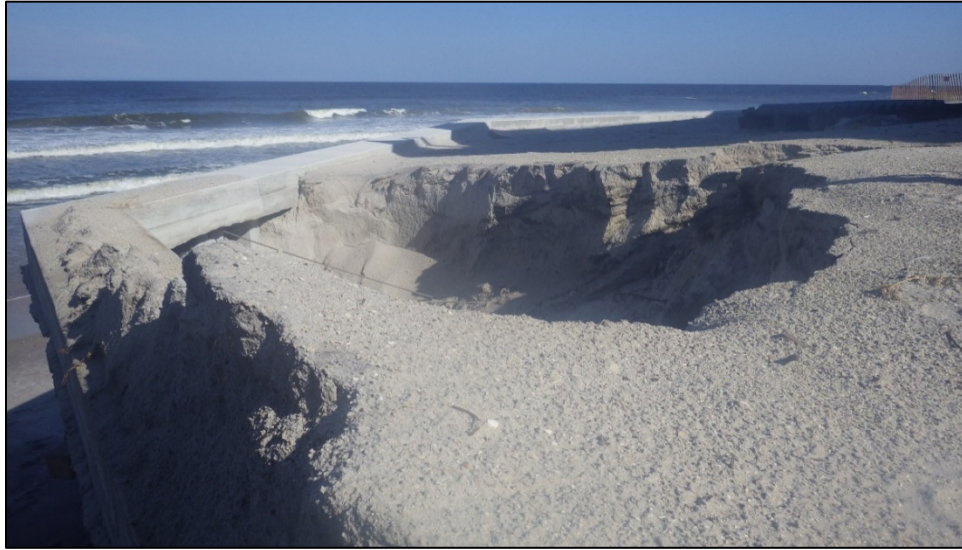
c) Ground loss behind sheet pile (Latitude 29°56'58.16"N / Longitude 81°18'11.96"W).

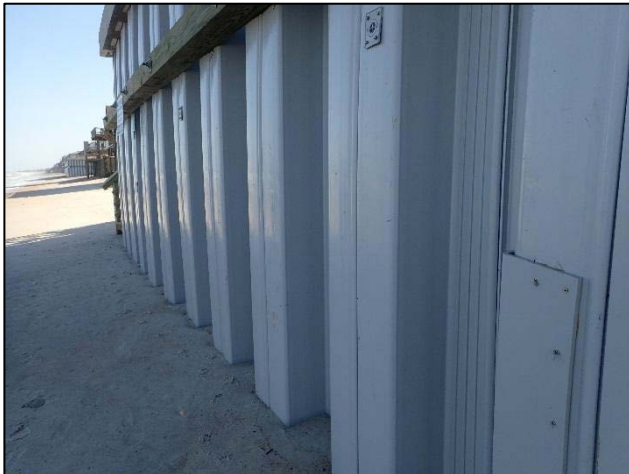
a) Wall bowing below wale and anchors (Latitude 29°57'46'1.08"N / Longitude 81°18'12.22"W).

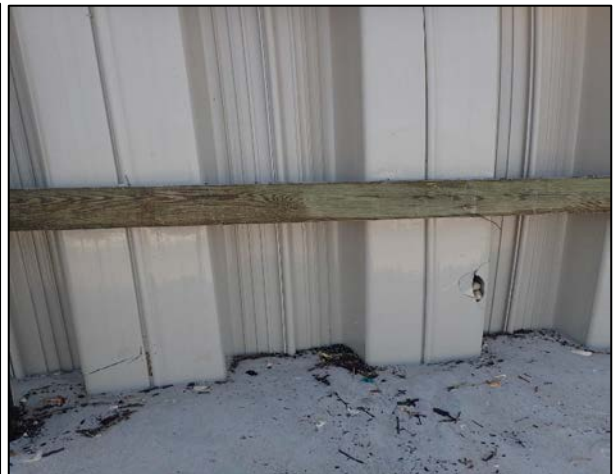
b) Cracking and hole in sheet pile material (Latitude 29°56'44.79"N / Longitude 81°18'7.05"W).

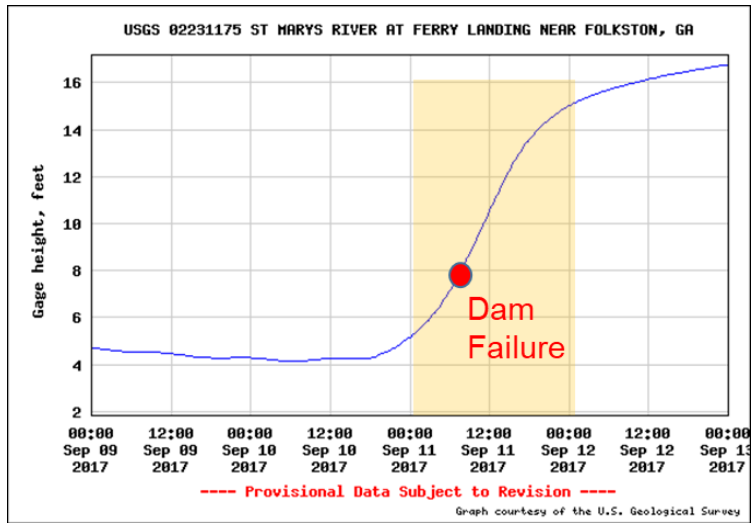
Figure 86. Dam failure and St. Mary's River hydrograph.

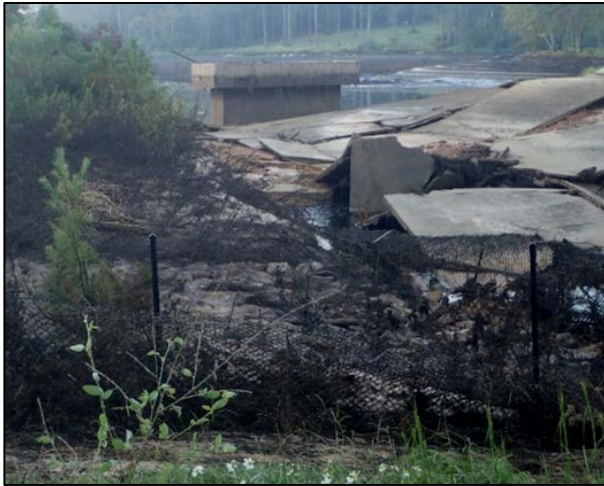
a) Failed dam showing concrete box weir intact
(Latitude 30°46'40.1"N / Longitude
81°58'13.0"W).

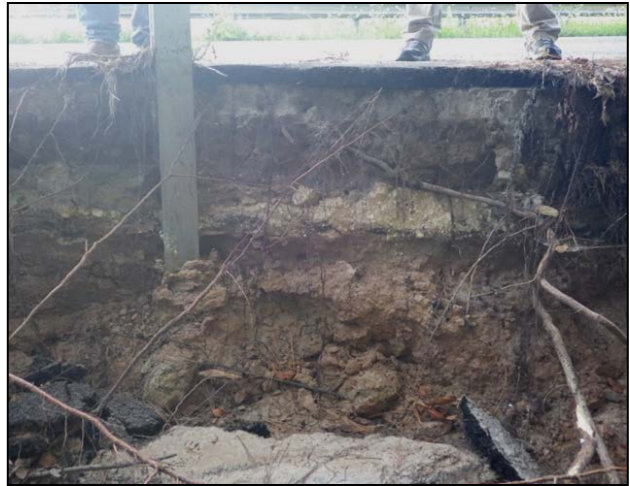
b) Scour at pavement edge on north shoulder of
Lake Hampton Road (Latitude 30°46'45.19"N /
Longitude 81°58'24.6"W).

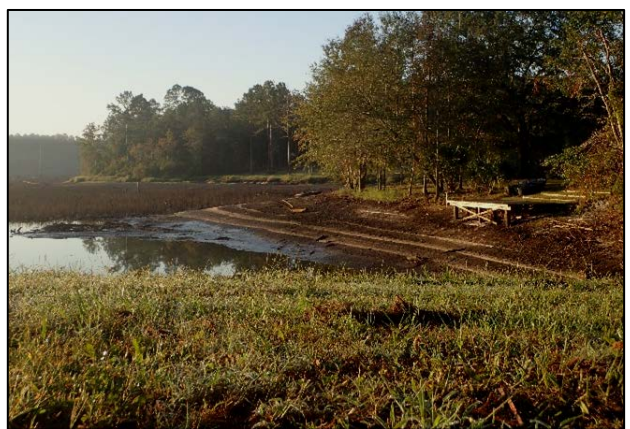
d) Lowered water levels in Lake Hampton
(Latitude 30°46'37.97"N / Longitude
81°58'14.27"W).

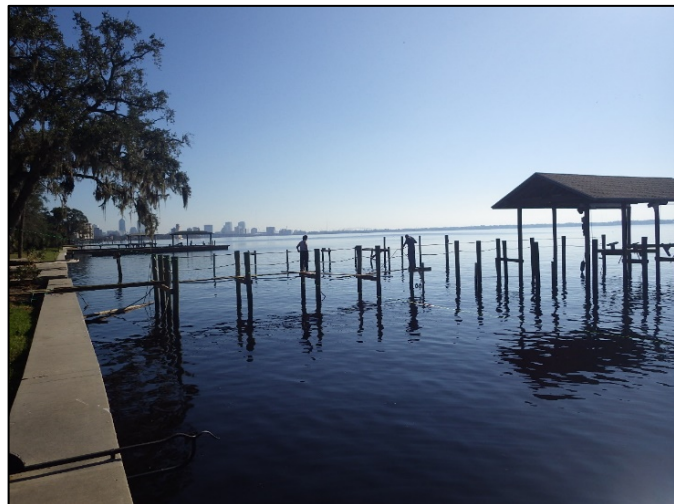
b) Damage to private dock.

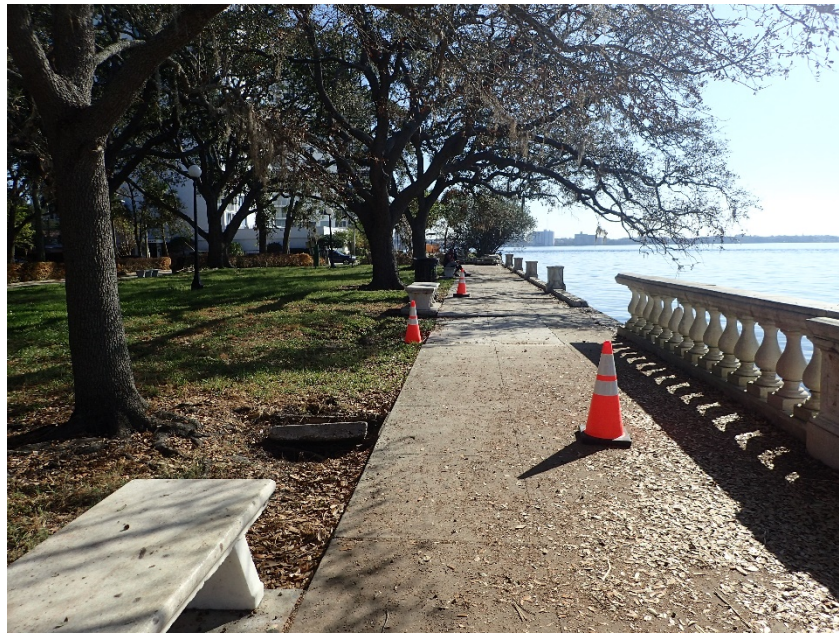
Figure 91. Photo showing sections of the broken decorative railing. Photograph taken looking north. (Latitude 30°18'36.11"N / Longitude 81°40'44.68"W).
