Geotechnical Extreme Events Reconnaissance

Geotechnical Damage in Central and Northeastern Florida from Hurricane Irma

GEER Association Report No. GEER-056b

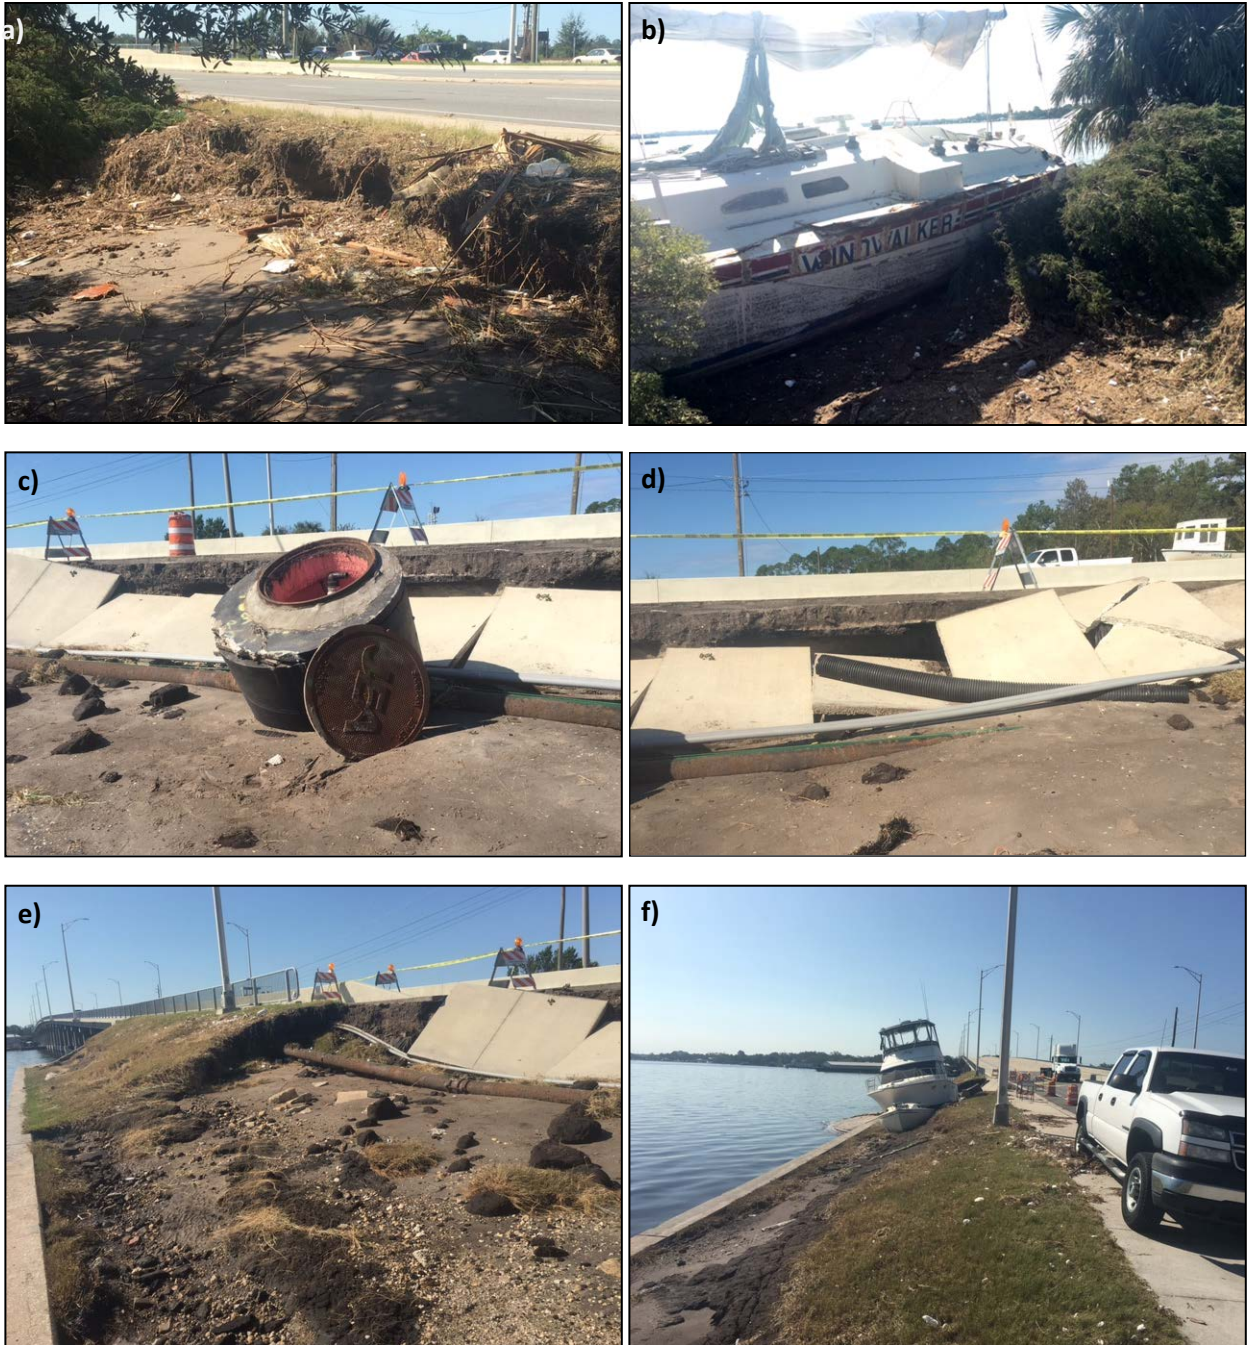
Figure 94. Scour damage along the northeast bridge embankment of the US 17 bridge over the Trout River, (Latitude 30°23'45.44"N / Longitude 81°38'53.95"W). Scour features are presented from north to south toward the concrete cover of the embankment that demonstrate erosion of soil below the road shoulder that resulted in broken pavement and exposed buried infrastructure that included: shallow roadside scour (a); boat washed ashore and scour pattern (b); an exposed sewer access structure and sewer pipe originally located 5 feet below finished grade (c); exposed sewer pipe and conduit for electrical service to light poles (d), and; the terminus of scour (e). Scour was likely caused by eddies and turbulence around two boats washed ashore (f).

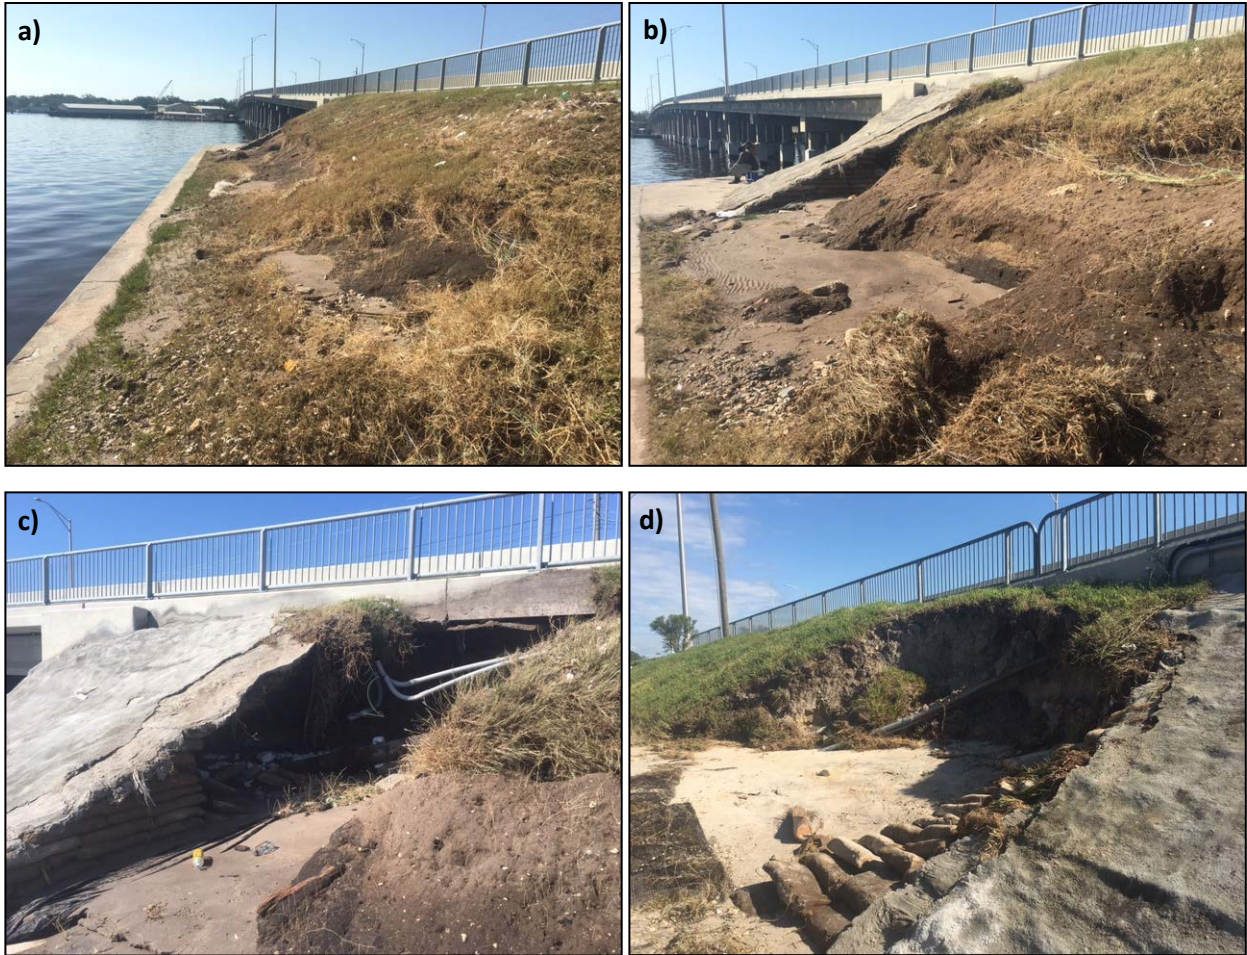
Figure 95. Scour damage along the northern bridge embankment of the US 17 bridge over the Trout River, (Latitude 30°23'44.43"N / Longitude 81°38'54.13"W). Scour features are presented from north east to north west near the concrete cover of the embankment that demonstrate erosion, which included: embankment soil erosion north of the bridge abutment (a, b), and erosion at the interface between the soil and concrete faced, stacked concrete sack wall at the east (c), and west (d) side of the north abutment.
