# The 2021 Marshall Fire, Boulder County, Colorado

## Geotechnical Extreme Events Reconnaissance Association

Version 1.0  
May, 2022

GEER—075

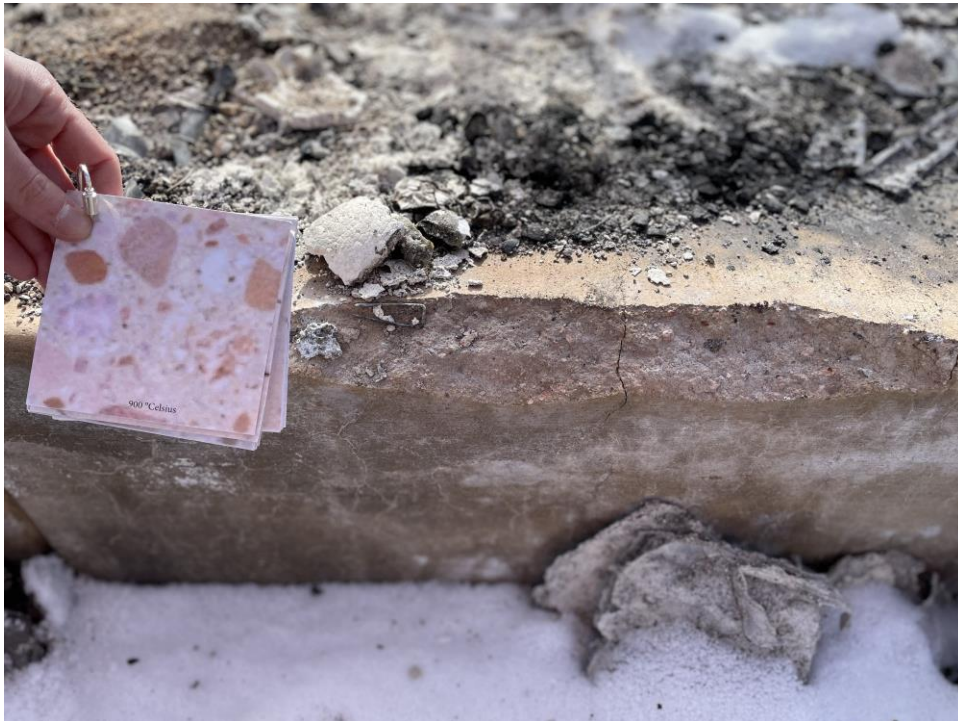
The temperature of the foundation was determined by comparing the colors of concrete provided in Hager (2014) to the foundation itself (Figure 2-6). The temperature range investigated by Hager (2014) was 300°C – 900°C. Temperature ranges of the foundation were noted in groupings of:

Figure 2-6. Comparing concrete colors from Hager (2014) to foundation colors in the field (39°58'20.0" N, 105°09'22.2" W)

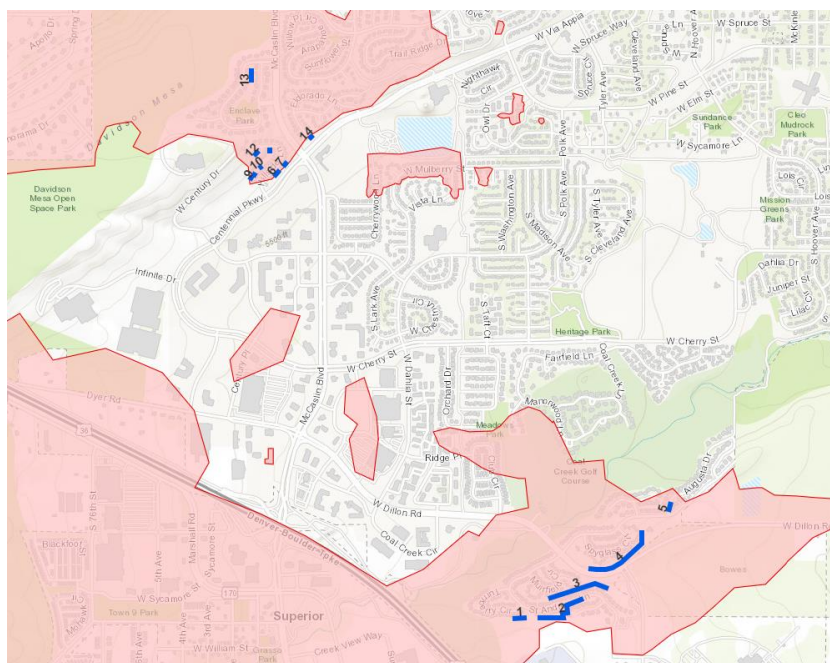
Timber retaining walls suffered the most damage. In several locations, wall facings were completely consumed, lateral timber supports were dislodged or completely consumed, and members embedded in the soil were fully charred at various embedment depths.

Figure 6-1. Locations of impacted retaining walls in Louisville, CO (Walls 1-5: 39°57'21.0" N, 105°09'01.3" W; Walls 6-14: 39°58'27.3" N, 105°09'56.6" W)

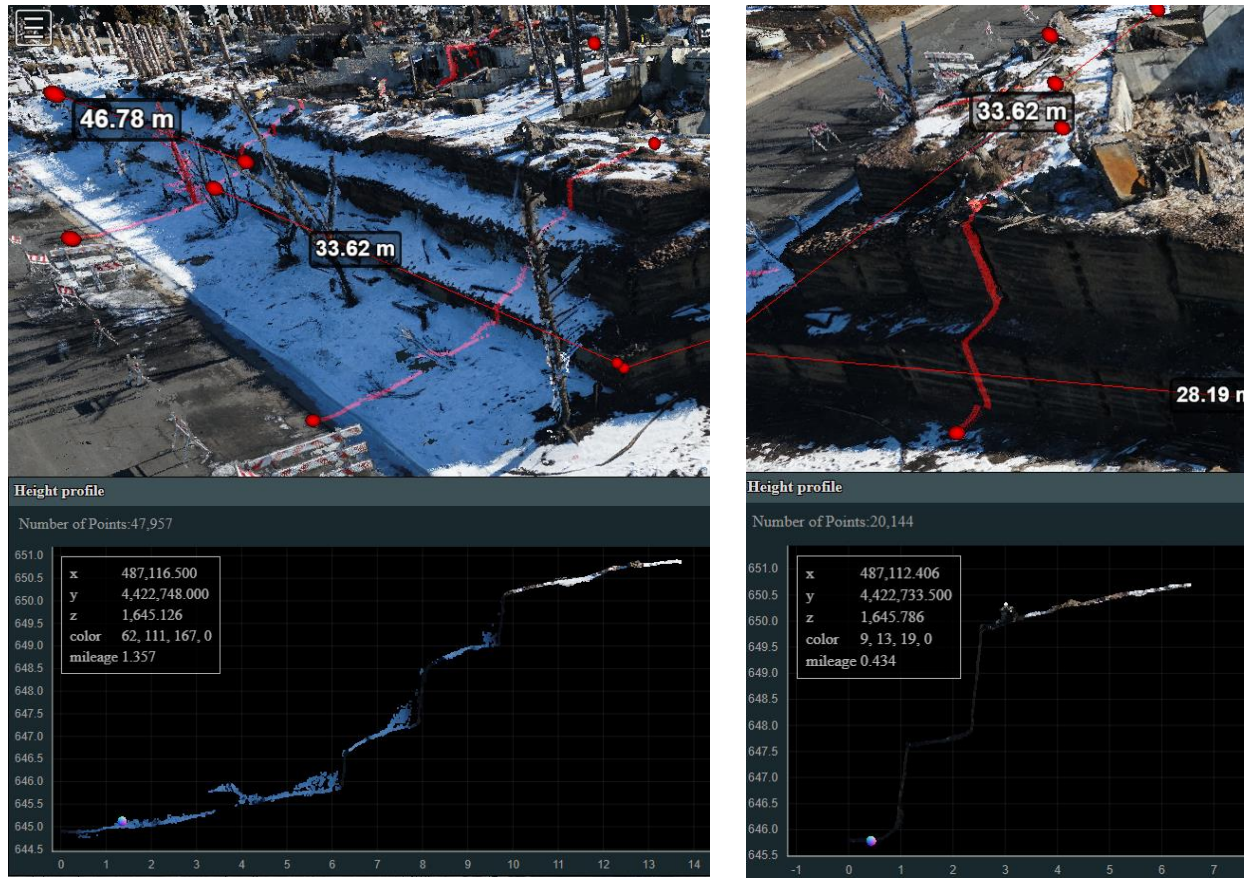
At Profile B (Figure 6-6a), along the North Wall closer to the corner, the total wall height of 15.4 ft (4.7m) exceeds the horizontal offset from toe to top [12.5 ft (3.8m)].

Figure 6-6. RS1 profiles (a) Profile B extending from St. Andrews Lane to elevated foundation (39°57'16.3" N, 105°09'02.2" W) and (b) Profile C the RAPID mobile equipment vehicle (39°57'15.8" N, 105°09'02.1" W)

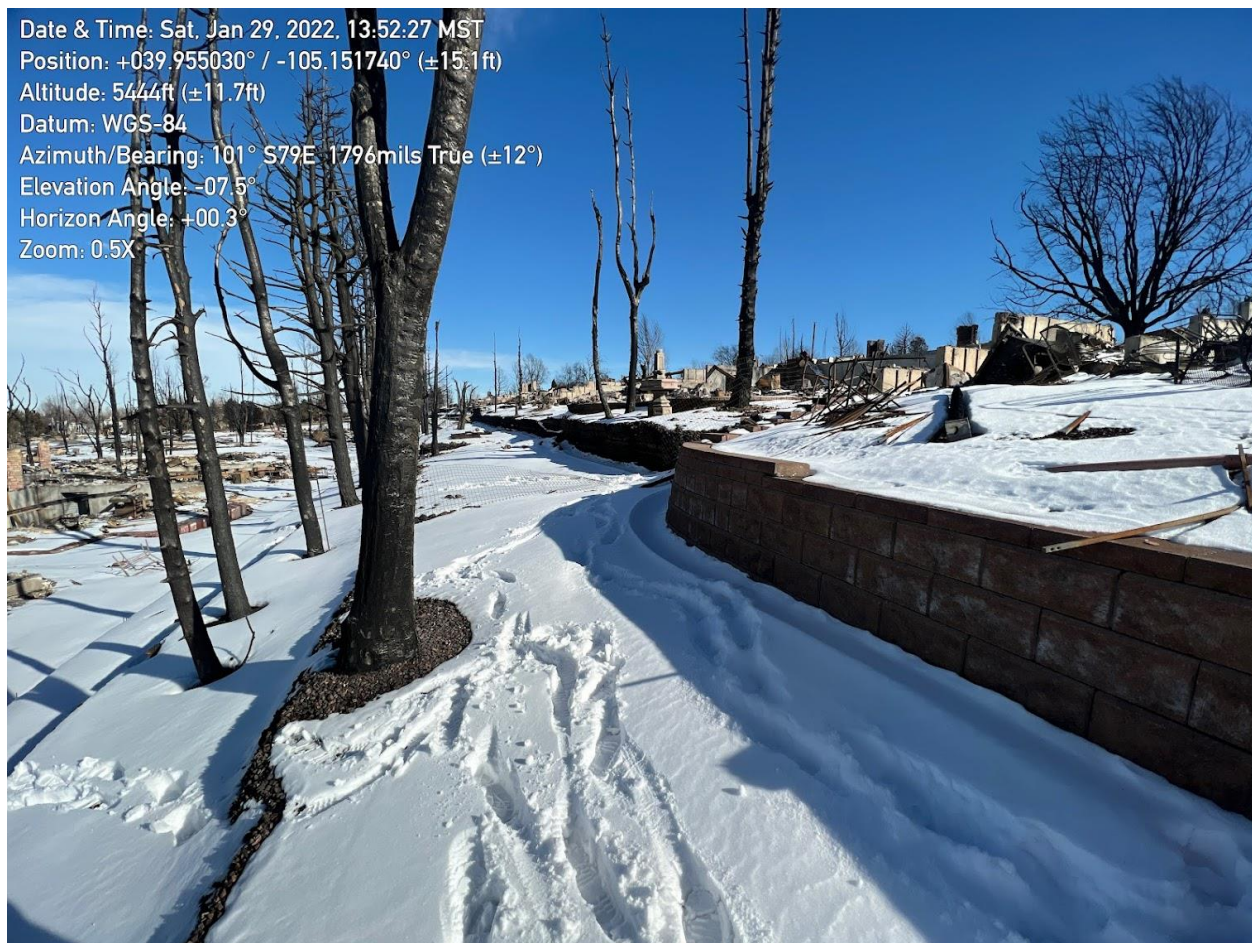
Figure 6-13. Backyard retaining walls behind houses along the north side of St. Andrews Ln showing good performance of masonry block wall (foreground) relative to fully burned tiers in the background and below (39°57'18.1" N, 105°09'06.3" W)

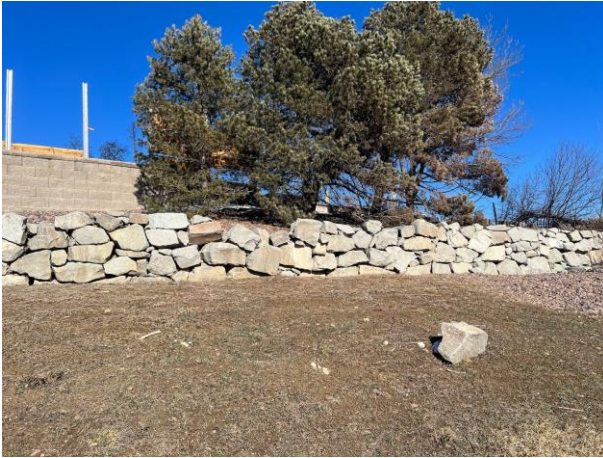
(a) Dislodgment at McCaslin and Via Appia  
(39°58'22.7" N, 105°09'52.5" W)

Figure 6-14. Stone retaining structures in Louisville, along Via Appia Way

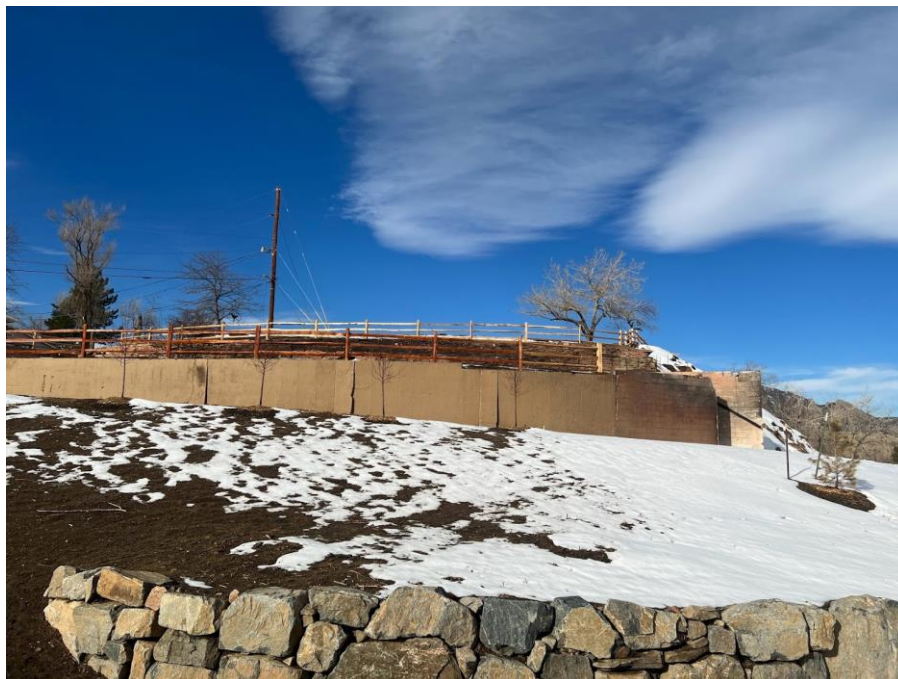
Figure 6-15. Reinforced concrete wall at corner of Marshall Rd and Eldorado Springs Dr.  
(39°57'22.3" N, 105°13'46.4" W)

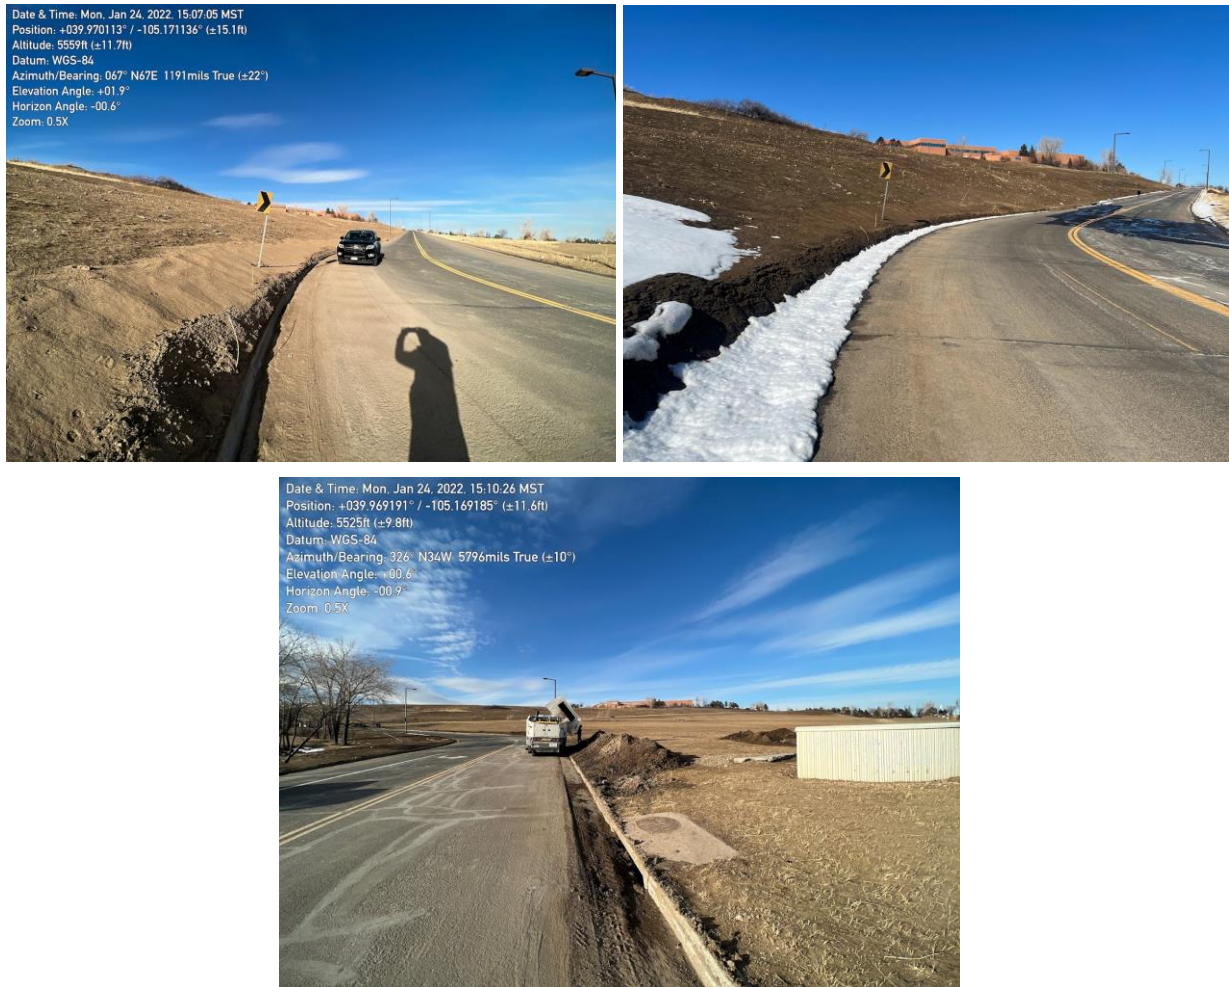
Figure 6-17. Images of soil erosion along Century Blvd. (39°58'12.4" N, 105°10'16.1" W)

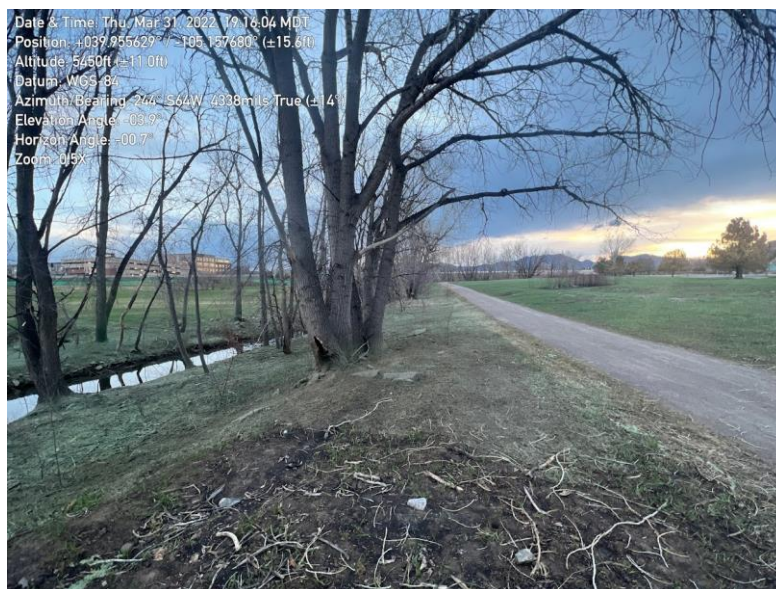
Figure 6-19. Example of hydro-mulch placed at burned areas along waterways; adjacent Coal Creek Golf Course (39°57'20.3" N, 105°09'27.6" W)

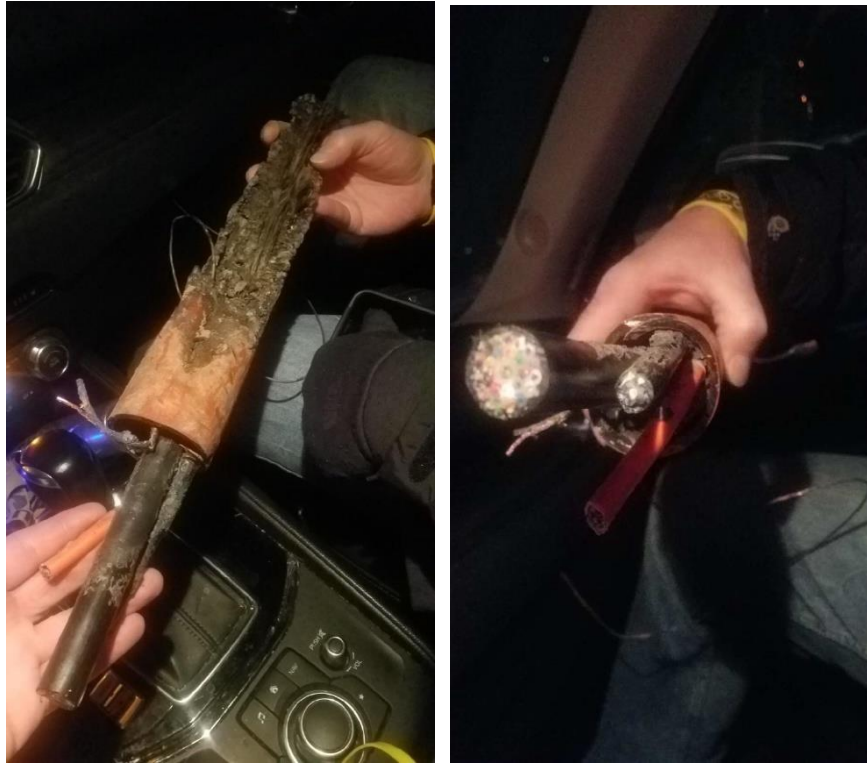
Figure 7–3. Damaged fiber optic cable linking Louisville water treatment plants (approximate location: 39°58'30.6"N 105°09'57.7"W)

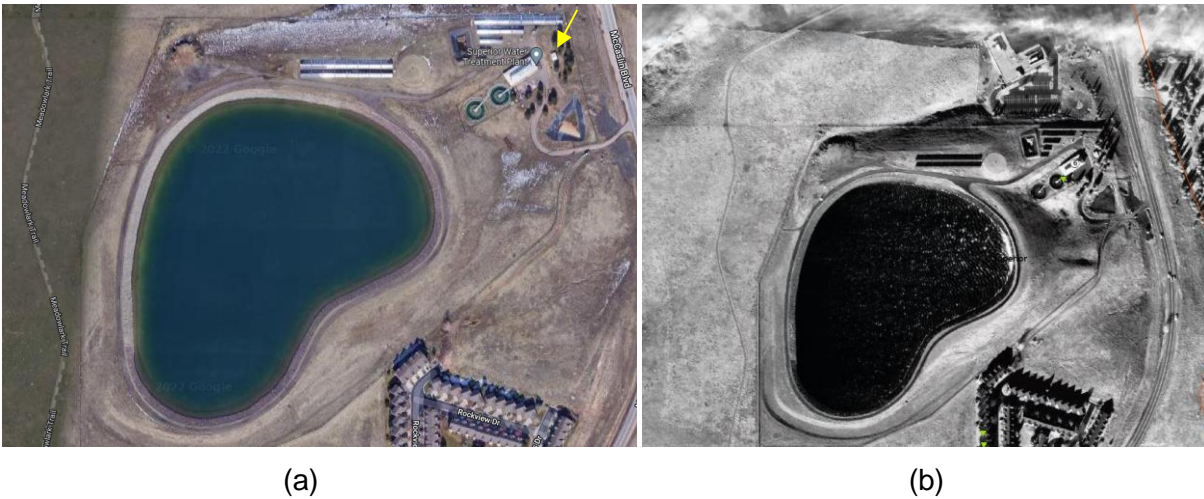
Figure 7-4. Superior WTP overhead (a) google earth image showing location of destroyed backup generator and (b) at 2 PM 12/30 with fire to the north (39°56'33.8" N, 105°09'50.2" W)

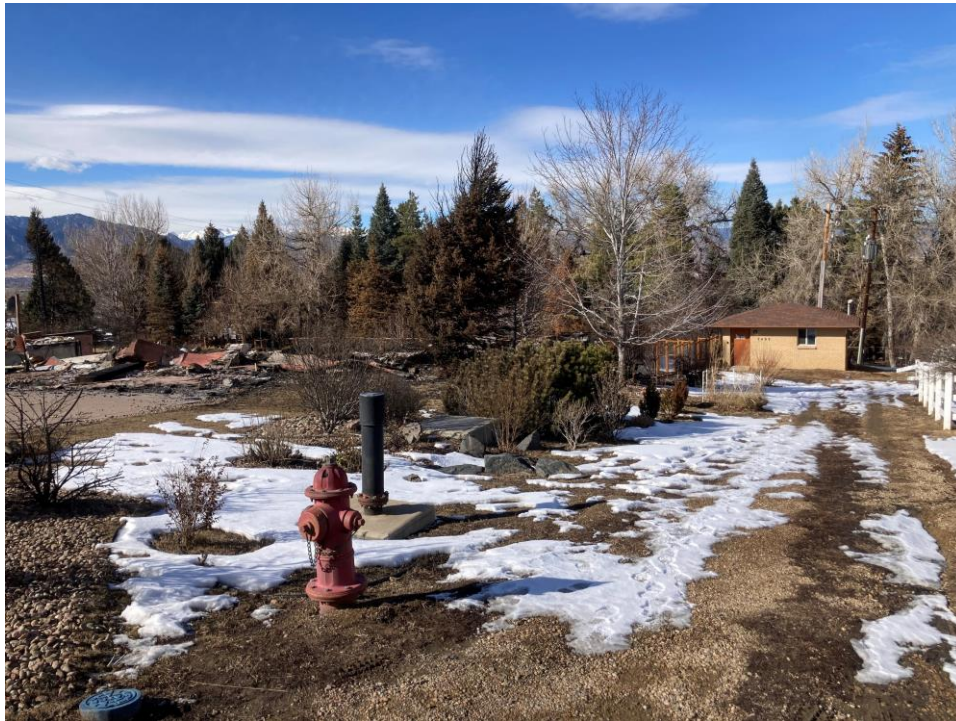
Figure 7–6. EBCWD Pump house with buried storage water tank in the foreground, adjacent to destroyed home (39°58'33.2" N, 105°10'40.8" W))

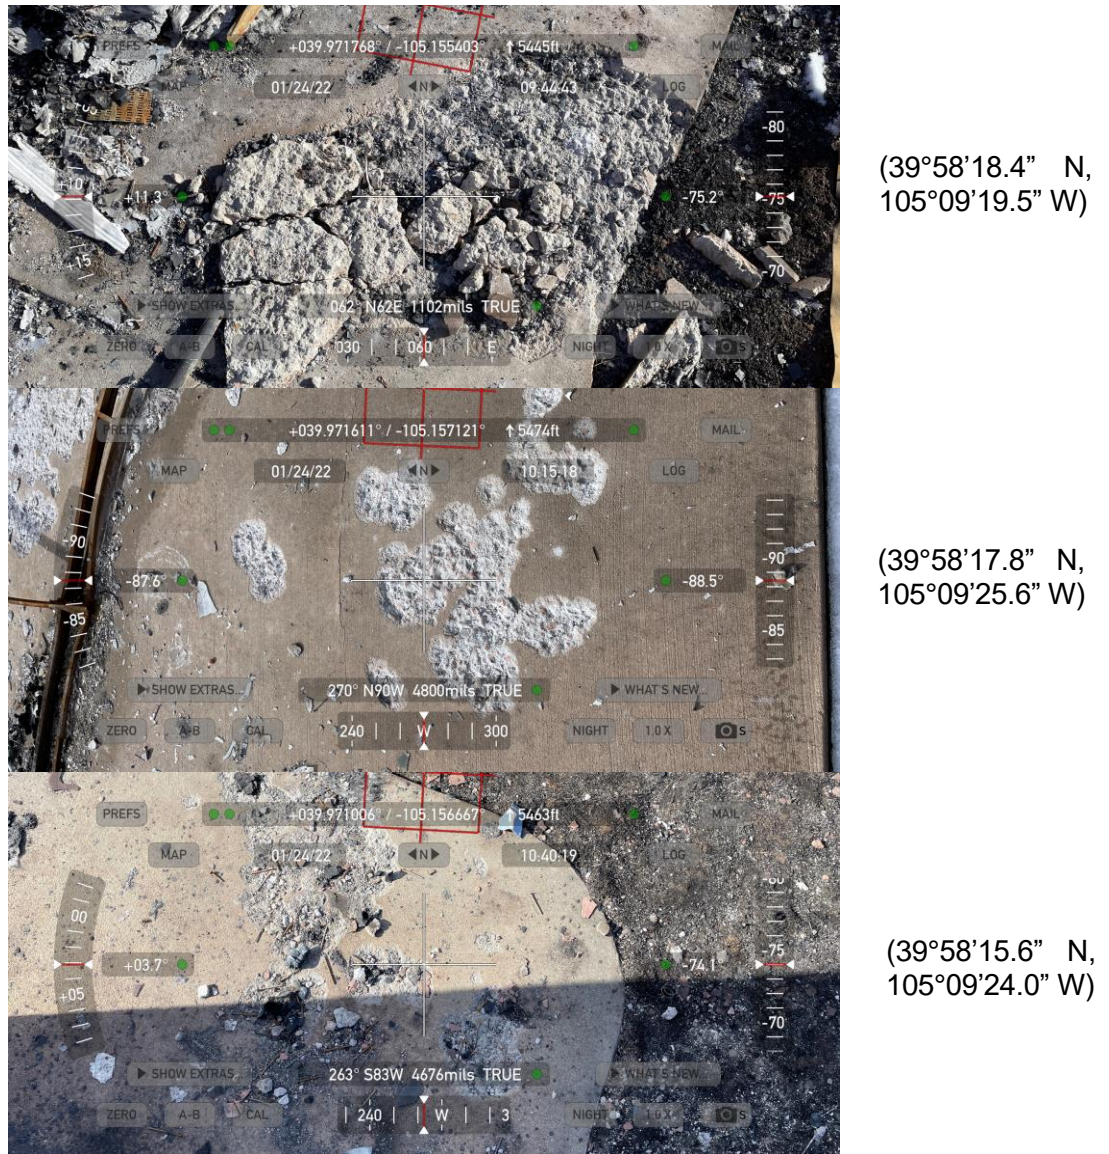
Figure 8-10. Spalling of concrete on S. Tanager Ct, S. Warbler Ct, and W. Mulberry St. indicated temperatures in excess of 300°C

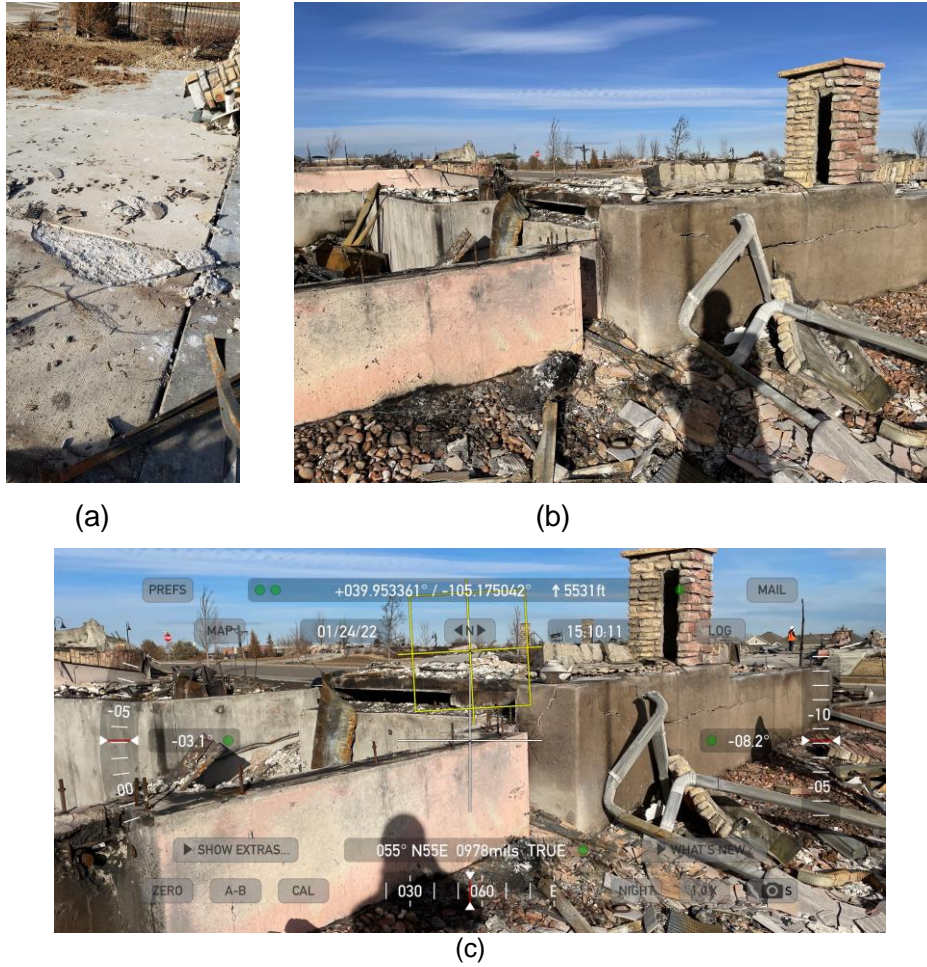
Figure 8-18. Evidence of elevated temperatures on 8<sup>th</sup> Avenue in Superior (a) concrete spalling, (b) and (c) pinkish foundations of houses

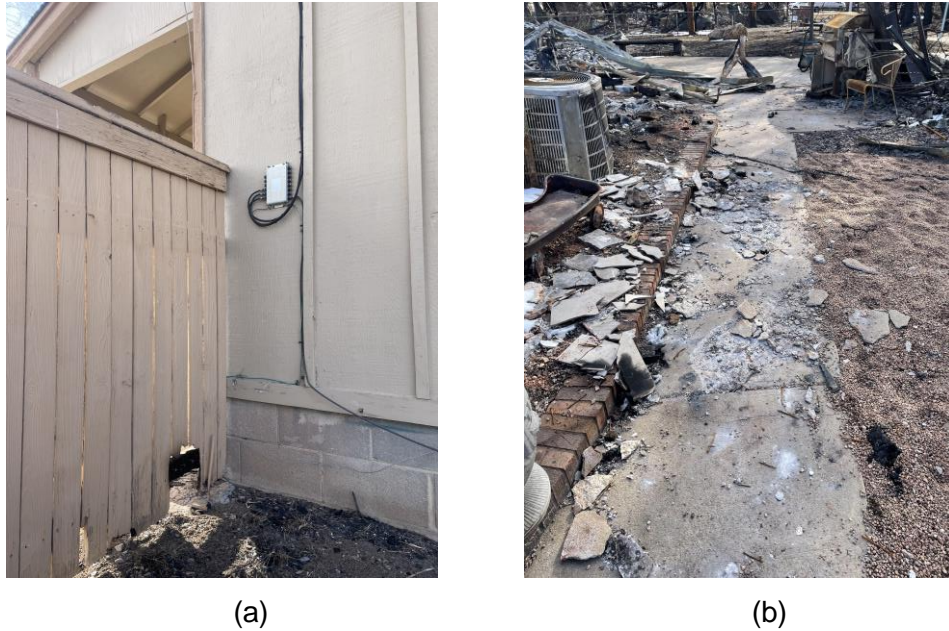
Figure 8-21. Housing characteristics in Original Town Superior (a) burnt fences touching homes and (b) spalling of concrete sidewalks (37°57'12.204" N, 105°10'4.368" W)

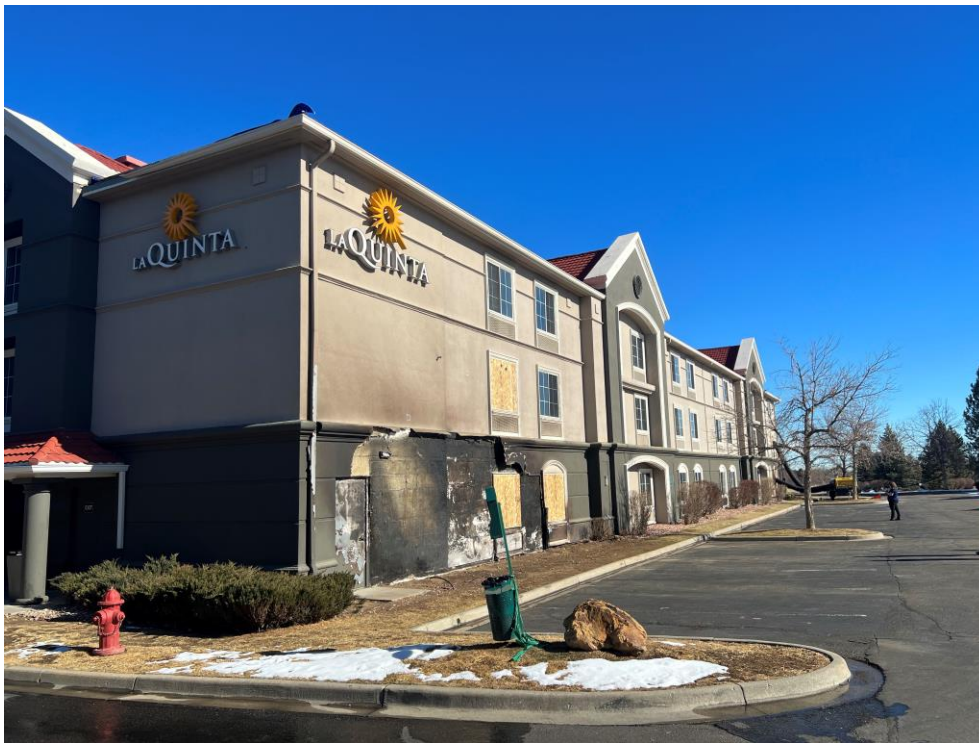
Figure 8-28. Damaged La Quinta Inn in Louisville, along Highway 36 (39°57'32.2" N, 105°09'43.6" W)
