Geotechnical Reconnaissance of the 2022 Southern Montana/ Yellowstone Floods

Flood Event: June 13-24, 2022

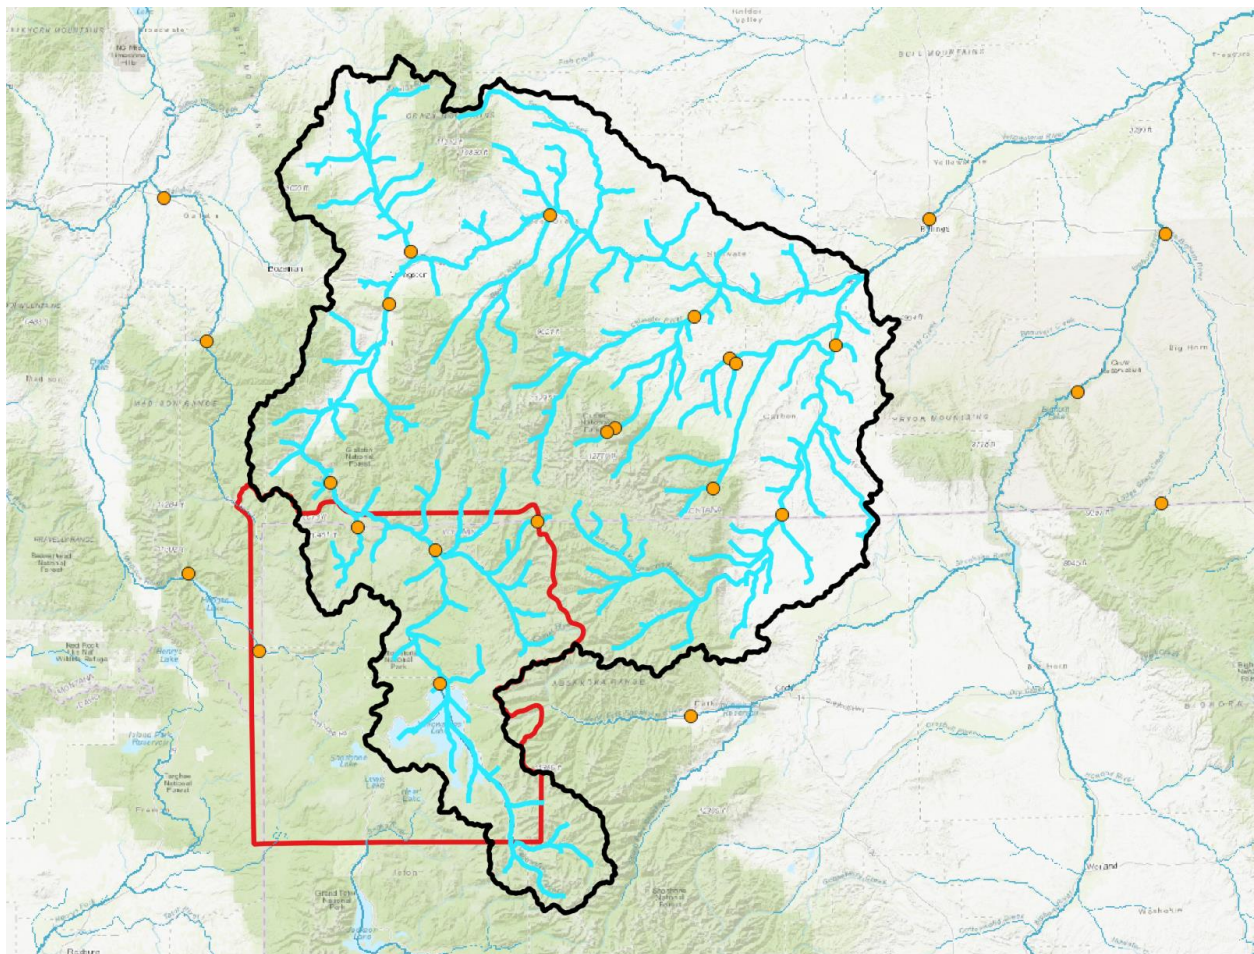
Figure 1.1: Map of Yellowstone Park boundaries (red), delineated hydrography, and USGS gauges (orange dots)

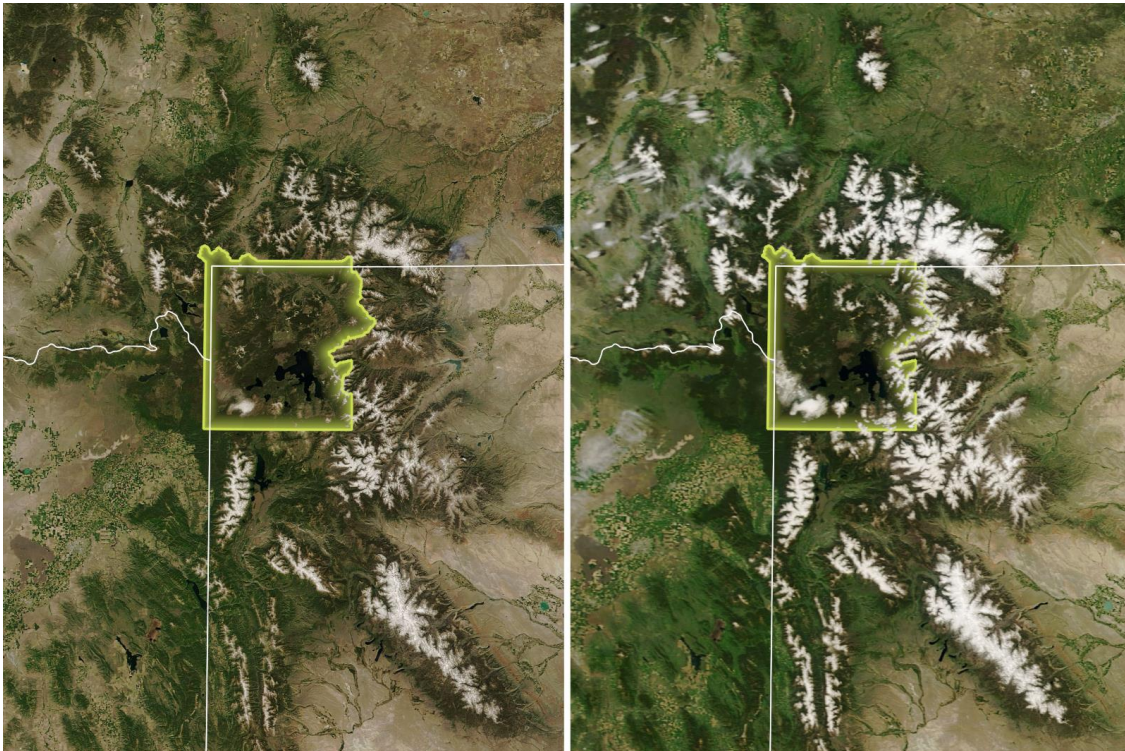
Figure 1.2: These images captured by the Moderate Resolution Imaging Spectrometer (MODIS) on June 16, 2021 (left panel) and June 16, 2022 (right panel) compares the snowpack one year apart (NASA 2022, accessed at <https://earthobservatory.nasa.gov/images/150010/catastrophic-flooding-in-yellowstone>)

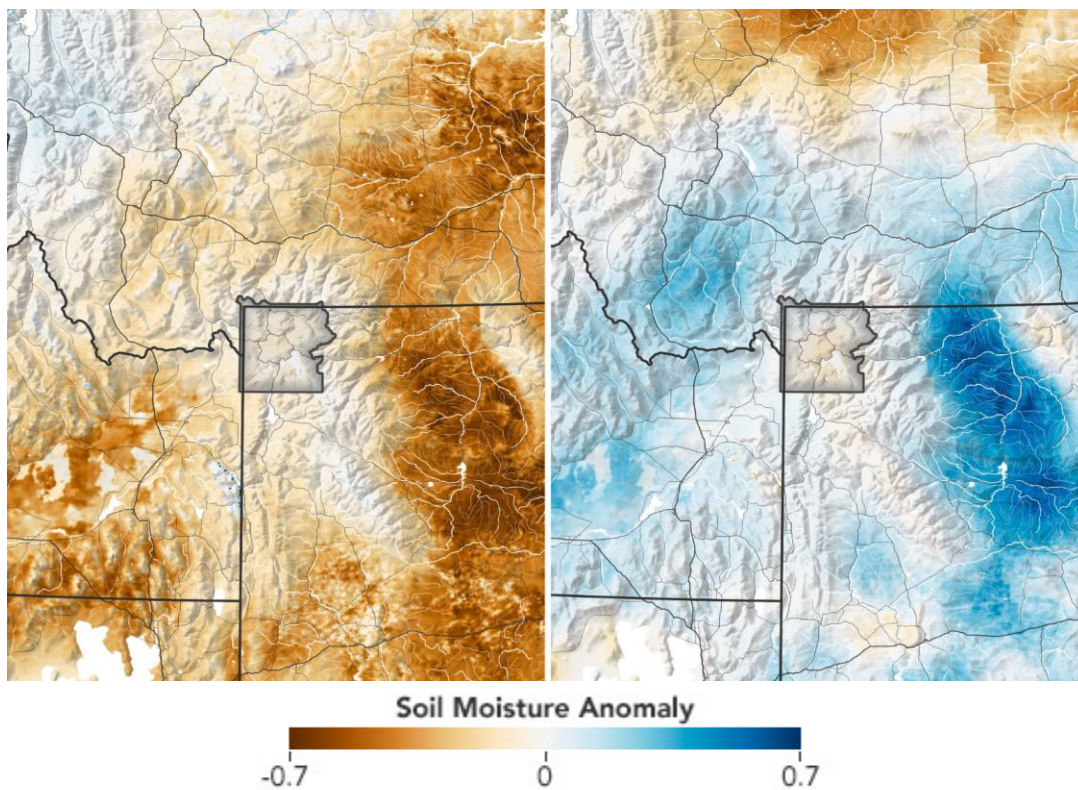
Figure 1.3: Soil moisture anomaly from May (about 1 month before the floods) for 2021 (left panel) and 2022 (right panel) showing the significant increase in soil moisture. (Image from NASA 2022)

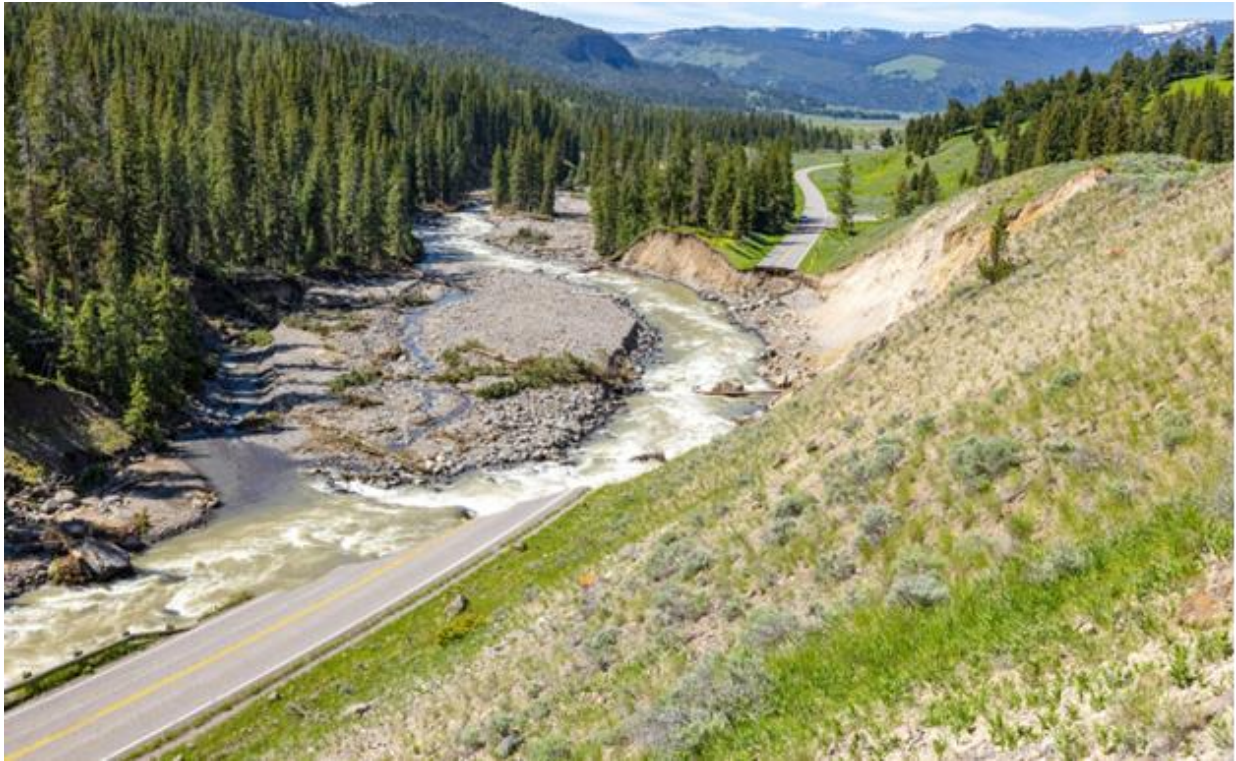
Figure 1.12: The Northeast Entrance Road washout near Trout Lake Trailhead showing the new river course in the canyon after the flood. (Yellowstone National Park 2022)

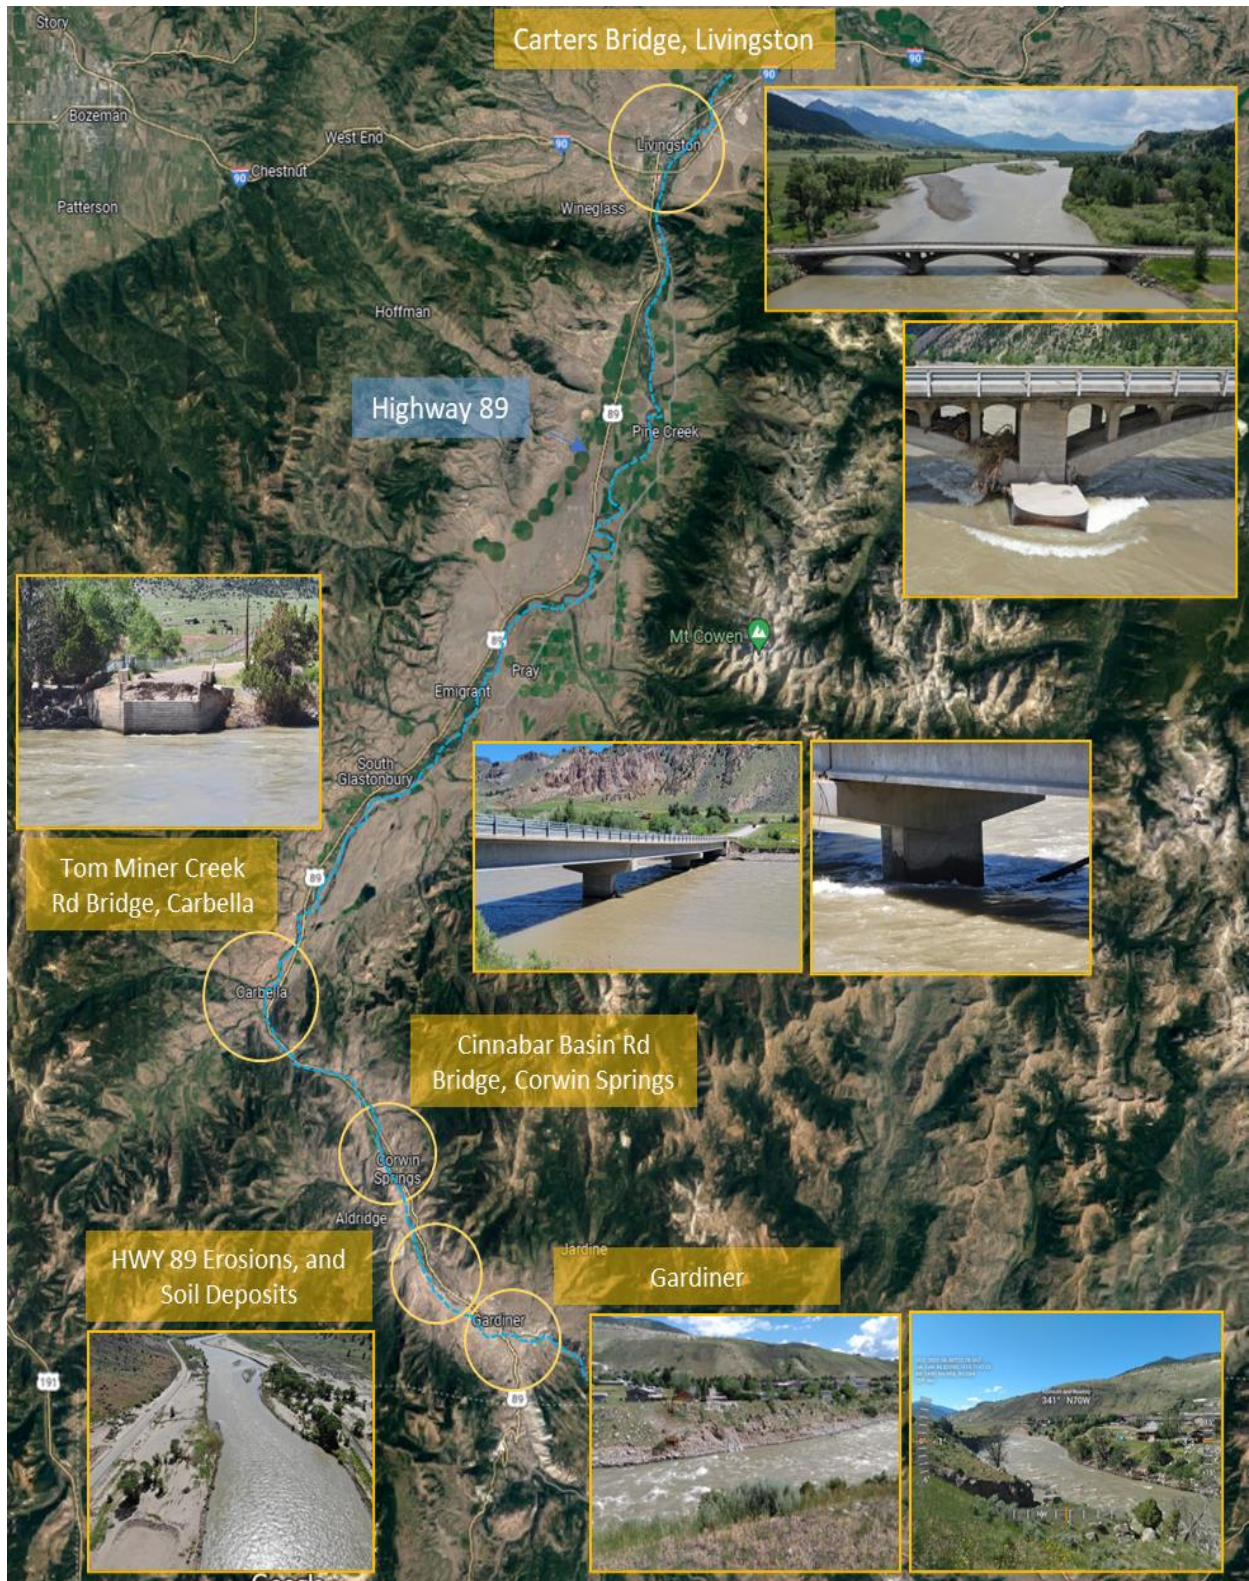
Figure 3.1: Locations with major flood related observations

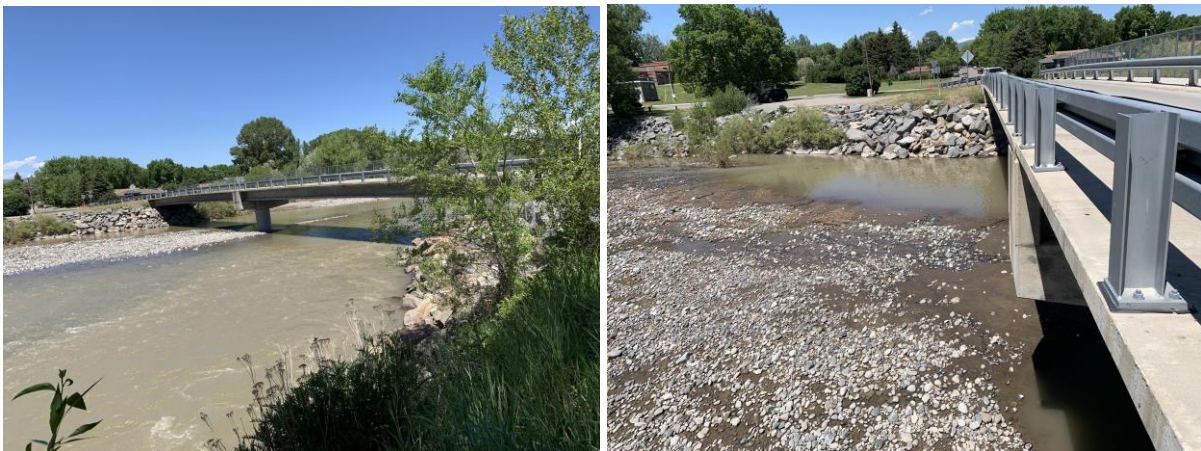
Figure 3.2: Bridge @ 9th street/Yellowstone during GEER visit. An extra span allows for the river to move between the banks and erode and deposit sediments freely. Note the new gravel bar deposited from the recent floods. Also note the “dirty” nature of the bar, indicating flow velocities were low enough for finer sediments to deposit at this bridge in the flood. (45.64970166034406, -110.56177707651814).

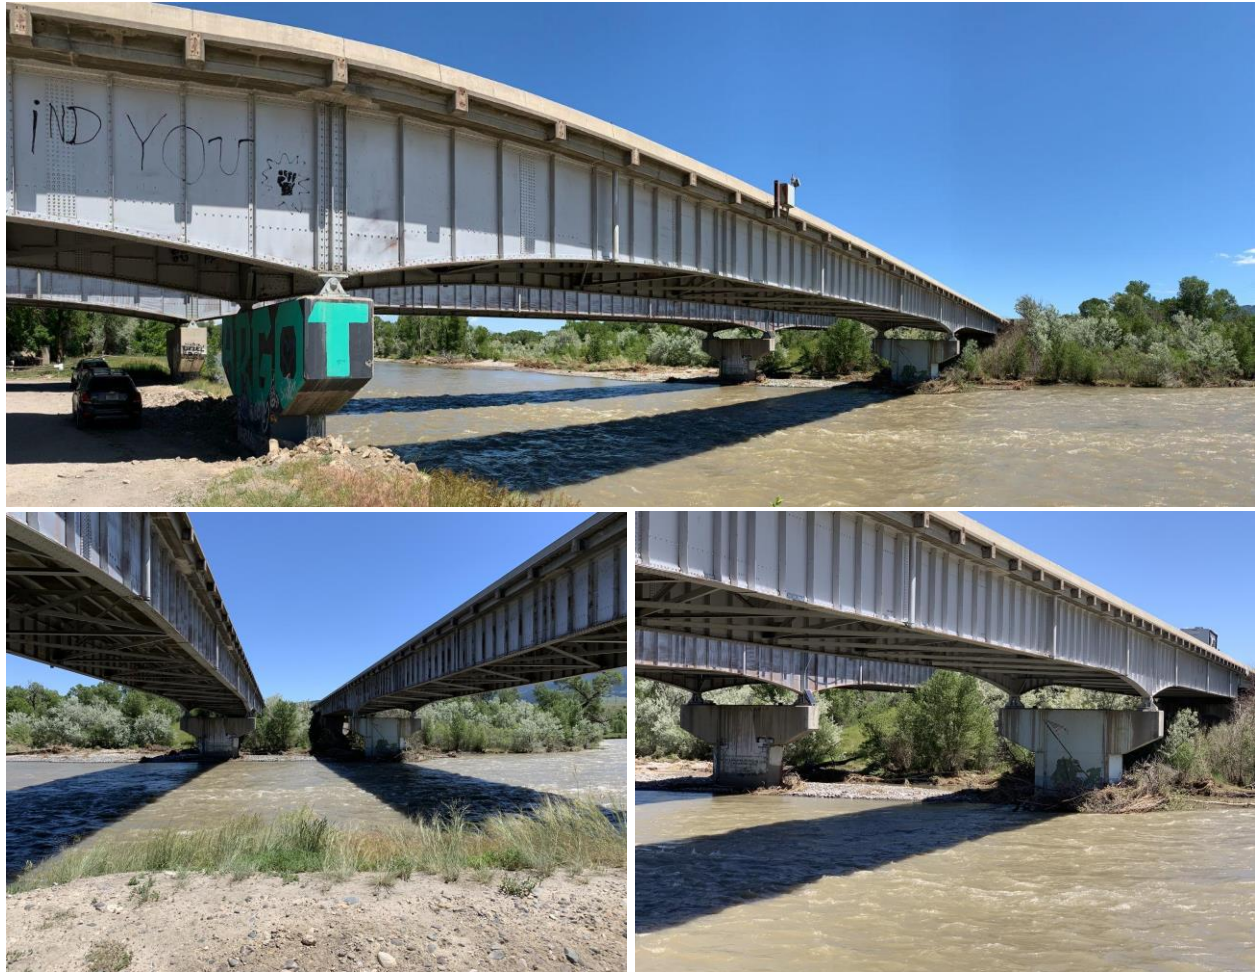
Figure 3.3: HWY 90 crossing of the Yellowstone River. Of particular interest are spans over dry river bottoms, which allow the river to migrate within the floodplain (45.64447387617702, -110.56115186026274).

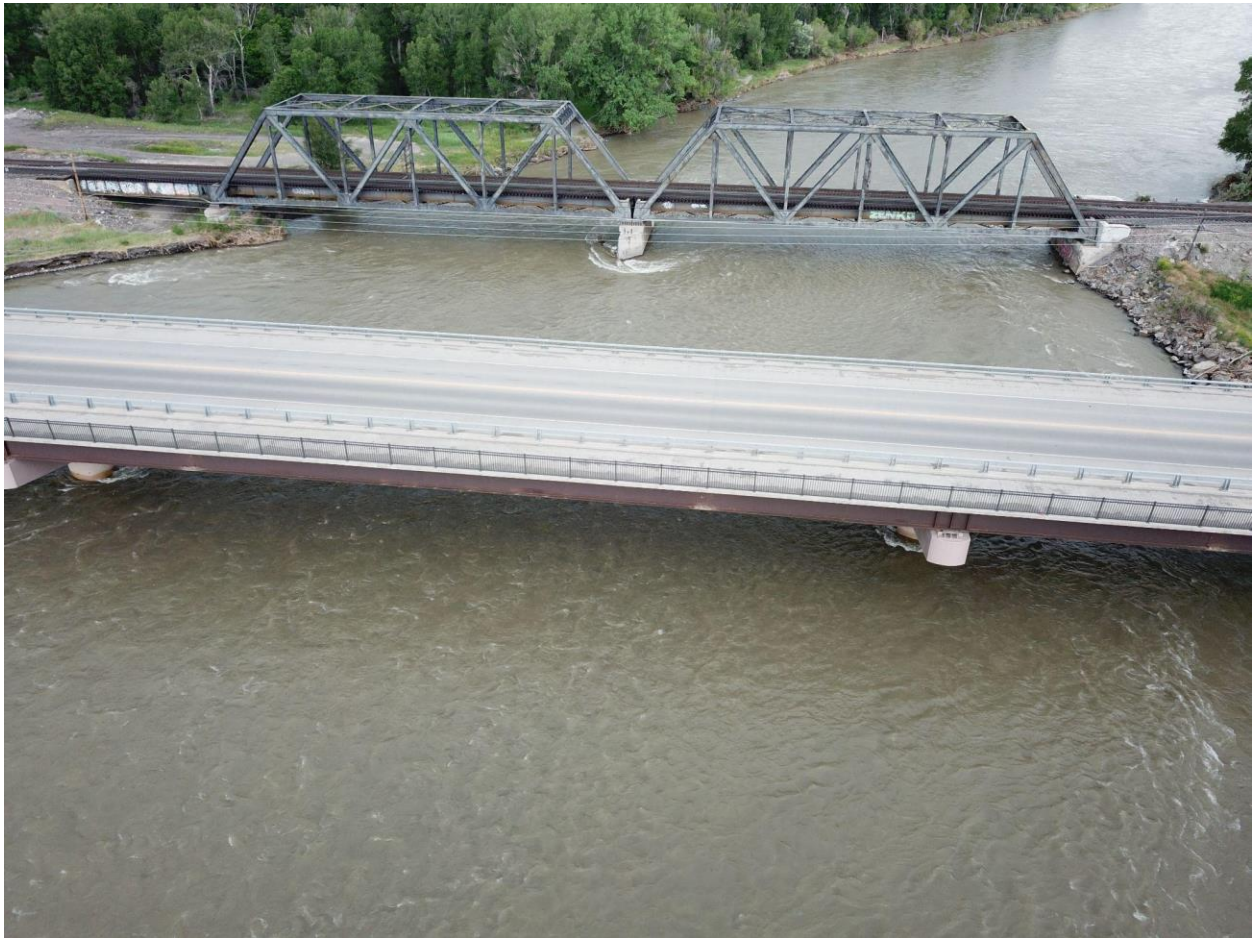
Figure 3.4: I-90 Business Route Bridge (bottom) and Railway Truss Bridge (top) over the Yellowstone River in Livingston (45.6749 N 110.5368 W)

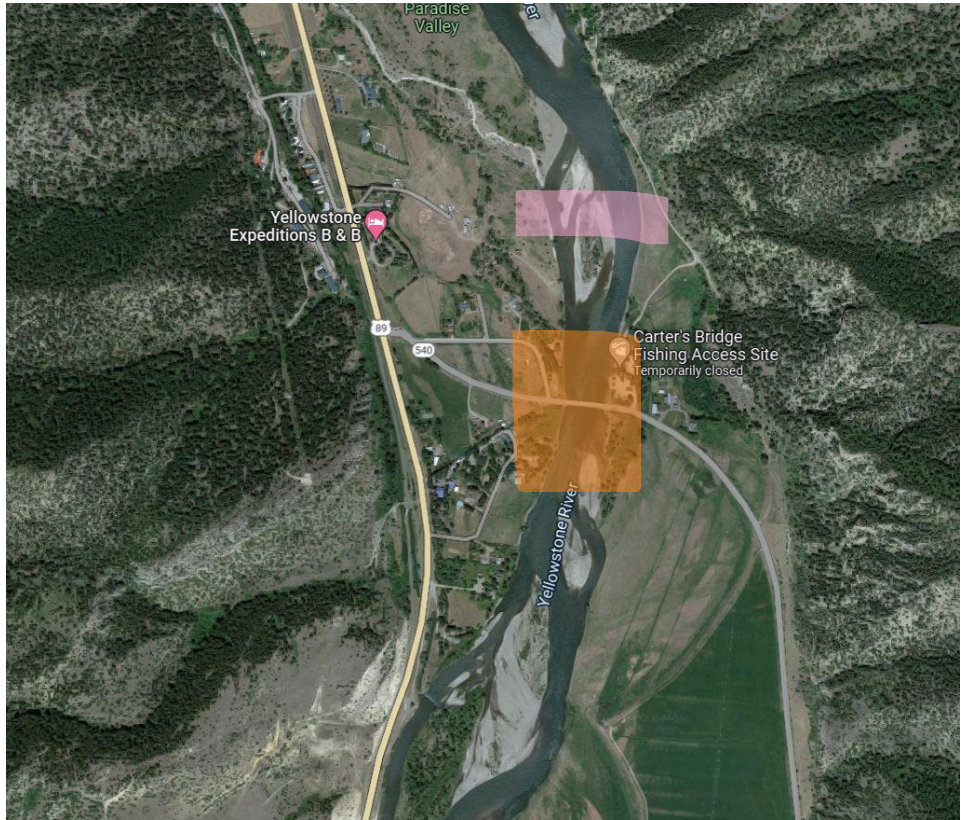
Figure 3.5: Location of Carters bridge and surroundings (source: google maps satellite image)

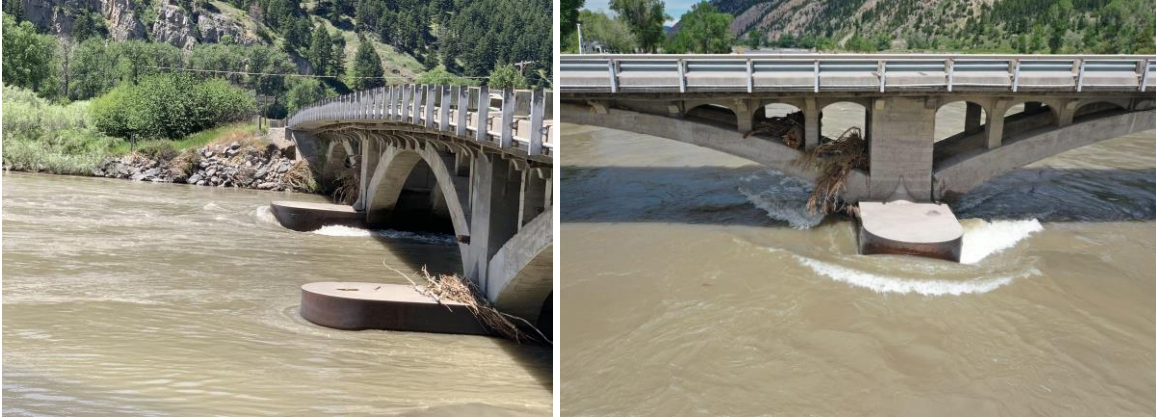
Figure 3.7: Downstream view of Yellowstone River and change in flow. Damage to the middle pier from scour erosion and subsequent slope instability can also be seen. (45.597005176806064, -110.56656540935629)

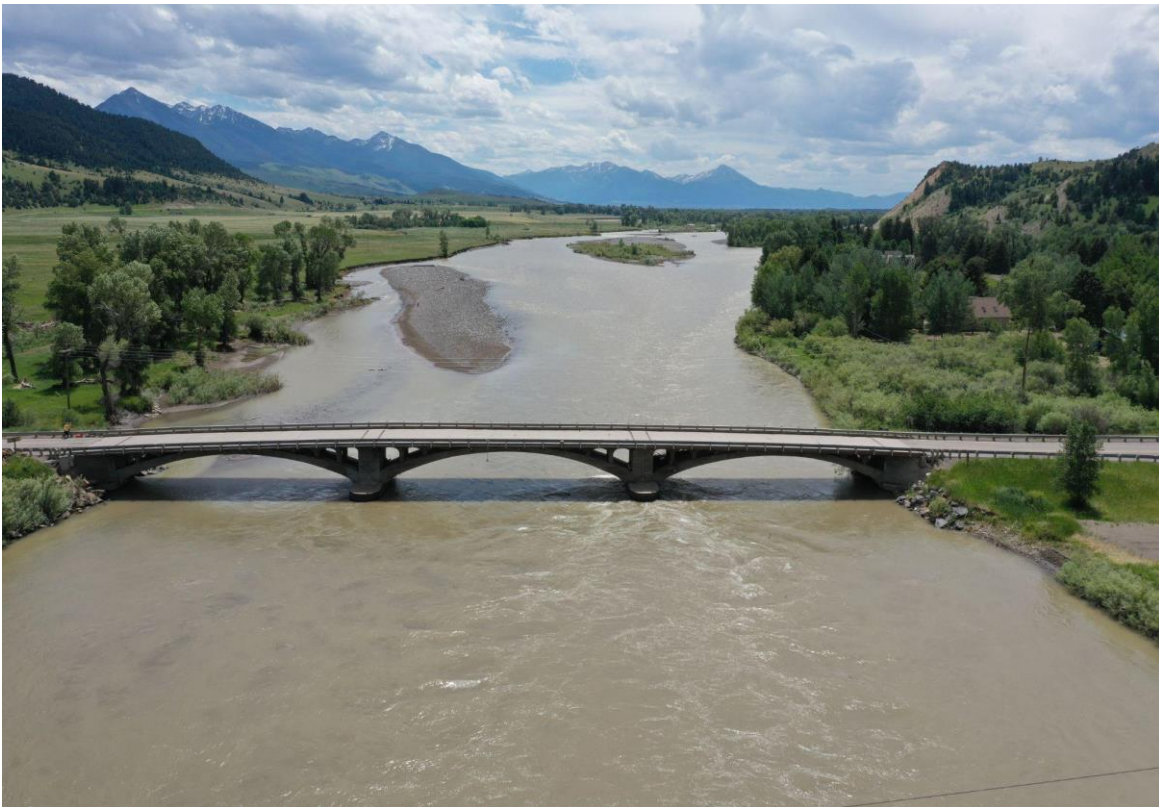
Figure 3.8: UAV aerial view of Carter bridge from downstream direction (45.59757057191095, -110.56653085768644)

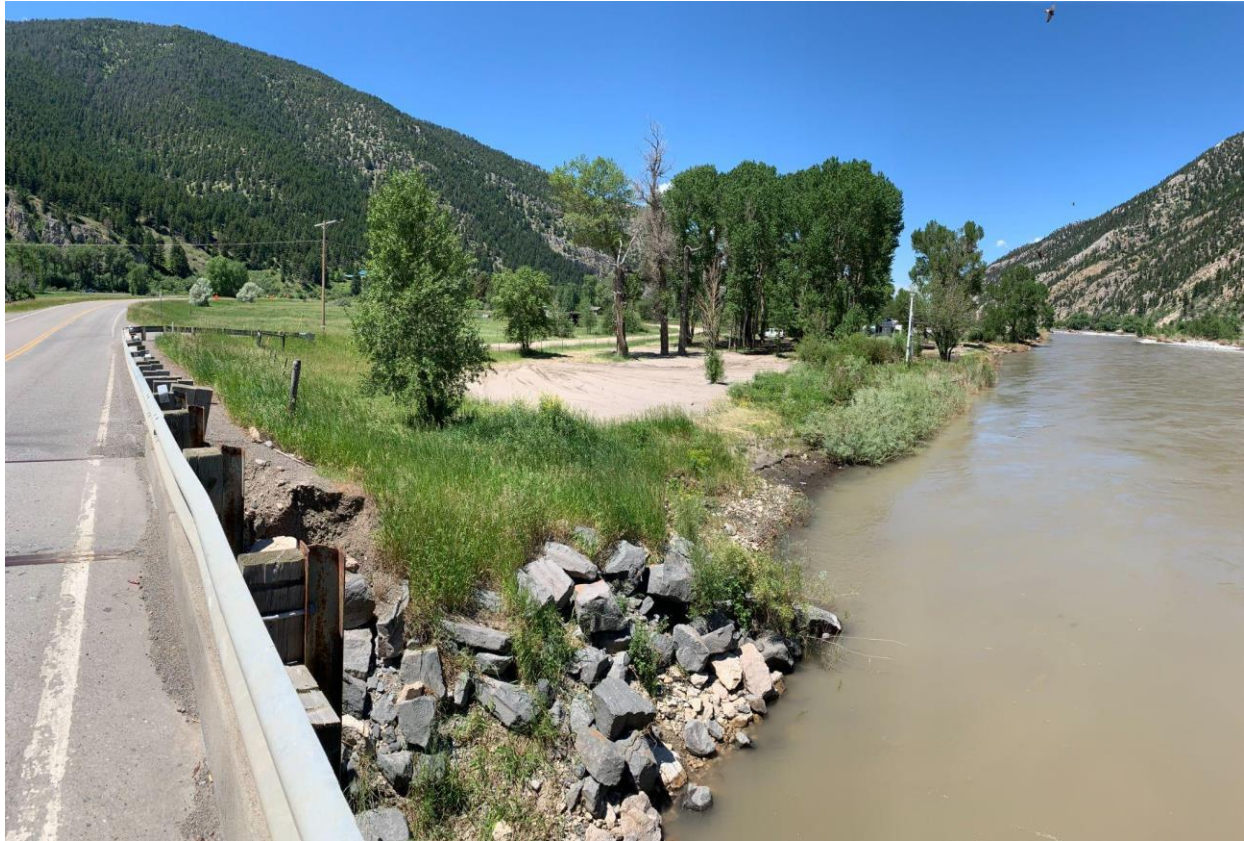
Figure 3.9: Large Sediment Deposit and abutment armoring slope instability damage around the Carter bridge, downstream (45.59693187817401, -110.56611409046789)

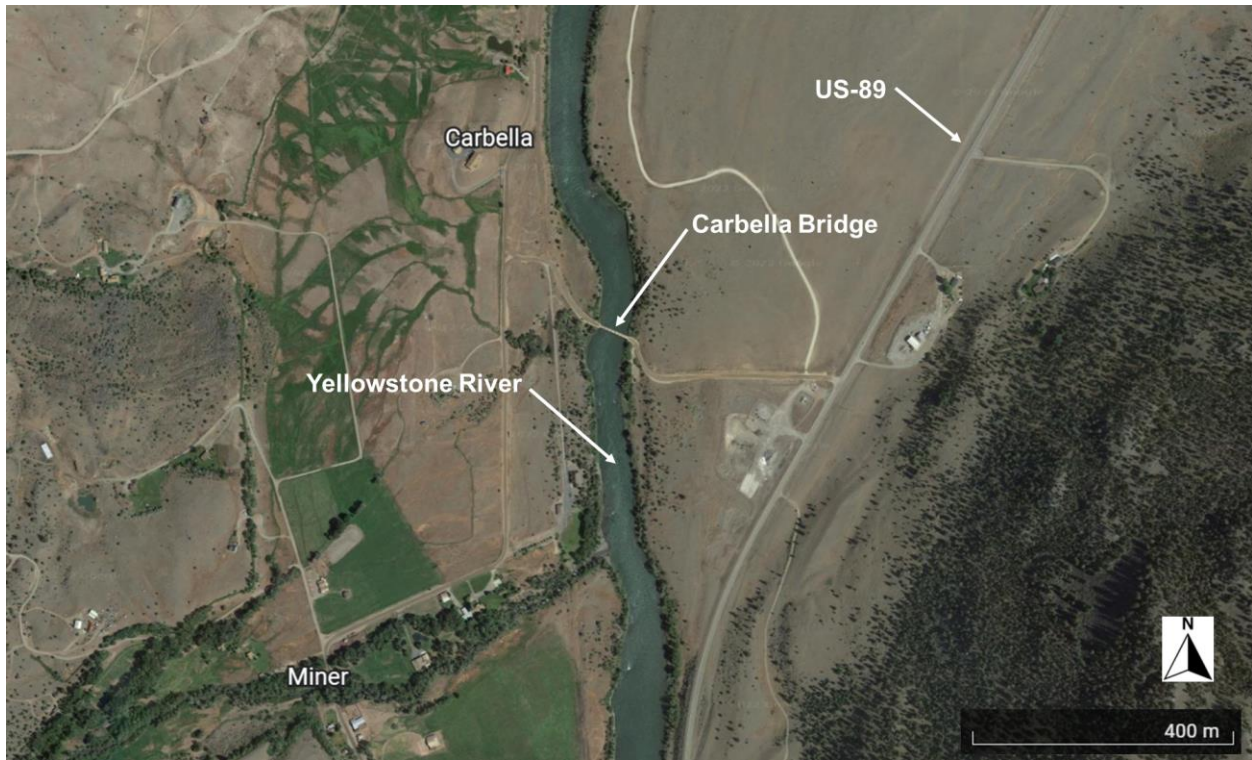
Figure 3.10: Google Earth Image (image taken in June 2022 and provided by Maxar Technologies) of southeastern parts of Carbella area - including Yellowstone River, Carbella Bridge, and US-89 (all labeled with white arrows).

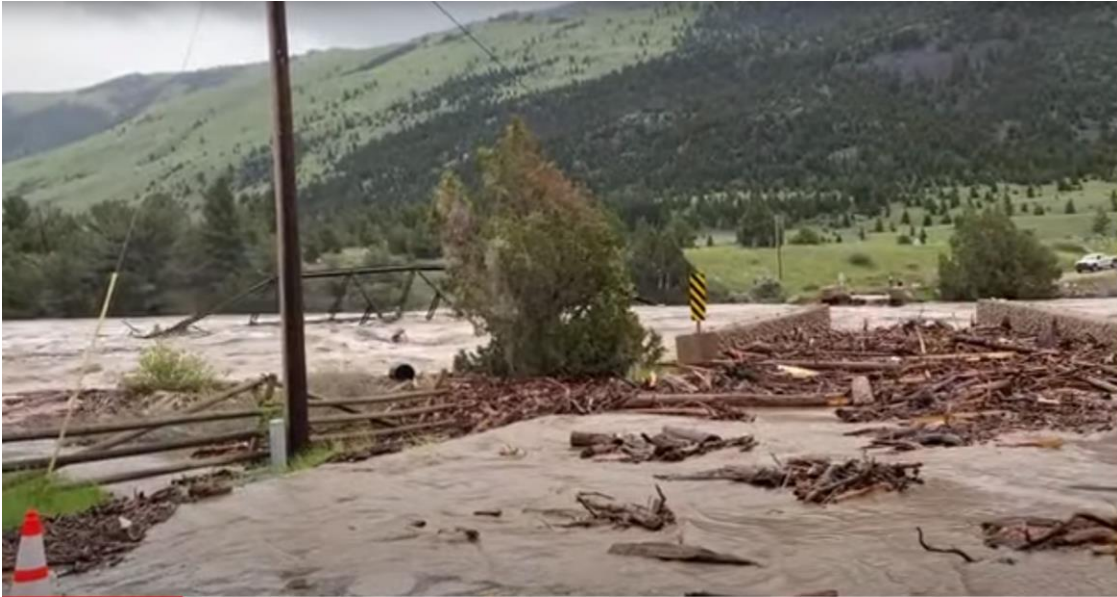
Figure 3.13: Video footage showing bridge flowing down the river, Source: Billings Gazette, accessed through: <https://www.youtube.com/watch?v=REALicH5pX4>.

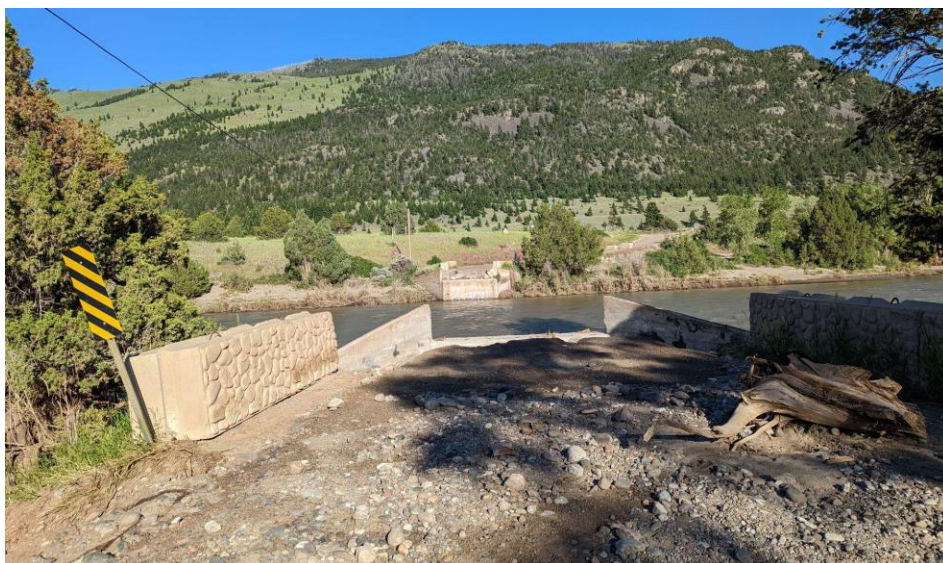
Figure 3.14: Remaining bridge abutments of the Carbella bridge at the time of the team’s visit.

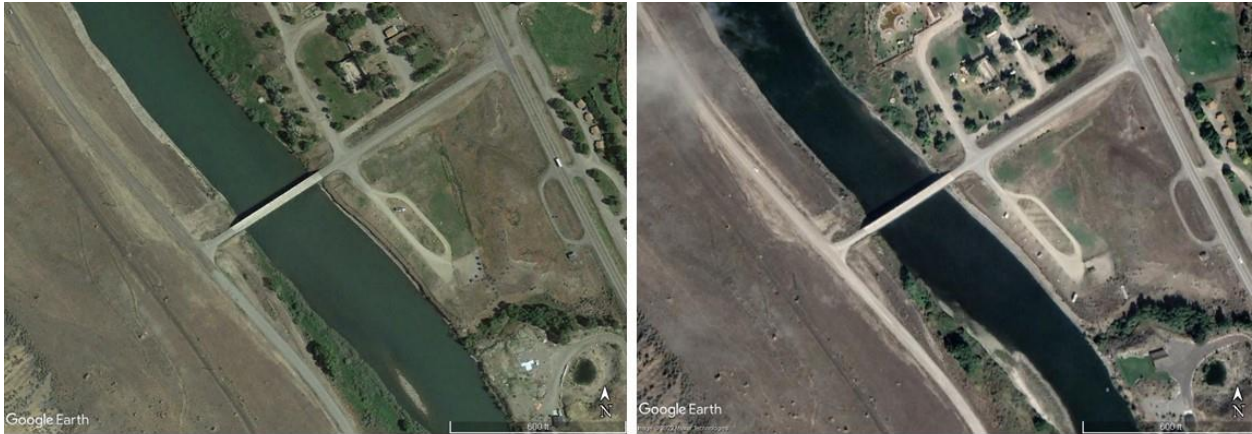
Figure 3.17: Cinnabar Basin Rd Bridge crossing the Yellowstone River downstream of the town of Gardiner, MT, in Google Earth images from July 2014 (left) and September 2019 (right).

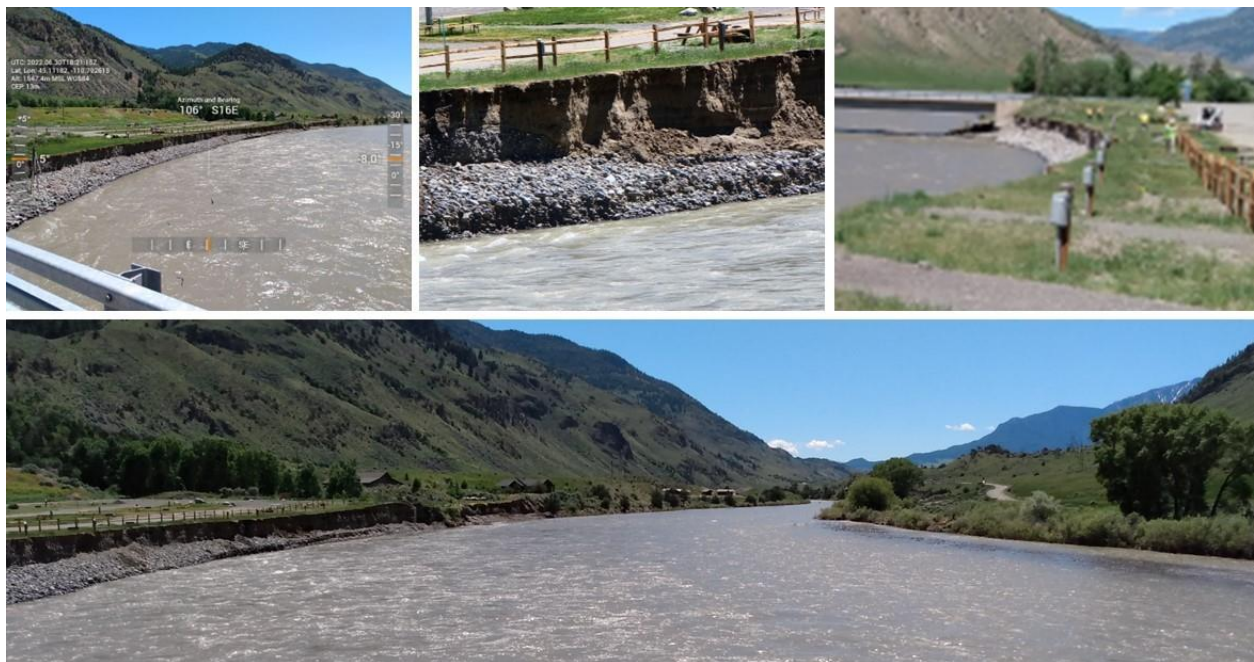
Figure 3.21: NE upstream riverbank being subject to significant erosion (45.1115243, -110.79229245).

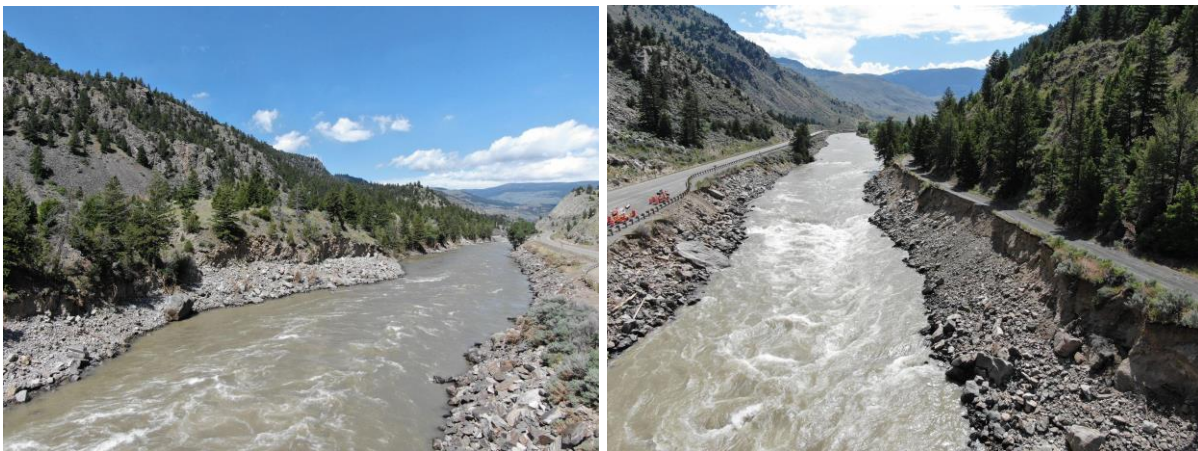
Figure 3.24: The Yellowstone River Gorge. Significant scour all through the gorge, with peak water surfaces up to 1-m above the pavement of the highway (45.17018368, -110.86630538).

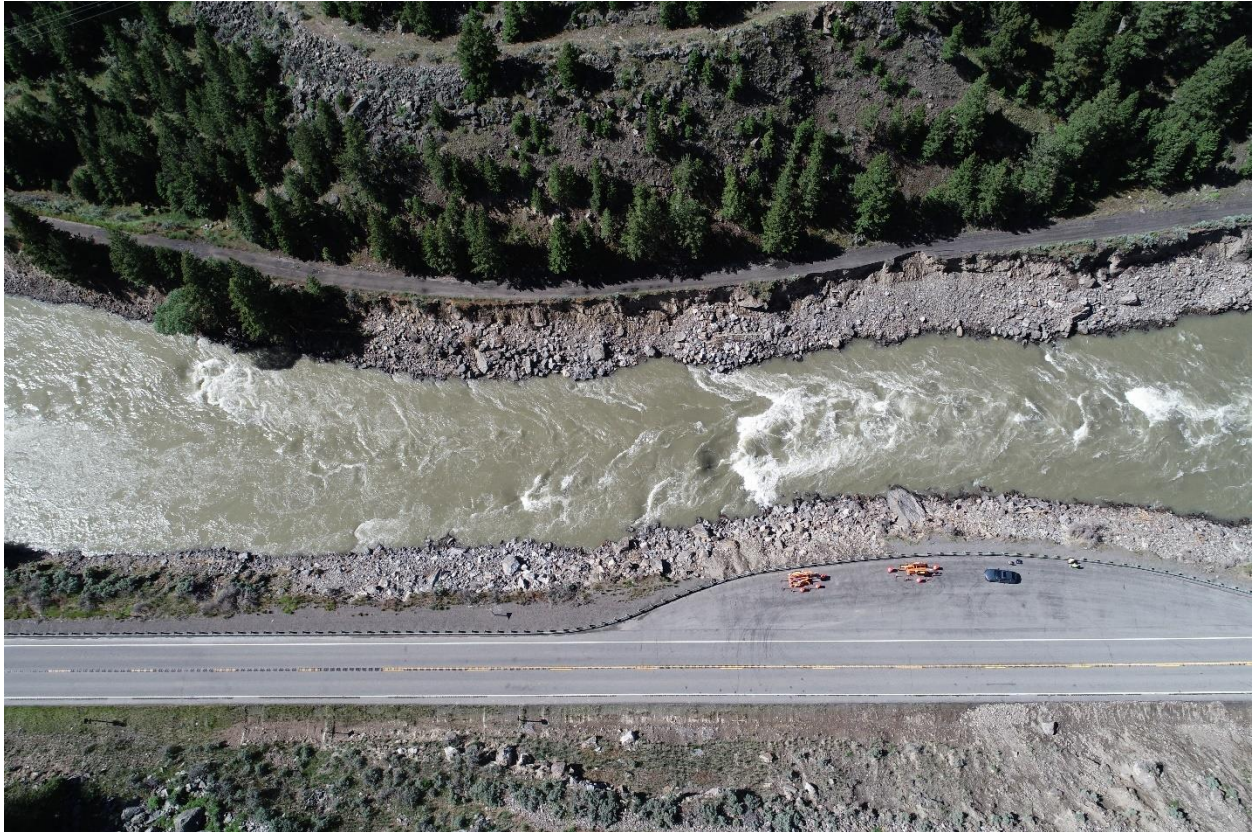
Figure 3.25: Rock Erosion along Highway 89 near Sphinx-Creek and Yellowstone River confluence (45.17018368, -110.86630538)

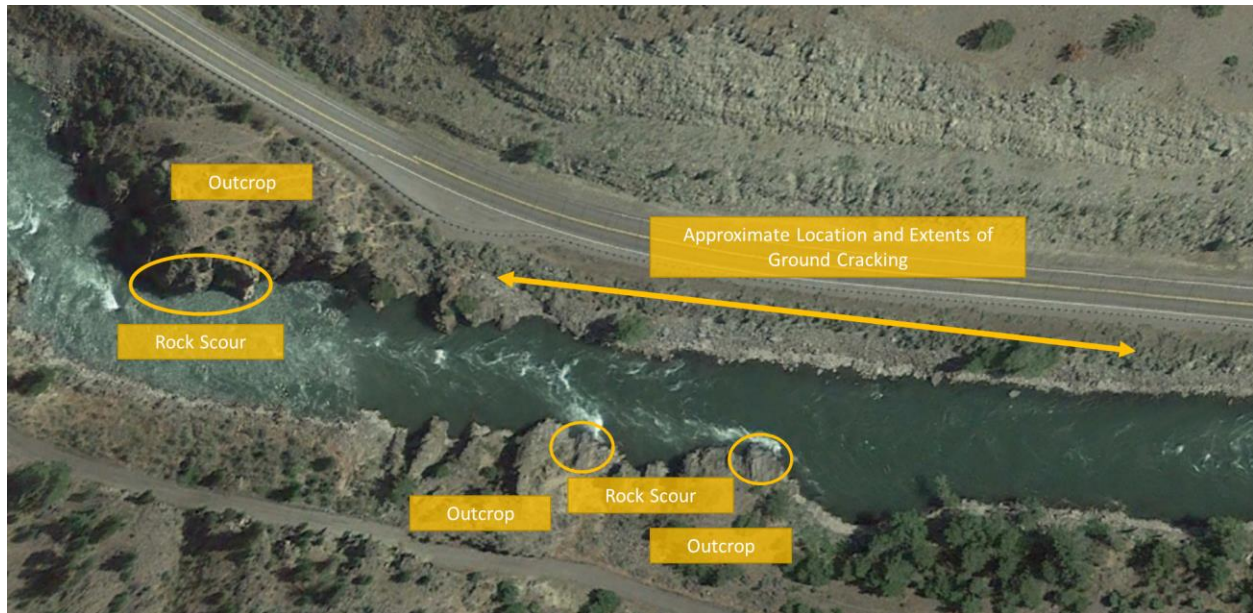
Figure 3.26: Area of special study by the GEER team in the Yellowstone River Gorge (45.17657N, - 110.88198E).

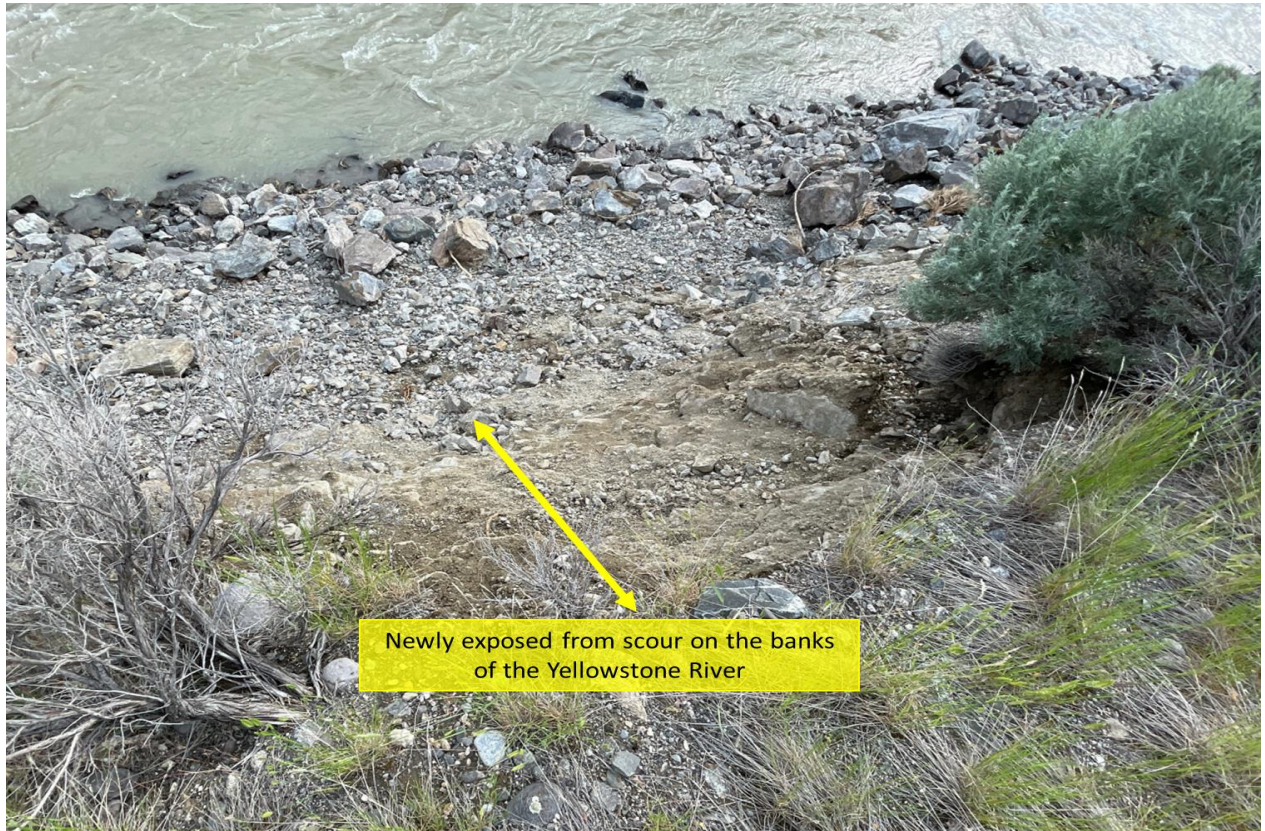
Figure 3.27: Newly exposed soil in the Yellowstone River Gorge, 1-m to 3-m high forming over-steepened slopes. (45.17657N, -110.88198E)

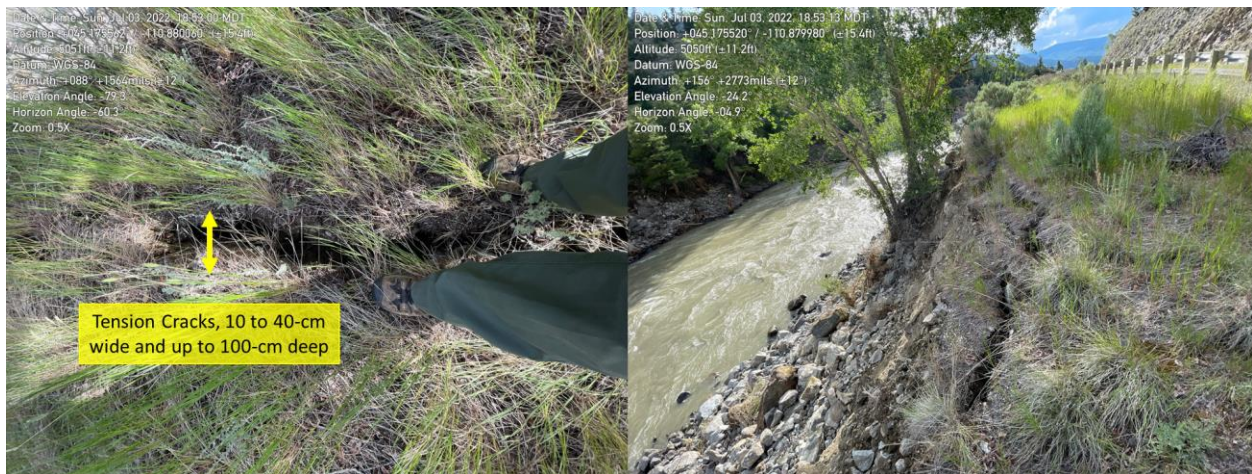
Figure 3.28: Tension cracks documented by the GEER team.

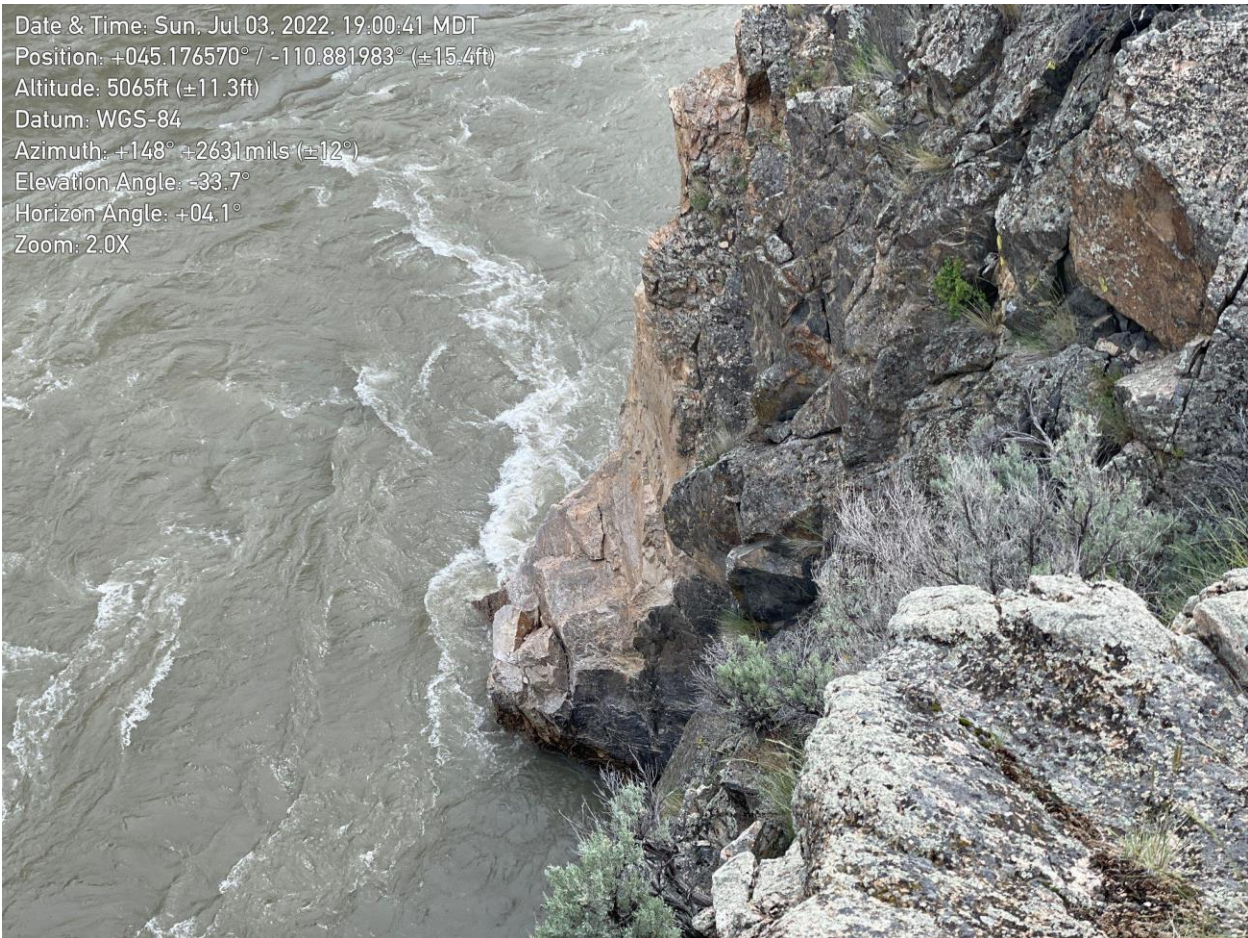
Figure 3.29: Rock scour occurrence in the Yellowstone River Gorge. Lighter colored rock is newly exposed.

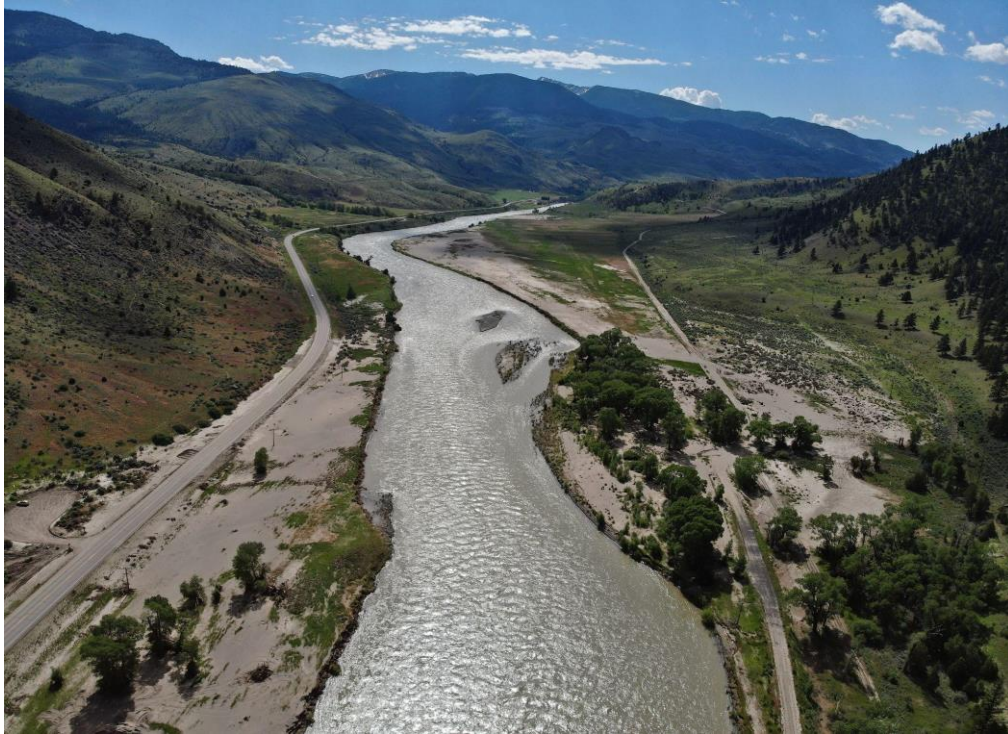
Figure 3.30. Sediments deposited from flooding at the top (upstream end) of the Yellowstone River Gorge (45.1676340, -110.8532592).
