Geotechnical Reconnaissance of the 2022 Southern Montana/ Yellowstone Floods

Flood Event: June 13-24, 2022

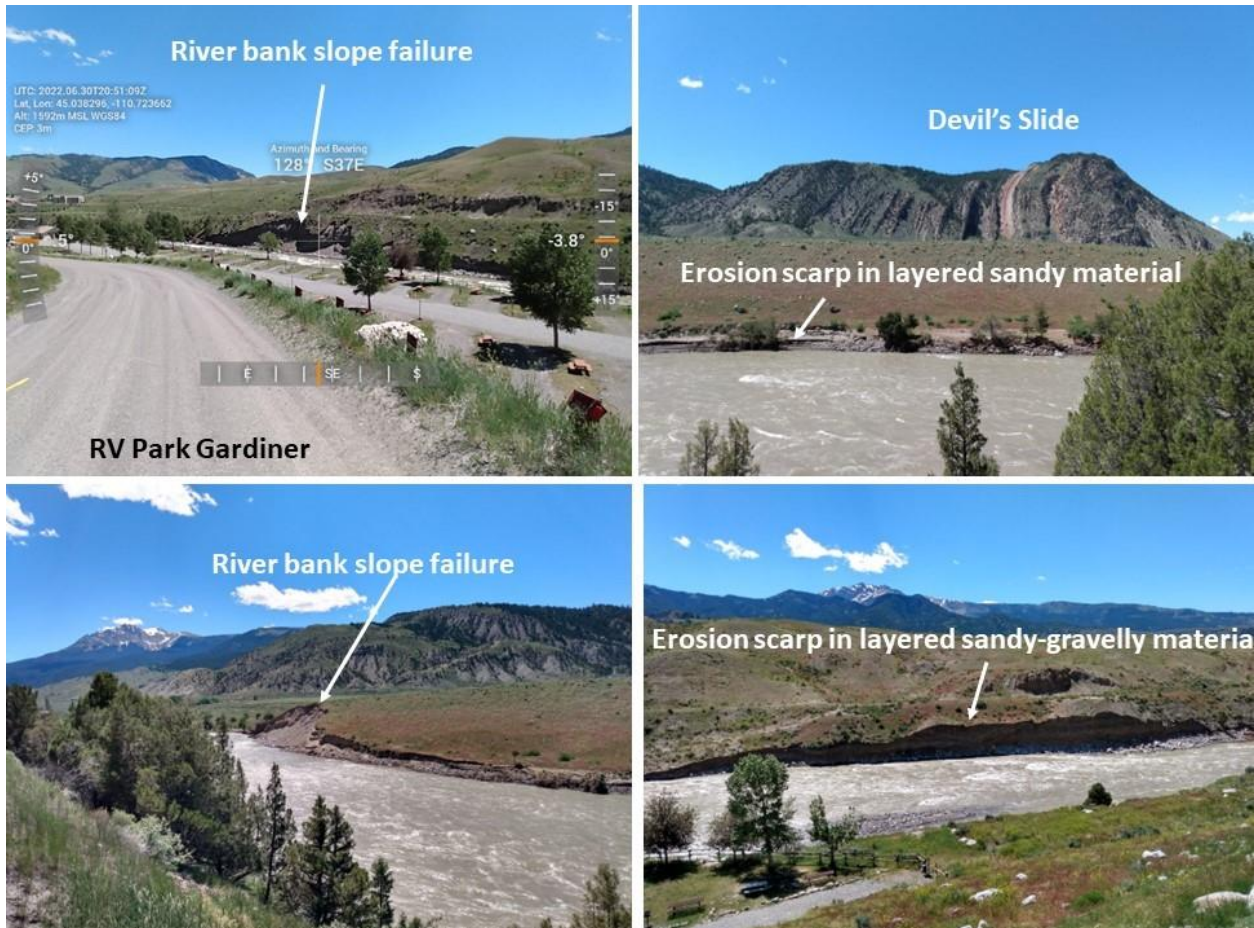
Figure 3.33: Selected photos showing erosion along the Yellowstone River between Gardiner, MT, and the Yellowstone River Gorge in glacial moraines and alluvial terraces (45.0941353, -110.7816088)

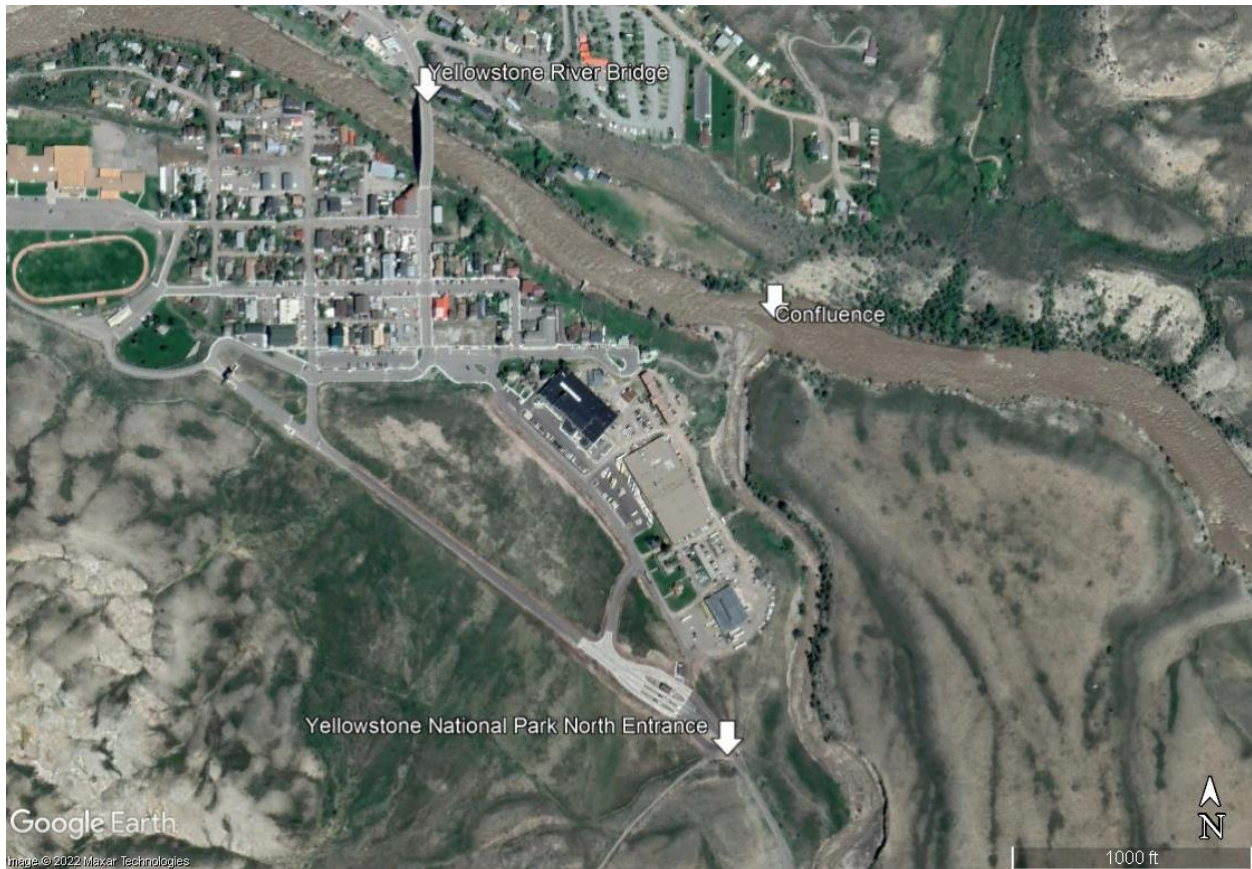
Figure 3.34: Google Earth Image (image taken in June 2022 and provided by Maxar Technologies) of southeastern parts of Gardiner including the Gardner River - Yellowstone River confluence, the Yellowstone National Park North Entrance, and the Yellowstone River bridge (all labeled with white arrows).

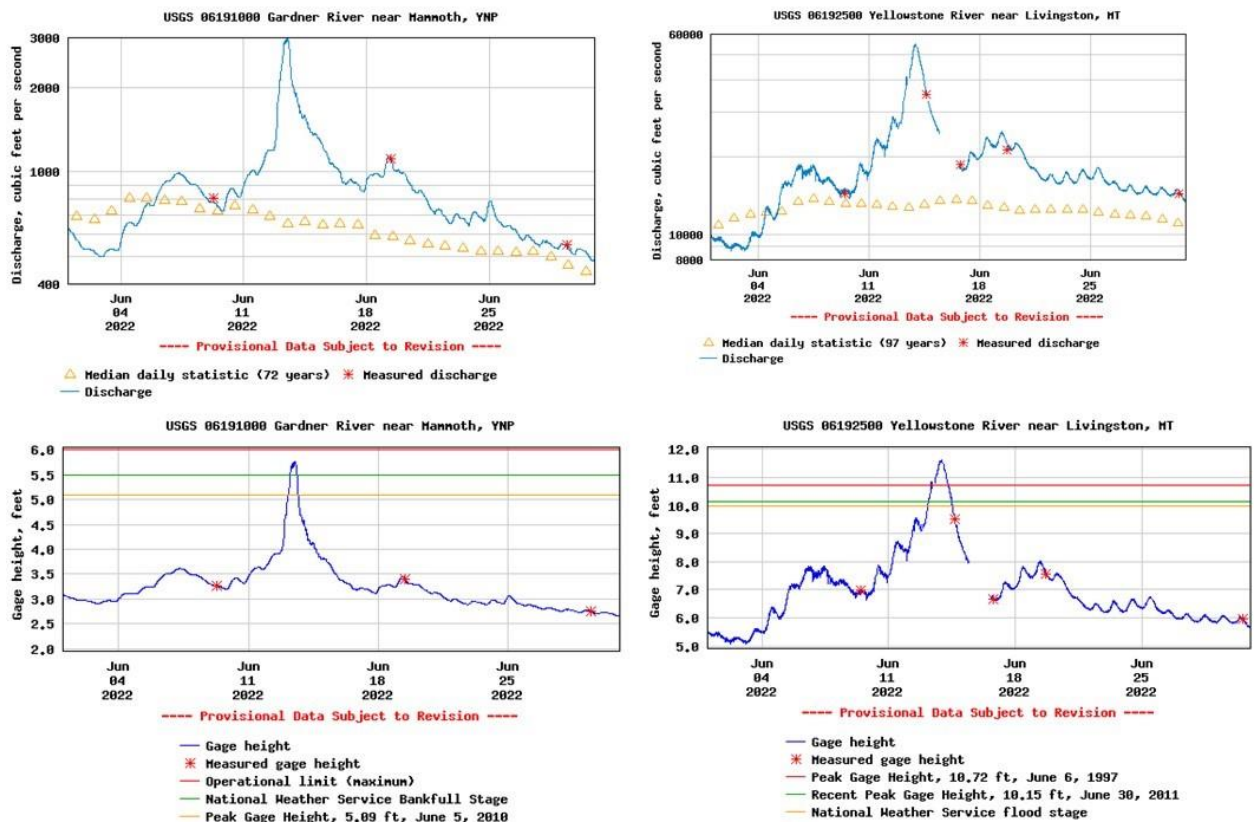
Figure 3.36: USGS gage readings for June 2022 from the Gardner River near Mammoth, YNP (gage #06191000; left) and from the Yellowstone River near Livingston, MT (gage #06192500).

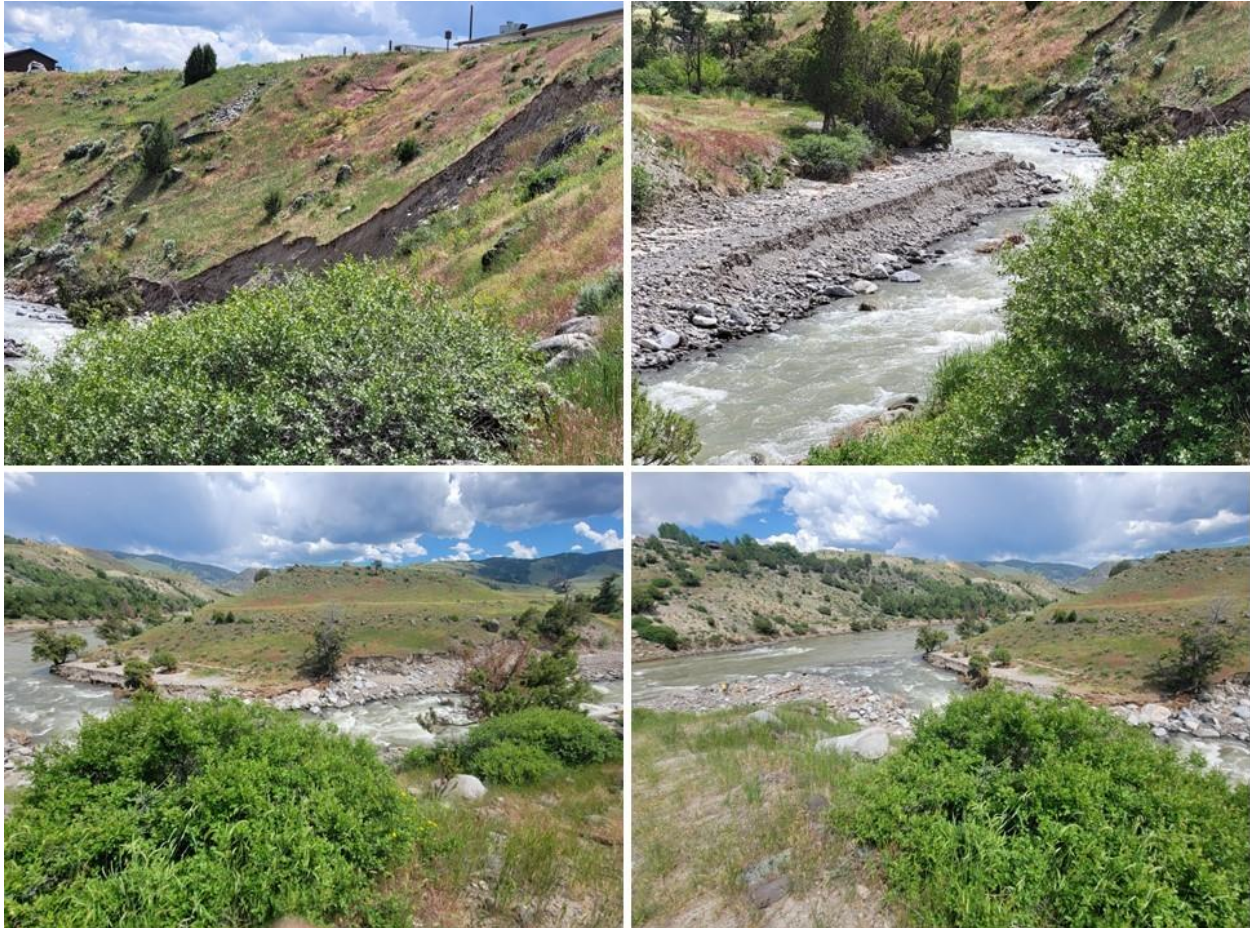
Figure 3.37: Photos taken during the GEER team visit on July 3, 2022. Top left) Slope failure at the western bank of the Gardner River just upstream of the confluence and direct vicinity of building on top of the slope; top right) Gardner River and erosion scarp on the eastern bank just upstream of the confluence; bottom left) different erosion scarp formations on the eastern side of the Gardner Riverbank approaching the confluence; bottom right) confluence during the GEER team visit (45.0298548, -110.7001440).

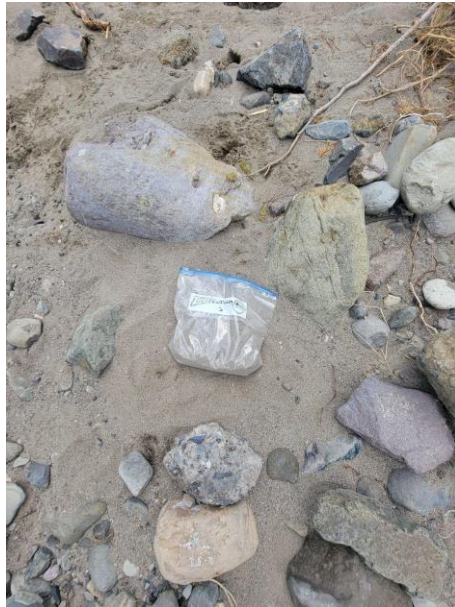
Figure 3.38: Photo of sandy to cobbly sediments on the western confluence corner shoal.

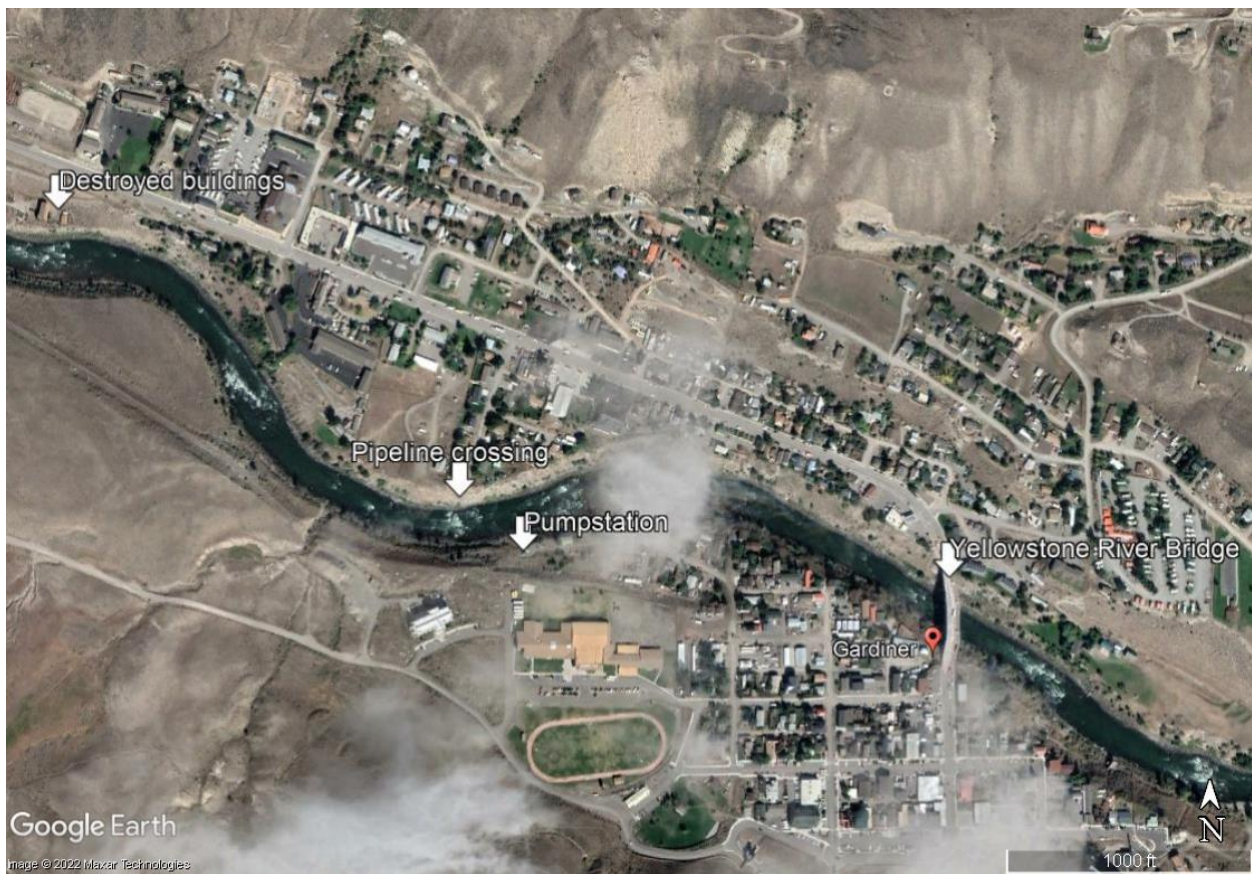
Figure 3.41: Google Earth image (by Maxar Technologies) from September 2019 showing Gardiner, MT, highlighting (white arrows) the Yellowstone River Bridge in the East, the pipeline crossing location and pump station, and the buildings that were swept away during the 2022 flood event.

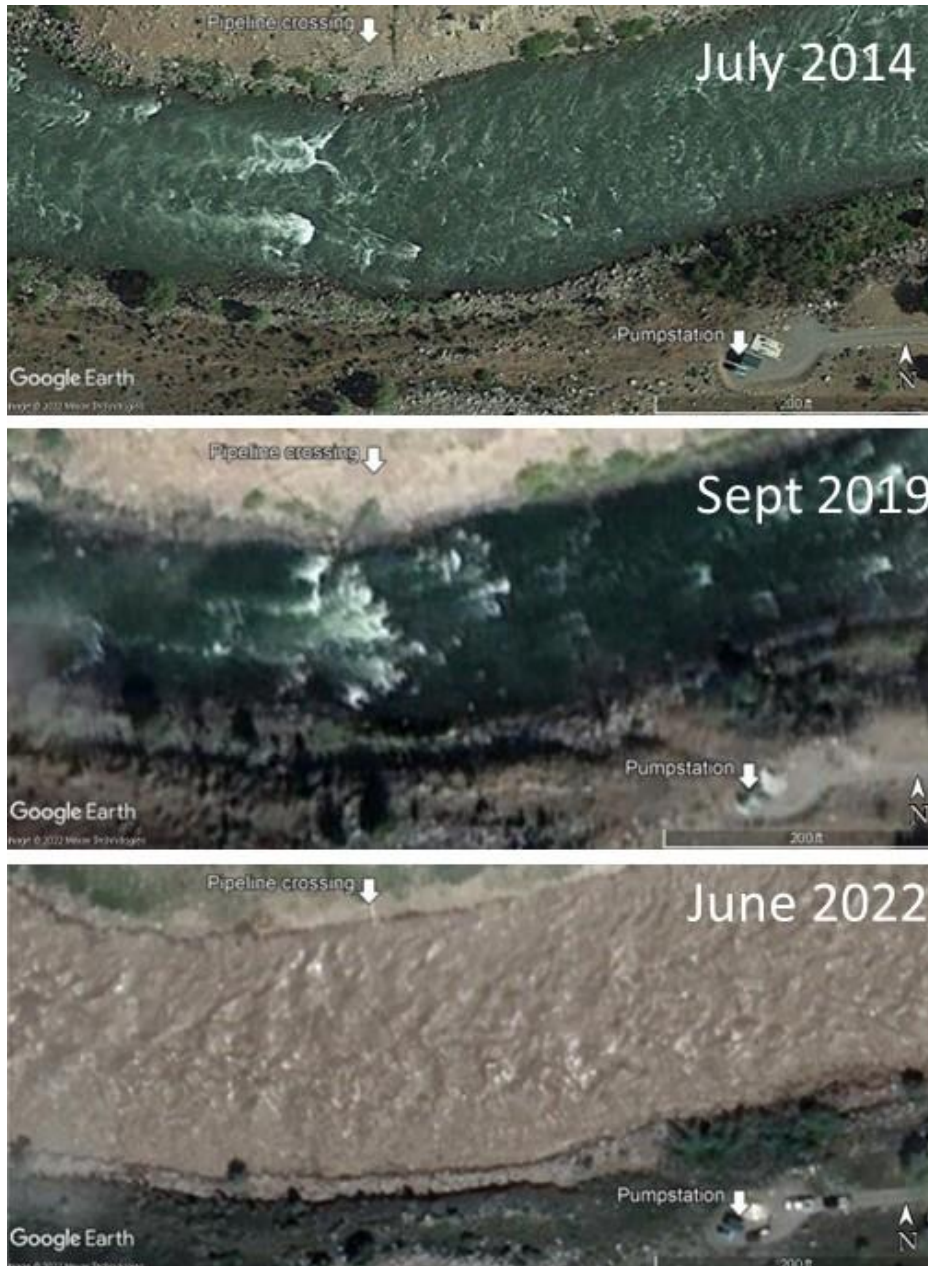
Figure 3.42: Zoom on the pipeline crossing areas using Google Earth images (provided by Maxar Technologies) from July 2014, September 2019, and June 2022.

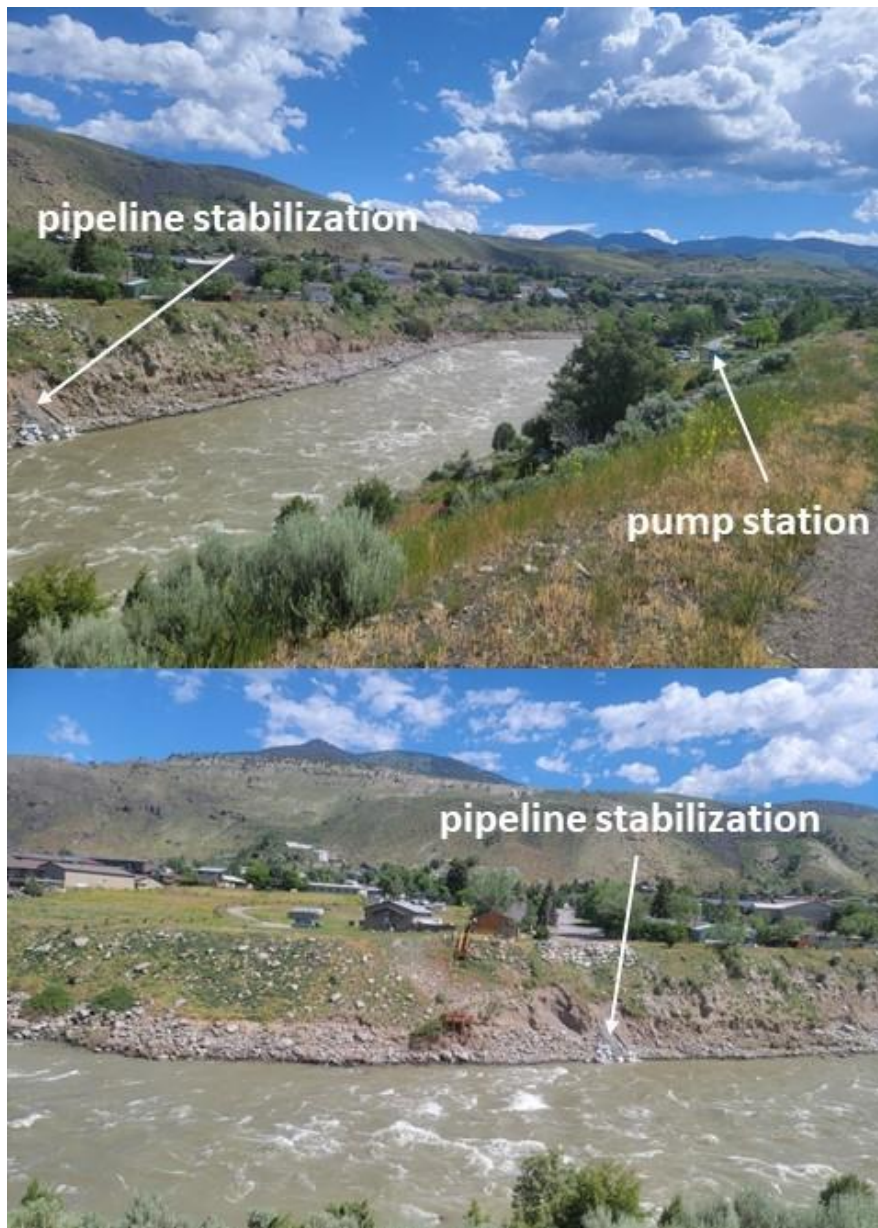
Figure 3.43: Photos taken by the GEER team on July 2, 2022 of the pipeline Yellowstone River crossing section.

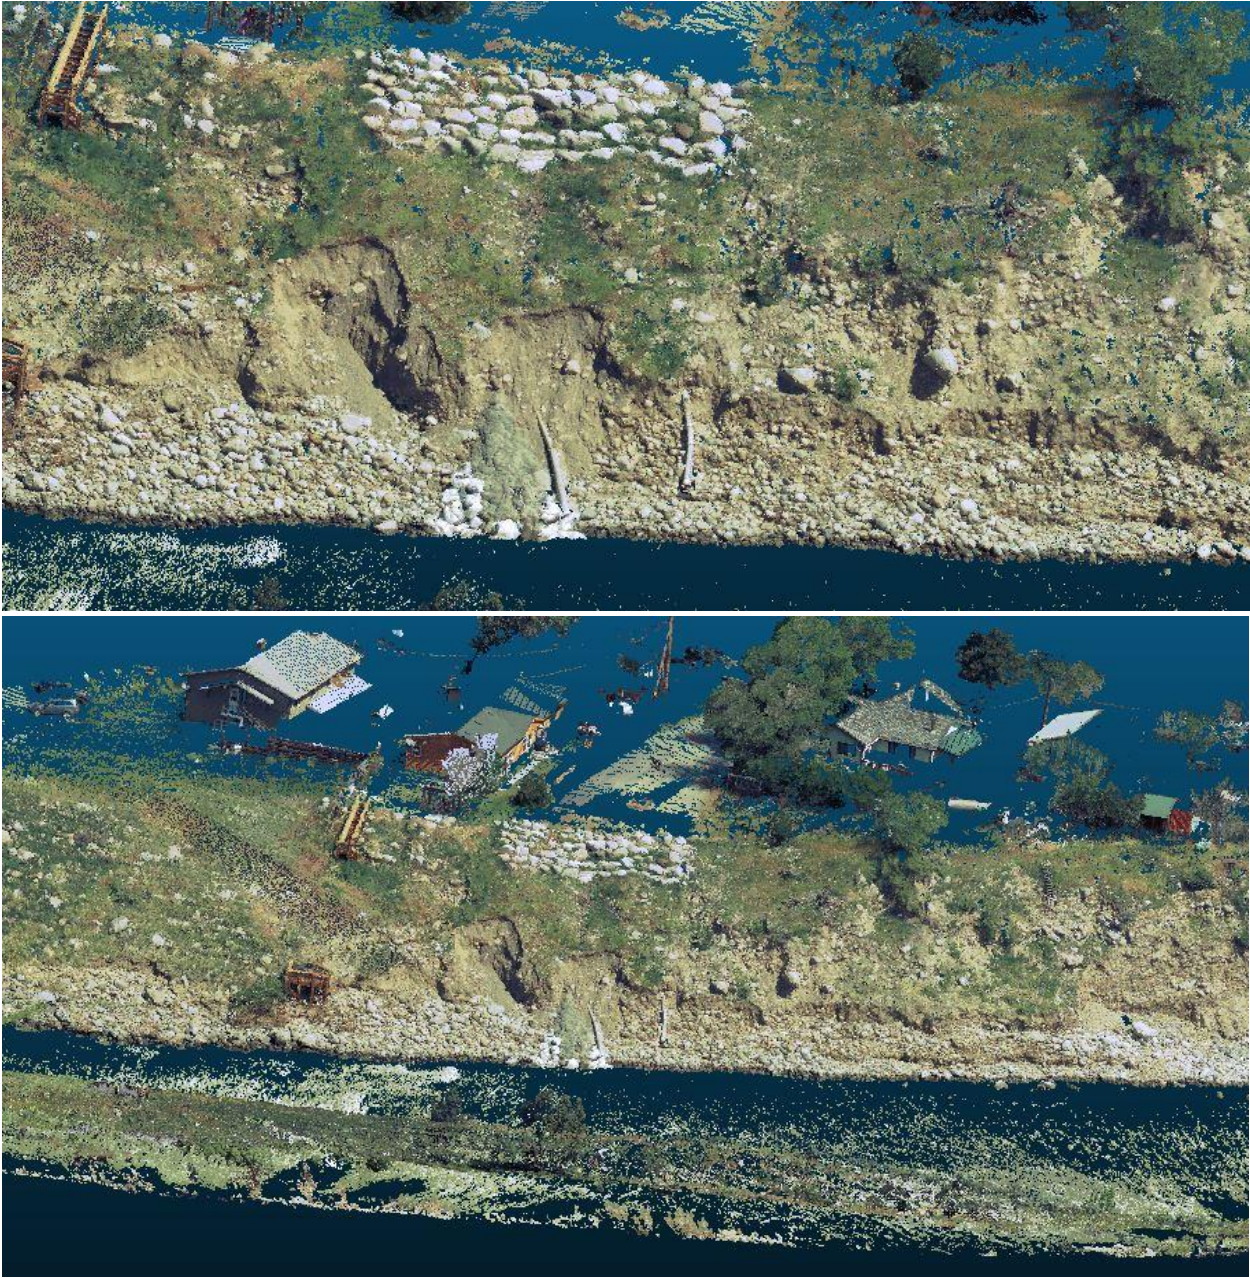
Figure 3.44: Lidar scan of Pipeline crossing

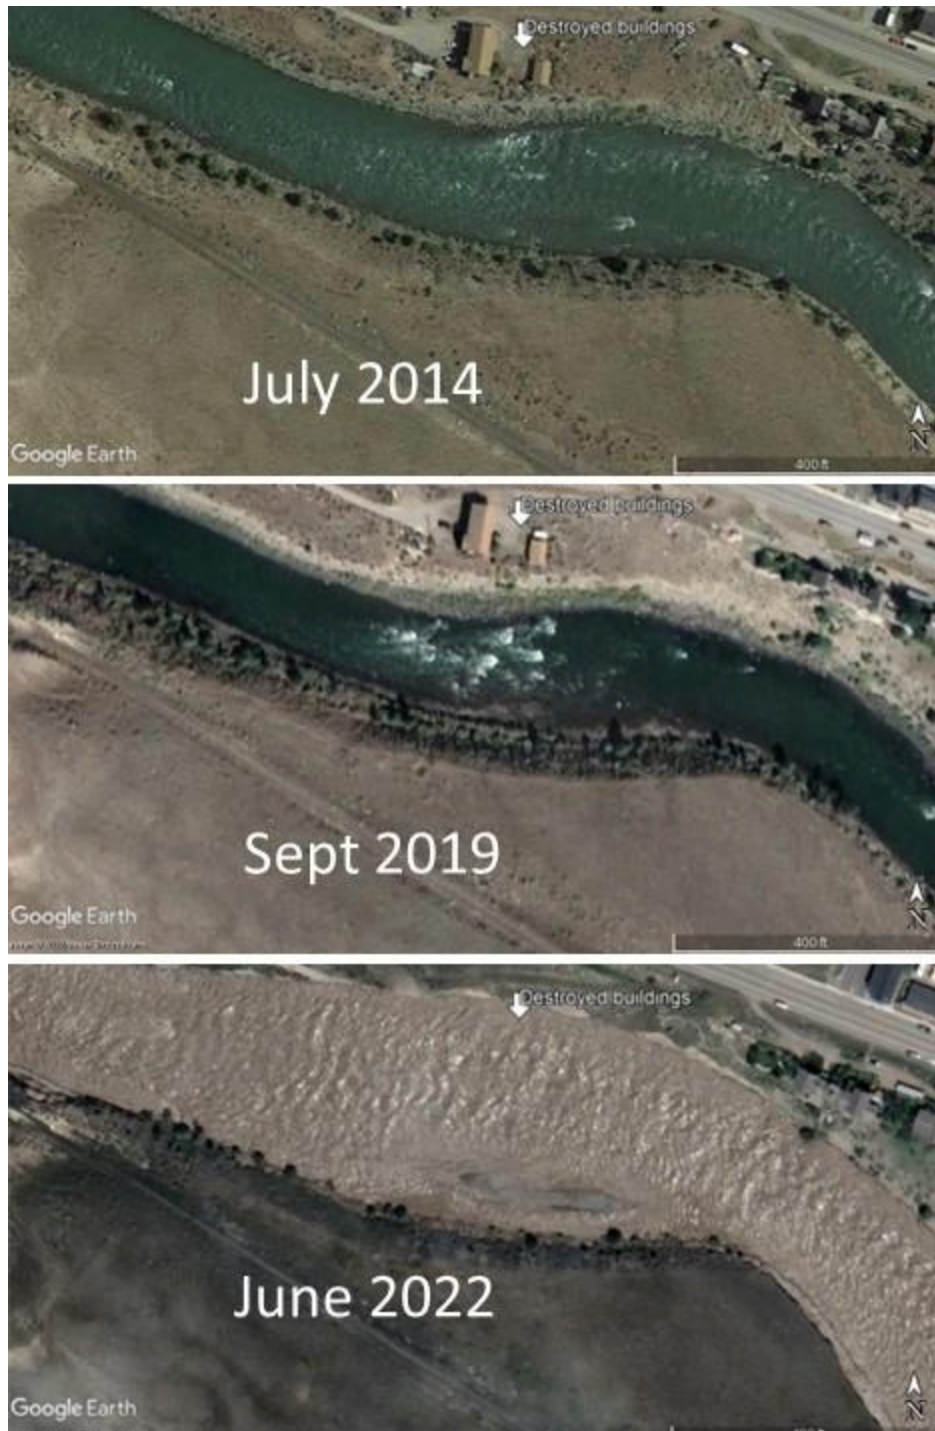
Figure 3.45: Google Earth images (provided by Maxar Technologies) from the Yellowstone River section where two buildings (marked by white arrow) were lost at 123 US-89, Gardiner, MT (N45°2'12.26", W110°43'11.02") from July 2014, September 2019, and during the receding flood in June 2022.

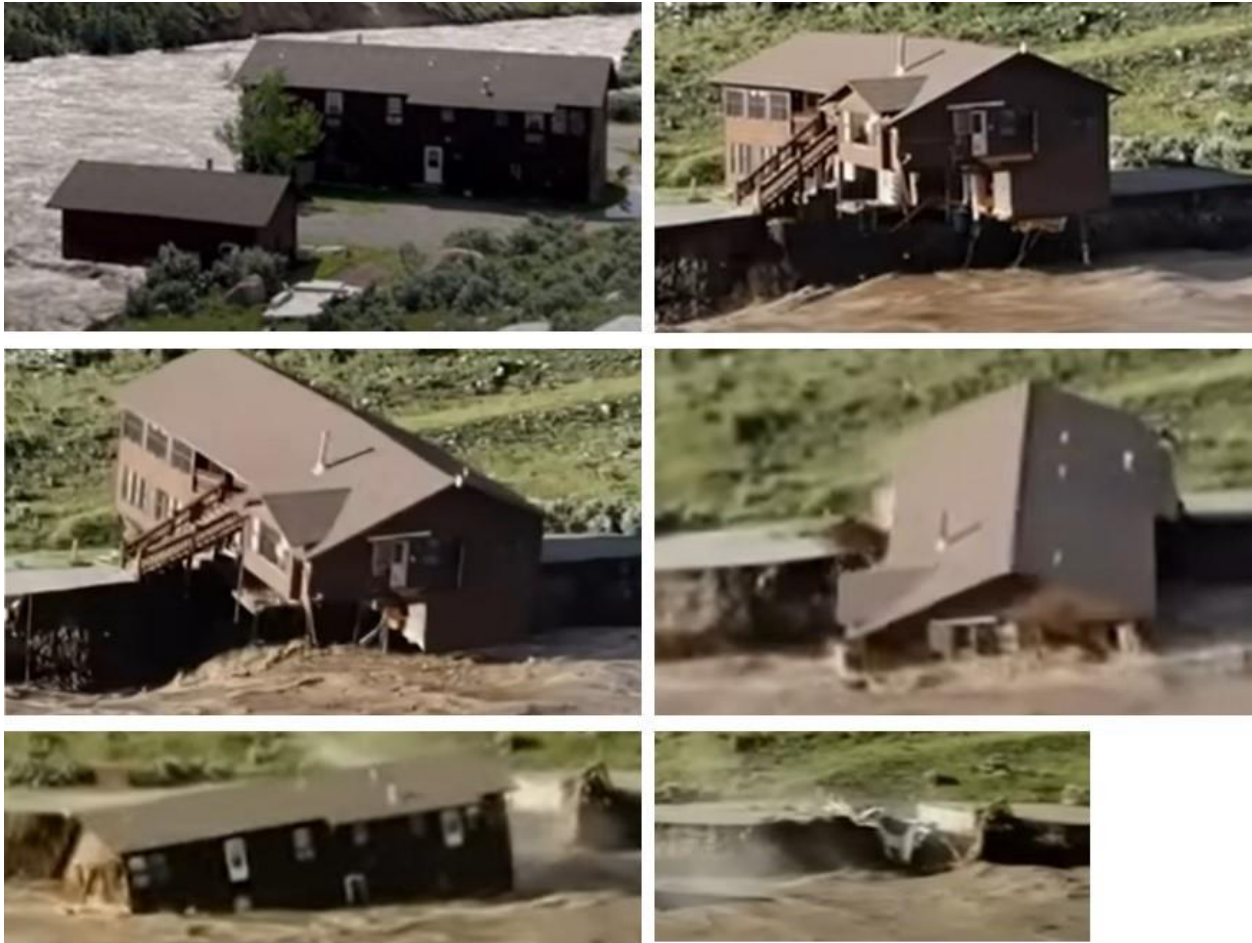
Figure 3.46: Image sequence obtained from videos available on YouTube (<https://www.youtube.com/watch?v=3Q0fpeObMT4>; <https://www.youtube.com/watch?v=GrtV0asee2I>) of building failures at 123 US-89 in Gardiner, MT.

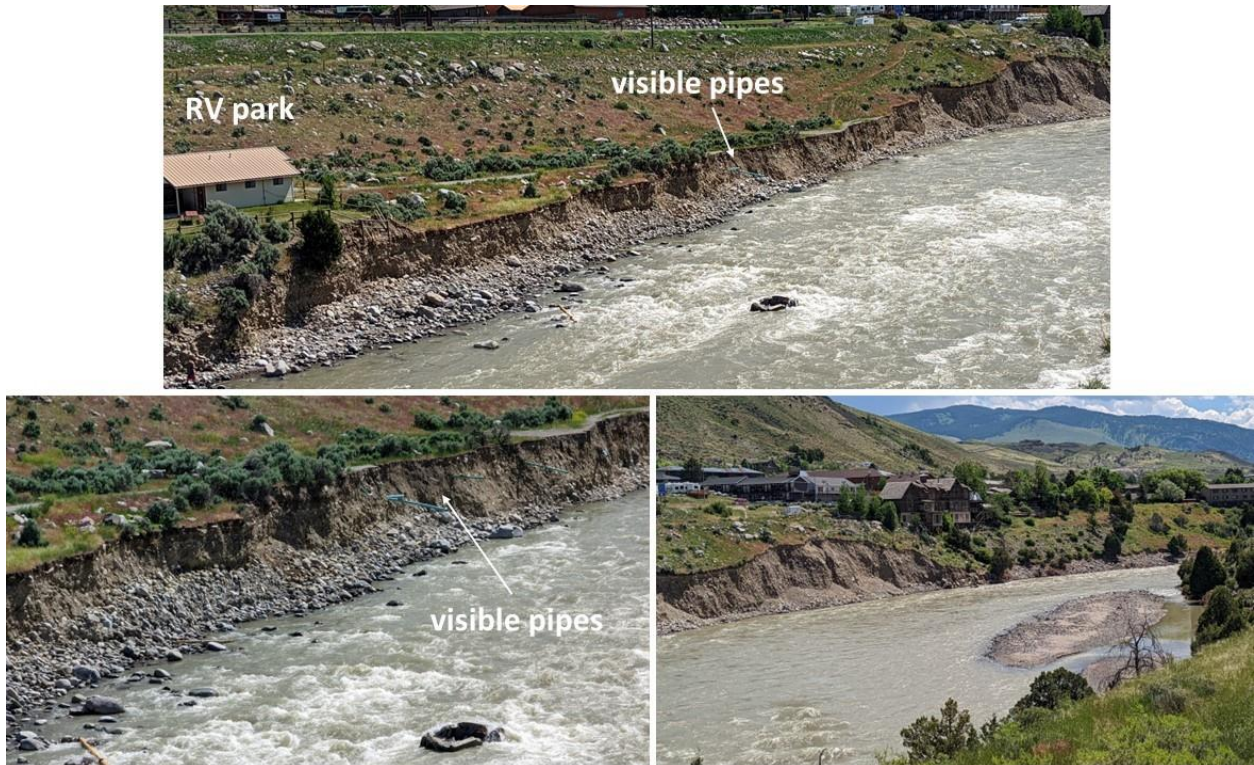
Figure 3.47: Annotated photos by the GEER team obtained on July 3, 2022. Top) Northern riverbank scene of failure: erosion scarp, remaining pipes, and the related location of a RV park building. Left) Erosion scarp composed of gravelly to cobbly materials at the riverbank toe and sandy materials above it.. Right) Gravelly to sandy shoal across the river from the location where the significant erosion scarp starts upstream. (45.0368767, -110.7218001)

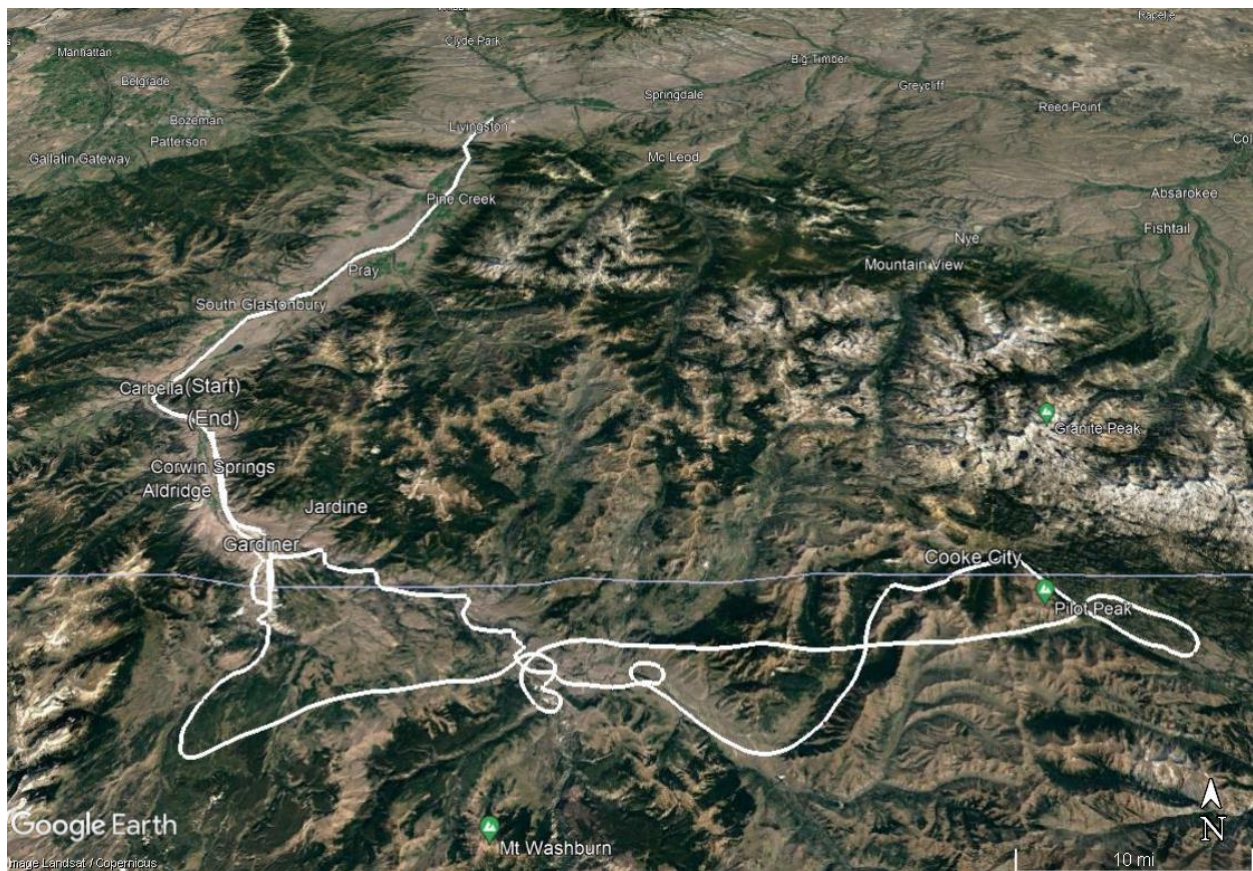
Figure 3.48: Flight path of GEER overflight on Jul 1, 2022.

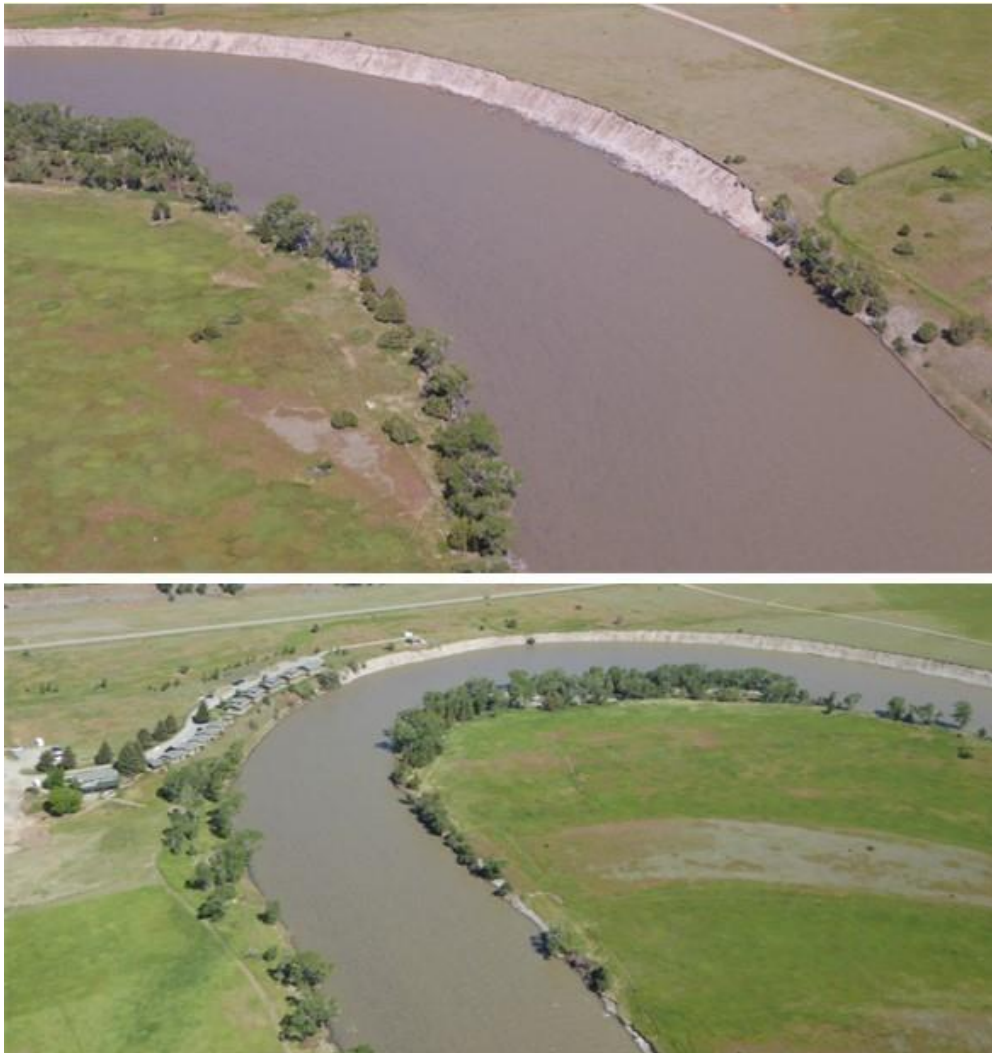
Figure 3.51: Erosion scarp visible at the outer meander riverbank at N45°26'33.24" W110°37'10.81".

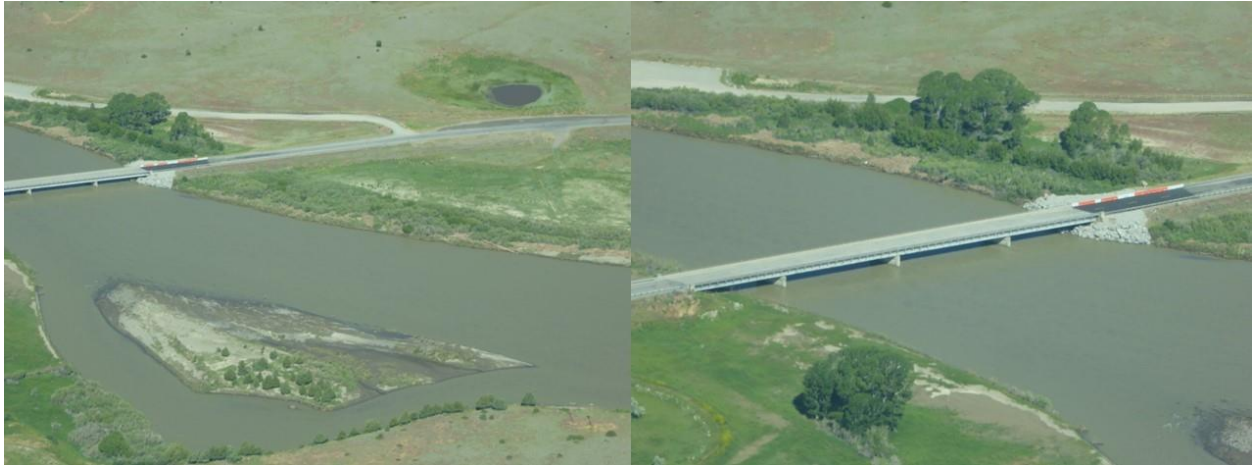
Figure 3.52: Bridge south of South Glastonbury (N45°15'14.77" W110°51'10.81") with apparent repair work of riprap and bridge deck at the northern abutment.

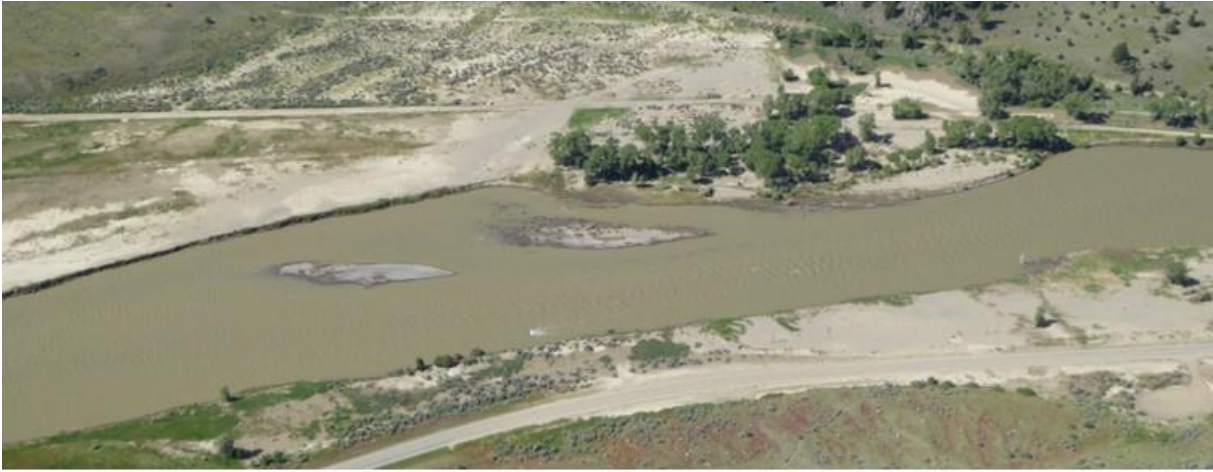
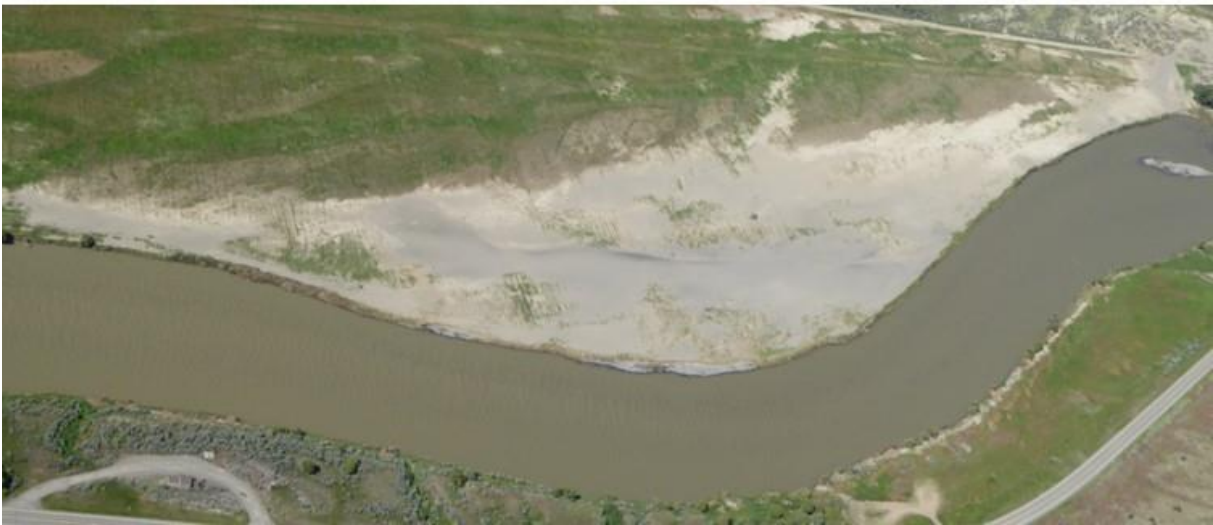
Figure 3.53: Sandy flood deposits in the Carbella area (N45°10'27.40" W110°51'28.24").

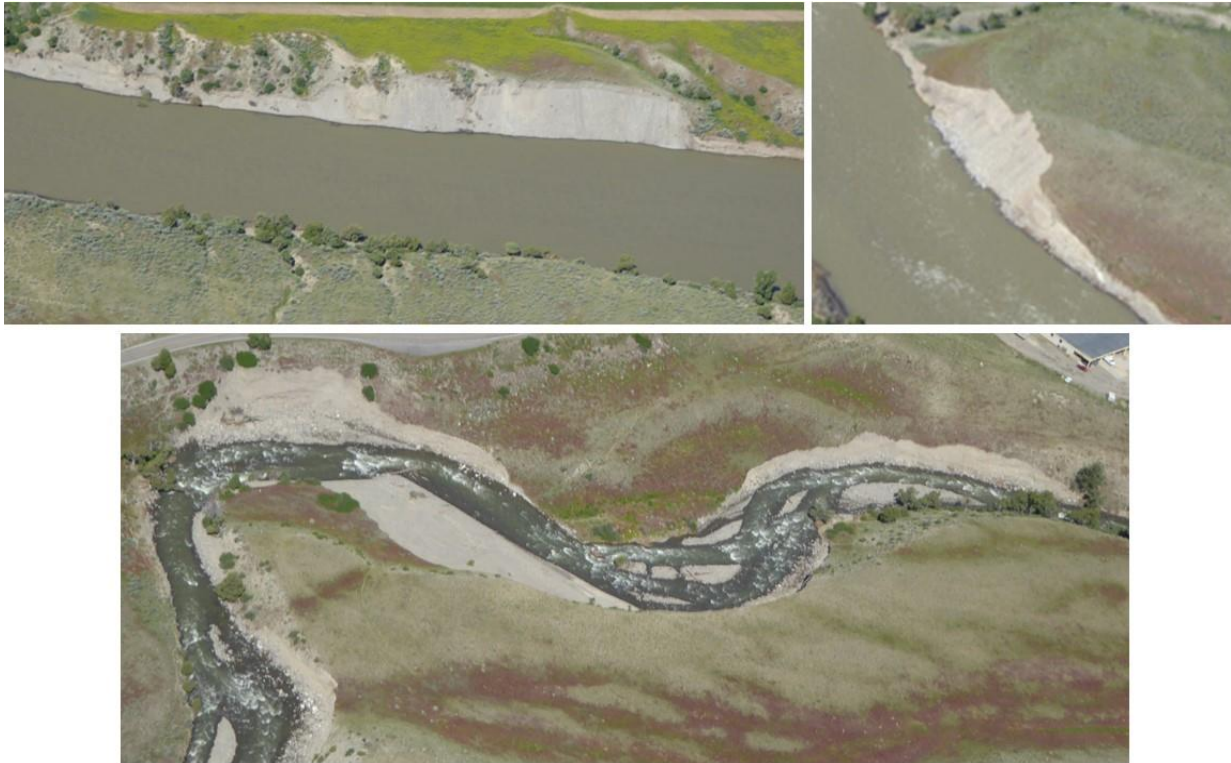
Figure 3.55: Examples of erosion observations along the Yellowstone River (various locations).

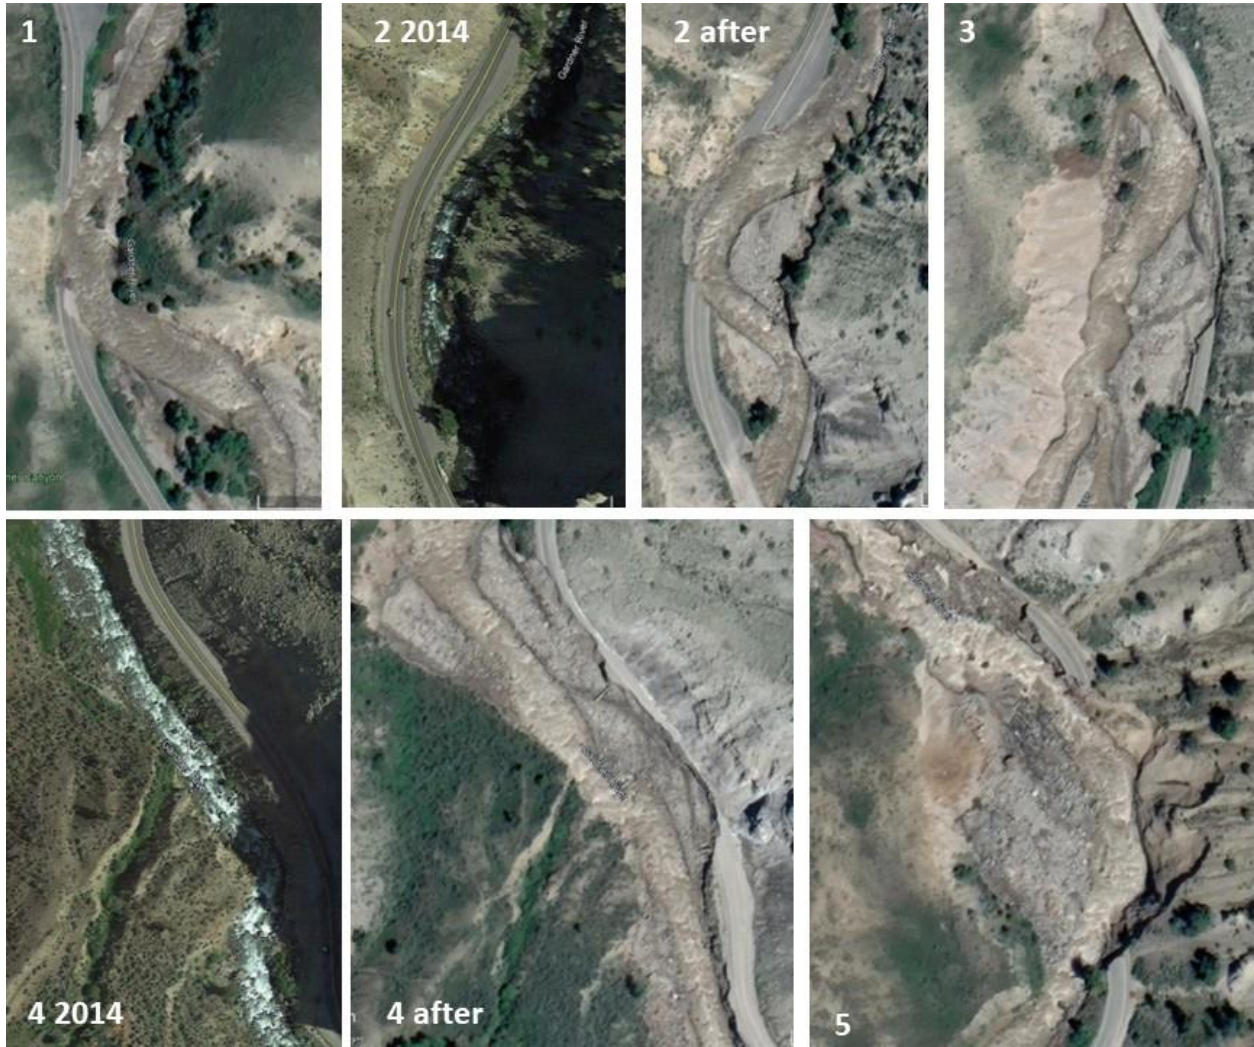
Figure 3.56: Google Earth imagery along the Gardner River starting near Gardner Canyon (1) and following the road to the South showing significant road damages from erosion and slope failures (from scene 1 at N45°1'1.44" W110°41'37.77" to scene 5 at N45°0'14.58" W110°41'30.41").

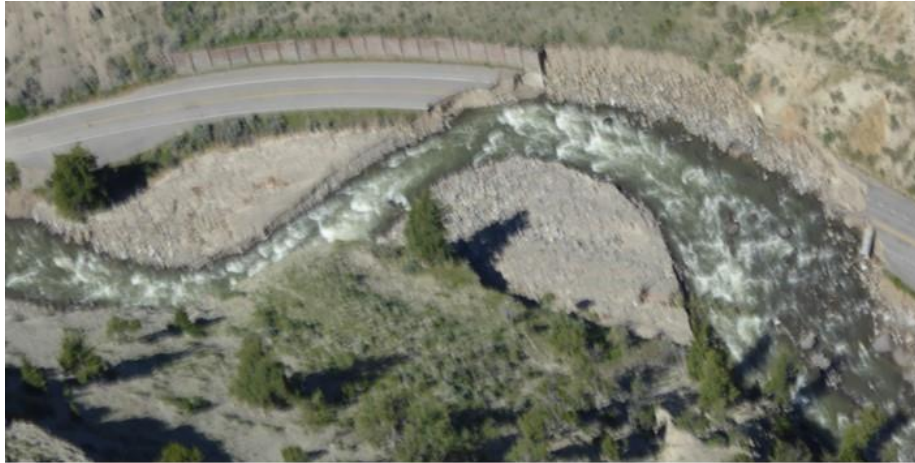
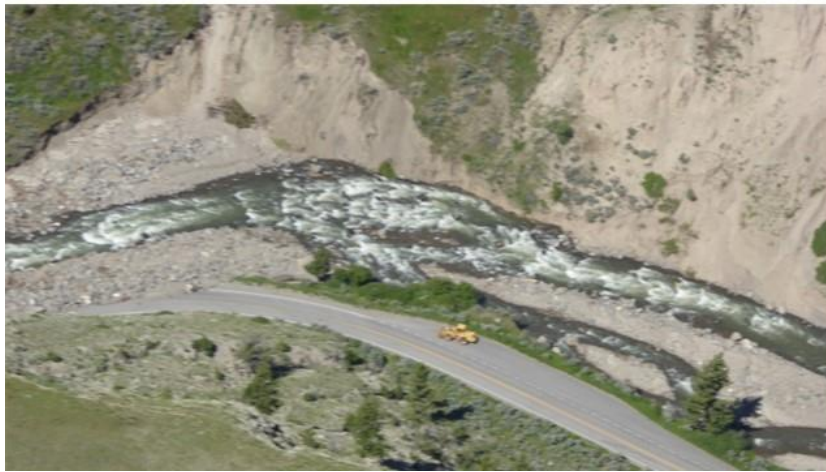
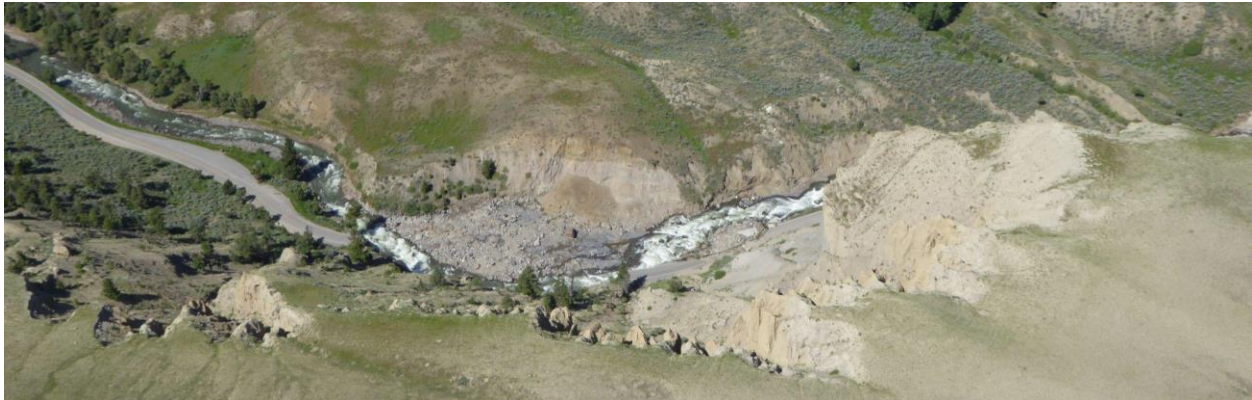
Figure 3.57: Aerial images of road damages along the Gardner River between Gardiner and Mammoth Hot Springs taken on Jul 1, 2022.

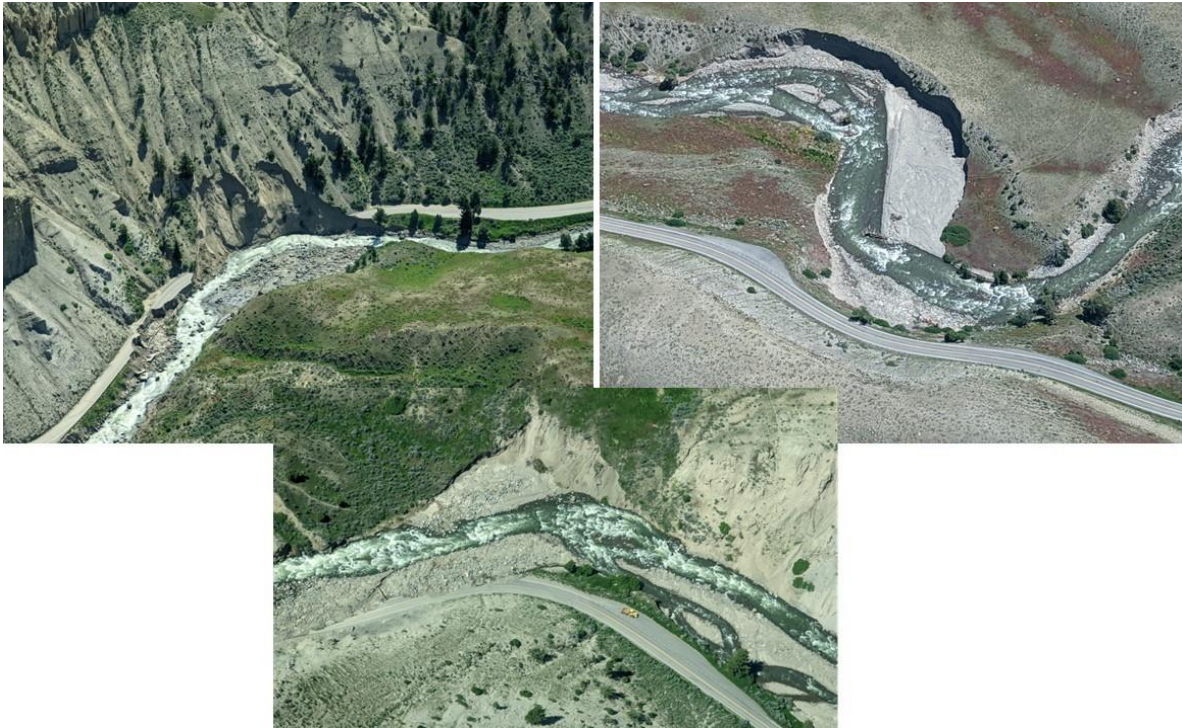
Figure 3.58: Aerial images of road failures, erosion, and slope failures near the Gardner River (Top left photo: 45.005255, -110.691759, Top right photo: 45.023285, -110.698620, Bottom photo: 45.016004, -110.692658)

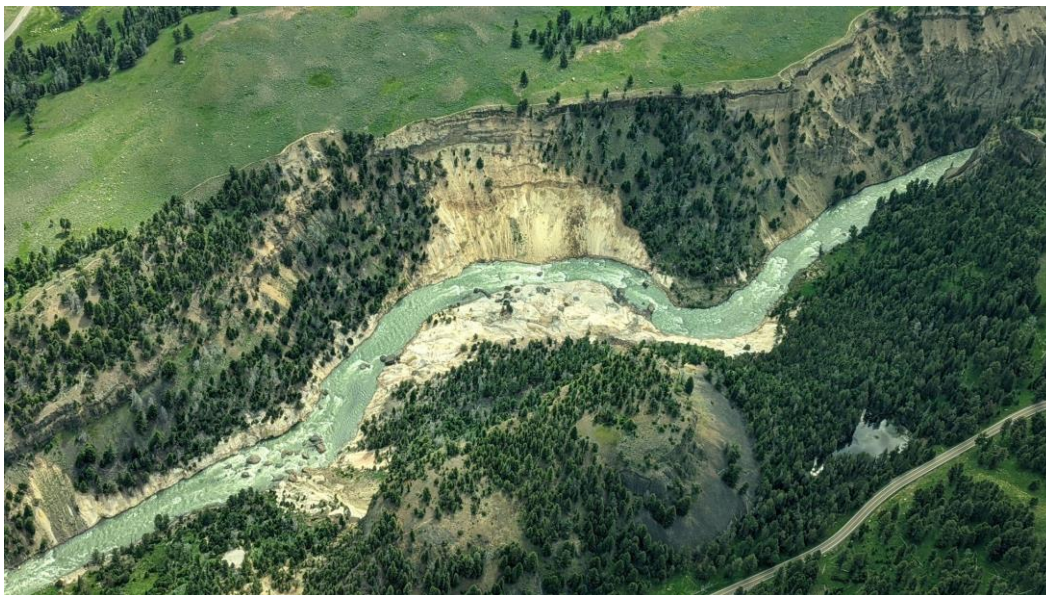
Figure 3.59: Over-steepened riverbank at the Yellowstone River with most recent slope failure in an outer meander (44.908112, -110.394739).
