Geotechnical Reconnaissance of the 2022 Southern Montana/ Yellowstone Floods

Flood Event: June 13-24, 2022

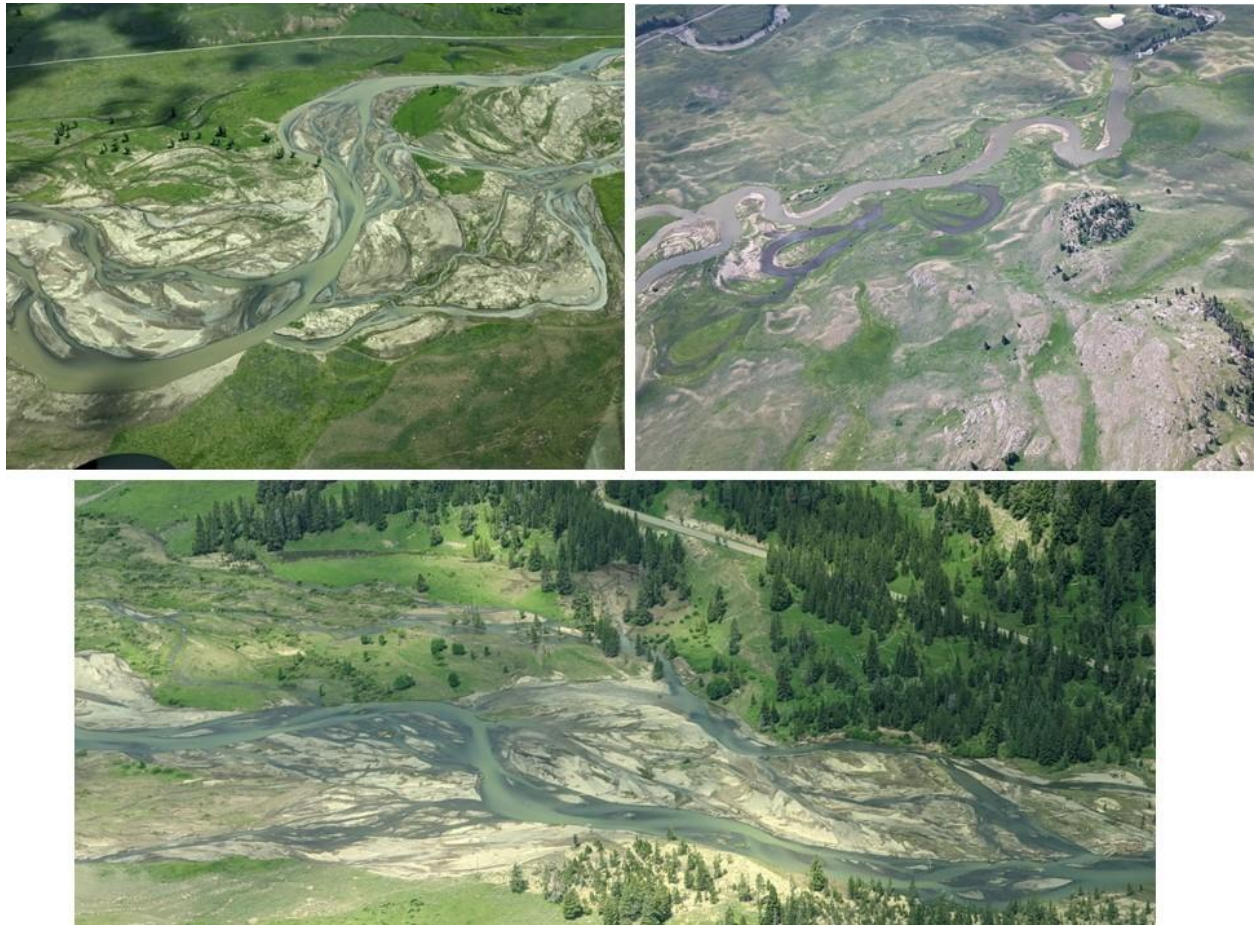
Figure 3.60: River braiding and meandering including abandoned channels and meanders in the Lamar Valley (44.86798694, -110.1910517).

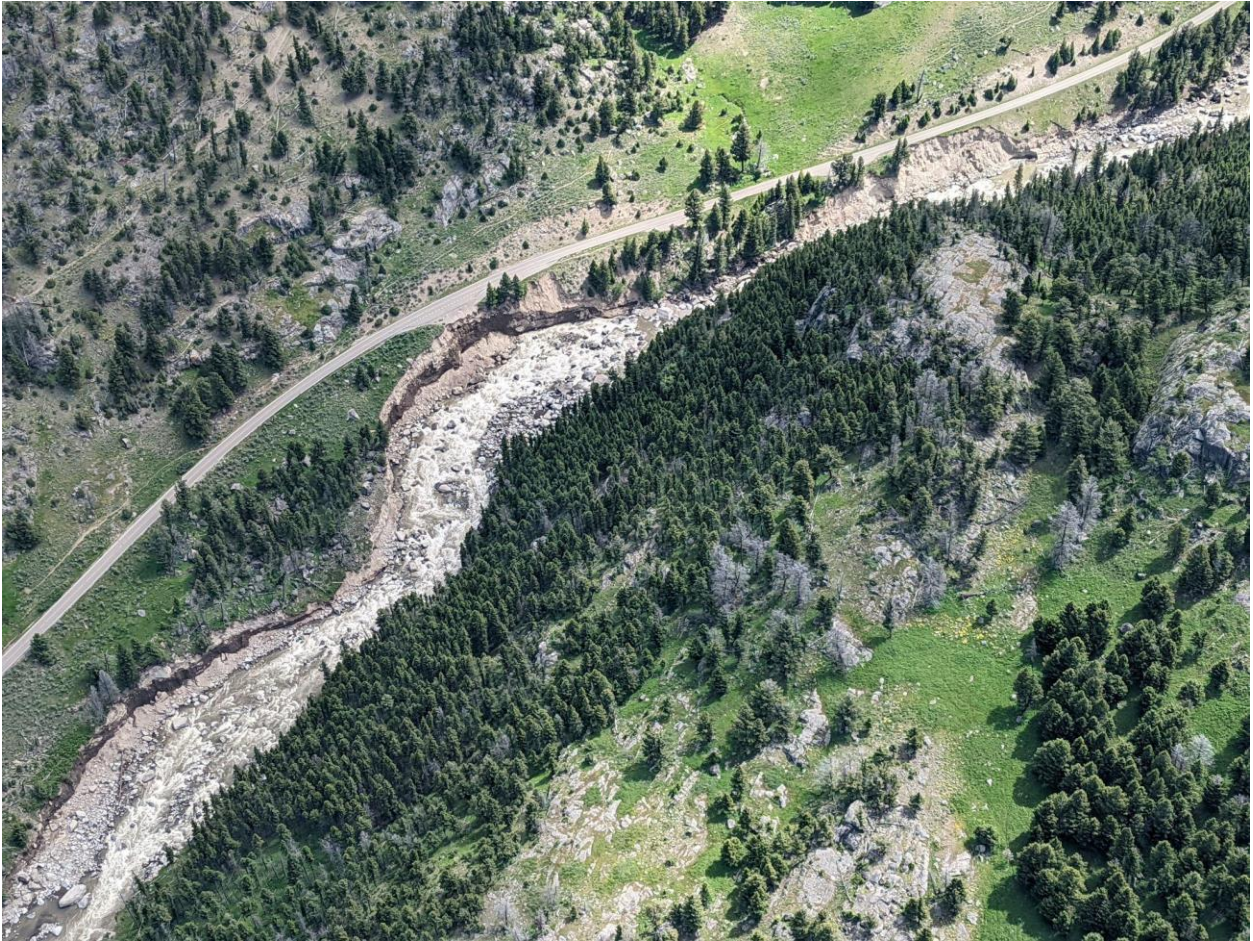
Figure 3.61: Initial meandering of the river approaching road sections (44.953619, -110.074767).

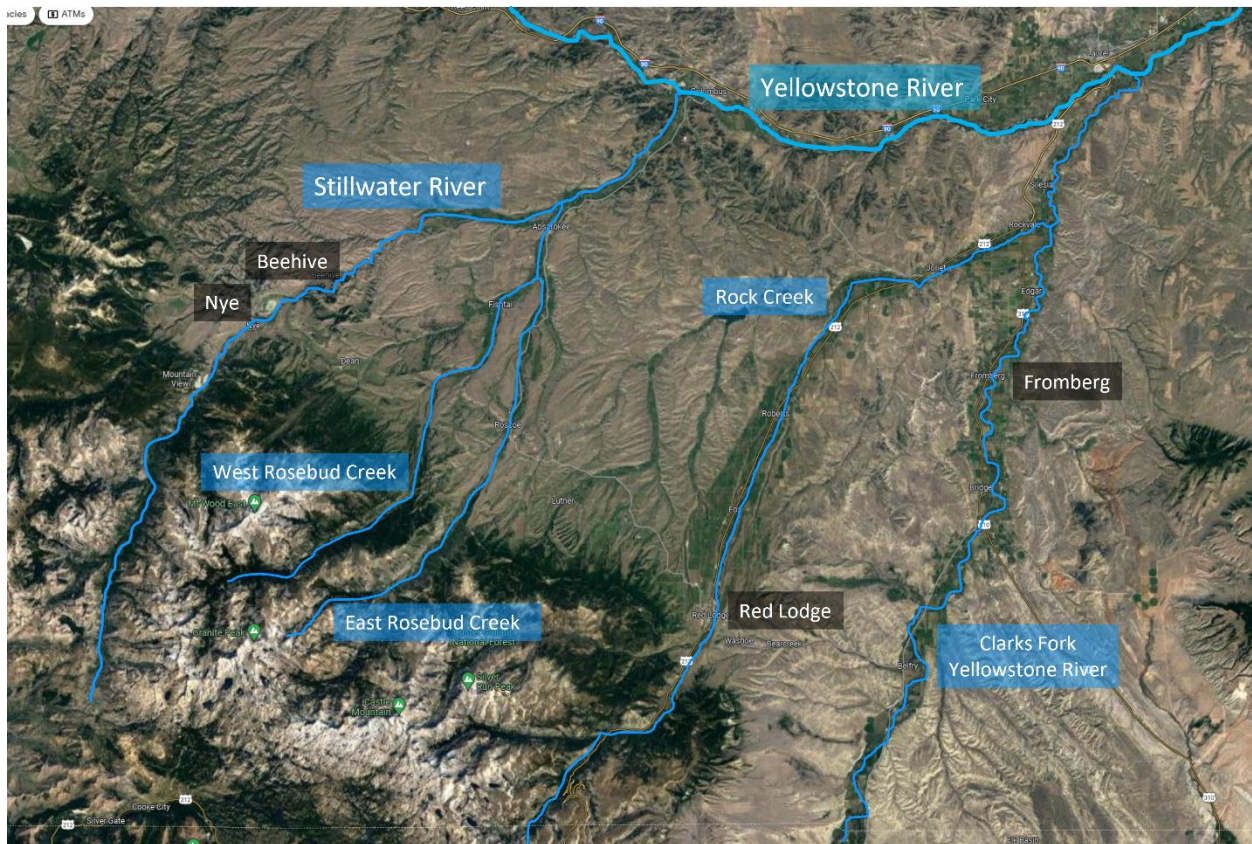
Figure 3.62: Major tributaries to the Yellowstone West Area in Southern Montana

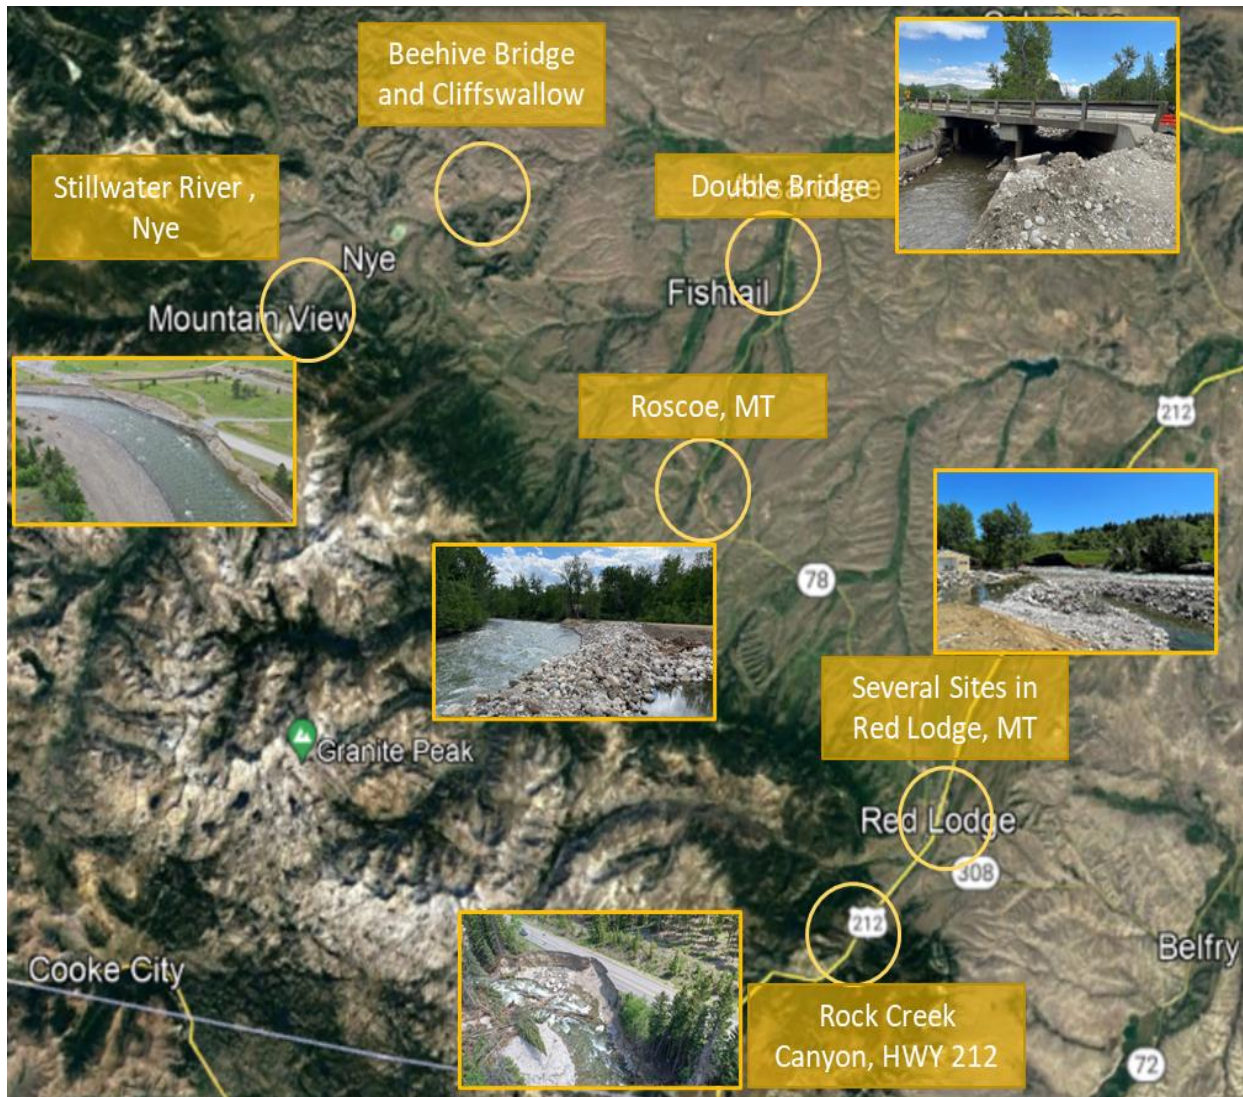
Figure 3.63: Overview of general areas visited by the GEER Team along the Northeast Slope Tributaries (Stillwater River, East and West Rosebud Creeks, Rock Creek, and Clarks Fork).

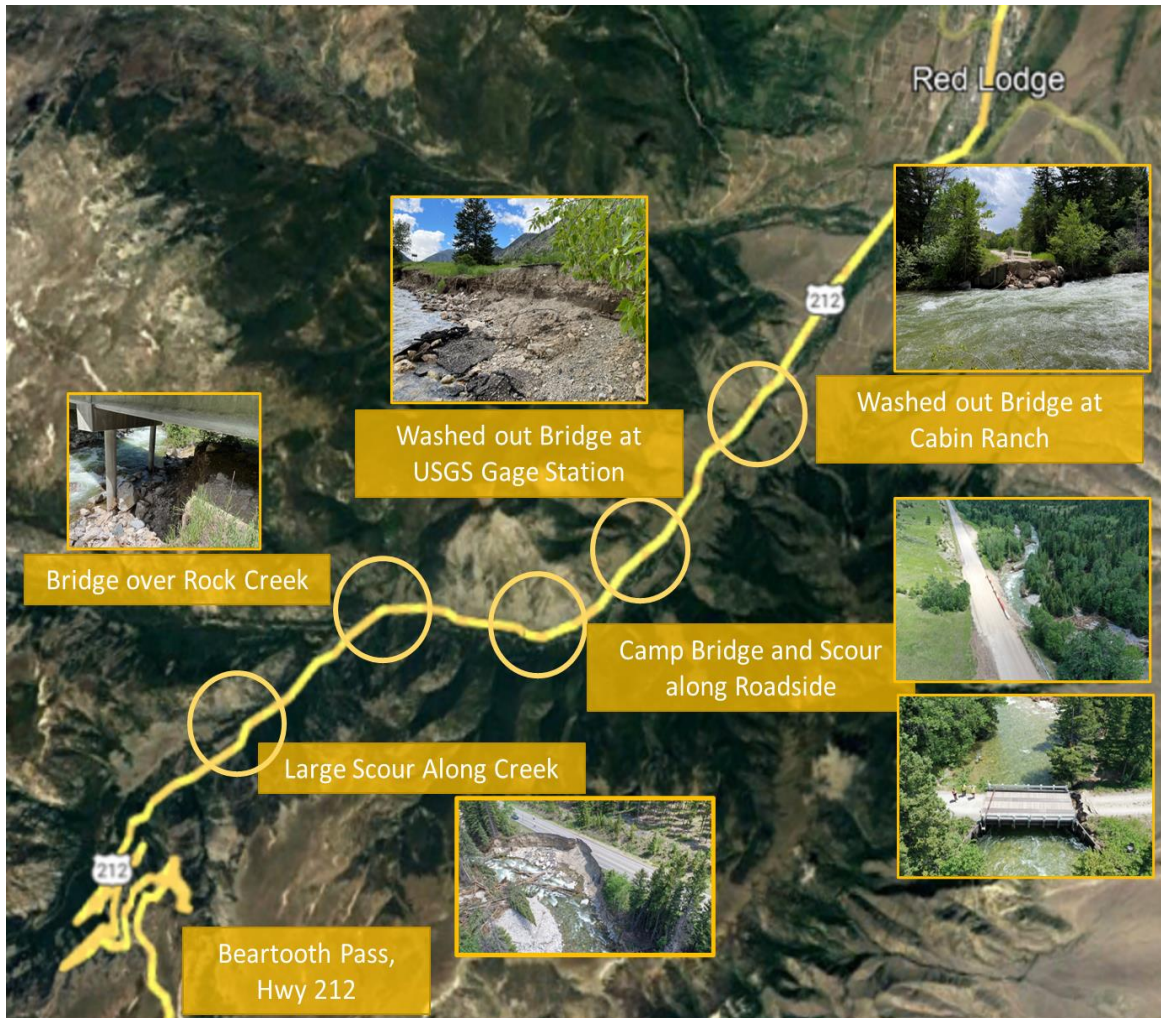
Figure 3.64: Google Map of Beartooth Highway (Montana Highway 212) south of Red Lodge, MT (45.1377 N 109.2826 W)

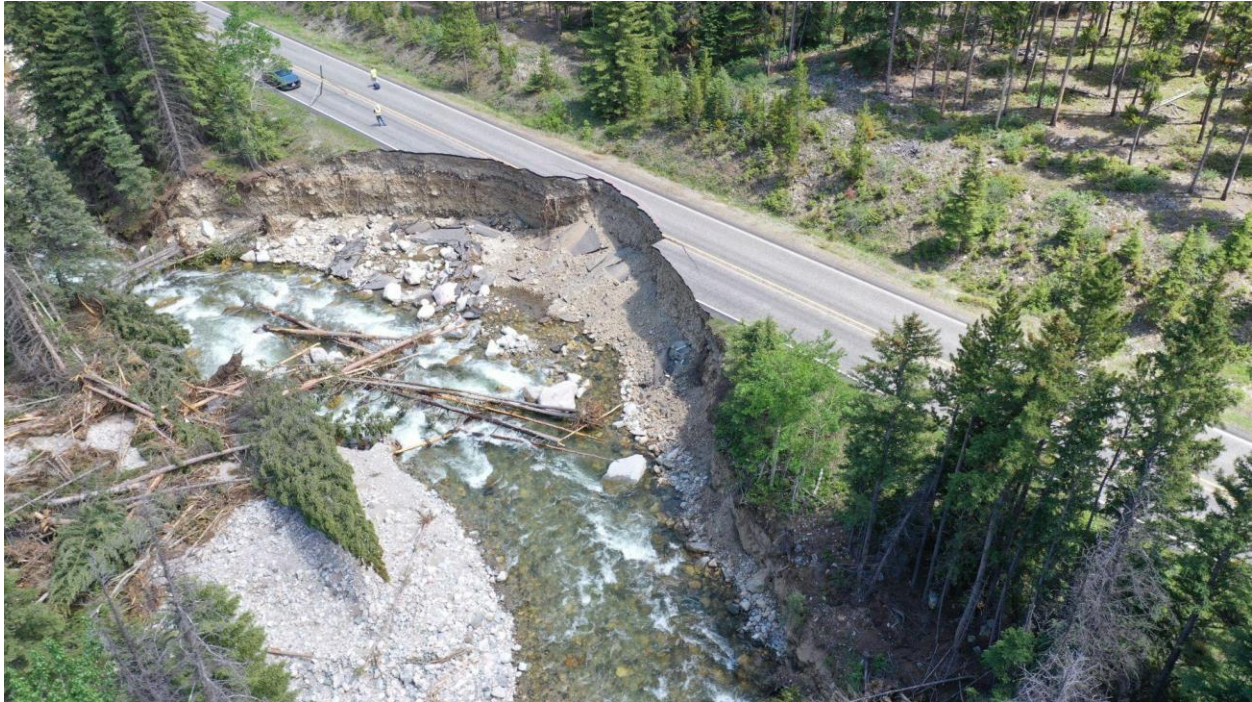
Figure 3.67: Large scour scarp along the Beartooth Highway south of Red Lodge (45.0691 N 109.3896 W)

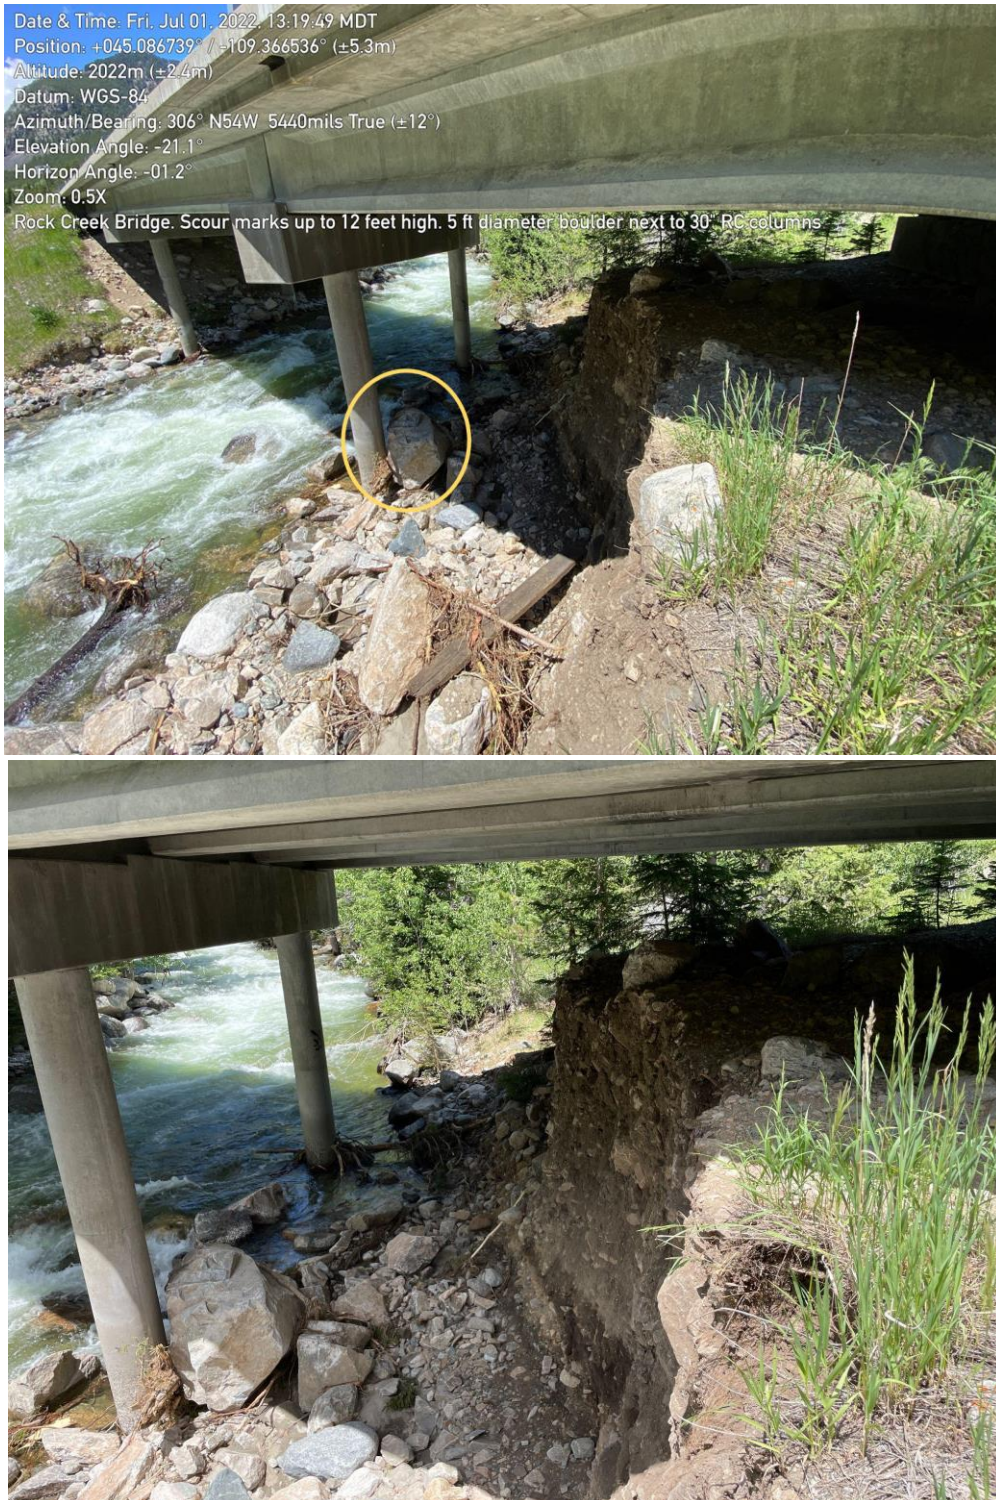
Figure 3.68: Highway 212 Bridge over Rock Creek (45.0867 N 109.3665 W). Boulder is circled in Yellow.

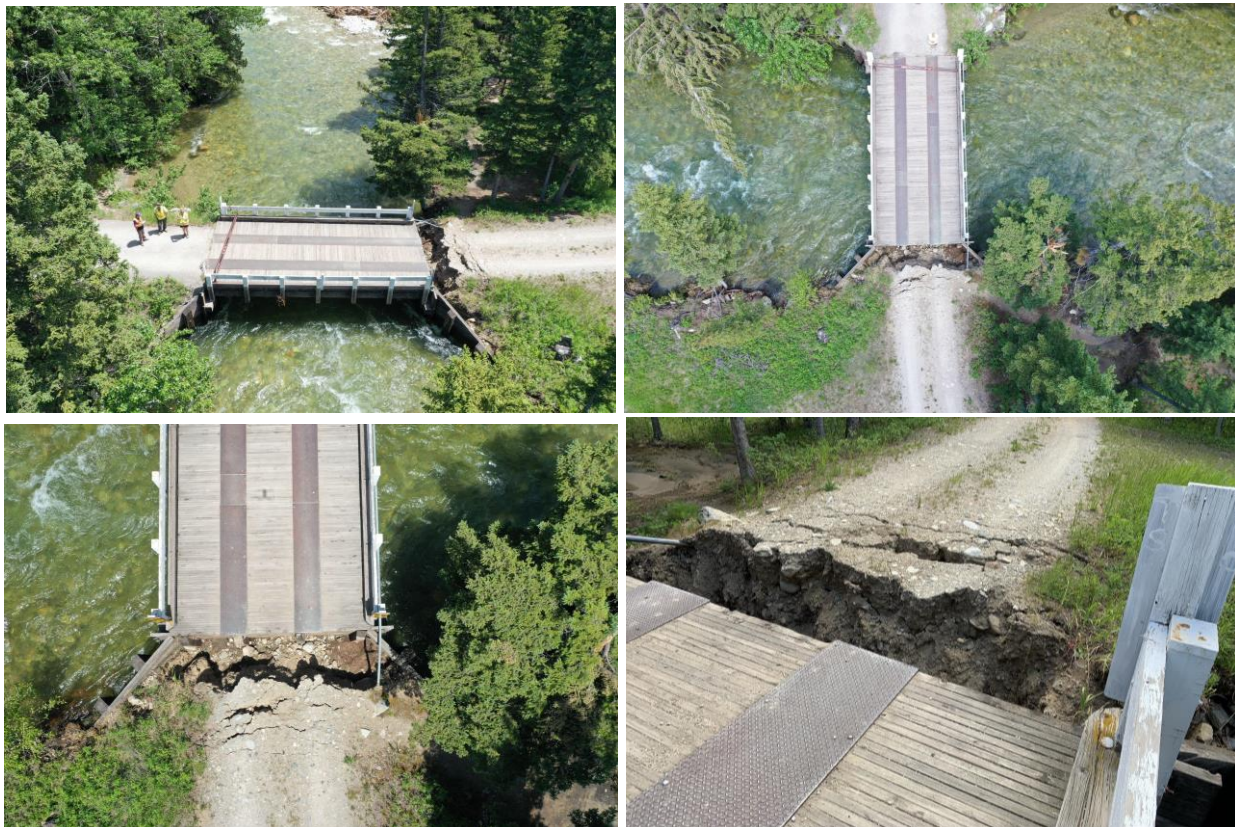
Figure 3.69: Imagery showing damage behind the abutment at the Westminster Church Camp Bridge near Highway 212 South of Red Lodge (45.0859 N 109.3508 W).

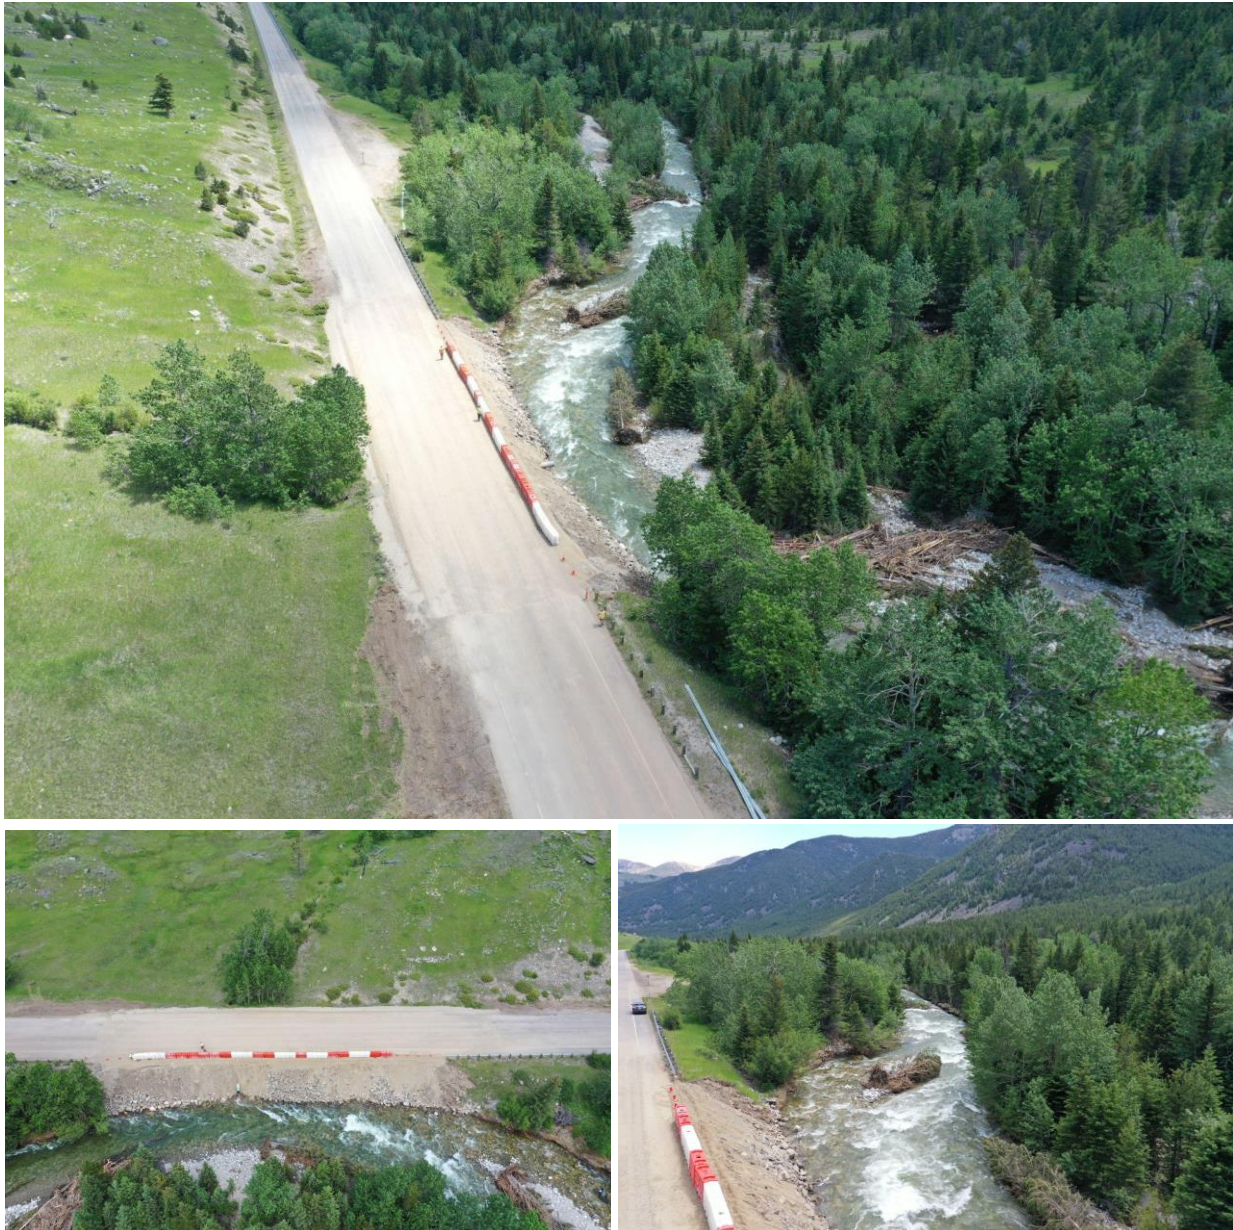
Figure 3.70: A repaired scarp on the Beartooth Highway south of Red Lodge (45.0866 N 109.3470 W)

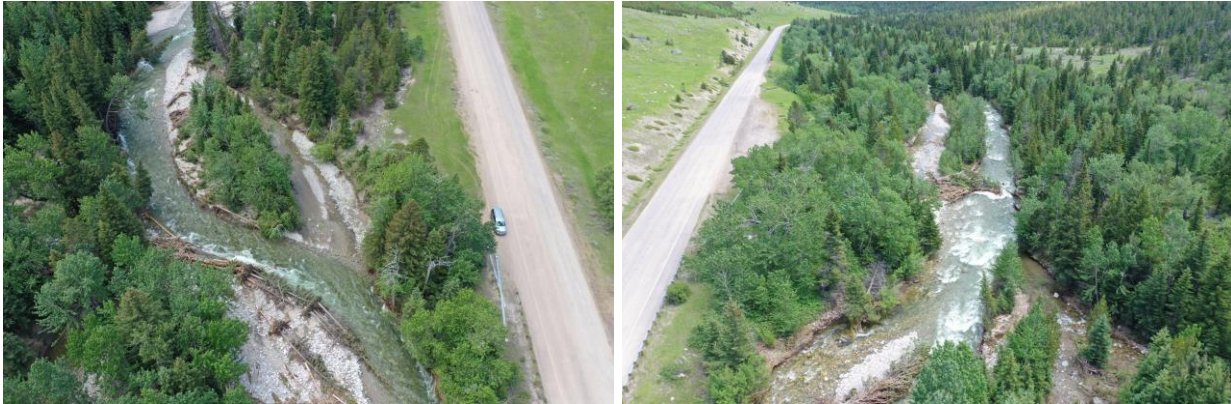
Figure 3.71: Imagery showing upstream (left) and downstream (right) from the repaired scarp on the Beartooth Highway south of Red Lodge (45.0866 N 109.3470 W)

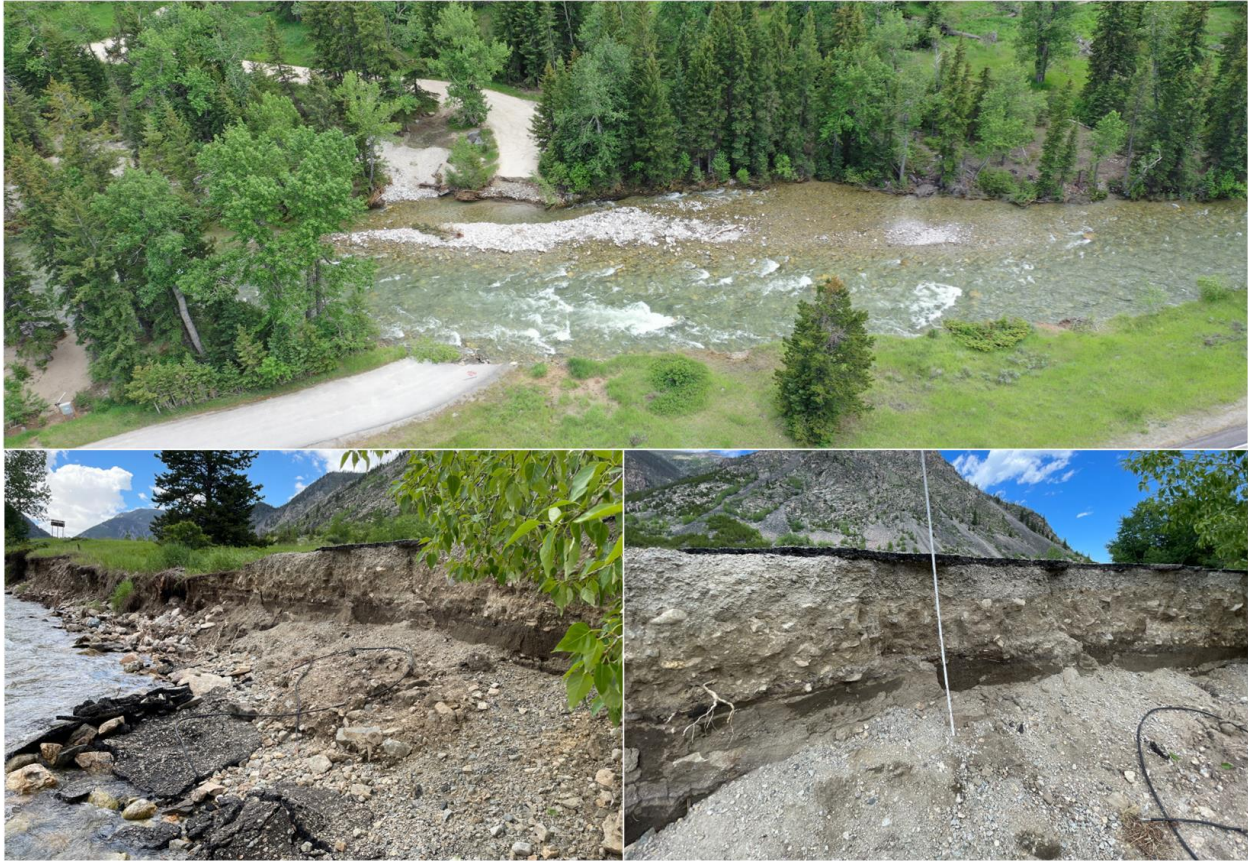
Figure 3.72: Washed out bridge at USGS Gauge Station on Rock Creek (45.086N 109.330826W).

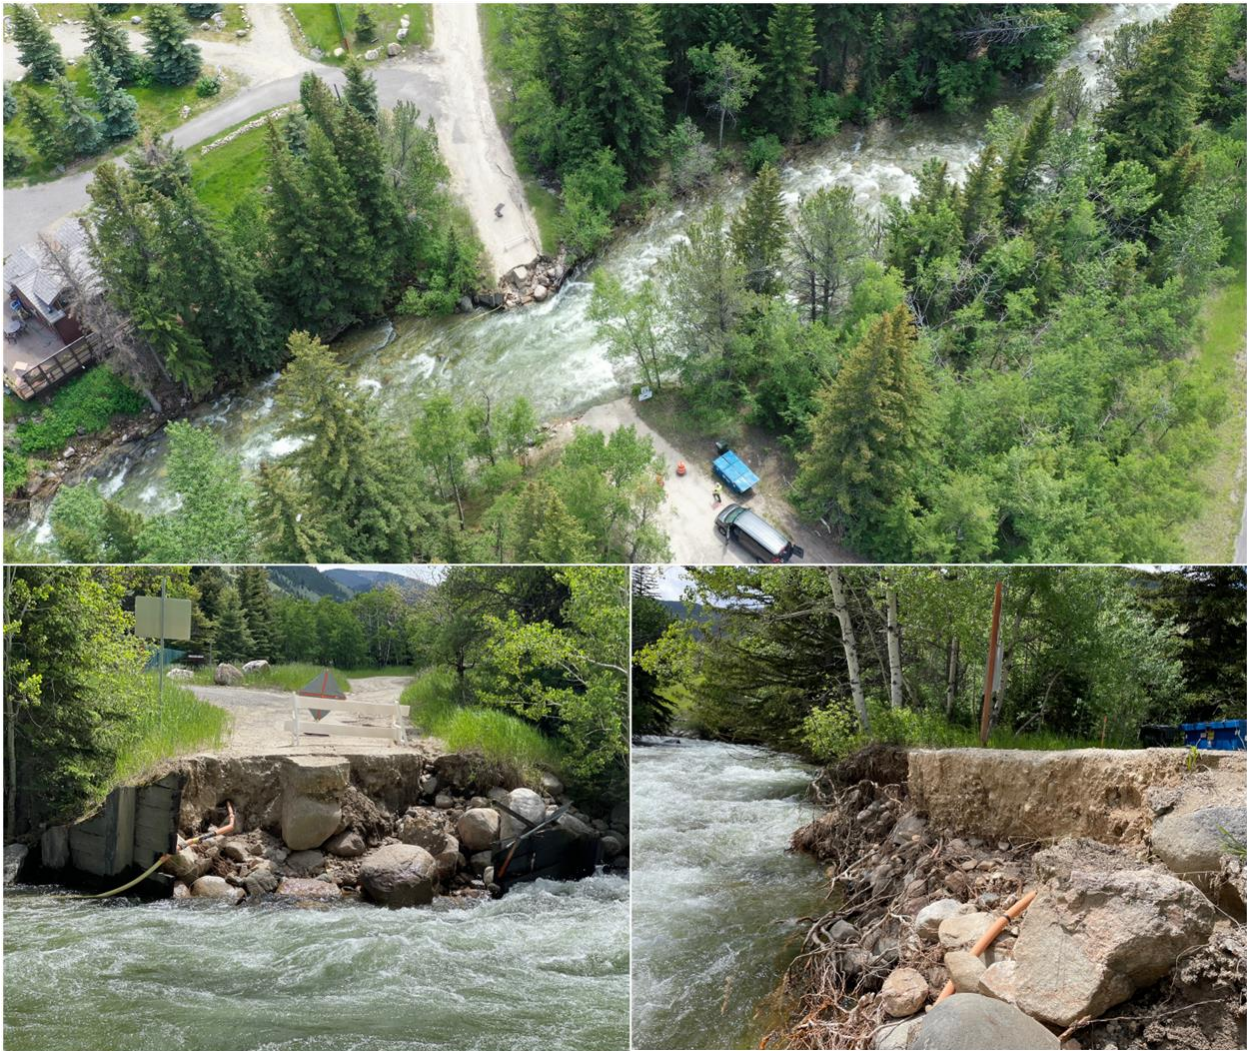
Figure 3.73: Washed out bridge at Cabin Ranch. Note the size of boulders that were behind the wing-walls at this bridge (45.12065N 109.2966W).

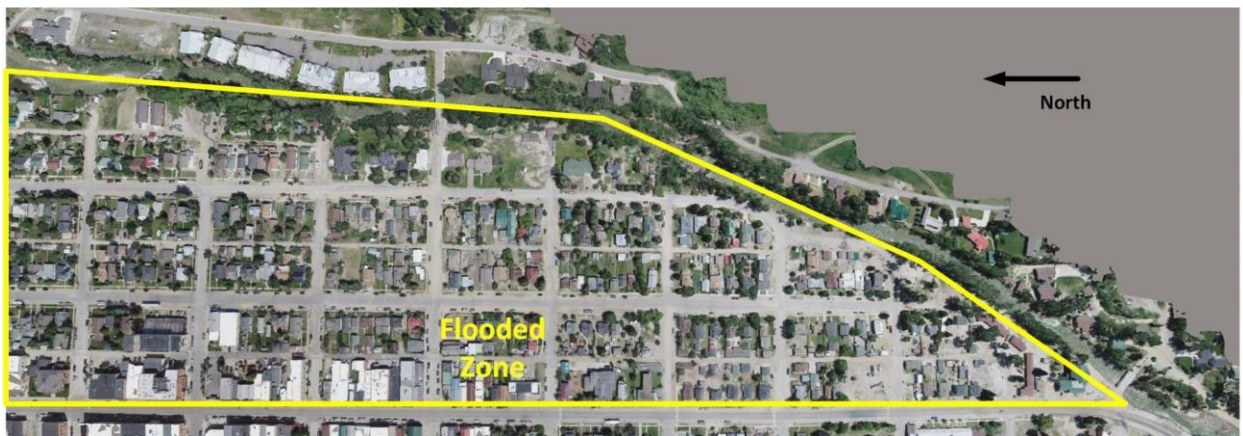
Figure 3.74: 3D model image depicting the observed flood zone in Red Lodge, Montana

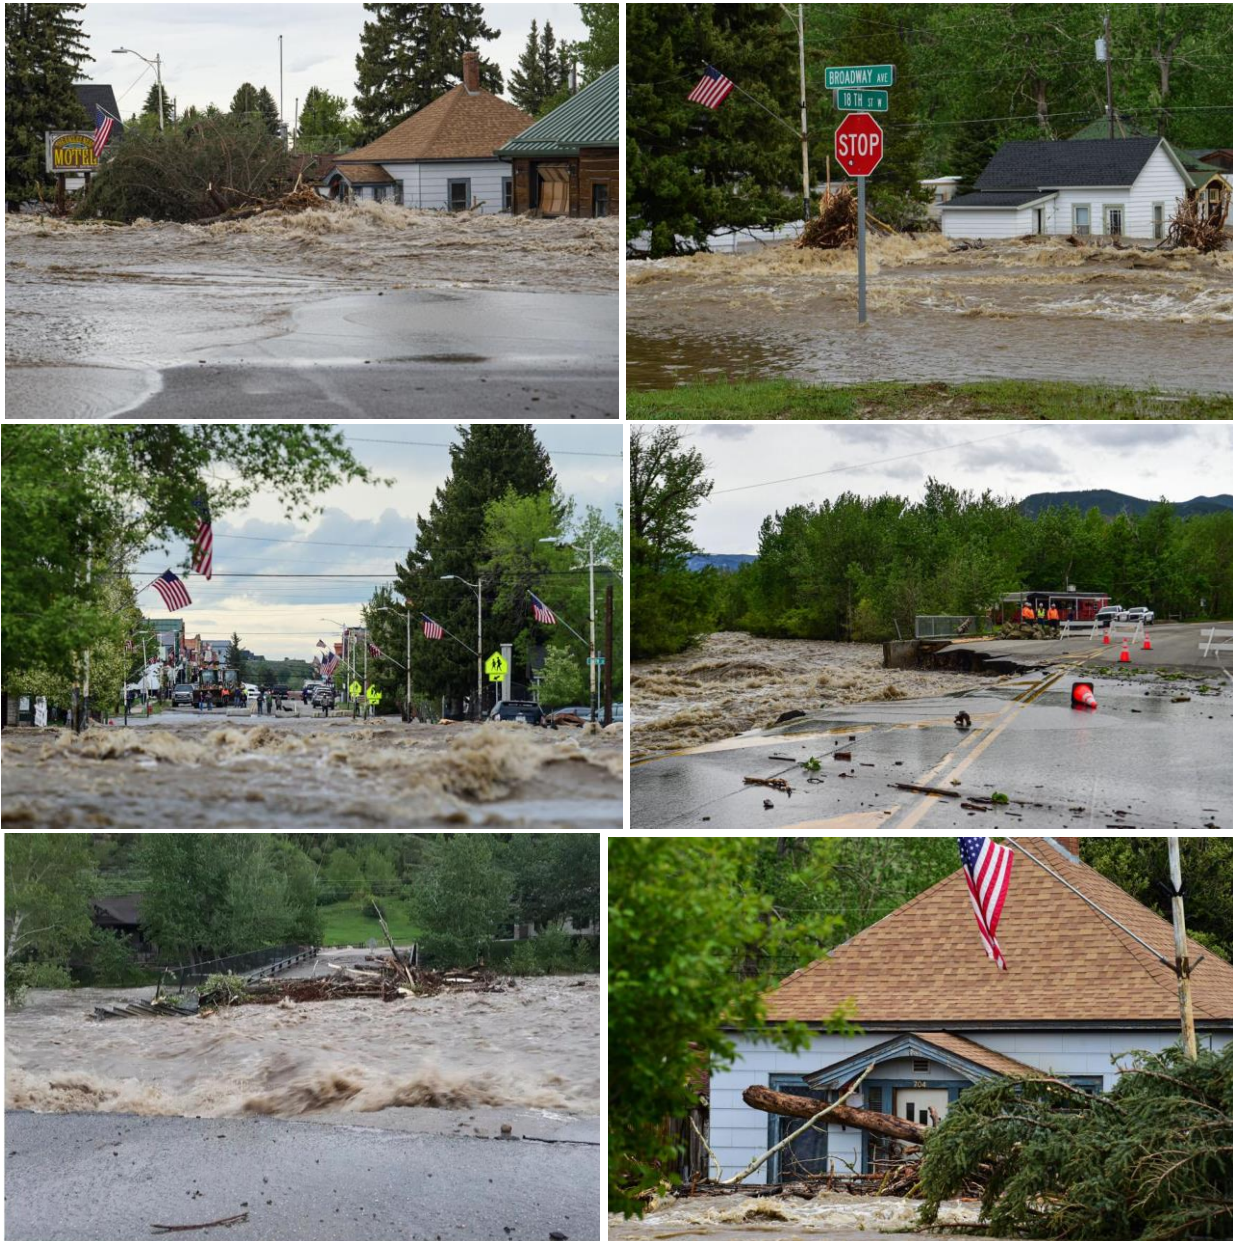
Figure 3.75: Damage in Red Lodge, MT. Source: https://billingsgazette.com/news/local/photos-extreme-flooding-devastates-red-lodge-and-the-surrounding-region/collection_d3f7e430-eb63-11ec-b484-7bd00158f809.html#26; Photo source of bottom left photo: Source: <https://www.ypradio.org/regional-news/2022-06-20/red-lodge-area-continues-recovery-following-last-weeks-flooding>, credit: Sandra Haisler

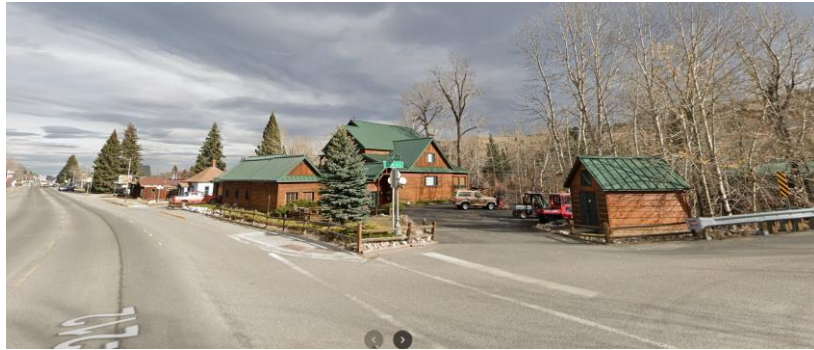
Figure 3.76 Residential Structure at Broadway/19th Street W, before the flood (45.179494, -109.246217). Photo Source: Google Street View

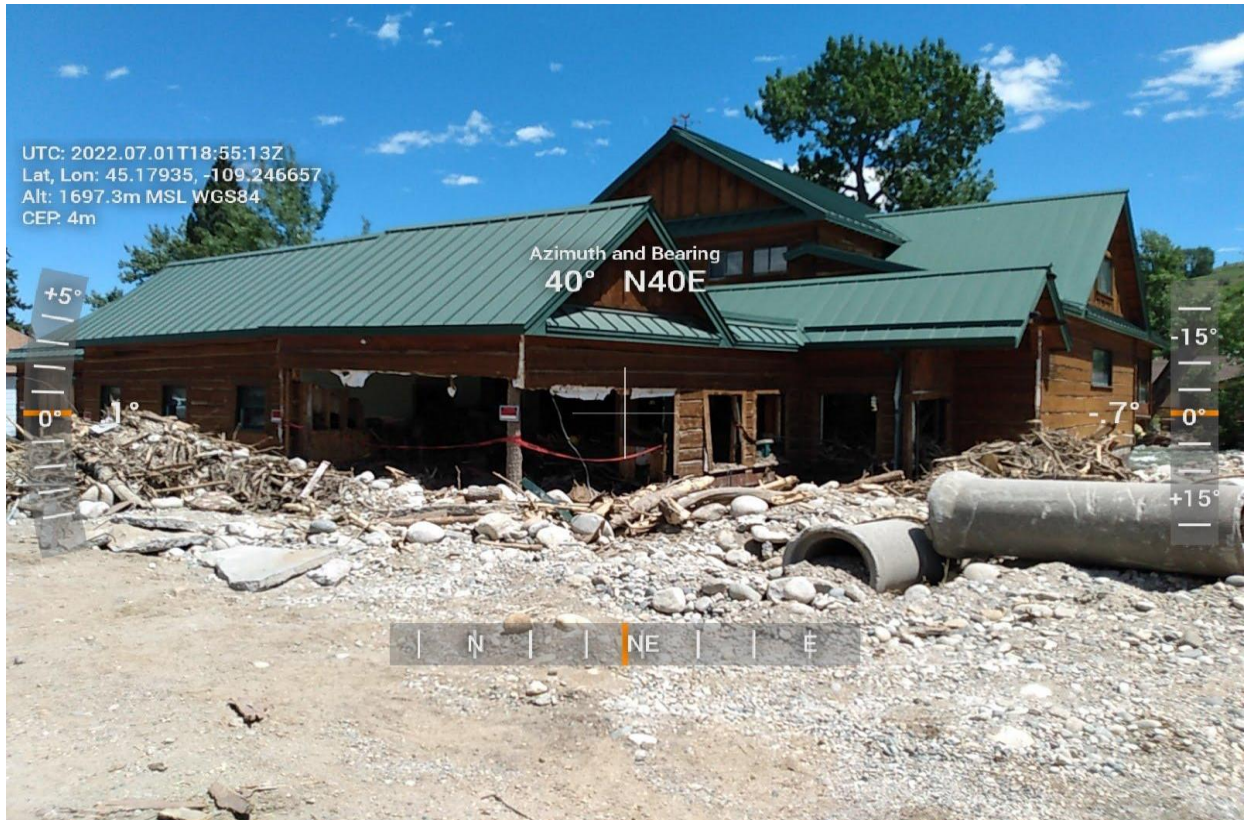
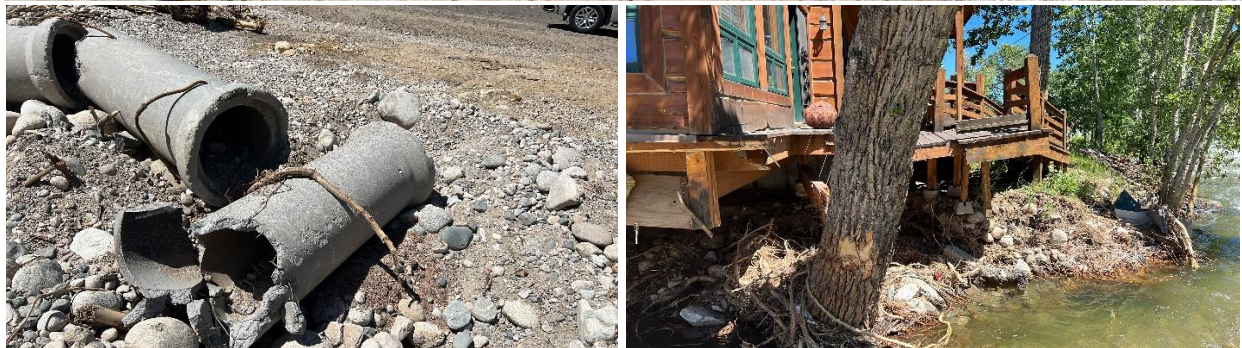
Figure 3.78: Residential Structure at Broadway/19th Street W, at the time of the GEER team visit (45.179494, -109.246217)

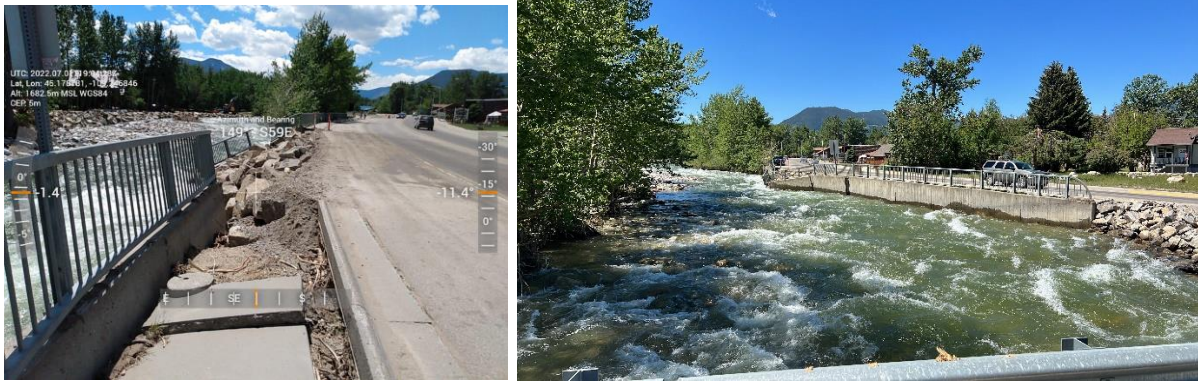
Figure 3.79: Collapsed sidewalk along Broadway Ave S due to scour damage. The sidewalk was located along an outside bend of the creek (45.1784 N 109.2468 W).

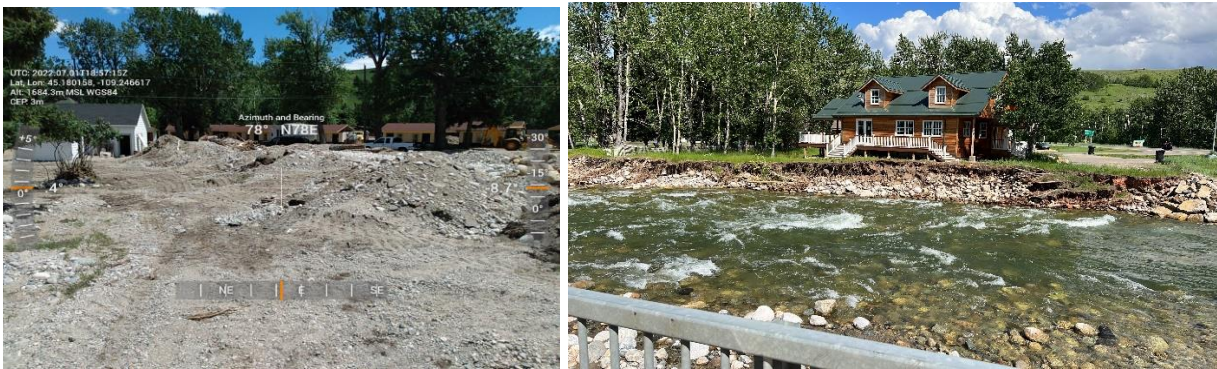
Figure 3.80: Sediment deposits greater than 1 meter in thickness. Cobbles are visible in the deposits (45.1802 N 109.2466 W), and erosion along Rock Creek River near Broadway Ave S.

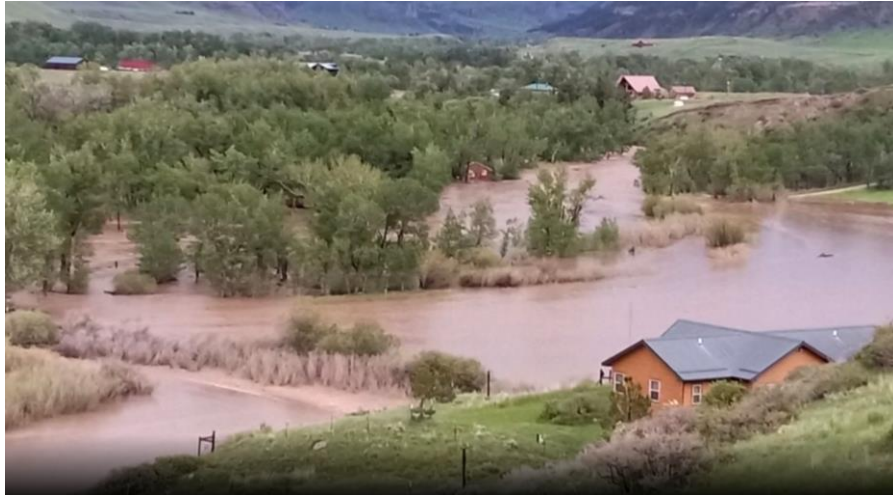
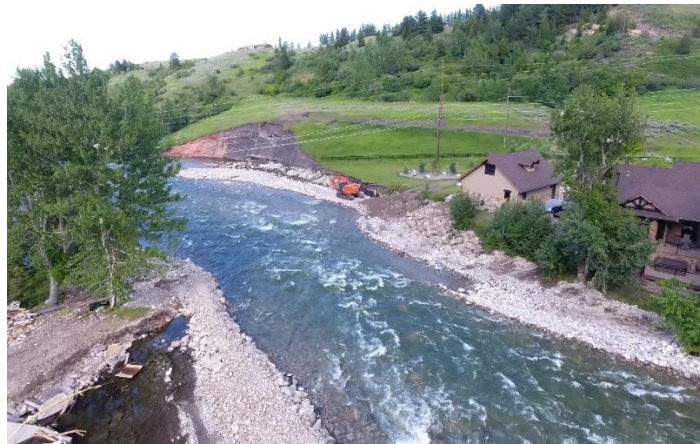
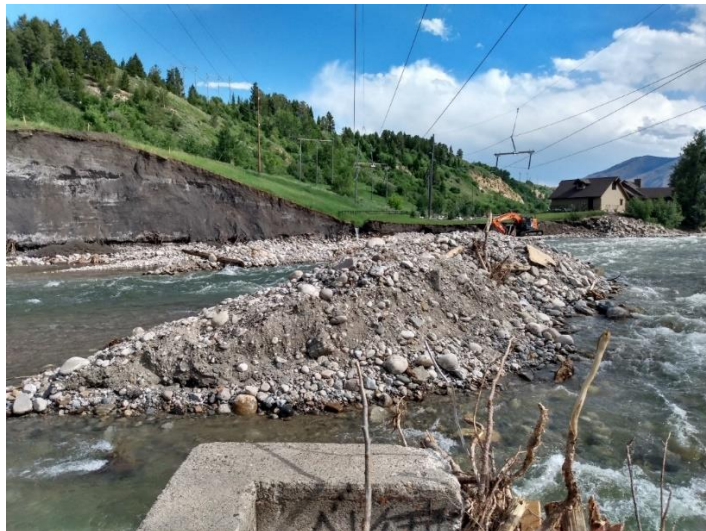
Figure 3.81: Large hillside erosion near 9th street and Rock Creek intersection (45.1897 N 109.2415 W); top photo obtained from <https://www.ktvq.com/news/gianforte-declares-statewide-disaster>

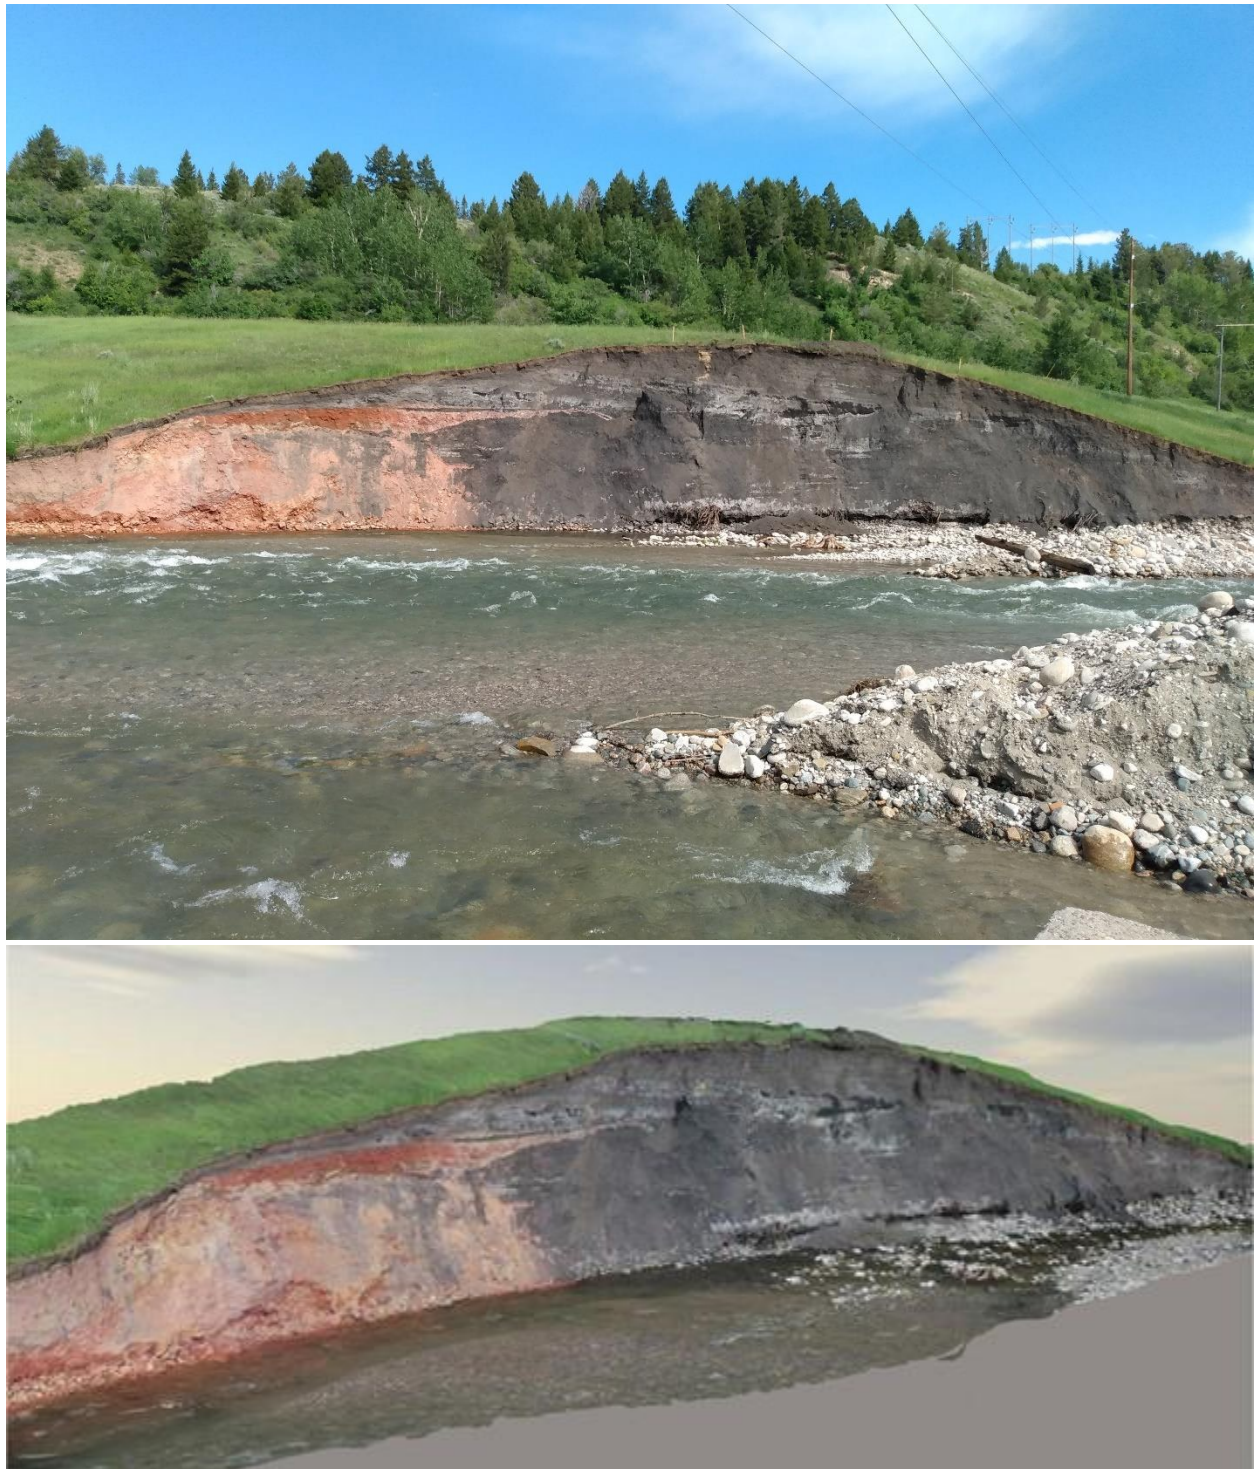
Figure 3.82: Photographs and SfM model of the 11.5-meter-high scour scarp exposed by the June flood along Rock Creek (9th street intersection, 45.1897 N 109.2415 W)

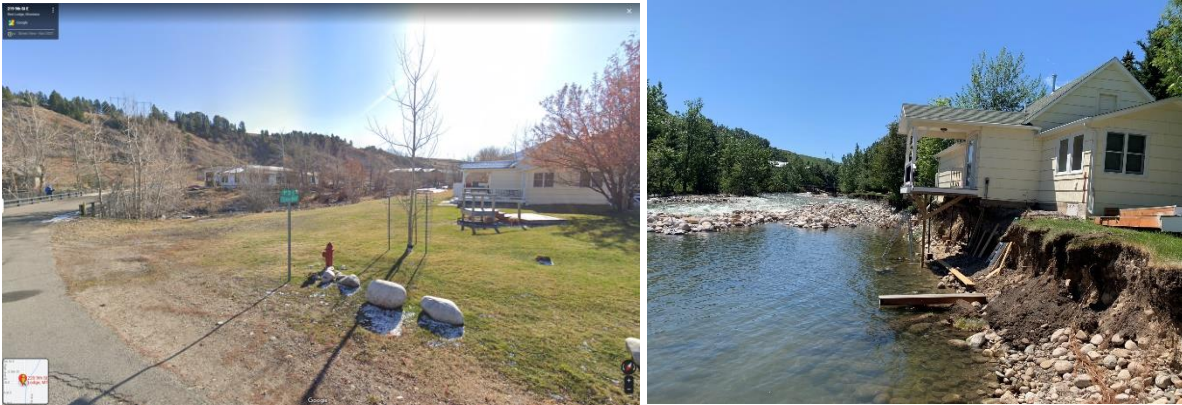
Figure 3.83: Before and after images of a residential home along the Rock Creek River (45.1886855, -109.2433483)
