Geotechnical Reconnaissance of the 2022 Southern Montana/ Yellowstone Floods

Flood Event: June 13-24, 2022

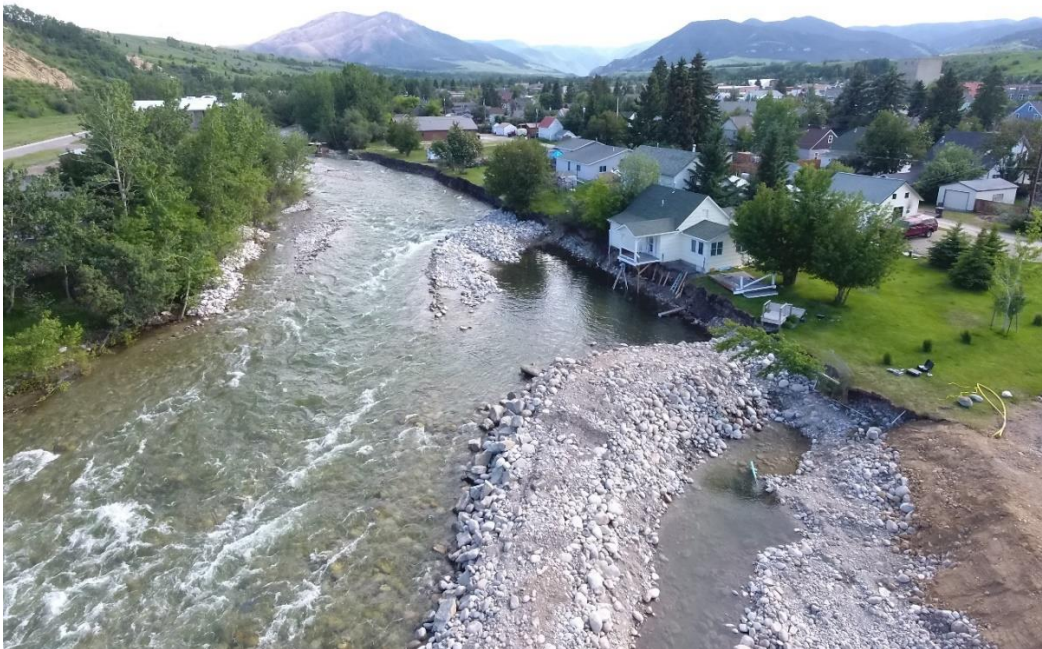
Figure 3.84: Erosion cuts and washouts along the Rock Creek River leaving substantial damage and support loss to a residential home

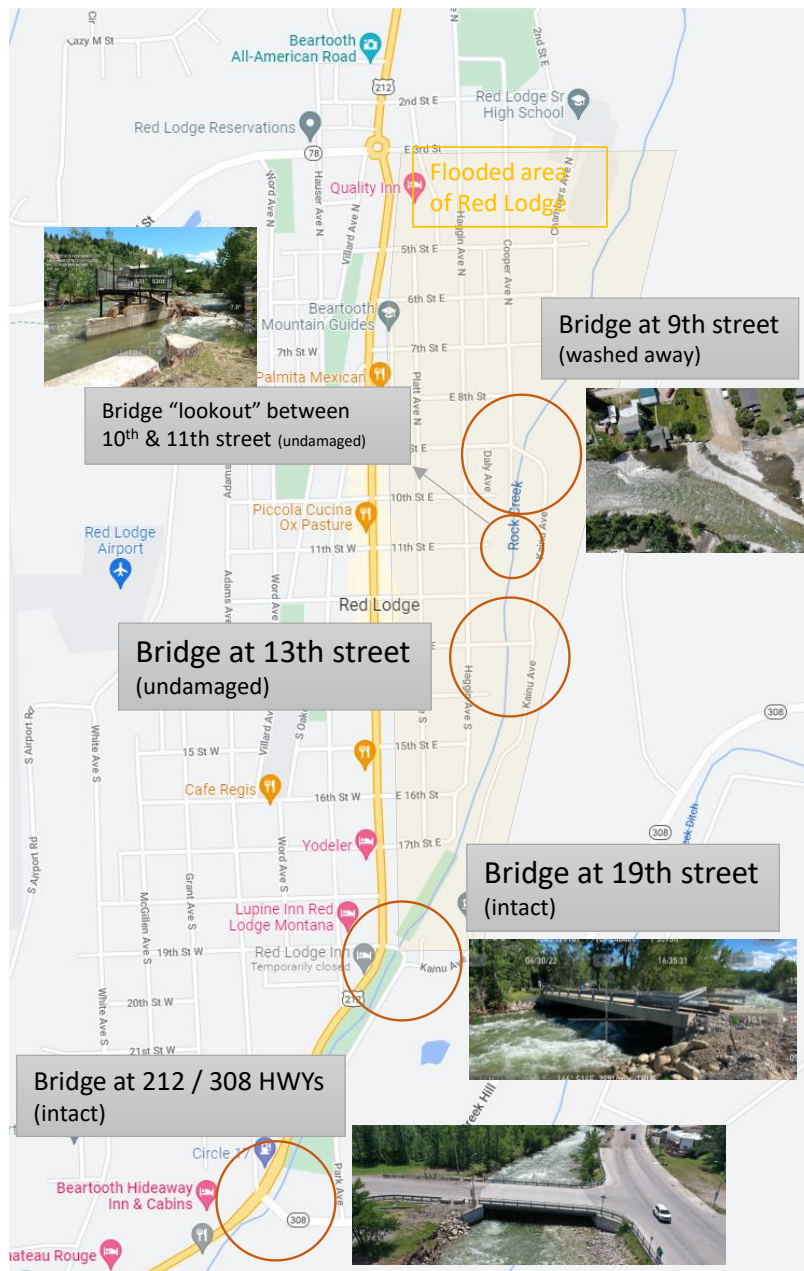
Figure 3.85: Map of Red Lodge (google maps) showing flooded area and bridges across Rock Creek

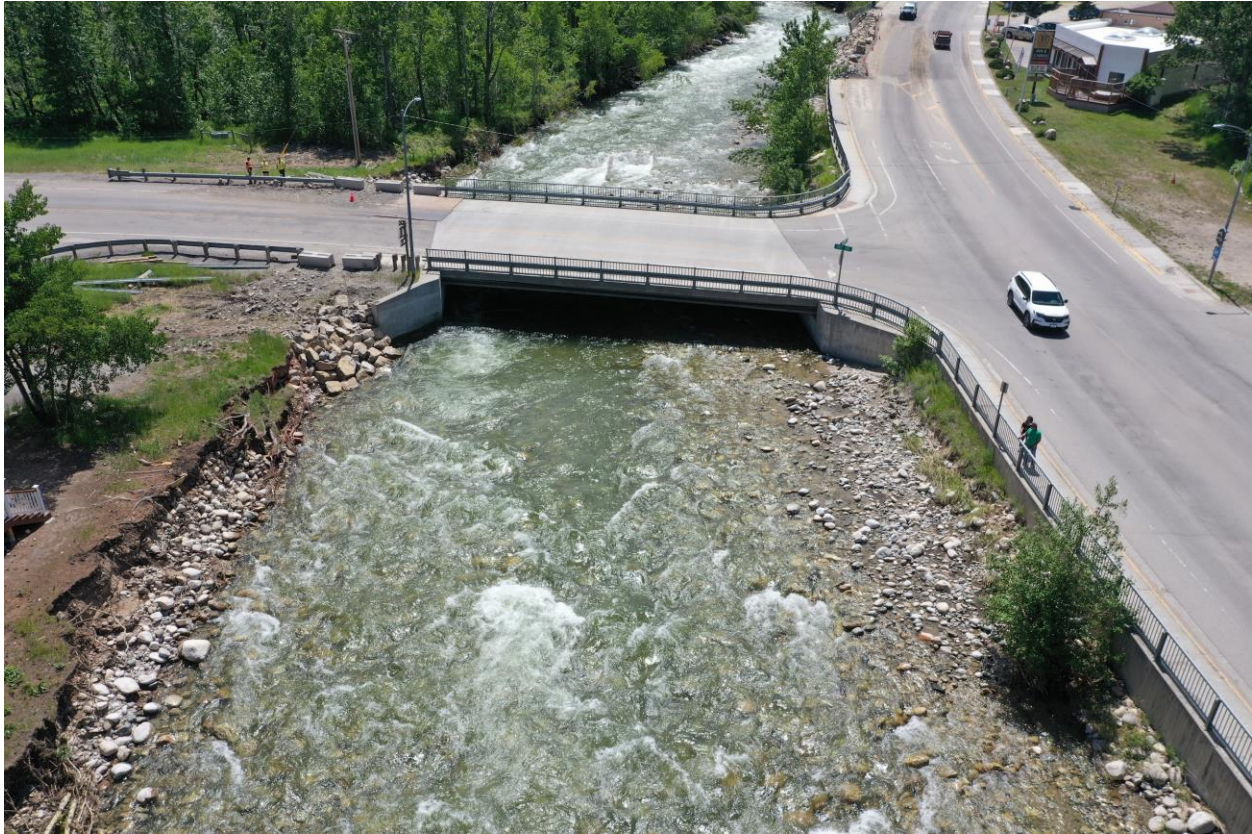
Figure 3.86: UAV image of the Montana Highway 308 bridge in Red Lodge (45.1739 N 109.2500 W)

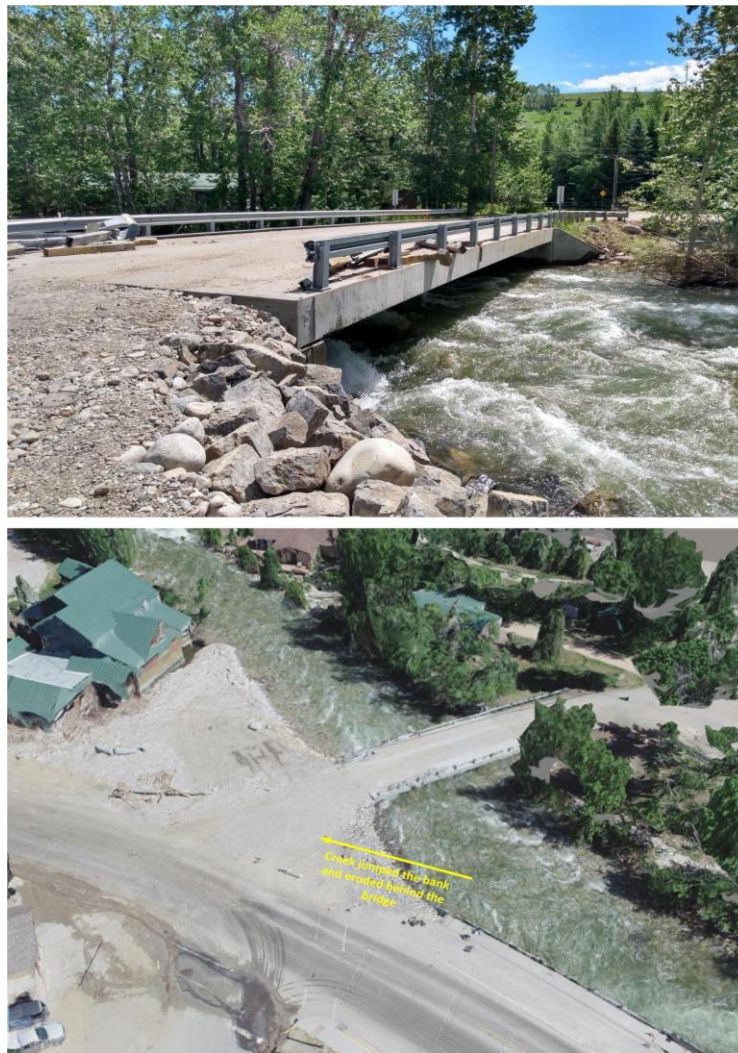
Figure 3.87: Imagery of the 19th Street/Park Avenue bridge in Red Lodge. Top image shows the eroded and repaired abutment; bottom image is a screenshot from the 3D UAV SfM model (45.1791 N 109.2465 W)

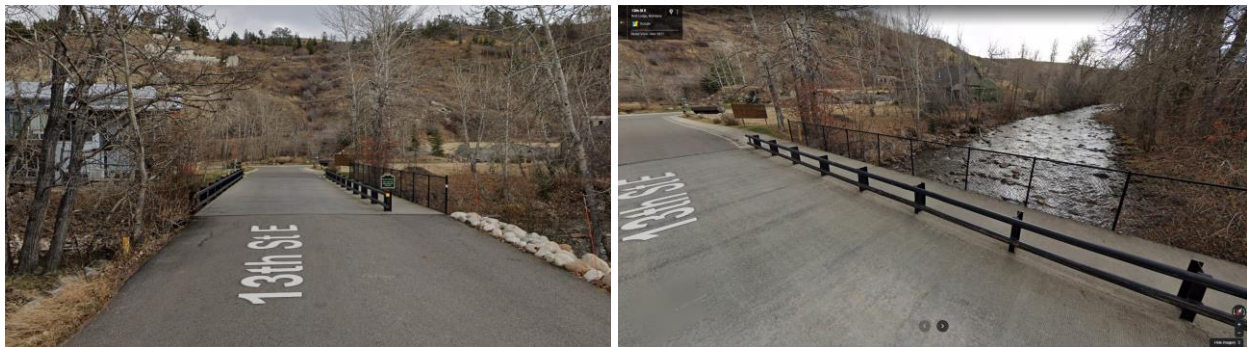
Figure 3.88: Bridge at 13th Street in Red Lodge prior to the flood. Google Street View image from Nov 2021, (45.1850339, -109.2432589)

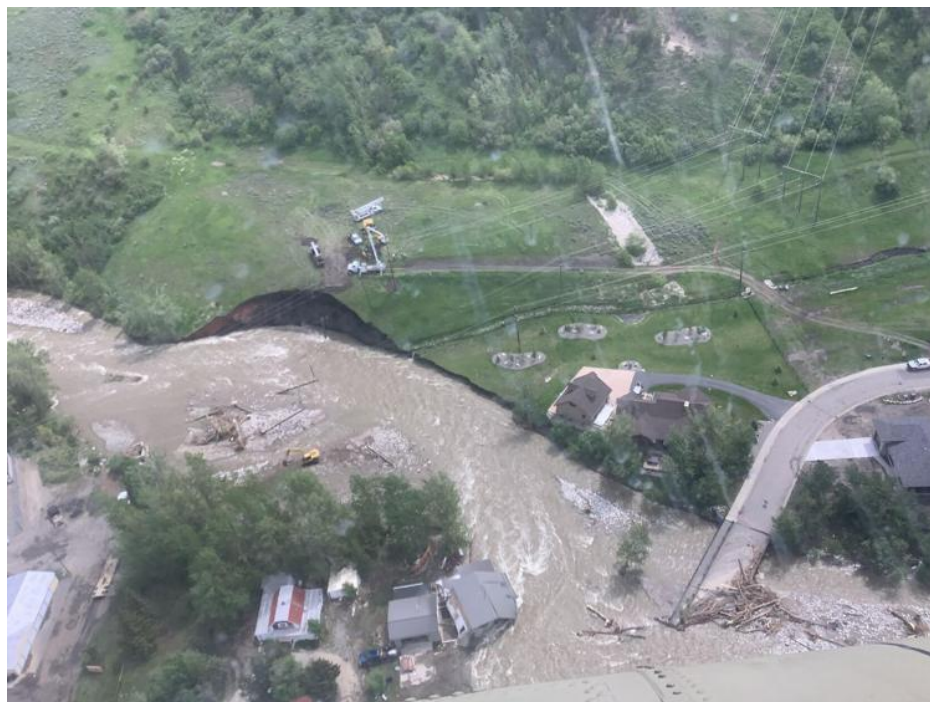
Figure 3.91: Bridge Collapse at 9th street and large erosion failure, Source: https://www.kulr8.com/news/officials-gather-in-red-lodge-to-discuss-flooding-impacts/article_d7e3a7b2-edbd-11ec-a518-9bfe1b67d2ad.html

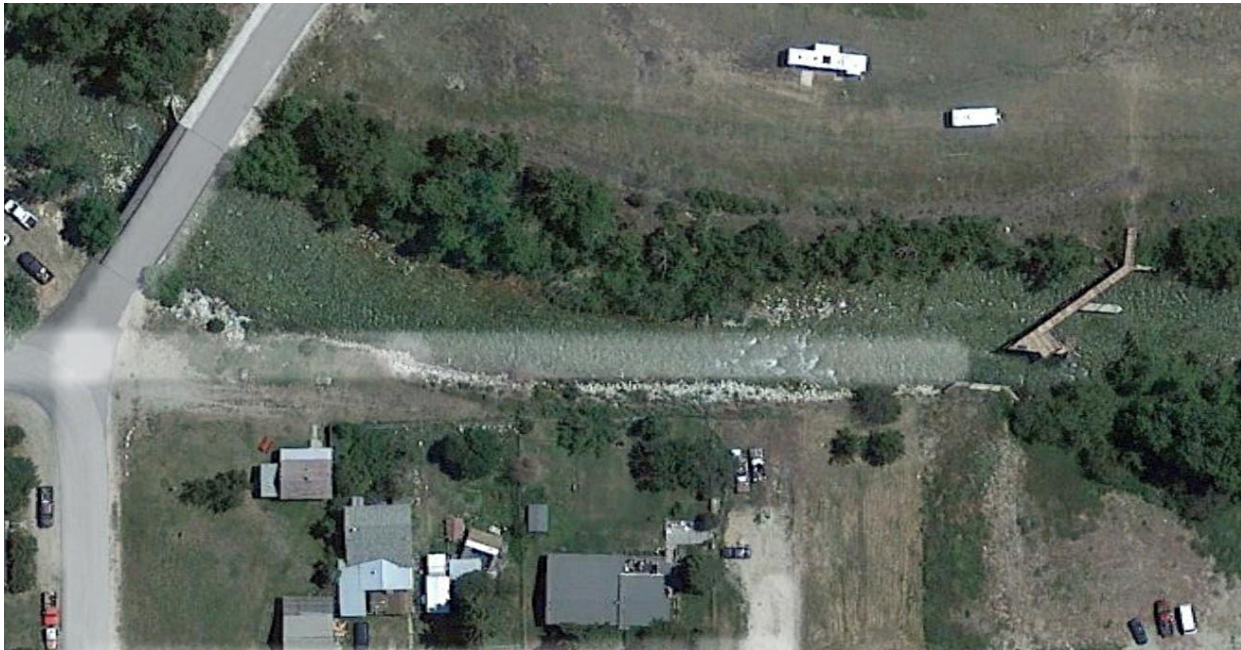
Figure 3.92: Imagery of ninth street bridge and pedestrian pier taken 8/3/2013. The image shows the natural flow of the stream pre flooding events. Image courtesy of Google Earth

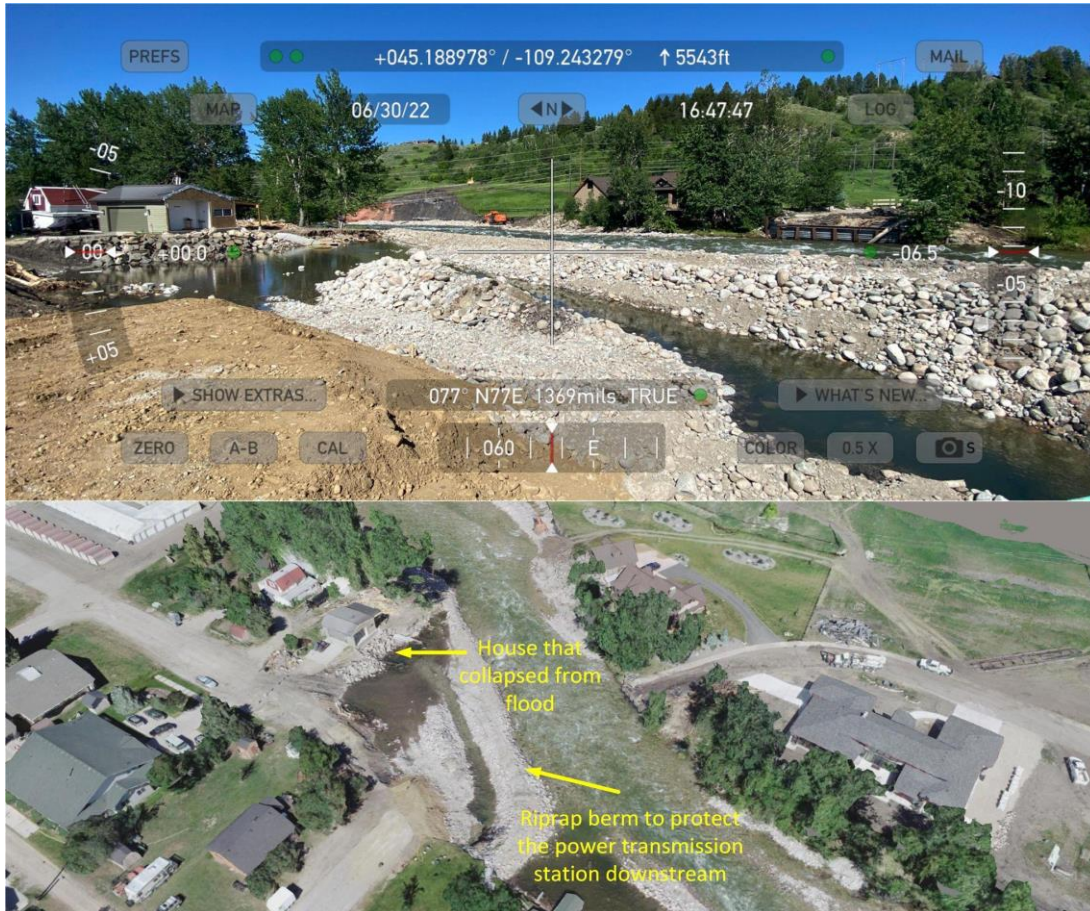
Figure 3.93: Imagery of the 9th Street/Kainu Avenue bridge in Red Lodge. Top image shows the eroded and repaired abutment; bottom image is a screenshot from the 3D UAV SfM model (45.1889 N 109.2428 W)

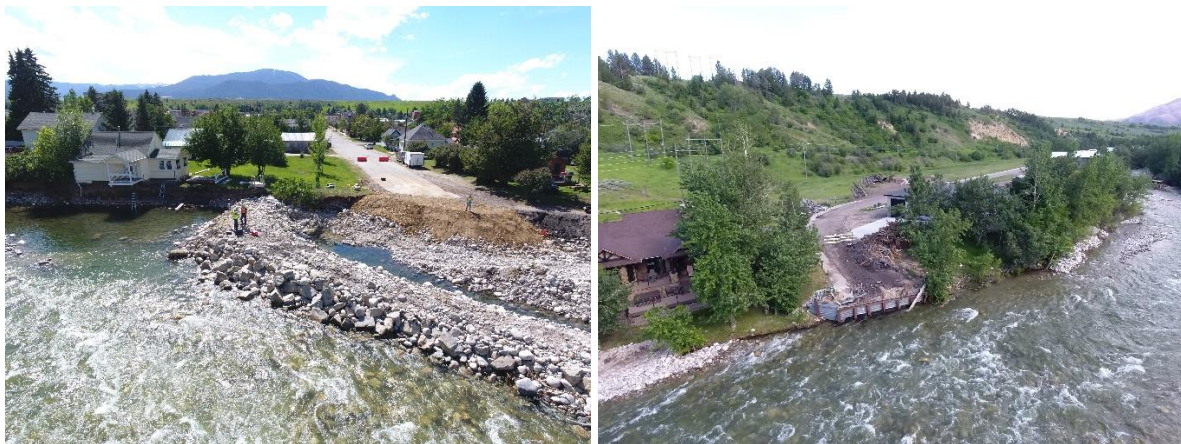
Figure 3.94: Photographs of bridge abutment and onramp area of former 9th Street bridge. (45.1889 N 109.2428 W)

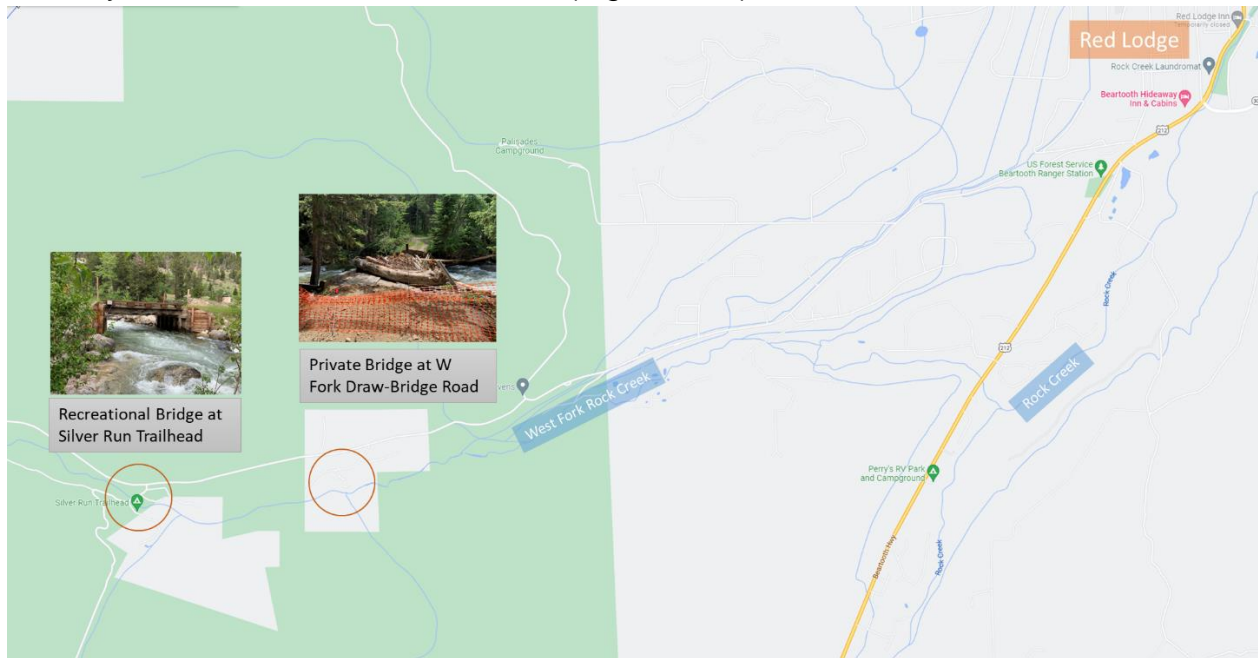
Figure 3.95: Location of West Fork Road relative to Red Lodge and Bridges Visited along West Fork Creek Road

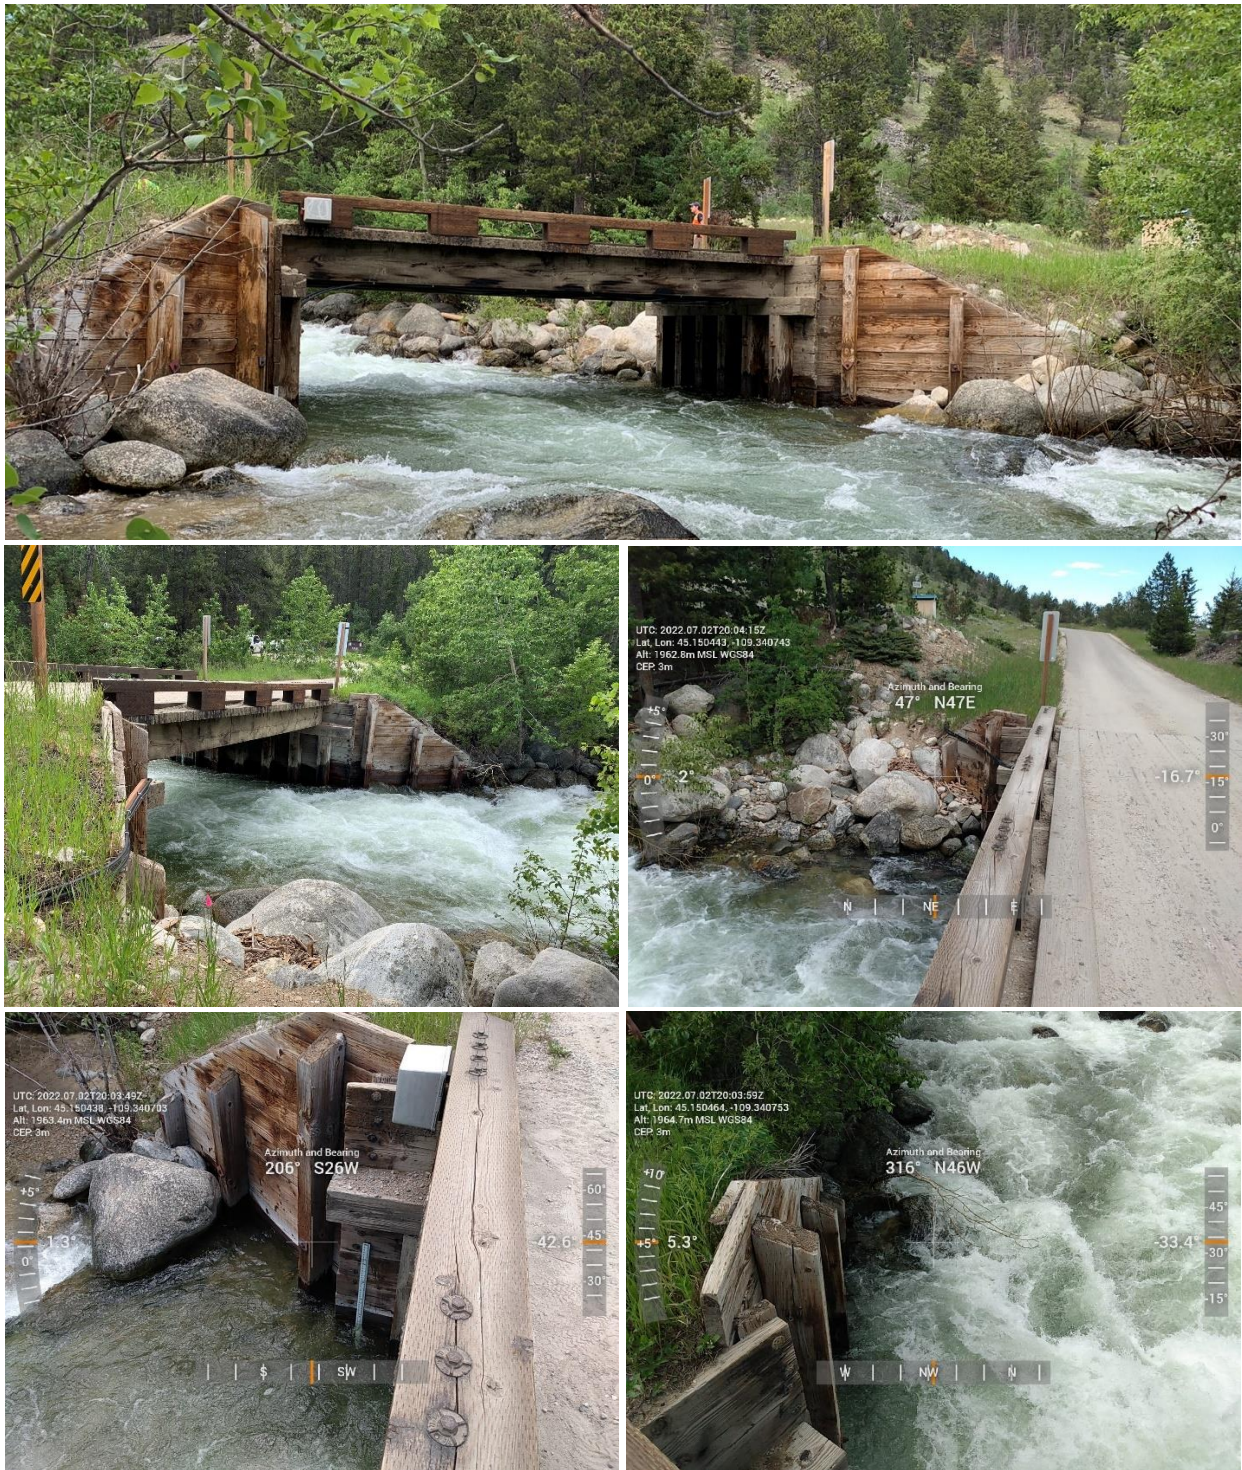
Figure 3.96: Bridge at Silver Run Trailhead (45.1504173, -109.3407752), no damage observed

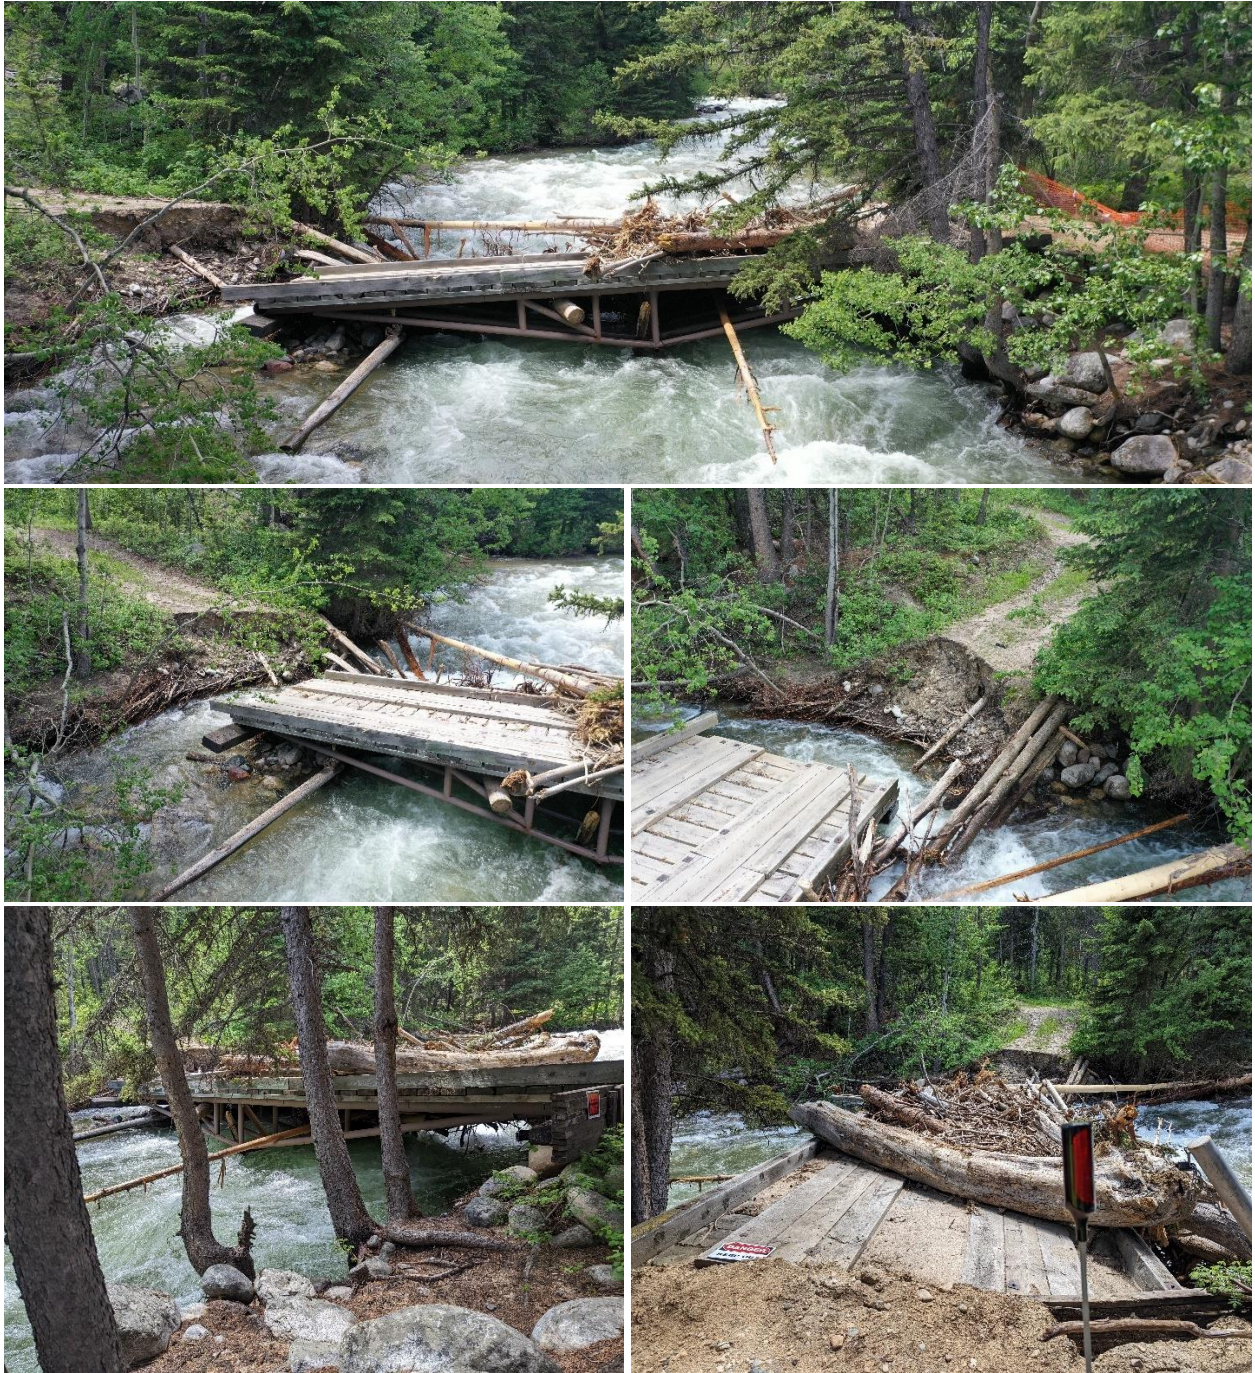
Figure 3.97: Private Bridge of West Fork Creek Road, Collapsed and closed (45.1507670, -109.3227090)

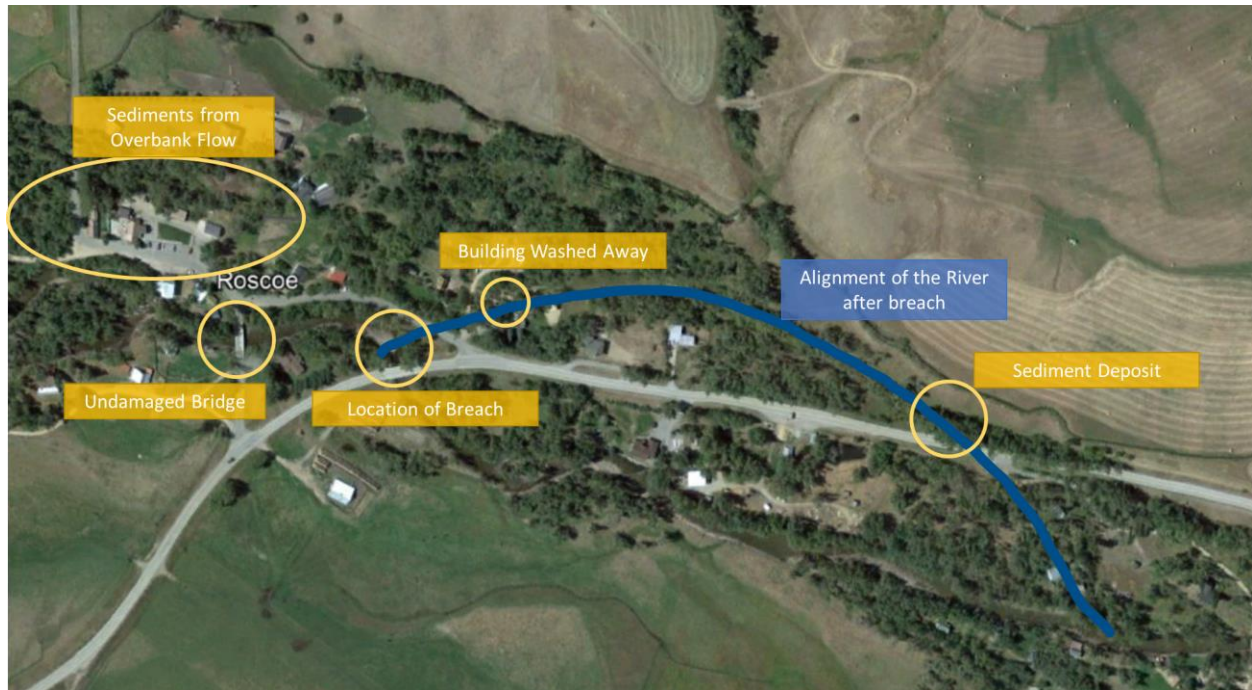
Figure 3.98: Overview of the Town of Roscoe and flood damage including new channel alignment after breach of the natural levee along East Rosebud Creek (45.34950, -109.49595). The figure is oriented with West at the top of the image, and north to the right.

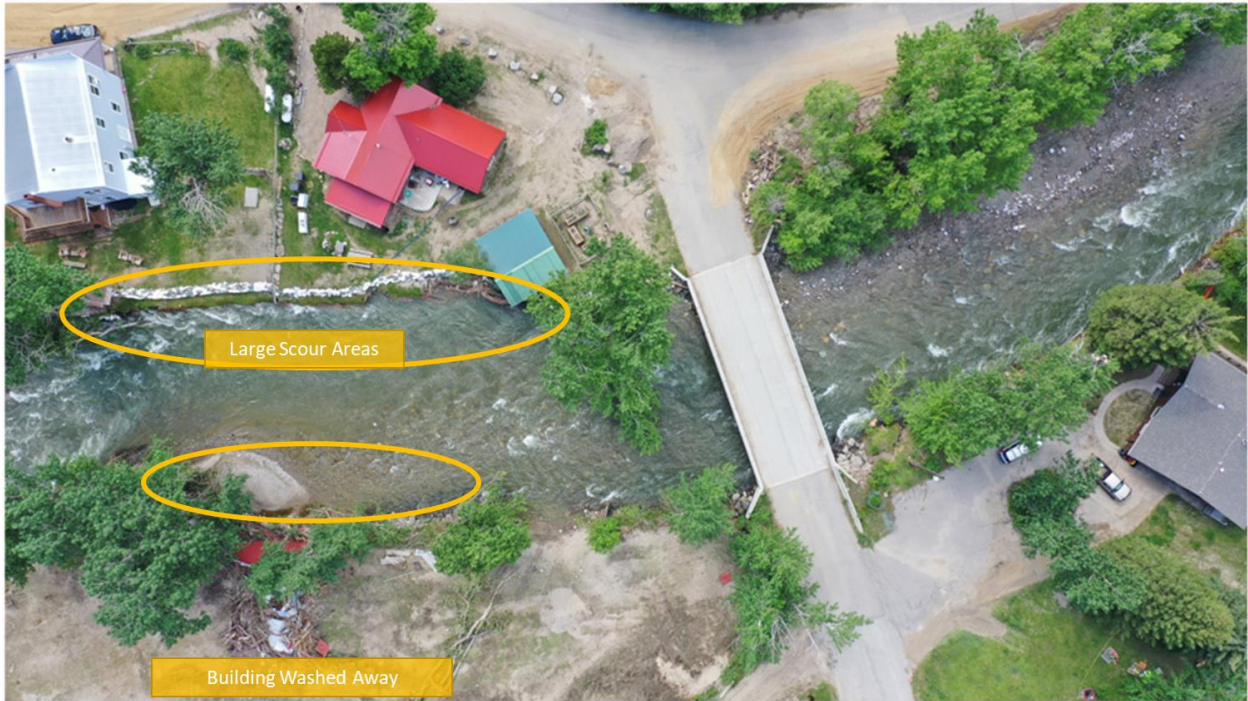
Figure 3.99: Undamaged bridge in Roscoe, MT. Note sediments deposited from overbank flow. Areas lost to scour in the flood are indicated (45.349492, -109.495930).

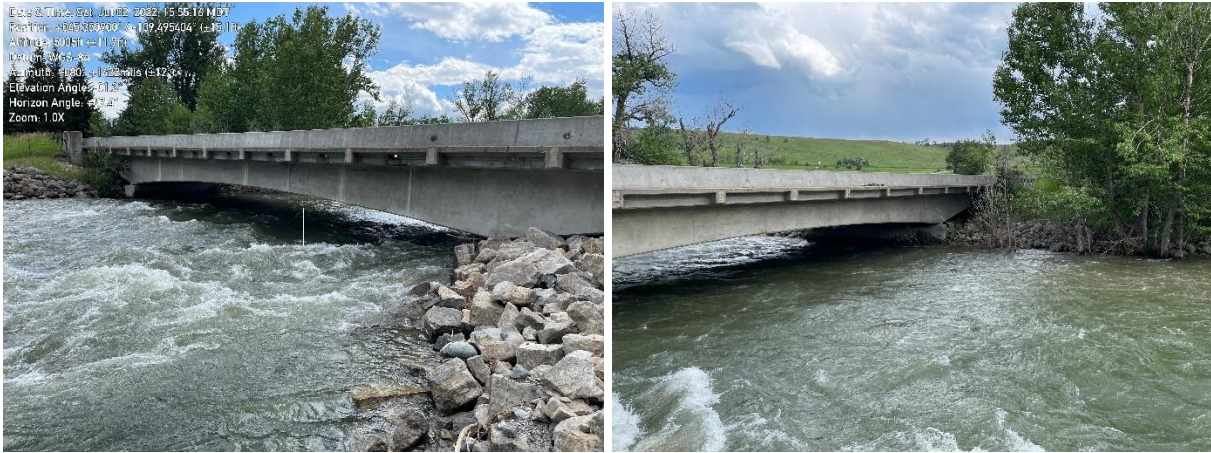
Figure 3.101: Undamaged bridge along E Rosebud Rd in Roscoe (45.34949, -109.495908).

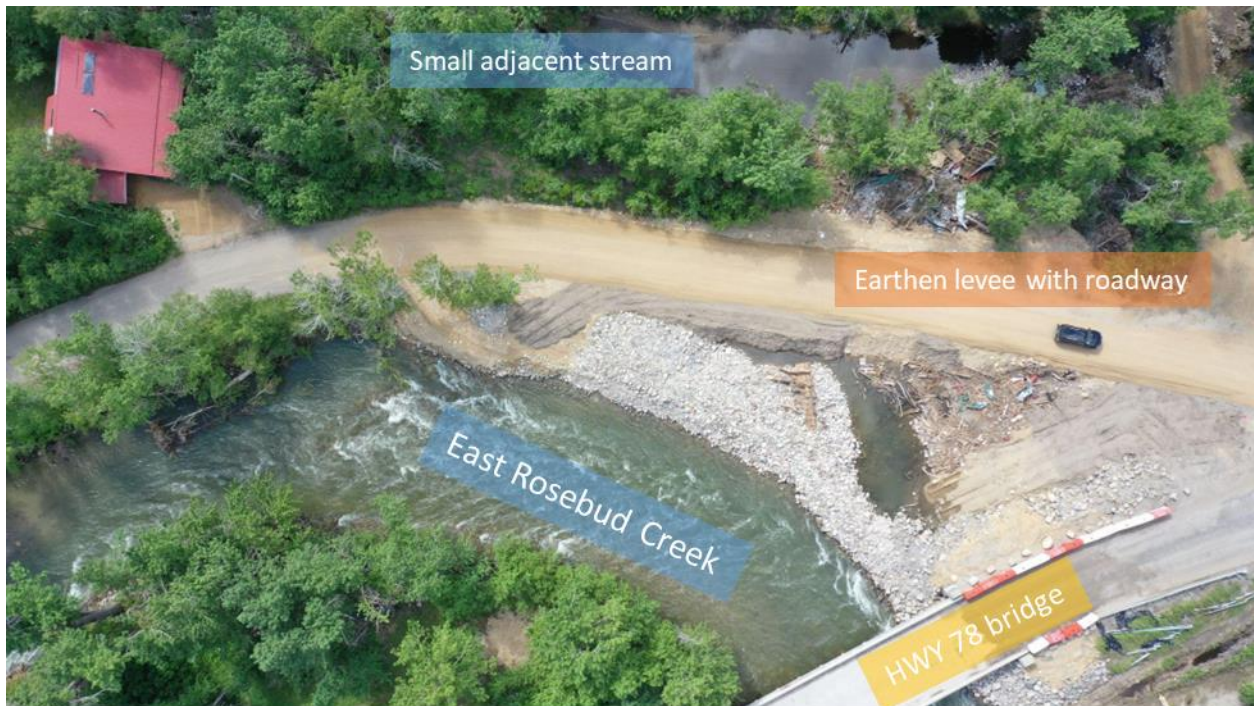
Figure 3.102: UAV image of the repaired breach and abutment scour damage that had been repaired at the time of the GEER visit. (45.35073, -109.4955034)

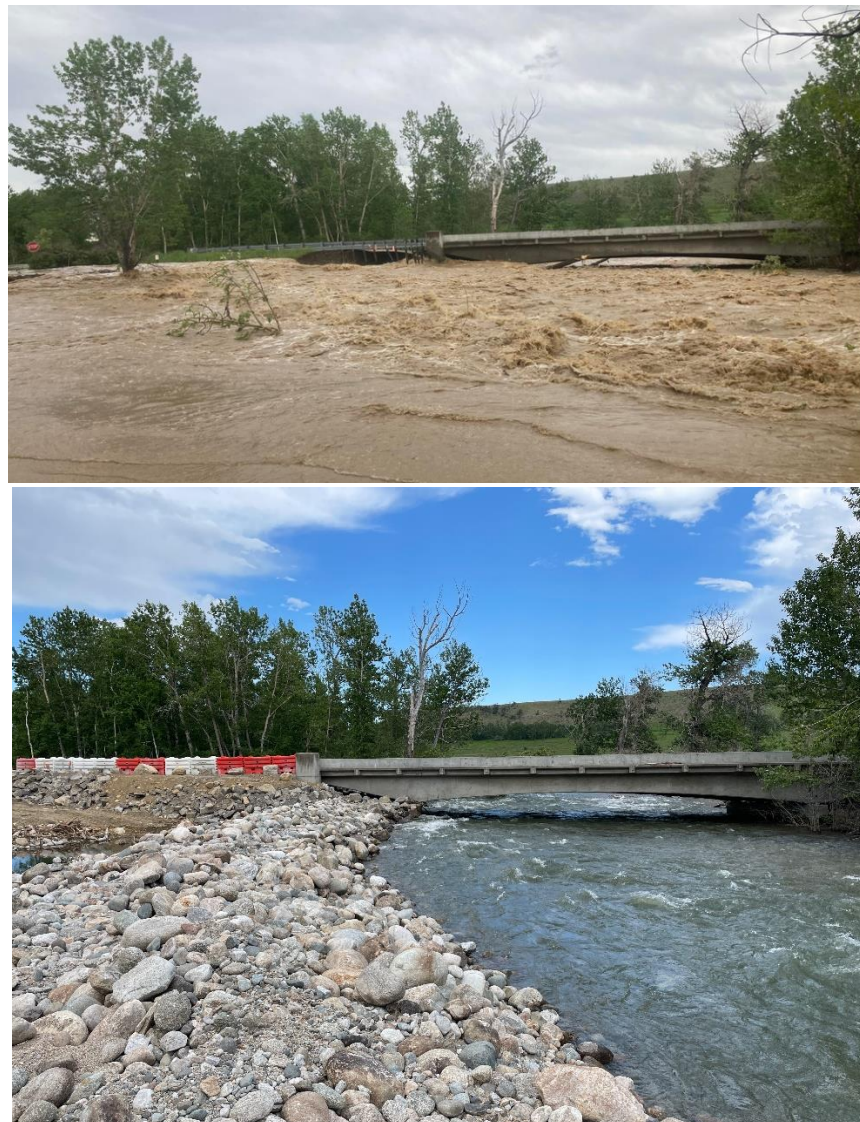
Figure 3.103: HWY 78 bridge across East Rosebud Creek in Roscoe during (top) and after the flood event;
Source for top photo: <https://nbcmontana.com/news/local/montana-national-guard-assists-with-search-rescue-efforts-amid-flooding>; (45.35073, -109.4955034)

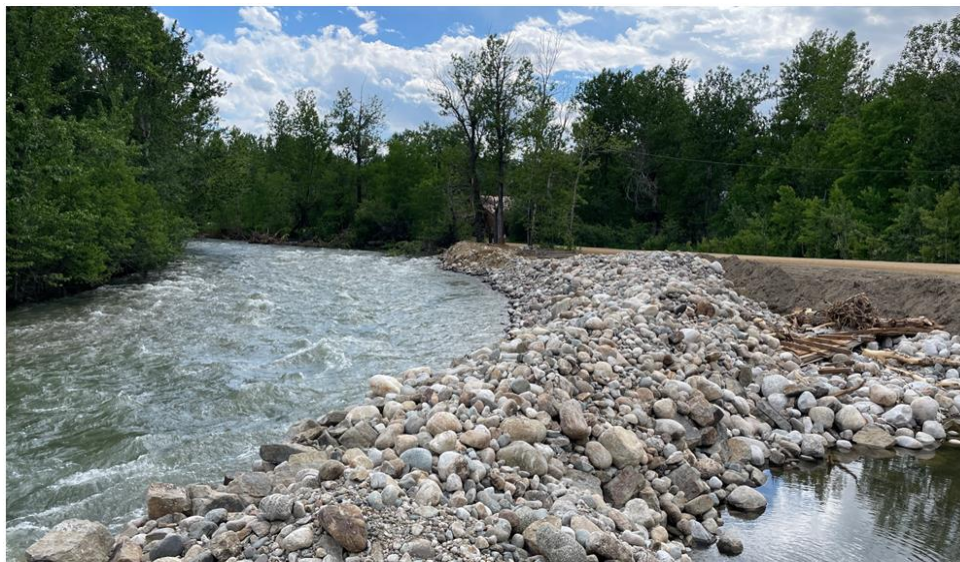
Figure 3. 105: Terrestrial view of the repairs of the breach, taken from the damaged bridge. Locals pushed rock from nearby moraines into the new channel that the river had cut to repair the breach of the natural levee. The road was constructed a few hours after the breach was repaired and the river redirected under the bridge.

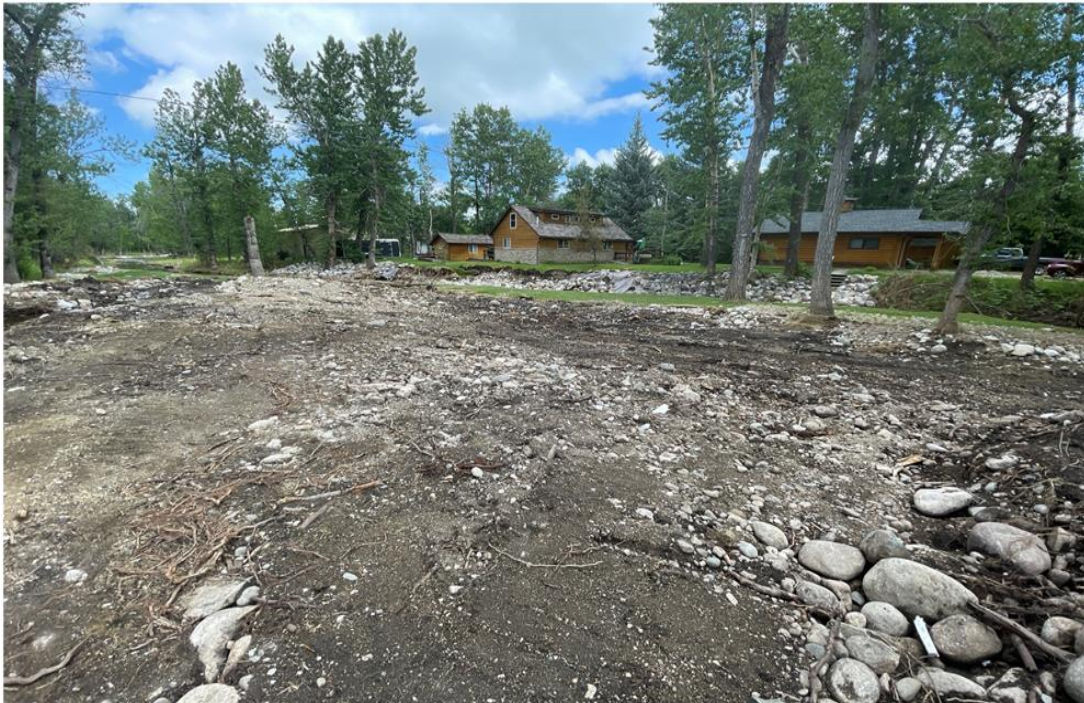
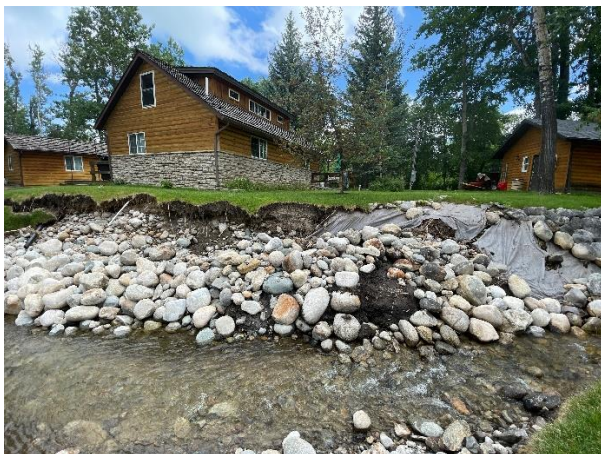
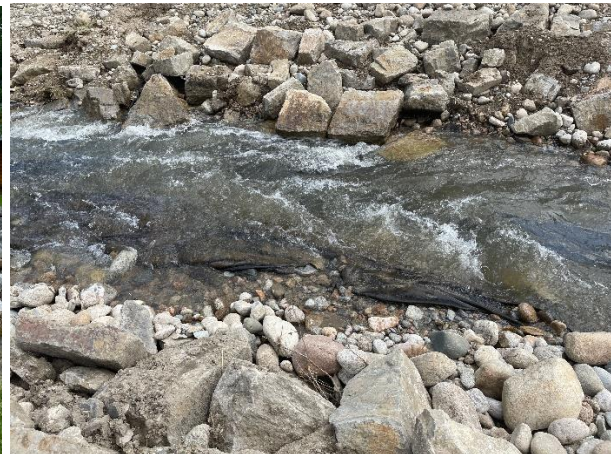
Figure 3.106: Top: Location of a cabin that was washed away after the breach. Very little evidence of the shallow foundations are left. Note the boulder armoring from the neighboring cabin owners on the banks of the small stream (bottom photos); (45.351377 N 109.496156W)

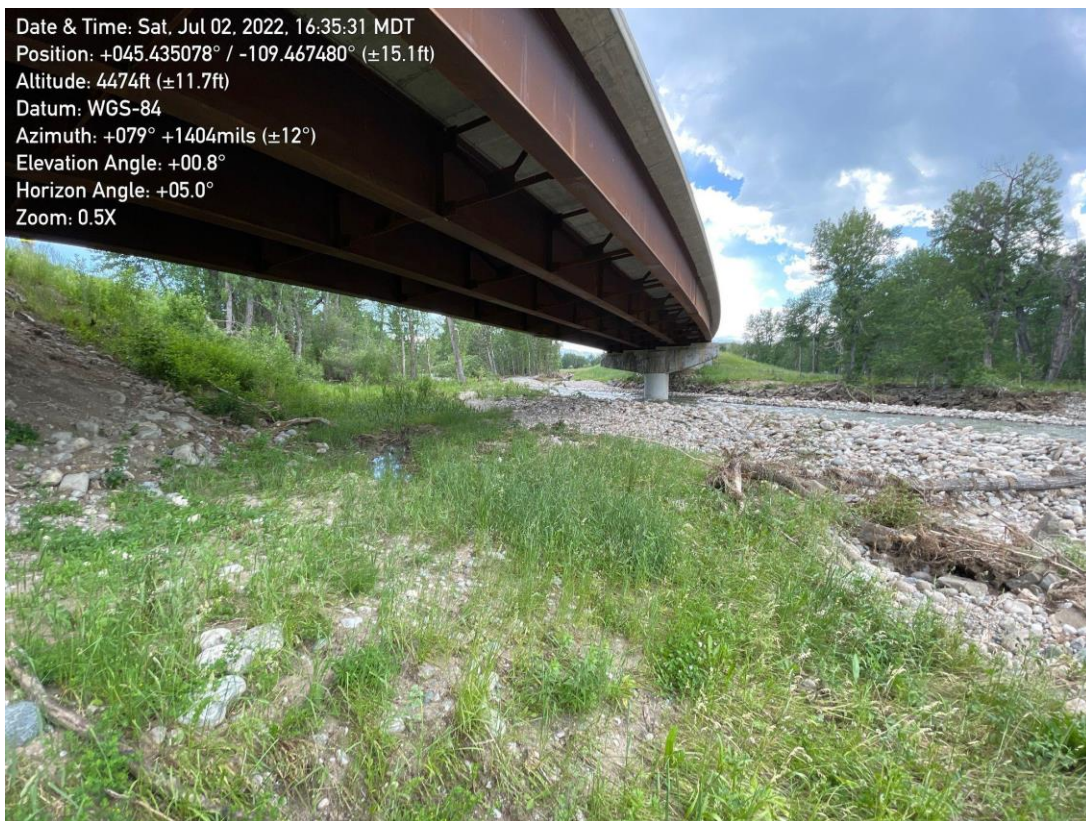
Figure 3.108: Terrestrial oblique view of the Highway 78 bridge over East Rosebud Creek (45.4351 N, 109.4675W).

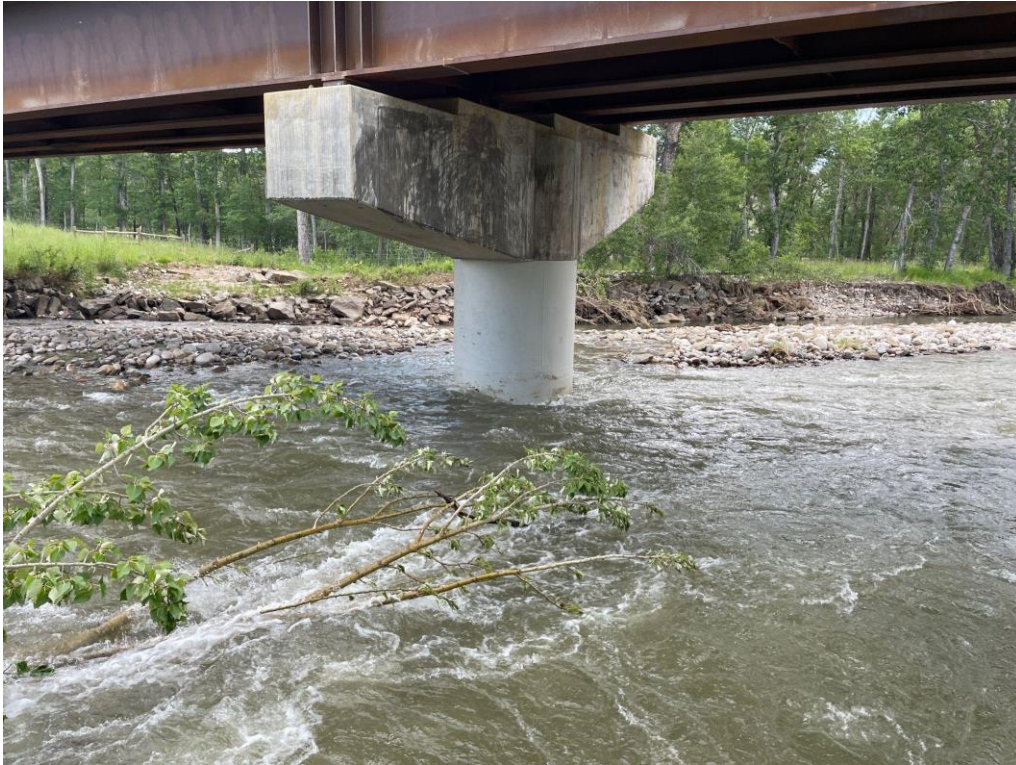
Figure 3.109: Large monopier supporting the HWY 78 DOT bridge across East Rosebud Creek at 45.4351 N, 109.4675W.

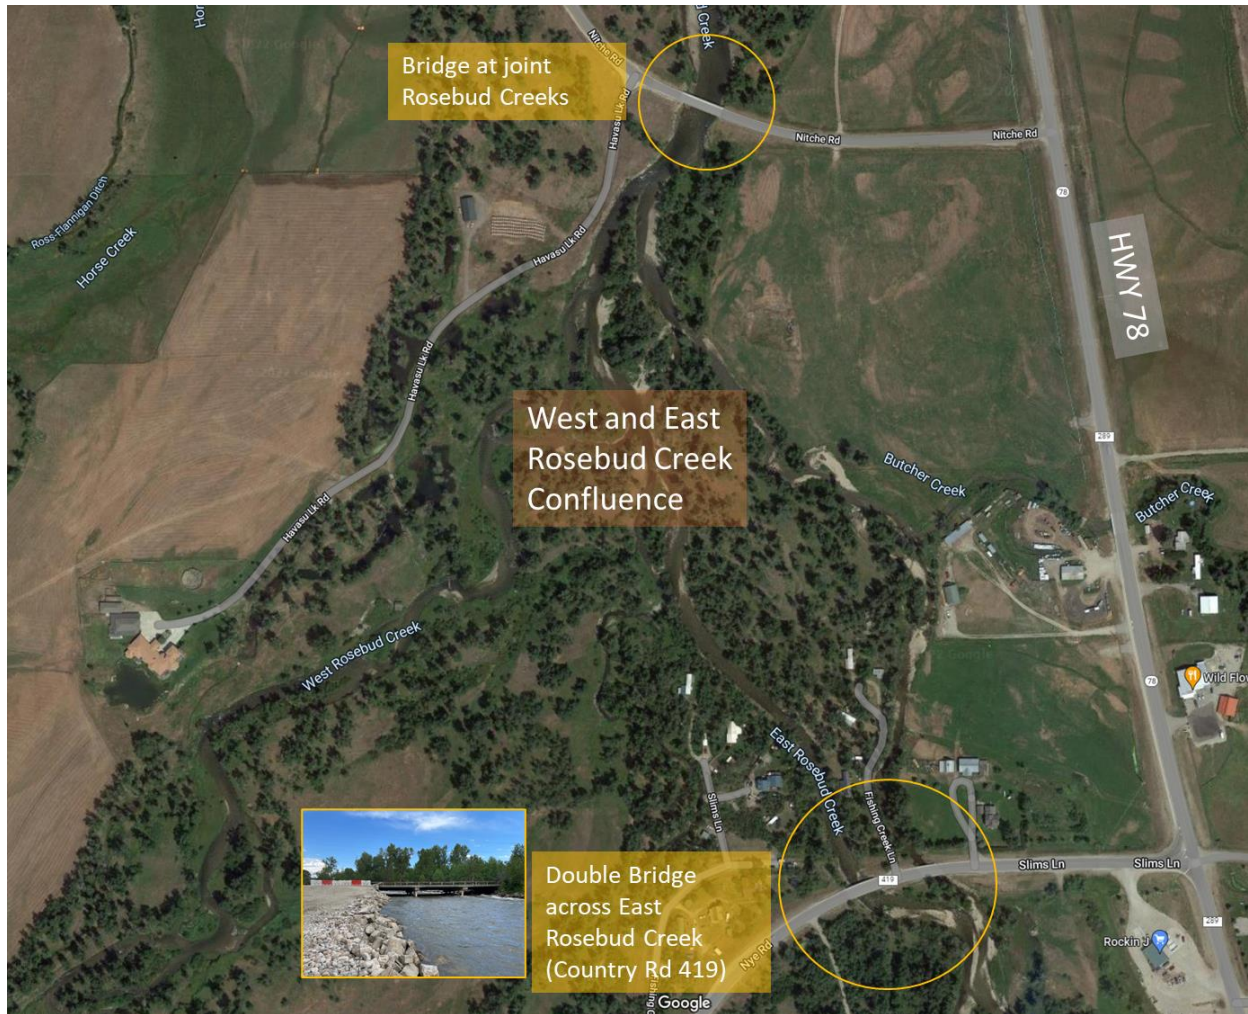
Figure 3.110: Location of the East Rosebud Double Bridge and the confluence of the East and West Rosebud Creeks.

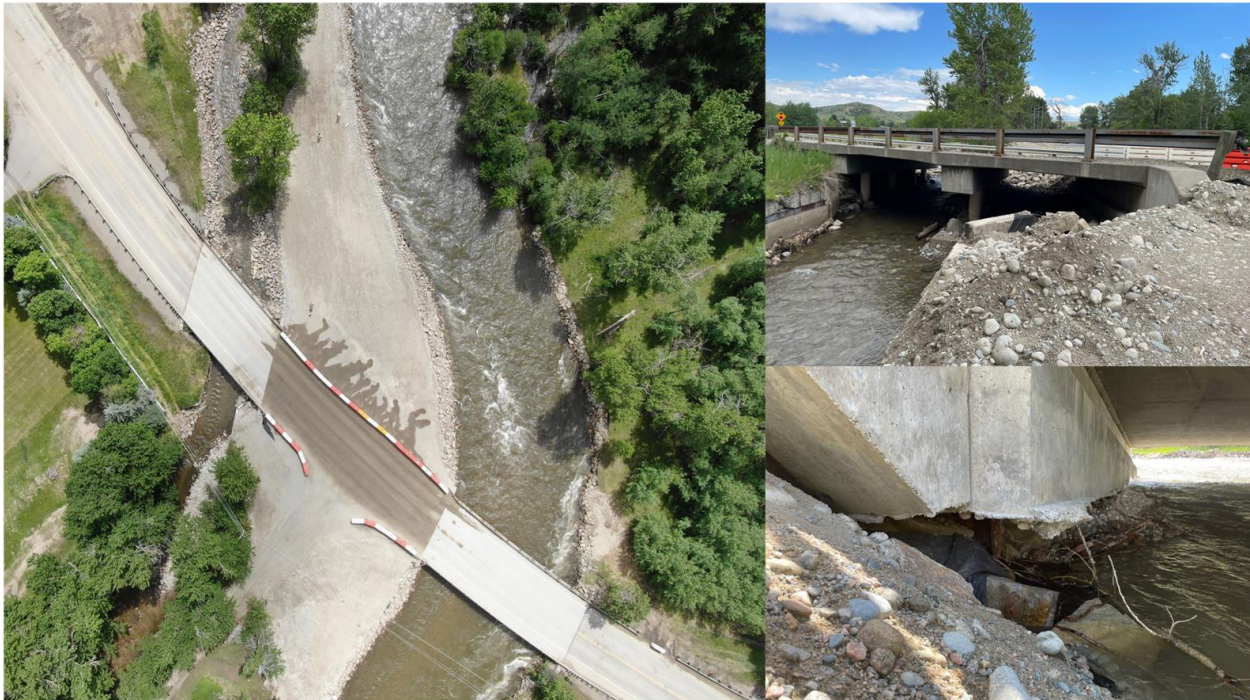
Figure 3.111: Aerial UAV view of repaired double bridge location. Terrestrial photos show exposed pilings on both bridges post-repair. Corrosion of piling is moderate (covers ~60% of steel, 45.4805 N, 109.454 W).

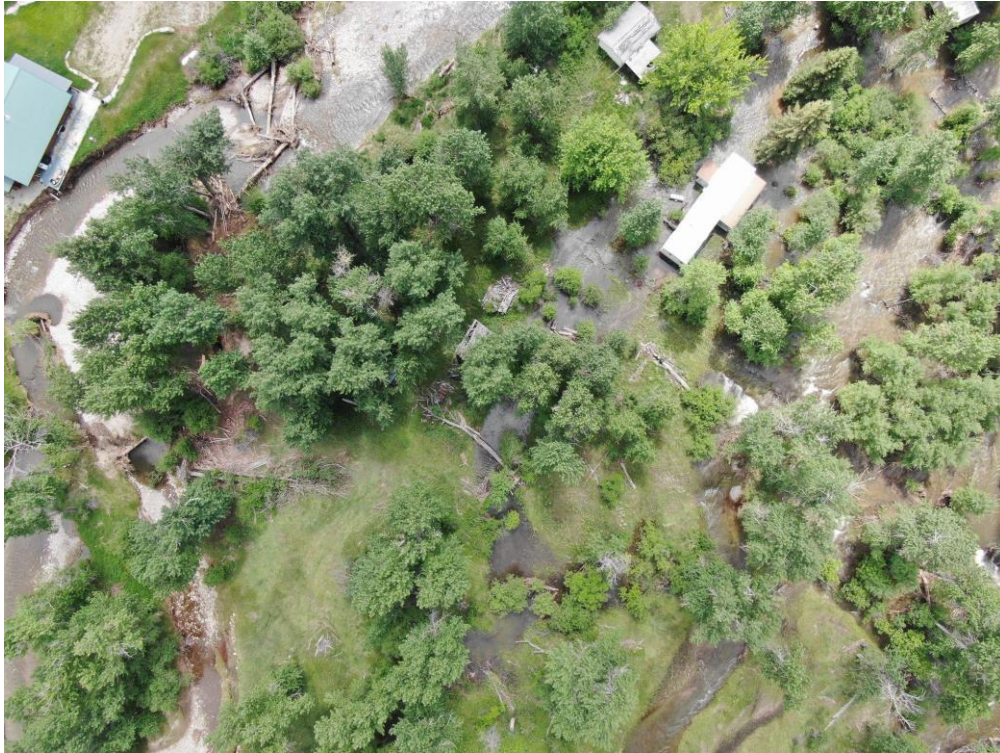
Figure 3.112: Overbank flooding persisted several weeks after the main flood event from breaches in the natural levees along East and West Rosebud Creeks and pooling from log dams in the main and side channels. (45.482N, 109.456W)
