Geotechnical Reconnaissance of the 2022 Southern Montana/ Yellowstone Floods

Flood Event: June 13-24, 2022

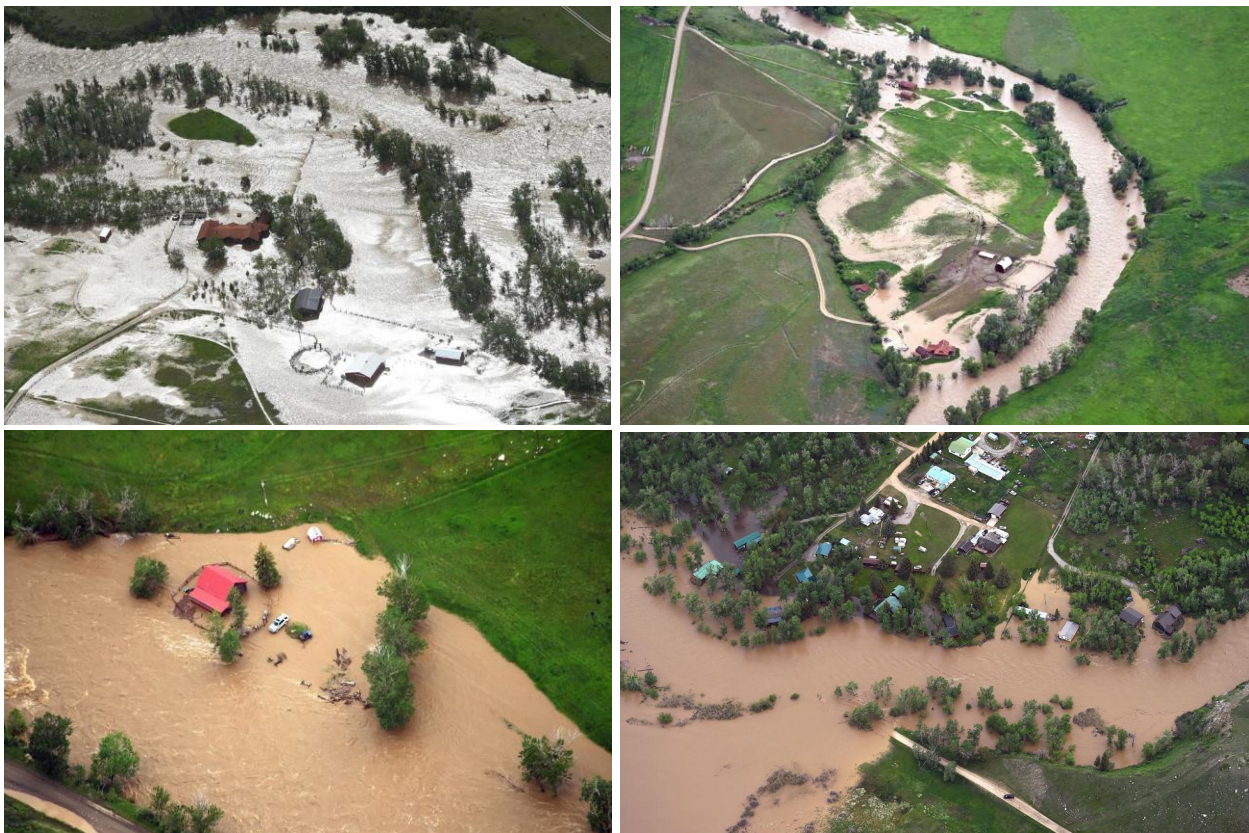
Figure 3.113: Aerial Images of the Stillwater River around Nye. Picture Credit: Larry Mayer, Source: https://billingsgazette.com/news/local/photos-aerials-of-stillwater-and-boulder-river-flooding/collection_9a55b73c-eb65-11ec-a418-237d88c84135.html#2

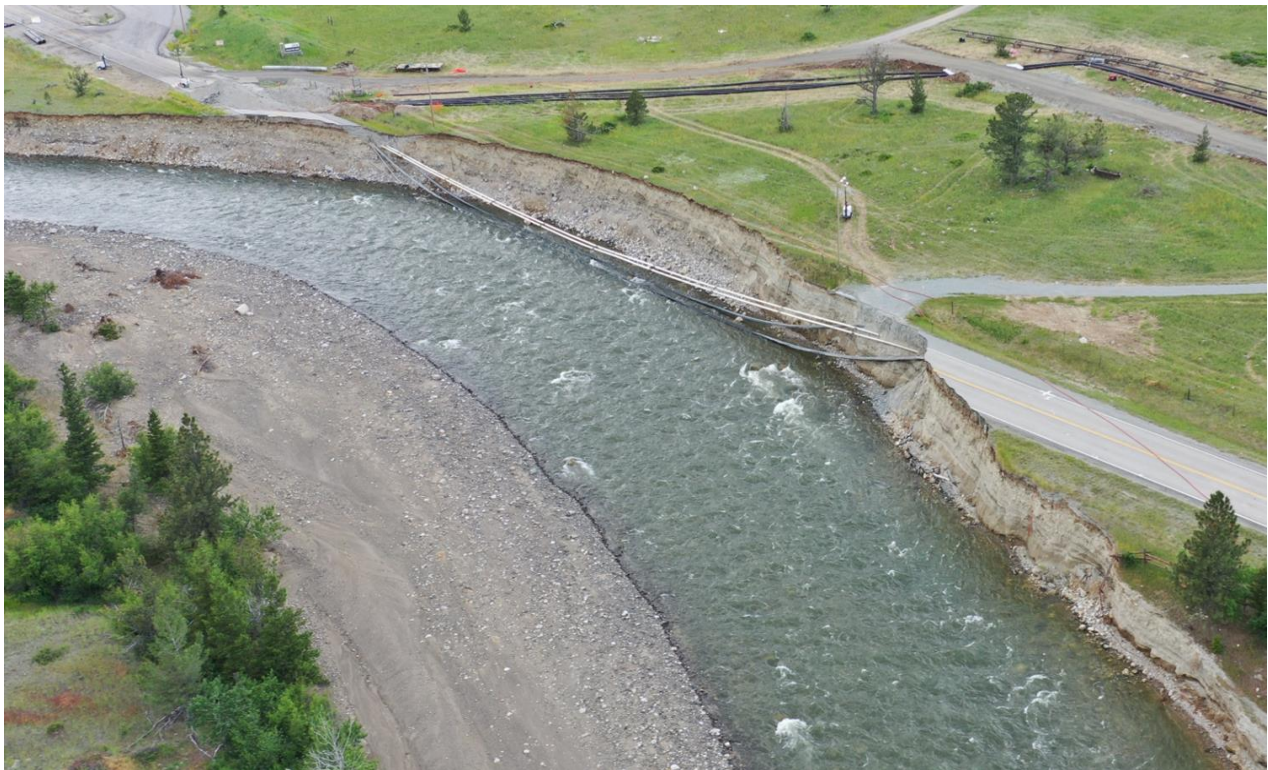
Figure 3.114: Major erosion immediately below the Mountain View Mine on the Stillwater River. Approximately 300-m of road has scoured away, with a scarp approximately 20-m high. Ductile utility lines can be seen suspended above the river. The historic channel appears on the left as a gravel beach (45.39317N, 109.87111 W).

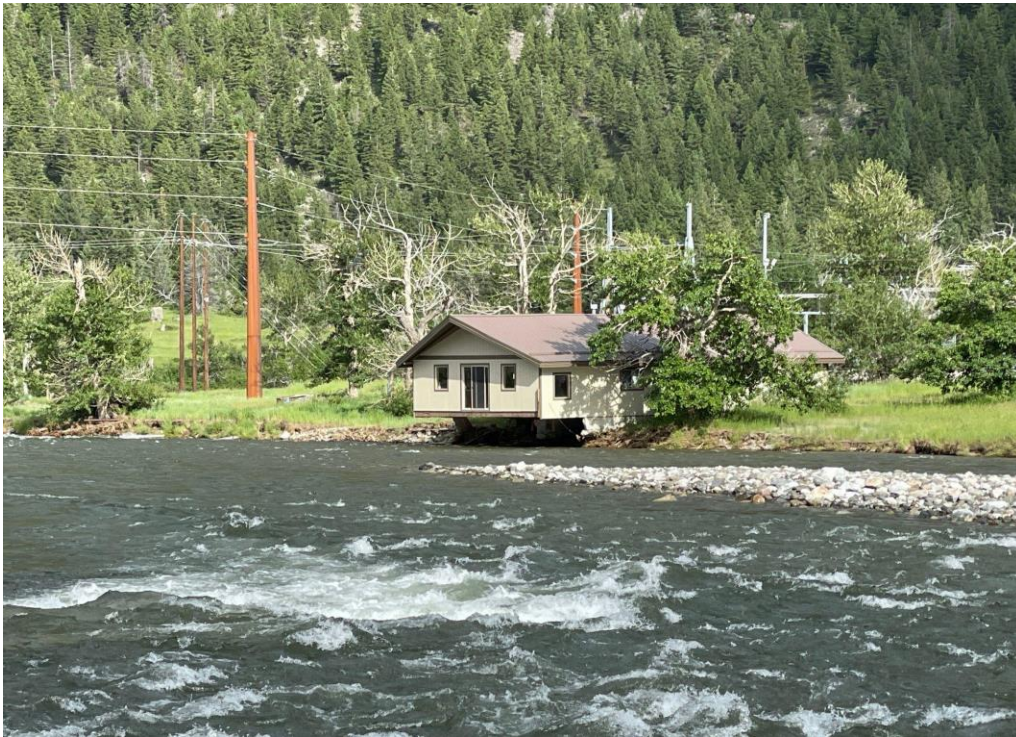
Figure 3.116: House on the Stillwater River to the North of the Mountain View Mine cantilevering over the new channel. Two identical buildings to the left have been swept away. (45.396N, 109.864W)

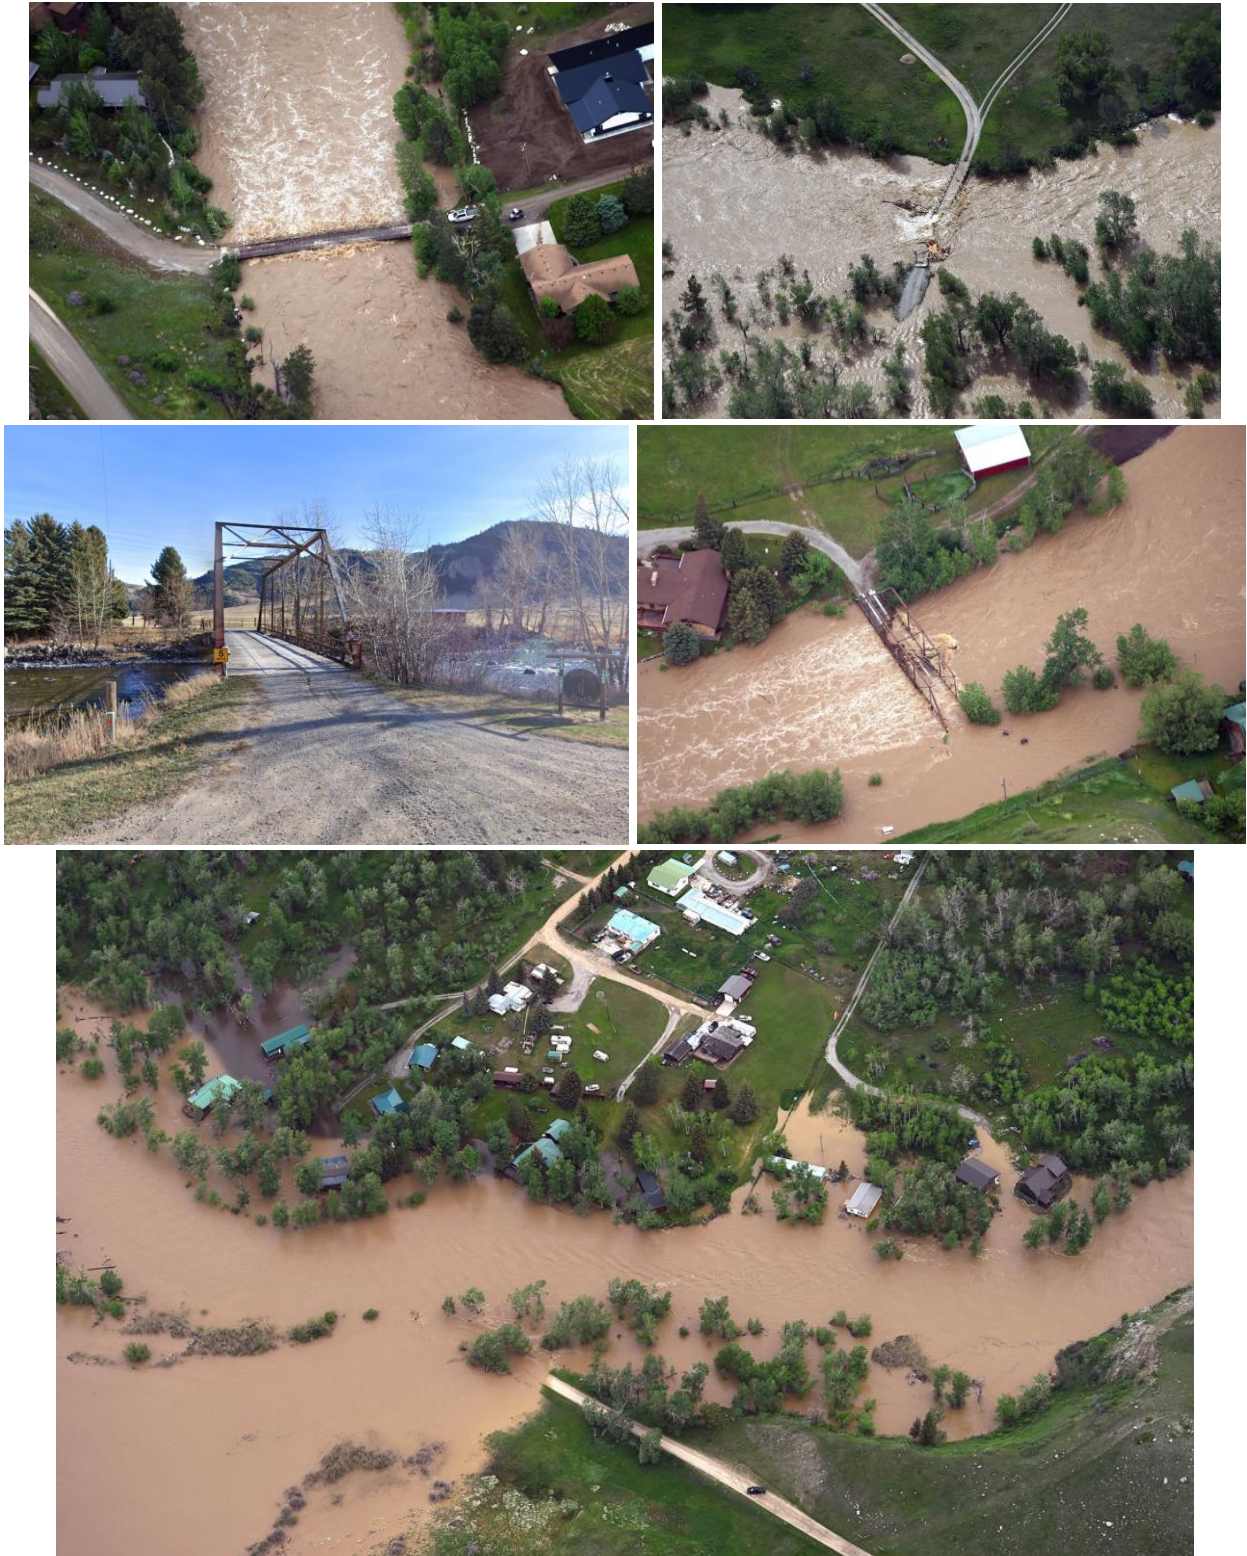
Figure 3.117: Bridge damage along the Stillwater River near Nye, photo Sources: https://billingsgazette.com/news/local/photos-aerials-of-stillwater-and-boulder-river-flooding/collection_9a55b73c-eb65-11ec-a418-237d88c84135.html#2

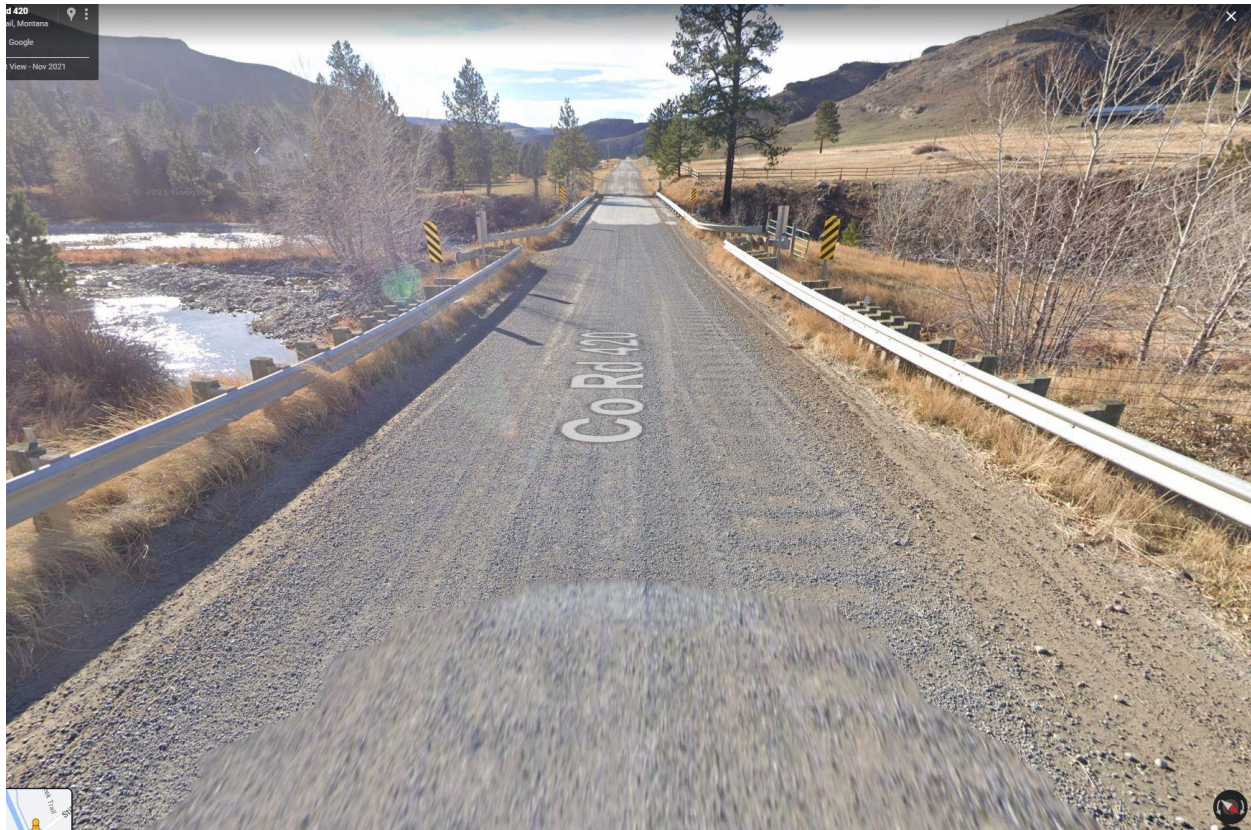
Figure 3.118: Stillwater Rd Bridge along County Rd 420, across the Stillwater River prior to the flood event. Image obtained from Google Street view.

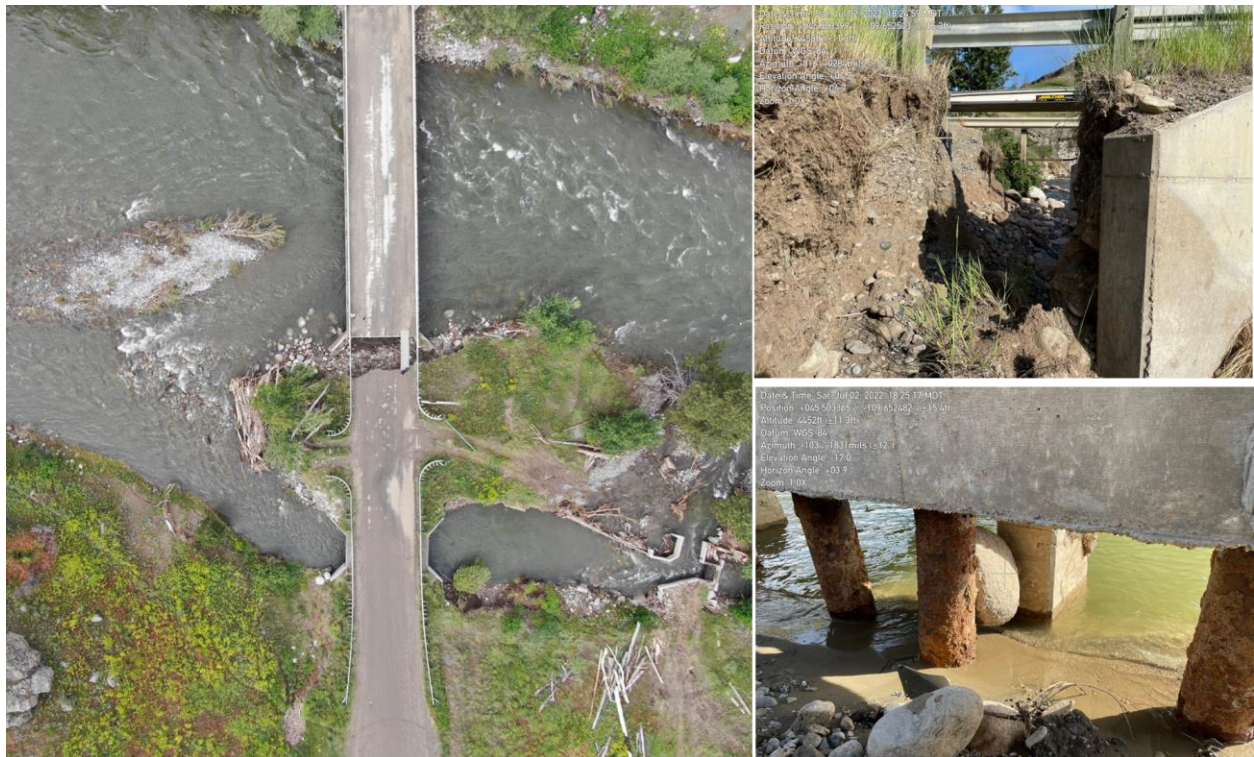
Figure 3.119: The Beehive Bridge on the Stillwater River showing the washed-out north abutment (45.5033376, -109.6524668).

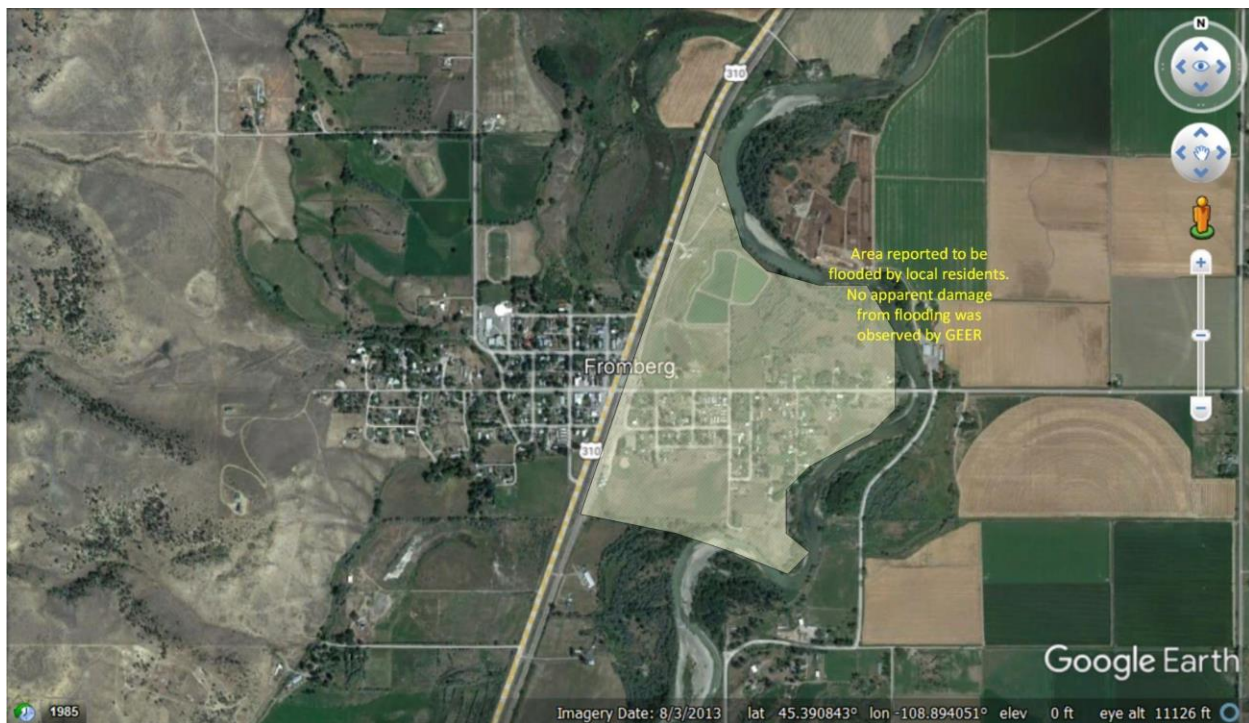
Figure 3.121: Satellite image of Fromberg identifying the area that was flooded according to local eyewitness accounts. No apparent evidence of flooding was observed by the GEER Team during our visit
